NOBLE PROPERTY INSPECTION REPORT

12708 28th St
Santa Fe, TX 77510

PROPERTY INSPECTION REPORT FORM

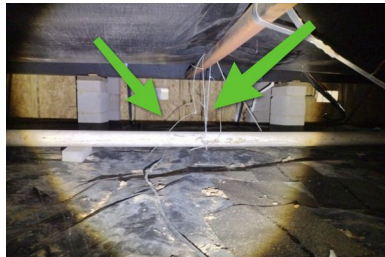
Back Middle

Areas of support under the home in the crawlspace are getting wet. These areas are wet due to seepage and infiltration of rain water to the substructure. Some substructure elements do not appear to be built of treated

lumber and some lumber is sitting on the ground. Lumber not rated for ground contact can attract termites and will rot quickly. General moisture under the home and on the backside of the siding material is considered a deficiency of the installation. Shotty craftsmanship and incorrect materials will lead to elevated deterioration of the skirting.

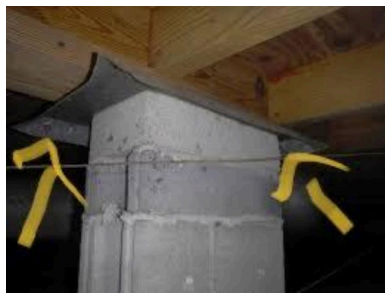
Piers missing termite blocks :
Termite blocks not present at the time of inspection.

Termite blocks not present

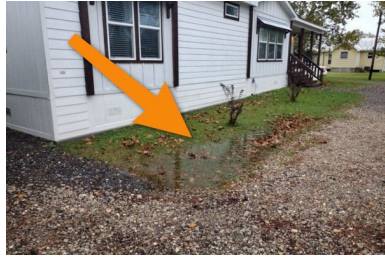
Front Left

Standing water observed, which could indicate poor drainage and/or grading. Recommend monitor and/or have landscaper correct.

Recommendation: Contact a qualified landscaping contractor

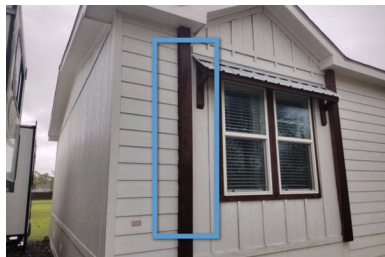
Front Left

1: Caulking deteriorated and/or missing

Caulking is necessary to seal gaps less than 1/2-inch. Caulking that is missing can provide for water penetration and allow insect access into the structure.

Recommendation: Contact a qualified general contractor.

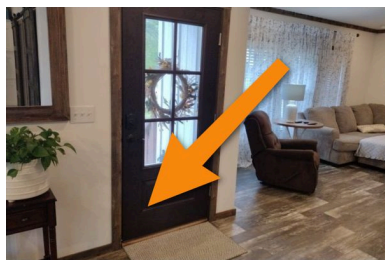
Front

One or more gaps could result in energy loss. Recommend handyman or door contractor evaluate.

Recommendation: Contact a qualified door repair/installation contractor.

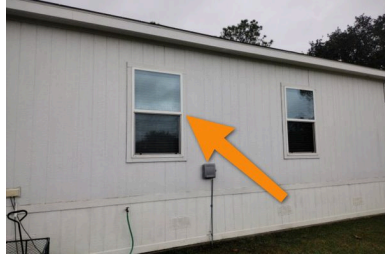
Back Middle

1: Window seal is broken

Double pane windows appear to have broken seals between the glass panes. This is indicated by moisture present between the panes or the seal being visibly ruptured (cracked, torn, or squeezed out). If windows were argon gas-filled, the gas is likely gone. The efficiency of the window is compromised.

Recommendation: Contact a qualified window repair/installation contractor.

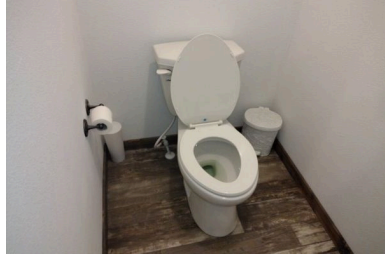
Primary Bathroom

The toilet caulking is missing and/or the caulking has deteriorated and is considered damaged. Recommend a plumber re-caulk the toilet.

Recommendation: Contact a qualified plumbing contractor.

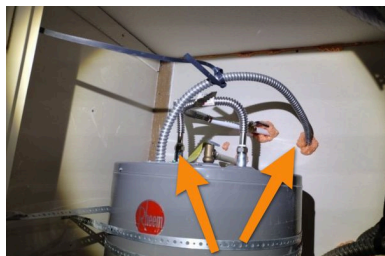
Laundry

The water heater has no electrical disconnect. This is important because it would allow a person to directly disconnect the power to the water heater in the event of an emergency. Recommend hiring an electrical contractor to install a disconnect.

Recommendation: Contact a qualified electrical contractor.

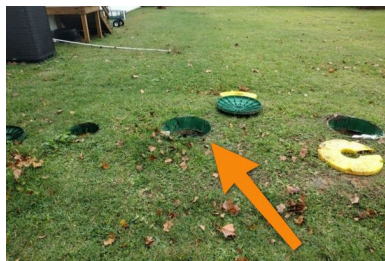
Back Right

1: Bleach tablet container empty

No 3-inch bleach tablets were found in the container. Bleach tablets slowly dissolve into the pump tank to provide treatment prior to pumping to the drip/spray field. Recommend adding tablets. Note: pool bleach tablets are not the same as septic bleach and should not be used as a substitute.

Recommendation: Contact a qualified contact a professional or do it yourself

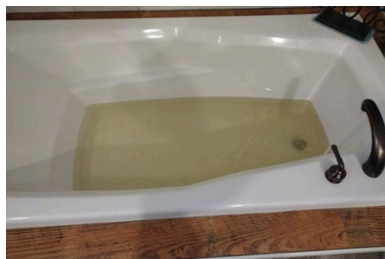
Primary Bathroom

Water color is unfavorable. Water well color and odor can be an indication that the water well source is contaminated, treatable and/or not treatable. In most cases however, water color and/or odor may be a characteristic of the aquifer. Some water wells produce water that is less clear than others. It is recommended that the water be treated, at a minimum, for high bacteria (BacT) levels to indicate a well contamination of chloroform or E. coli. Other tests to determine if the water is consumable may be chosen.

Recommendation: Contact a qualified professional.
