FRANCIS HOME INSPECTIONS, PLLC TREC #24926

PROPERTY INSPECTION REPORT FORM

Ali Hamade <i>Name of Client</i>	05/08/2026 1:00 pm <i>Date of Inspection</i>
3906 Beggs St, Houston, TX 77009 <i>Address of Inspected Property</i>	
David Francis <i>Name of Inspector</i>	24926 <i>TREC License #</i>
<i>Name of Sponsor (if applicable)</i>	<i>TREC License #</i>

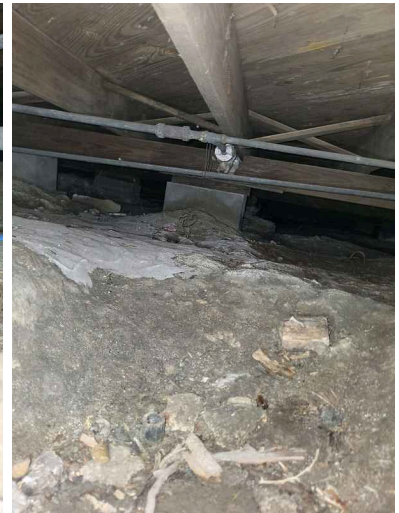
1: Missing Vapor Barrier (Moisture Retarder)

A vapor barrier (moisture retarder) was not observed on the exposed soil in the vented crawlspace at the time of inspection. Vapor barriers help reduce ground moisture migration into the crawlspace, which can contribute to elevated humidity, condensation, mold-like growth, and wood deterioration/rot. *IRC Section R408* generally requires a Class I or II vapor retarder in vented crawlspaces to cover exposed earth.

It is recommended to have a qualified contractor install a properly fitted vapor barrier over the exposed soil in accordance with current standards and local requirements, and monitor the crawlspace for moisture-related conditions.

Recommendation: Contact a qualified professional.

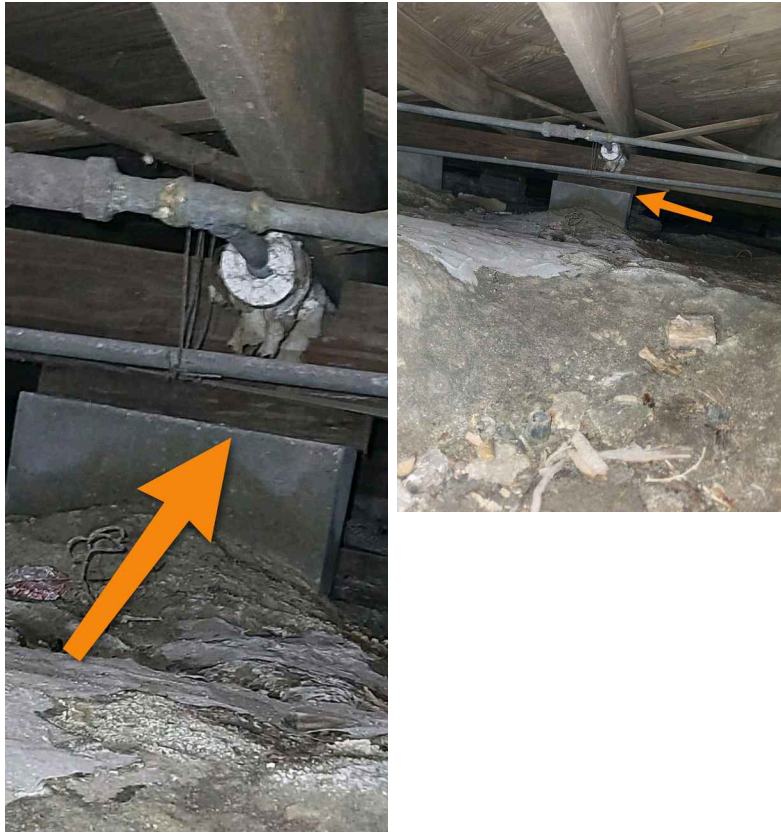
2: Missing Termite Shield Flashing – Block and Beam Foundation

The block and beam foundation was observed to be missing termite shield flashing. Termite shields are typically installed to help deter concealed termite entry between foundation piers and wooden structural components. While not always required, their absence may increase the risk of undetected wood-destroying insect activity.

We recommend evaluation by a licensed pest control professional and implementation of preventative measures as needed.

Recommendation: Contact a qualified pest control specialist.

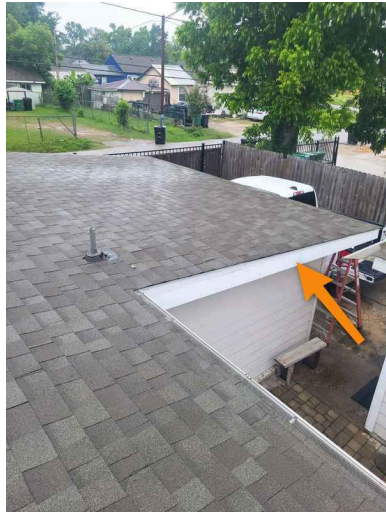
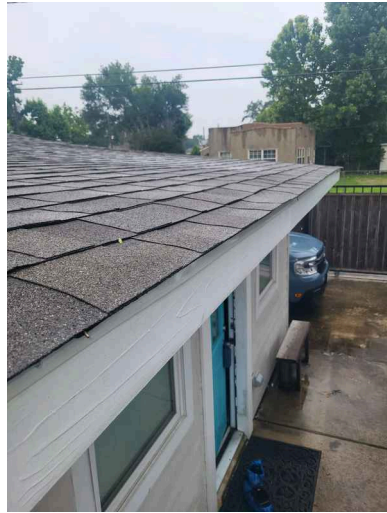
1: Improper Coverings

A section of the flat roof was observed to have asphalt shingles installed. Shingles are generally not recommended for flat roofs because they are designed for steeper slopes that allow water to run off. Flat roofs have a small pitch, but it's not enough for water to drain quickly, and shingles aren't meant to sit in water. This can cause water to pool on the shingles, which can shorten their lifespan and lead to leaks.

It is recommended to have a qualified roofing contractor evaluate the current roofing material and consider replacing the shingles with an appropriate flat roofing system. Options may include modified bitumen, TPO (Thermoplastic Olefin), EPDM (Ethylene Propylene Diene Monomer), or other materials specifically designed for flat roofs.

Recommendation: Contact a qualified roofing professional.

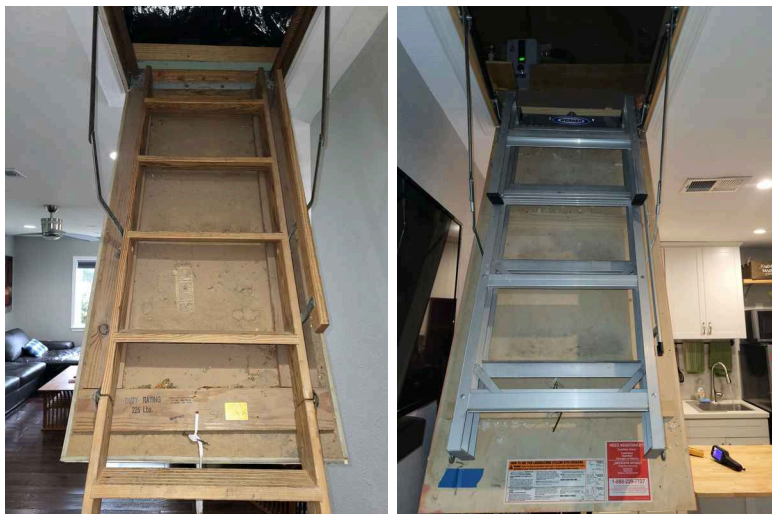
1: MISSING INSULATION-ATTIC STAIRWAY

Observed missing insulation on attic stairway. The absence of insulation on the attic access door can lead to significant heat loss, particularly during the winter months. This can result in higher energy bills and discomfort in the living space below.

Recommendation: Contact a handyman or DIY project

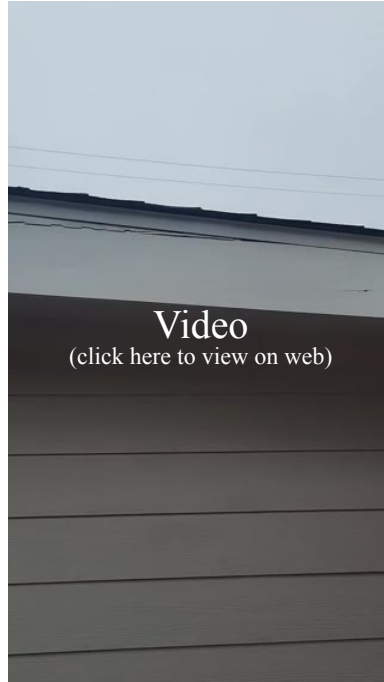
Back of home

1: MISSING/DETERIORATING CAULK

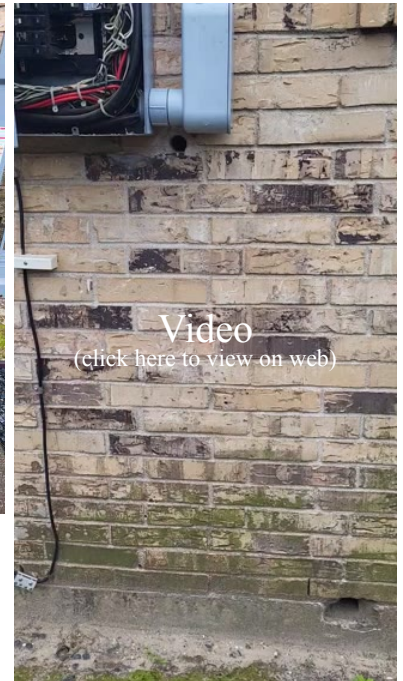
Left side of home

2: UNSEALED PENETRATION OPENING

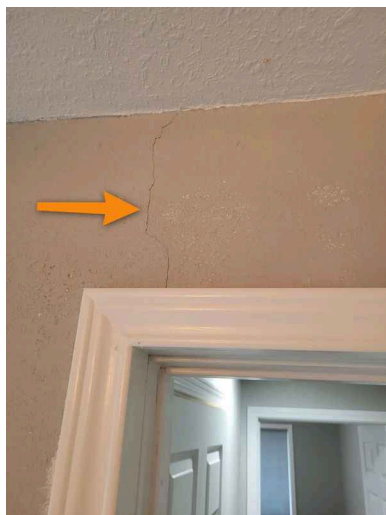
Bedroom 3

3: Settlement Cracks

Settlement cracks were observed in the drywall above one or more windows and doors. These types of cracks are common in older homes and are often due to normal settling of the structure over time. While they do not appear to indicate active structural movement at the time of inspection, recommend monitoring for any changes and consulting a qualified contractor if the cracks widen or additional movement is suspected.

Recommendation: Contact a qualified drywall contractor.

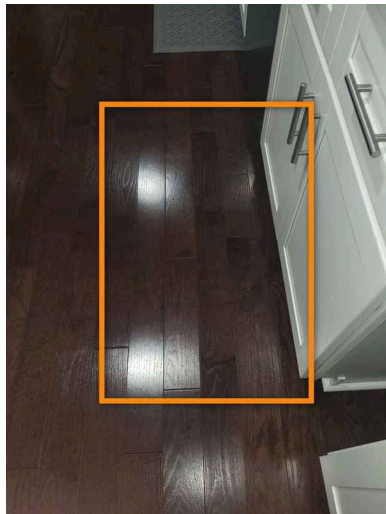
Kitchen

2: Soft spot in floor

It is recommended to consult with a qualified professional, or a licensed contractor experienced in flooring issues to further evaluate.

Recommendation: Contact a qualified flooring contractor

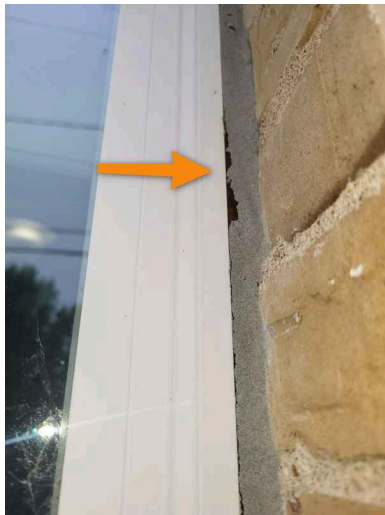
Left side of home

2: CAULKING AROUND INTERIOR/EXTERIOR WINDOWS

Action to replace the caulk by a qualified professional is recommended to prevent moisture intrusion and ensure the integrity of the windows within the property

Recommendation: Contact a qualified professional.

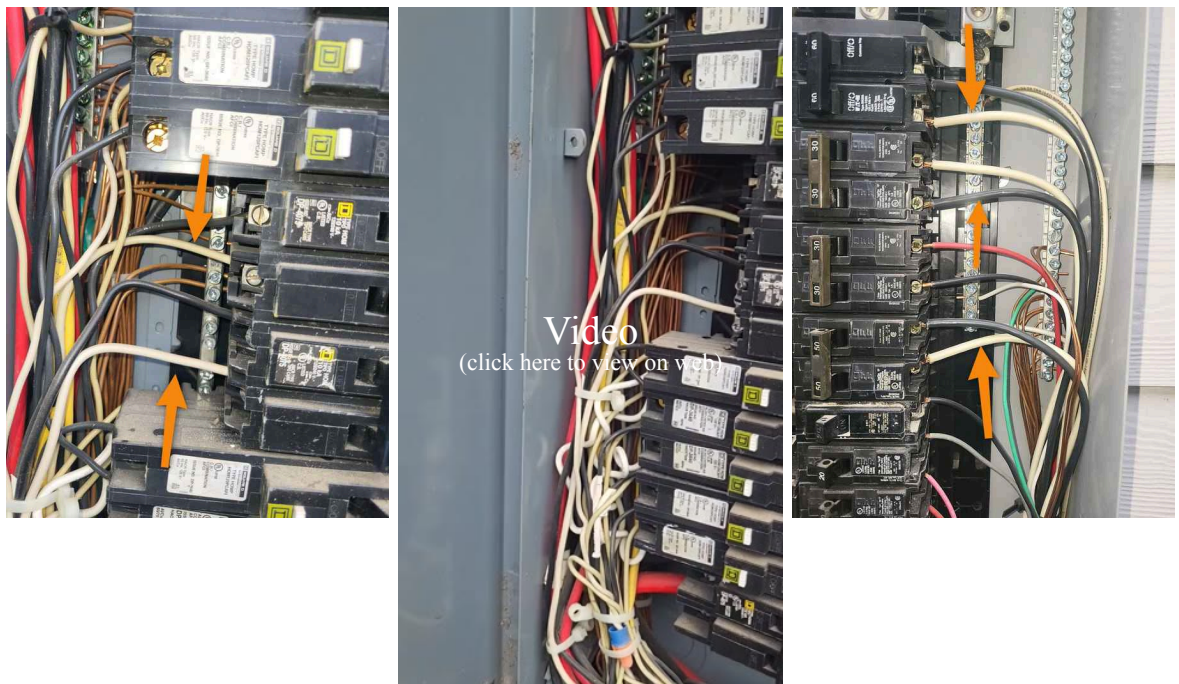
Observed white conductor wire without identifier marking label. White wires are typically used for neutrals but when used on breakers that are not GFCI/AFCI breakers they must be identified with black electrical tape to identify them as hot.

Recommendation: Contact a qualified electrical contractor.

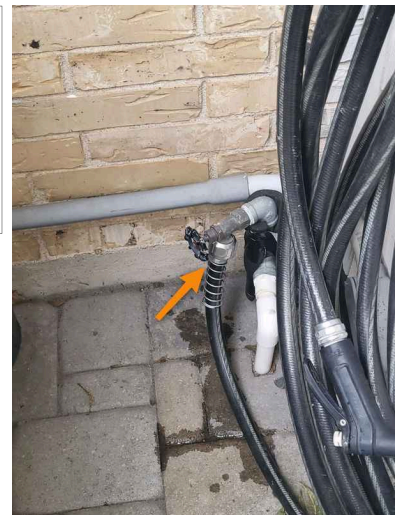
Exterior Hosebib

Backflow is the reversal of the normal and intended direction of water flow in a water system. Devices and assemblies known as backflow preventers are installed to prevent backflow, which can contaminate potable water supplies.

Recommendation: Contact a qualified professional.

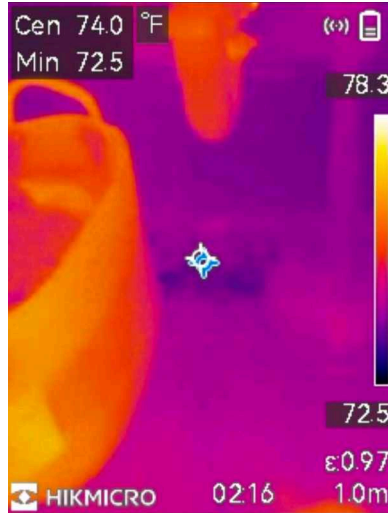
Garage apartment

2: Sink leaking

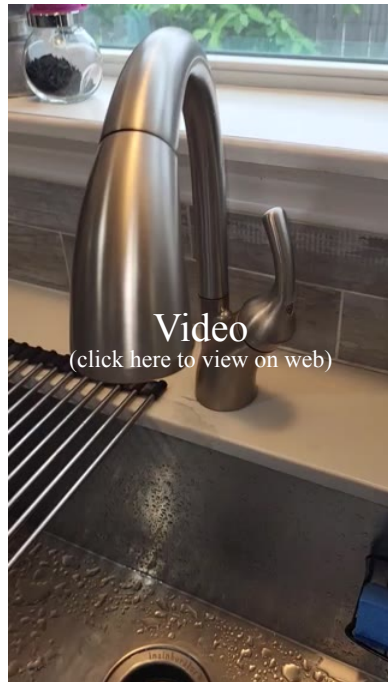
Kitchen

3: Low water pressure at fixture
