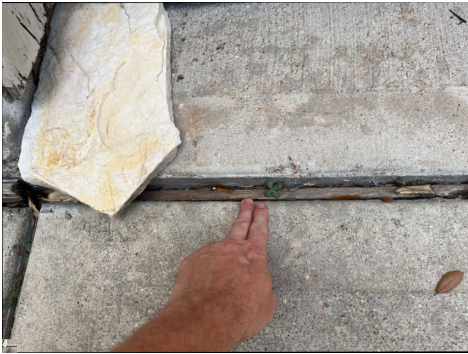
Wood form boards were left in place and were in contact with the foundation. We recommend having them removed to prevent creating conducive conditions for wood destroying insect activity. This was noted on the front, rear, left.

Driveway/walk to foundation: Remove wood boards, Monitor area for insect activity

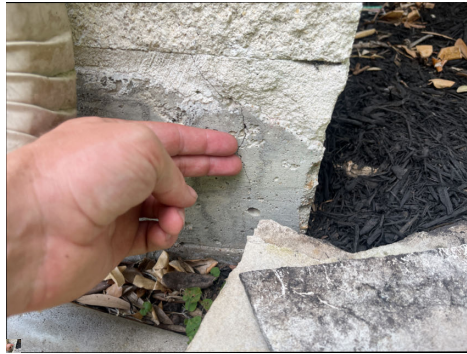
Corner cracks were noted on one or more corners of the foundation. Corner cracks are generally caused by the early removal of form boards and/or improper flashing installation between the slab and the brick veneer/stone veneer. No structural defect was noted with this condition. We recommend having these cracks patched/sealed to minimize the opportunity of insect infestation. This was observed on the front

Left front: Corner crack

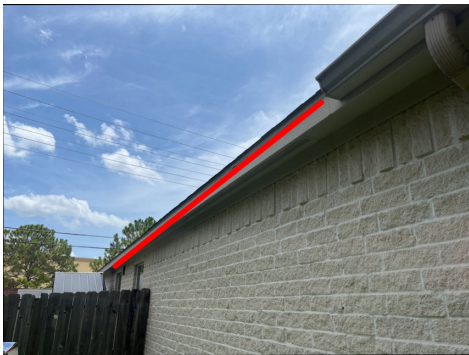
Incomplete gutter system

RECOMMENDATION: This structure had an incomplete gutter system. We recommend gutters to be used under all roof sides to redirect water from the roof to the downspouts and extensions 5 feet away from the foundation.

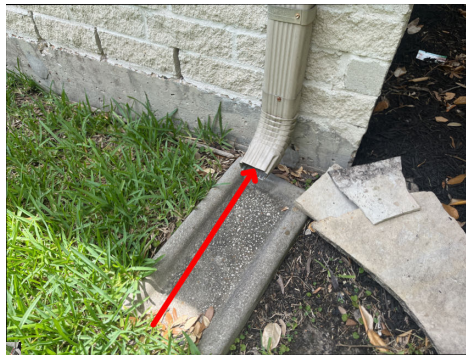
Downspout extension missing, discharge near structure

One or more downspouts were discharging too close to the foundation. We recommend having downspouts discharge water at least five (5) feet from the house. Storm water should be encouraged to flow away from the building at the point of discharge.

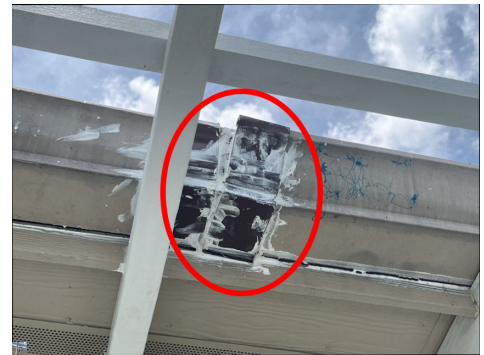
Rear: Bent/disconnected gutter

Loose, bent, or damaged gutters were noted. We recommend having these repaired.

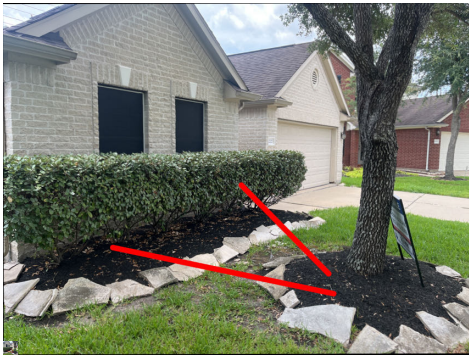
Front: Tree roots adjacent to foundation

Tree roots adjacent to the structure could have a potential of damaging the foundation. We recommend consulting with a professional, competent and qualified arborist for the best solution to protect the structure as well as the tree. These roots were located on the front.

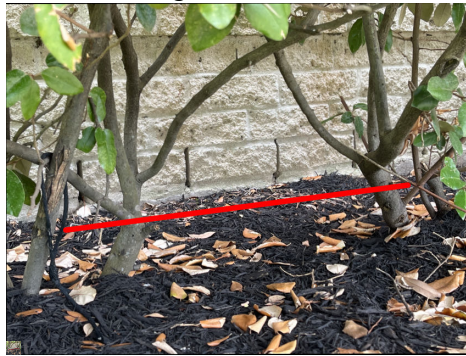
Front: High soil/mulch

High soil was observed around the structure. We recommend having 4 inches minimum clearance between soil/brick and 6 inches minimum clearance between soil/siding and/or stucco, in order to prevent moisture intrusion/damage, as well as conducive conditions for wood destroying insects and other pests. The high areas were observed on the front.

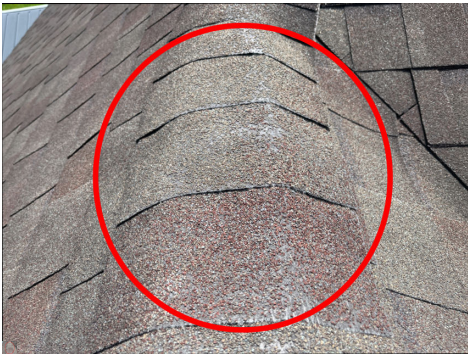
The degree of granule loss/deterioration on the shingles indicated the roofing material was nearing the end of its life cycle. Replacement will become necessary in the near future. It would be wise to budget for the replacement.

Granule loss/deterioration at ridge shingles

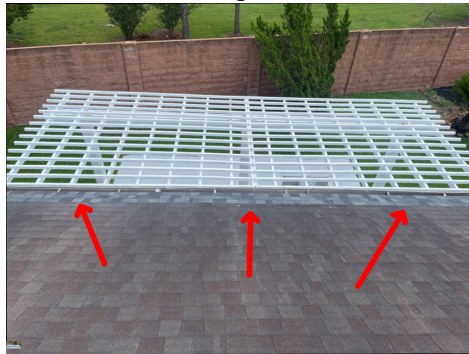
Prior repairs to the roofing were evident. This would suggest that problems have been experienced in the past. We recommend asking the sellers about any previous roof leaks and monitoring these areas.

Rear: Evidence of prior repair

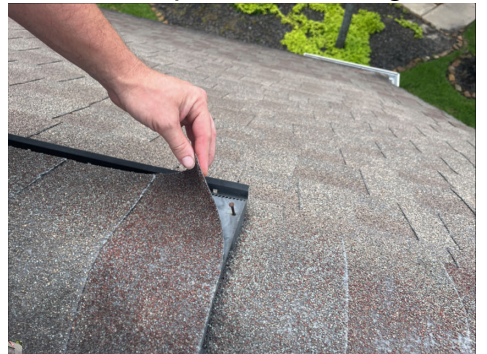
Right front ridge: Loose/uplifted shingle

Uplifted shingles were observed. We recommend having the fastener (nail) resecured and the shingles sealed down to prevent further uplift and potential damage. This was noted on the right side, and right front ridge.

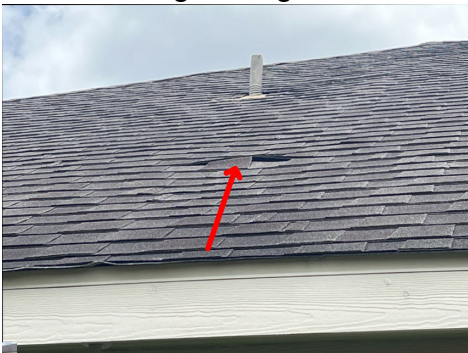
Right: Uplifted shingle

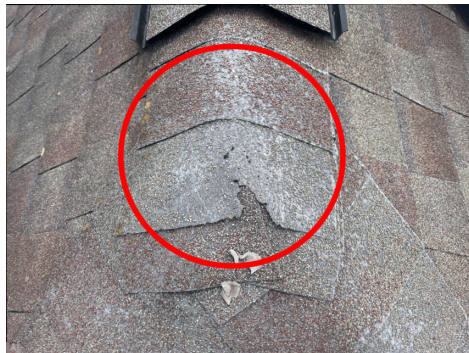
Top ridge: Damaged/deteriorated shingle

**Damaged, torn and/or missing shingles were observed on the roof. We recommend having all damaged shingles replaced to prevent further damage and water intrusion.**

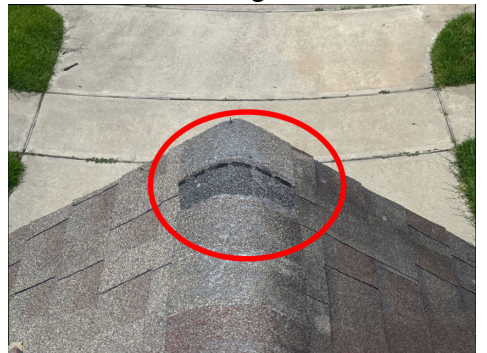
Right front ridge: Torn/damaged shingle

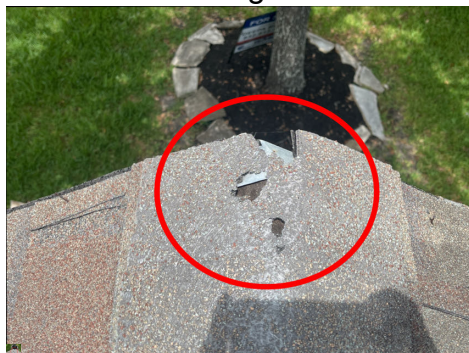
Left front: Damaged shingles with exposed roof deck/structure

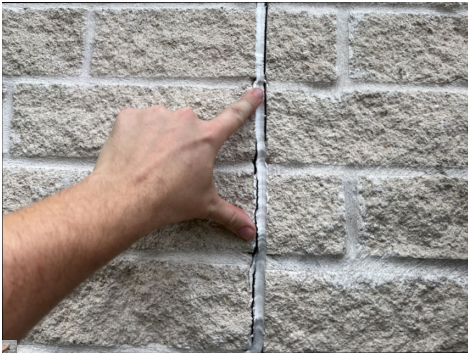
The exterior caulking in multiple areas around the house at various siding transitions, expansion joints, wall protrusions, doors, windows and other areas, was deteriorated or insufficient. Exterior caulking is the first energy efficient measure to install. This helps minimize air flow and moisture through cracks, seams, utility penetrations and openings. Controlling air infiltration is one of the most cost effective measure in modern construction practice. Good caulking and sealing will reduce dust, dirt, and prevent damage to structural elements. We recommend updating regularly.

Right: Deteriorated caulk at expansion joint

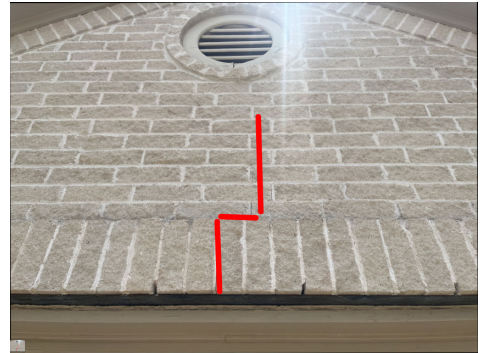
A step crack was observed on the exterior brick veneer. This typically is an indication of structural movement. We recommend patching and monitoring. This was noted on the front.

Front: Step crack

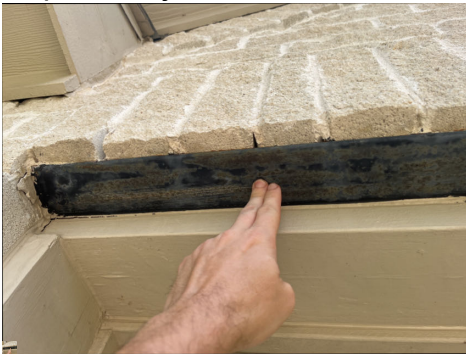
The lintels over the openings (windows/doors) were found to be rusted. These elements support the brick veneer above the openings. We recommend having them (re)ainted to prevent deterioration.

Front: Rust at lintels

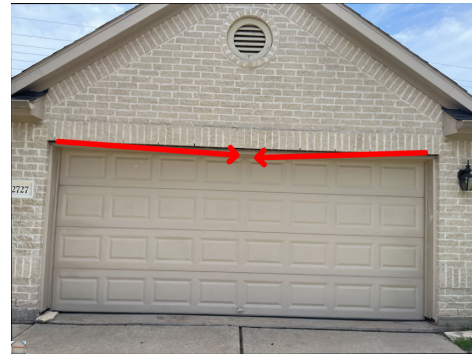
Front: Sagging header

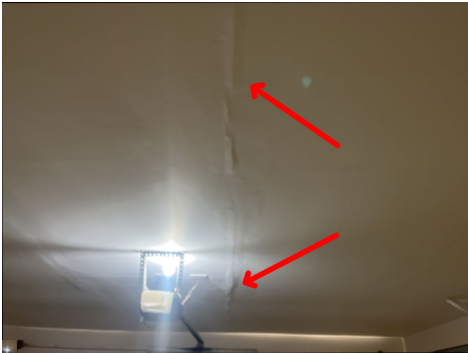
Garage: Hairline cracks/patching

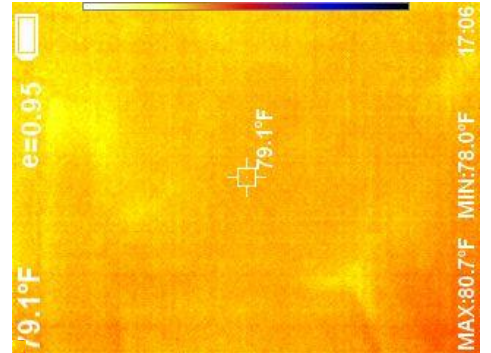
Bathroom 1: Moisture stain confirmed dry at time of inspection

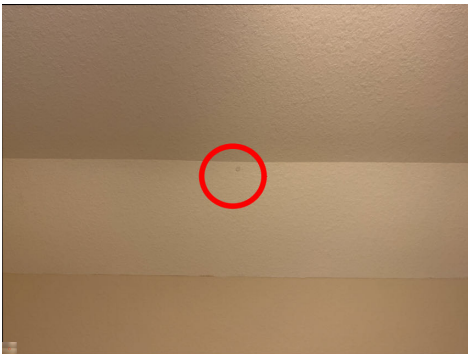
Bedroom 1: Nail pop

Nailpops, which are by nature cosmetic, were noted. We recommend these be re-secured, caulked and painted.

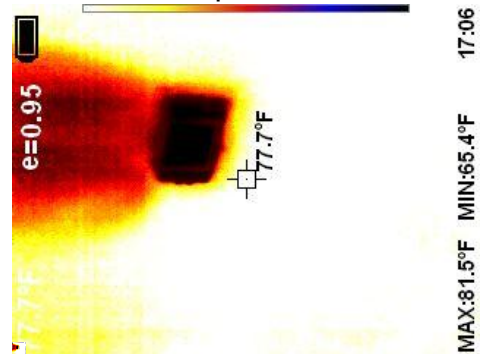
Dining room: Moisture stain confirmed dry at time of inspection

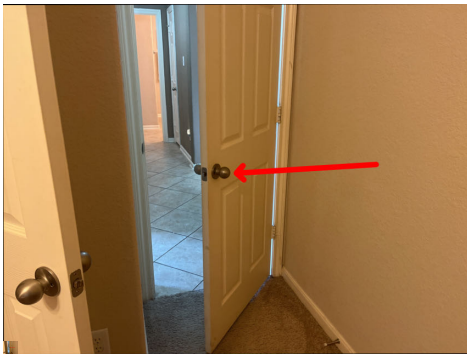
Bedroom 1: Out of plumb

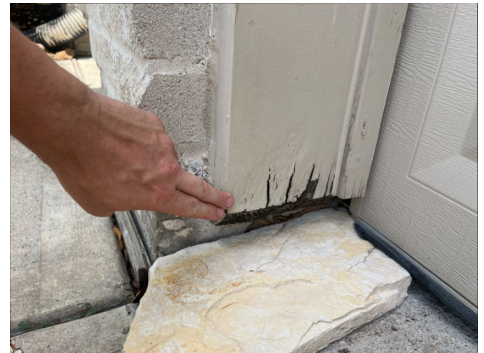
The trim at the overhead garage door showed evidence of localized rot. We recommend having this repaired to prevent further deterioration.

Garage: Wood decay at trim

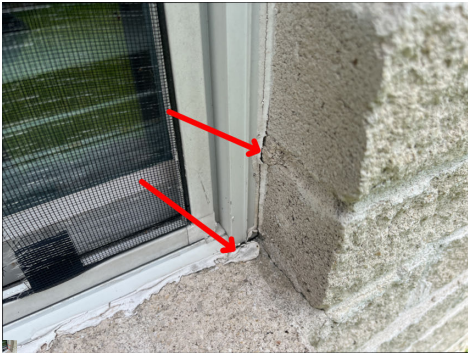
Around house: Deteriorated caulk

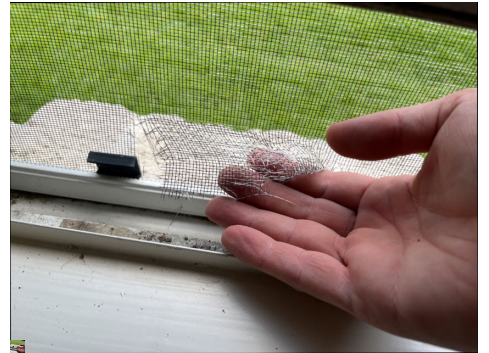
Dining room: Damaged screen

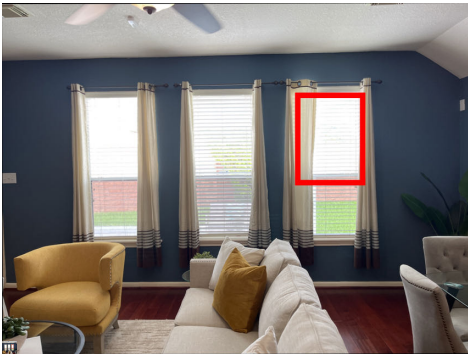
Living room: Lost seal

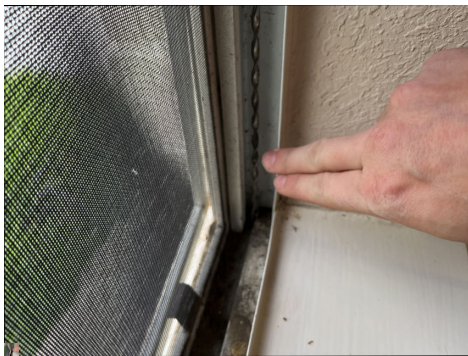
Bedroom 4: Loose spring

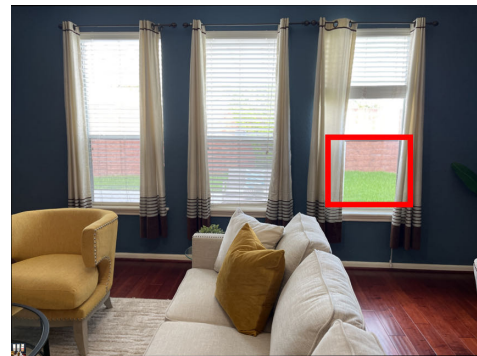
Living room: Would not stay open

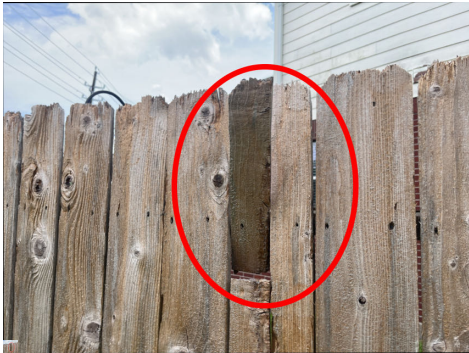
Fence: Damaged picket

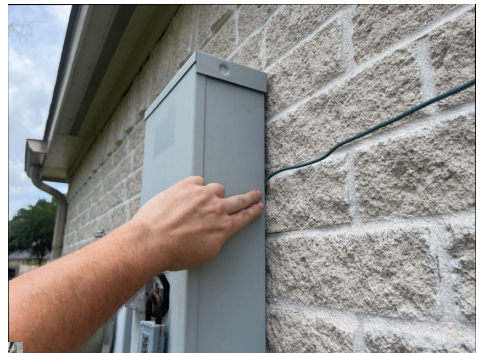
Top and side: Caulk missing at wall connection

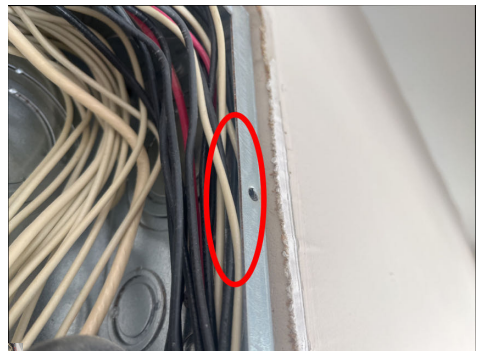
Sub panel: Missing spacer

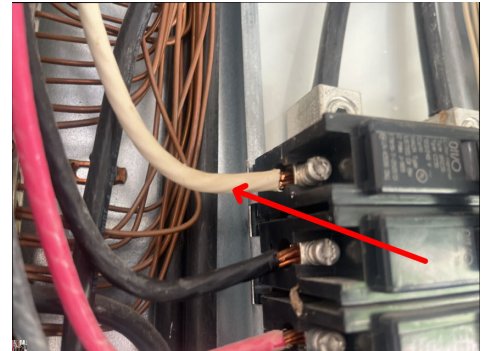
Sub panel: Improperly color coded conductor

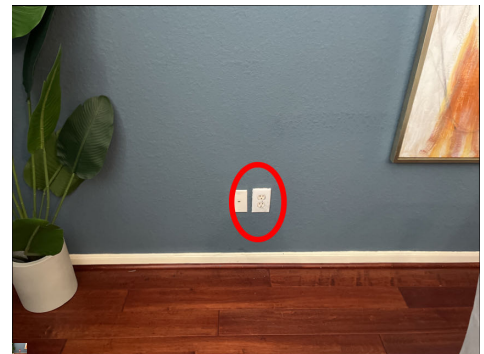
Living room: Loose outlet

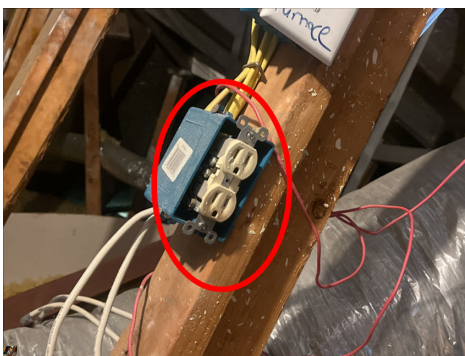
Attic: Missing cover plate

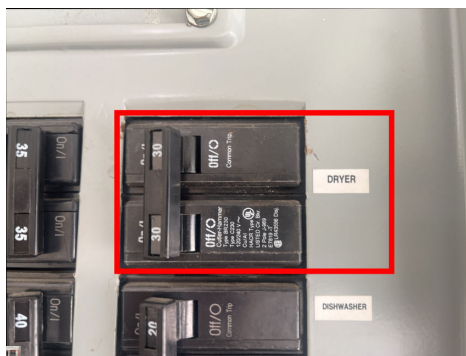
Dryer outlet: Not GFCI protected

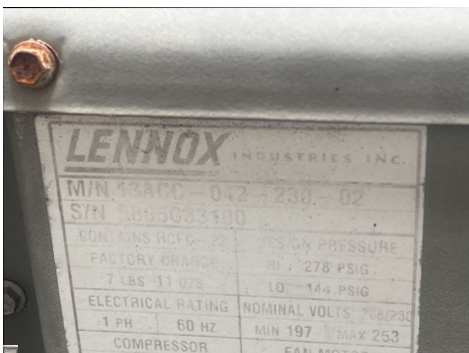
Condenser unit model and serial numbers faded

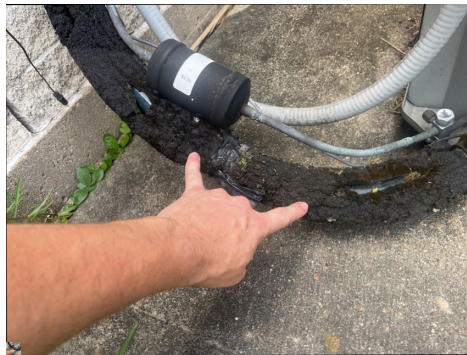
Old and deteriorated refrigerant line insulation

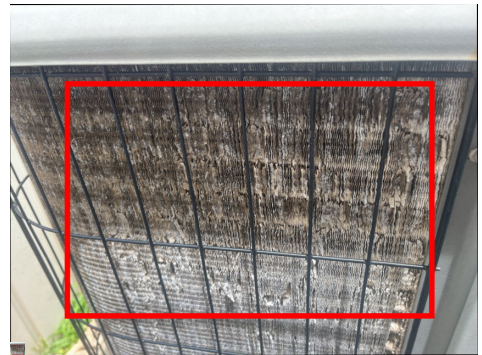
Damaged/deteriorated coil fins

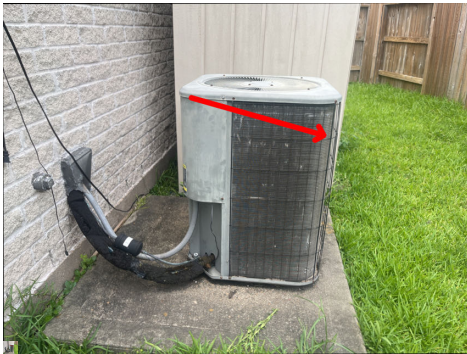
Out of level

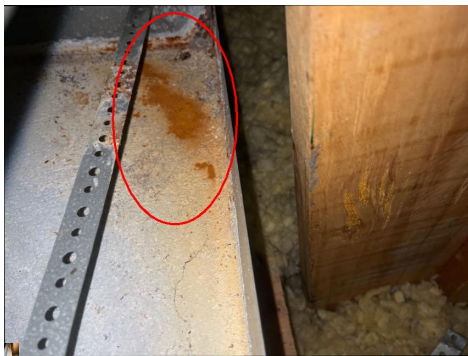
Rust in safety pan

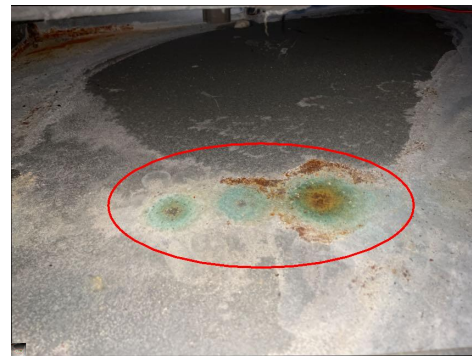
Evidence of a coolant leak was noted in the form of blue staining on the evaporator coils cabinet and/or in the safety pan. This may or may not have been repaired. We recommend having the system serviced any active coolant leaks identified and repaired.

Evidence of coolant leak

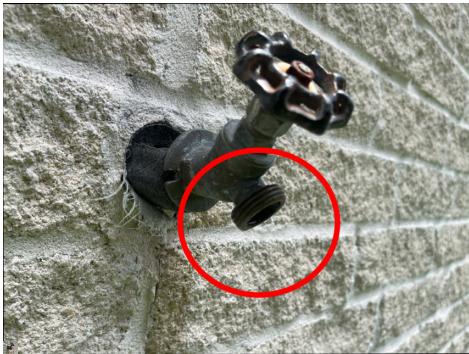
Right: Back flow preventer recommended

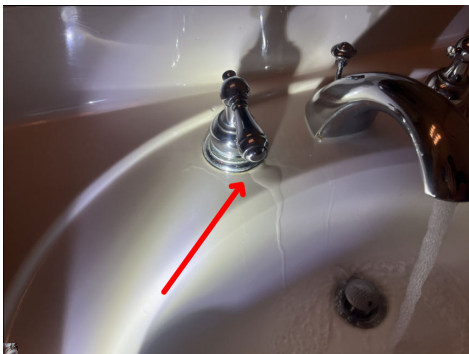
Bathroom 2: Leak at control

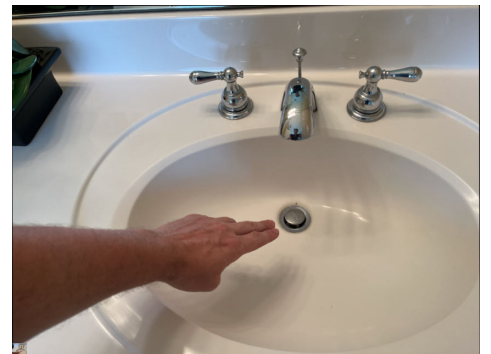
Bathroom 2: Drain stops did not retain water.

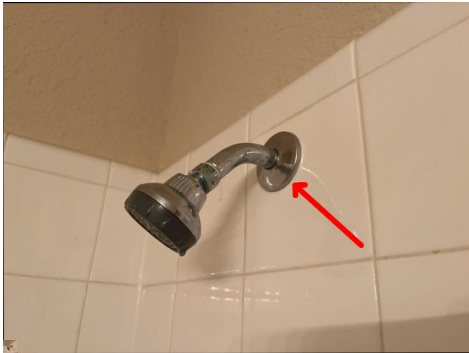
Bathrooms: Caulk needed at shower wall protrusions

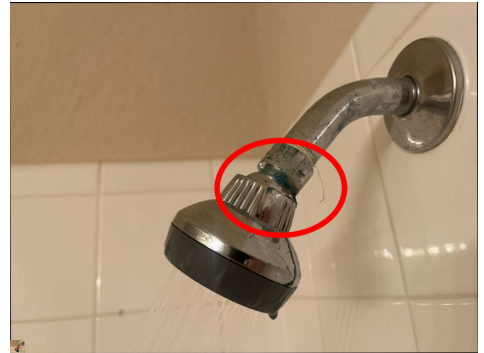
Bathroom 1: Leak at shower head

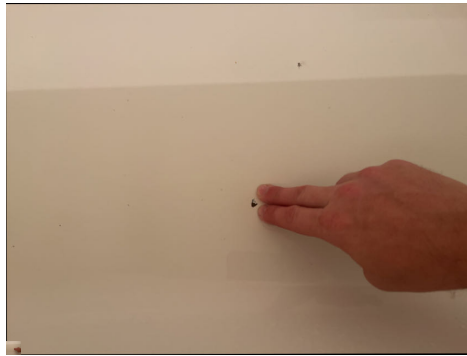
Bathroom 1: Tub damage

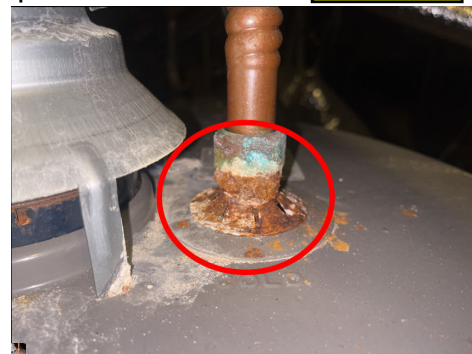
Corroded fitting

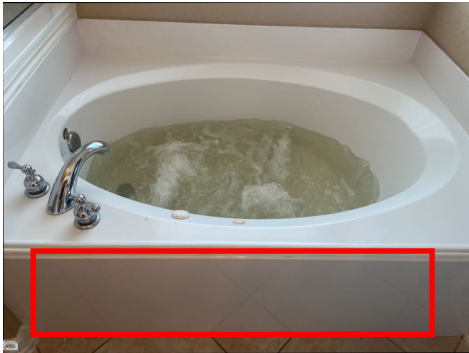
Whirlpool on with no access panel to pump/drain line

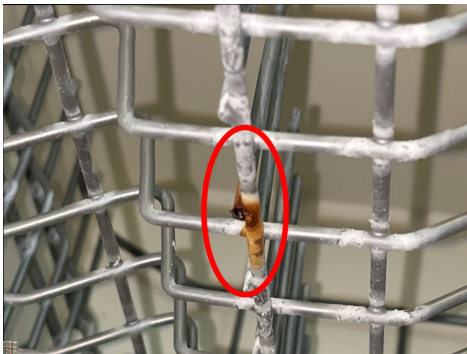
Rust on trays

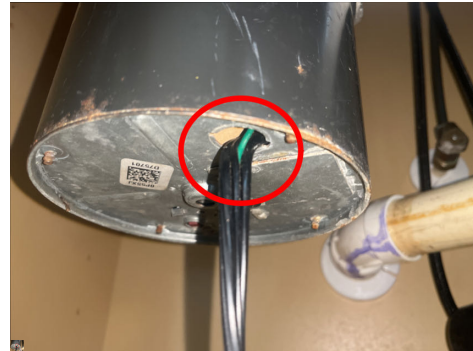
Wire clamp missing

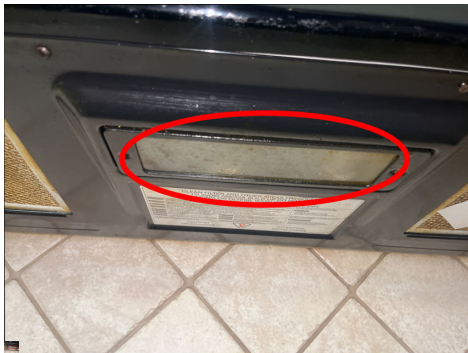
Range hood lights were inoperable at the time of the inspection. The bulb may be burned out, or there may be a problem with the switch, wiring or light fixture. If after replacing the bulb the light fixture still does not respond, the Inspector recommends correction by a qualified contractor.

Inoperative light

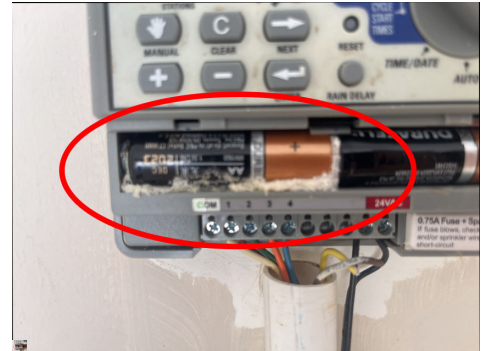
Controls: Corrosion at batteries

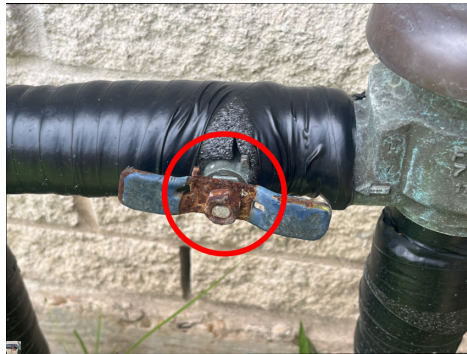
Backflow preventer: Corroded valve control

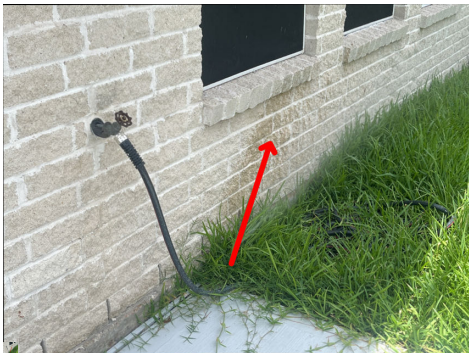
Zone 3: Sprayed structure
