## TREC REI 7-6 SUPER INSPECTOR RESIDENTIAL INSPECTION

11027 Hilltop Park Ln  
Cypress, TX 77433

# PROPERTY INSPECTION REPORT FORM

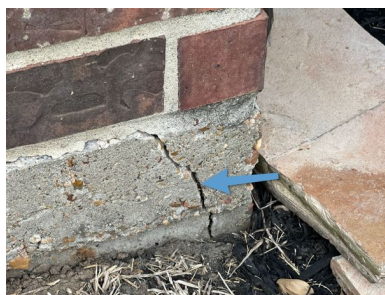
Foundation corner fracture(s) existed, which are generally the result of differential movement between the masonry walls (expanding) and the concrete foundation (shrinking). Although this condition did not appear to adversely affect the structure, sealing these cracks may be desired as they could provide hidden access for wood destroying insects. Please note that the corners should be examined periodically. If the fracturing worsens and the corner(s) break off then the brick veneer may lack proper support and repair would be needed.

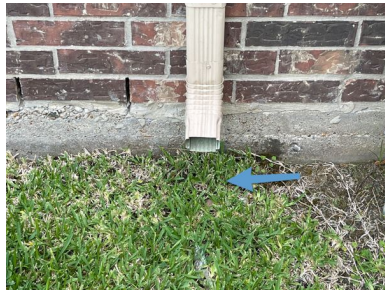
**2: No splash blocks**

There are no splash blocks at one or more gutter downspouts. Splash blocks should be installed to help direct drainage away from the foundation and to prevent soil erosion in those areas.

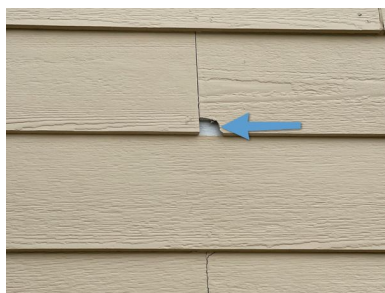
**2: Mechanical damage to exterior walls**

There is mechanical damage to the siding at one or more locations. Repair as needed.

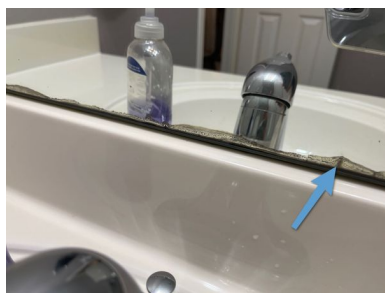
**3: Mirror Degrading**

One or more mirrors are degrading. This can happen over time as the mirror ages or with exposure to UV rays. Replace the mirror as needed.

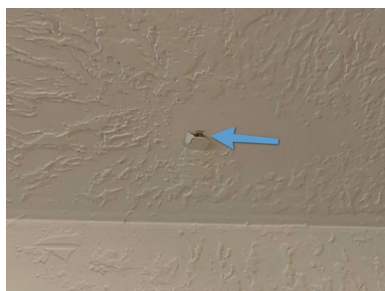
There are nails backing out of the ceilings at one or more locations. This is a common occurrence usually related to expansion and contraction of the roof rafters and/or seasonal structural movement.

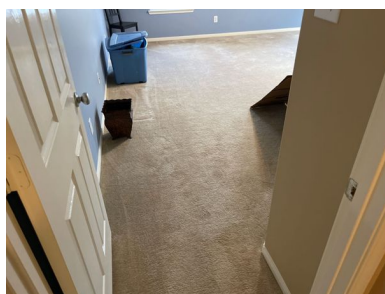
**3: Flooring Creak/Pops**

The sub flooring makes noise when walked on at one or more locations. This may indicate the sub floor is loose from the joists in those areas. This is a common occurrence this is typically addressed when the floor coverings are replaced.

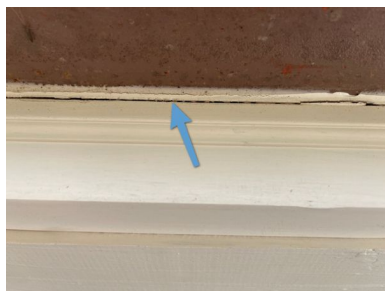
One or more exterior door frames are not sealed to the exterior wall covering. The door frames should be sealed to the exterior wall coverings to help prevent moisture and/or pest intrusion in those areas.

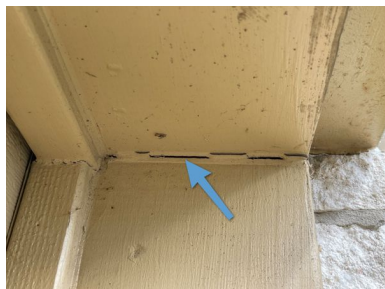
**3: Garage door- Seal caulk joint**

There are separated caulk joints at the overhead garage door casing. The joints should be sealed to help prevent moisture penetration in those areas.

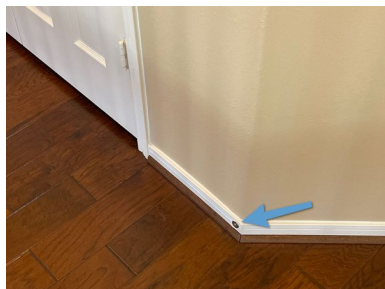
**4: Missing doorstops**

There are one or more doors without door stoppers or with non functioning door stoppers. The door stoppers should be repaired or replaced to protect walls adjacent to doors.

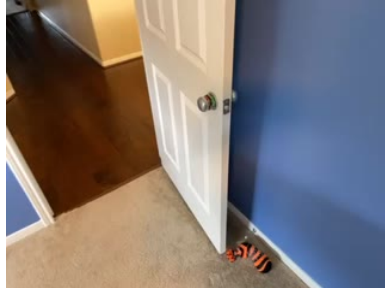
One or more door(s) swing(s) on their own when set at a partially open position. This is commonly referred to as "ghosting". This repair can be accomplished by removing a hinge pin and bending the pin slightly and then replacing the pin. This will add friction on the hinge and prevent ghosting.

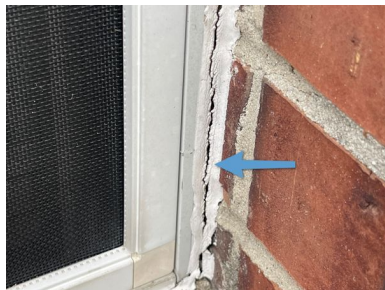
There are separated caulk joints around the exterior window frames at one or more locations. This may indicate settling and/or seasonal movement in those areas. The caulk should be touched up or replaced to exclude pests and moisture from those areas. Where deteriorating caulk is noted it should be assumed that some moisture penetration has occurred and that some hidden damage may be present.

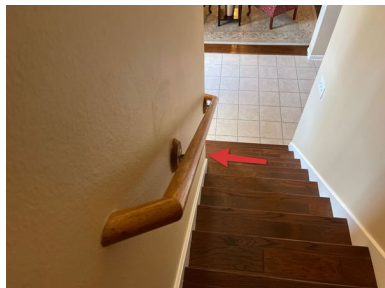
The stairway handrail is loose. This could pose a safety hazard. Recommend a qualified handyman evaluate and fasten.

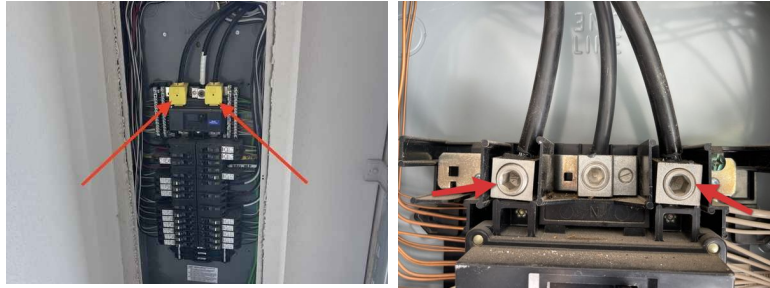
There are no terminal covers installed over the service entrance conductors. Terminal covers should be in place to protect against accidental contact with high voltage wiring. Repair is advised.

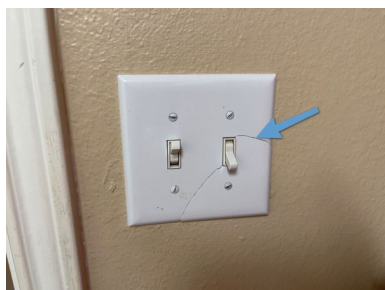
**1: Cover Plates Damaged**

One or more receptacles/switches have a damaged cover plate. Recommend replacement.

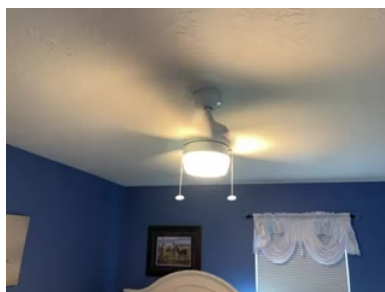
**2: Ceiling fans out of balance**

The ceiling fans are out of balance in one or more locations. Repair as required.

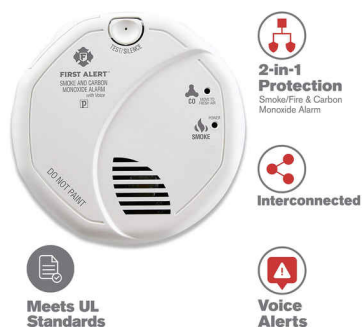
There are missing carbon monoxide alarms in the home. Carbon monoxide alarms should be installed in accordance with current standards, as follows: 2009 International Residential Code R315.2.1 New construction. Carbon monoxide alarms shall be provided in dwelling units when either or both of the following conditions exist. 1. The dwelling unit contains a fuel- fired appliance. 2. The dwelling unit has an attached garage with an opening that communicates with the dwelling unit. R315.3 Location. Carbon monoxide alarms in dwelling units shall be installed outside of each separate sleeping area in the immediate vicinity of the bedrooms. When a fuel-burning appliance is located within a bedroom or its attached bathroom, a carbon monoxide alarm shall be installed within the bedroom. Carbon monoxide is an odorless, colorless, and tasteless gas that is near impossible to identify without a proper detector. It is caused by fuels not burning completely, including wood, gasoline, coal, propane, natural gas, gasoline, and heating oil. This unburned fuel can come from anything from clothes dryers, water heaters, and ovens to ranges, a fire-burning fireplace, or a car left running in a closed garage.

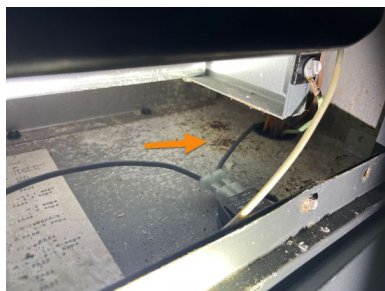
Rust was observed in the furnace housing. This may indicate a leak in the flue vent and/or condensation accumulation. Further evaluation and/or repair by a licensed HVAC technician is advised.

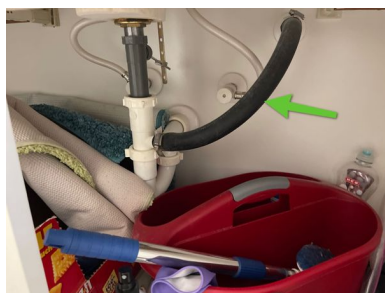
If the condensate drain line could not be located this may indicate the drain line is not properly terminated. Locating the drain line is advised.

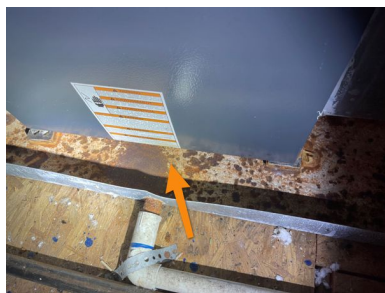
There is rust in the evaporator coil emergency condensate drain pan. This may indicate that the primary drain is clogged or that the system is under performing. Further evaluation and/or repair by a licensed HVAC technician is advised.

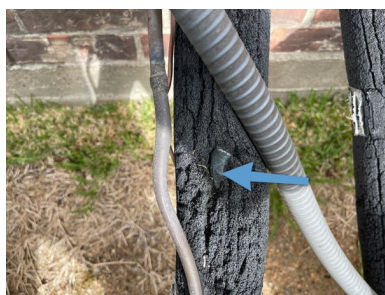
**3: Condenser suction line insulation deteriorated**

The suction line insulation is deteriorated and/or missing near the outside condensing unit. The insulation should be replaced to ensure proper operation.

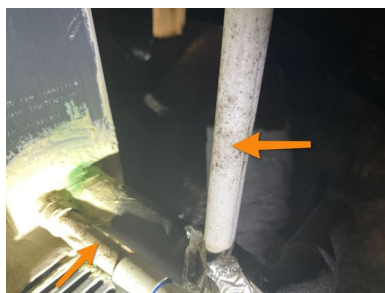
**4: Fungal growth**

Fungal growth was observed on the condensate drain pipes. The pipes should be better insulated to prevent condensation forming.

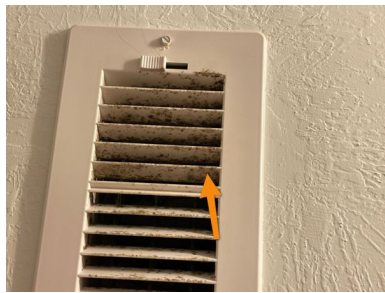
There is a buildup of grime on the air diffusers, registers, and inside the ducts. This commonly occurs when the cooling equipment is under performing or oversized and not dehumidifying the air as intended. This allows moisture to condense on duct equipment. Moisture mixes with dust and dirt creating a build up of grime. This can also result in fungal growth. The ducts and registers should be inspected and cleaned as necessary by a professional duct cleaning contractor.

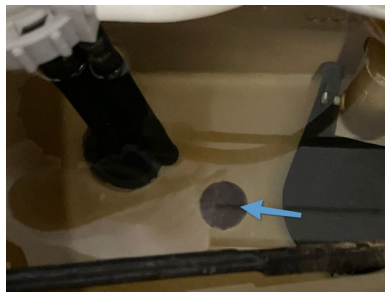
One or more toilet tank bolts are rusted. The bolts should be monitored for leaks and replaced as required.

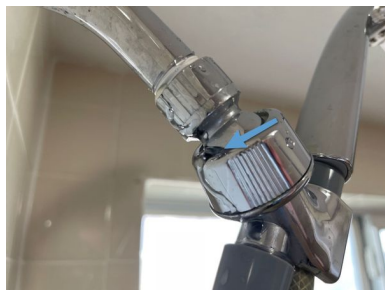
**3: Leak at shower head**

One or more shower heads leaked when tested. Repair or replace as required.

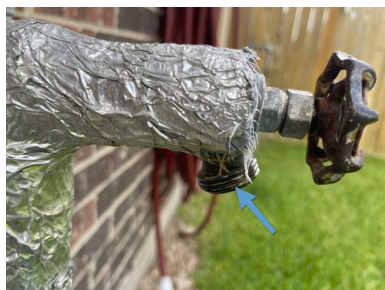
**4: Missing anti siphon**

The anti-siphon device has been removed from the exterior faucet. The fine threads for the anti siphon device will not connect to a standard water hose thread. A hose cannot be connected without installing an anti siphon device as a result. The anti-siphon device helps prevent hose water from being siphoned into the potable water supply. Replacement is advised.

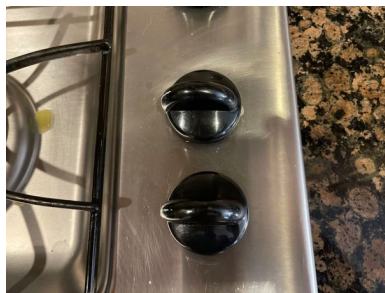
The readings are worn from the cooktop control knobs. Replace as necessary.

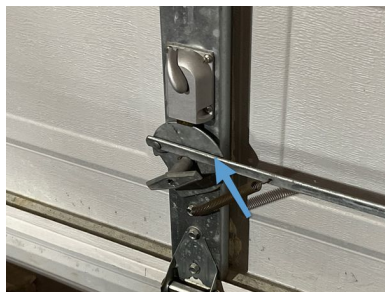
The overhead door lock should be disabled because there is an automatic garage door operator in place. This will help prevent accidentally activating the automatic opener when the door is locked, which may result in damage to the door and/or the automatic operator.

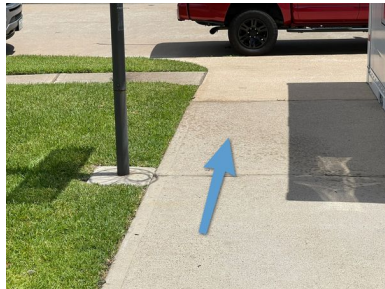
The irrigation spray heads are spraying on the sidewalk/roadways. These heads should be adjusted to prevent wasted water.

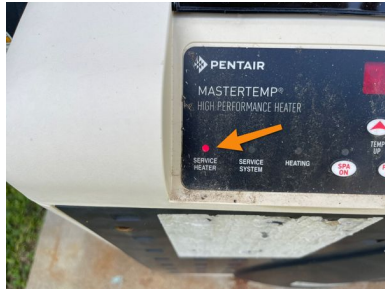
Pool heater displayed service light on the controller when activated. Further evaluation by a qualified irrigation specialist is recommended.
