# 20119 Forest Dr

# Spring, Texas 77388

| Type | <b>Home Inspection and Floor Plan Report - 20119 Forest Dr</b> |
| Inspected by | <b>HomeTeam Inspection Service - North Houston</b> |

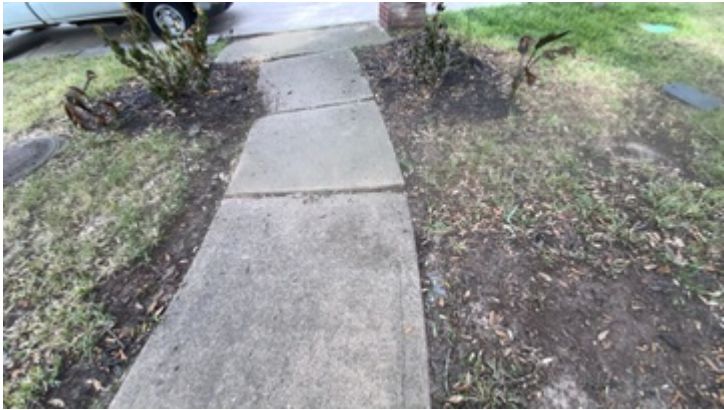
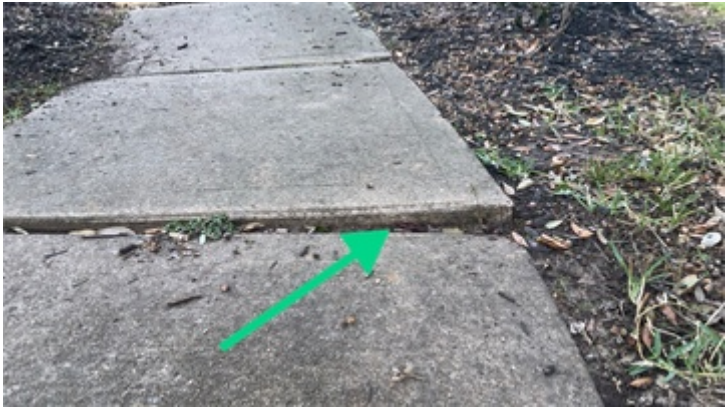
Trip Hazard

The sidewalk, patio, driveway, or walkway is unlevel.

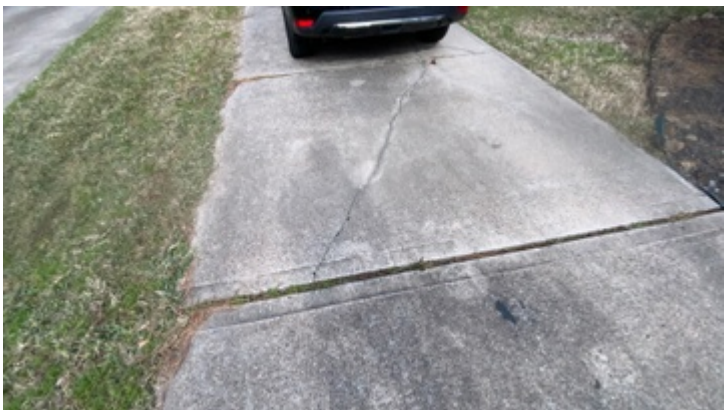
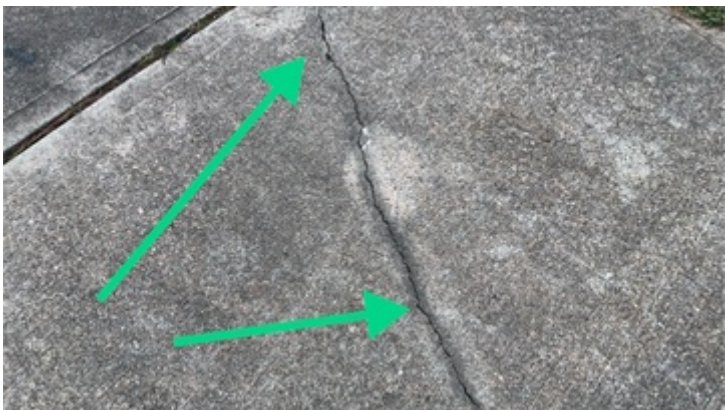
Minor Cracks in the Driveway

The driveway has minor cosmetic cracks.

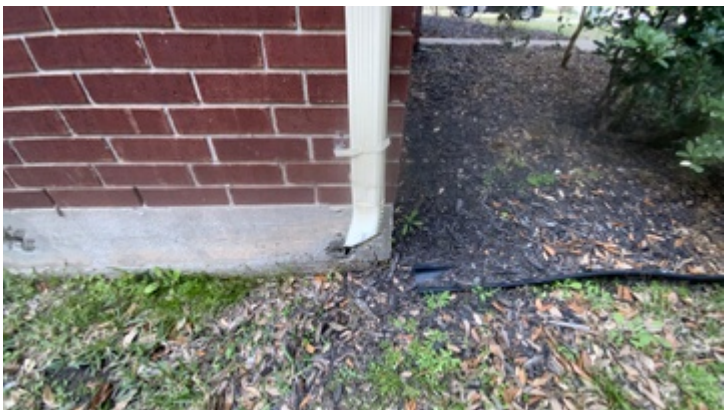
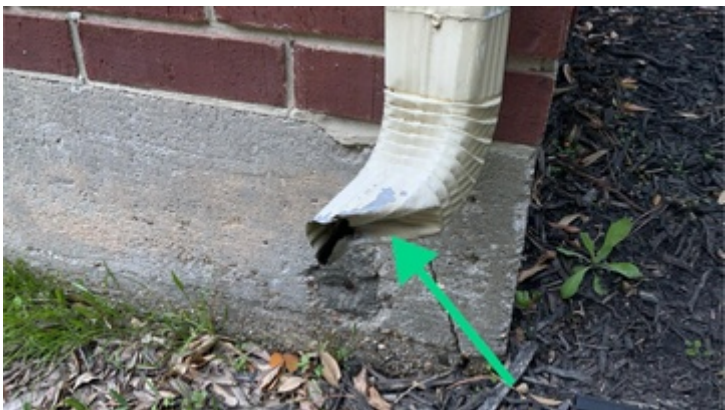
**Damaged Gutter / Downspout**

The gutter / downspout is damaged.

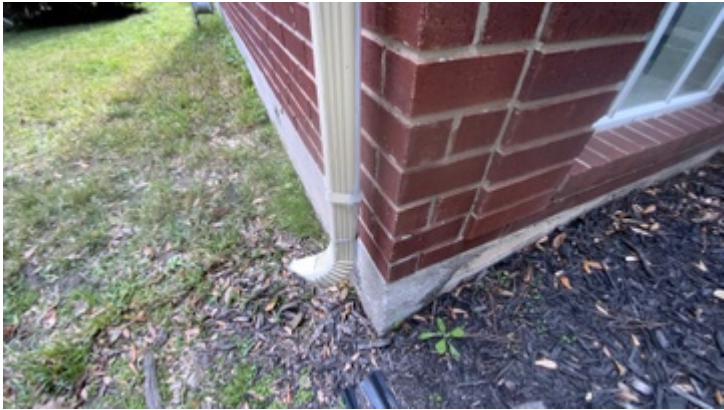
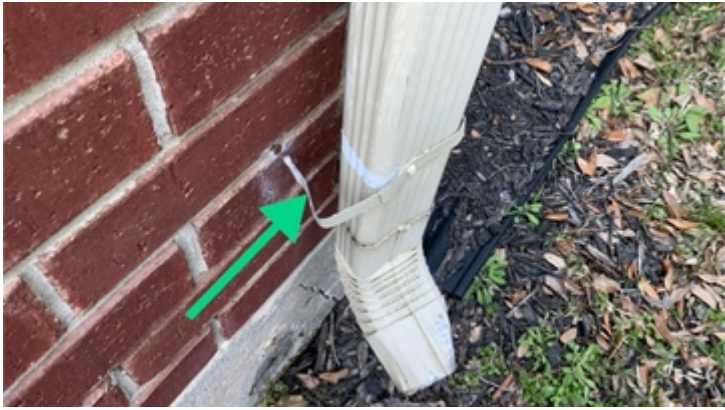
The downspouts are not attached / strapped to the structure.

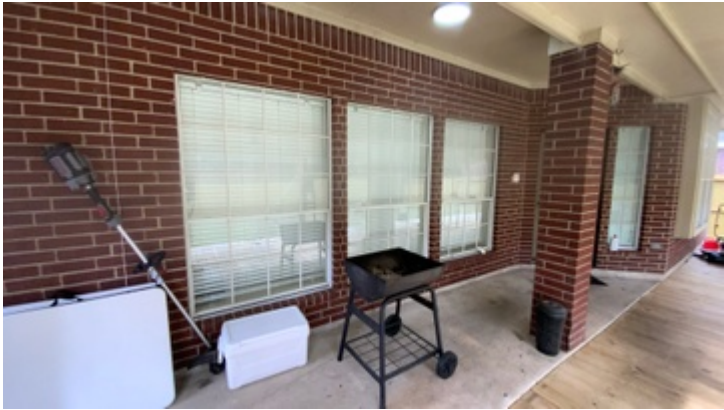
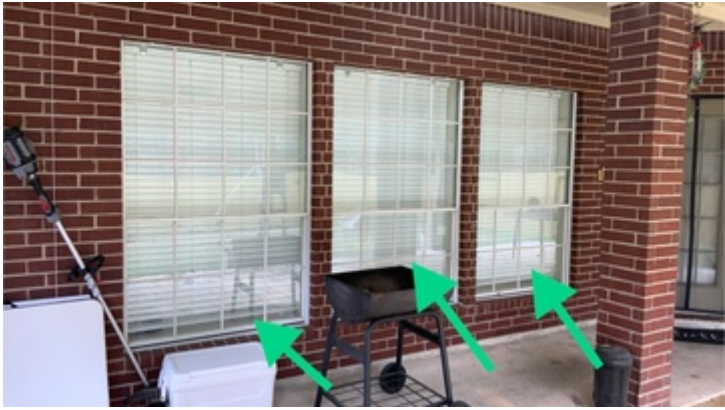
Missing Window Screen

One or more windows are missing a screen.

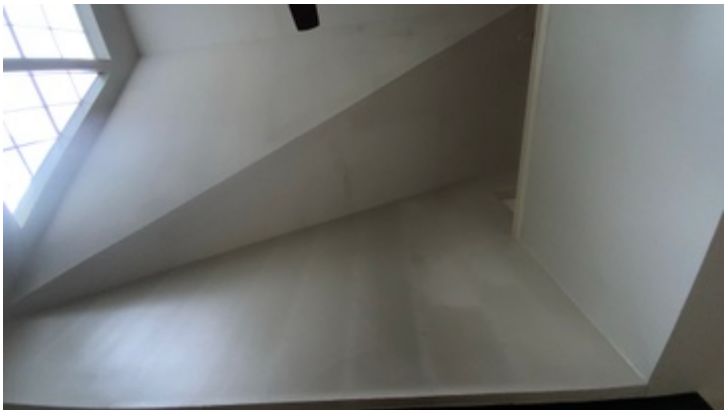
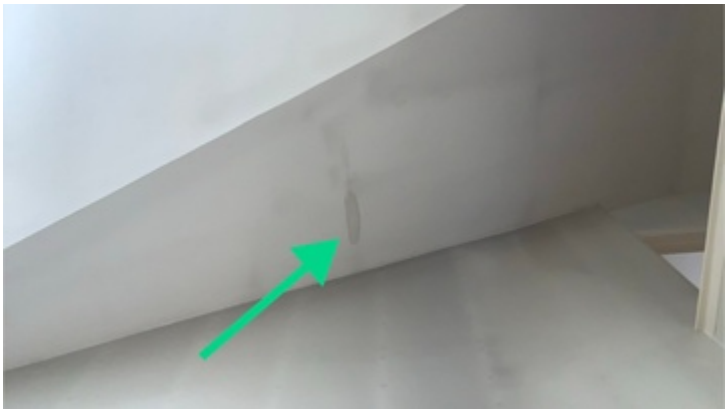
**Water Stained Ceiling**

The ceiling has one or more moisture stains.

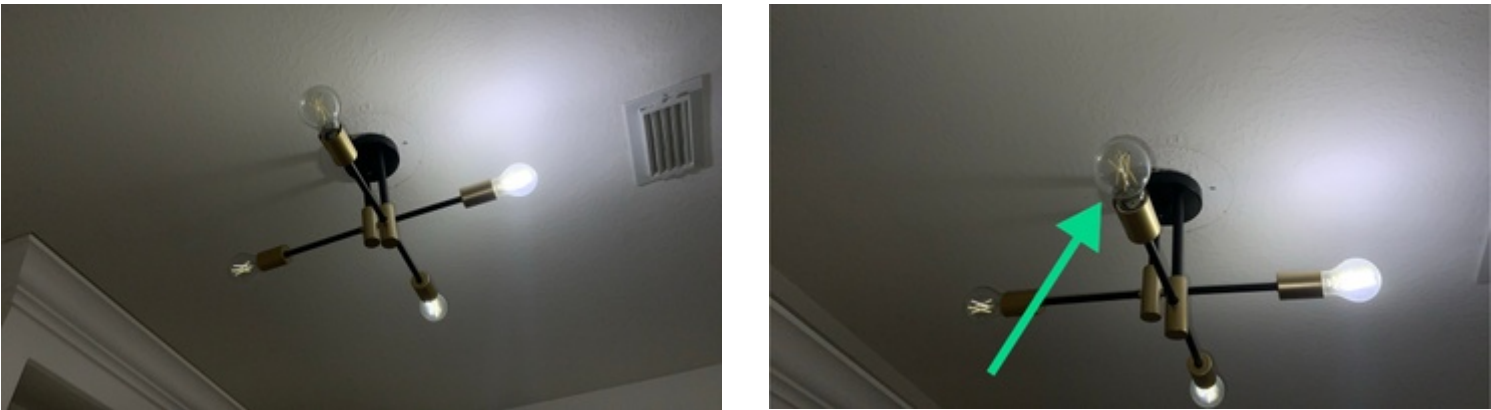
Inoperable or Missing Light Bulb

One or more light bulbs have burnt out or are missing.

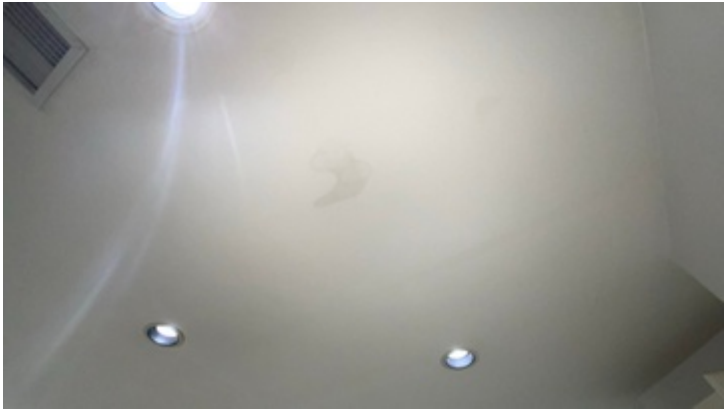
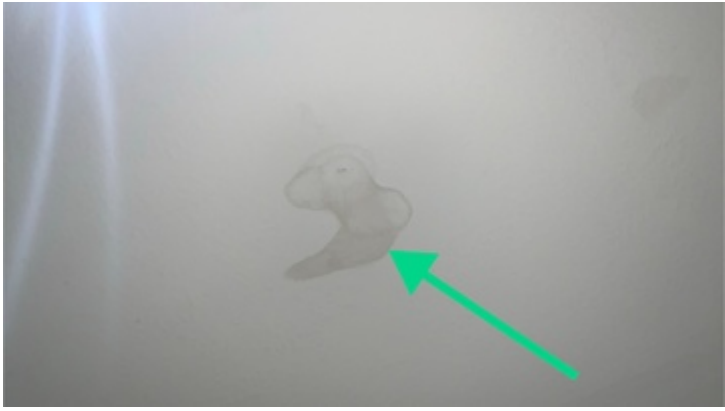
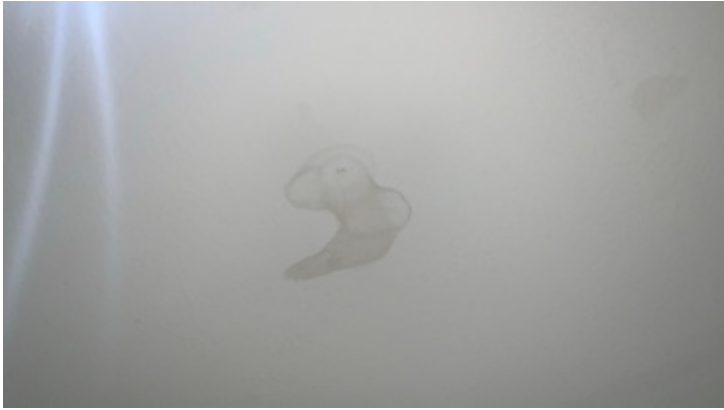
**Water Stained Ceiling**

The ceiling has one or more moisture stains.

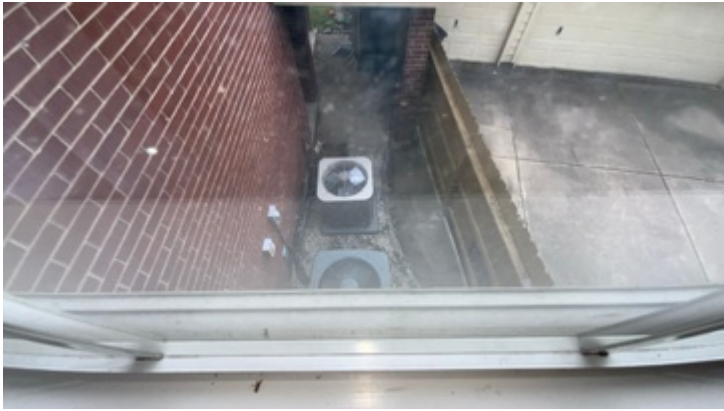
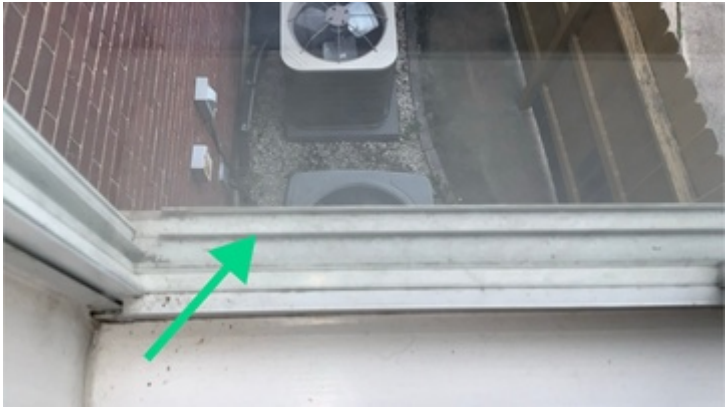
Missing Window Screen

One or more windows are missing a screen.

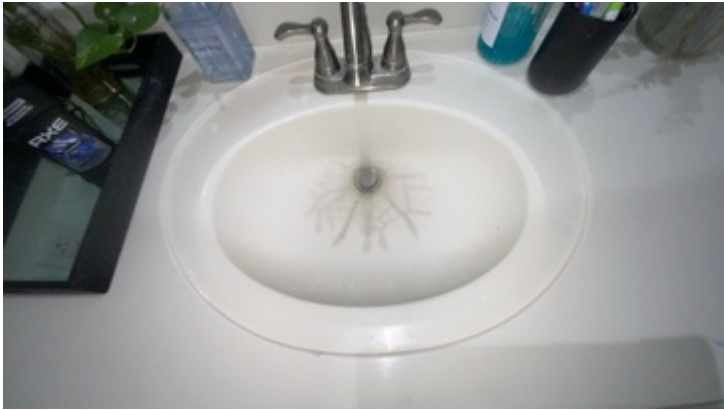
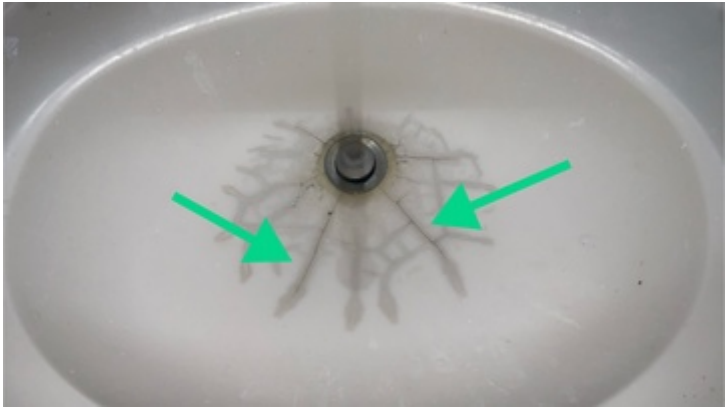
**Cracked Sink**

The sink is cracked and may leak.

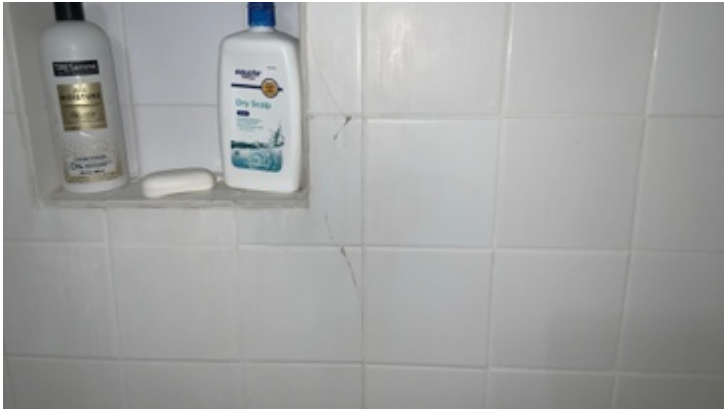
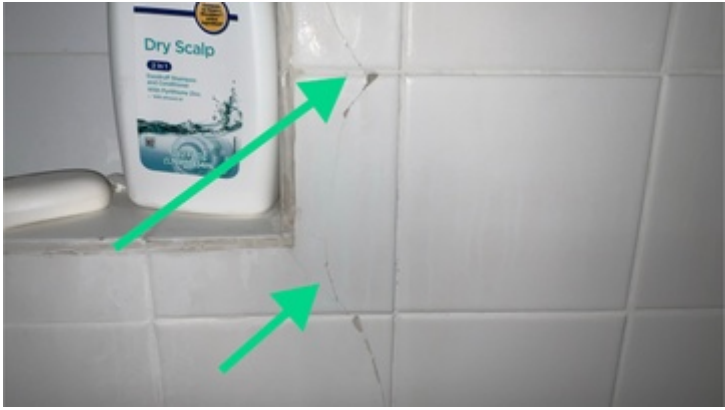
**Damaged Shower Tile**

The shower tile surface in the bathroom is cracked, damaged, or missing.

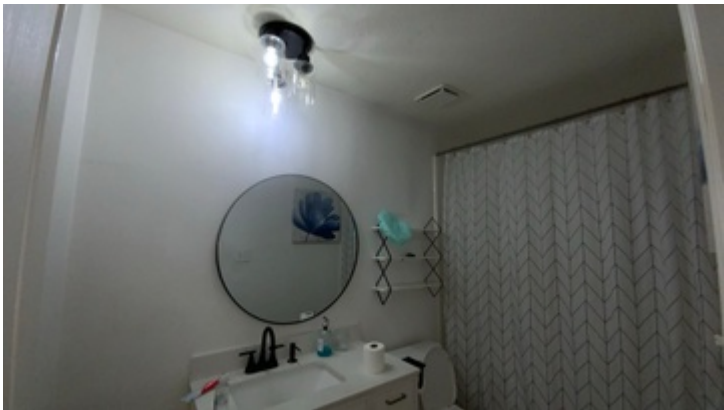
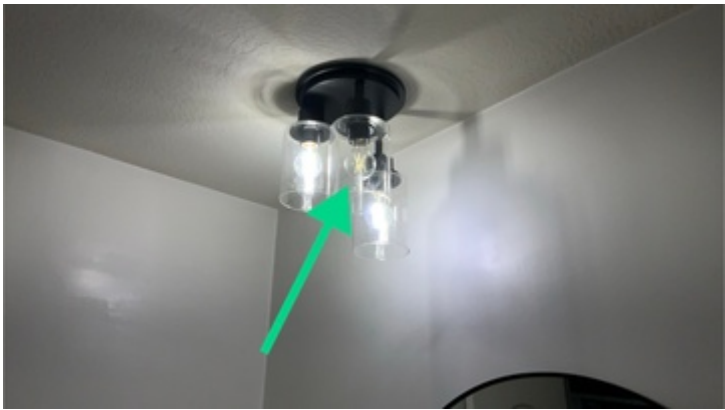
Inoperable or Missing Light Bulb

One or more light bulbs have burnt out or are missing.

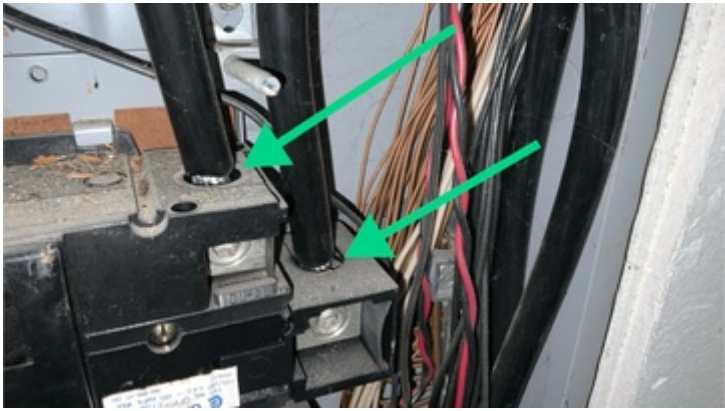
Aluminum wiring in electrical panels is missing an antioxidant application.

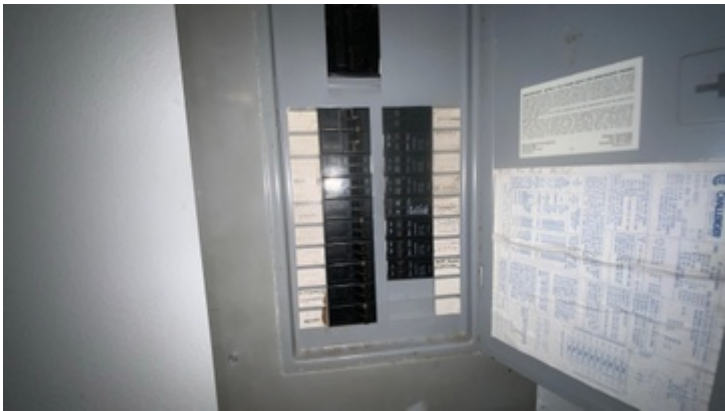
Missing AFCI Breaker

A required Arc-Fault Circuit Interrupter is missing.
