# BIANCHI HOME INSPECTIONS

## PROPERTY INSPECTION REPORT

**Property Address: 1519 Brook Grove Dr.**

**Date of Inspection: 07/18/2024**

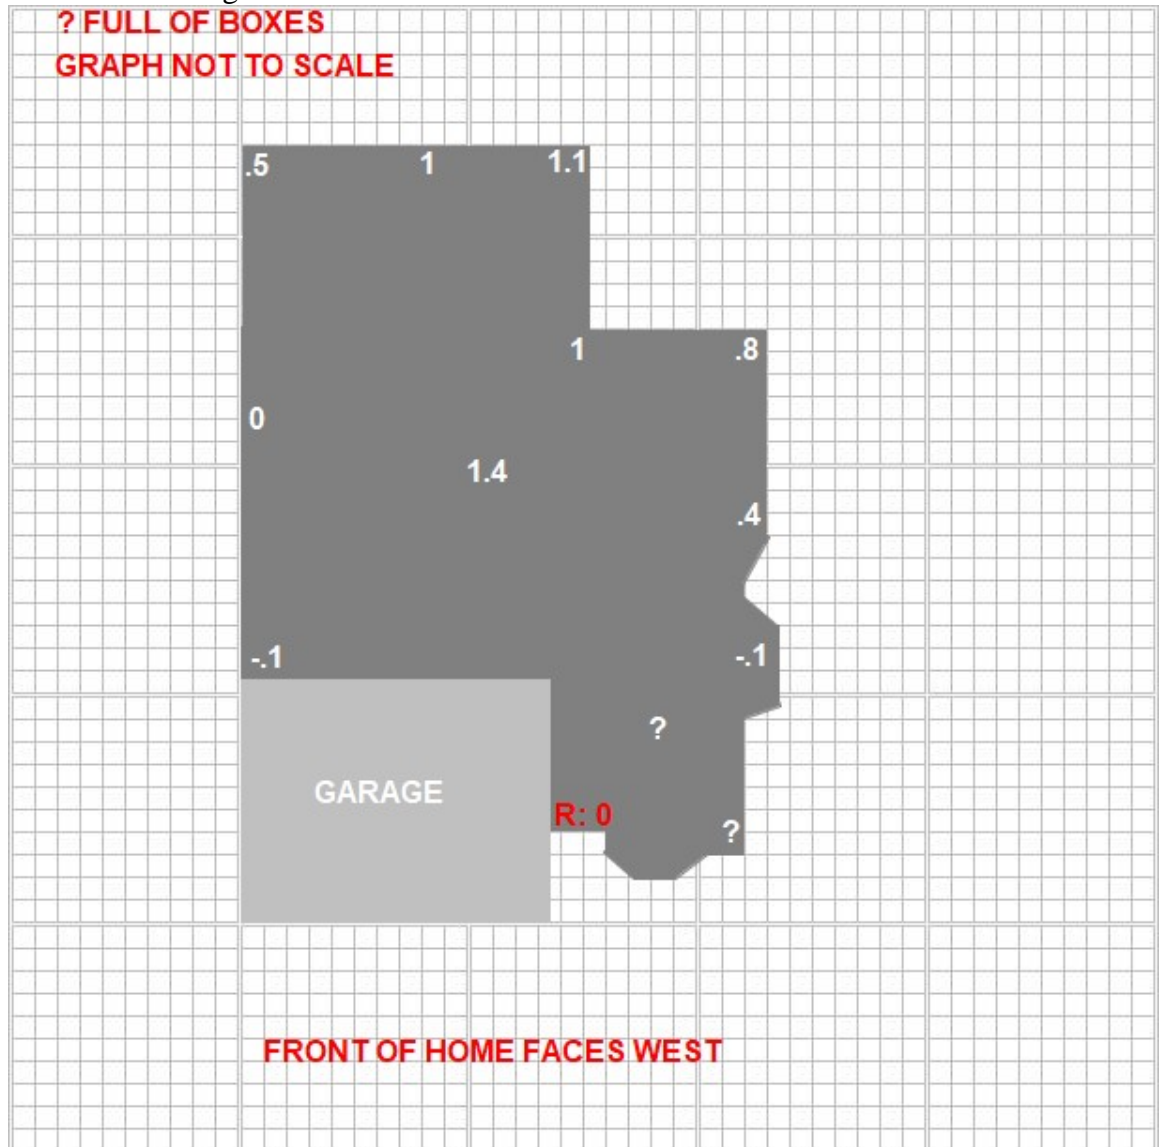
A foundation elevation survey was conducted during the inspection. The table below represents data gathered using a Zip Level and adjusting for floor covering height differences. The greatest variance was 1.5"

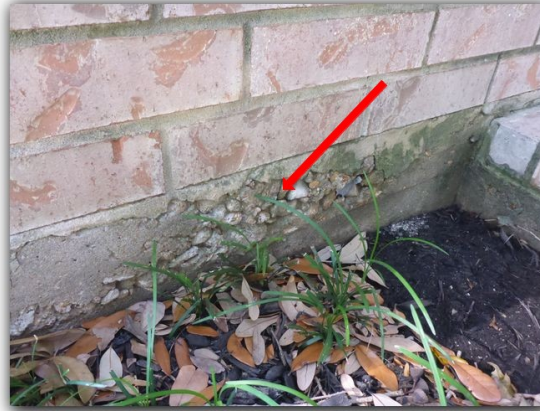
Honeycombing in the foundation observed at one or more locations.

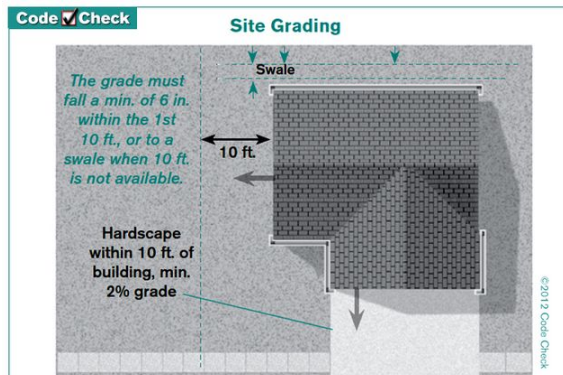
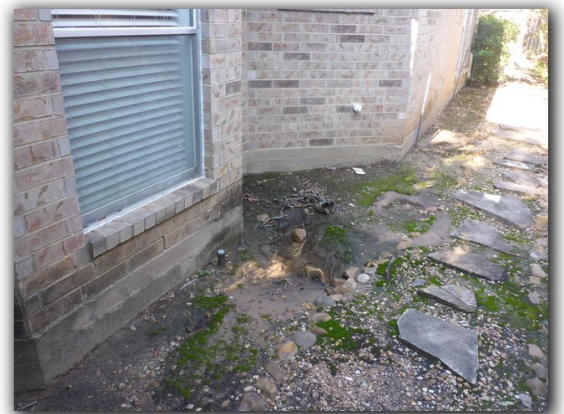
Soil grade and drainage patterns around some areas of the house do not appear to properly direct water away from the foundation to aid in controlling runoff water and could cause differential movement of the foundation or water penetration during heavy rains.

*Ants entering the house at brick weep holes, use insecticide treatment, do not seal up weep holes.*

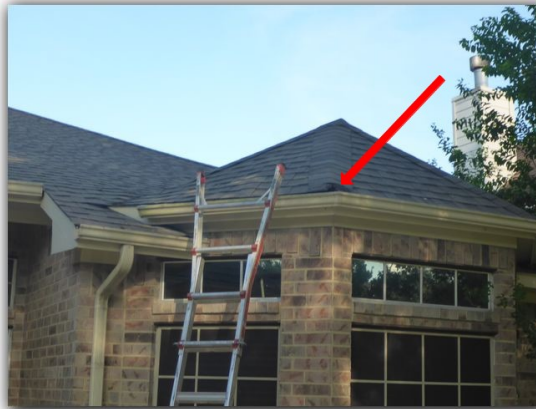
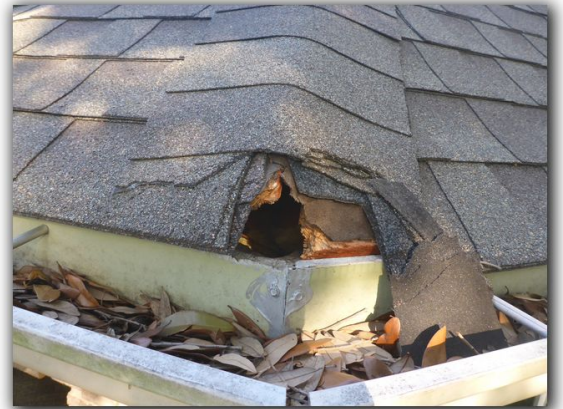
**Large hole in roof / decking observed at the front of the house. Appears to be a rodent entry access point. Needs repair.**

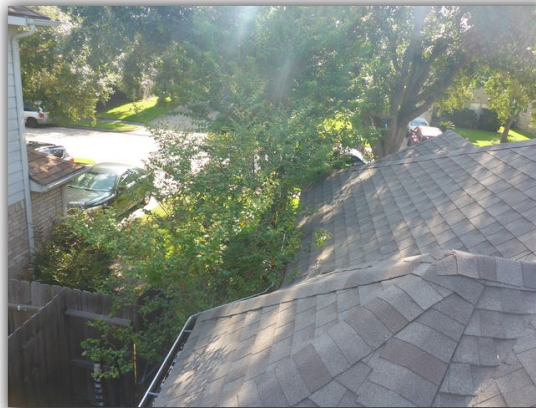
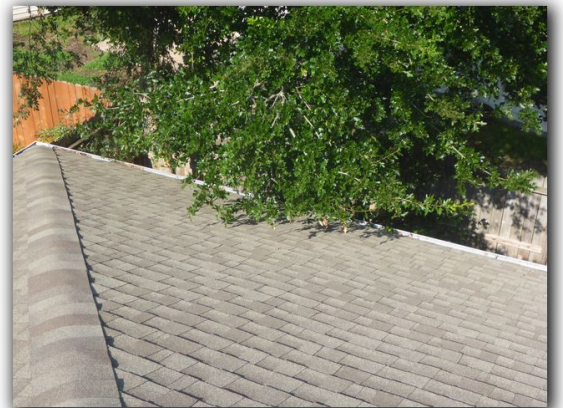
Tree limbs in contact with the roof can/ will damage the roof.

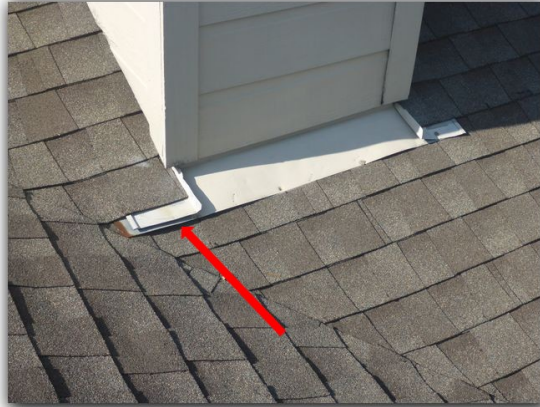
The lower side of flashing is not sealed down, wind-driven rains can cause water penetration.

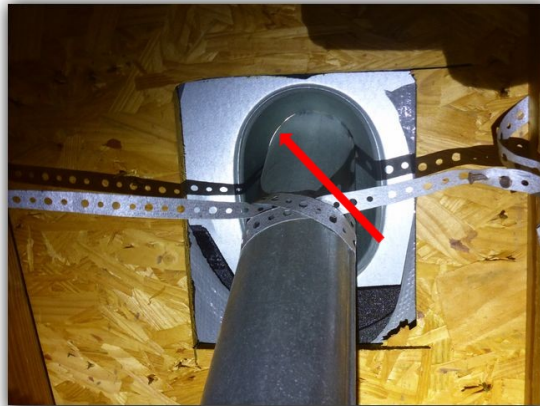
Storm collar not properly sealed on all house and water heater vent pipes.

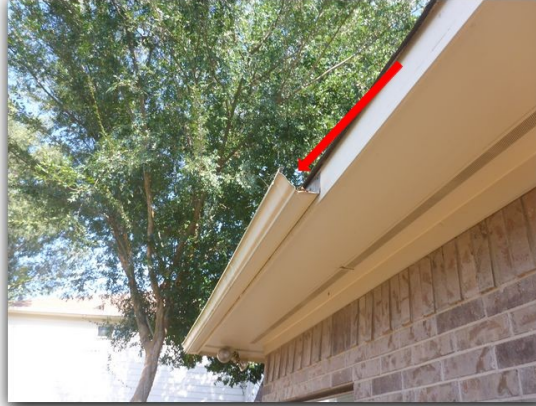
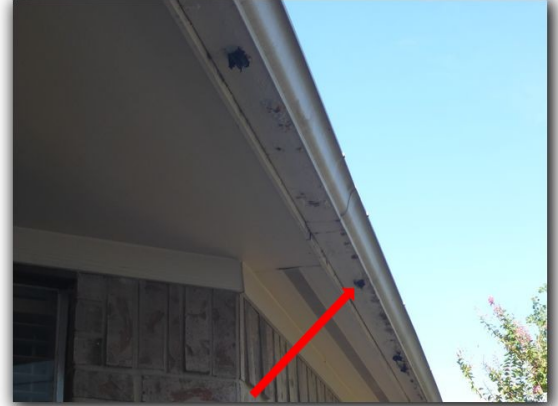
Observed one or more sections of damaged and/or rusting/ rusted thru sections of rain gutter which indicate they are at/near end of serviceable life.

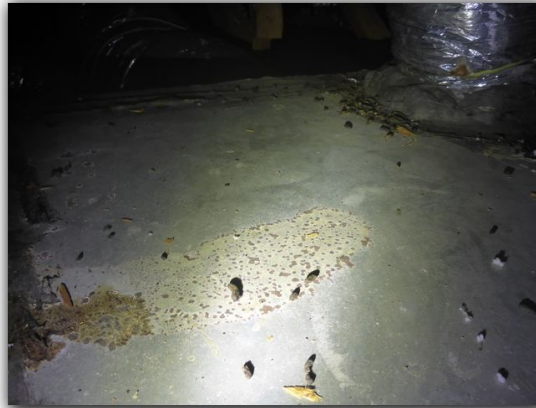
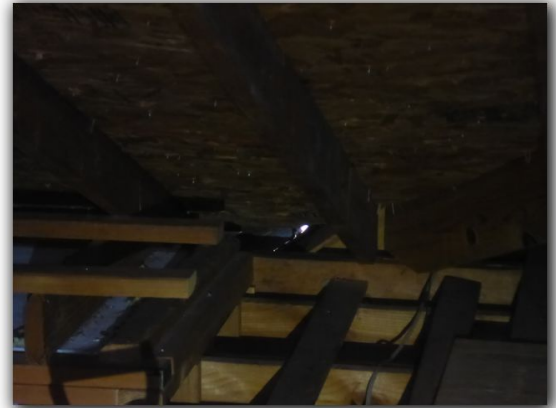
**Evidence of previous ( possibly current) rodent activity in the attic. Recommend repairing / sealing any holes on the exterior siding/roof.**

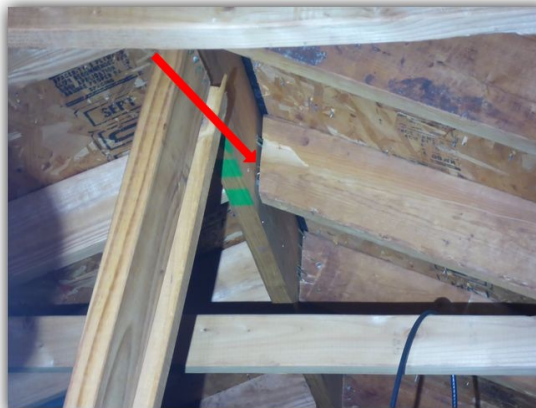
One or more ends of rafters were observed to be not cut flush with corresponding components, some degree of misfit was observed, average/mediocre framing. No repairs recommended.

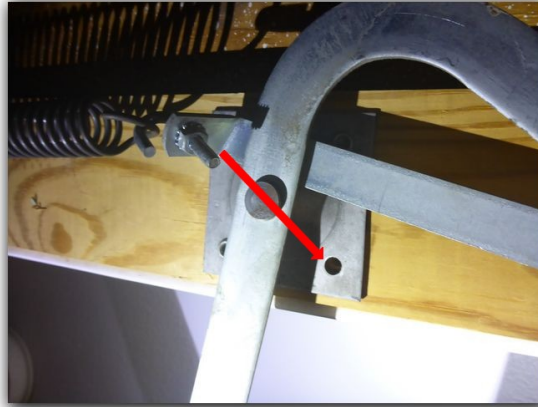
Not installed per manufacturer's installation instructions. Missing securing nails/lag bolts in holes of metal pivot points and corner braces.

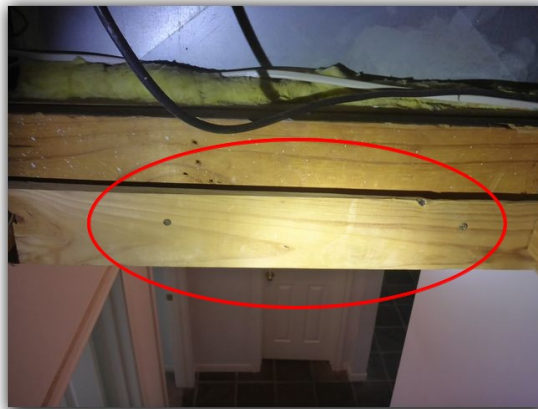
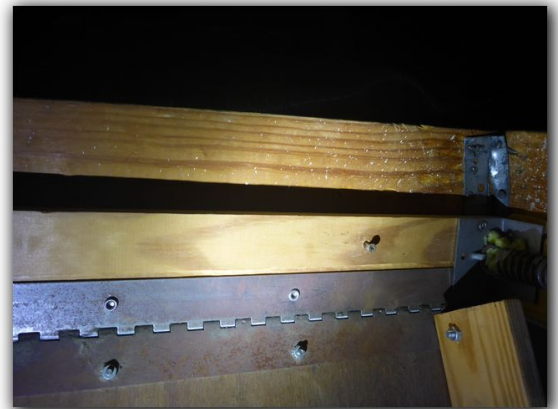
Stairway frame is inadequately secured into ceiling opening with screws, recommend complying with manufacturer's specifications calling for 16d nails or 1/4 inch diameter lag screws be added to secure stairway frame to the ceiling at specific locations.

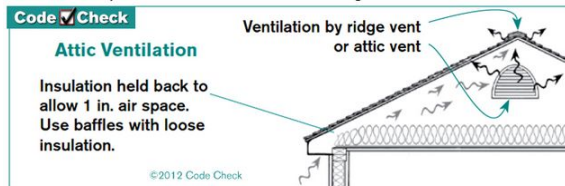
Inadequate amount of soffit or roof venting to allow proper ventilation of the attic, can incur larger utility bills as well as shortened roof life with poor attic ventilation.

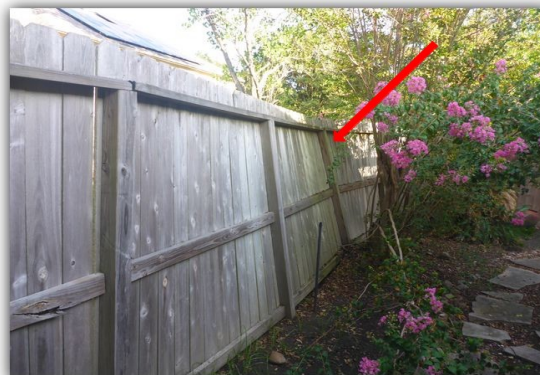
Backyard fence observed to be in poor condition. In need of repair.

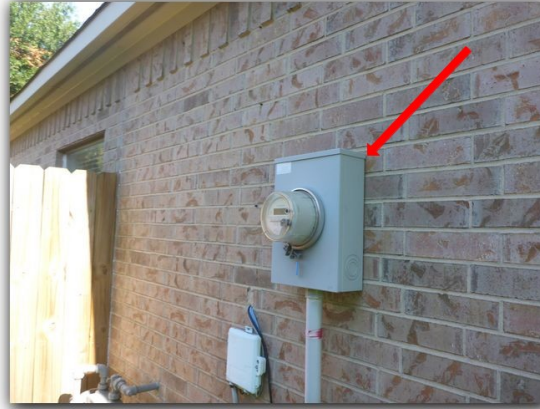
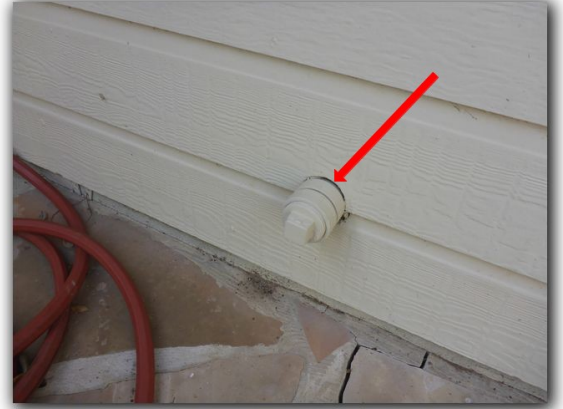
Need sealing/caulking around all holes and exterior siding penetrations on top and both sides, (leave the bottom open) to prevent water entry. Including but not limited to dryer, bath and range top vents, light fixtures, etc.

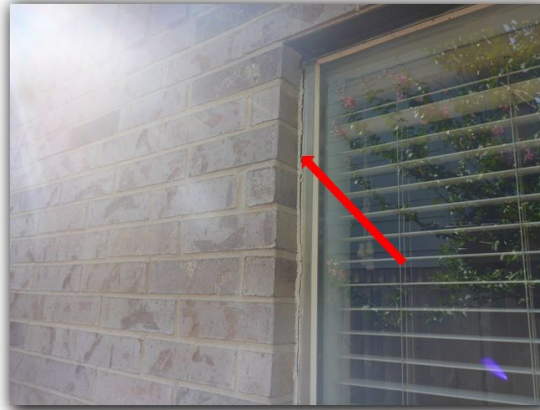
Caulking deficient around one or more windows will allow water penetration during heavy/wind-driven rains.

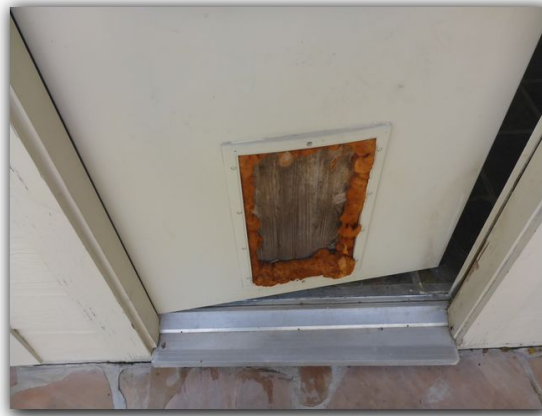
Rear exterior door observed to have dog access door that was improperly sealed.

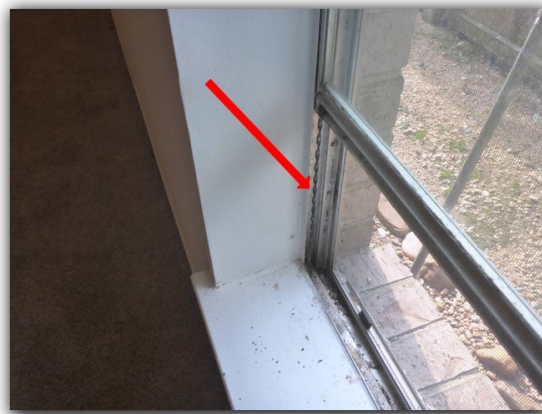
One or more window spring(s) were observed to be sprung/broken/detached.

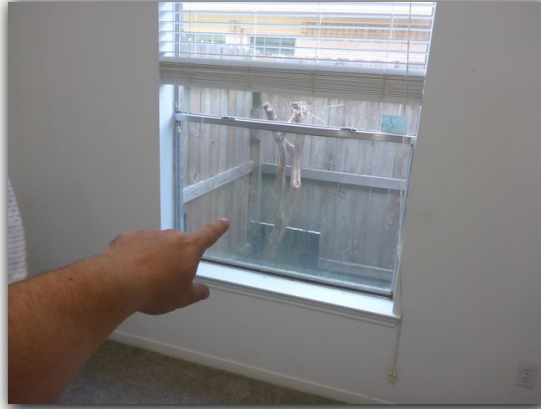
One or more windows will not fully open. (north guest room)

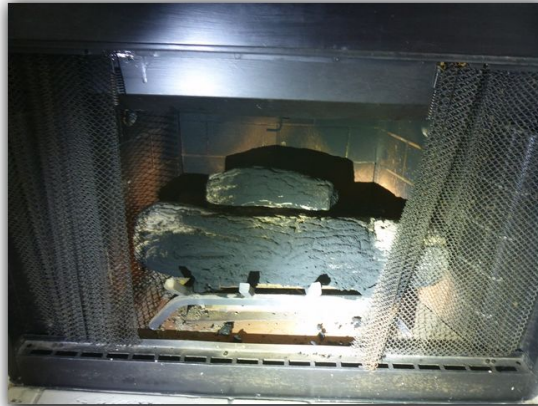
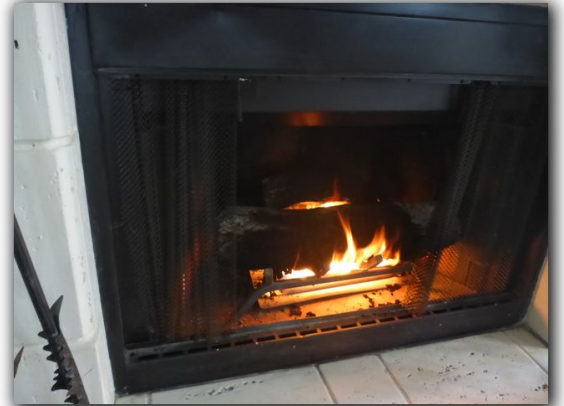
Soot build up on Faux logs indicates improper combustion - air/fuel mixture.

Recommend service to clean soot and adjust the air/fuel mix to reduce/eliminate soot production.

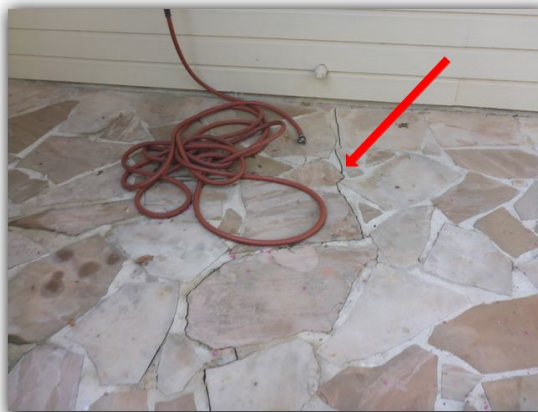
Rear exterior patio observed to be cracked.

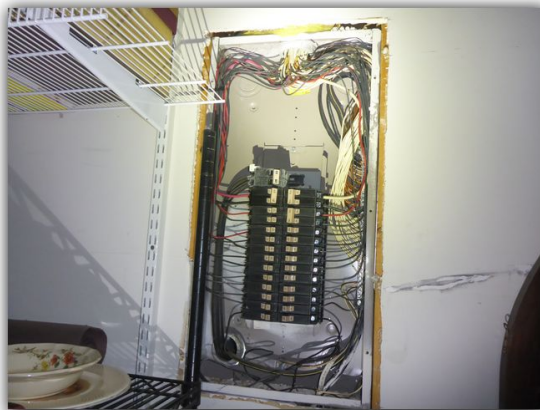
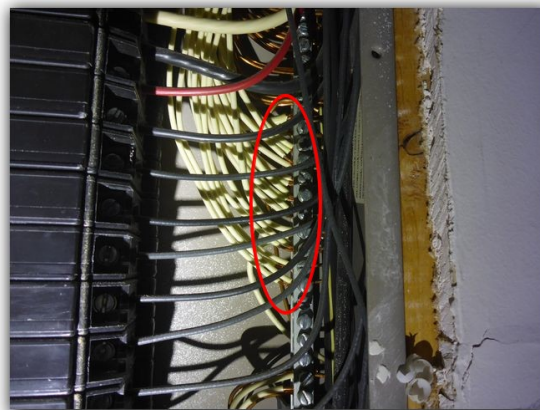
125 AMP ELECTRICAL SERVICE PANEL LOCATED INSIDE THE GARAGE. Observed two or more neutral conductors under one screw lug on the neutral bus. Current industry standards and National Electric Code permit one neutral conductor per screw lug.

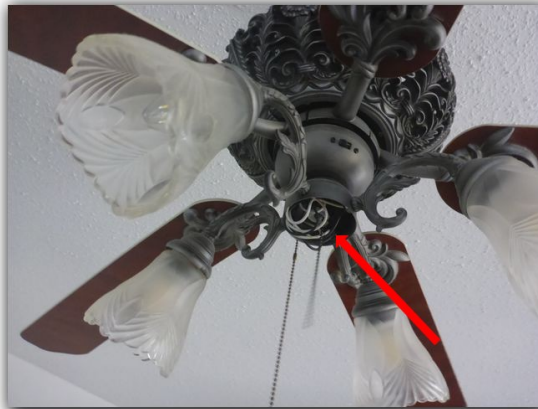
Ceiling fan base missing at one or more locations.

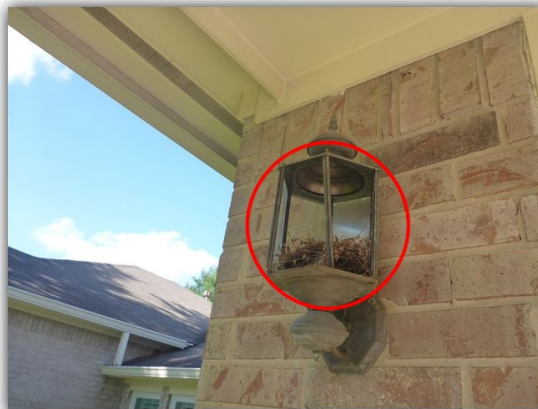
Front light fixture observed to be damaged.

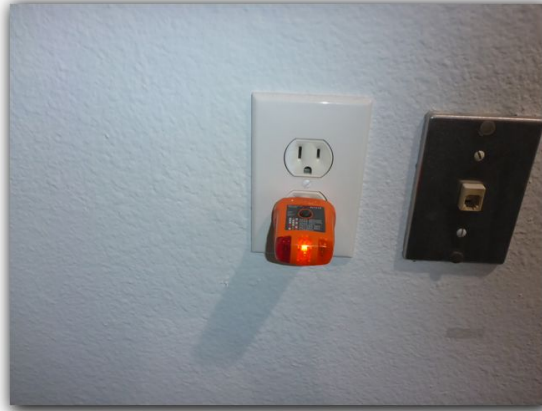
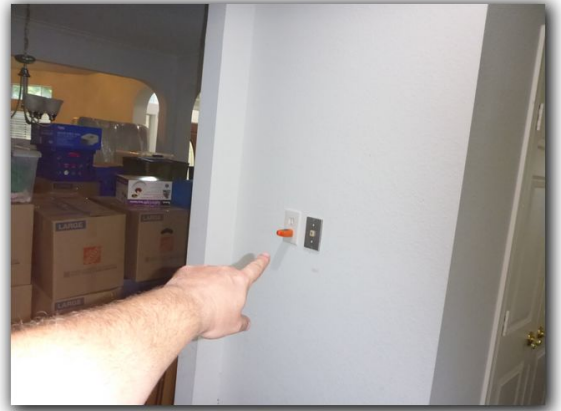
Improperly wired, 3 prong outlet not grounded or polarity reversed, including but not limited to; kitchen

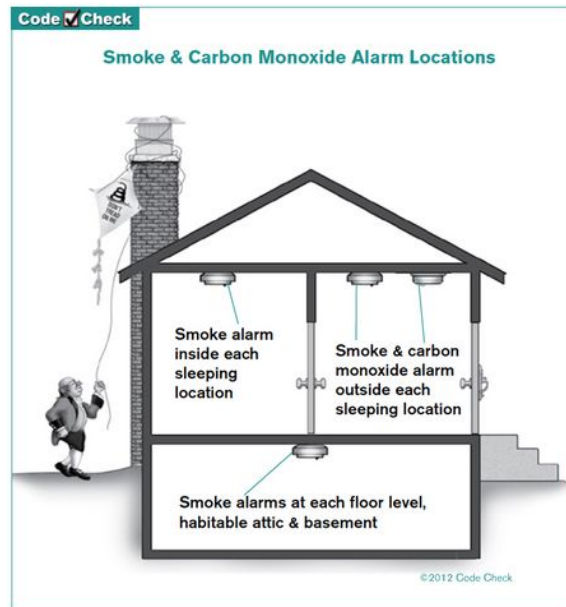
**There appears to be an inadequate number and/or improper location of smoke detectors in the home. Smoke detectors should be located on each level of the home as well as inside AND outside of all sleeping rooms. Consult the smoke detector manufacturer's instructions regarding the specific placement of detectors.**

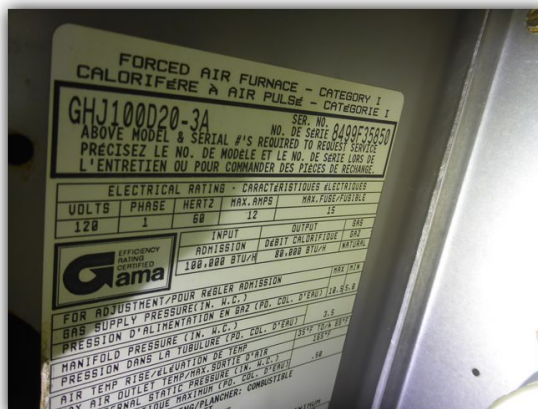
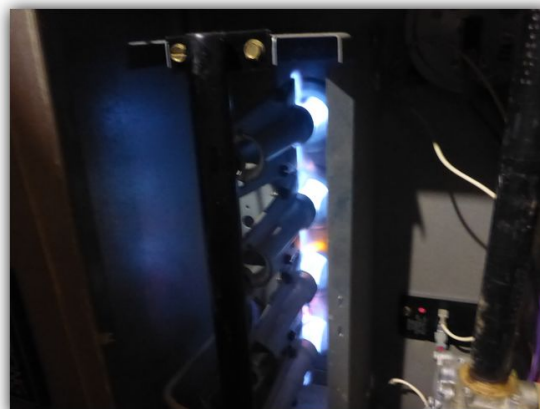
**Excessive rust on burners.** Recommend qualified/licensed HVAC technician clean, service, verify the integrity of heat exchanger, and repair as needed.

**The unit has exceeded its normal serviceable life; budget for repair or replacement.**

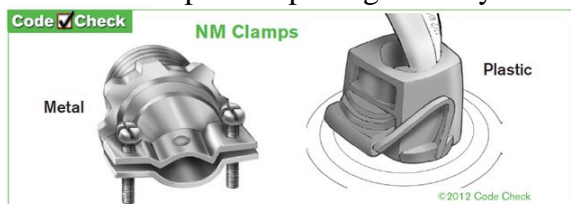
Thermostat wiring not secured to attic unit(s), missing small fitting that secures wiring to the cabinet to prevent pulling loose by service personnel or homeowner.

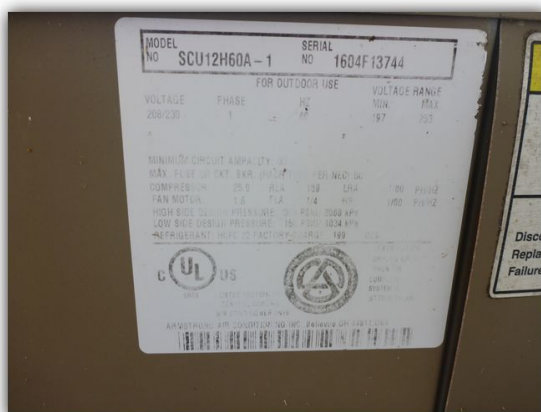
**The condenser unit has exceeded its normal serviceable life span; replacement should be expected and budgeted for in the near future.**

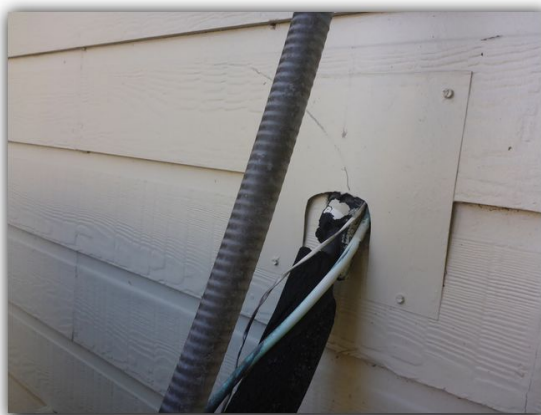
Recommend sealing exterior where AC lines enter the house.

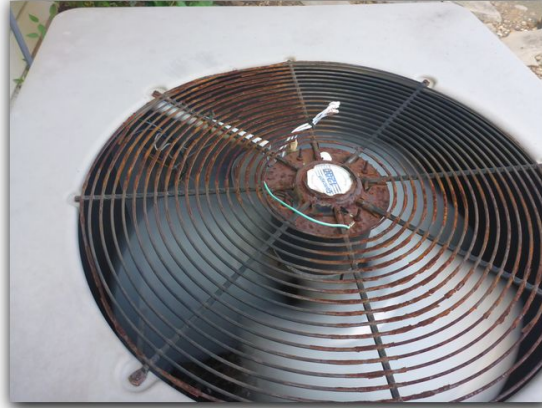
*Previous repairs noted. This inspection does not rate the substance or adequacy of these repairs.*

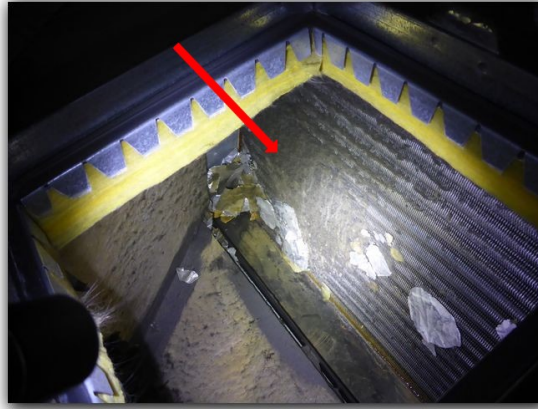
Coils are dirty, needs cleaning. Dirty coils reduce airflow through the system and create high head pressures at the compressor, thereby unduly stressing and reducing the life span of system components.

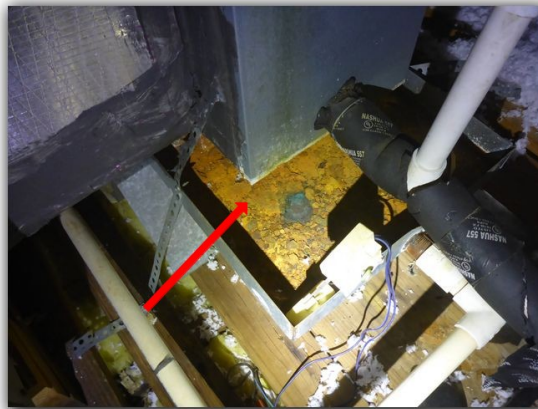
CONDENSATION DRAIN PAN DRAIN LINES:  
Secondary drain pan is very rusted, recommend replacement.

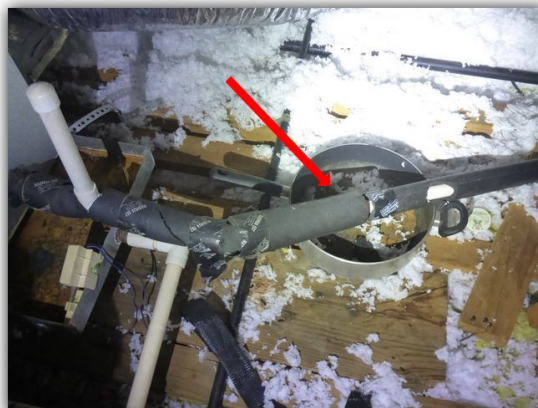
Pan in attic observed to placed below the primary drain line. Indication of a previous leak.

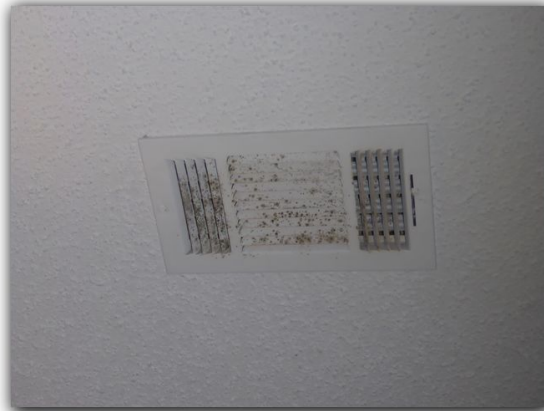
Observed possible microorganism growth on air supply grills/vents which may be a concern due to increased awareness of environmental issues associated with molds. *This inspector does not inspect for and is not qualified to render opinions on any type of environmental or other biohazards. If this is a concern or potential concern, Bianchi Home Inspections recommends having a qualified professional of your choice for further information / investigation.*

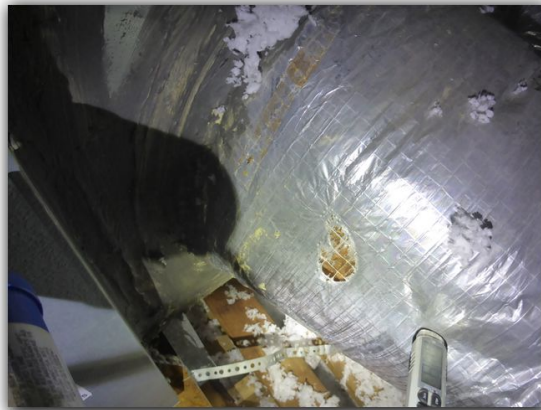
One or more ducts observed to be damaged.

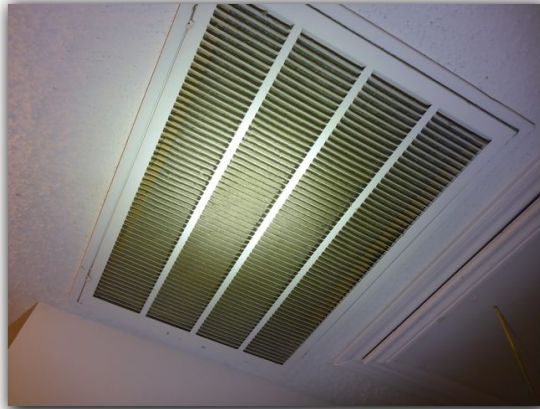
Return air filter is dirty.

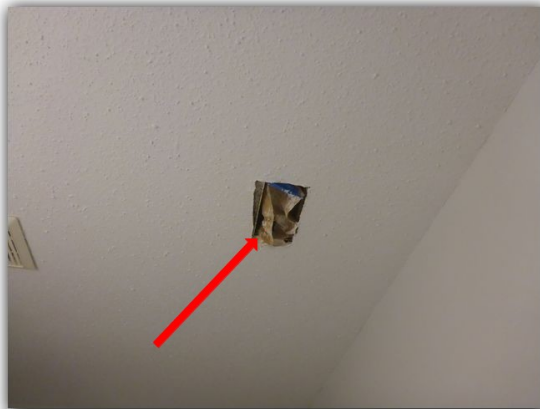
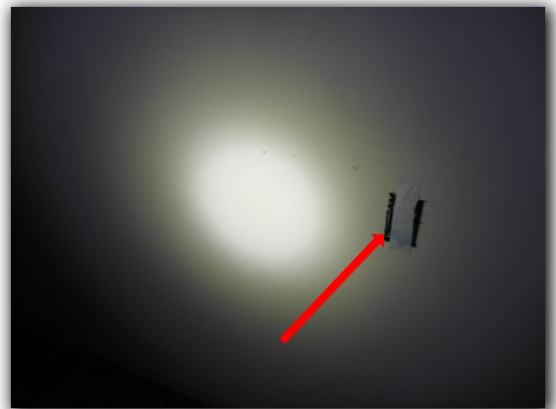
Register is loose, damaged, and/or missing; guest bathroom, laundry room

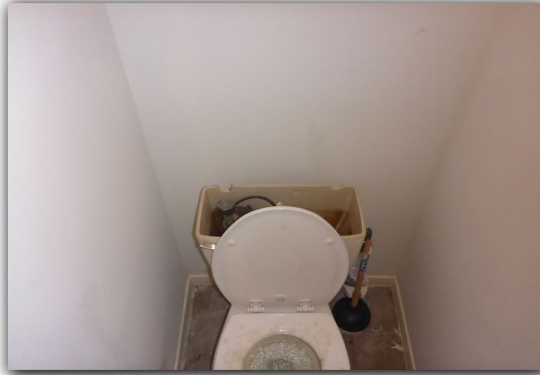
Commode tank lid missing, primary bathroom

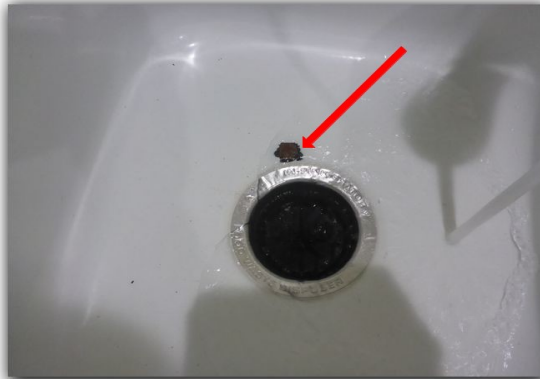
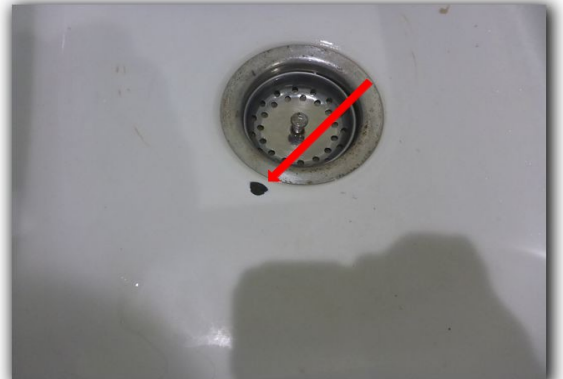
Porcelain damaged/chipped on steel sink; kitchen

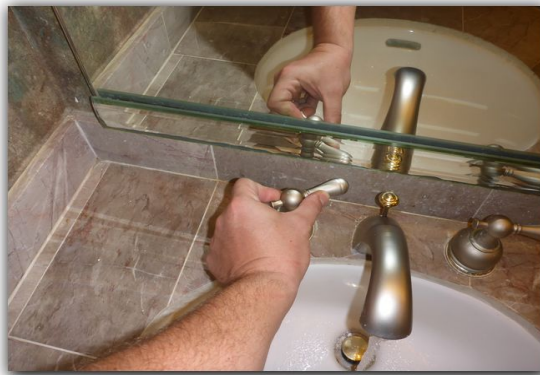
Faucet stop broken, [turns 360°]; primary bathroom

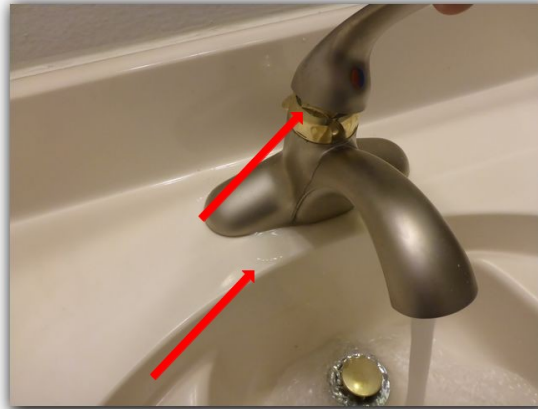
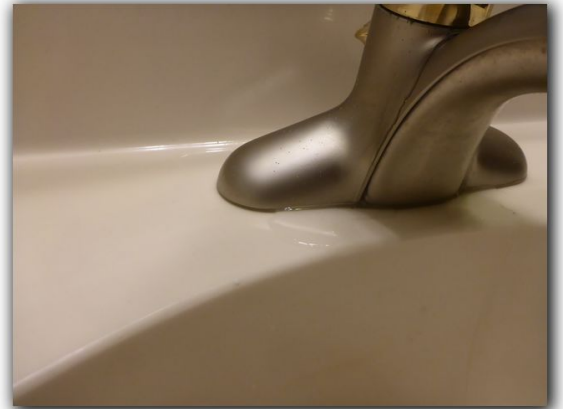
Leaks at base "O" rings, and/or stem washers; guest bathroom

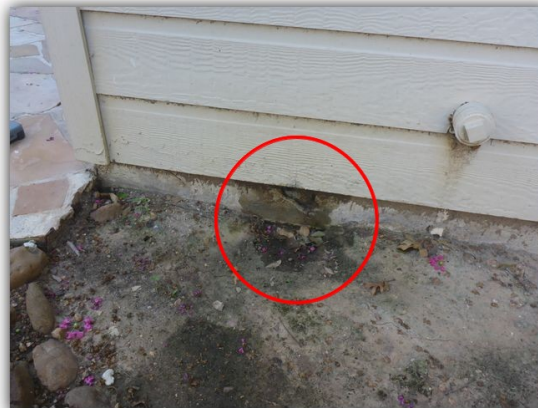
**Large leak below primary bathroom tub observed. Leaks water at the base of the tub where drain line connects.**

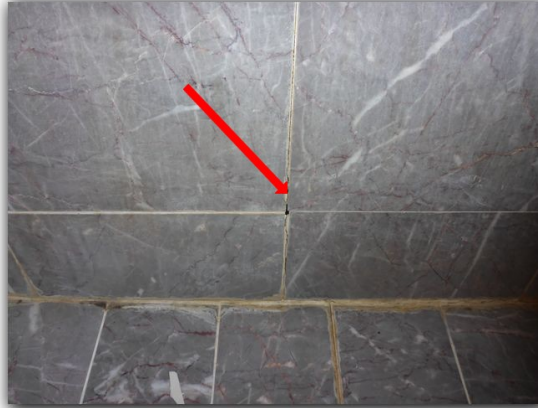
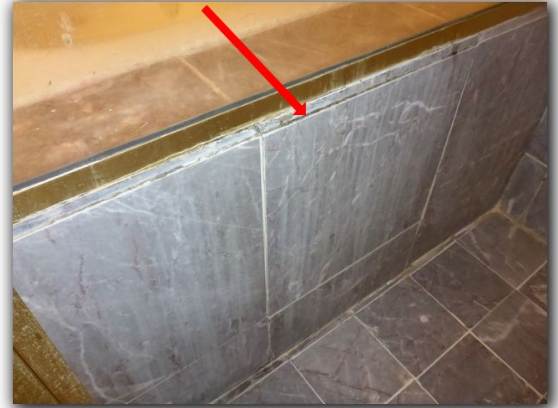
Observed loose tiles; primary bathroom

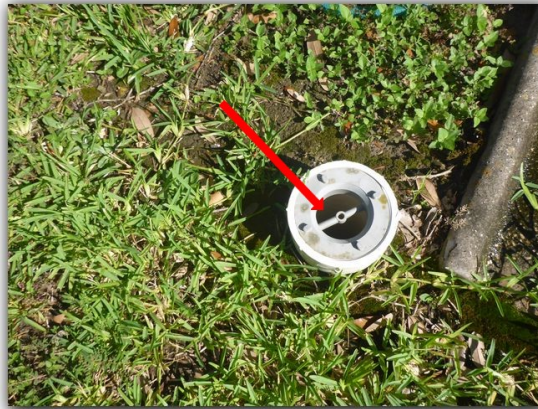
Missing/damaged drain cleanout cap, front of home

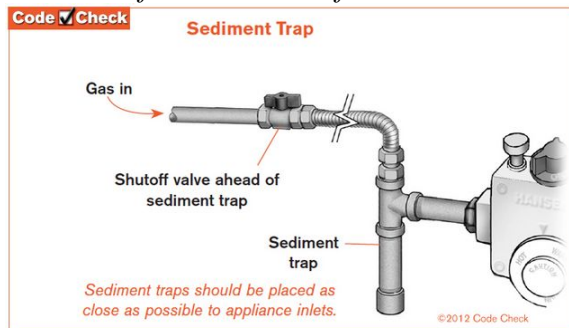
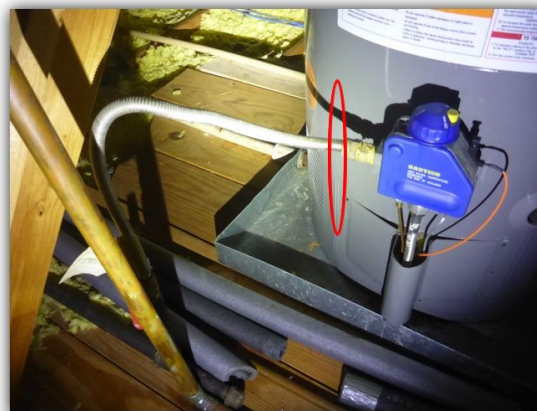
*Did not observe gas line drip leg(s) on gas house heater and/or gas water heaters which are called for in the manufacturer's installation instructions.*

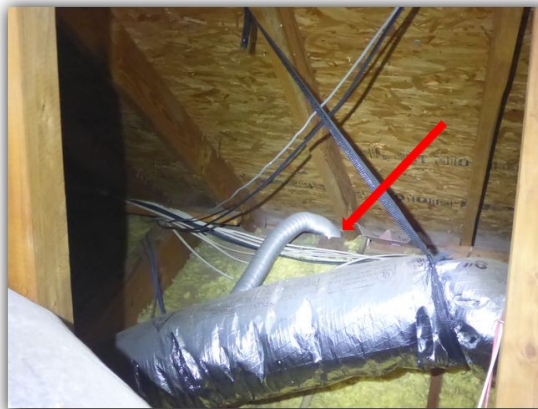
Exhaust improperly vents into the attic, ducting should vent to the exterior.

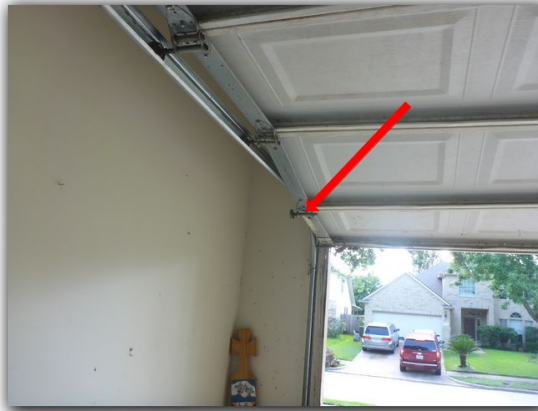
Garage wheel observed to be out of the track. Needs repair.

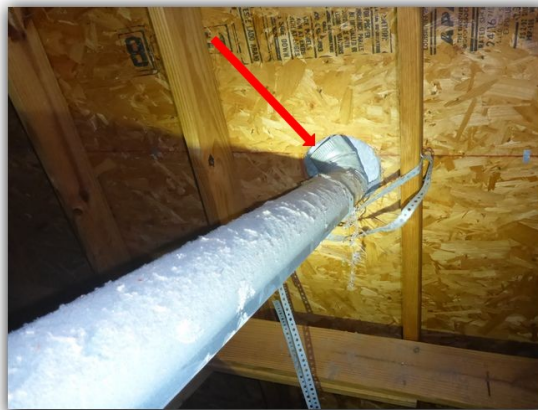
Improperly vented, vent pipe does not extend fully 3/4 into the base of roof jack, potential fire hazard. Attic observed to be full of lint.

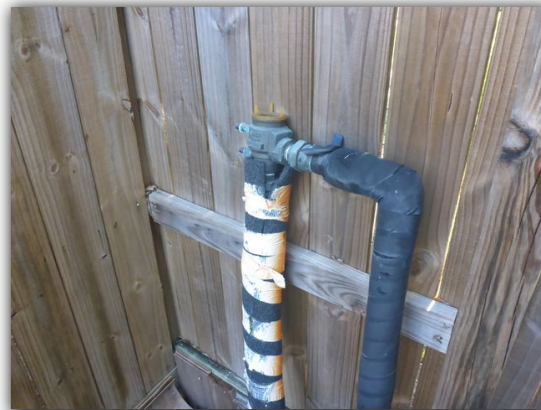
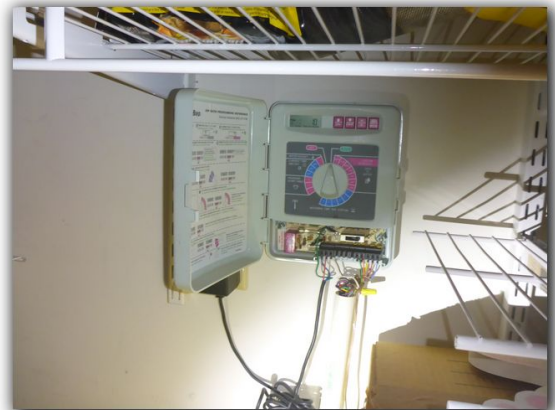
Backflow prevention device observed to be damaged.

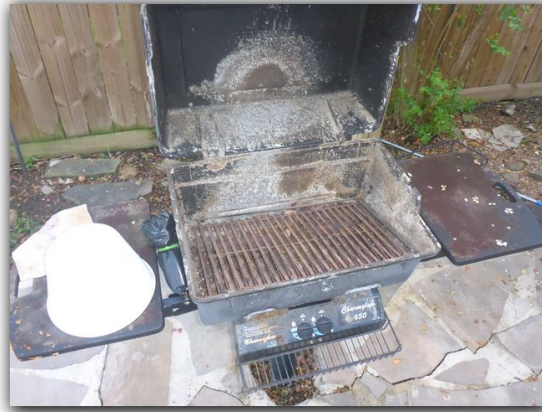
The unit was not operational, not performing its intended function, in need of repair/replacement.
