Inspection Report

Property Address:
11803 Old Spanish Trail
Santa Fe TX 77510

American Dream Inspections TX, llc

PROPERTY INSPECTION REPORT FORM

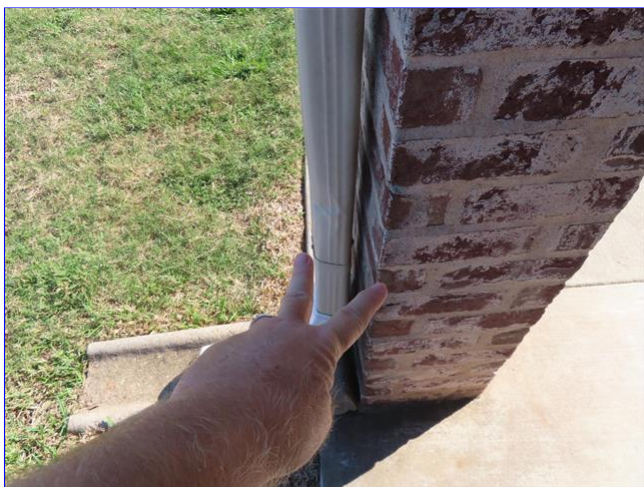
B. Item 2(Picture)

(2) Rear exterior gutter downspout was loose from the structure at time of inspection. Should correct properly.

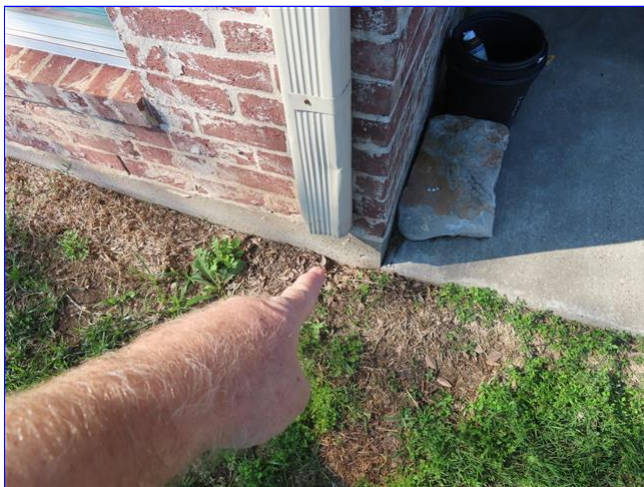
B. Item 3(Picture)

(3) Rear exterior gutter downspout was missing elbow to divert moisture properly away from the structure at time of inspection. Should have a professional correct properly.

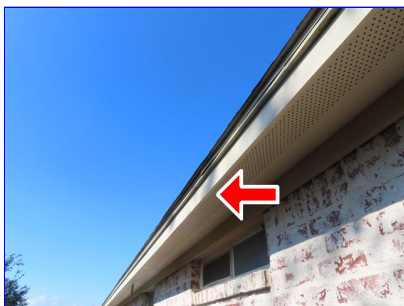
B. Item 6(Picture)

(5) Gutters were missing in several areas of the structure to disperse the water properly away from the foundation and structure at time of inspection. Recommend installing gutters in these areas.

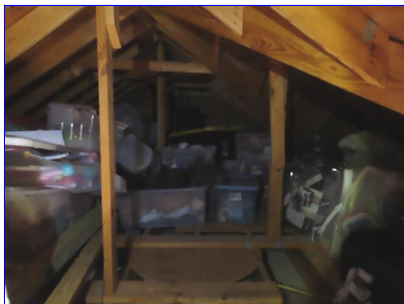
D. Item 1(Picture)

(1) Areas of the attic was not accessible to inspect at time of inspection. These areas were not inspected for any defects or deficiencies at time of inspection.

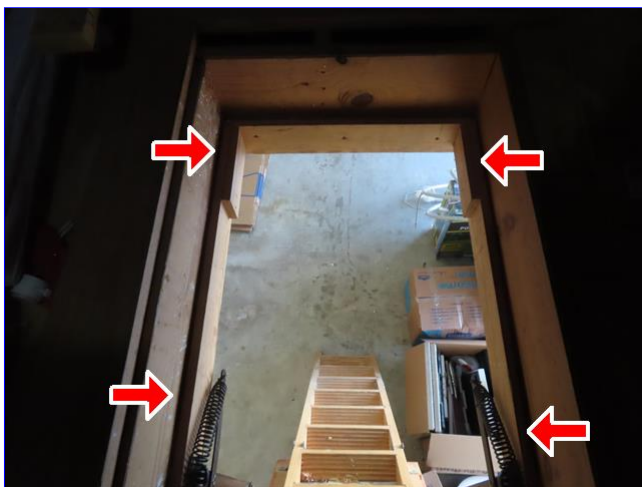
D. Item 2(Picture)

(2) Attic door access in the garage should be sealed and insulated properly. Conducive to leaking Carbon Monoxide into attic and into living space. Possible safety hazard.

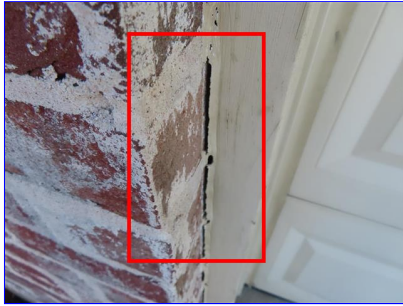
E. Item 1(Picture)

(1) All exterior and interior trim around garage doors should be sealed properly. Conducive to moisture and WDI (Wood Destroying Insect) intrusion.

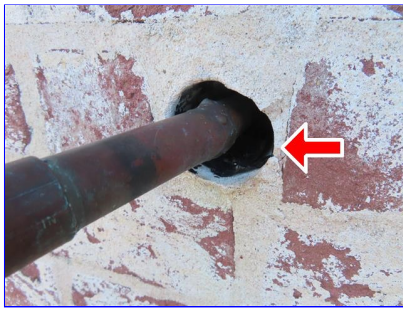
E. Item 2(Picture)

(2) All exterior wall plumbing, and electrical penetrations should be sealed properly. Conducive to moisture intrusion and causing possible damage.

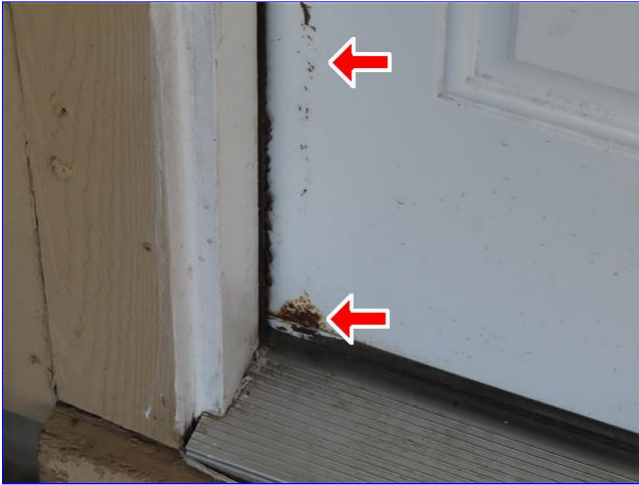
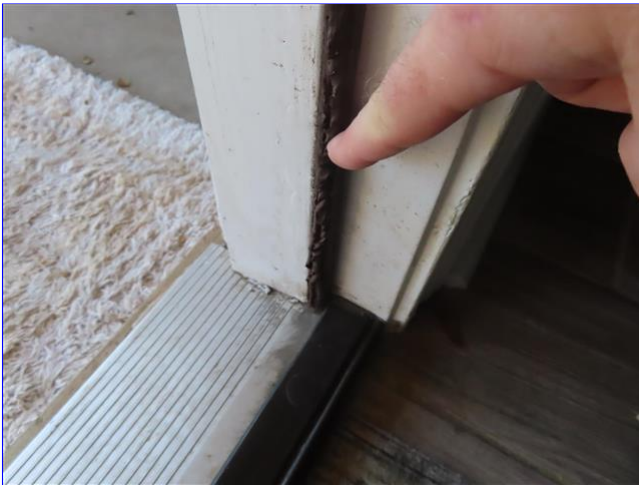
(1) Rear exterior door was rusting in several areas and door frame gasket was damaged at time of inspection. Should correct properly.

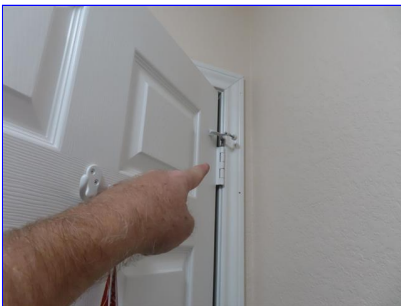
G. Item 3(Picture)

(2) Interior garage door was missing self closing hinges at time of inspection. Should have a professional correct properly.

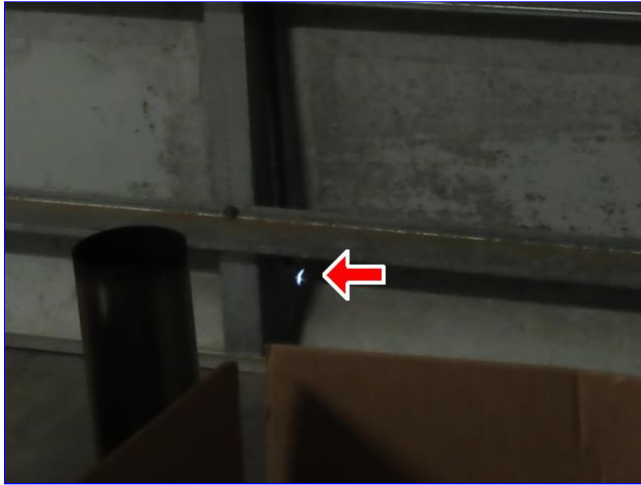
G. Item 4(Picture)

(3) Bottom garage door panel is rusting and cracked leaking daylight into the interior at time of inspection. Should have a professional Door Tech inspect and correct properly.

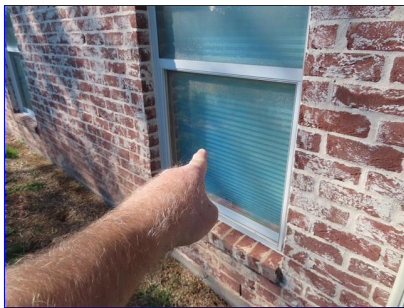
H. Item 2(Picture)

(2) Several windows were missing screens at time of inspection. Should correct properly.

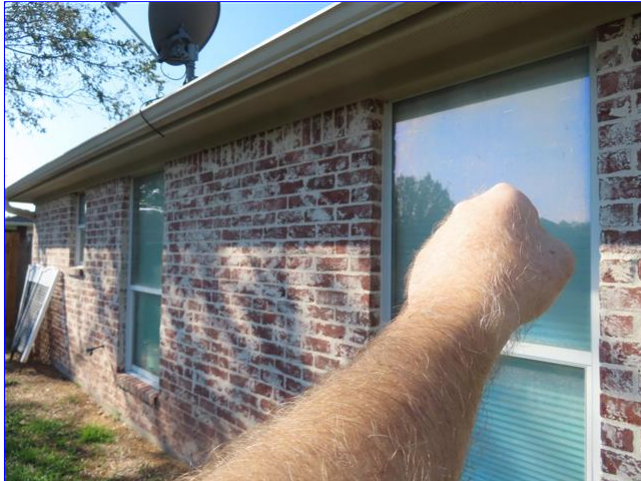
H. Item 3(Picture)

(3) Several windows were discolored at time of inspection. This is signs of possible seal damage causing window to not be energy efficient. Should have a professional replace damaged glass properly.

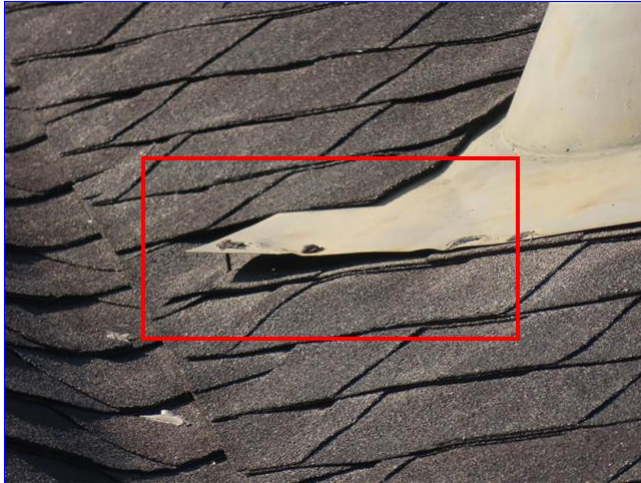
J. Item 1(Picture)

(1) Fireplace exhaust roof lifted jack should be corrected by a professional roofer. Conducive to moisture intrusion and causing possible damage.

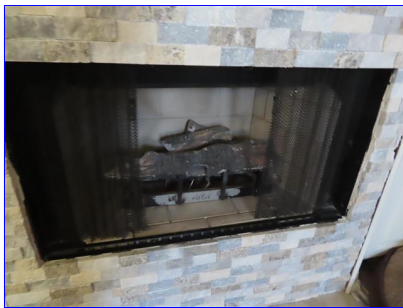
J. Item 2(Picture)

(2) Gas fireplace. Fireplace was only visually inspected for defects or deficiencies at time of inspection. Did not inspect operation of fireplace at time of inspection. Fireplace did not have any visible defects at time of inspection. Inspection of fireplace is not part of home inspection per TREC Standards of Practice. Recommend having a professional Fireplace Tech further evaluate unit.

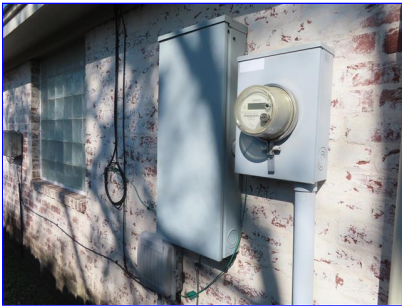
A. Item 1(Picture)

(1) Cutler Hammer breaker box and electric meter. Box was missing AFCI breakers for all livable rooms at time of inspection. Should have a professional electrician correct properly.

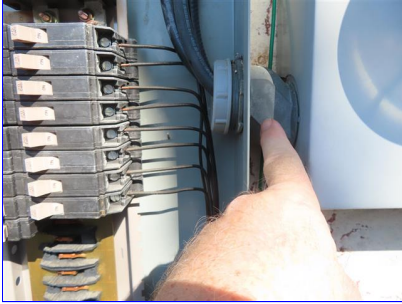
A. Item 4(Picture)

(3) Connector between meter and breaker box was missing electrical bonding at time of inspection. Should have a professional electrician correct.

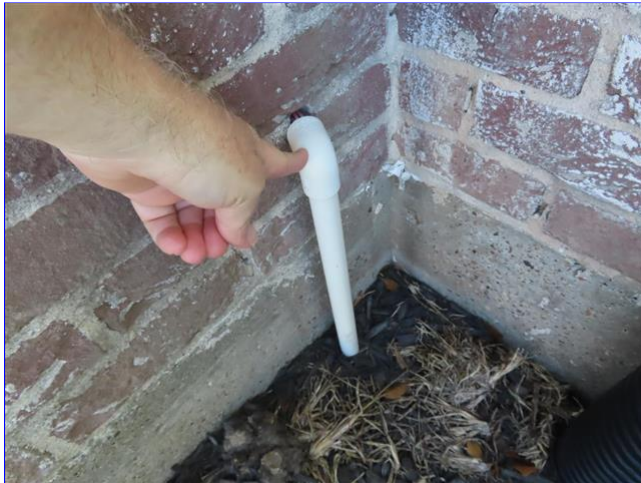
B. Item 3(Picture)

(2) Exterior sprinkler electrical conduit was loose from the structure at time of inspection. Should have a professional correct properly.

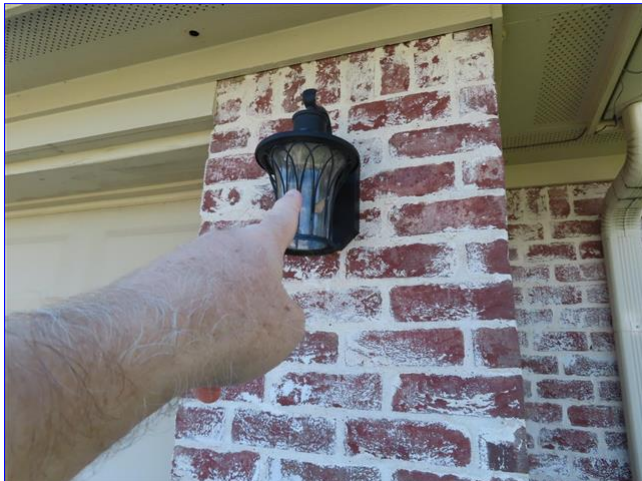
B. Item 4(Picture)

(3) Exterior lighting was loose to structure in several areas at time of inspection. Should be secured and sealed properly to the structure by a professional electrician.

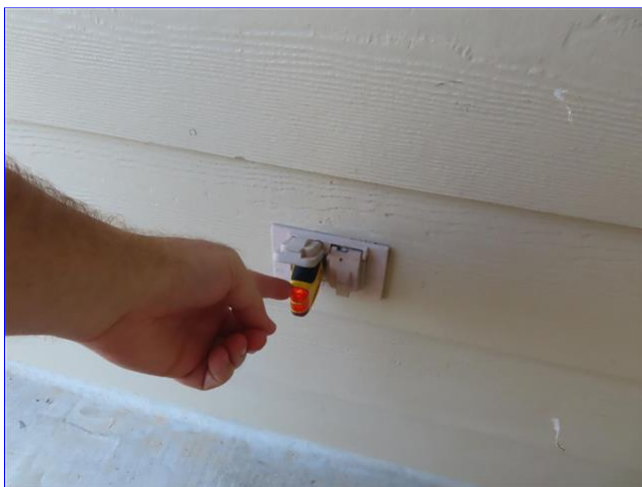
B. Item 5(Picture)

(4) Several exterior electrical outlets were loose to the wall at time of inspection. Should have a professional electrician secure and seal to the structure.

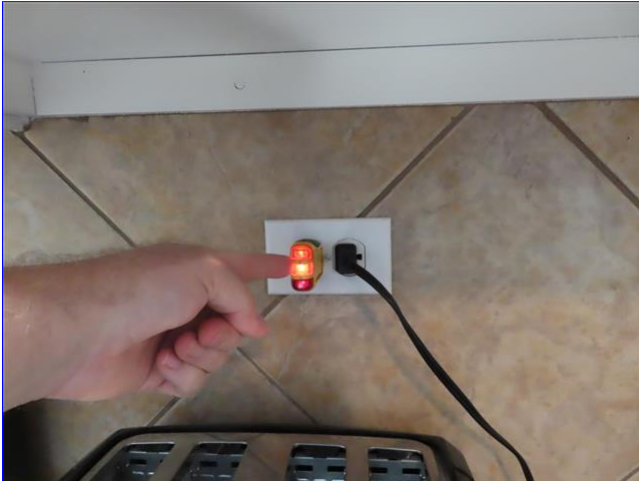
B. Item 6(Picture)

(5) Several interior electrical outlets were loose to the wall at time of inspection. Should a professional electrician secure properly.

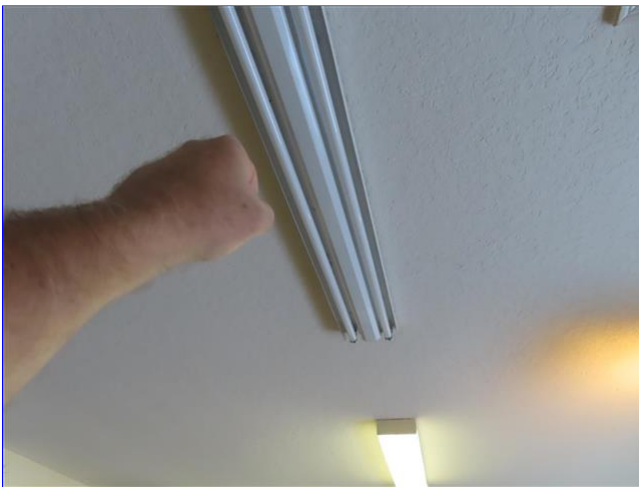
B. Item 7(Picture)

(6) One garage light was not operating properly at time of inspection. Should have a professional electrician inspect and correct properly.

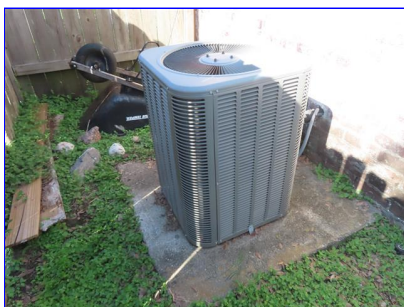
A. Item 1(Picture)

2013 Lennox 3 ton AC unit was operating properly at time of inspection. Recommend having a professional AC Tech inspect and service unit for proper efficiency. Electrical from unit was not protruding into the brick wall properly and exposing electrical at time of inspection. Should have a professional correct properly.

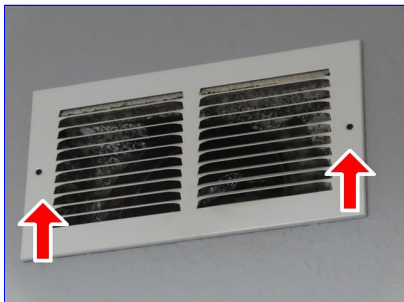
C. Item 1(Picture)

Bedroom HVAC register was missing fasteners at time of inspection. Should correct properly.

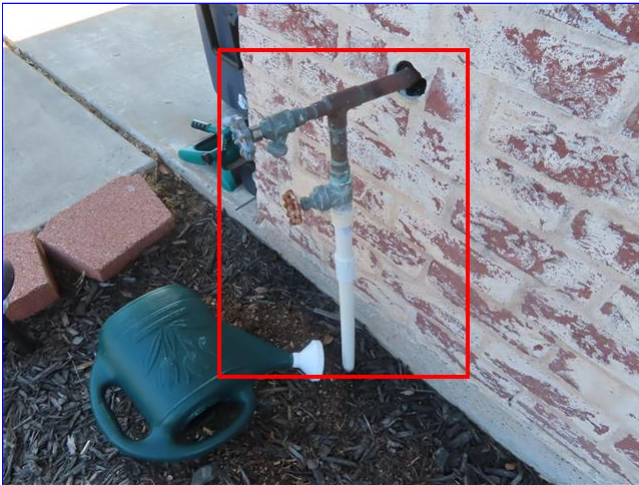
A. Item 1(Picture)

(1) Main water line and shut off valve to the structure. Plumbing was missing insulation at time of inspection. Plumbing is conducive to freezing in cold weather. Should correct properly.

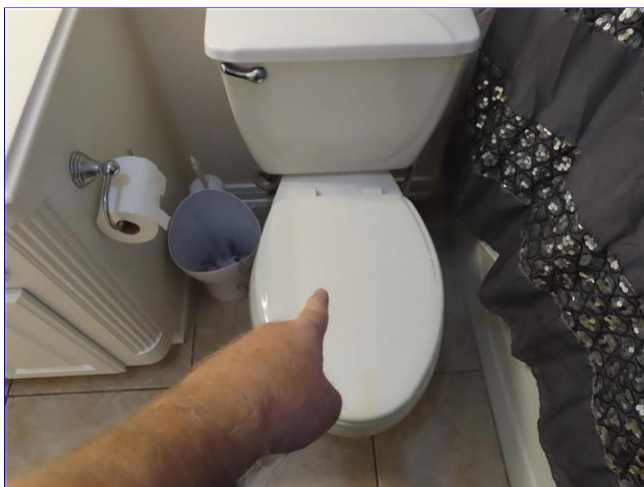
A. Item 4(Picture)

(4) Toilets were loose to the floor at time of inspection. Should be corrected by a professional plumber. Conducive to leaking and causing possible damage.

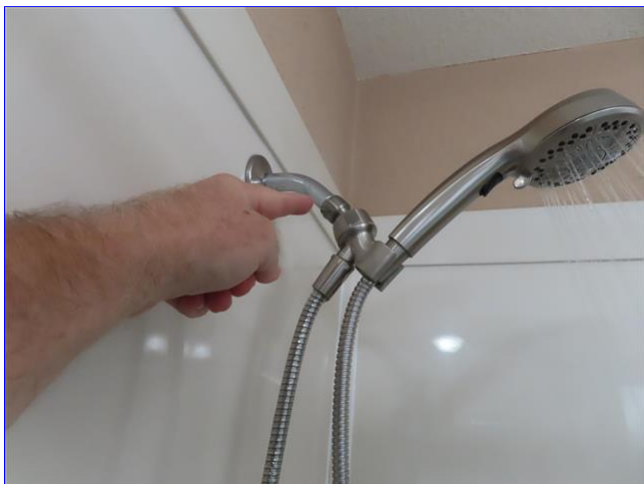
A. Item 5(Picture)

(5) Master showerhead was leaking at plumbing connection at time of inspection. Should have a professional plumber correct properly.

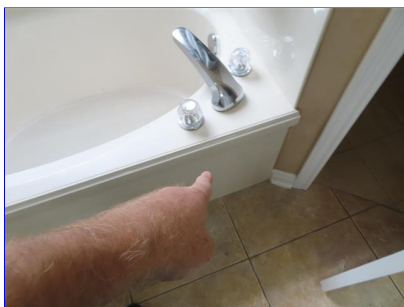
A. Item 6(Picture)

(6) Bathtubs and showers were missing plumbing access panel at time of inspection. Should have a professional plumber correct properly.

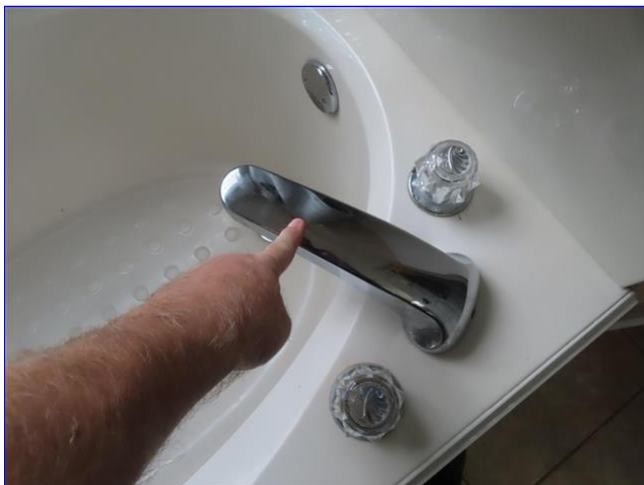
A. Item 7(Picture)

(7) Master bathtub faucet was loose at time of inspection. Should have a professional plumber correct properly.

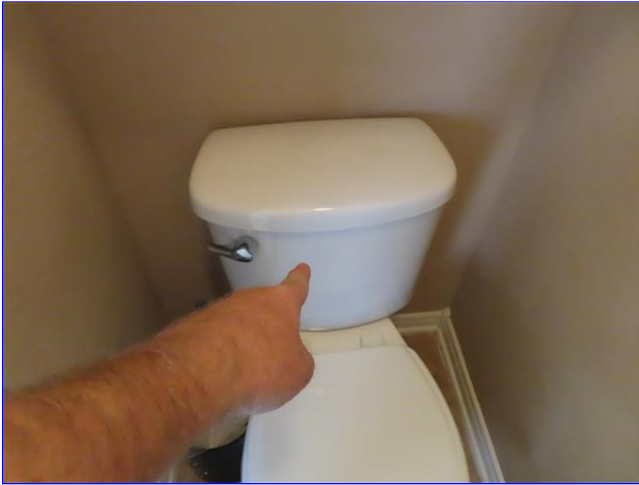
A. Item 8(Picture)

(8) Toilets bowls were loose at time of inspection. Should have a professional plumber correct properly. Conducive to leaking and causing possible damage.

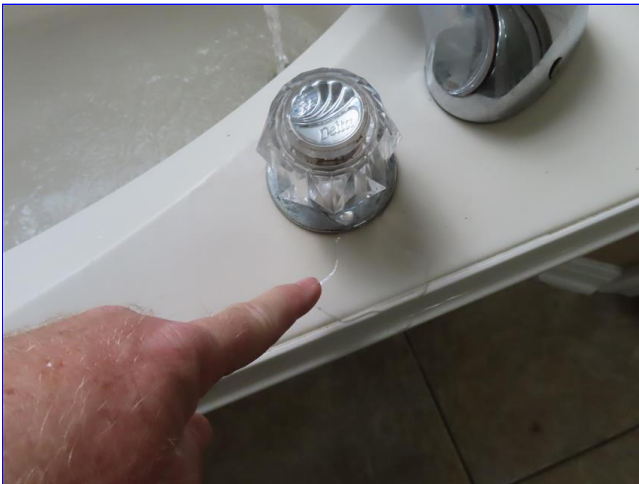
A. Item 9(Picture)

(9) Master bathtub cold side plumbing valve was leaking at time of inspection. Should have a professional plumber correct properly.

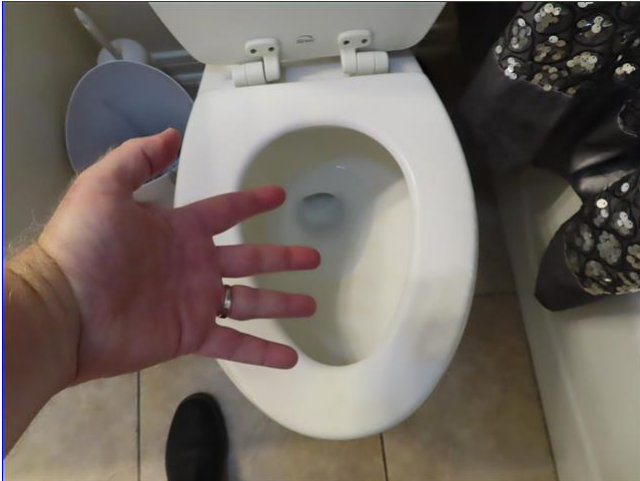
A. Item 10(Picture)

(10) Middle bathroom toilet would not shut off completely after flushing at time of inspection. Should have a professional plumber inspect and correct properly.

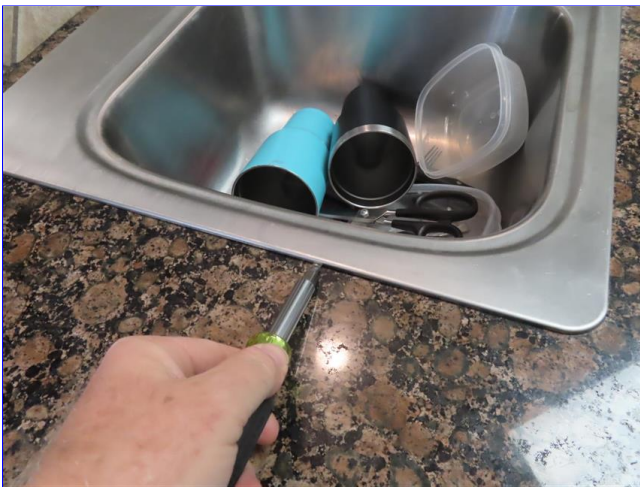
A. Item 11(Picture)

(11) Kitchen sink should be sealed properly to the countertop. Conducive to moisture intrusion and causing possible damage.

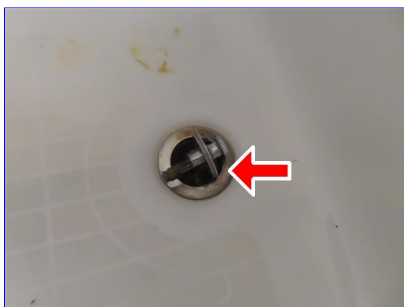
B. Item 2(Picture)

(2) Several bathtub drain stoppers were not installed properly at time of inspection. Should correct properly.

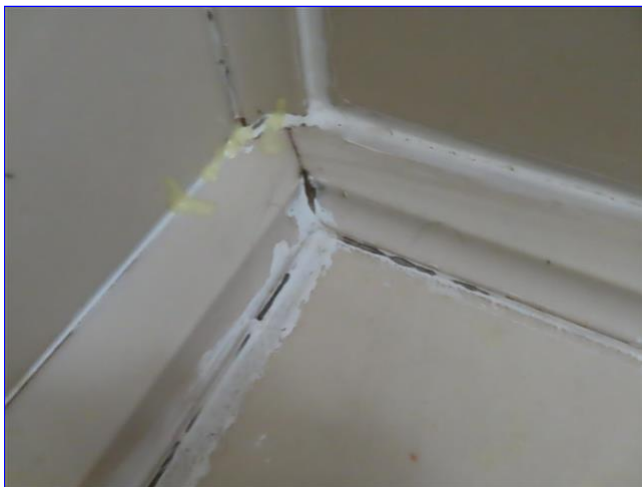
B. Item 3(Picture)

(3) All master shower pan penetrations and gaps should be sealed properly. Conducive to leaking and causing possible damage.

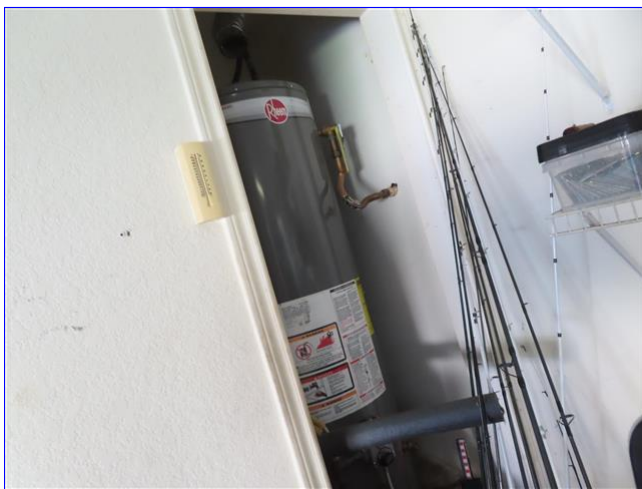
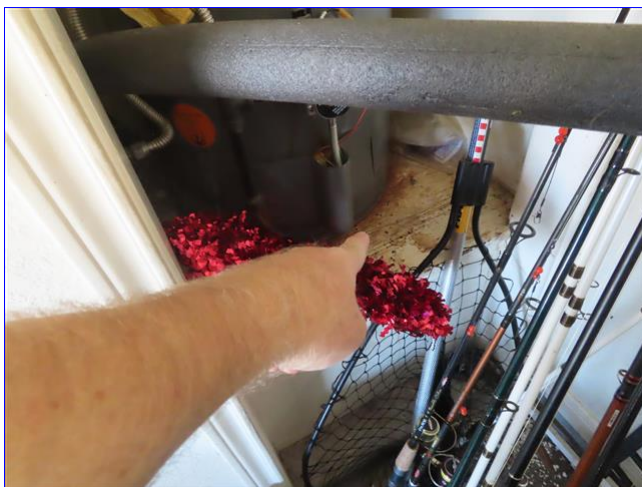
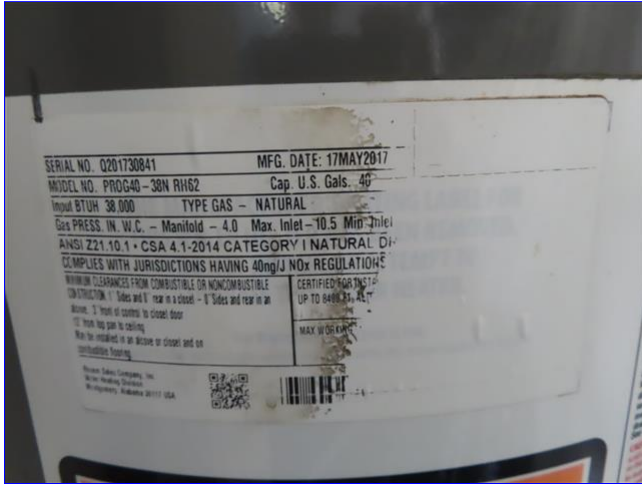
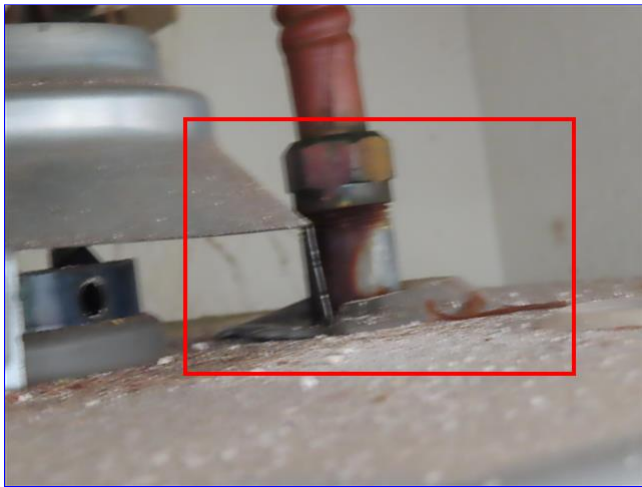
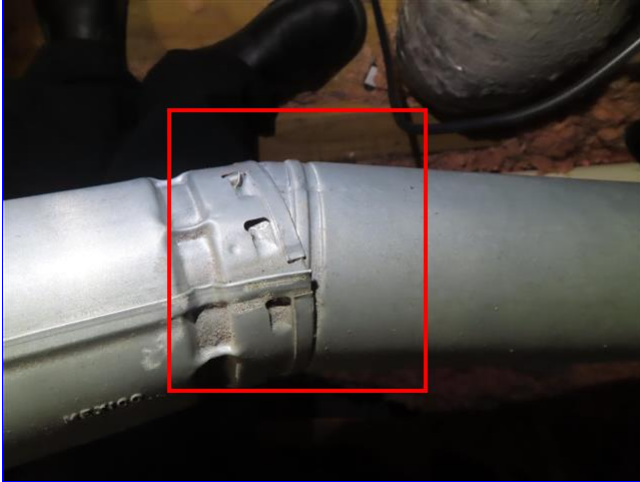
2017 Rheem gas 40 gallon hot water heater in the garage was operating properly at time of inspection. Unit was missing drip pan and drain to exterior, top plumbing connection is rusting and has signs of possibly leaking, exhaust duct is disconnected from flue and leaking possible Carbon Monoxide into the garage and possible living space, exhaust duct in the attic is disconnecting at joint, gas plumbing to unit was missing electrical bonding at time of inspection. Should have a professional plumber inspect and correct properly.

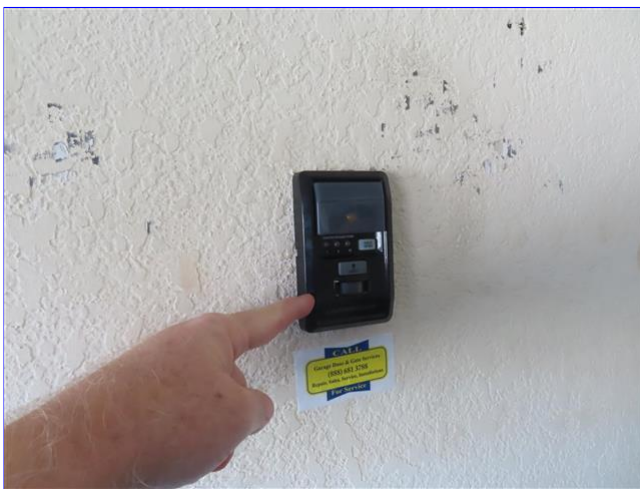
G. Item 2(Picture)

(2) Garage door opener controller is loose from the wall at time of inspection. Should correct properly.
