February 18, 2026

A slab on grade foundation check was conducted on the home property at 11533 Sandy Loam Trail, Austin, TX, 78750. This is an onsite foundation evaluation only and does not take the place of a full home inspection report as it only addresses the foundation of the home. No baseline foundation elevation report was available at the time of this inspection to verify how the foundation was performing when new or what the original elevation of the home was after construction.

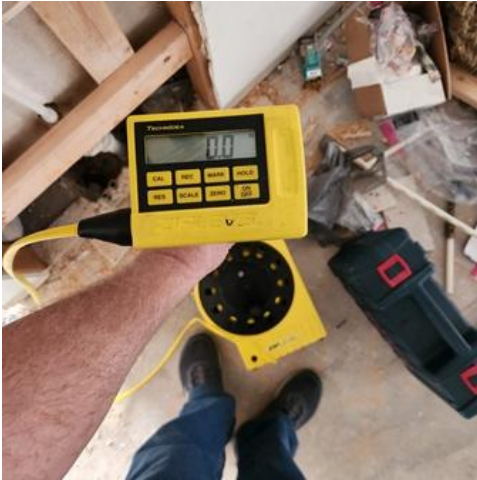
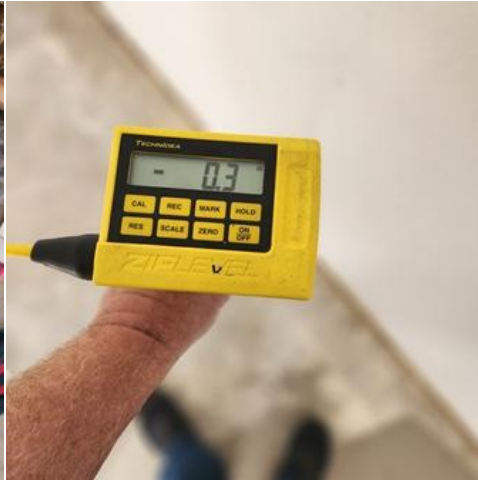
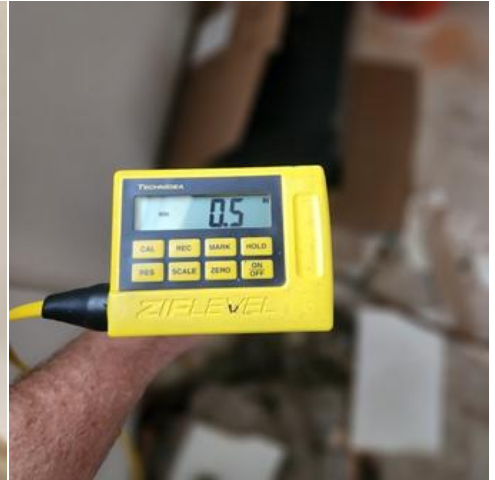
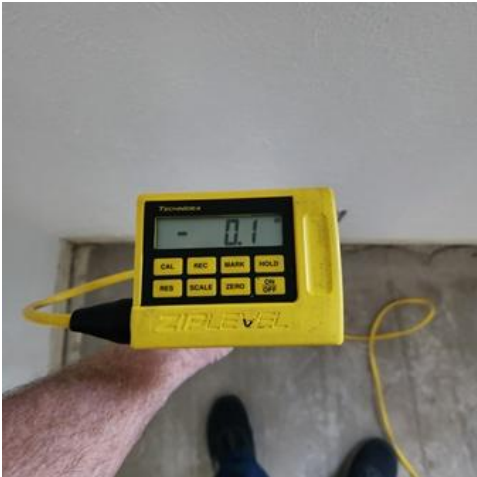
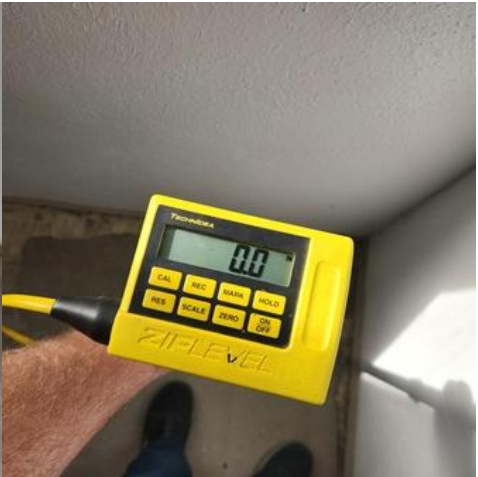
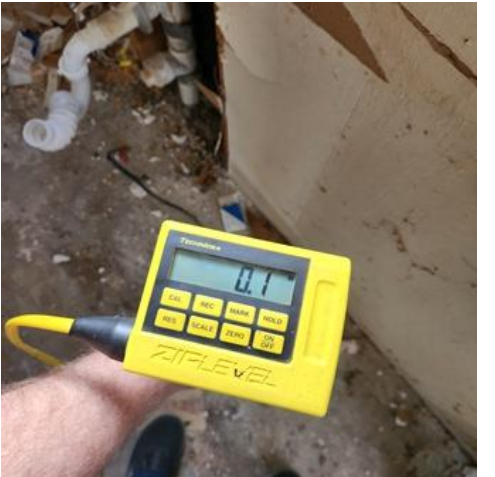
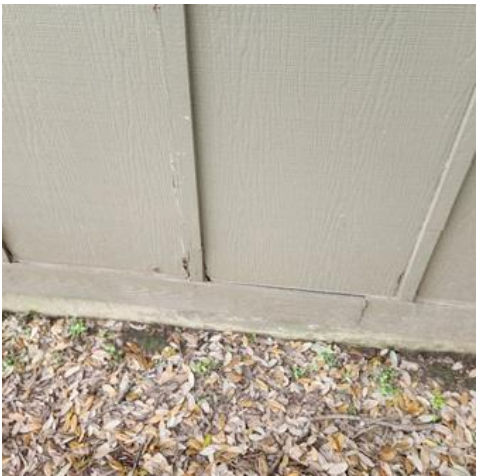
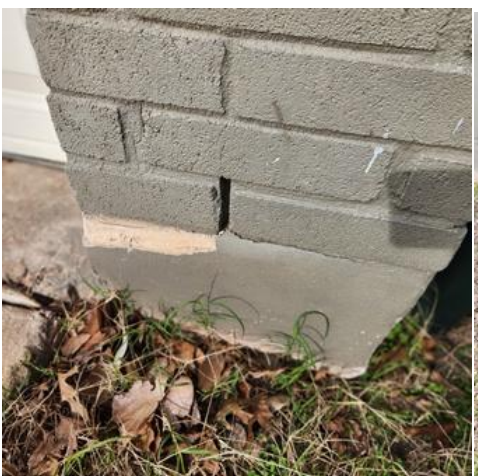
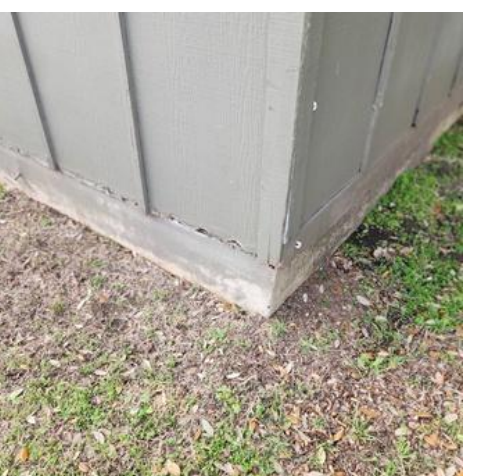
Photo sampling shown below.
