## SUMMARY

17819 Serene Shore Dr, Cypress, TX  
77429  
Gwedolyn Burwell  
February 10, 2023

Jeff Ashley  
TREC #23924  
J. Ashe Home Inspection, LLC  
8326415338  
jashe832@gmail.com

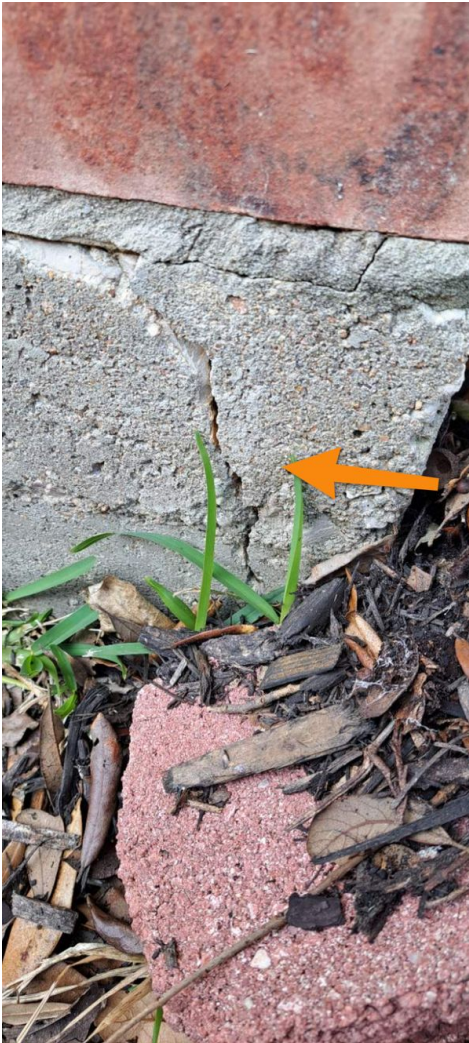
Front left corner

### 2.1.1 A. Foundations SLAB - CORNER CRACK/POP

One or more of the foundation perimeter beam corners were observed to be either cracked, or sheared off (corner pop). This is a common condition in slab on grade foundations. This condition does not adversely affect the performance of the foundation. However, in some cases, some cosmetic improvements may be necessary.

Recommendation  
Contact a qualified professional.

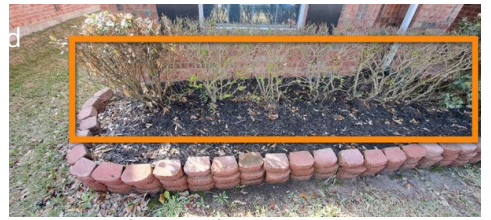
Front at planters box

**SLAB - FOUNDATION NOT VISIBLE IN AREAS AROUND THE HOME.**

The foundation was not visible in all areas due to obstruction, this is a condition that is conducive to wood destroying insects. We recommend that a WDI (Wood Destroying Insect) inspection be done by a certified WDI inspector.

The foundation should be visible around all areas of the home the proper clearance for wood siding should be at least 6" above the earth and brick should be at least 4 " above the earth to keep the chance of wood destroying insects and water from damaging or entering the home undetected.

Contact a qualified professional.

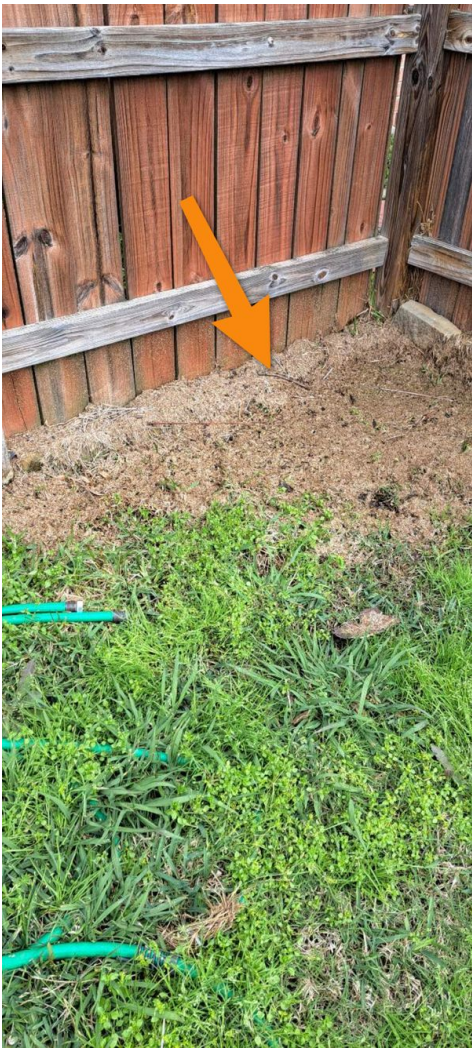
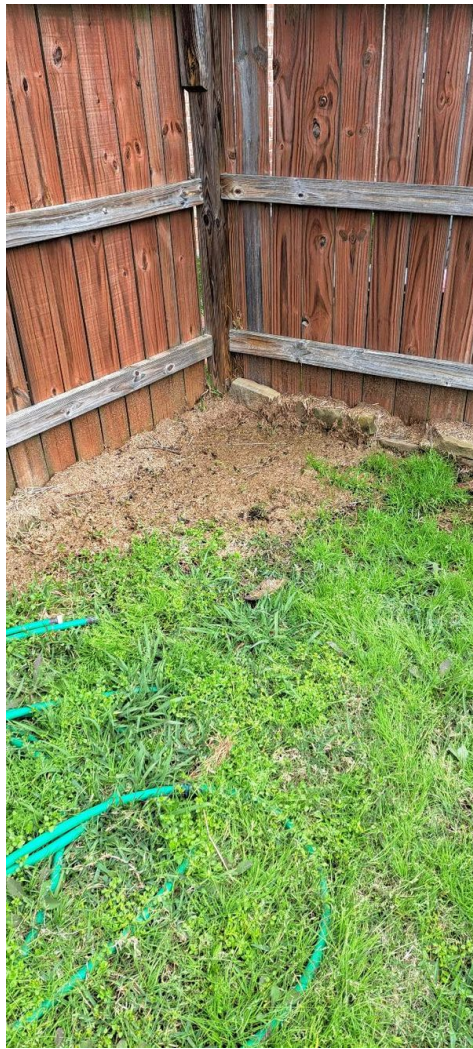
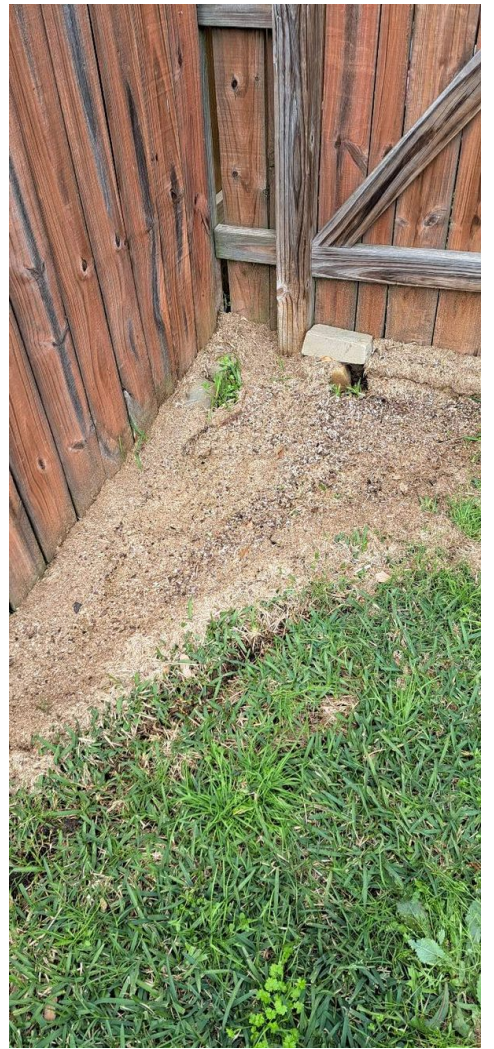
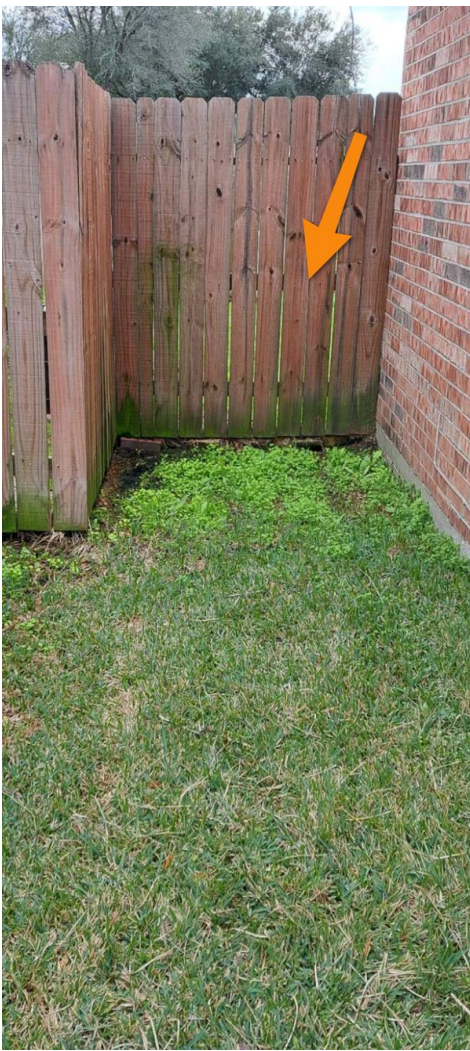
**EROSION AND  
SETTLING SHOULD BE FILLED IN**

We recommend all areas of erosion and settlement in the dirt be filled around the home, to keep water from pooling or erosion from continuing next to the structure. When there are low spots next to a structure, this could allow water to penetrate the brick and seep into the home and cause damage to the interior.

Contact a handyman or DIY project

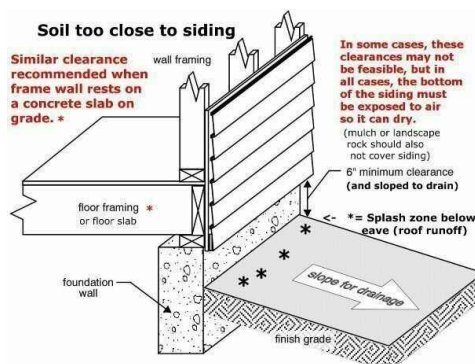
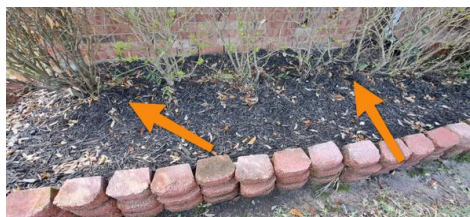
### GRADING- HIGH SOIL/MULCH NEXT TO THE HOME

The soil/mulch levels were high against isolated areas of the foundation grade beam. When soil or mulch levels and vegetation are high against the face of the foundation it promotes water penetration, wood rot and insect infestation. Brick veneer wall cladding should have about 4" of clearance between the soil/mulch and the first course of bricks, and other materials should have 6" of clearance between other materials and the soil/mulch. When siding is installed directly on the ground it is important to note that inspectors cannot see the foundation grade beam and there is more of a chance for water to enter the home in times of heavy rains. It is very important to check with the Owner to make sure there has not been flooding into the home and if there has, That proactive measures should be taken to make sure that the water issues have been repaired.

Contact a qualified professional.

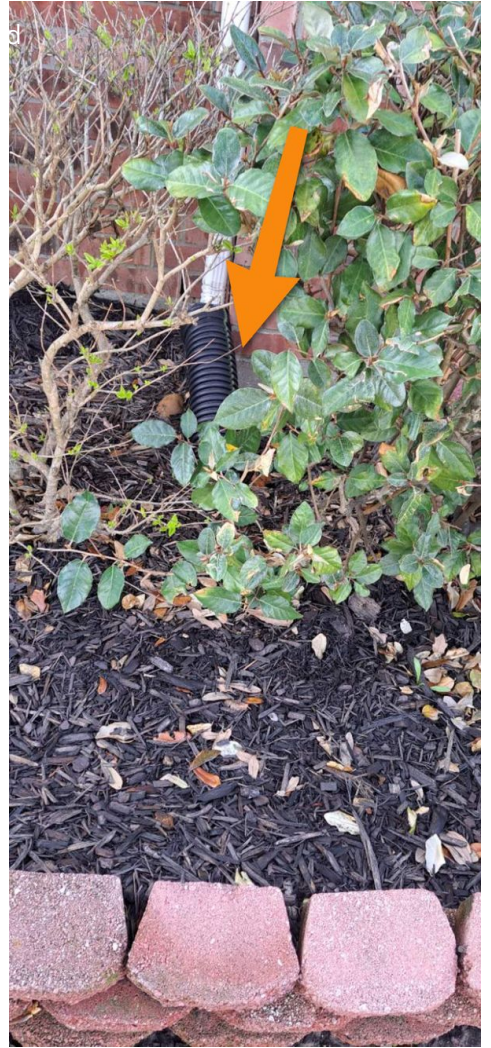
Front

**BURIED CORRUGATED DRAIN**

Unable to determine if buried corrugated drain functions properly. Recommend monitoring during and after a rain event to determine if corrections are needed.

Contact a qualified professional.

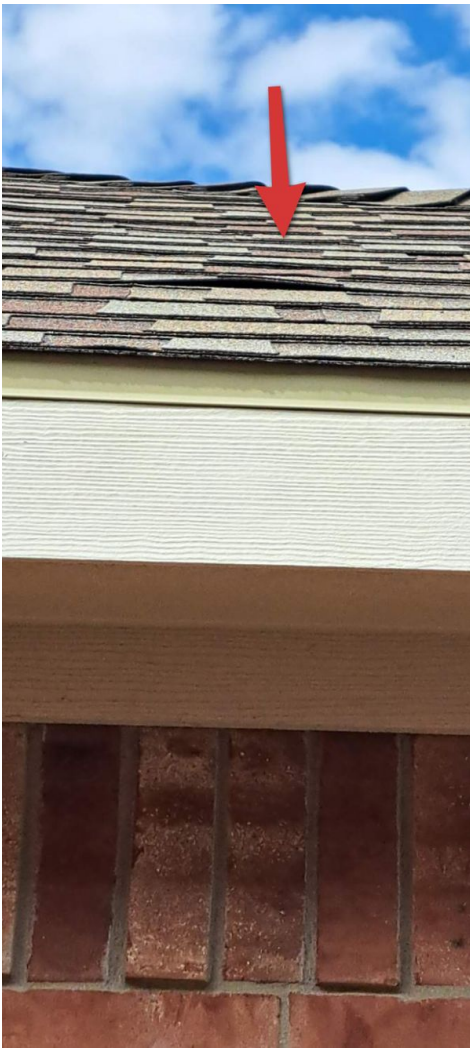
Left side near front

**LIFTED SHINGLE(S)**

Observe lifted shingle(s) around different areas of the roof. Lifted shingle(s) can cause leaks during a wind driven rain and cause other shingles to lift up and have moisture intrusion into the home.

Contact a qualified roofing professional.

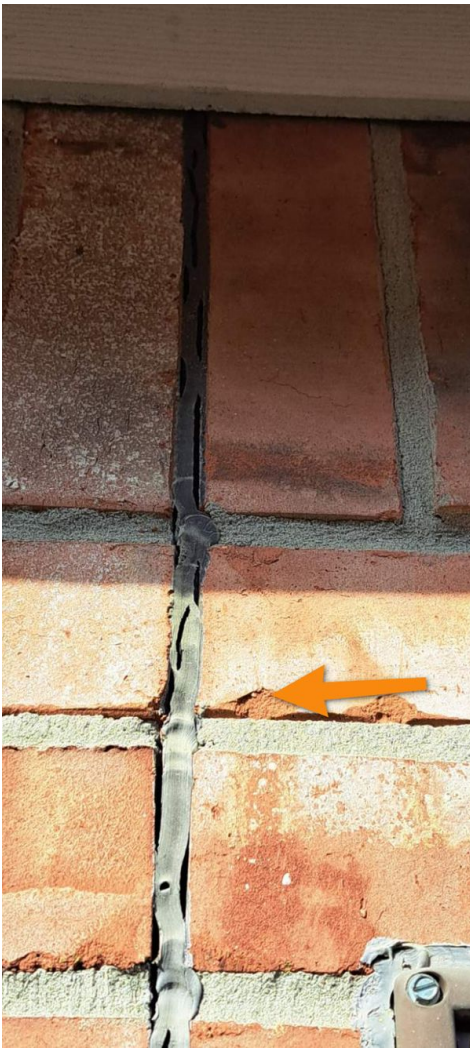
Left side at 1st expansion joint

**EXTERIOR: LACK OF AND/OR DETERIORATING SEALANT**

Observed a lack of sealant and/or deteriorating sealant in one or more exterior locations. Recommend sealing to prevent water intrusion.

Contact a qualified professional.

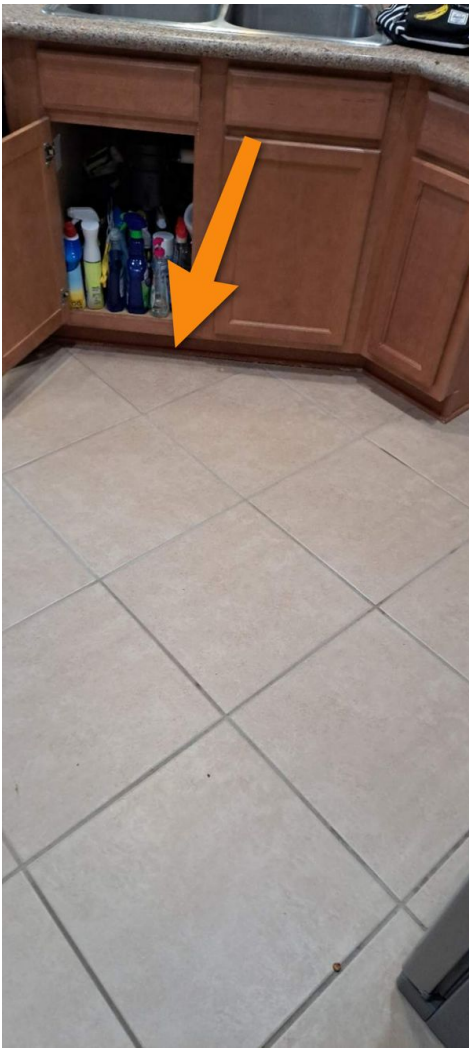
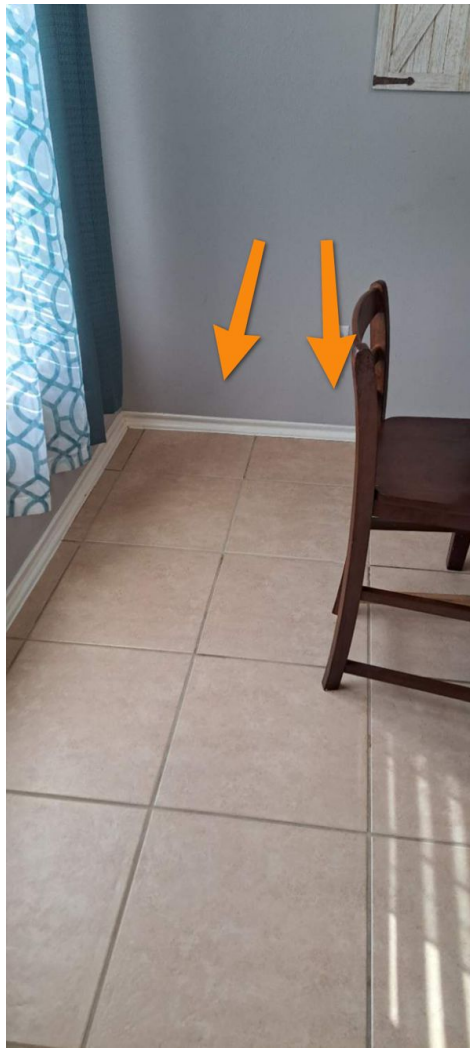
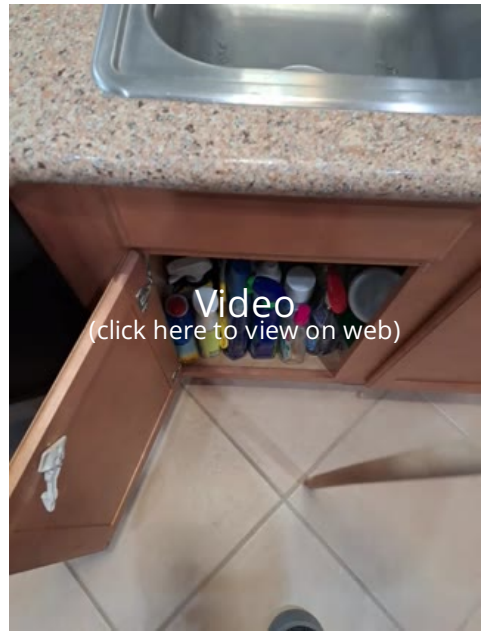
**HOLLOW TILE**

Hollow tile was observed in the home.

Contact a qualified flooring contractor

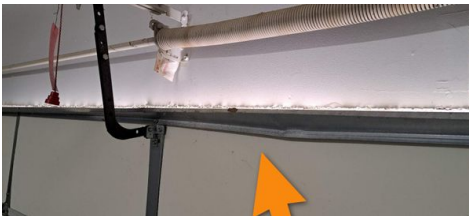
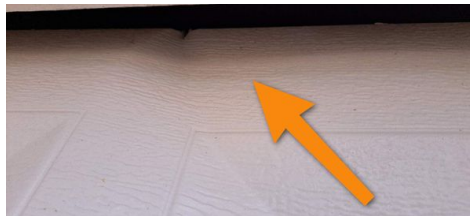
**GARAGE DOOR HAS SOME DAMAGE**

There are areas on the garage door that are in need of repair at the door section seams. It is recommended that you keep all areas of the garage door painted to prevent wood rot.

Recommendation  
Contact a qualified professional.

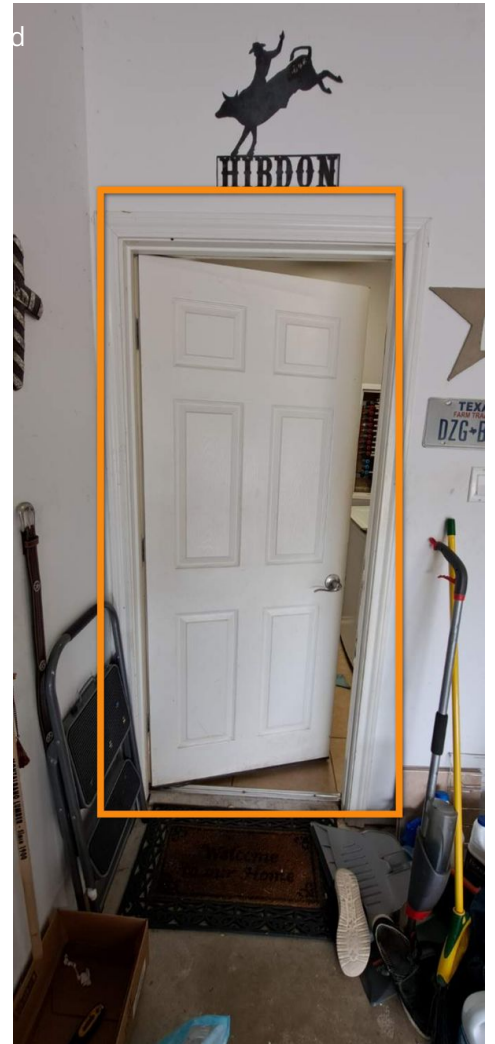
### **GARAGE PEDESTRIAN DOOR NOT SELF CLOSING**

The garage pedestrian door was not self-closing at the time of the inspection. Recommend installing or adjusting self-closing hinges/device.

Contact a qualified professional.

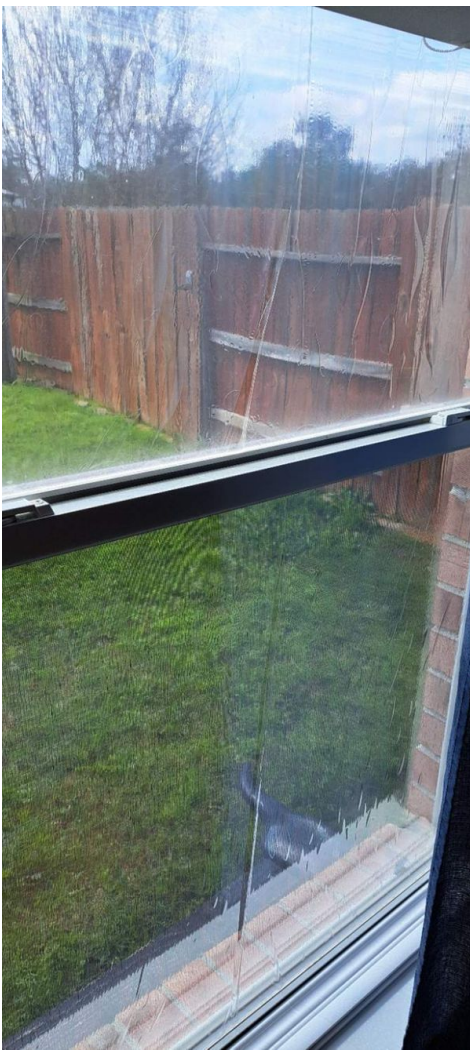
### **TINT PEELING ON WINDOW(S)**

There are one or more windows that have tint on them that is damaged or peeling and these areas should be repaired.

Bubbling tint

Contact a qualified professional.

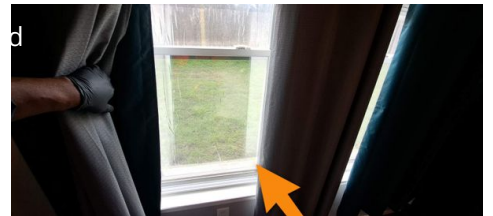
Left window in primary bedroom

**WINDOWS NOT REMAINING IN OPEN POSITION**

One or more windows in normal operation will not remain in the open position. Recommend repair.

Recommendation  
Contact a qualified professional.

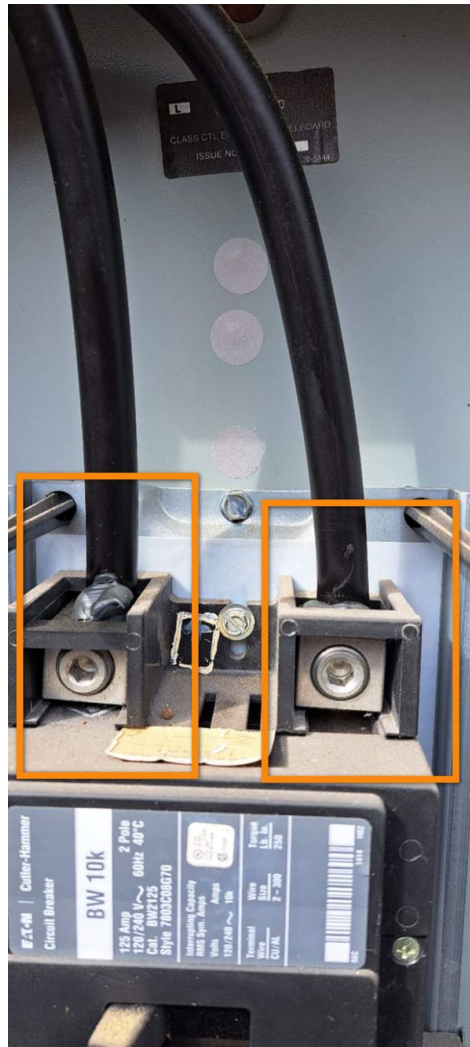
**ELECTRICAL LUG COVERS MISSING ON SERVICE ENTRANCE WIRES**

Service entrance lug covers were not installed over the main entrance connector lugs. This is a requirement per NEC 17.

Recommendation  
Contact a qualified electrical contractor.

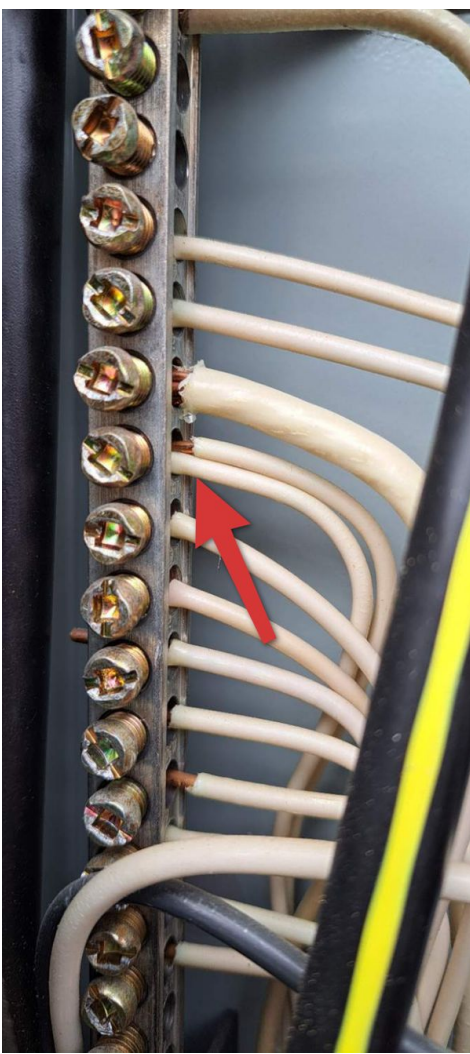
### DOUBLE TAPPED NEUTRALS

Each neutral conductor should terminate under individual terminations and not share a termination with other neutral or ground wires. When neutral wires share a termination point with another wire it is likely that the connection will become loose due to expansion and contraction of wires.

NEC. 2017 408.41 Grounded Conductor Terminations. Each grounded conductor shall terminate within the panelboard in an individual terminal that is not also used for another conductor.

Double tapped neutrals can expand and contract enough to the point where the connection becomes loose. The loose connection could overheat and cause a fire. Check out these double tapped neutrals I found during an inspection. These connections loosened up over time causing arcing and overheating.

Recommendation  
Contact a qualified electrical contractor.

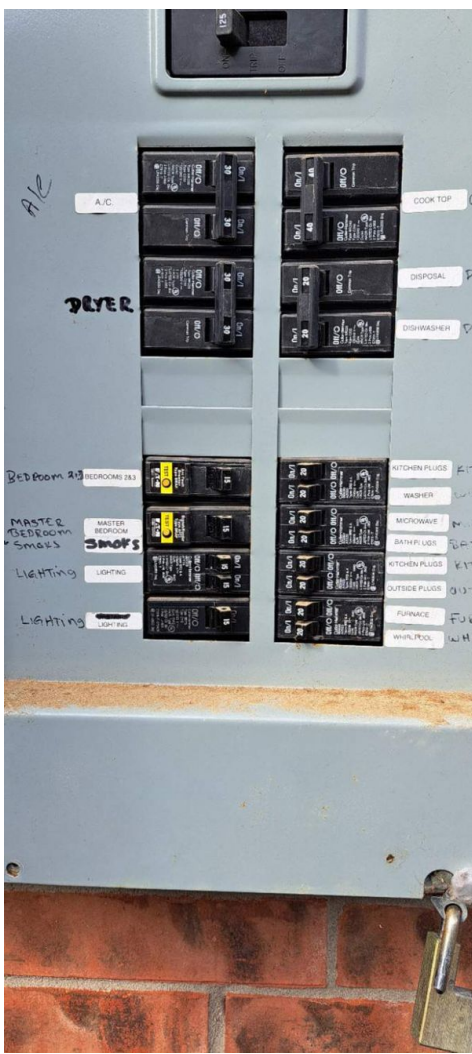
##### **INSUFFICIENT NUMBER OF ARC FAULT BREAKERS**

This home did not meet current arc fault circuit interrupter (AFCI) Requirements. This is an as built condition. Some Items reported as deficient may be considered upgrades to the property for more information return the requirements. This is an as built condition. Some items reported as deficient may be considered upgrades to the property. This home was built prior to the requirements for all living areas to be arc fault protected.

Keep in mind if any electrical work is performed that there is a good possibility that an electrician may be required to add additional arc fault breakers to the electrical panel to meet current requirements.

Contact a qualified professional.

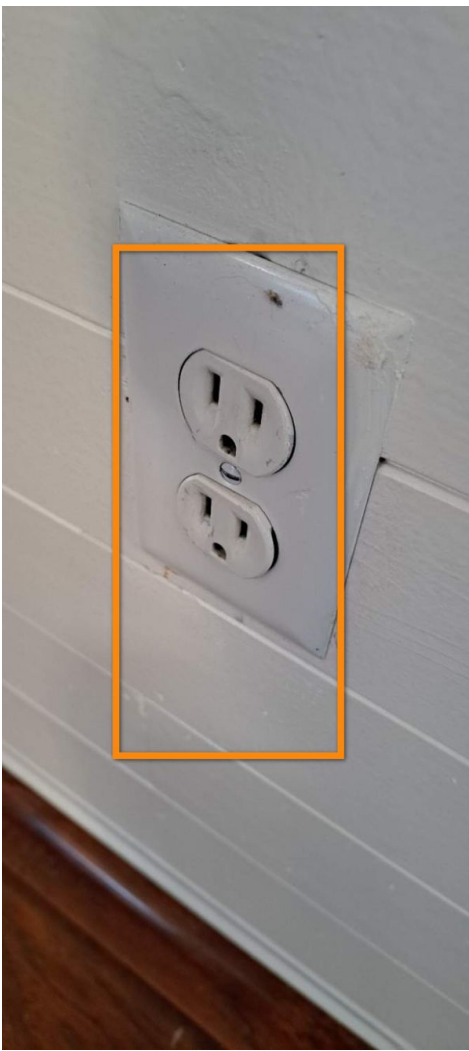
Hall outside of laundry room

#### **LOOSE RECEPTACLES/SWITCHES**

All receptacles and light switches that are loose in their junction box should be tightened. Or the junction box should be secured if applicable.

Contact a qualified professional.

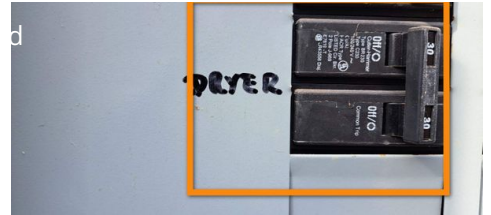
Dryer receptacle

**NO GFCI PROTECTION**

GFCI protection was not present at the time of the inspection. Recommend licensed electrician upgrade by installing ground fault receptacles in all locations.

GFCI protection is required within 6' of the sink. The 6' requirement is due to appliance cord length near the sink.

Contact a qualified electrical contractor.

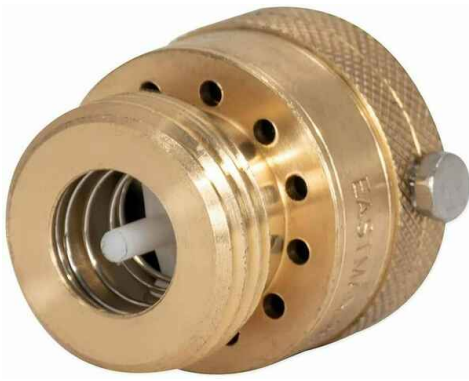
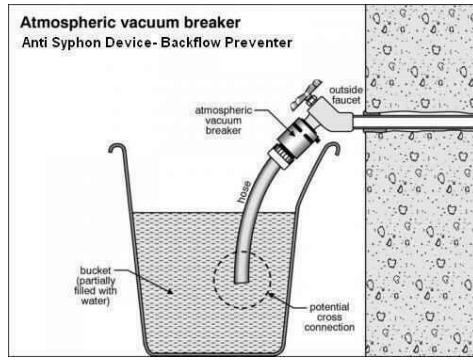
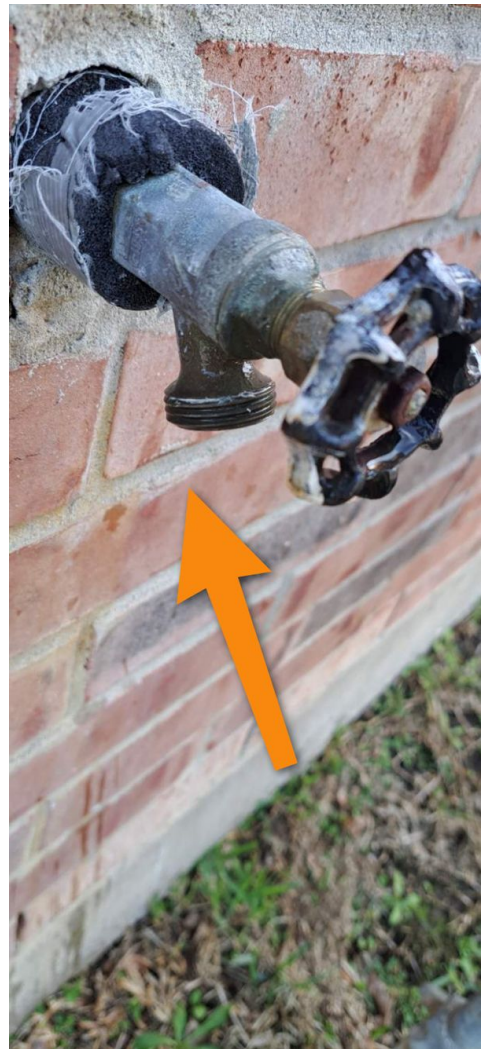
Right exterior faucet

**NO ANTI-SIPHON**

Water spigots on the exterior of the home should have anti-siphon/ back flow prevention devices installed on them to keep the supply lines from being contaminated with trash or severe flood waters. In some cases hose bibs may have a built in anti-siphon but it is difficult to tell unless the tag is left on the hose bib.

Contact a handyman or DIY project

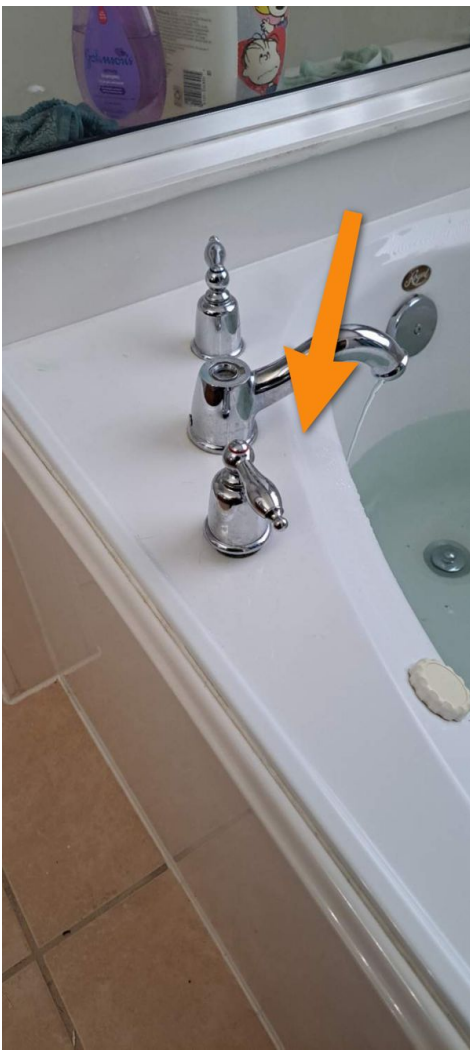
Primary bathroom

**NO STOP ON VALVE HANDLE**

There are one or more valve handles that do not have stops on them. These valve handle will turn continuously.

Contact a qualified plumbing contractor.

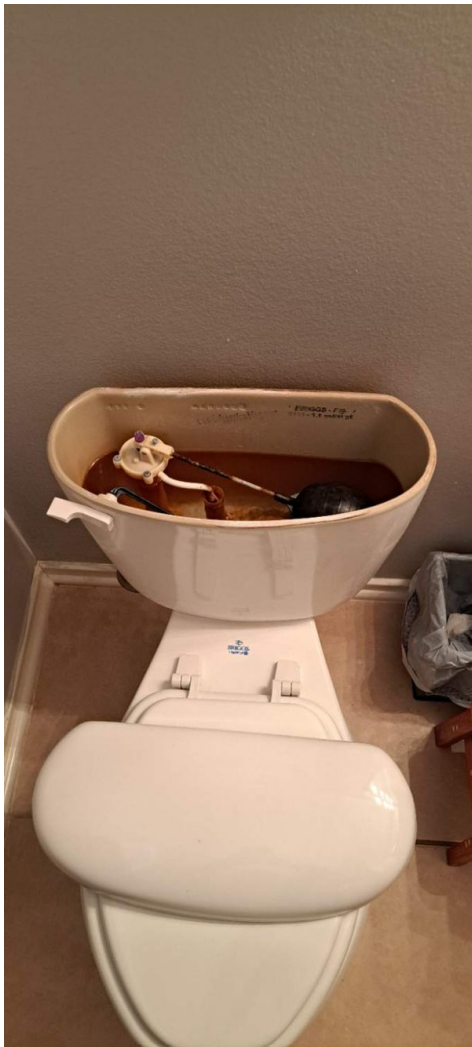
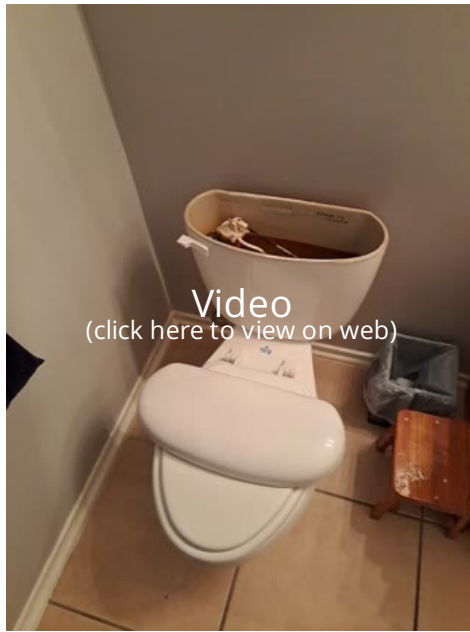
**TOILET RUNNING CONSTANTLY**

There are one or more toilets in this home that are running constantly and need to have adjustments made to the components in the tank.

Contact a qualified plumbing contractor.

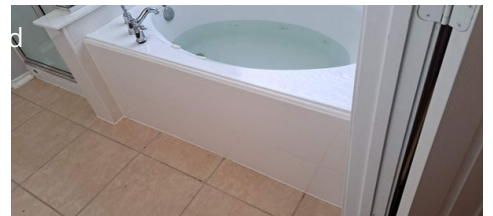
**NO ACCESS**

The hydrotherapy bathtub did not have an access opening present. Access opening are required to obtain access to the hydrotherapy plumbing and the motor. Recommend adding an access point.

Recommendation  
Contact a qualified professional.

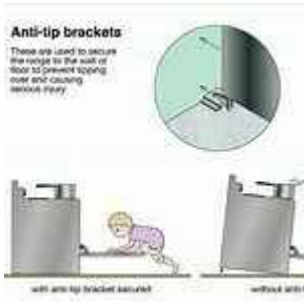
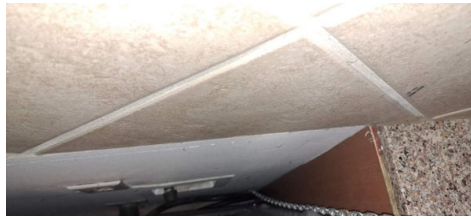
**ANTI TIP BRACKET MISSING**

*An anti-tip bracket was not present for the the range. An anti-tip bracket prevents the range from tipping over, if weight is applied to an open oven door, such as a child stepping or sitting on the door. Ranges contain a warning label on the inside of the oven door with more information. This bracket can be purchased at home improvement stores for approximately ten dollars and the installation of this bracket is highly recommended.*

Recommendation  
Contact a qualified appliance repair professional.
