Property Data Report

Property Type	Property Street Address	Property Street Address (unit #)
Single Family	2630 Skyview Ridge Ct	
Property City	Property State	Property Zip Code
Houston	Texas	77047
Property County

4. Repair and Inspection

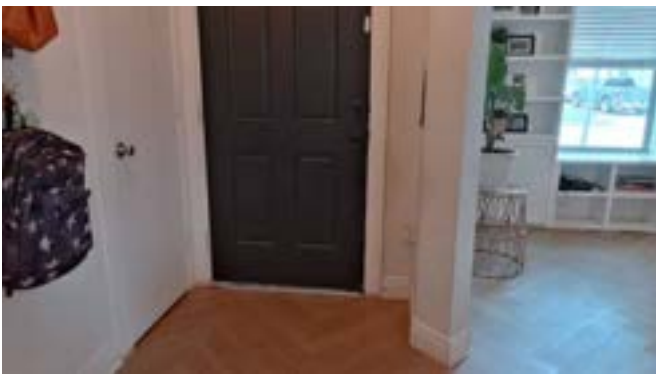
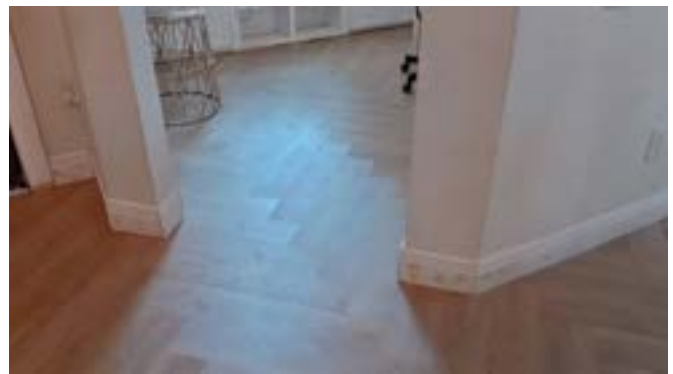
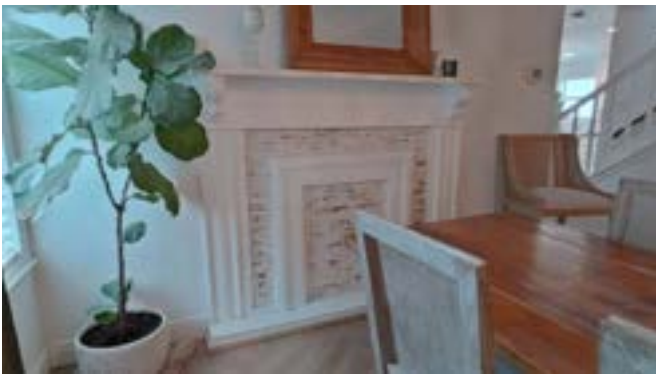
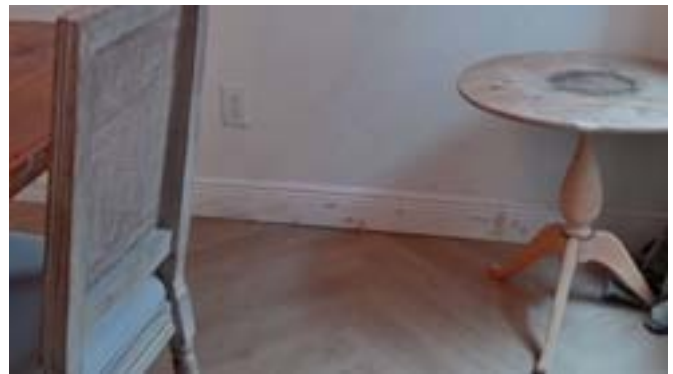
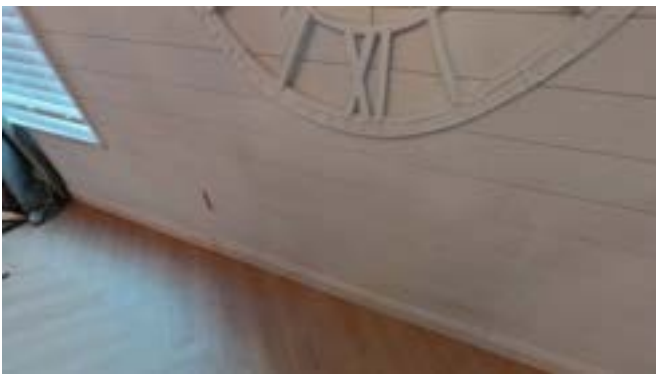
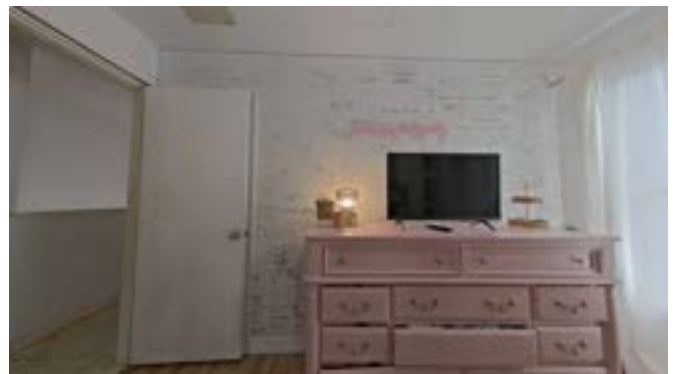
Additional Repair Photos

There are uneven paint on the foyer, dining room, bedroom 2, kitchen and property left side walls. There are stain on the bathroom 2, half bath and primary bedroom doors. There are stain on the office ceiling and wall. There are uneven paint missing switch plate and unfinish flooring at second floor hallway. Missing base board and unfinish flooring at bedroom 3, primary bedroom and walk-in closet. The property right siding has minor damage. There are cracks on the driveway. Missing base board and unfinish flooring at loft.
