HOME INSPECTION 7-6

12818 Ribbon Meadow Ct  
Humble, TX 77346

# PROPERTY INSPECTION REPORT FORM

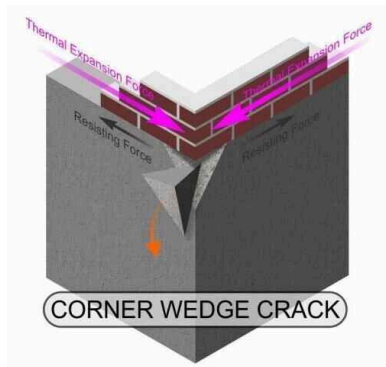
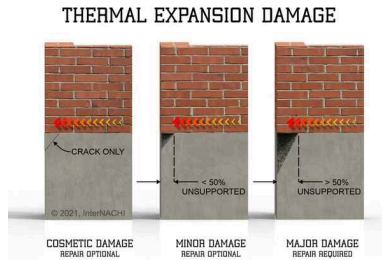
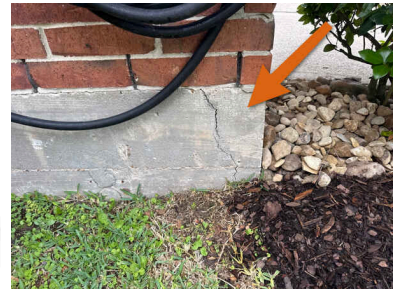
Front left

### 1: Corner Cracks

Cracking was noted at one or more corners of the concrete slab-on-grade foundation. This type of cracking is commonly referred to as a corner crack or corner pop and is typically considered a cosmetic or minor maintenance condition when not accompanied by displacement or other indicators of foundation movement. The cracks appeared localized at the slab corners and did not appear to indicate significant foundation movement at the time of inspection.

Recommendation: Contact a qualified professional.

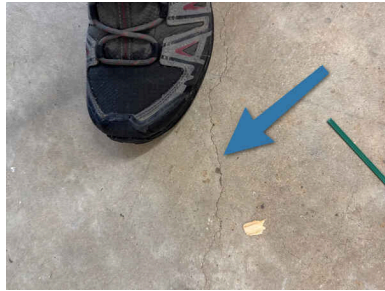
Minor shrinkage cracks were observed in the post-tension concrete slab. These are common, result from the normal curing process of concrete, and are not considered a structural concern. No further action is needed unless the cracks widen or show signs of displacement.

Shrinkage cracks

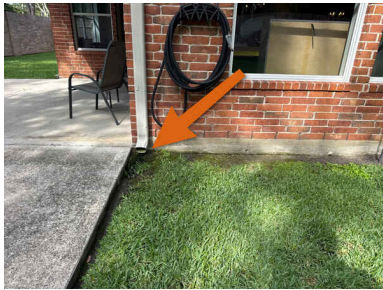
One or more downspouts discharge roof drainage next to the foundation. Concentrated roof drainage at the foundation can create excessive soil moisture and may contribute to soil expansion, erosion, or other conditions that can adversely affect foundation performance over time.

Discharges to foundation

Recommendation: Install downspout extensions to discharge roof drainage away from the foundation, preferably a minimum of 6 feet from the structure where site conditions allow.

Recommendation: Contact a qualified gutter contractor

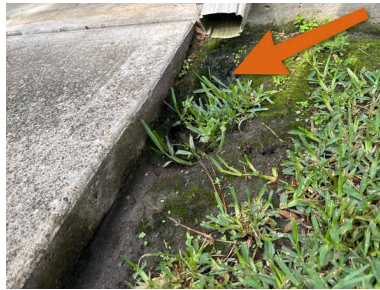
Discharges to foundation

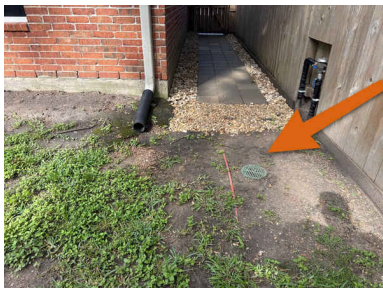
**2: Bare Soil Subject to Erosion**

Bare soil

Recommendation: Stabilize the exposed soil with appropriate ground cover, gravel/rock, splash blocks, or other suitable erosion-control measures while maintaining positive drainage away from the foundation and toward the intended drain

Recommendation: Contact a qualified professional.

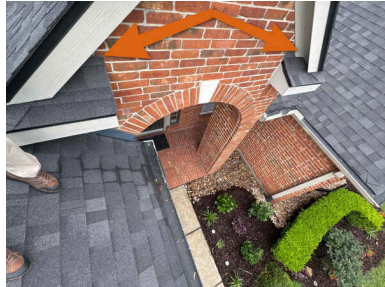
Gaps were noted at the top edge of roof-to-wall base flashing where the roof abuts a vertical brick wall. Proper counterflashing was not visible, and the flashing appeared to rely on sealant at the brick veneer. Sealant is a maintenance-dependent material and should not be relied on as the primary flashing protection. This condition can allow water behind the flashing and can create conditions conducive to moisture intrusion. Correction by a qualified roofing contractor is recommended.

Missing counterflashing

Recommendation: Contact a qualified roofing professional.

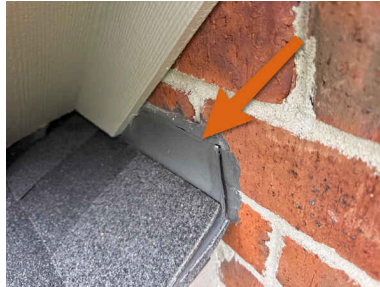
Gaps at wall

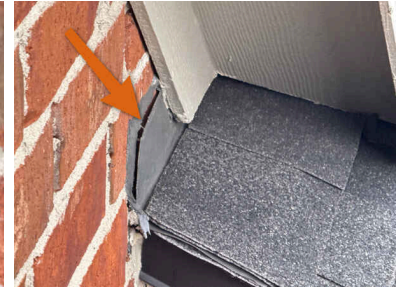
Gaps at wall

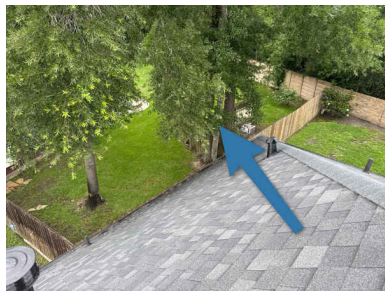
Removing tree limbs that are in proximity to a roof is essential for preventing roof damage, minimizing the accumulation of debris, reducing the risk of falling branches, preventing pest access, and mitigating fire hazards. Regular tree maintenance and pruning are important for preserving the integrity of the roof and ensuring the safety and longevity of the property.

Tree limbs close to roof

Recommendation: Contact a qualified tree service company.

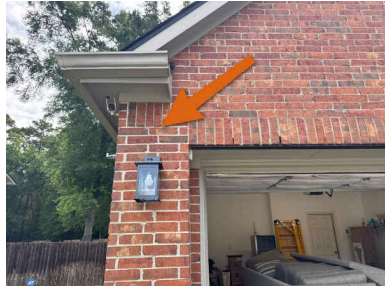
A fine, localized crack was noted in the brick mortar joints near the garage door opening, adjacent to the lintel. No related movement indicators were noted in the readily visible interior areas at the time of inspection. The crack appeared to be a minor cosmetic/maintenance condition. Seal or repair the affected mortar joint as needed and monitor for changes.

Mortar joint crack

Recommendation: Contact a qualified masonry professional.

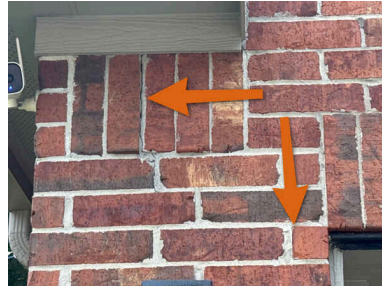
Mortar joint crack

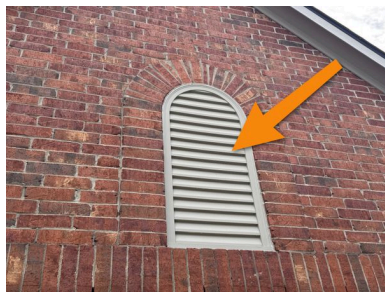
**2: Decorative Gable Vent Separated**

The separated condition can allow moisture entry behind the component and may continue to worsen if not corrected. Reinstallation, securement, and proper sealing of the gable vent by a qualified contractor are recommended.

Recommendation: Contact a qualified professional.

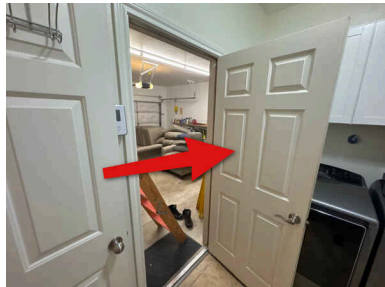
**This may not have been a requirement when the home was originally constructed.**

Missing self closing hinges.

Recommendation: Contact a qualified handyman.

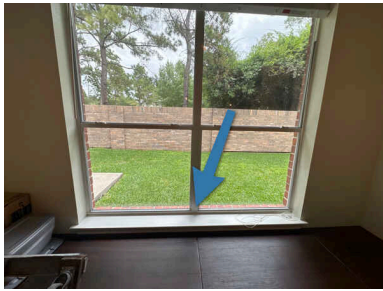
This condition appeared consistent with localized condensation at the aluminum-framed window rather than active moisture intrusion at the time of inspection. Condensation can occur at aluminum window frames during periods of high indoor humidity, cooler exterior temperatures, or limited air circulation.

Localized finish damage at windowsill

Recommendation: Contact a qualified painting contractor.

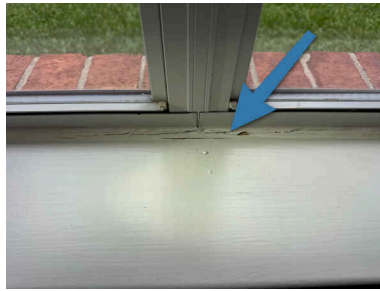
Localized finish damage at windowsill

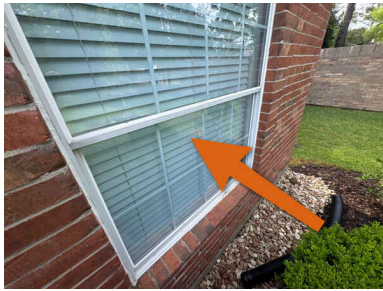
These conditions appeared consistent with normal age, use, and exterior weather exposure. Repair, adjustment, sealing, and routine maintenance are recommended as needed to improve operation and reduce continued deterioration.

General deterioration

Recommendation: Contact a qualified window repair/installation contractor.

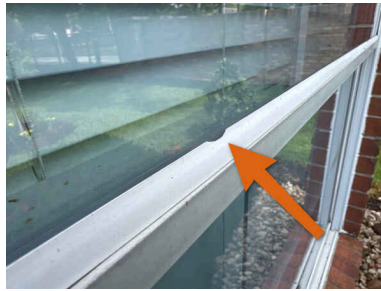
Trim decay

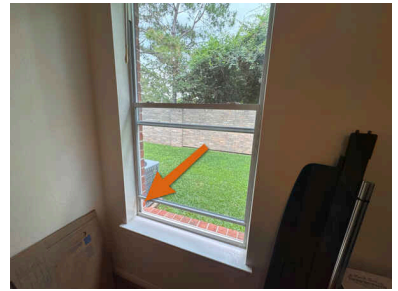
Stuck/separated window balances

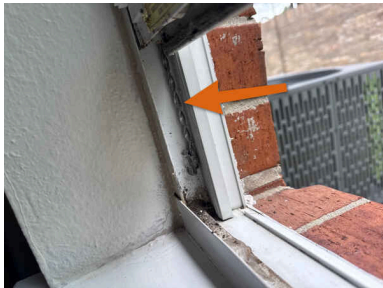
Stuck/separated window balances

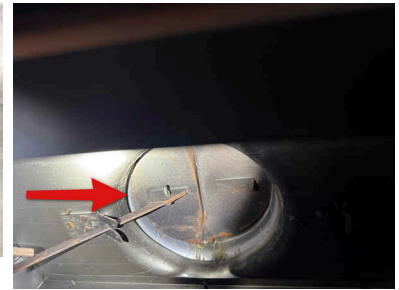
The gas log fireplace does not have a damper clamp. A damper clamp is a required safety device designed to keep the damper partially open at all times. This ensures proper venting of combustion gases, including carbon monoxide, out of the home. Without a damper clamp, the damper could be fully closed while the gas logs are in use, which could lead to dangerous gas buildup inside the home.

Damper clamp not present

Recommendation: Contact a qualified professional.

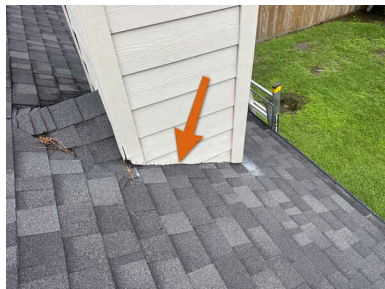
The fiber-cement siding at the chimney chase was in contact with or too close to the roof surface, with minor deterioration noted at the lower edge. Correction is recommended to maintain proper clearance above the roof covering and reduce continued moisture-related deterioration.

Minor siding deterioration at roof

Recommendation: Contact a qualified siding specialist.

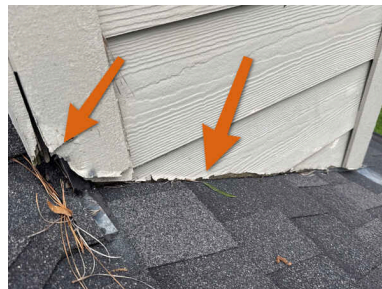
Minor siding deterioration at roof

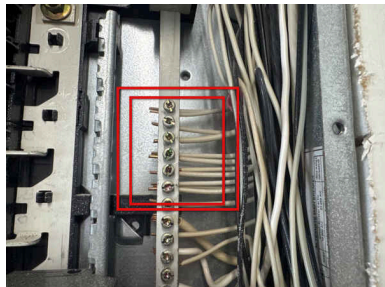
This is an improper wiring condition that can result in loose or unreliable connections and may create an overheating or arcing hazard. Correction by a licensed electrician is recommended.

Double lugged neutrals

Recommendation: Contact a qualified electrical contractor.

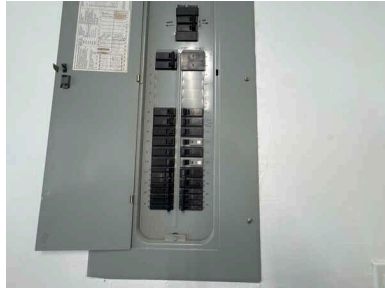
This is noted as a required TREC reporting item. It does not necessarily mean the home is required to be retrofitted solely due to age or changes in electrical standards. Expanding AFCI protection may improve electrical safety, and a licensed electrician can review the system and discuss practical options if upgrades are desired or otherwise required.

Partial AFCI protection

Recommendation: Contact a qualified electrical contractor.

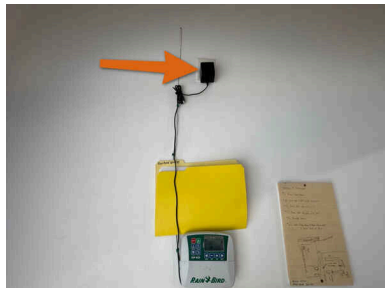
Missing GFCI protection

Recommendation: Contact a qualified electrical contractor.

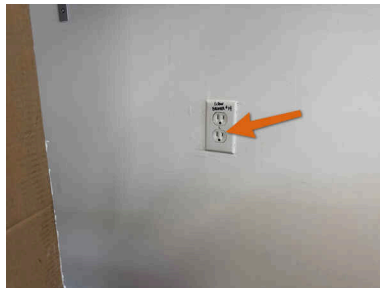
Missing GFCI protection

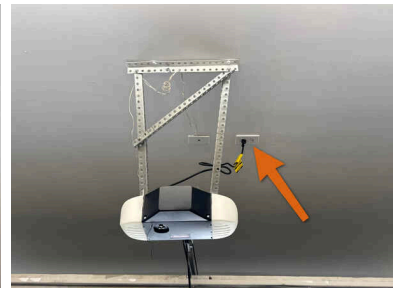
Missing GFCI protection

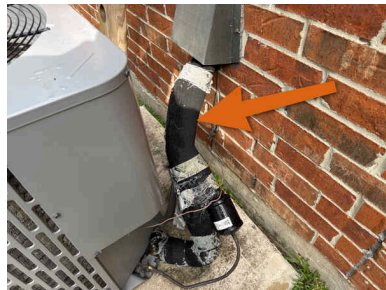
**1: Refrigerant Line Insulation Missing/Damaged**

Deteriorated insulation

Recommendation: Contact a qualified professional.

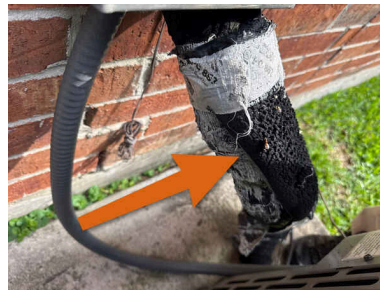
Deteriorated insulation

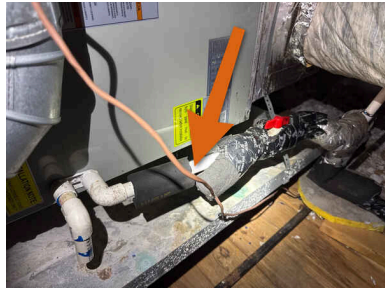
Damaged insulation

Recommendation: Contact a qualified professional.

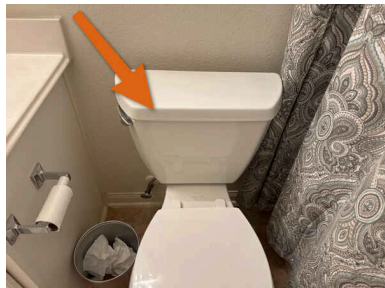
Loose water tank

Recommendation: Contact a qualified plumbing contractor.

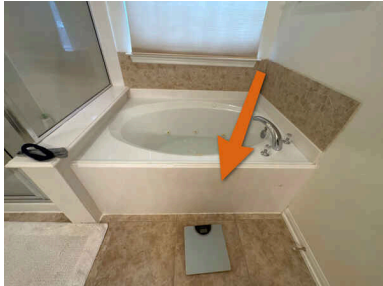
If adequate access is not provided, future service or repair may require cutting or removing finished materials. Correction is recommended to provide proper access in accordance with the tub/pump manufacturer's installation requirements.

Missing pump access

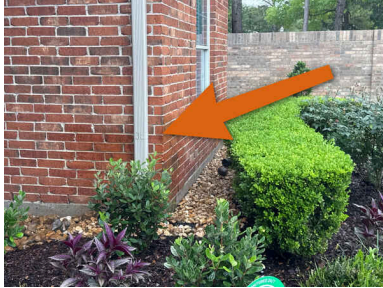
#### 1: Broken heads

Heads water foundation

Recommendation: Contact a qualified professional.
