# Weston Inspection

## Inspection Report

**Property Address:**  
1311 Coppercrest Dr  
Spring Texas 77386

Greg Brainerd	9/2/2025
<i>Name of Client</i>	<i>Date of Inspection</i>
1311 Coppercrest Dr, Spring, Texas 77386	
<i>Address of Inspected Property</i>	
Stephen Weston	TREC #21249
<i>Name of Inspector</i>	<i>TREC License #</i>
<i>Name of Sponsor (if applicable)</i>	<i>TREC License #</i>

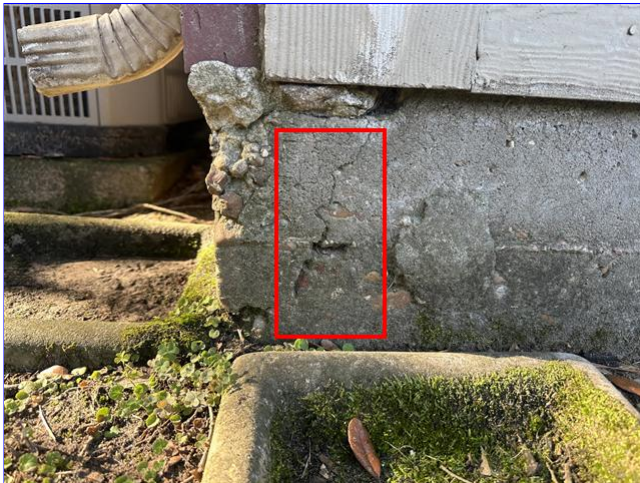
A. Item 1(Picture)

(1) **Cosmetic-** Break observed multiple corners of the foundation. This is referred to as a "corner pop". "Corner pops" are considered to be cosmetic and are common due to excessive pressure at these locations.

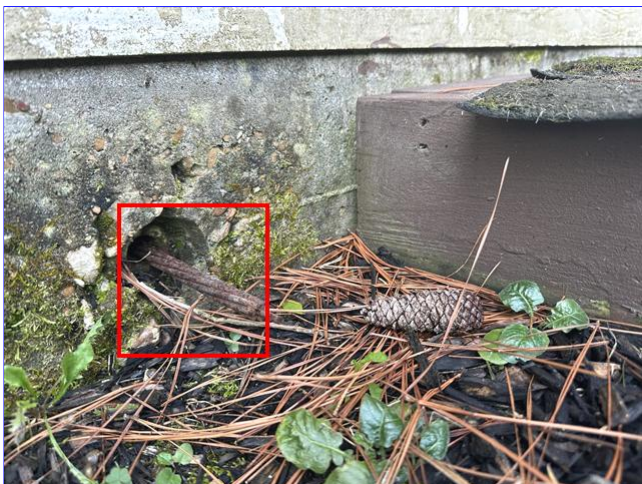
A. Item 2(Picture) rear

(2) **Deficiency-** Observed one or more exposed and corroded tension cables. Prolonged moisture exposure can cause cable corrosion and breakage, potentially damaging the foundation slab. Inspector recommends cleaning, prime, and patch the affected area with approved cement. This work should be performed by a qualified contractor.

Repairs should be made to the exposed tension cables.

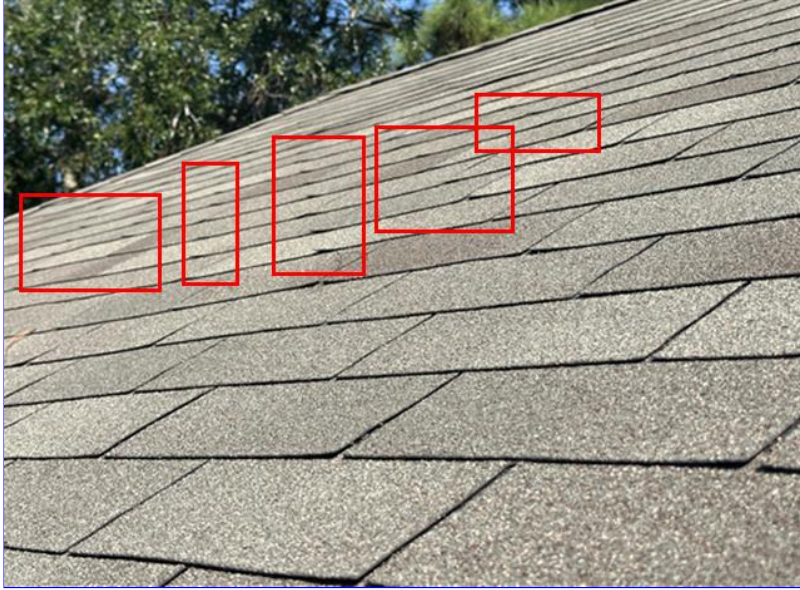
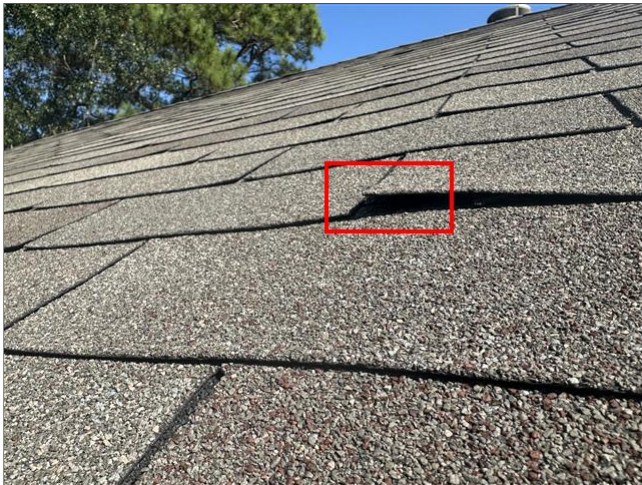
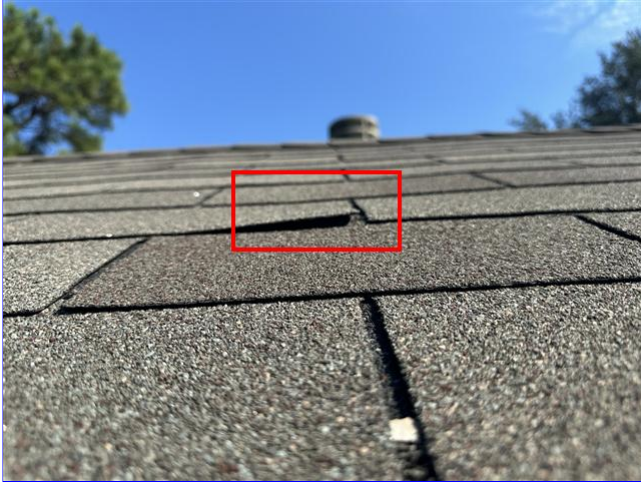
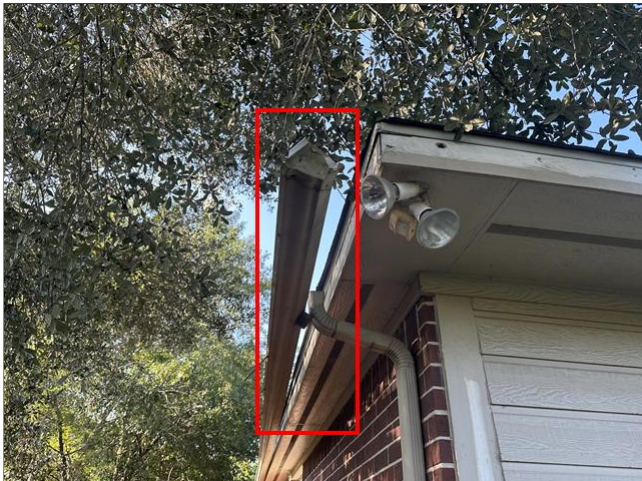
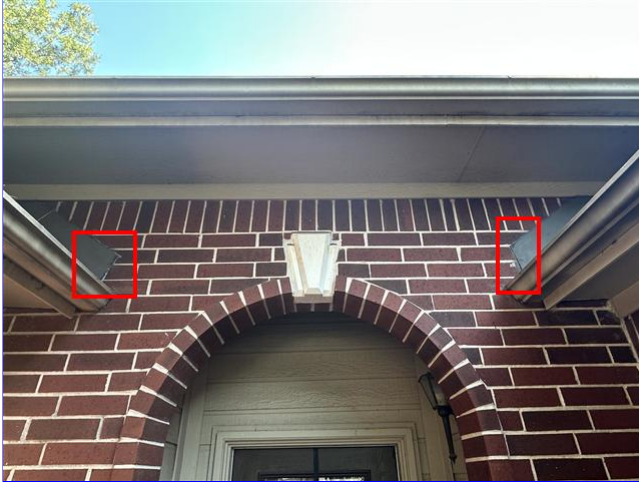
(1) The inspector observed more than 20 shingles with curling at the bottom corners. This condition is often caused by aging, improper installation, or a lack of proper ventilation in the attic. Shingle curling compromises the roof's ability to shed water, which can lead to moisture intrusion into the underlying structure and significant water damage. It also makes the shingles more susceptible to wind damage. It is recommended that a qualified roofing professional evaluate the condition and perform the necessary repairs or replacement to ensure the integrity of the roof system.

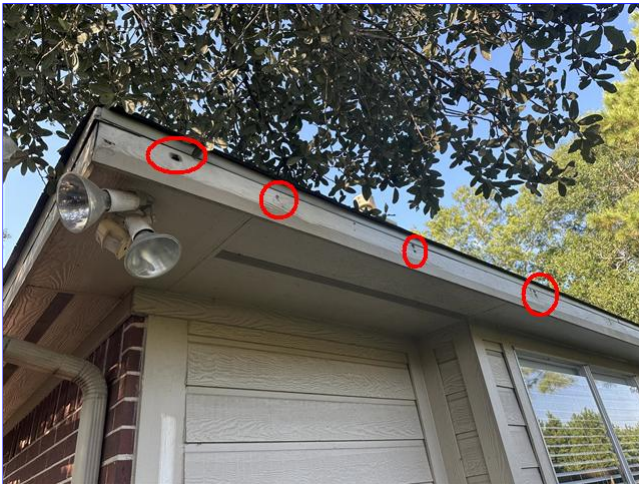
C. Item 9(Picture)

(4) Gutter along the rear roof eave was missing leaving holes in the fascia boards.

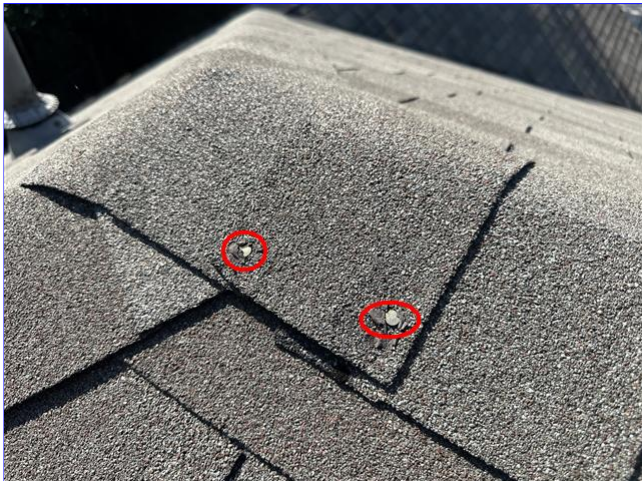
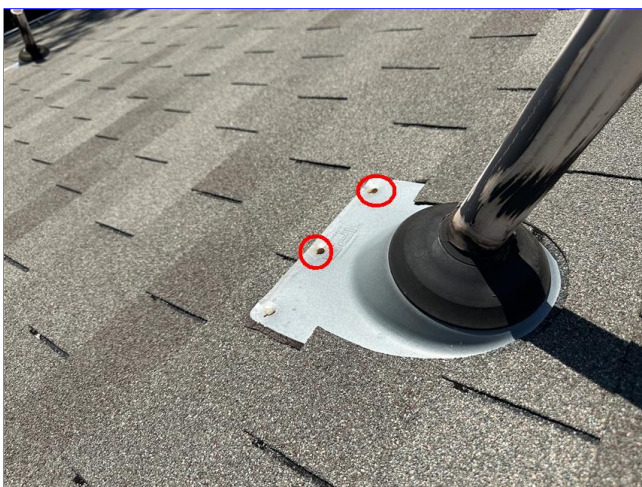
(5) Exposed nail heads were observed at one or more flashing details or ridge shingles. To prevent potential moisture intrusion, the inspector recommends either replacing any corroded nails or applying fresh sealant over the exposed nail heads.

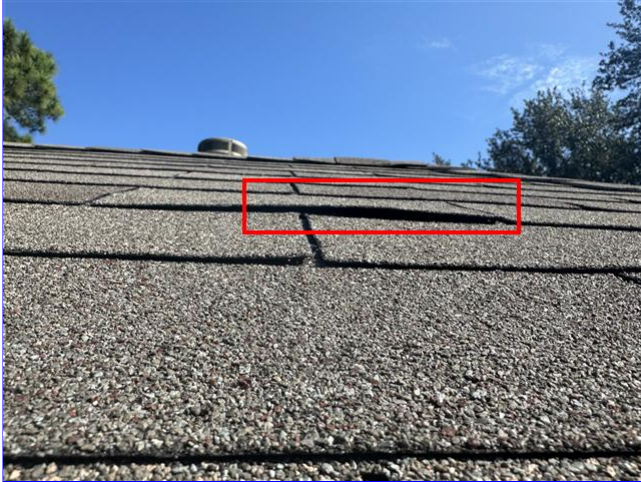
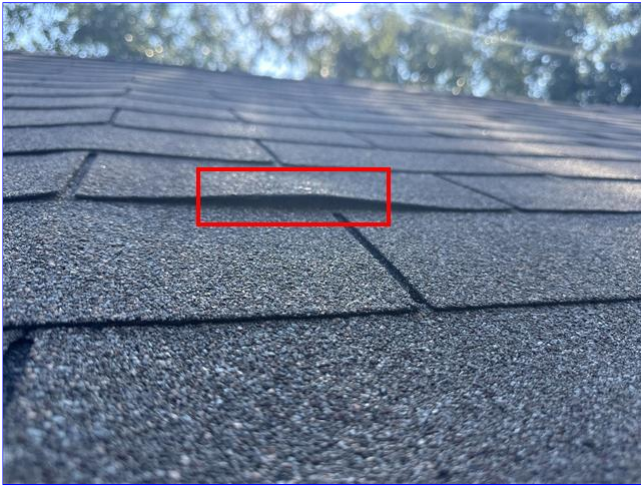
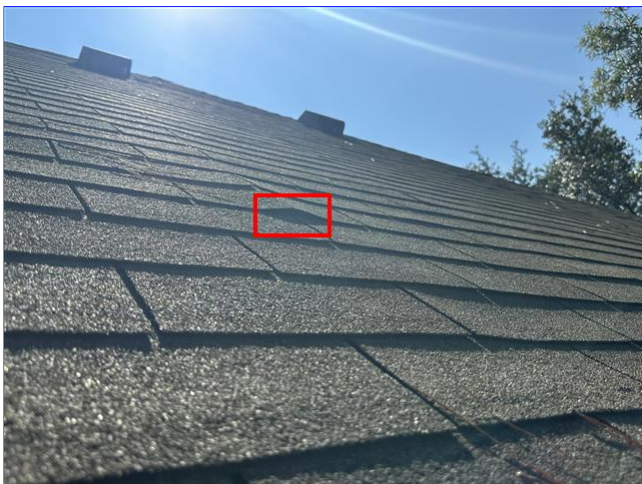
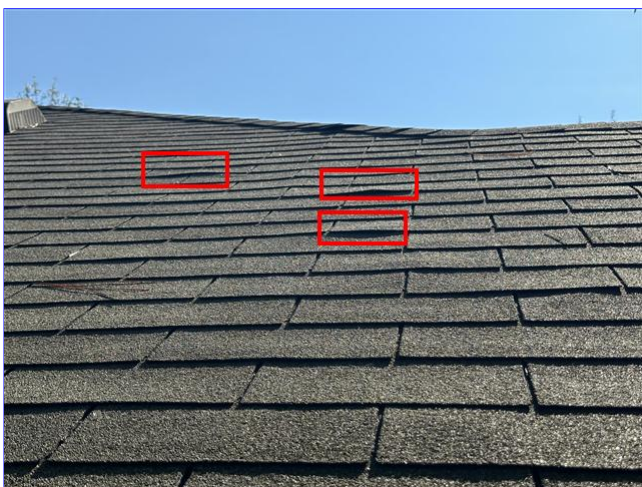
(6) One or more roof shingles were observed to be buckled. This condition is often caused by underdriven nails, which can leave the shingles vulnerable to uplift during high winds. Inspector recommends repair or replacement as necessary by a qualified roofing contractor.

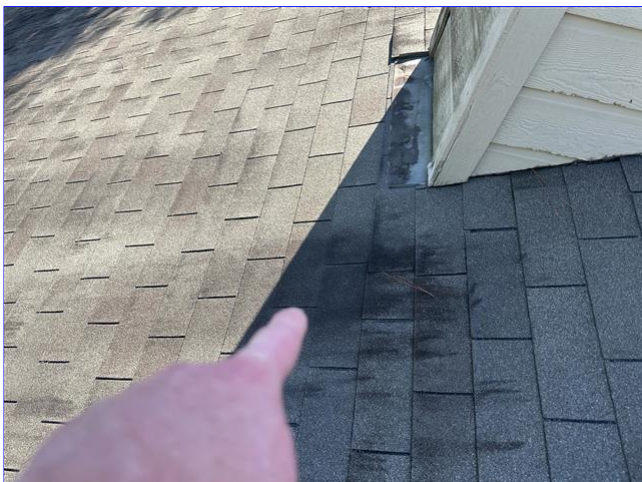
C. Item 16(Picture)

- (7) The tree limbs that are in contact with roof or hanging near roof should be trimmed.
- (8) In localized areas of the roof, when it was walked on, sheathing deflected to a greater degree than on the rest of the roof. This can be the result of a number of conditions, including wood decay, undersized wooden panels, and sheathing panels with damaged or defective sections.

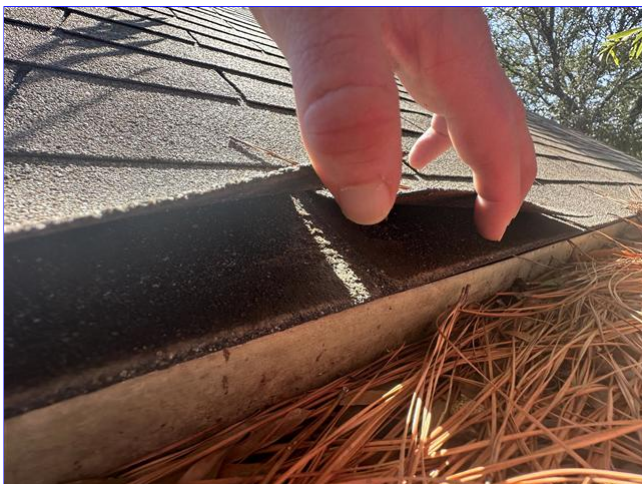
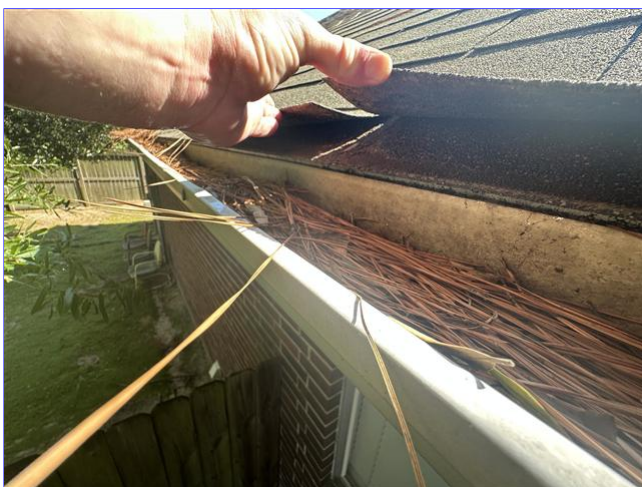
(9) Bond was insufficient at the first row of shingles along some areas of the roof eaves. This condition leaves these shingles vulnerable to uplift and detachment during heavy winds, which can lead to larger areas of roof damage and water intrusion. A qualified roofing contractor should repair or re-bond these shingles to ensure proper adherence and enhance wind resistance.

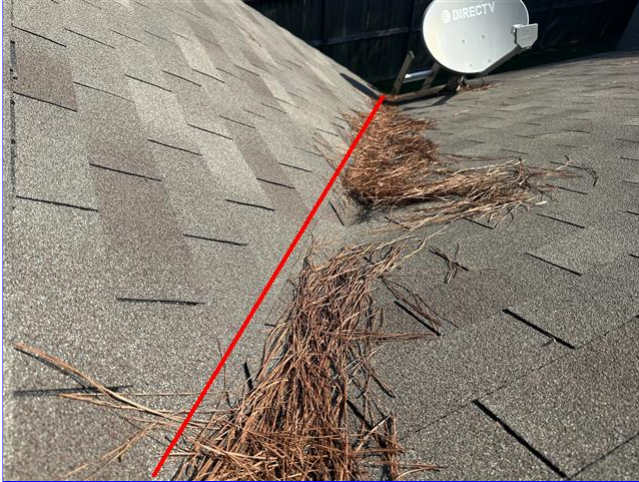
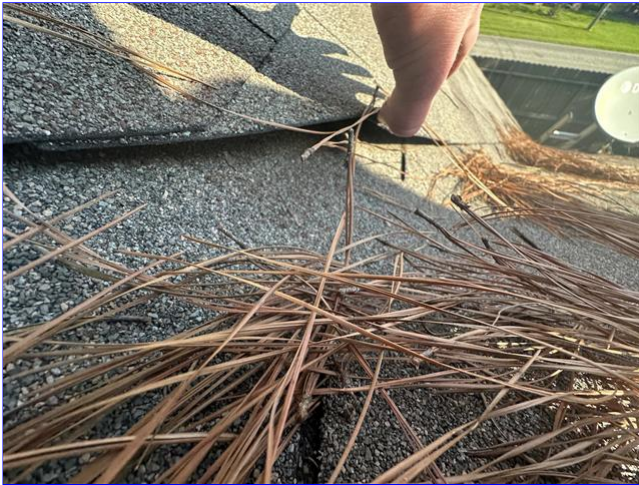
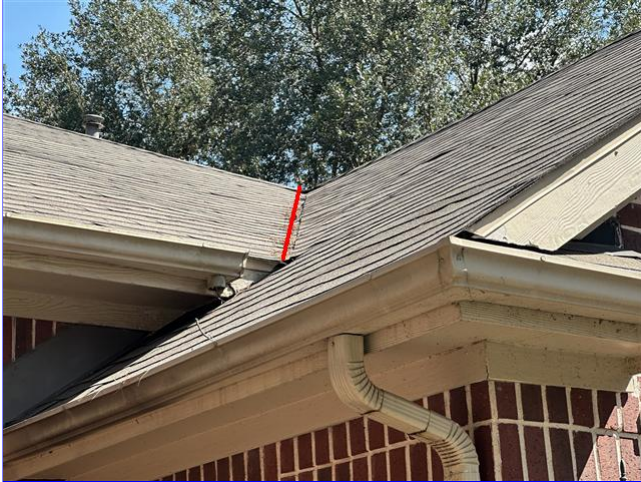
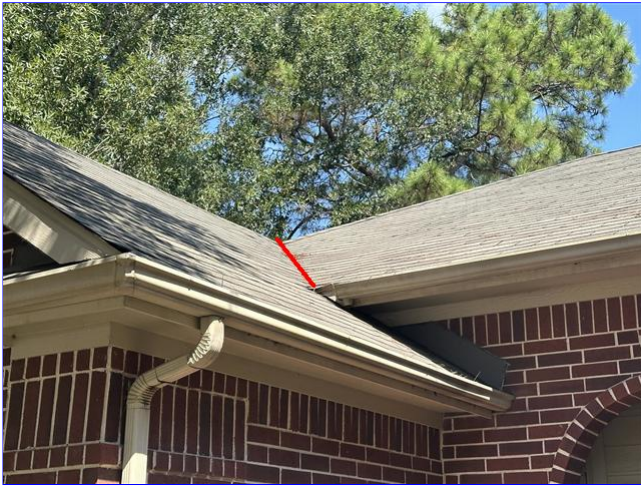
(10) Bond was insufficient at valley seams. This can allow water to crosswash below the seam and into the home. Inspector recommends repair by a qualified roofing contractor.

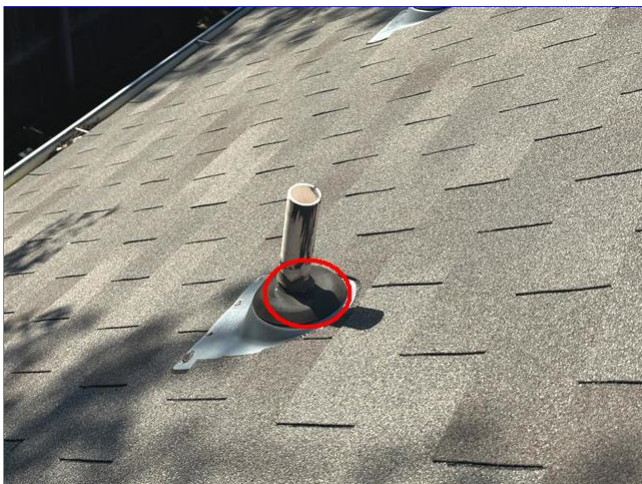
C. Item 24(Picture)

(11) One or more of the roof level plumbing vent stack flashing details were buckled downward around the plumbing stack. This condition could allow water penetration and should be repaired by a qualified roofing contractor.

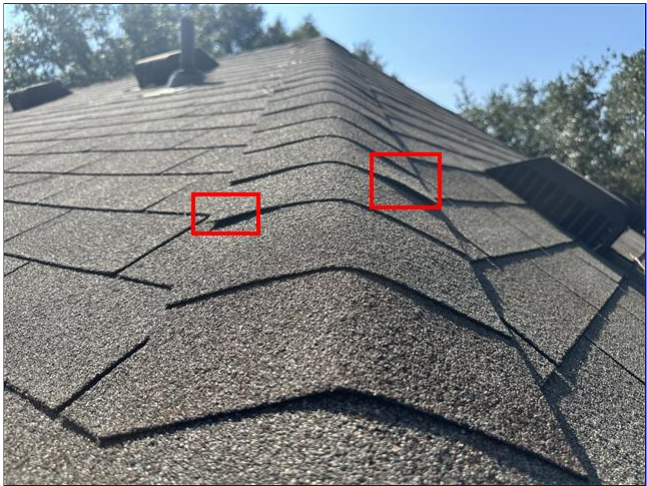
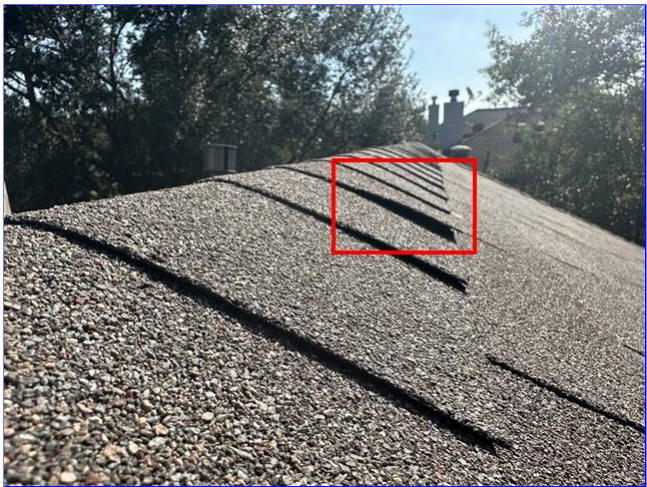
(12) The shingle bond at some hip and ridge shingles was insufficient, causing them to be lifting at the bottom corners. This condition can lead to premature wear, wind damage, and potential water intrusion. The inspector recommends a qualified roofing contractor re-secure or replace these shingles to ensure proper weather protection.

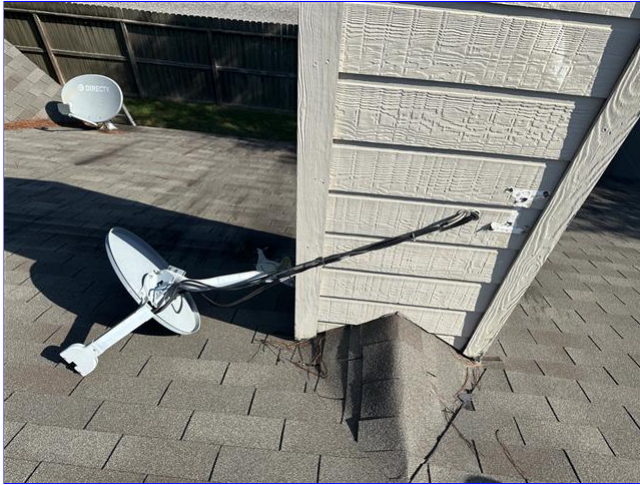
C. Item 29(Picture)

(13) A satellite dish was observed lying unmounted on the roof. An unmounted satellite dish presents a

hazard to the roof system, as its weight and potential for movement could cause damage to the shingles and underlying roofing materials.

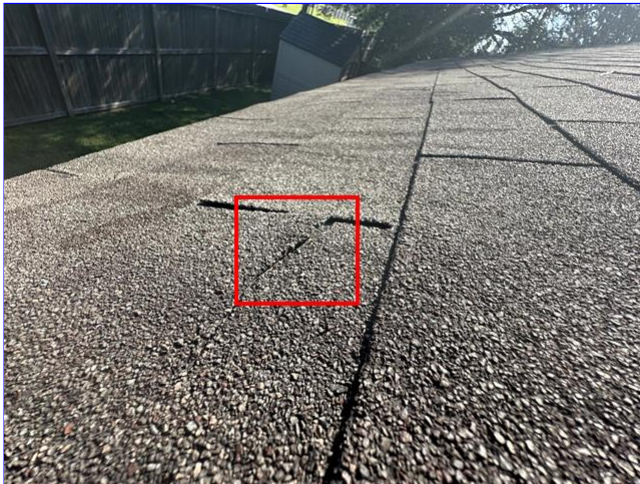
C. Item 30(Picture)

(14) Torn shingle was observed at the rear roof eave.

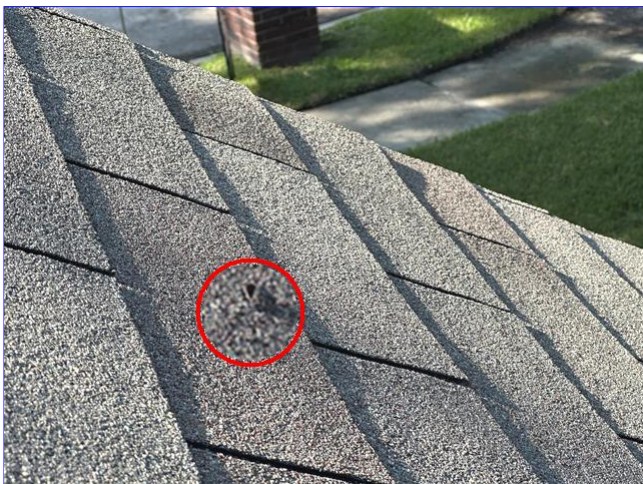
C. Item 31(Picture)

(16) An underdriven nail has penetrated the face surface of a shingle above the roof. Inspector recommends repair.

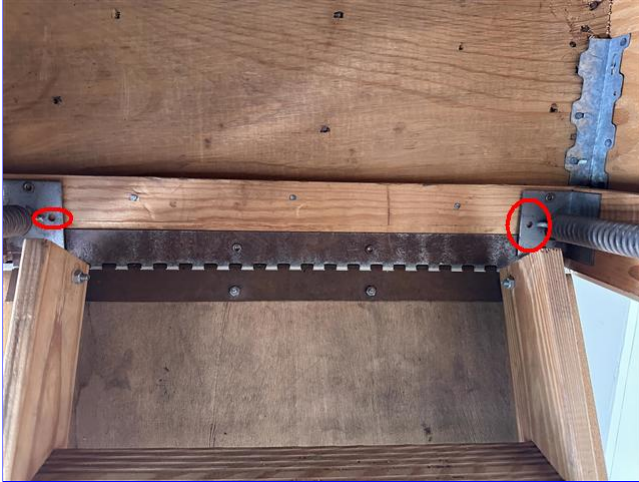
D. Item 1(Picture)

Fasteners were missing at the pull down attic ladder mounting brackets

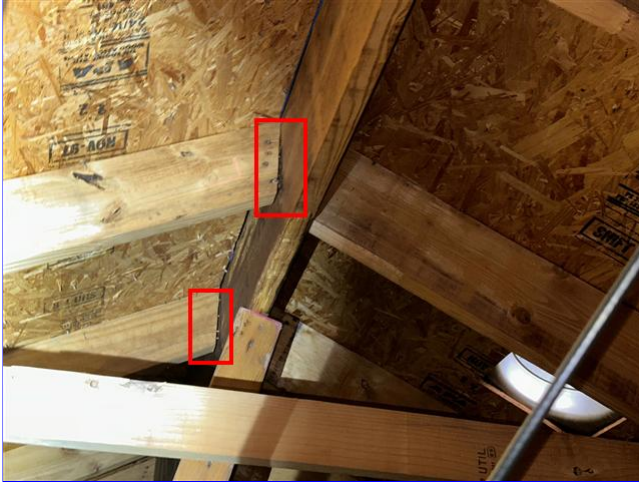
D. Item 3(Picture)

(4) One or more rafters do not fit snugly against the ridge board due to mild structural movement or inaccurate framing cuts. Rafters should be in full contact with the ridge board or opposing rafter. This condition reduces the strength of these connections and the rafters are prone to splitting.

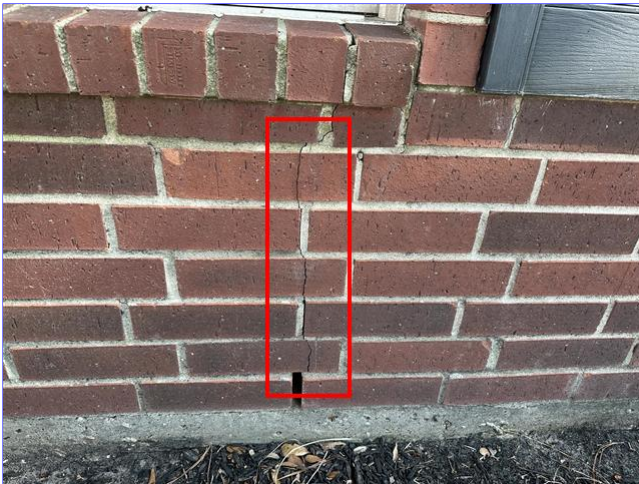
E. Item 1(Picture)

(1) One or more small cracks (roughly 1/16 of an inch wide) observed on exterior walls. Cracks appeared to be the result of long-term settling. Some settling is not unusual in a home of this age, due to their size and length, these cracks do not appear to be a significant structural concern at the time of inspection.

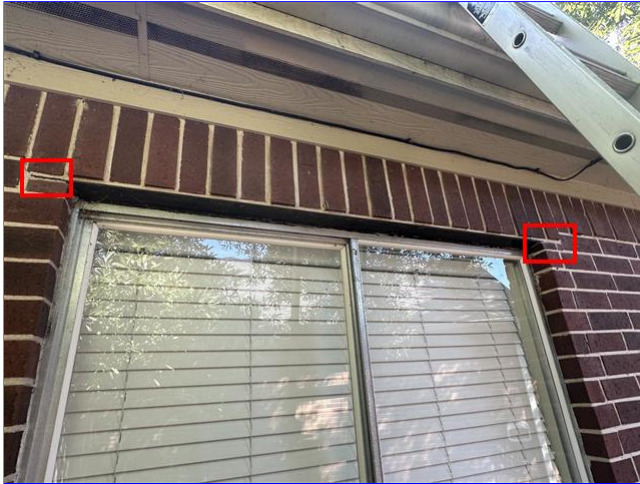
E. Item 2(Picture)

(2) The bearing ends of one or more steel lintel above door and/or window openings were exposed and should be embedded in mortar.

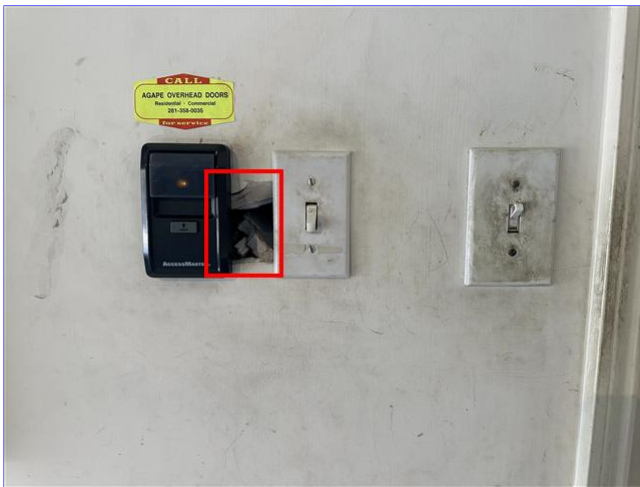
E. Item 3(Picture)

(3) Hole observed in the garage wall that divides the garage and living space. Inspector recommends sealing all gaps, voids or holes to ensure an intact fire barrier exists.

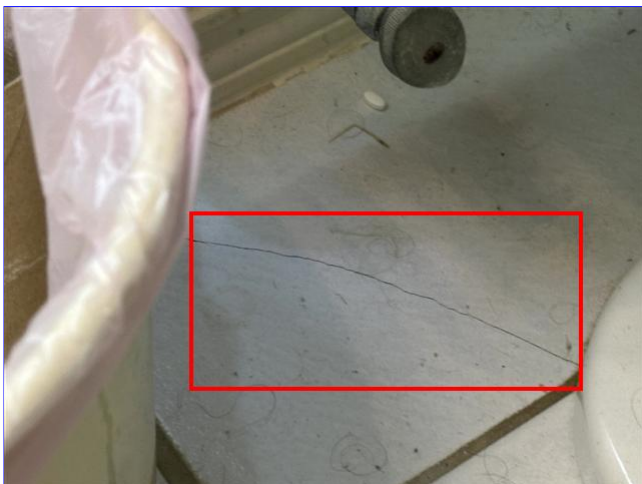
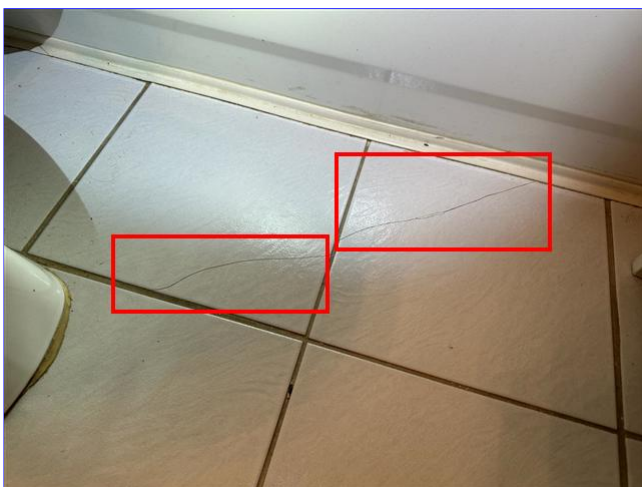
(1) Cracked floor tiles were observed in the guest bathroom.

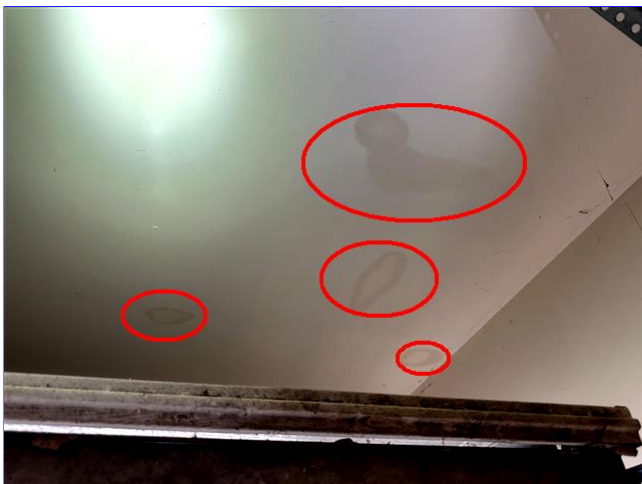
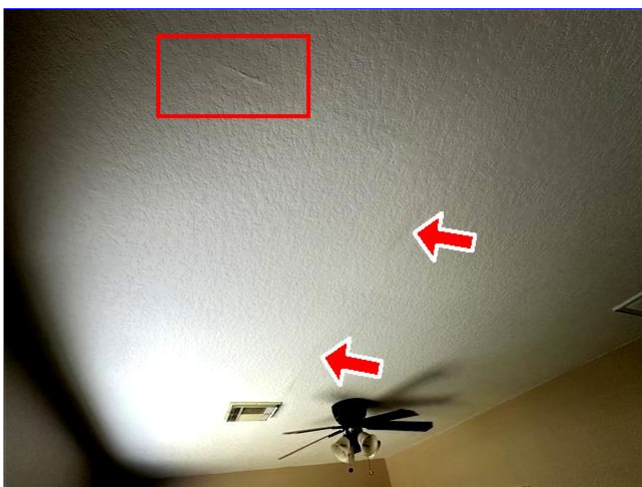
(2) Stains on interior ceiling appeared to be the result of moisture. The moisture meter showed ***no*** elevated moisture levels in the affected areas at the time of the inspection. Although this condition indicated that the source of moisture may have been corrected, further examination by a qualified contractor would be required to provide confirmation.

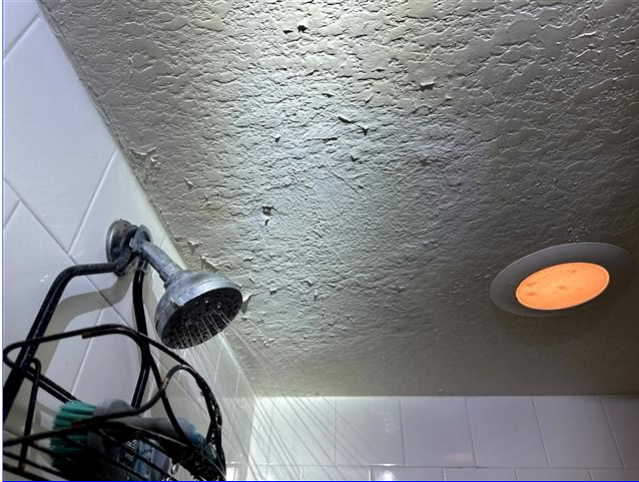
F. Item 5(Picture)

(3) Peeling paint was observed on the master bathroom shower enclosure ceiling. This condition is typically the result of excessive moisture buildup due to poor ventilation. An ongoing lack of proper ventilation can cause damage to the ceiling materials and contribute to organic growth.

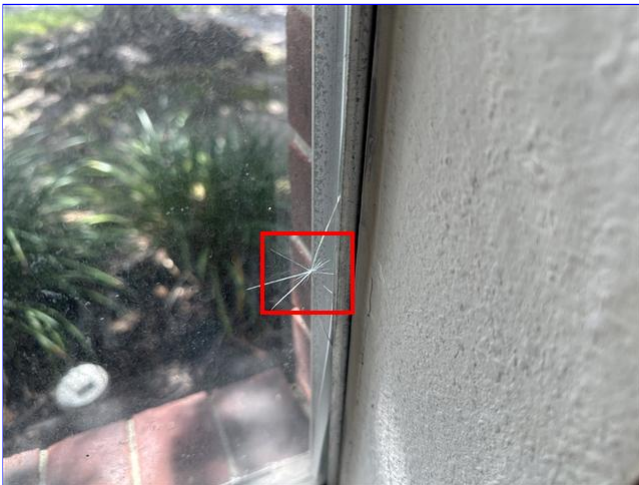
H. Item 1(Picture)

- (1) A front left window pane is cracked.

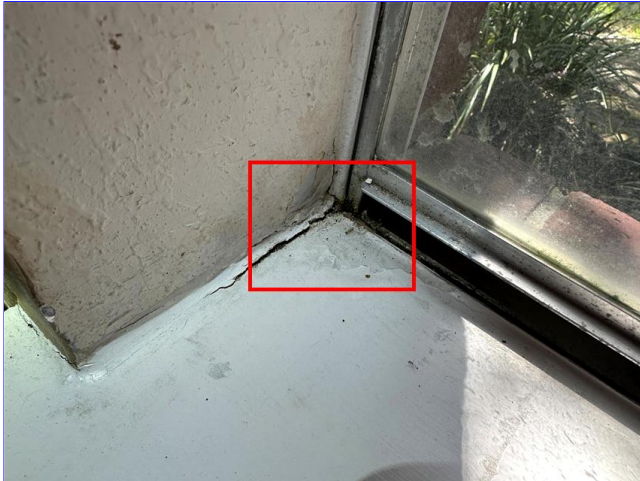
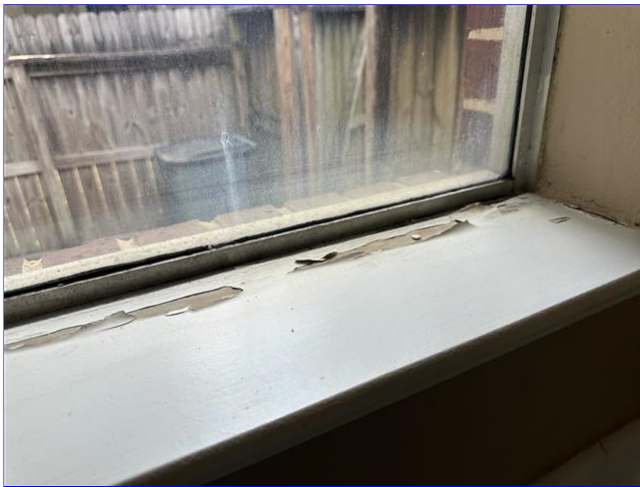
- (2) Front left bedroom window was difficult to open when the inspector applied excessive force. This could be from lack of use.
- (3) Damage at multiple interior window sills appeared to be the result of moisture, from leaks or humidity. The moisture meter showed ***no*** elevated moisture levels in the affected areas at the time of the inspection. Although this condition indicated that the source of moisture may have been corrected, further examination by a qualified contractor would be required to provide confirmation.

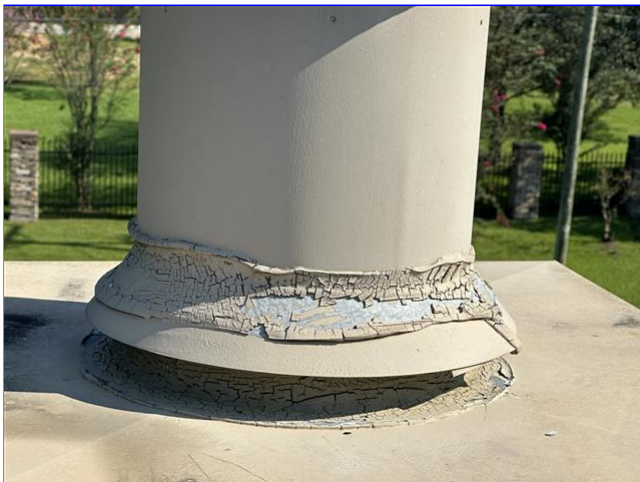
J. Item 3(Picture)

(2) Sealant around the chimney storm collar was worn and cracking. Inspector recommends removing and reapplying fresh sealant.

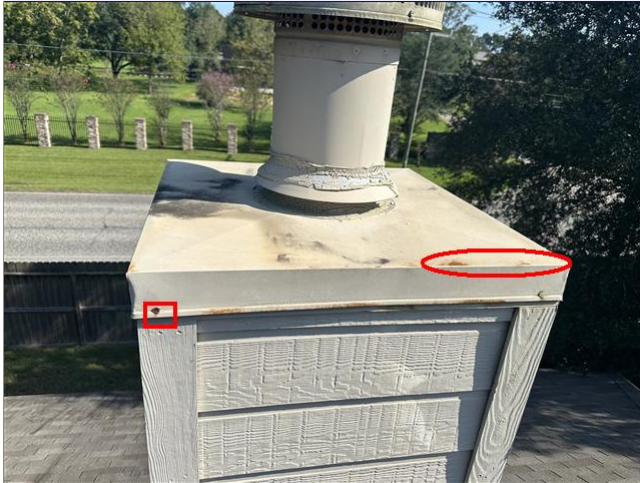
J. Item 4(Picture)

(3) Pan flashing and fasteners at the top of the chimney were beginning to corrode.

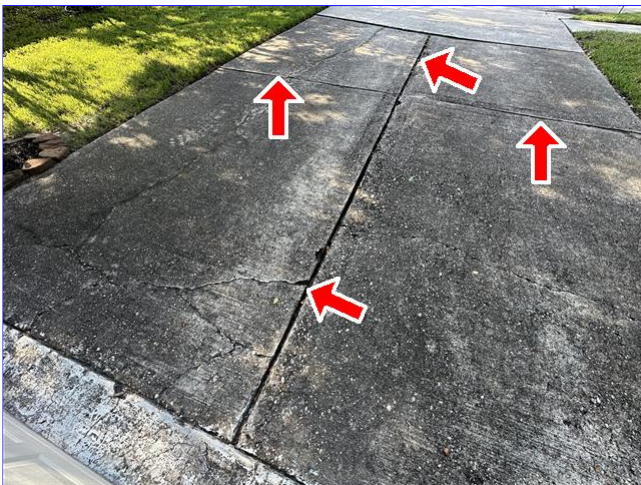
K. Item 3(Picture)

(2) Driveway expansion joints should be sealed.

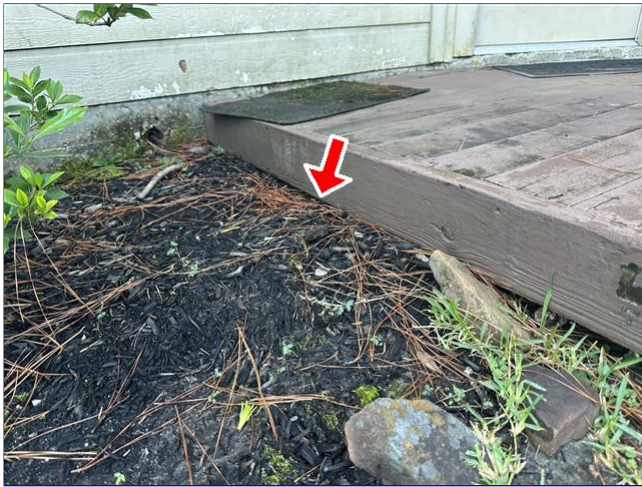
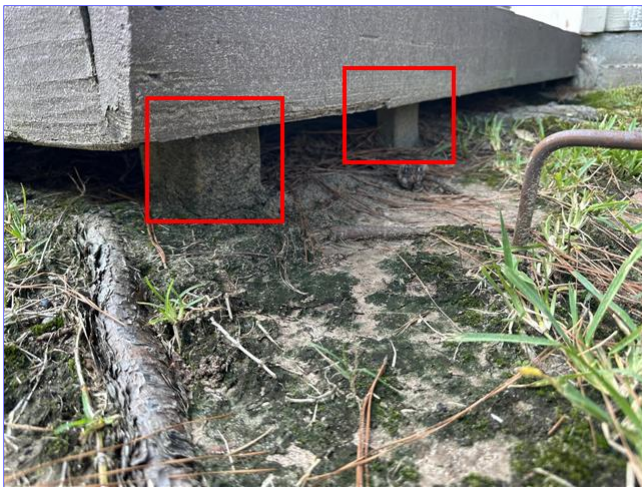
(3) The rear deck had components in direct contact with the soil, which can lead to rapid deterioration from moisture and create a high risk of wood-destroying insects.

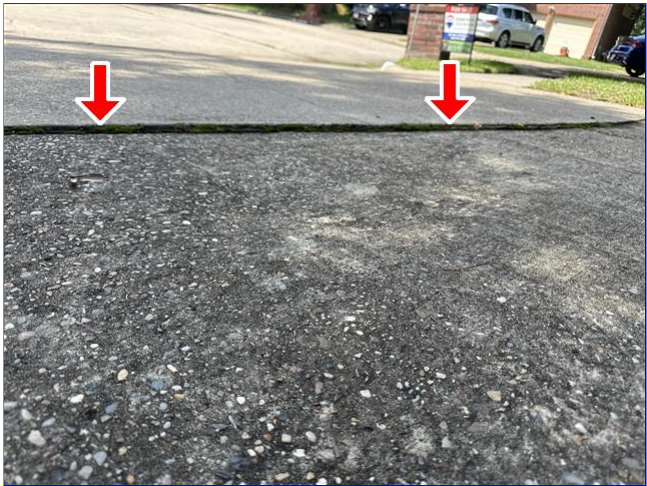
K. Item 6(Picture)

(4) Portions of the driveway have sunk into the ground, creating a trip hazard.

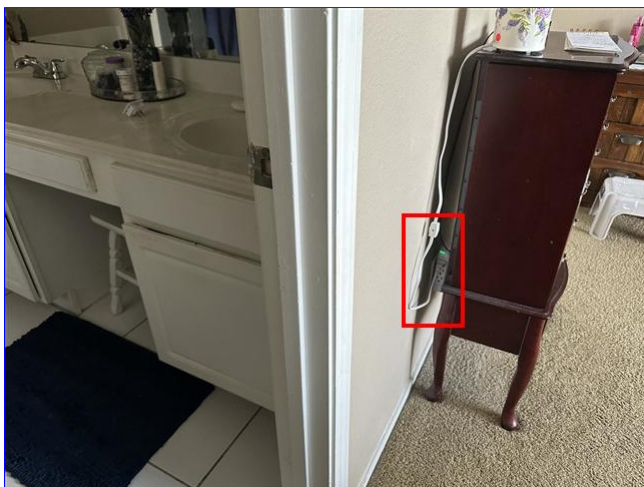
B. Item 1(Picture)

- (1) One or more electrical outlets were improperly secured and moved when plugs were inserted. Outlets should be secured.
- (2) Outlets throughout the home were not tamper resistant (TR). These were not required when the home was originally constructed. However, modern safety standards now require all outlets within 5ft 6in from the floor to be tamper resistant.
- (3) Laundry room outlet and some outlets were located within 6ft. of a sink or tub that were not GFCI protected as required by modern safety standards. Inspector recommends correction by a licensed electrician. (This may not have been a requirement when the home was originally constructed)

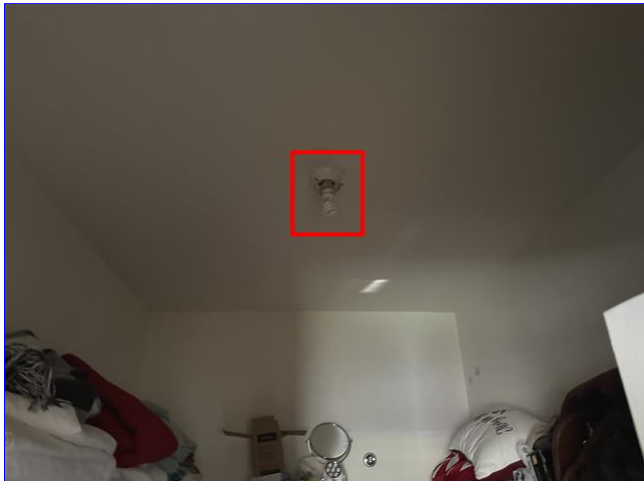
B. Item 2(Picture)

- (4) All smoke and carbon monoxide detectors older than 10 years should be replaced.
- (5) Covers were missing at one or more ceiling light fixture. This is considered a **FIRE HAZARD** inside of clothes closets.

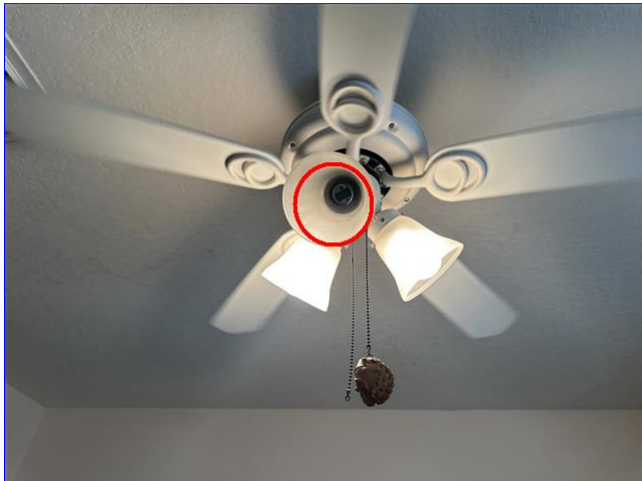
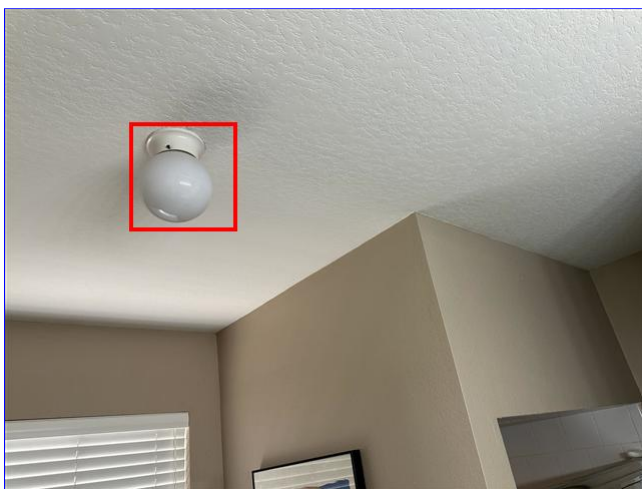
(6) One or more light fixtures in the home appeared to be inoperable or were missing bulbs. The bulbs may be burned out, or a problem may exist with the fixtures, wiring or switches.

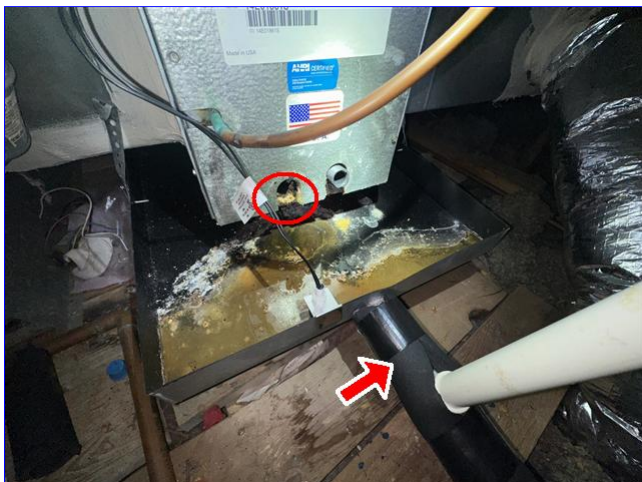
B. Item 1(Picture) Primary condensate draining into the pan, pan drain carries water to exterior

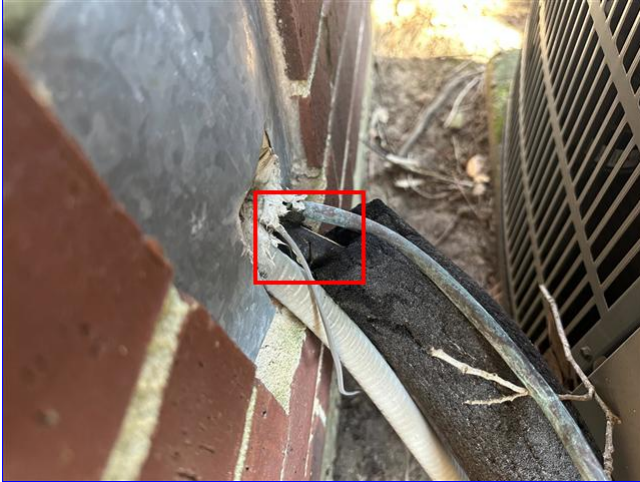
B. Item 3(Picture)

(2) Insulation on the air-conditioning suction (large, insulated) line was damaged or missing at areas and should be replaced.

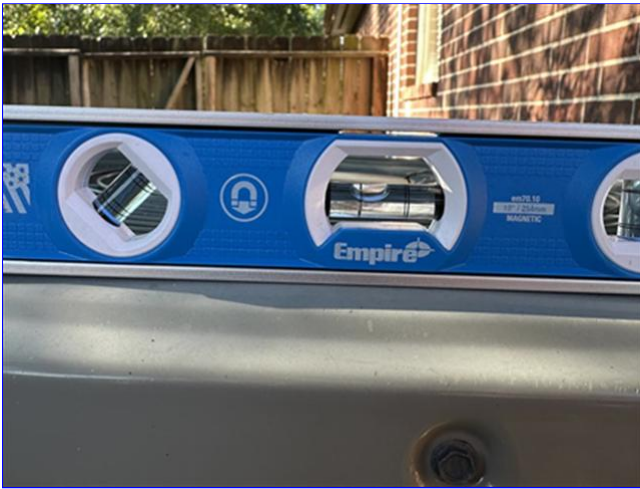
B. Item 4(Picture)

(3) The pad supporting the air-conditioner compressor housing was not level. Over time, this may result in damage to the fan bearings and a shortened fan lifespan, or it may result in movement of the compressor housing which can stress the refrigerant lines resulting in damage and expensive service. The Inspector recommends that the compressor housing be leveled by a qualified HVAC contractor.

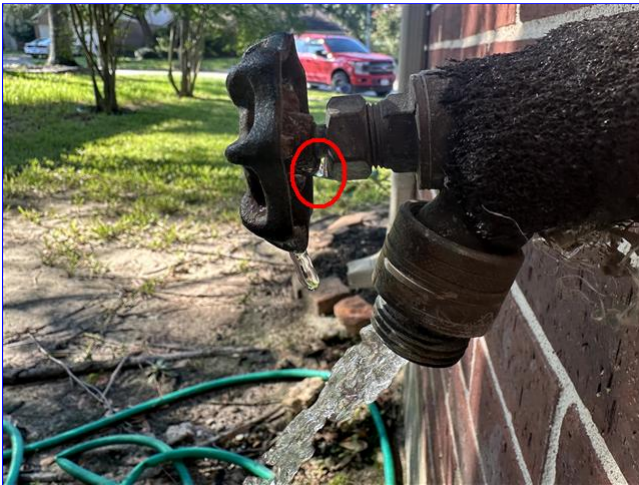
A. Item 1(Picture)

(1) Water was leaking from the valve at the front right hose bib when the water was turned on.

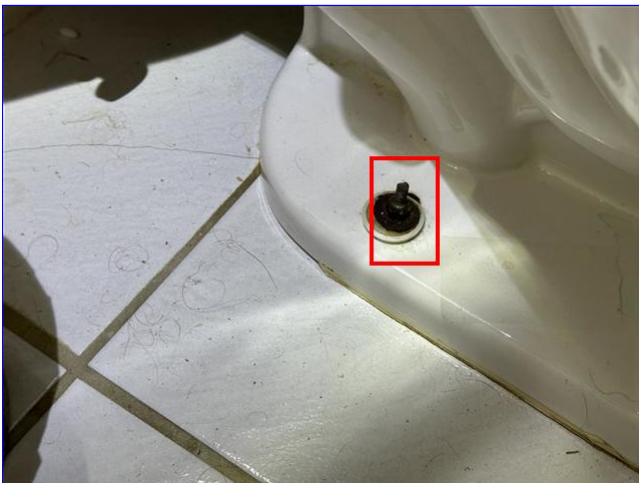
A. Item 2(Picture)

(2) Both toilet water tanks were loose and moved independently of the bowl. The Inspector recommends correction to avoid damage to the home from leakage.

(3) Guest bathroom toilet mounting bolts should be capped.

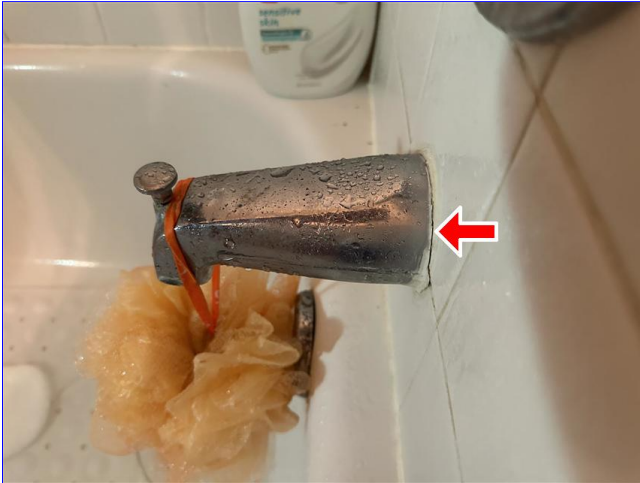
A. Item 3(Picture)

- (5) Guest bathtub diverter valves did not operate correctly (the diverter is the valve which diverts water from the tub faucet to the shower head). Water would spray out of shower head and faucet.
- (6) Sealant where bathroom fixtures or enclosure meet the walls or floor was old or had sections of missing sealant that may allow damage from moisture intrusion of the wall or subfloor assembly. Inspector recommends applying fresh sealant at these locations.

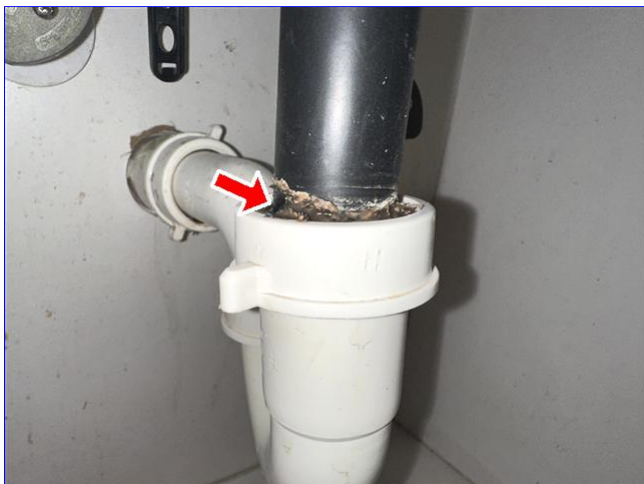
B. Item 1(Picture) very small leak

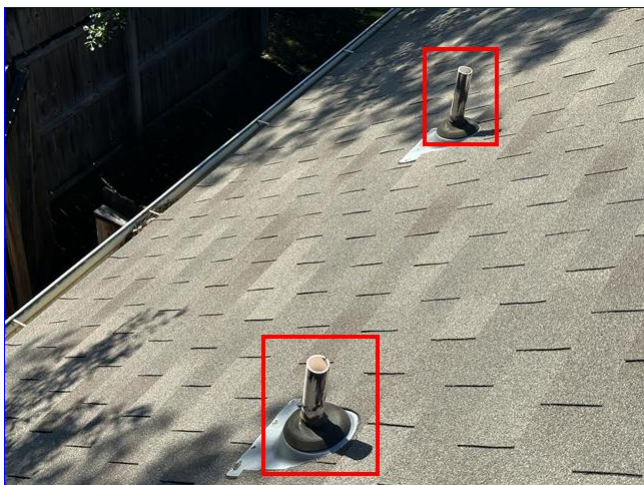
B. Item 2(Picture)

(2) All PVC vent pipes above the roof should be painted to prevent damage from UV rays.

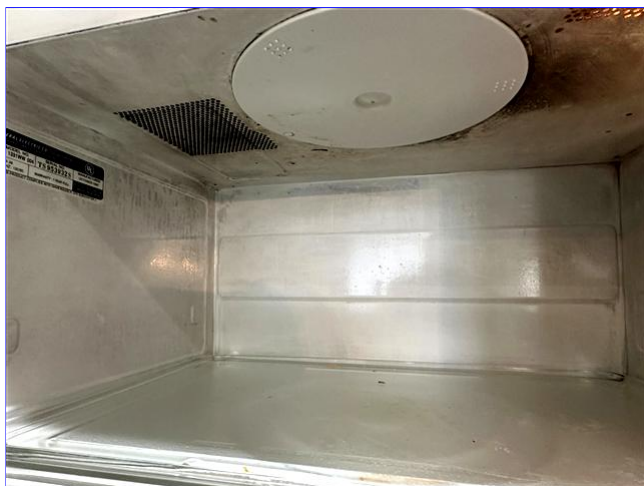
E. Item 1(Picture)

(1) The microwave's interior surface coating appears to be faded, indicating that the unit may be nearing the end of its serviceable life expectancy. This condition can lead to rust and arcing, which are potential fire hazards.

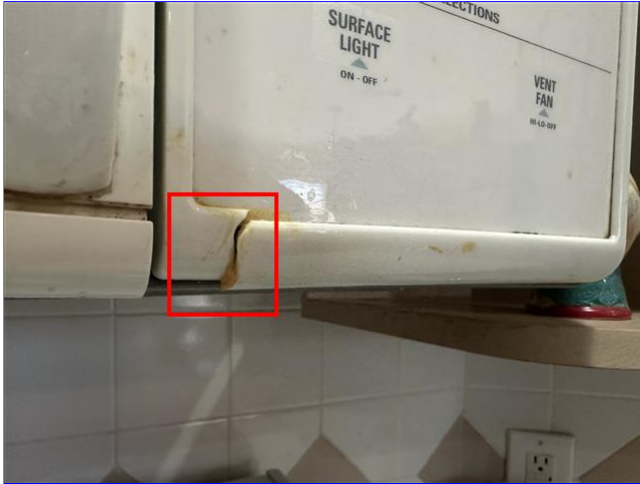
E. Item 2(Picture)

(2) Exterior trim is cracked on the microwave.

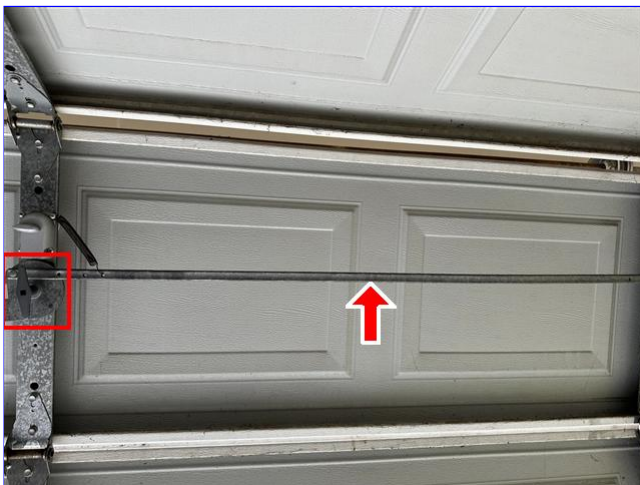
G. Item 1(Picture)

- (1) Photoelectric sensors should be lowered to no more than 6 inches above the ground.
- (2) Manual lock should be removed or permanently disabled on automatic garage doors. This is required for entering and exiting in the event of an emergency and to prevent damaging the door. Disabling can be achieved by installing a nut and bolt in the latch.
