REDSTAR PROFESSIONAL HOME INSPECTION, INC

REDSTAR RESIDENTIAL INSPECTION REI 7-6

8 Cambridge Rd  
Conroe, TX 77304

# PROPERTY INSPECTION REPORT FORM

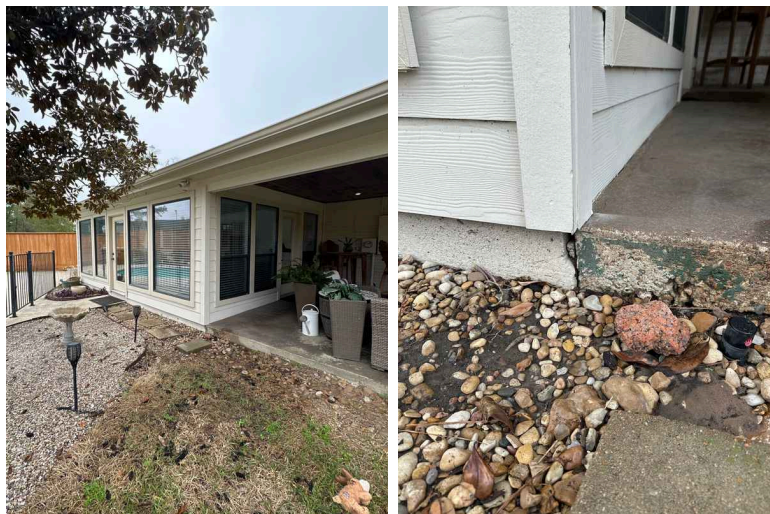
Inspector noted that this property has had foundation additions made at the rear of the structure. Recommend any questions to be directed to the seller or the evaluating Contractor.

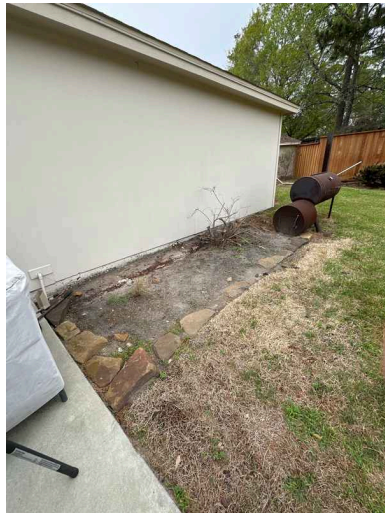
Soil erosion was observed at one or multiple locations along the exterior of the home. Recommend correction to grading issues to prevent standing water. Recommend further evaluation and correction as needed to prevent further erosion and ensure proper drainage conditions.

Recommendation: Contact a qualified landscaping contractor

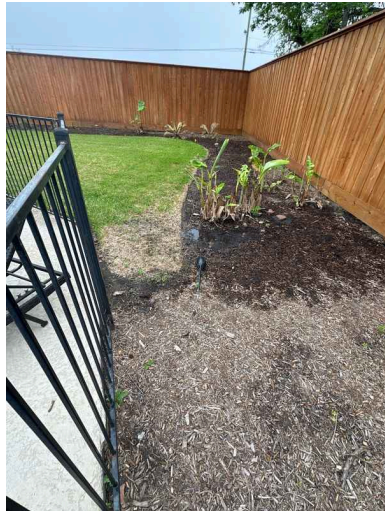
**4: Grading and Drainage: Low Spots/Standing Water**

Locations were observed around the property that were low or improperly sloped and likely holding water. Low spots in the grade should be properly repaired to ensure proper drainage and avoid a potential hazard. Recommend consulting a qualified contractor to determine the best method of repair.

Note: Potential solutions may include the installation of an underground drain system around the property.

Recommendation: Contact a qualified landscaping contractor

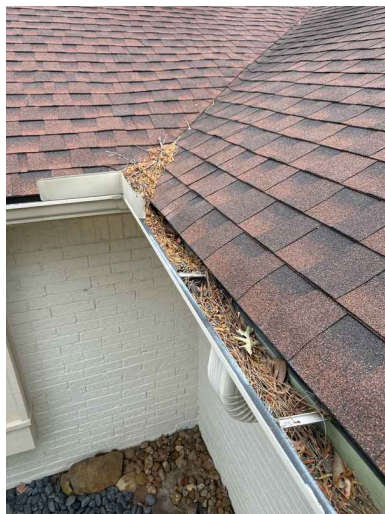
**5: Gutters: Clogged/Dirty**

Recommend clearing gutters of debris to improve drainage. Debris in the gutters can cause water to back up under the roof covering and cause damage to the home.

Recommendation: Contact a handyman or DIY project

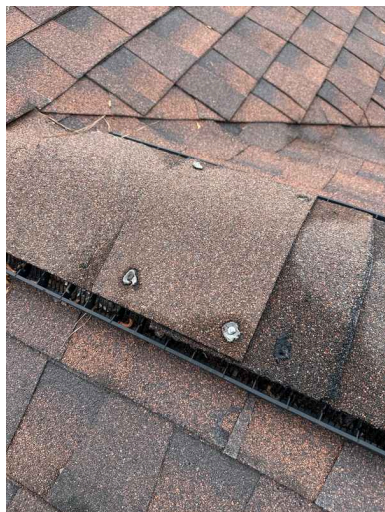
**2: Flashing: Deteriorated Sealant**

Deteriorated sealant was observed around plumbing and other flashing components. It is vital to maintain these locations to ensure performance of the covering. Recommend correction to avoid further deterioration or potential moisture intrusion issues.

Recommendation: Contact a qualified roofing professional.

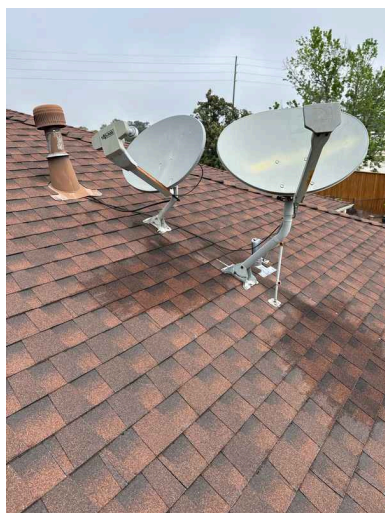
### 3: Satellite Dish(es) on Roof

A satellite dish was observed to be secured to the roof covering. This installation is prone to leaking over time, recommend you consider further evaluation and repair or removal.

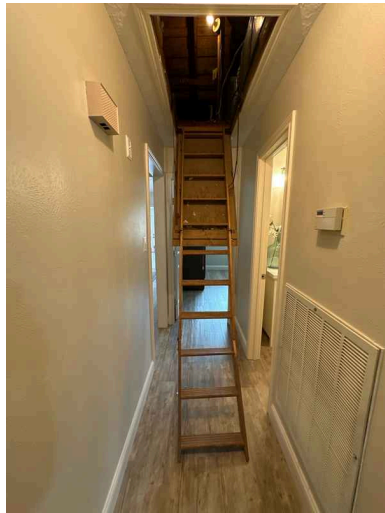
**1: Attic Door: Issues Observed**

Door not insulated, Screws/Hardware loose or damaged, Ladder is damaged, Door not properly secured to ceiling framing -

The above stated issues were observed in relation to the attic access door at the time of inspection. Attic access doors are required to be properly insulated, weatherstripped, and seal firmly for energy efficiency reasons. Pull down attic ladders are required to be properly secured to the ceiling framing with appropriate fasteners, the hardware on the doors should be kept in good condition and be regularly serviced for safety reasons. Recommend correction of any above referenced issues to ensure performance and proper installation.

Recommendation: Contact a qualified handyman.

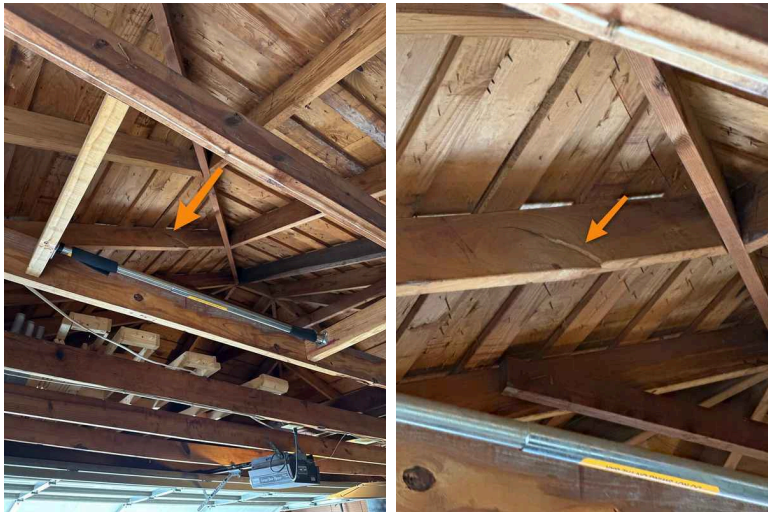
**3: Garage roof: Cracked rafter**

Inspector noted one of the rafters at the detached garage roof structure has cracked. This did not appear to be affecting the performance of the roof, but I recommend repair to avoid further deterioration.

Recommendation: Contact a qualified professional.

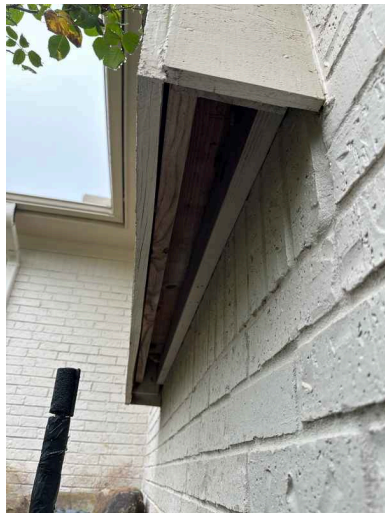
### 3: Exterior siding and trim observations

Inspector noted a need for some minor maintenance or repairs at some locations on the siding, including trim absent from underneath the windows at the front of the home, as well as some deterioration to the siding around the pillars at the front. Recommend evaluation and correction as needed.

Recommendation: Contact a qualified professional.

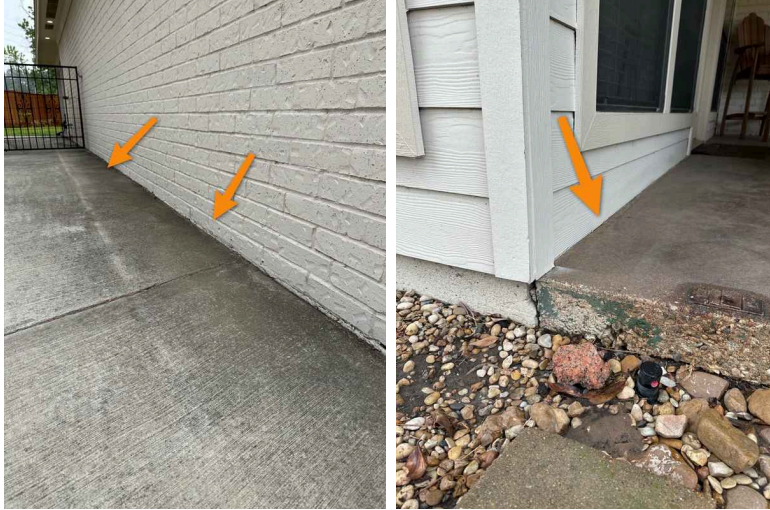
### 4: Left side foundation clearance

Recommend evaluation by qualified contractor to determine the best method of repair to avoid further issues at the exterior walls and to ensure that water is directed away from the structure. Recommend preventative treatment of the areas for termites.

Recommendation: Contact a qualified professional.

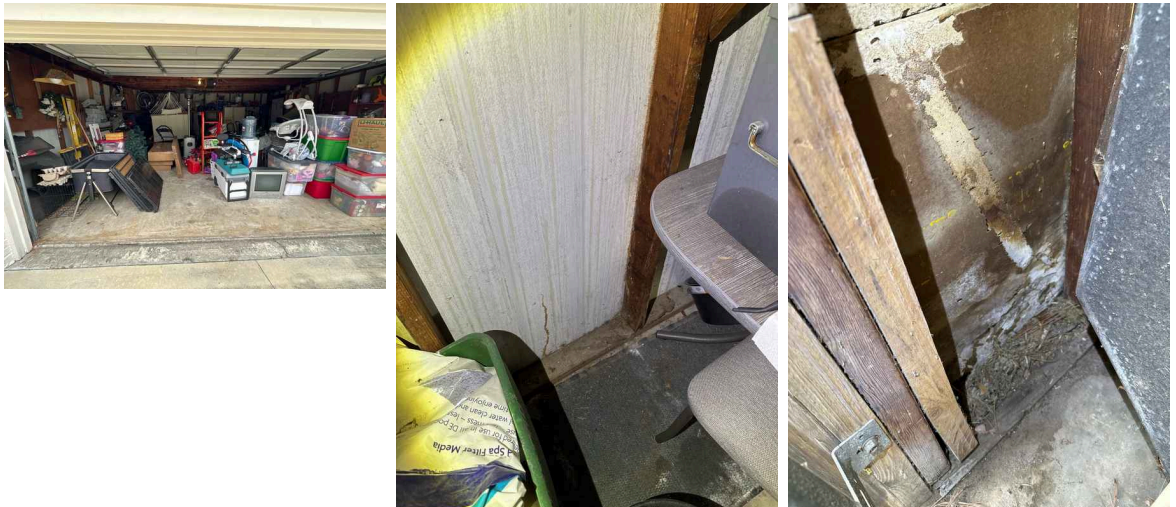
**5: Garage evaluation**

Inspector noted several areas with some signs of minor structural damage to the detached garage wall framing. Inspection of the area was extremely limited due to stored items at the time of inspection. Issues observed include signs of some water damage around the base of the walls, cracked or damaged studs, and some minor subterranean termite damage. Recommend further evaluation of the structure once all items have been removed to determine the extent of any needed maintenance or repairs.

Recommendation: Contact a qualified professional.

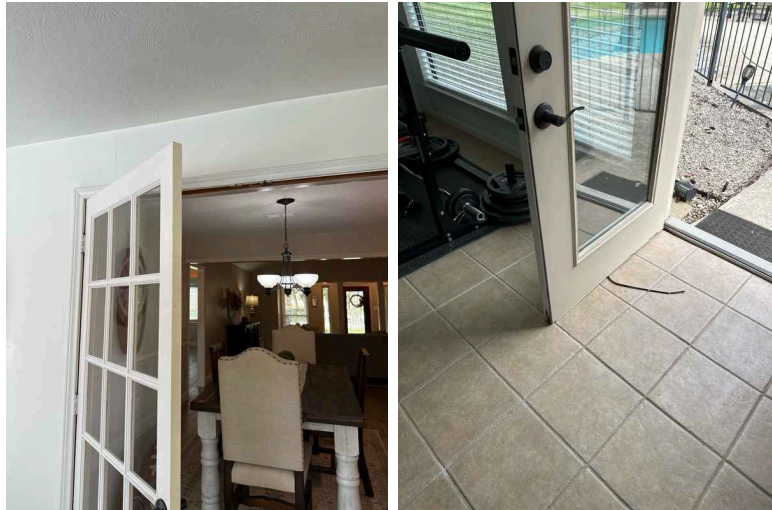
**3: Double door to addition**

The hardware on one of the double doors to the rear addition is catching excessively and in need of adjustment. Recommend correct

Recommendation: Contact a qualified professional.

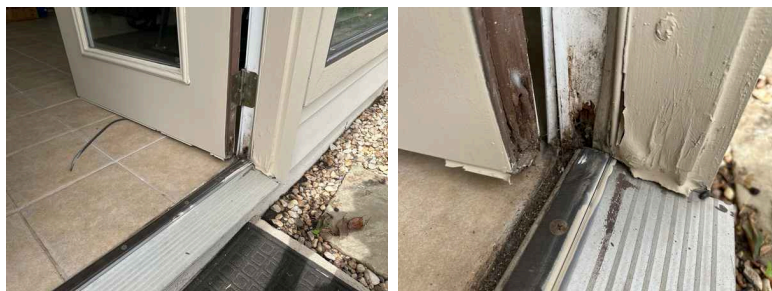
**4: Exterior door off addition**

Inspector noted some moderate wood rot and deterioration around the base of the door at the rear edition area. Damage could be observed to the door jamb, the door itself, and the threshold was excessively loose. Recommend further evaluation to determine the extent of needed repairs to probably repair the door and ensure that no further moisture intrusion issues occur.

Recommendation: Contact a qualified professional.

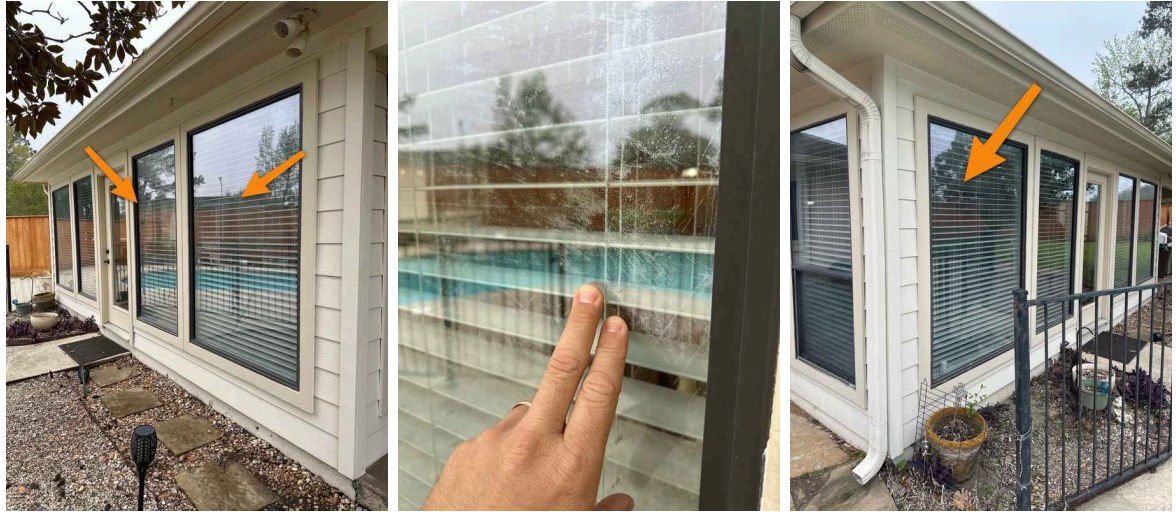
The seal appears compromised or a Low-E coating defect appear to be present on the double pane window glass at the above stated locations. This condition is indicated by build-up observed between the panes of glass and will potentially require replacement of the glass. Recommend further evaluation and correction as needed. Consult with a qualified window contractor to evaluate above stated locations as well as thoroughly inspect all other units to identify any other seals that are compromised.

Recommendation: Contact a qualified window repair/installation contractor.

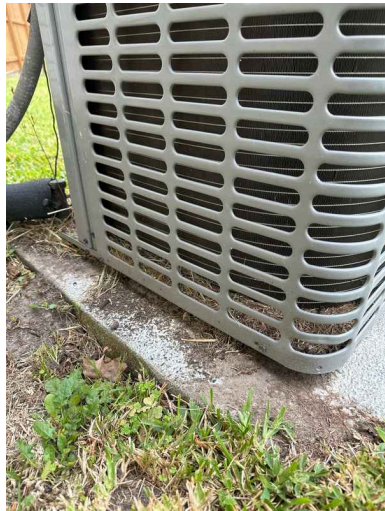
**1: Condenser Maintenance Required**

The air conditioning condenser requires leveling and cleaning to maintain proper operation and efficiency. Recommendation: Contact a qualified professional.

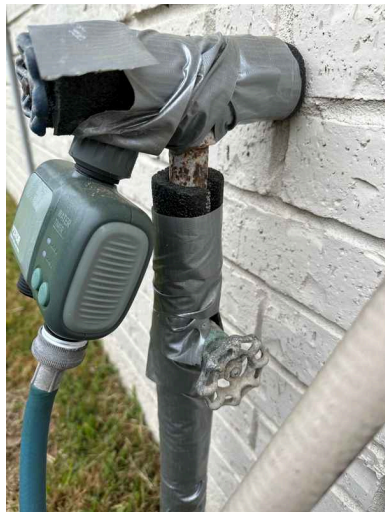
Galvanized plumbing was observed to be partially in use at the home, this type of plumbing is known to develop issues over time such as low water pressure and pin hole leaks. It would be wise to budget for replacement in the future. Typical life expectancy for Galvanized piping is between 40-50 years.
