HEDDERMAN ENGINEERING, INC.

FOUNDATION INSPECTION

28010 Fulshear Plantation Dr
Fulshear, TX 77042

05/04/2026

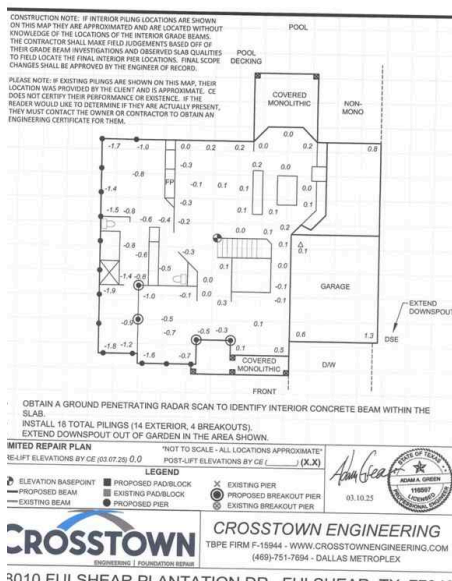
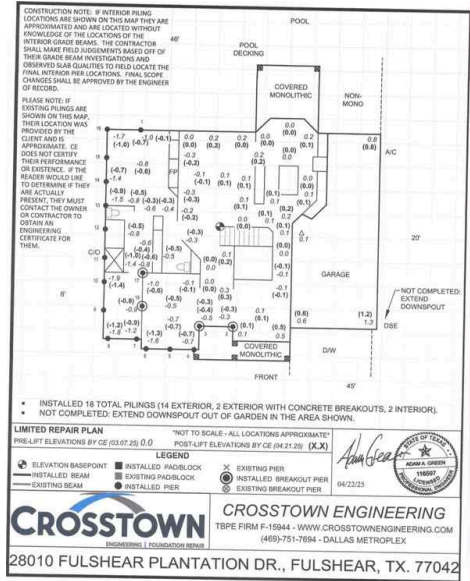
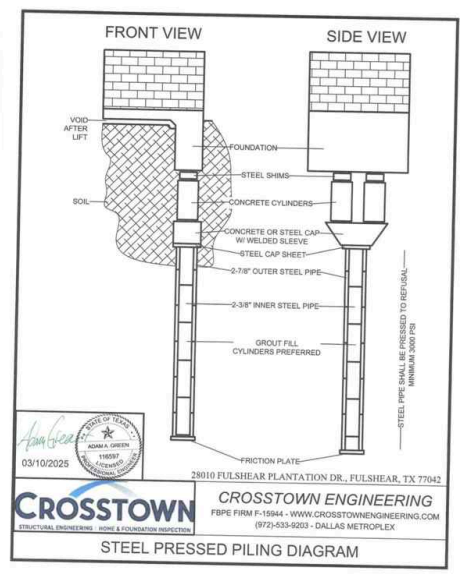
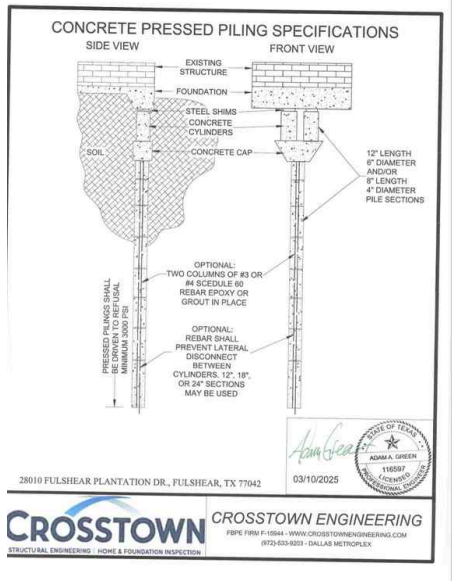
It was observed/disclosed that the foundation of this house has been repaired previously. The scope of the repairs reportedly included piers installed as shown in the sketch below provided to HEI. It is pointed out that HEDDERMAN ENGINEERING, INC. cannot and does not take any responsibility for the adequacy and/or future performance of the repair work. Any opinions given in this report concerning the levelness of the house are for the day of the inspection only, and are not a warranty against future foundation movement of the house. It is recommended that you obtain all available information and warranties from the homeowner relating to the foundation repair(s).

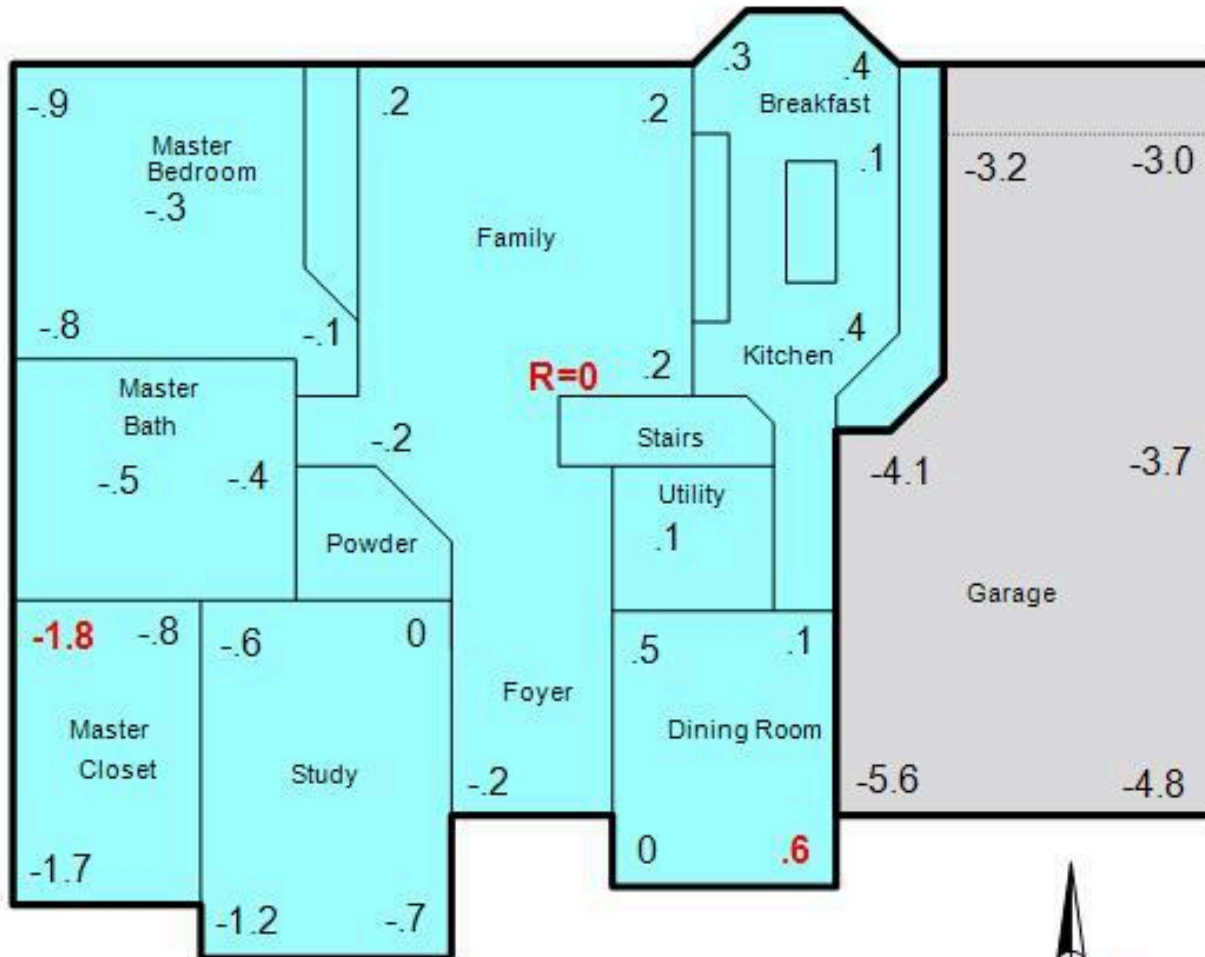
Elevation Readings
28010 Fulshear Plantation Dr.
(Not to scale)

The floors were checked with an electronic level, and were observed to be sloping towards the west side of the house. The difference in elevation between the high point and low point was 2.4 inches. The high point was located at the dining room, and the low point was located at the master closet. The unlevelness takes place over a horizontal distance of approximately 40-45 feet.

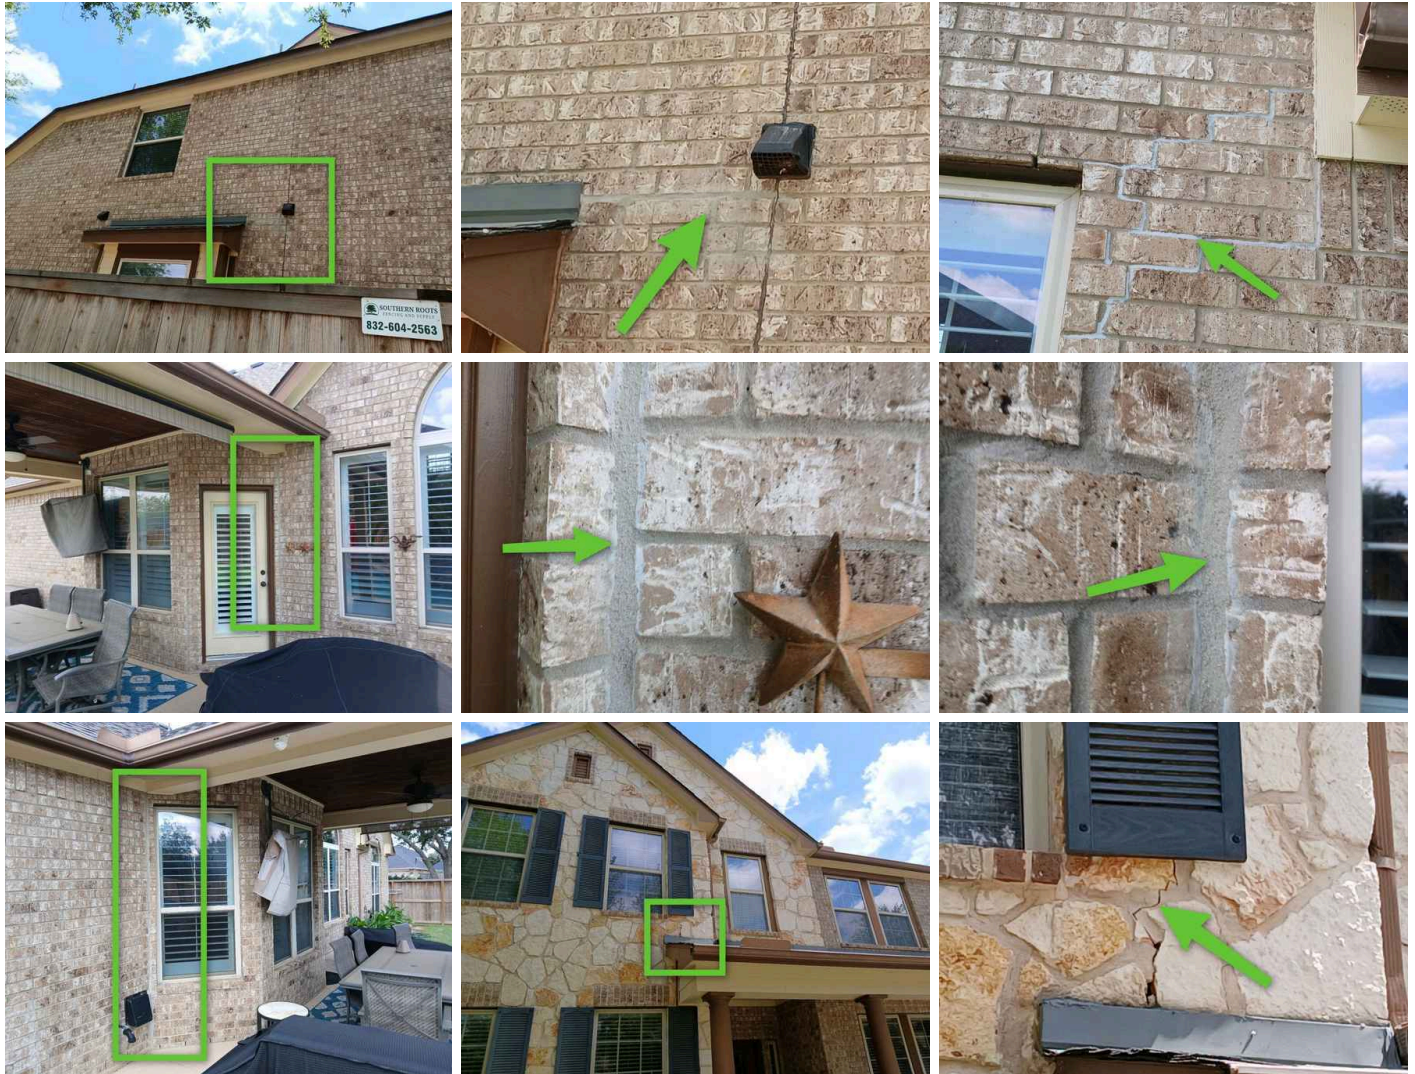
Cracks and/or patches were observed in the exterior veneer at the time of the inspection, including at the locations shown in the photos. It is recommended to repair the cracks.

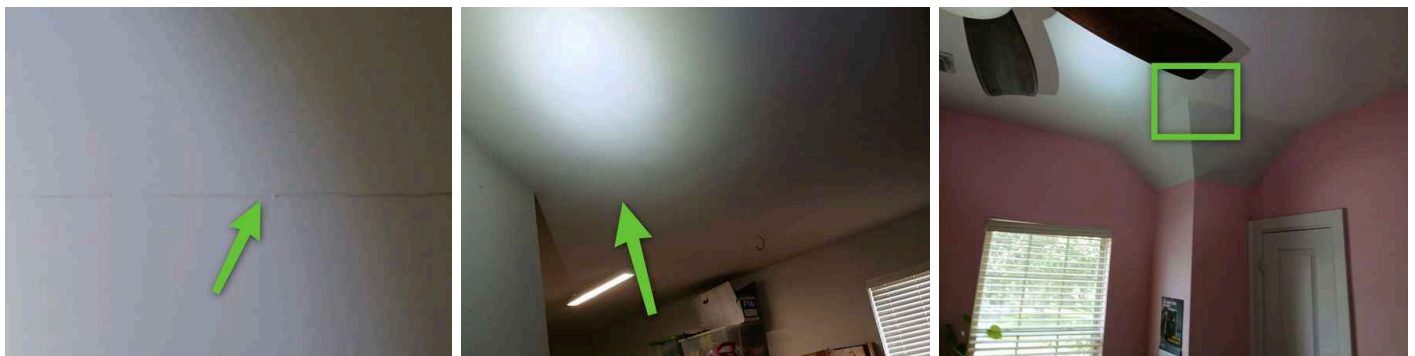
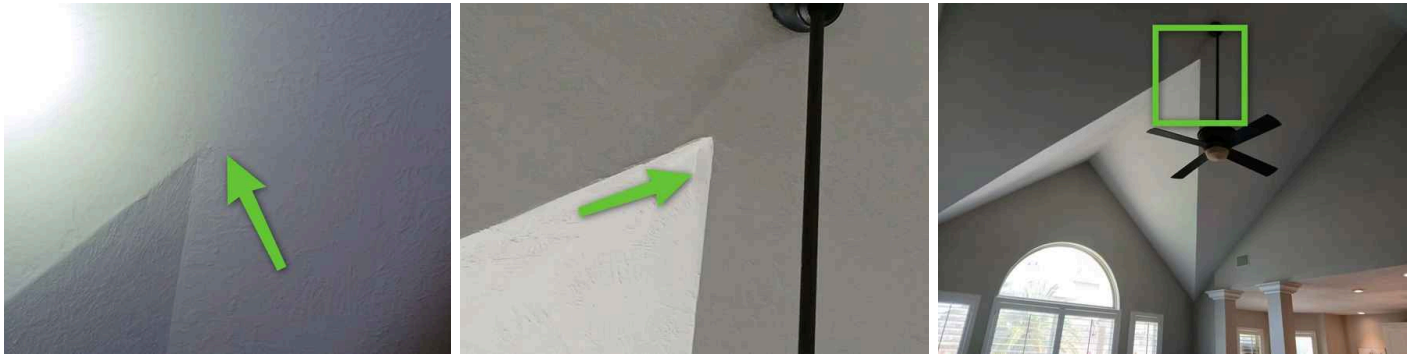
Garage, family, and the southwest bedroom.

Sheetrock cracks, patches, and/or compression ridges were observed in the house during the inspection, including at the above locations.

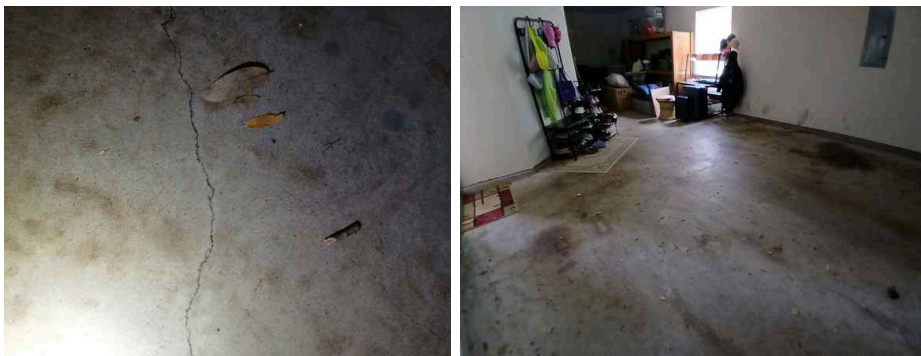
Cracking of the foundation concrete exists in virtually all foundations. It is pointed out that cracking is a normal property of concrete and other brittle materials, and Hedderman Engineering, Inc. assumes no responsibility should cracks be found that are not mentioned in this report. Some cracking was observed in this concrete foundation, including at the garage floor.

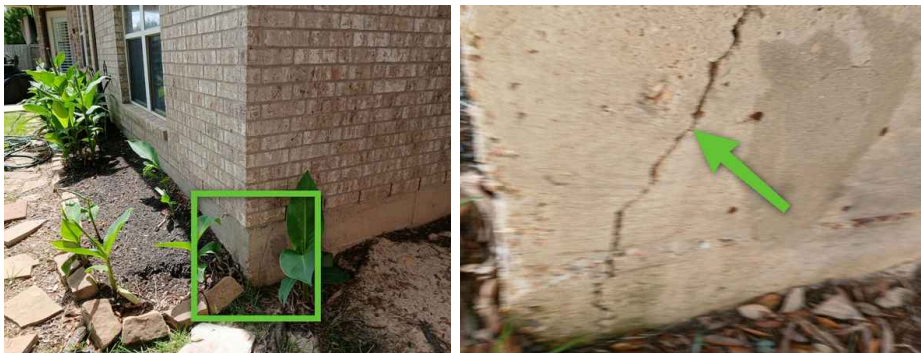
The corner of the foundation was observed to be chipped at the above locations. This condition is typically caused by differences in thermal expansion between the brick veneer and the concrete foundation. Also, this condition can be caused by a lack of reinforcement in the corner of the foundation during original construction. In our opinion, this condition does not affect the overall structural integrity of the foundation.

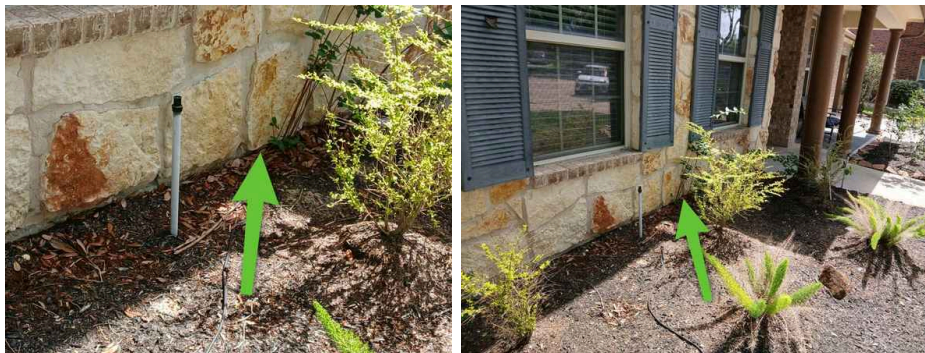
It is pointed out that a portion of the foundation concrete could not be viewed due to soil that was graded near or above the top of the foundation and/or heavy foliage growing against the house. The soil and/or foliage should be removed, and 3-4 inches of foundation concrete exposed.

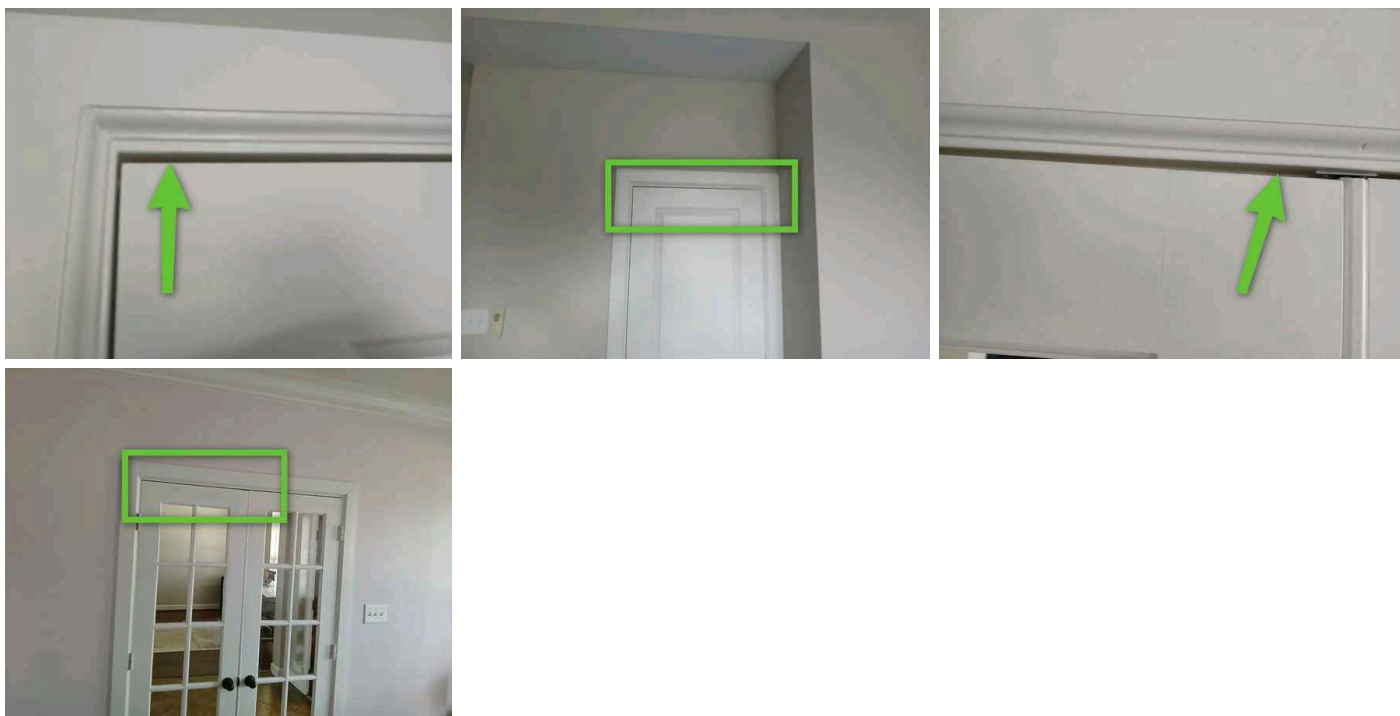
Study, master bathroom, northeast bedroom, northeast bedroom closet, northeast attic, second floor East bathroom, and the second floor West bathroom.

Door frames that were out of square, leaving a triangular separation between the door and the door frame at the top of the door were observed.

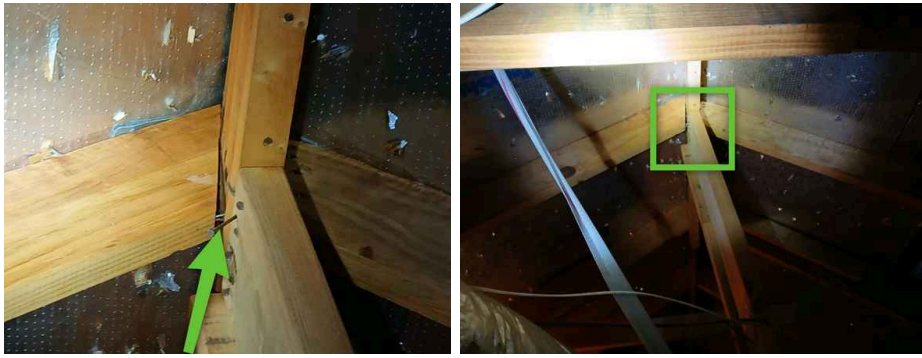
One or more rafters were observed to be separated from the ridge beam in the attic, which can be an evidence of movement.

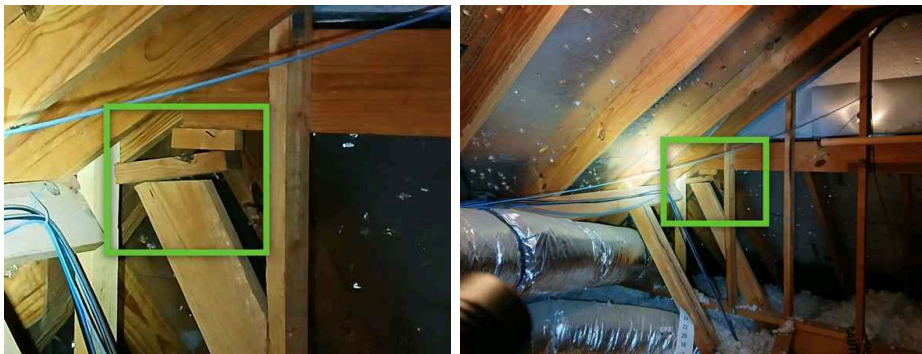
West side of the upper attic

Our vertical bracer was observed to be separated from the ridge beam in the attic, which can be an evidence of movement.

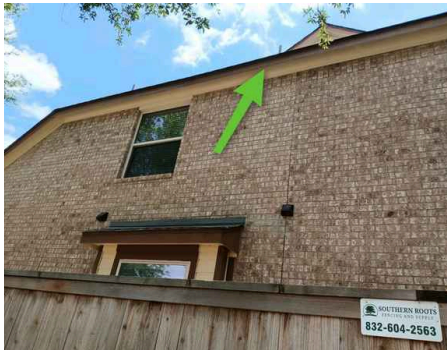
The expansion joint was tight at the time of the inspection with no separation visible.

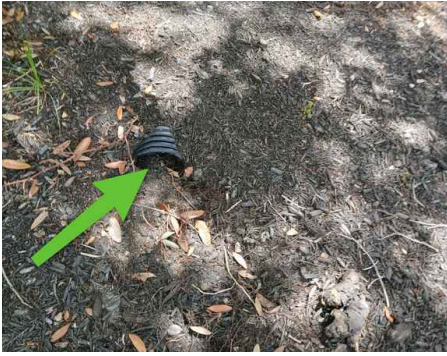
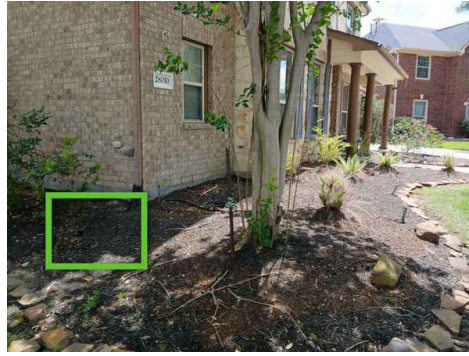
A downspout was observed close to the house specifically at the area with more evidences of movement. It is recommended to extend the downspout away from the house foundation to minimize excess moisture at that area after rain events.

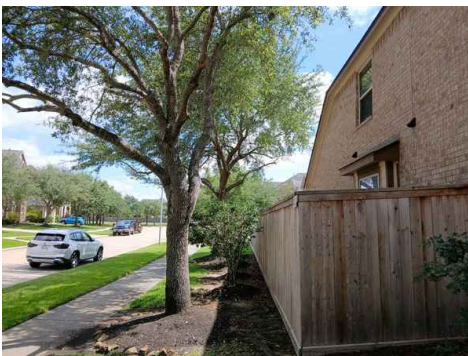
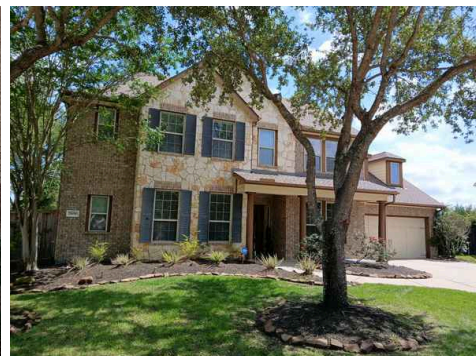
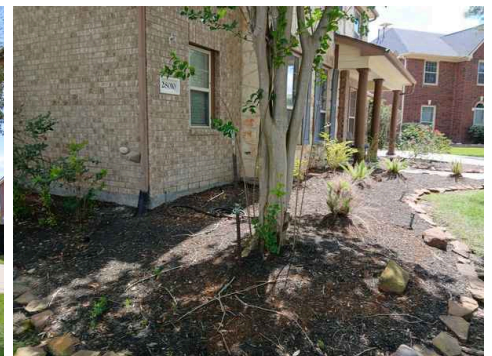
Trees and/or foliage were observed in the vicinity of the house, which can contribute significantly to differential movement of the house foundation. Care should be taken to prevent the trees and foliage from removing an excessive amount of water from near the foundation of the house. Consideration should also be given to cutting the tree roots that extend under the foundation, and installing a root barrier to prevent any further moisture from being removed from under the interior of the house.

Contact a qualified professional.

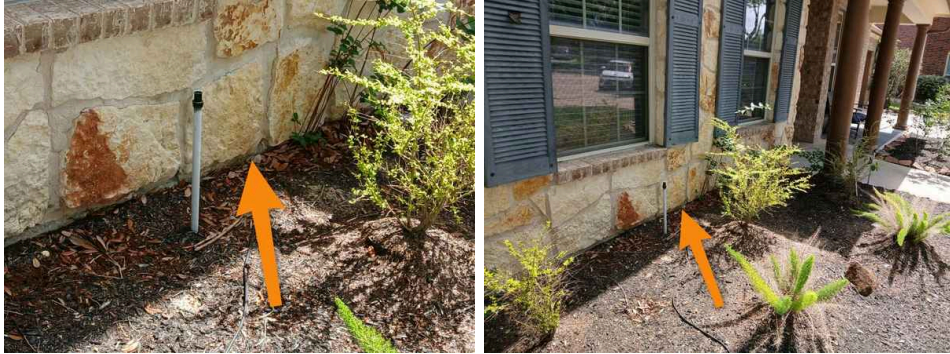
The flower bed and/or perimeter grading was too high at some areas, and was graded near or above the top of the foundation. It is recommended that the beds/soil be regraded as needed to prevent water penetration into the house, and to allow for proper drainage.

Contact a qualified landscaping contractor

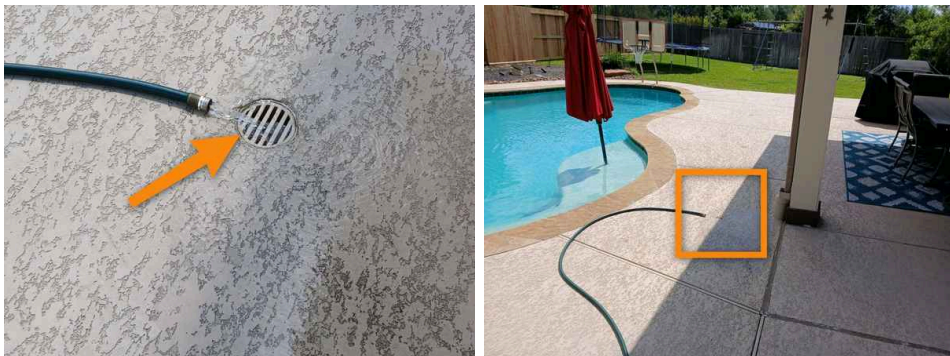
The underground drainage system at the rear of the house was checked by running water into the drain, and the system was observed to be draining properly. However, we could not determine the exit point of the drainage system, and further investigation with the homeowner and/or a service company is recommended.

Contact a qualified landscaping contractor

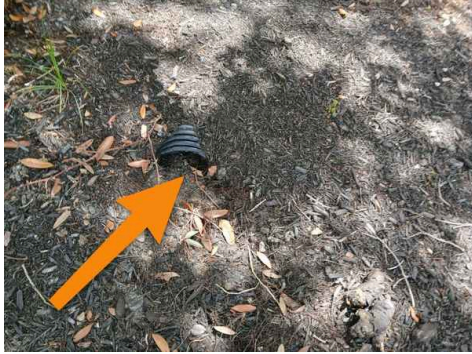
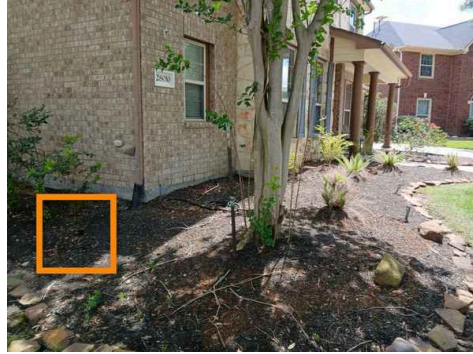
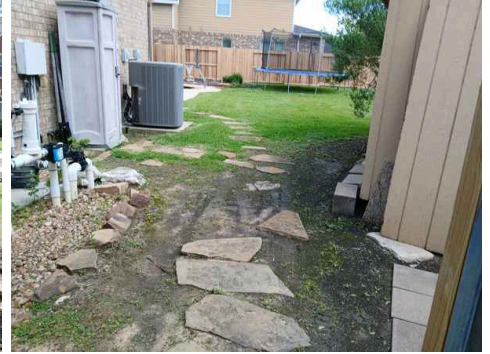
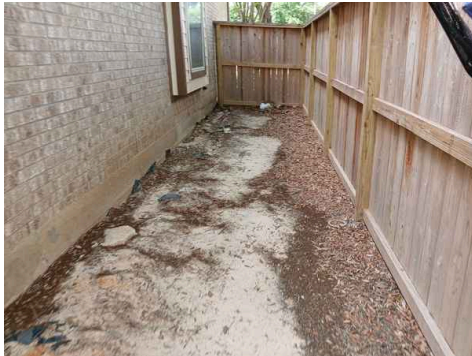
BOTH SIDES OF THE HOUSE

The drainage was observed to be poor at some low areas where it appears that water will pond. It is recommended that a company specializing in drainage solutions be contacted to provide a recommended solution, along with a cost estimate to provide proper drainage.

Contact a qualified professional.

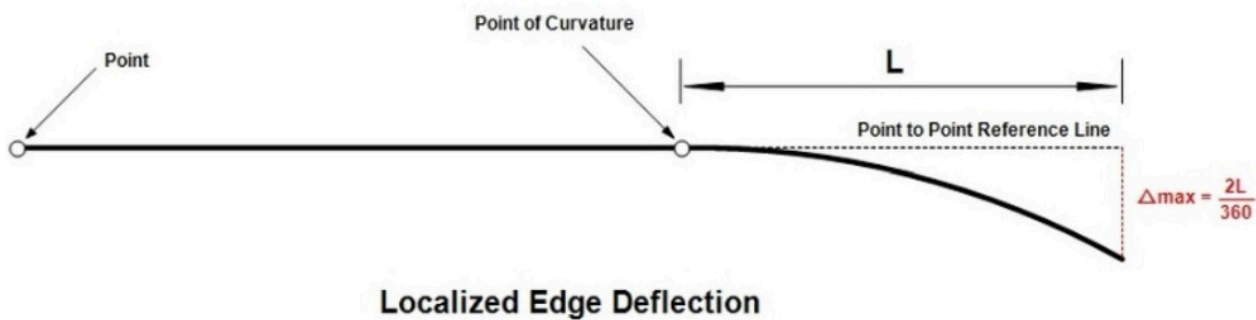
In accordance with the "Guidelines for the Evaluation and Repair of Residential Foundations" Version 3 by the Texas Section of the American Society of Civil Engineers (ASCE), we looked at our graphs of the actual shape of the foundation and determined that the deflection curve of the foundation most closely resembles the localized edge-condition deflection described in the ASCE Guidelines rather than overall deflection or tilt deflection. Therefore, our analysis of this foundation will use the recommended Guidelines for localized edge-condition deflection.

According to the ASCE Guidelines, the evaluation of localized **localized edge-condition deflections** shall be evaluated as a cantilevered member (allowable deflection = one inch deflection in a 15-foot horizontal distance ($2L/\Delta = 360$ per the building code)).

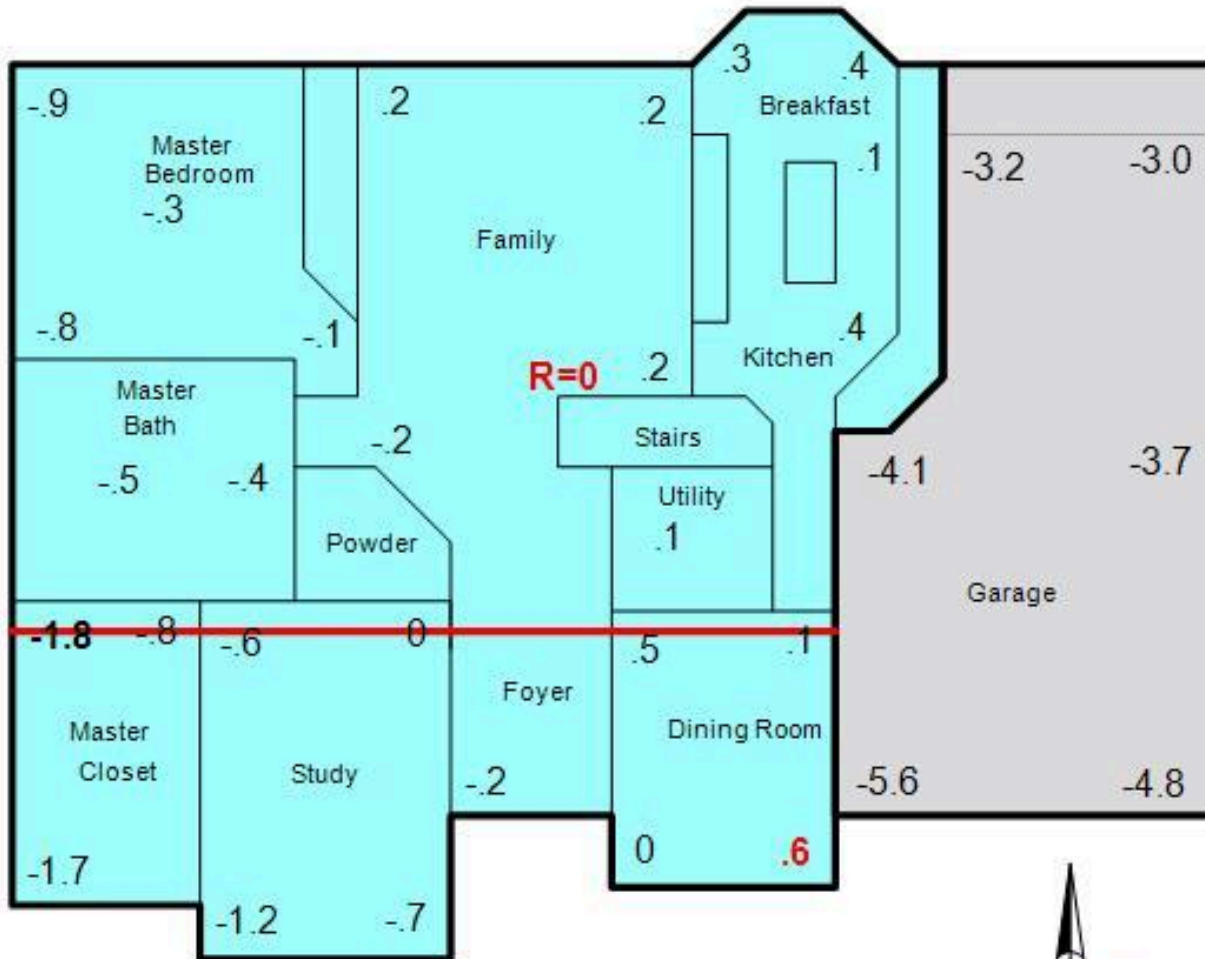
Elevation Readings
28010 Fulshear Plantation Dr.
(Not to scale)

From the point of curvature located at the study to the west wall of the master closet ($L = 21$ feet), the maximum allowable deflection is 1.40 inches. We calculated a deflection of 1.69 inches at the time of inspection across this span, which is **greater than the maximum allowable deflection**. This observation can be observed along the **Red Line** in the sketch below.

Most of the structures previously inspected by this firm have experienced some degree of differential foundation movement, and this structure was no exception. After careful examination, the engineering analysis above showed that the degree of the foundation movement is more than what is acceptable by the standards set forth by the American Society of Civil Engineers. The most significant movement was located at the west side of the master closet.

Due to the more than acceptable amount of movement of the foundation of this structure, the foundation needs to be releveled. It is recommended that at least three foundation repair contractors be contacted in order that they may make their own assessment of the scope and cost of the work needed to bring this foundation back to an acceptable degree of levelness. Each foundation repair contractor should provide their own design proposal showing the types of piers to be used to underpin the foundation, the number of piers, and the pier locations, along with their warranty information. Note that HEI does not prepare or approve foundation repair designs due to a multitude of potential engineering, legal, and/or ethical issues.
