Subject: Standard Initial Foundation Repair Evaluation
Slab Foundation
28010 Fulshear Plantation Dr., Fulshear, TX 77042

Date: April 22, 2025
Attention: Structured Foundation Repairs Houston (SFR) (via e-mail)
Subject: Final Report & Inspection
28010 Fulshear Plantation Dr., Fulshear, TX
Houston Permit #

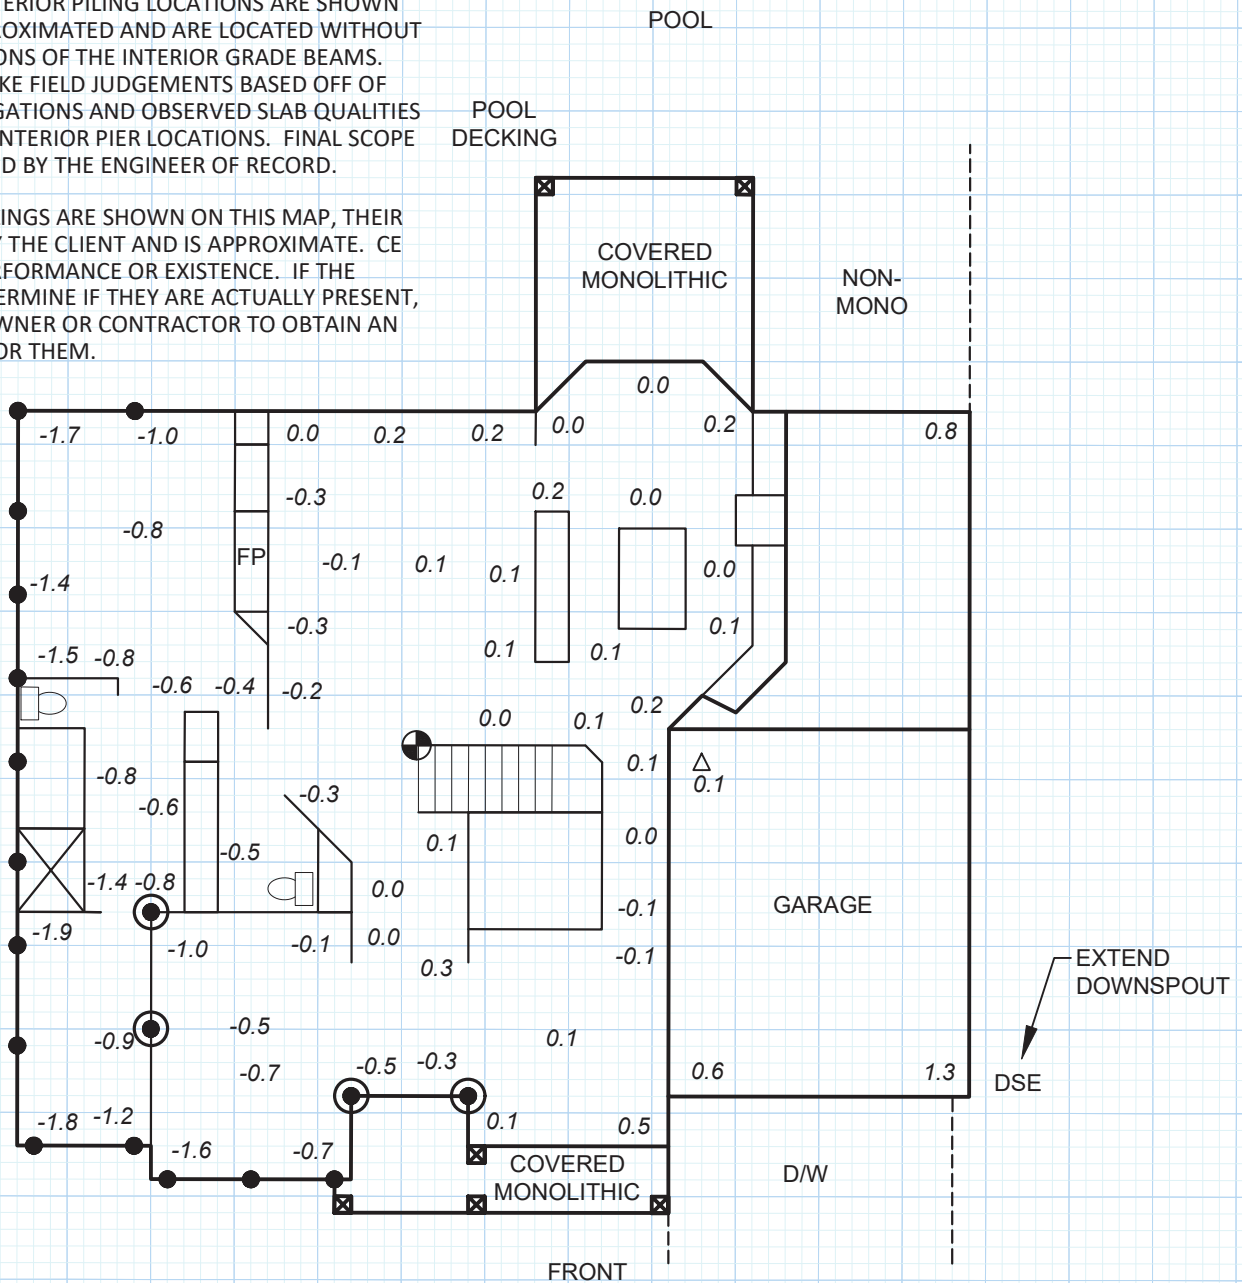
LIMITED REPAIR PLAN

Brick cracks, drywall cracks, floor cracks and trim separations were observed. Based on our observations of the structure, the structure’s physical damage, and review of the elevation map, we believe the structure has experienced foundation movement over the life of the structure, resulting in differential movement of the slab-on-grade foundation.

Damage observations were notable in multiple areas of the structure and are correlated with floor elevation data.

- Obtaining a ground penetrating radar scan to identify interior concrete beam within the slab.
- Installing 18 total pilings (14 exterior, 4 breakouts).
- Extending the downspout out of the garden in the area shown on the map.

- OBTAIN A GROUND PENETRATING RADAR SCAN TO IDENTIFY INTERIOR CONCRETE BEAM WITHIN THE SLAB.
- INSTALL 18 TOTAL PILINGS (14 EXTERIOR, 4 BREAKOUTS).
- EXTEND DOWNSPOUT OUT OF GARDEN IN THE AREA SHOWN.

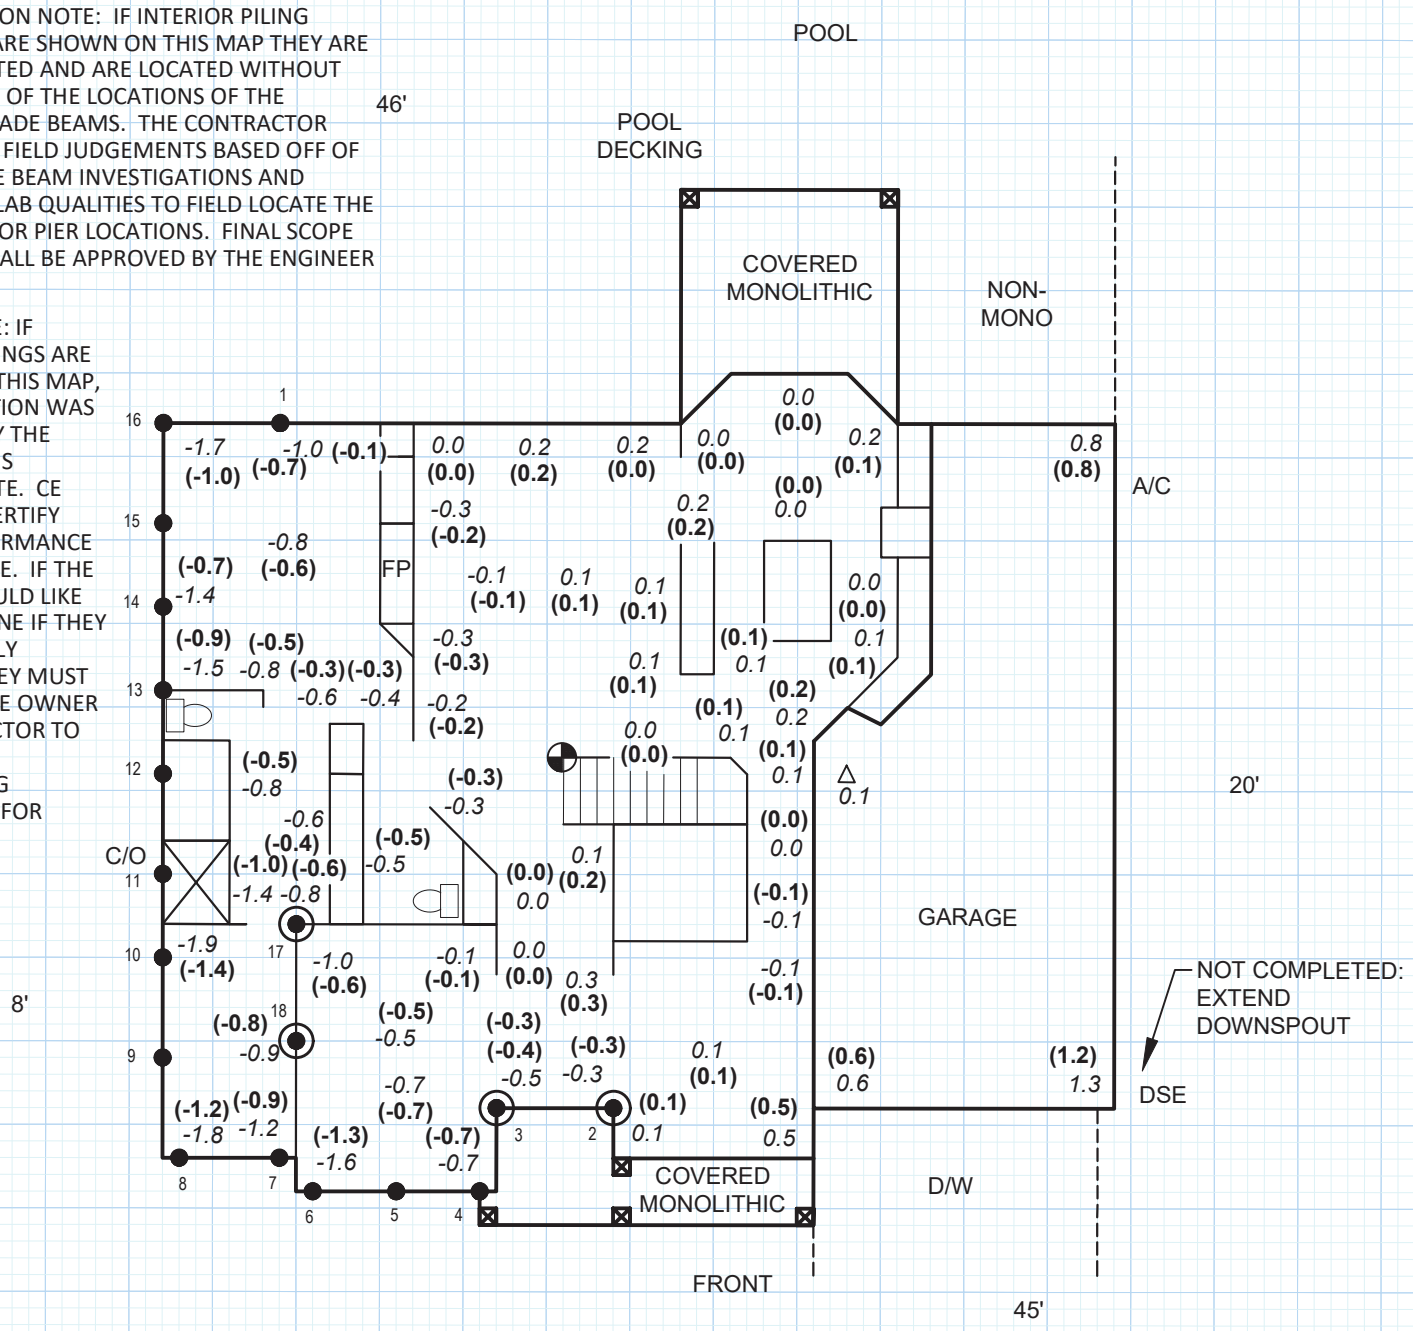
LIMITED REPAIR PLAN

The following changes were made to the original repair plan: 1 downspout was not extended. The elevation data obtained during the inspection indicates the foundation is supported by pilings to prevent further downward movement and may have been lifted. In some cases, the pilings are meant to support the foundation and minimal to zero lift was intentional.

- INSTALLED 18 TOTAL PILINGS (14 EXTERIOR, 2 EXTERIOR WITH CONCRETE BREAKOUTS, 2 INTERIOR).
- NOT COMPLETED: EXTEND DOWNSPOUT OUT OF GARDEN IN THE AREA SHOWN.
