SUMMARY

2506 Seedling St, Richmond, TX 77406
Shama Tharwani
04/14/2025

RedStar Professional Home Inspection, Inc

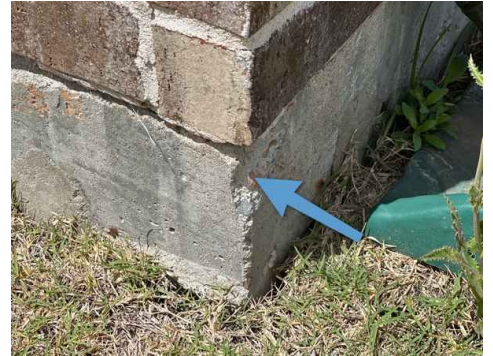
REAR RIGHT

SLAB: CORNER POPS

Cracks were noted at the corners of the foundation walls. Referred to as a "corner pop", these are very common and not a structural issue at this time. They should however be properly sealed to prevent further deterioration.

Contact a qualified concrete contractor.

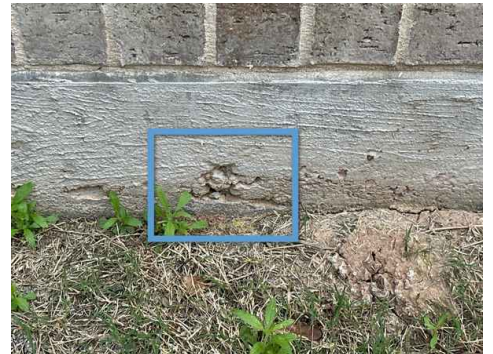
LEFT

HONEYCOMBING

"Honeycombing" was observed at the foundation sidewall at the above stated locations. This condition can cause deterioration to the concrete over time and I recommend that you consider sealing to avoid further deterioration and for cosmetic reasons.

Contact a qualified handyman.

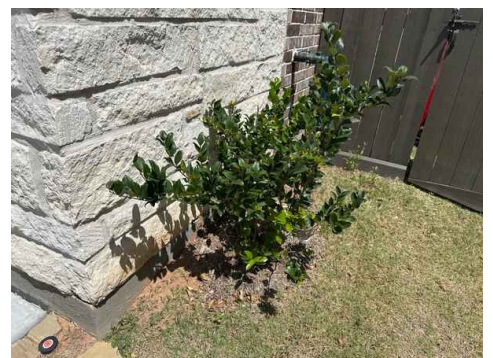
RIGHT

LANDSCAPING: TRIM TREES AND HEAVY FOLIAGE

Recommend trimming foliage in contact with the structure to prevent damage to the veneer and moisture penetration over time. Recommend all tree limbs be cleared back a minimum of 3' from the roof covering and foliage 18" from the exterior walls.

Contact a qualified landscaping contractor

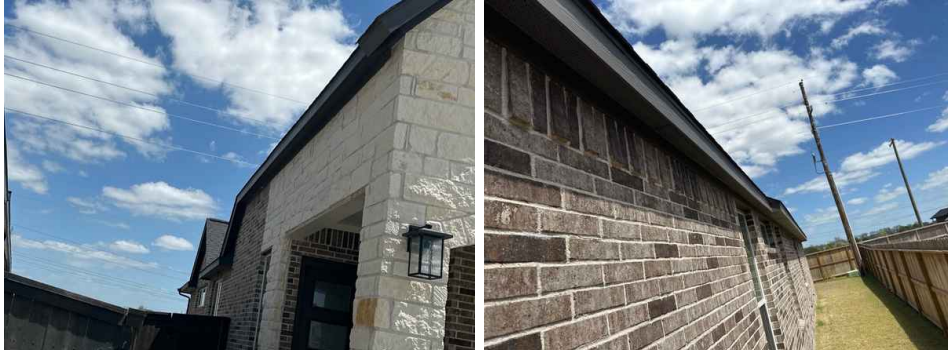
LEFT, RIGHT

GUTTERS ABSENT

No gutters were observed to be installed along portions of the roof slopes. Installation is highly recommended to prevent further erosion of the soil resulting in standing water near the foundation.

Contact a qualified gutter contractor

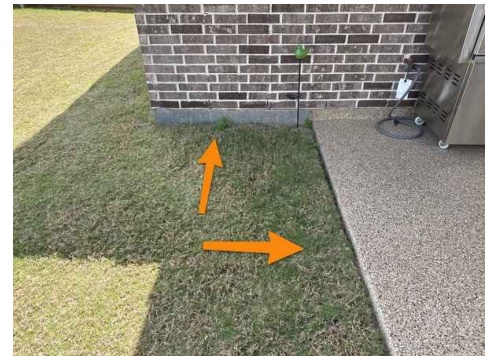
REAR

GRADING AND DRAINAGE: INADEQUATE/IMPROPER SLOPE

Inspector observed areas around the exterior of the home where the grade/slope away from the home was inadequate at the time of inspection. This can cause issues with water pooling around the home affecting the foundation performance. Recommend evaluation and correction by a qualified contractor to determine the extent of repairs necessary.

Contact a qualified landscaping contractor

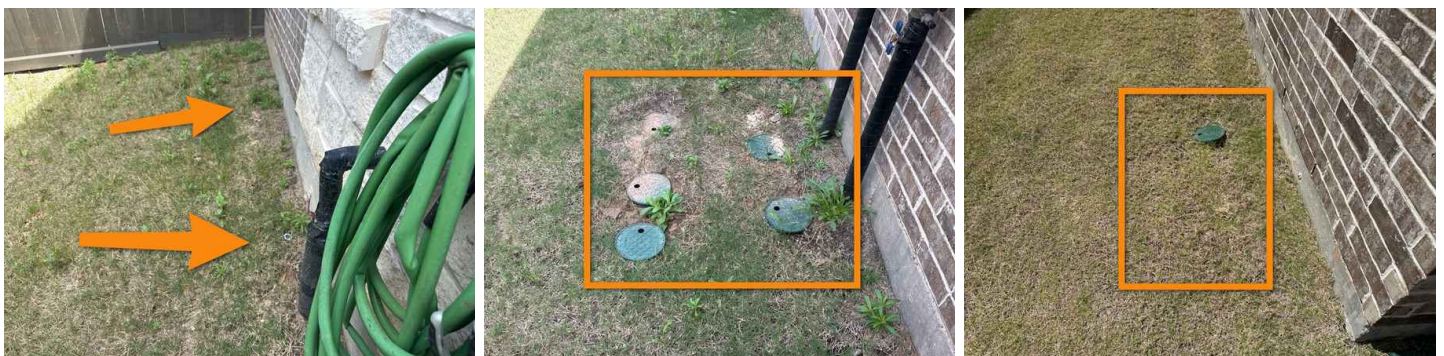
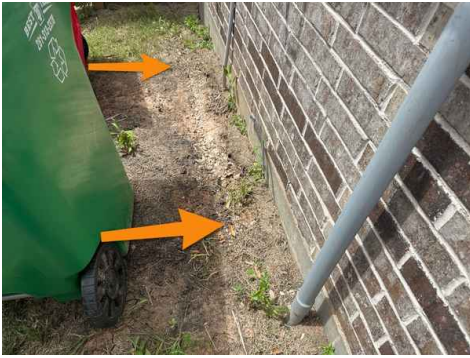
LEFT, RIGHT

GRADING & DRAINAGE: SOIL EROSION

Soil erosion was observed at multiple locations along the exterior of the home. Recommend correction to grading issues to prevent standing water. Recommend further evaluation and correction **as needed to prevent further erosion and ensure proper drainage conditions.**

Contact a qualified landscaping contractor

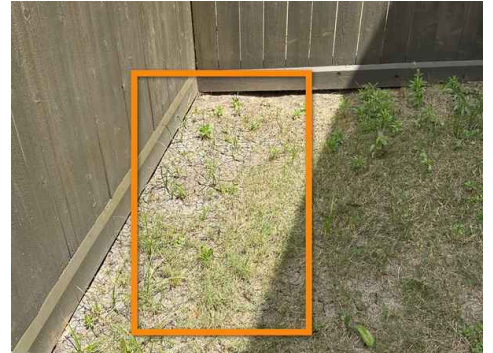
LEFT

2.2.5 B. Grading and Drainage **GRADING AND DRAINAGE: LOW SPOTS/STANDING WATER**

Locations were observed around the property that were low or improperly sloped and likely holding water. Low spots in the grade should be properly repaired to ensure proper drainage and avoid a potential hazard. Recommend consulting a qualified contractor to determine the best method of repair.

Note: Potential solutions may include the installation of an underground drain system around the property.

Contact a qualified landscaping contractor

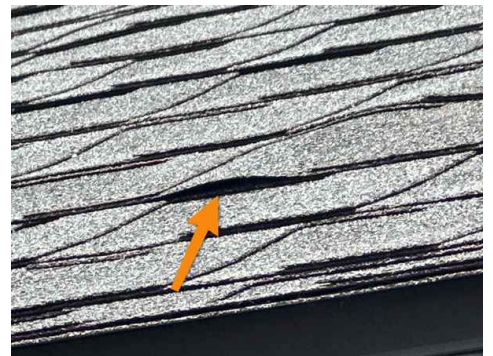
RIGHT

2.3.1 C. Roof Covering Materials **SHINGLES: LIFTED/CUPPED**

Observed buckled/lifted shingles on the roof covering. This condition is where the shingles are lifted or are not laying flat due to wrinkling of the underlayment or a shingle issue. High humidity and moisture issues at decking can also contribute to this condition. Recommend further evaluation by a roofing contractor to determine the extent of necessary repair.

Contact a qualified roofing professional.

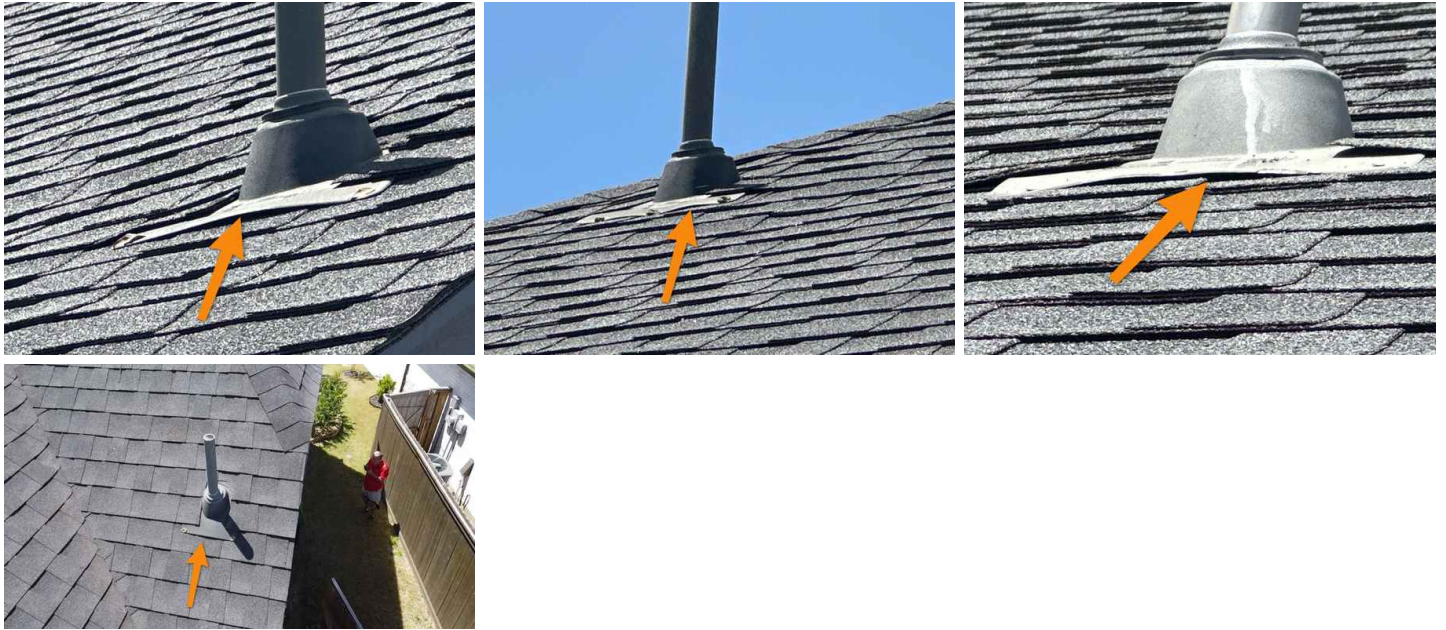
RIGHT, LEFT

2.3.2 C. Roof Covering Materials **FLASHING: LOOSE/RAISED FLASHING**

Raised or loose flashing areas were observed around the roof covering. This condition leaves the covering exposed to potential moisture or pest intrusion. Recommend all areas be evaluated and secured/sealed as needed.

Contact a qualified roofing professional.

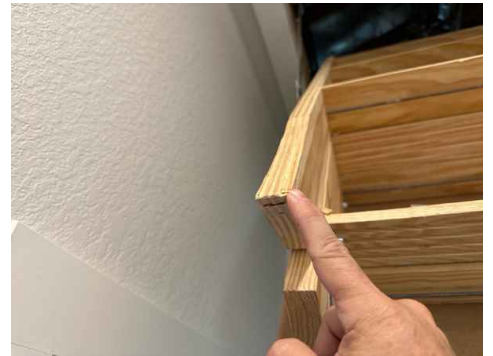
2.4.1 D. Roof Structures and Attics **ATTIC DOOR: ISSUES OBSERVED**

Ladder is damaged

The above stated issues were observed in relation to the attic access door at the time of inspection. Attic access doors are required to be properly insulated, weatherstripped, and seal firmly for energy efficiency reasons. Pull down attic ladders are required to be properly secured to the ceiling framing with appropriate fasteners, the hardware on the doors should be kept in good condition and be regularly serviced for safety reasons. Recommend correction of any above referenced issues to ensure performance and proper installation.

Recommendation
Contact a qualified handyman.

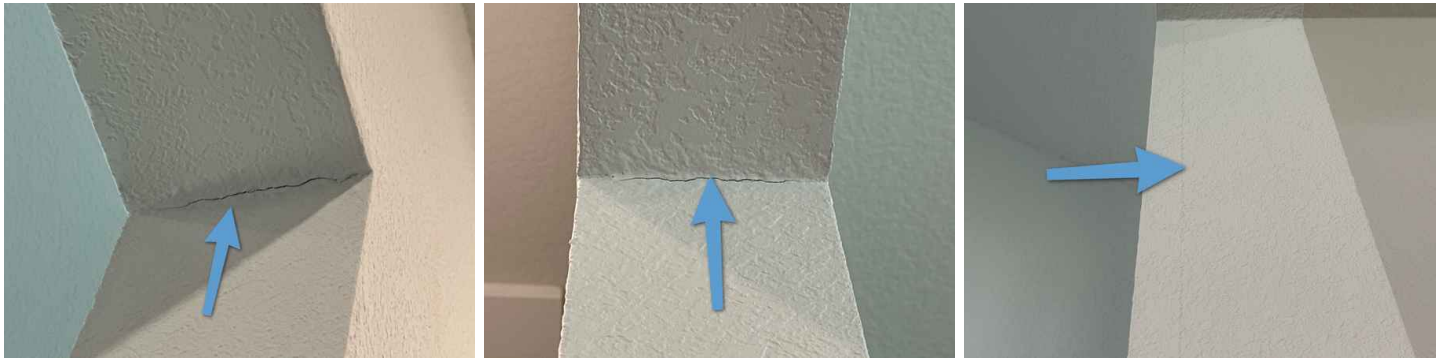
HALL, DINING ROOM

2.5.2 E. Walls (Interior and Exterior) **MINOR COSMETIC/MAINTENANCE ISSUES**

Minor drywall cracks or cosmetic issues

The above stated issues were observed at the home at time of inspection. These items are related to cosmetic issues or maintenance due to expected wear and tear. Recommend you budget for repair of these issues for cosmetic reasons, or to avoid further deterioration.

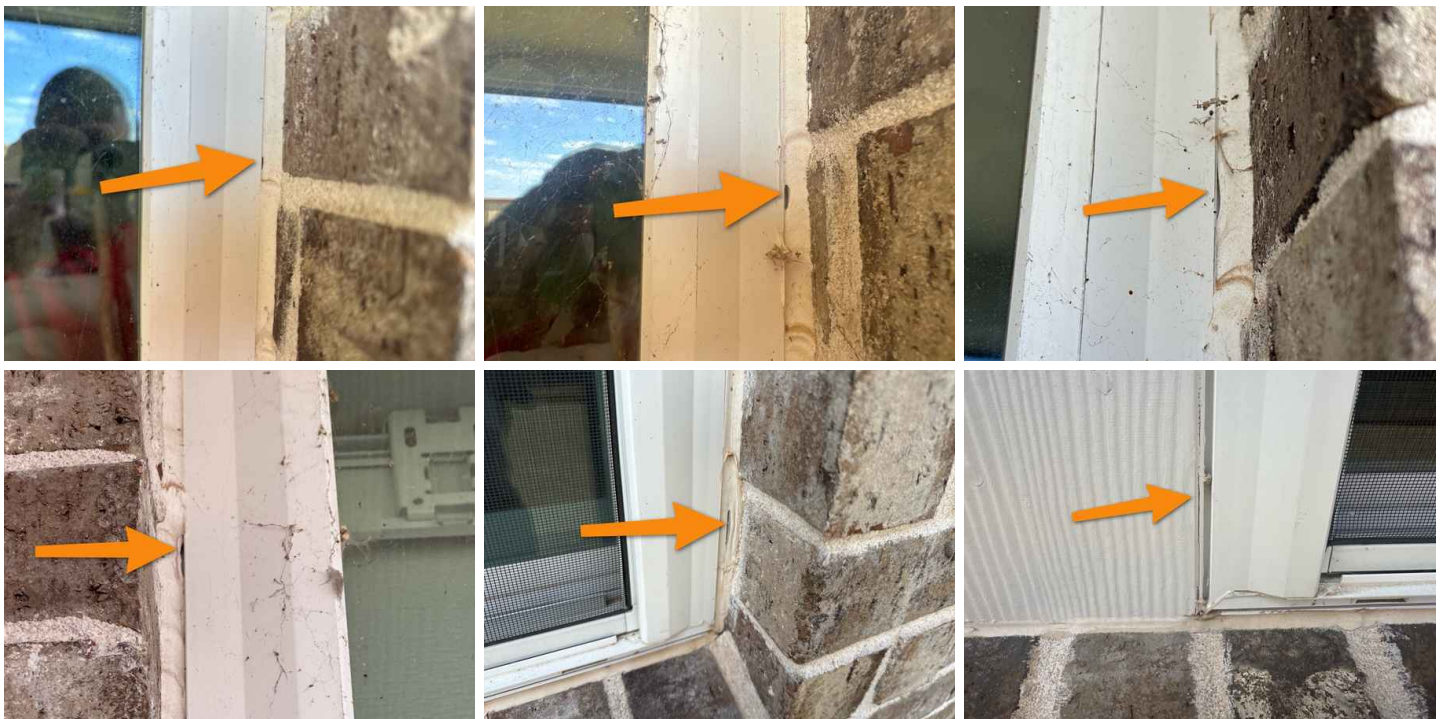
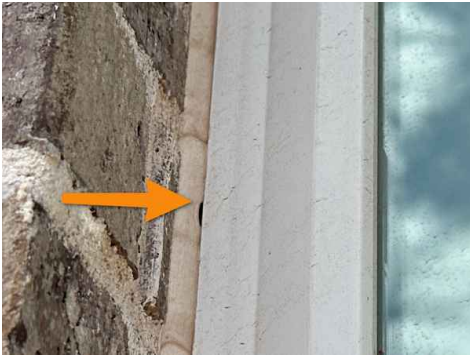
REAR PATIO, REAR, LEFT
Around windows

2.5.3 E. Walls (Interior and Exterior)
CAULKING AND SEALING NEEDED

The above stated locations were identified as areas in need of proper caulking and sealing, or maintenance to the existing sealant. Examples of locations needing sealing are pictured for your reference. Recommend further evaluation of these areas and all others to determine the extent of needed repairs.

Recommendation
Contact a qualified handyman.

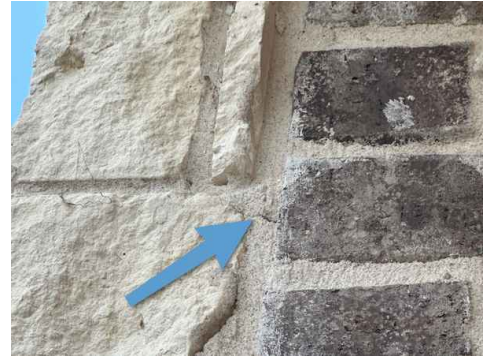
FRONT PORCH

**MASONRY: MINOR
CRACKS/MAINTENANCE
RECOMMENDED**

Minor cracks were observed in the masonry walls and/or mortar lines around the home. These conditions appear related to typical or normal settlement. Recommend you consider correction to avoid further deterioration and for cosmetic reasons.

Contact a qualified masonry professional.

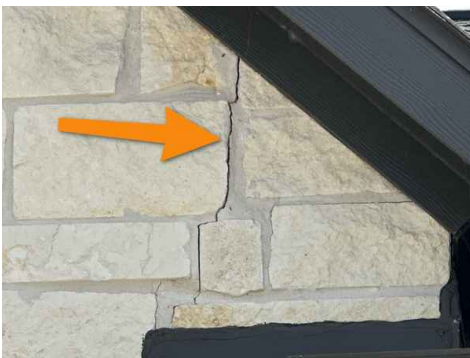
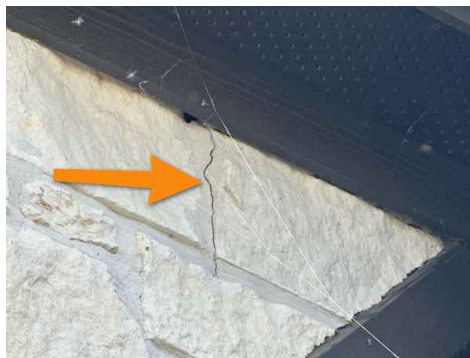
FRONT

MASONRY: MODERATE CRACKS/SEPARATIONS

Moderate cracks and/or separations were observed in the masonry walls around the exterior of the home. Common areas of issues include around windows, doors, and/or expansion joints. These cracks and separations are excessive and I recommend further evaluation to determine extent of necessary repairs.

Contact a qualified masonry professional.

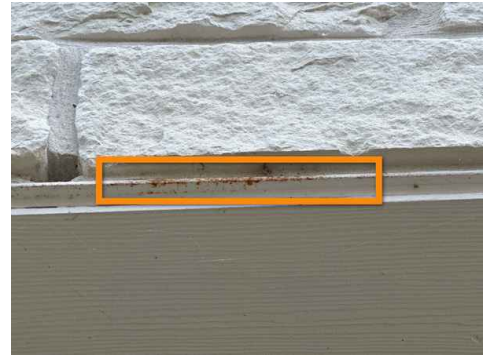
FRONT PORCH

**MASONRY: LINTELS
RUSTED/MAINTENANCE NEEDED**

Steel lintels above the windows and doors were observed to be unpainted or the paint finish displayed rusting/corrosion.

Recommend properly painting/sealing to prevent deterioration.

Contact a qualified painting contractor.

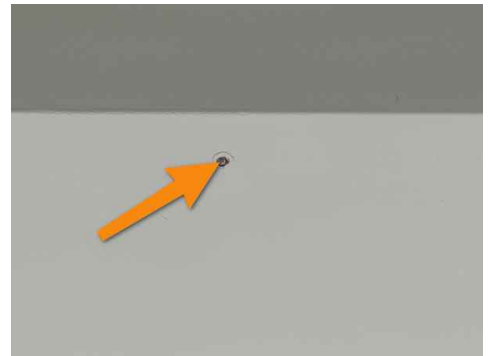
GARAGE

EXPOSED DRYWALL NAILS

Inspector observed what appeared to be drywall nails that were exposed in multiple locations at the time of inspection. Recommend consulting with the builder to correct for aesthetic purposes.

Contact a qualified professional.

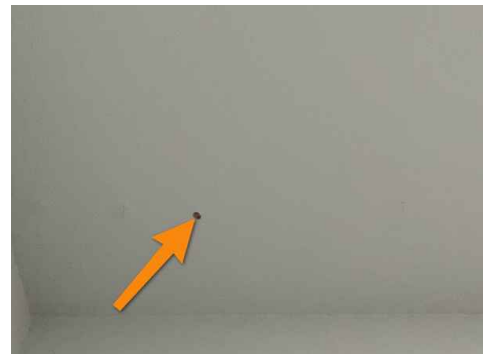
UTILITY ROOM

CEILING: "POPPED" NAILS

"Popped" (loose) drywall nails were observed at the time of the inspection. Nails pops often occur because of ceiling design, and heat in the attic area. This condition is not related to a structural issue. Repair as desired.

Contact a qualified painting contractor.

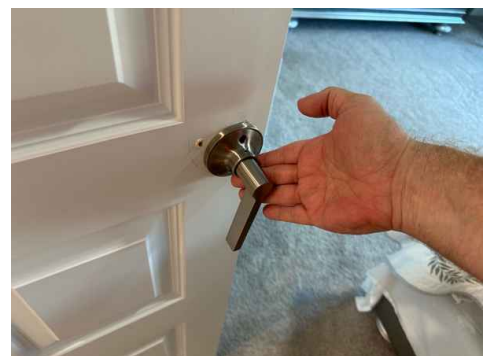
MASTER BATHROOM

INTERIOR DOOR: LOOSE HARDWARE/HANDLE

The door knob hardware at one or more doors around the home was observed to be damaged or loose. Recommend tightening to allow for easier operation of the doors.

Contact a qualified professional.

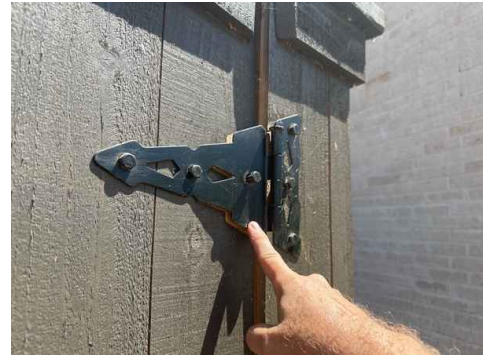
RIGHT

FENCE: ISSUES

Loose, damaged and missing fence boards were observed at various locations. Recommend further evaluation and repair for security purposes.

Contact a qualified professional.

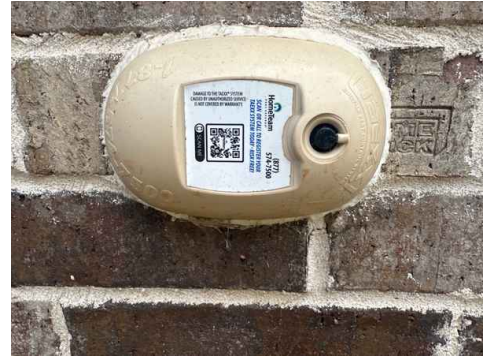
SUBTERRANEAN TERMITE MONITORING/BAIT STATIONS

Inspector observed termite monitoring/bait stations around the perimeter of the foundation. Recommend consulting with the seller regarding these items to determine why the system was installed and if the system is currently being monitored or is under warranty. Recommend consulting with a qualified pest control to evaluate the system or removal as desired.

Contact the seller for more info

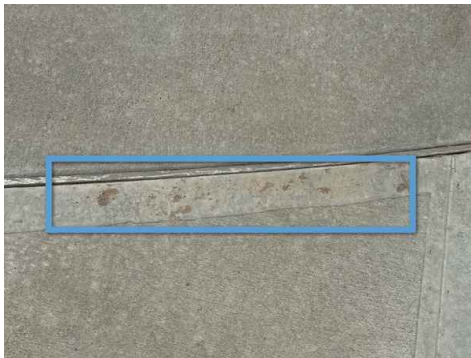
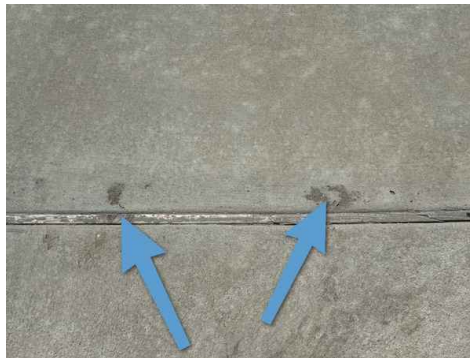
DRIVEWAY/WALKWAY CHIPPED

Driveway and or walkway concrete damage/chipped at one more areas, evaluate and repair as needed.

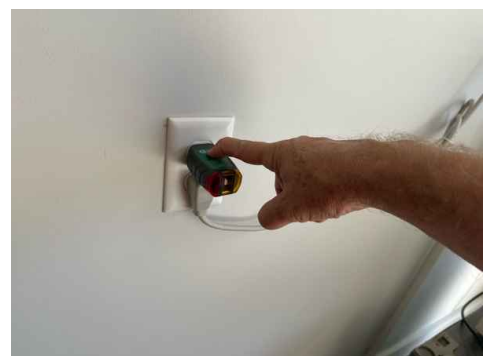
Garage

OUTLETS: GFCI PROTECTION INADEQUATE

Multiple outlets throughout the homes wet locations were in need of GFCI protection. GFCI outlets weren't required when the home was built but updating to GFCI would avoid safety hazards.

Contact a qualified professional.

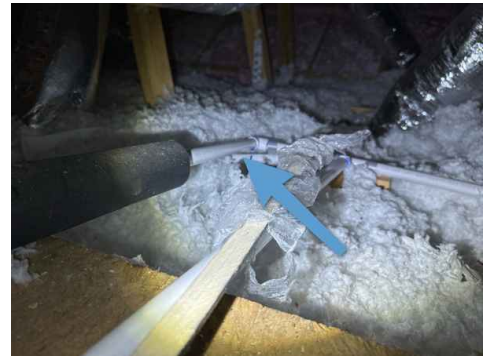
CONDENSATE: ATTIC LINE NOT INSULATED

A portion of the primary drain line was not insulated or insulation was damaged in the attic space. Recommend repair to prevent condensation on this drain line which could drip moisture into the ceiling below.

Contact a qualified professional.

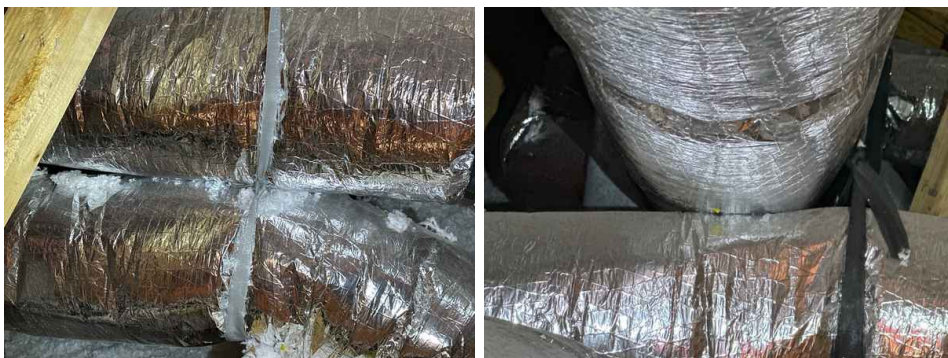
DUCTS: DUCTS RESTING ON EACH OTHER

Ducts were observed to be resting on each other. This could cause condensation between the two and restricted air flow with compression. Recommend to separate duct work or placing insulation between them.

Contact a qualified professional.

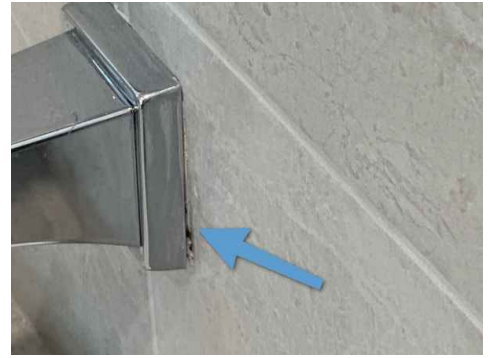
MASTER BATHROOM

TUB: CAULKING MISSING/DETERIORATED FIXTURES

Fixtures going through the wall should be sealed with caulking to prevent moisture penetration through the walls. Remedy as needed.

Recommendation
Contact a handyman or DIY project

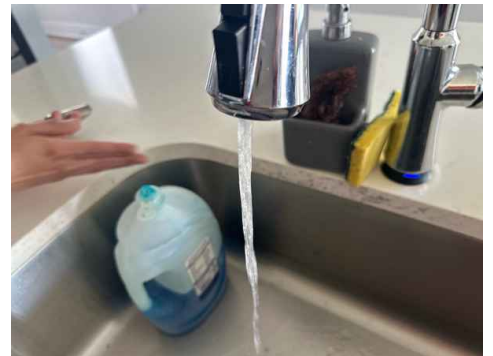
KITCHEN

WATER PRESSURE AT FIXTURE

Low water pressure observed at kitchen island sink fixture, recommend for the evaluation by builders licensed plumber.
