Property Address: **9715 Greenwillow St, Houston, TX 77096**

Inspection Report

Property Address:
9715 Greenwillow St
Houston TX 77096

PROPERTY INSPECTION REPORT FORM

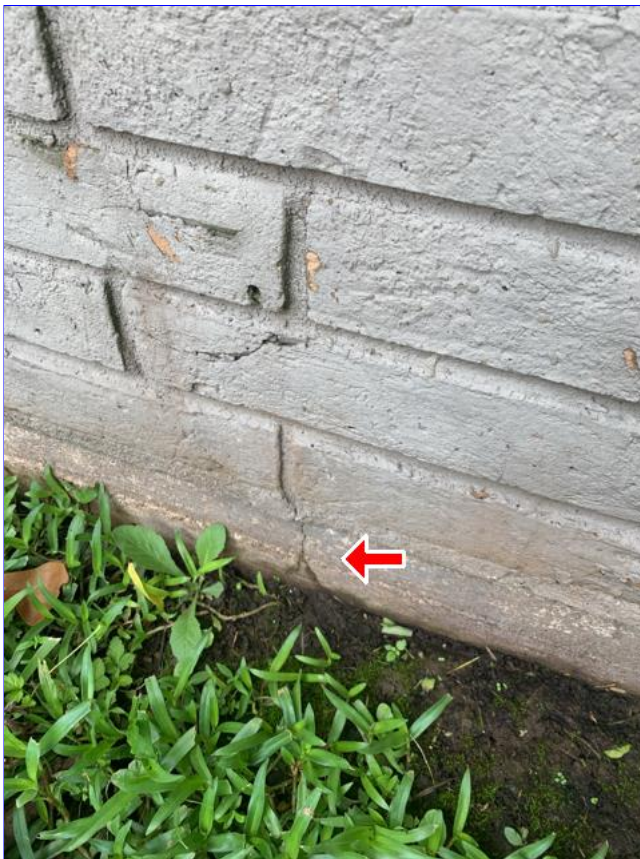
(1) There is some slab edge cracking. There is little to no deflection across the crack. This type of flexural crack is generally the result of seasonal variations in soil moisture causing the soils to shrink and/or swell exerting pressure on the foundation.

This type of crack is not structurally significant.

A. Item 1(Picture) There is some slab edge cracking.

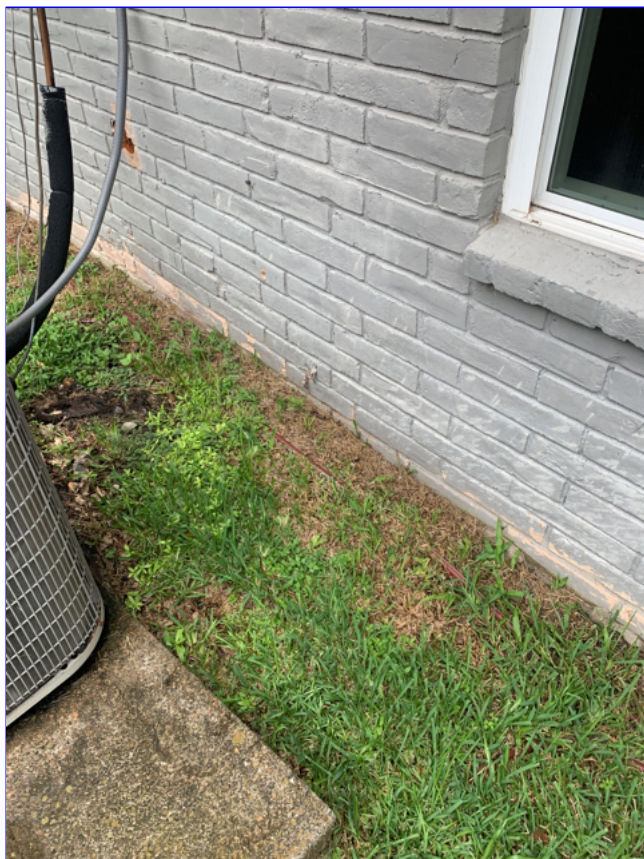
(1) High soil conditions observed at front of home left side and right side. High soil conditions are conducive to wood destroying insects and should be avoided. I recommend a minimum six inch foundation side wall exposure around the entire perimeter of the foundation. High soil levels prevent a quality Termite inspection. Recommend correction.

B. Item 1(Picture) High soil conditions observed at front of home left side and right side.

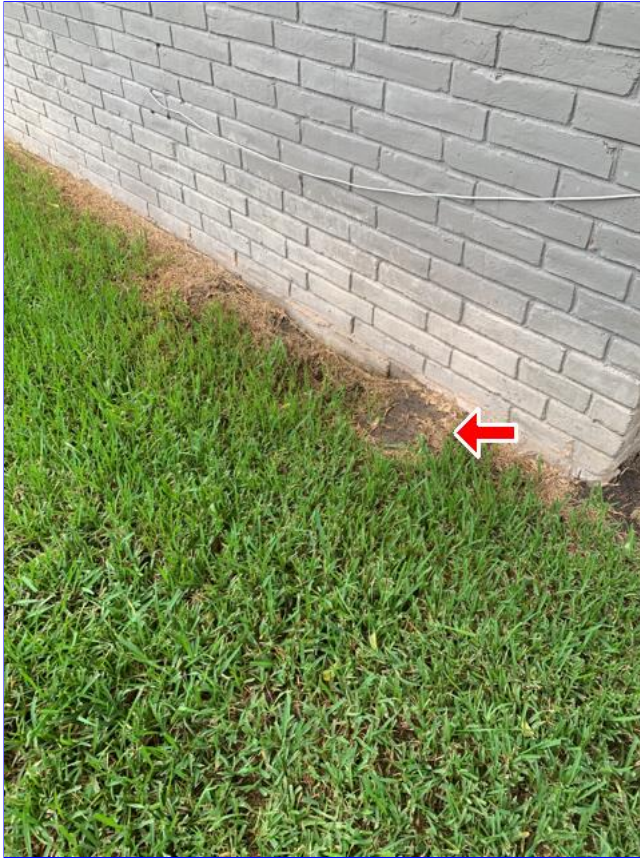
(2) Drainage swales at rear and sides of home appears to have low spots. Water will most likely pool in the drainage swales and not drain normally towards the street. Possible remedies might include the installation of catch basins, or French Drains at low spots connected to underground drain pipe to the street.

B. Item 2(Picture) Drainage swales at rear and sides of home appears to have low spots.

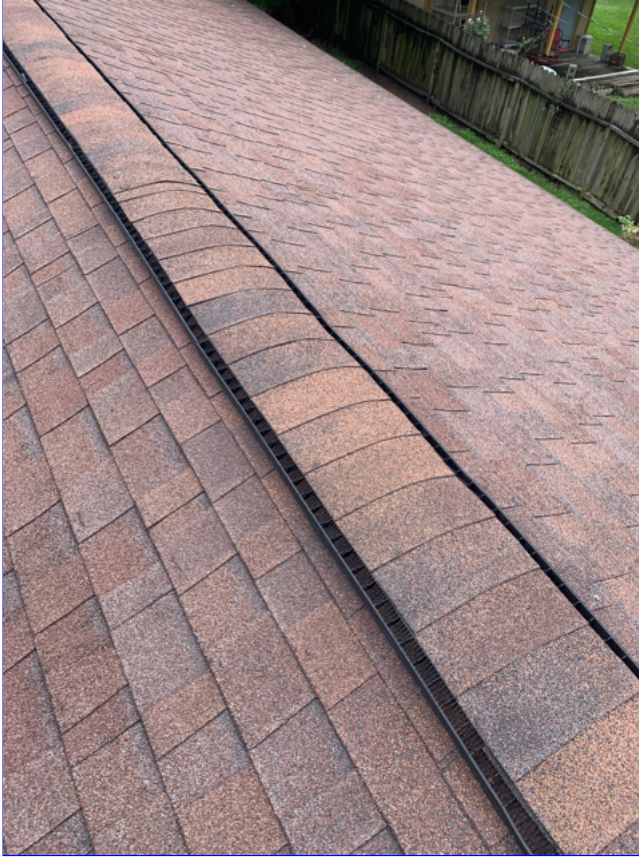
The roof covering, is not new and shows signs of wear consistent with its age. Hail damage was observed on the south facing area of the roof. Flashing and roof jacks need to be replaced. This roof covering is probably around 8 to 12 years old. This type of architectural style composition shingles typically lasts about 20 years in this climate. This roof is in need of replacement.

C. Item 1(Picture) The roof covering, is not new and shows signs of wear consistent with its age. Hail damage was observed on the south facing area of the roof.

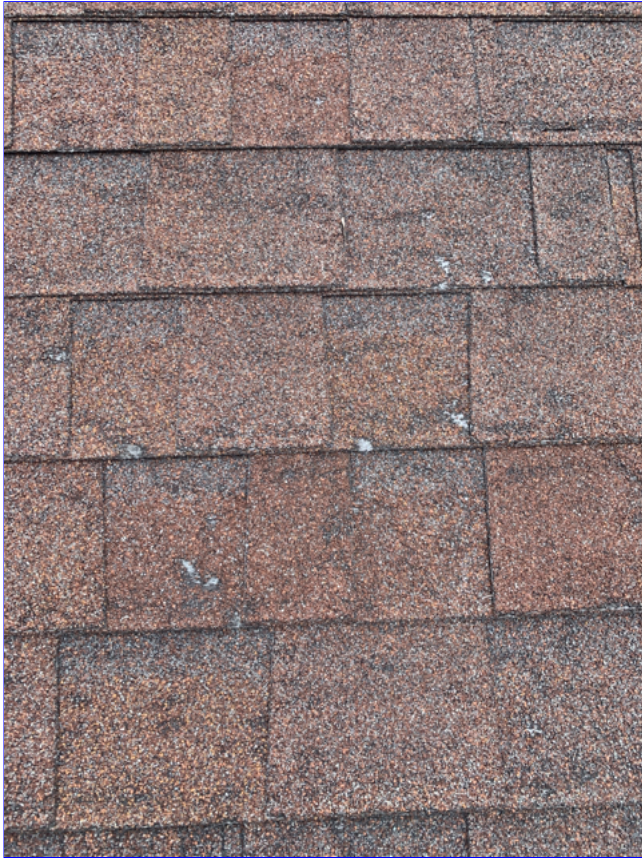
C. Item 2(Picture) The roof covering, is not new and shows signs of wear consistent with its age. Hail damage was observed on the south facing area of the roof.

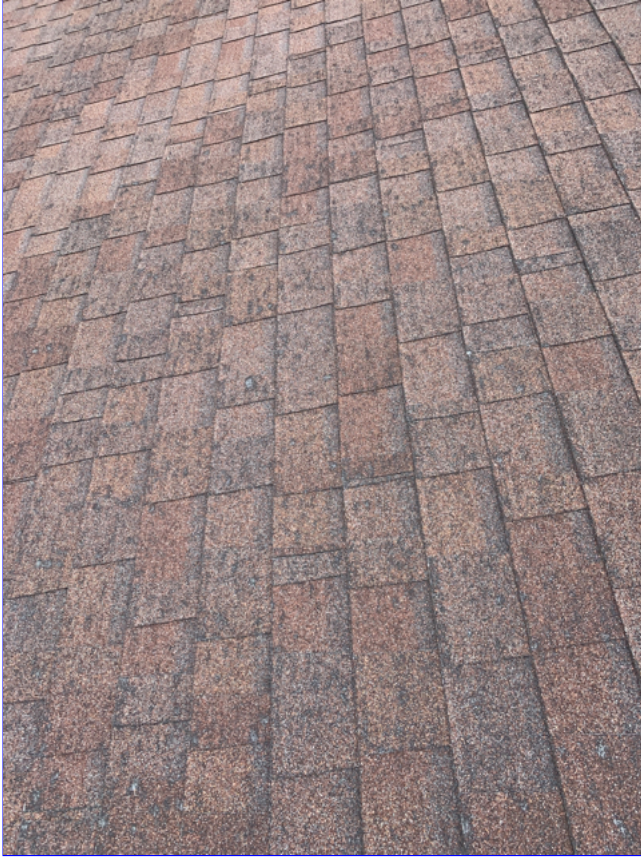
C. Item 3(Picture) The roof covering, is not new and shows signs of wear consistent with its age. Hail damage was observed on the south facing area of the roof.

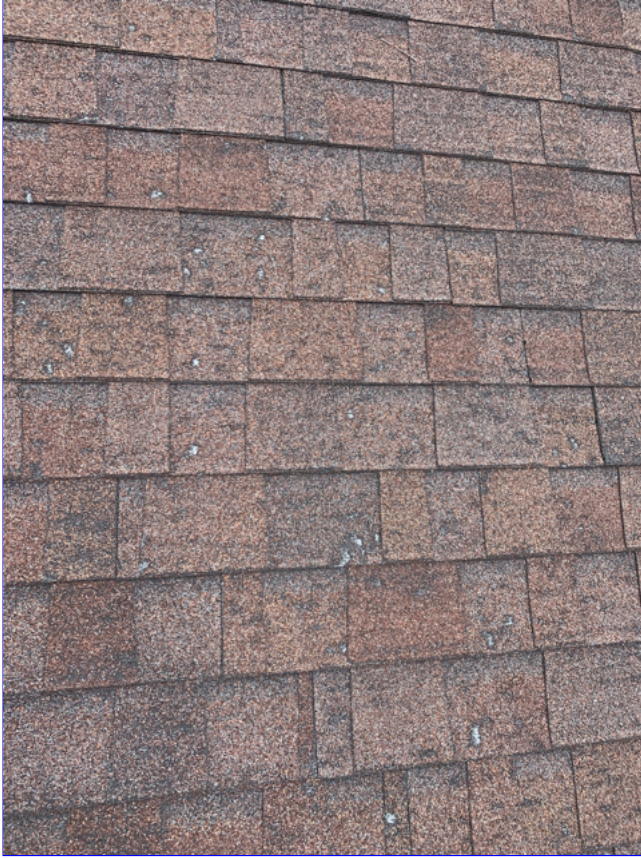
C. Item 4(Picture) The roof covering, is not new and shows signs of wear consistent with its age. Hail damage was observed on the south facing area of the roof.

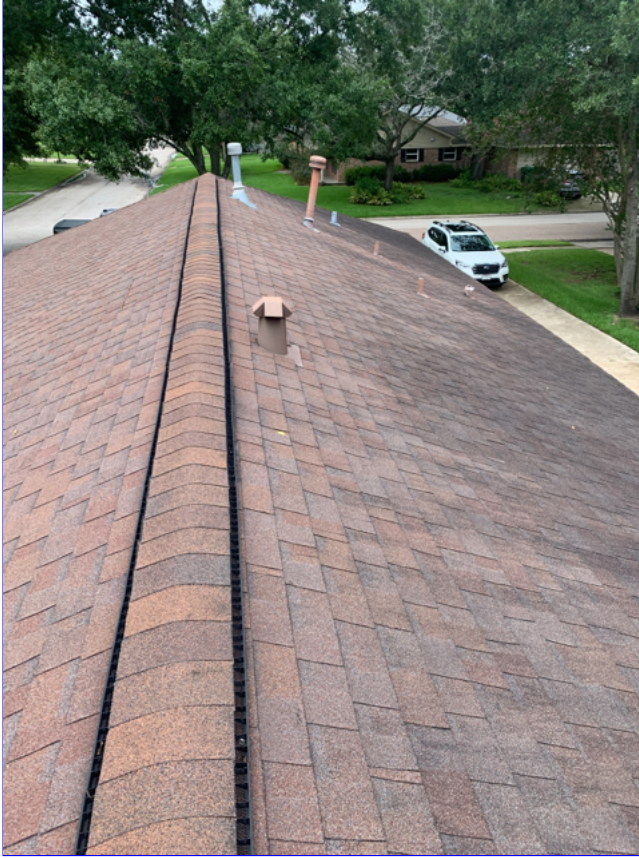
C. Item 5(Picture) The roof covering, is not new and shows signs of wear consistent with its age. Hail damage was observed on the south facing area of the roof.

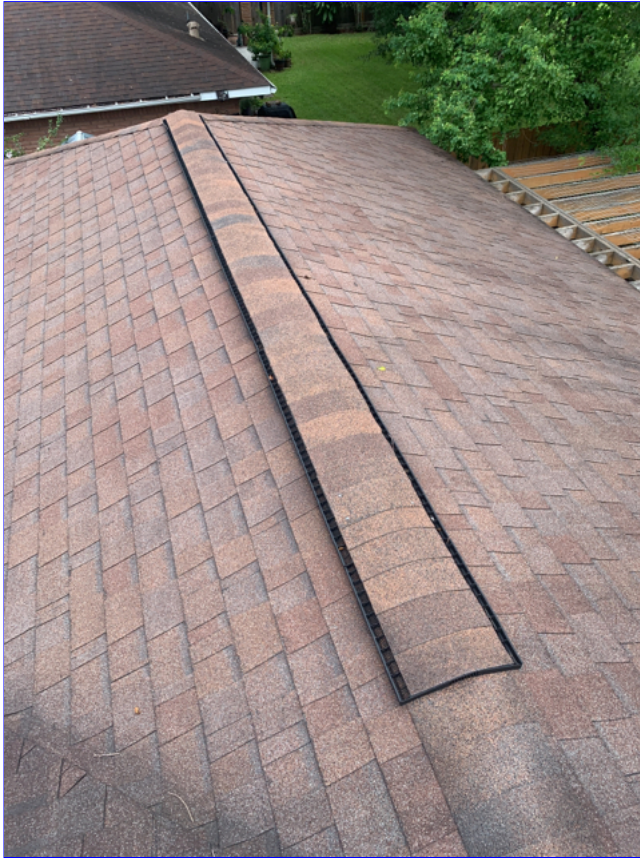
C. Item 6(Picture) The roof covering, is not new and shows signs of wear consistent with its age. Hail damage was observed on the south facing area of the roof.

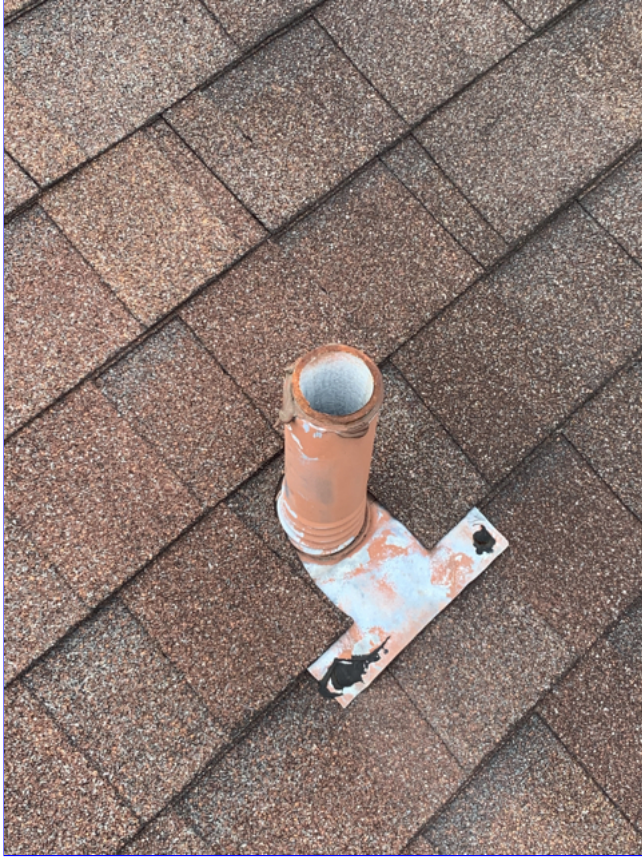
C. Item 7(Picture) Flashing need to be replaced.

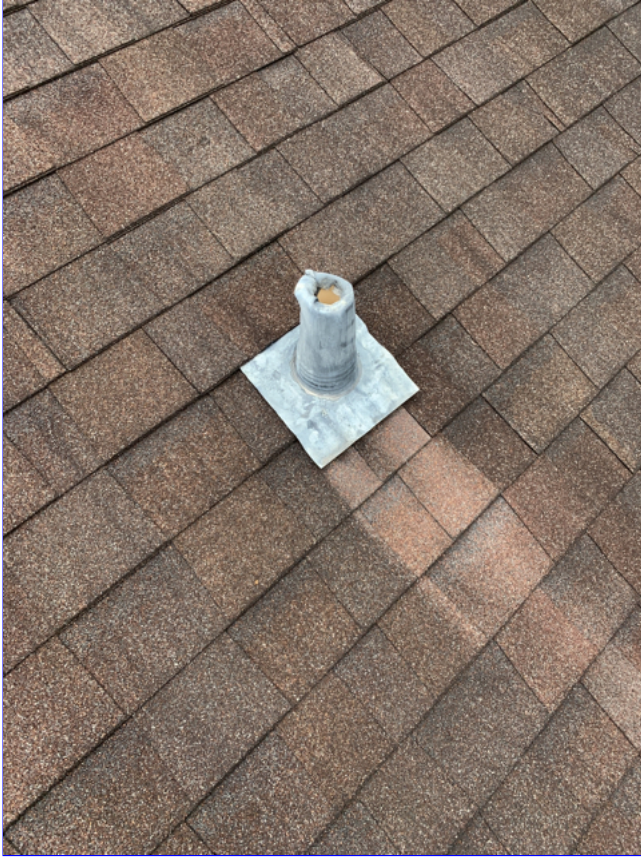
C. Item 8(Picture) Flashing need to be replaced.

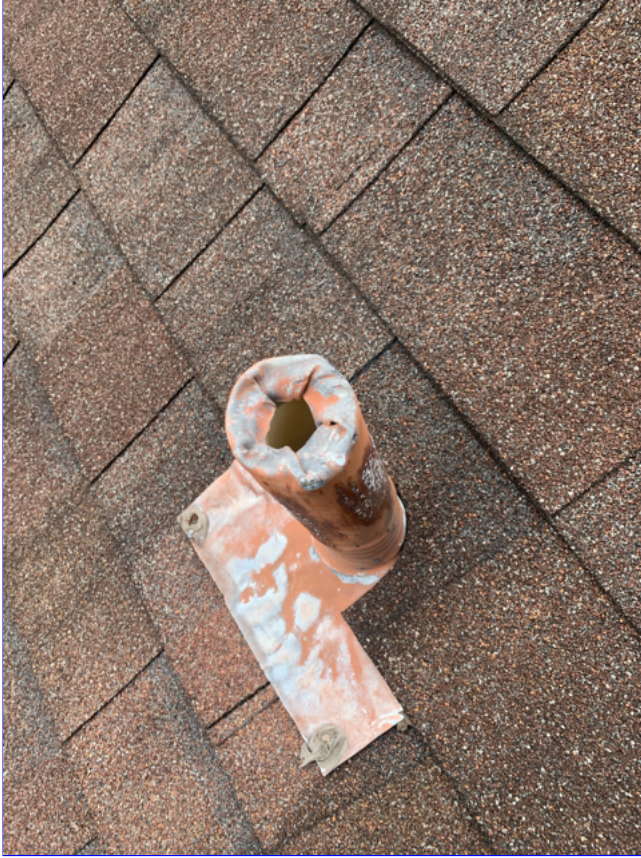
C. Item 9(Picture) Flashing need to be replaced.

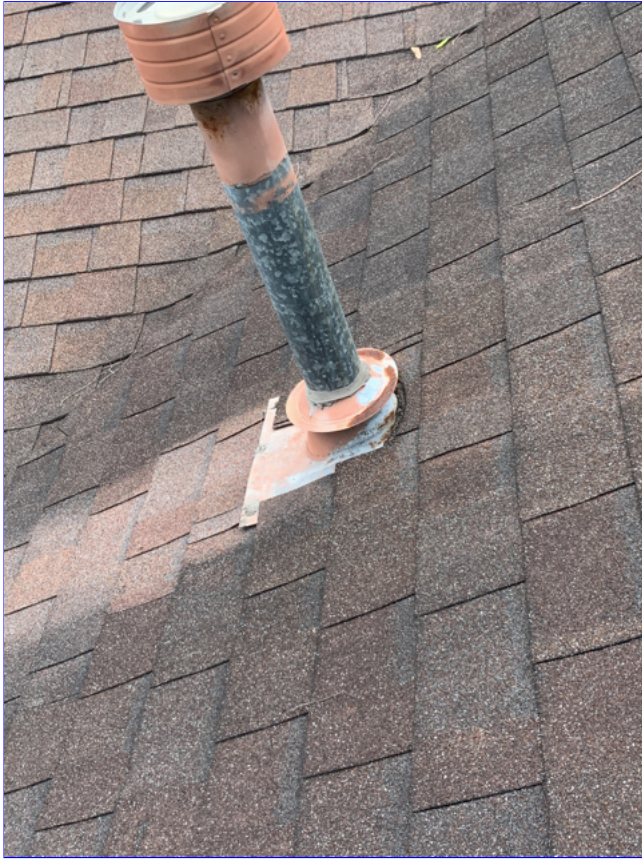
C. Item 10(Picture) Flashing need to be replaced.

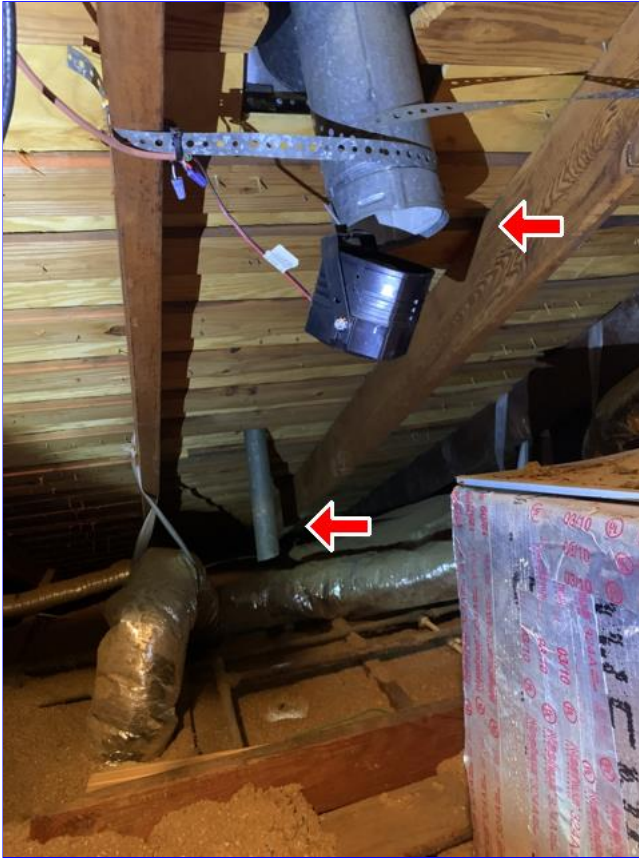
C. Item 11(Picture) Old vents need to be removed.

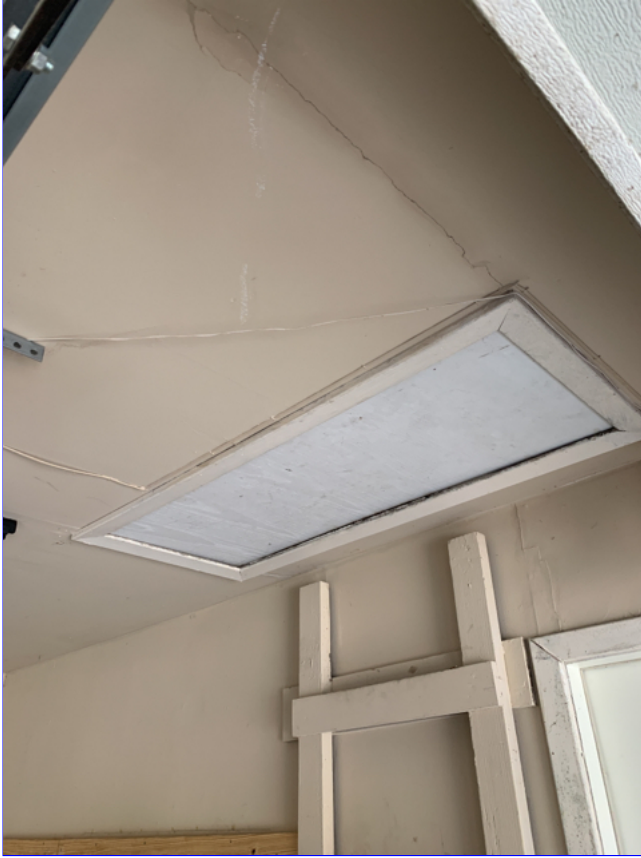
(1) The attic access material is not fire rated. Recommend correction.

D. Item 1(Picture) The attic access material is not fire rated. Recommend correction.

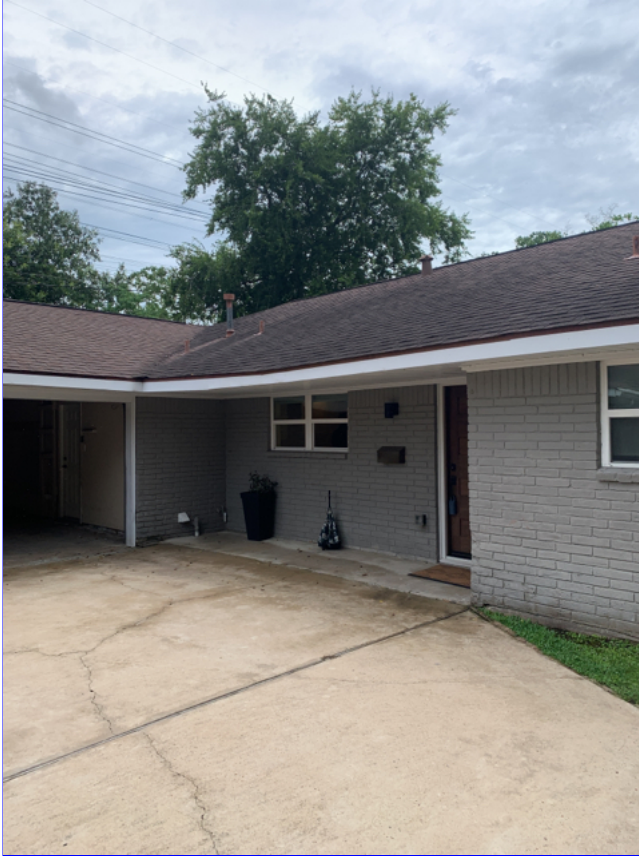
(2) The area of the front door porch has a sag. Recommend correction.

D. Item 2(Picture) The area of the front door porch has a sag. Recommend correction.

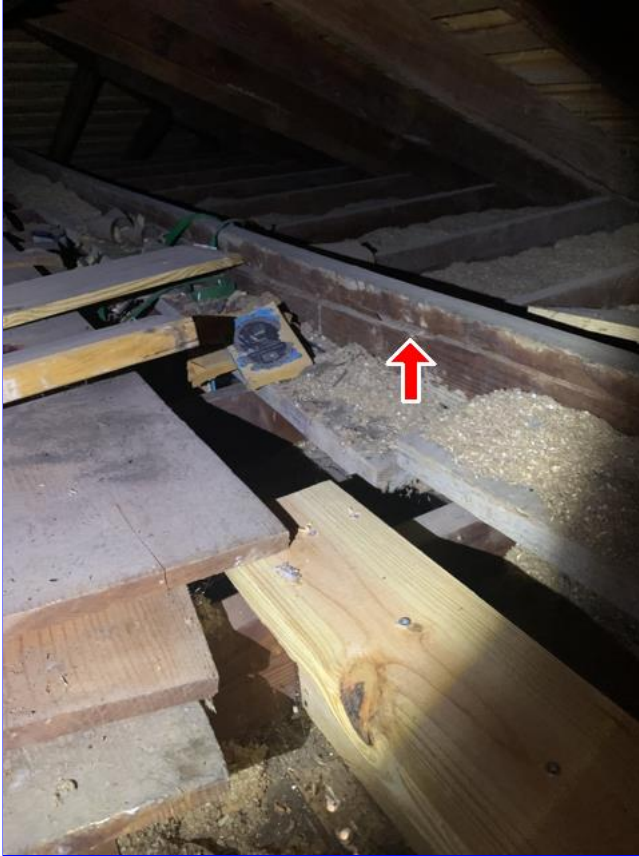
(3) The strong back bracing over the garage has a crack or has been cut. Recommend having a contractor to evaluate.

D. Item 3(Picture) The strong back bracing over the garage has a crack or has been cut. Recommend having a contractor to evaluate.

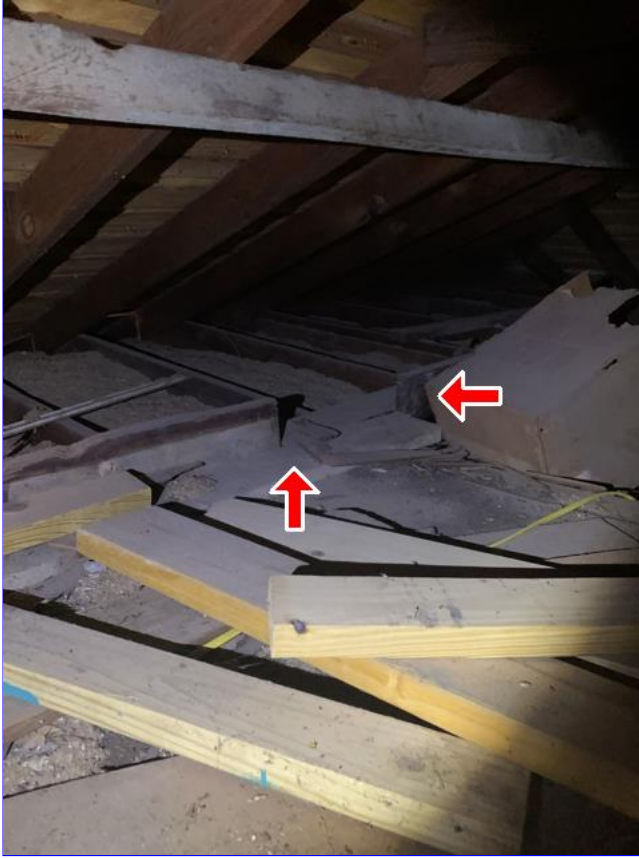
D. Item 4(Picture) The strong back bracing over the garage has a crack or has been cut. Recommend having a contractor to evaluate.

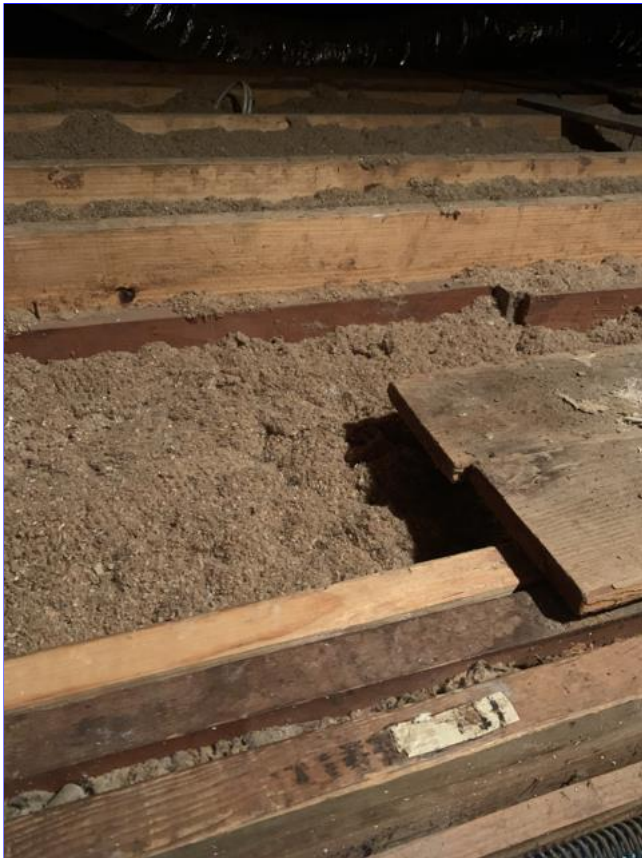
(4) The insulation in the attic is very thin. Recommend correction.

D. Item 5(Picture) The insulation in the attic is very thin. Recommend correction.

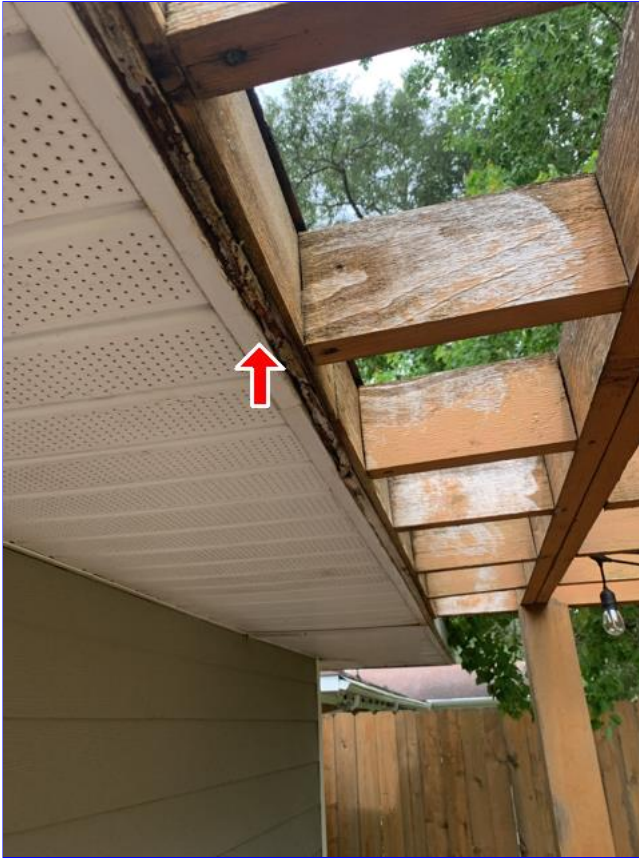
(1) Wood rot was observed on the fascia at the back of the home. Recommend correction.

E. Item 1(Picture) Wood rot was observed on the fascia at the back of the home. Recommend correction.

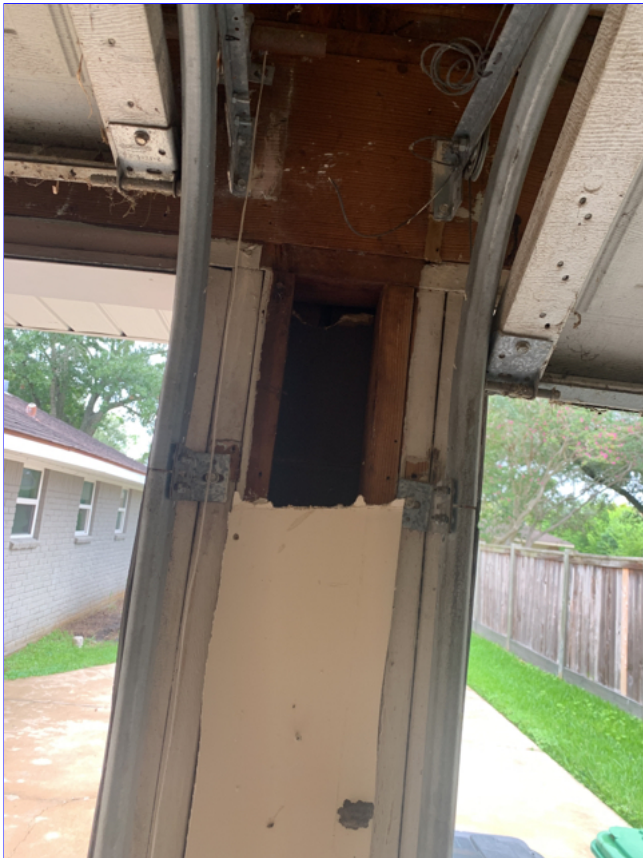
(2) Drywall was missing in parts of the garage. Recommend correction.

E. Item 2(Picture) Drywall was missing in parts of the garage. Recommend correction.

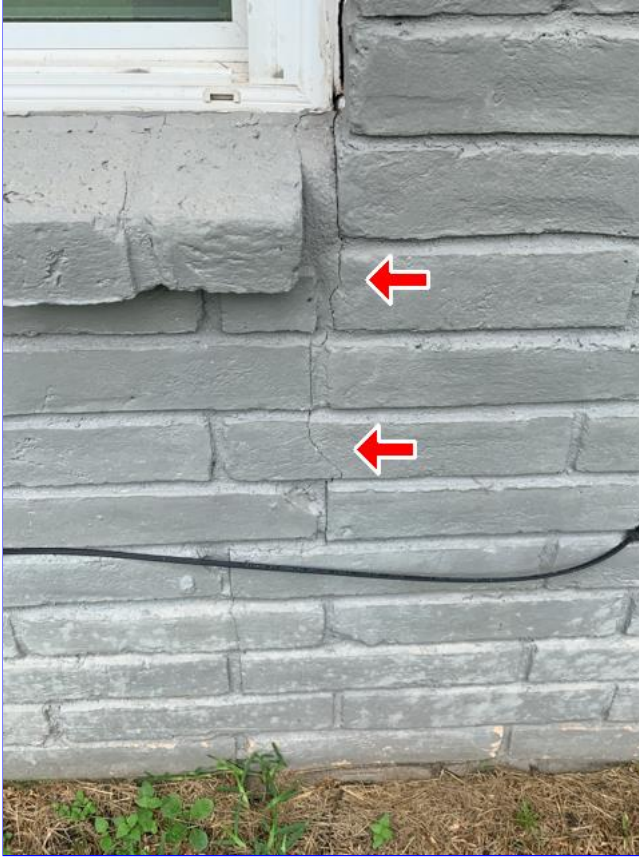
(3) Brick veneer mortar cracks were observed. This condition is cosmetic in nature and not structurally significant. The cracking of the brick veneer is likely due to flexing of the foundation during repeated seasonal changes. The expansive clay soil in the area is prone to excessive swelling during rainy periods and shrinkage during dry periods.

E. Item 3(Picture) Brick veneer mortar cracks were observed.

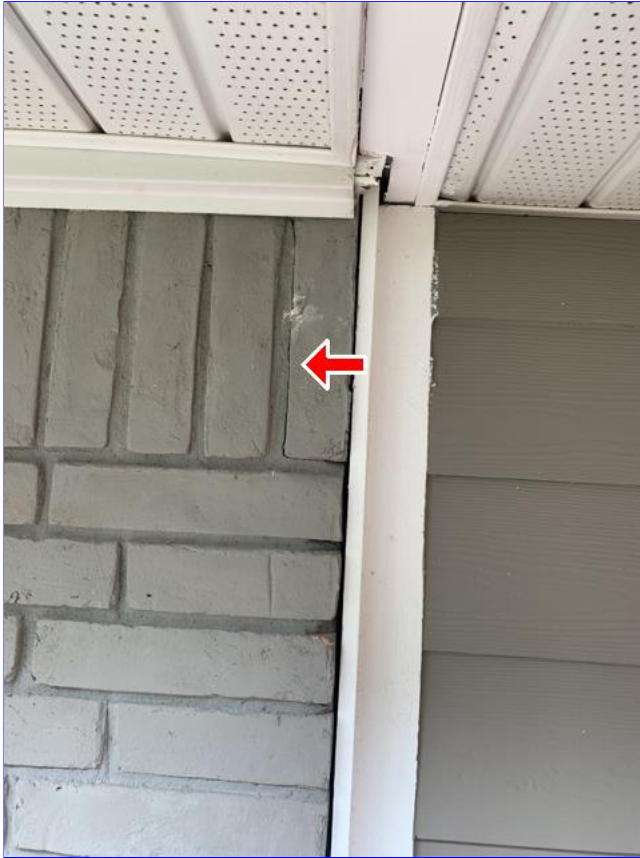
E. Item 4(Picture) Brick veneer mortar cracks were observed.

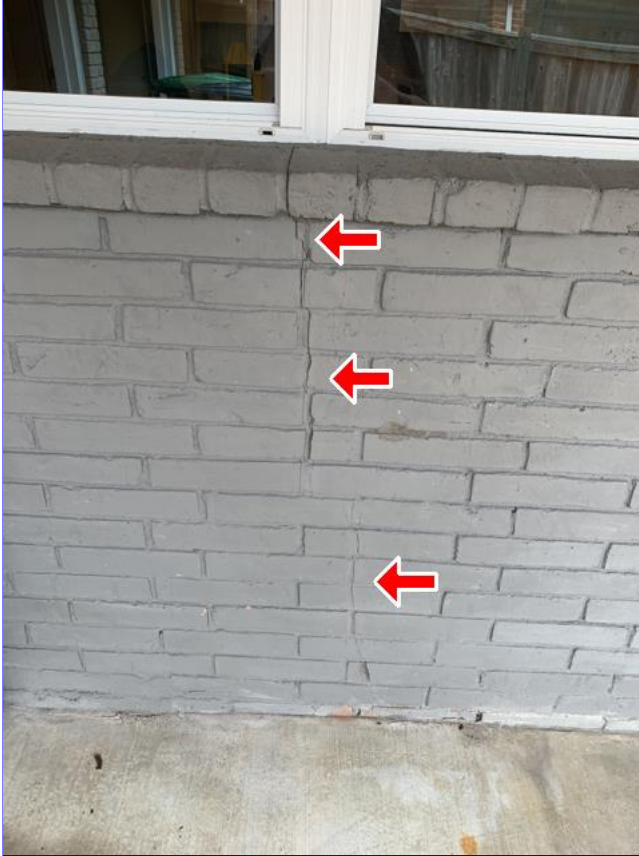
E. Item 5(Picture) Brick veneer mortar cracks were observed.

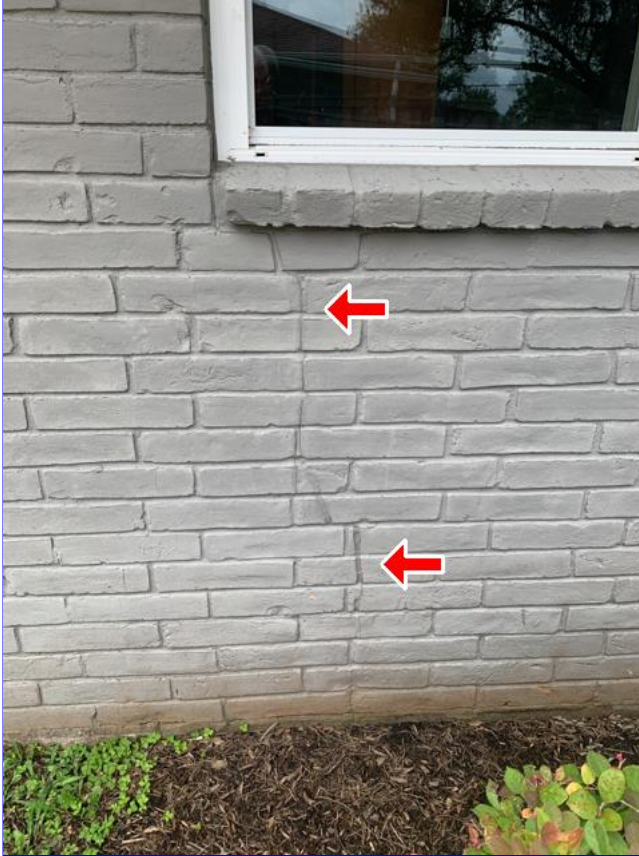
E. Item 6(Picture) Brick veneer mortar cracks were observed.

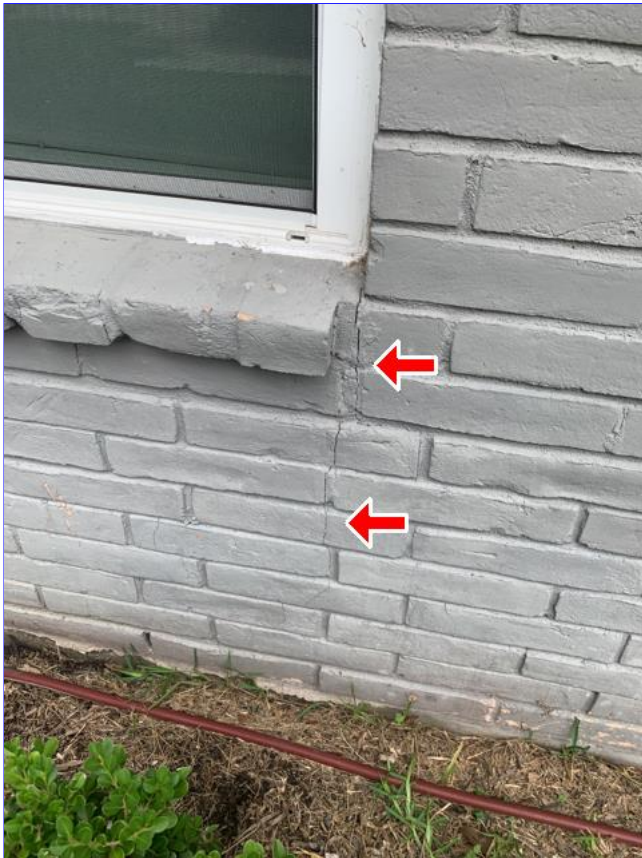
E. Item 7(Picture) Brick veneer mortar cracks were observed.

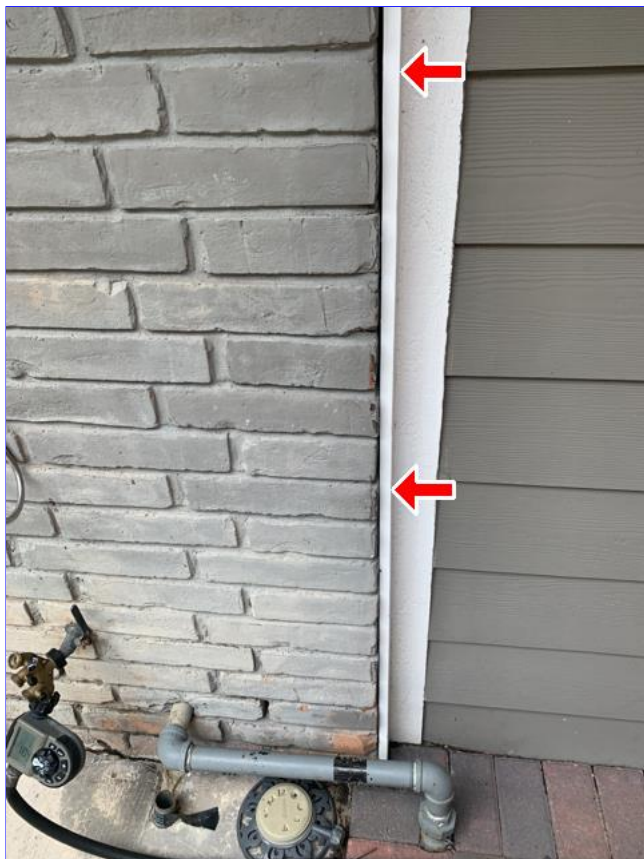
E. Item 8(Picture) Areas around the home where the brick, trim, and siding meet, need to be caulked and sealed.

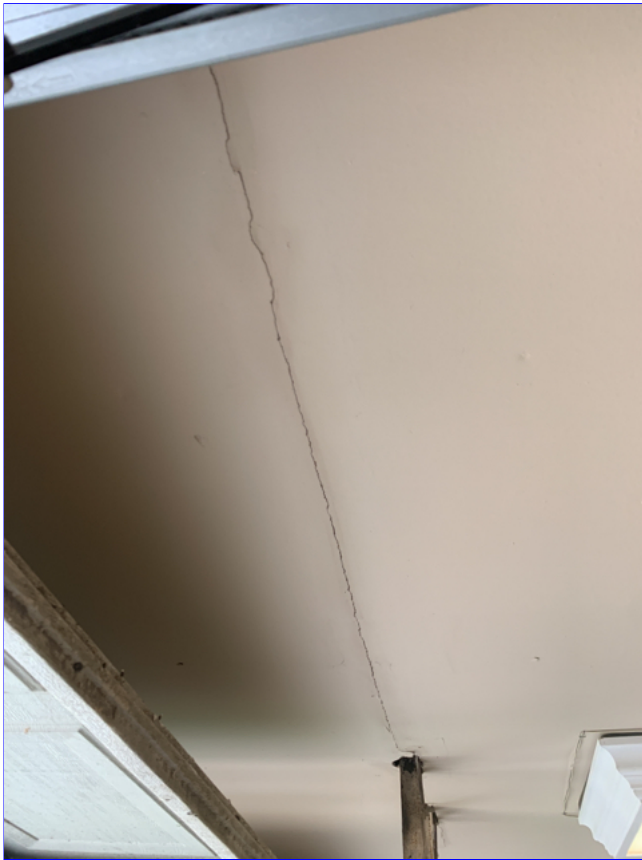
(1) Drywall tape joint cracks observed in the garage ceiling. Recommend correction.

F. Item 1(Picture) Drywall tape joint cracks observed in the garage ceiling. Recommend correction.

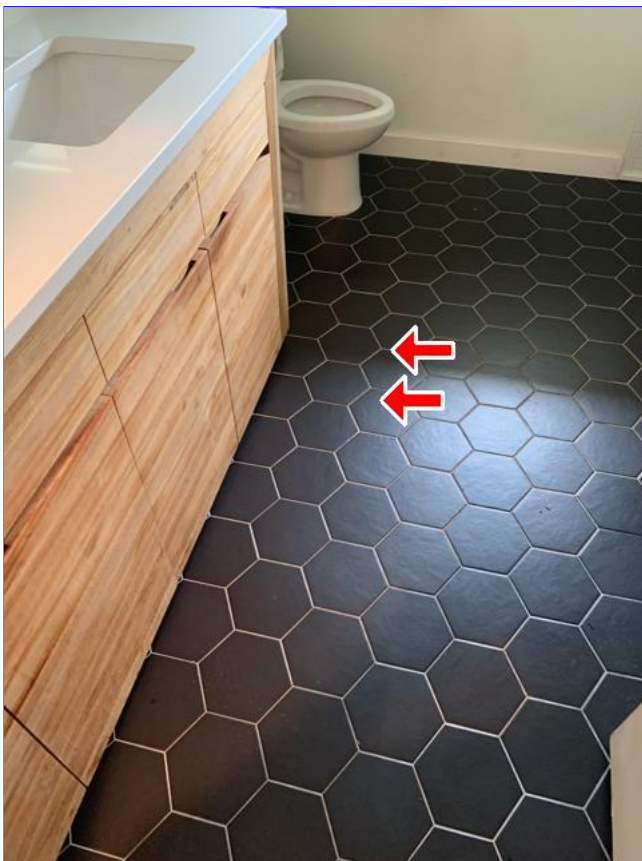
(2) Some floor tiles are not fully set to slab. This is suggested by hollow sound coming from tiles when tapped with a hard object. The tiles may become loose and the grout surrounding them may begin to crack over time. Recommend correction as needed.

F. Item 2(Picture) Some floor tiles are not fully set to slab.

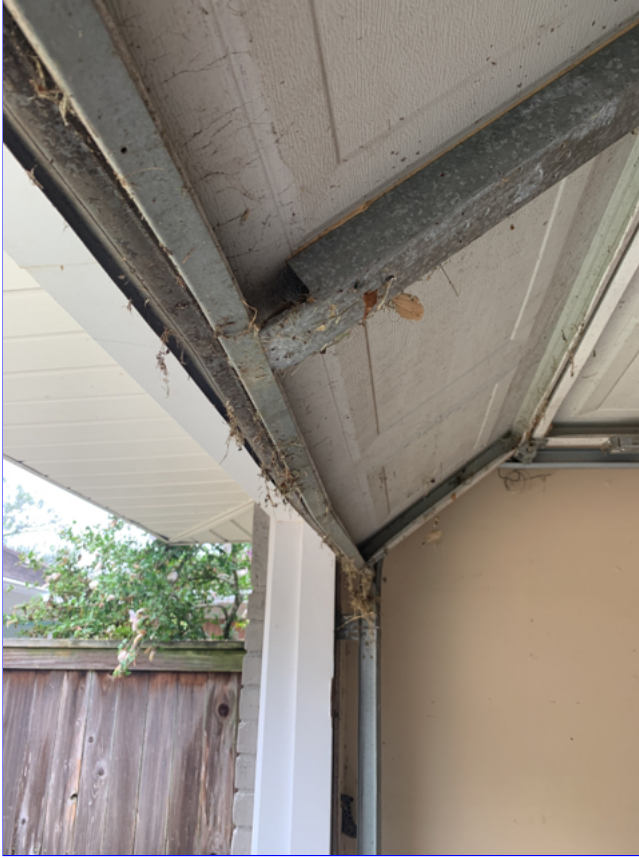
(1) Damage was observed to both garage doors. The weather stripping on both is deteriorated. Both doors do open.

G. Item 1(Picture) Damage was observed to both garage doors. The weather stripping on both is deteriorated. Both doors do open.

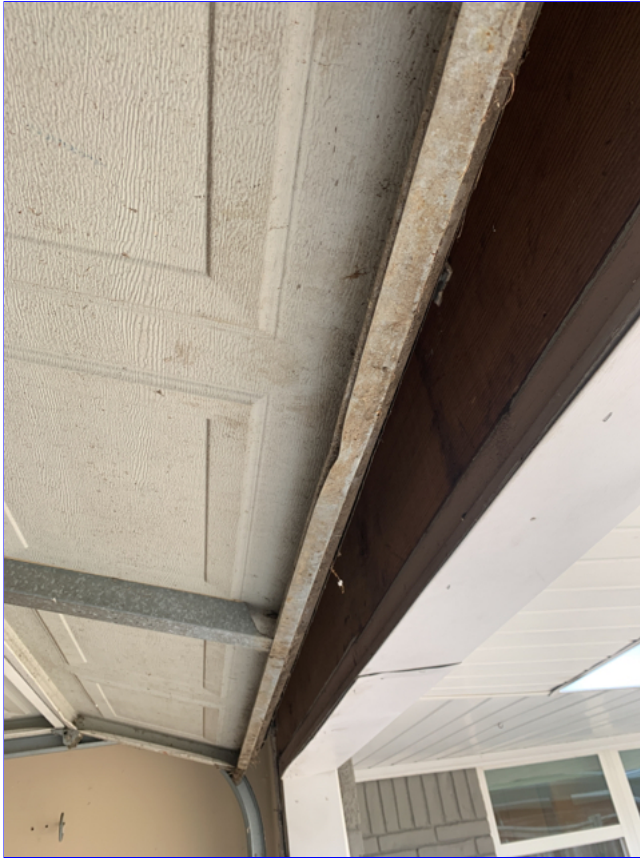
G. Item 2(Picture) Damage was observed to both garage doors. The weather stripping on both is deteriorated. Both doors do open.

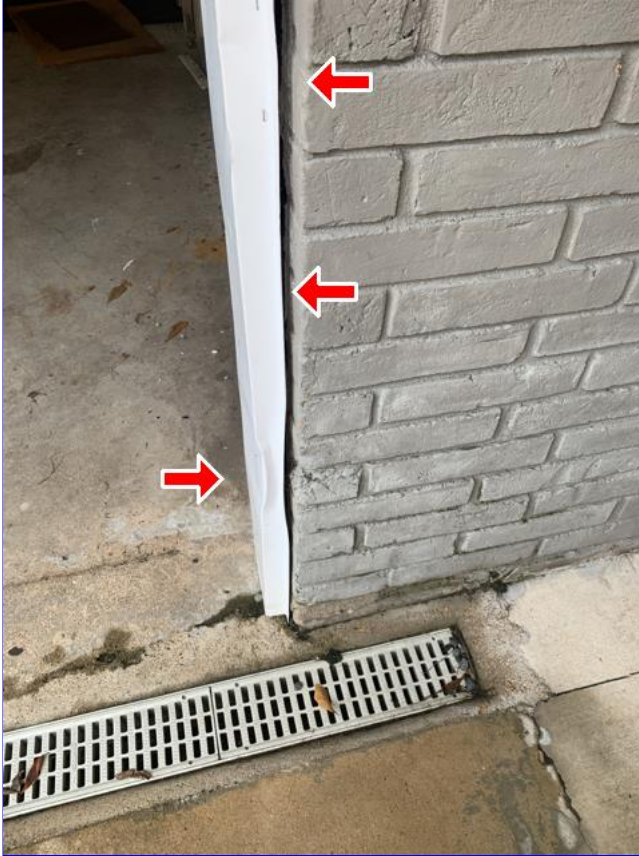
(2) Damage to the garage door trim and areas that need to be caulked were observed.

G. Item 3(Picture) Damage to the garage door trim and areas that need to be caulked were observed.

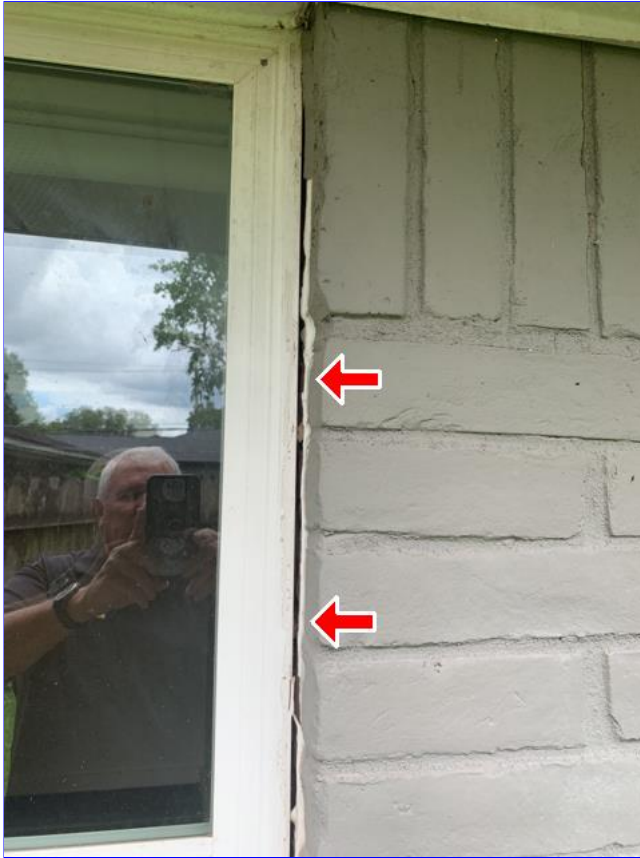
(1) The perimeter sealant, has failed on some windows. Recommend caulking.

H. Item 1(Picture) The perimeter sealant, has failed on some windows. Recommend caulking.

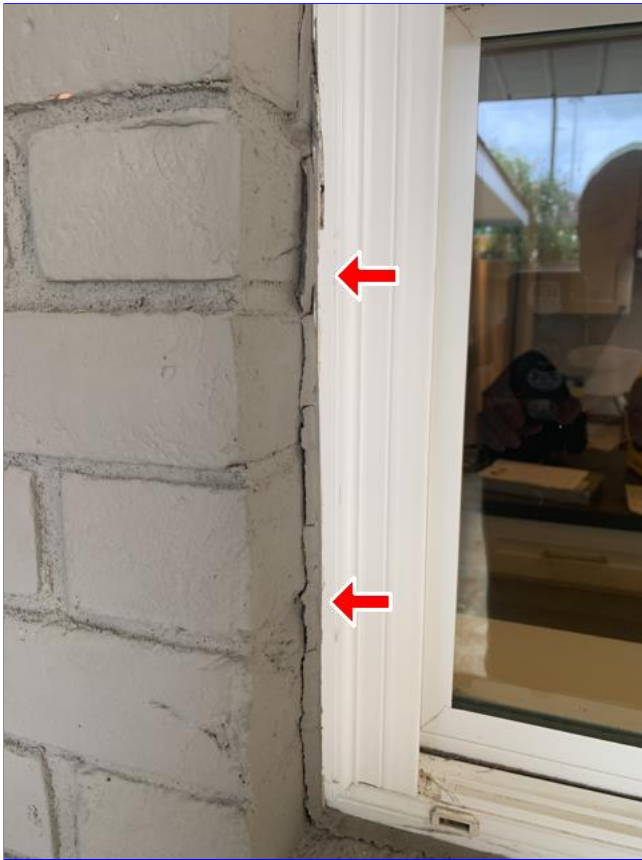
H. Item 2(Picture) The perimeter sealant, has failed on some windows. Recommend caulking.

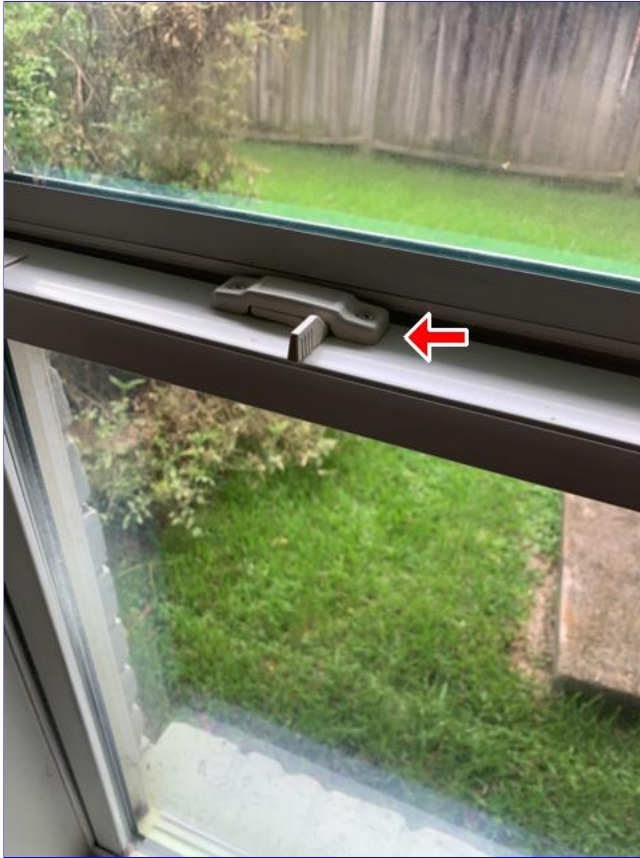
H. Item 3(Picture) Window latch does not operate properly. Recommend correction.

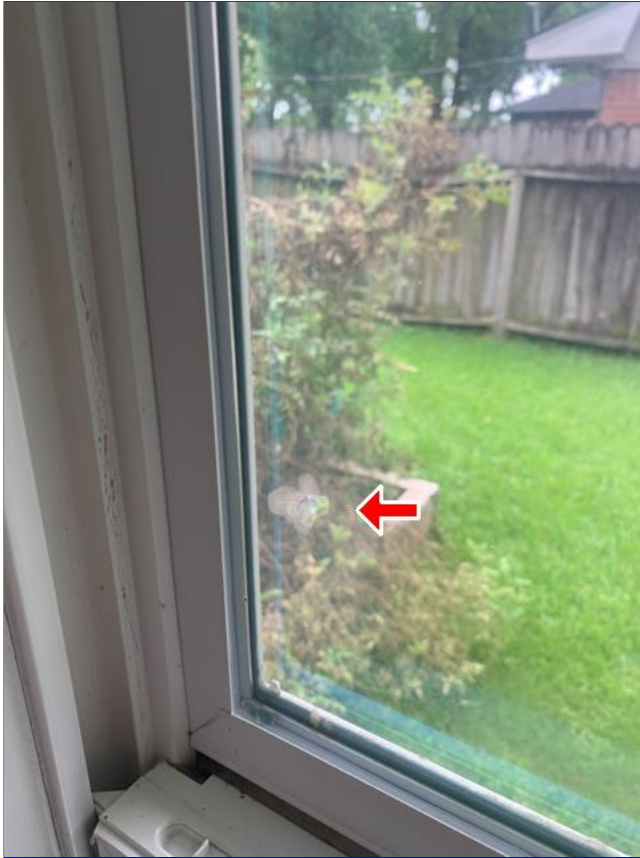
(5) There is cracked glass in some windows. Recommend correction.

H. Item 4(Picture) There is cracked glass in some windows. Recommend correction.

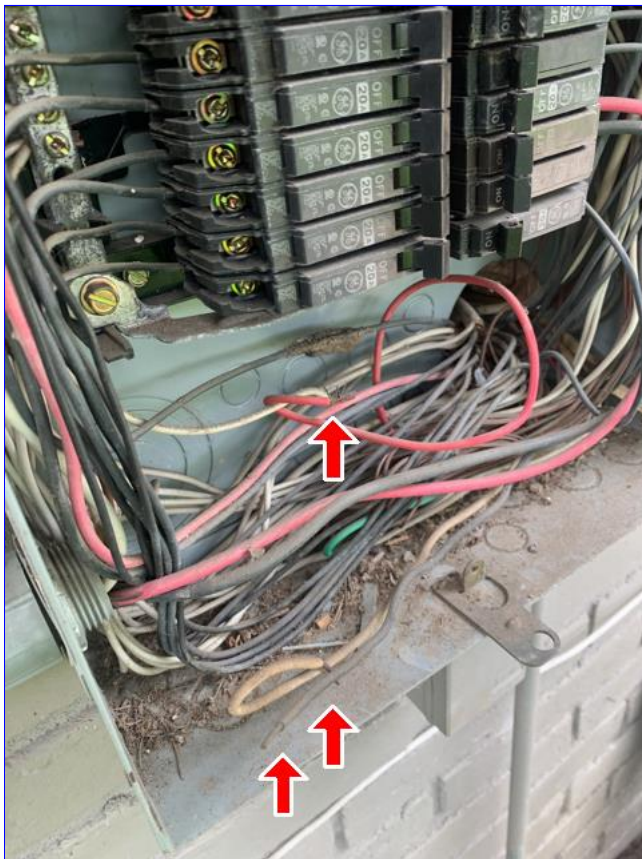
(3) Wiring in the panel box was not terminated properly. Recommend correction.

A. Item 2(Picture) Wiring in the panel box was not terminated properly. Recommend correction.

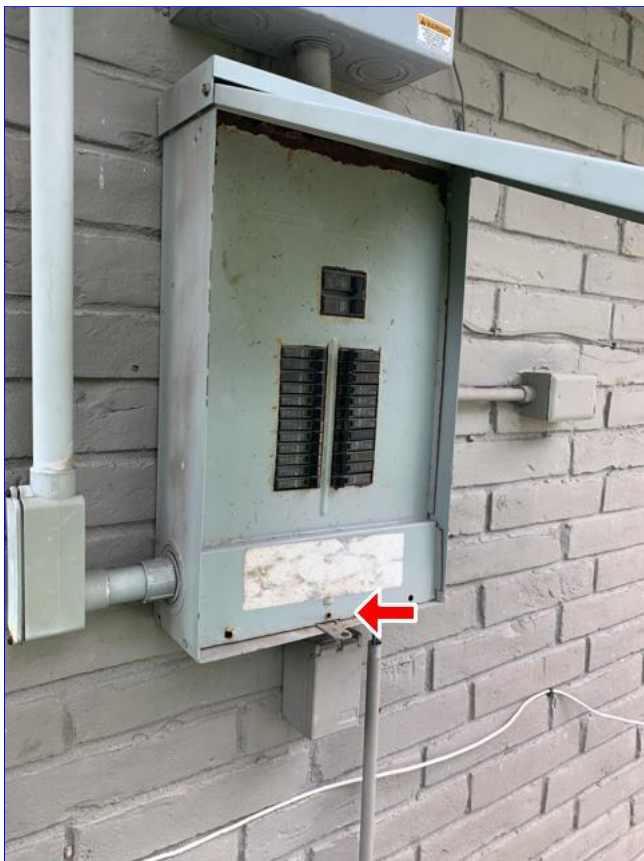
(4) Some labels are present, but are illegible or confusing. The cover is missing a screw to hold it in place. I recommend correcting for safety reasons.

A. Item 3(Picture) Some labels are present, but are illegible or confusing. I recommend correcting for safety reasons.
