Property Address: **9715 Greenwillow St, Houston, TX 77096**

Inspection Report

Property Address:
9715 Greenwillow St
Houston TX 77096

PROPERTY INSPECTION REPORT FORM

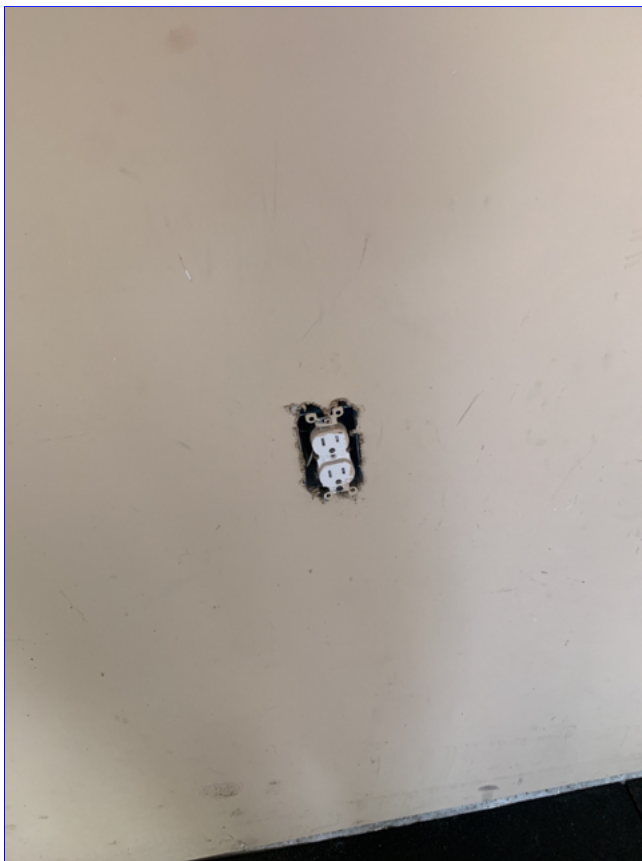
(1) There are damaged/missing receptacle/switch, cover plates. These plates should be replaced for safety reasons.

B. Item 1(Picture) There are damaged/missing receptacle/switch, cover plates. These plates should be replaced for safety reasons.

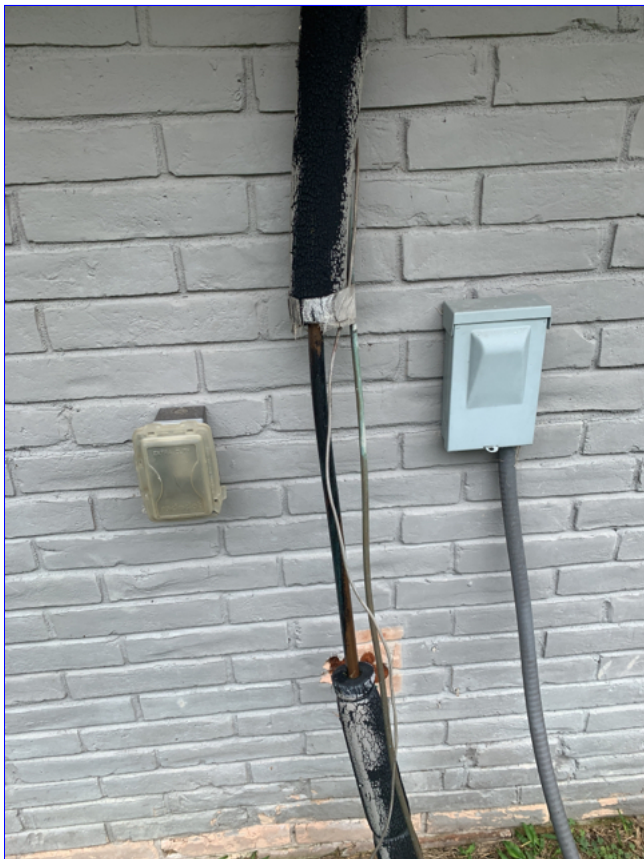
(2) The insulation, on the refrigeration line(s) is deteriorated. I recommend it be repaired or replaced.

B. Item 2(Picture) The insulation, on the refrigeration line(s) is deteriorated. I recommend it be repaired or replaced.

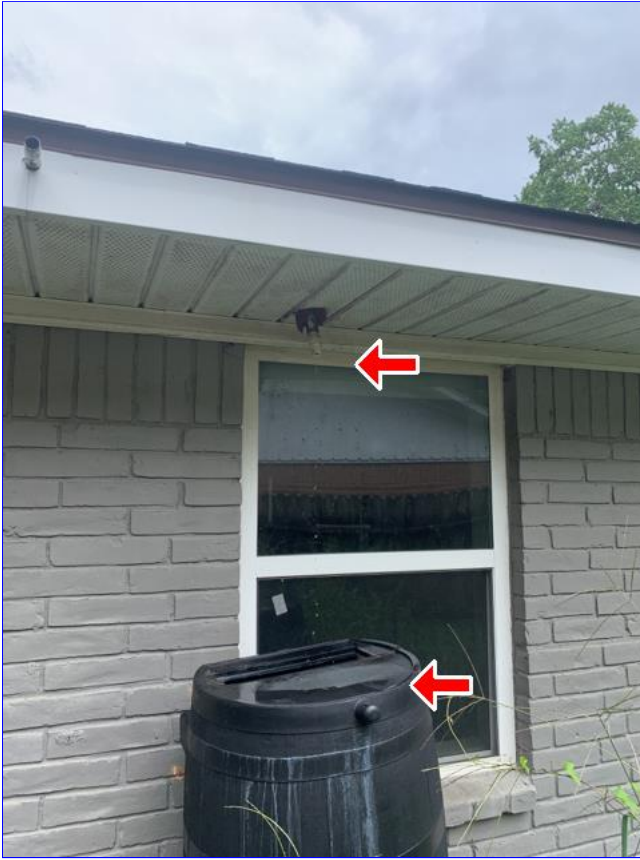
(3) The AC drain line was observed to be draining into a barrel outside.

B. Item 3(Picture) The AC drain line was observed to be draining into a barrel outside.

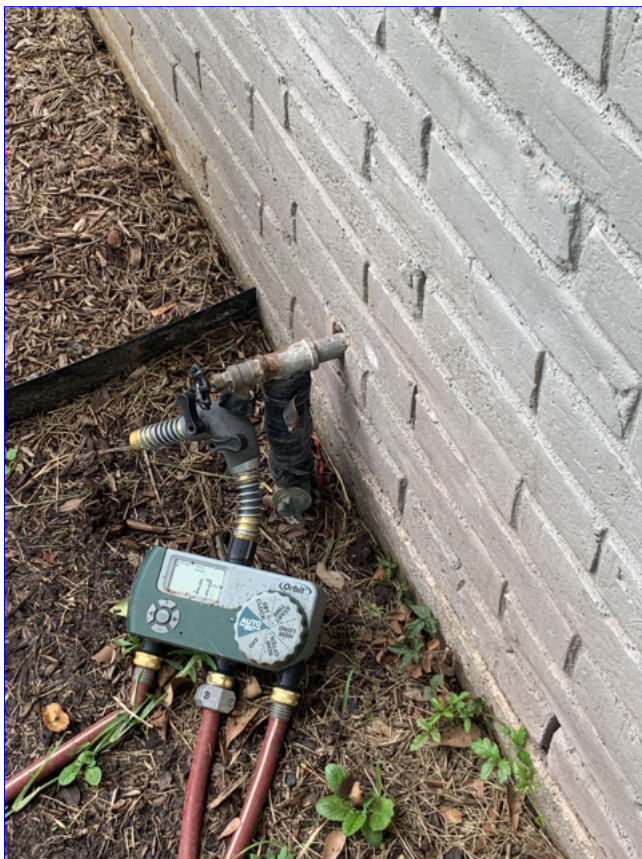
A. Item 1(Picture) The main water supply line at the exterior, is not properly protected from freezing.

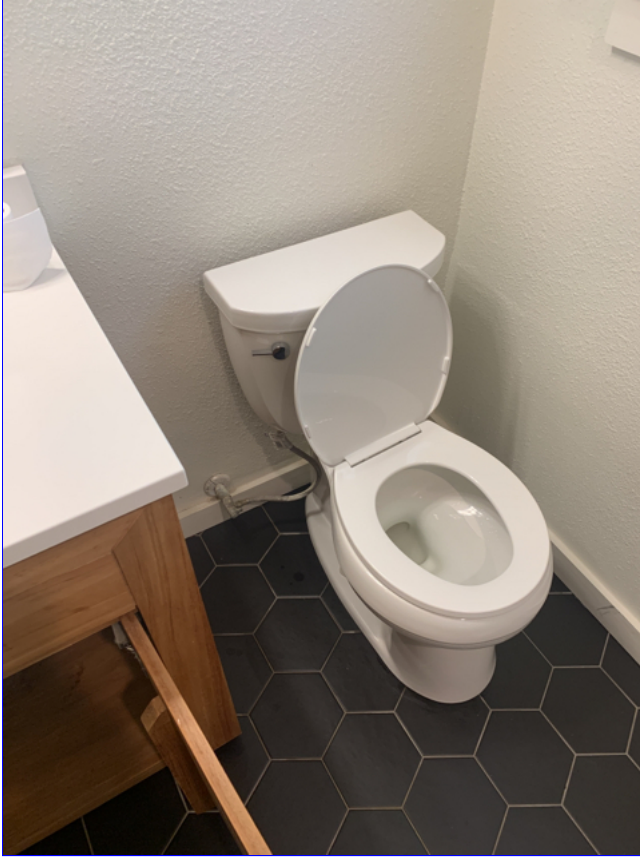
A. Item 2(Picture) The toilet is loose at floor at the bath.

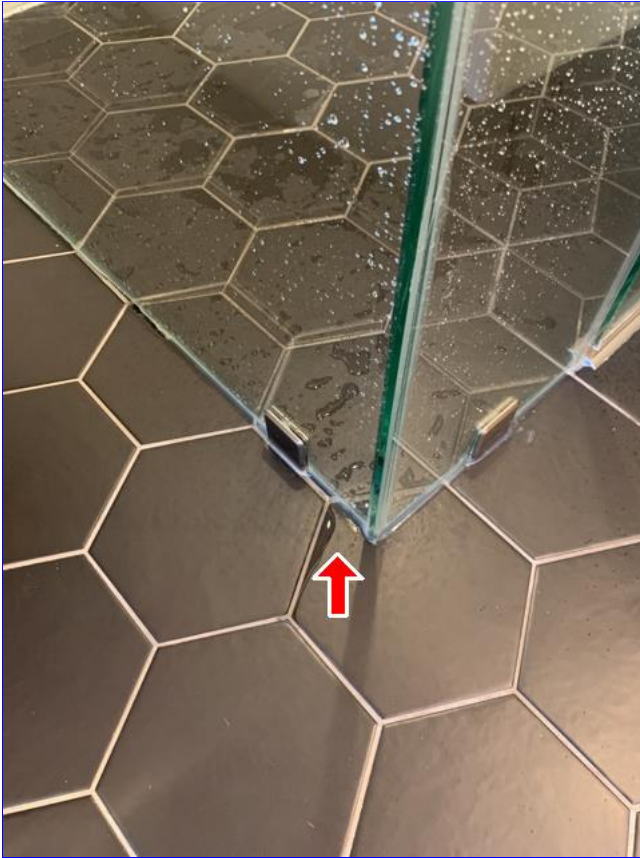
A. Item 3(Picture) The surround for the master shower is deteriorated at the bottom. Recommend caulking.

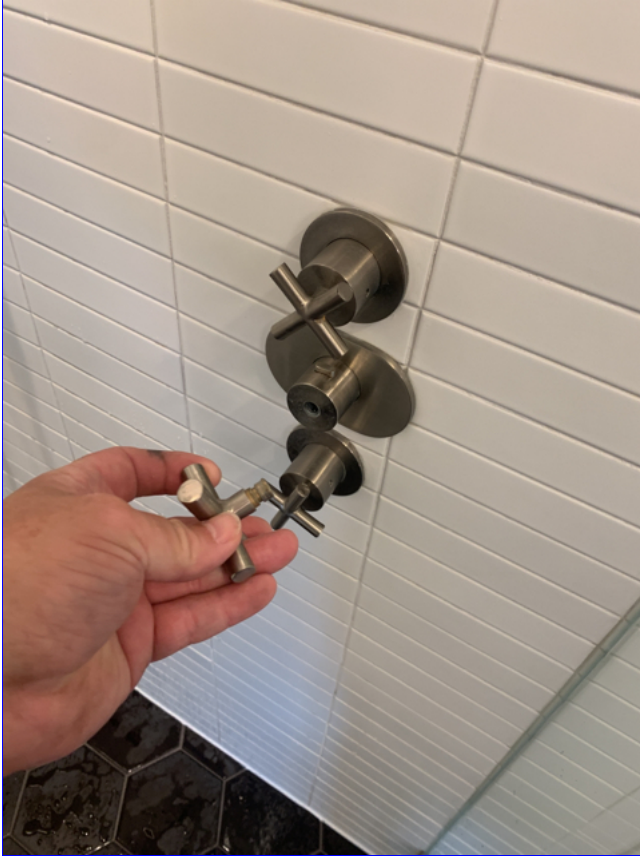
A. Item 4(Picture) Faucet handles at the master shower are loose and in need of adjustment. Recommend correction.

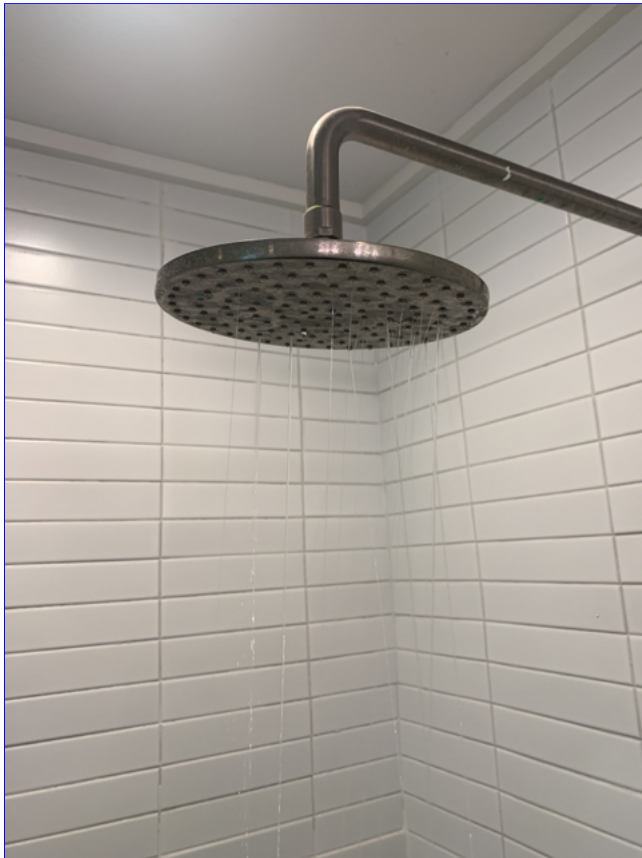
A. Item 5(Picture) Faucet handles at the master shower are loose and in need of adjustment. The shower head is partly stopped up. Recommend correction.

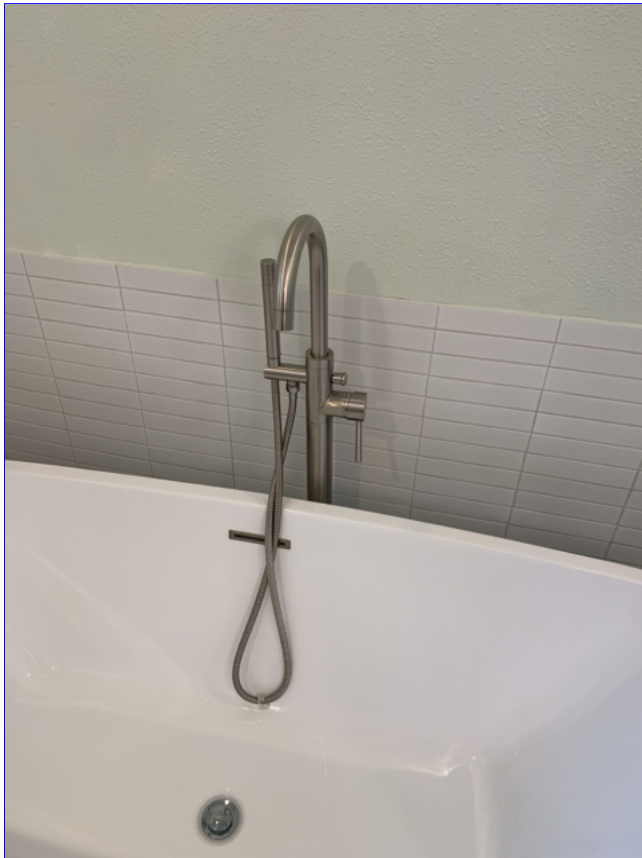
A. Item 6(Picture) The faucet stand for the master bath is loose. Recommend correction.

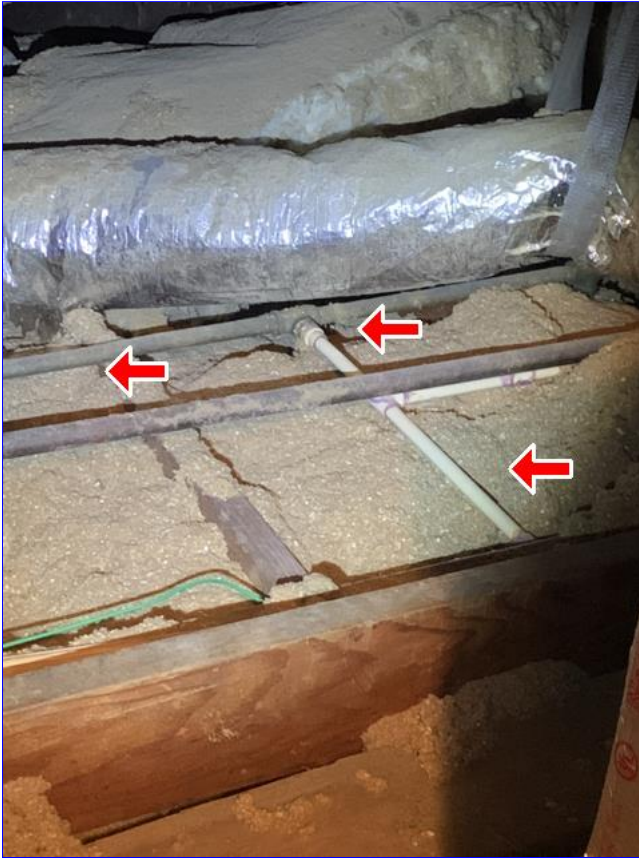
A. Item 7(Picture) Exposed water pipes observed in the attic space are not properly protected from freezing.

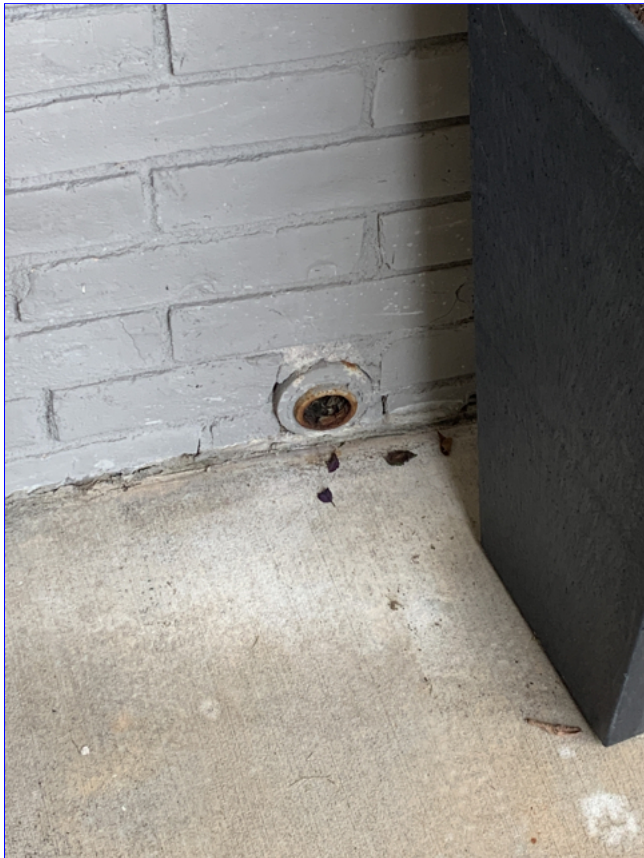
B. Item 1(Picture) Cast iron pipe that is not capped.

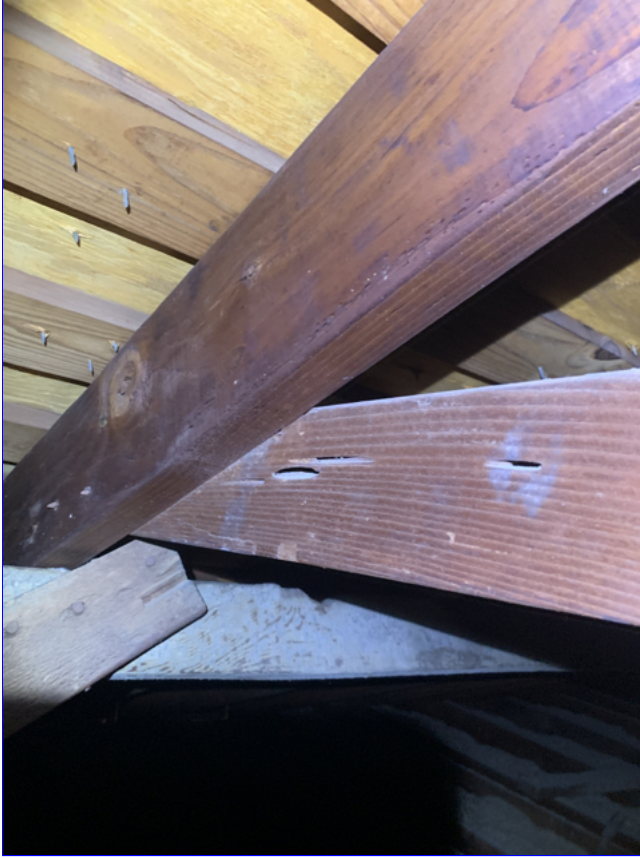
D. Item 1(Picture) Termite damage observed over garage.

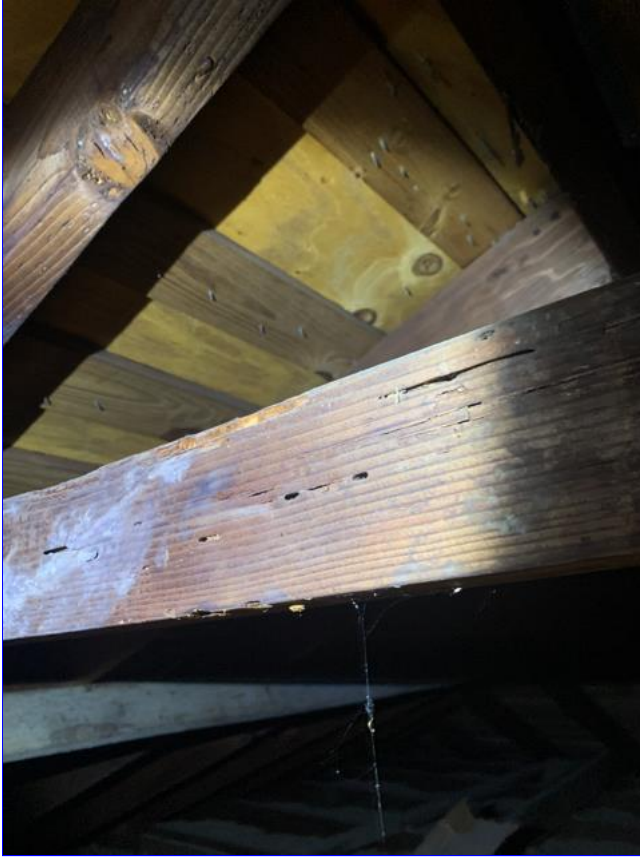
D. Item 2(Picture) Termite damage observed in the attic over garage.
