Inspection for Property located at 27615 Brentsprings Run Lane  
05/06/2023  
Prepared for : Roy Howard

# PROPERTY INSPECTION REPORT FORM

27615 Brentsprings Run Lane, Katy, TX 77494

**Description:** One Story, Wood framed single family residence ; Brick exterior ;  
Composition roof ; Attached garage

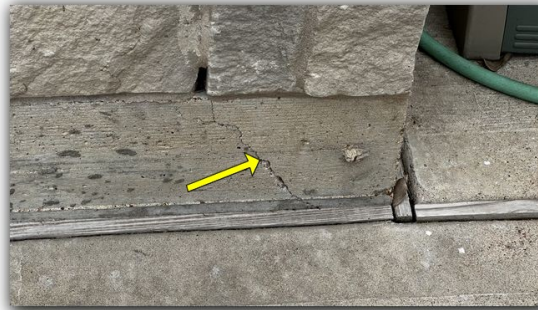
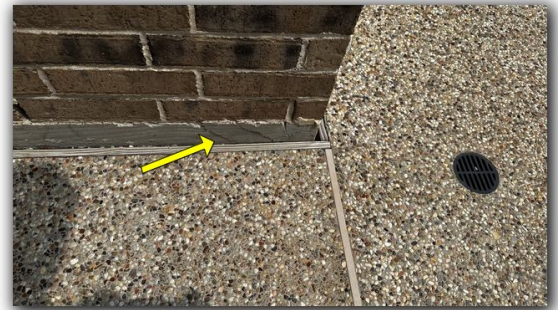
Spalling (i.e., corner pops) at one or more corner(s), Corner spalling is common to slab foundations and does not affect the structural integrity of the foundation. However, if the spalling crack extends into the soil it should be monitored as a possible termite entry point.

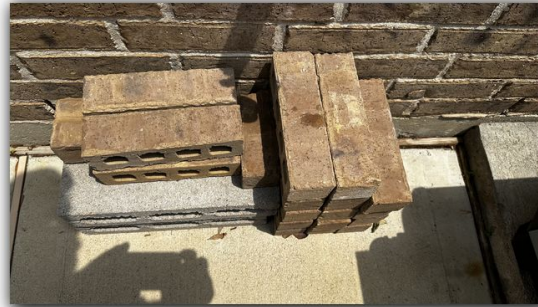
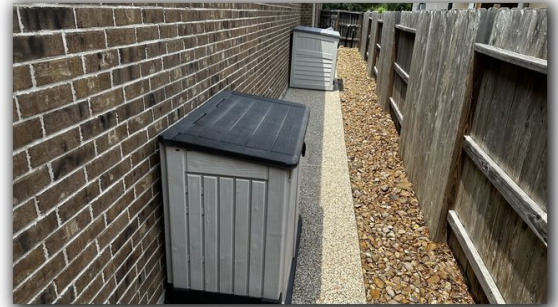
Comments: Bricks, stone, sheds, etc. should not be stored near house or garage, can hide evidence of wood destroying insect activity, recommend relocating away from house / garage.

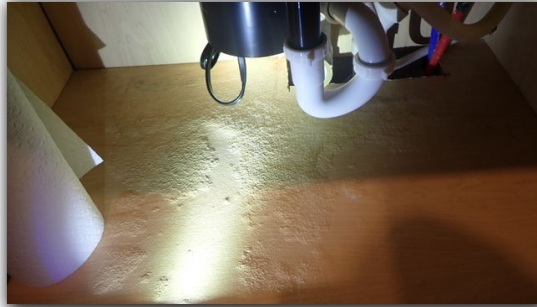
*Water damage to base of cabinet below sink.*

Observed musty/moldy smell/odors which may be a concern due to increased awareness of environmental issues associated with molds. If this is a concern or potential concern, Texas House Check recommends contacting us for further information / investigation.

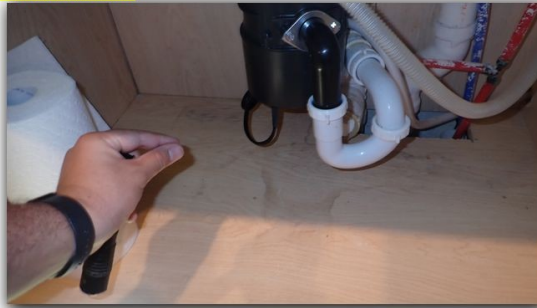
**Under Kitchen Sink**

Observed possible micro-organism growth (Mold ) which may be a concern due to increased awareness of environmental issues associated with molds. Recommend removal of all sheetrock and other building materials containing visible mold growth plus an additional 2 feet surrounding area. If this is a concern or potential concern, Texas House Check recommends contacting us for further information / investigation / Testing.

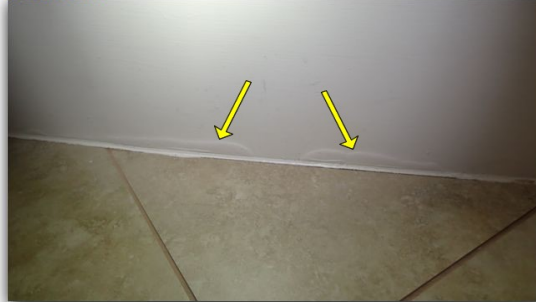
Kitchen pantry

Water stains / damage or repairs observed at multiple locations. Dry at the time of inspection via moisture detection equipment.

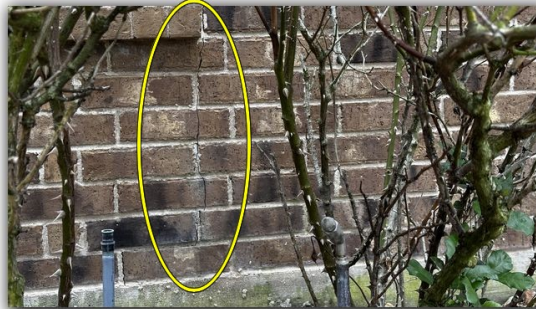
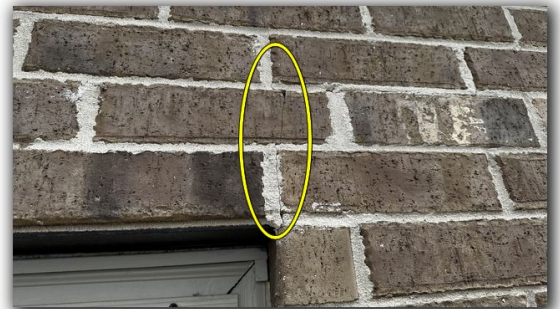
Cracks in brick veneer and/or repairs, one or more locations, Recommend having cracks repaired, then take photographs of cracks, their location, and width [ruler across the crack] with a high resolution camera that has a date stamp for future reference.

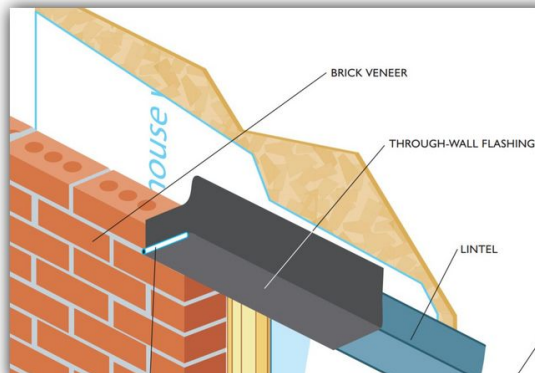
Metal lintel(s) over window/door openings do not appear to be flashed as required by current building standards. flashing is required to direct water out of the weepholes, create a chemical barrier between the metal lintel and the caustic mortar (reduces rust), and also to create a bond break to reduce cracks. Ref:IRC 2015 Section R703.8.5 For more information, please view this video

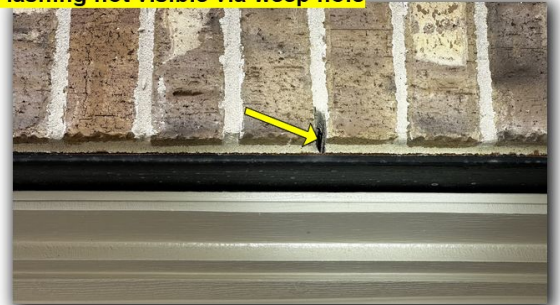
Flashing not visible via weep hole

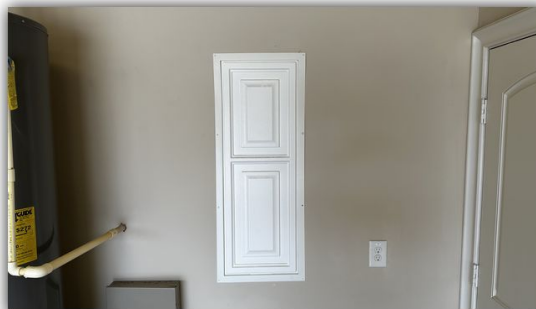
**Fire rated wall in the garage is compromised by installation of the plumbing manifold.** The water distribution manifold can be mounted in a fire rated wall only if either the box is fireblocked within the wall or the access door meets the same rating requirements as the wall and is installed over the access opening. The manifold manufacturer makes a fire rated access panel for this purpose.

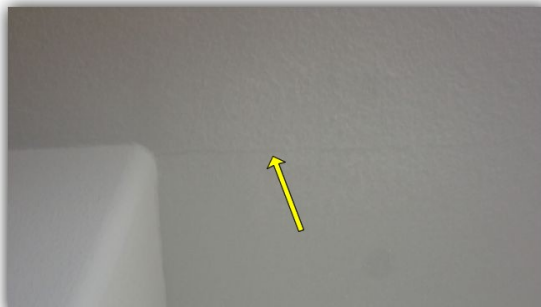
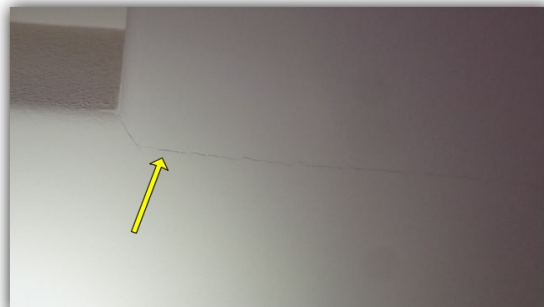
*Comments: Observed cosmetic cracks and/or repairs in drywall ceiling of one or more rooms.*

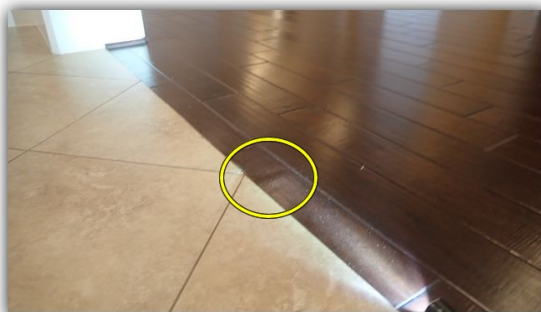
Possible water damaged wood flooring observed.

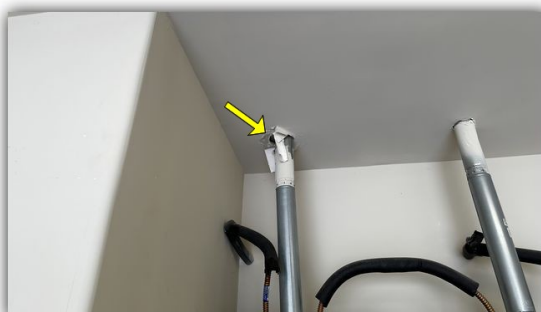
Water stains observed on ceiling around water heater exhaust vent, indication of previous / current water penetration, recommend caulking / sealing vent and storm collar above roof line.

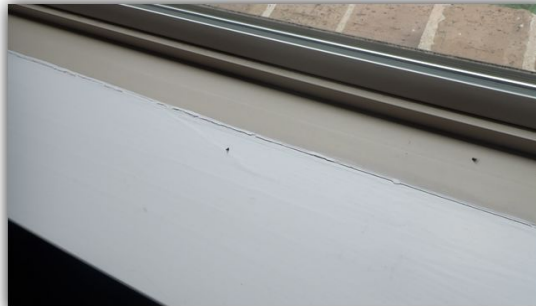
*Comments:* The window frames require caulk or caulk replacement.

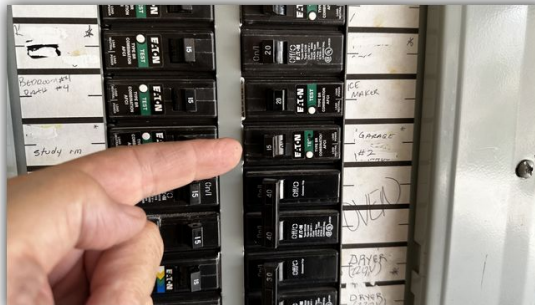
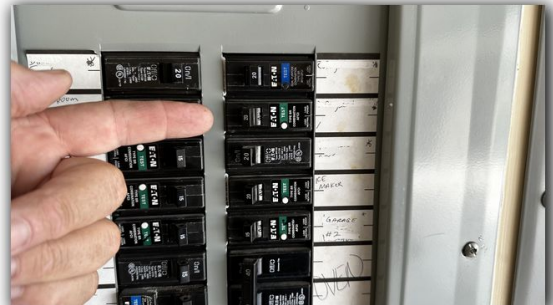
Comments: AFCI (Arc Fault Circuit Interrupt) device (multiple) did not operate properly, when tested with the manufacturer provided test button, during inspection. The device may not be providing arc fault protection as intended. This is considered a hazardous condition. We recommend a qualified, licensed electrician diagnose and correct the condition.

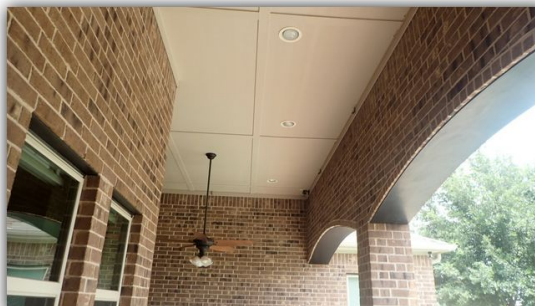
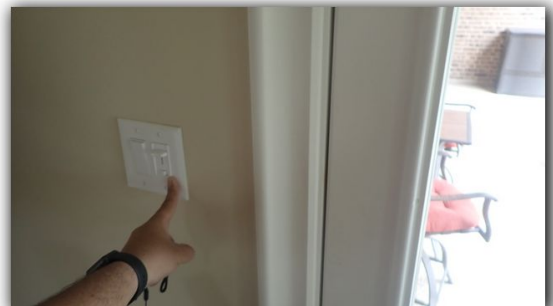
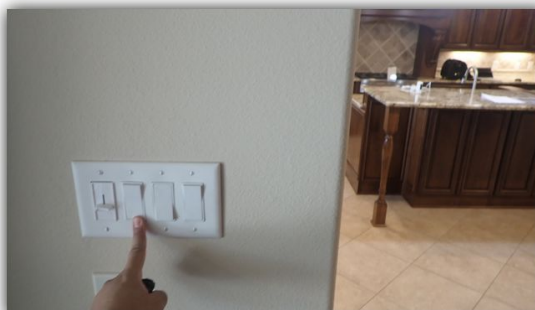
Comments: Switch improperly wired, does not operate like proper a proper 3 or 4-way type, (Fixture cannot be turned on/off from all switch locations, regardless of the position of other switches); Patio lighting

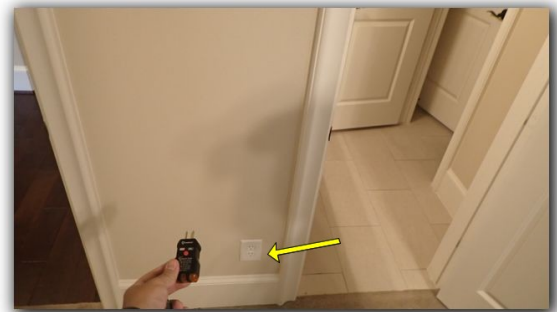
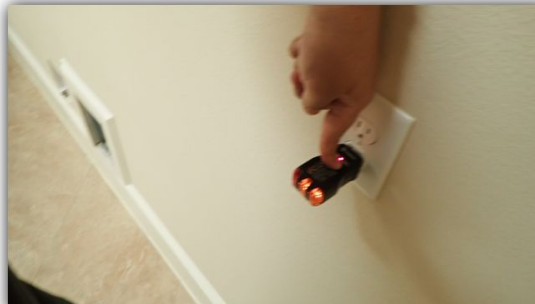
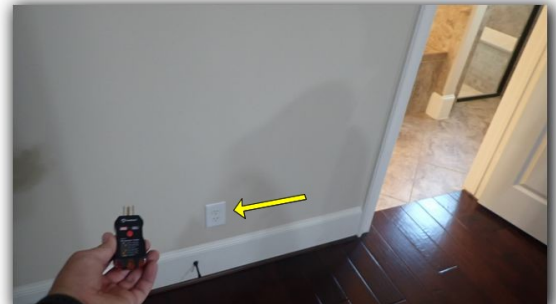
Did not observe GFCI protection of all outlets in required locations, including but not limited to the location marked below. This condition is a recognized safety hazard and is in need of repair.

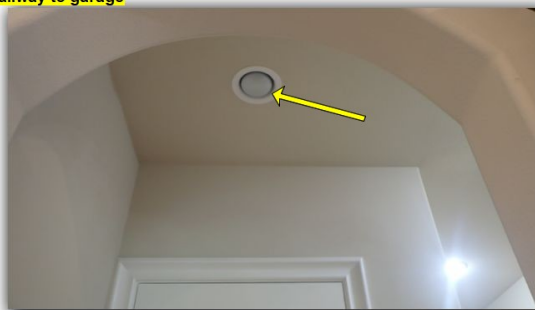
Hallway to garage

Light(s) found to be not functioning. Probably just a burned out bulb, or it could be a broken fixture / switch or improper wiring. Including but not limited to;

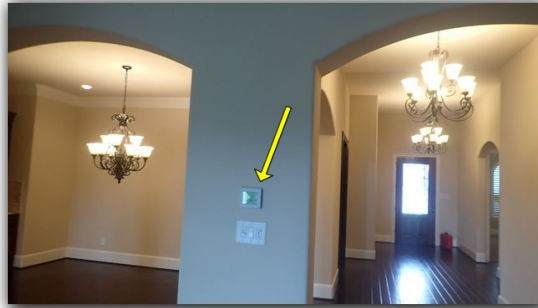
Comments: Improperly located, thermostats are supposed to be located near return air chase.

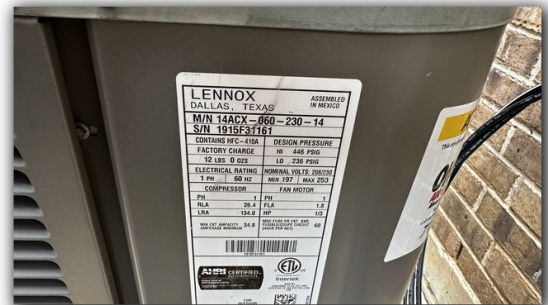
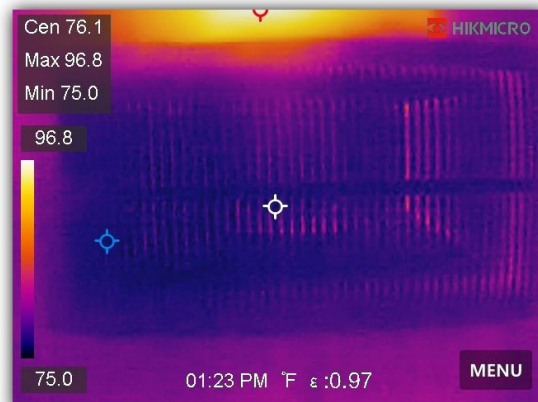
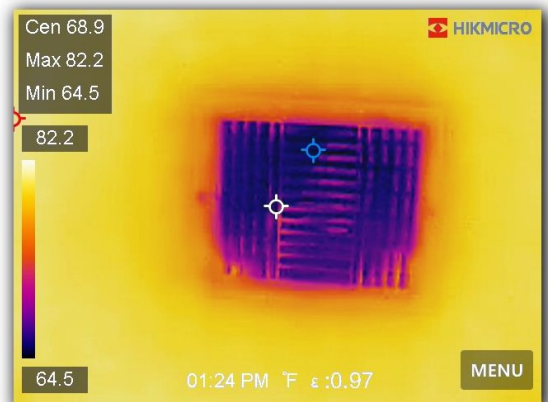
Comments: Both A/C units are producing a low temperature differential when measured at the return and supply registers. According to the Texas Real Estate Commission, the temperature differential is deficient if it is below 15 degrees or above 22 degrees. Because of this condition Texas House Check recommends that the Air Conditioning systems be serviced by an HVAC contractor when the temperature differential is below 15 Degrees F.

*The main air conditioner produces a differential temperature of 11.6 degrees F.*

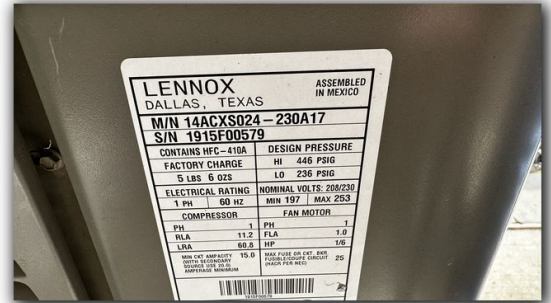
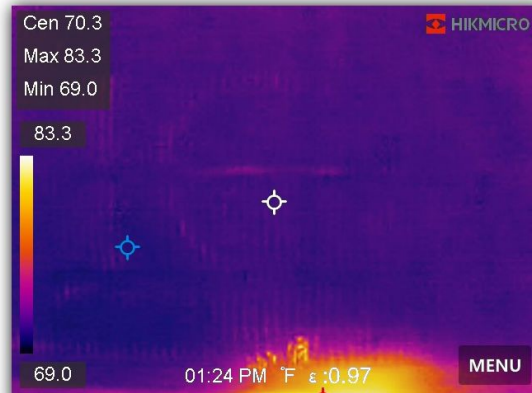
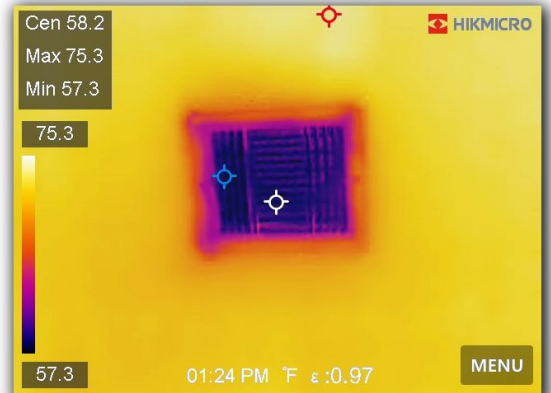
The master air conditioner produces a differential temperature of 13 degrees F.

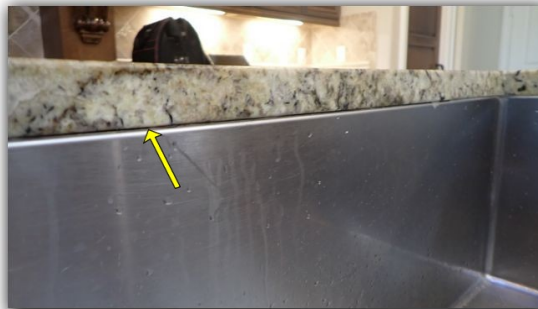
Comments: Where the sink connects to the countertop the caulk is either missing/damaged and should be reapplied to create a smooth surface to prevent surfaces prone to fouling. Refer to IRC P2701.1 Quality of fixtures

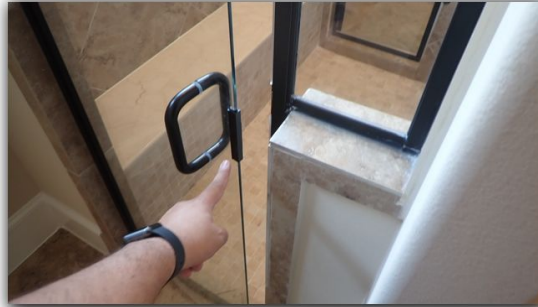
Shower door needs adjustment to operate/close properly.

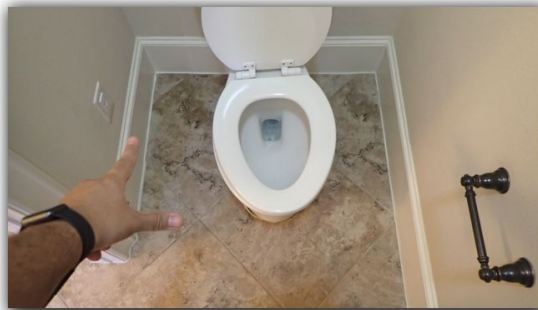
Commode not secured to floor, This condition will leak sewer gas and may also leak water/moisture. Recommend removal of commode, inspection of flange serviceability, install new wax ring and new securing bolts.

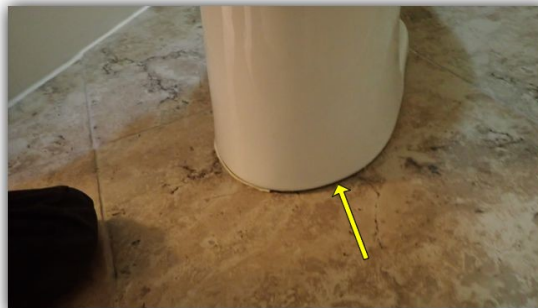
Recommend caulking around base of all commodes.

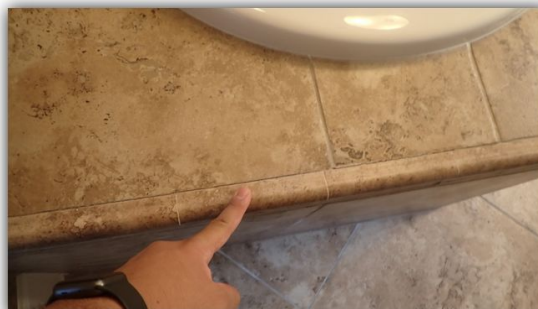
Grout / caulking needed at vertical tile corners, cracks in tile and/or mortar between tiles, and where tile meets tub to prevent water entry behind wall.

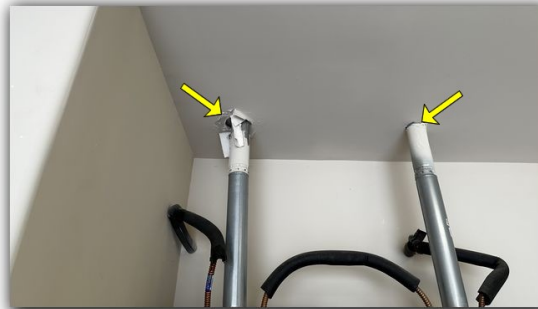
Vent collar not secured around vent pipe at ceiling and/or is missing.

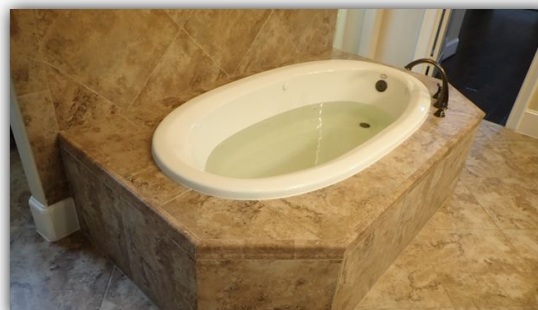
Comments: Was not able to access motor for visual inspection. Does not fully comply with National Electric Code (Reference NEC 680-72. Accessibility. "hydromassage bathtub electrical equipment shall be accessible for repair / replacement without damaging the building structure or building finish".) Should have access panel installed for servicing / access to pump motor IRC 4109.3.

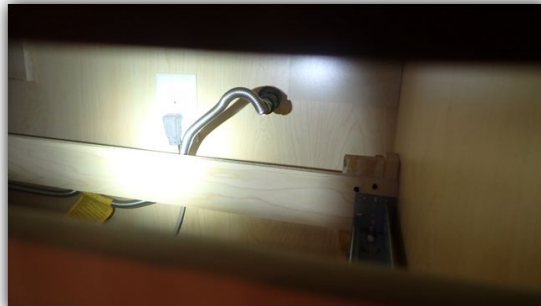
*Comments: **Active gas leak observed underneath the range. Recommend immediate repair by a licensed plumber. The supply was shut off at the valve during the inspection to help prevent further leaking.***

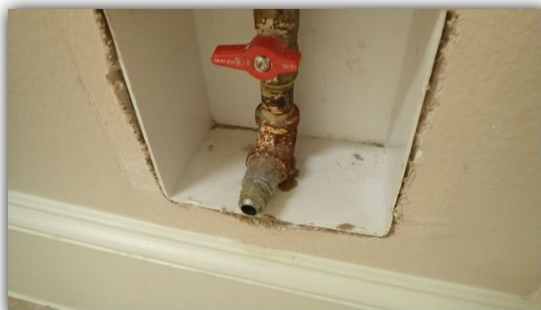
Uncapped gas valve at laundry room. Gas line needs to be capped if not used.

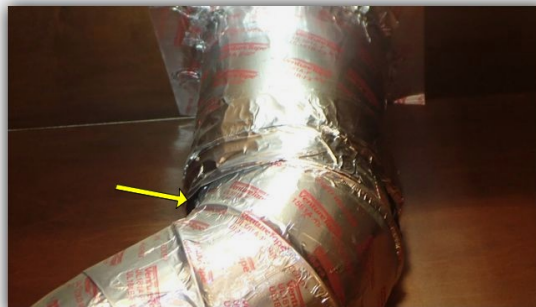
*Comments: Range hood vent duct is not properly sealed.*

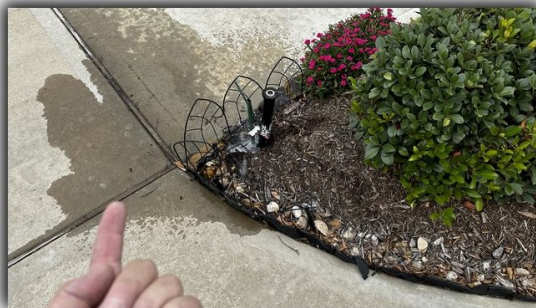
Damaged water line, water gusher in yard; Zone 1

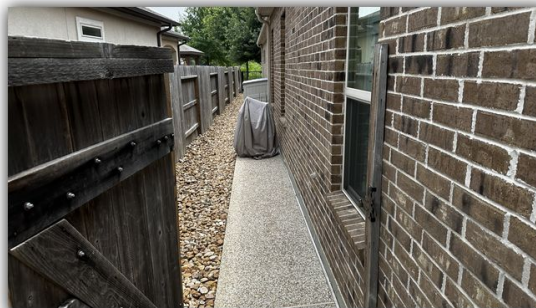
*Comments:* Access gates shall comply with the requirements of International Residential Code Section AG105.2, and shall be equipped to accommodate a locking device. Access gates shall open outward away from the pool and shall be self-closing and have a self-latching device. Where the release mechanism of the self-latching device is located less than 54 inches (1372 mm) from the bottom of the gate, the release mechanism and openings shall comply with the following:

1. The release mechanism shall be located on the pool side of the gate at least 3 inches (76 mm) below the top of the gate; and
2. The gate and barrier shall have no opening larger than 1/2 inch (12.7 mm) within 18 inches (457 mm) of the release mechanism.
3. House doors opening to the back yard should have an audible notification when opened.

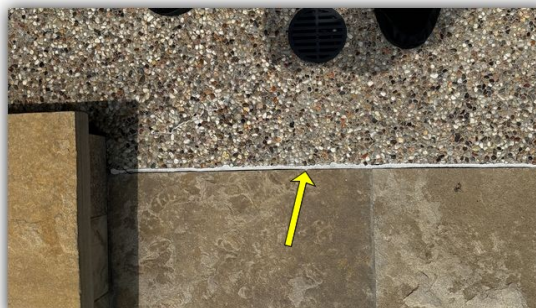
Expansion Gap between coping and deck needs to be caulked.

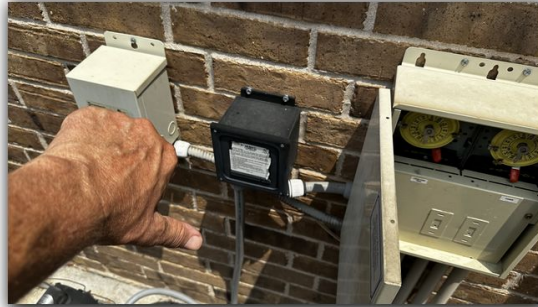
The pneumatic switch for the spa blower does not function as intended.

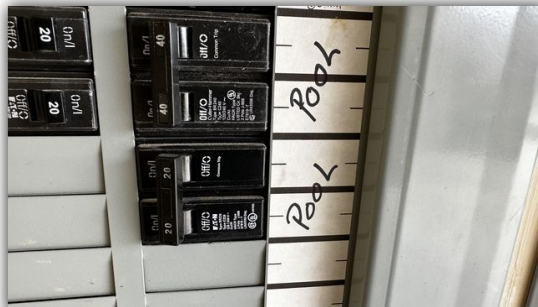
**The pool equipment panel did not have any GFCI protection. This condition should be evaluated by an electrical contractor.**
