# Inspection Report

16958 Nicole Ln  
Houston TX 77084

**Sunbelt Inspections**

# PROPERTY INSPECTION REPORT FORM

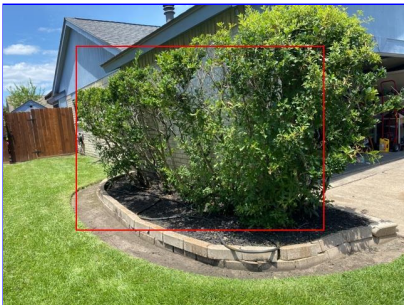
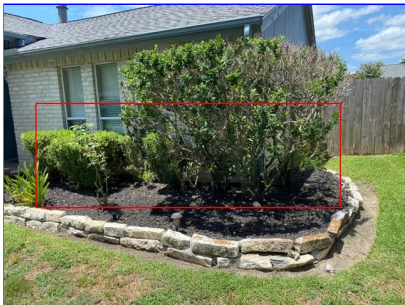
(1) There were trees or shrubs observed to be growing in close proximity to the foundation and or roofline (front left corner, front right corner).

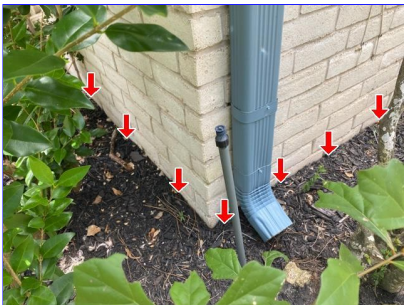
- (1) Concrete splash blocks or downspout extensions, are absent at some gutter downspouts. Gutter downspouts should discharge a minimum of 18" away from the foundation.
- (2) No gutters were observed at the left side of the home, Gutters are recommended at all appropriate roof slopes to channel and direct rain water away from the structure and to promote foundation health.
- (3) High soil conditions were observed at the front right corner of the home. High soil conditions are conducive to wood destroying insects and should be avoided. I recommend a minimum six inch foundation side wall exposure around the entire perimeter of the foundation. High soil levels prevent a quality Termite inspection. Recommend correction.

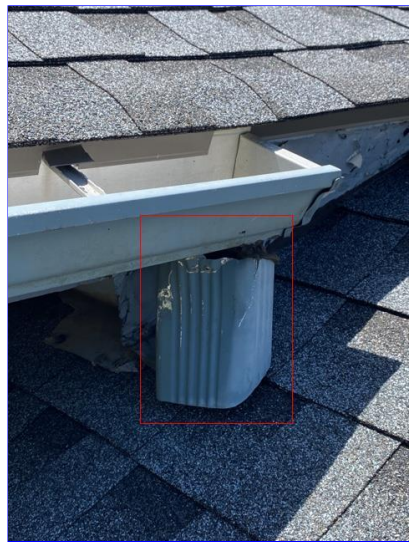
(4) At the roof surface, there was a damaged section of gutter downspout that requires repair or replacement.

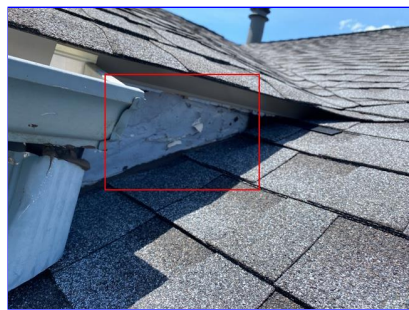
(1) At the roof surface, there was wood rot at the fascia near the front entryway roofline that requires repair.

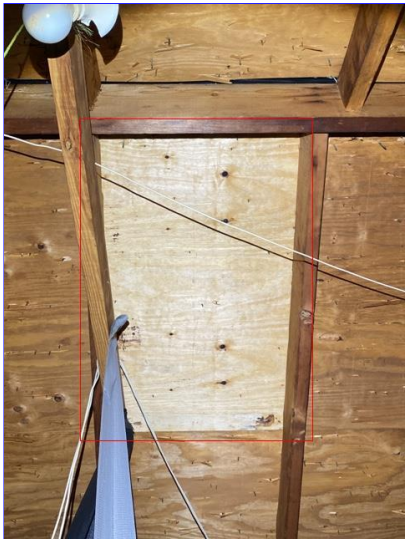
(3) Previous roof repairs were observed from the attic space.

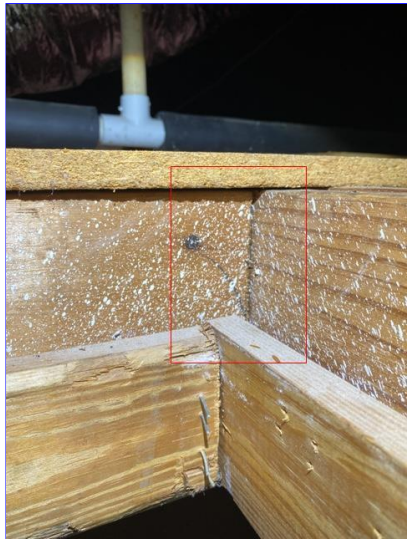
(1) The attic access ladder is not properly insulated for an interior location. The legs are wobbly, unstable and cut too short too short causing them too hyper extend at the hinge whenever weight is applied. There were missing structural joist hangers at all four all corners of the attic ladder framed opening. I recommend that the ladder be replaced for energy and safety purposes.

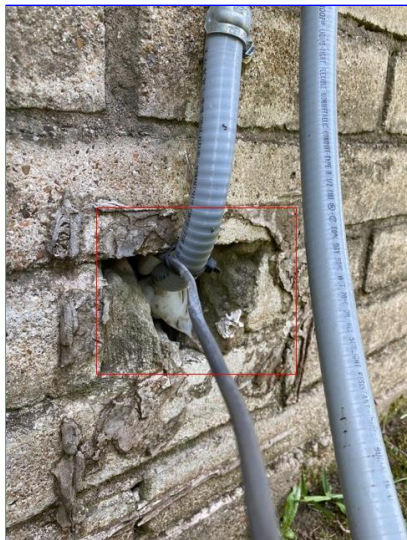
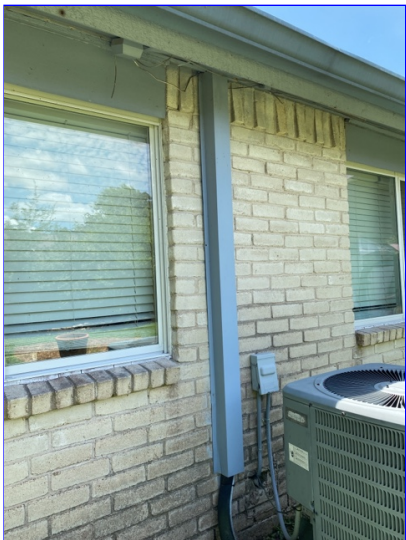
(1) The A/C condenser line penetration into structure, should be sealed to prevent unwanted intrusion by pests and to reduce noise reverberation into structure.

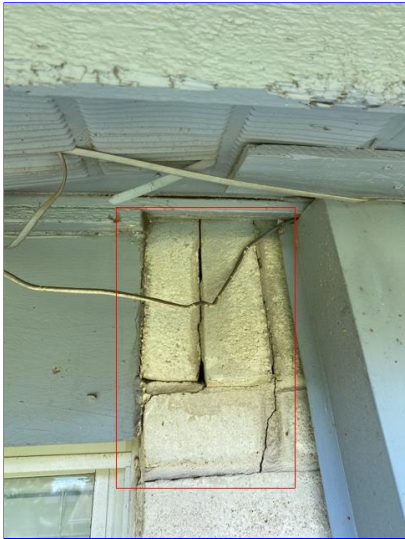
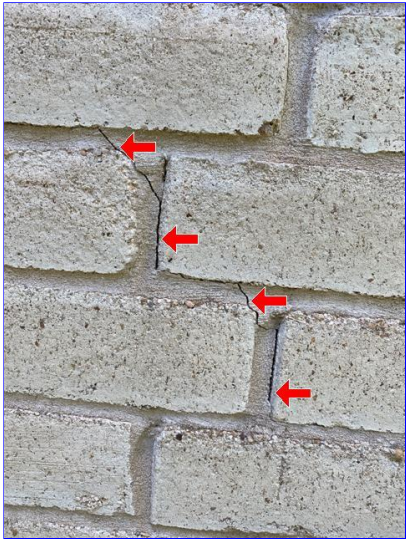
(3) Brick veneer mortar cracks were observed at one or more areas of the exterior. This condition is cosmetic in nature and not structurally significant. The cracking of the brick veneer is likely due to flexing of the foundation during repeated seasonal changes. The expansive clay soil in the area is prone to excessive swelling during rainy periods and shrinkage during dry periods.

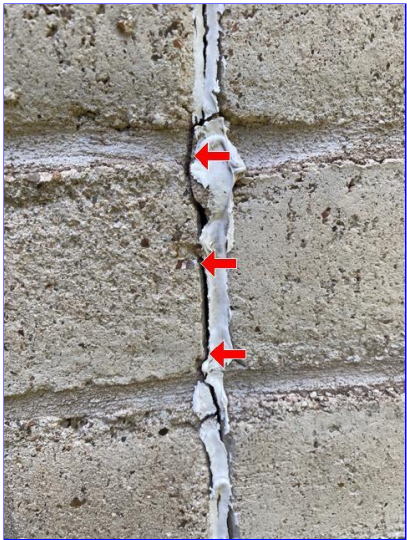
(5) The brick veneer expansion joint sealant has failed/missing, or not properly installed. Recommend correction.

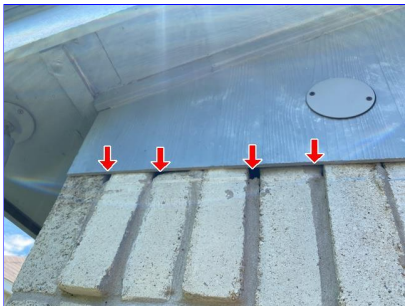
(7) There was missing mortar below the frieze board at one or more areas.

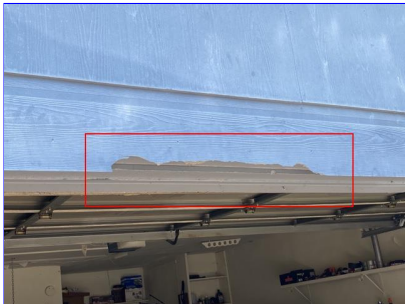
(8) There was damaged horizontal trim above the garage opening that requires repair.

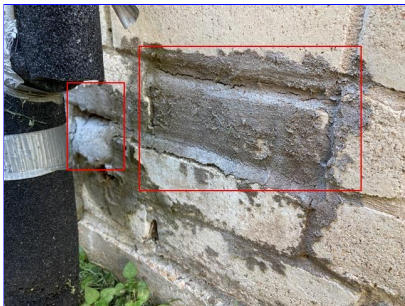
(10) There were previous repairs to the brick veneer observed.

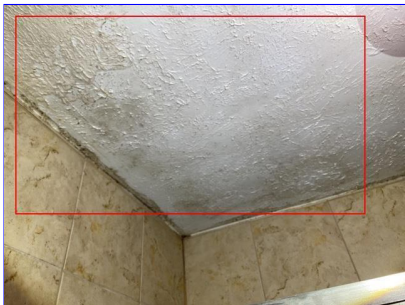
What appears to be fungi or mildew is present (primary bathroom ceiling). The identification of the organism(s) is beyond the scope of this home inspection. My recommendation is to remove moisture source and clean up the mold. Consult with a licensed mold remediation expert to determine the best method for remediation, estimate costs, and perform the remediation.

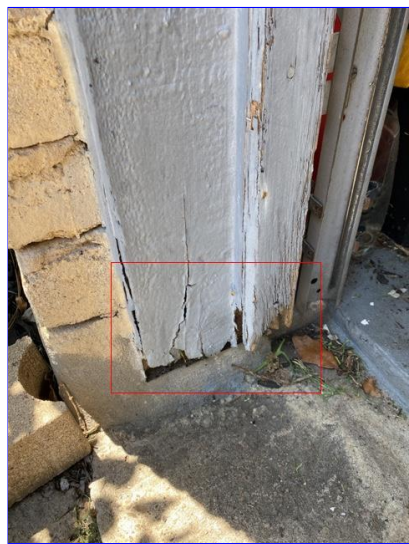
(1) There was wood rot observed at the bottom edge of both garage door jamb stringers that requires repair.

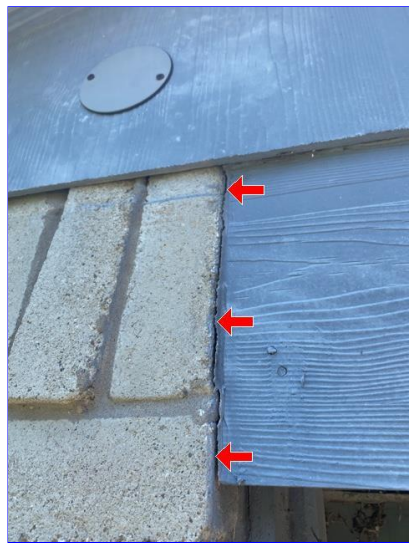
(2) There was caulk separation at one or more areas of the garage horizontal siding that requires additional caulk sealant.

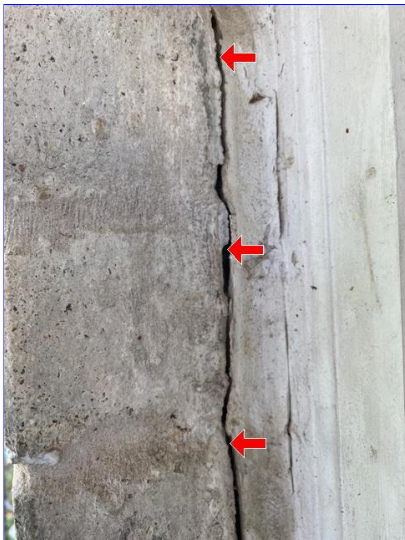
(4) The exterior perimeter sealant around door frames has deteriorated (back patio door).

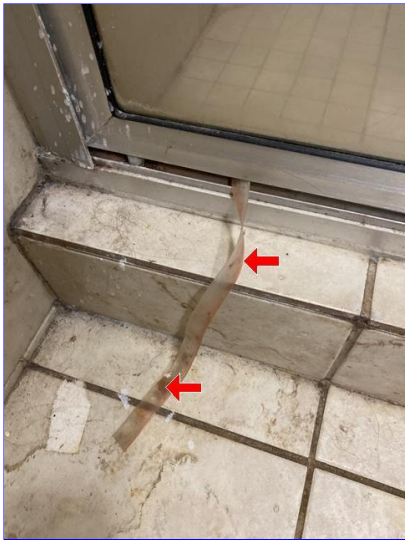
(7) In the primary bathroom, the glass shower door has a deteriorated door sweep at the bottom edge of the door and requires replacement.

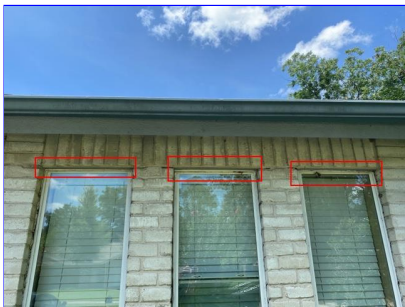
(3) The brick ledge support lentils above one or more windows have faded paint and are showing rust. I recommend that the lentils above all of the windows have an additional coat of rust inhibitive paint to prevent further rust and corrosion.

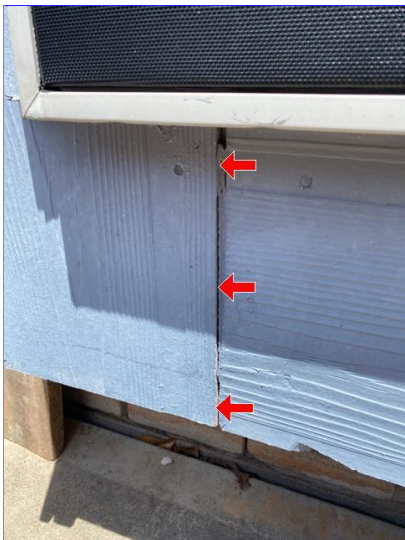
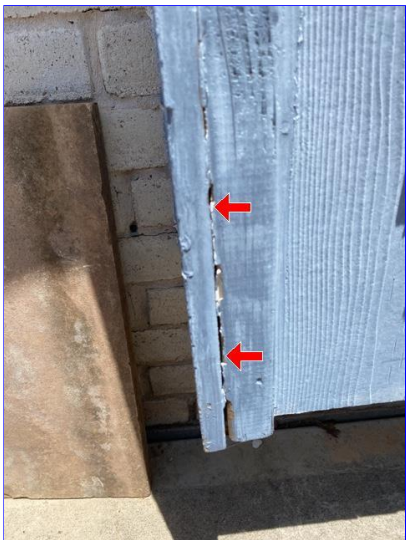
(4) One or more bay windows have caulk separation at the siding or vertical trim and require repair and caulk sealant.

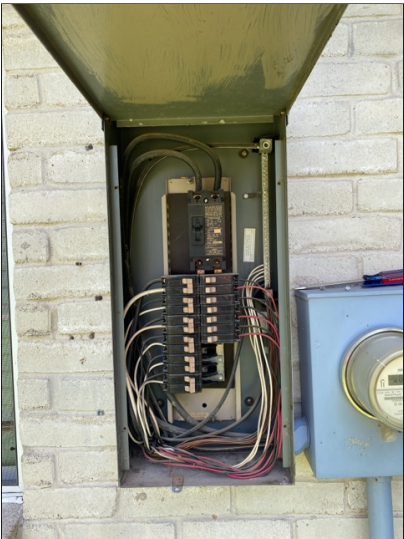
(1) The main electrical service panel, shown with dead front cover removed for inspection purposes. The panel inspected okay.

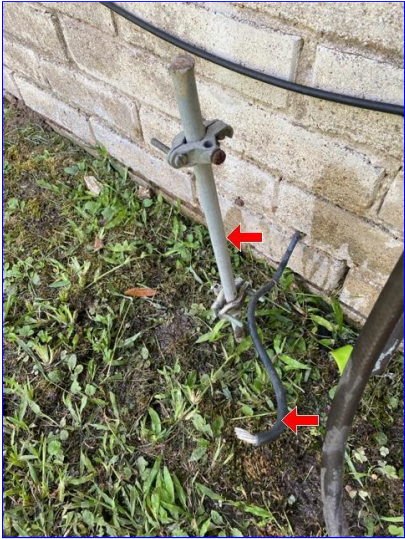
(2) The system ground wire, is loose from the ground clamp or the ground clamp, is loose on the ground rod (electrode).

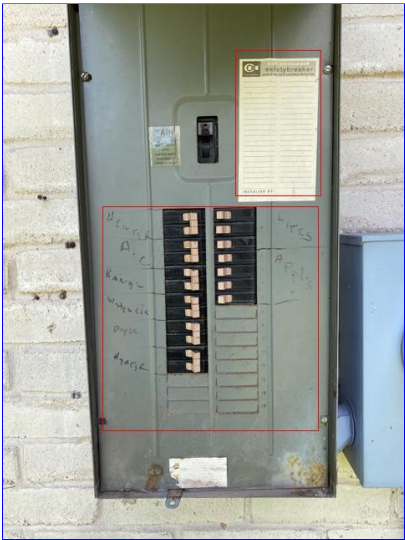
- (3) The ground wire clamp is not an acorn type clamp.
- (4) Some labels are present, but are illegible or confusing. I recommend correcting for safety reasons.

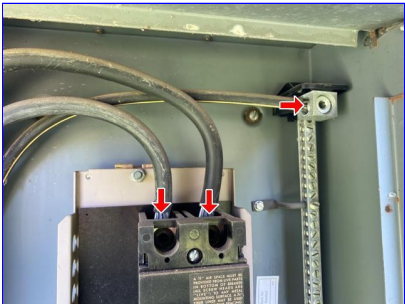
- (5) Anti-oxidant paste, was not observed on service entrance conductor terminations. Anti-oxidant paste is recommended to prevent corrosion at the terminations.

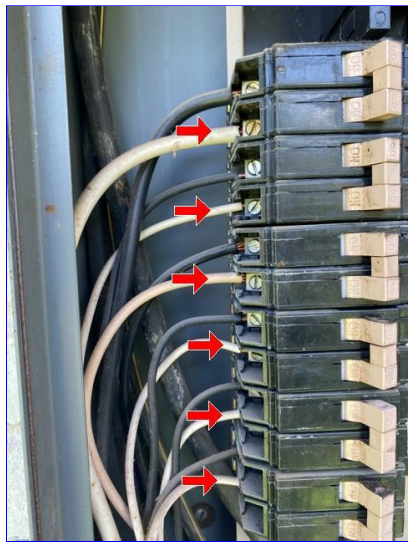
(6) White wire(s) used as hot leg(s) inside panel, and not marked as such. Recommend correction as needed.

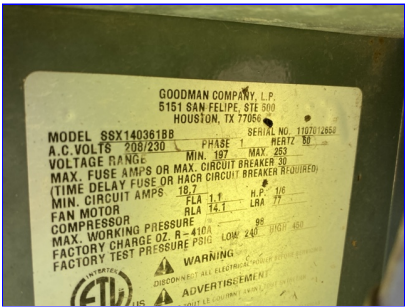
(1) Air Conditioning service tag(s).

Manufacture date(s) - 2011 year model.

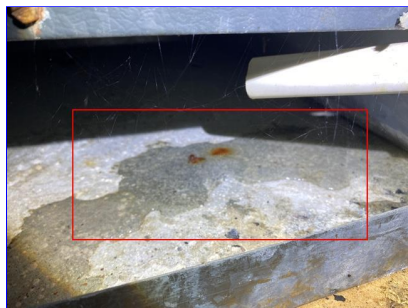
(4) There was condensation buildup observed inside of the A/C emergency drain pan.

(5) I recommend that you consult with a licensed, qualified, heating, ventilation and air conditioning professional to evaluate further, determine the best method for repair, estimate cost and to perform the repairs.

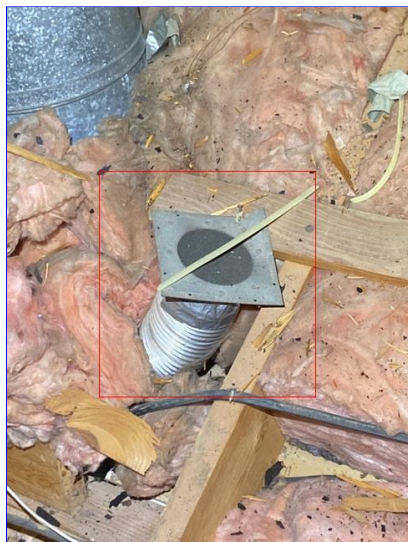
(1) The ductwork for the bathroom exhaust fan(s) terminates in the attic or soffit. Should vent to the exterior.

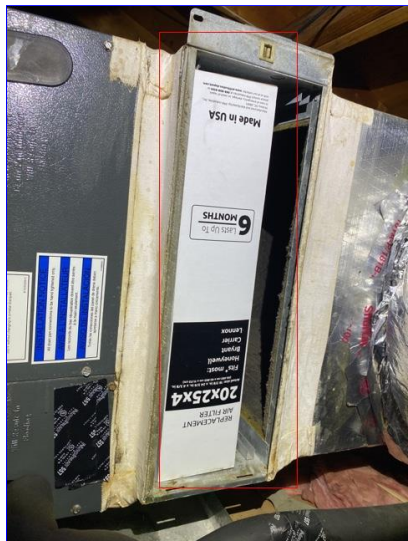
- (2) The disposable filter is dirty & clogged. The filter needs to be replaced. I recommend replacement as needed.
- (3) The air filter is located at the unit in the attic space. This type of filter should be replaced every 6 months.

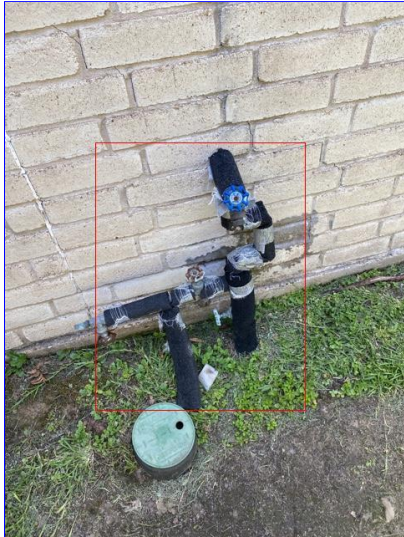
(1) The main water supply line at the exterior, is not properly protected from freezing.

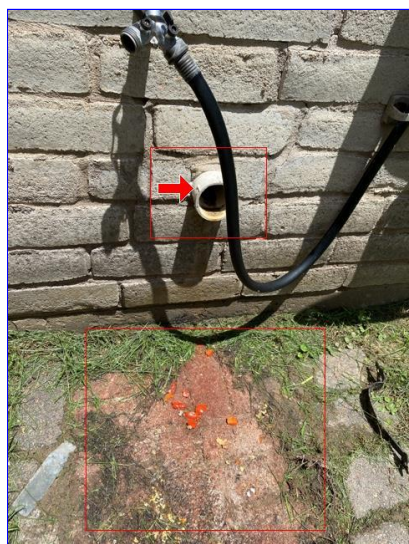
(2) The sewer clean out at the exterior kitchen sink wall is missing the cap and the soil in this area is wet from sink water and food debris. The clean out was observed to have sink water flowing out of the drain line while the sink and garbage disposal plumbing was tested. This area of the drain line plumbing may have a clog in the line and require a sewer scope or hydro-static test in order to rule out any blockages that may be in the sewer line. Recommend correction.

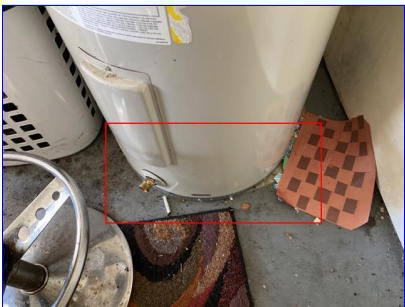
(2) The water heater is in need of an emergency drain pan under the unit. The drain pan should have a drain line ran to the outside. A water heater leak can cause very expensive repair to a home. Recommend correction.

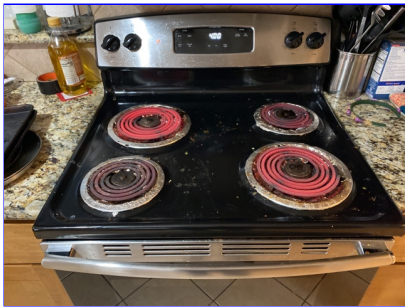
The oven heated to 355 degrees when set to 350, the normal variance is +/- 25 degrees.

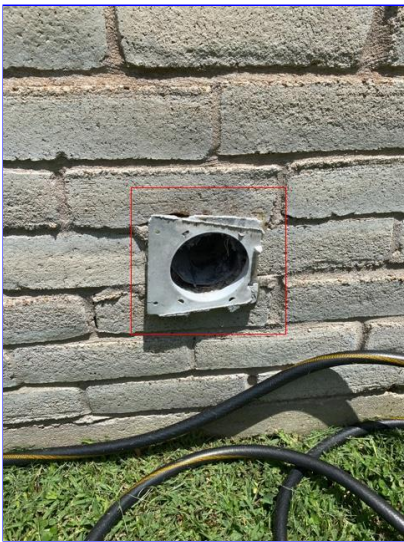
The back draft damper, installed at dryer vent discharge is damaged. I recommend proper termination of dryer duct.

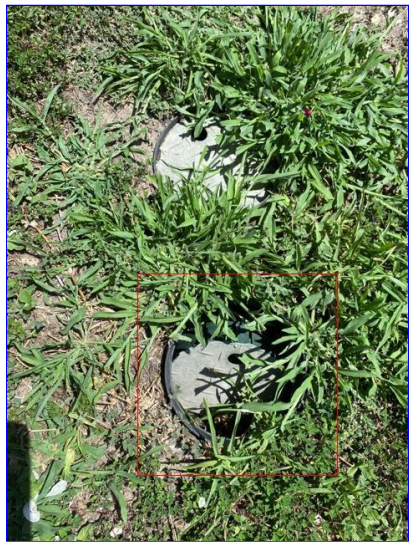
(1) There were missing or damaged sprinkler zone valve box covers that require replacement.

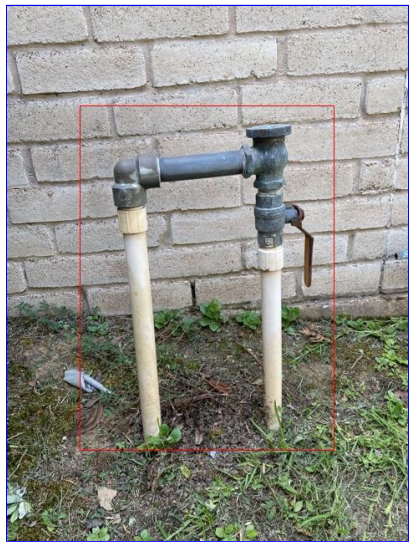
The vacuum breaker is not properly supported to prevent the system from being damaged. I recommend a wall clamp or stake supports be added.

The vacuum breaker is missing the required insulation needed to prevent damage during freezing conditions.

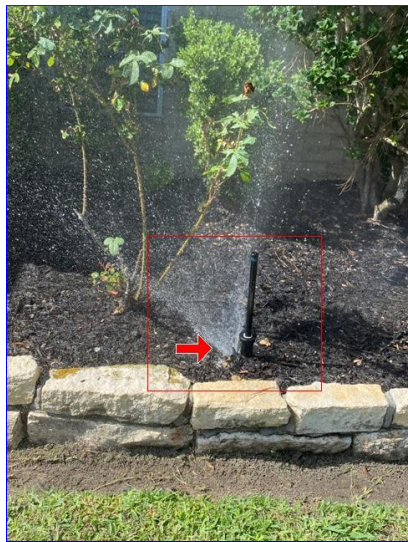
Zone 1, there is a broken pop up sprinkler head or a break in the irrigation water supply line at the front right area of the home.
