Maria Fernandez
2534 Halstead Dr
Spring, TX 77386

March 23, 2023

PROPERTY INSPECTION REPORT FORM

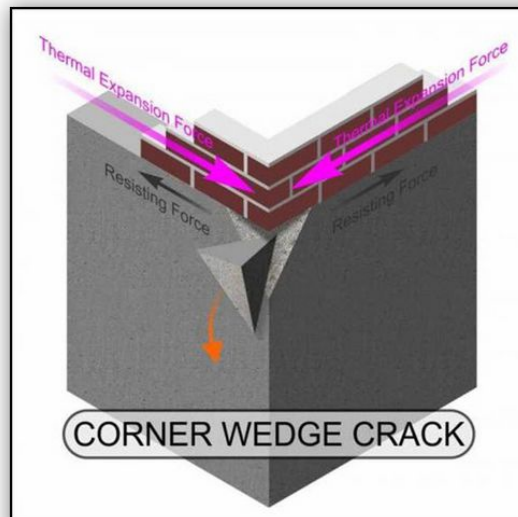
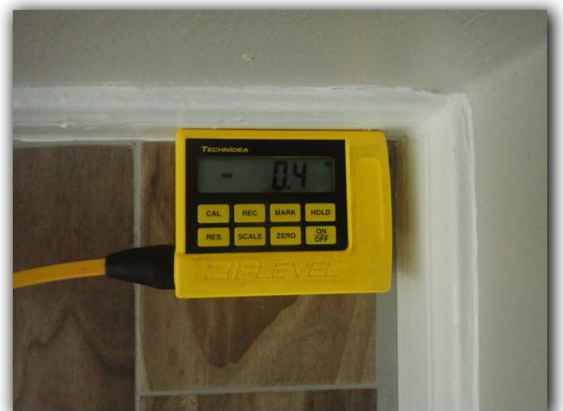
- The concrete beam was observed to have some deterioration (scaling and/or spalling) on the east side of the structure.

Note: One or more of the foundation perimeter beam corners were observed to be sheared off (corner pop). This is a common condition to observe and is due to thermal expansion and contraction of the different building materials. This condition does not adversely affect the foundation performance. However, in some cases, some cosmetic improvements may be necessary.

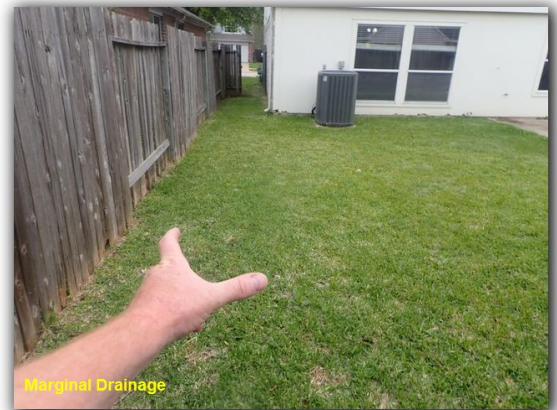
- Marginal site drainage was observed on the north, east, west and south sides of the structure. Proper drainage is needed to help prevent water from standing and/or ponding next to the foundation beam. Corrective measures may be needed if the water stands within 10-feet of the foundation perimeter beam for more than 24-hours.
- Fill dirt is needed on the south side of the structure. The low spots in the finished grade (ground) adjacent to the foundation perimeter wall need to be filled in to help prevent water from standing and/or ponding next to the foundation area.

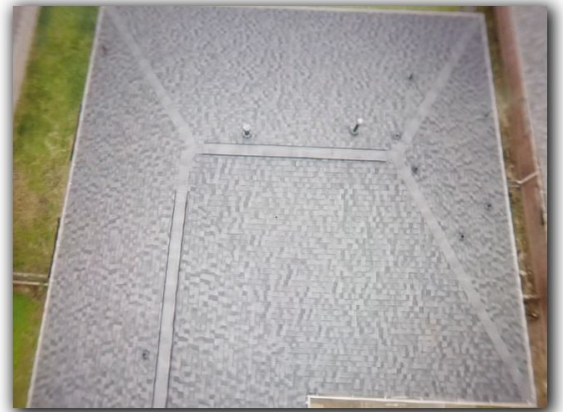
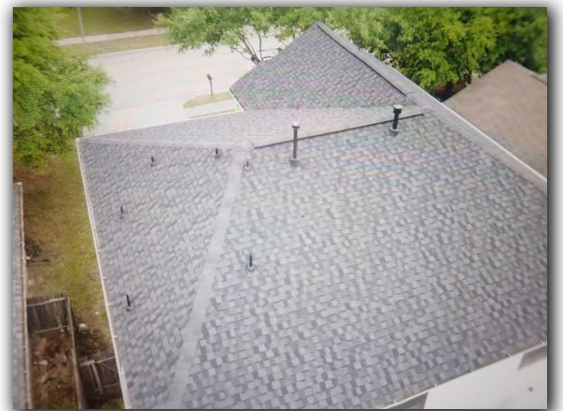
- One or more of the shingles were observed to be lifting on the north side of the roof structure.

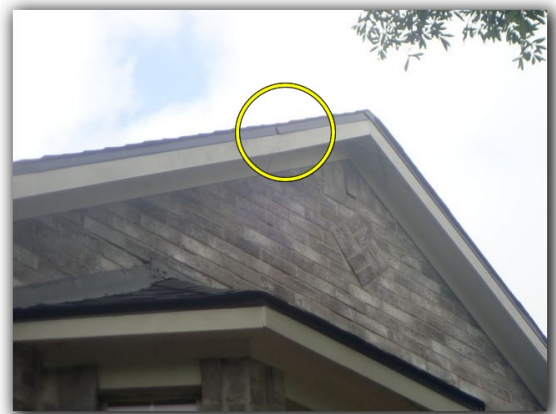
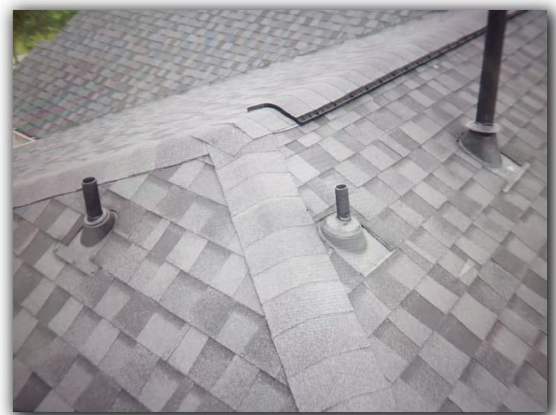
- The flashing is lifting and/or pulling loose on the north side of the roof structure. This condition could allow water intrusion at this location.
- It is recommended to paint the flashing details to prevent rust and/or UV damage.
- One or more of the roof level plumbing vent stack flashing details are buckled downward around the plumbing stack. This condition could allow water penetration at this point and corrective measures are recommended.
- It is recommended to properly seal the storm collar(s) at the roof level gas equipment vent pipe(s) to help prevent water intrusion into the structure.
- There was no kickout flashing details observed at the lower bottom edge of the roof line interface and the sidewall that continues past the edge of the roof. The lack of this kickout flashing could allow water to penetrate at these points.

The flashing details should be checked, reset or repaired as necessary. The observations made to support the rendering of this opinion are listed but may not be limited to:

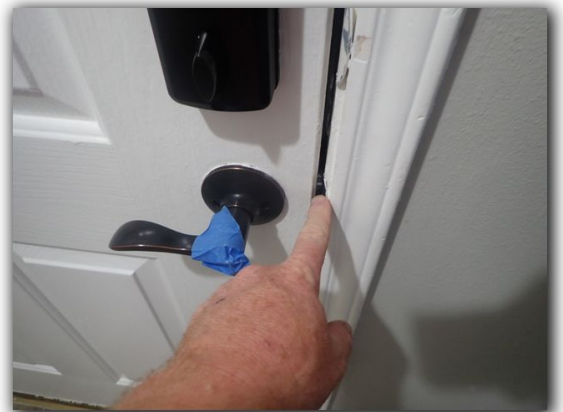
- Weather-stripping improvements are recommended for the front entry, backyard entry, garage entry exterior door(s).
- Visible evidence of previous water intrusion was observed at and/or around the exterior backyard entry, front entry door(s). The cause and remedy should be investigated and corrected as necessary.
- The door is damaged to the garage, backyard entry door.
- The door hardware does not function properly to the front entry door.
- The garage entry door is not equipped with a self-closing device.

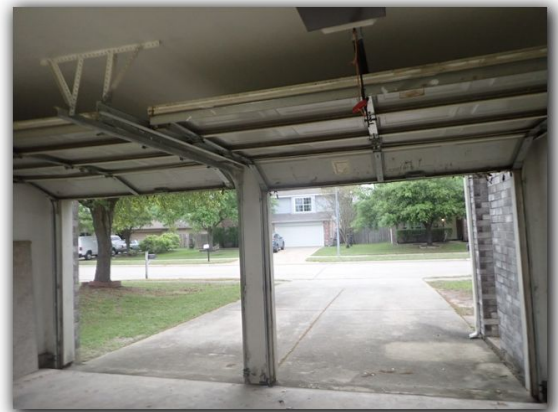
- Some damage to the overhead garage door was observed.

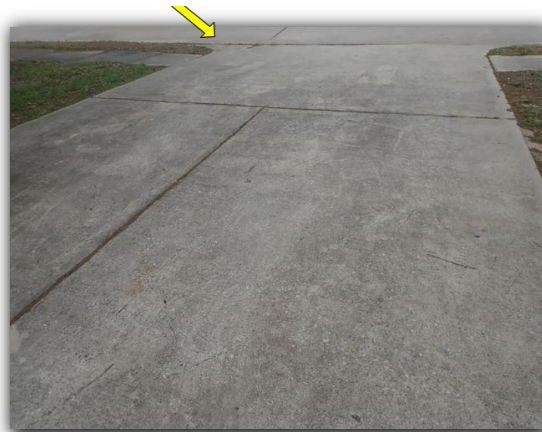
- Minor cracks and/or deficiencies were observed in the driveway.

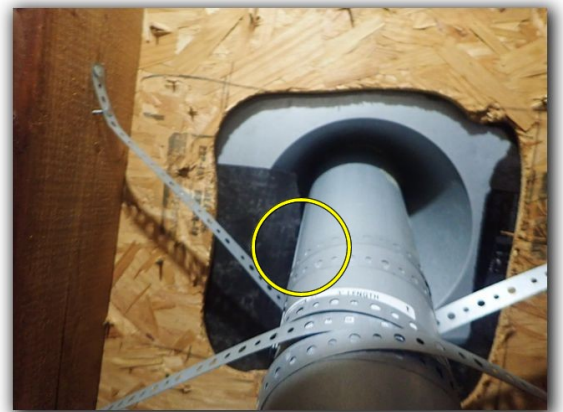
- The heating unit flue (vent pipe) has inadequate clearance from combustibles materials. Double walled vent pipes should have at least 1-inch of clearance and single walled vent pipes should have at least 6-inches of clearance from combustible material.

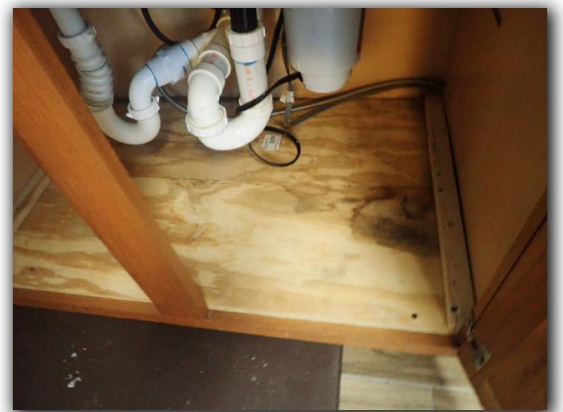
- The faucet assembly is loose.
- The drain line is made of corrugated material. It is recommended to use smooth wall/PVC type material to prevent blockage/poor drainage.
- The faucet hot/cold water orientation is reversed.

Note: Previous water leaks were observed at and/or around the drain connections under the sink. This would indicate previous problems and should be closely monitored and corrected when necessary.

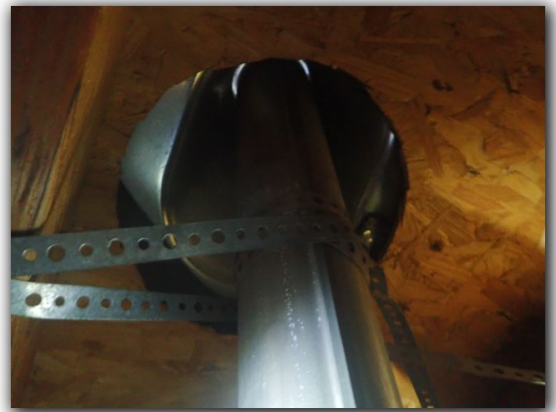
- There is debris at the water fixtures when the hot water is operated. This condition should be further evaluated and corrected as necessary.
- Some corrosion was observed at the water supply connections at the top of the water heater.
- The roof level flue storm collar should be properly sealed to help prevent water intrusion into the structure.

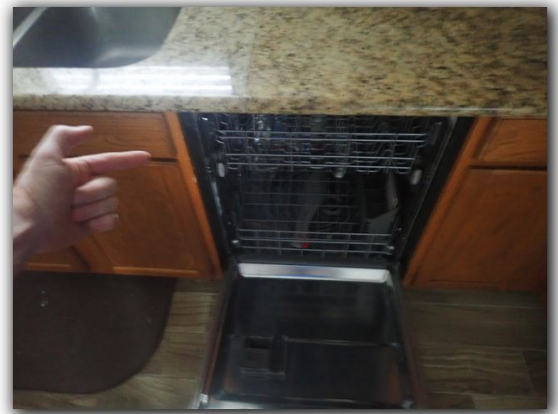
- The dishwasher is loose at the cabinetry and should be better secured.
- Some damage to the dishwasher door or door facing was observed.

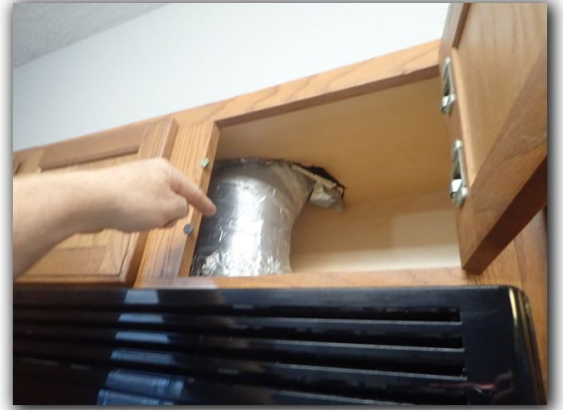
- The range exhaust vent is terminating into the cabinet area. Range exhaust vents should vent to the exterior of the house.
- The exterior termination cover was observed to be not operating properly.

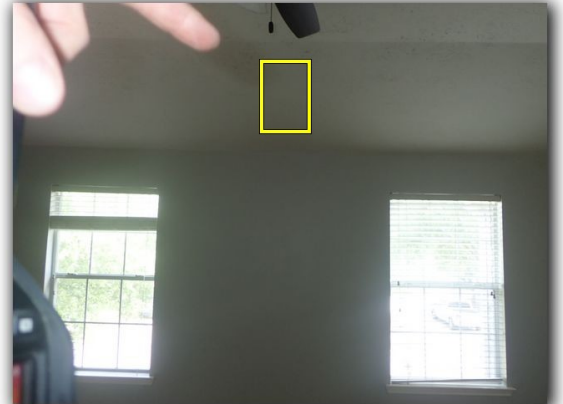
- Missing/or out of place insulation was observed in the primary bedroom.

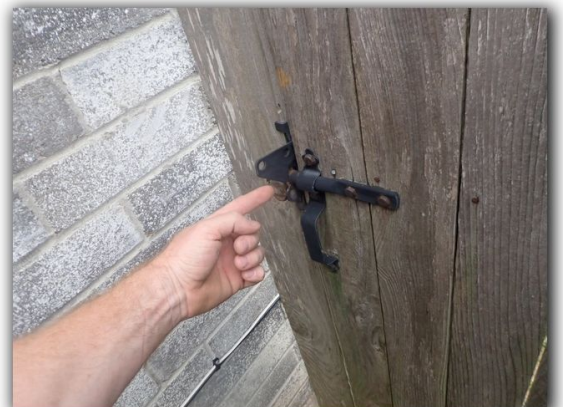
- The overall condition of the fence material, railing and posts are in poor condition and repair or replacement is recommended.
- One or more of the fence boards are damaged / deteriorated and repairs are recommended.
- The gate for the fence does not function properly and repairs are recommended.
- One or more of the posts are damaged and the fence panels are leaning.
- Termite damage was observed on several of the fence components.

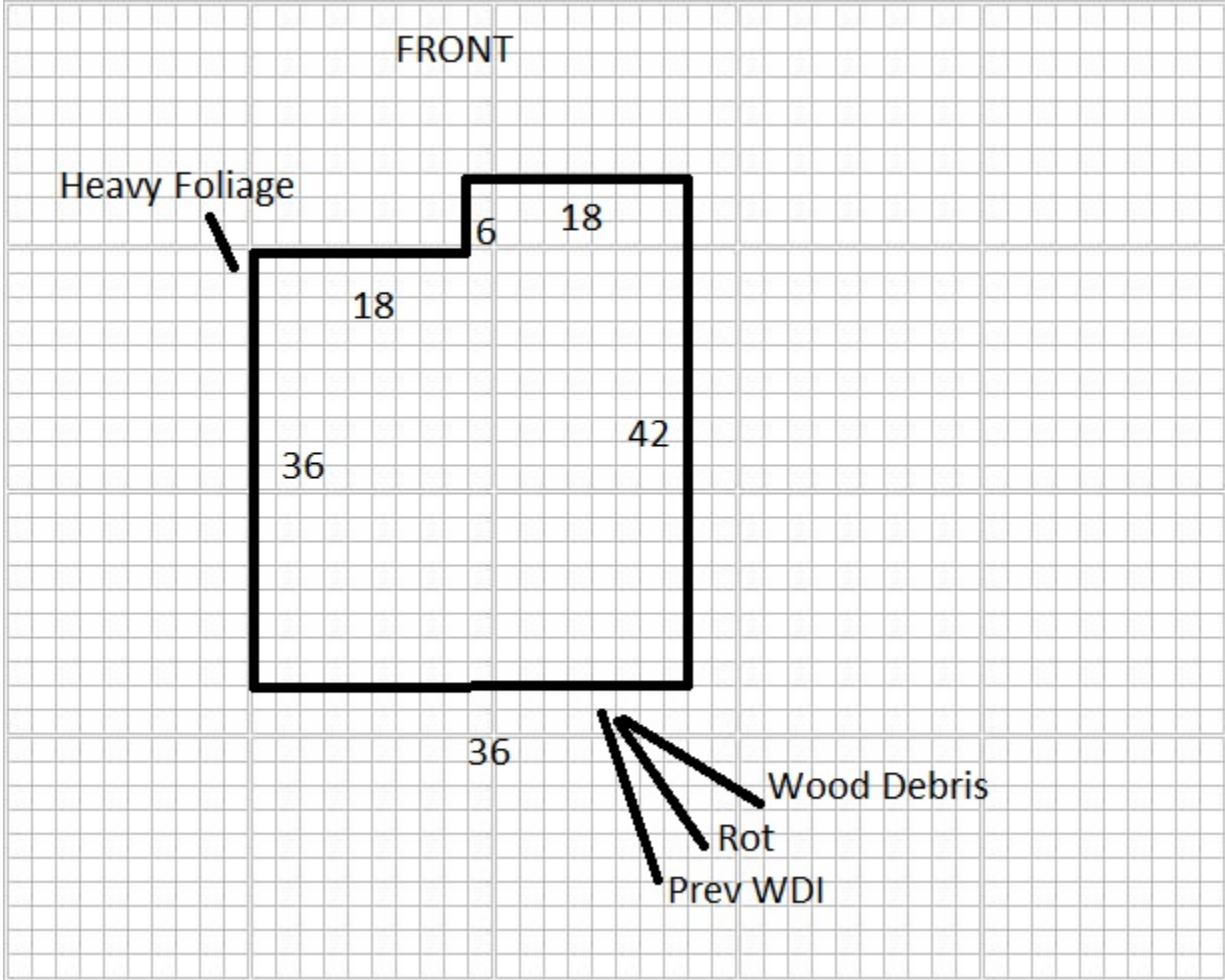
Additional Comments There is visible evidence of a previous WDI infestation at the time of this inspection without signs of previous treatment or records of previous treatment. Treatment is recommended at this time. See diagram for location(s).
