BUILDING ENVELOPE MOISTURE INSPECTION

2135 Quenby St
Houston, TX 77005

Maja Djukic
04/03/2025

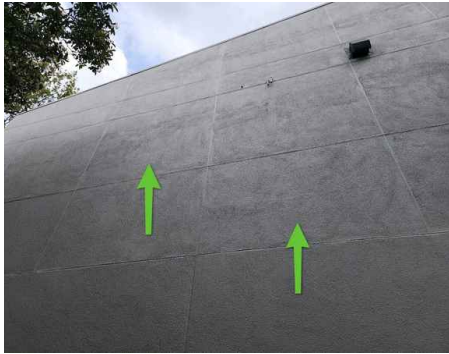
Previous Repairs

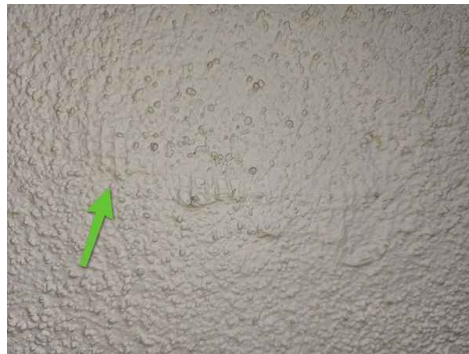
Painted Mesh: Left Elevation

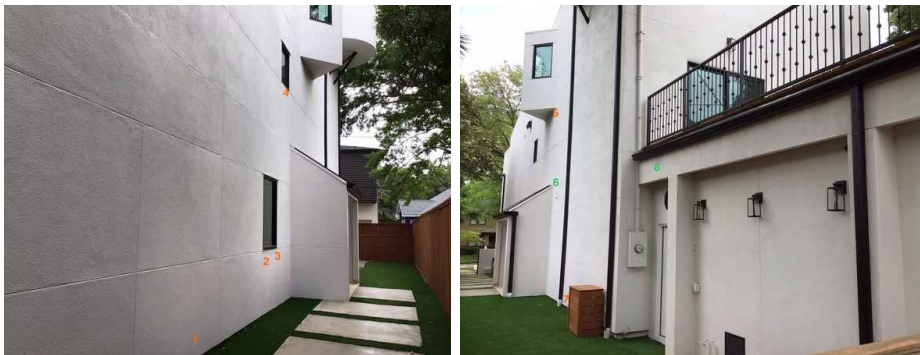
Photo of elevation with test sites: Photo of Elevation

3.1.1 Photo of elevation with test sites

ELEVATED SITES

Test Site	%	Substrate Condition
1	25% (Saturated)	Firm
2	33% (Saturated)	Firm
3	24% (Saturated)	Firm
4	21% (Saturated)	Firm
5	26% (Saturated)	Firm
7	23% (Saturated)	Firm

ACCEPTABLE SITES

Test Sites	%	Substrate Condition
6	14%	Firm
8	12%	Firm

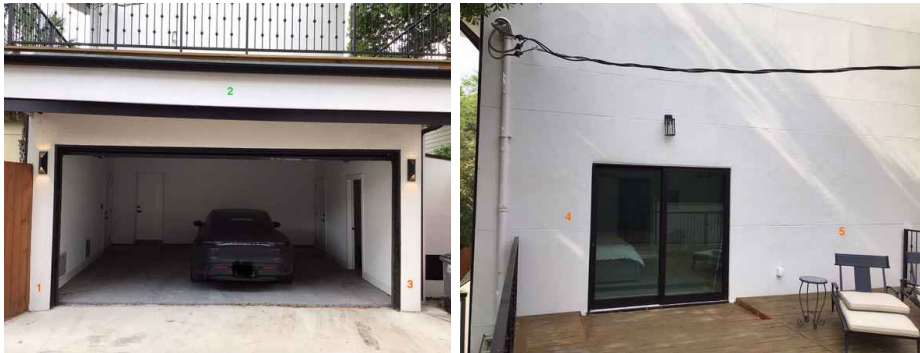
Photo of elevation with test sites: Photo of Elevation

4.1.1 Photo of elevation with test sites

ELEVATED SITES

Test Site	%	Substrate Condition
1	19%	Firm
3	24% (Saturated)	Firm
4	17%	Firm
5	21% (Saturated)	Firm

ACCEPTABLE SITES

Test Sites	%	Substrate Condition
2	14%	Firm

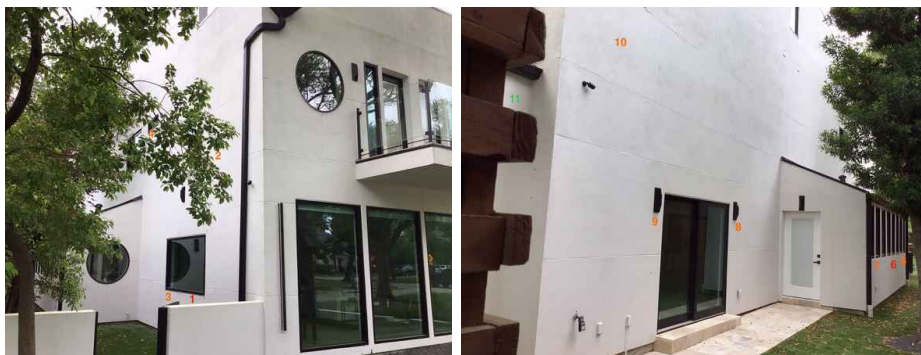
Photo of elevation with test sites: Photo of Elevation

5.1.1 Photo of elevation with test sites

DETERIORATED SITES

Test Sites	%	Substrate Condition
1	None Taken	Soft
6	None Taken	Soft

ELEVATED SITES

Test Site	%	Substrate Condition
2	15%	Firm
3	29% (Saturated)	Firm
4	22% (Saturated)	Firm
5	21% (Saturated)	Firm
7	18%	Firm
8	27% (Saturated)	Firm
9	29% (Saturated)	Firm
10	21% (Saturated)	Firm

ACCEPTABLE SITES

Test Sites	%	Substrate Condition
11	13	Firm

Left Elevation Site(s): 1, 6

The substrate appears soft or severely deteriorated indicating the wall is not performing as intended. A small area of stucco should be removed in this area to verify the inspectors findings and the damaged substrate should be repaired. Further evaluation by a stucco contractor to determine the best method of remedy is recommended. All repairs should be performed by qualified contractors according to industry standard installation instructions.

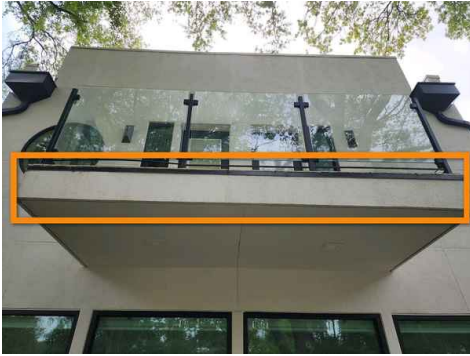
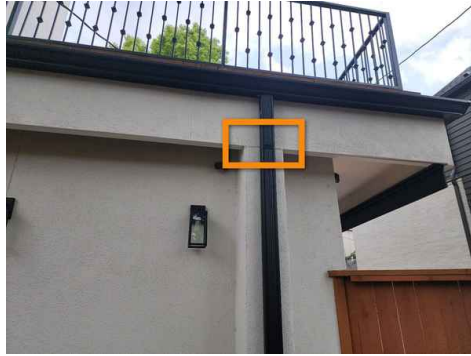
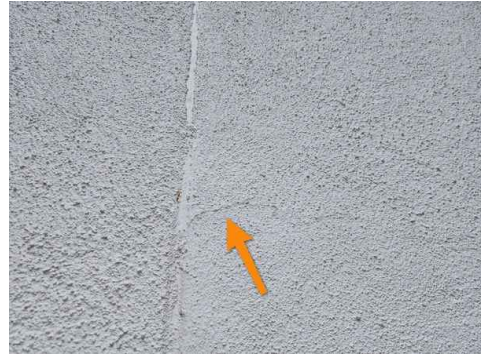
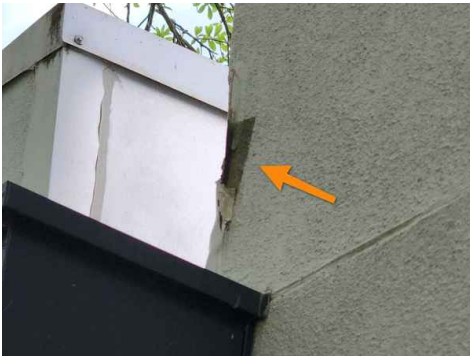
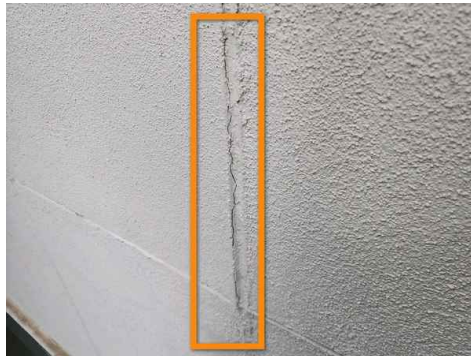
CRACKED OR DAMAGED STUCCO

There are multiple hairline cracks at the exterior stucco material. These cracks may be an indication of poor fastener patterns in the lathe supporting the stucco or be caused by typical settlement . Repairs may be necessary to prevent moisture intrusion and further cracking.

1. Apply a base coat adhesive mixed with Portland cement over the entire wall section showing cracks to the nearest control joint.
2. With base coat cement still wet, embed a fiber mesh over the area that the base coat has been applied to using a metal trowel and let dry overnight.
3. This process allows the base coat mixture to seep into and fill the cracks within the stucco cladding. The fiber mesh allows the wall to stay flexible to movement and less susceptible to cracks reappearing over time.
4. Once dry, apply new texture to the entire panel of the cracked area from joint to closest joint.

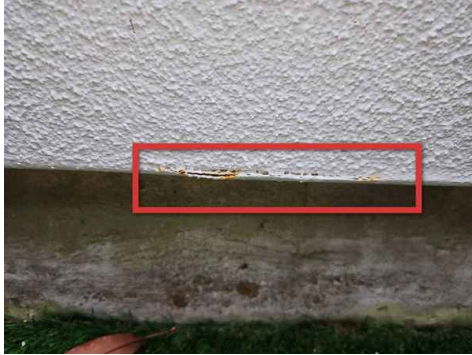
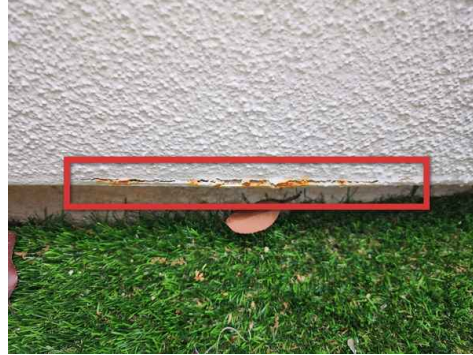
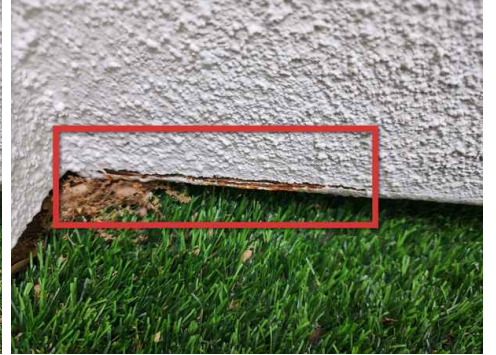
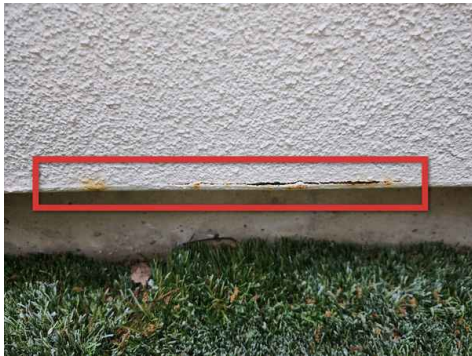
RUSTING AGGREGATES AND ACCESSORIES

There is visible rusting on or in the Stucco material near metal components such as near windows and the bottom of the wall. This may indicate long term moisture contact. Recommend modifying or repairing these areas by a stucco contractor.

Rusting aggregates and accessories should be repaired/replace and the source of the moisture should be remedied to prevent further moisture intrusion and damage. All repairs should be performed by qualified contractors according to industry standard installation instructions.

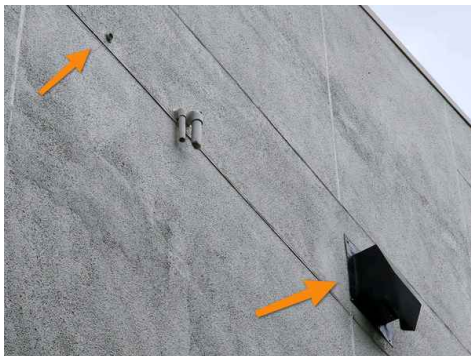
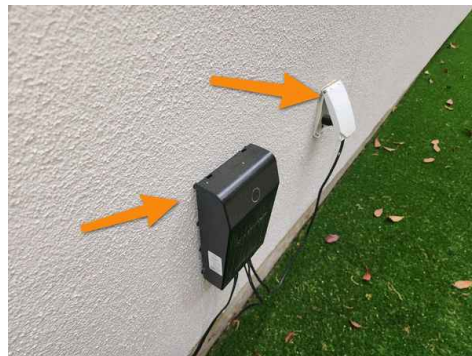
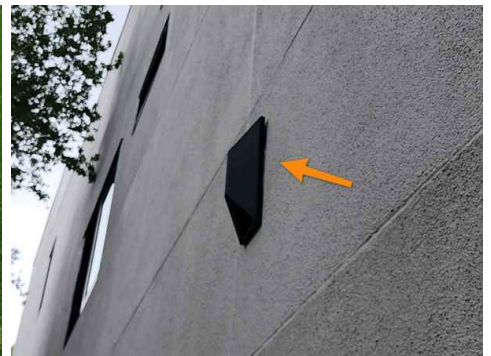
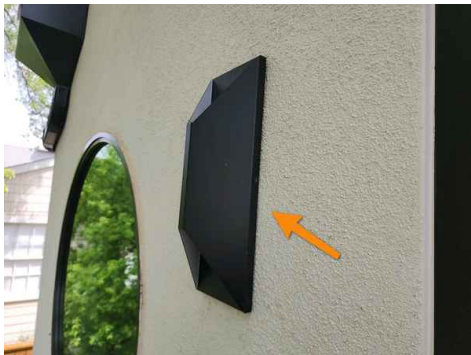
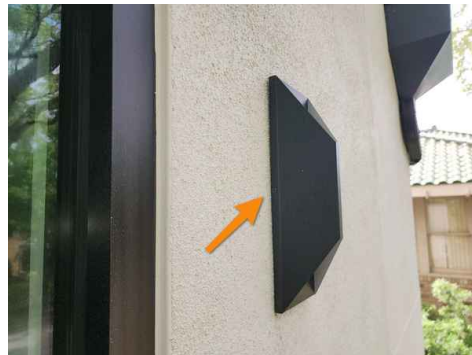
MISSING OR DETERIORATED SEALANT

Missing or deteriorated sealant was observed at one or more wall penetrations or items that are mounted to the walls. Sealing anything that is mounted to or passes through the walls to help prevent moisture intrusion is recommended.

Missing, damaged, and deteriorated sealant should be removed and replaced to prevent moisture intrusion. The lifespan of most sealants suitable for stucco is **18 to 24 months in high-UV exposure (up to 36 months in low-UV exposure) and should be replaced on a maintenance schedule that reflects that lifespan.** All repairs should be performed by qualified contractors according to industry standard installation instructions.

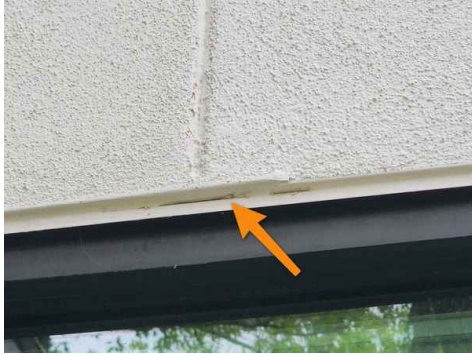
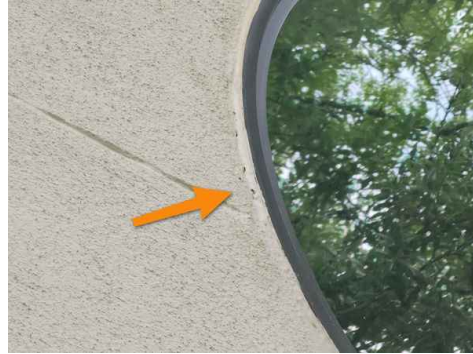
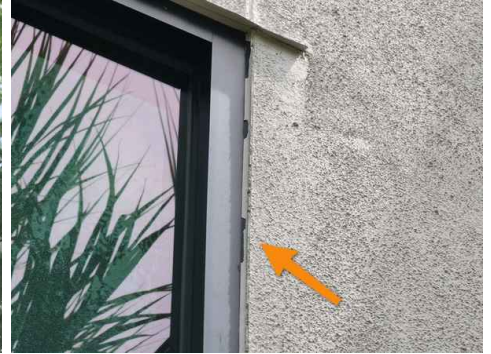
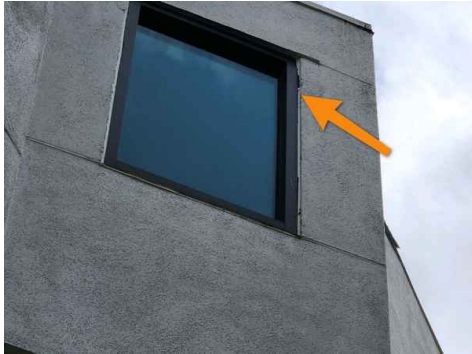
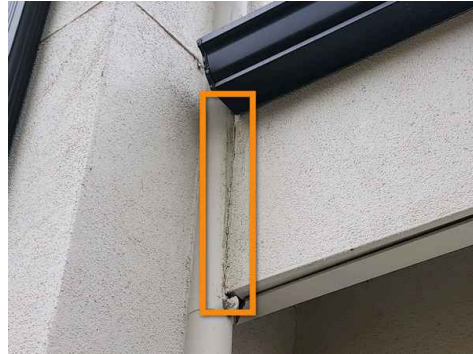
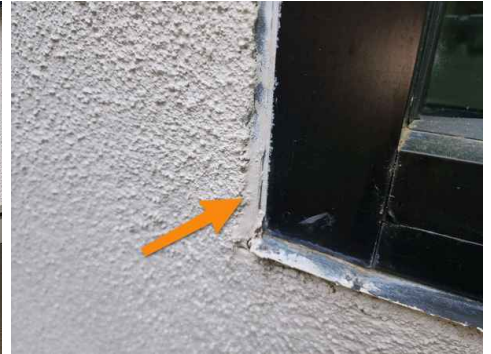
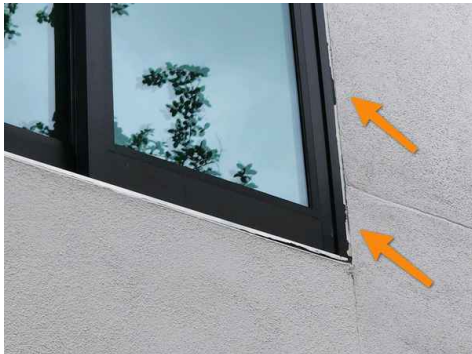
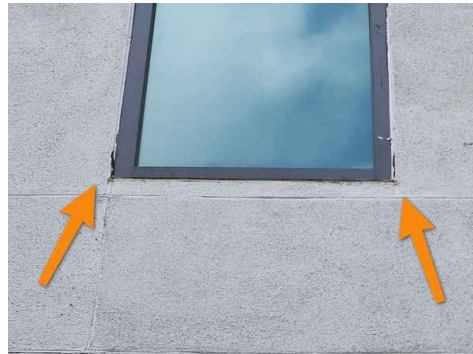
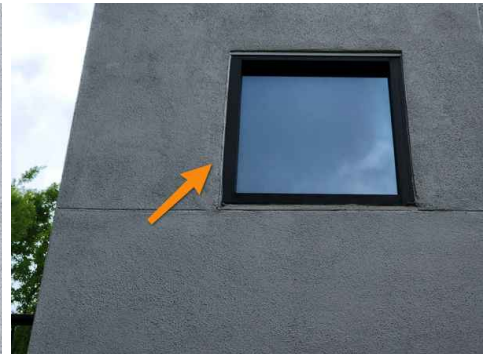
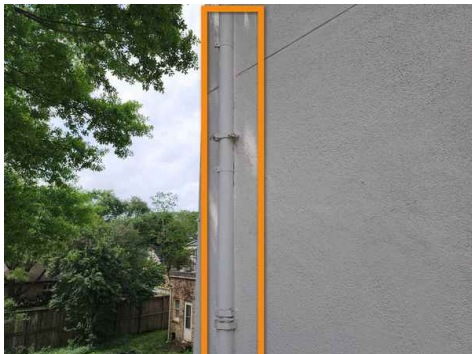
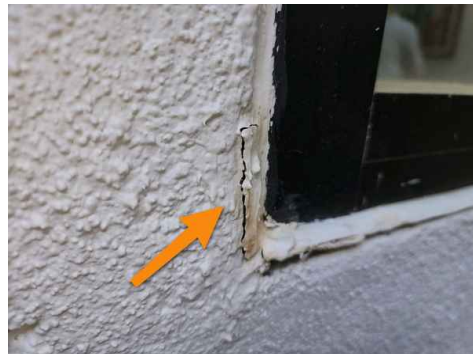
DAMAGED/DETERIORATED SEALANT

Sealant was damaged or deteriorated around the door/window frames. Damaged or deteriorated sealant can lead to moisture intrusion.

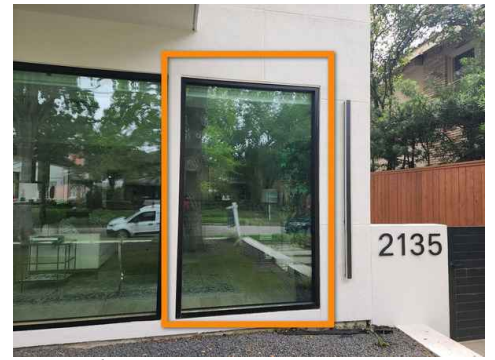
Front Elevation

STUCCO INSTALLED UP TO WINDOW/DOOR FRAME

Stucco/EIFS was installed directly against window/door frame. Current building standards call for a proper caulk joint between the cladding and the window/door frame.

Contact a stucco repair contractor

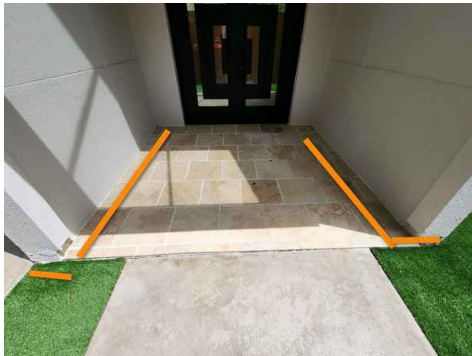
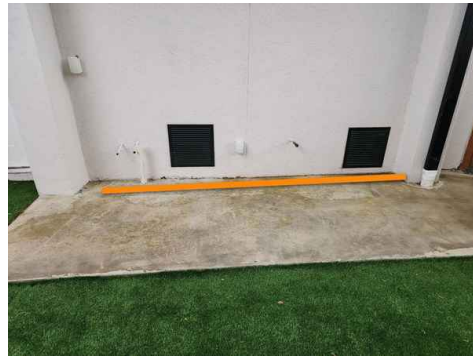
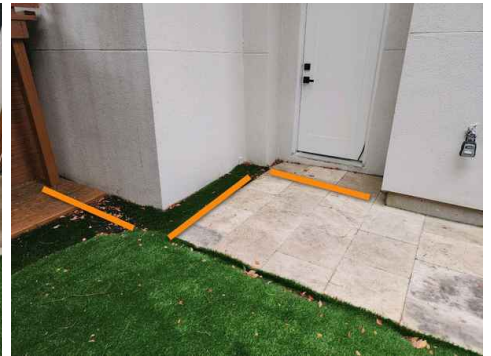
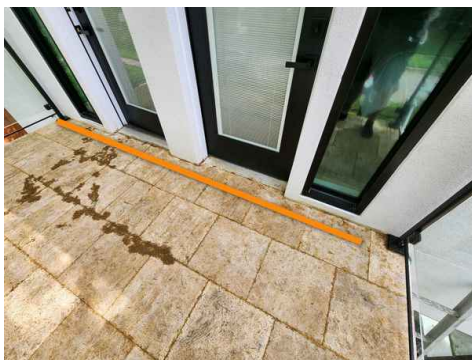
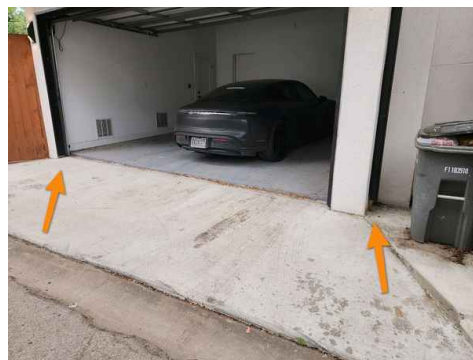
STUCCO IN CONTACT WITH GRADE OR FLAT WORK

Stucco is touching flat work or grading. Stucco should terminate above flat work or grading to prevent moisture wicking up into the wall. Modification by a stucco contractor is recommended.

Contact a stucco repair contractor

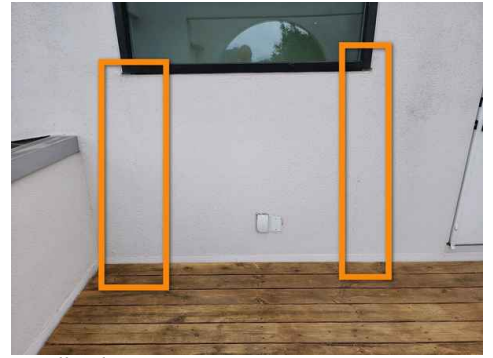
MISSING/INADEQUATE EXPANSION/TRANSITION JOINTS

Expansion/Transition joints are required a maximum spacing in walls of 18 ft o/c both horizontally and vertically enclosing an area no more than 144 sf.

Caulked Over: Terrace

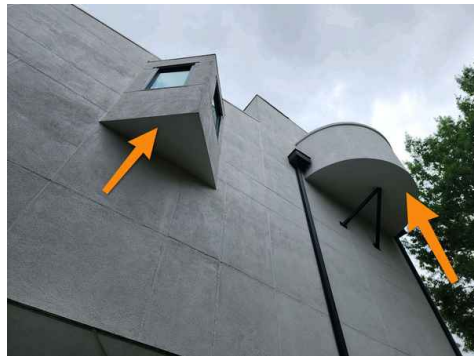
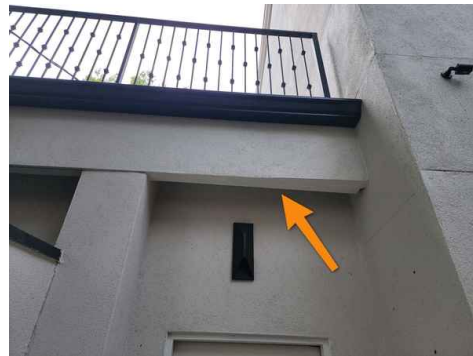
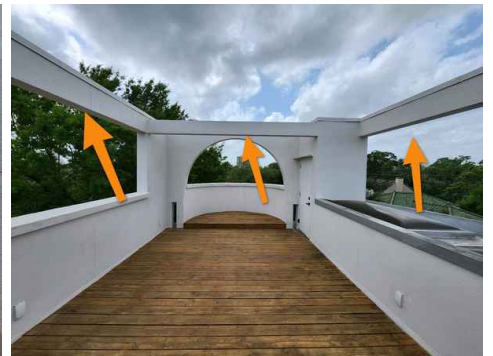
MISSING DRAINAGE

A relief or drainage track was missing. Current building standards call for some type of drainage to be installed. Without some type of drainage any moisture that gets behind the stucco will be trapped and prematurely deteriorate the wooden beams.

Contact a stucco repair contractor

Drainage provisions or Relief cuts should be installed at all balconies and overhangs to prevent water accumulation at these locations. Without these provisions, the accumulation of moisture can lead to deterioration of the wooden structure of the building. All repairs should be performed by qualified contractors according to industry standard installation instructions.

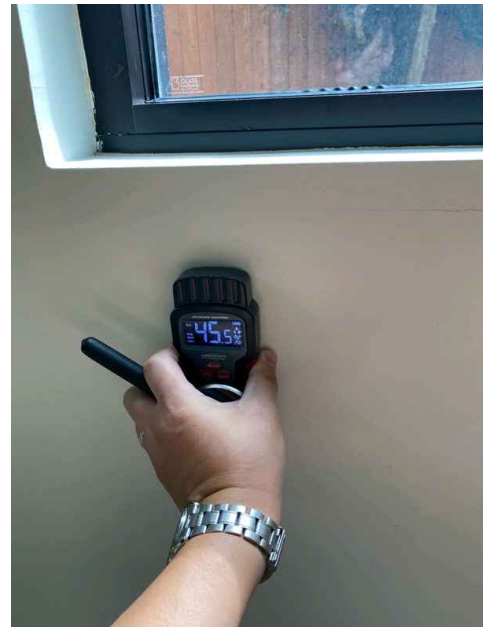
MOISTURE READING LEVEL: ELEVATED

Elevated moisture levels for standard building materials generally fall within the range of 15-19%.

Contact a stucco repair contractor
