Moisture Inspection Report

Inspected for
Adam Garst
2135 Quenby St
Houston, TX 77005
1/2/2026

Property Address: 2135 Quenby St , Houston TX 77005			
Property Information		Inspection Information	
Client's Name	Adam Garst	Inspection Type	Invasive Moisture Inspection
Client's Phone	281-610-1296	Date of Inspection	1/2/2026
Client's Email	garstadam@gmail.com	Inspector	Tony Trinidad EDI #TX-192
Type of Exterior	Hard Coat Stucco	Present at Inspection	Buyer(s), Buyer's realtor(s), Home Inspector
Substrate (if known)	Wood	Temperature	70-80 degrees
Property Age	46	Weather Conditions	Clear, Dry
Square Footage	4079	Last Known Rainfall	2-5 days
Stories	3		
Type of Windows	Metal

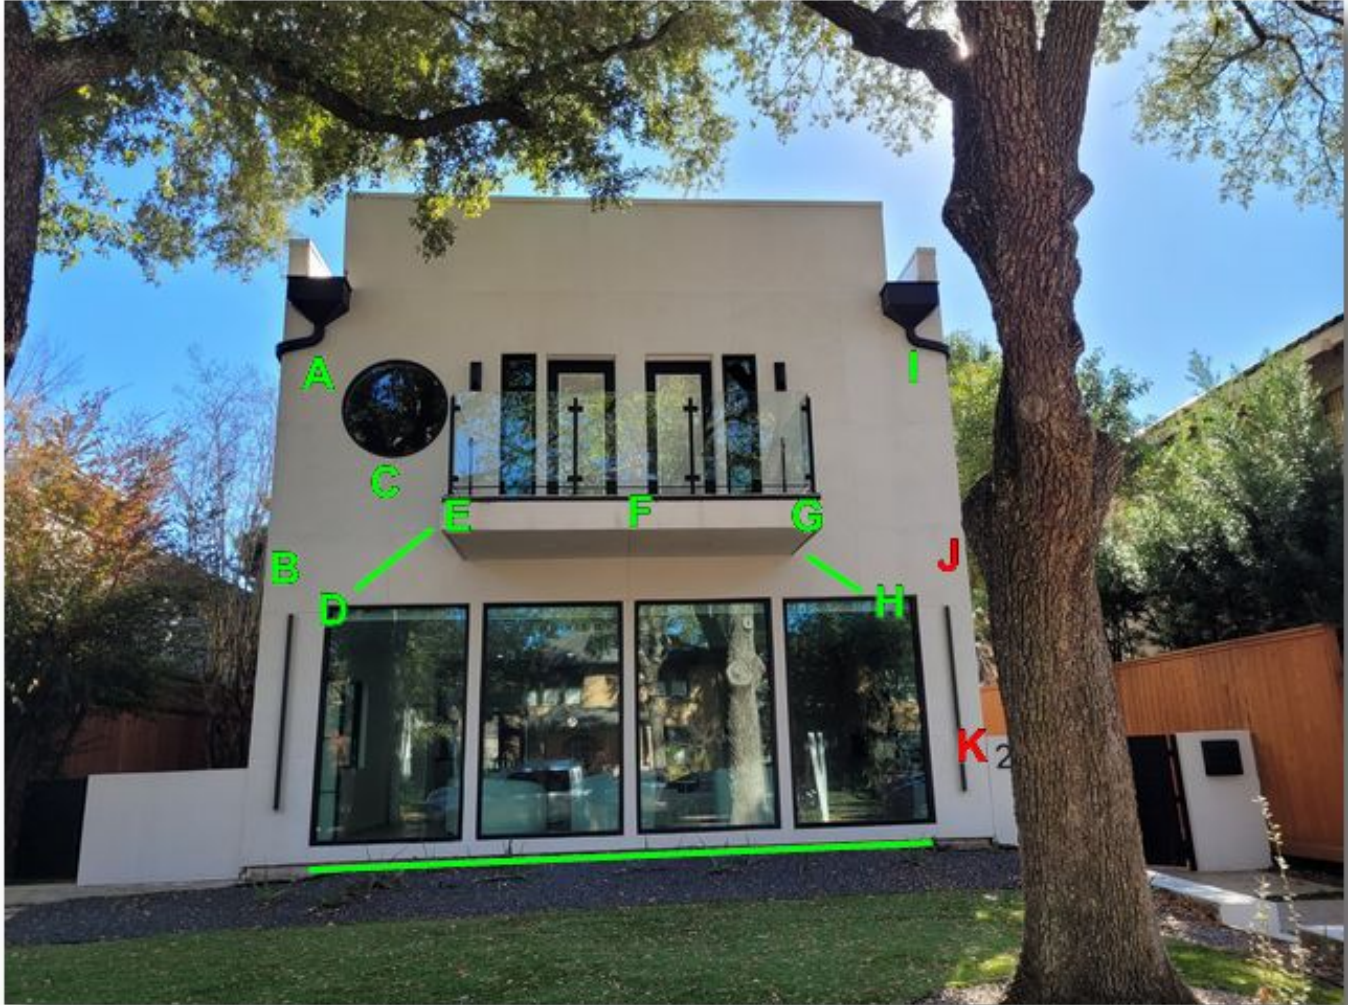
Moisture Testing (1)

Test Location	Moisture Content	Substrate Condition	Additional comments
A	<15%	Firm	
B	<15%	Firm	Corner cracks needing repair present.
C	<15%	Firm	
D	<15%	Firm	Diverter flashing not installed at balcony intersection.
E	<15%	Firm	
F	<15%	Firm	
G	<15%	Firm	
H	<15%	Firm	Diverter flashing not installed at balcony intersection.
I	<15%	Firm	
J	N/A	Soft	Soft substrate was observed when drilling/probing. This is an indication of moisture damage / wood rot. Corner cracks needing repair present.
K	N/A	Soft	Soft substrate was observed when drilling/probing. This is an indication of moisture damage / wood rot.
Green Line	N/A	Physical Touch	The inspector was able to confirm firm substrate by physical touch at weep screed opening.

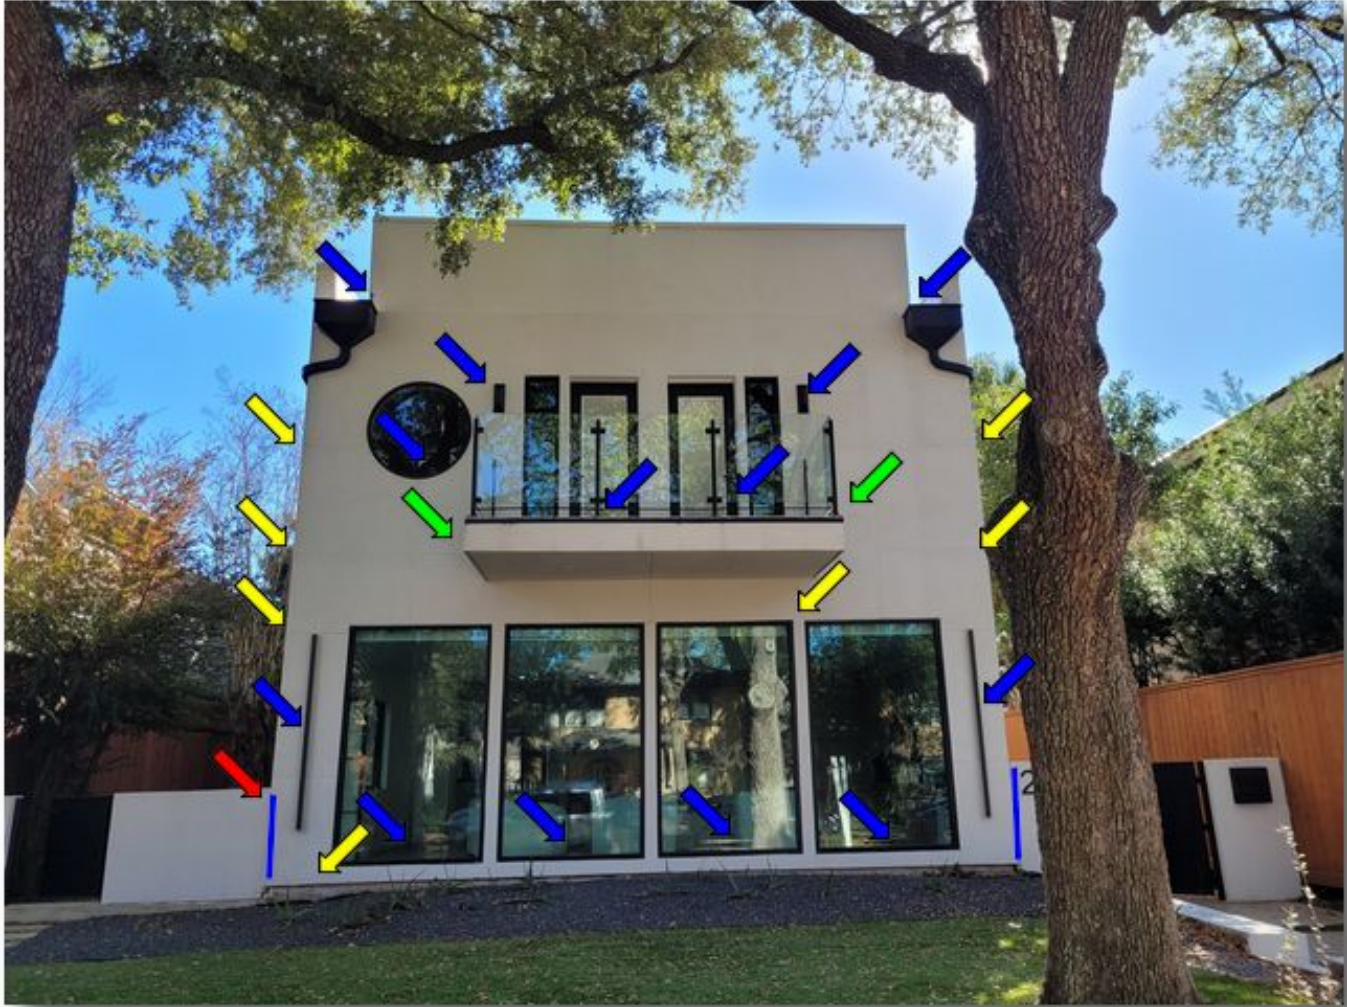
Deficiencies (1)

Identifier	Comments
Blue Arrows and Lines	Damaged / Aged / Missing Sealant: Damaged, aged, and / or missing sealant was found at wall penetrations, joints, windows, and / or other voids on the exterior. Properly installed sealant provides a barrier against moisture intrusion. Recommend repairs using a top quality, low modulus, polyurethane sealant or sealant recommended by the manufacturer of your system.
Yellow Arrows	Cracks Present: Cracks were found at the stucco cladding. Hairline cracks (generally 1/16 of an inch) are commonly found with stucco systems. These cracks should be monitored and repaired as needed. It is recommend that cracks larger than hairline are repaired by a qualified stucco contractor.
Red Arrow	Rust: Rust was observed at this location. It is recommended this area is repaired to prevent further rust / damage from occurring.
Green Arrows	Balcony Diverter Flashing Missing: Diverter flashing has not been installed at the wall and balcony intersections. Diverter flashing helps to prevent moisture intrusion and allow water to properly drain away from the wall. It is recommended to install diverter flashing when elevated moisture or damage is discovered as a result of the missing flashing. Installation typically requires removal of all waterproofing/tiles so the flashing can be installed over the wood or appropriate membrane. Retrofitting flashing is not a recommended repair.

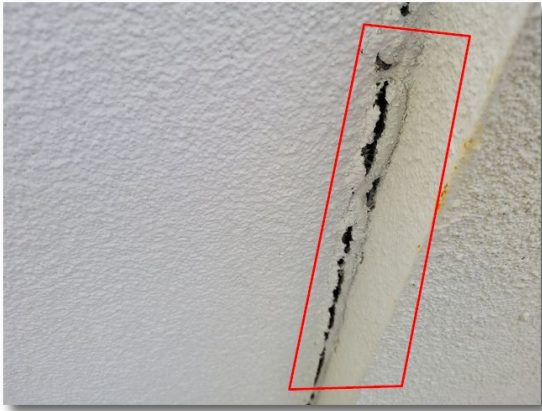
1 - 2: Damaged / Aged / Missing Sealant: Damaged, aged, and / or missing sealant was found at wall penetrations, joints, windows, and / or other voids on the exterior. Properly installed sealant provides a barrier against moisture intrusion. Recommend repairs using a top quality, low modulus, polyurethane sealant or sealant recommended by the manufacturer of your system.

1- 2.1 Privacy wall pulling away from structure, reattach wall and seal.

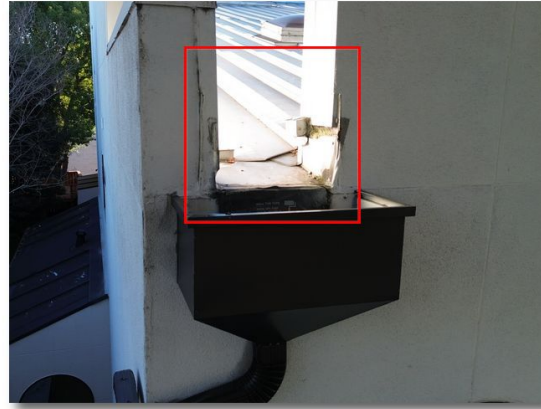
1- 2.8 Seal scupper drain

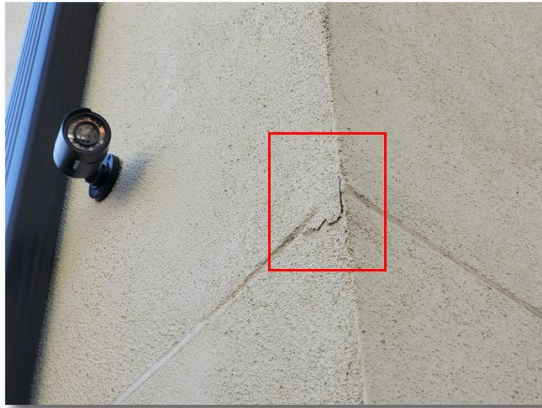
1 - 3: **Cracks Present:** Cracks were found at the stucco cladding. Hairline cracks (generally 1/16 of an inch) are commonly found with stucco systems. These cracks should be monitored and repaired as needed. It is recommend that cracks larger than hairline are repaired by a qualified stucco contractor.

1- 3.1 Corner cracks

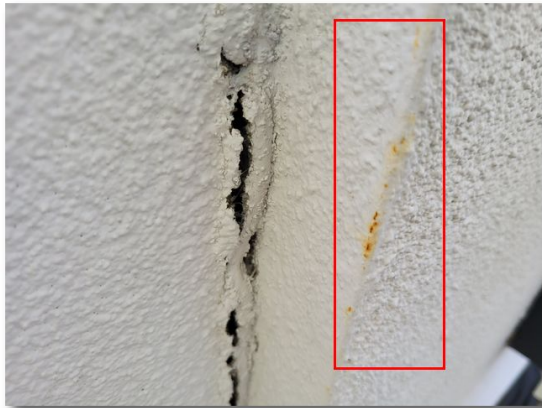
1- 4.1

1 - 4: **Rust:** Rust was observed at this location. It is recommended this area is repaired to prevent further rust / damage from occurring.

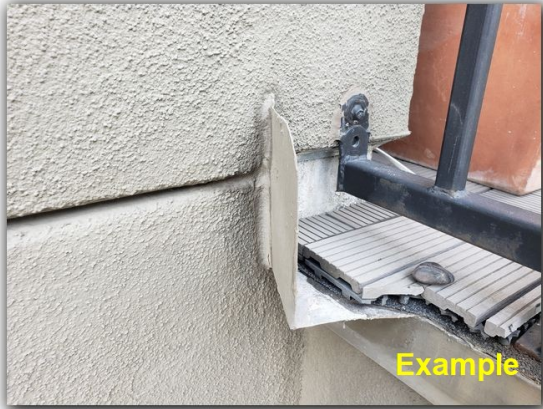
1 - 5: Balcony Diverter Flashing Missing: Diverter flashing has not been installed at the wall and balcony intersections. Diverter flashing helps to prevent moisture intrusion and allow water to properly drain away from the wall. It is recommended to install diverter flashing when elevated moisture or damage is discovered as a result of the missing flashing. Installation typically requires removal of all waterproofing/tiles so the flashing can be installed over the wood or appropriate membrane. **Retrofitting flashing is not a recommended repair.**

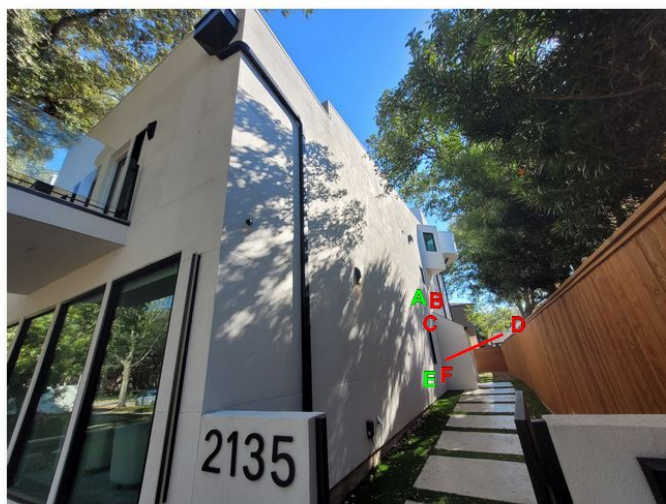
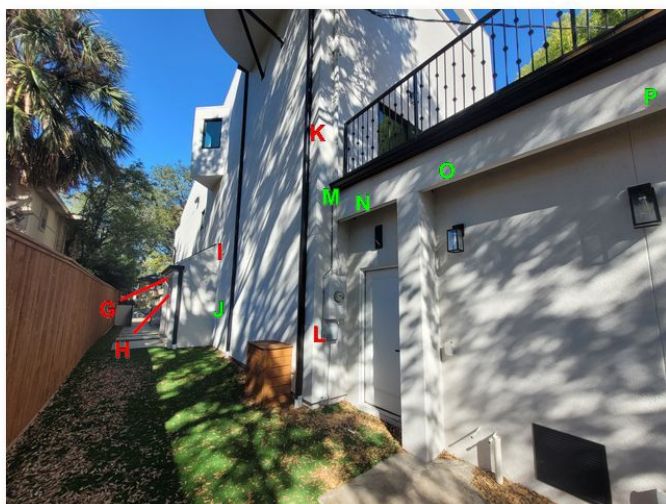
Right Side of Structure Moisture Testing (2)

Test Location	Moisture Content	Substrate Condition	Additional comments
A	<15%	Firm	Reading taken below window.
B	N/A	Soft	Soft substrate was observed when drilling/probing. This is an indication of moisture damage / wood rot. Reading taken below window.
C	N/A	Soft	Soft substrate was observed when drilling/probing. This is an indication of moisture damage / wood rot. Reading taken at roof / wall intersection.
D	N/A	Soft	Soft substrate was observed when drilling/probing. This is an indication of moisture damage / wood rot. Reading taken mid wall.
E	<15%	Firm	
F	N/A	Soft	Soft substrate was observed when drilling/probing. This is an indication of moisture damage / wood rot. Reading taken below window.
G	N/A	Soft	Soft substrate was observed when drilling/probing. This is an indication of moisture damage / wood rot. Drainage relief not present.
H	N/A	Soft	Soft substrate was observed when drilling/probing. This is an indication of moisture damage / wood rot. Drainage relief not present.

I	N/A	Soft	Soft substrate was observed when drilling/probing. This is an indication of moisture damage / wood rot.
J	<15%	Firm	
K	N/A	Soft	Soft substrate was observed when drilling/probing. This is an indication of moisture damage / wood rot. Corner cracks needing repair present.
L	N/A	Soft	Soft substrate was observed when drilling/probing. This is an indication of moisture damage / wood rot. Corner cracks needing repair present.
M	<15%	Firm	Diverter flashing not installed at balcony intersection.
N	<15%	Firm	
O	15-19%	Firm	Dark stains present at drainage relief.
P	15-19%	Firm	Dark stains present at drainage relief.

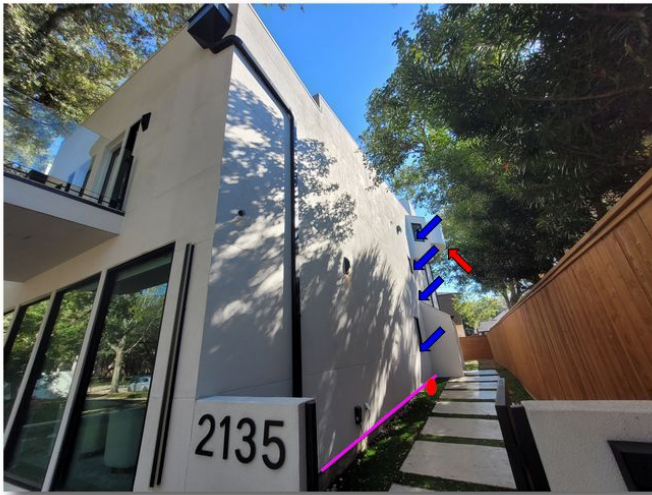
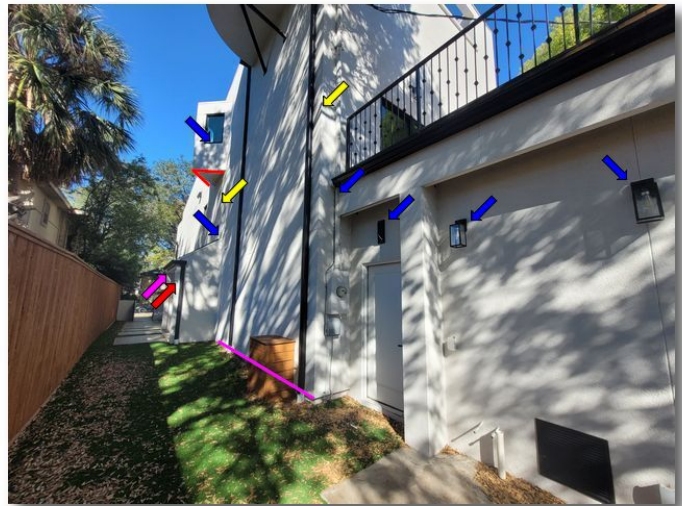
Right Side of Structure Deficiencies (2)

Identifier	Comments
Blue Arrows	Damaged / Aged / Missing Sealant: Damaged, aged, and / or missing sealant was found at wall penetrations, joints, windows, and / or other voids on the exterior. Properly installed sealant provides a barrier against moisture intrusion. Recommend repairs using a top quality, low modulus, polyurethane sealant or sealant recommended by the manufacturer of your system.
Yellow Arrows	Cracks Present: Cracks were found at the stucco cladding. Hairline cracks (generally 1/16 of an inch) are commonly found with stucco systems. These cracks should be monitored and repaired as needed. It is recommend that cracks larger than hairline are repaired by a qualified stucco contractor.
Red Arrows and Lines	Missing Drainage Openings: Drainage openings are not installed at the stucco walls / soffit. Drainage openings assist with allowing incidental moisture to escape. Incidental moisture can become trapped in these enclosed areas, sometimes referred to as a "stucco bucket". This trapped moisture can lead to wood rot at the substrate and framing. If elevated moisture or possible substrate / framing damage was found, a drainage opening should be installed during repairs.

Pink Arrow and Lines	Rust: Rust was observed at these locations. It is recommended these areas are repaired to prevent further rust / damage from occurring.
Red Dot	Damaged Substrate at Bottom of Wall: Damaged substrate was observed at the bottom of the wall by physically touching the substrate from behind the weep screed. It is recommended that these areas be further assessed and repaired by a qualified stucco contractor, as needed.

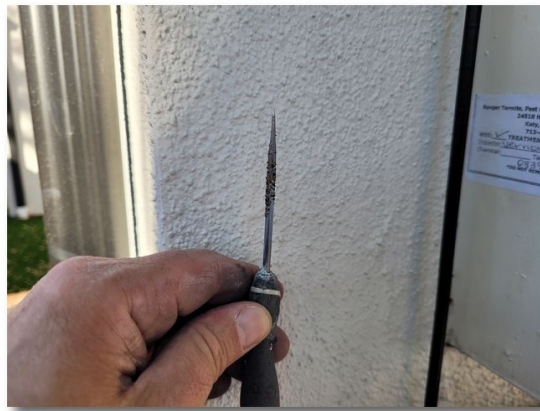
2 - 1: Moisture Intrusion: Areas of elevated moisture and / or possible substrate / framing damage was found at the following locations as reported on the "Moisture Testing" page:

2- 1.10 Test Location L - Soft substrate encountered

Repair Process: It is recommended that these areas be further assessed and repaired by a qualified stucco contractor, as needed. Core sampling or inspection holes should be performed by your contractor to confirm any suspected substrate and / or framing damage found by the inspector. Test locations are not representative of the total area of suspected damage, but provide information on general areas where repairs may be needed. Typical repairs to remedy soft or missing substrate include doing a partial tear-off of the stucco around the location until clean dry substrate is found and repairing as needed. During repairs, the total area any underlying damage should be determined by your contractor. It is important to thoroughly review and understand the scope of work in the repair proposal provided by your contractor. In addition, it is recommended to discuss the potential for "Change Orders" that may occur once work begins.

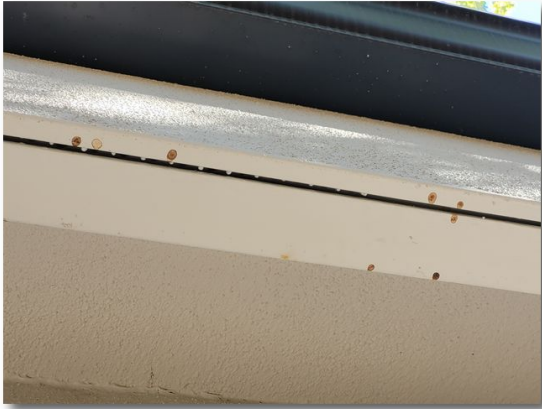
2- 1.11 Dark stains present at drainage relief.

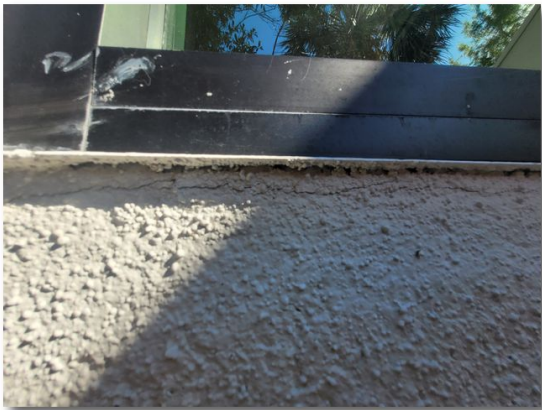
2 - 2: Damaged / Aged / Missing Sealant: Damaged, aged, and / or missing sealant was found at wall penetrations, joints, windows, and / or other voids on the exterior. Properly installed sealant provides a barrier against moisture intrusion. Recommend repairs using a top quality, low modulus, polyurethane sealant or sealant recommended by the manufacturer of your system.

2- 2.1 Seal windows

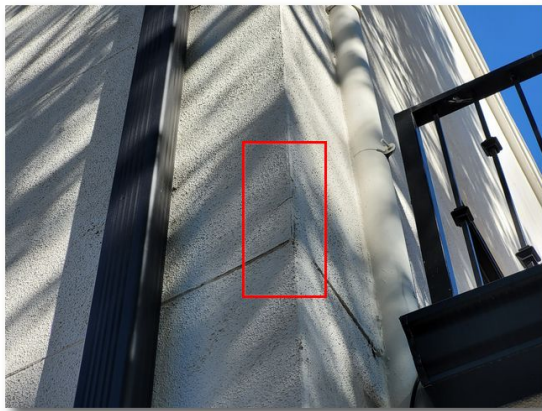
2 - 3: Cracks Present: Cracks were found at the stucco cladding. Hairline cracks (generally 1/16 of an inch) are commonly found with stucco systems. These cracks should be monitored and repaired as needed. It is recommend that cracks larger than hairline are repaired by a qualified stucco contractor.

2- 3.1 Corner crack

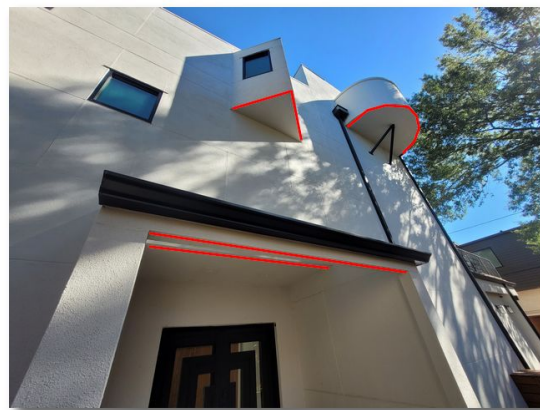
2- 4.2

2 - 4: Missing Drainage Openings: Drainage openings are not installed at the stucco walls / soffit. Drainage openings assist with allowing incidental moisture to escape. Incidental moisture can become trapped in these enclosed areas, sometimes referred to as a "stucco bucket". This trapped moisture can lead to wood rot at the substrate and framing. **If** elevated moisture or possible substrate / framing damage was found, a drainage opening should be installed during repairs.

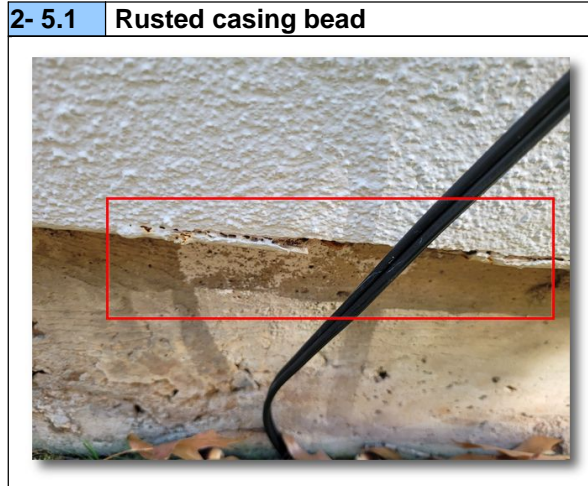
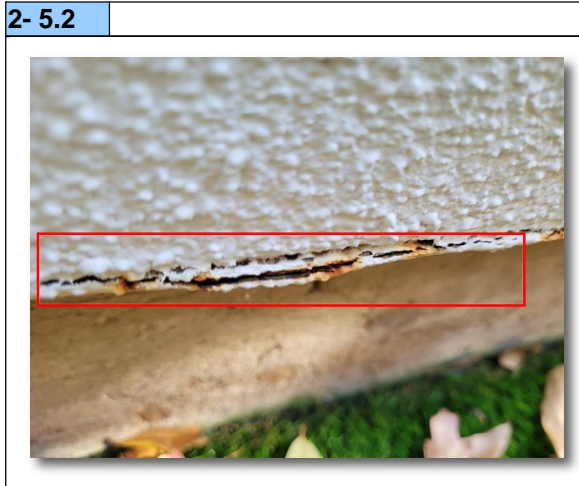
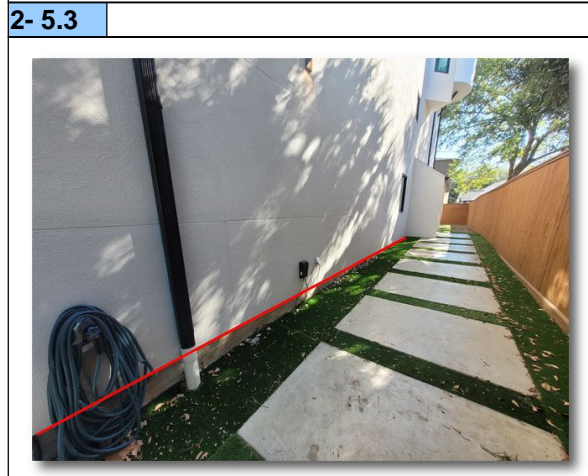
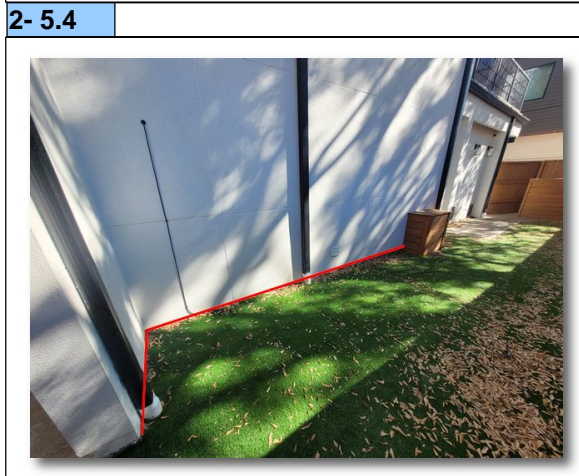
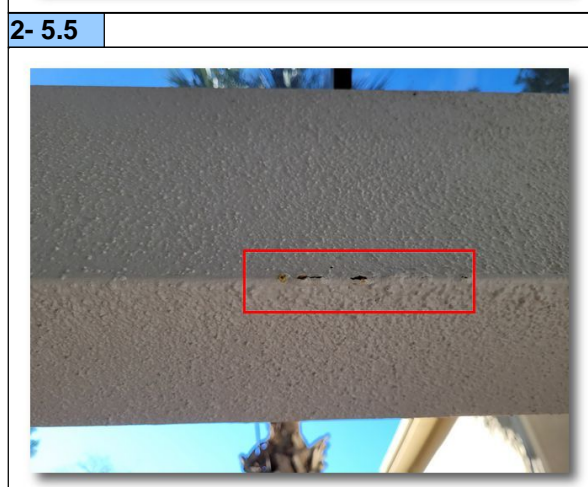
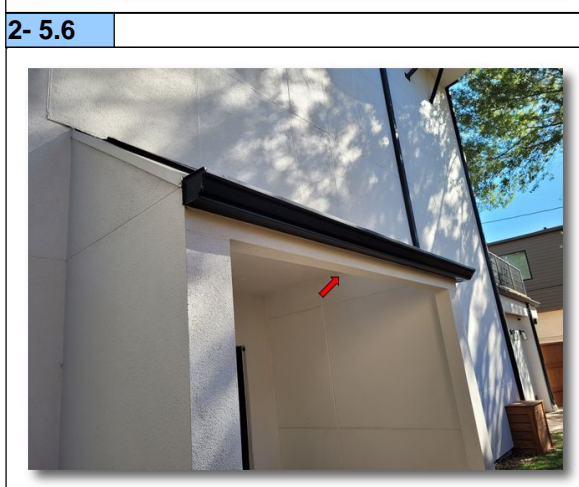
2 - 5: **Rust:** Rust was observed at these locations. It is recommended these areas are repaired to prevent further rust / damage from occurring.

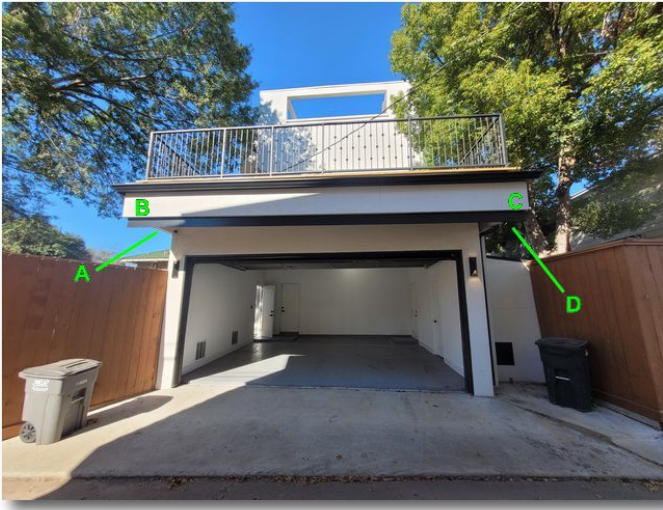
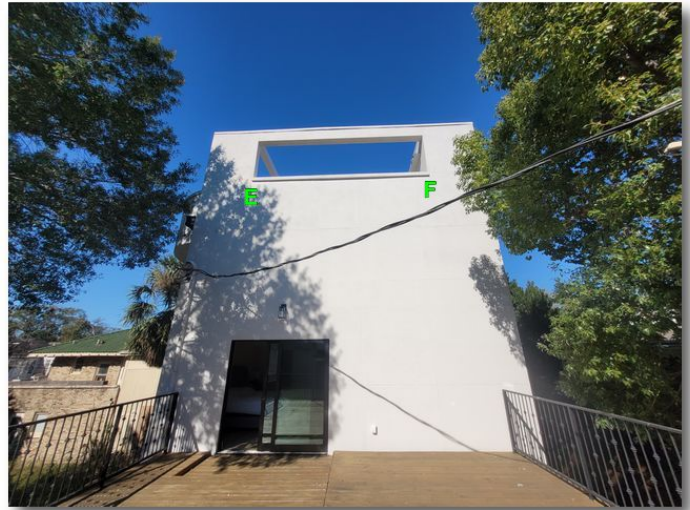
Rear Side of Structure Moisture Testing (3)

Test Location	Moisture Content	Substrate Condition	Additional comments
A	<15%	Firm	
B	<15%	Firm	Drainage relief obstructed with metal beam.
C	<15%	Firm	Drainage relief obstructed with metal beam.
D	<15%	Firm	
E	<15%	Firm	Cap flashing not installed at flat / low slope surface.
F	<15%	Firm	Cap flashing not installed at flat / low slope surface.

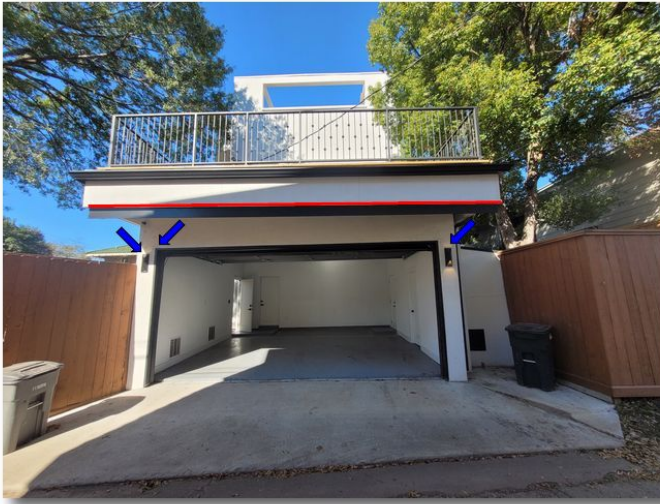
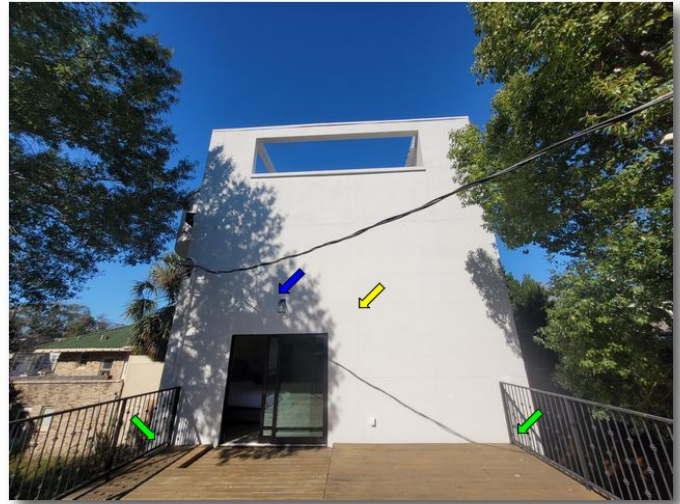
Rear Side of Structure Deficiencies (3)

Identifier	Comments
Blue Arrows	Damaged / Aged / Missing Sealant: Damaged, aged, and / or missing sealant was found at wall penetrations, joints, windows, and / or other voids on the exterior. Properly installed sealant provides a barrier against moisture intrusion. Recommend repairs using a top quality, low modulus, polyurethane sealant or sealant recommended by the manufacturer of your system.
Yellow Arrow	Cracks Present: Cracks were found at the stucco cladding. Hairline cracks (generally 1/16 of an inch) are commonly found with stucco systems. These cracks should be monitored and repaired as needed. It is recommend that cracks larger than hairline are repaired by a qualified stucco contractor.
Green Arrows	Balcony Diverter Flashing Missing: Diverter flashing has not been installed at the wall and balcony intersections. Diverter flashing helps to prevent moisture intrusion and allow water to properly drain away from the wall. It is recommended to install diverter flashing when elevated moisture or damage is discovered as a result of the missing flashing. Installation typically requires removal of all waterproofing/tiles so the flashing can be installed over the wood or appropriate membrane. <i>Retrofitting flashing is not a recommended repair.</i>

Red Line	Drainage Relief Obstructed: The drainage relief has been obstructed with a metal beam at the stucco walls / soffit. Drainage openings assist with allowing incidental moisture to escape. Incidental moisture can become trapped in these enclosed areas, sometimes referred to as a "stucco bucket". This trapped moisture can lead to wood rot at the substrate and framing. Removal of the beam is recommended.

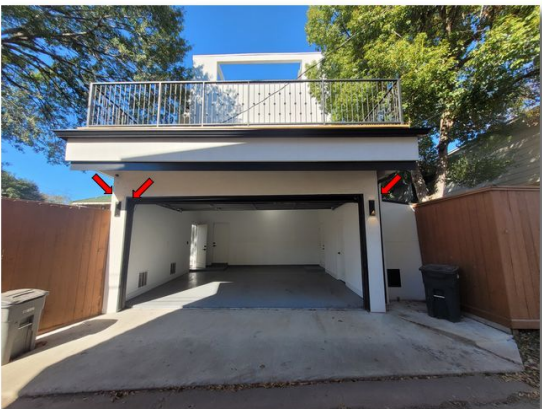
3- 1.5

3 - 1: Damaged / Aged / Missing Sealant: Damaged, aged, and / or missing sealant was found at wall penetrations, joints, windows, and / or other voids on the exterior. Properly installed sealant provides a barrier against moisture intrusion. Recommend repairs using a top quality, low modulus, polyurethane sealant or sealant recommended by the manufacturer of your system.

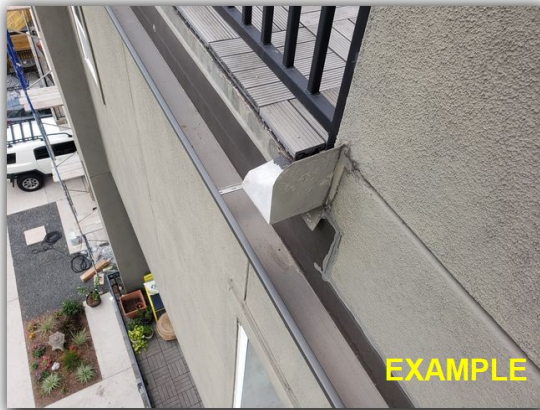
3 - 3: Balcony Diverter Flashing Missing: Diverter flashing has not been installed at the wall and balcony intersections. Diverter flashing helps to prevent moisture intrusion and allow water to properly drain away from the wall. It is recommended to install diverter flashing when elevated moisture or damage is discovered as a result of the missing flashing. Installation typically requires removal of all waterproofing/tiles so the flashing can be installed over the wood or appropriate membrane. *Retrofitting flashing is not a recommended repair.*

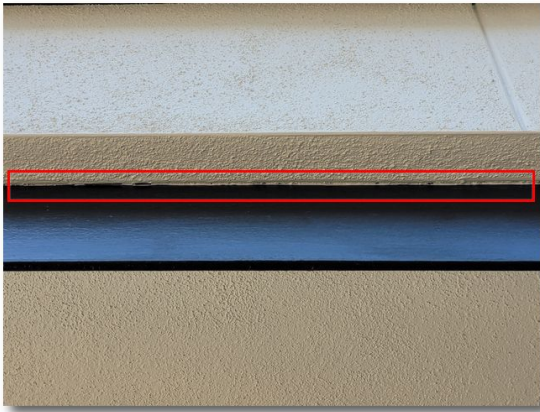
3- 4.1

3 - 4: Drainage Relief Obstructed: The drainage relief has been obstructed with a metal beam at the stucco walls / soffit. Drainage openings assist with allowing incidental moisture to escape. Incidental moisture can become trapped in these enclosed areas, sometimes referred to as a "stucco bucket". This trapped moisture can lead to wood rot at the substrate and framing. Removal of the beam is recommended.

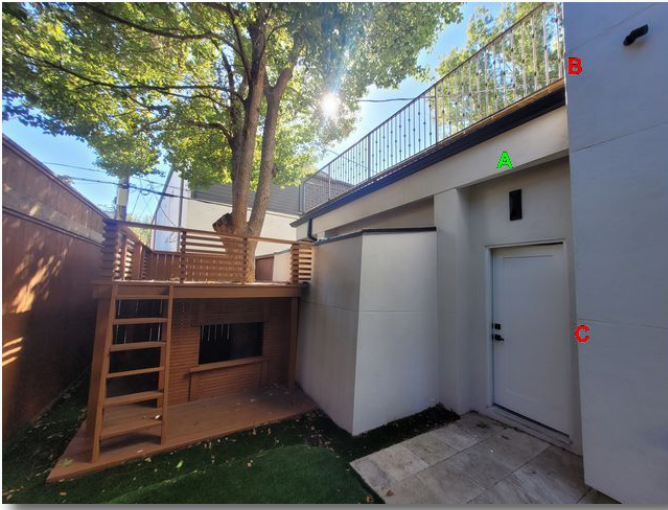
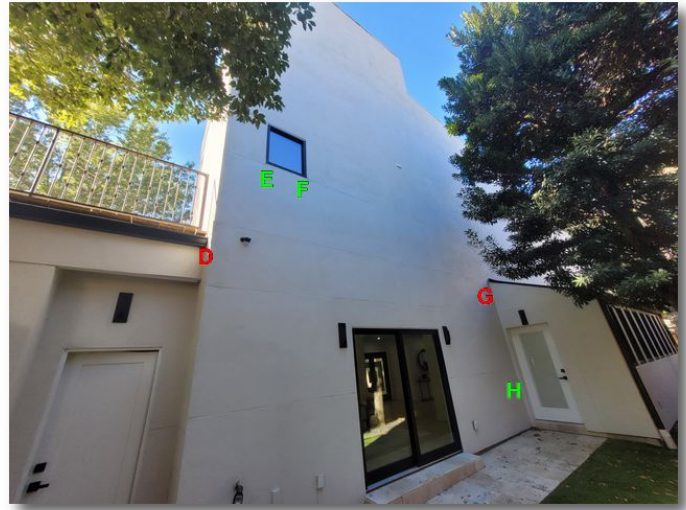
Moisture Testing (4)

Test Location	Moisture Content	Substrate Condition	Additional comments
A	<15%	Firm	
B	N/A	Soft	Soft substrate was observed when drilling/probing. This is an indication of moisture damage / wood rot. Corner cracks needing repair present.
C	N/A	Soft	Soft substrate was observed when drilling/probing. This is an indication of moisture damage / wood rot. Corner cracks needing repair present.
D	N/A	Soft	Soft substrate was observed when drilling/probing. This is an indication of moisture damage / wood rot. Diverter flashing not installed at balcony intersection.
E	<15%	Firm	
F	<15%	Firm	
G	N/A	Soft	Soft substrate was observed when drilling/probing. This is an indication of moisture damage / wood rot.
H	<15%	Firm

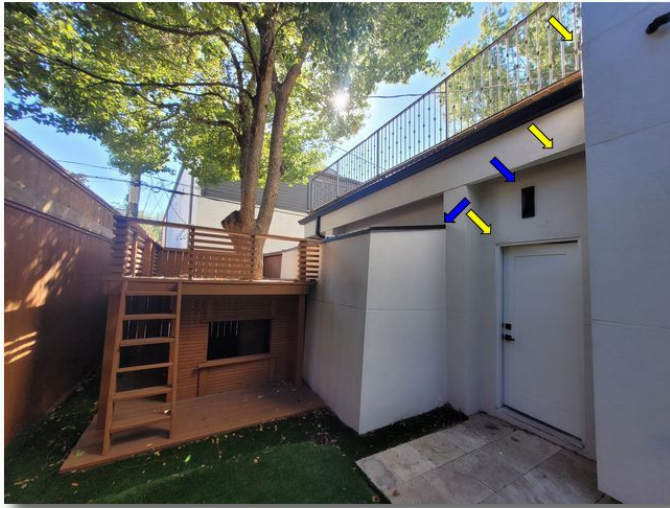
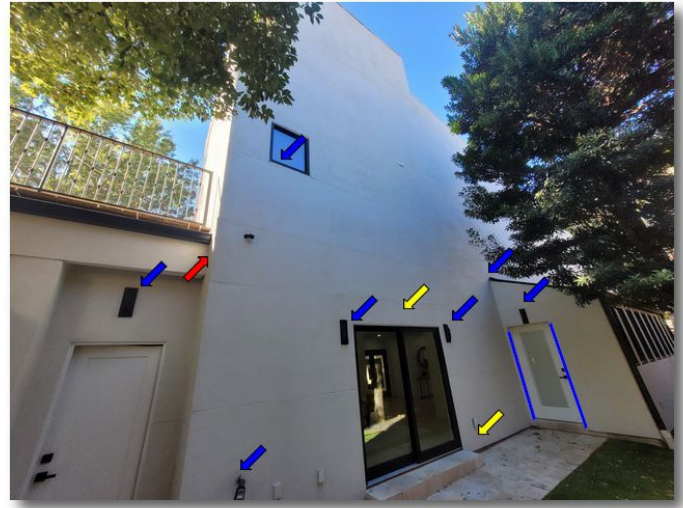
Deficiencies (4)

Identifier	Comments
Blue Arrows and Lines	Damaged / Aged / Missing Sealant: Damaged, aged, and / or missing sealant was found at wall penetrations, joints, windows, and / or other voids on the exterior. Properly installed sealant provides a barrier against moisture intrusion. Recommend repairs using a top quality, low modulus, polyurethane sealant or sealant recommended by the manufacturer of your system.
Yellow Arrows	Cracks Present: Cracks were found at the stucco cladding. Hairline cracks (generally 1/16 of an inch) are commonly found with stucco systems. These cracks should be monitored and repaired as needed. It is recommend that cracks larger than hairline are repaired by a qualified stucco contractor.
Red Arrow	Rust: Rust was observed at this location. It is recommended this area is repaired to prevent further rust / damage from occurring.

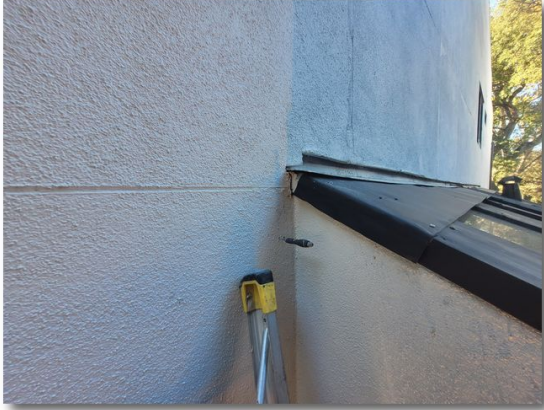
4 - 1: Moisture Intrusion: Areas of elevated moisture and / or possible substrate / framing damage was found at the following locations as reported on the "Moisture Testing" page:

4- 1.5 Test Location G - Soft substrate encountered

Repair Process: It is recommended that these areas be further assessed and repaired by a qualified stucco contractor, as needed. Core sampling or inspection holes should be performed by your contractor to confirm any suspected substrate and / or framing damage found by the inspector. Test locations are not representative of the total area of suspected damage, but provide information on general areas where repairs may be needed. Typical repairs to remedy soft or missing substrate include doing a partial tear-off of the stucco around the location until clean dry substrate is found and repairing as needed. During repairs, the total area any underlying damage should be determined by your contractor. It is important to thoroughly review and understand the scope of work in the repair proposal provided by your contractor. In addition, it is recommended to discuss the potential for "Change Orders" that may occur once work begins.

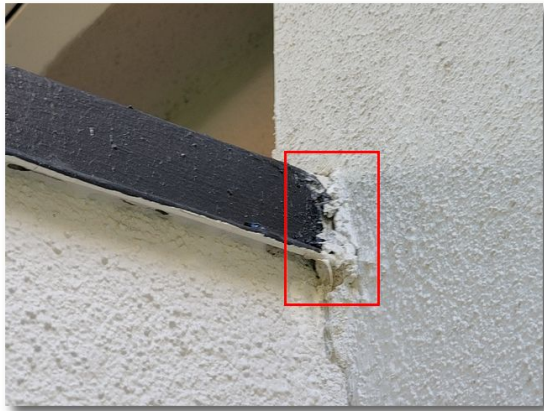
4 - 2: Damaged / Aged / Missing Sealant: Damaged, aged, and / or missing sealant was found at wall penetrations, joints, windows, and / or other voids on the exterior. Properly installed sealant provides a barrier against moisture intrusion. Recommend repairs using a top quality, low modulus, polyurethane sealant or sealant recommended by the manufacturer of your system.

4- 2.1 Seal roof / wall intersection

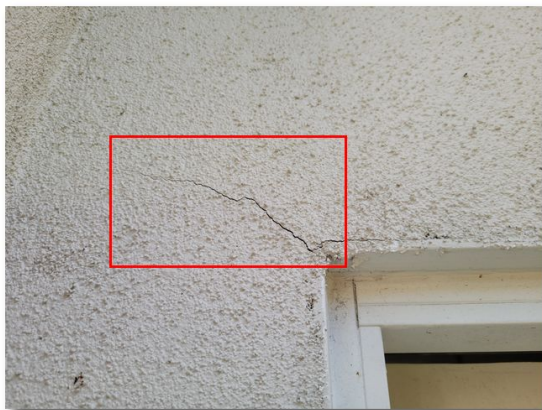
4- 3.1

4 - 3: Cracks Present: Cracks were found at the stucco cladding. Hairline cracks (generally 1/16 of an inch) are commonly found with stucco systems. These cracks should be monitored and repaired as needed. It is recommend that cracks larger than hairline are repaired by a qualified stucco contractor.

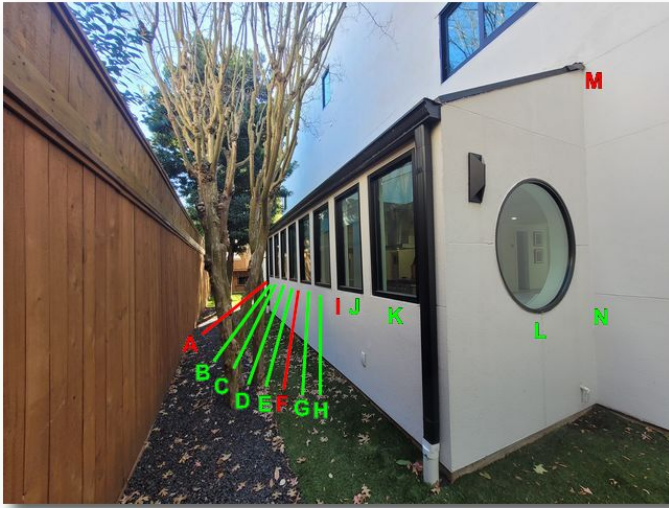
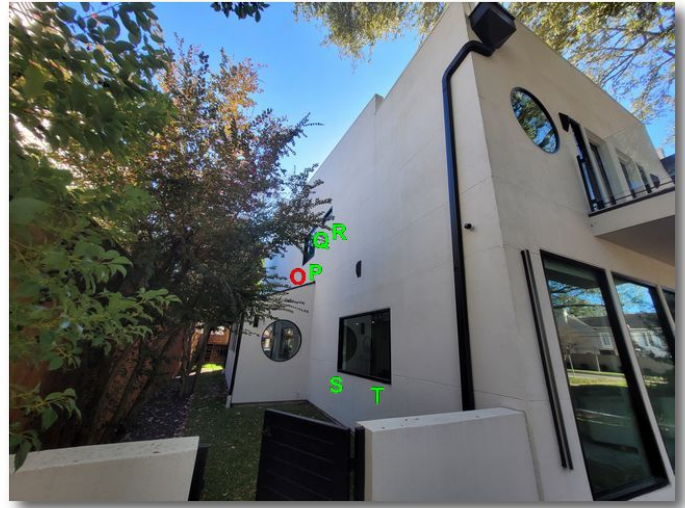
Moisture Testing (5)

Test Location	Moisture Content	Substrate Condition	Additional comments
A	N/A	Soft	Soft substrate was observed when drilling/probing. This is an indication of moisture damage / wood rot.
B	<15%	Firm	
C	<15%	Firm	
D	<15%	Firm	
E	<15%	Firm	
F	N/A	Soft	Soft substrate was observed when drilling/probing. This is an indication of moisture damage / wood rot.
G	<15%	Firm	
H	<15%	Firm	
I	N/A	Soft	Soft substrate was observed when drilling/probing. This is an indication of moisture damage / wood rot.
J	<15%	Firm	
K	<15%	Firm	
L	<15%	Firm	
M	N/A	Soft	Soft substrate was observed when drilling/probing. This is an indication of moisture damage / wood rot.
N	<15%	Firm	
O	N/A	Soft	Soft substrate was observed when drilling/probing. This is an indication of moisture damage / wood rot.
P	<15%	Firm	
Q	<15%	Firm	
R	<15%	Firm	
S	<15%	Firm	
T	<15%	Firm

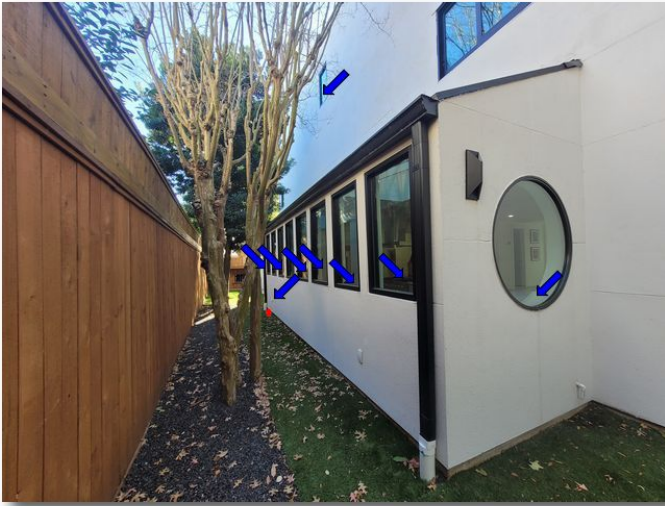
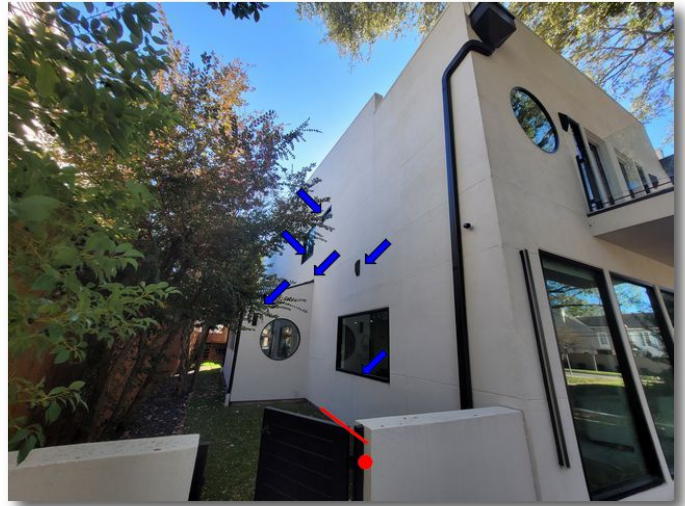
Deficiencies (5)

Identifier	Comments
Blue Arrows	Damaged / Aged / Missing Sealant: Damaged, aged, and / or missing sealant was found at wall penetrations, joints, windows, and / or other voids on the exterior. Properly installed sealant provides a barrier against moisture intrusion. Recommend repairs using a top quality, low modulus, polyurethane sealant or sealant recommended by the manufacturer of your system.
Red Line	Rust: Rust was observed at this location. It is recommended this area is repaired to prevent further rust / damage from occurring.
Red Dot	Damaged Substrate at Bottom of Wall: Damaged substrate was observed at the bottom of the wall by physically touching the substrate from behind the weep screed. It is recommended that these areas be further assessed and repaired by a qualified stucco contractor, as needed.

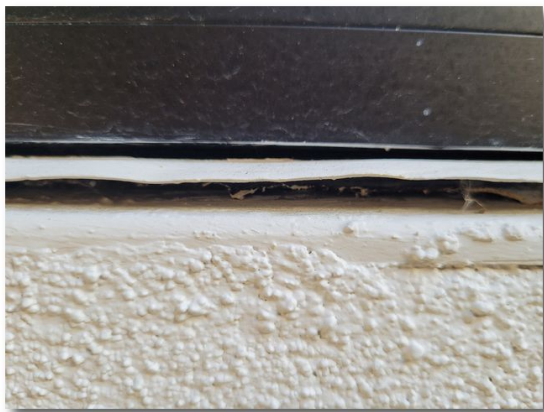
5 - 2: Damaged / Aged / Missing Sealant: Damaged, aged, and / or missing sealant was found at wall penetrations, joints, windows, and / or other voids on the exterior. Properly installed sealant provides a barrier against moisture intrusion. Recommend repairs using a top quality, low modulus, polyurethane sealant or sealant recommended by the manufacturer of your system.

5- 2.1 Seal lights

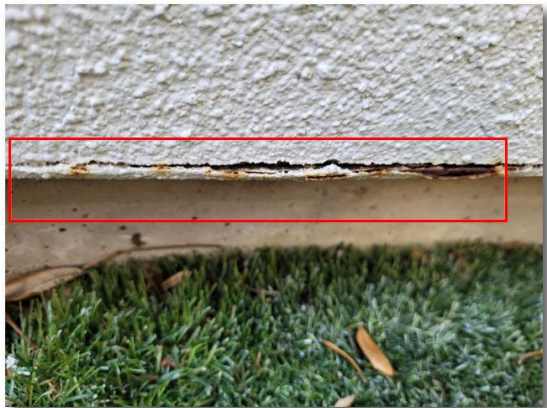
5 - 3: **Rust:** Rust was observed at this location. It is recommended this area is repaired to prevent further rust / damage from occurring.

5- 3.1 **Rusted casing bead**

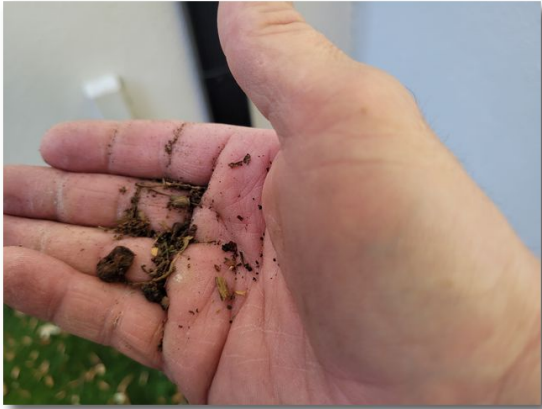
5 - 4: Damaged Substrate at Bottom of Wall: Damaged substrate was observed at the bottom of the wall by physically touching the substrate from behind the weep screed. It is recommended that these areas be further assessed and repaired by a qualified stucco contractor, as needed.

5- 4.1 Damaged substrate from behind the casing bead

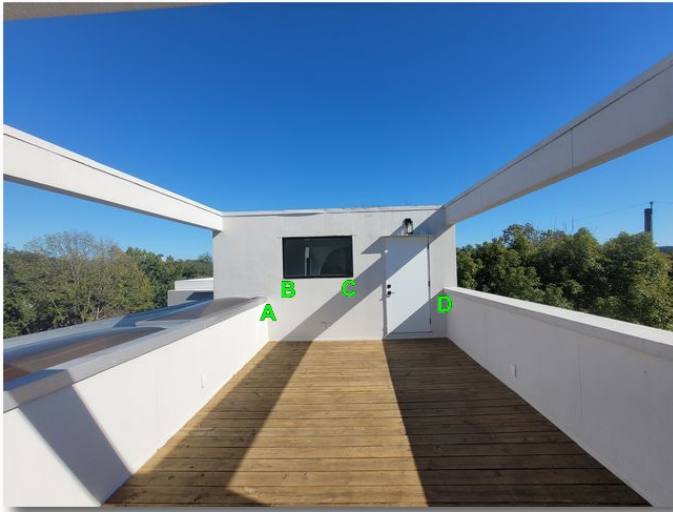
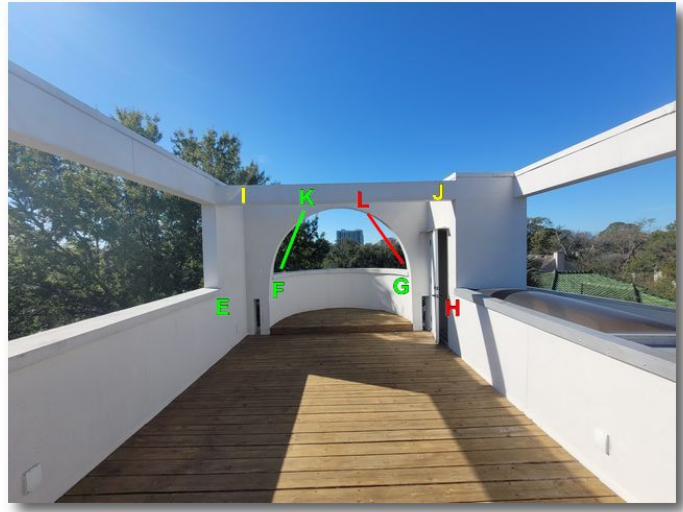
Moisture Testing (6)

Test Location	Moisture Content	Substrate Condition	Additional comments
A	<15%	Firm	
B	<15%	Firm	
C	<15%	Firm	
D	<15%	Firm	Cap flashing not installed at flat / low slope surface.
E	<15%	Firm	Cap flashing not installed at flat / low slope surface.
F	<15%	Firm	Cap flashing not installed at flat / low slope surface.
G	<15%	Firm	Cap flashing not installed at flat / low slope surface.
H	N/A	Soft	Soft substrate was observed when drilling/probing. This is an indication of moisture damage / wood rot. Cap flashing not installed at flat / low slope surface.
I	15-19%	Firm	Cap flashing not installed at flat / low slope surface. Drainage relief not present.
J	15-19%	Firm	Cap flashing not installed at flat / low slope surface. Drainage relief not present.
K	<15%	Firm	Cap flashing not installed at flat / low slope surface.
L	N/A	Soft	Soft substrate was observed when drilling/probing. This is an indication of moisture damage / wood rot. Cap flashing not installed at flat / low slope surface.

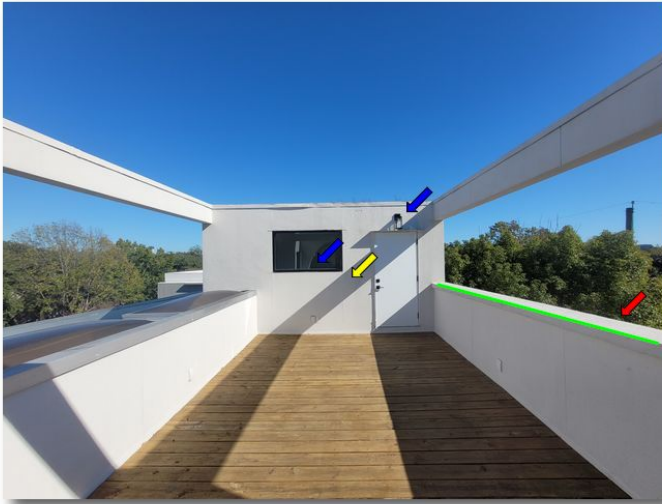
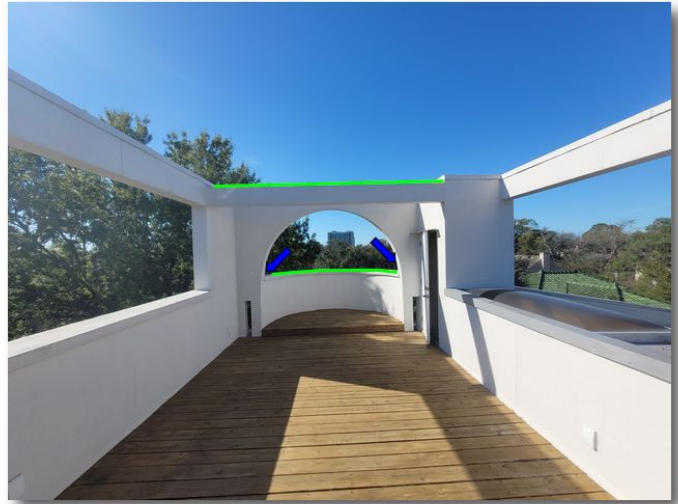
Deficiencies (6)

Identifier	Comments
Blue Arrows	Damaged / Aged / Missing Sealant: Damaged, aged, and / or missing sealant was found at wall penetrations, joints, windows, and / or other voids on the exterior. Properly installed sealant provides a barrier against moisture intrusion. Recommend repairs using a top quality, low modulus, polyurethane sealant or sealant recommended by the manufacturer of your system.
Yellow Arrow	Cracks Present: Cracks were found at the stucco cladding. Hairline cracks (generally 1/16 of an inch) are commonly found with stucco systems. These cracks should be monitored and repaired as needed. It is recommend that cracks larger than hairline are repaired by a qualified stucco contractor.
Green Lines	Flat Surfaces Without Cap Flashing: Flat / low slope surfaces were observed at the stucco walls. Flat / low slope surfaces are more prone to cracking, standing water, and moisture intrusion, leading to wood rot of the sheathing and framing within the wall cavity. Recommend installing cap flashing or other waterproofing methods to prevent damages from occurring. <i>Cap flashing should be installed with fasteners on the sides, not through the top surface.</i>

Red Arrow	Rust: Rust was observed at this location. It is recommended this area is repaired to prevent further rust / damage from occurring.
