Moisture Inspection Report

Inspected for
Adam Garst
2135 Quenby St
Houston, TX 77005
1/2/2026

Property Address: 2135 Quenby St , Houston TX 77005			
Property Information		Inspection Information	
Client's Name	Adam Garst	Inspection Type	Invasive Moisture Inspection
Client's Phone	281-610-1296	Date of Inspection	1/2/2026
Client's Email	garstadam@gmail.com	Inspector	Tony Trinidad EDI #TX-192
Type of Exterior	Hard Coat Stucco	Present at Inspection	Buyer(s), Buyer's realtor(s), Home Inspector
Substrate (if known)	Wood	Temperature	70-80 degrees
Property Age	46	Weather Conditions	Clear, Dry
Square Footage	4079	Last Known Rainfall	2-5 days
Stories	3		
Type of Windows	Metal

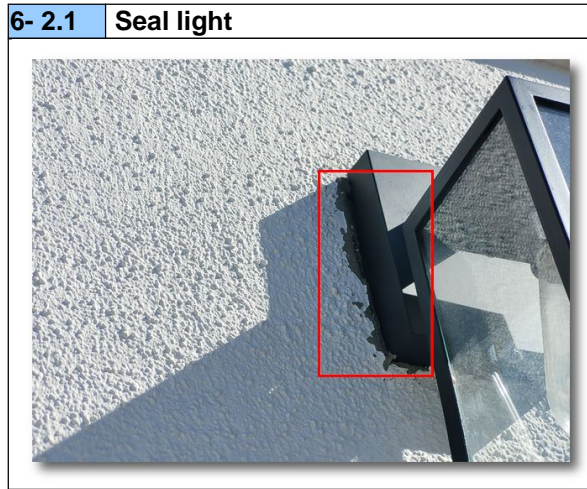
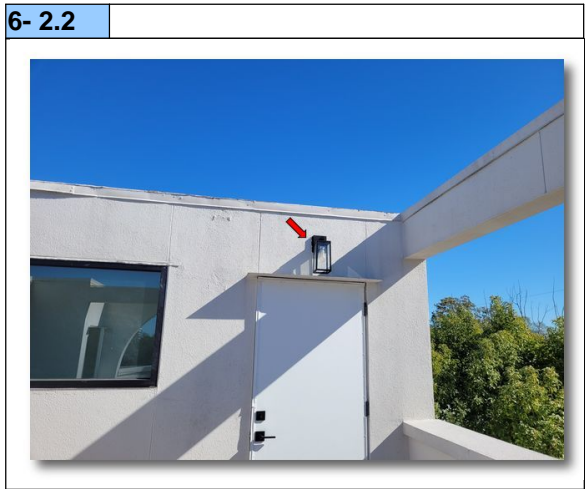
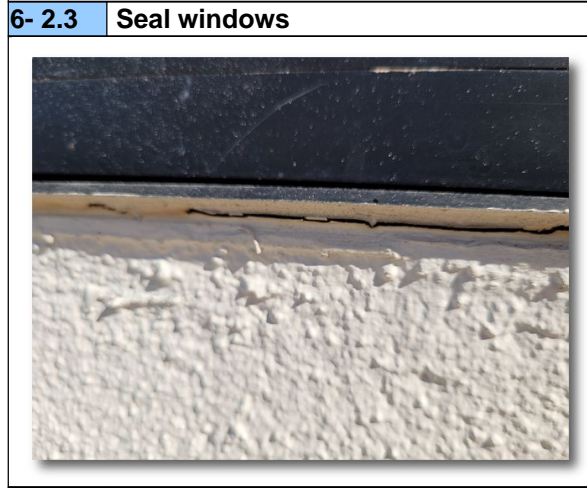
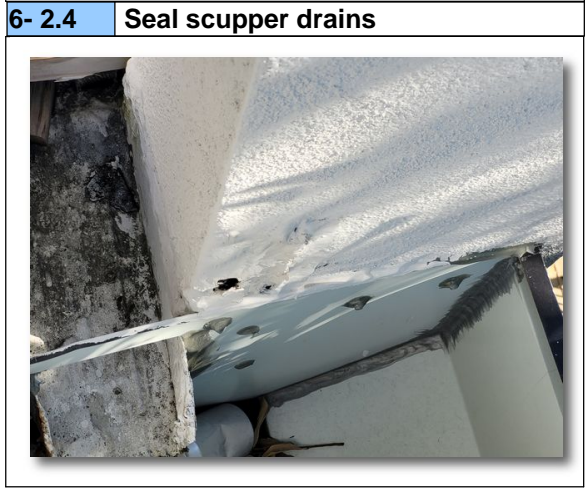
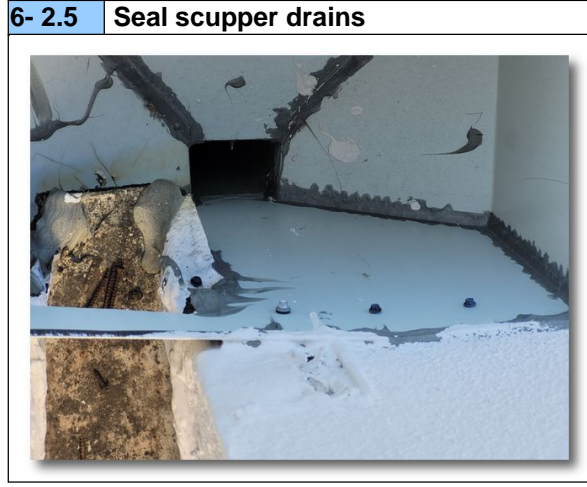
6 - 2: Damaged / Aged / Missing Sealant: Damaged, aged, and / or missing sealant was found at wall penetrations, joints, windows, and / or other voids on the exterior. Properly installed sealant provides a barrier against moisture intrusion. Recommend repairs using a top quality, low modulus, polyurethane sealant or sealant recommended by the manufacturer of your system.

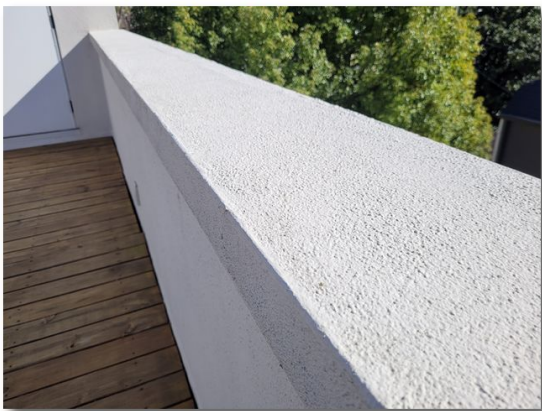
6- 4.1

6 - 4: Flat Surfaces Without Cap Flashing: Flat / low slope surfaces were observed at the stucco walls. Flat / low slope surfaces are more prone to cracking, standing water, and moisture intrusion, leading to wood rot of the sheathing and framing within the wall cavity. Recommend installing cap flashing or other waterproofing methods to prevent damages from occurring. *Cap flashing should be installed with fasteners on the sides, not through the top surface.*

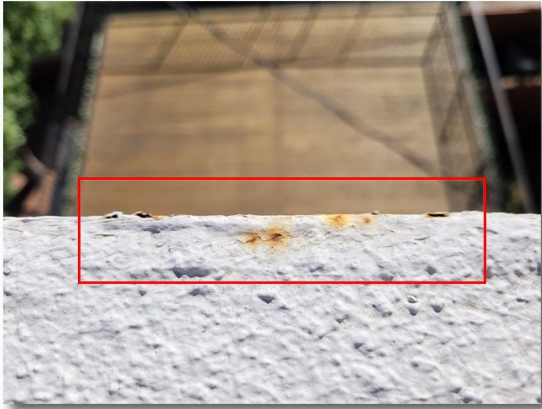
6- 5.1

6 - 5: Rust: Rust was observed at this location. It is recommended this area is repaired to prevent further rust / damage from occurring.

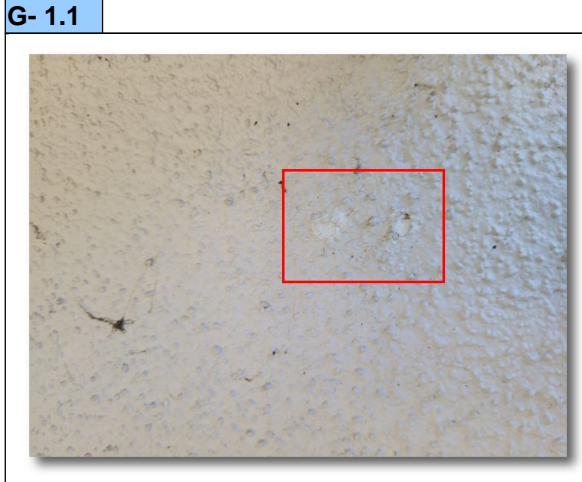
G - 1: Previous Inspection: Evidence of a previous inspection was observed at the property as evident by previous inspection holes.

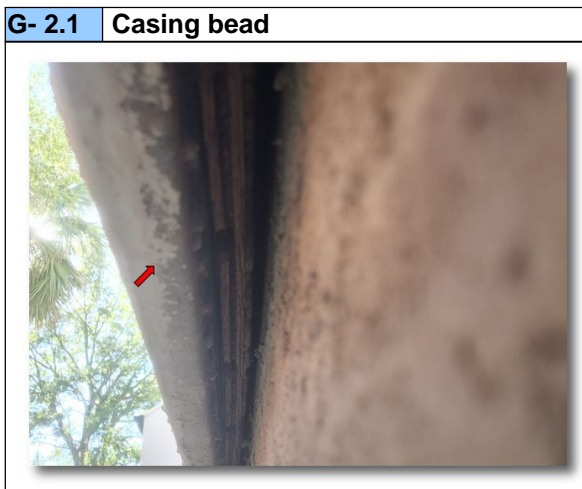
G - 2: Casing Bead in Lieu of Weep Screed: The bottom of the wall terminates into a casing bead, rather than a weep screed. Current standards require that stucco terminates into a weep screed to provide a means of incidental moisture in the wall to drain. If substrate damage is found, it is recommended that a weep screed is installed during repairs.
