# Inspection Report

**Property Address:**  
5623 Dumfries Drive  
Houston TX 77096

**Sandstone Inspections**

# PROPERTY INSPECTION REPORT FORM

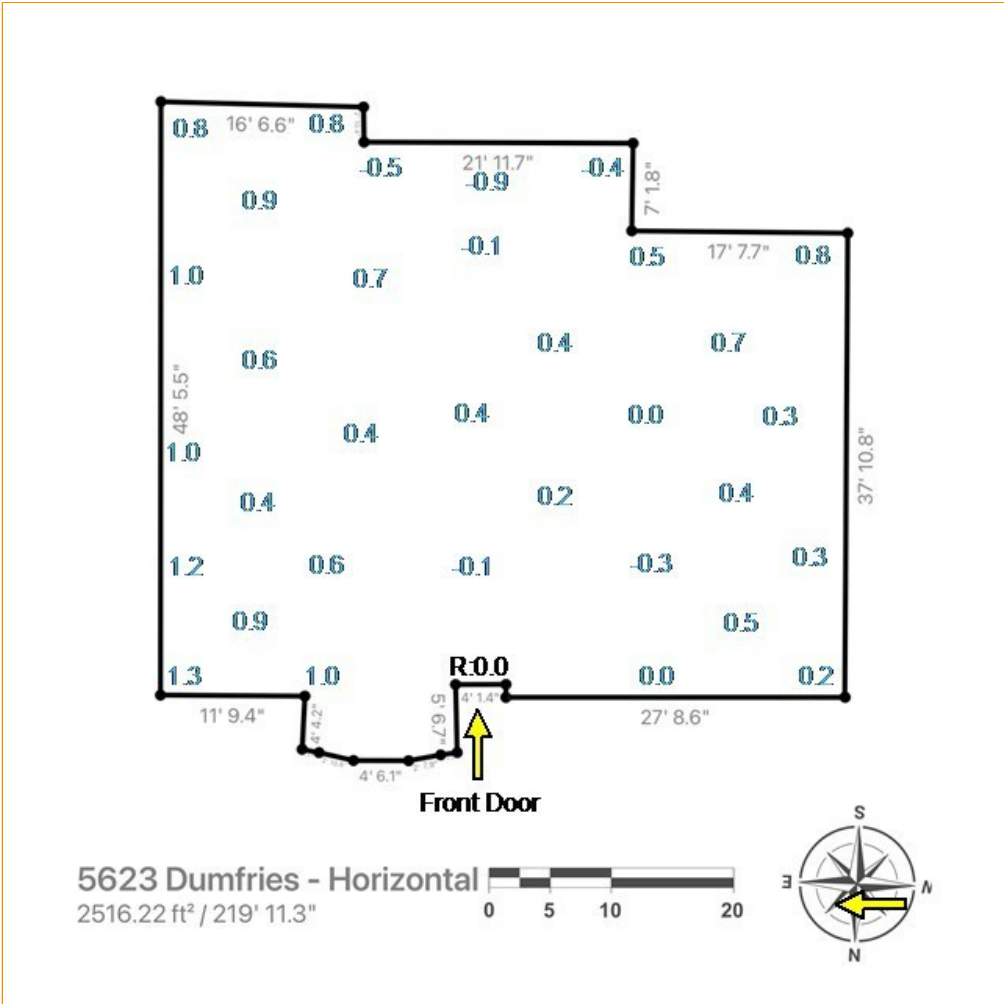
Foundation elevation measurements were taken during the inspection using a PRO 2000 Zip Level and adjusting for floor covering differences between different types of floor covering material. The reference point was located at the front door.

arrangement of the rooms and the location of the homeowner’s belongings may limit the location of individual measurements. Industry standards dictate that foundations are expected to remain reasonably flat and level to provide acceptable performance. Localized slopes of less than 1 inch in 10 feet are generally consistent with satisfactory foundation performance in this region.

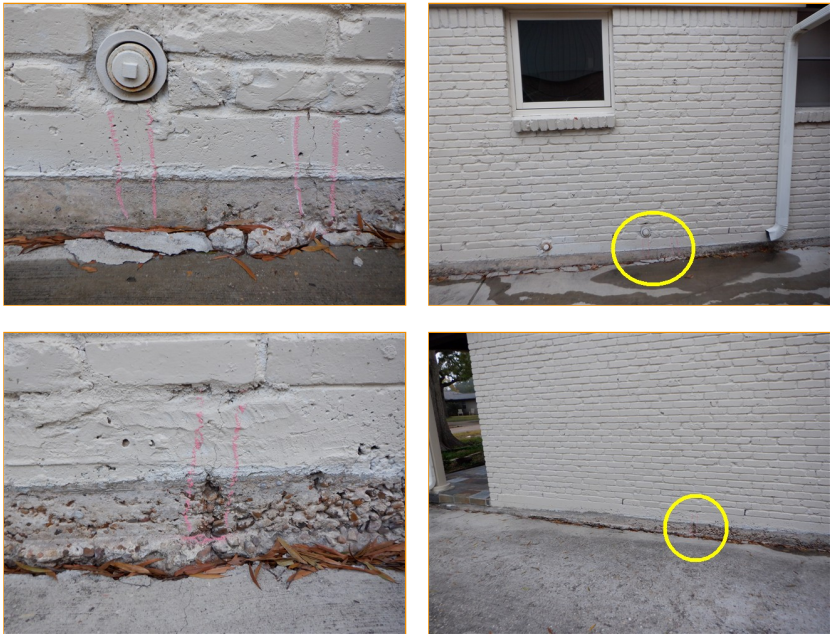
Hairline cracks observed on the foundation at west side of the house (driveway side).

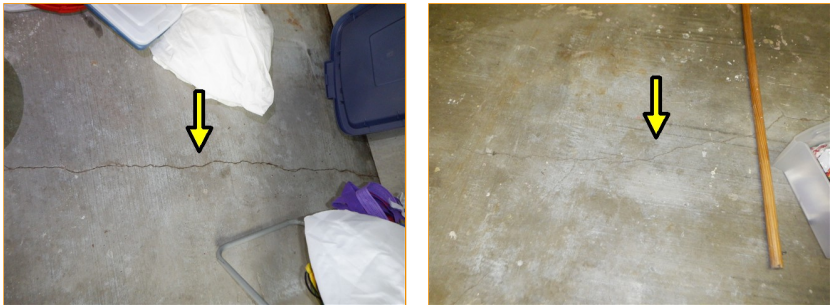
Cracks observed on the garage slab.

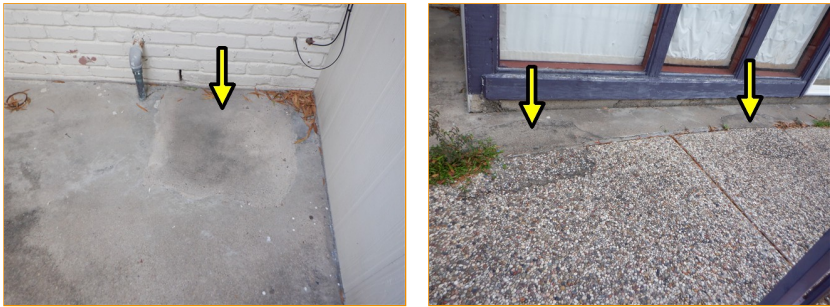
Evidence suggests that the foundation has been repaired. Recommend that buyer requests and reviews paperwork regarding scope of work done and steps necessary to transfer warranty.

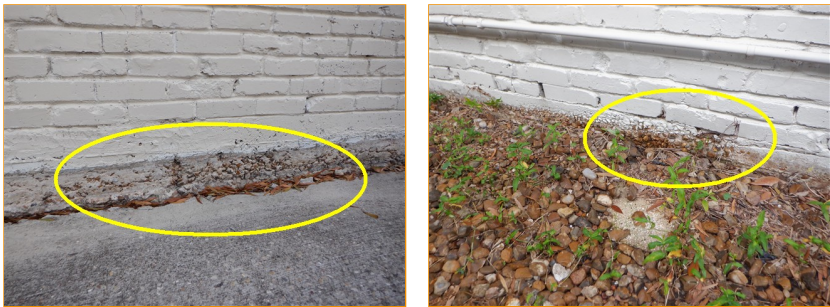
"Honeycombs" are common to slab foundations and do not affect foundation integrity. Honeycombs is normally the result of air pockets in the concrete from when the form boards were removed. Recommend covering with mortar.

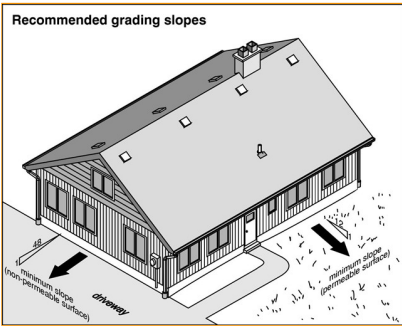
Soil grade and drainage patterns around some areas of the house and the garage do not appear to properly direct water away from the foundation to aid in controlling run off water. Water may pond/accumulate against the foundation. This condition may cause differential movement of the foundation and/or water penetration during heavy rains. Recommend filling in yard with soil to reach a grade slope away from the foundation of at least one inch per foot, and/or creating a drainage swale to help divert water away from the foundation.

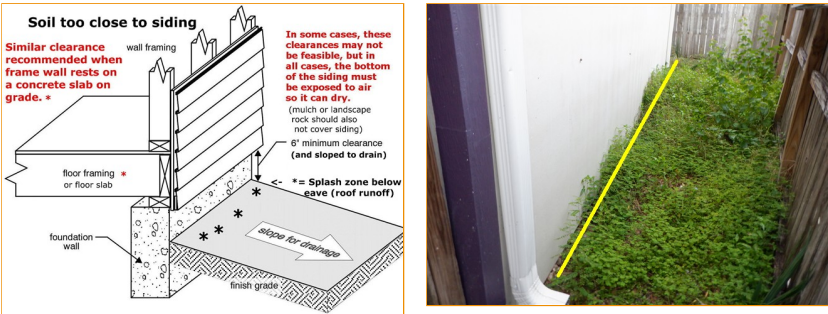
Soil level too high around areas with brick and/or cement board siding. Common industry practice requires a clearance of at least 4 inches from bottom of brick/stone veneer to soil and at least 6 inches to siding. High soil level near brick/ siding promotes wood rot and is considered a conducive condition to termite activity and water penetration.

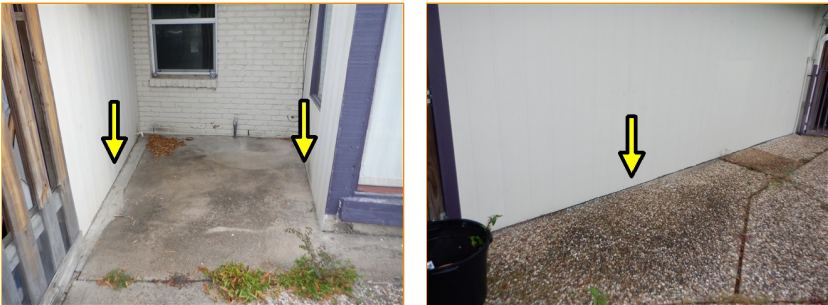
Observed high concrete/hard surface around areas with wood siding . Common industry practice requires a clearance of at least 2 inches from bottom of wood siding material to exterior paved areas. High soil level near brick siding promotes wood rot and is considered a conducive condition to termite activity and water penetration.

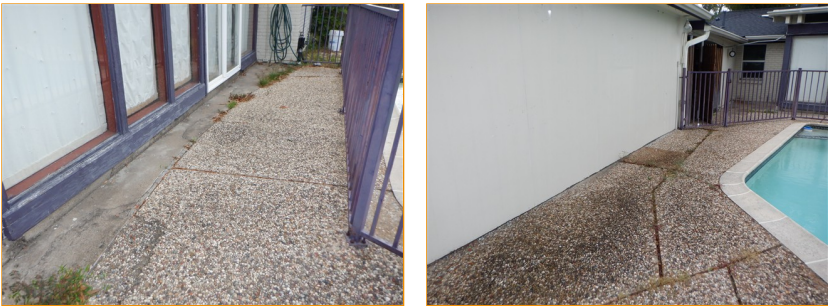
No drainage system observed around the swimming pool; rain water will pond against the house and garage foundation walls.

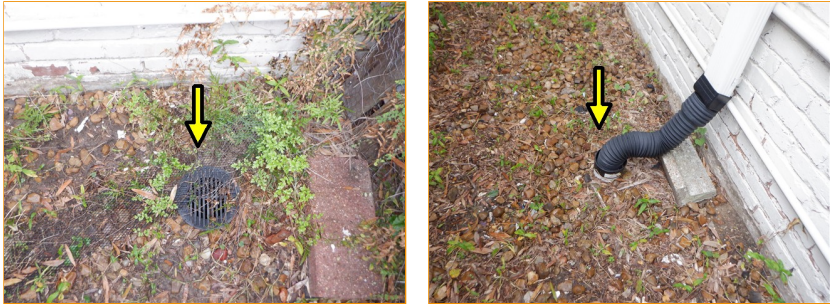
The underground yard drainage system was not inspected. We did not verify that yard drains operate properly and that there are not clogged or collapsed areas. The inspector is unable to induce sufficient amounts of water to determine if the system will operate properly when needed. We recommend observing the performance during heavy rains, and ensure that the system is maintained and cleaned regularly.

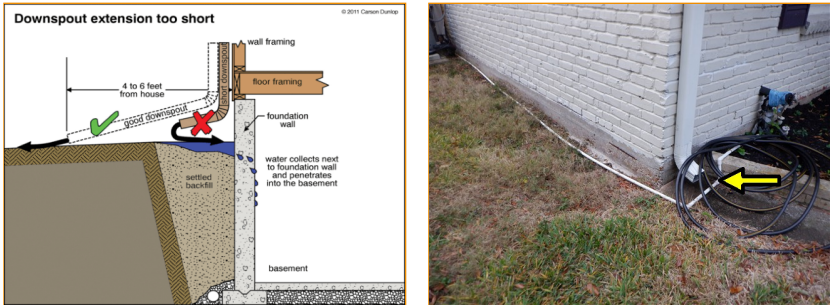
Rain gutter downspouts need to be redirected to drain water at least 36 inches away from the foundation and minimize possible wood rot, water entry, and/or foundation distress at one or more locations. Recommend extending downspouts to within 4 inches of the soil, installing downspout elbows, and installing splasblocks.

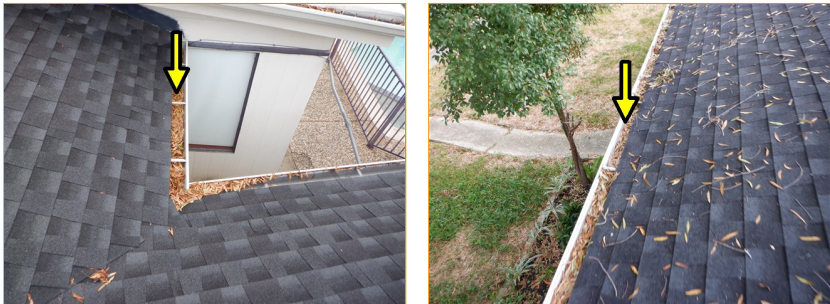
Gutters are full of debris and/or holding standing water at one or more locations.

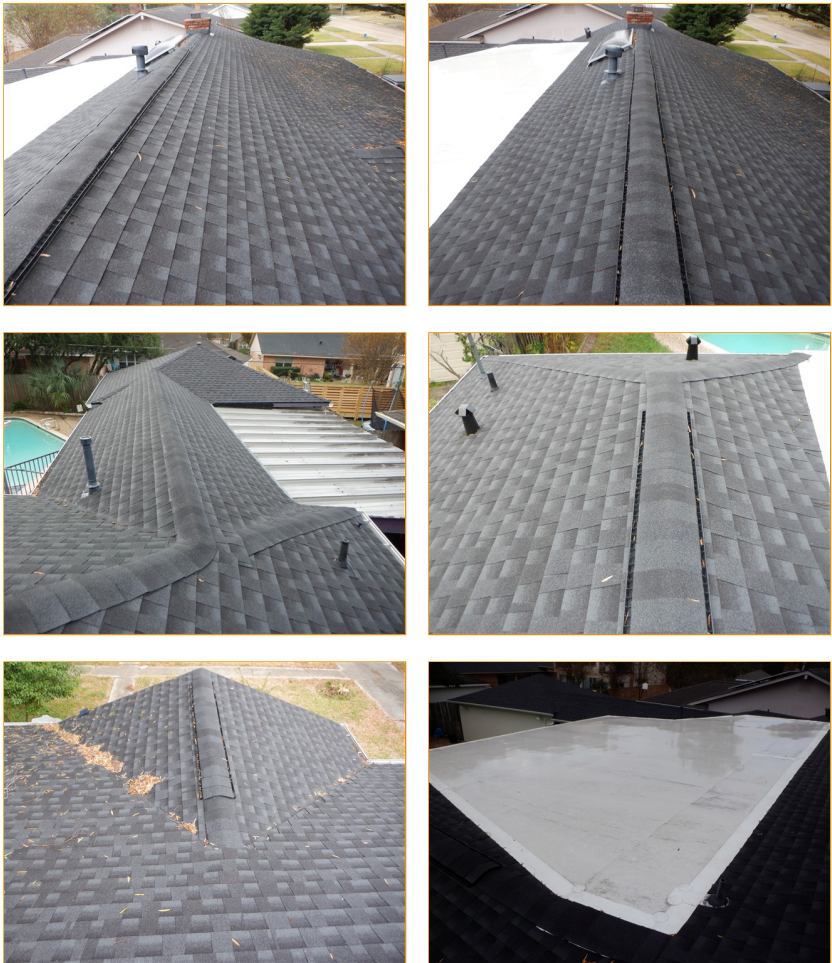
Tree limbs/branches are in contact with and/or hanging over the roof. This condition brings moisture and damage the roof. Overhanging tree branches rubbing on the shingles can cause abrasion or tear damage. Recommend trimming trees to prevent further damage to the roof covering material.

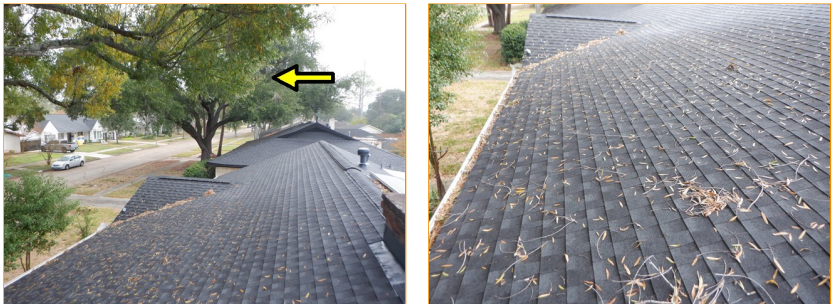
Debris observed on roof, which brings excessive moisture to the roof, can damage/ puncture the membrane and prevents visual inspection. It is recommended to keep leaves from collecting on the roof, especially in valleys and keep tree limbs away from the roof to prevent damage to shingles and getting a roof clean up.

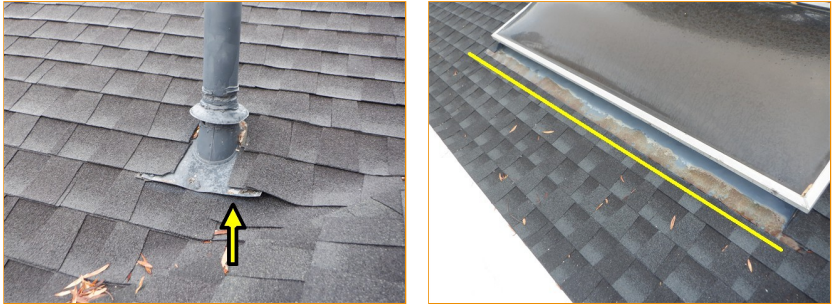
Observed roof flashing around the skylights old and rusted. Recommend applying protective coating with anti-corrosive paint to prevent further deterioration.

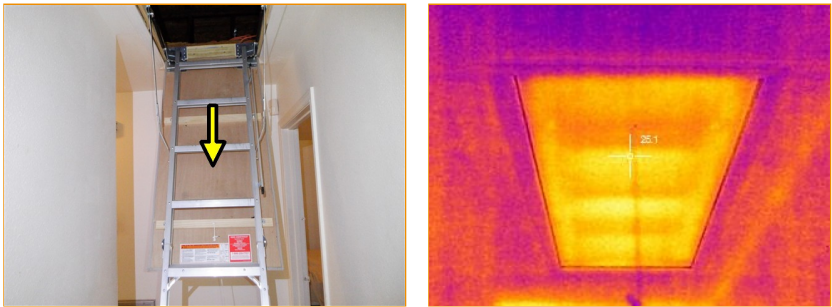
The attic access stairway is not sealed with weather stripping to prevent loss of conditioned air to the attic and/or sucking attic air into the house and/or is missing insulation on stairway. The infrared image to the right reveals area of energy loss. Recommend repair to save on energy bills.

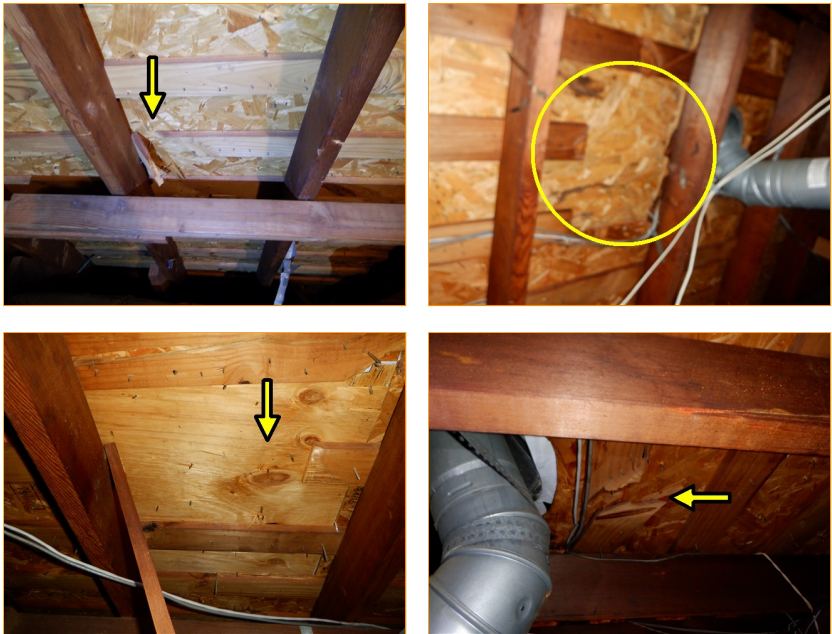
Damaged roof decking observed at various locations in the attic.

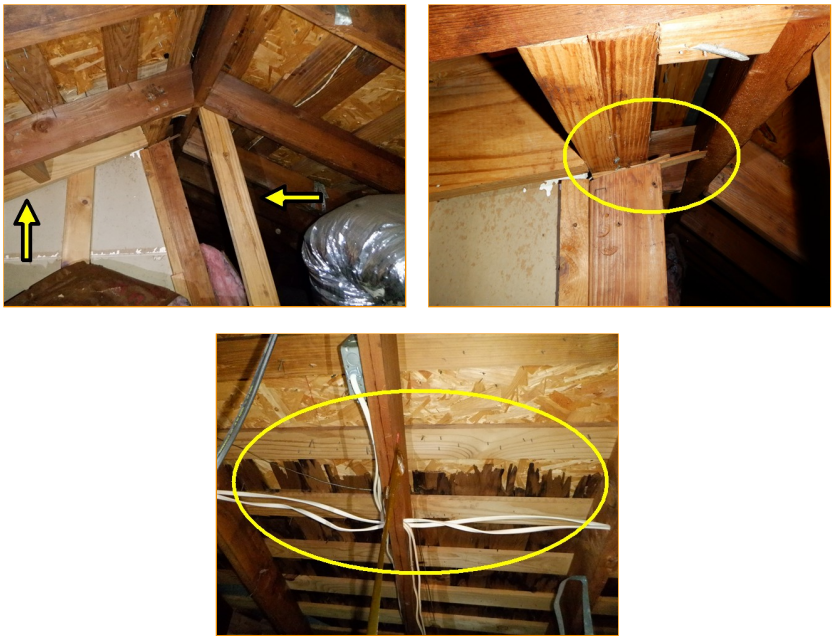
Evidence of prior repairs to the roof structure observed at one or more locations in the attic. Recommend consulting the seller about documentation about the scope of work and warranty and further evaluation and repair as needed by a qualified roofing contractor or a structural engineer.

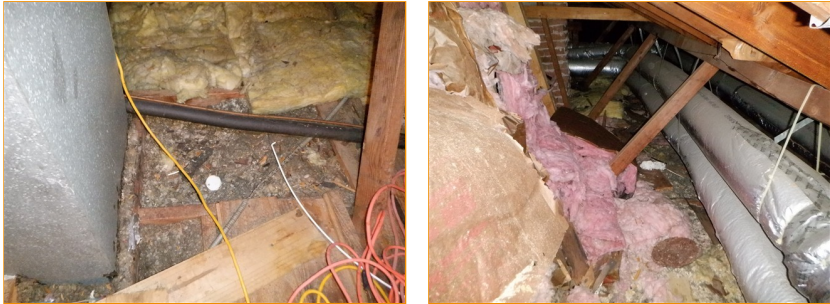
Observed insulation around ceiling light fixture not IC-rated. Only IC-rated recessed lights should be installed because they are airtight and can be covered with insulation. Ensure insulation is maintained a minimum of 3 inches and leave a minimum of 1 inch from around all recessed lights to reduce possible fire hazard.

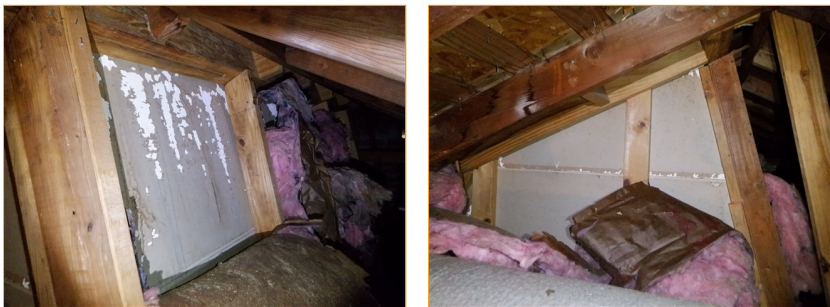
Vertical sections of insulation were observed to be missing and/or displaced on interior walls in attic. The infrared image to the right reveals area of energy loss.

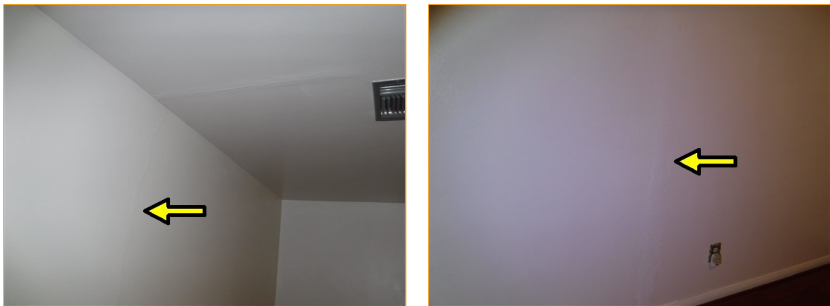
Cracks in sheetrock observed at various locations may have been caused by foundation settlement movement.

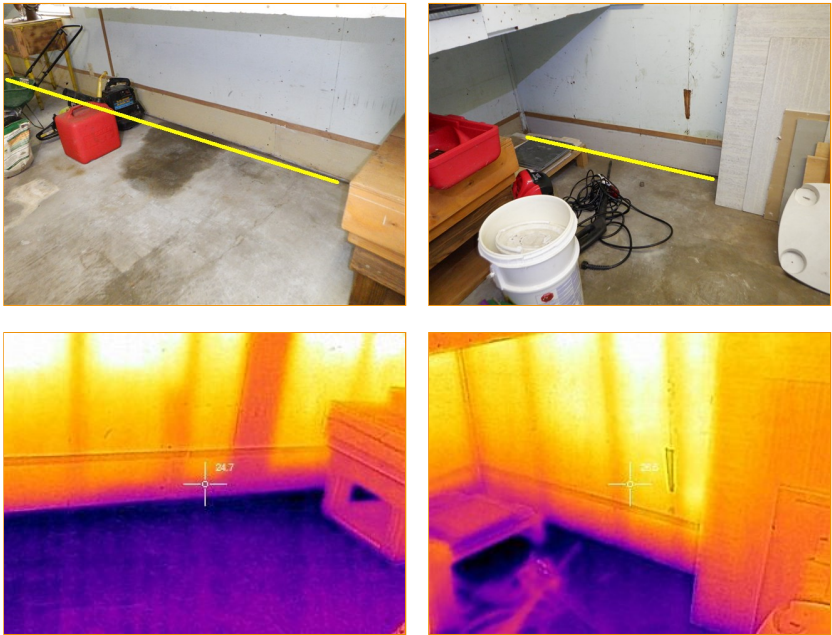
Repairs to the interior wall covering material was observed at the bottom of garage walls. No excessive moisture was observed at the time of the inspection.

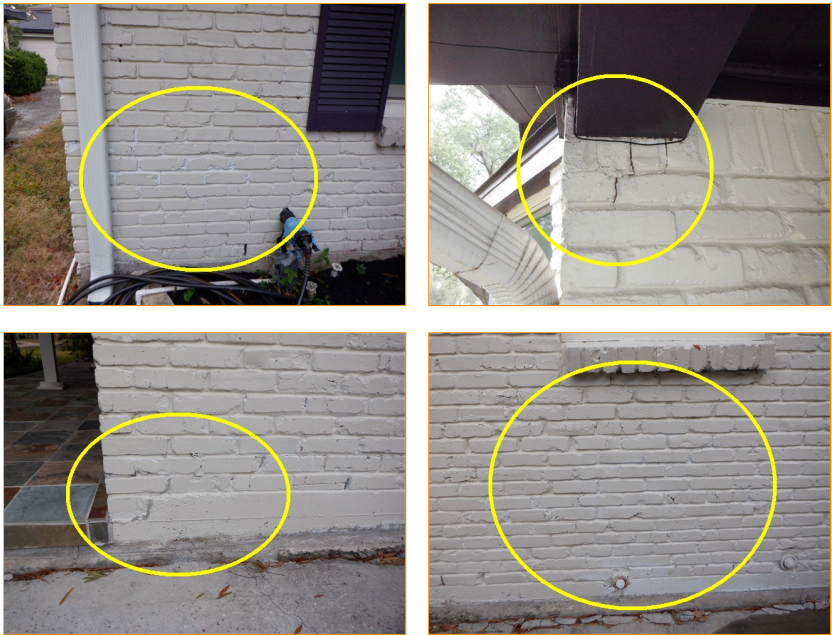
Cracks in brick veneer and loose bricks observed at various locations around the house. These cracks appear to be caused by foundation settlement movement, which is common to slab foundations. Recommend tracking movement of cracks if any by taking pictures and recording width.

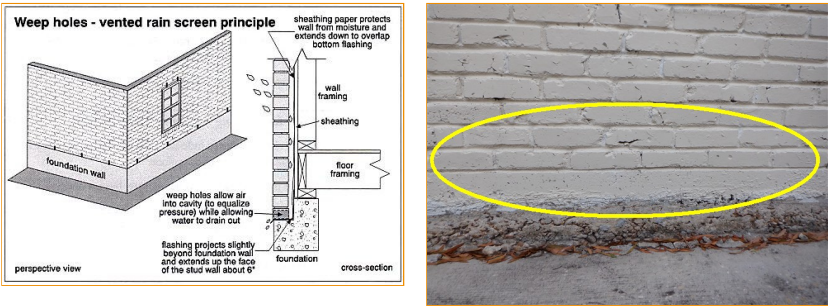
Observed various weep holes at bottom of brick wall are blocked and/or have been sealed over. Weep

holes are needed to allow for proper drying of the wall cavity. Recommend clearing any blocked weep holes.

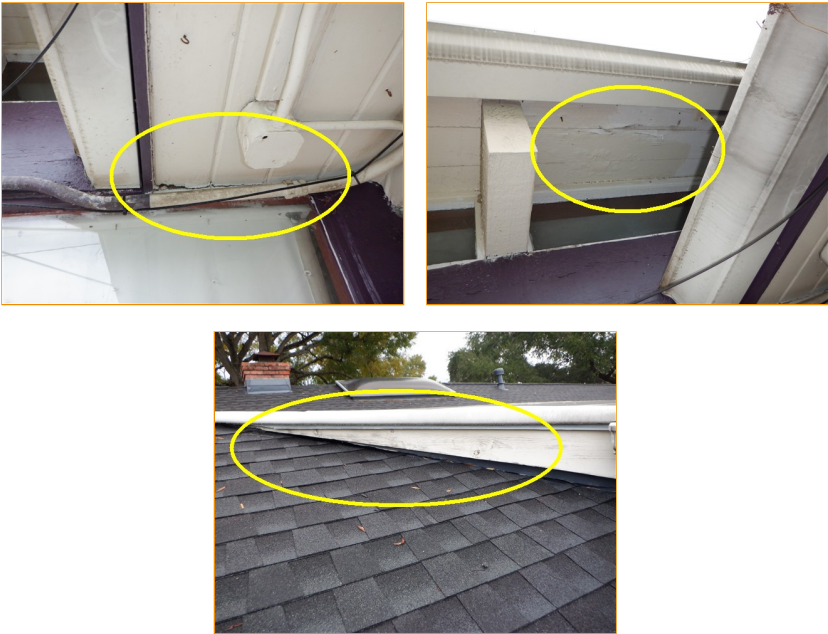
Wood damage observed around exterior fascia and/or soffit at various locations.

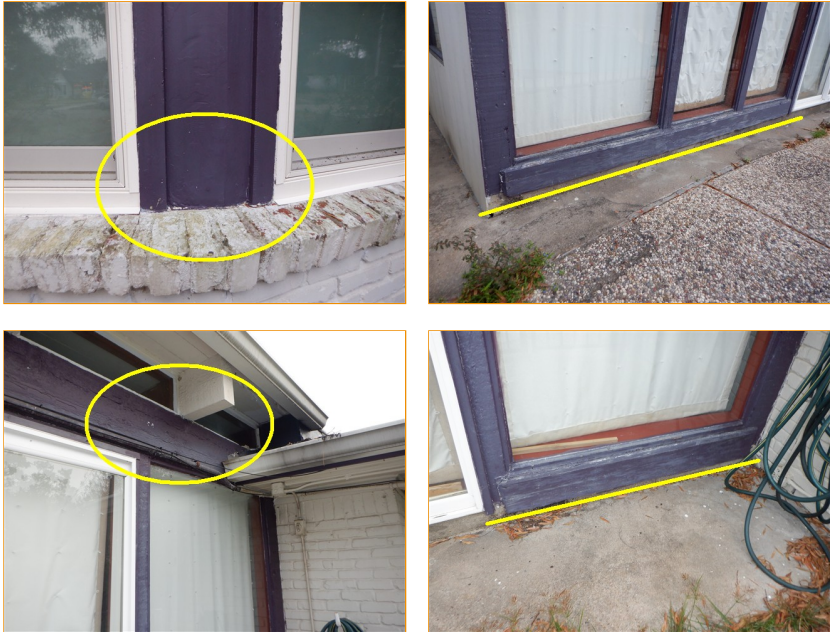
Damage/deterioration observed on exterior siding at various locations including around window frames. I recommend repair/maintenance to prevent water penetration.

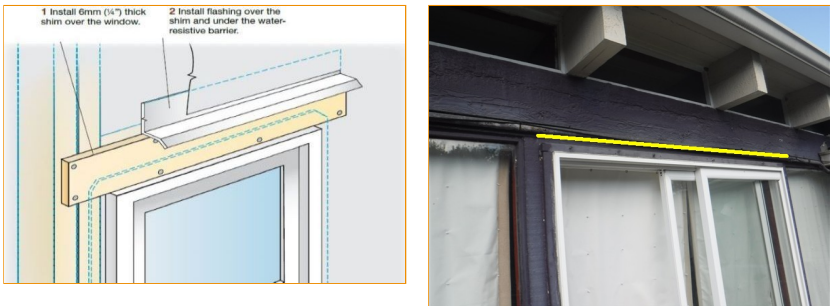
Head flashing missing over exterior sliding door. Head flashing helps prevent water penetration. Without head flashing windows/ sealing must be maintained as the only defense against water penetration.

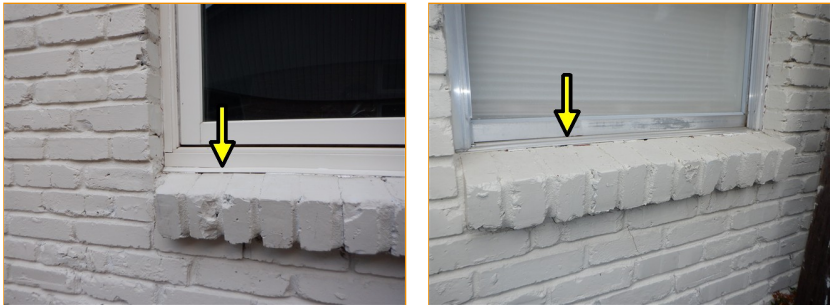
Sealing/caulking deficient around one or more windows, will allow water penetration during heavy / wind driven rains. Recommend checking exterior windows to improve sealing.

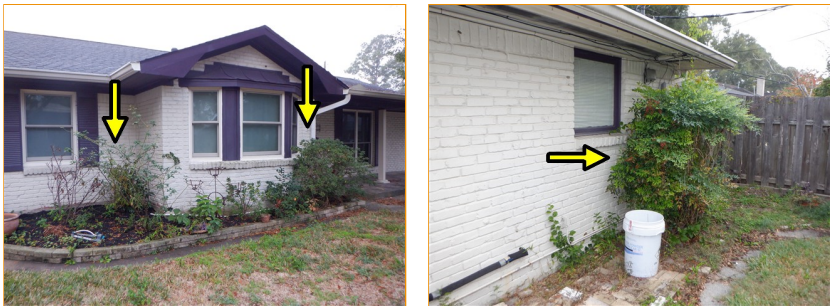
Bushes / trees / foliage should not contact siding of house to prevent wood rot, insect access and excessive moisture. Recommend removing tree stumps/roots close to the house foundation as they represent a source of wood destroying insect activity .

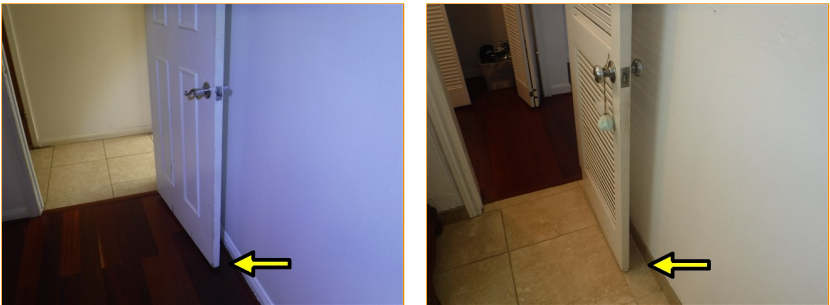
Observed missing or non-functioning door stop behind one or more doors to prevent damage to sheetrock.

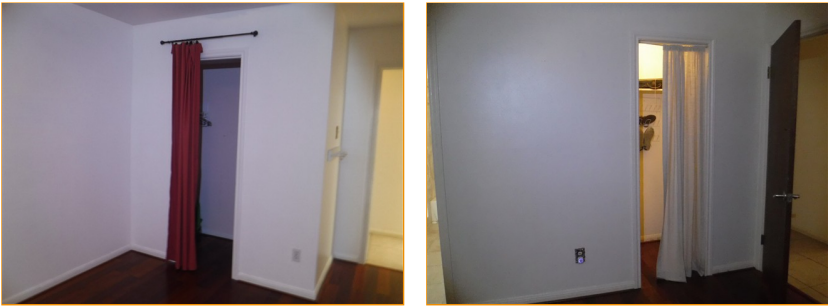
The closet doors at the secondary bedrooms are missing.

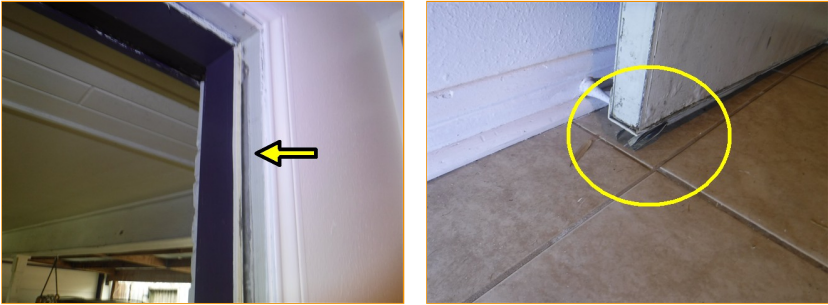
Observed weather stripping torn/damaged at the backyard door.

The lower weather stripping is also damaged.

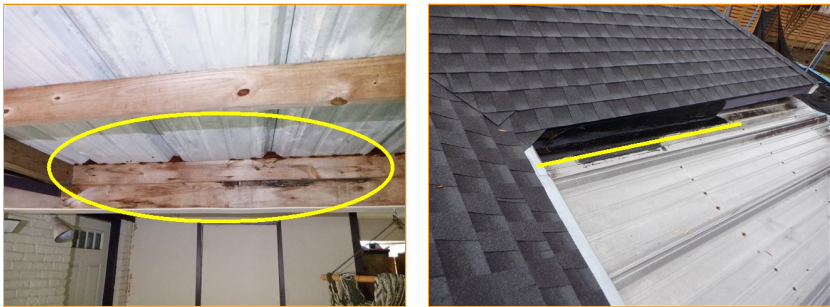
Deficient sealing and evidence of water penetration observed in the carport.

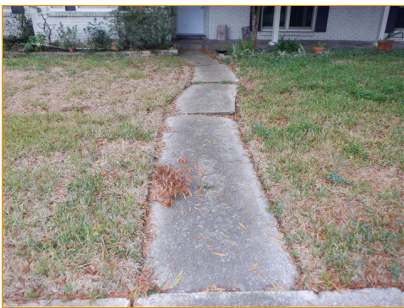
Tripping hazard observed at front of the house; the walkways and/or driveways are uneven.

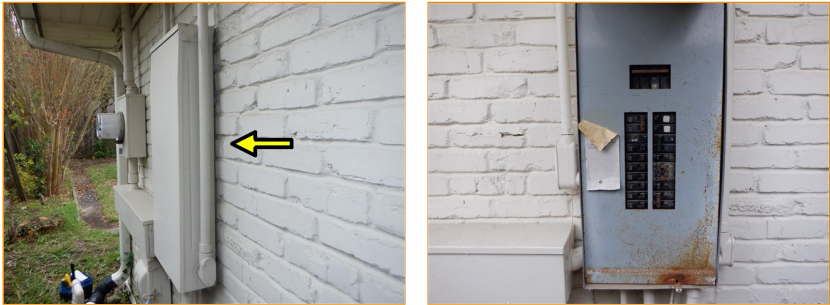
No insulated barrier observed at service entrance conductors. By current code (NEC 230.62C), any un-insulated, un-grounded conductor terminal or bus bar in the service disconnect must have a barrier covering it to protect service personnel.

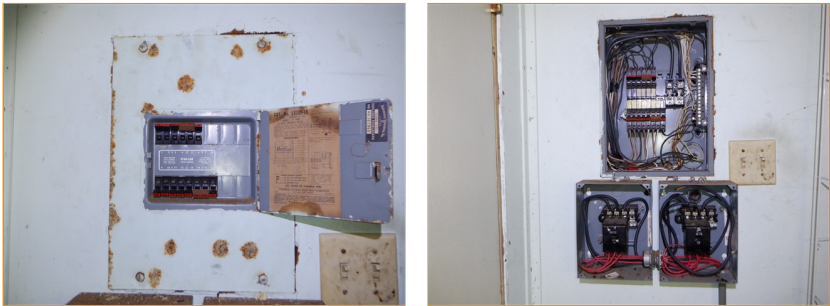
Observed older electrical sub-panel is missing a single main electrical disconnect breaker to turn off power to house. By current industry standards, when there are more than 6 breakers at the electrical panel, a single main electrical disconnect should be present.

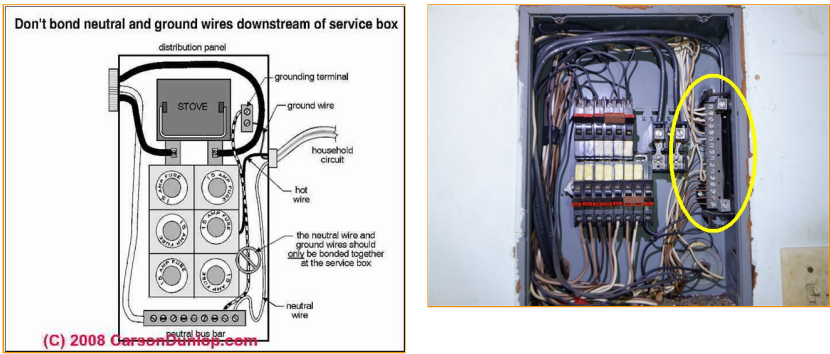
Loose wires were observed at electrical box running from the sub-panel. This condition represents a safety hazard. Recommend further evaluation and repair as needed by a licensed electrician.

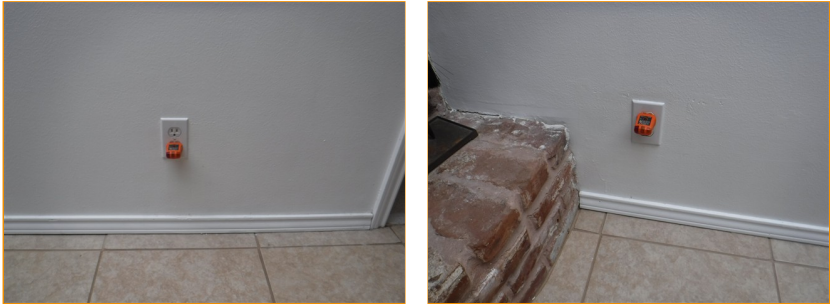
Older two prong outlets with no grounding bare wire observed at various locations around the house.

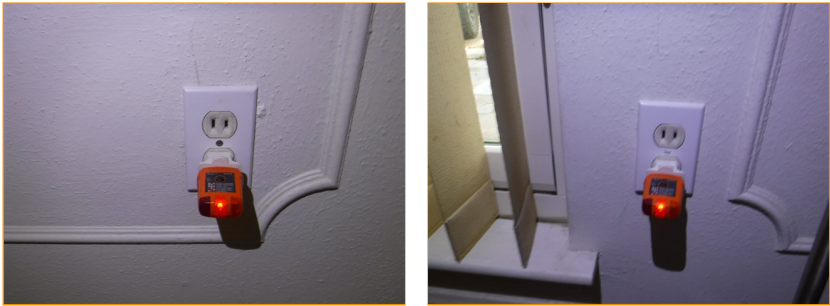
3 prong outlet(s) with an open ground observed at various locations around the house.

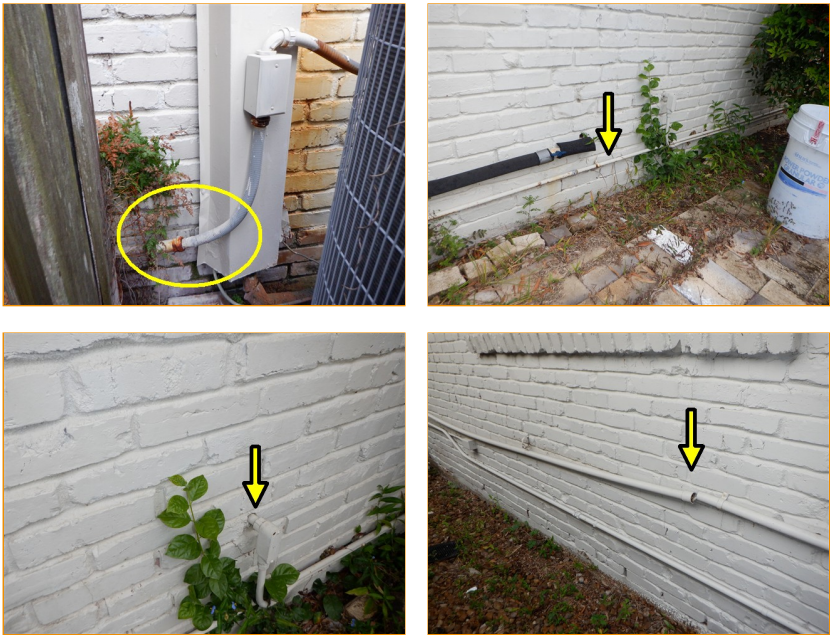
Observed 120 V wiring was cut and left exposed in the backyard area. This condition represents a safety hazard, recommend further evaluation and repair by a licensed electrician.

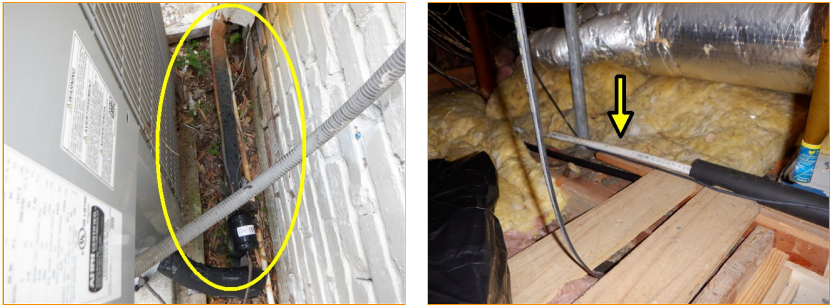
The primary drain line appears to have been installed to drain along the exterior wall, which may cause damage to the wall covering materials and causing soil depression next to the foundation. Recommend further evaluation/service by a licensed HVAC technician.

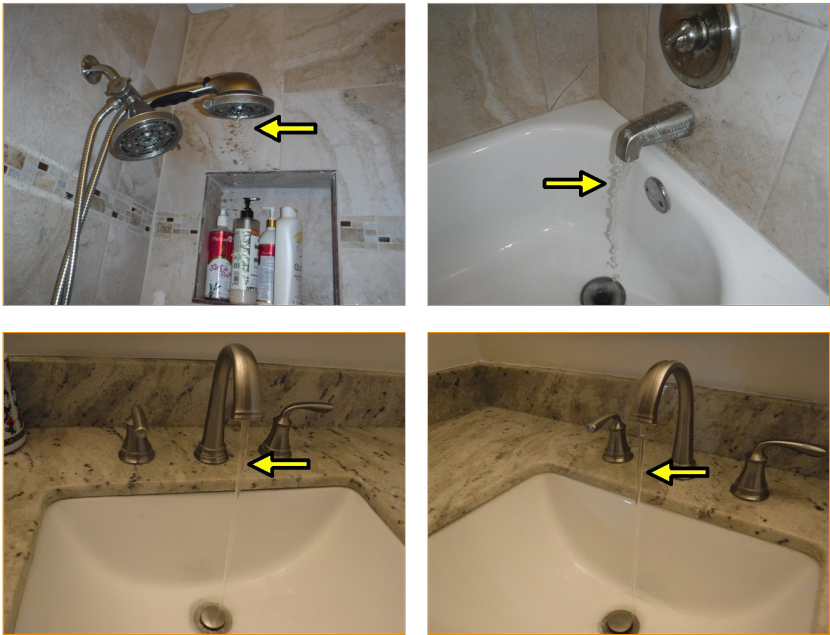
Low water pressure observed at the half bathroom sink . Recommend further evaluation and/or repair as needed by a licensed plumber.

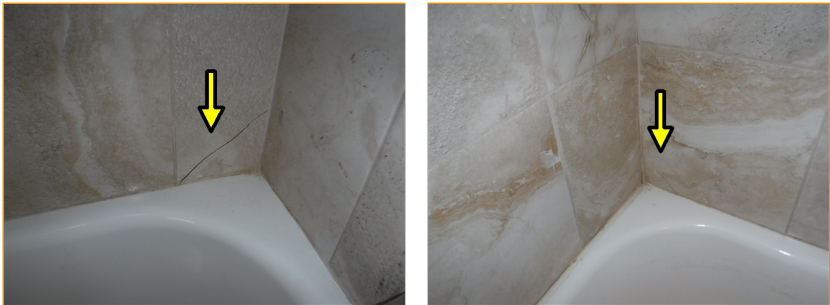
Observed grout / caulking needed in primary bathroom shower enclosure at vertical tile corners to prevent water entry behind wall.

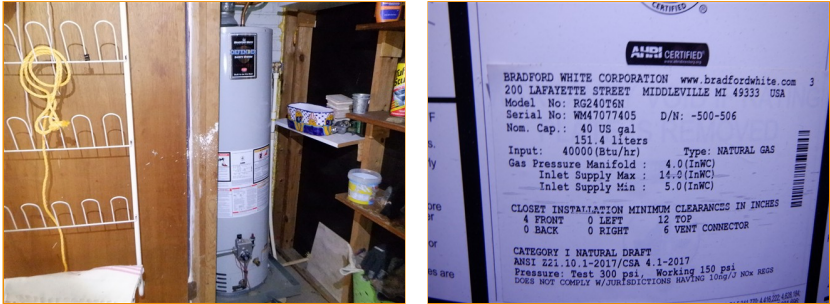
Observed water heater draft hood is not properly connected to the exhaust vent. Combustion gases escape into living/storage space. This condition represents a safety hazard; recommend repair.

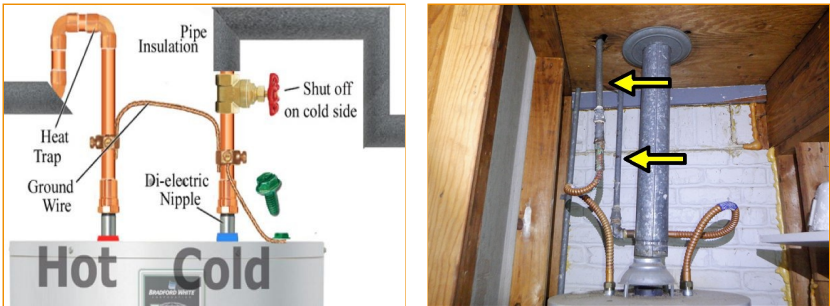
Water heater temperature and pressure relief valves should be installed in a way that flows by gravity (IRC CODE P2804).

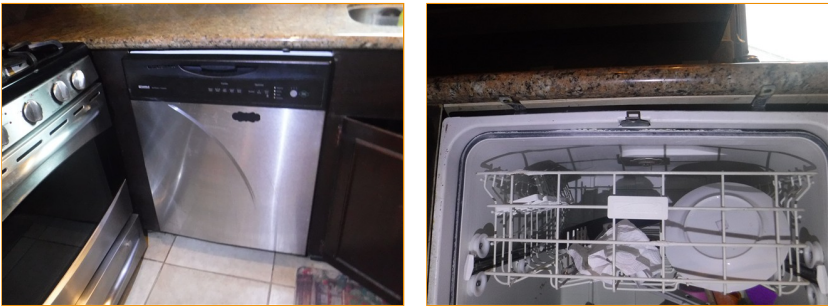
The drain line needs to be elevated above side inlet of disposal to underside of countertop to prevent debris and gray water from draining down line from disposal and back into dishwasher.
