# GOLDFISH HOME INSPECTIONS, PLLC

# PROPERTY INSPECTION REPORT FORM

04/19/2025 9:00 am

10935 Ashland Bridge Ln, Sugar Land, TX 77498

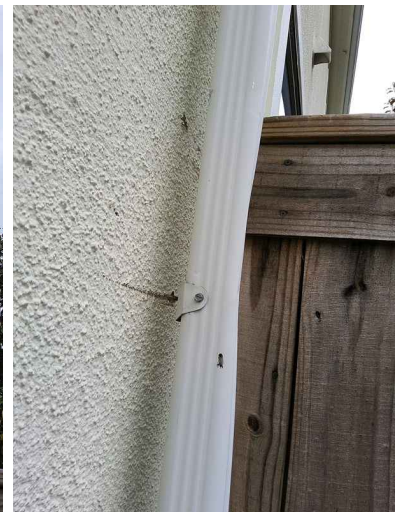
## 3: Gutters: Damaged

Sections of the gutters were observed with damaged. Further evaluation is recommended for any necessary repairs.

Recommendation: Contact a qualified gutter contractor

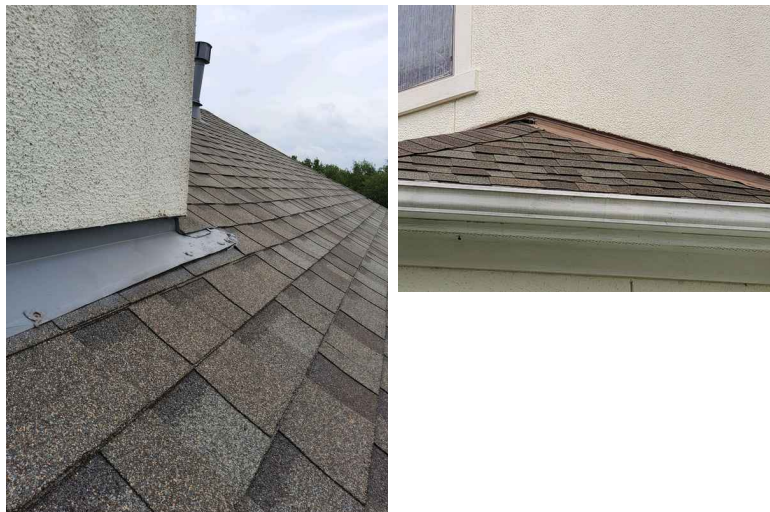
### 3: Loose or raised flashing

Loose or raised flashing was observed on roof or adjacent walls. These areas may be prone to moisture intrusion. Correction is recommended.

Recommendation: Contact a qualified professional.

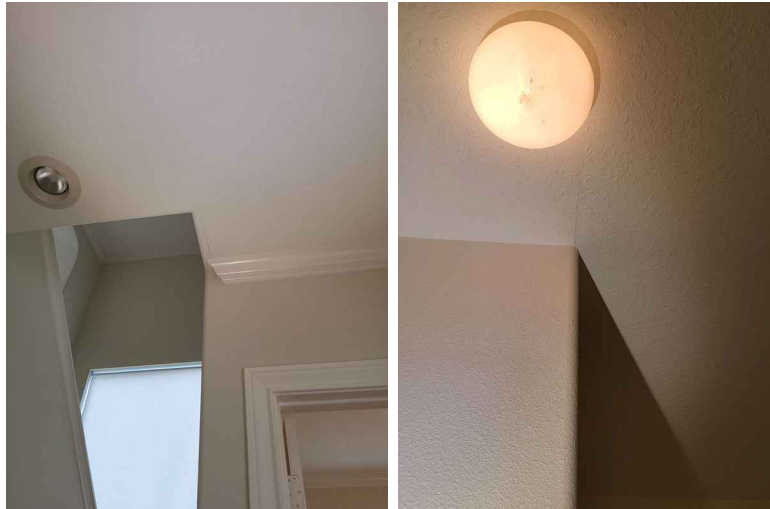
### 1: Ceiling - Minor cracks

Minor cracks were observed on the ceiling. Possibly from settlement of the structure. Repair and monitoring is recommended.

Recommendation: Contact a qualified drywall contractor.

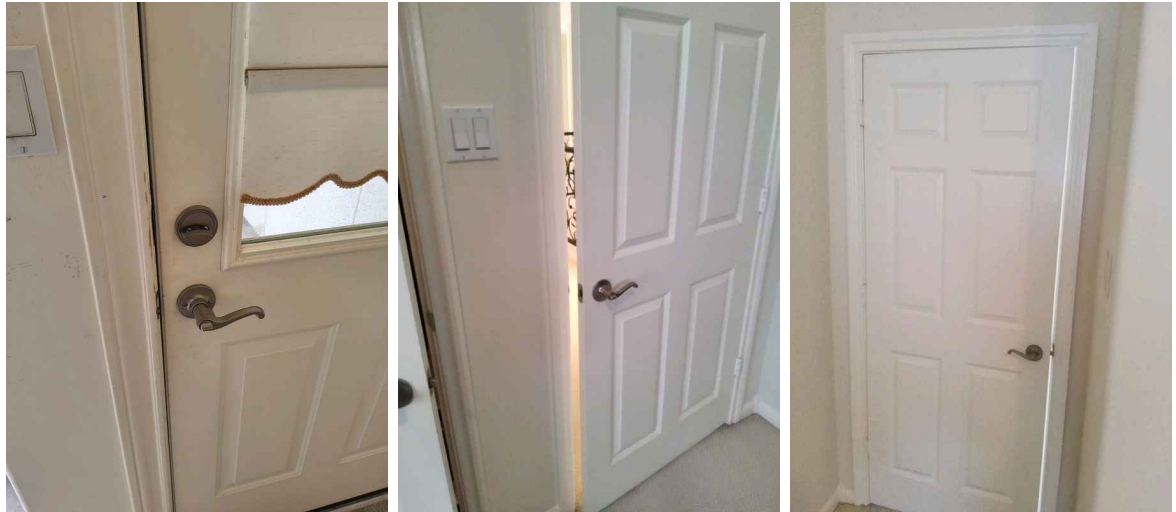
Multiple doors would not latch properly while being put in the closed position. Correction is recommended.

Recommendation: Contact a qualified handyman.

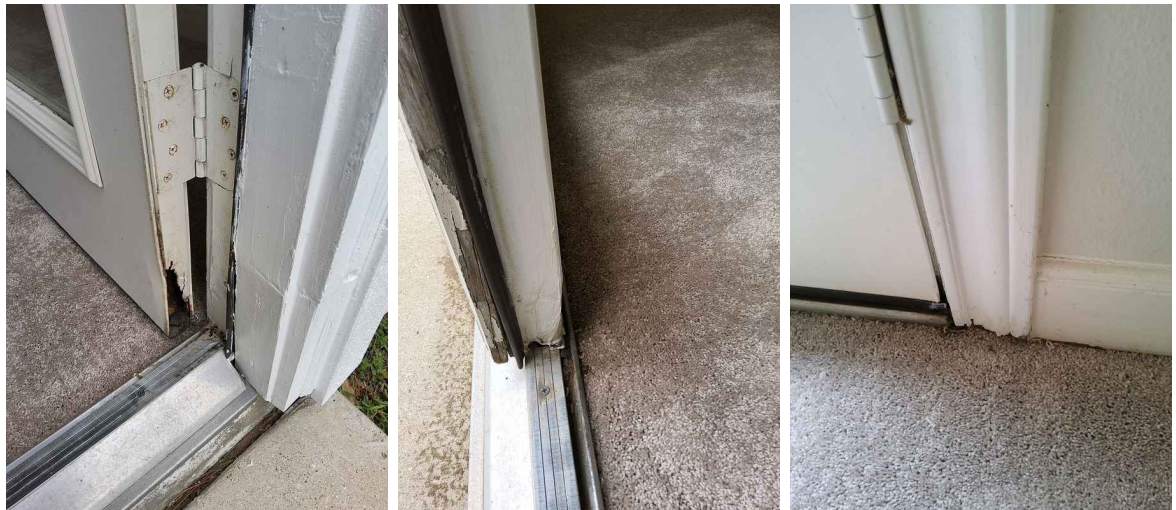
## 2: Wood rot at base of door / frame

Moisture damage was observed at the base of the door or door frame. Further evaluation for repair is recommended to prevent possible further deterioration.

Recommendation: Contact a qualified professional.

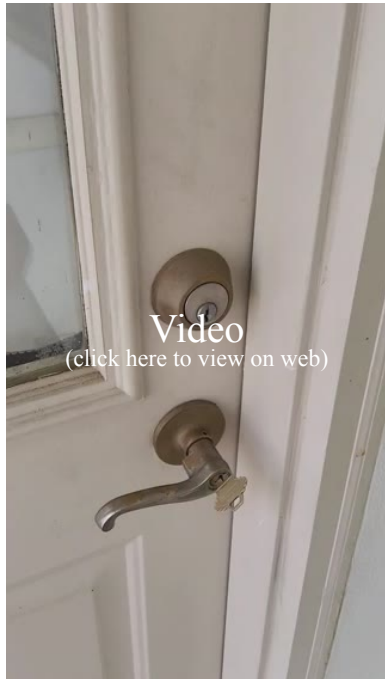
The deadbolt was inoperable and the key side on the bottom knob exterior was inoperable.

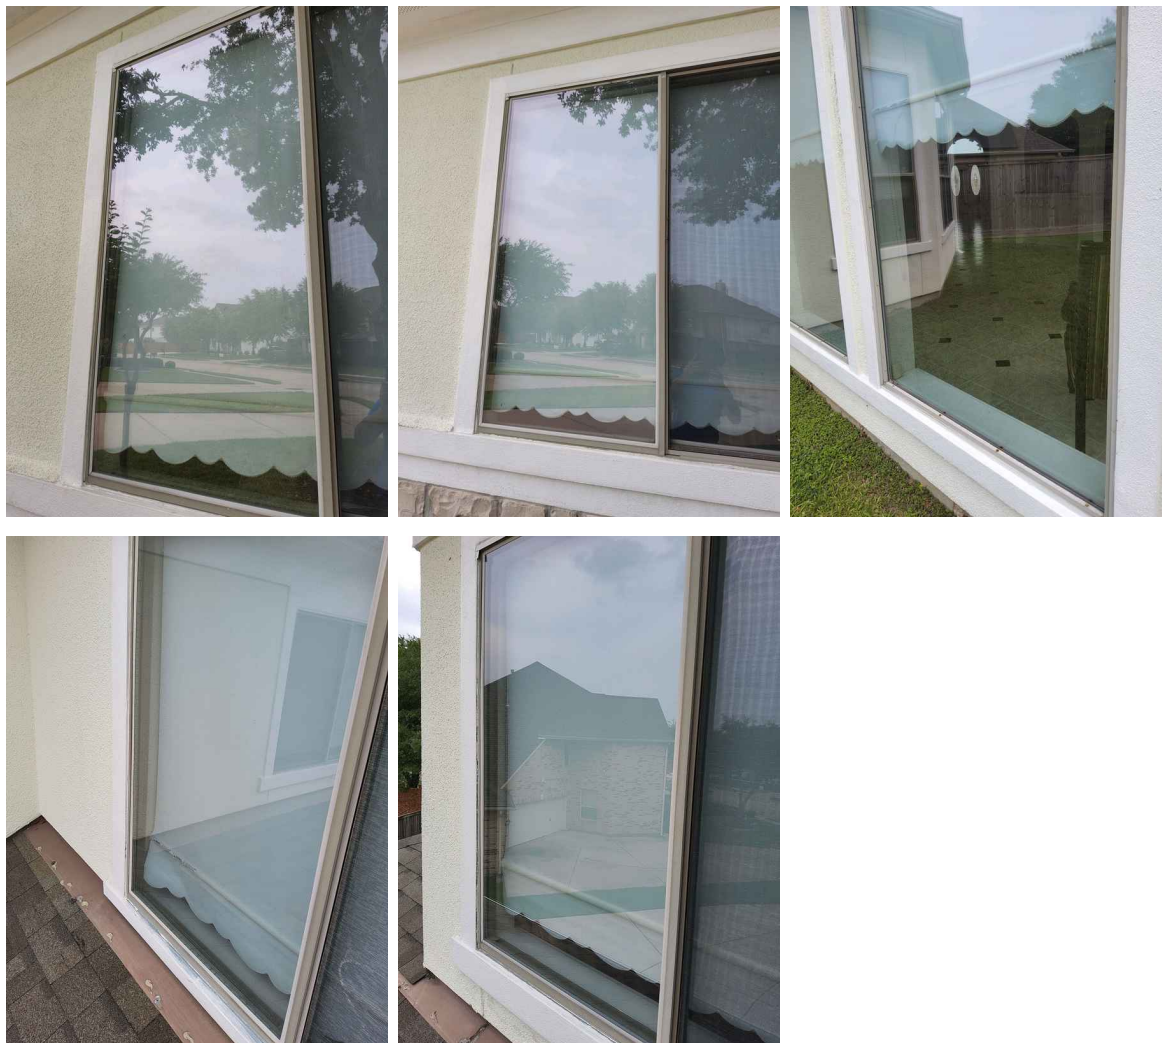
**1: Failed Seal**

Observed streaking between the window panes, which indicates a failed seal. Further evaluation and correction is recommended.

Recommendation: Contact a qualified window repair/installation contractor.

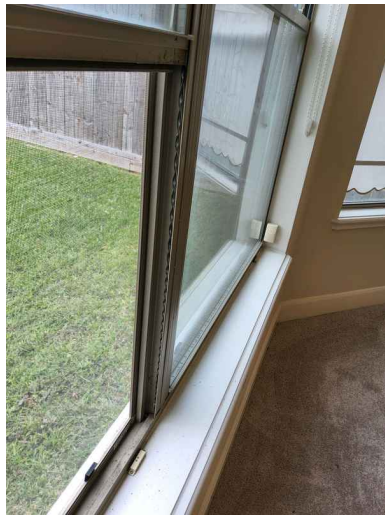
The lift springs of the window were observed detached or would not support the window when opened. Further evaluation for repair or replacement is recommended.

Recommendation: Contact a qualified professional.

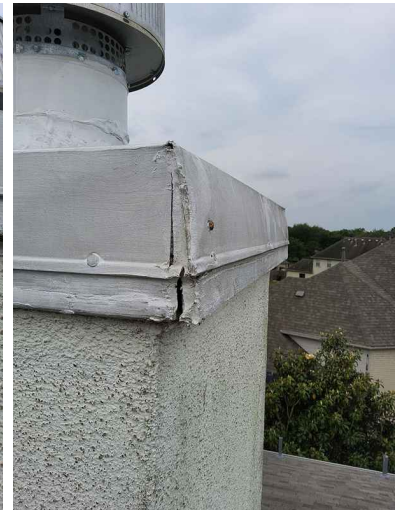
Sections of the chimney exterior were observed with moisture damage to the wood trim and areas requiring sealing to prevent possible moisture intrusion. Further evaluation and correction is recommended.

Recommendation: Contact a qualified professional.

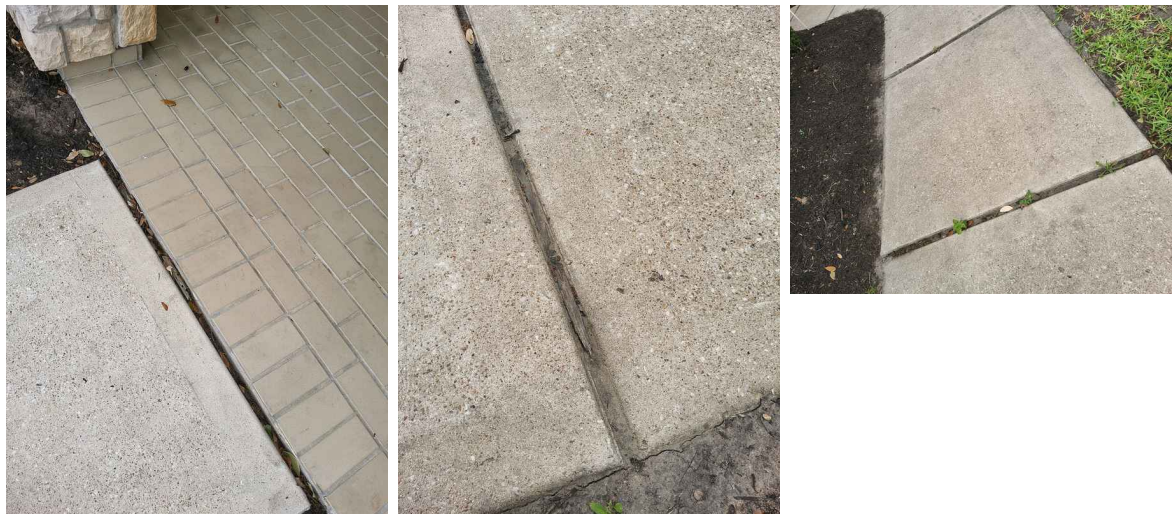
**1: Expansion joints missing/ deteriorated**

Multiple expansion joints for the walkway and driveway were observed missing or deteriorated. Correction is recommended.

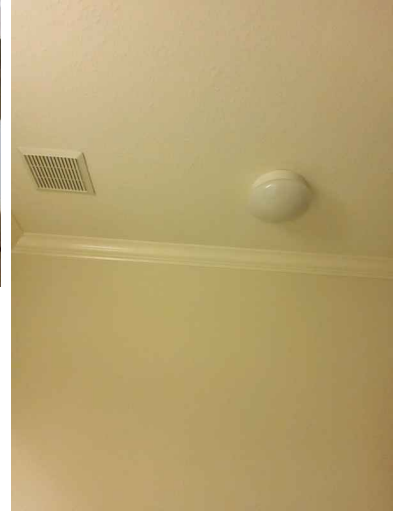
One or more lights are not operating. Further evaluation and correction is recommended.

Recommendation: Contact a qualified professional.

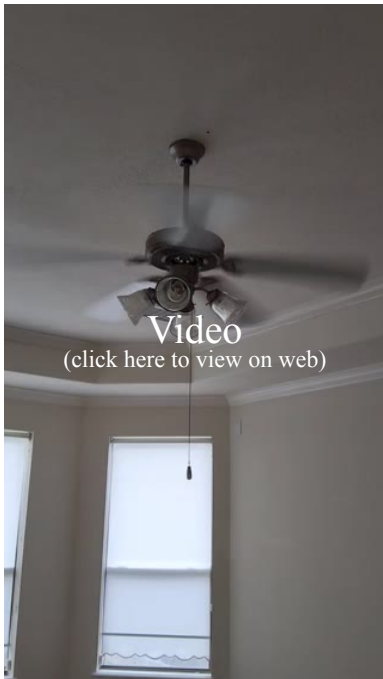
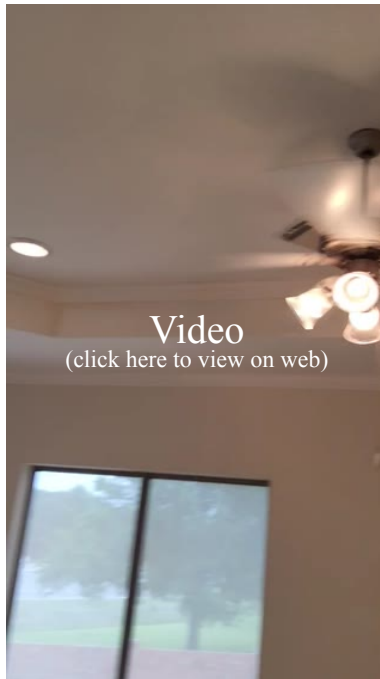
### 3: Ceiling fan out of balance

The ceiling fan was observed wobbling while in operation. Further evaluation and correction is recommended.

Recommendation: Contact a qualified professional.

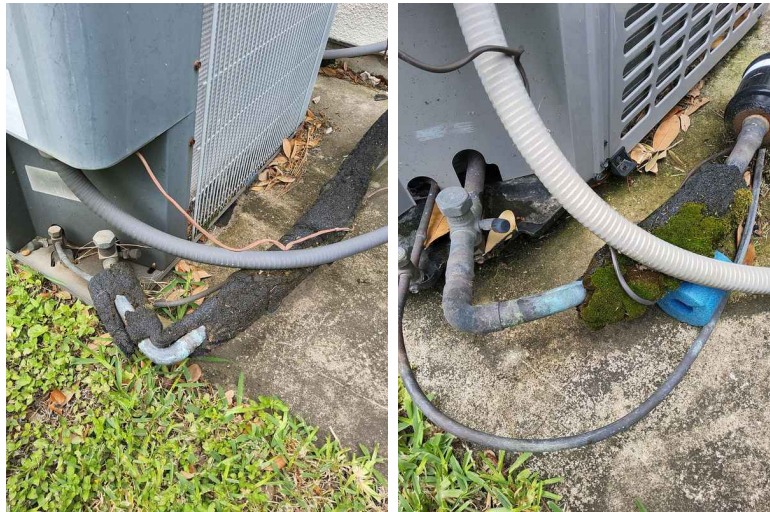
#### 4: Corrosion- Refrigerant lines

Corrosion was observed on the refrigerant lines of the condenser. Further evaluation and correction is recommended.

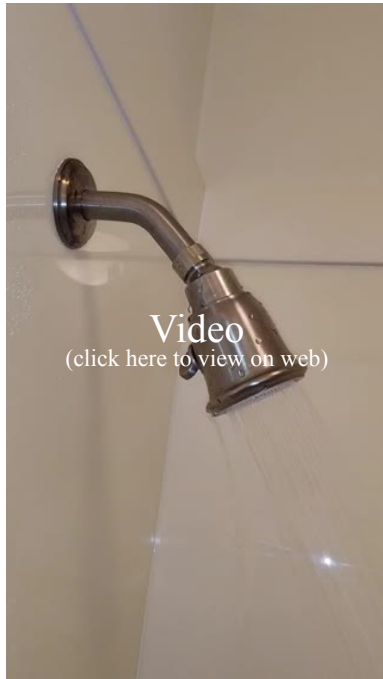
The shower head was observed dripping in multiple areas while in operation. Further evaluation and correction is recommended.

Recommendation: Contact a qualified professional.

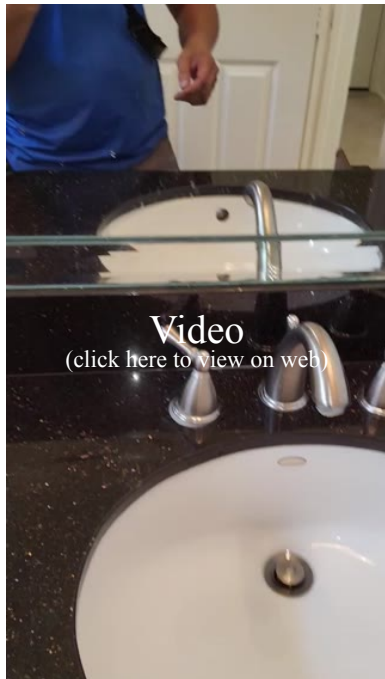
### 3: Fixture loose

The valve was observed loose while operated. Correction is recommended.

Recommendation: Contact a qualified professional.

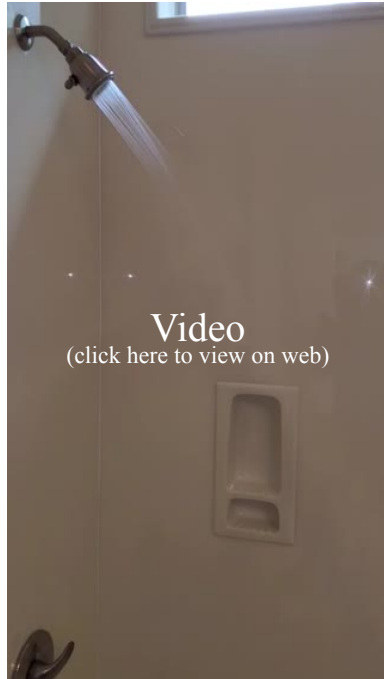
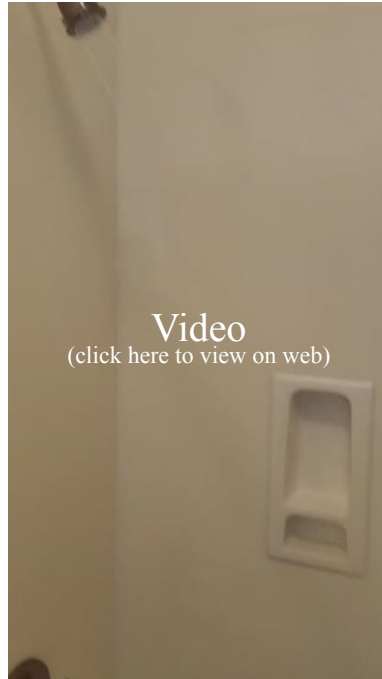
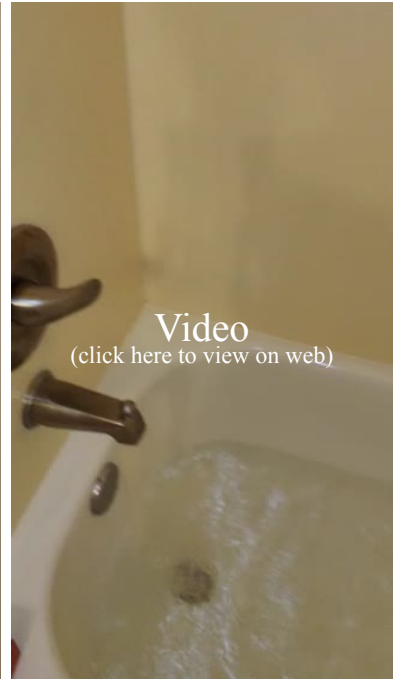
- Multiple shower diverters were leaking while in the closed position.
- The shower diverter was inoperable.

Recommendation: Contact a qualified professional.

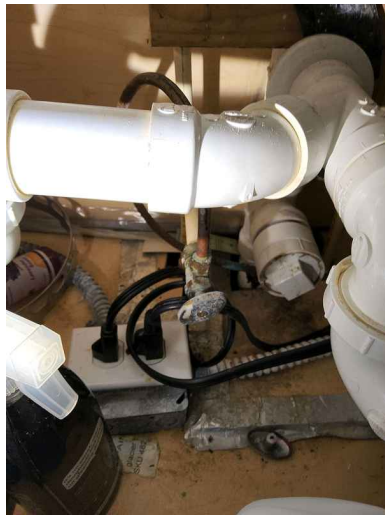
## 8: Corrosion

Multiple shut-off valves were observed with corrosion. Further evaluation and correction is recommended to prevent possible further deterioration.

Recommendation: Contact a qualified professional.
