# Property Inspection Report

1523 Ainsdale Dr., Houston, TX 77077

*Date of Inspection: 10/17/2024*

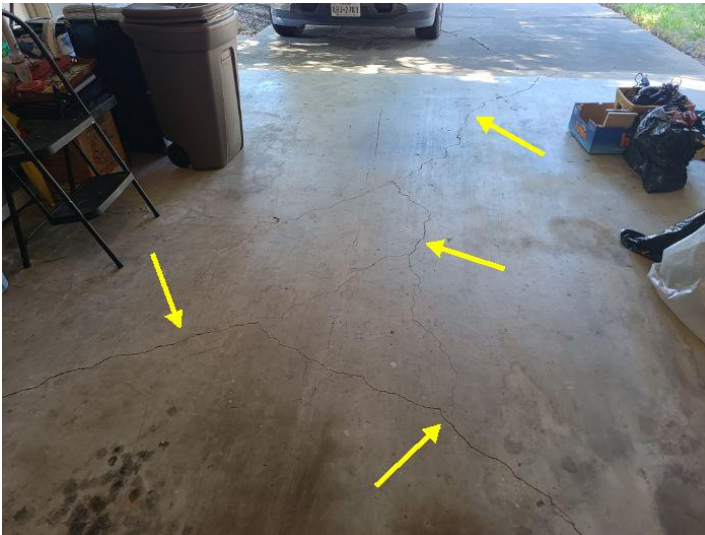
• There are large cracks in the brickwork on the left side. Some doors are out of level and there are stress cracks in the interior walls. The chimney is detached from the house. The floor is out of level in many areas. Visible cracks are present in the garage floor and ceiling. Recommend further evaluation

Cracks in the garage floor

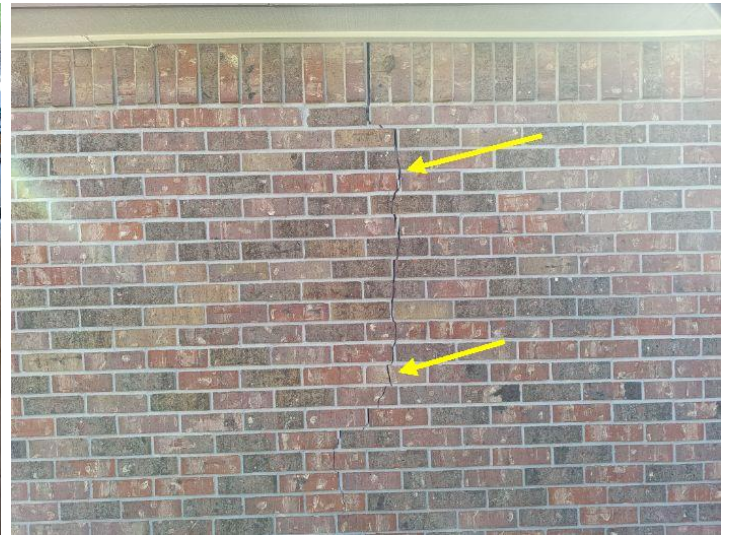
Cracks in the brickwork in the left wall

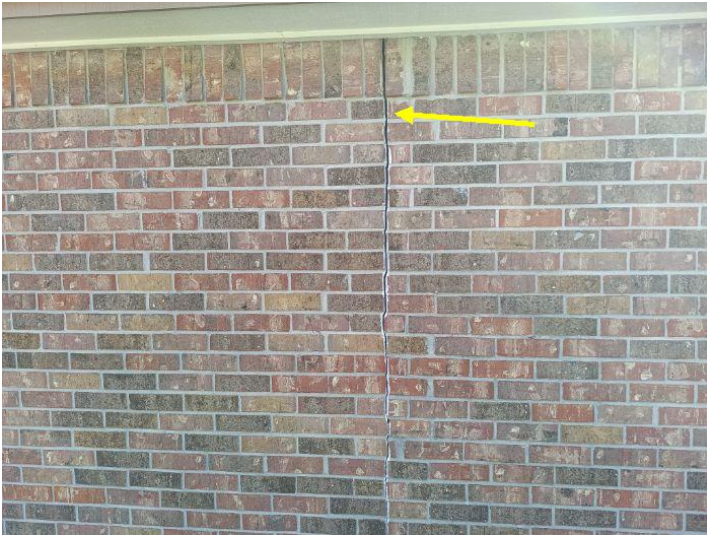
*Uneven crack in the left wall*

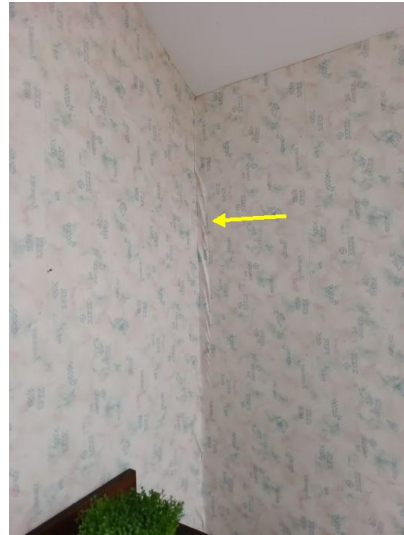
*Stress in the wallpaper from the foundation shifts*

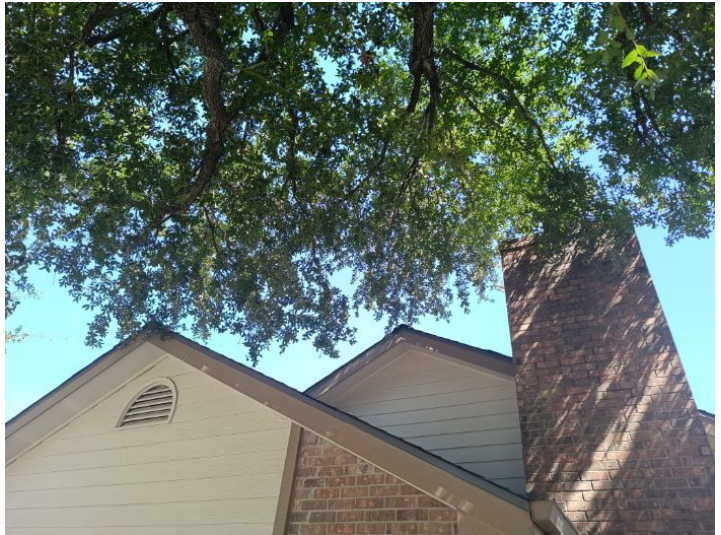
*Tree branches are <3' from the structure*

| Page 5 Item: C | Roof Covering Materials | <ul style="list-style-type: none"> <li>• Trees too close to structure. The tree branches are touching the roof and need to be trimmed &gt;3' away to prevent rodent access</li> <li>• The gutter system was partially blocked with debris and should be cleaned to prevent water backup and moisture entry into the house</li> </ul> |

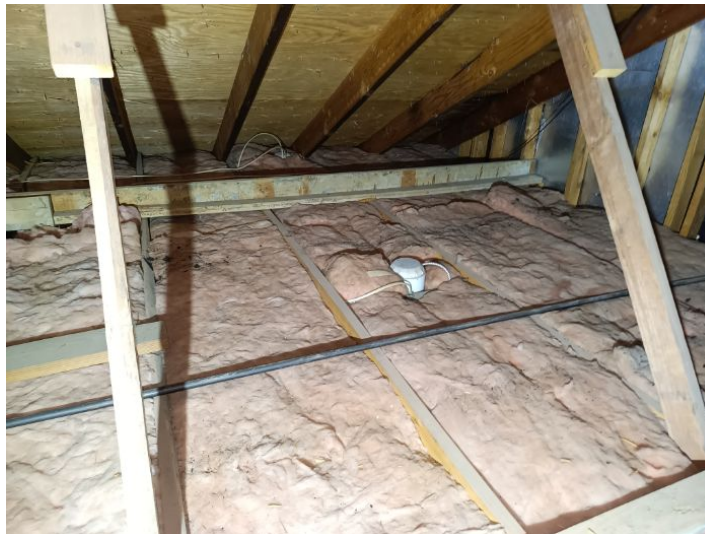
- The attic structure was observed to be conventionally framed with rafters, purlins and collar ties
- Non IC-rated recessed lights in the attic need to be >3" from insulation
- There is a lack of ventilation in the attic. Ridge vents are present but there are no significant soffit vents present to let air in. Attic ventilation needs to be >1:150

*non IC-rated lights are <3" away from insulation*

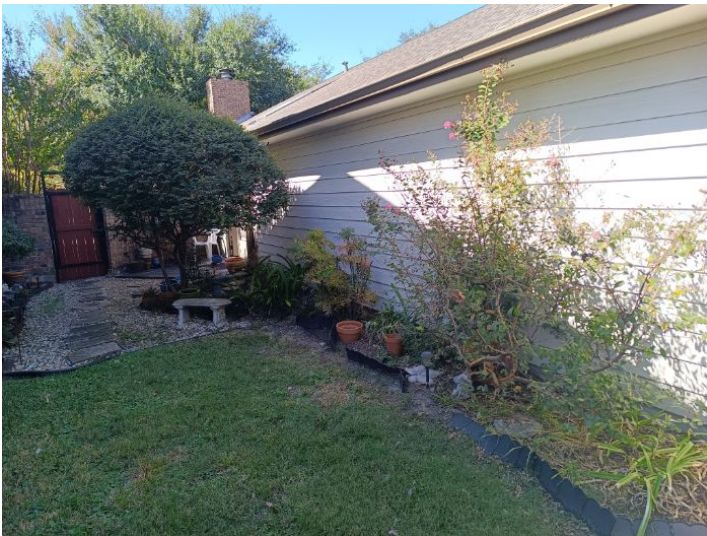
*Foliage is <18" from the structure*

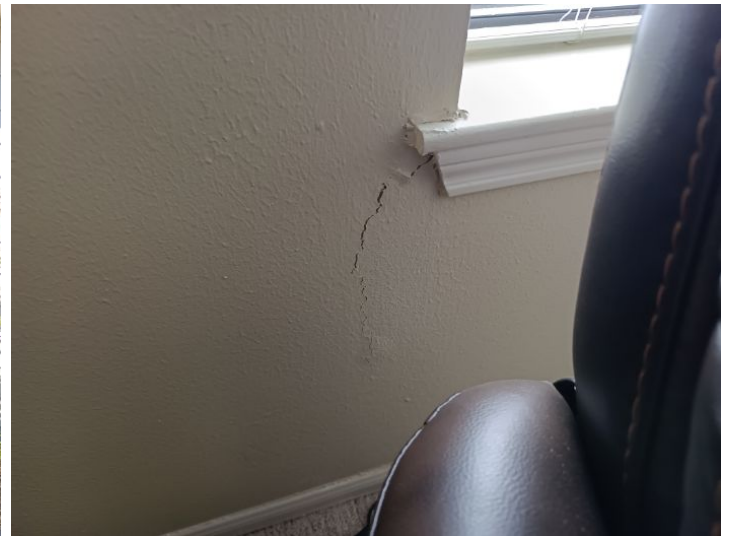
*Stress crack*

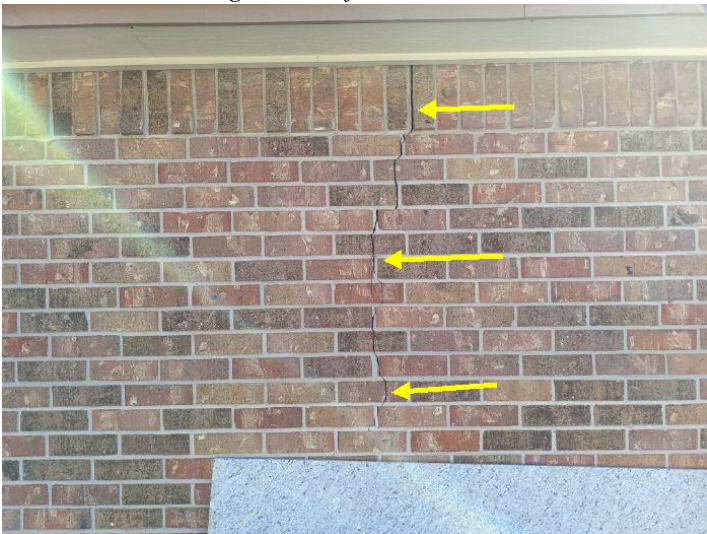
*Cracks in the brickwork in the left wall*

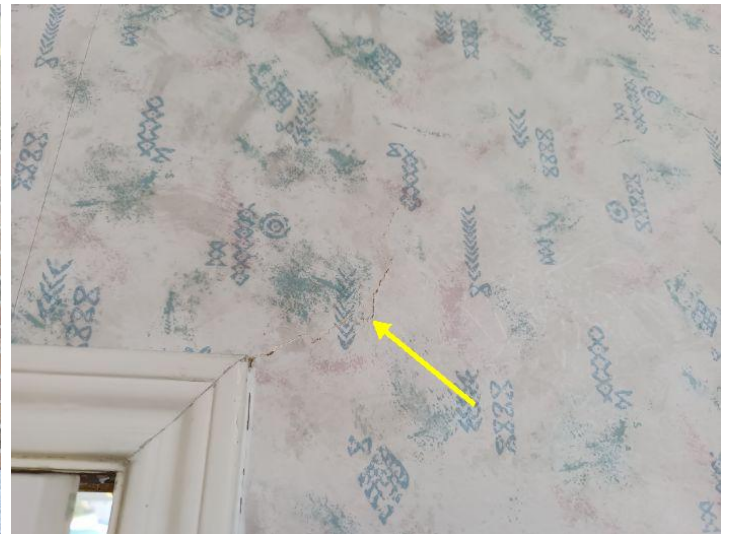
*Stress crack in the dining room wall*

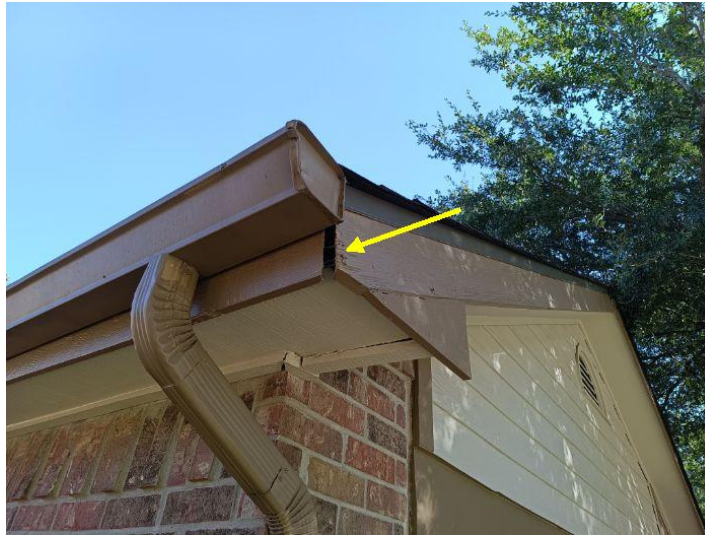
*Detached trim by the garage*

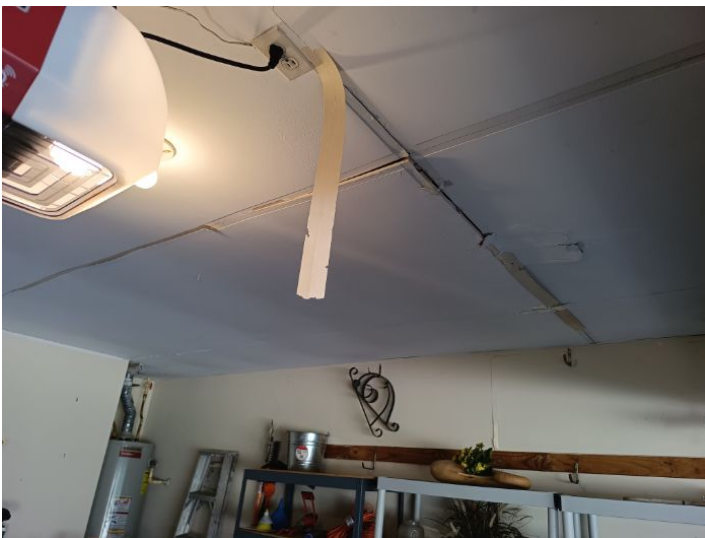
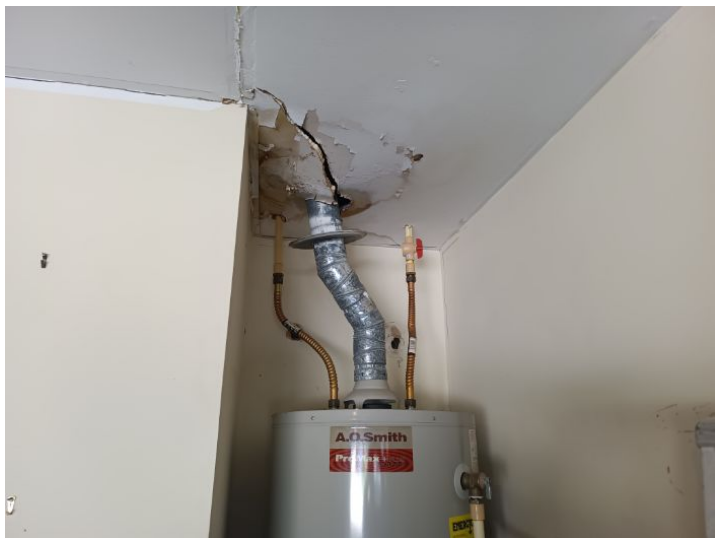
- Slab not visible due to floor coverings
- Patches were made to the ceiling finish in various areas
- The garage ceiling is detached and damaged by the water heater. Recommend repairs
- The floors were observed to be out-of-level, primarily in the living room

*Garage ceiling is not secure*

*Garage ceiling is detached*

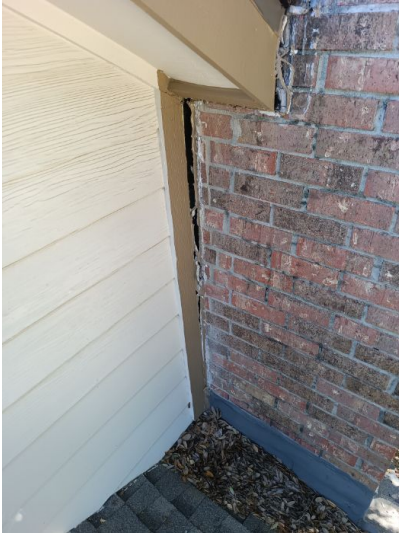
*Chimney has separated from the house, leaf buildup*

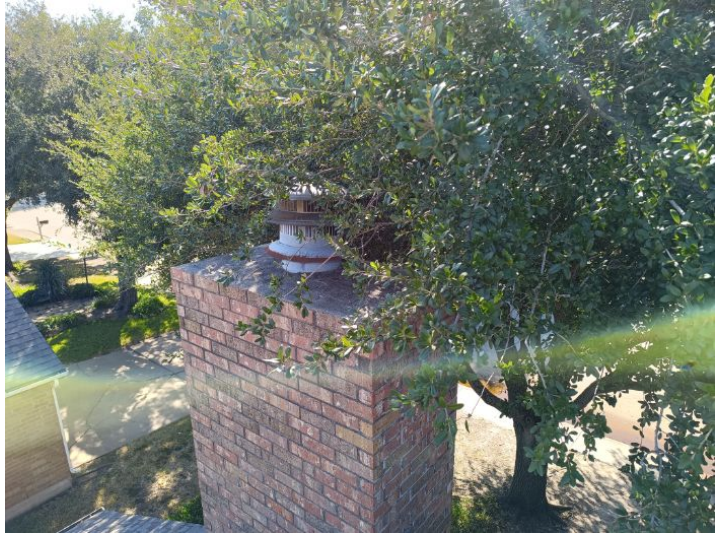
- A damper clamp is required to permanently block the damper in the open position to prohibit accidental spillage of natural gas into the living space
- It was noted that excessive tree branches are in close proximity of the chimney and need to be trimmed to a minimum of 10' from the chimney opening
- The chimney is detached from the house. Recommend further evaluation
- There is no diverter to divert leaves away from the chimney to prevent leaf buildup. Recommend cleaning

*Tree branches are <10' from the chimney*

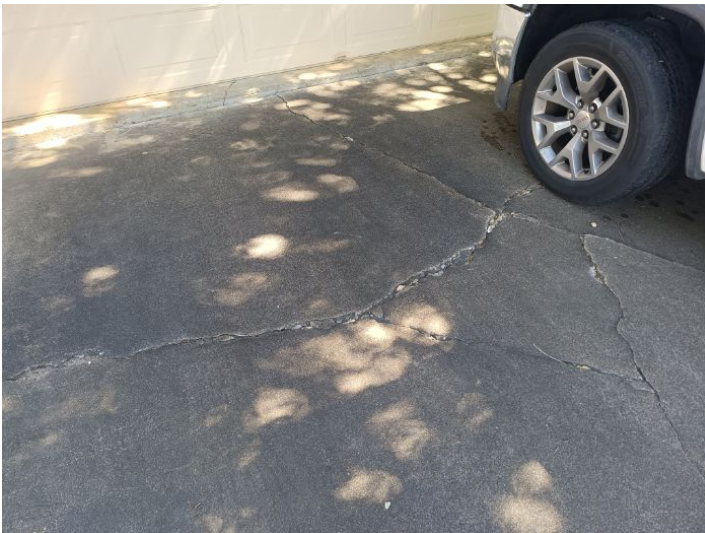
- Concrete driveway was noted
- Concrete sidewalks were noted
- Cracks were visible in the driveway that appear larger than normal settlement cracking and should be monitored
- The driveway was settled by the garage 4"

*Cracked driveway*

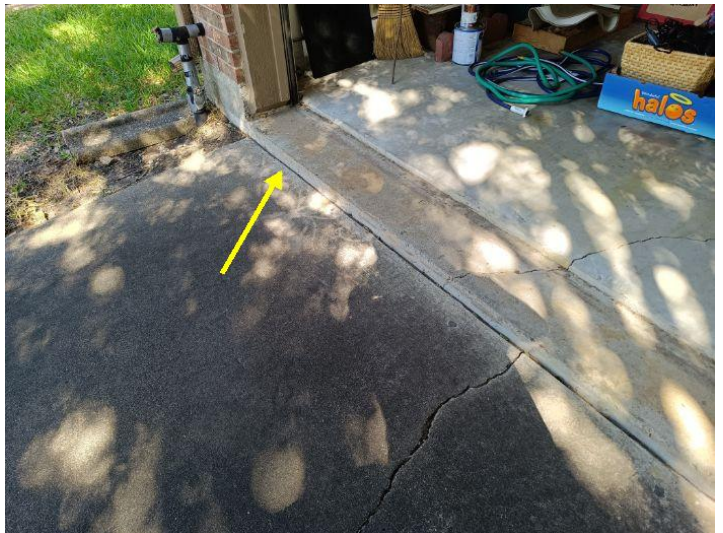
*Driveway has settled 4"*

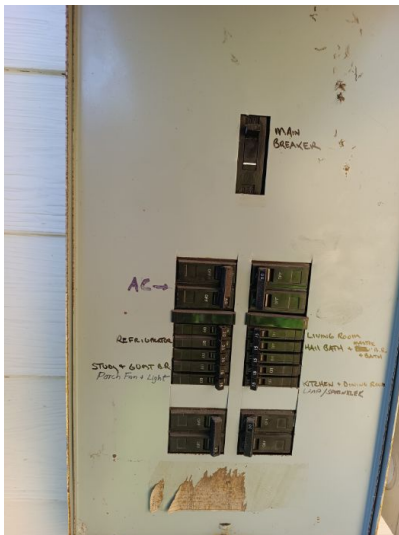
Electrical panel is not fully labeled

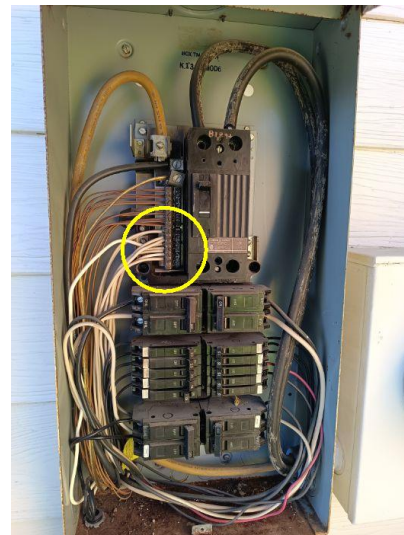
- Double tapped neutral wires were observed in the service panel. One neutral wire per screw set is the recommended installation requirement
- There are white wires in the panel that should be labeled/marked as hot wires

Electrical panel - double tapped neutral wires

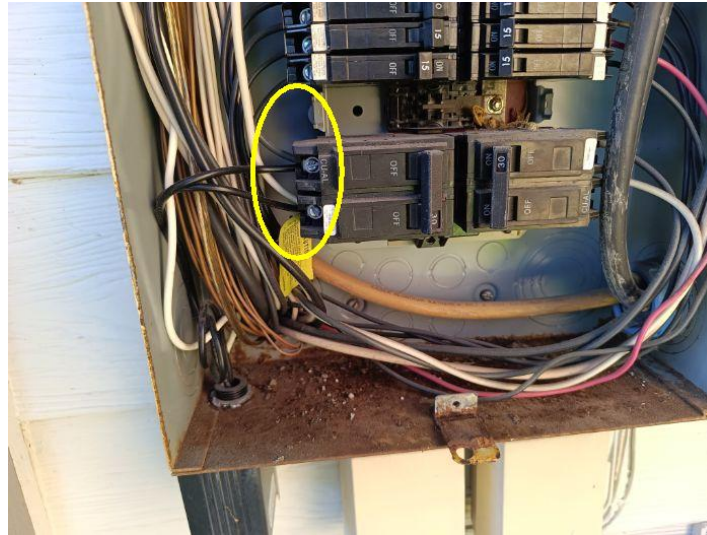
- The aluminum wiring in the service panel was not treated with anti-oxidant sealant
- Double tapped breaker was observed in the service panel. One wire per screw set is the recommended installation requirement

*Double tapped breaker*

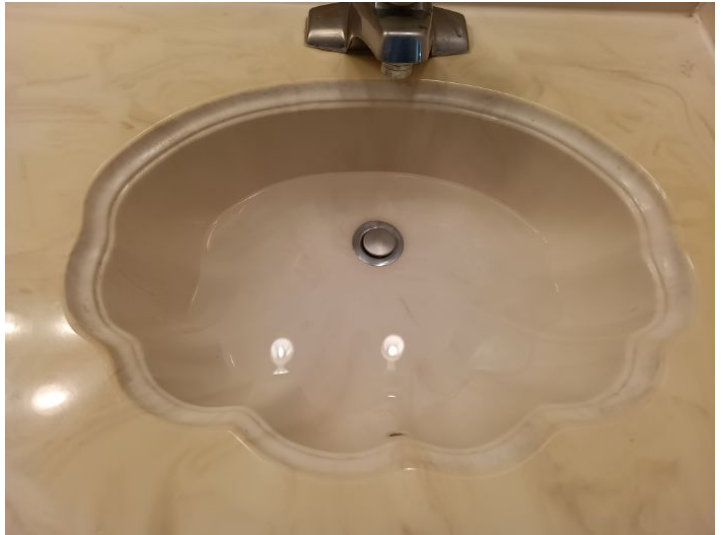
- The right primary bathroom sink is slow to drain
- The primary bathroom tub is missing an overflow drain cover and the shower has low flow
- The hall bathroom tub faucet is difficult to turn on

*Right sink in the primary bathroom is slow to drain*

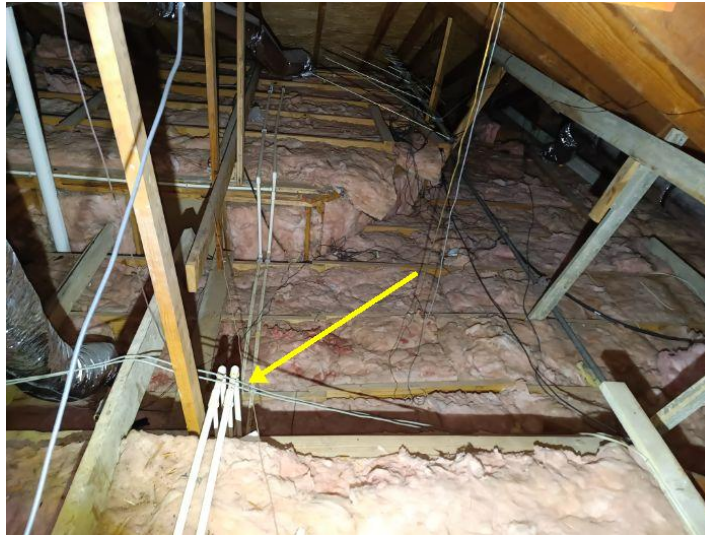
- The measured water pressure from the outside hose bib was 61 psi which is between the normal operating range of 40 - 80 psi
- Water supply pipes in the attic should be insulated to avoid freeze damage

*uninsulated pipes in the attic*

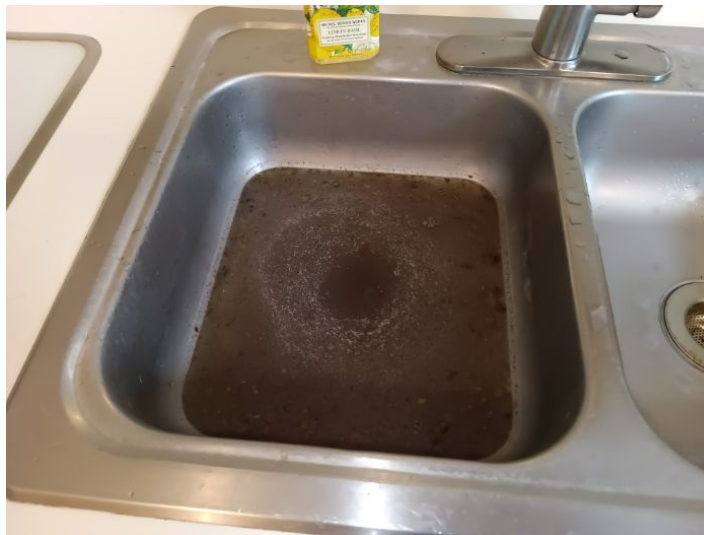
- Disposal was inoperable at time of inspection.

*Garbage disposal is non functional and the drain is plugged*
