## MECHANICAL REPORT

10814 Overbrook Ln  
Houston, TX 77042

# PROPERTY INSPECTION REPORT FORM

10814 Overbrook Ln, Houston, TX 77042

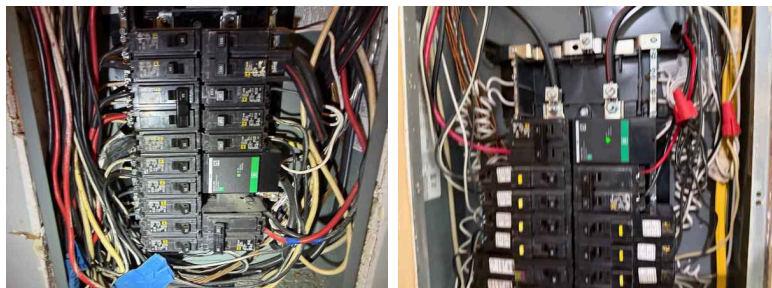
**1: No Antioxidation Solution**

The aluminum conductors were not coated with an anti-oxidation solution. Per the standards set forth by the Texas Real Estate Commission, we are required to recommend that the wires should be coated with an anti-oxidation solution, however this is not required by the current building codes.

**Obtain cost estimate**

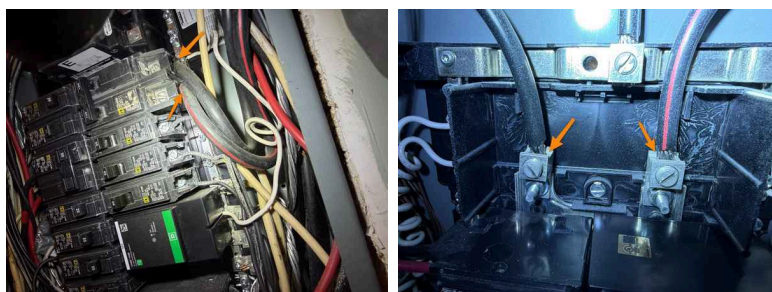
**2: Electrical Service - Undersized**

The electrical service to the property was undersized by today's standards, and it is recommended that an electrician be contacted to provide a cost estimate for all of the needed repairs to bring the electrical service and/or breaker panel into compliance with today's standards. It is pointed out that the service appears to be adequately sized for the house and equipment of the house as it was built. However, should any modifications be made to the house, the currently installed electrical service may not be adequate.

**Further investigation is recommended**

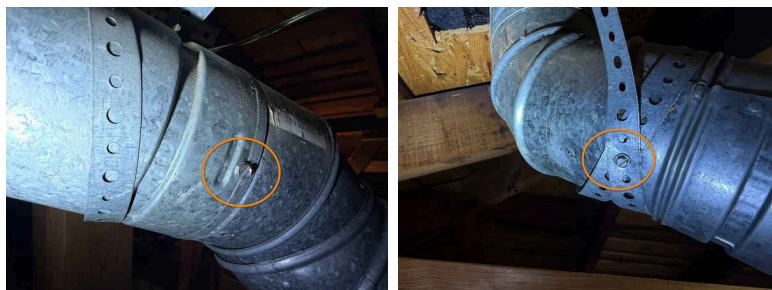
The vent pipe was fastened with screws, which is improper. The vent is designed to connect without fasteners, as screws holes can allow carbon monoxide to seep from the vent pipe. The portions of the vent pipe that were damaged with screws should be repaired.

**Obtain Cost Estimate**

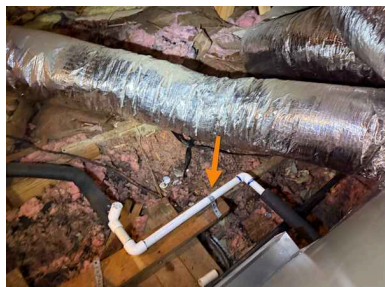
**1: Primary Drain Line - Missing insulation**

A portion of the primary condensate drain line was missing insulation which can cause the drain line to "sweat" and drip water. The drain line should be insulated for the first 10 feet to prevent condensation from forming on the drain line.

**Obtain Cost Estimate**

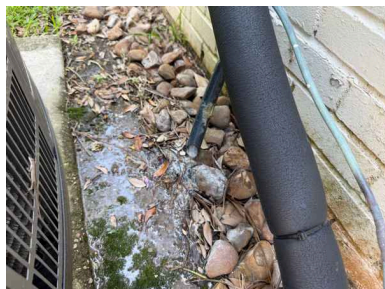
**2: Primary Drain Line - Terminated outside**

The primary condensate drain line terminates outside at the side of the foundation. Over time, the constant moisture that is produced by the HVAC system and emptied onto the ground can contribute to foundation

**Obtain Cost Estimate**

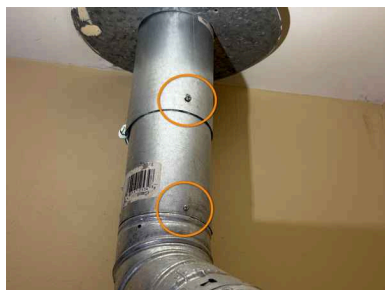
**2: Vent Pipe - fastened with screws**

The vent pipe was fastened with screws, which is improper. The vent is to be mechanically fastened only, and repair is needed.

**Obtain Cost Estimate**

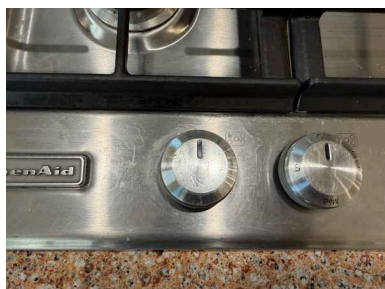
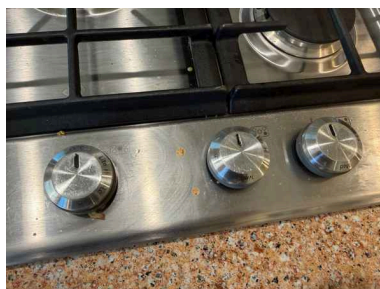
**1: Control Knobs - Settings Not Visible**

The settings for the control knobs were not visible and repair is needed for the safe use of the appliance.

**Obtain Cost Estimate**

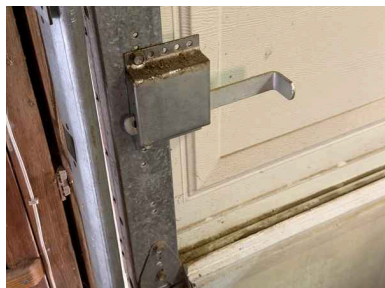
**1: Door Lock**

The door lock was still connected to the garage door. Manufacturers of garage door openers recommend that the locks be disengaged or removed when an automatic opener is installed. Damage to the door and/or door opener may occur if the door is operated with the garage door lock is engaged.

Recommendation: Contact a qualified professional.
