## STRUCTURAL REPORT

10814 Overbrook Ln  
Houston, TX 77042

07/30/2026

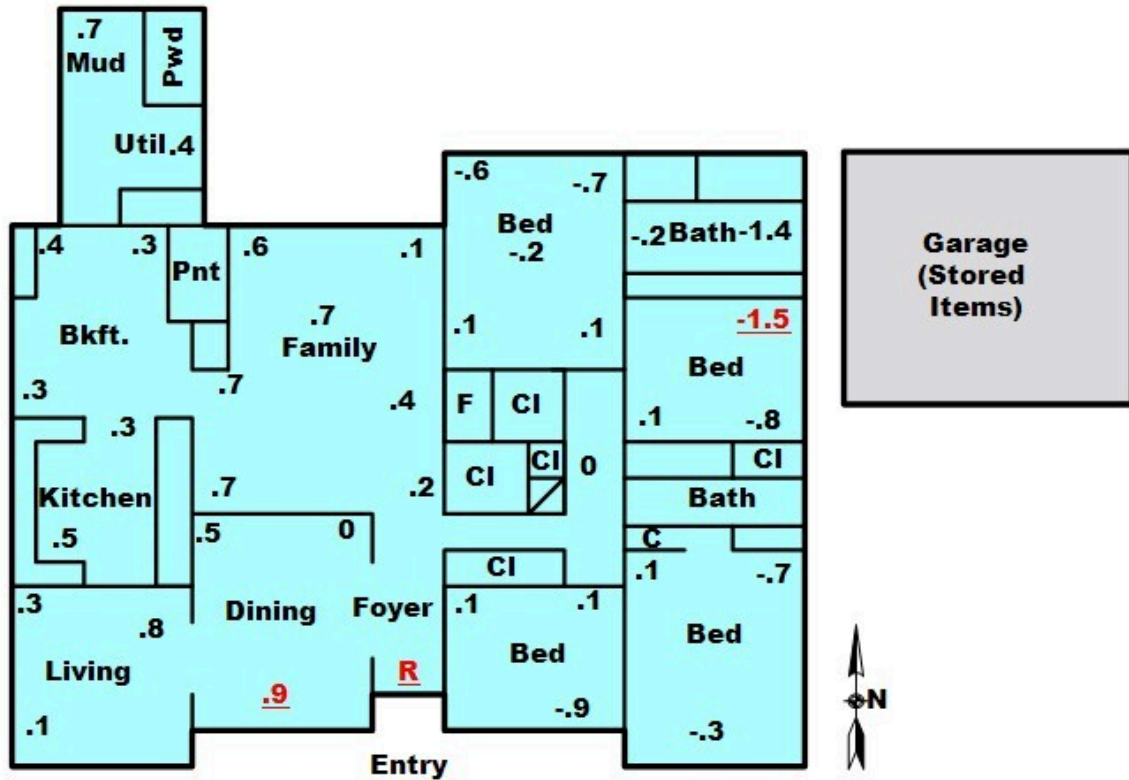
**Elevation Readings**  
**10814 Overbrook Ln**  
 (Not to scale)

The floors were checked with an electronic level, and were observed to be sloping a more than normal degree. The difference in elevation between the high point and low point was 2.4 inches. The high point was located at the dining room, and the low point was located at the east bedroom. The unlevelness takes place over a horizontal distance of approximately 40 to 45 feet.

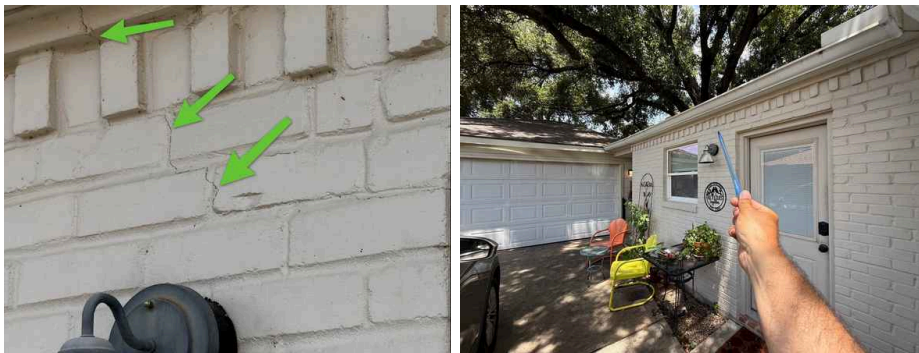
Cracks and/or patches were observed in the exterior veneer at the time of the inspection, including at the locations shown in the photos. It is recommended that the cracks be repaired for cosmetic purposes.

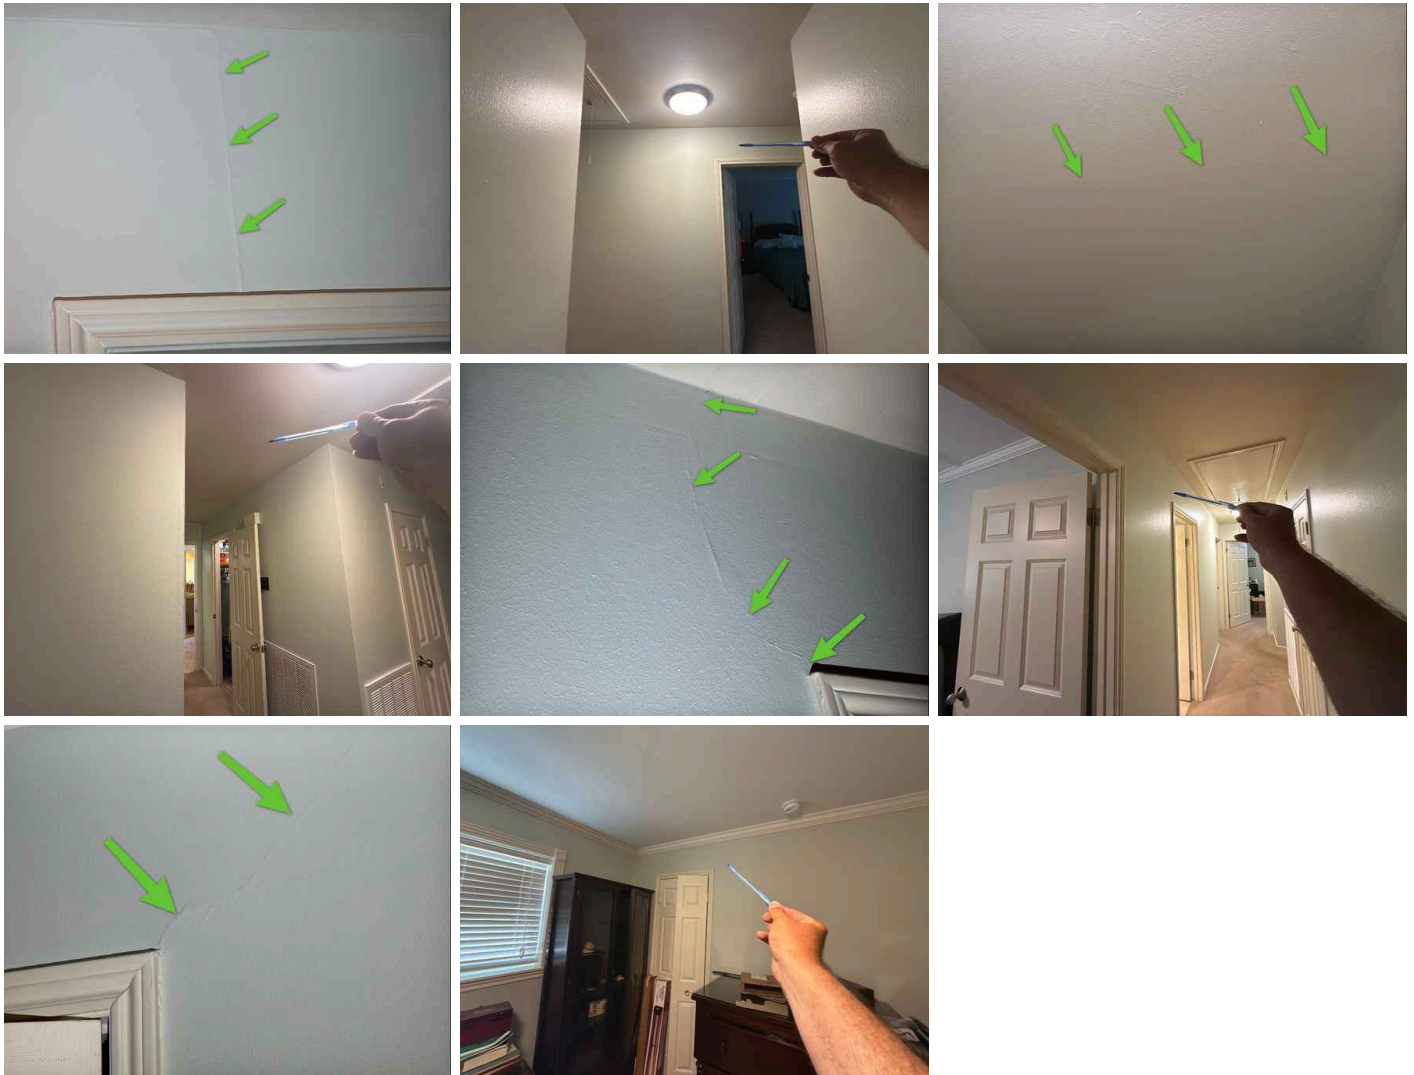
Sheetrock cracks, patches, and/or compression ridges were observed in the house during the inspection, including as shown in the photos below. It is recommended that the cracks be cosmetically repaired.

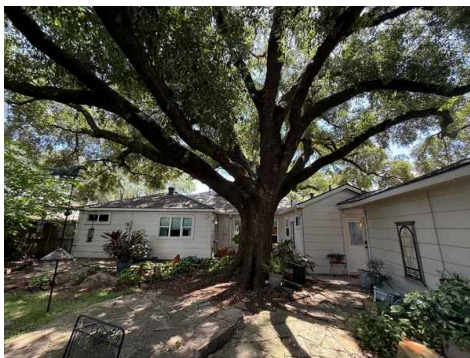
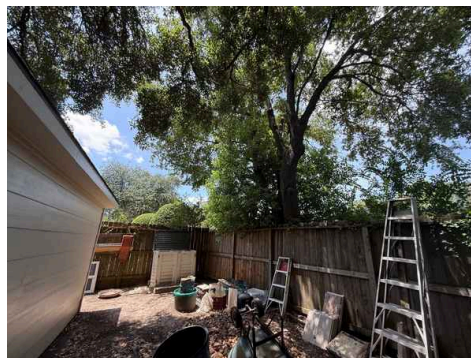
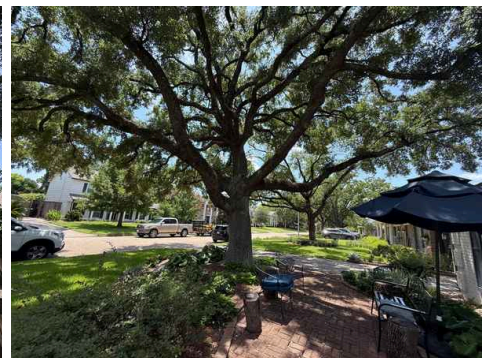
Trees and/or foliage were observed in the vicinity of the house which can contribute significantly to differential movement of the house foundation. Care should be taken to prevent the trees and foliage from removing an excessive amount of water from near the foundation of the house.

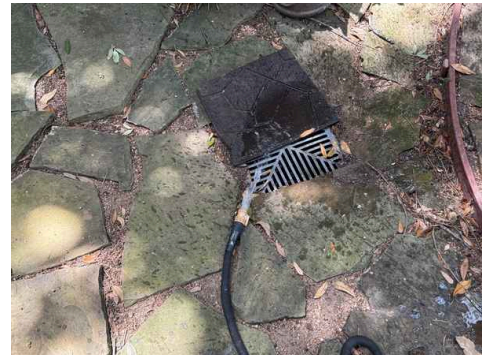
The underground drainage system at the rear of the house was checked by running water into the drain, and the system was observed to be draining properly. However, we could not determine the exit point of the drainage system, and further investigation with the homeowner and/or a service company is recommended.

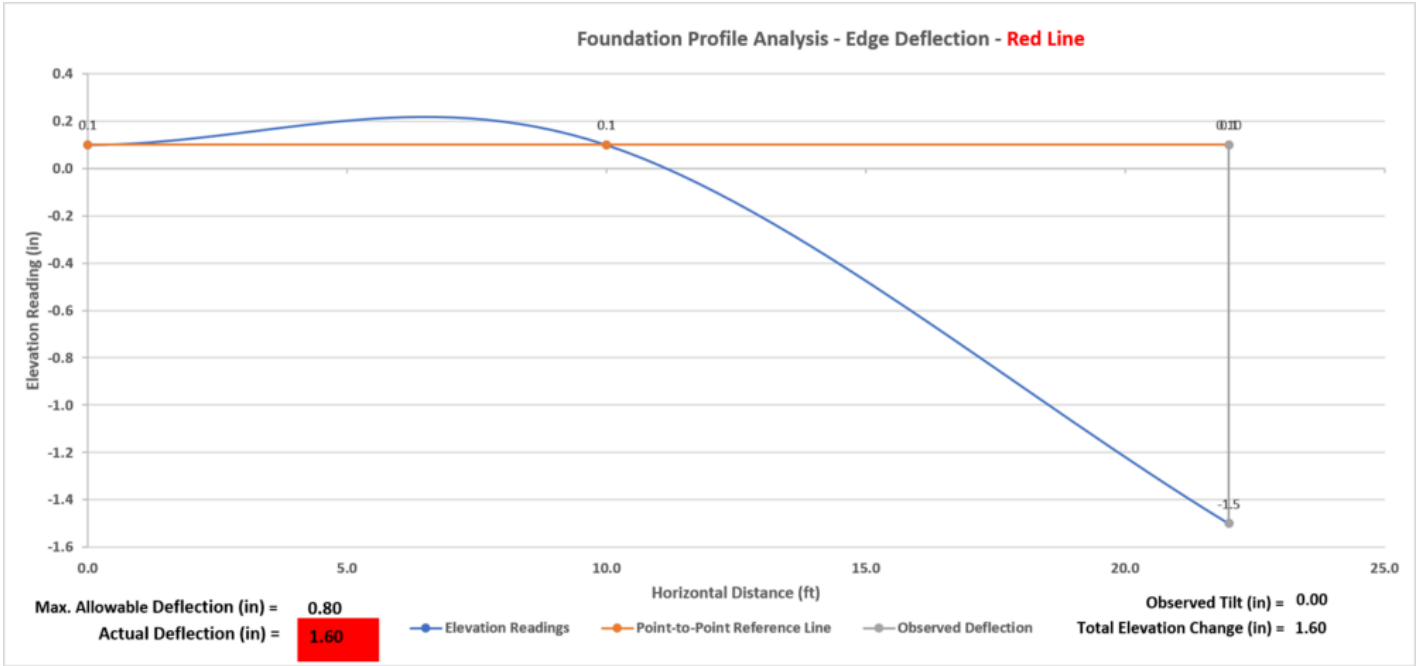
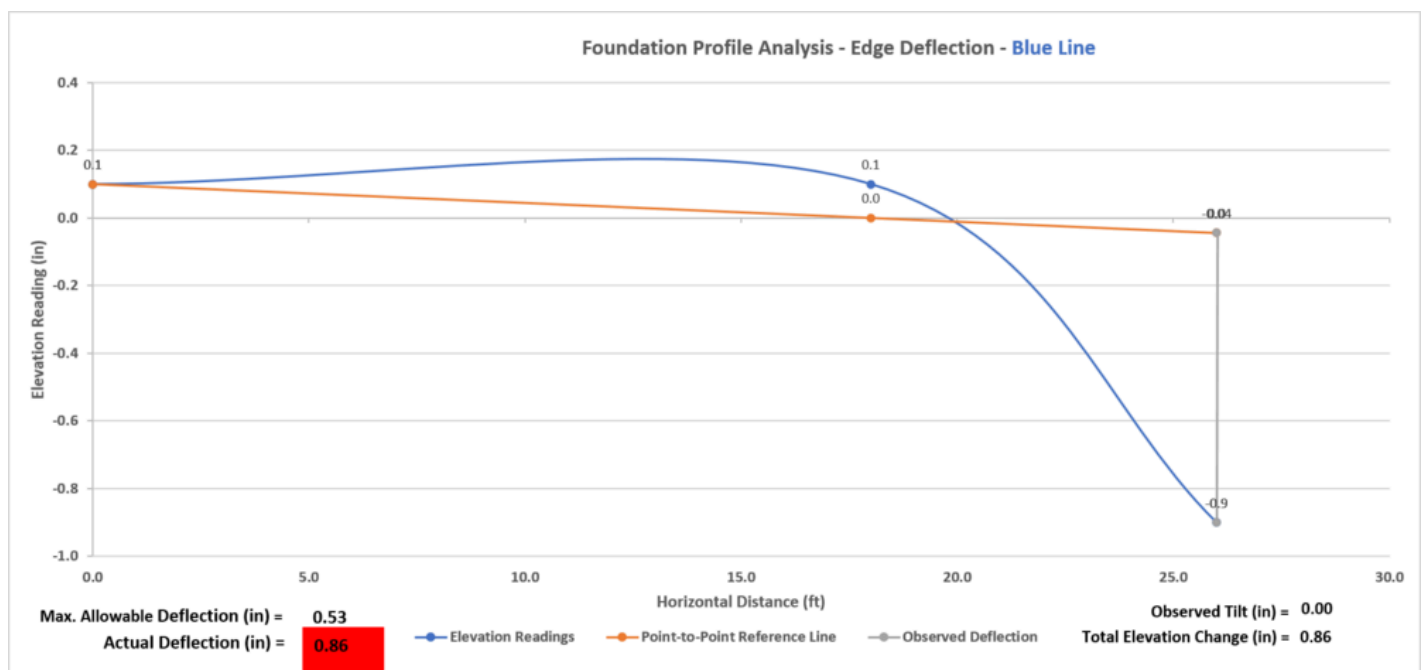
From the point of curvature located at the master bedroom to the east bedroom ( $L = 22$  feet), the maximum allowable deflection is 0.80 inches. We calculated a deflection of 1.60 inches at the time of inspection across this span, which is **greater than the maximum allowable deflection**. This observation can be observed along the **Red Line** in the sketch below.

Additionally, we analyzed the foundation a second time at a different location for **localized edge-condition deflections**. From the point of curvature located at the master bedroom to the south bedroom ( $L = 26$  feet), the maximum allowable deflection is 0.53 inches. We calculated an actual deflection of 0.86 inches at the time of inspection across this span, which is **greater than the maximum allowable deflection**. This observation can be observed along the **Blue Line** in the sketch below.

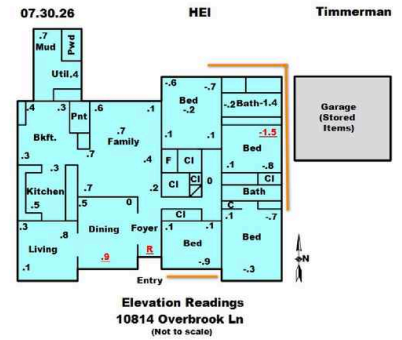
Suggested Area in Need of Repairs.

After observing the interior and exterior of the house, it is my opinion that the foundation has not been brought back to within an acceptable degree of levelness. The floors and other normally horizontal surfaces were still sloping an unacceptable degree at the east bedroom and south bedroom.

Due to the above condition, the foundation is in need of further releveled work at the locations described above. It is recommended that the foundation repair company that performed the repair work be contacted concerning the unacceptable degree of levelness and the necessary steps taken to correct the problem.

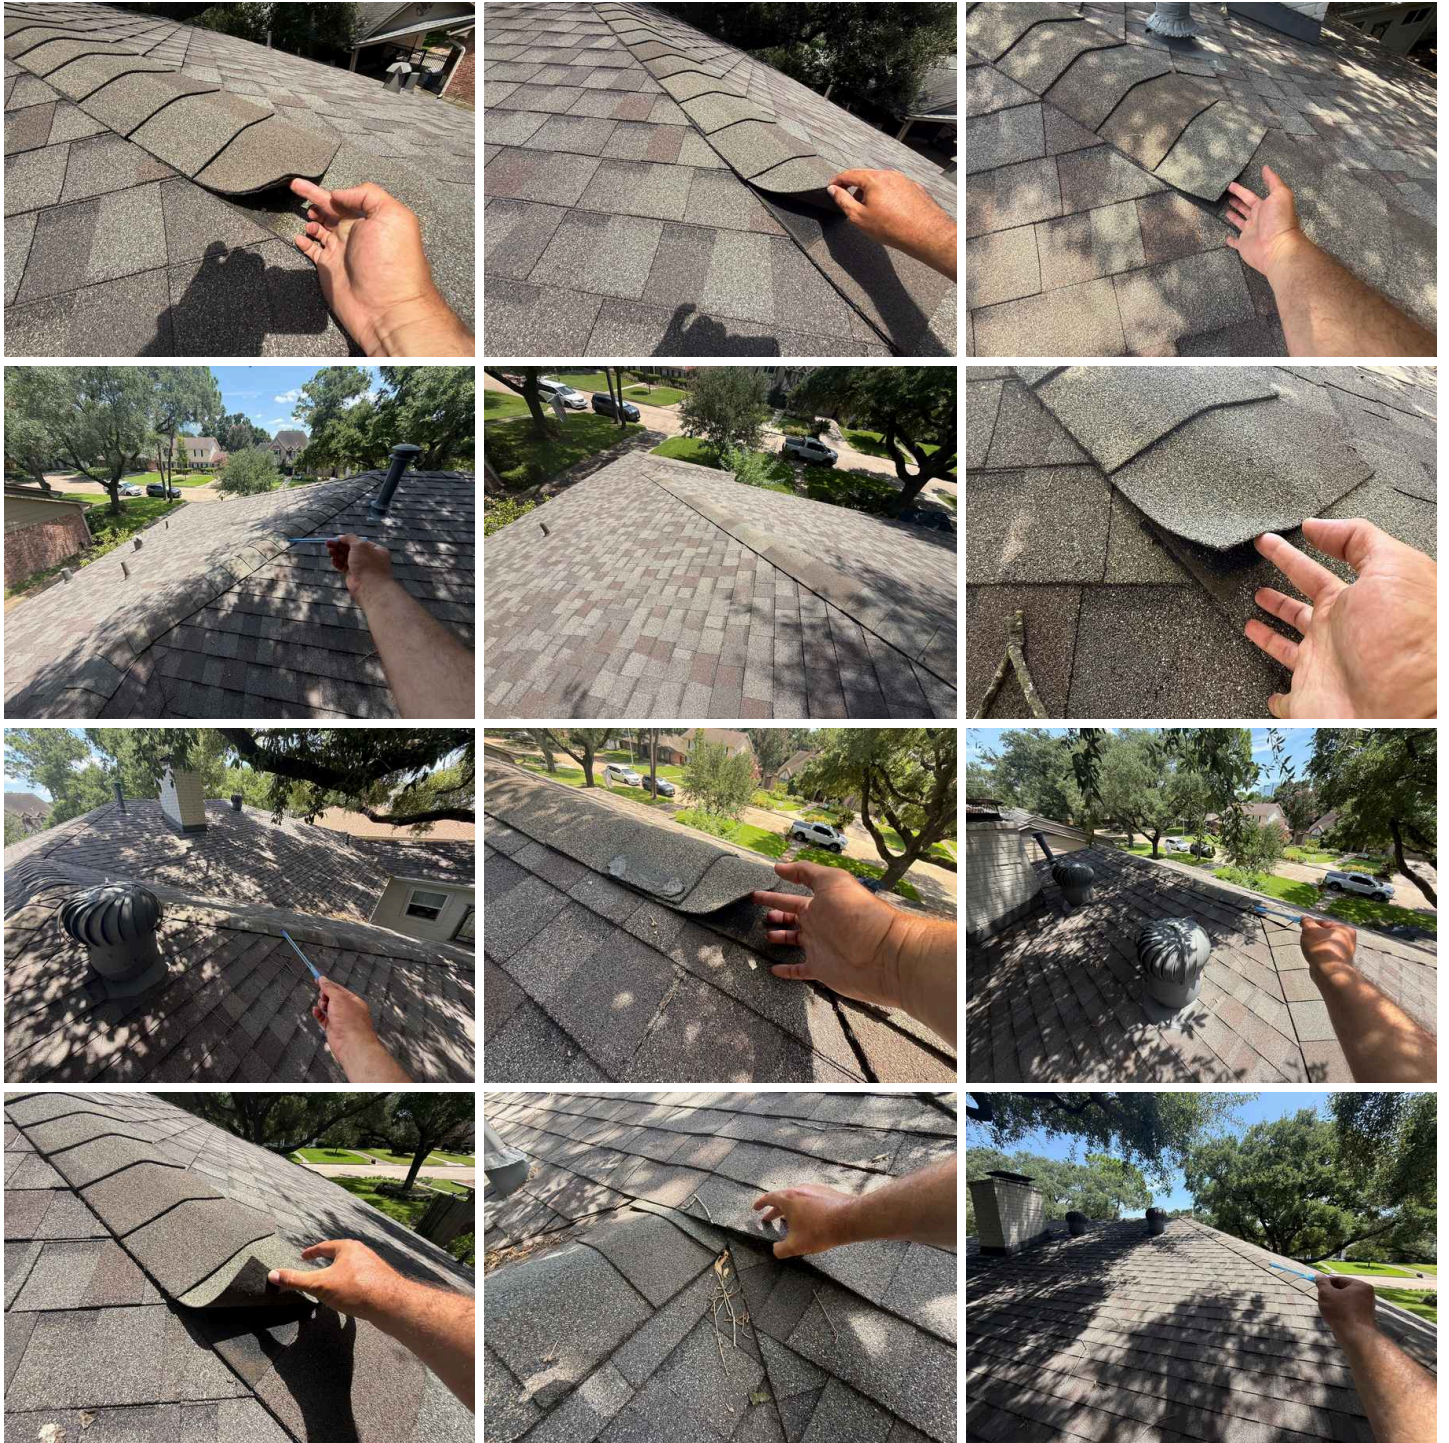
**SHINGLES LOOSE**

We observed shingles that were loose or, and need to be repaired/replaced.

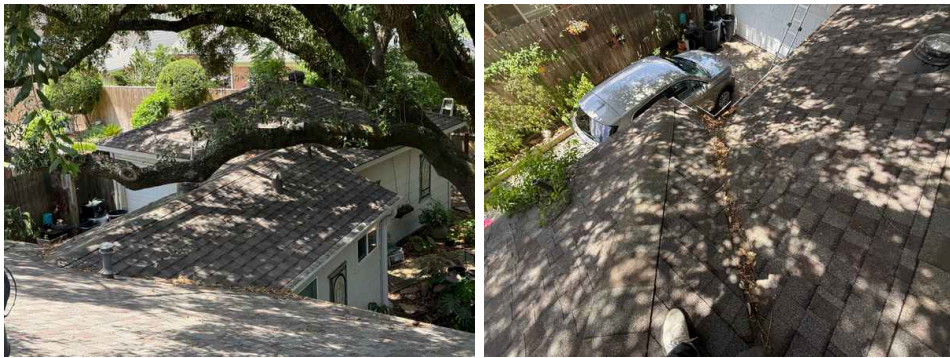
We observed some miscellaneous items related to the surface of the roof, including the items listed above. Have a roofing company determine the entire scope of the condition, and provide a cost estimate for repairs.

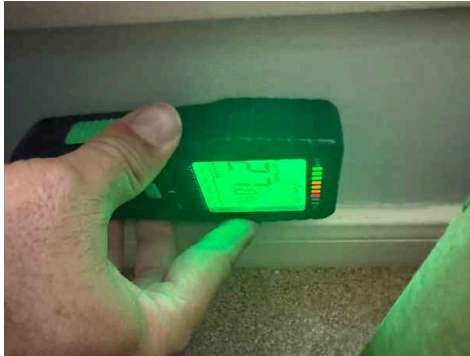
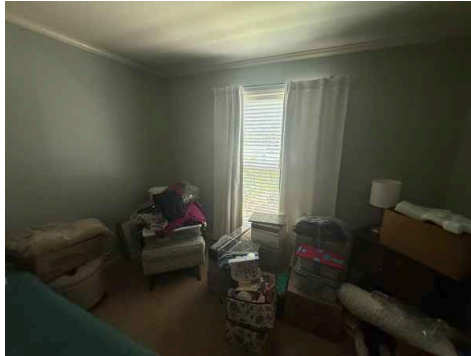
We checked around window and door openings and other locations susceptible to moisture with a moisture meter, and evidences of possible water penetration to the interior of the structure were observed, including the following conditions described above and shown below. Further investigation is recommended with service companies to determine possible source(s) of water penetration along with the scope of all secondary damages, and also to provide a cost estimate for all needed repairs.

Our moisture meter showed a higher than normal reading as shown in the photos below.

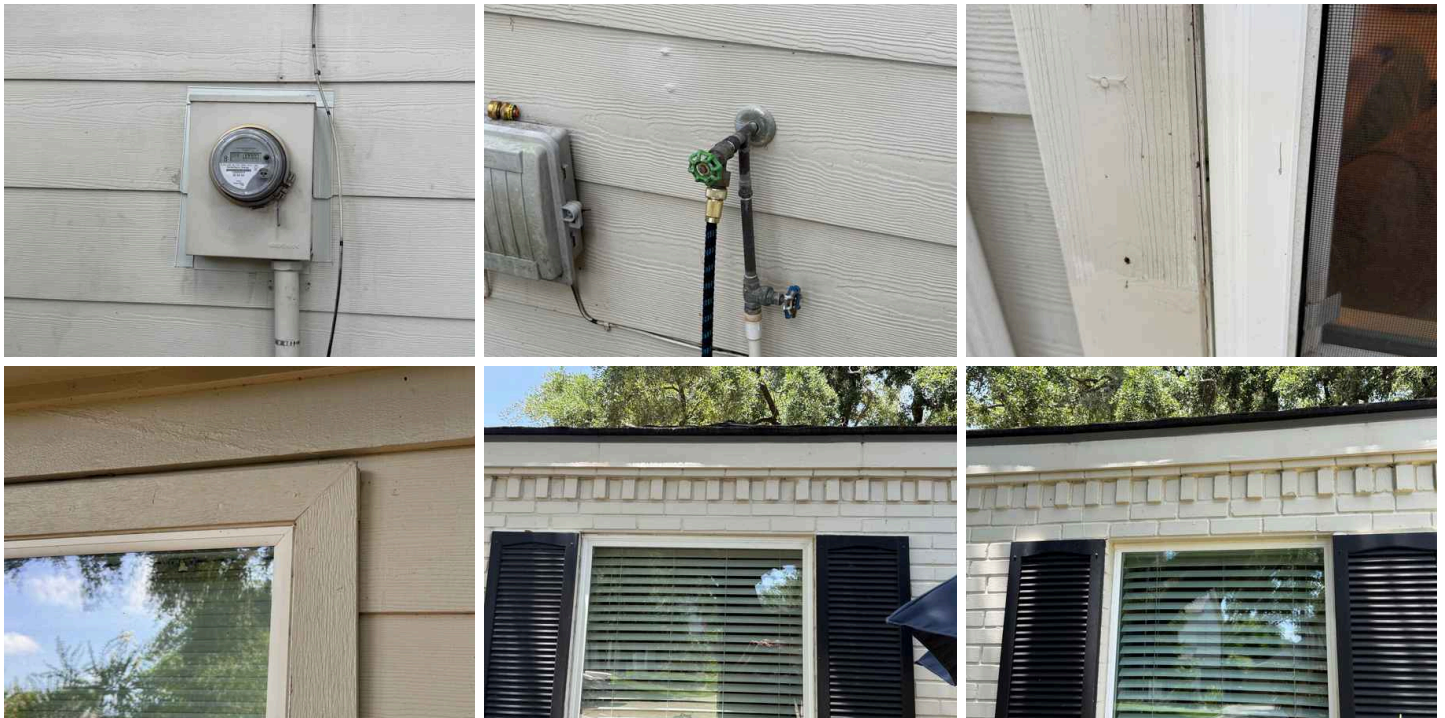
Sealants deteriorated/missing, Weepholes missing above steel lintel at windows and/or doors, Flashing missing

A substantial vulnerability to water penetration was observed at penetrations/openings through the exterior building envelope, and it is recommended that all penetrations/openings be sealed against water penetration. Typical examples on a structure may include light fixtures/outlets, electrical panels, air conditioning refrigerant lines, water piping, gas piping, vent caps, windows, doors, expansion joints, cracks/voids in brick/stone veneer, chimney caps, etc. Below is a representative sample of locations and/or photographs showing some, but not necessarily all, locations where there is a vulnerability to water penetration. Have a contractor determine the entire scope of water entry vulnerability provide a cost estimate to seal all vulnerable areas on the exterior building envelope against water penetration and/or open up any clogged weepholes in the veneer.

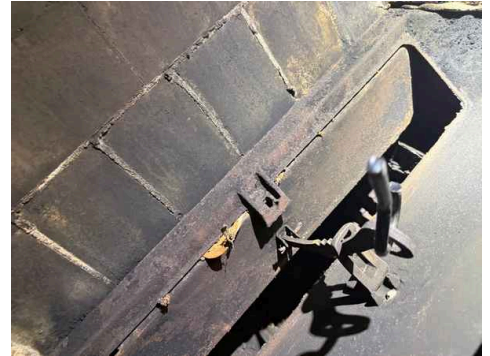
The damper was not equipped with a C-Clamp device to prevent closing the damper completely to allow the hazardous combustion gases a path to escape up the chimney.

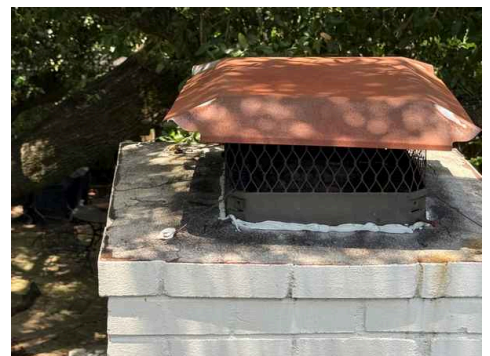
The cap was rusted and needs to be cleaned and sealed to prevent further deterioration. Also, the masonry cap at the top of the chimney was cracked/broken, and needs to be repaired to prevent water penetration.

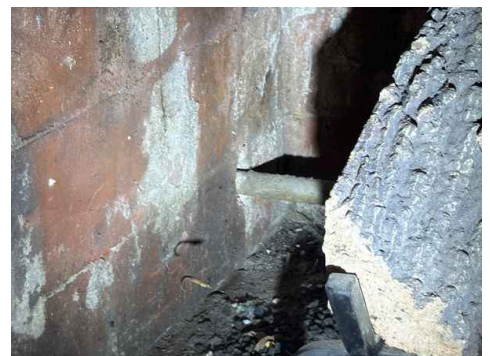
Mortar was observed to be missing at the firebox at the point where the gas line penetrates the firebrick.

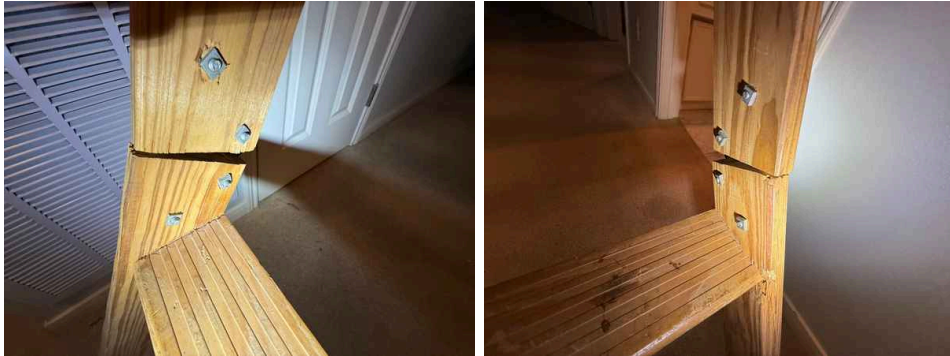
The stair assembly was not properly installed or secured to the framing members, and repair is needed for safety purposes. The condition(s) can be a safety hazard, and repair is needed, as an improperly installed stair assembly can possibly collapse.

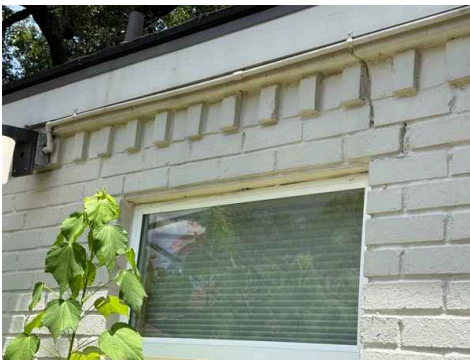
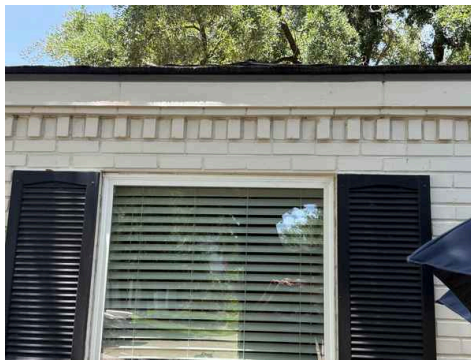
The weepholes were missing in the bricks at the lintel above the window/door in a brick wall. Weepholes are intended to be gaps left in the course of bricks installed above a lintel on a brick wall to allow moisture behind the bricks a path to exit the wall cavity, and also to allow for some ventilation inside the wall cavity. This requirement is typically grandfathered for older houses, and is not required. However, it is recommended that consideration be given to having the weepholes installed to help protect against water penetration.

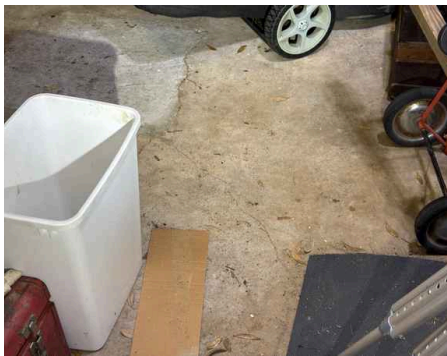
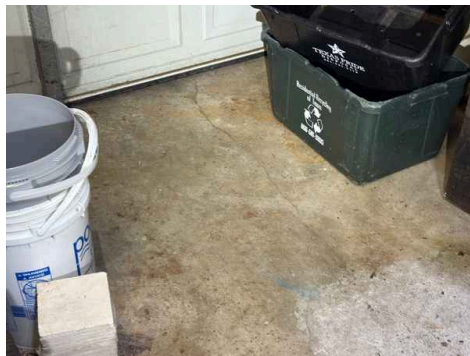
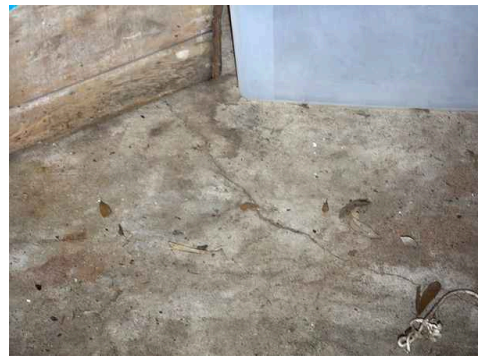
The concrete floor of the garage was observed to have one or more cracks, but was still functional at the time of the inspection. The exterior perimeter of the garage has experienced some settlement, but the degree is not such at this time to recommend foundation releveling. The garage foundation should be monitored in the future for additional movement as it can be expected that additional movement can take place.

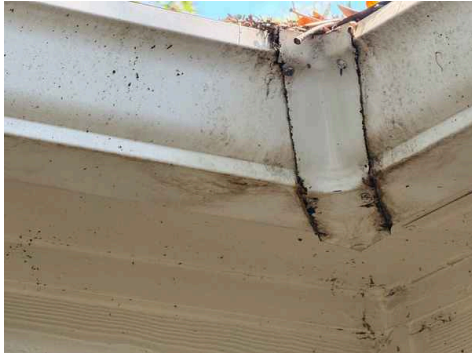
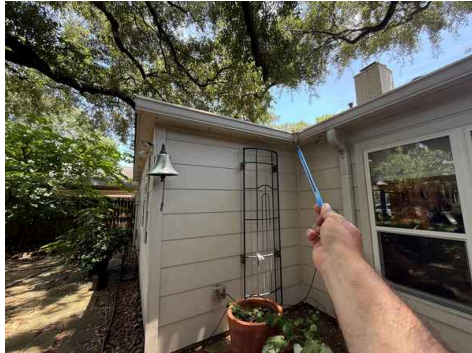
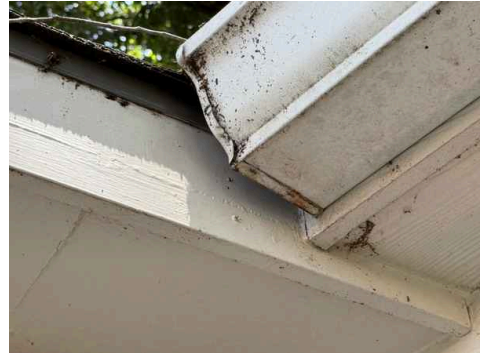
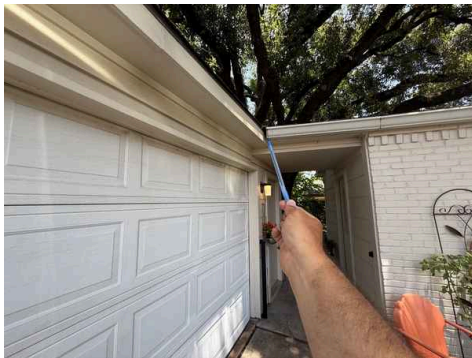
Leaking/Jts.

The gutters had item(s) in need of repair as listed above.

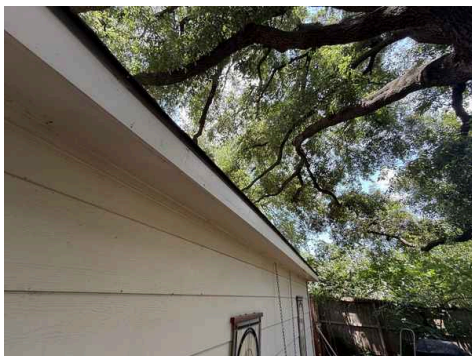
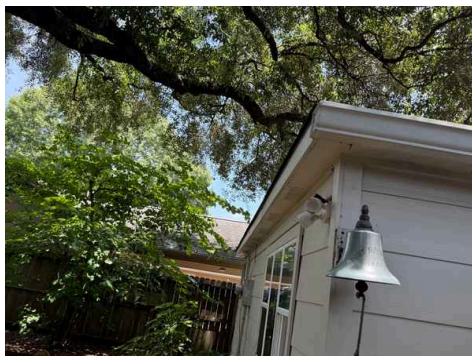
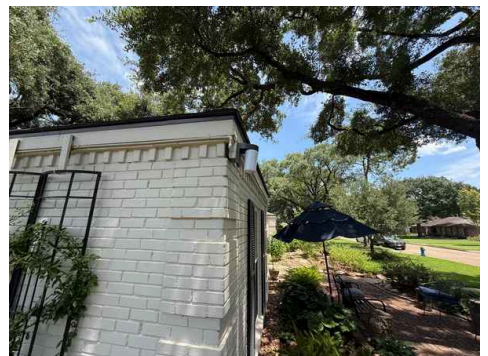
Minimal gutters have been installed on this house, and it is recommended that additional be installed to help control differential foundation movement and prevent wood rot and water entry.

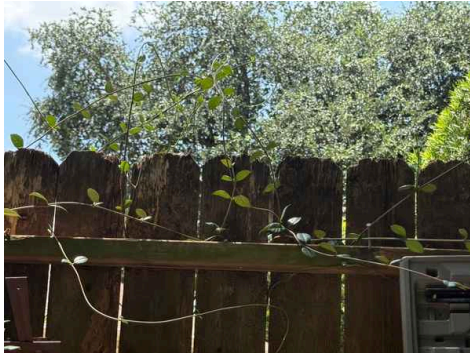
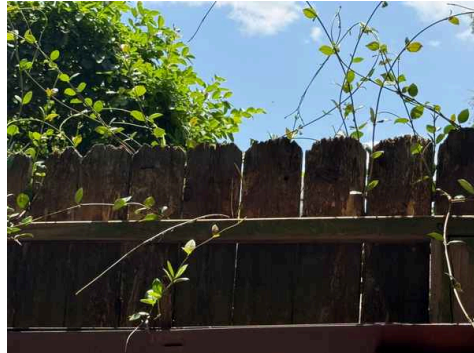
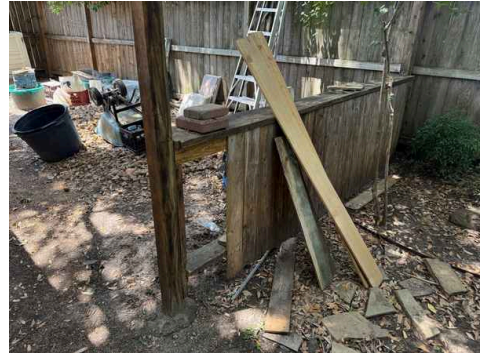
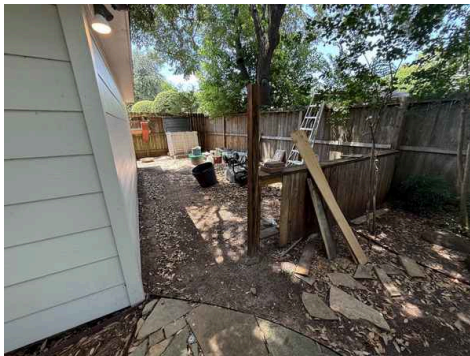
Starting to rot, Not Completed at the Rear of the Garage

The wood fence was in need of some repairs.

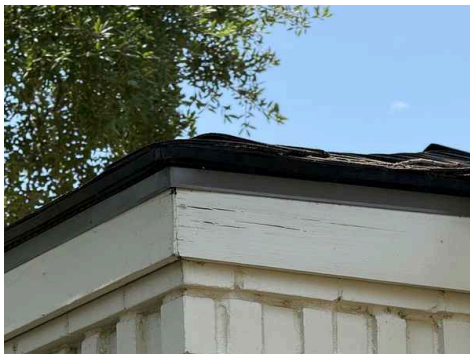
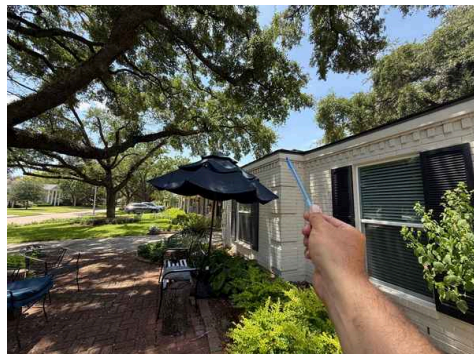
We observed evidences of wood decay and it is recommended that all decayed wood be replaced. Below are a representative sample of photos showing some, but not necessarily all, of the deteriorated wood/trim. Have a contractor determine the entire scope of the wood decay throughout the house, and provide a cost estimate to replace all decayed wood in the house.

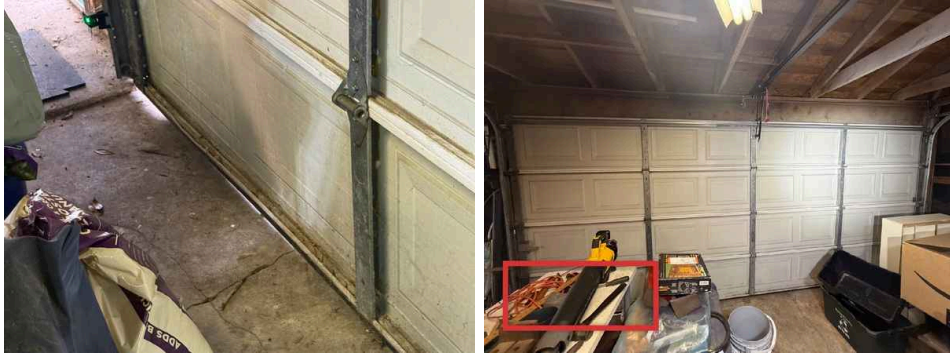
A gap was observed between the door and the foundation when the garage door was closed. It is recommend that a contractor be contacted to make the needed repairs to provide a proper seal at the bottom of the door to prevent pest from entering under the door.

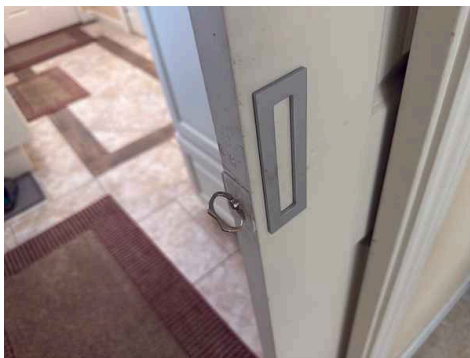
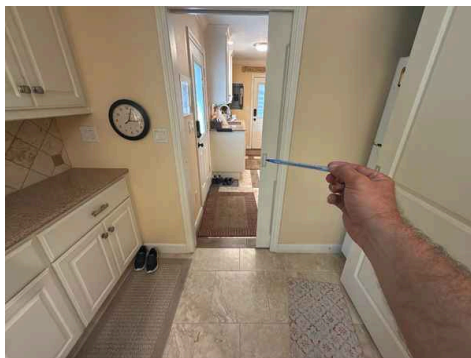
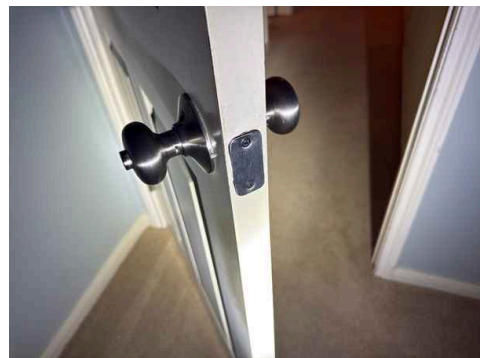
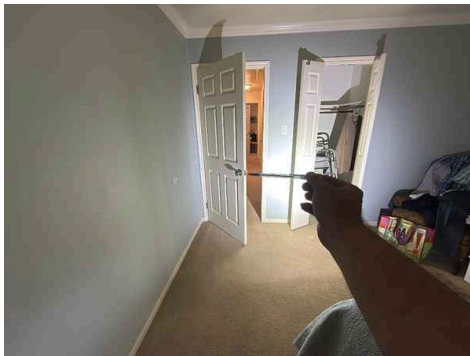
Doors had missing hardware that needs to be replaced. Have a service company provide a cost estimate.

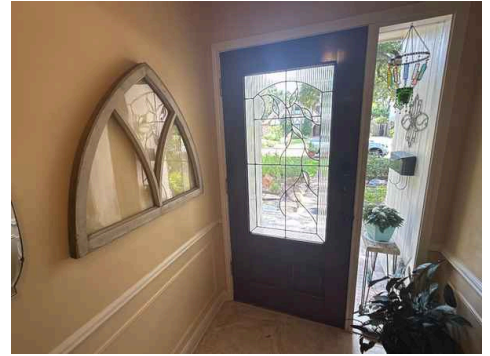
The glass in the door was not marked as being safety glass as required. Contact a service company to make the needed repairs.

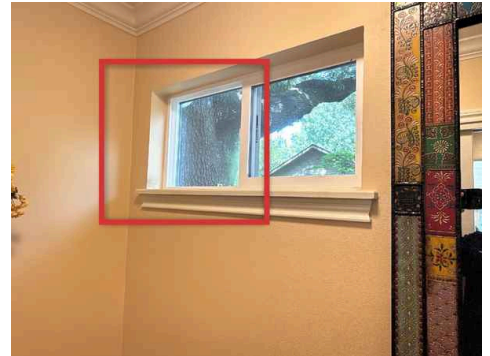
One or more double pane windows were observed where the seal has been compromised and allowed moisture between the two panes. It is pointed out that we were not able to view every window under differing lighting conditions at different times of the day, and we may not be able to see discoloration that may become visible under different lighting and/or weather conditions, other than at the locations listed below. Further investigation with a window specialist is recommended concerning the windows to determine the extent of the condition throughout the house, and to make all needed repairs.

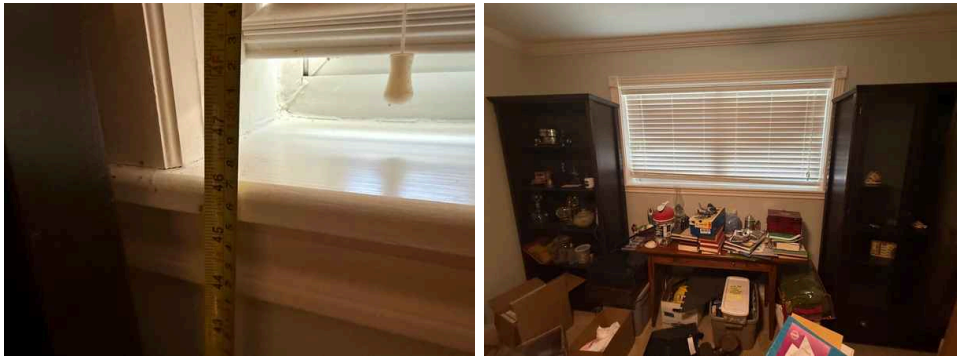
WINDOW GREATER THAN 44 INCHES ABOVE GRADE

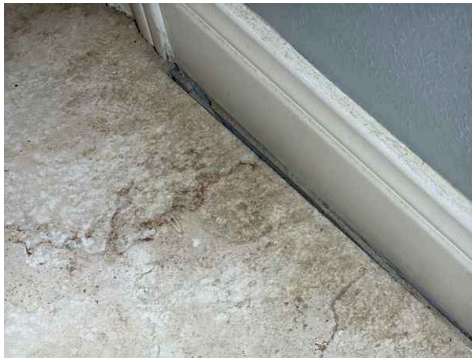
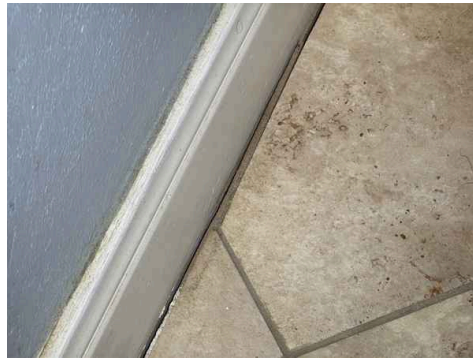
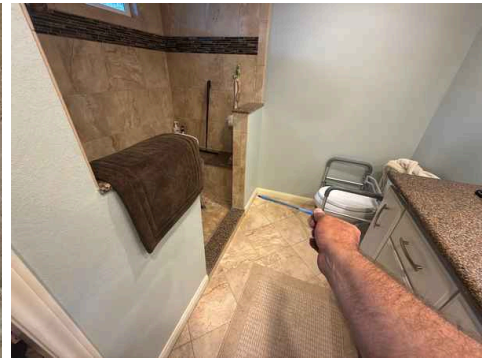
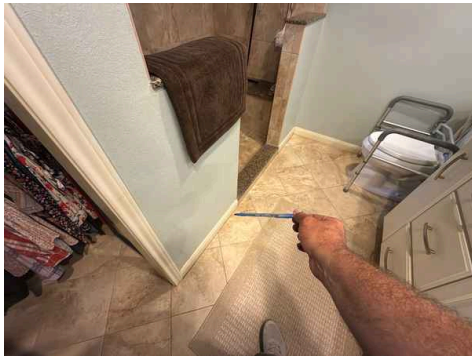
The grout was cracked/missing and needs to be repaired.
