# ***Fox Inspection Group***

## **Frame Inspection Report**

13802 Arroyo Grande, Cypress, TX 77433  
Inspection prepared for: Jorge Galeano  
Real Estate Agent: Aaron Greeley - CB&A, Realtors

Date of Inspection: 9/21/2023 Time: 9:00 AM  
Age of Home: 2023 Size: 3001  
Order ID: 108701

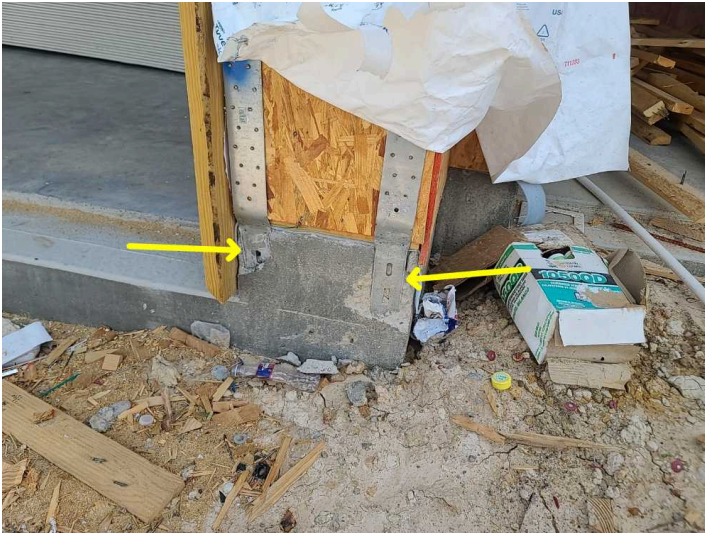
Framing straps appear to have been placed to close to edge during the pour, causing concrete to spall; between garages.

Framing straps appear to have been placed to close to edge, causing concrete to spall; between garages.

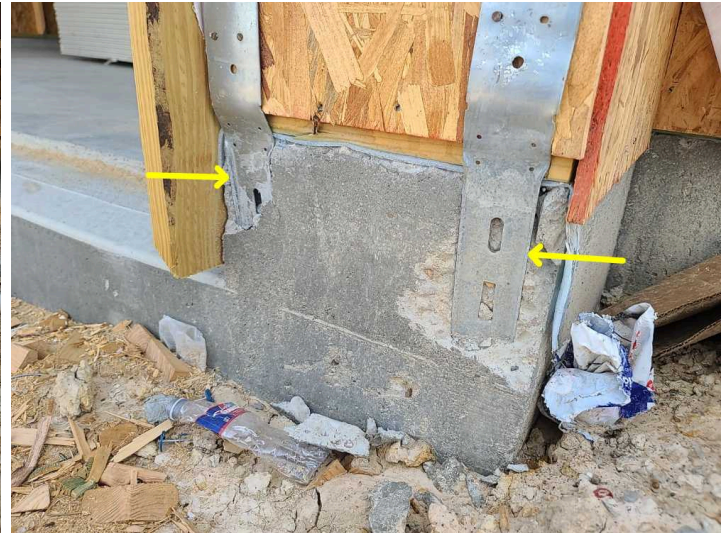
Framing straps appear to have been placed to close to edge, causing concrete to spall; between garages.

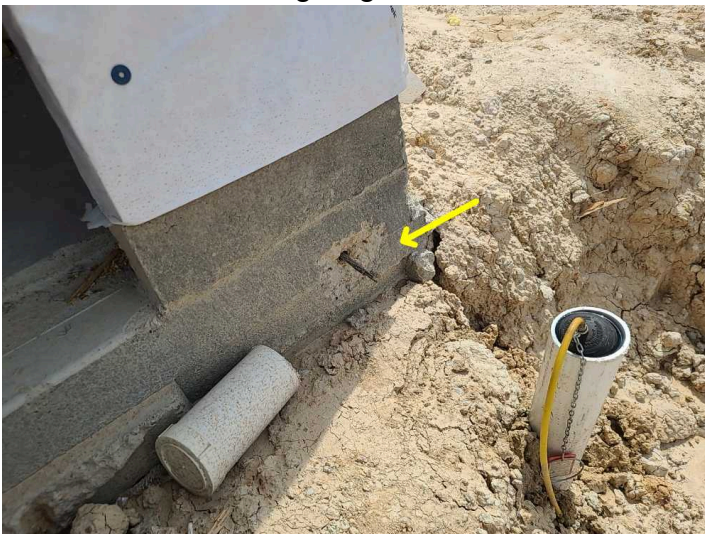
Post tension cable live ends are exposed/ not cut back at all four corners.

Post tension cable live ends are exposed/ not cut back at all four corners

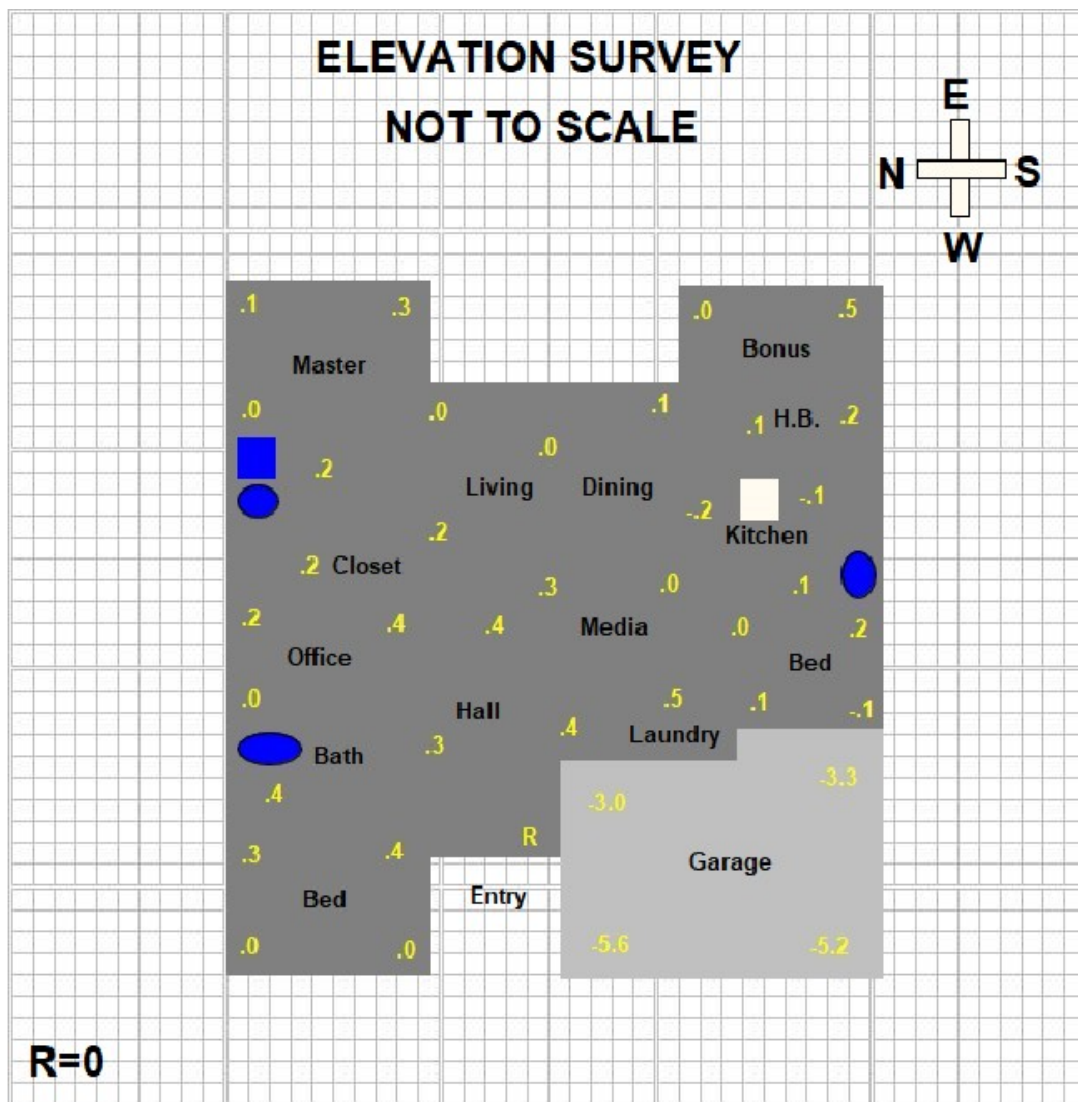
A foundation elevation survey was conducted during the inspection. The floor plan drawing (not to scale) below represents data gathered using a Zip Level. Measurements are listed to the nearest 1/10th of an inch. The greatest variance was 0.5 to -0.1

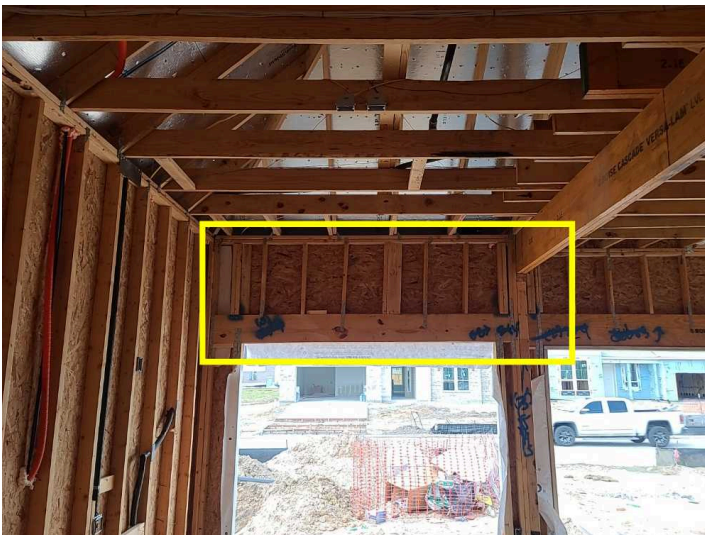
Framing above single bay garage header is not square/ leaning to the right.

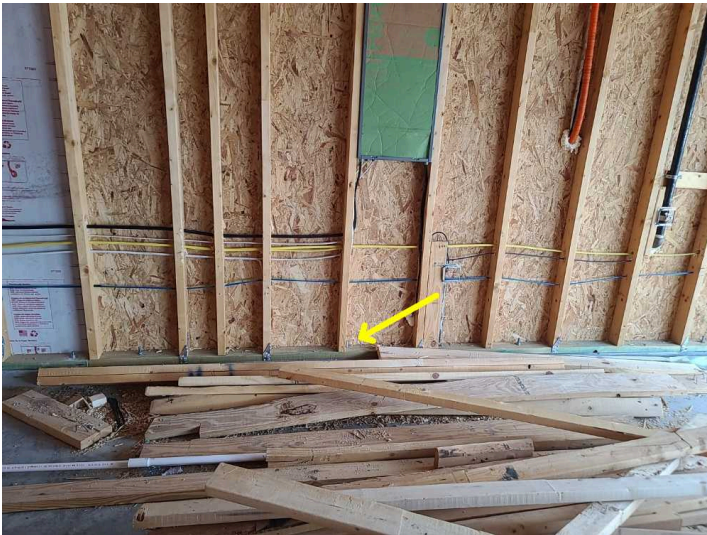
Wall framing not properly attached to foundation, missing a threaded bolt, washer, and or a nut; Northwest corner/ bedroom, and garage.

Wall framing not properly attached to foundation, missing a washer, and a nut; garage

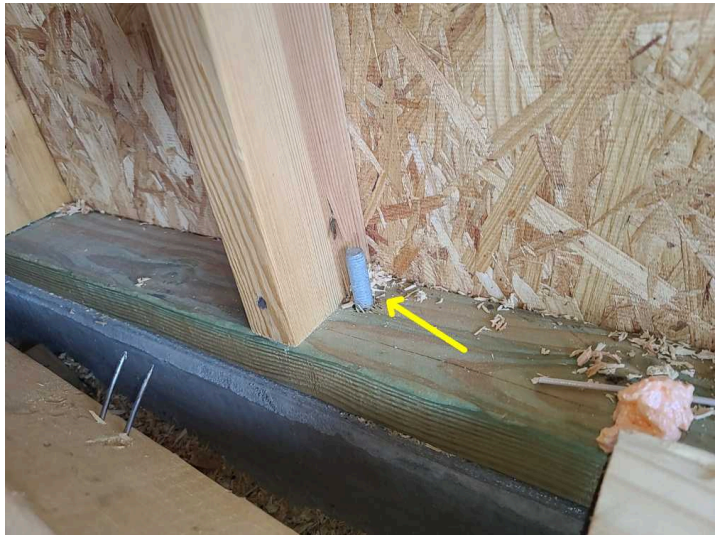
Wall framing not properly attached to foundation, missing a washer, and a nut; garage

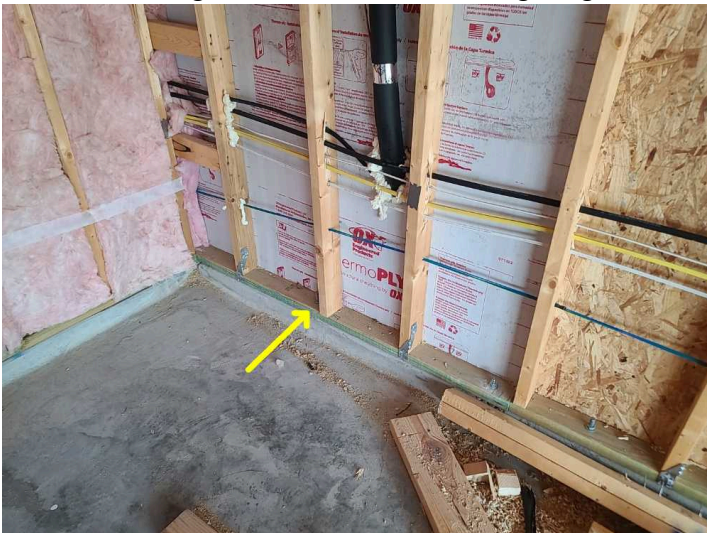
Garage wall stud is not flush with sole plate. May cause a bow in sheetrock; South wall.

Garage wall stud is not flush with sole plate. May cause a bow in sheetrock.

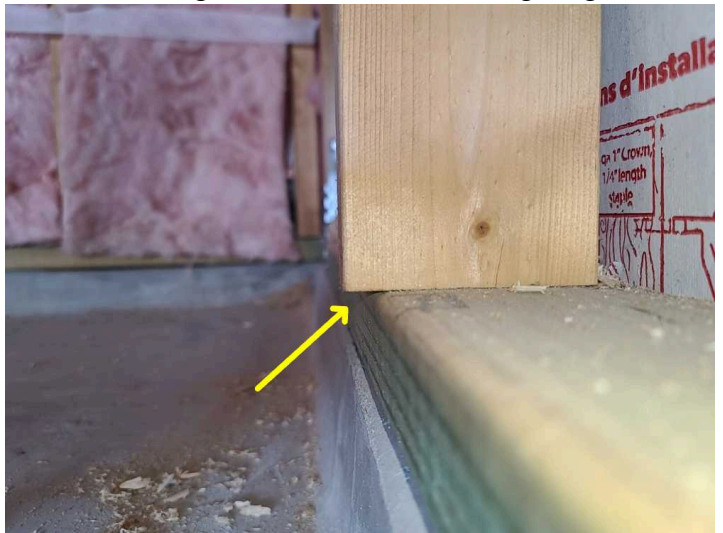
Garage wall stud is not flush with sole plate. May cause a bow in sheetrock.

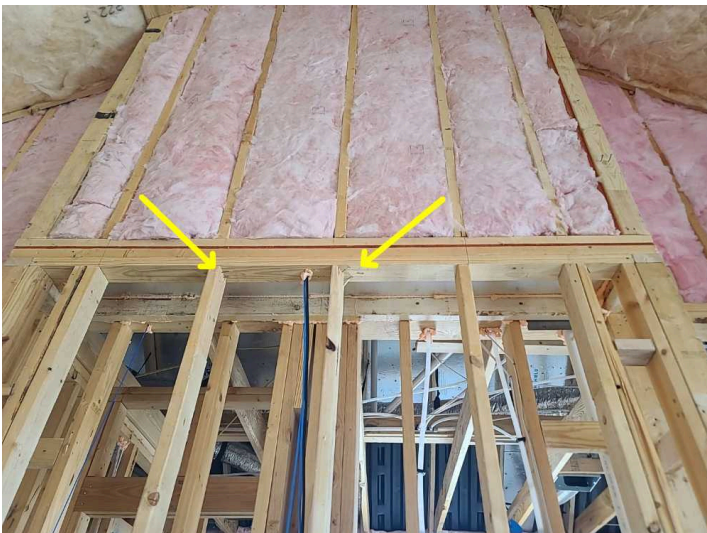
Non load bearing framing/ stud above fireplace is damaged and are not completely nailed in place properly.

Framing/ stud above fireplace is damaged and are not completely nailed in place properly.

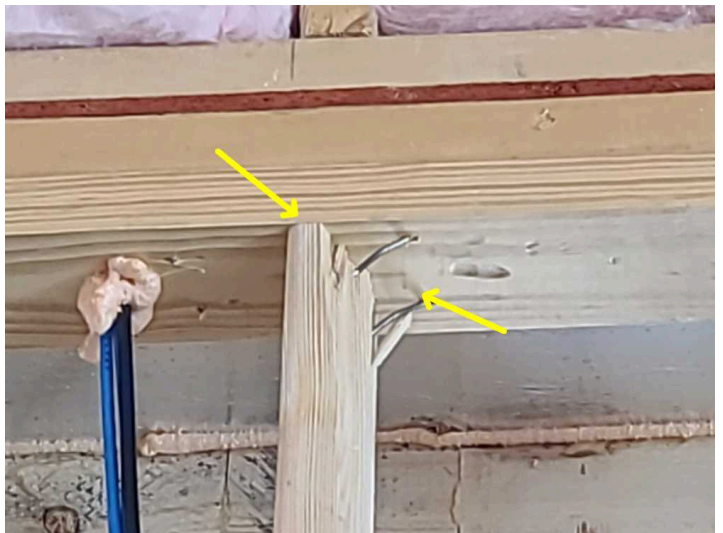
Framing/ stud above fireplace is damaged and are not completely nailed in place properly.

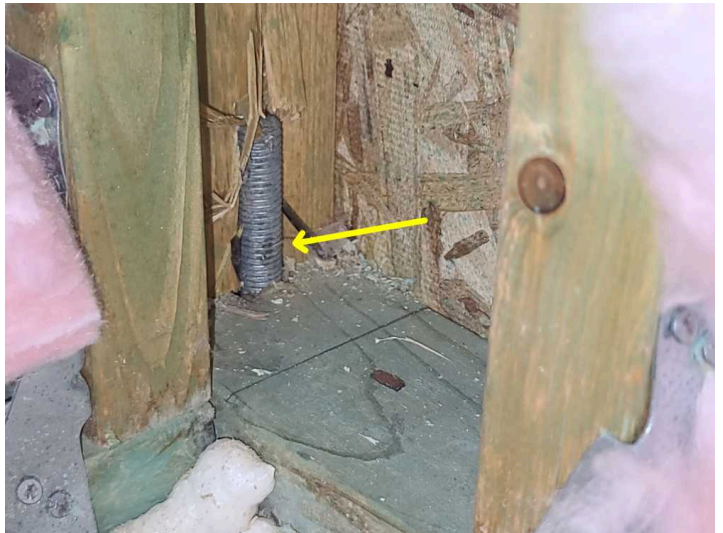
Wall framing not properly attached to foundation, missing a washer, and a nut; Northwest corner/ bedroom

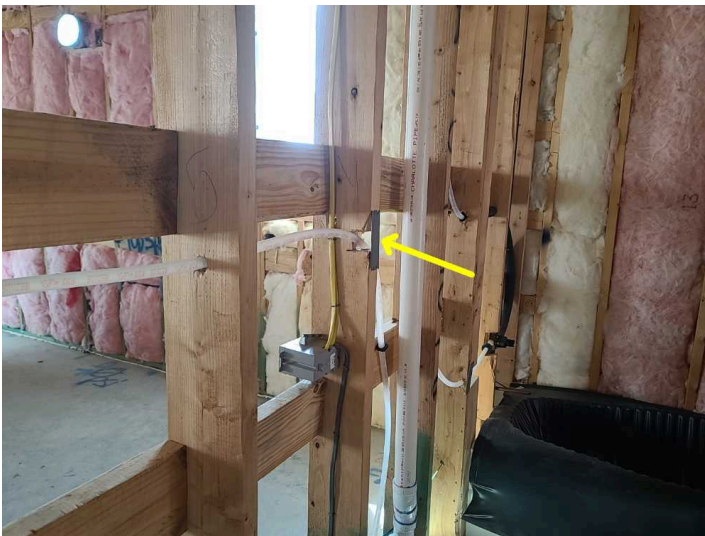
Improperly/ excessively notched framing at South guest bathroom.

Excessively notched framing at South guest bathroom.

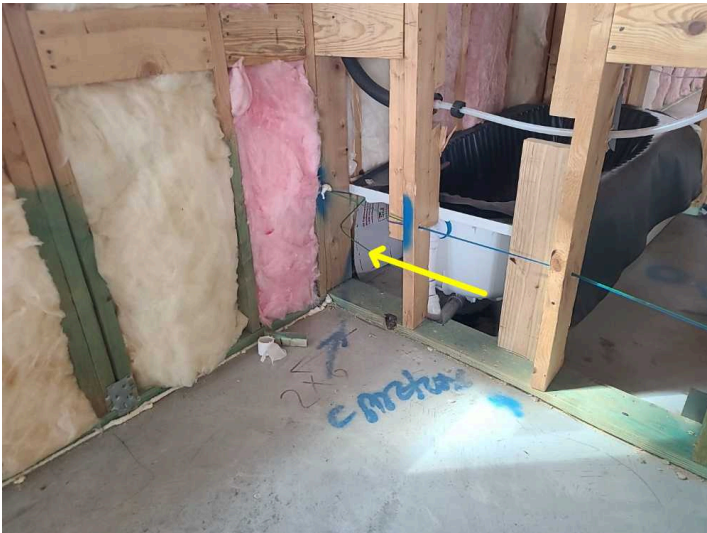
Vertical insulation missing at exterior wall behind/ below South guest tub.

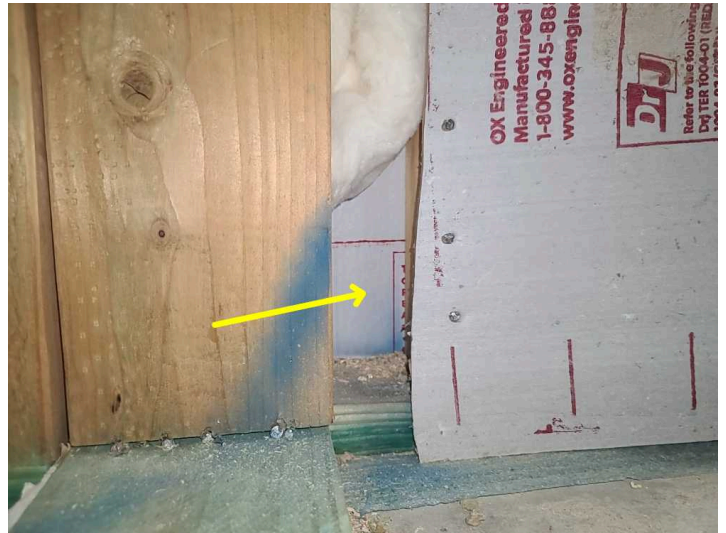
Vertical insulation missing at exterior wall behind/ below South guest tub.

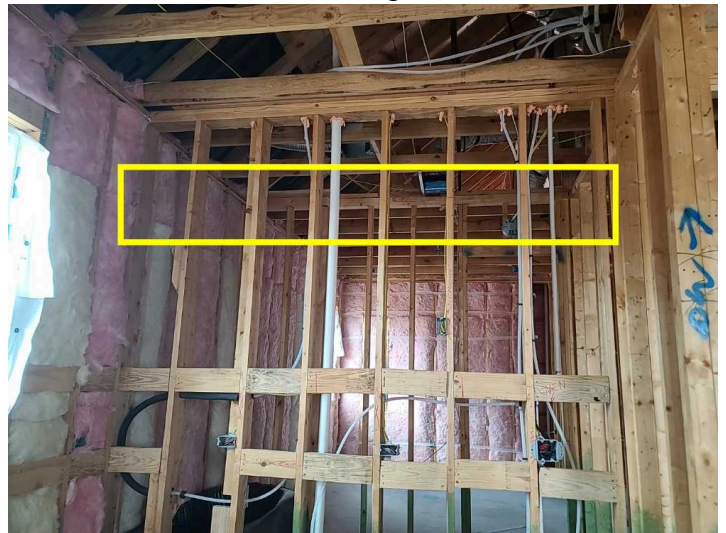
Kitchen cabinet blocking is missing along West wall. Additional blocking is needed to properly attach/ support cabinetry.

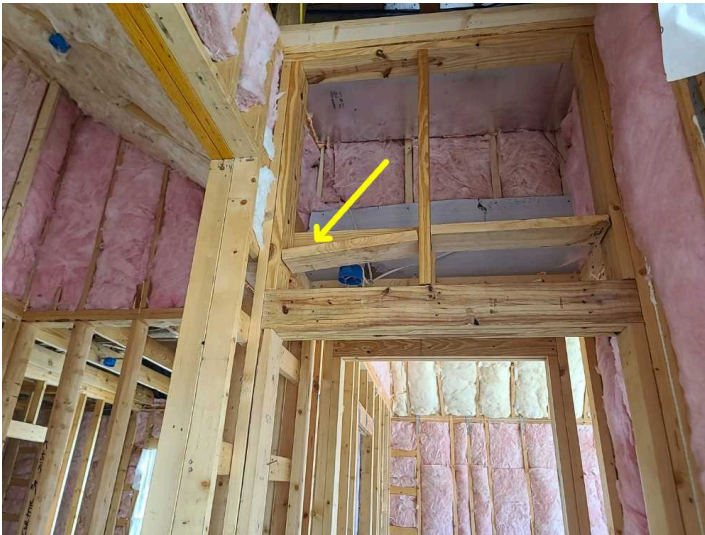
Blocking loose, not square above master bedroom entrance.

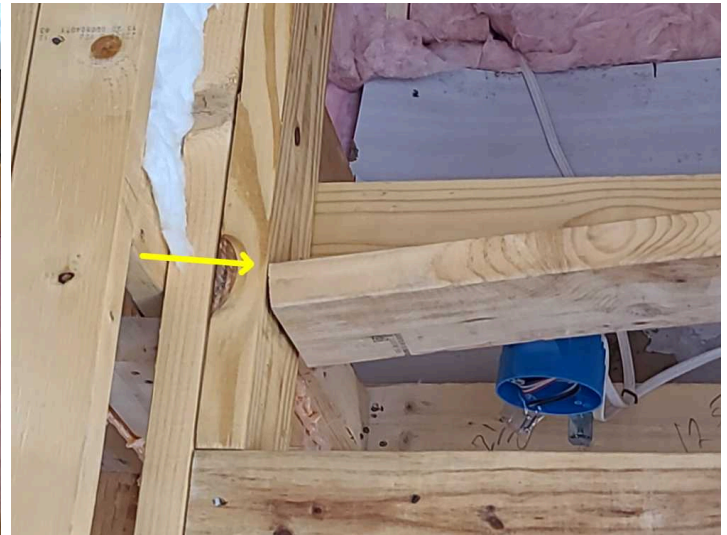
Blocking loose, not square above master bedroom entrance.

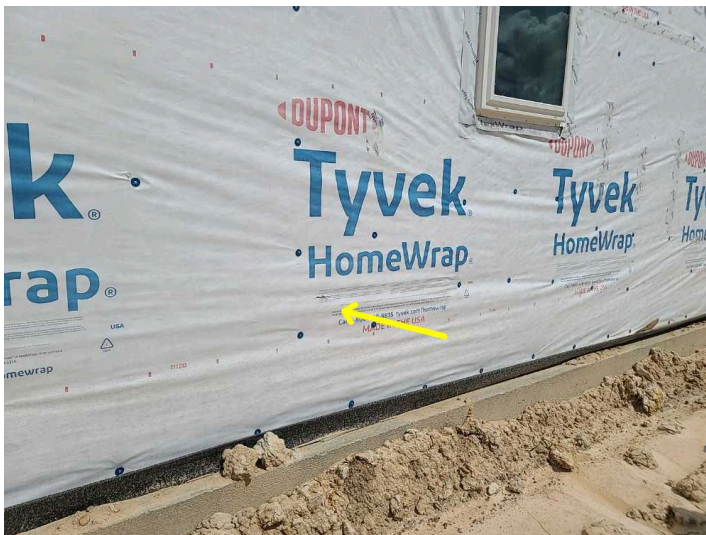
Repair holes/tears in house wrap; South exterior.

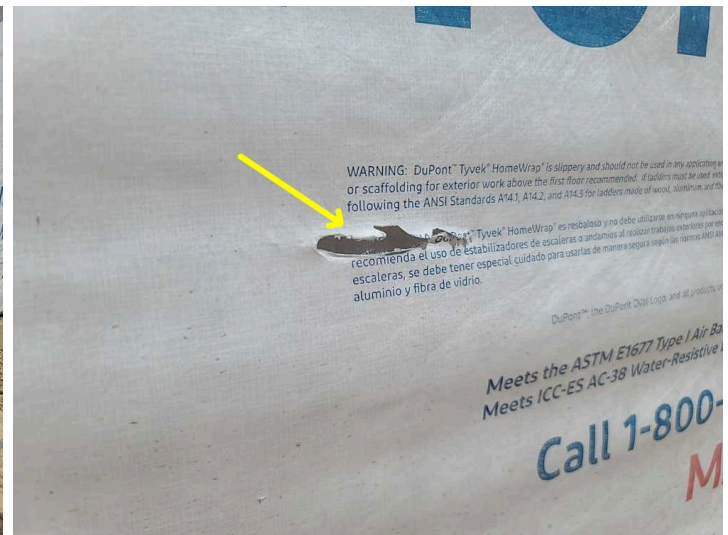
Repair holes/tears in house wrap; South exterior.

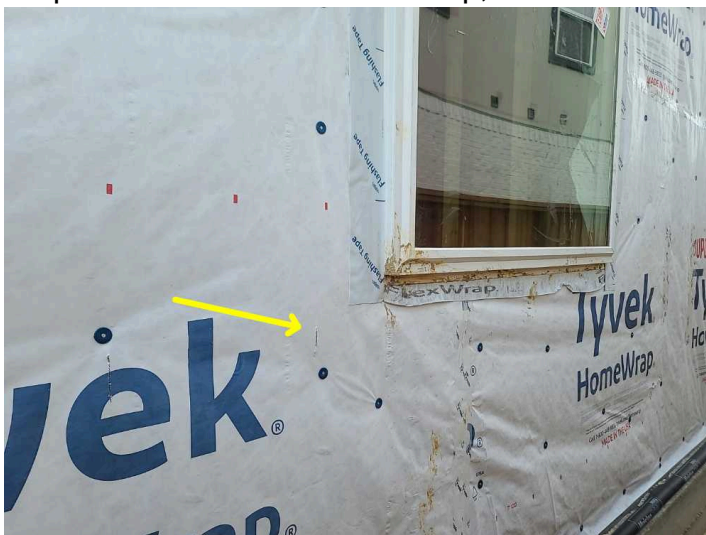
Repair holes/tears in house wrap; North exterior.

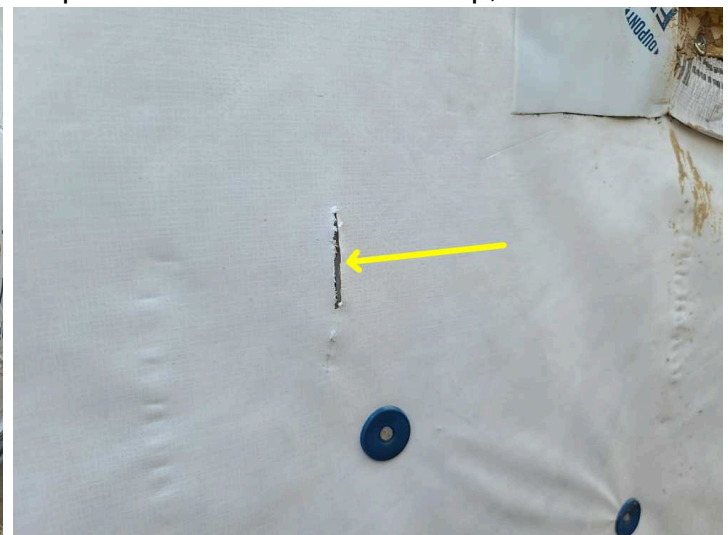
Repair holes/tears in house wrap; North exterior.

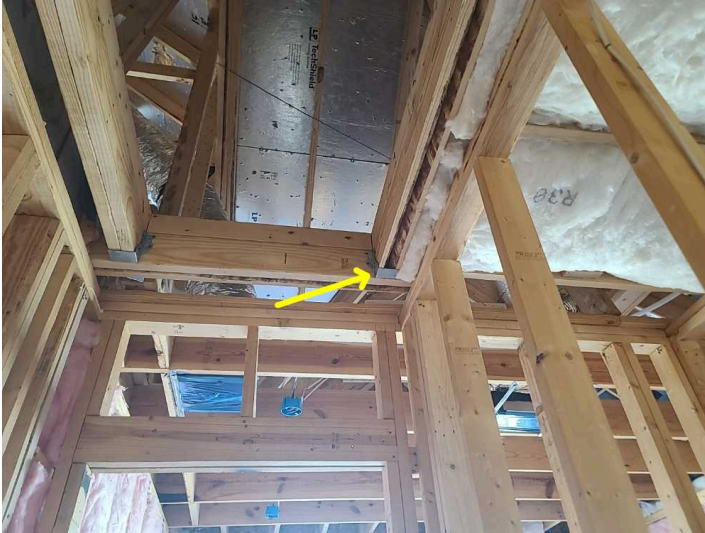
Joist hanger missing nails/ fasteners at one or more locations; attic access.

Joist hanger missing nails/ fasteners at the attic access.

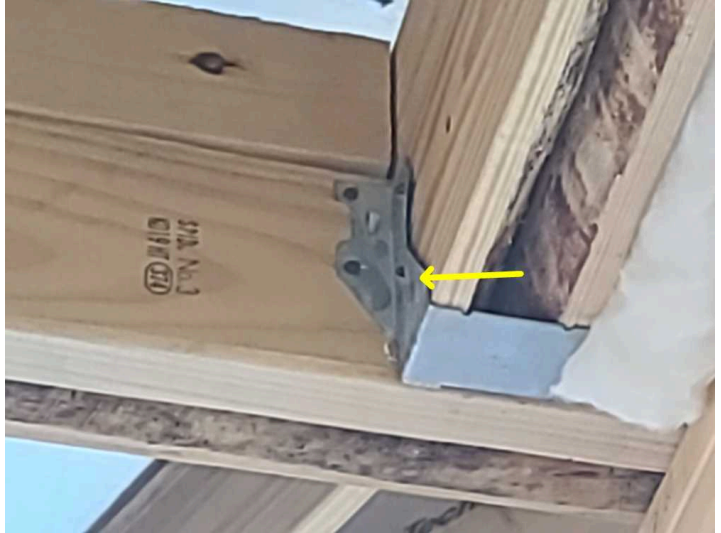
Joist hanger missing nails/ fasteners at the attic access.

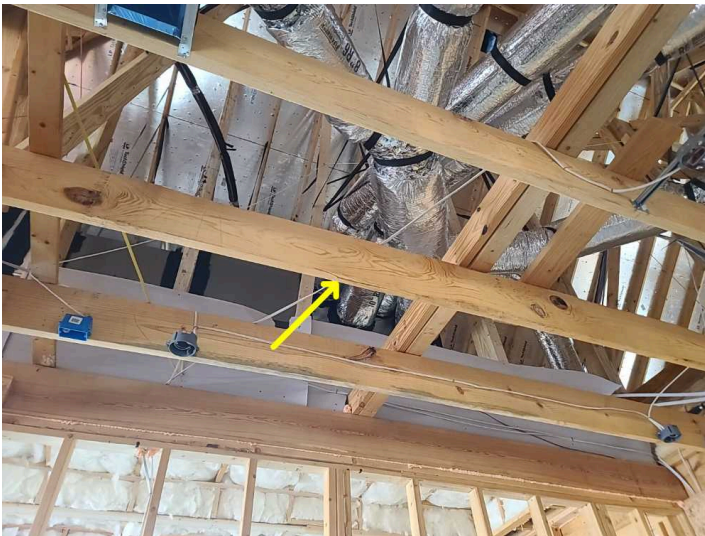
Cracked/ split/ damaged ceiling joist observed at media room ceiling.

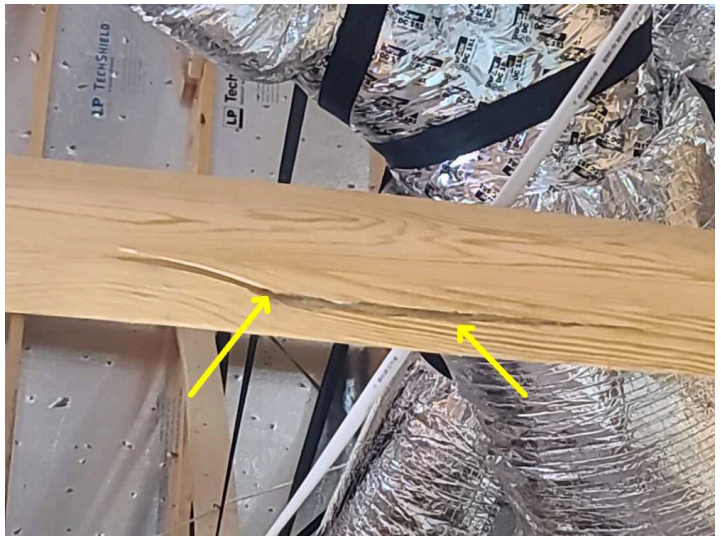
Cracked/ split/ damaged ceiling joist observed at media room ceiling.

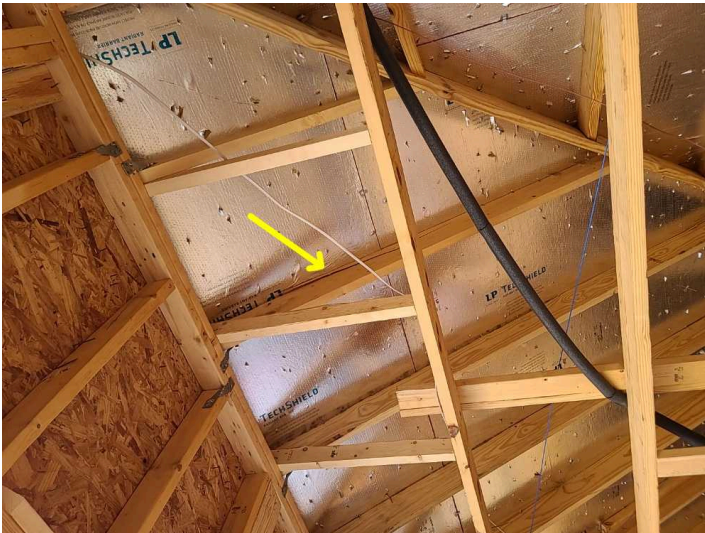
Damaged / cracked / split rafter observed above; guest bedroom.

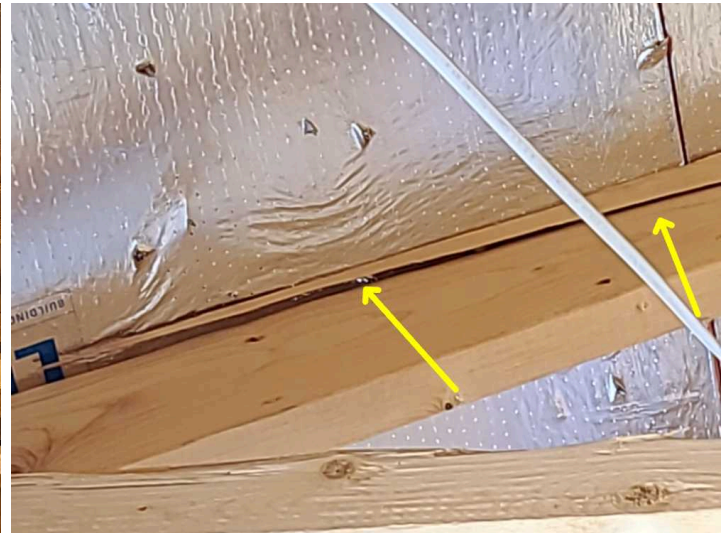
Damaged / cracked / split rafter observed above; guest bedroom.

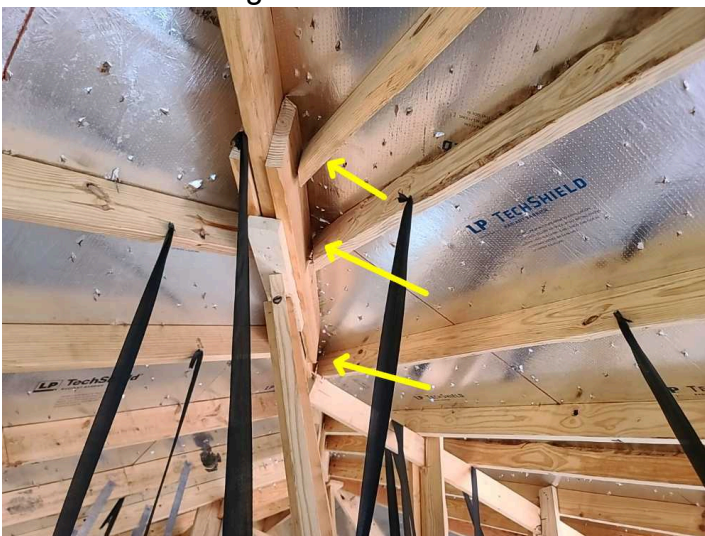
Several ends of rafters were observed to be not cut flush with corresponding components, some degree of misfit was observed, average/mediocre framing. Area that needs repair is above attic access.

Ends of rafters were observed to be not cut flush with corresponding components; Area that needs repair is above attic access.

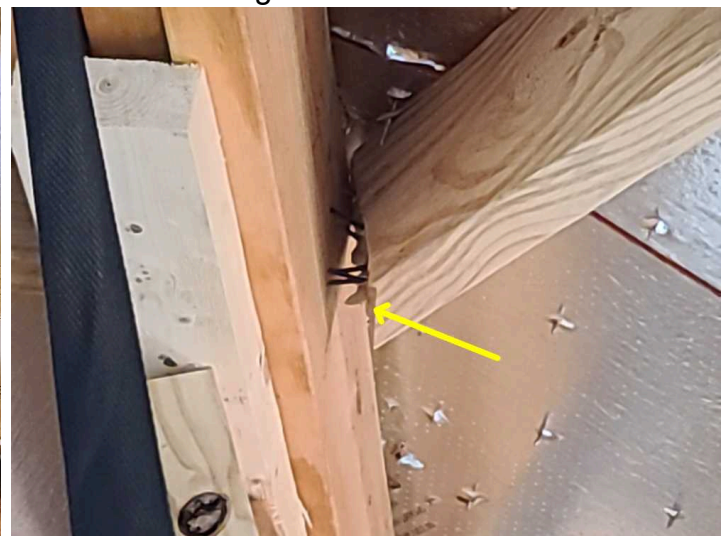
Ends of rafters were observed to be not cut flush with corresponding components; Area that needs repair is above attic access.

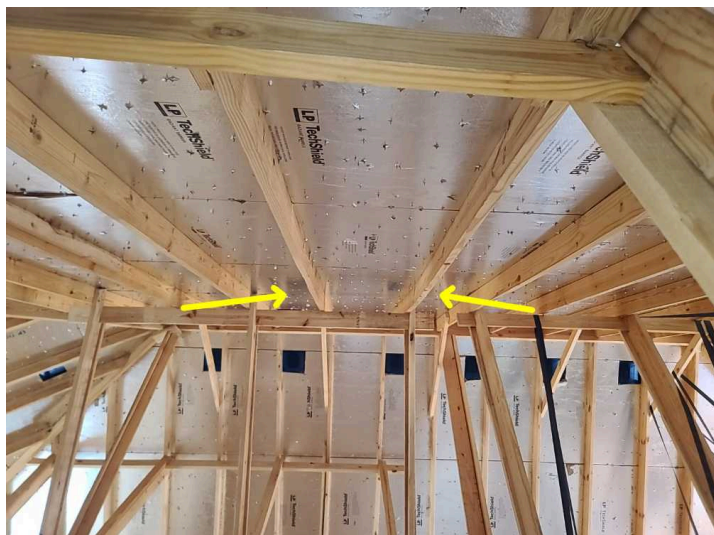
Rafters warped North side of attic above entry hall. Roof decking is not rated for the distance between rafters. May cause sags in roof decking and or soft spots.

Rafters warped North side of attic above entry hall.

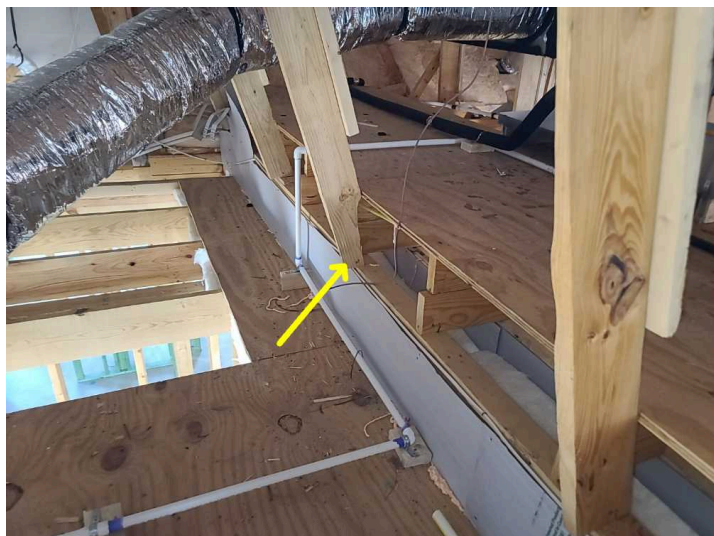
Purlin strut is damaged and is not properly bearing on the top plate. Needs repair; near HVAC.

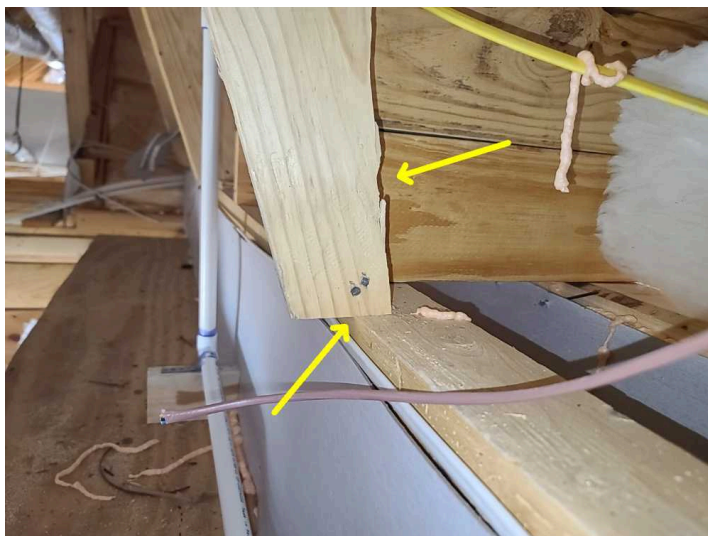
Purlin strut is damaged and is not properly bearing on the top plate. Needs repair; near HVAC.

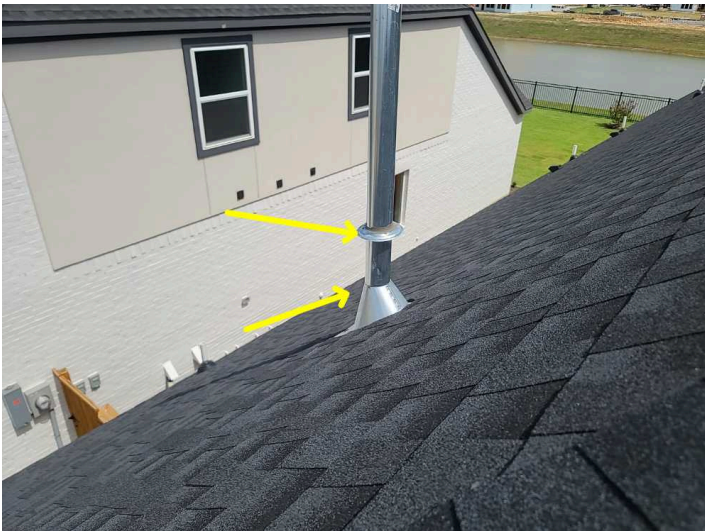
Storm collar not properly positioned on water heater vent pipe, daylight observed in attic.

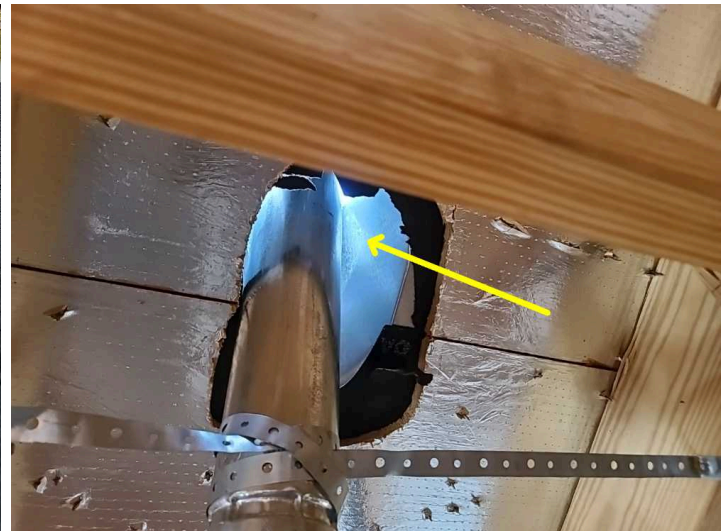
Storm collar not properly positioned on water heater vent pipe, daylight observed in attic.

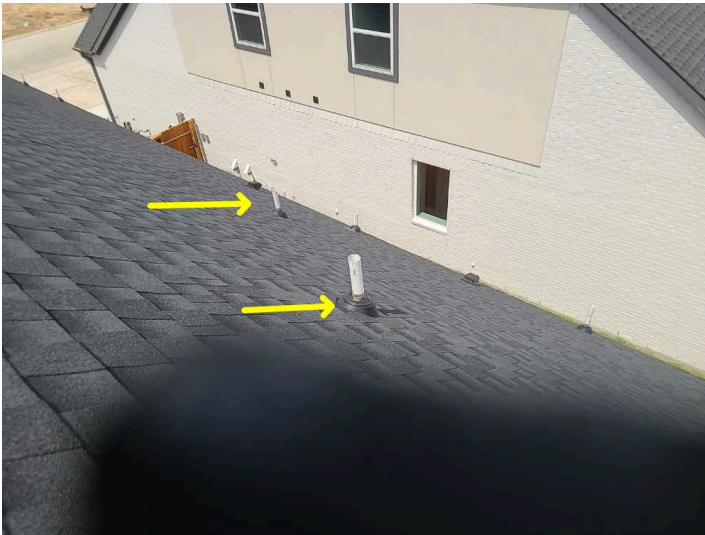
Rubber gasket of one or more drain waste vents was observed to have an inverted rubber gasket. This condition can allow rainwater to accumulate and penetrate.

Rubber gasket of drain waste vents have an inverted rubber gasket

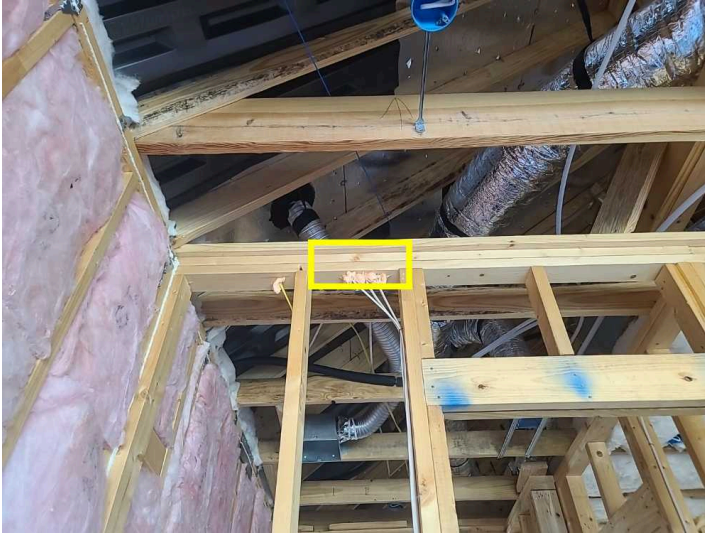
Nail plates missing at Northwest bedroom

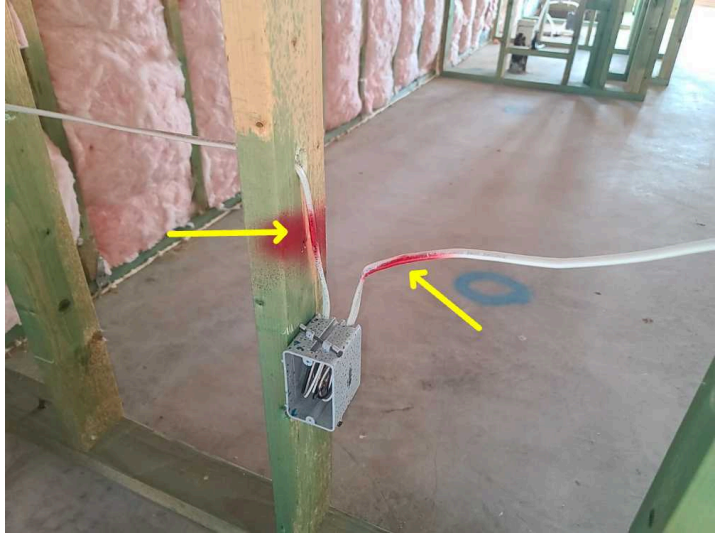
Electrical wiring is not properly secured in place, within twelve inches of leaving a junction box; office, bonus/ flex room ceiling.

Electrical wiring is not properly secured in place, within twelve inches of leaving a junction box; office

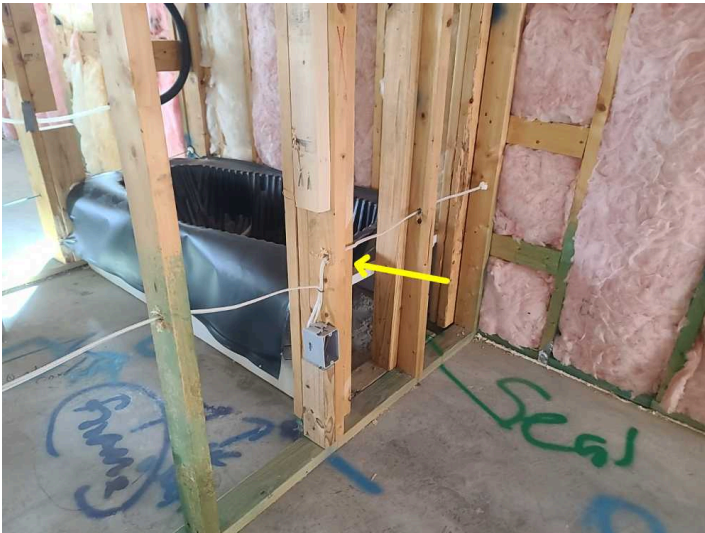
Nail plates missing at office near tub

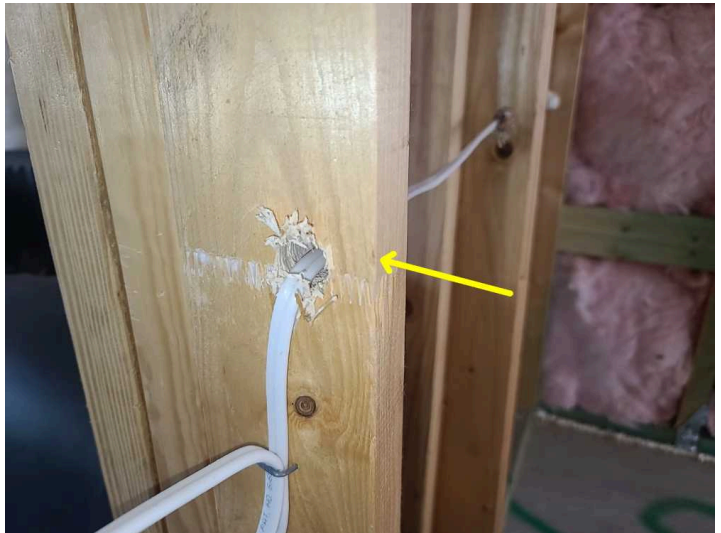
Nail plates missing at office near tub

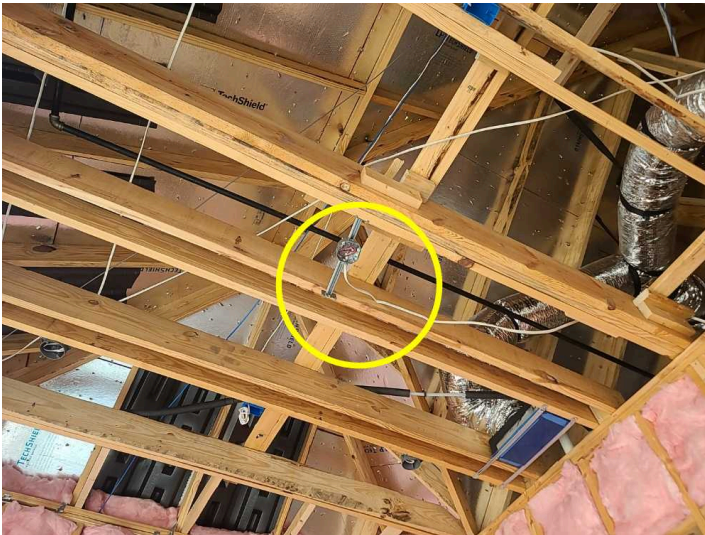
Electrical/ fixture boxes are not properly secured in place, pulled loose for added framing; bonus/ flex room ceiling.

Fixture boxes are not properly secured in place, pulled loose for added framing; bonus/ flex room ceiling.

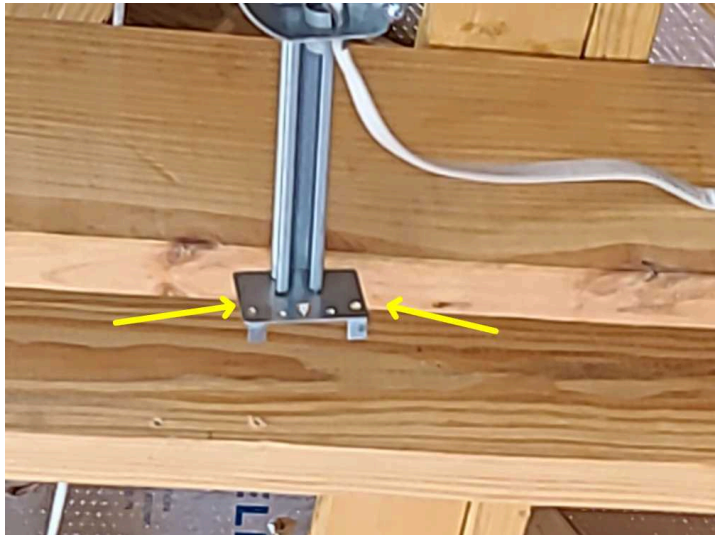
Fixture boxes are not properly secured in place, pulled loose for added framing; bonus/ flex room ceiling.

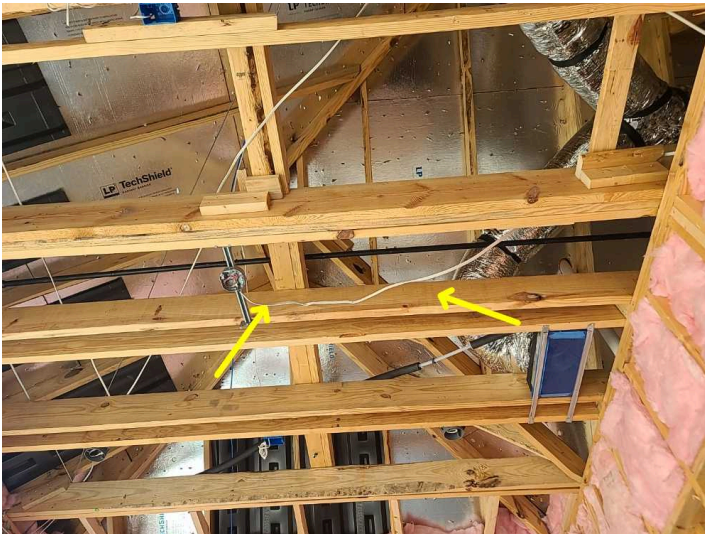
Electrical wiring is not properly secured in place; bonus/ flex room ceiling

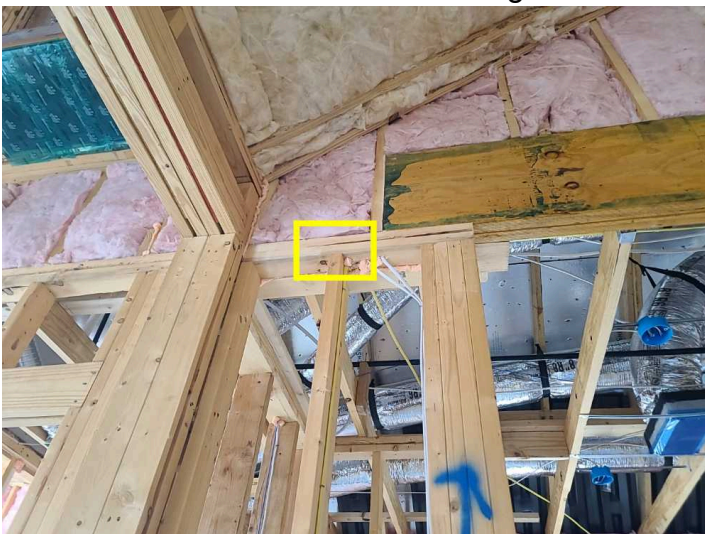
Nail plates missing near kitchen

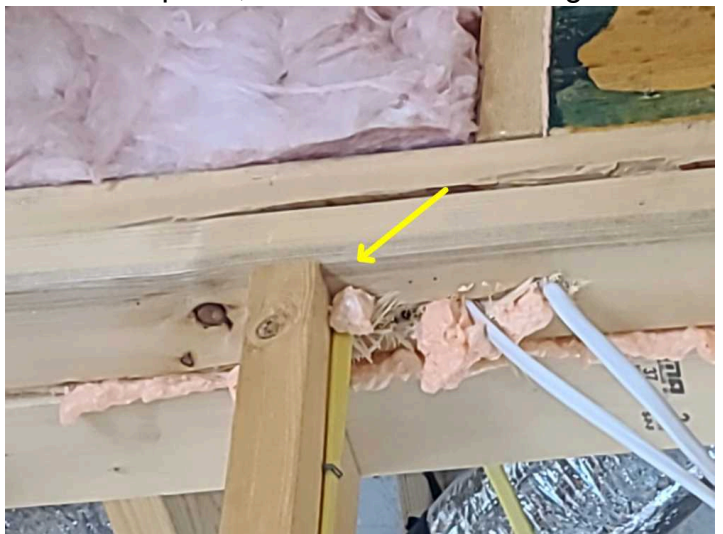
Nail plates missing near kitchen

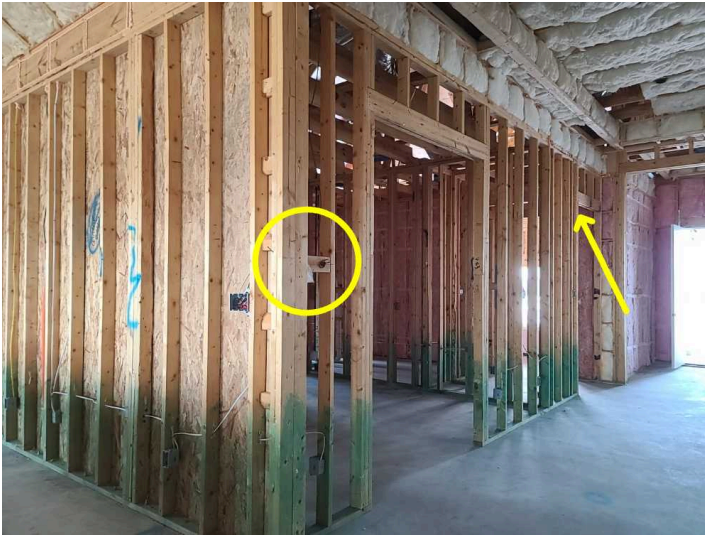
Possibly improperly located, thermostats are typically/ supposed to be located near the return air chase. Thermostat is located in the middle of at least three returns. Recommend consulting building plans and or a qualified HVAC technician.

Thermostats are typically/ supposed to be located near the return air chase.

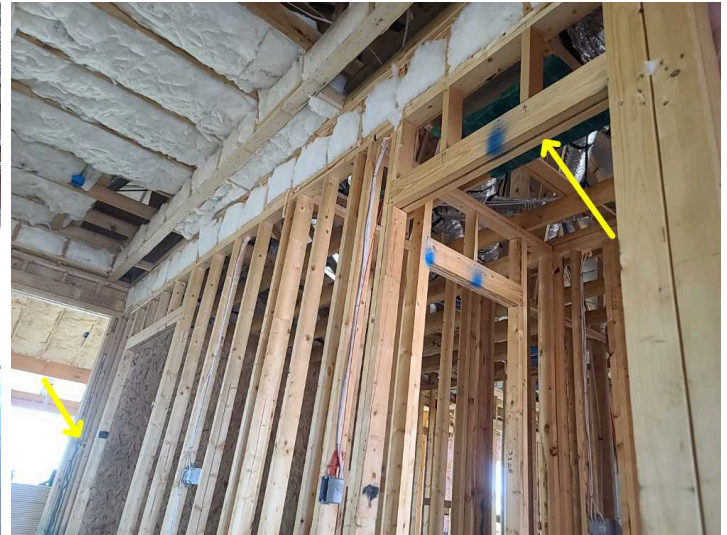
Thermostat is located in the middle of at least three returns. Recommend consulting building plans and or a qualified HVAC technician

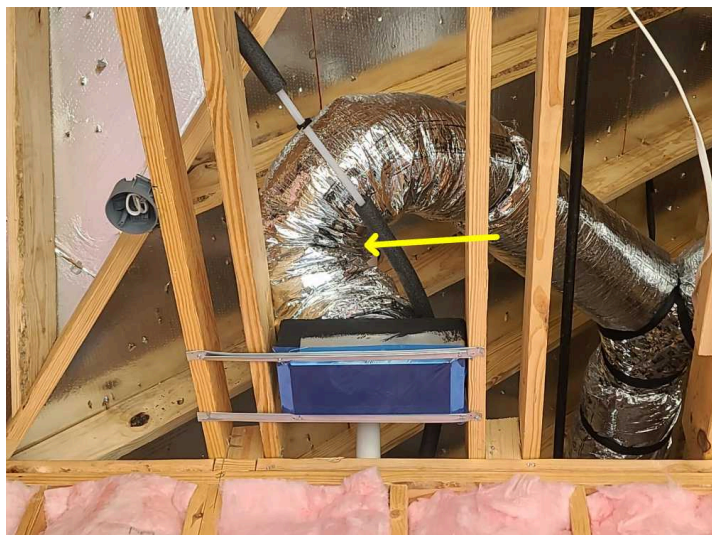
Some flex ducts observed to be improperly routed with sharp bends and/or excess material in bends. Improper routing increases frictional loss in the duct and reduces heating and cooling efficiency. Radius at the centerline of the bend should be no less than the diameter of the duct; bonus/ flex room.

Flex duct excess material in bends; bonus/ flex room.

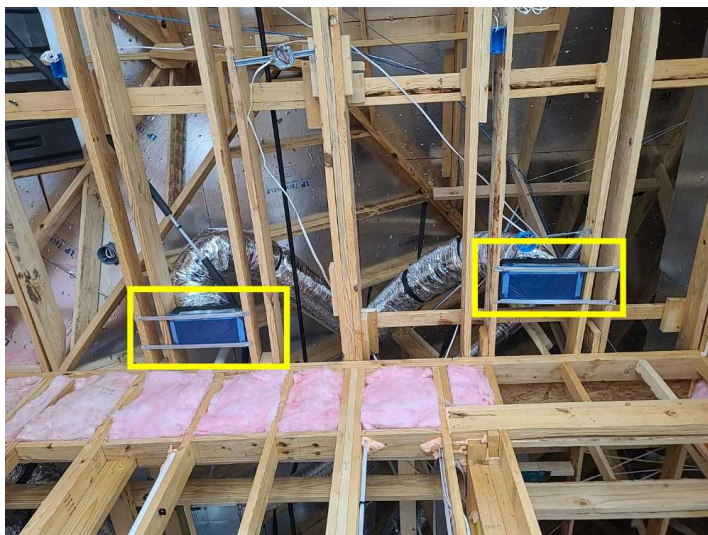
HVAC supply register boxes are not square with each other due to framing changes. Recommend reinstalling before sheetrock; bonus/ flex room ceiling.

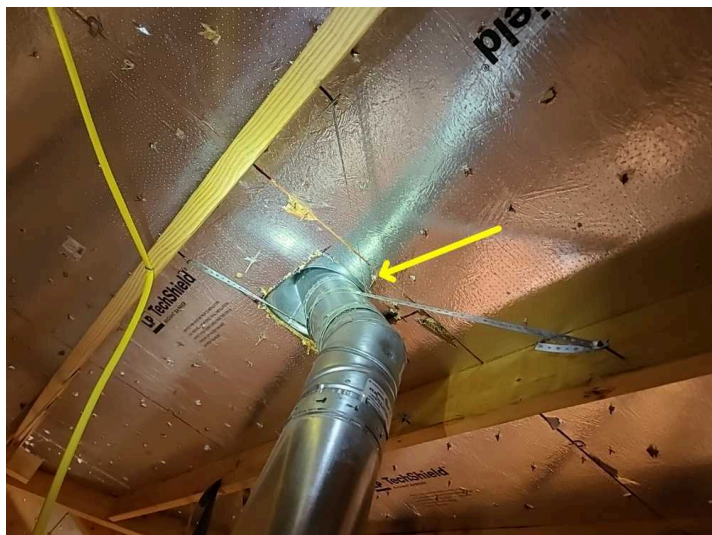
The exhaust vent pipe is in contact with or does not have required minimum 1" clearance from combustible material, [wooden roof decking / framing].

The furnace exhaust vent pipe is in contact with or does not have required minimum 1" clearance from combustible material

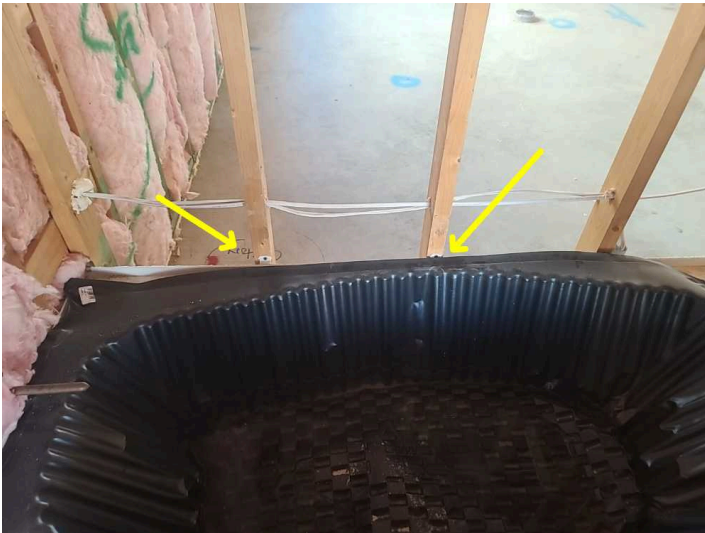
Fiberglass tub securing clips are not properly seated at tub lip; Northwest guest bedroom.

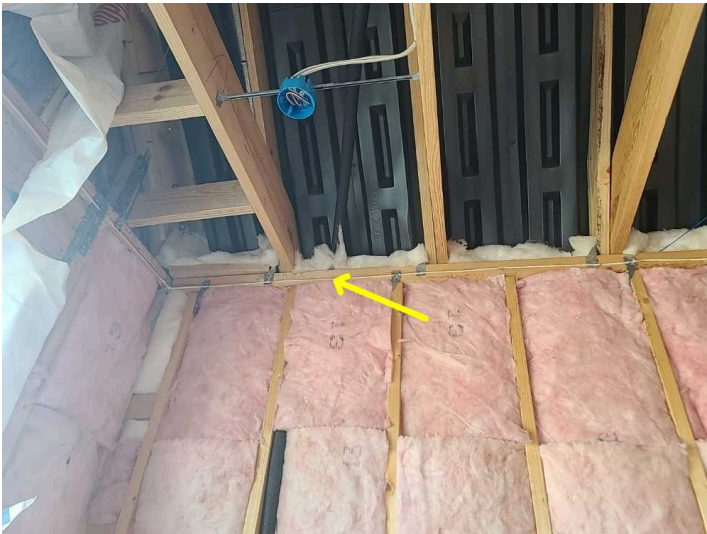
Nail plates missing at Northwest corner bedroom

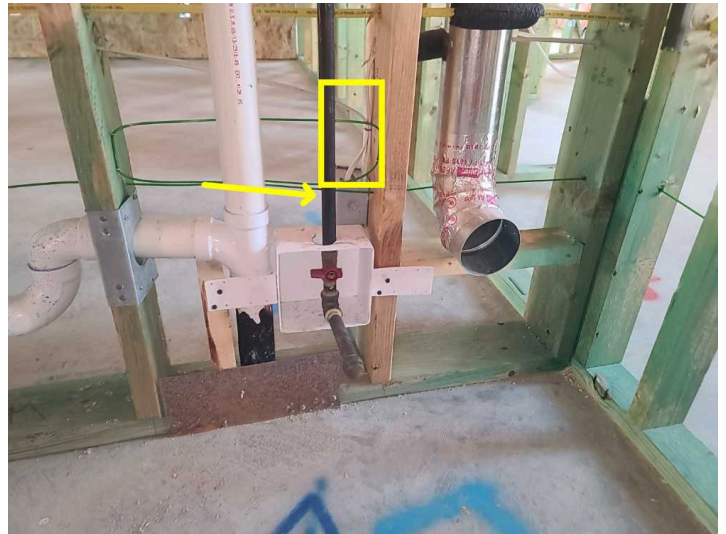
Gas line not properly supported or secured at; laundry room.
