# ***Fox Inspection Group***

## **Frame Inspection Report**

13802 Arroyo Grande, Cypress, TX 77433  
Inspection prepared for: Jorge Galeano  
Real Estate Agent: Aaron Greeley - CB&A, Realtors

Date of Inspection: 9/21/2023 Time: 9:00 AM  
Age of Home: 2023 Size: 3001  
Order ID: 108701

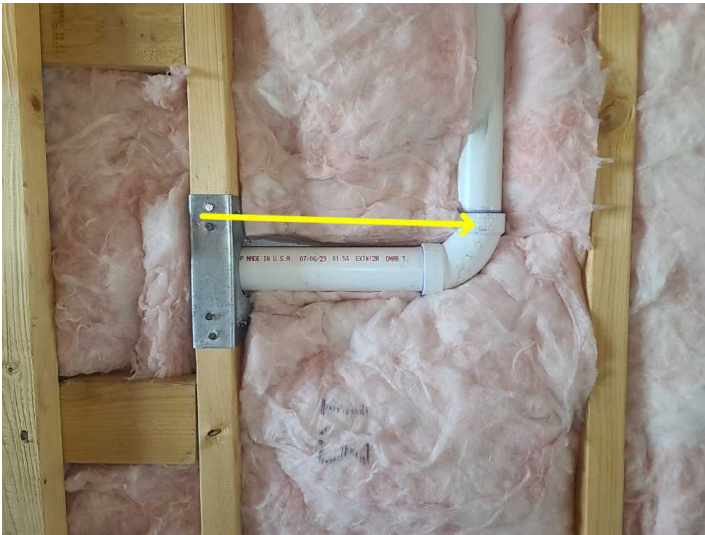
Improper slope of the drain waste vent line observed. The line does not tilt downhill for drainage of condensate; office exterior wall.

Improper slope of the drain waste vent line observed. The line does not tilt downhill for drainage of condensate; office exterior wall

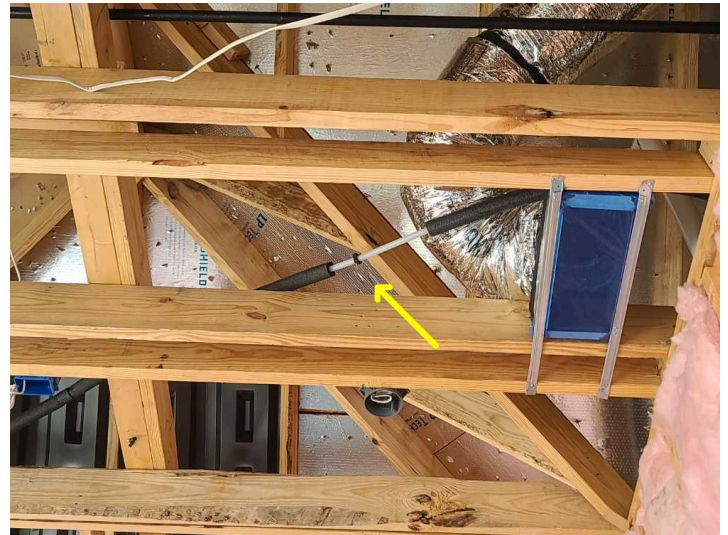
Water supply line not properly secured at; bonus room ceiling

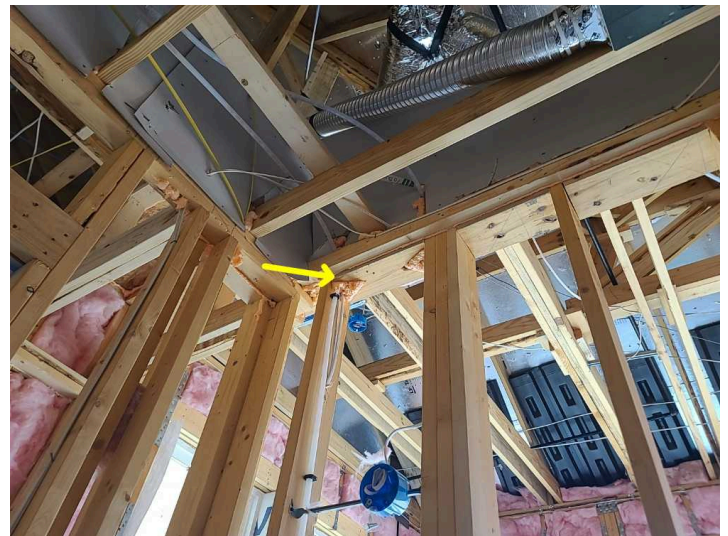
Nail plates missing at half bath

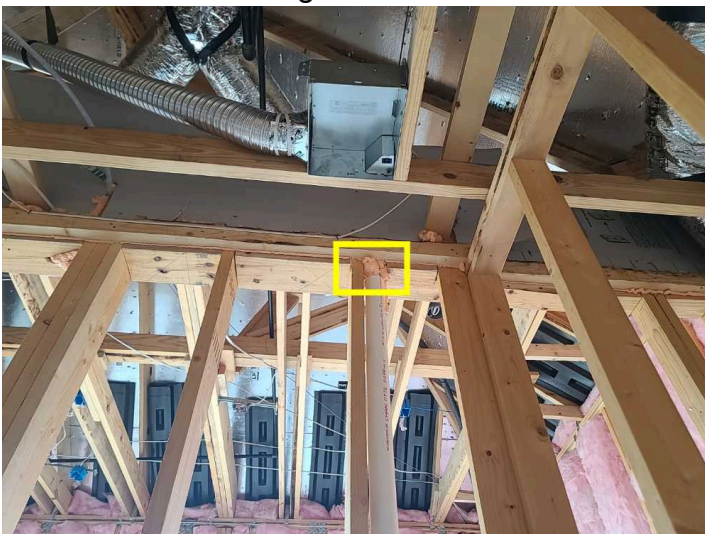
Nail plates missing at half bath

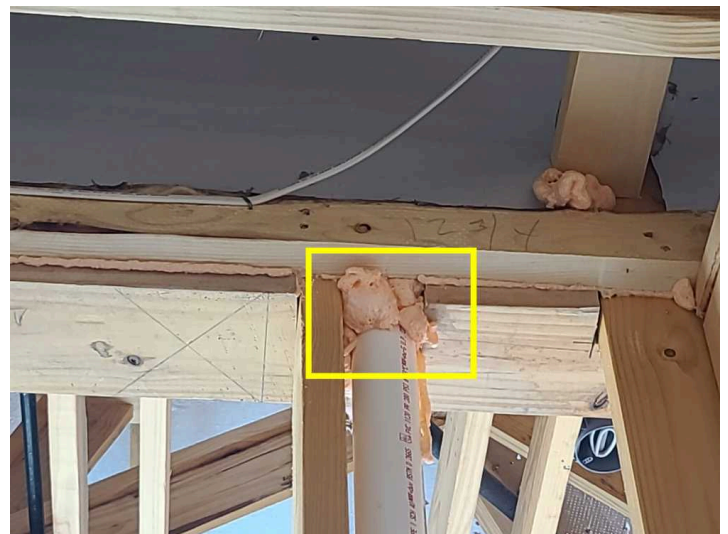
Nail plates missing at half bath

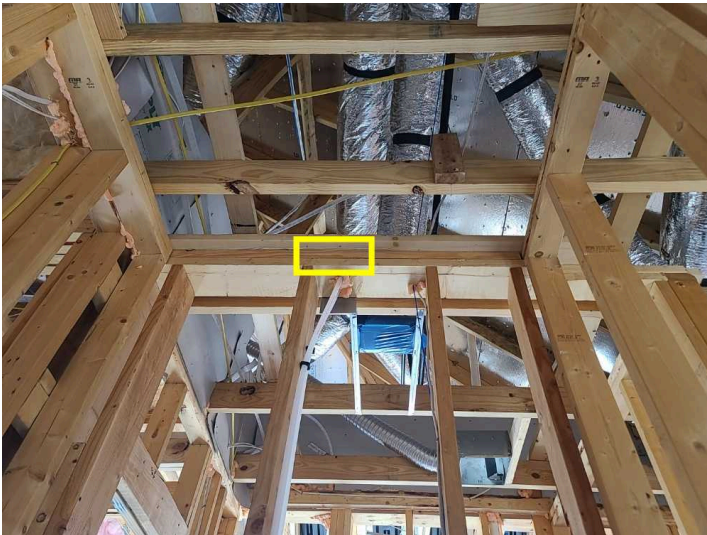
Nail plates missing at refrigerator nook

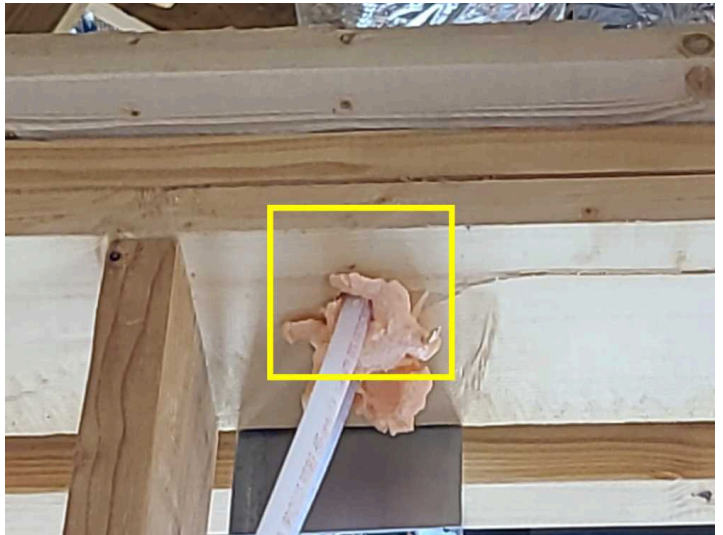
Nail plates missing at refrigerator nook

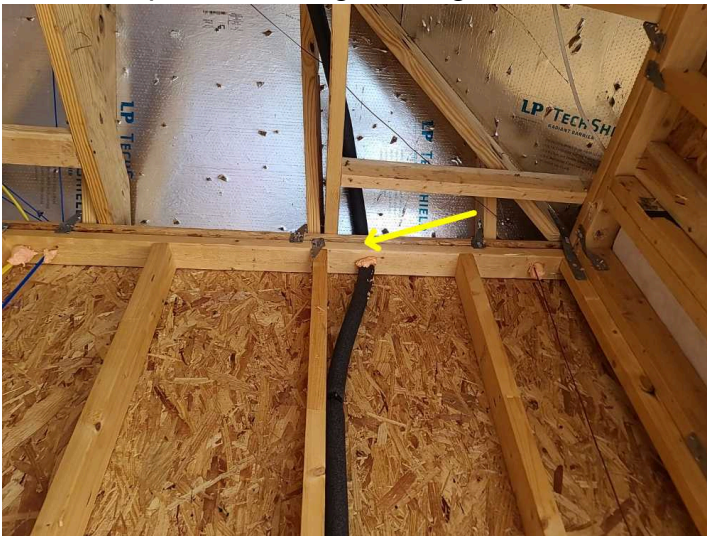
Nail plates missing at garage

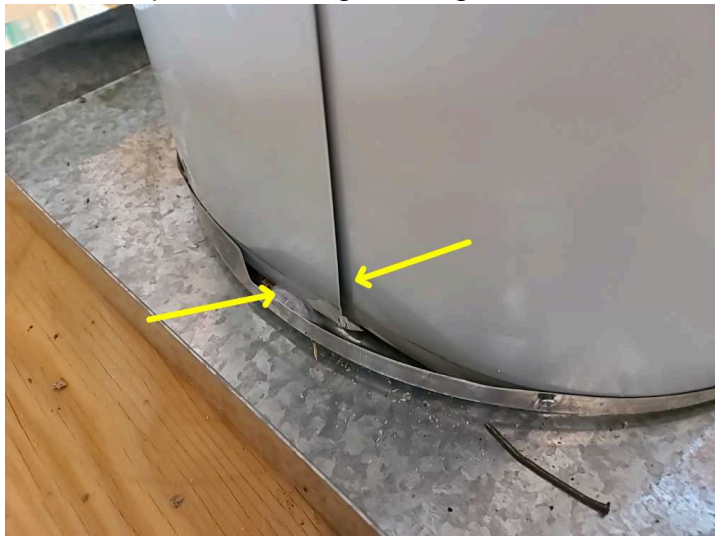
Damage observed to the body of the water heater. Possibility of hidden damage to the unit.

Damage observed to the body of the water heater.  
Possibility of hidden damage to the unit.

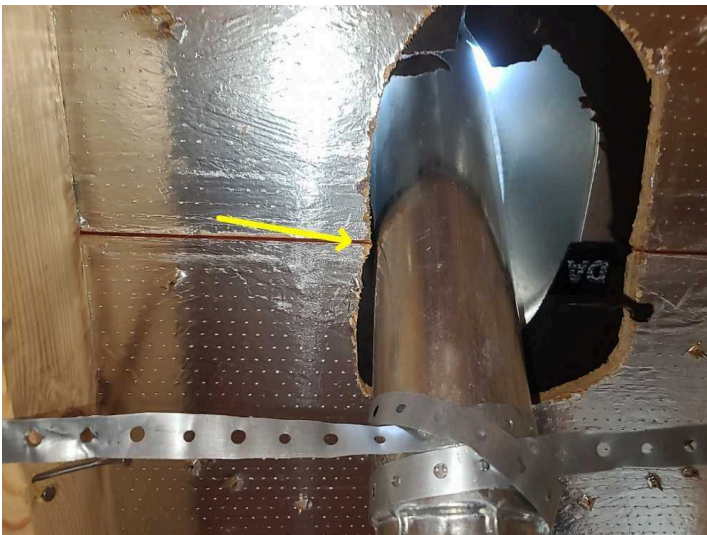
The exhaust vent pipe is in contact with or does not have required minimum 1" clearance from combustible material, [wooden roof decking / framing].

Exhaust vent pipe is in contact with or does not have required minimum 1" clearance from combustible material

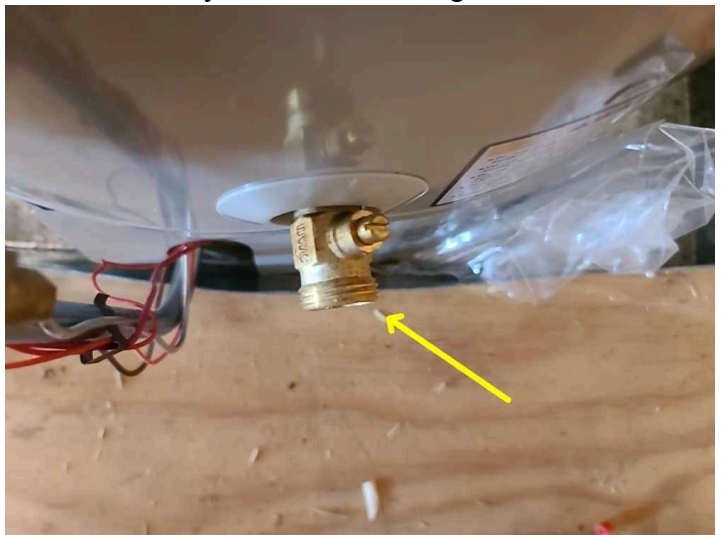
Lower drain valve of water heater extends over drain pan, should valve leak, water will not be contained in drain pan Standard Plumbing Code 1213.7.2

Lower drain valve of water heater extends over drain pan, should valve leak, water will not be contained in drain pan

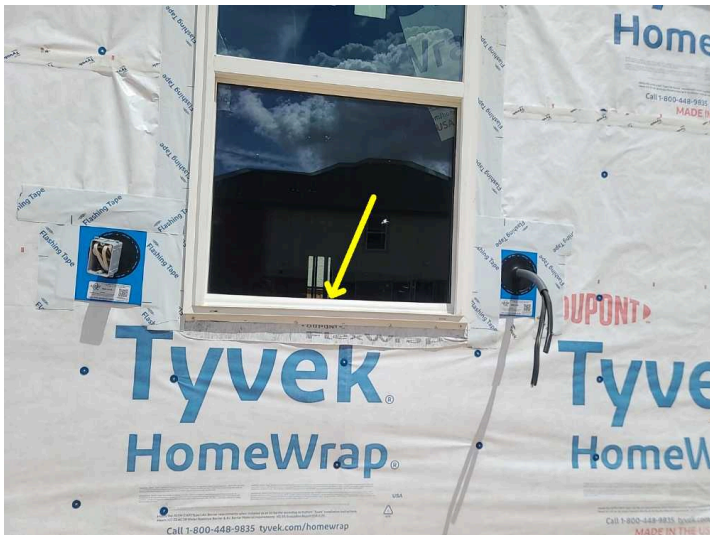
Lower window frames/ sills are not square/ not level. Possibly causing window not to seal, or close properly. Flanges need adjustment; South bedroom, and bonus/ flex room.

Lower window frames/ sills are not square/ not level. Flanges need adjustment; South bedroom
