True Grit Home Inspection

Property Inspection Report

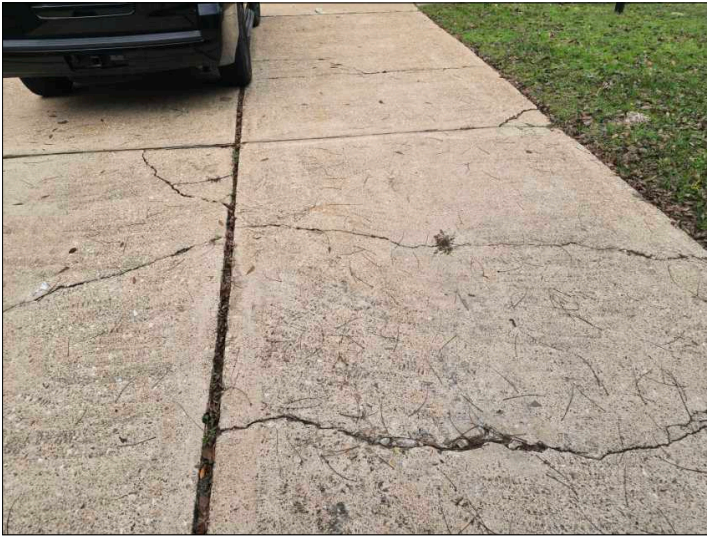
Driveway / sidewalk is cracked / lifted and has some tripping hazards.

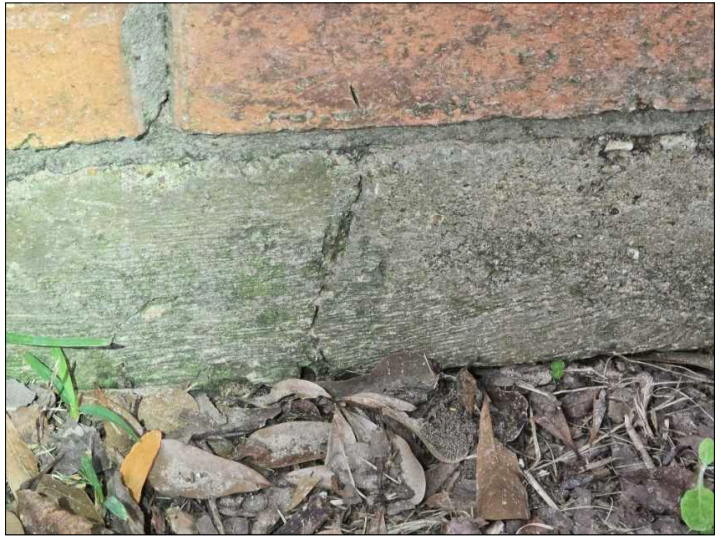
Exterior cracks in foundation noted. 2 found.

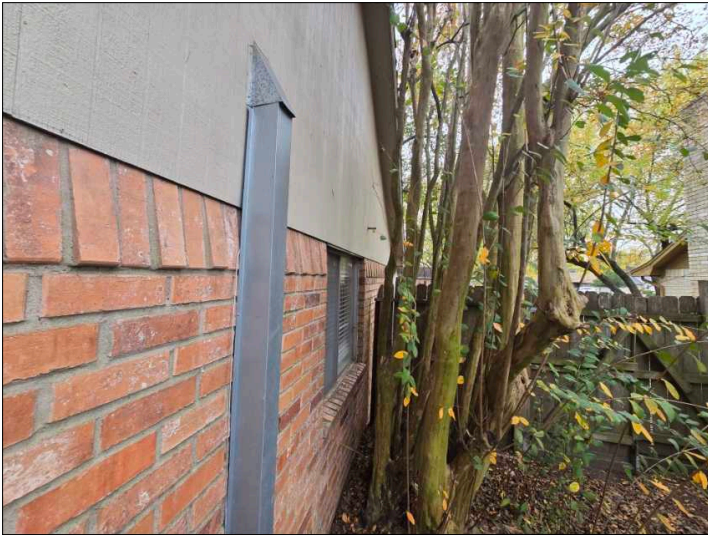
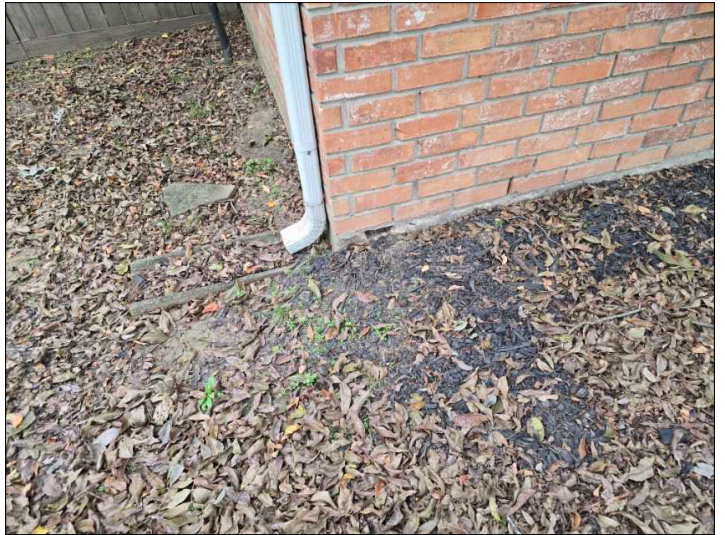
Note: Growth of nearby trees may cause issues to foundation and sidewalks.

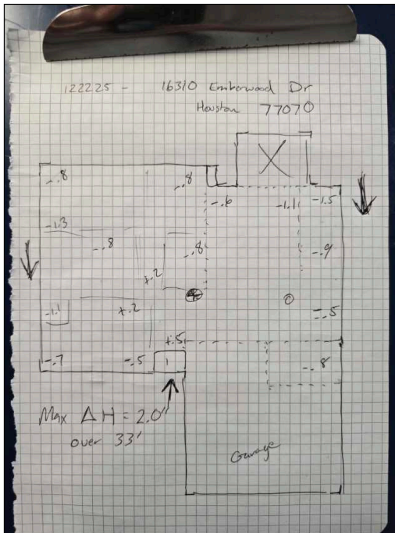
Measured elevation readings suggest a back corner drop and cracked foundation. 2.0" drop over 33'

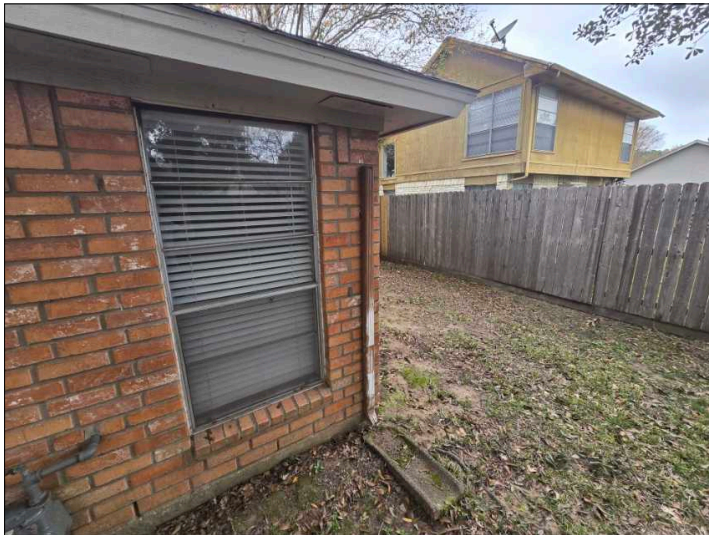
Removed gutters noted

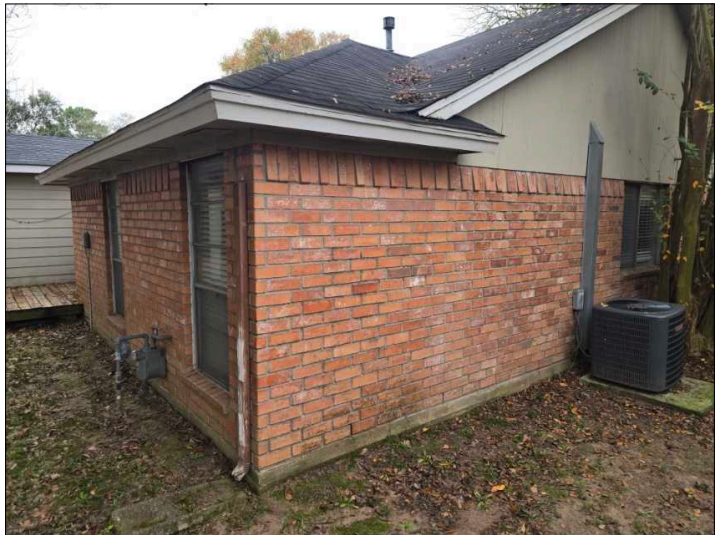
Recommend a Gutter system to aid in drainage away from house.

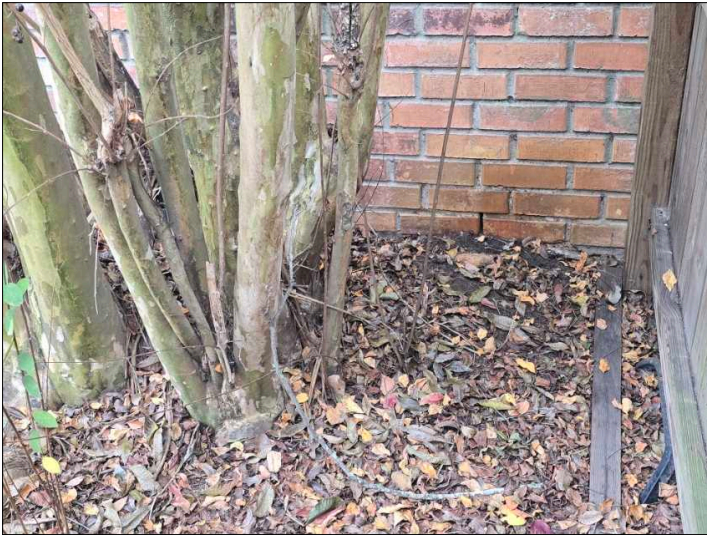
Tree root growth along house can be dangerous for roots in sewer lines, drainage, foundation issues and termites.

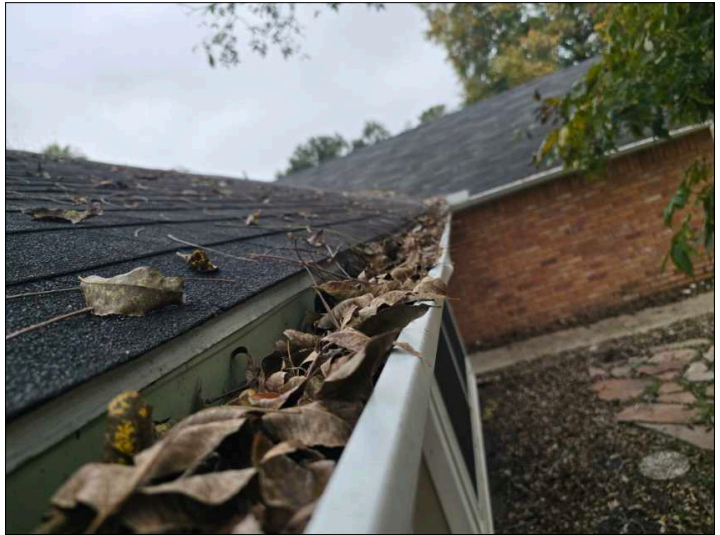
Heavy debris in gutters. These should be cleaned to provided good water flow away from house.

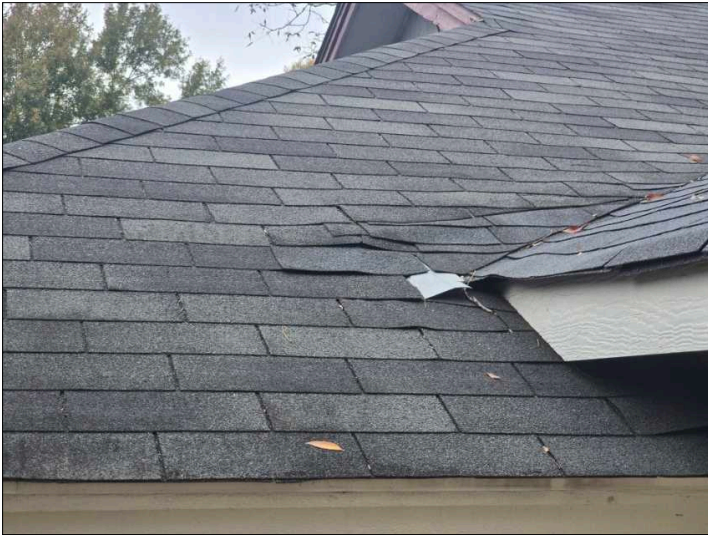
Evidence of previous repair. Multiple shingles present.

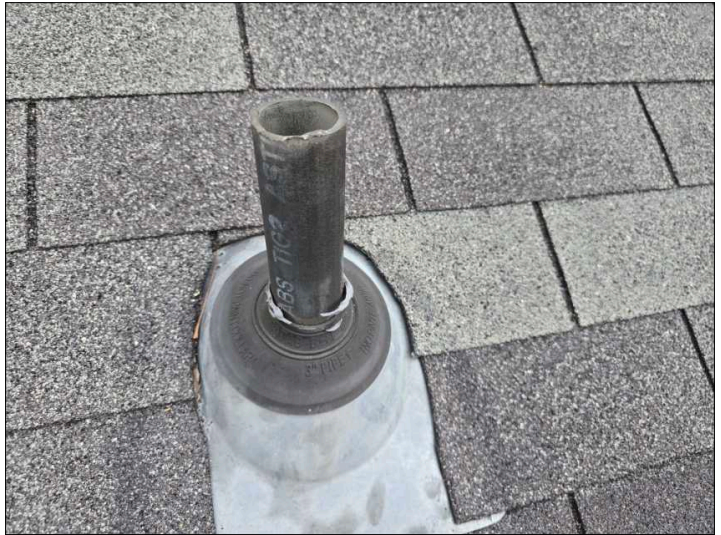
Vent boots are dry and broken. Leaks will occur. Repairs needed.

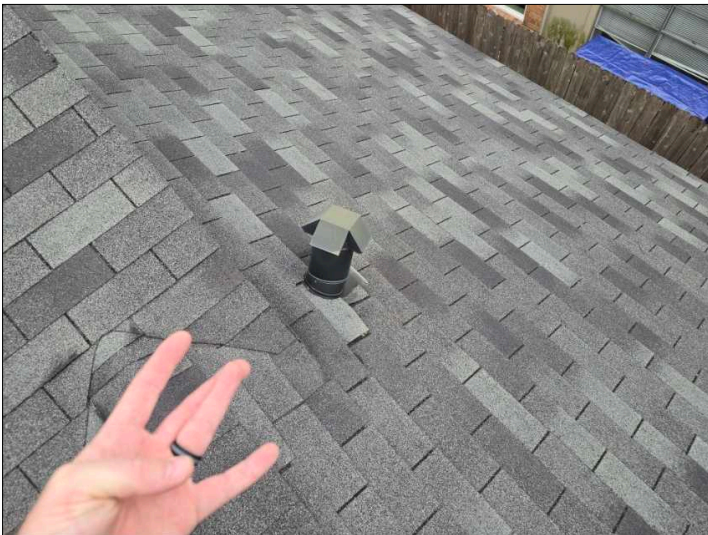
Incorrect furnace /water heater exhaust vent pipe. Should be a double wall type B vent and cap above roofline.

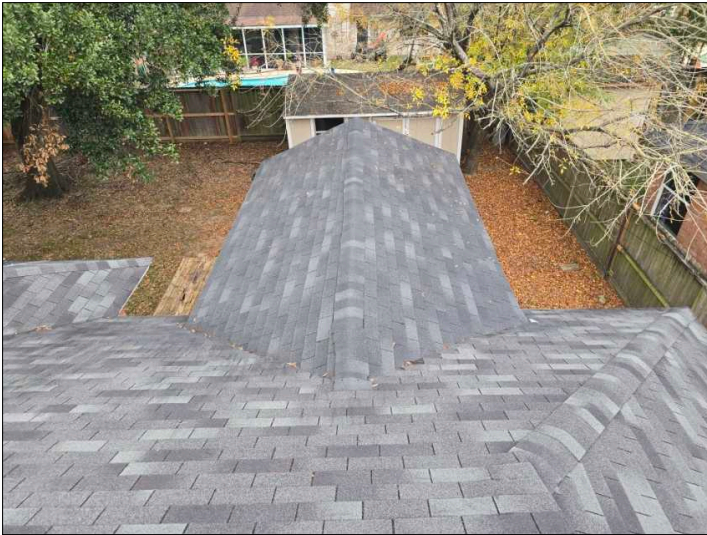
I	NI	NP	D
---	----	----	---

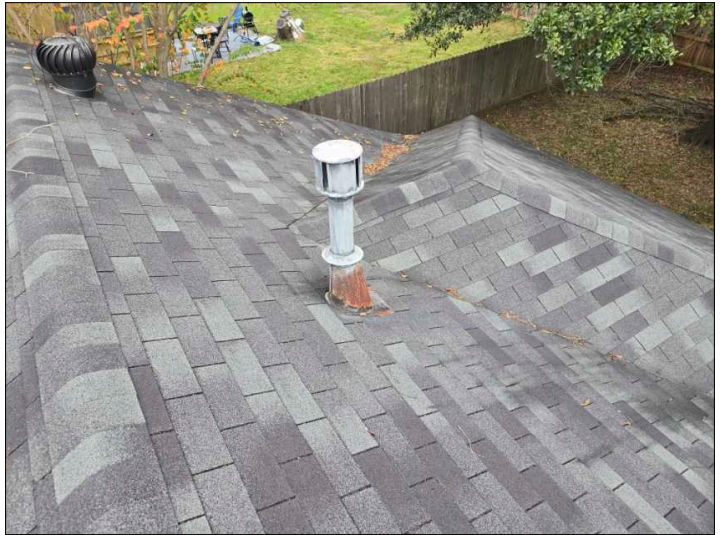
Rusted vents and flashing on roof.

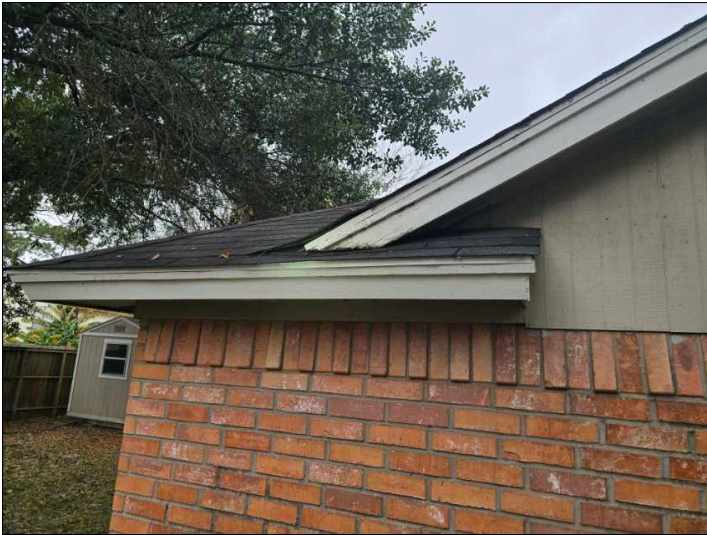
Multiple locations of deterioration around soffit and eave. Wood rot is subject to WDI

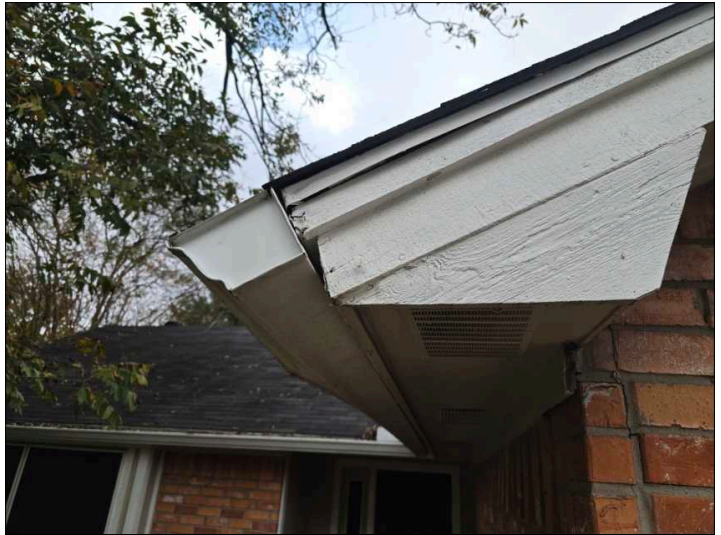
Multiple locations of deterioration around soffit and eave. Wood rot is subject to WDI

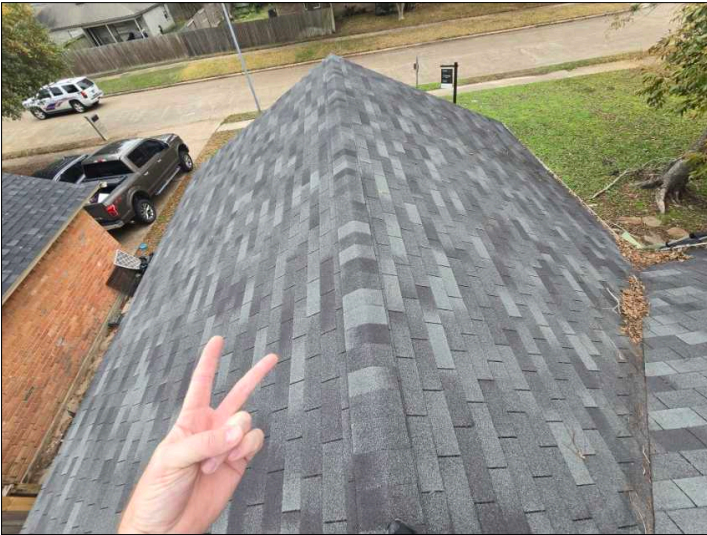
Ventilation is inadequate over garage.

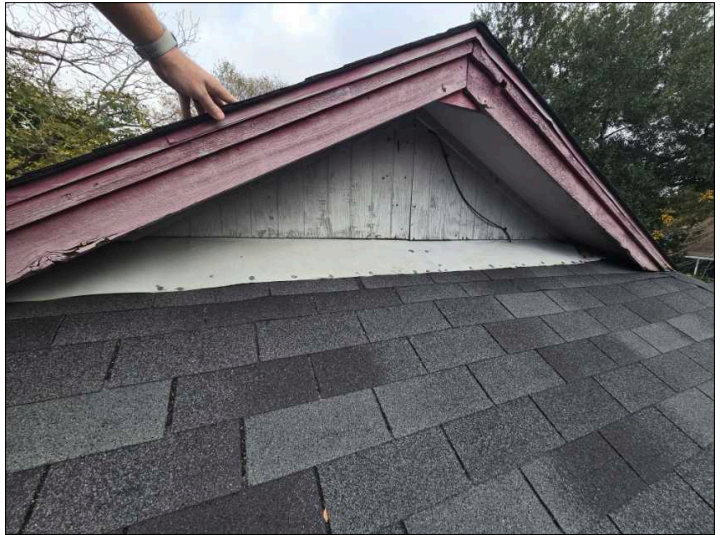
Multiple locations of deterioration around soffit and eave. Wood rot is subject to WDI

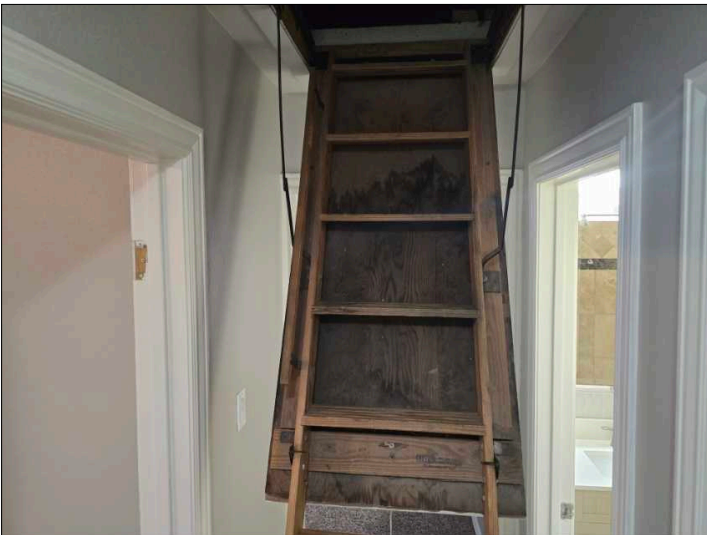
Attic access ladder is missing insulation. This door should be insulated at the same R Value as the attic space.

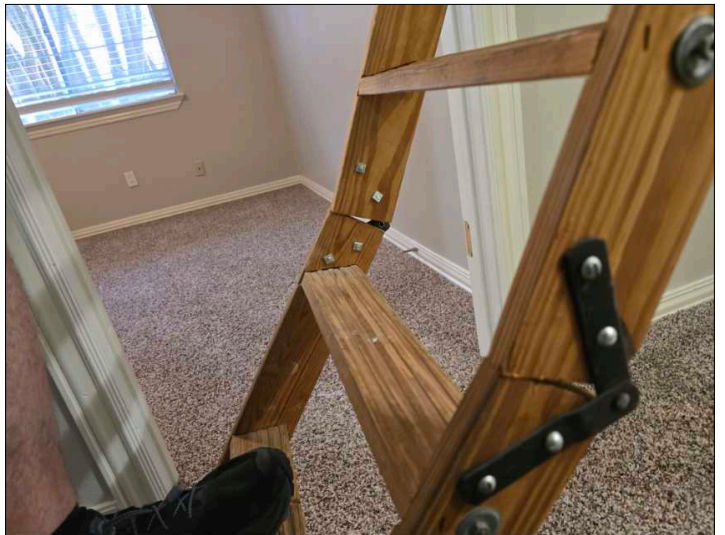
Attic access ladder is not cut to the correct length. Foot should sit flat on floor with all joints closed.

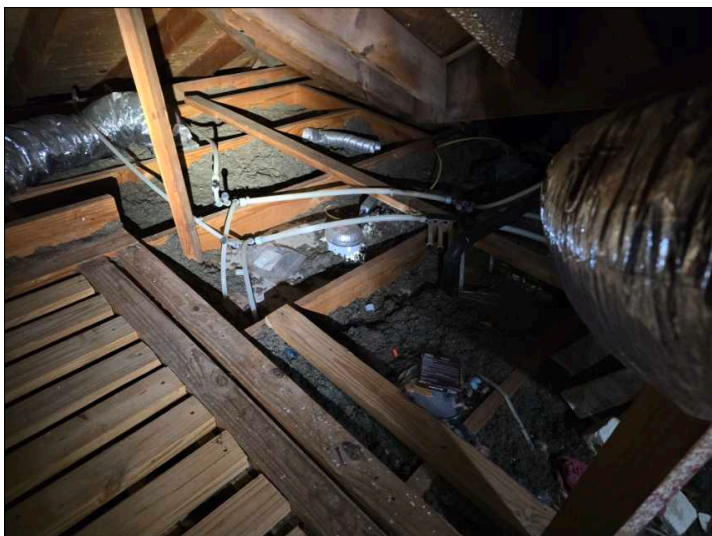
Insulation thickness varies and is of multiple types. Suggest additional insulation to meet R30 requirements for our area.

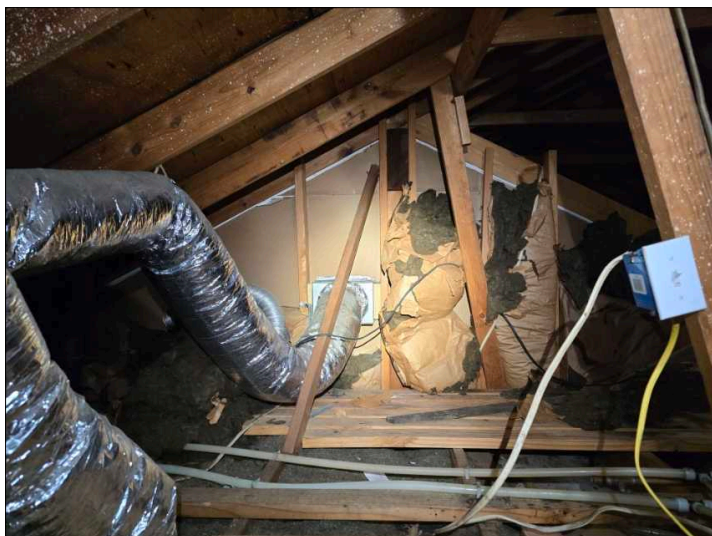
Missing insulation in several places.

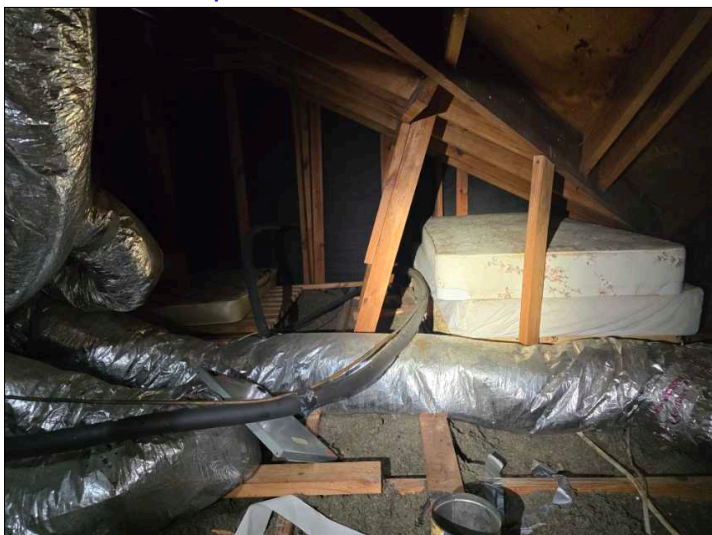
Heavy debris and belongings left in attic space noted.

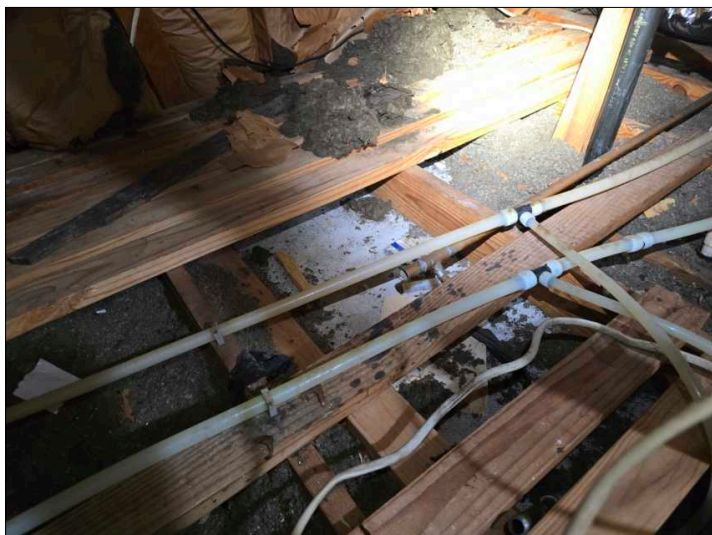
Missing insulation in several places.

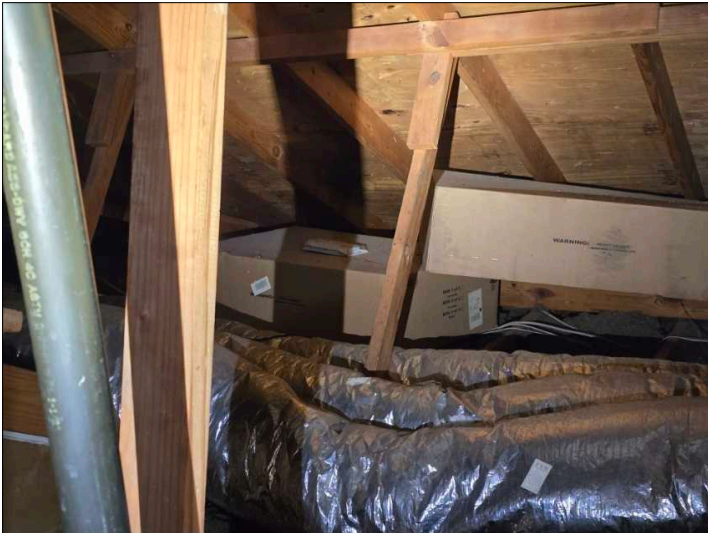
Heavy debris and belongings left in attic space noted.

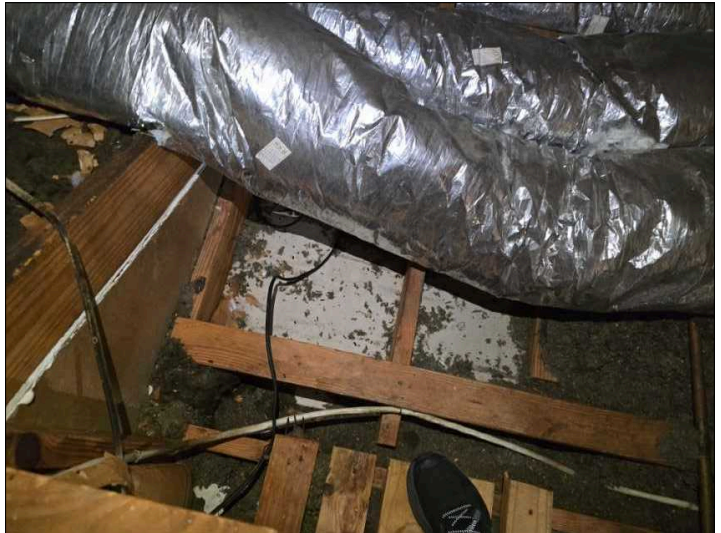
Missing insulation in several places.

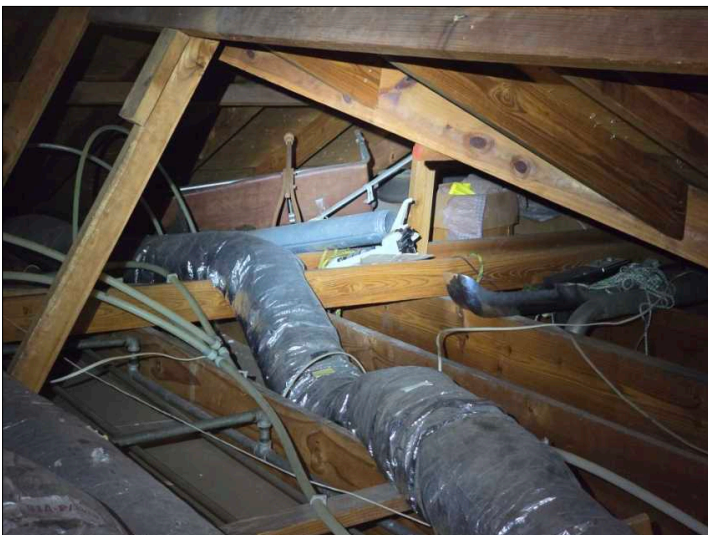
Heavy debris and belongings left in attic space noted.

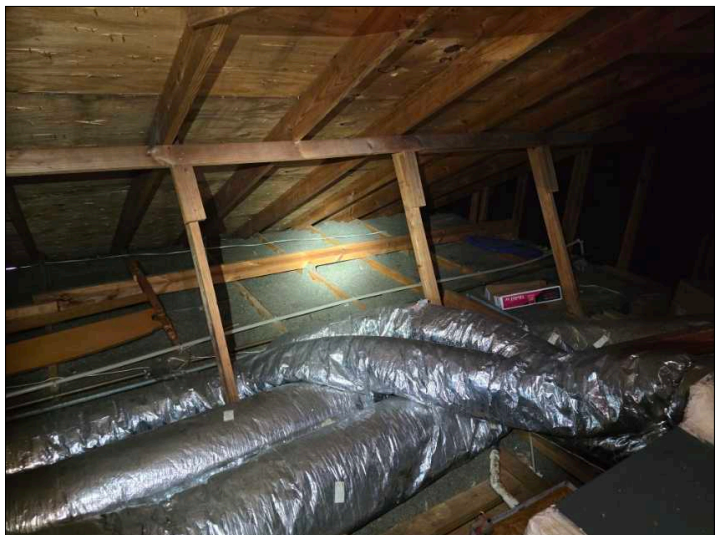
Insulation thickness varies and is of multiple types. Suggest additional insulation to meet R30 requirements for our area.

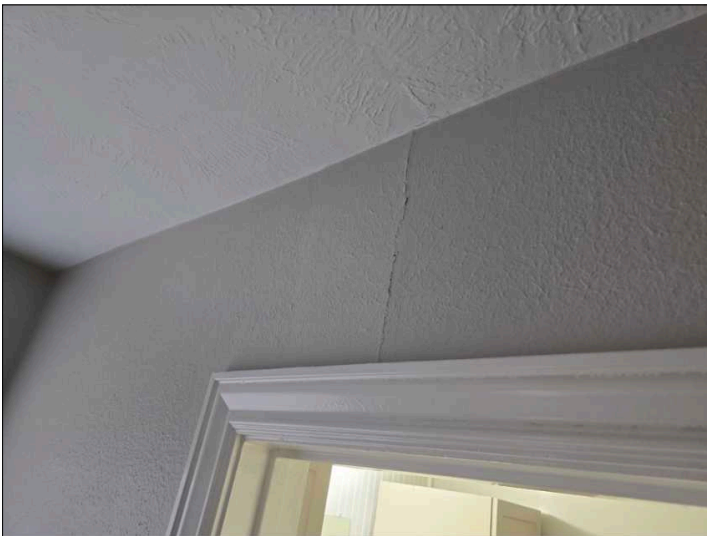
Cracks / Holes in drywall noted.

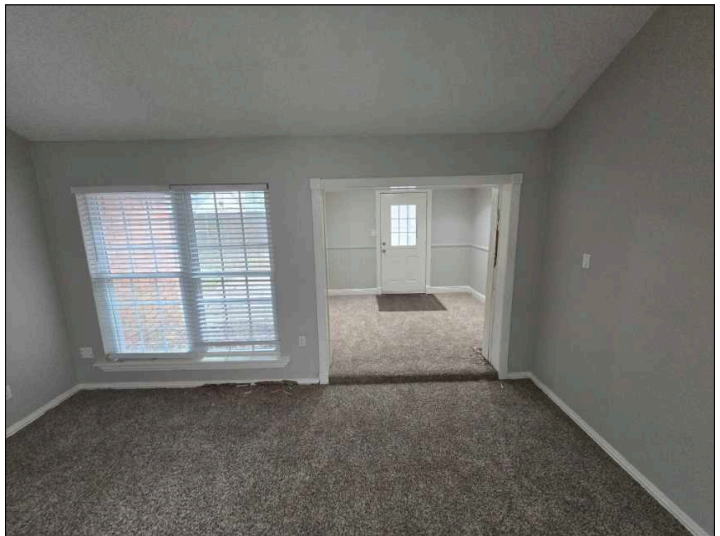
Active termite damages appear to stretch from kitchen to master bedroom. Heavy repairs and demo will be needed.

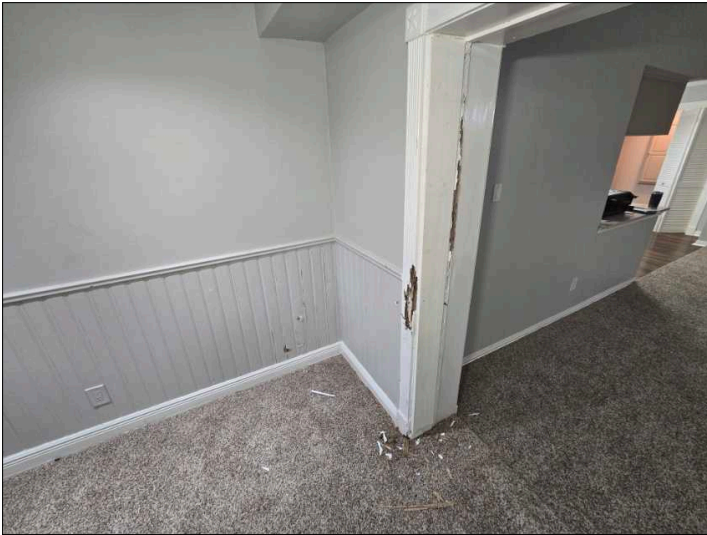
Active termite damages appear to stretch from kitchen to master bedroom. Heavy repairs and demo will be needed.

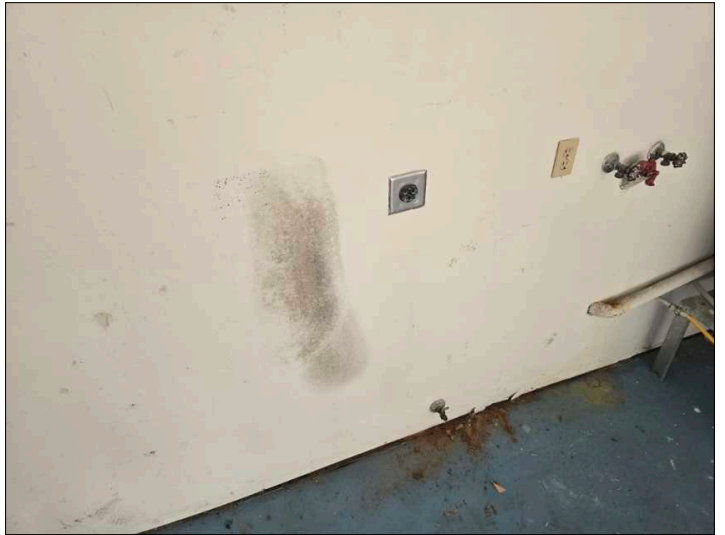
Mold damages along wall of garage.

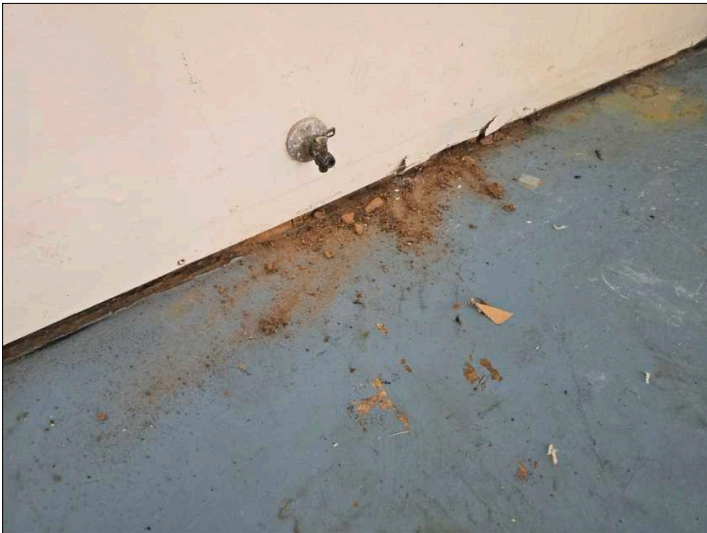
Ant and wall damages in garage.

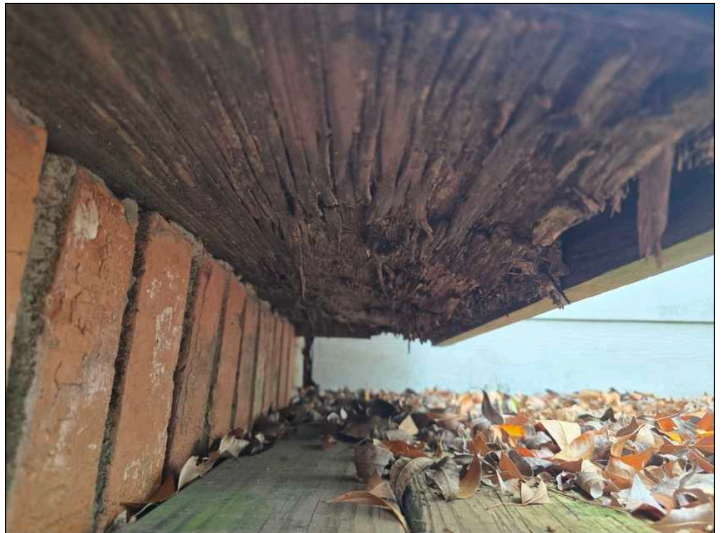
Wood rot / termites damages at wall alcove.

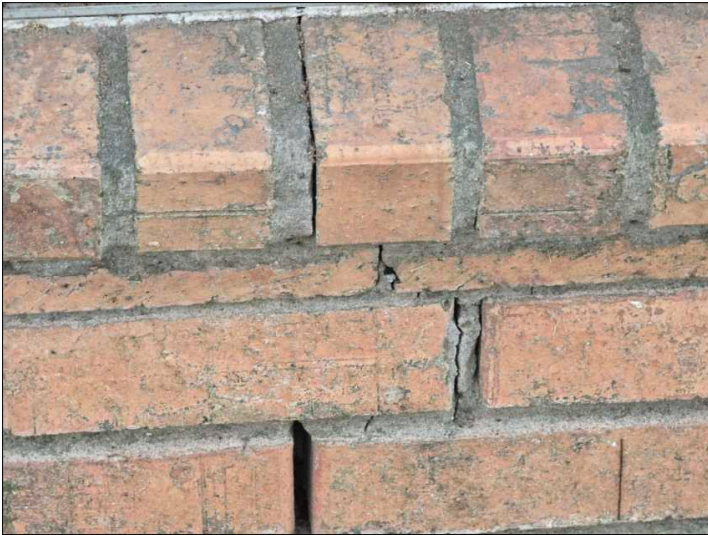
Exterior cracks in brick veneer noted. Cracks located at window corners are from settlement or uneven weight distribution.

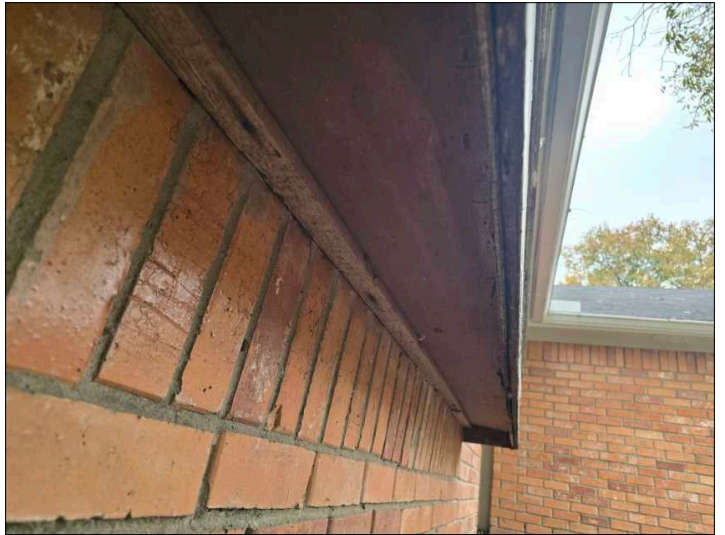
Wood rot in several places.

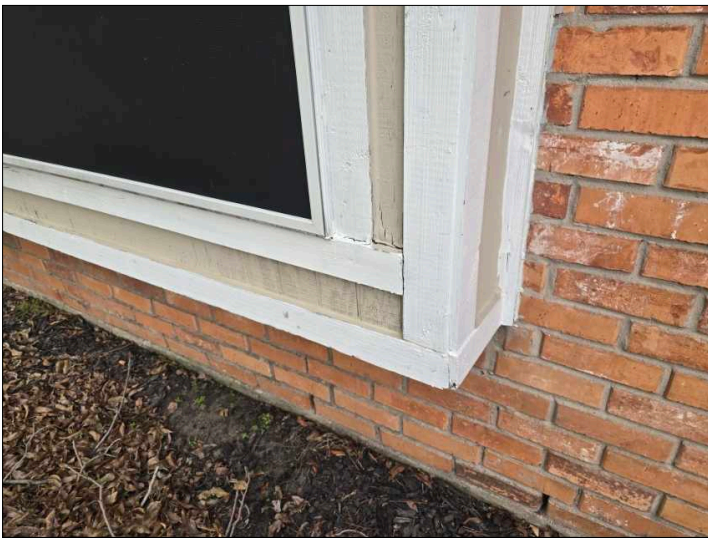
Wood rot in several places.

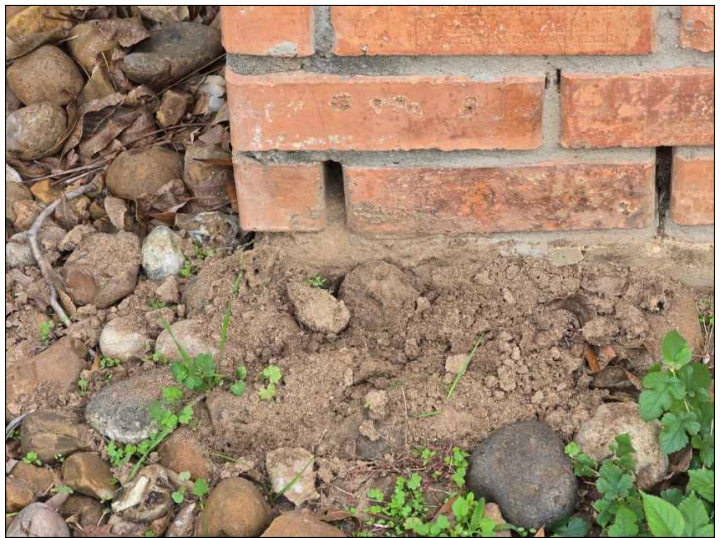
Ants entering walls.

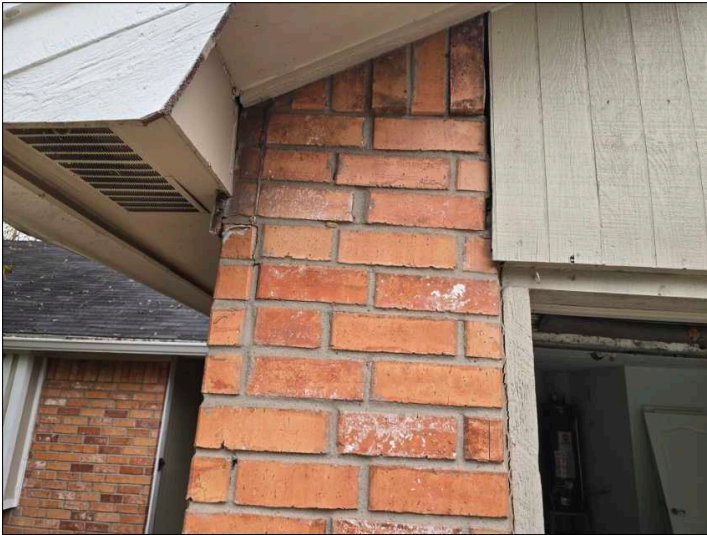
Recommend exterior siding weather proofing

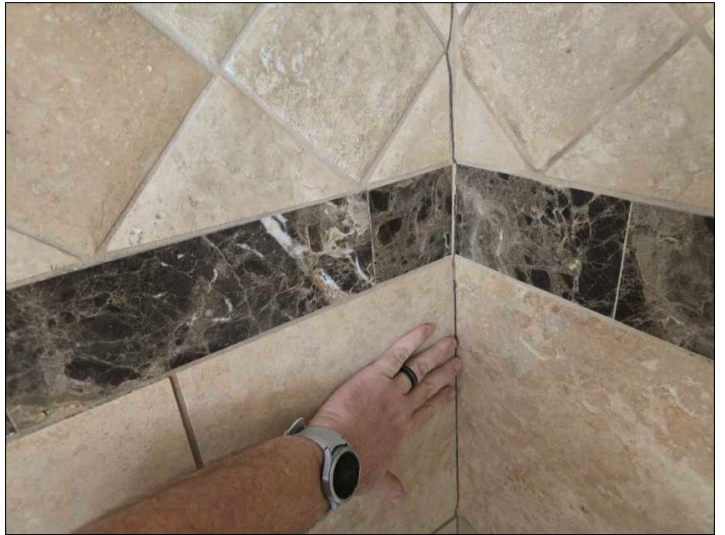
Cracks in tile grout at tub area. Suggest sealing these areas

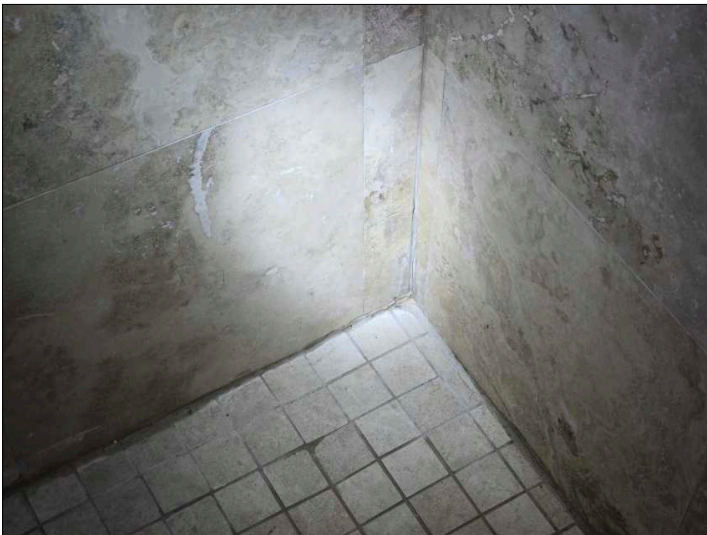
Cracks in tile grout at tub area. Suggest sealing these areas

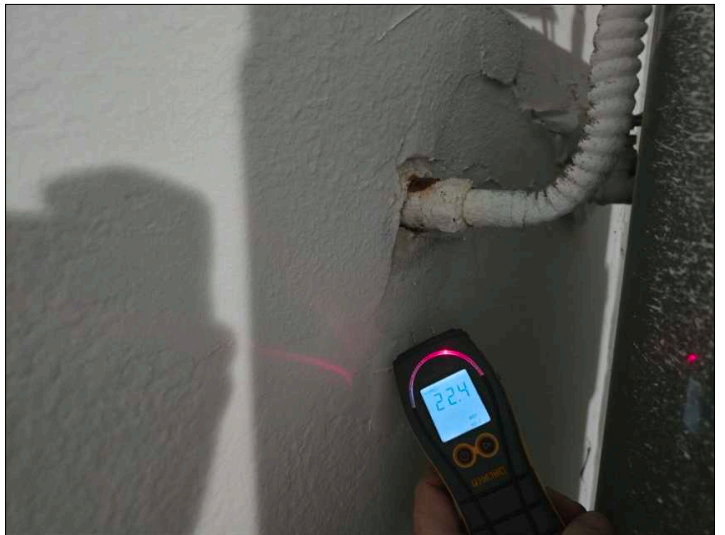
Moisture damages noted in wall of garage. Moisture detected.

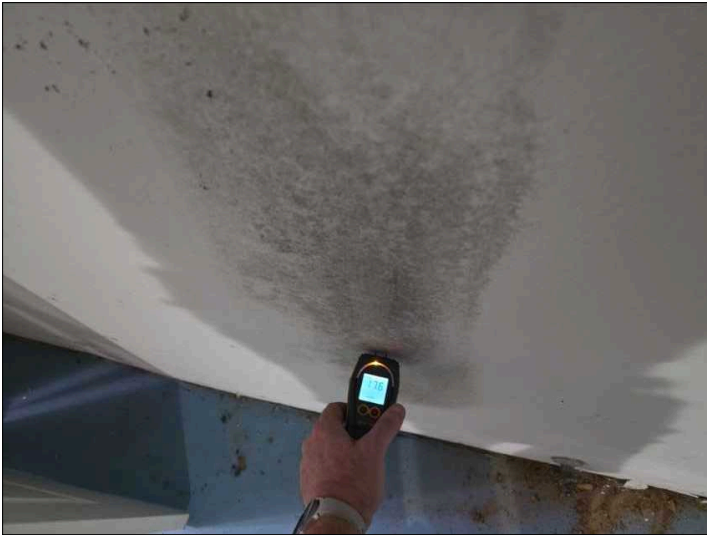
Moisture damages noted in wall of garage. Moisture detected.

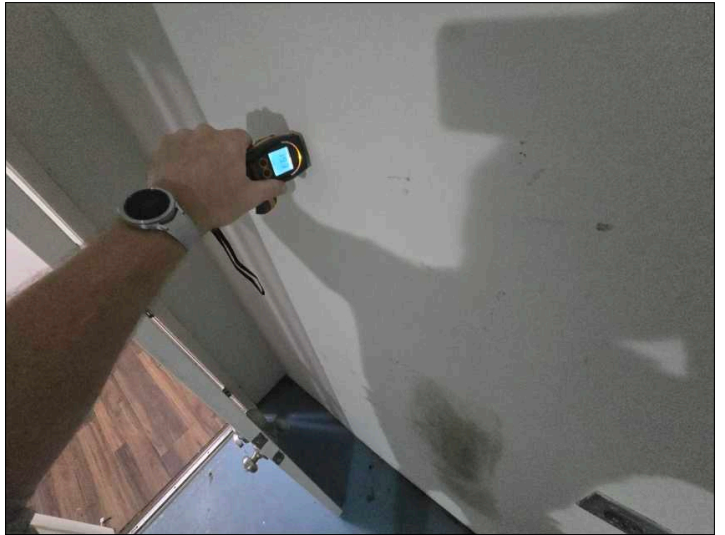
Moisture damages noted in wall of garage. Moisture detected.

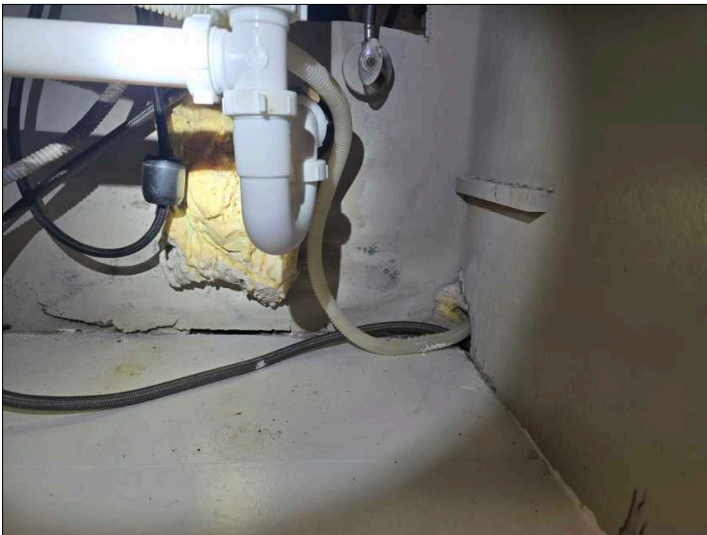
Active water leak in drain line of kitchen. Water pouring from exterior wall. Walls are likely heavily water and mold damaged. Full remediation suggested as needed.

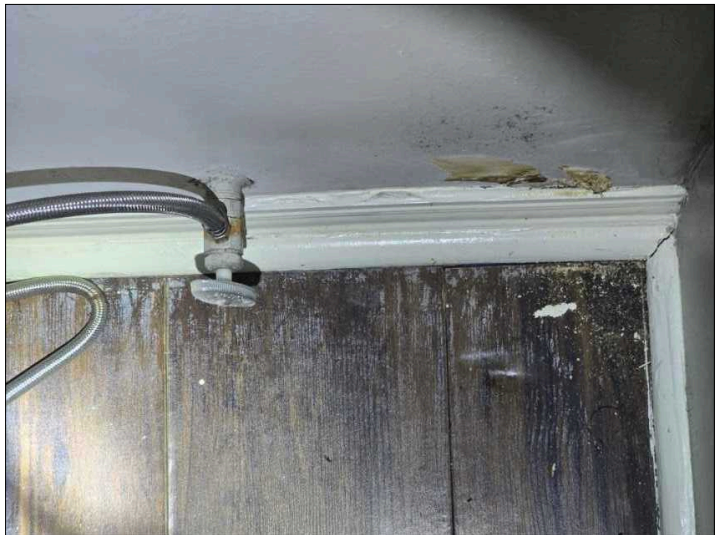
Active water leak in drain line of kitchen. Water pouring from exterior wall. Walls are likely heavily water and mold damaged. Full remediation suggested as needed.

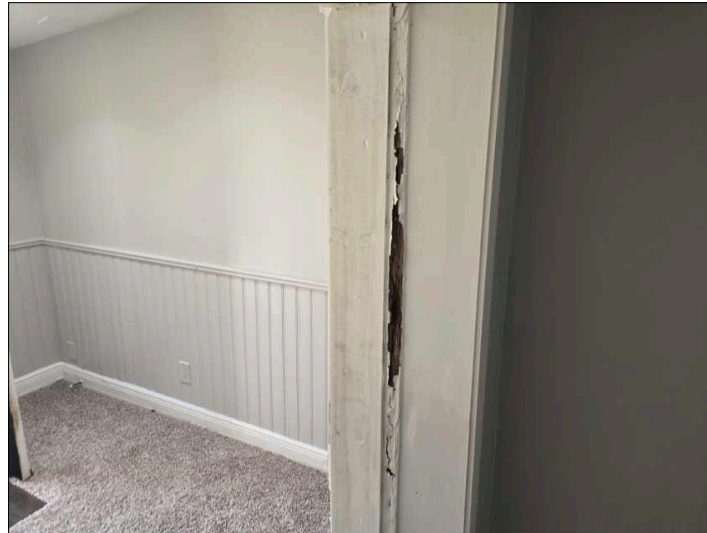
Active termite damages appear to stretch from kitchen to master bedroom. Heavy repairs and demo will be needed.

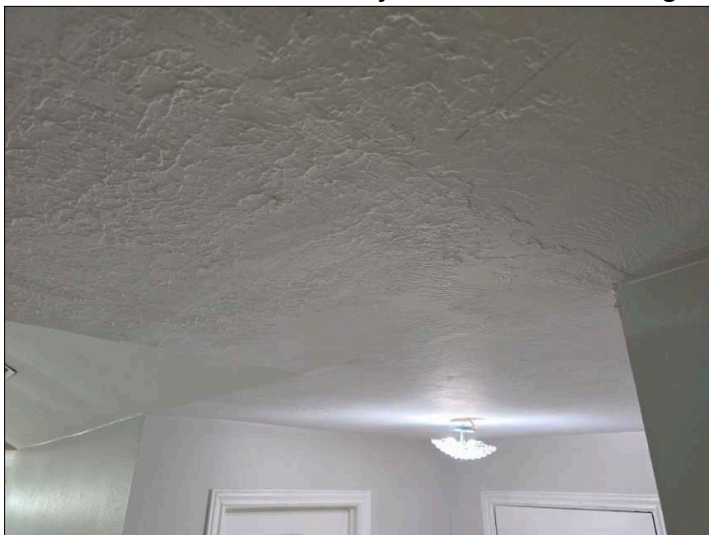
Ceiling is sagging. May be loose nails, or previous damage.

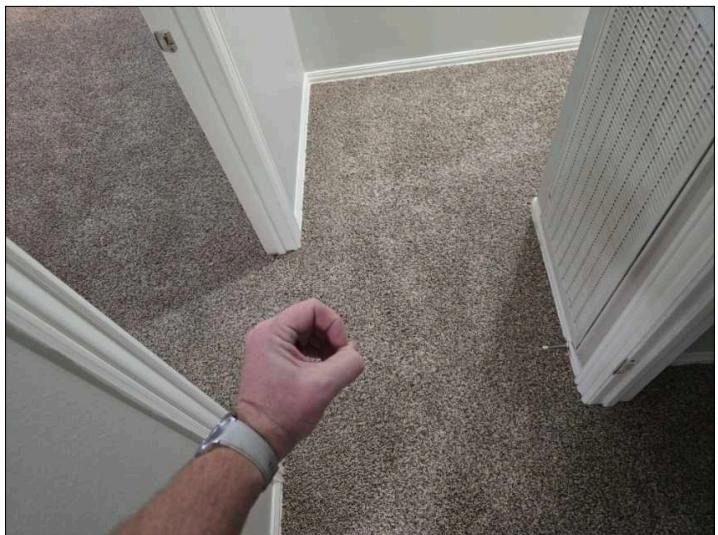
Floors were covered with carpet over various different flooring materials.

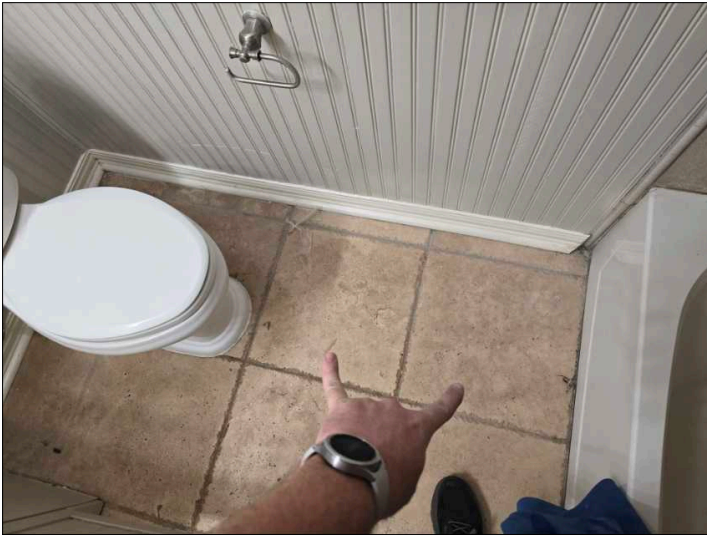
Crack in floor of 2nd bath. Appears to be foundation related.

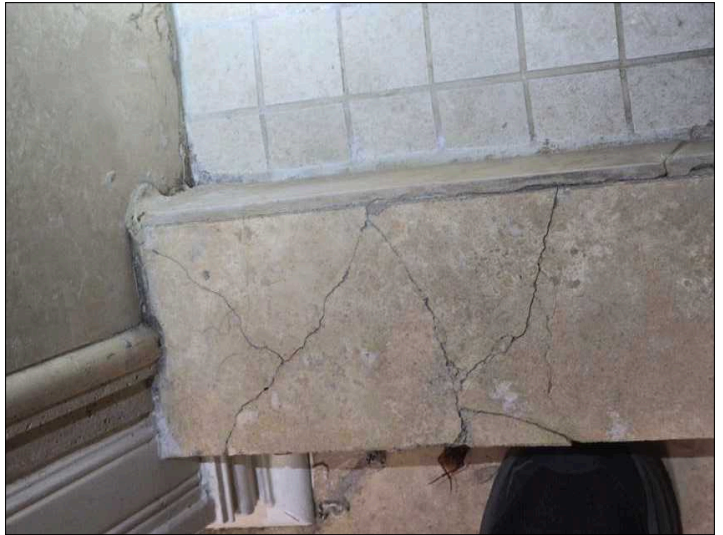
Floor tile of shower curb is broken in several places.

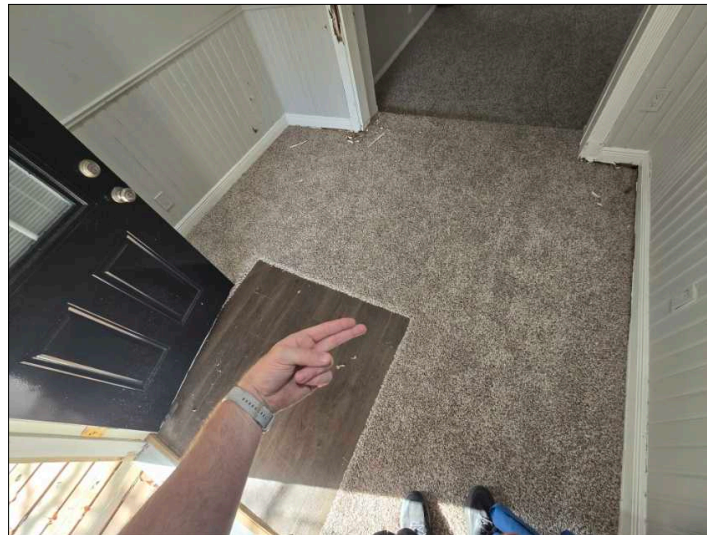
Added patio room is hollow floor over patio floors. This area is not accessible, but subject to termite damages as well.

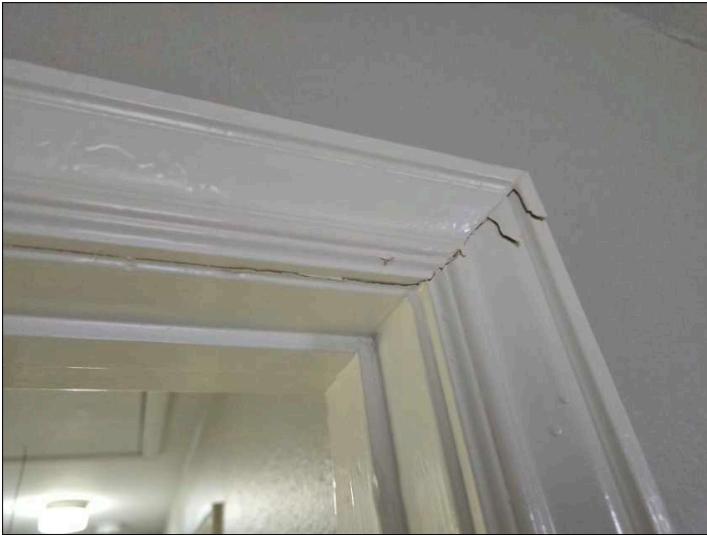
Shift settlement noted at door frame.

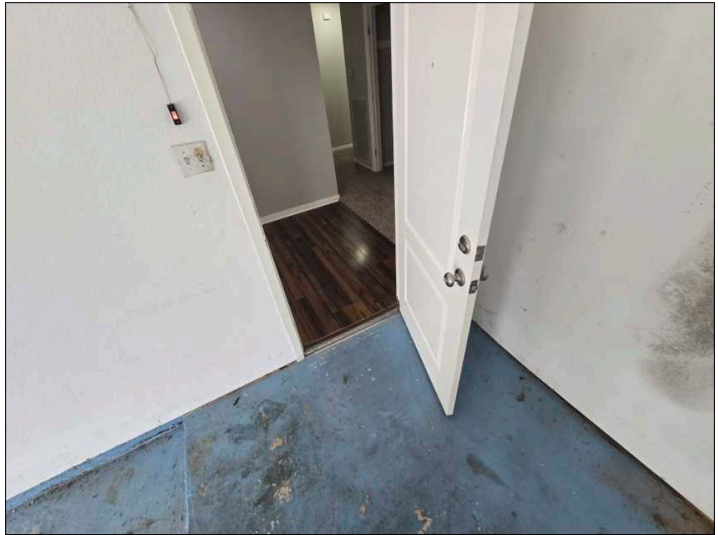
Garage door should have self-closing hinges that close door from wide open. Adjust hinge setting.

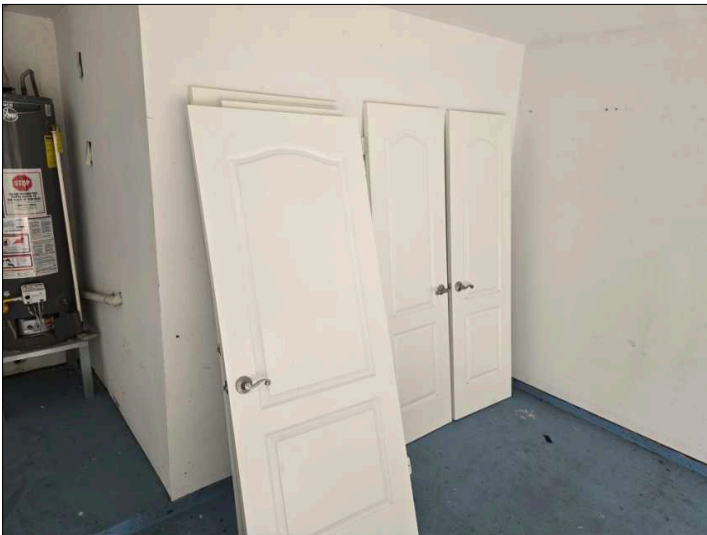
Many doors missing / not installed.

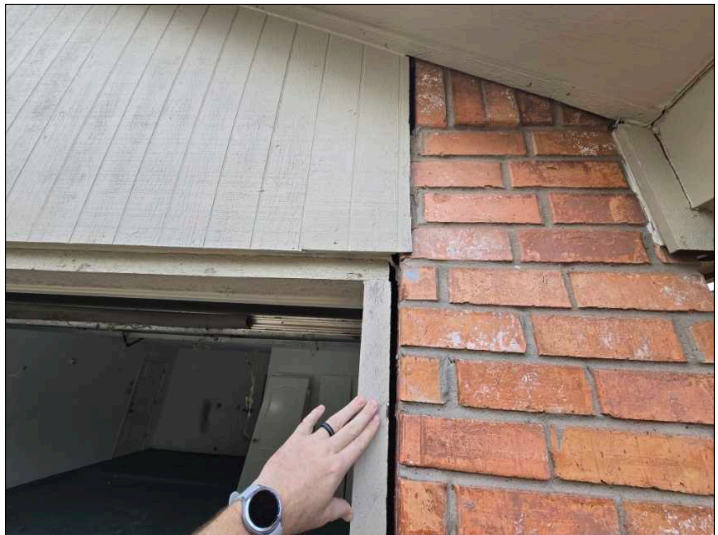
Garage door frame is not square, has separation, and needs weatherproofing.

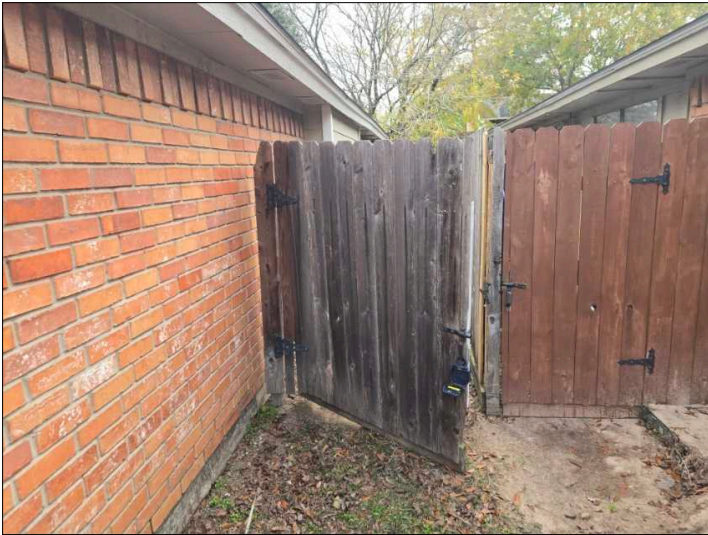
Gates are damaged and not fully functional.

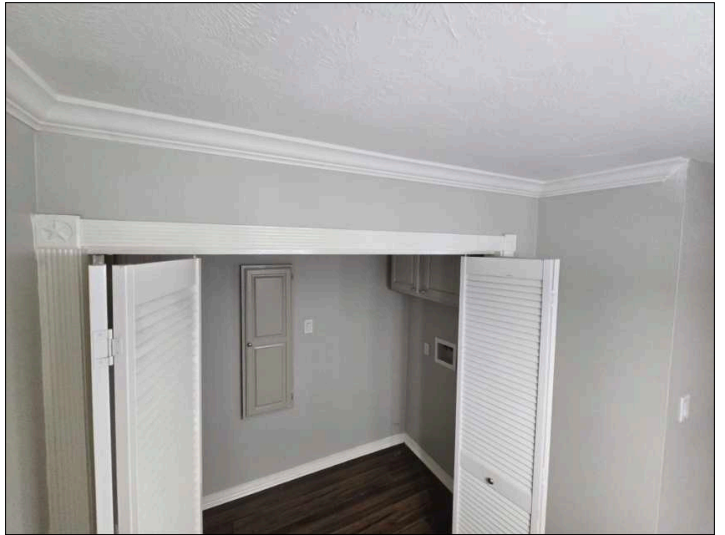
Bifold doors jump off tracks.
