True Grit Home Inspection

Property Inspection Report

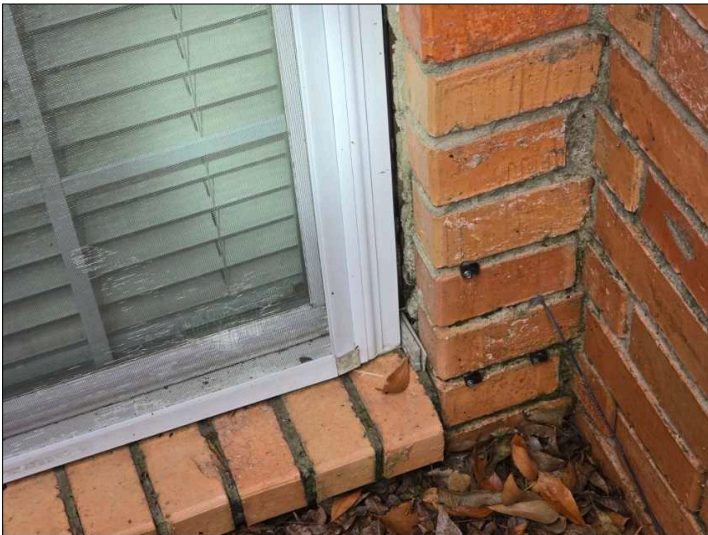
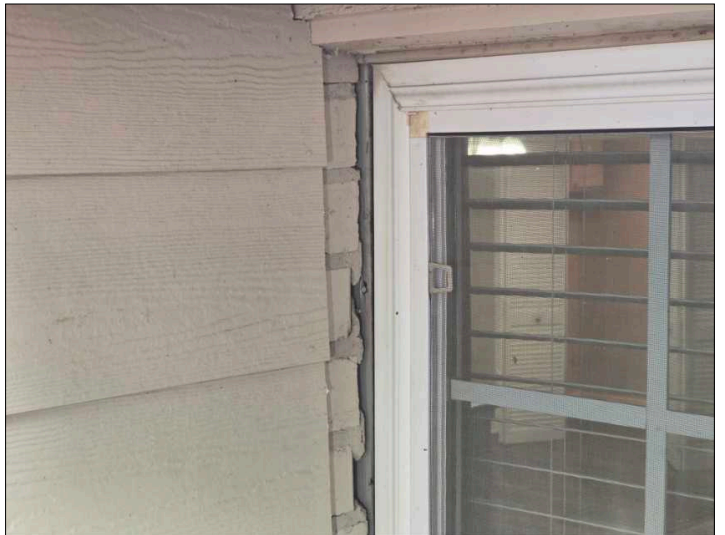
Large open holes around window near back patio. Large open holes around window near back patio.

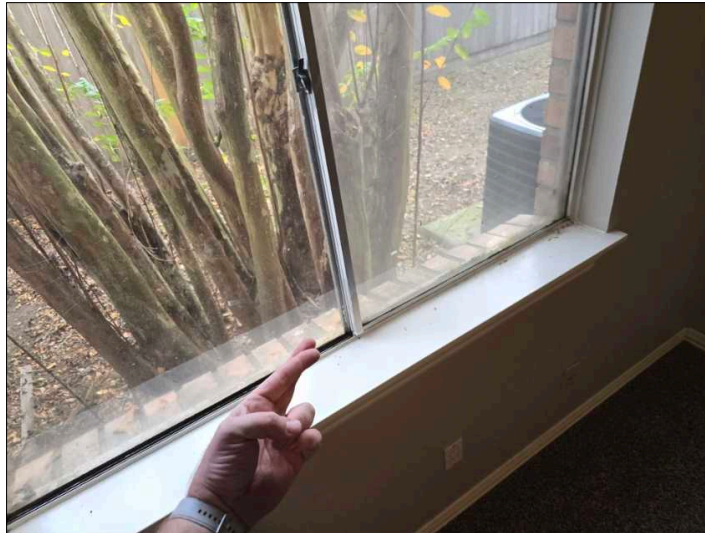
Window did not open in several locations.

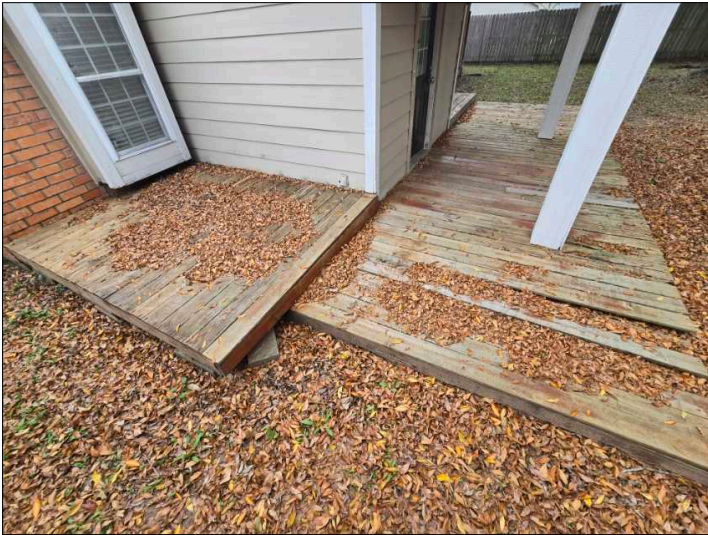
Deck in direct contact with earth. This is a possible location for wood destroying insects to enter.

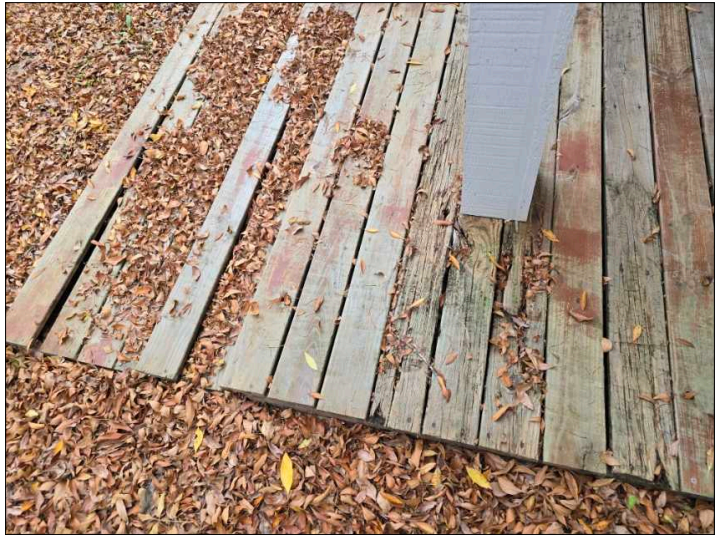
Termite damages, wood rot and trip hazards.

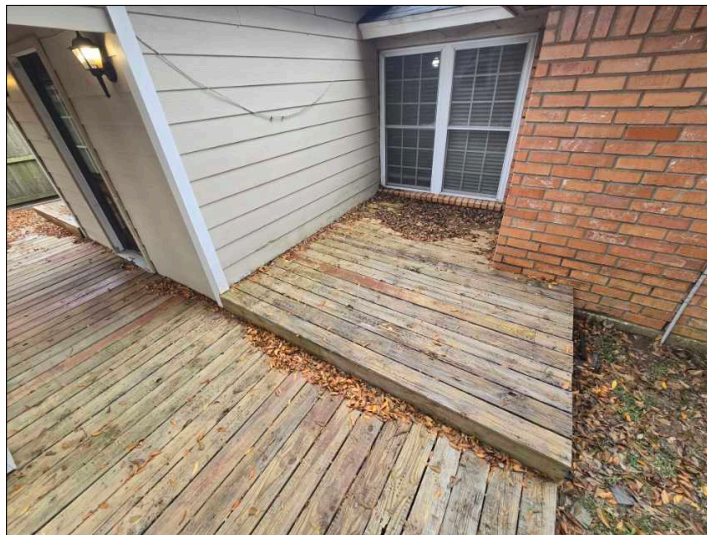
Deck in contact with house. Possible termite penetration location.

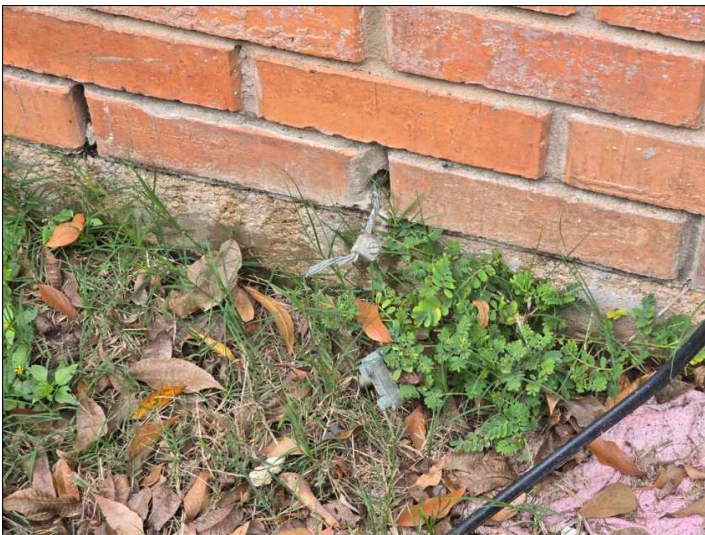
Ground rod is disconnected from the grounding conductor. This should be repaired.

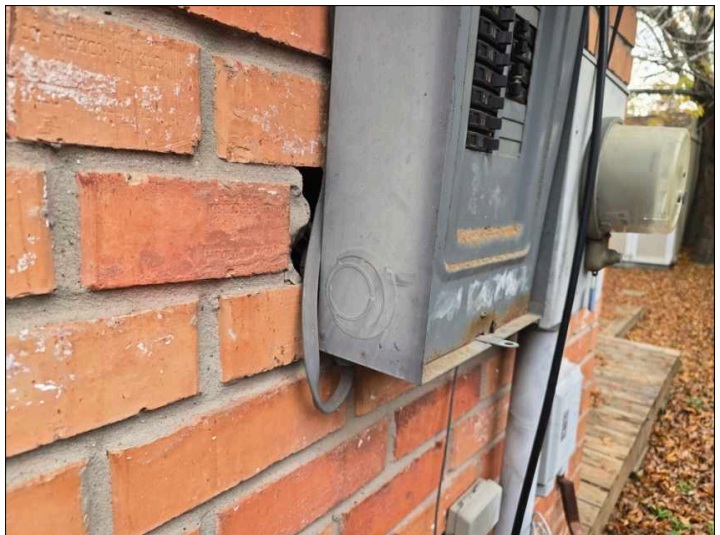
Panels that attach to exterior walls should be sealed on top and sides, but not bottom.

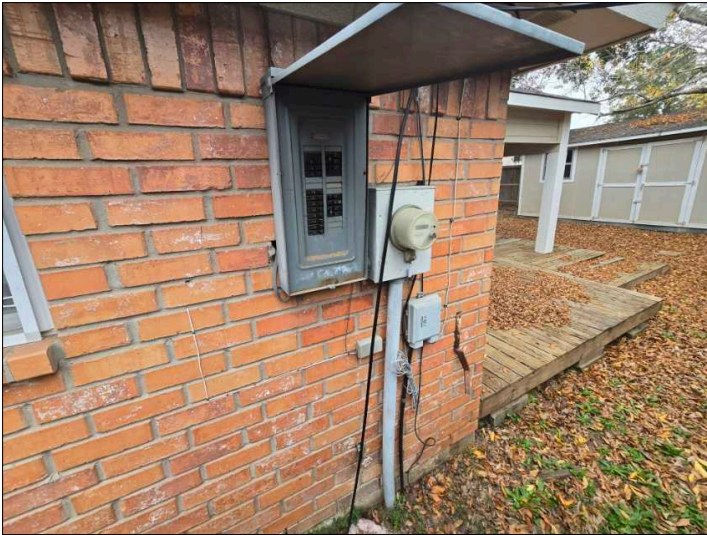
I	NI	NP	D
---	----	----	---

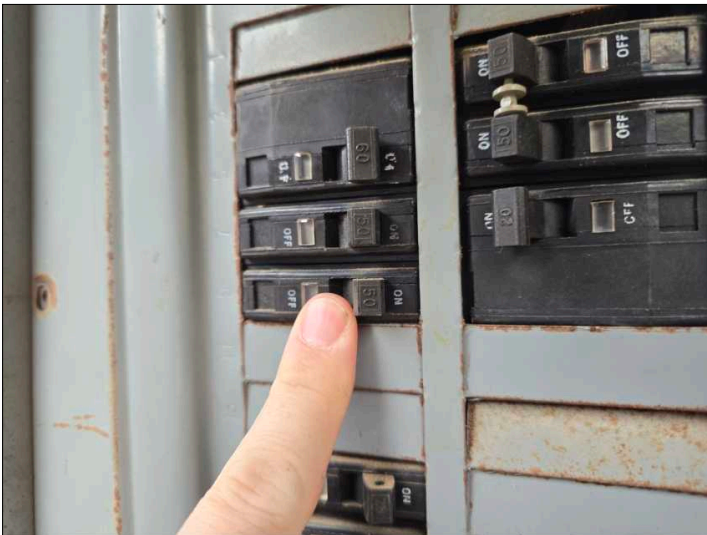
Missing trip ties in panel. Certain breakers should be tied together, so to trip at the same time. Consult electrician for repairs.

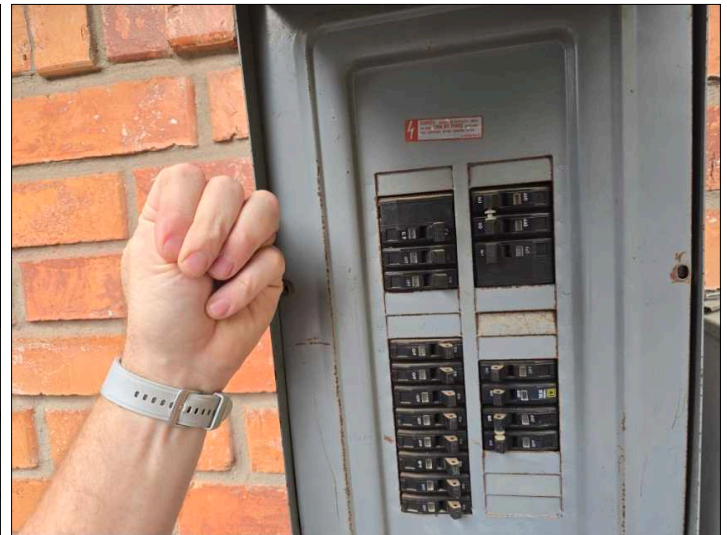
No main disconnect. Falls under old 4 throws of the hand rule.

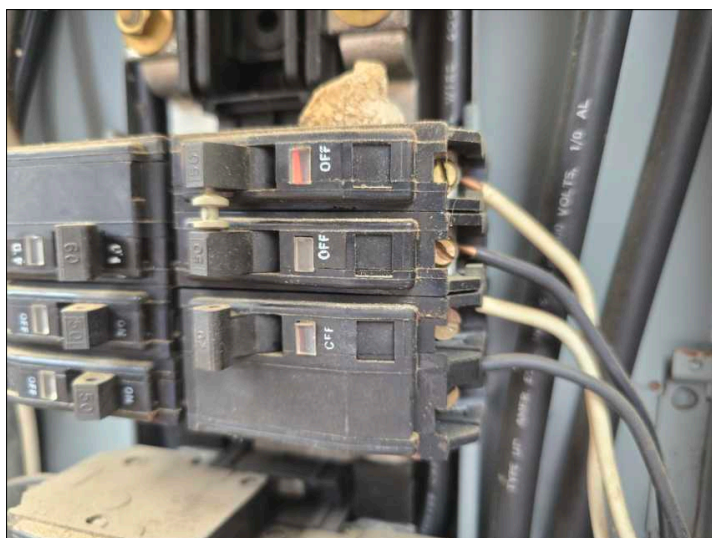
There are white wires in the panel that should be labeled as hot wires

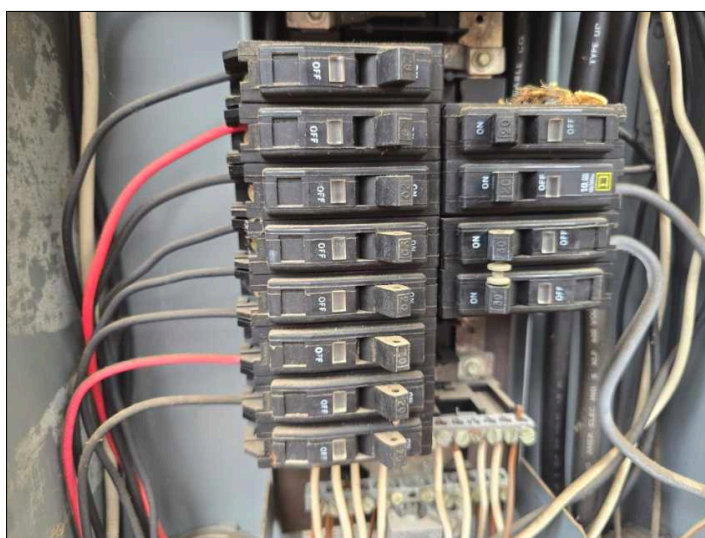
Arc fault circuit interrupters (AFCI) protection is currently required for all 15 and 20 amp branch circuits providing power to outlets in residential family rooms, dining rooms, living rooms, parlors, libraries, dens, bedrooms, sun-rooms, recreation rooms, closets, hallways, and similar rooms or areas. One or more areas missing.

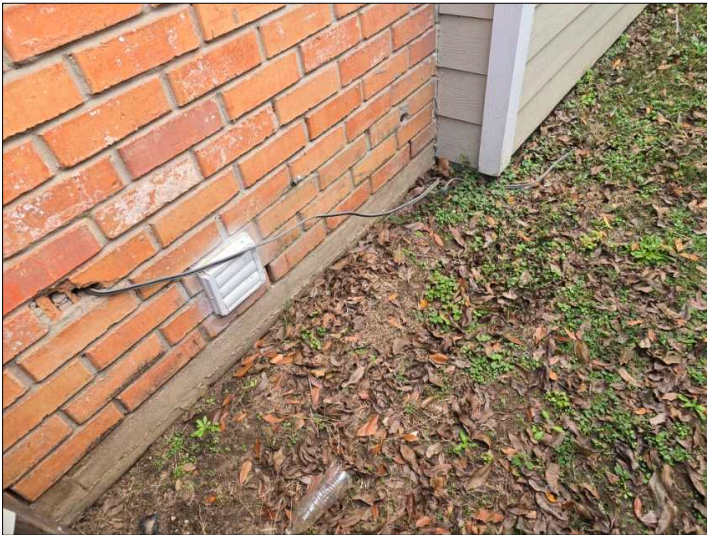
Dryer wire added to panel, but wire loosely exposed and not properly protected

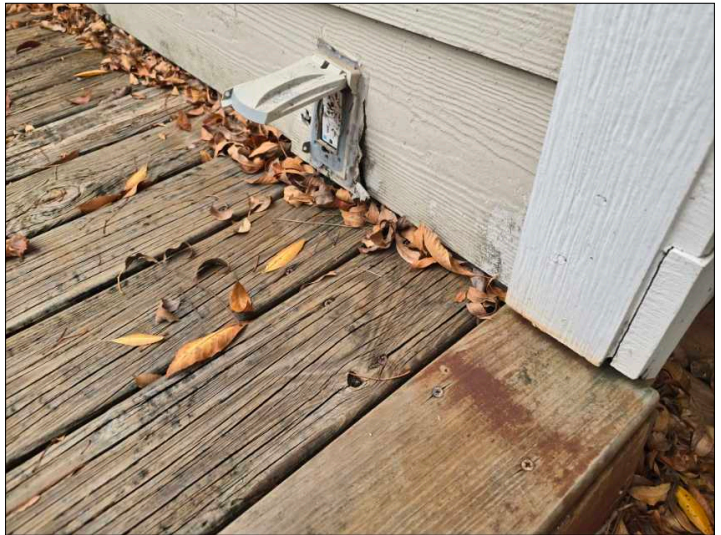
Loose receptacle found.

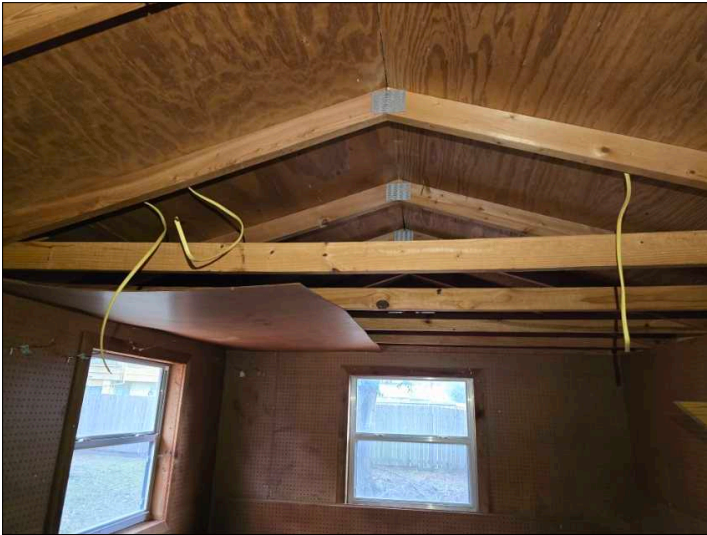
Unfinished electric to shop. No power to panel.

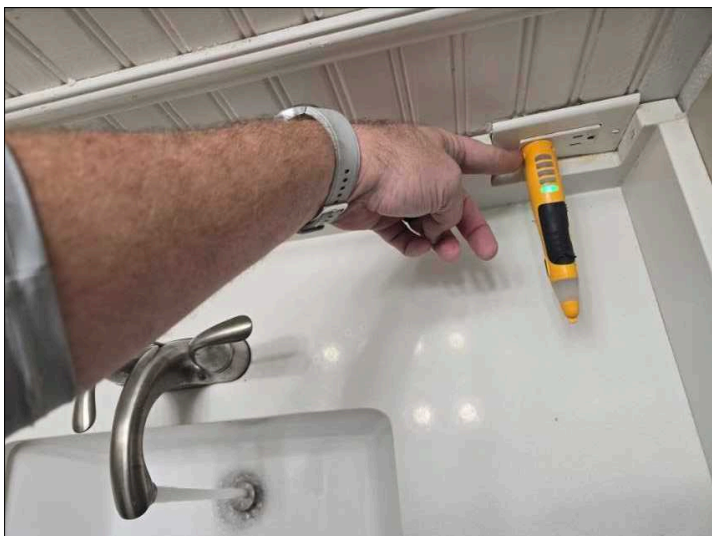
All receptacles near "wet" locations should be GFCI protected. This includes bathrooms, kitchen counter area, outside receptacles, garage and utility areas.

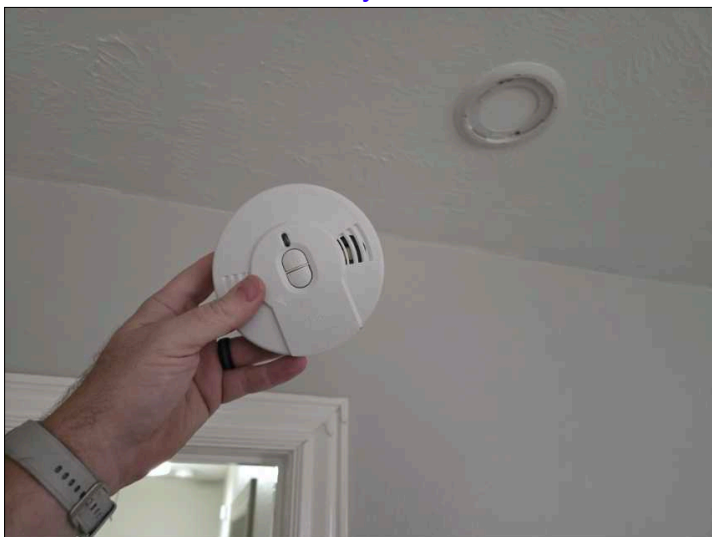
Smoke detectors not tied to other and missing CO detector.

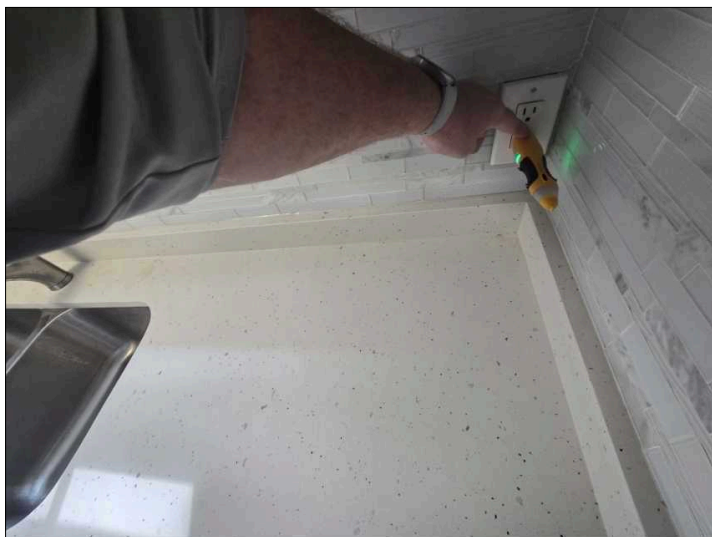
All receptacles near "wet" locations should be GFCI protected. This includes bathrooms, kitchen counter area, outside receptacles, garage and utility areas.

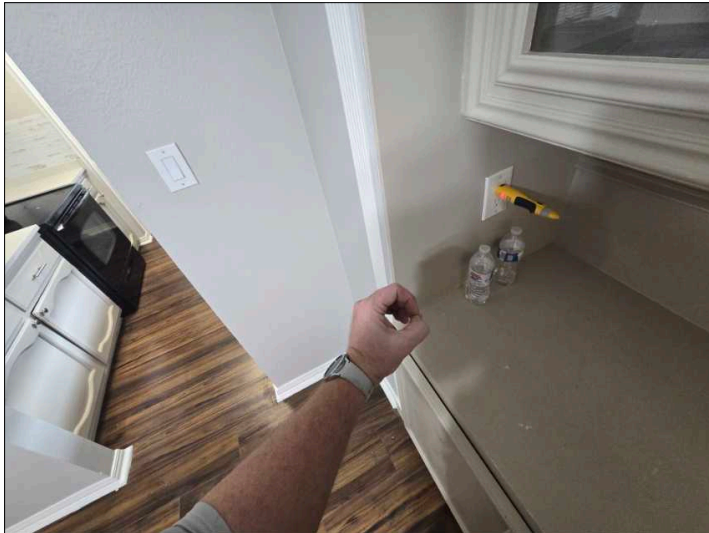
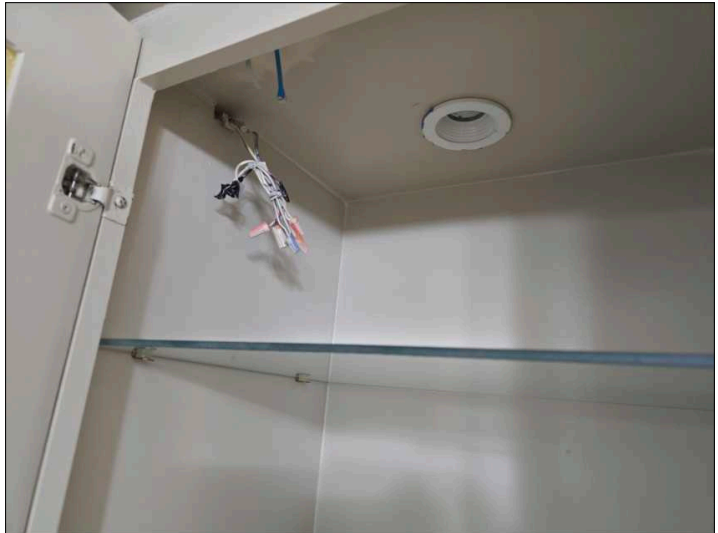
All receptacles near "wet" locations should be GFCI protected. This includes bathrooms, kitchen counter area, outside receptacles, garage and utility areas.

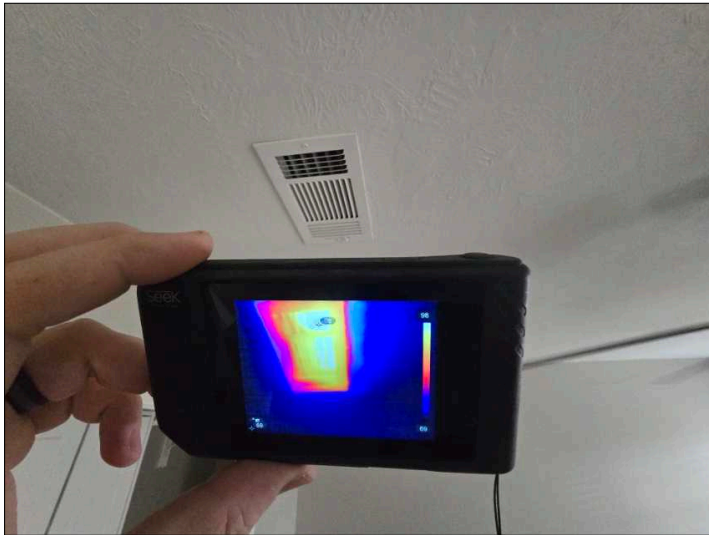
- Furnace visually inspected and checked.
- Estimated Age of Furnace :2022
- Flue should be clear of combustibles by minimum 1".
- Flex gas line entering furnace cabinet is a fire hazard and should be corrected.

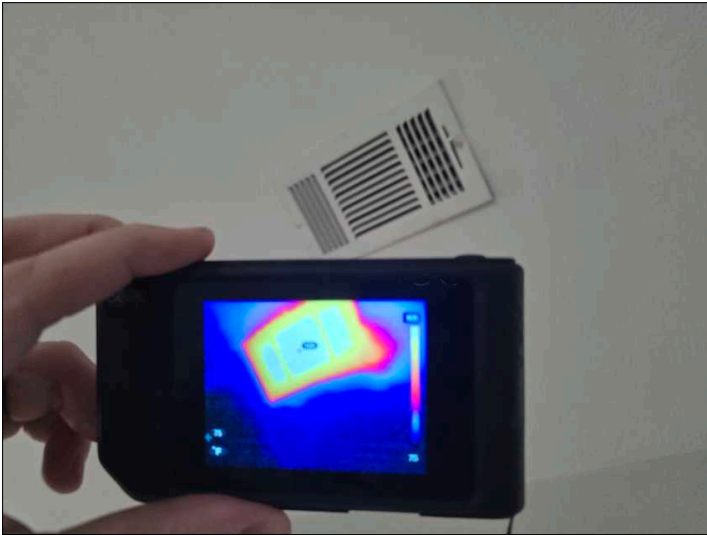
I	NI	NP	D
---	----	----	---

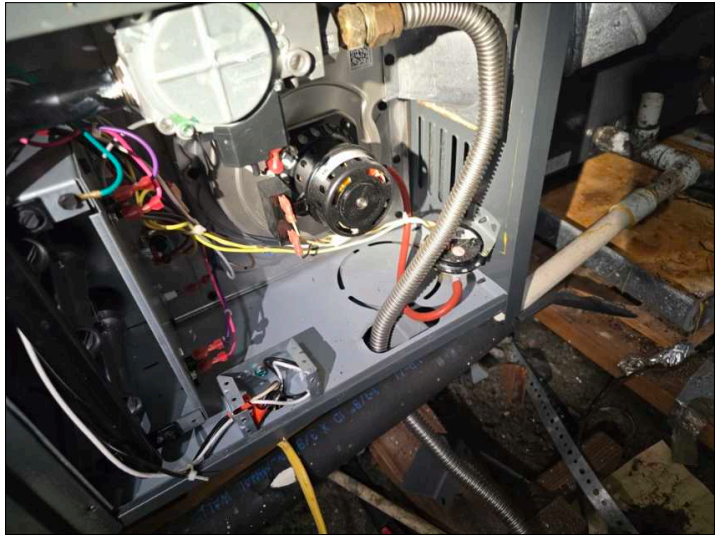
Flex gas line entering furnace cabinet is a fire hazard and should be corrected.

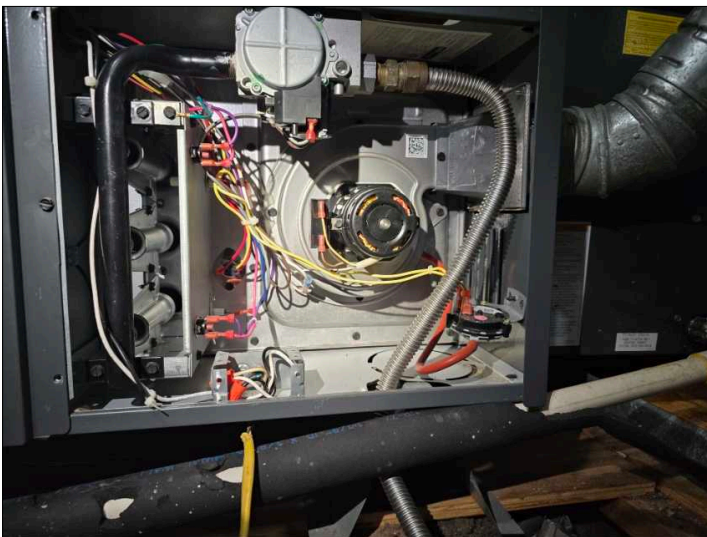
Furnace visually inspected and checked.

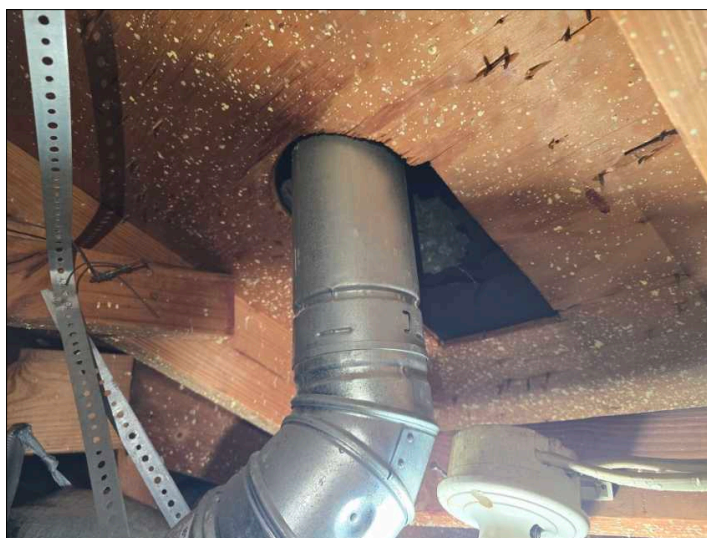
Flue should be clear of combustibles by minimum 1".

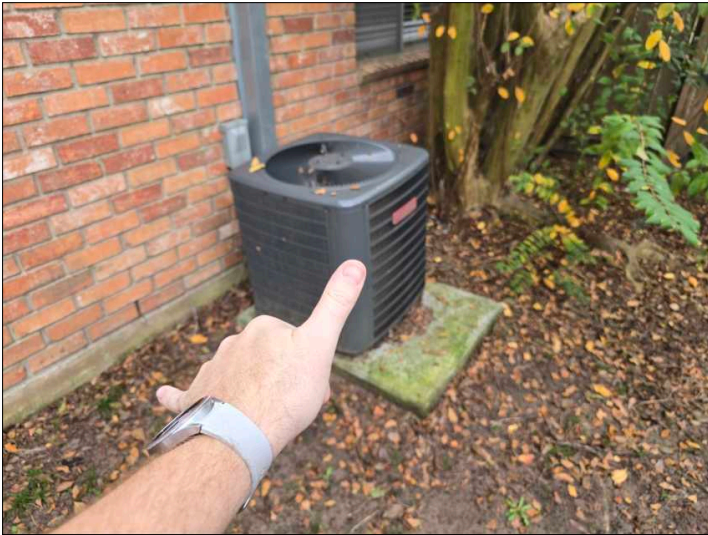
Exterior condensing unit should be resting level. Not currently level

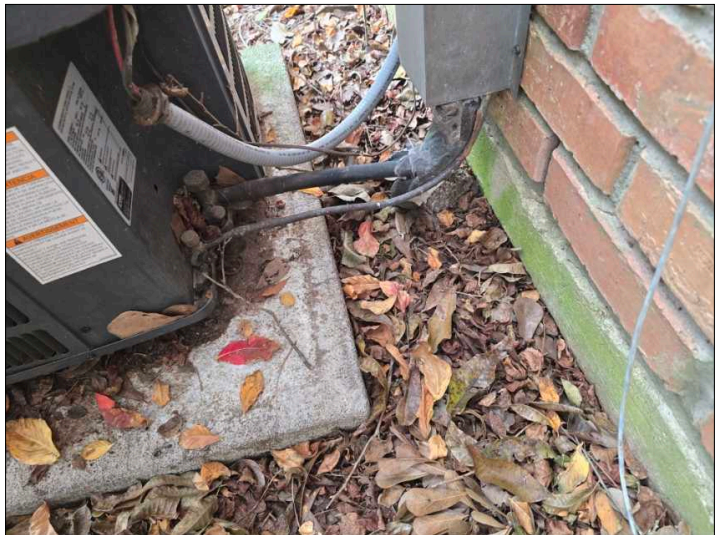
Refrigerant lines are missing insulation at the A/C unit

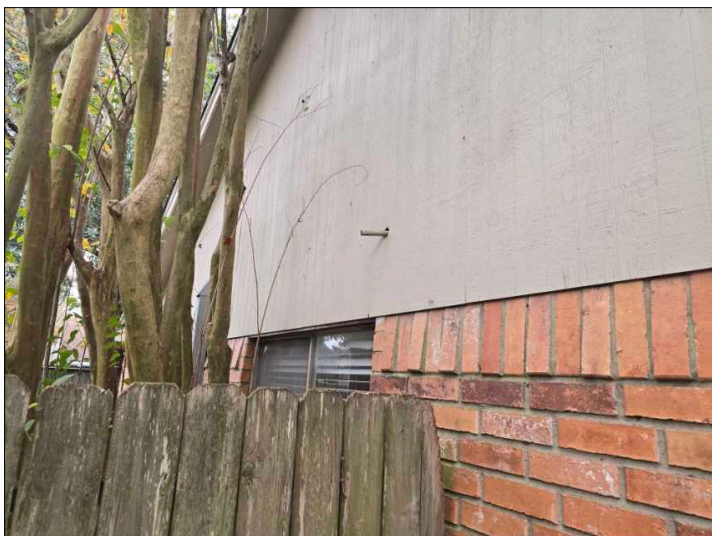
Secondary Drain line discharge location is over window. If water is seen coming from here, the primary may be stopped up. Contact HVAC service immediately to prevent possible damage.

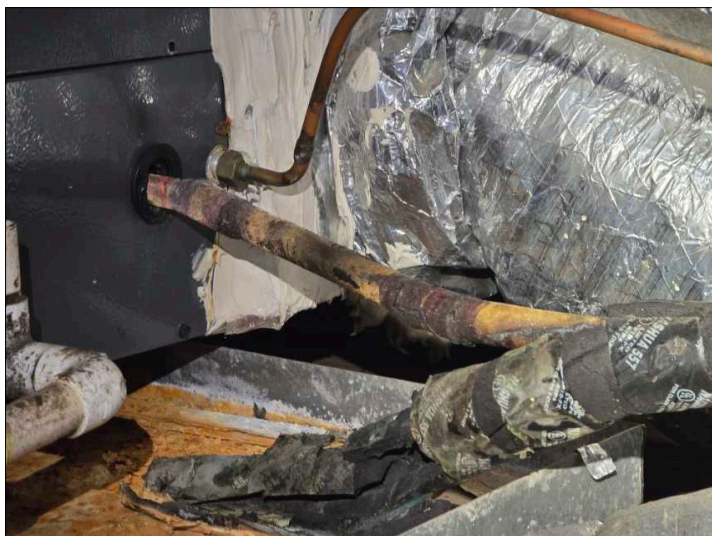
Coolant lines missing insulation in attic space. This will condensate and drip onto attic floor / ceiling.

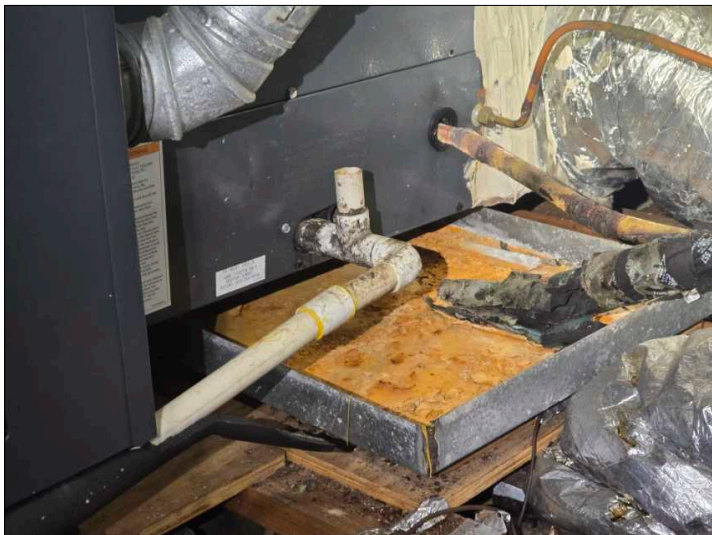
No secondary drain installed. This should drain into a catch pan if the primary is clogged.

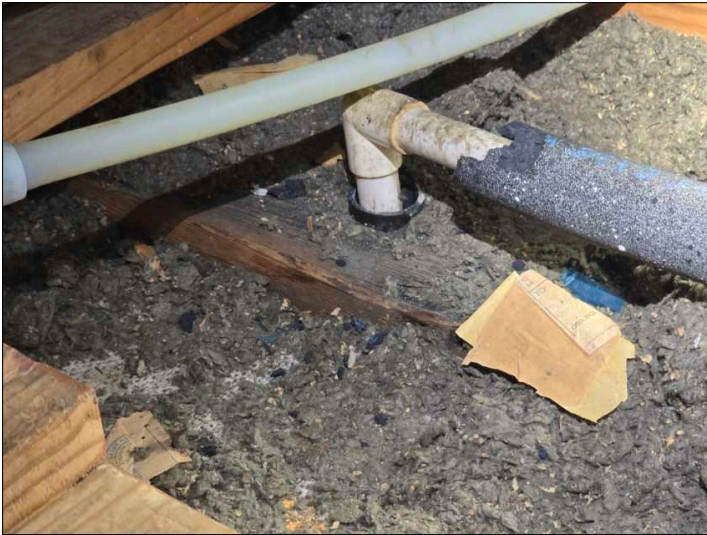
Main drain is tied to an open vent line in the attic. This is a risk of water overflow and damages. Plumber should seal connections.

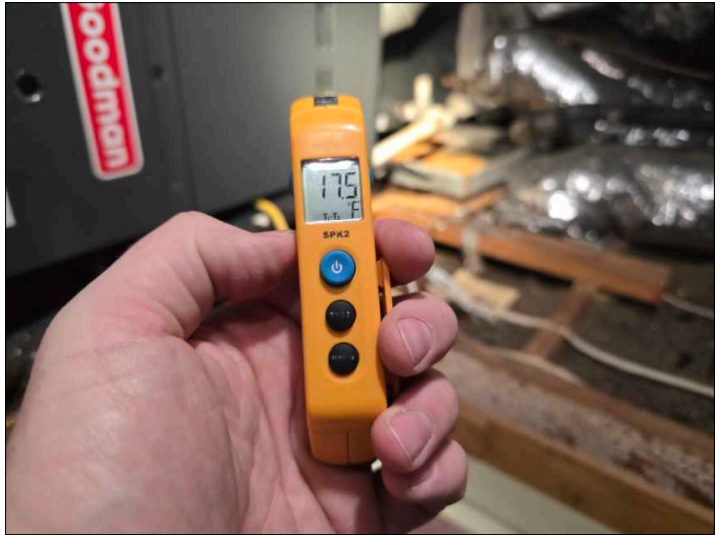
17f delta T across coil is acceptable.

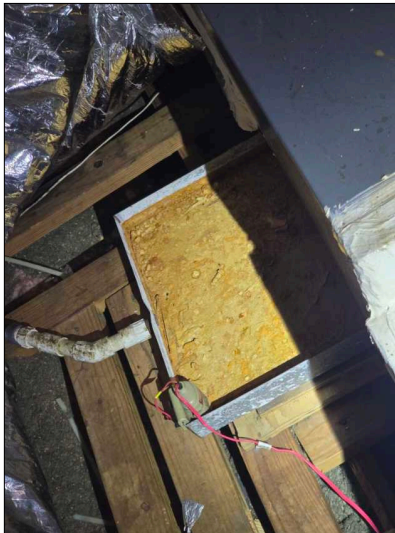
Heavy rust in overflow pan. Recommend replacement of overflow pan, as rust can cause holes to leak.

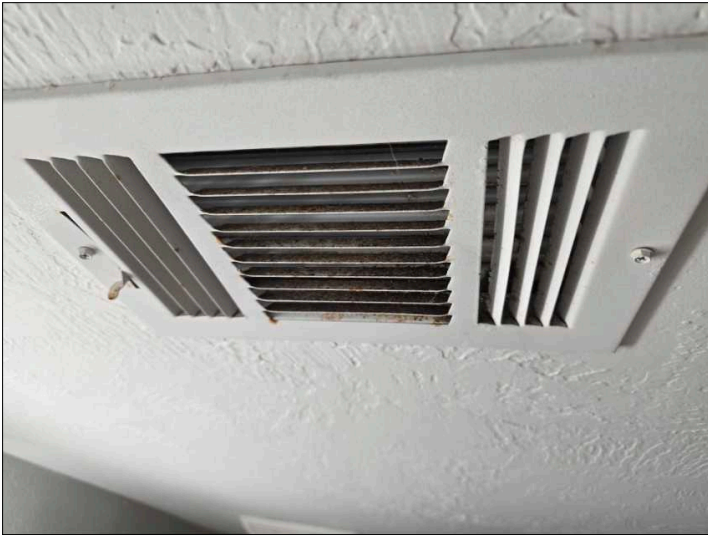
Rusted register noted in bathroom.

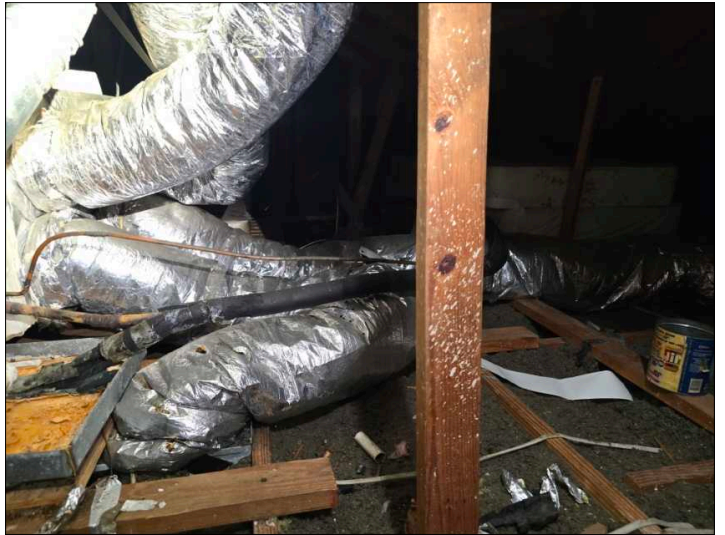
90 degree bend in flex lines present. This restricts air flow and balance of conditioned air in home.

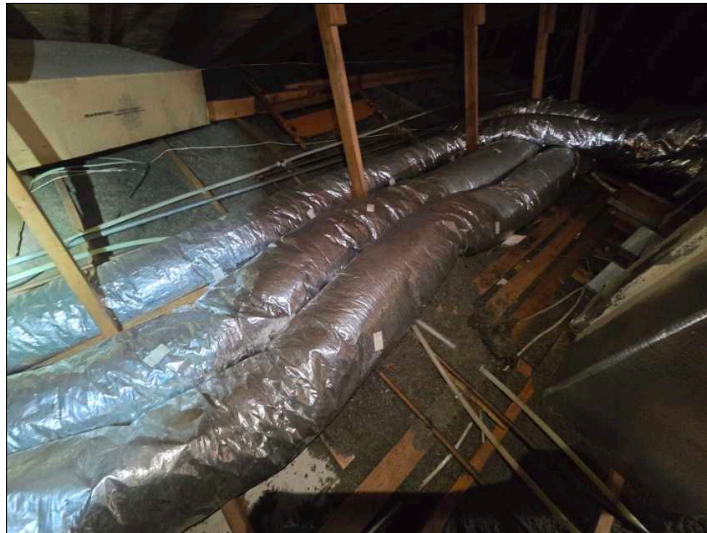
Flex ducting in contact with blown in insulation. This can cause mold growth. Flex ducting should be fully suspended.

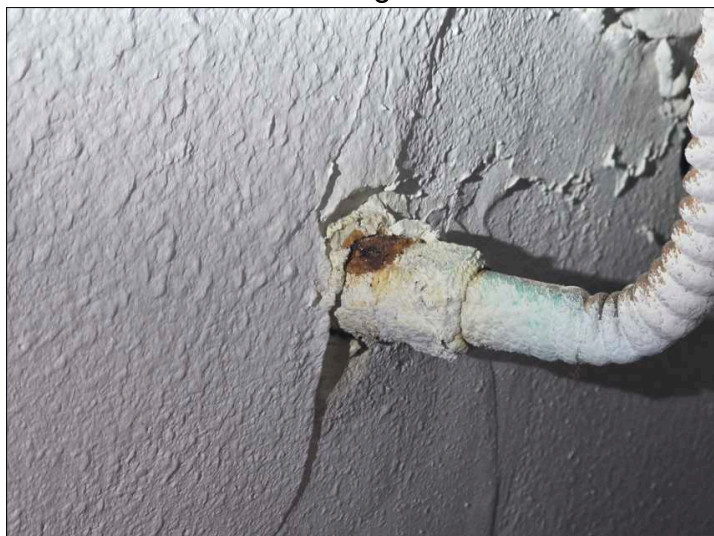
Home appears to have been repiped, but some rusted galvanized still present near water heater.

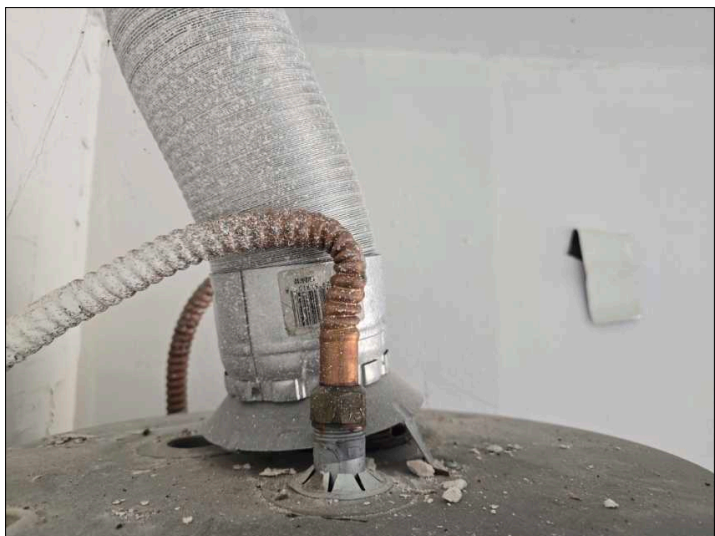
Damaged water line at water heater.

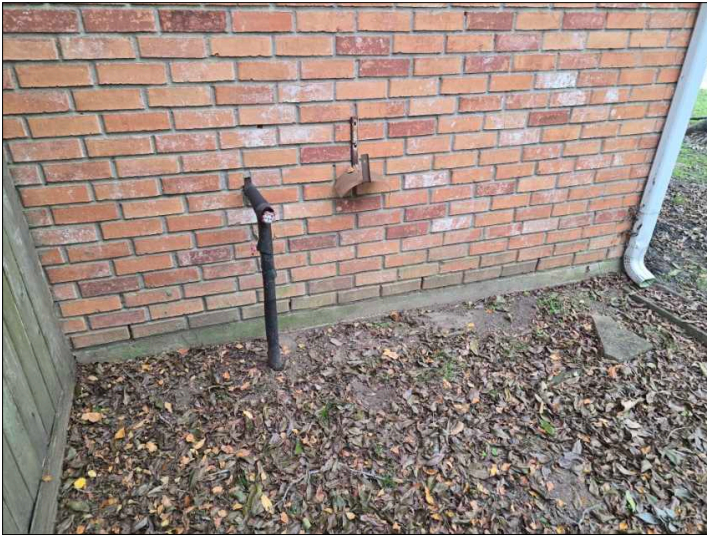
Water shutoff location.

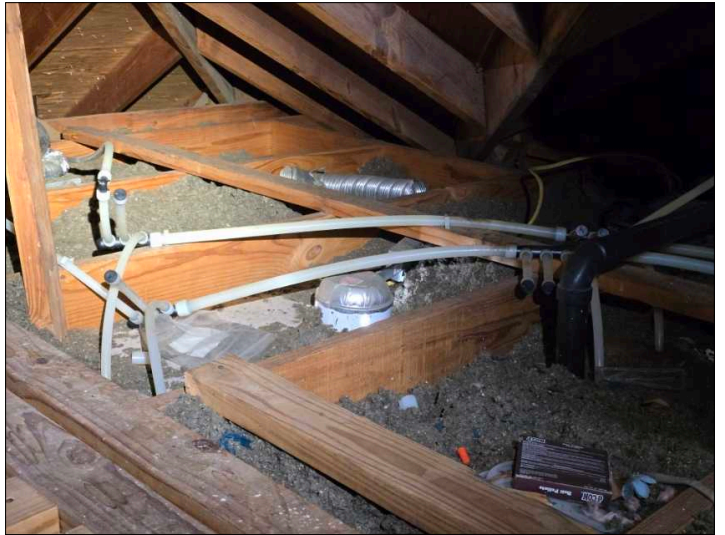
Home appears to have been repiped, but some rusted galvanized still present near water heater.

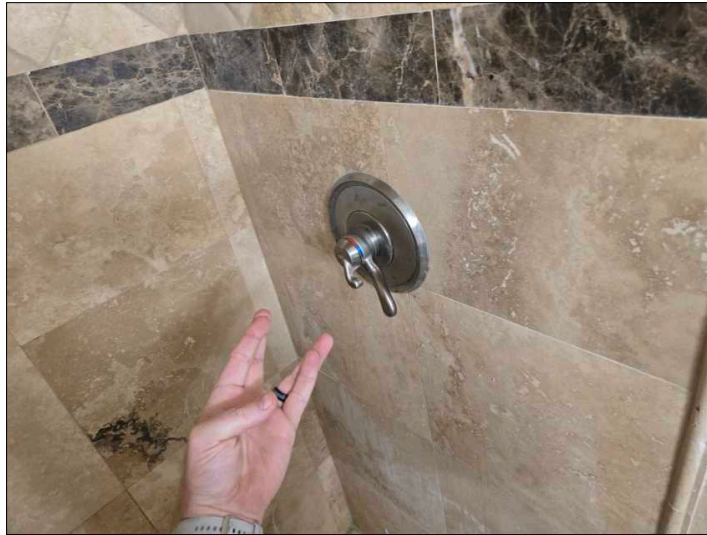
B. Drains, Wastes, and Vents

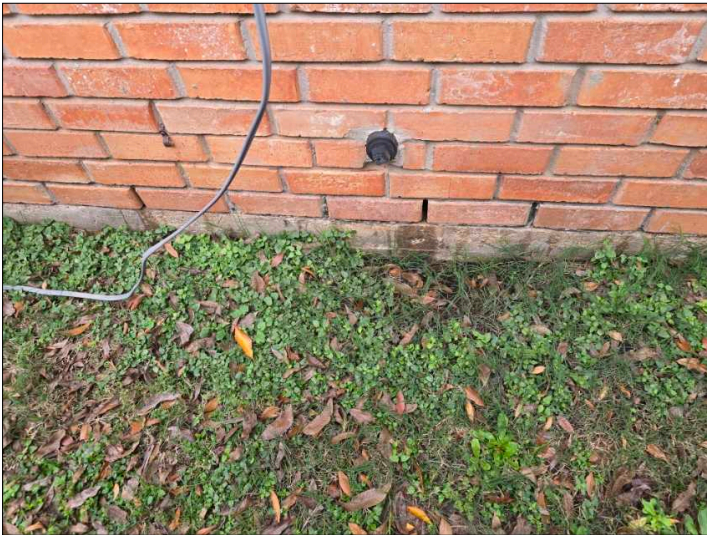
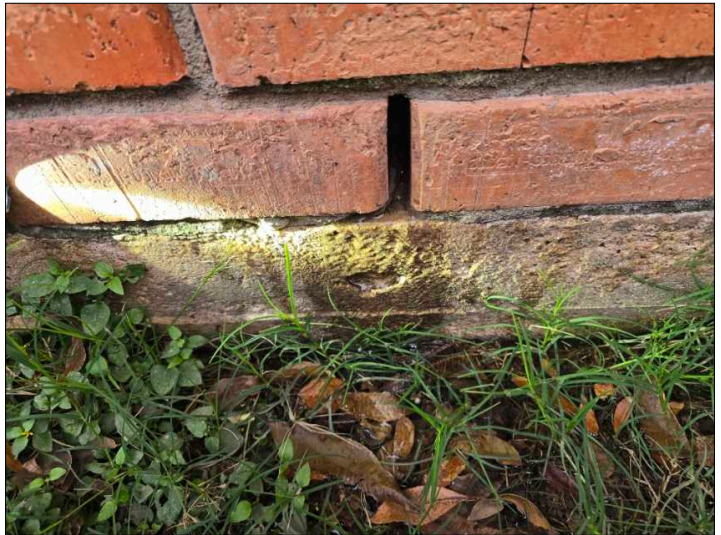
Active leak at drian in kitchen. Water flows freely from wall when sink/ dishwasher are running. Exact reason is unknown. Possible broken / clogged pipe or under ground blockage. Repairs needed.

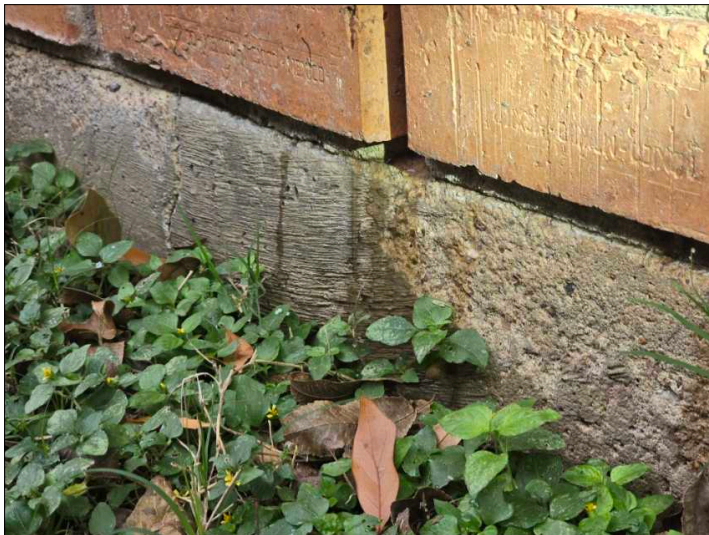
Active leak at drian in kitchen. Water flows freely from wall when sink/ dishwasher are running. Exact reason is unknown. Possible broken / clogged pipe or under ground blockage. Repairs needed.

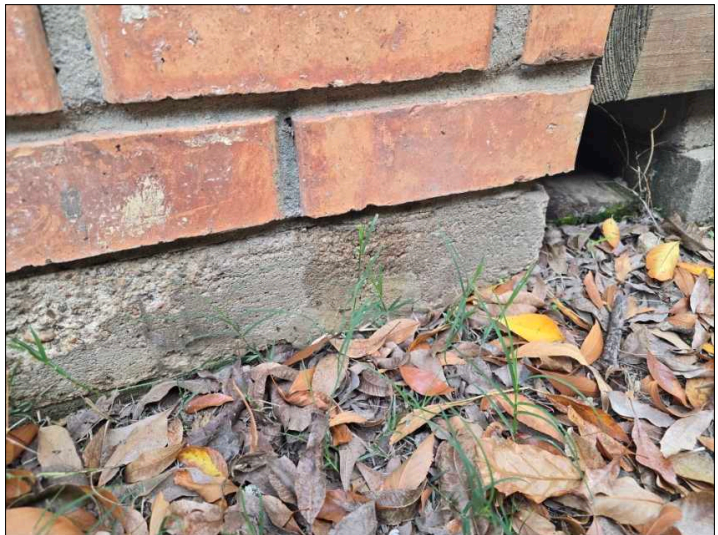
Active leak at drian in kitchen. Water flows freely from wall when sink/ dishwasher are running. Exact reason is unknown. Possible broken / clogged pipe or under ground blockage. Repairs needed.

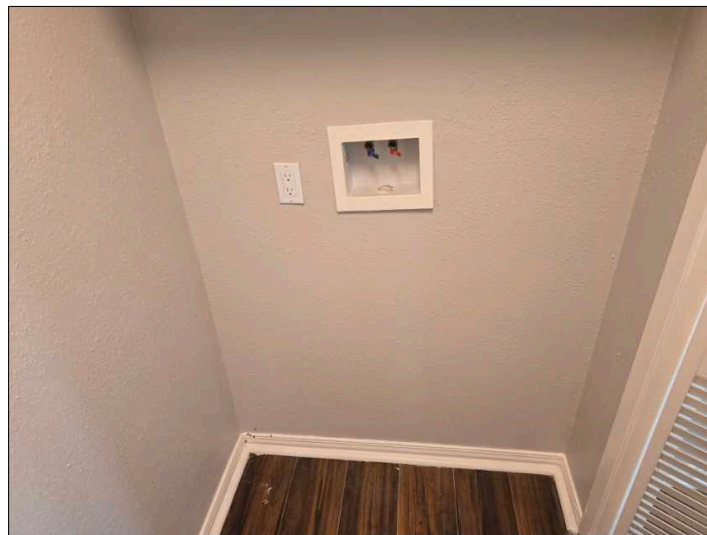
Missing plumbing cleanout

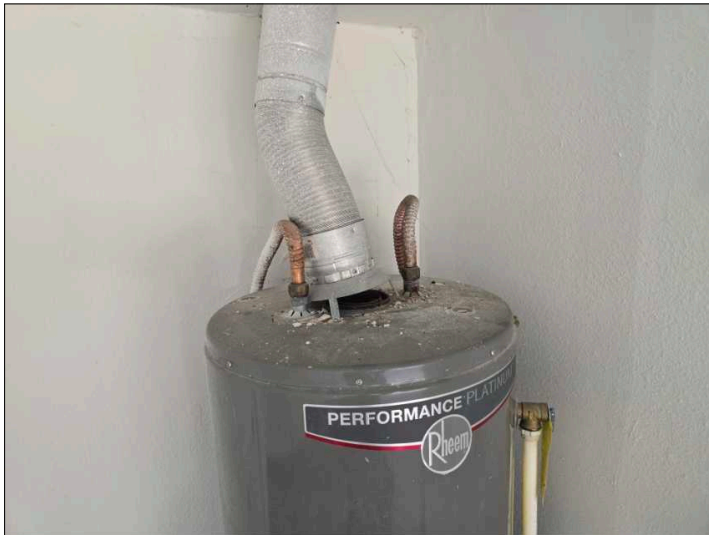
Flue pipe not secured to top of water heater. Heater exhaust gas leakage around flue catch. This should be repaired immediately.

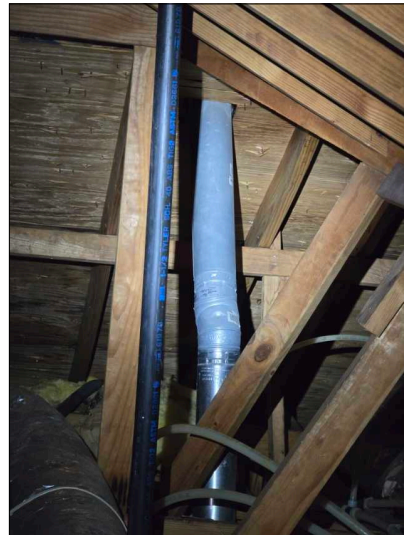
Flues are missing metal strapping.

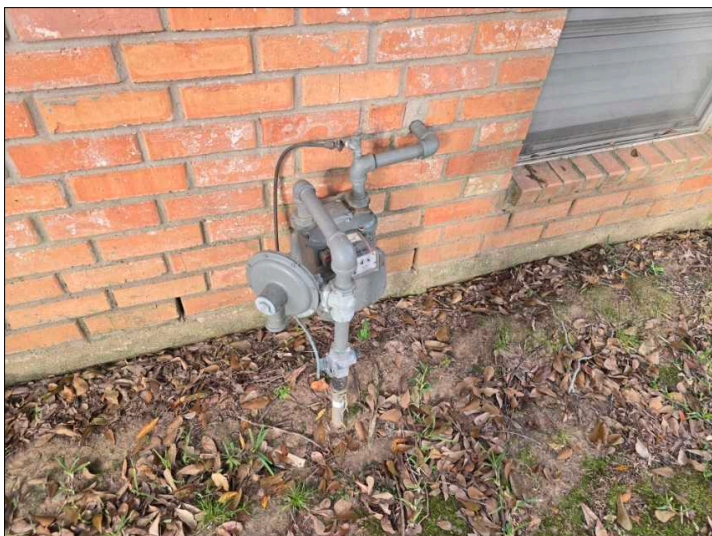
Gas Meter and Shutoff Location.

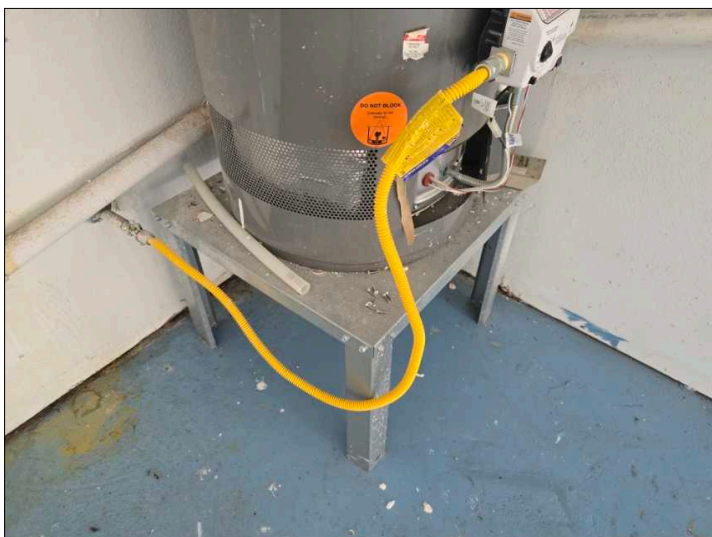
Sediment trap missing / not correct at fuel fired appliance.

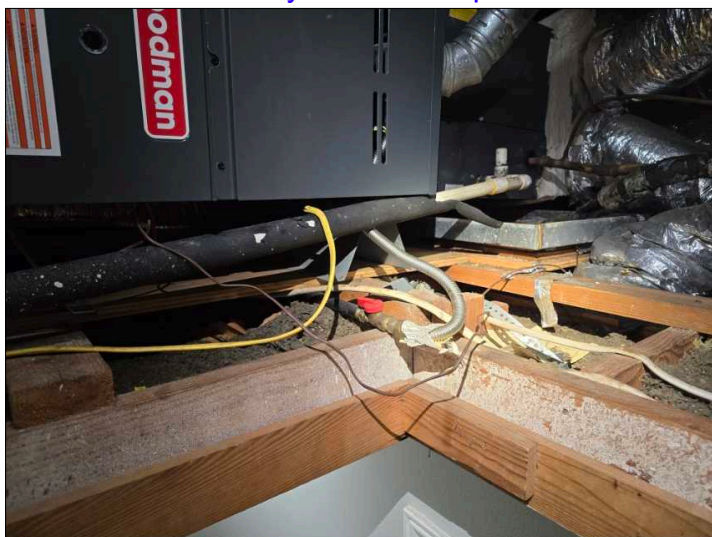
Sediment trap missing / not correct at fuel fired appliance.

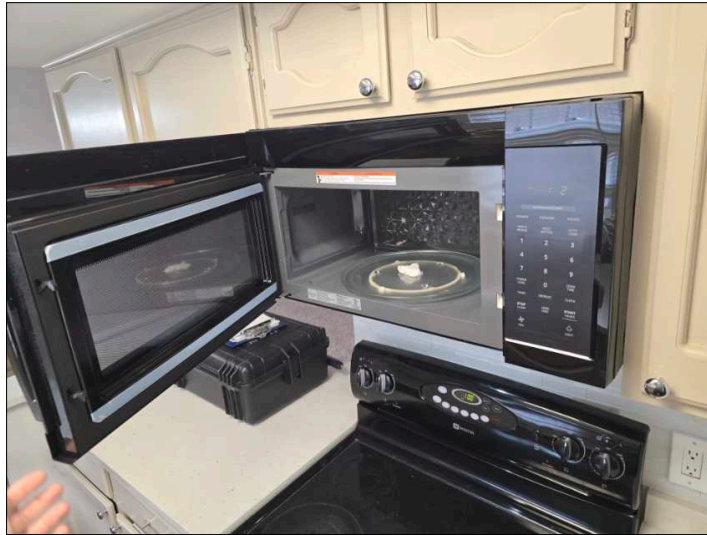
D. Ranges, Cooktops, and Ovens

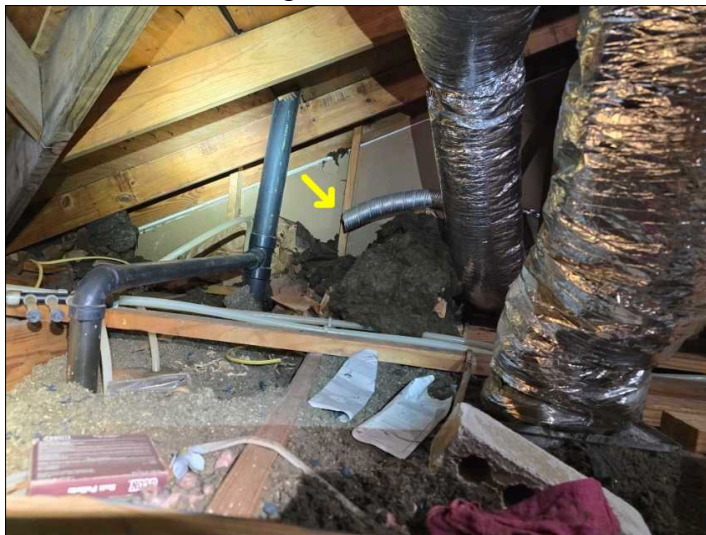
Bathroom fans exhaust into attic space. This can create additional hot moist air in the attic space causing mold growth. Suggest having vents terminate to the exterior of the house through the roof.

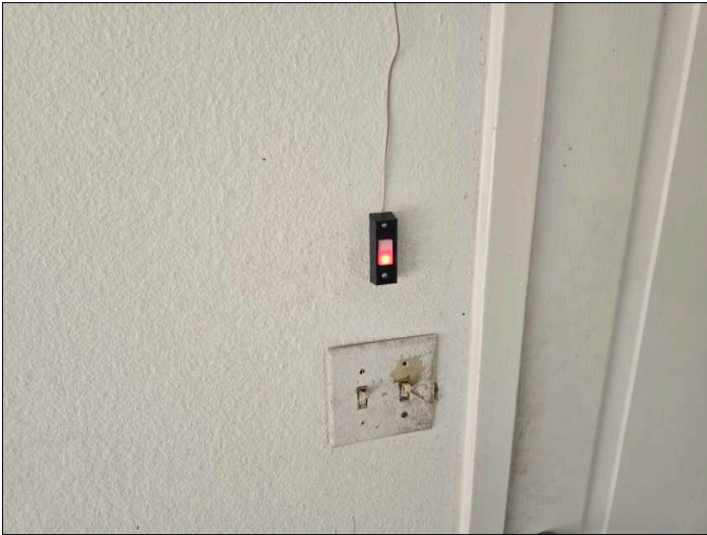
Missing safety test instructions on wall next to the operators.

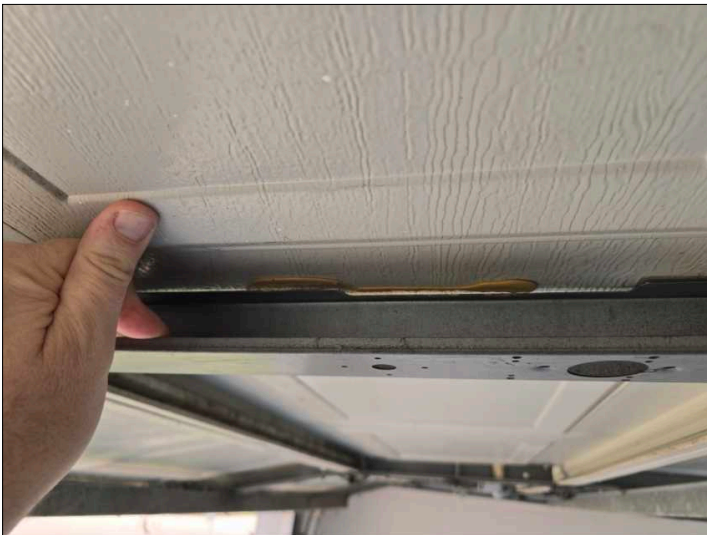
Glue from panels and frame has come loose. This glue helps secure the structure.

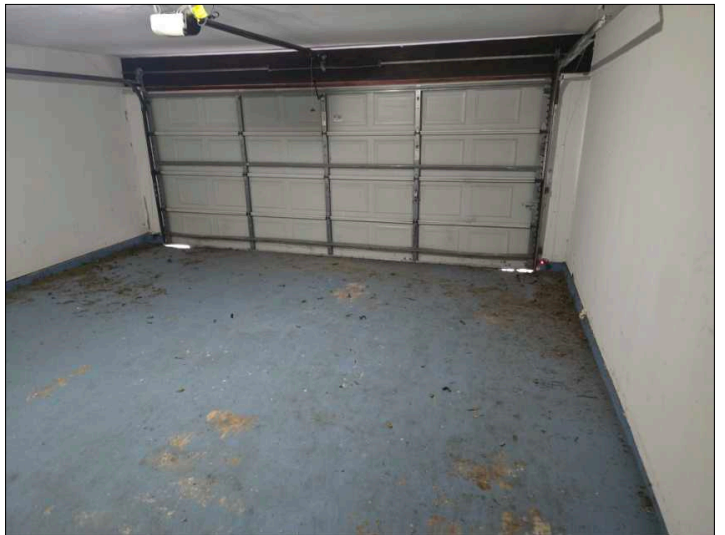
Garage door seal is damaged.

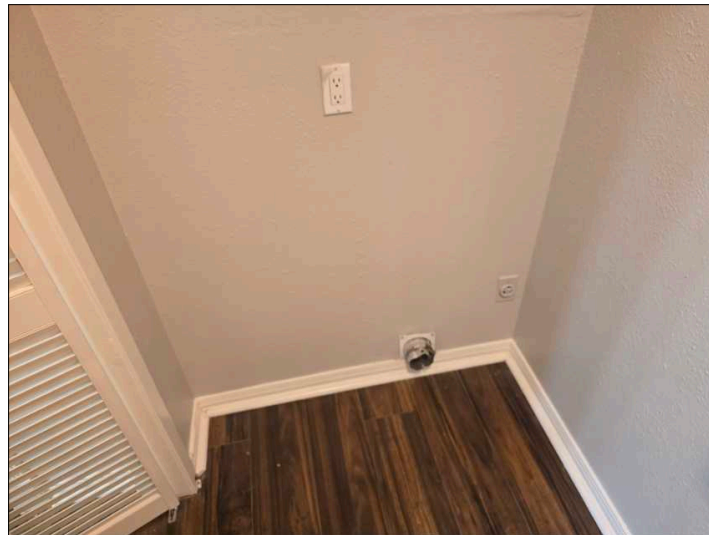
Moved dryer location.
