True Grit Home Inspection

Property Inspection Report

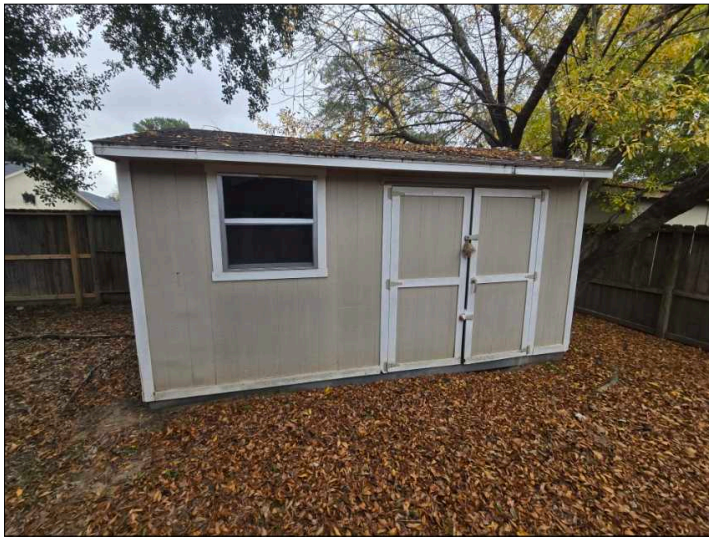
Building visually reviewed only.

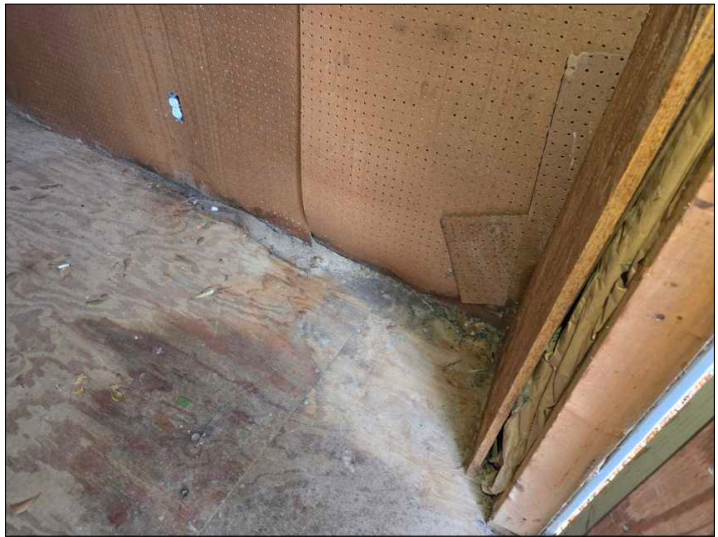
Shop too close to tree. Damage to side wall.

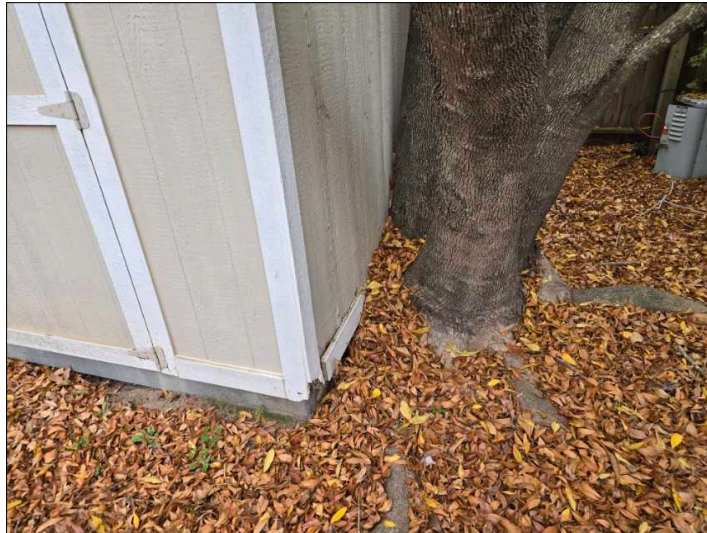
Shop too close to tree. Damage to side wall.

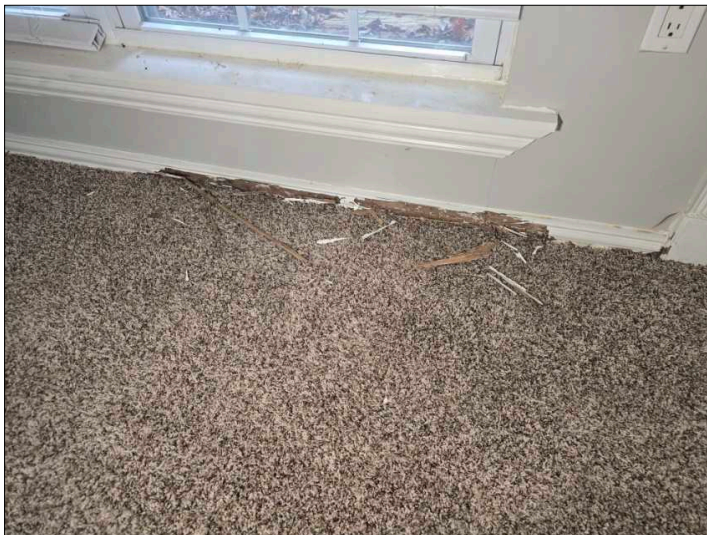
Extensive damage to rear of house. Deck, back room, and walls are all likely going to need to be opened to check for damages and repair.

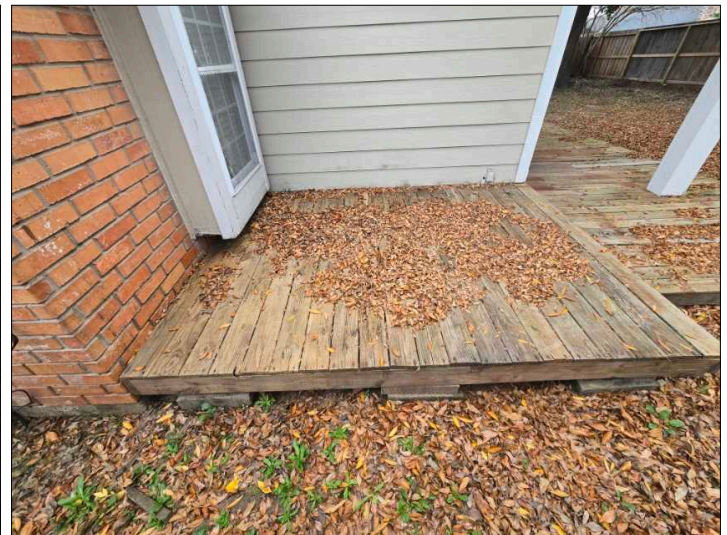
Extensive damage to rear of house. Deck, back room, and walls are all likely going to need to be opened to check for damages and repair.

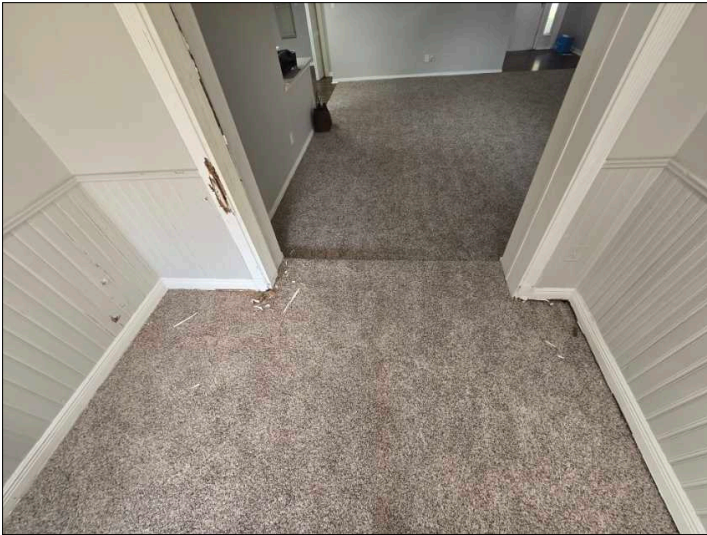
Extensive damage to rear of house. Deck, back room, and walls are all likely going to need to be opened to check for damages and repair.

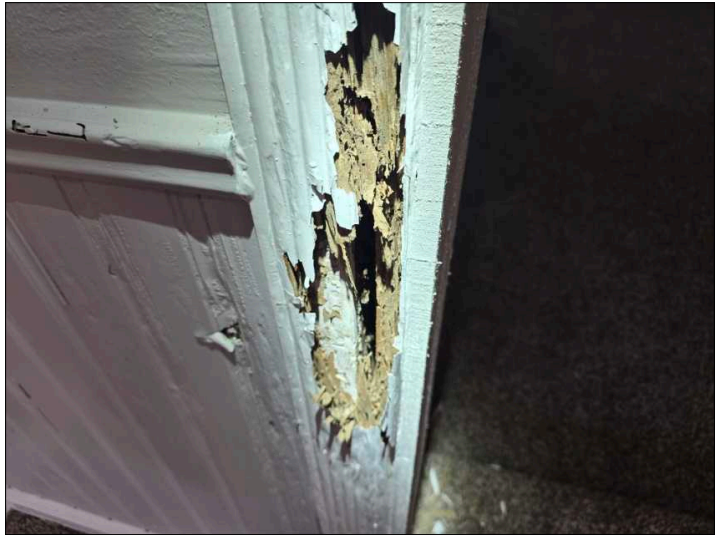
Extensive damage to rear of house. Deck, back room, and walls are all likely going to need to be opened to check for damages and repair.
