Inspection Report

Gary & Mary McSwain

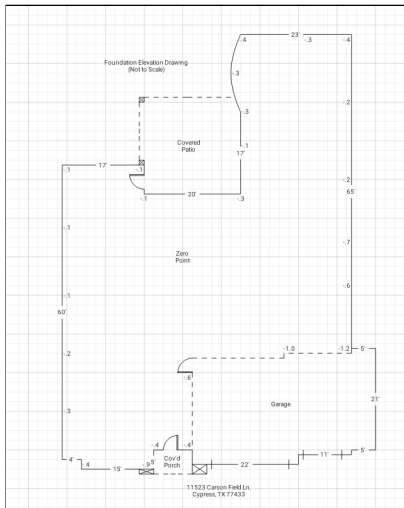
A. Item 1 Foundation Elevation Drawing (SEE Report Attachments Page 35)

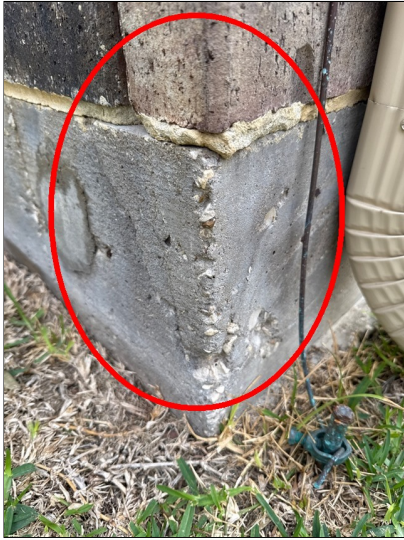
A. Item 2 Common corner crack observed at left rear corner of home

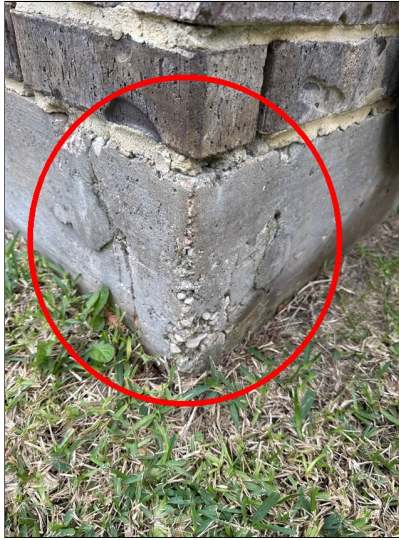
A. Item 3 Common corner crack observed at right rear corner of home

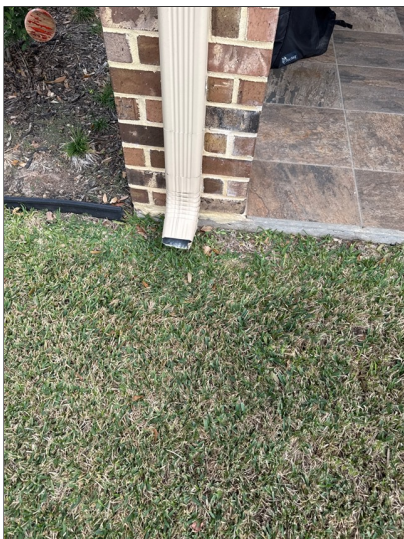
B. Item 1 Splash block or downspout extensions are absent at left rear corner of patio

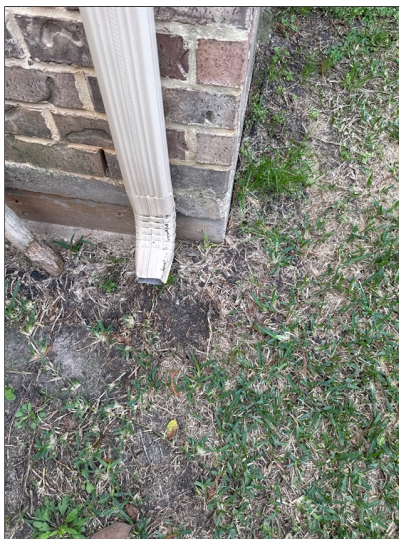
B. Item 2 Splash block or downspout extensions are absent at right rear corner of garage

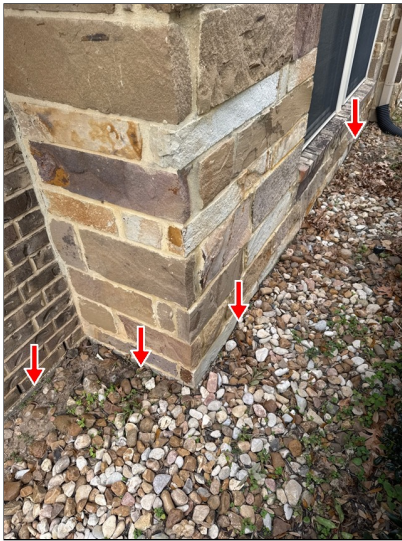
B. Item 3 High soil conditions observed at front of home, left of entry.

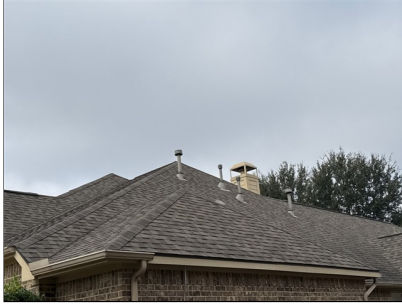
C. Item 1 This roof covering is probably around 5-7 years old and shows signs of wear consistent with its age, except as otherwise noted

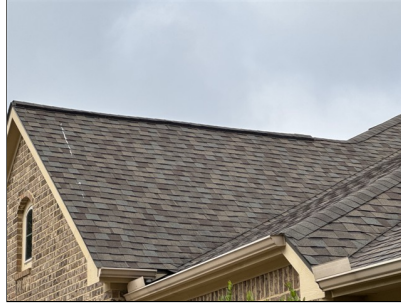
C. Item 2 This roof covering is probably around 5-7 years old and shows signs of wear consistent with its age, except as otherwise noted

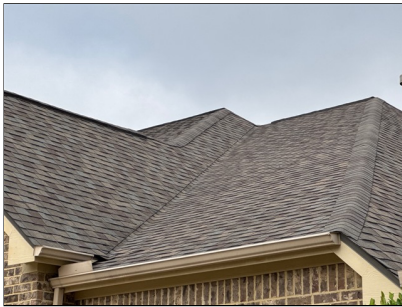
C. Item 3 This roof covering is probably around 5-7 years old and shows signs of wear consistent with its age, except as otherwise noted

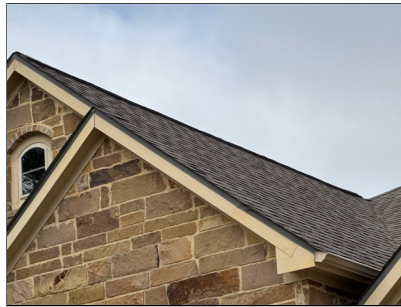
C. Item 4 This roof covering is probably around 5-7 years old and shows signs of wear consistent with its age, except as otherwise noted

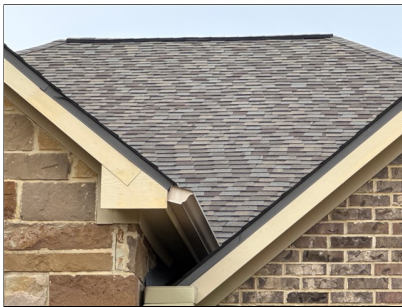
C. Item 5 This roof covering is probably around 5-7 years old and shows signs of wear consistent with its age, except as otherwise noted

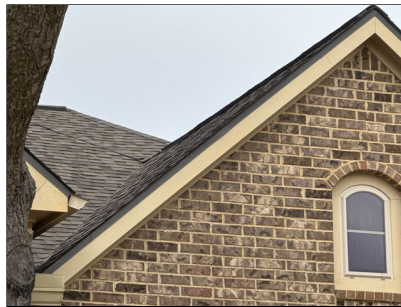
C. Item 6 This roof covering is probably around 5-7 years old and shows signs of wear consistent with its age, except as otherwise noted

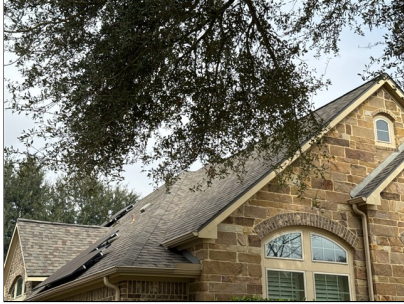
C. Item 7 This roof covering is probably around 5-7 years old and shows signs of wear consistent with its age, except as otherwise noted

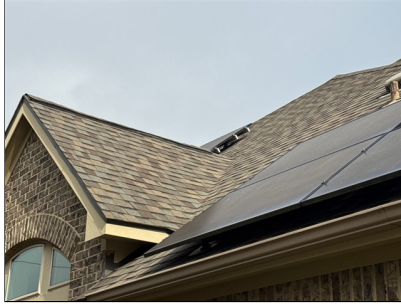
C. Item 8 This roof covering is probably around 5-7 years old and shows signs of wear consistent with its age, except as otherwise noted

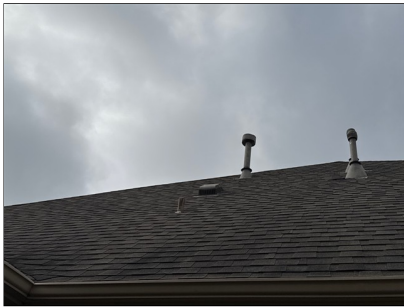
C. Item 9 This roof covering is probably around 5-7 years old and shows signs of wear consistent with its age, except as otherwise noted

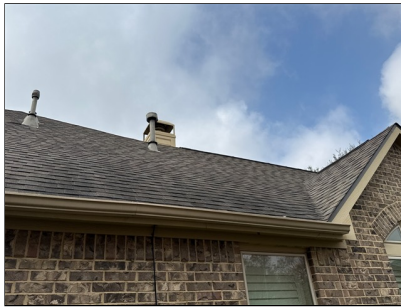
C. Item 10 This roof covering is probably around 5-7 years old and shows signs of wear consistent with its age, except as otherwise noted

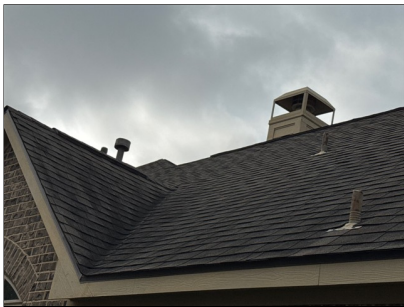
C. Item 11 This roof covering is probably around 5-7 years old and shows signs of wear consistent with its age, except as otherwise noted

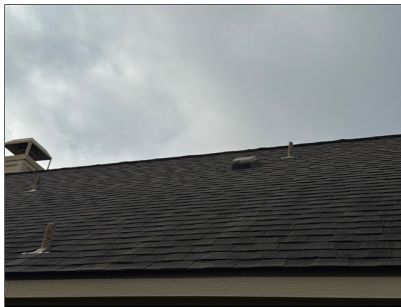
C. Item 12 This roof covering is probably around 5-7 years old and shows signs of wear consistent with its age, except as otherwise noted

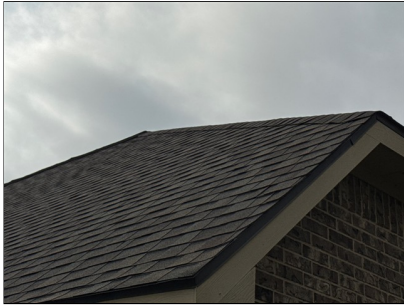
C. Item 13 This roof covering is probably around 5-7 years old and shows signs of wear consistent with its age, except as otherwise noted

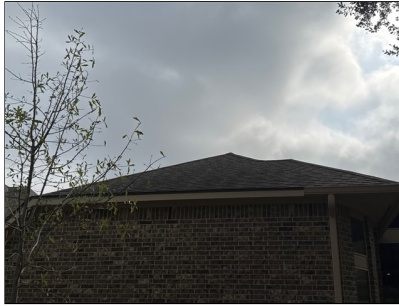
C. Item 14 This roof covering is probably around 5-7 years old and shows signs of wear consistent with its age, except as otherwise noted

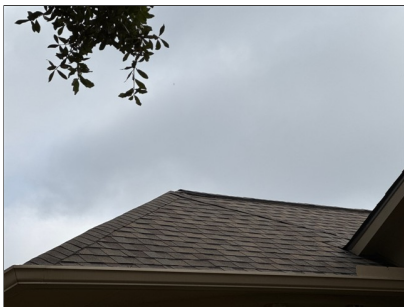
C. Item 15 This roof covering is probably around 5-7 years old and shows signs of wear consistent with its age, except as otherwise noted

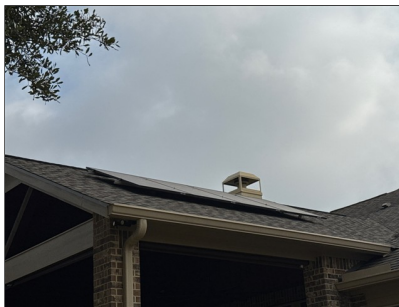
C. Item 16 This roof covering is probably around 5-7 years old and shows signs of wear consistent with its age, except as otherwise noted

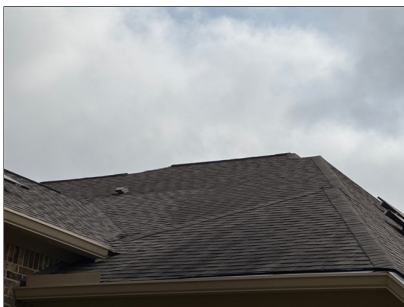
C. Item 17 This roof covering is probably around 5-7 years old and shows signs of wear consistent with its age, except as otherwise noted

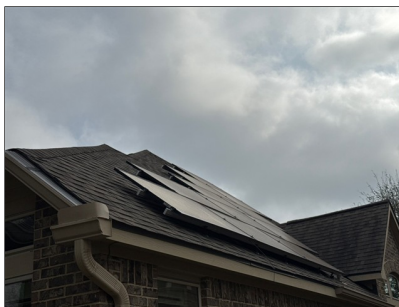
C. Item 18 This roof covering is probably around 5-7 years old and shows signs of wear consistent with its age, except as otherwise noted

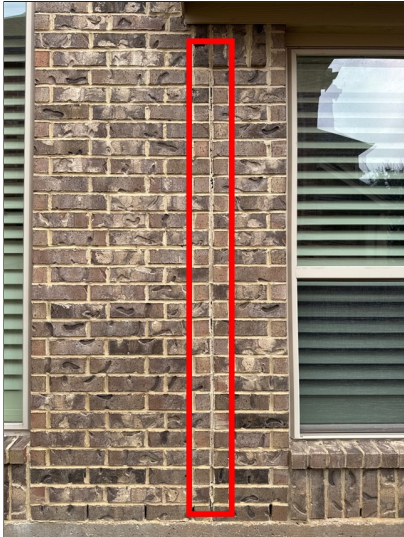
F. Item 1 The brick veneer expansion joint sealant has deteriorated at left side of home

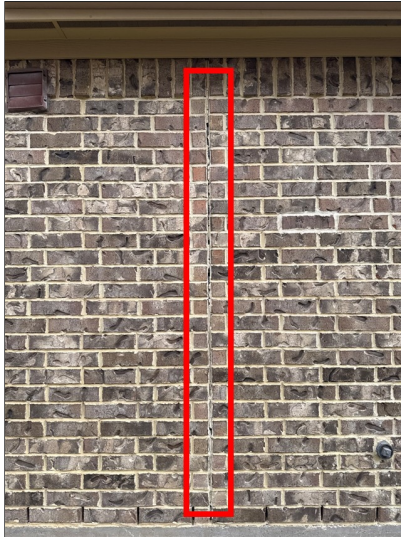
F. Item 2 The brick veneer expansion joint sealant has deteriorated at left side of home

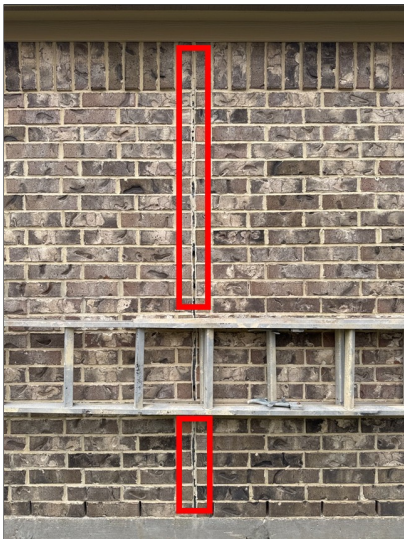
F. Item 3 The brick veneer expansion joint sealant has deteriorated at right side of home

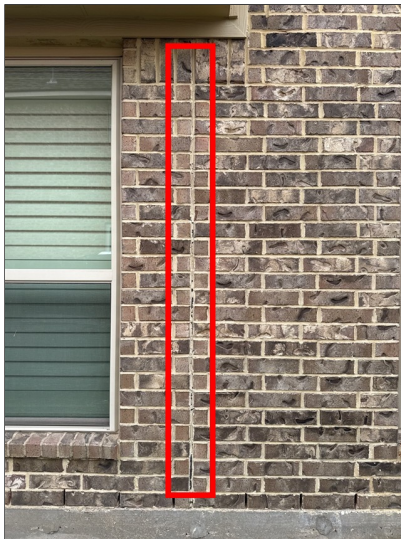
F. Item 4 The brick veneer expansion joint sealant has deteriorated at right side of home

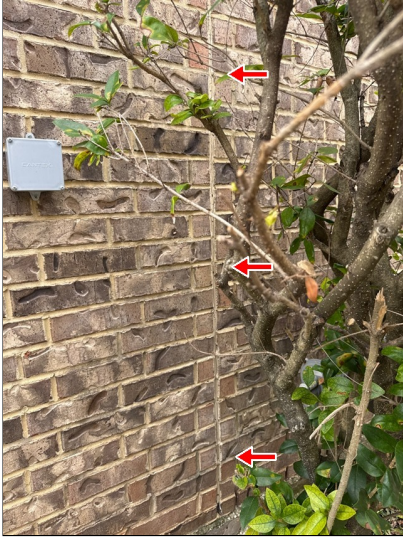
F. Item 5 The brick veneer expansion joint sealant has deteriorated at right side of garage

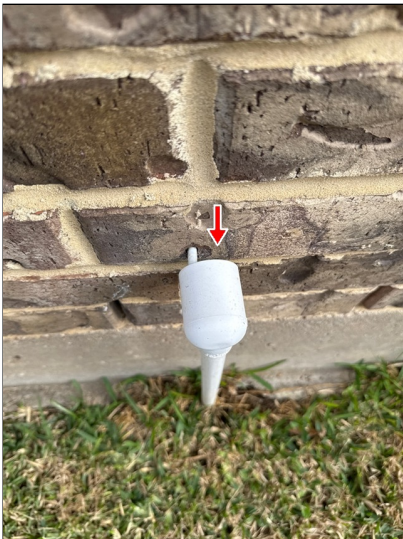
F. Item 6 Exterior wall penetrations need to be sealed at left side of home

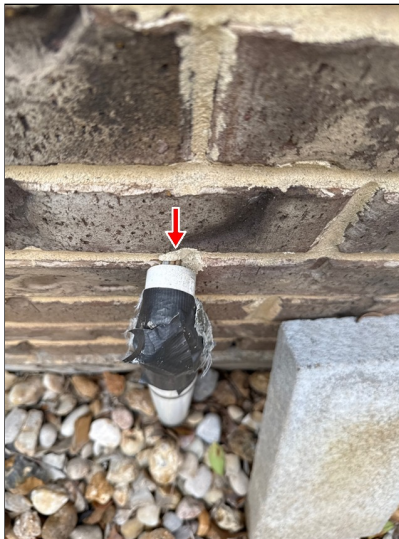
F. Item 7 Exterior wall penetrations need to be sealed at right side of garage

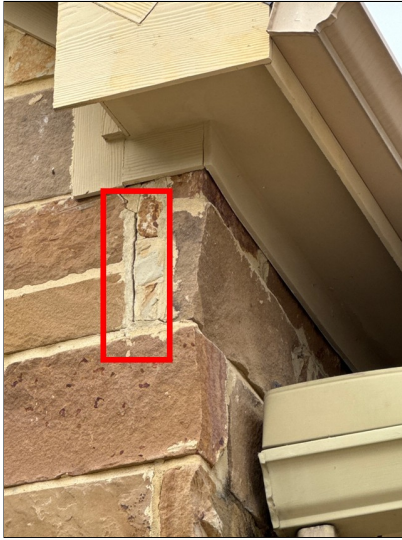
F. Item 8 Observed cracks in stone veneer at right side of entry

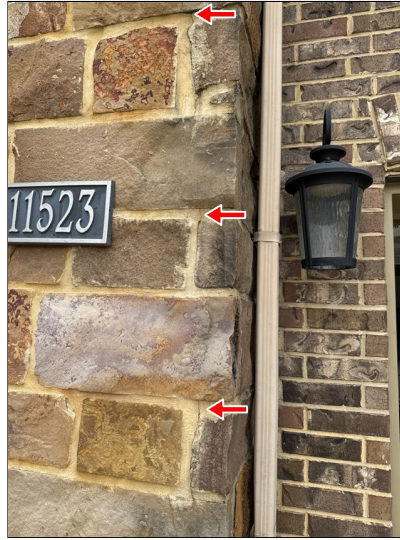
F. Item 9 Observed cracks in stone veneer at right side of entry

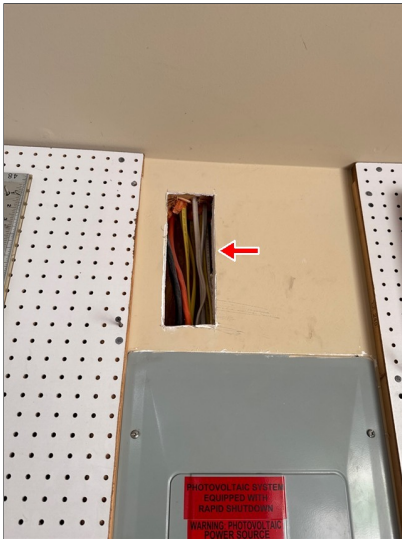
F. Item 10 Observed un-patched hole in drywall at garage

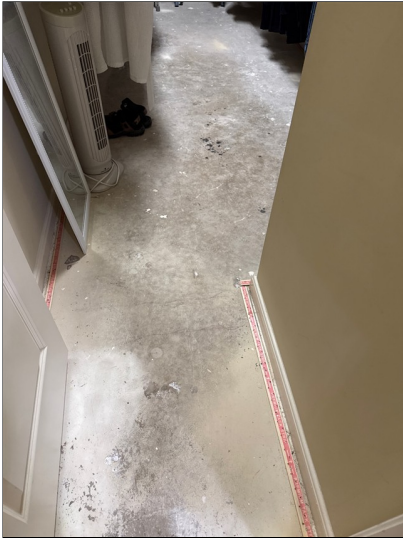
G. Item 1 Observed missing floor covering at master closet

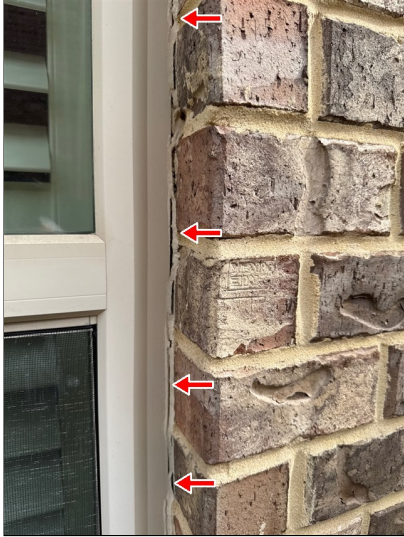
I. Item 1 The perimeter sealant has deteriorated at numerous windows throughout

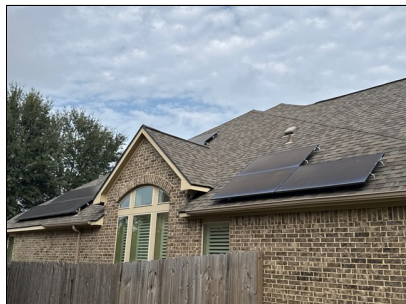
A. Item 1 There are solar panels installed at left side of home

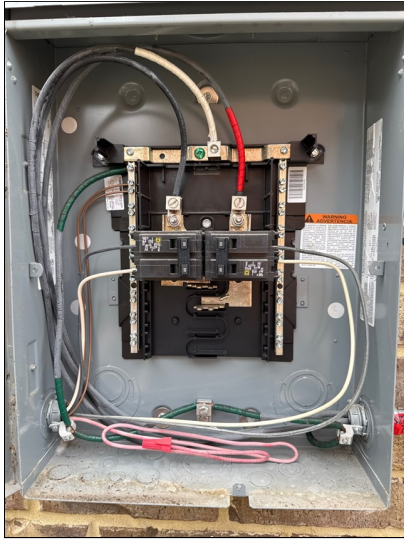
A. Item 2 The electrical service (breaker/fuse) panel, shown with dead front cover removed for inspection purposes at solar sub-panel

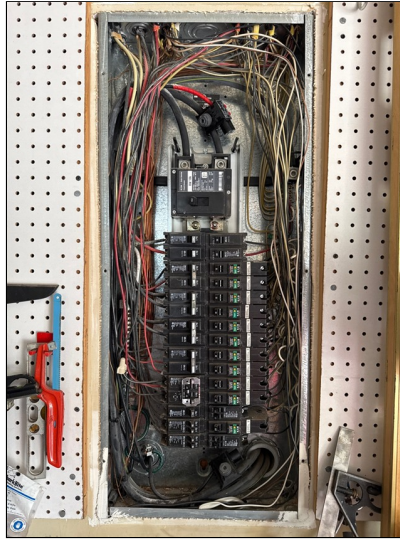
A. Item 3 The electrical service (breaker/fuse) panel, shown with dead front cover removed for inspection purposes at main panel

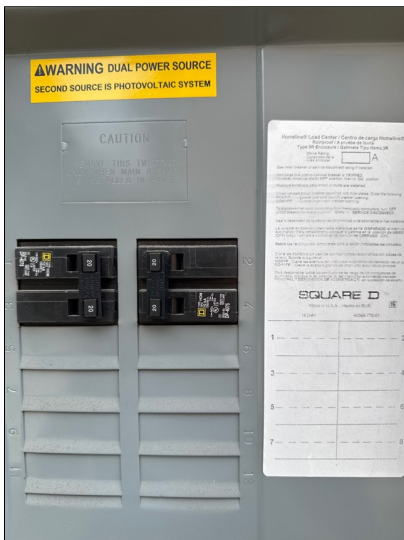
A. Item 4 No labels are present at solar sub-panel

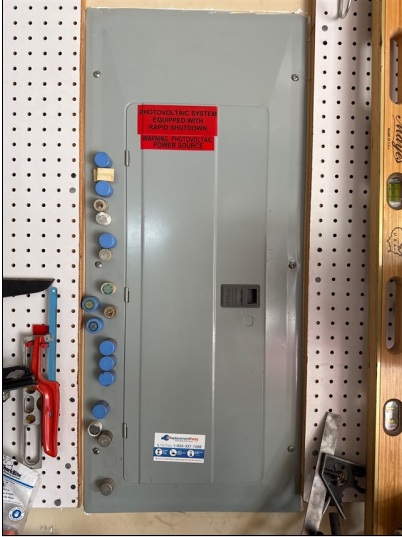
A. Item 5 The main panel box is located at the garage

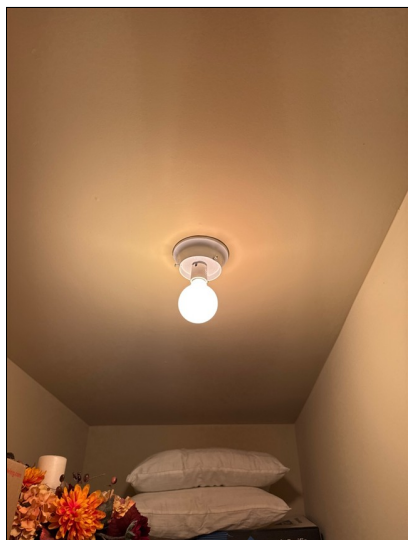
B. Item 1 Light fixture is missing globe/cover at front left bedroom closet

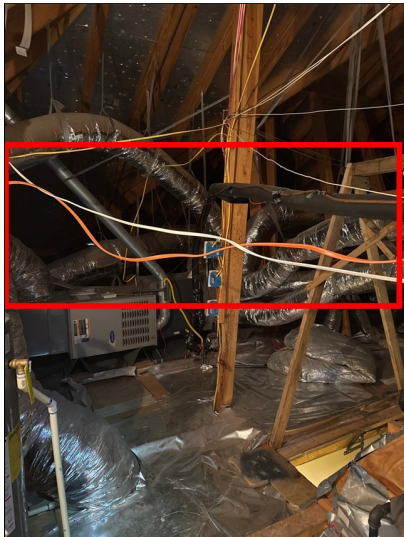
B. Item 2 Observed loose conductors in attic space

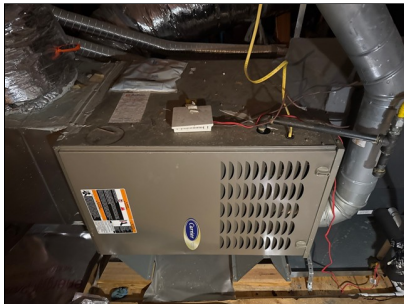
A. Item 1 The heating unit appeared to operate normally using the standard controls at primary system

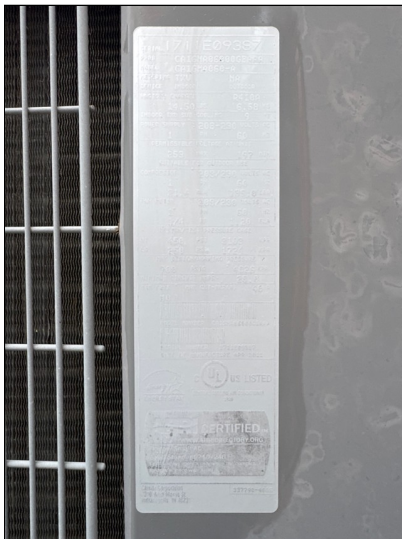
B. Item 1 Condensing Unit Data Label

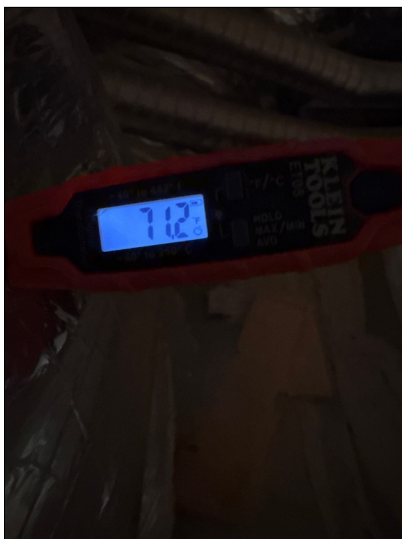
B. Item 3 Return Side

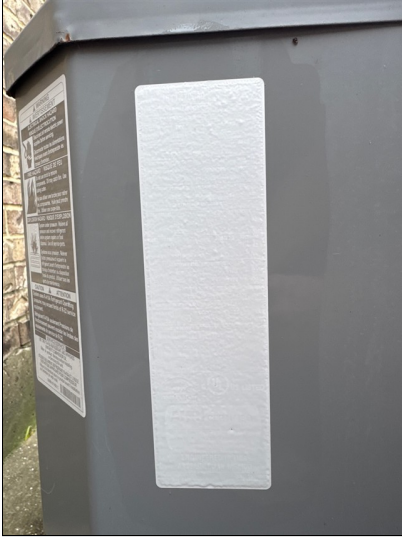
B. Item 4 Condensing Unit Data Label

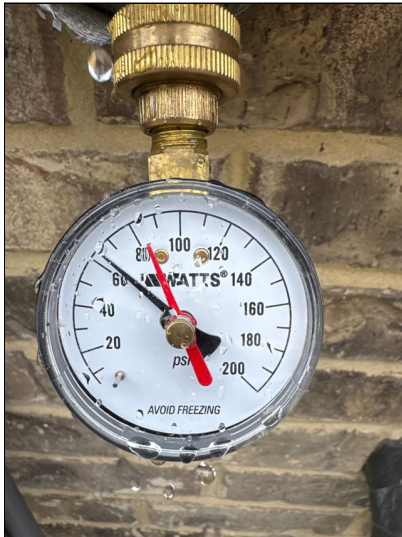
A. Item 1 Static Water Pressure
62 psi

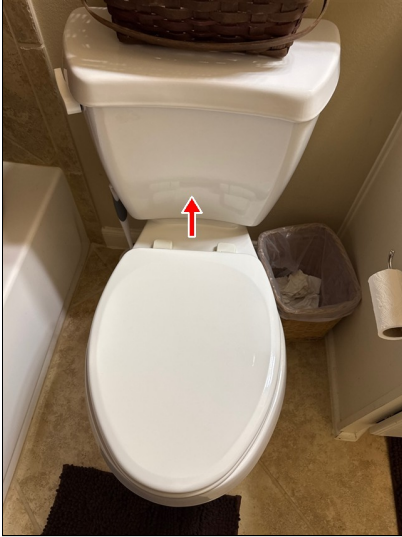
A. Item 2 Commode tank is loose at the bowl at hall bath

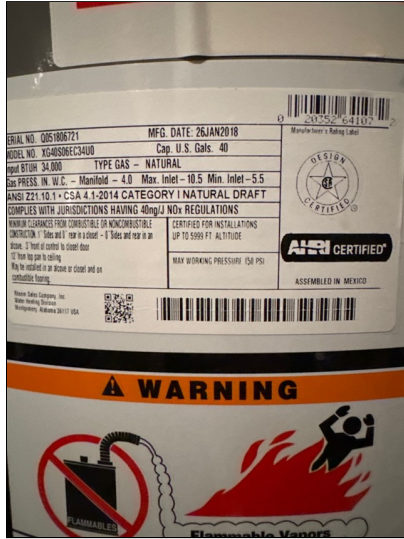
C. Item 1 Water Heater Data Label

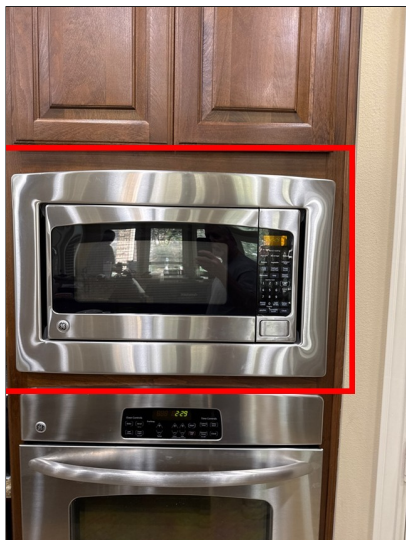
F. Item 1 Microwave has loud hum when running

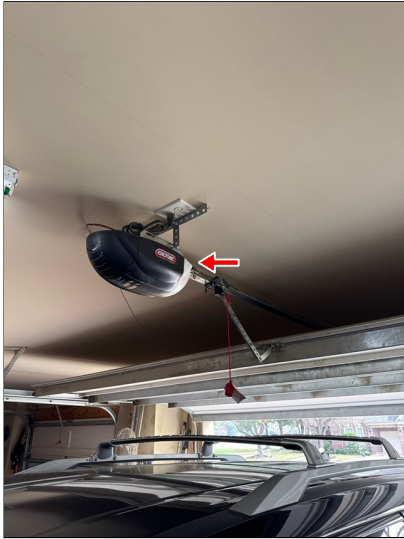
H. Item 1 The auto reverse on obstruction feature does not function normally at 2-car door

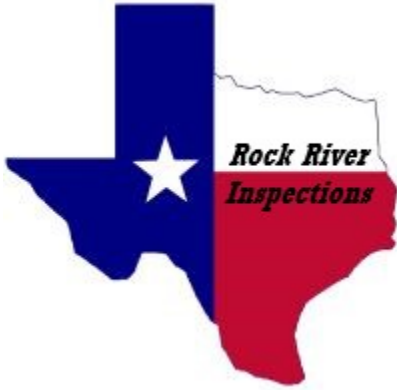
The built-in appliances of the home were inspected and reported on with the above information. While the inspector makes every effort to find all areas of concern, some areas can go unnoticed. Please be aware that the inspector has your best interest in mind. Any repair items mentioned in this report should be considered before purchase. It is recommended that qualified contractors be used in your further inspection or repair issues as it relates to the comments in this inspection report.

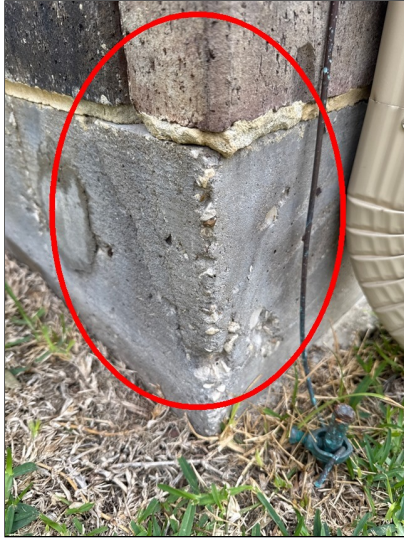
A. Item 2 Common corner crack observed at left rear corner of home

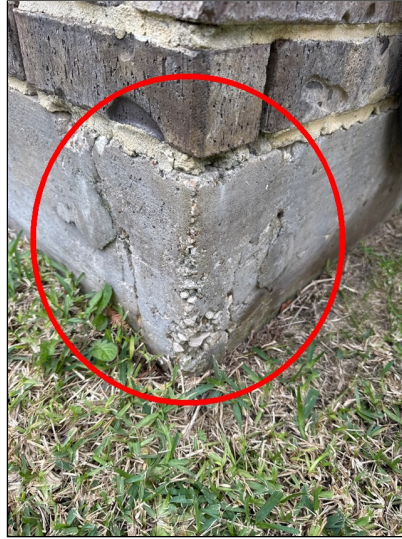
A. Item 3 Common corner crack observed at right rear corner of home

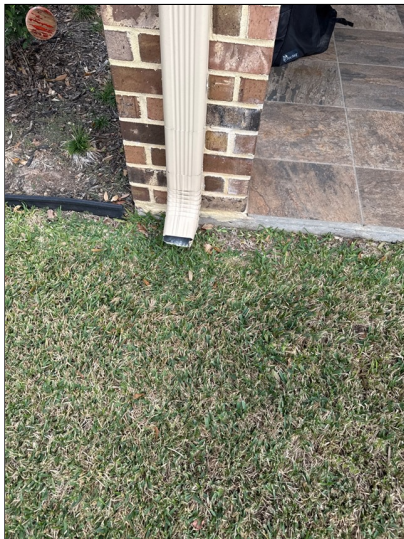
B. Item 1 Splash block or downspout extensions are absent at left rear corner of patio

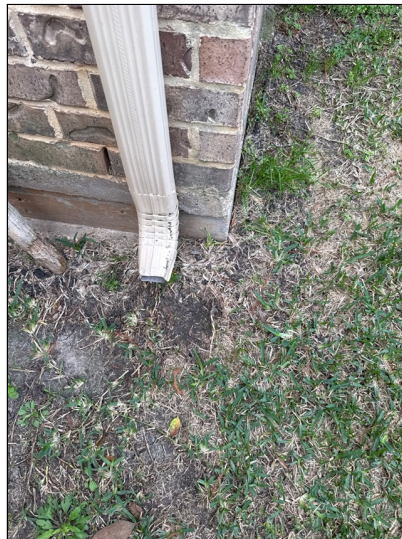
B. Item 2 Splash block or downspout extensions are absent at right rear corner of garage

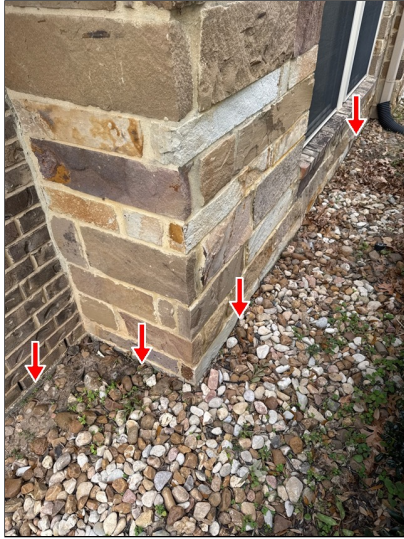
B. Item 3 High soil conditions observed at front of home, left of entry.

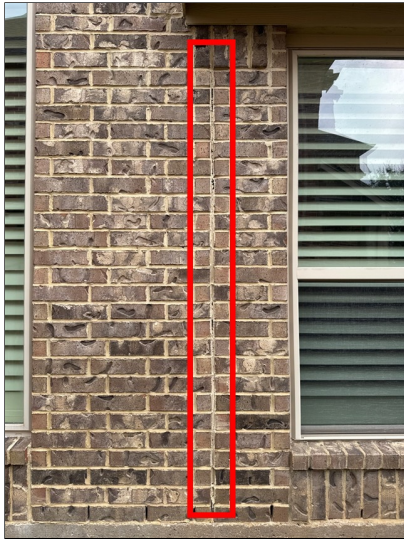
F. Item 1 The brick veneer expansion joint sealant has deteriorated at left side of home

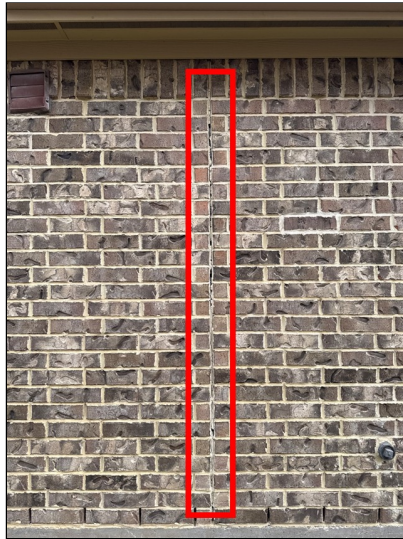
F. Item 2 The brick veneer expansion joint sealant has deteriorated at left side of home

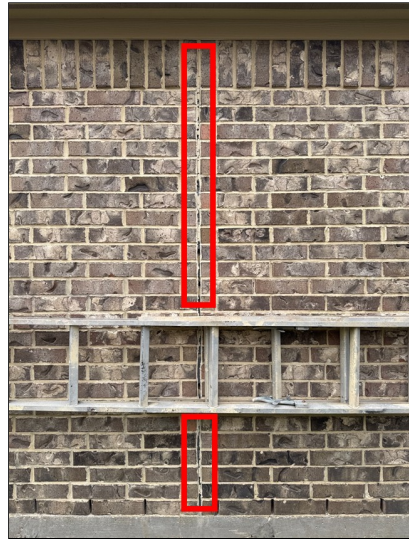
F. Item 3 The brick veneer expansion joint sealant has deteriorated at right side of home

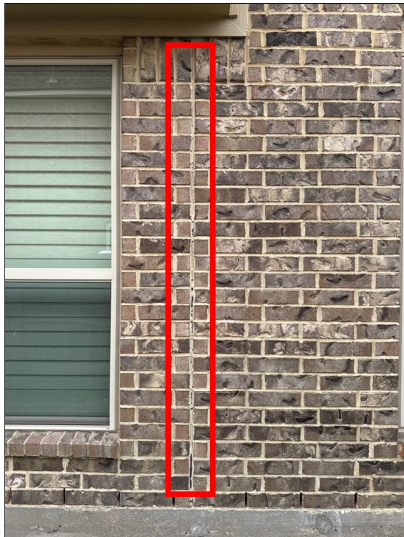
F. Item 4 The brick veneer expansion joint sealant has deteriorated at right side of home

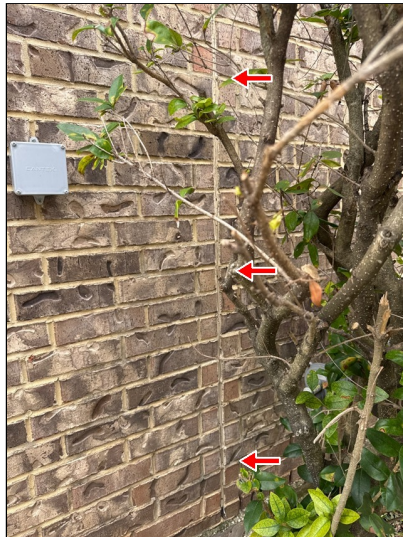
F. Item 5 The brick veneer expansion joint sealant has deteriorated at right side of garage

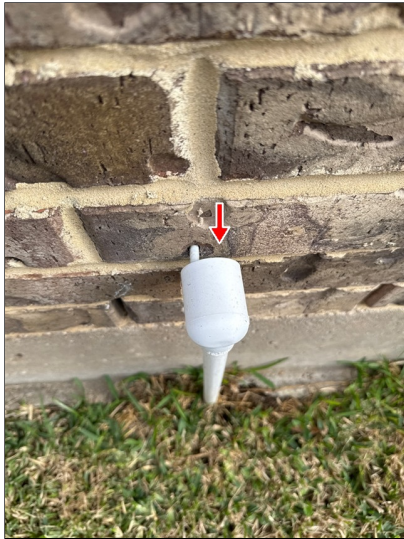
F. Item 6 Exterior wall penetrations need to be sealed at left side of home

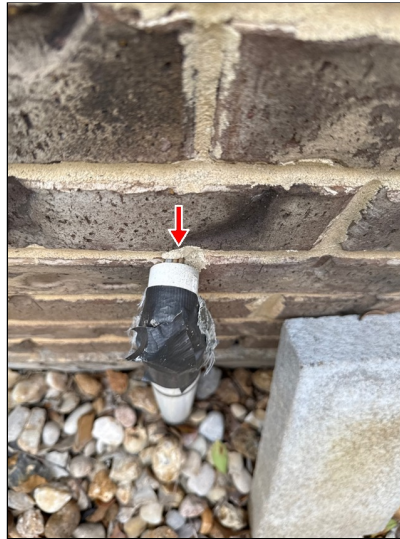
F. Item 7 Exterior wall penetrations need to be sealed at right side of garage

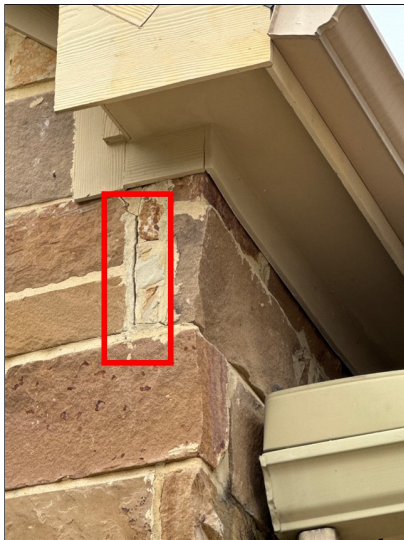
F. Item 8 Observed cracks in stone veneer at right side of entry

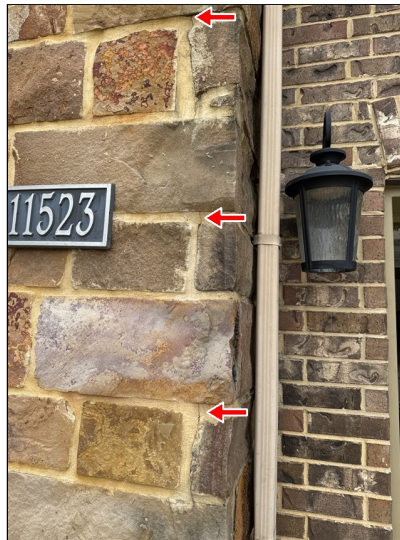
F. Item 9 Observed cracks in stone veneer at right side of entry

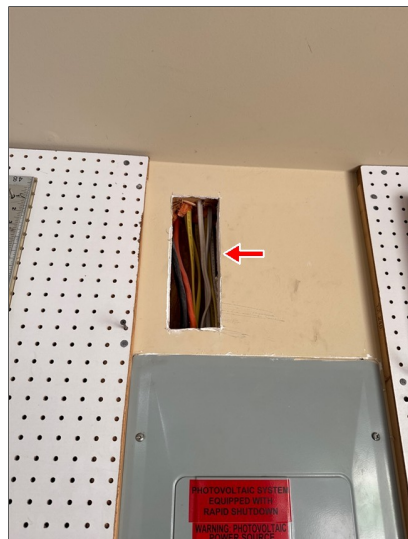
F. Item 10 Observed un-patched hole in drywall at garage

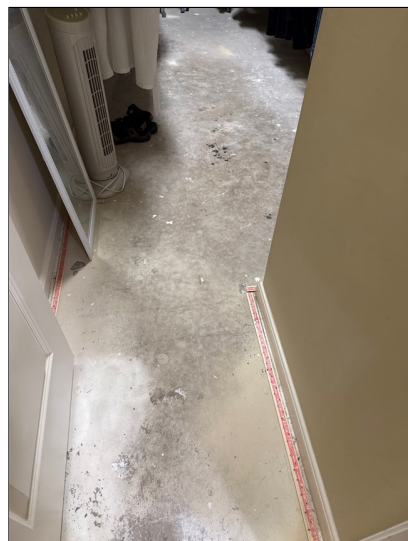
G. Item 1 Observed missing floor covering at master closet

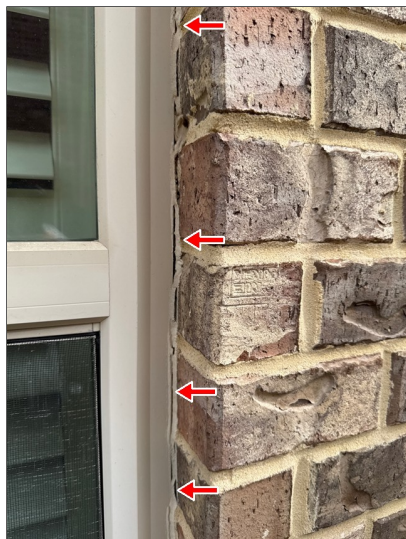
I. Item 1 The perimeter sealant has deteriorated at numerous windows throughout

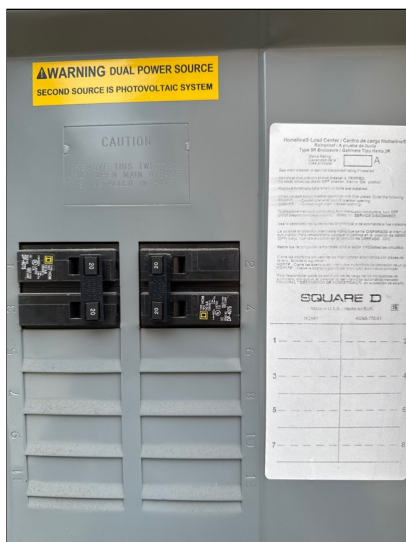
A. Item 4 No labels are present at solar sub-panel

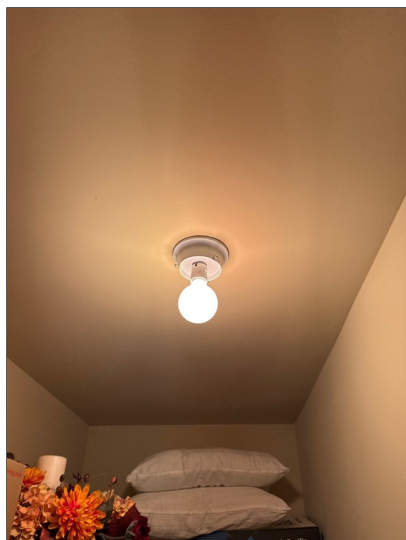
B. Item 1 Light fixture is missing globe/cover at front left bedroom closet

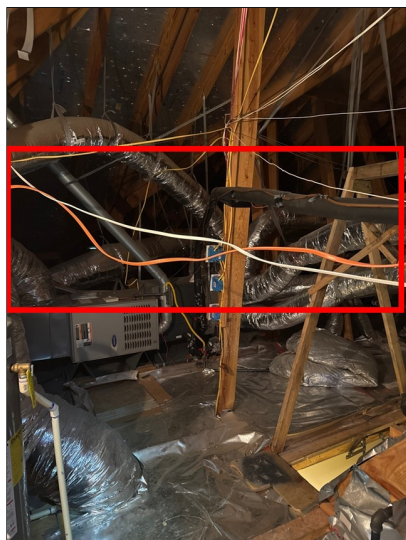
B. Item 2 Observed loose conductors in attic space

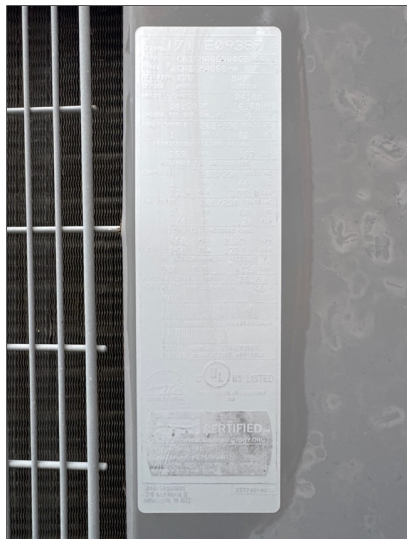
B. Item 1 Condensing Unit Data Label

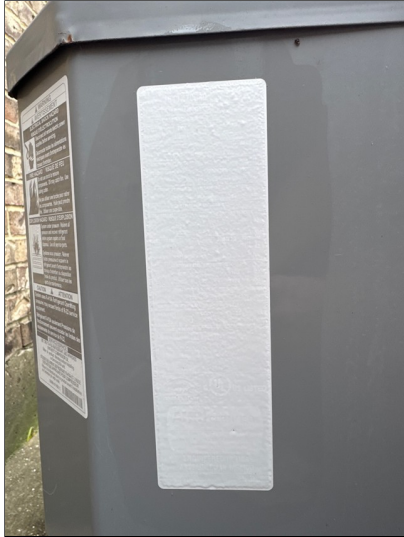
B. Item 4 Condensing Unit Data Label

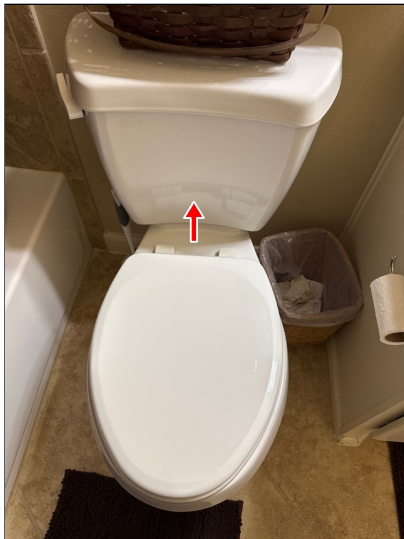
A. Item 2 Commode tank is loose at the bowl at hall bath

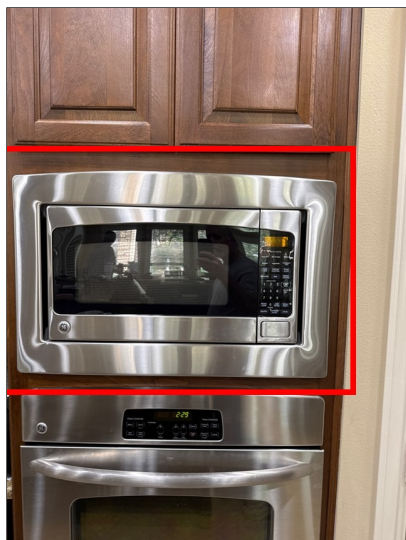
F. Item 1 Microwave has loud hum when running

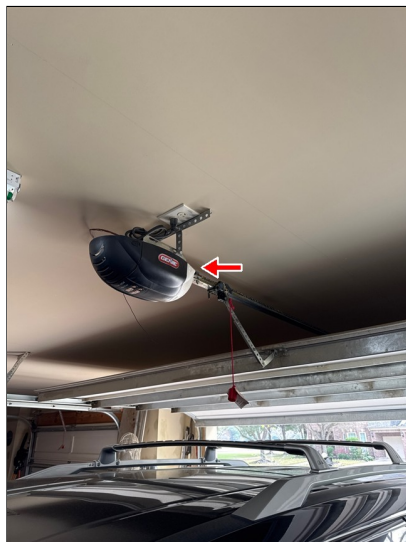
H. Item 1 The auto reverse on obstruction feature does not function normally at 2-car door
