PROPERTY INSPECTION REPORT

Stacey Megginson
Bayou City Home Inspections

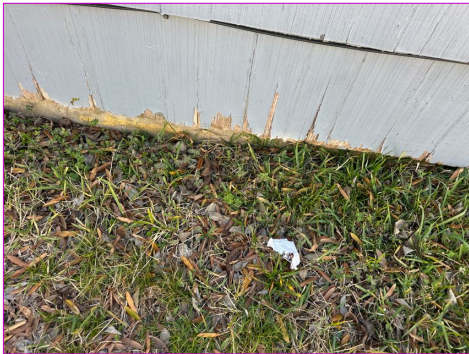
The foundation elevation measurements exceeded industry standards. The inspector recommends the foundation be evaluated by a structural engineer or qualified professional.

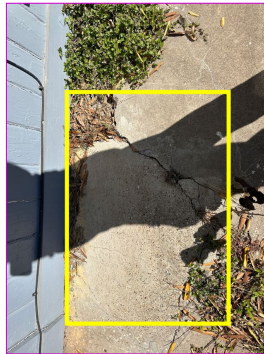
At the time of the inspection, the slab appeared to have been repaired in the past. The inspector recommends contacting the seller about the warranty and/or the transferability of the warranty for the foundation.

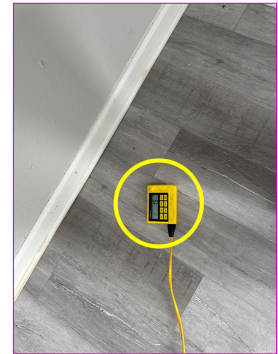
The foundation elevation measurements exceeded industry standards. The inspector recommends the foundation be evaluated by a structural engineer or qualified professional.

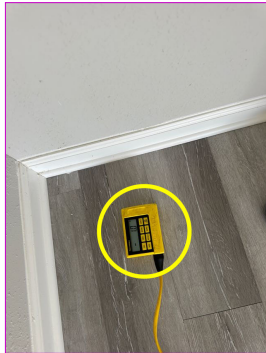
The foundation elevation measurements exceeded industry standards. The inspector recommends the foundation be evaluated by a structural engineer or qualified professional.

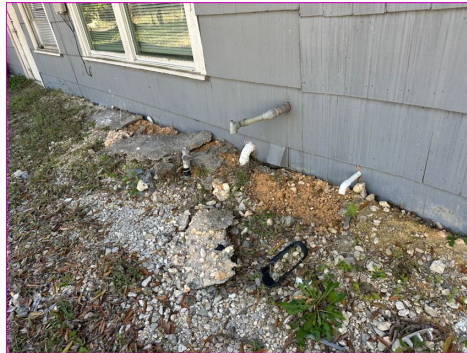
The top of the foundation wall had inadequate clearance from grade. The top of the foundation wall should be a minimum of six inches above soil. Inadequate clearance may result in moisture intrusion of the structure. Excessively high moisture levels can result in damage to the home structure or materials from decay or deterioration and may result in conditions which encourage the growth of microbes such as mold fungi. The Inspector recommends re-grading around the home perimeter to provide increased clearance from grade.

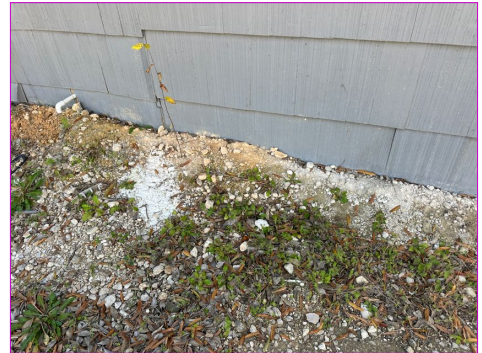
The top of the foundation wall had inadequate clearance from grade. The top of the foundation wall should be a minimum of six inches above soil. Inadequate clearance may result in moisture intrusion of the structure. Excessively high moisture levels can result in damage to the home structure or materials from decay or deterioration and may result in conditions which encourage the growth of microbes such as mold fungi. The Inspector recommends re-grading around the home perimeter to provide increased clearance from grade.

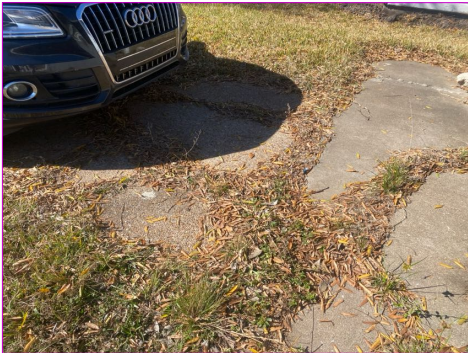
Significant cracks in the driveway should be filled with an appropriate material to avoid continued damage to the driveway.

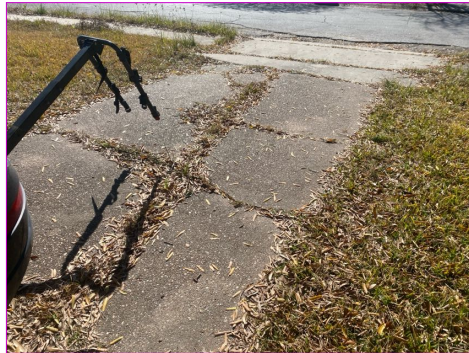
Significant cracks in the driveway should be filled with an appropriate material to avoid continued damage to the driveway.

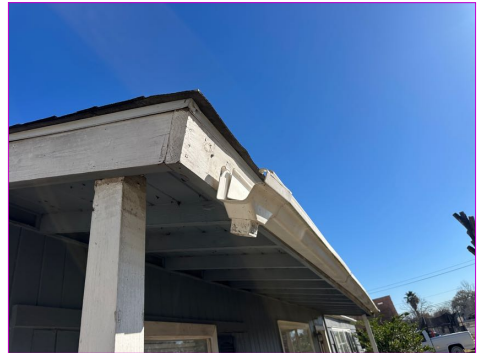
Some gutters were missing end caps at the time of the inspection. This condition can result in excessively high moisture levels in soil at the foundation and can cause damage related to soil/foundation movement. Excessive moisture levels in soil near the foundation can effect the ability of the soil to support the weight of the structure above and can cause damage related to soil/foundation movement. The Inspector recommends repair to help protect the home structure. All work should be performed by a qualified contractor.

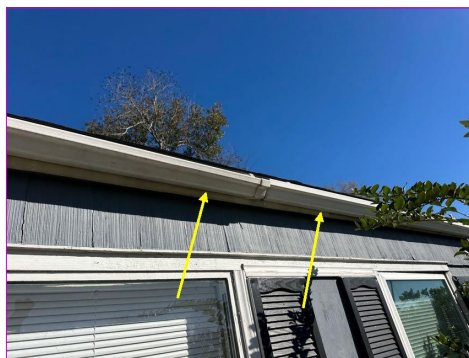
Gutters and downspouts were fabricated from vinyl.

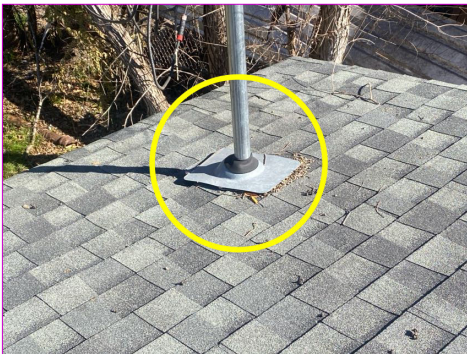
The electrical mast is loose on the roof. The inspector recommends that a qualified contractor evaluate and repair the condition.

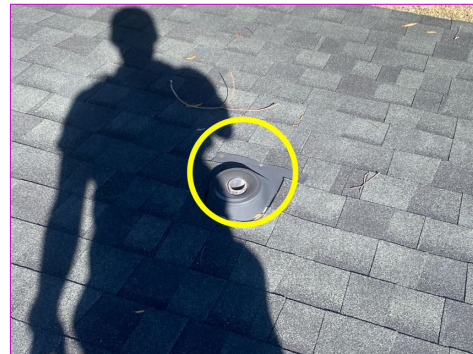
The plumbing vent was damaged. The inspector recommends that a qualified contractor evaluate and repair the condition.

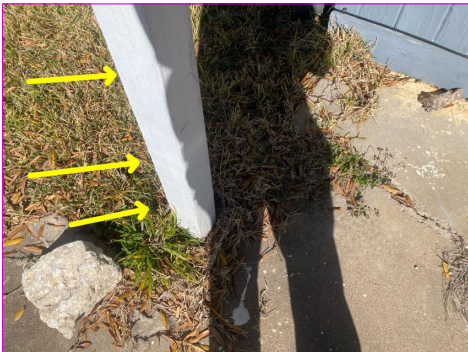
The exterior posts supporting the driveway overhang are not properly connected and/or are damaged. This condition may compromise the structural stability of the overhang. The inspector recommends that a qualified contractor evaluate and repair this condition as necessary.

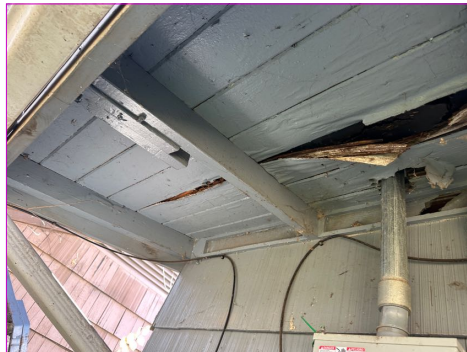
Soffits were old, severely deteriorated and sagging in some areas around the home. The Inspector recommends repair/replacement by a qualified contractor to prevent pests from entering the soffit space.

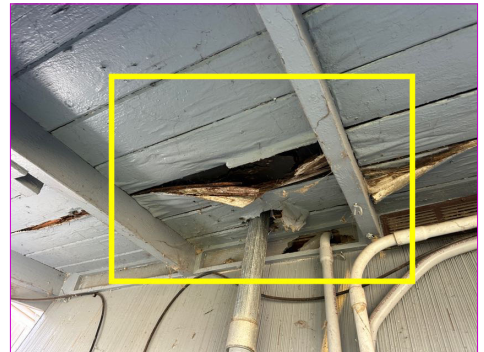
Soffits were old, severely deteriorated and sagging in some areas around the home. The Inspector recommends repair/replacement by a qualified contractor to prevent pests from entering the soffit space.

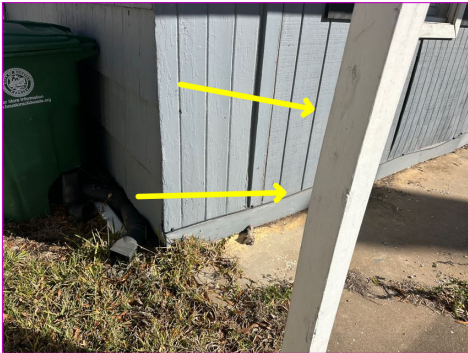
The exterior posts supporting the driveway overhang are not properly connected and/or are damaged. This condition may compromise the structural stability of the overhang. The inspector recommends that a qualified contractor evaluate and repair this condition as necessary.

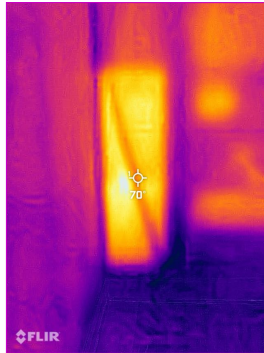
The exterior walls of the house appear to be missing insulation. This condition was verified using an infrared camera, which indicated temperature inconsistencies consistent with absent or inadequate insulation. Missing insulation can reduce energy efficiency and affect interior comfort. The inspector recommends that a qualified contractor further evaluate and repair this condition as needed.

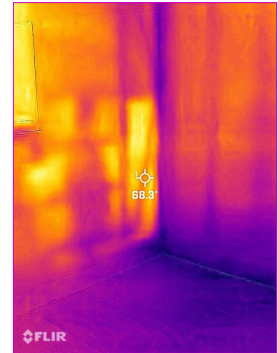
The exterior walls of the house appear to be missing insulation. This condition was verified using an infrared camera, which indicated temperature inconsistencies consistent with absent or inadequate insulation. Missing insulation can reduce energy efficiency and affect interior comfort. The inspector recommends that a qualified contractor further evaluate and repair this condition as needed.

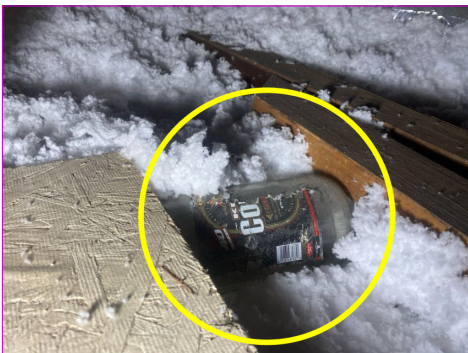
Debris visible in the attic should be removed.

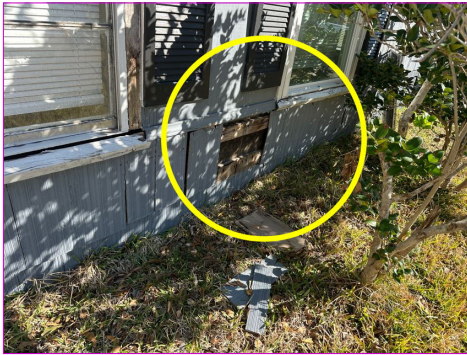
The exterior siding of the house is damaged. Damaged siding can allow moisture intrusion and may lead to further deterioration if not addressed. The inspector recommends a qualified contractor evaluate and repair this condition as needed.

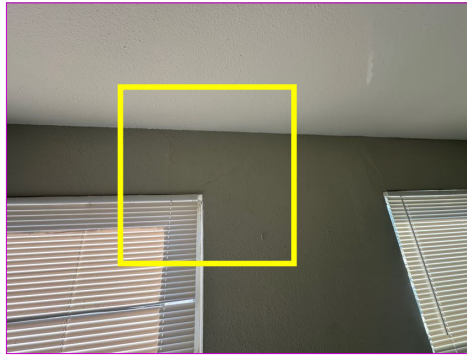
The walls exhibited settlement cracks. These cracks are commonly associated with normal foundation movement; however, the extent and cause could not be fully determined at the time of inspection. The inspector recommends a qualified contractor further evaluate and repair as needed.

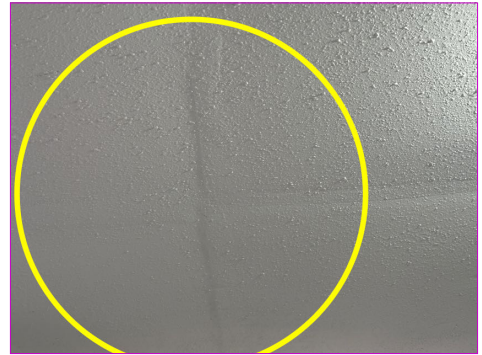
The walls exhibited settlement cracks. These cracks are commonly associated with normal foundation movement; however, the extent and cause could not be fully determined at the time of inspection. The inspector recommends a qualified contractor further evaluate and repair as needed.

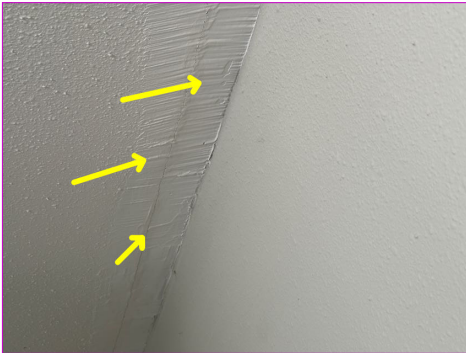
The walls exhibited settlement cracks. These cracks are commonly associated with normal foundation movement; however, the extent and cause could not be fully determined at the time of inspection. The inspector recommends a qualified contractor further evaluate and repair as needed.

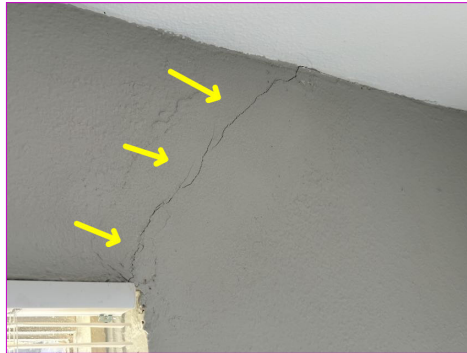
The walls exhibited settlement cracks. These cracks are commonly associated with normal foundation movement; however, the extent and cause could not be fully determined at the time of inspection. The inspector recommends a qualified contractor further evaluate and repair as needed.

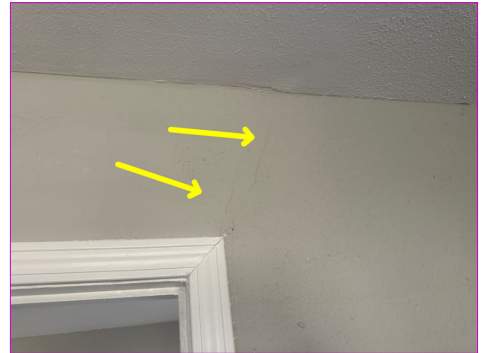
The walls exhibited settlement cracks. These cracks are commonly associated with normal foundation movement; however, the extent and cause could not be fully determined at the time of inspection. The inspector recommends a qualified contractor further evaluate and repair as needed.

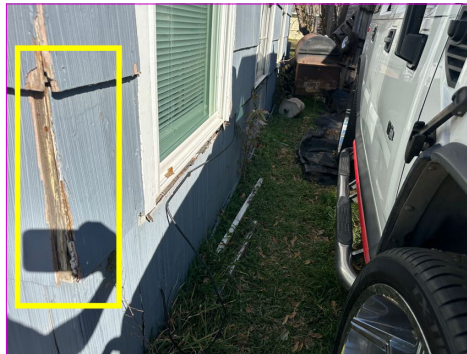
The exterior siding of the house is damaged. Damaged siding can allow moisture intrusion and may lead to further deterioration if not addressed. The inspector recommends a qualified contractor evaluate and repair this condition as needed.

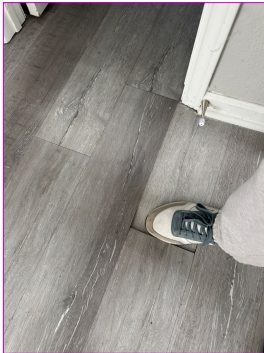
The flooring throughout the house is severely damaged, with sections missing and the wooden subfloor exposed in multiple areas. Several holes were observed in the floors, which present safety hazards and may indicate underlying structural or moisture-related issues. The inspector recommends a qualified contractor evaluate and repair this condition as necessary.

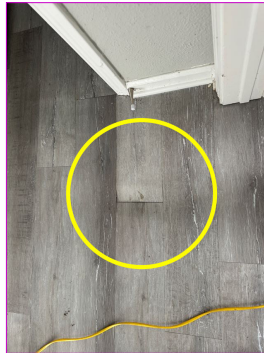
The flooring throughout the house is severely damaged, with sections missing and the wooden subfloor exposed in multiple areas. Several holes were observed in the floors, which present safety hazards and may indicate underlying structural or moisture-related issues. The inspector recommends a qualified contractor evaluate and repair this condition as necessary.

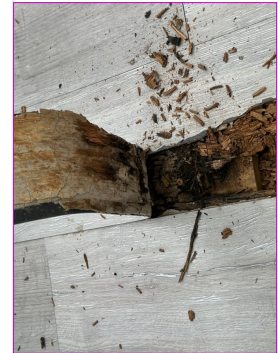
The flooring throughout the house is severely damaged, with sections missing and the wooden subfloor exposed in multiple areas. Several holes were observed in the floors, which present safety hazards and may indicate underlying structural or moisture-related issues. The inspector recommends a qualified contractor evaluate and repair this condition as necessary.

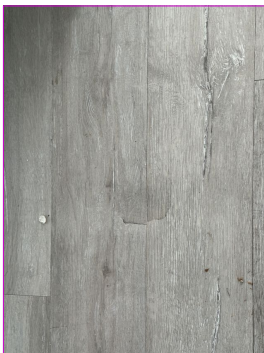
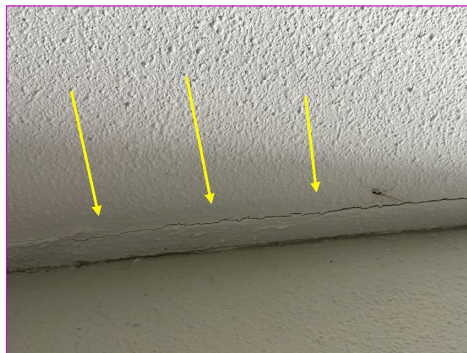
Settlement cracks were observed in the ceilings. While minor cracking can be associated with normal structural movement, the extent and cause could not be fully determined at the time of inspection. The inspector recommends a qualified contractor evaluate and repair as necessary.

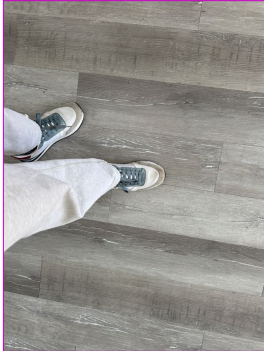
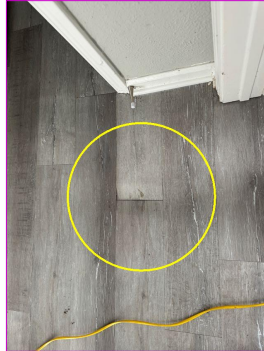
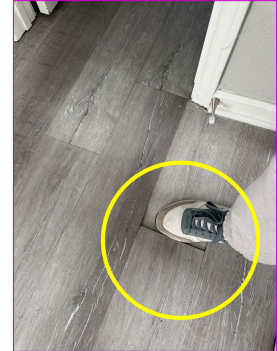
The flooring throughout the house is severely damaged, with sections missing and the wooden subfloor exposed in multiple areas. Several holes were observed in the floors, which present safety hazards and may indicate underlying structural or moisture-related issues. The inspector recommends a qualified contractor evaluate and repair this condition as necessary.

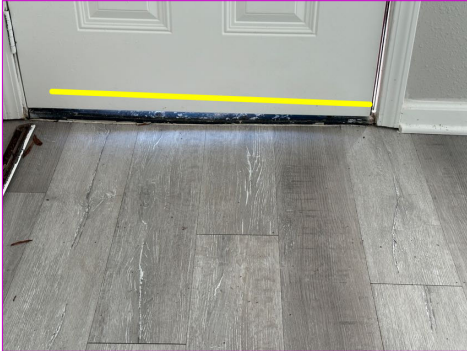
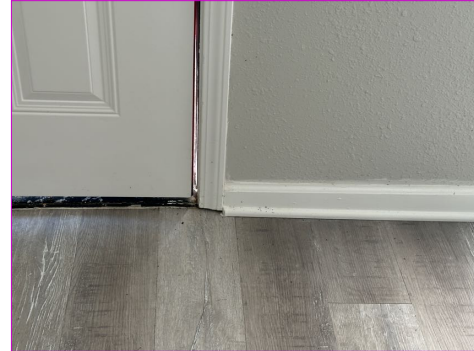
The front door has a large gap at the bottom, indicating missing or inadequate weather stripping. Door alignment issues may also be present and could require adjustment. This condition can allow air and moisture intrusion and reduce energy efficiency. The inspector recommends a qualified contractor evaluate and repair this condition as necessary.

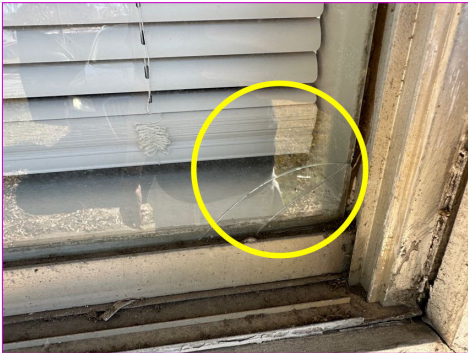
Some of the windows in the house are missing screens, and at least one window was observed to be cracked. Missing screens and damaged windows can affect safety, energy efficiency, and weather protection. The inspector recommends a qualified contractor evaluate and repair or replace these components as necessary.

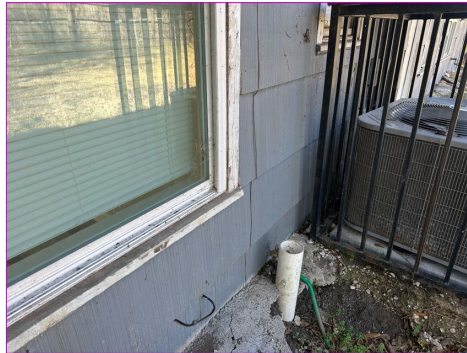
Some of the windows in the house are missing screens, and at least one window was observed to be cracked. Missing screens and damaged windows can affect safety, energy efficiency, and weather protection. The inspector recommends a qualified contractor evaluate and repair or replace these components as necessary.

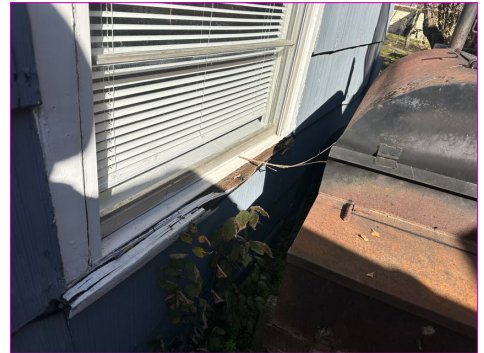
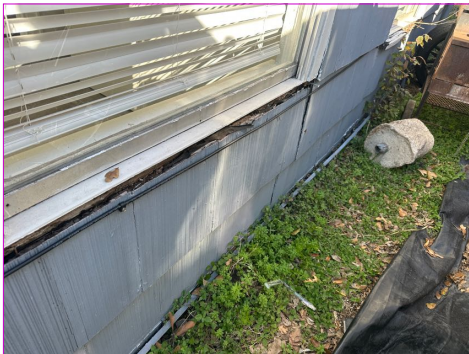
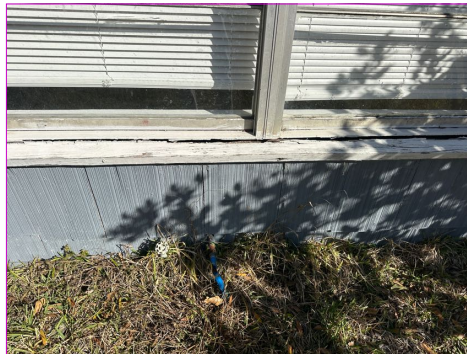
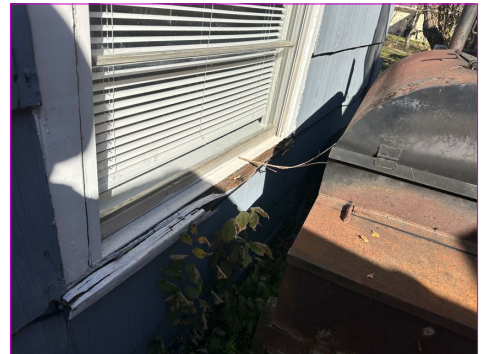
Some of the windows in the house are missing screens, and at least one window was observed to be cracked. Missing screens and damaged windows can affect safety, energy efficiency, and weather protection. The inspector recommends a qualified contractor evaluate and repair or replace these components as necessary.

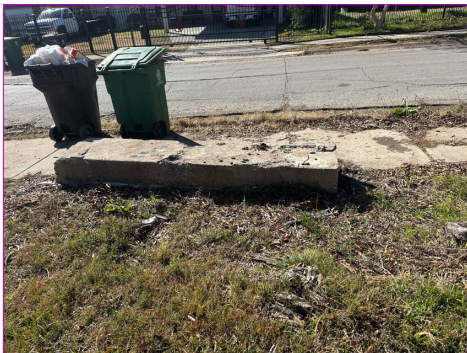
Several large objects were observed in the front yard, along with a dead tree. These conditions may present safety hazards and should be addressed. The inspector recommends removal of the debris and evaluation and removal of the dead tree by a qualified professional.

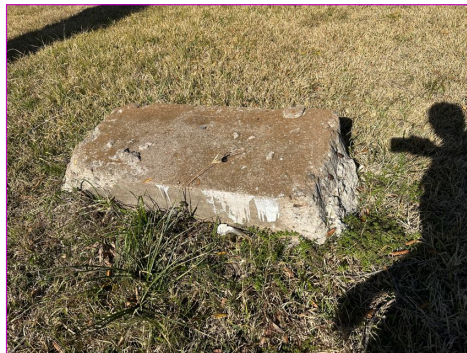
Several large objects were observed in the front yard, along with a dead tree. These conditions may present safety hazards and should be addressed. The inspector recommends removal of the debris and evaluation and removal of the dead tree by a qualified professional.

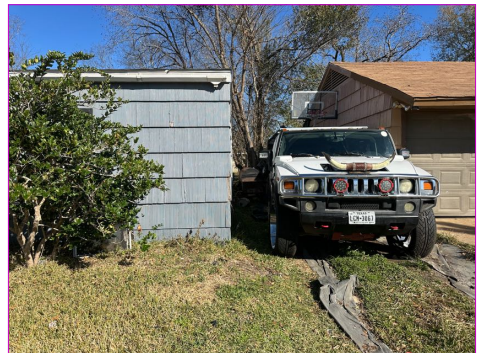
The inspector had limited access to inspect the right side of the house due to a vehicle parked extremely close to the exterior wall. As a result, portions of this area could not be fully evaluated at the time of inspection.

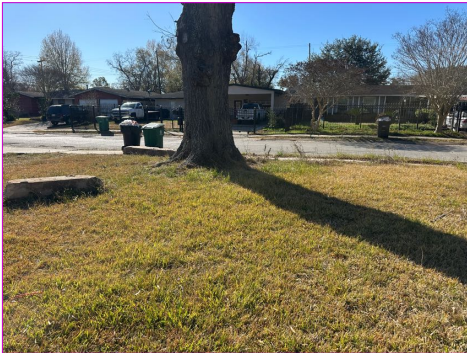
Several large objects were observed in the front yard, along with a dead tree. These conditions may present safety hazards and should be addressed. The inspector recommends removal of the debris and evaluation and removal of the dead tree by a qualified professional.

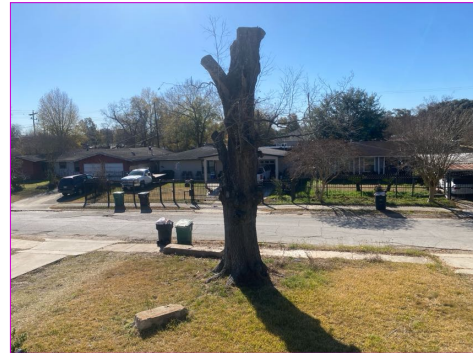
Several large objects were observed in the front yard, along with a dead tree. These conditions may present safety hazards and should be addressed. The inspector recommends removal of the debris and evaluation and removal of the dead tree by a qualified professional.

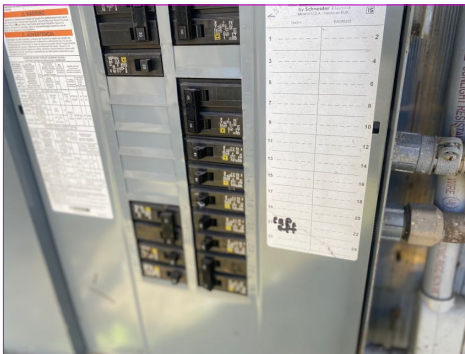
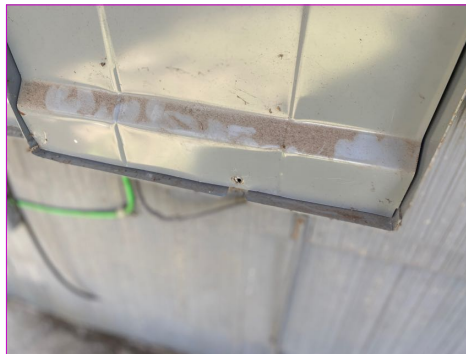
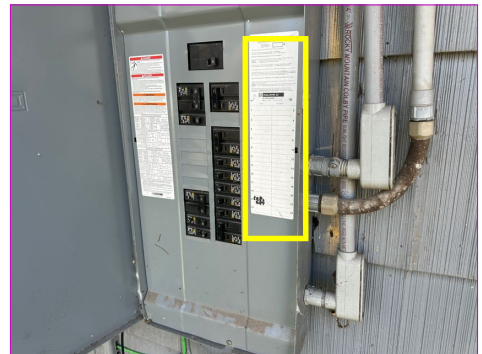
The inspector was unable to remove the cover of the electrical panel at the time of inspection. As a result, the interior components could not be evaluated. The inspector recommends that a qualified contractor evaluate the electrical panel and perform repairs as necessary.

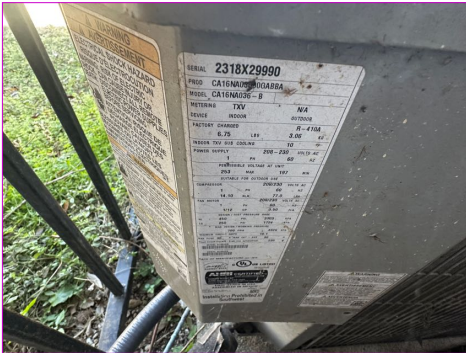
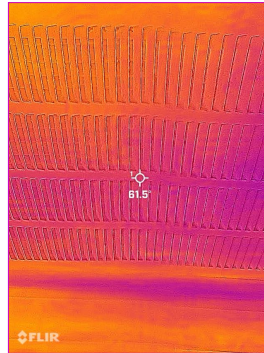
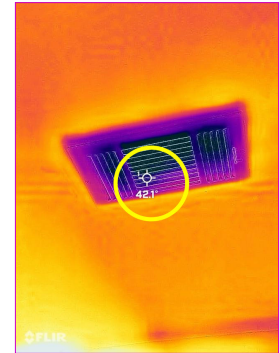
The differences in air temperature measured at supply and return registers fell within the acceptable range of between 14 and 22 degrees F.

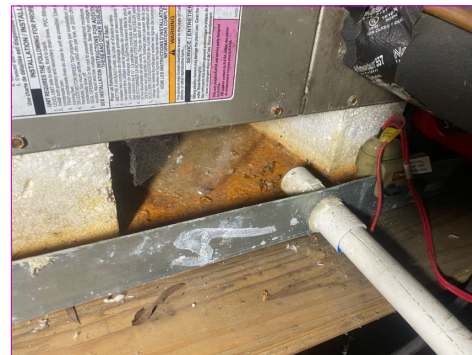
The attic-installed cooling system evaporator coil had a rusty condensate drain pan. This condition could result in moisture damage to attic or home interior materials.

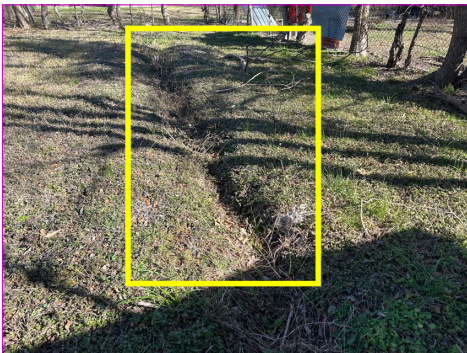
A large depression was observed in the backyard extending from the house toward what appears to be the main sewer line. This condition may indicate soil settlement or a potential drainage or sewer-related issue. The inspector recommends that a qualified contractor further evaluate the drainage system, potentially including a sewer camera inspection, to determine whether any blockage or failure is present.

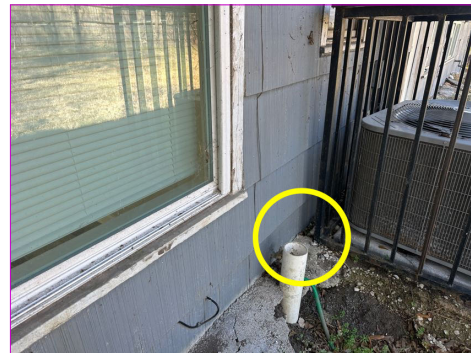
A clean out cover missing. The Inspector recommends repair by a qualified contractor.

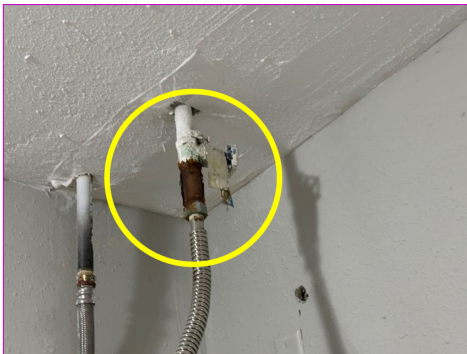
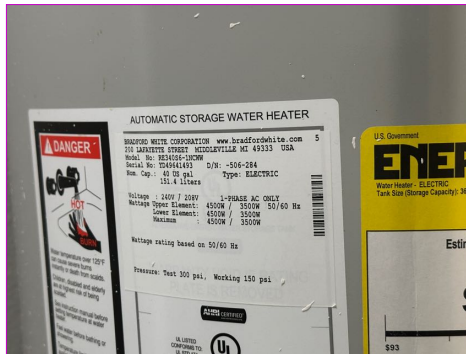
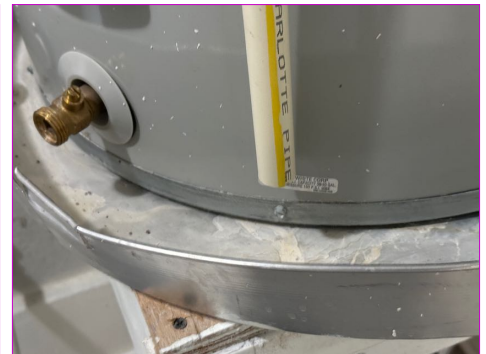
The discharge pipe of this water heater temperature/pressure relief (TPR) valve was not properly terminated. The discharge pipe from the pressure relief valve should be re-routed to terminate at an area in which it can not cause personal injury or damage if the valve activates. The Inspector recommends correction by a qualified HVAC or plumbing contractor.

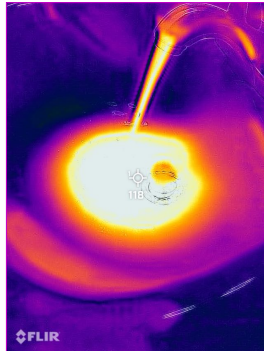
At the time of the inspection, the Inspector observed few deficiencies in the condition of the water heater. Notable exceptions will be listed in this report.

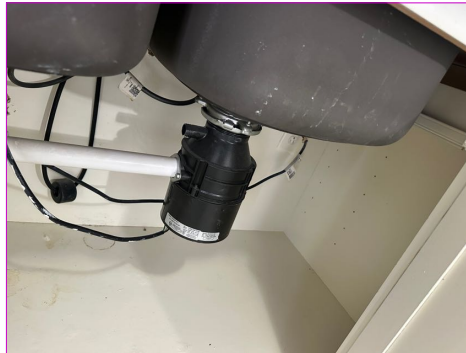
The garbage disposal appeared to be inoperable at the time of the inspection. The Inspector recommends that before the expiration of your Option Period you consult with a qualified contractor to discuss options and costs for repair or replacement.

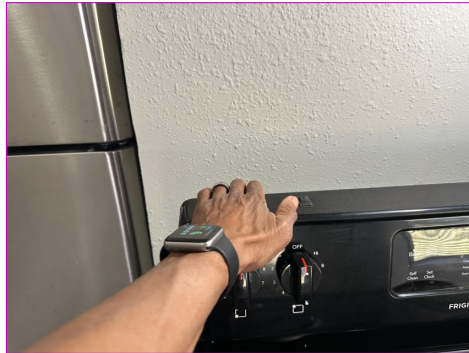
SAFETY CONCERN: *Anti-tip bracket is missing from range installation. See label inside oven door. All free-standing, slide-in ranges include an anti-tip device and is essential in the safe operation of the range. It provides protection when excess force or weight is applied to an open oven door. Carried by home building centers. Anti-Tip devices became a UL (Underwriters Laboratories) safety standard requirement in 1991. Should be installed.*

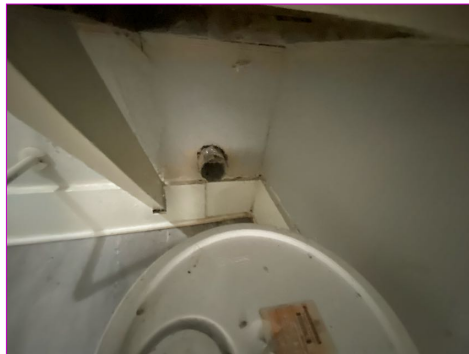
At the time of the inspection, the Inspector observed no deficiencies in the condition of the dryer vent. The Inspector recommends that you have the dryer vent cleaned at the time of purchase and annually in the future to help ensure that safe conditions exist. Lint accumulation can occur even in approved, properly installed vents. All work should be performed by a qualified contractor.
