TREC REI 7-6  
732 Allston St  
Houston, TX 77007

# PROPERTY INSPECTION REPORT FORM

Amy Marvin & Rob Marvin <i>Name of Client</i>	07/01/2022 9:00 am <i>Date of Inspection</i>
732 Allston St, Houston, TX 77007 <i>Address of Inspected Property</i>	
Dan Richter <i>Name of Inspector</i>	TREC#21351 <i>TREC License #</i>
<i>Name of Sponsor (if applicable)</i>	<i>TREC License #</i>

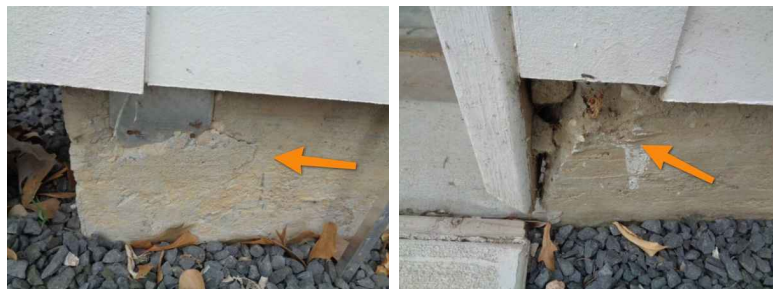
**1: Corner Cracks**

Corner cracks were present on some corners. Most notably at the garage right rear corner. These should be properly sealed and monitored. A small chunk of concrete was missing at the garage rear corner. Recommend this area be properly repaired.

Recommendation: Contact a qualified professional.

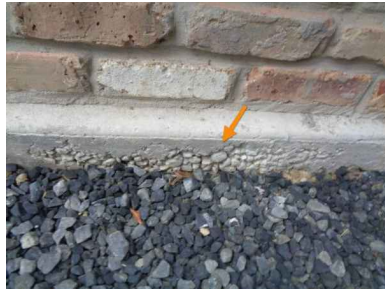
**2: Honeycombing**

There were some areas around the foundation that showed signs of honeycombing. It did not appear to be affecting the structural integrity of the foundation and no exposed steel was observed. These areas should be properly repaired.

Recommendation: Contact a qualified professional.

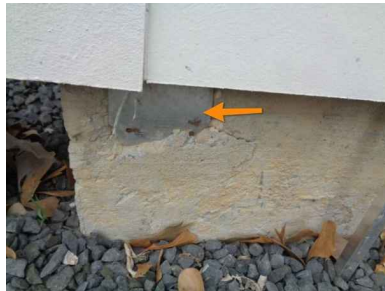
Steel was exposed around the perimeter.

Recommendation: Contact a qualified professional.

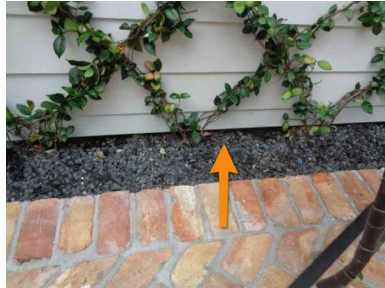
Siding exposure at some areas should be corrected. Common building code calls for 4" exposure to brick and 6" exposure to siding.

Recommendation: Contact a qualified professional.

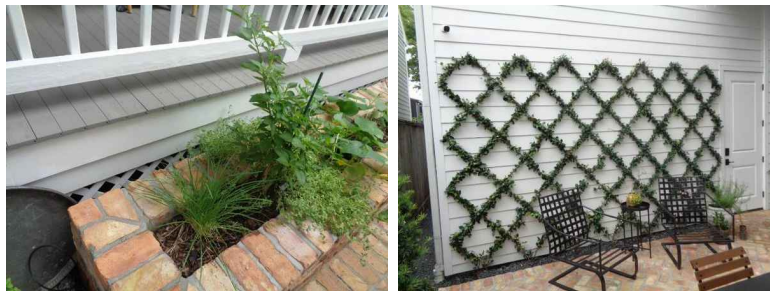
### 2: Excess Vegetation

Excessive vegetation was noted in some areas of the home. In our opinion vegetation should be cleared at least 12" from the exterior walls.

Recommendation: Contact a qualified professional.

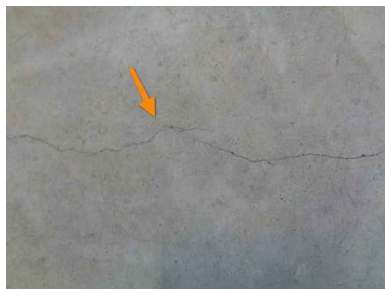
### 3: Cracked Flatwork

There were some cracks on flat work in the garage.

Recommendation: Contact a qualified professional.

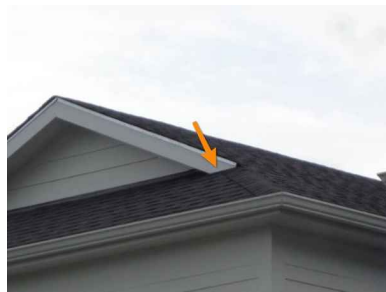
Siding/trim was too close to the roof surface.

Recommendation: Contact a qualified professional.

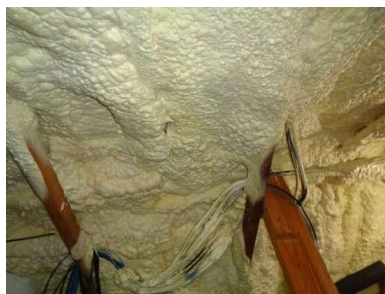
*Spray Foamed:*

Attic was spray foamed at the roof decking and framing. Most of the framing and decking concealed and not visible in the attic. Some imperfections may have been concealed.

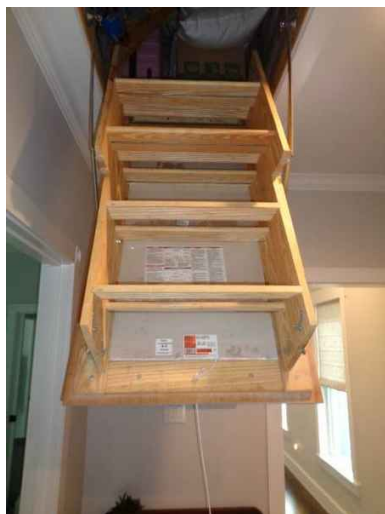
Access door was not sealed.

Recommendation: Contact a qualified professional.

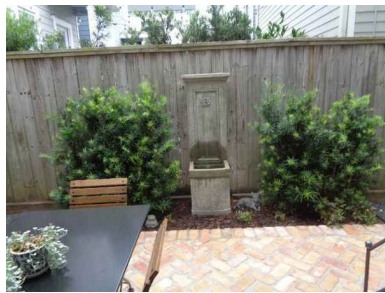
*Fountain Not Inspected:*

Rear exterior fountain was not inspected.

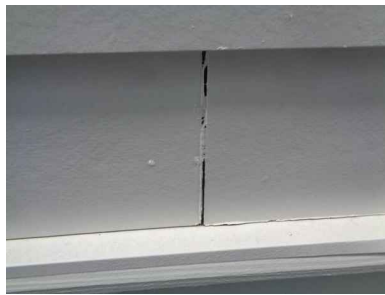
**2: Siding Not Sealed**

Exterior wall gaps were observed. Most notably at siding seams and/or nail heads. Fiber cement siding manufacturers recommend all gaps be sealed. All exterior wall penetrations, changes of materials and direction should be properly sealed to prevent water and pest intrusion.

Recommendation: Contact a qualified professional.

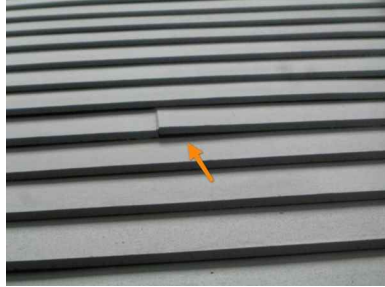
**3: Loose Siding**

Possible loose siding was observed at the left side exterior wall.

Recommendation: Contact a qualified professional.

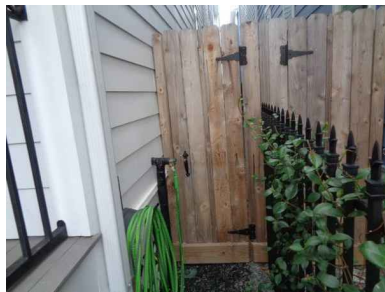
#### 4: Fence on Walls

Wood fence was contacting the exterior walls. This could be conducive condition for wood destroying insects.

Recommendation: Contact a qualified professional.

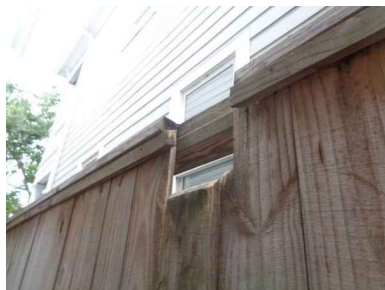
#### 5: Fence Damaged

Yard fence was damaged on the left side exterior.

Recommendation: Contact a qualified professional.

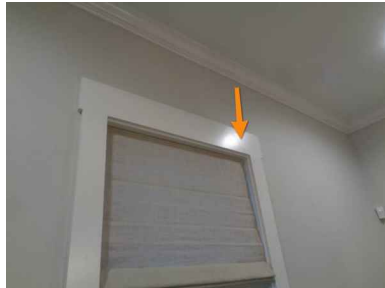
#### 7: Possible Previous Moisture Intrusion

Evidence of possible previous moisture was observed on the interior trim above the left side window in the dining room area. No significant moisture was detected at the time of inspection. Recommend this area be further evaluated and monitored.

Recommendation: Contact a qualified professional.

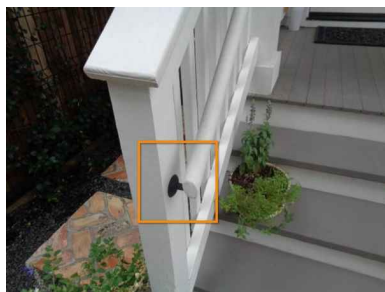
Handrail was not continuous to the walls/end on the rear exterior stairs.

Recommendation: Contact a qualified professional.

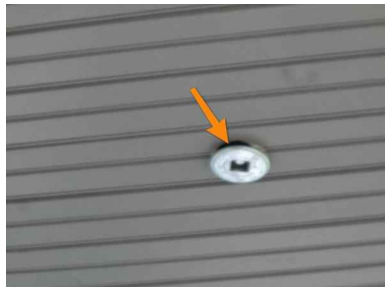
Ceiling gap was observed at the front porch.

Recommendation: Contact a qualified professional.

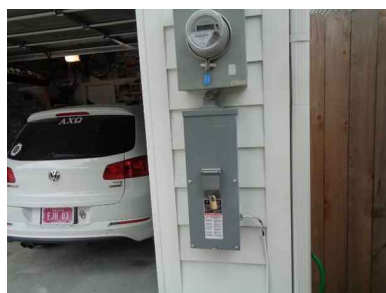
Main panel

*Service Panel(s) Description:*

3 wire 120/240v service drop feeds electrical main panel(exterior) with 4/0 AWG aluminum wire which is rated for 200 amps. The main disconnect breaker was 200 amps. The main cabinet (rated for 225 amps) appeared to be grounded and neutrals/grounds bonded. The electrical distribution panel(garage) appeared to be fed by 4/0 AWG aluminum wire which is rated for 200 amps. The main disconnect breaker was 200 amps. The distribution cabinet(rating not determined) appeared to be grounded. No trip ties were present. It appeared that AFCI circuits were properly installed.

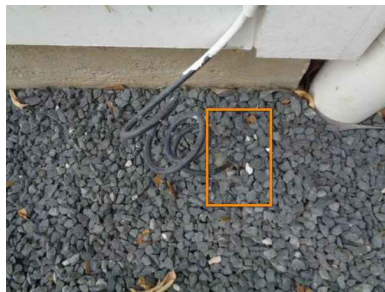
**4: Grounding Rod Below Grade and Not Visible**

Garage rear exterior grounding rod was buried below grade and not visible. Rod should be driven to grade level and fitted with a proper connector.

Recommendation: Contact a qualified professional.

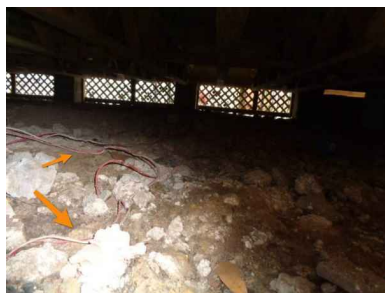
Wiring was not properly supported in the crawlspace under the home. Wiring was observed running along the ground. The wiring appeared to possibly be for the sprinkler system. Recommend further evaluation by a qualified licensed electrician.

Recommendation: Contact a qualified professional.

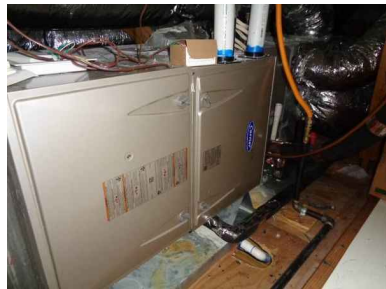
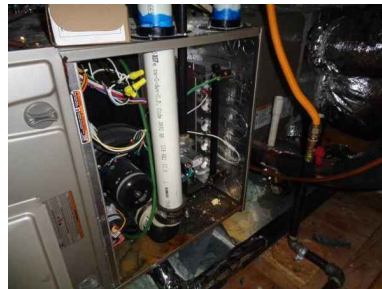
Left attic

*Furnaces Description:*

Both furnaces appeared to be manufactured by Carrier in 2020. Both furnaces were operated, access panels were removed and interiors were observed. Both appeared to be functioning as intended.

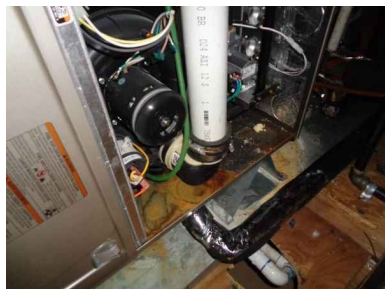
**1: Rust in Casing**

There was some visible rust observed on the interior of the left attic furnace. Recommend further evaluation by a qualified licensed HVAC professional.

Recommendation: Contact a qualified professional.

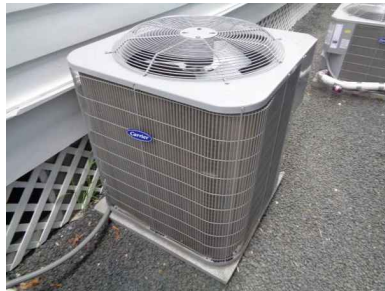
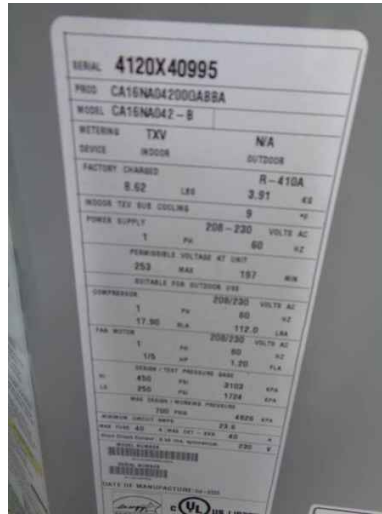
Right rear

*Condensing Unit Description:*

Condensing unit appeared to be manufactured by Carrier in 2020. Unit appeared to be 3.5 ton. Per the manufacturer's label, max amps on breaker should be 40. Per the labeling on the electrical panel, AC was connected to a 40 amp breaker.

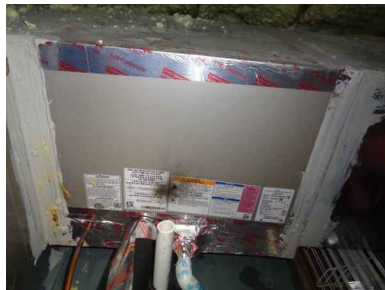
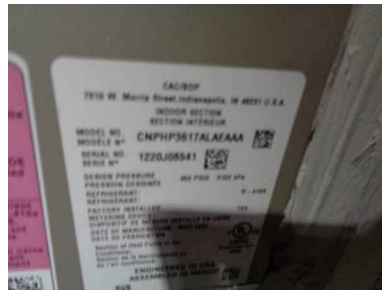
Right attic

*Evaporator Unit Description:*

Evaporator unit appeared to be manufactured by CARRIER IN 2020. Unit appeared to be 3 ton.

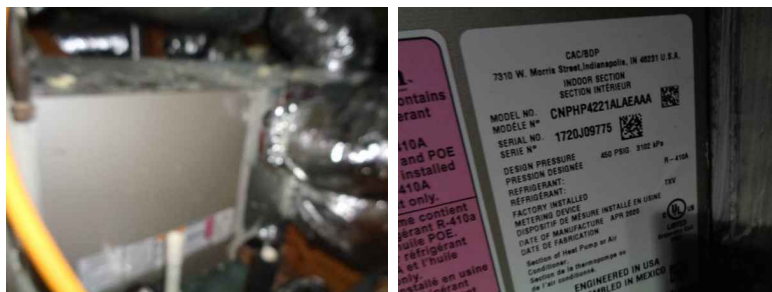
Left attic

Evaporator unit appeared to be manufactured by Carrier in 2020. Unit appeared to be 3.5 ton.

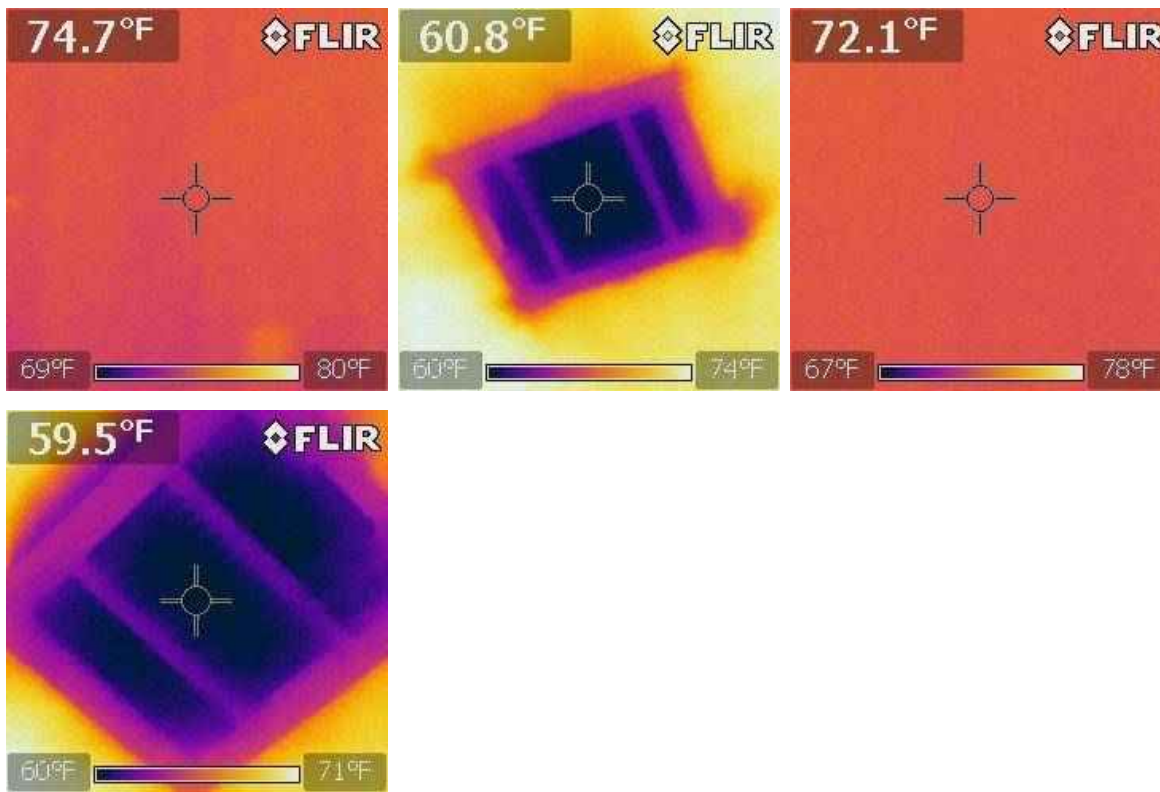
Both AC's did not appear to be cooling properly. Temperature differential measured only 14 degrees downstairs and 13 degrees upstairs between air supply and registers. Typical range should be 15 to 20 degrees. Recommend units be further evaluated and serviced by a qualified licensed HVAC professional.

Recommendation: Contact a qualified professional.

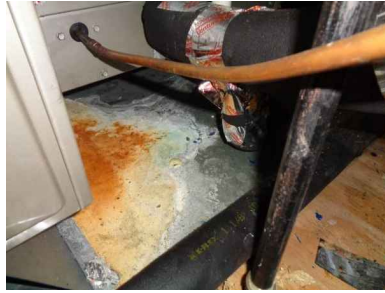
Evidence of possible water/rust stains were observed in the left attic evaporator secondary evaporator drain pan. This could be a sign of improper drainage of the main drain line. Recommend that unit be evaluated and serviced by a qualified, licensed HVAC professional.

Recommendation: Contact a qualified professional.

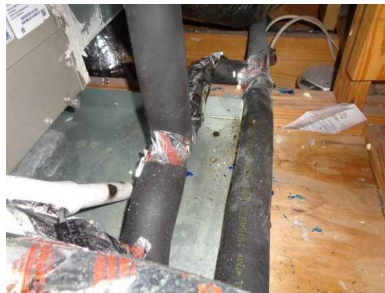
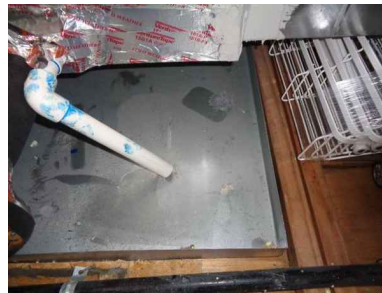
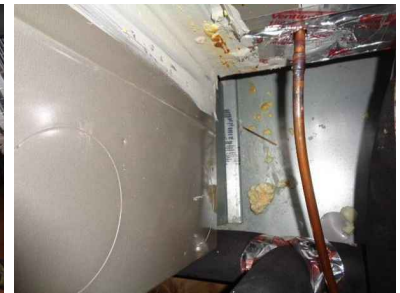
**3: Debris in Pan(s)**

Debris was located in both secondary drain pans. This should be cleared to allow for proper drainage.

Recommendation: Contact a qualified professional.

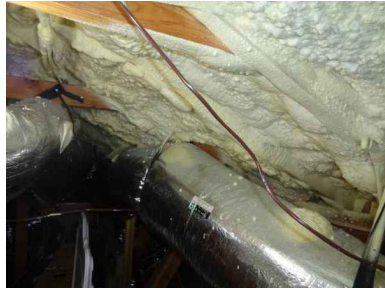
### 2: Spray Foam on Ducts

Some air ducts appeared to be in contact with the spray foam insulation in the attic. Typically manufacturer's require air gaps on the exterior all the way around the ducts. Manufacturer's recommendations should be consulted.

Recommendation: Contact a qualified professional.

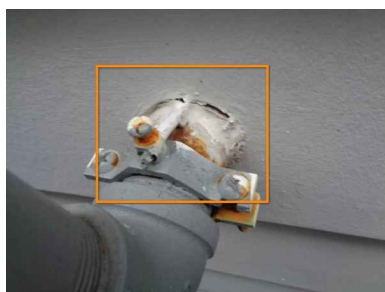
**2: Gas Line Not Sleeved**

Gas line was not sleeved at the exterior wall as a part of the original construction.

Recommendation: Contact a qualified professional.

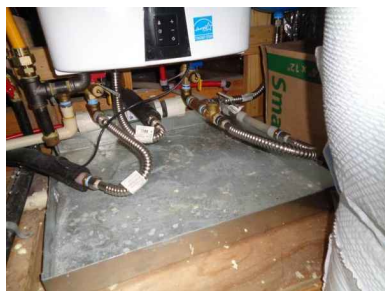
Drain pan showed signs of possible water stains.

Recommendation: Contact a qualified professional.

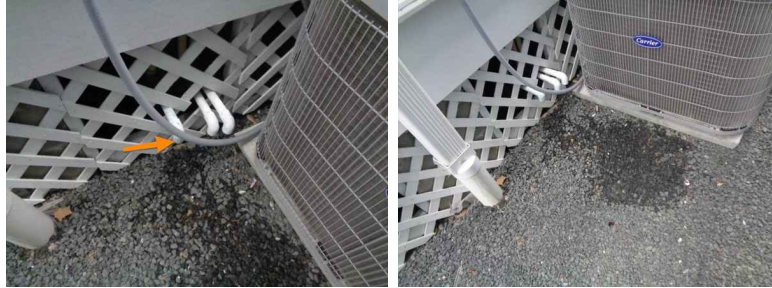
**2: Moisture**

is normal drainage/condensation, We recommend it be piped and routed to the plumbing or further away from the home. Recommend this be further evaluated by a qualified professional.

Recommendation: Contact a qualified professional.

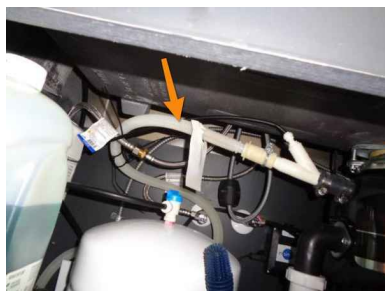
There was no anti-siphon device or high loop on the dishwasher drain. This would prevent water flowing back to the dishwasher in the event the sink backed up.

Recommendation: Contact a qualified plumbing contractor.

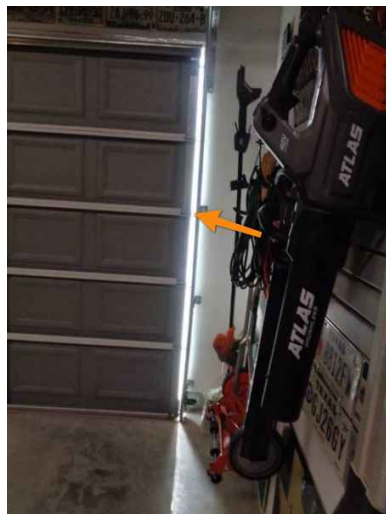
Gaps were observed around the garage door when fully closed.

Recommendation: Contact a qualified garage door contractor.

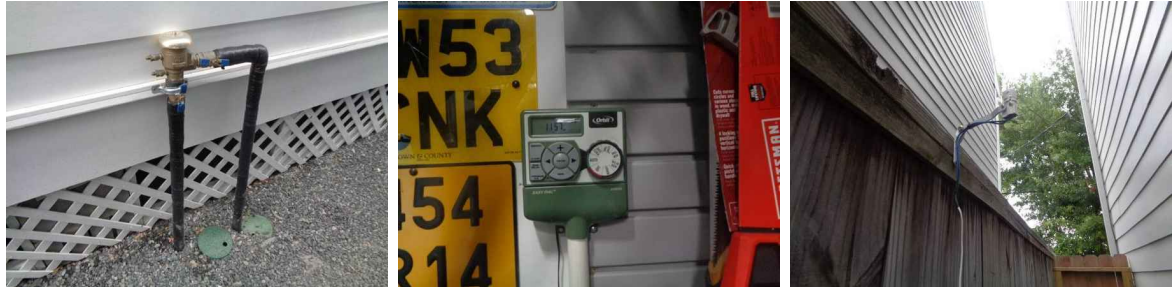
*System Components:*

Sprinkler system controller was located in the garage. vacuum break valve was at the right exterior. rain sensor was at the left fence. There appeared to be 2 zones. Both zones appeared to be functioning as intended at the time of inspection.
