INSPECTED FOR
Rosa Caffarena
5638 Briar Dr.
Houston, TX 77056

November 11, 2023

WOOD-DESTROYING INSECT INSPECTION AGREEMENT

TEXAS OFFICIAL WOOD DESTROYING INSECT REPORT

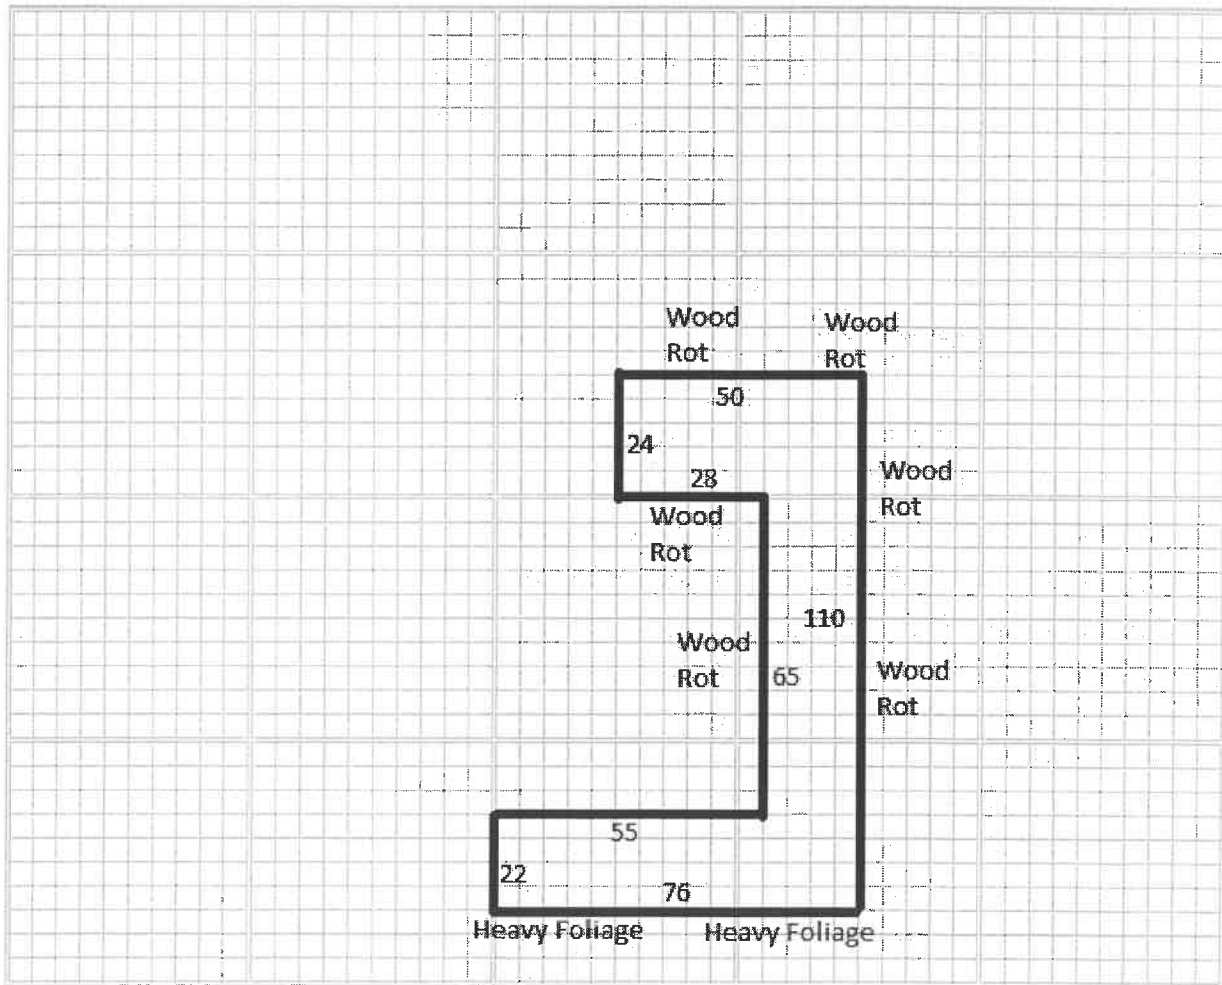
Diagram of Structure(s) Inspected

The inspector must draw a diagram including approximate perimeter measurements and indicate active or previous infestation and type of insect by using the following codes: E-Evidence of infestation; A-Active; P-Previous; D-Drywood Termites; S-Subterranean Termites; F-Formosan Termites; C-Conducive Conditions; B-Wood Boring Beetles; H-Carpenter Ants; Other(s) - Specify

Additional Comments There is no visible evidence of active wood destroying insects found at the time of this inspection.

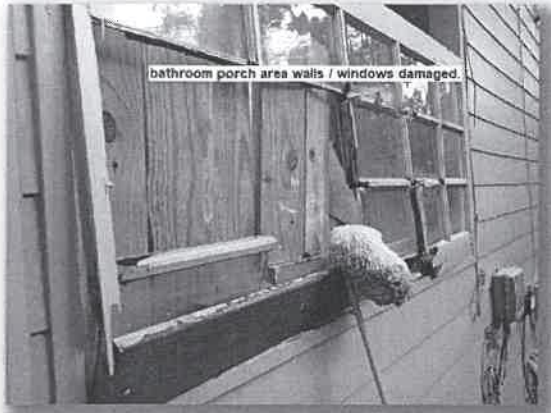
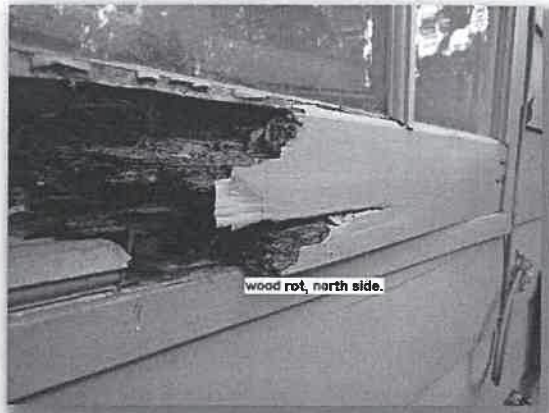
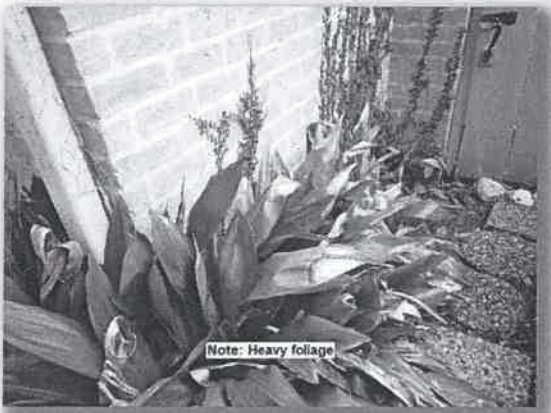
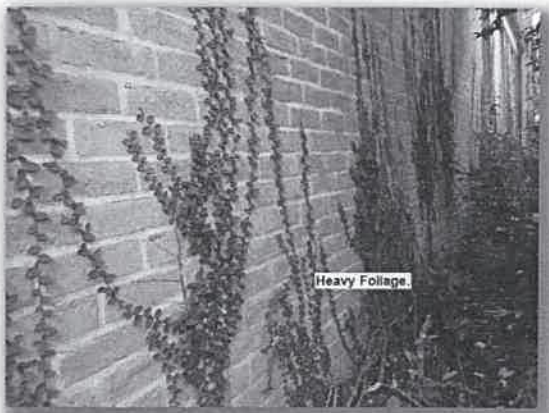
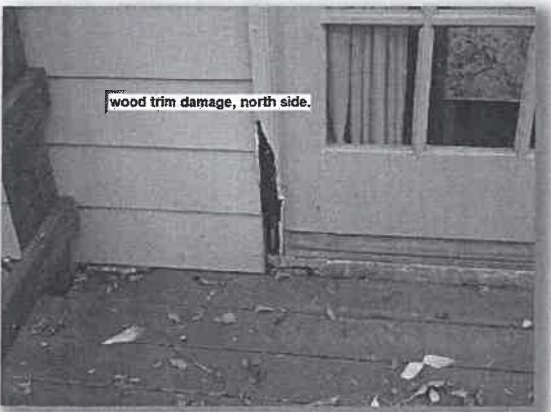
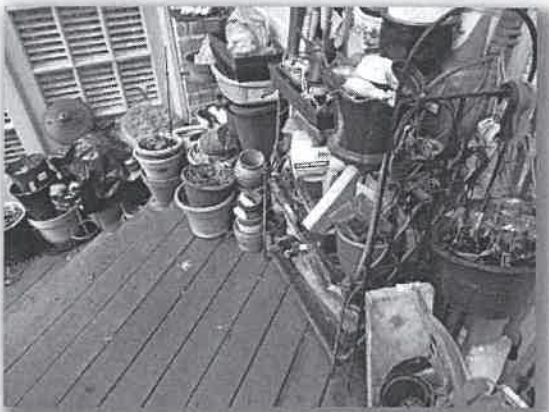
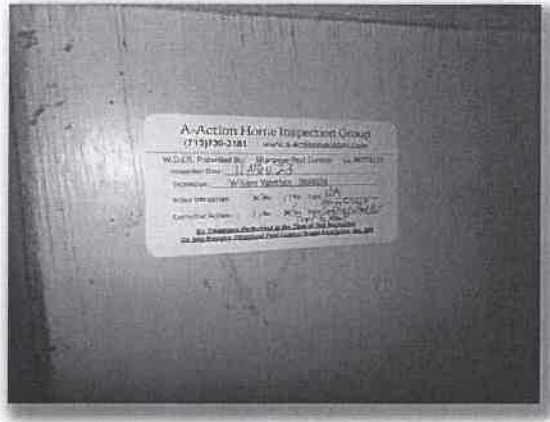
9B. The obstructed or inaccessible areas include but are not limited to the following:
Attic Insulated area of attic Plumbing Areas Planter box abutting structure
Deck Sub Floors Slab Joints Crawl Space
Soil Grade Too High Heavy Foliage Eaves Weepholes
Other Specify: Attic Partially Accessible, Construction Voids, Behind Floor/Wall Coverings, Behind Personal Effects, Storage & Furniture, Foundation Corner Pops, Debris Piled Next to Structure

10B. Conducive Conditions include but are not limited to:
Wood to Ground Contact (G) Formboards left in place (I) Excessive Moisture (J)
Debris under or around structure (K) Footing too low or soil line too high (L) Wood Rot (M) Heavy Foliage (N)
Planter box abutting structure (O) Wood Pile in Contact with Structure (Q) Wooden Fence in Contact with the Structure (R)
Insufficient ventilation (T) Other (C) Specify: Wood in Concrete Expansion Joints, Plumbing Penetrations, Tree Branches in Contact with Roof Structure

The digital pictures within this report are a representative sample of active/previous wood destroying insects, locations of active/previous infestations, inaccessible areas, conducive conditions, deficiencies or damages in place and should not be considered to show all. There will be active/previous wood destroying insects, locations of active/previous infestations, inaccessible areas, conducive conditions, deficiencies or damages not represented with digital imaging.

Specify reason: The heavy foliage should be trimmed at least 18-inches off the exterior walls. The tree and/or shrub branches in contact with the roof structure should be trimmed back. All wood rot and/or deterioration should be repaired. If active wood destroying insects are discovered during the correction process, treatment is recommended. The debris adjacent to / abutting the structure should be removed. If active wood destroying insects are discovered during the process, treatment is recommended.
