Inspection Report

Property Address:
3620 South Macgregor Way
Houston Texas 77021

PROPERTY INSPECTION REPORT FORM

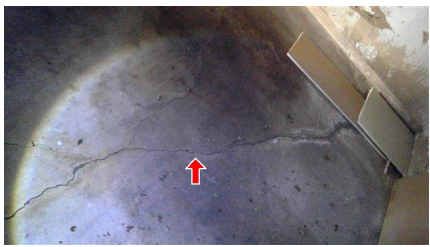
A. Item 1 (Picture)

1) The foundation is the home is Pier & Beam. Due to the issues noted in this report under walls and flooring, the foundation is no longer performing as intended. Resulting in the fractures/separation between and through the bricks and mortar on both sides, front and back of the home. This issue appears to have cause some structural issues with the bricks due to the separation in some areas. A foundation company was called out to inspect the foundation. Recommend referring to the foundation report, and all required recommend issues noted be made.

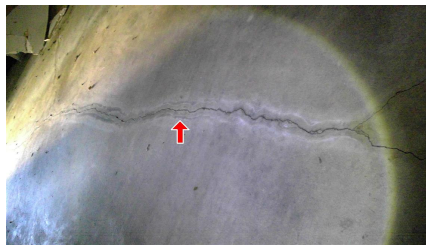
A. Item 2 (Picture)

2) Multiple cracks were located in the garage foundation, this issue is considered deficient and can prevent the garage foundation from functioning as intended over time. Recommend having this looked at further by a licensed foundation company and all required repairs noted and found be made.

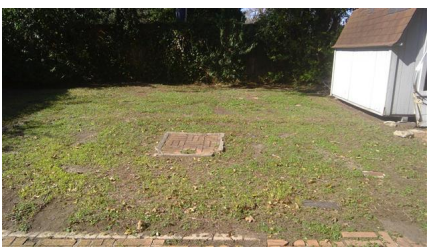
B. Item 1 (Picture)

1) The drainage around the home is considered deficient and do not meet the minimum standard practice/ required. Standard require that a minimum of 4 inches of the entire foundation must be exposed at all times, and the grade (soil) around the foundation must have a slope of 6 inches within the first 10 feet (width) of the grade, unless the grade is less the 10 feet in width, than the slope must be a minimum of 2% of the width of the grade. Recommend having this looked at further by a licensed landscaping company and all required repairs be made.

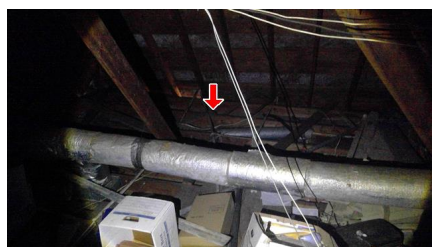
D. Item 1 (Picture)

No insulation was noted in the attic space over the habitable area of the home, this issue is considered deficient, standard require a minimum of 12 inches of R30 or greater insulation to be over the attic space, this is to help trap warm air in the home, allowing the air to be condition. Recommend having these issues looked at further by a licensed general contractor/roofer and all required repairs be made.

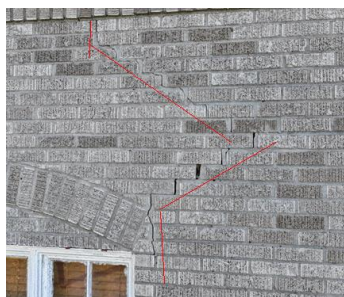
E. Item 1 (Picture)

1) Multiple fractures were noted going through the bricks and mortar on the sides, back and front of the home, this issue is considered deficient and does not meet the minimum standard practice/required. This issue is an indicator that the foundation is no longer functioning properly. The separation between the bricks in some areas pose a hazard, which can result in the bricks completely coming away from the framing members, while allowing moisture to get behind the exposed areas. Recommend having this looked at further by a general contractor and all required repairs noted and found be made.

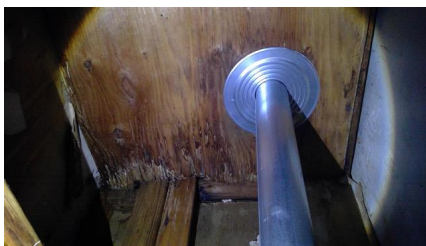
F. Item 1 (Picture)

- 1) Moisture damage was located on the ceiling material and ceiling joist in the closet housing the water heater, this issue is considered deficient and does not comply with the minimum standard practice/required. Recommend having this looked at further by a general contractor and all required repairs noted and found behind the degraded areas be made.

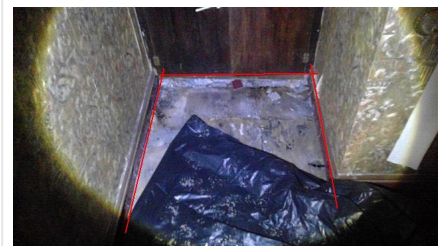
F. Item 2 (Picture)

- 2) A section of the flooring and sub flooring material in the power room (Half Bath) has been removed. This issue is considered deficient and does not comply with the minimum standard practice/required. Moisture damage was also located on the remaining sub flooring area. Recommend having this looked at further by a general contractor and all required repairs noted and found be made.

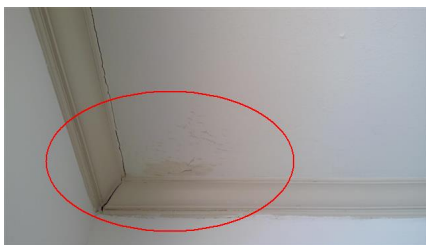
F. Item 3 (Picture)

- 3) Moisture damage was located on the back right corner of the ceiling in the formal dining area of the home, this issue is an indicator that there is a leak in this areas of the roof, as this issue was also located in the ceiling behind this wall, where the water heater is being stored. Recommend having this looked at further by a general contractor and all required repairs noted and found be made.

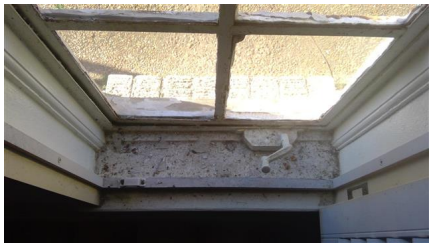
H. Item 1 (Picture)

1) The windows in the home are not operable, this issue prevents the windows from being opened. This issue has created a life, health and safety hazard. Windows are a means of egress and must easily be opened from the inside of the home incase of an emergency, and the windows is the safest, nearest and only option for egress. Recommend having this looked at further by a window company and all required repairs needed be made, this may include replacing the windows.

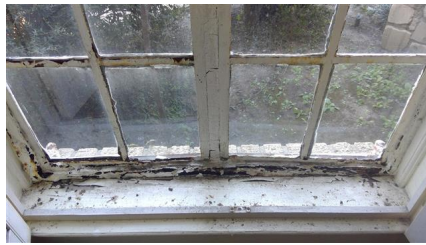
2) All of the windows in the home are considered old, they all appear to have moisture damage, and have passed their shelf life expectancy, resulting in the windows not functioning properly any more. Recommend having this looked at further by a window company and all required repairs noted and found be made, this may include replacing all of the windows. (A window company was called out to the home, to give a quote on the cost to replace the windows in the home.

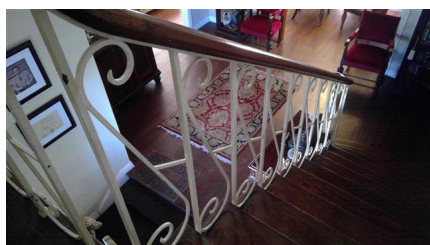
I. Item 1 (Picture)

The stairs at the back and front of the home are wrong, standard require that each riser be a 7 3/4 inches in height, and because each stairs has more than 4 risers, a hand/guard rail on them, with a minimum height of 34-38 inches in height with a maximum of 4 inches between the baluster. This issue is considered a safety hazard. Recommend having this looked at further by a general contractor to be repaired.

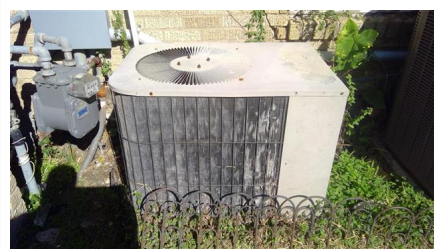
B. Item 1 (Picture)

1) The AC compressor on the left, and the entire air handler system appears to have reach the end of its shelf life expectancy. The coils on the compressor are degraded, this issue is preventing air from circulating around the unit, forcing the unit to work longer and harder, which shorten the life expectancy of the unit. Recommend having this looked at further by a licensed HVAC Tech and all required repairs which may require the unit being replaced.

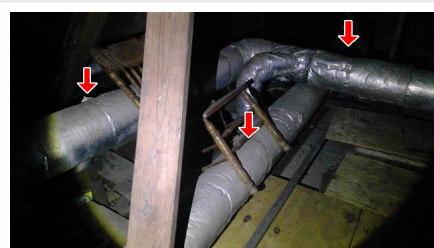
C. Item 1 (Picture)

All of the ac ducts are considered old and have passed their life expectancy, this issue is considered deficient and do not meet the minimum standard. This can lead to the ducts leaking air into the attic space of the home, causing the unit to work longer and harder. Recommend having this looked at further by a licensed HVAC Tech and all required repairs be made.

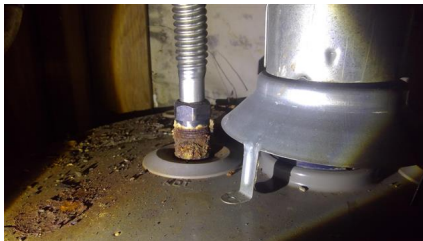
C. Item 1 (Picture)

1) Corrosion was noted on the left water heater nipple, and shut off water valve, these issue are considered deficient and does not meet the minimum standard required. This issue can result in the water heater degrading faster than intended, and leaking in the degraded areas. Recommend having this looked at further by a licensed plumber and all required repairs, this should including servicing be done.

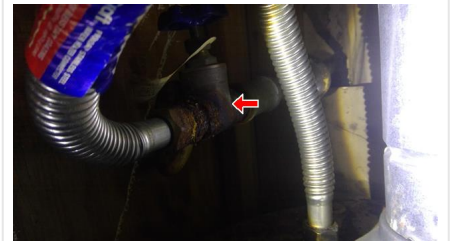
C. Item 2 (Picture)

2) The water heater is considered deficient and do not meet the minimum standard practice. Standard requires all water heaters be placed at a minimum of 18 inches off the floor, sitting in a drain pan, with a drain line from the T&P valve and drain pan terminating on the exterior side of the home, unless in the garage, the drain pan drain line can terminate halfway down the slope section of the floor. The water heater is not sitting in a drain pan. Recommend having this looked at further by a licensed plumber to be corrected, and any other repairs required be made.

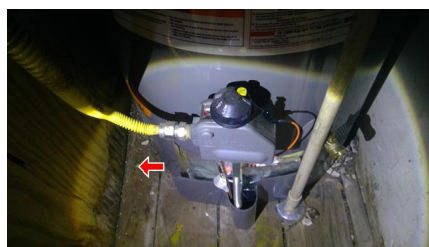
C. Item 3 (Picture)

3) The drip leg is missing from the gas line to the water heater and furnace. The drip leg is used to help prevent any moisture and dirt in the gas from getting to the mechanical component that operates the water heater and furnace, which can shorten the life expectancy of the equipment. Recommend having this looked at further by a licensed plumber and all required corrections be made.

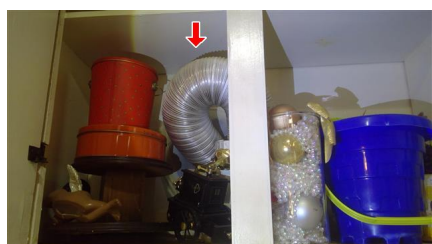
C. Item 1 (Picture)

1) The wrong material is being used for the flue in the cabinet above cooktop exhaust, is damaged, and the flue is not properly installed. This issue can result in grease buildup in the flue material over time, resulting in the grease draining back into the vent. Recommend having this looked at further by a licensed plumber and all required repairs needed be made.

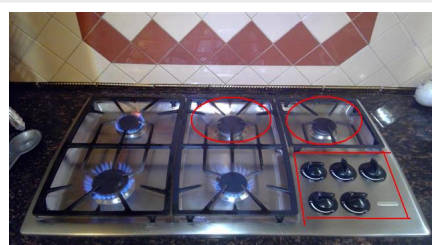
D. Item 1 (Picture)

1) The operational labeling on each burner is missing, this issue prevents the proper used of the stove, because the diagram used to turn on each burner and operate the flames for each burner is not present. This issue is considered a safety hazard. Recommend having this looked at further by a small appliance tech and all required repairs be made.
