# Inspection Report

**Property Address:**  
14810 Forest Lodge Drive  
Houston TX 77070

**Inspections By Pat, LLC**

# PROPERTY INSPECTION REPORT FORM

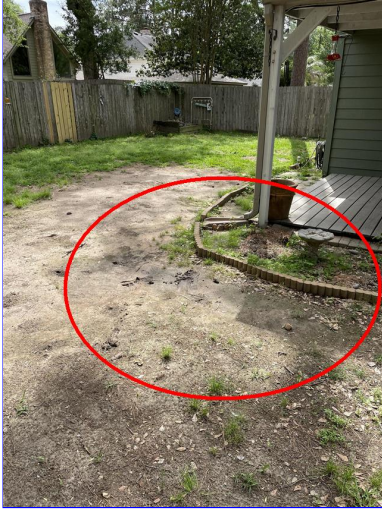
B. Item 14(Picture)

● (7) Area of standing water on right side of patio.

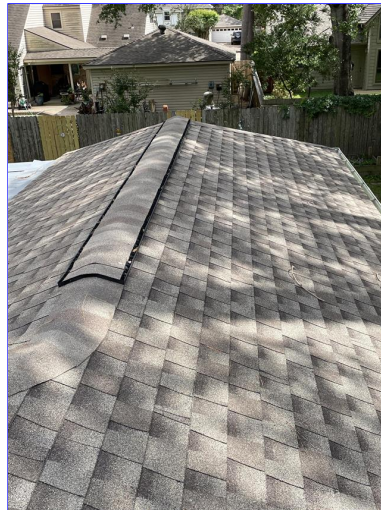
C. Item 2(Picture)

- (3) Remove debris from roof slopes and valleys. Leaf debris may hide possible defects and damage to roofing materials. Debris may also cause water to dam up under shingle tabs.

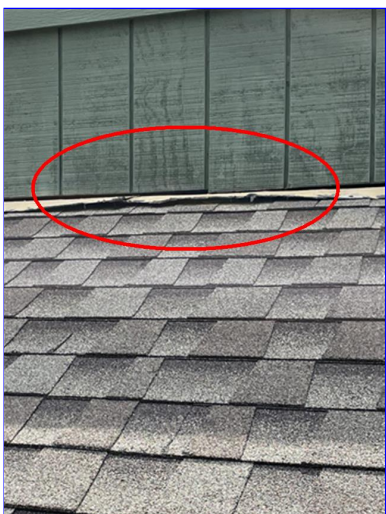
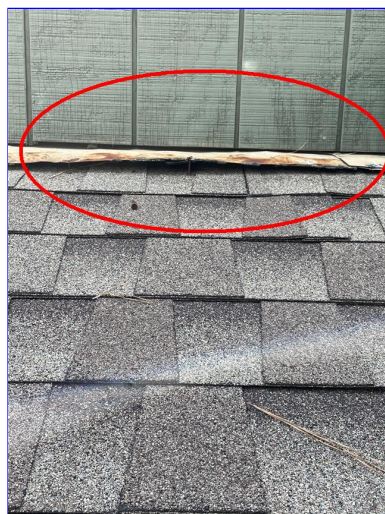
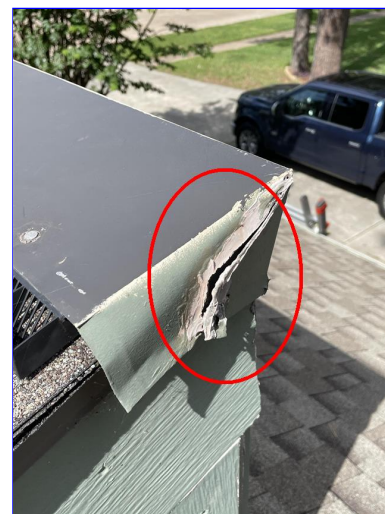
● (5) Seal (caulk) all exposed roofing fasteners (nail heads) in various locations (i.e. plumbing vents, flue pipe roof jacks, flashings, and ridges lines.)

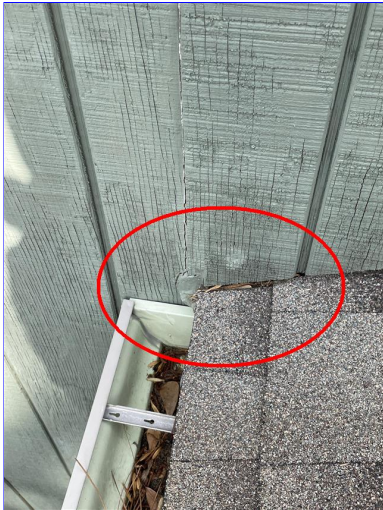
C. Item 13(Picture)

- (7) There was no kickout flashing observed at the lower bottom edge of the roof and the sidewall. The lack of this kickout flashing will allow water to penetrate at these points.

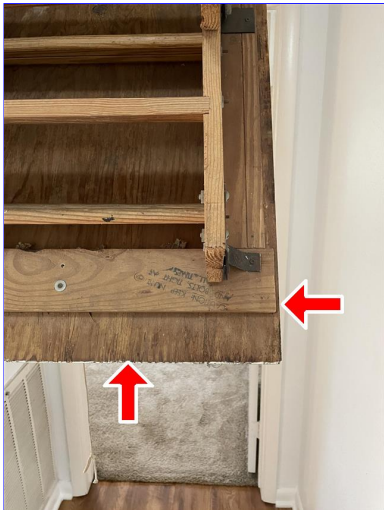
D. Item 1(Picture)

- (2) The attic stairs missing insulation and or weather stripping. This can cause some heat loss in winter and loss of cool air in summer if not corrected. A qualified person should repair or replace as needed.

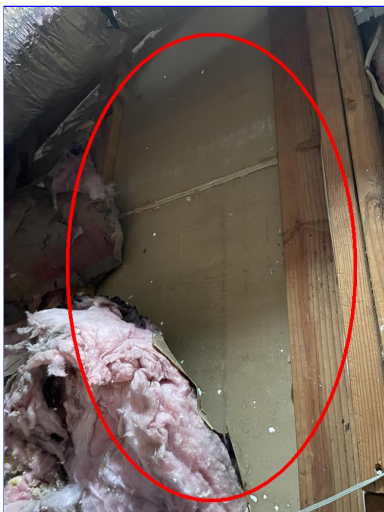
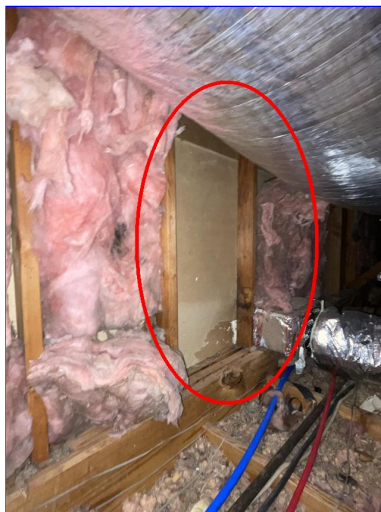
D. Item 2(Picture)

● (3) Attic insulation missing in various locations. Current standards is R30.

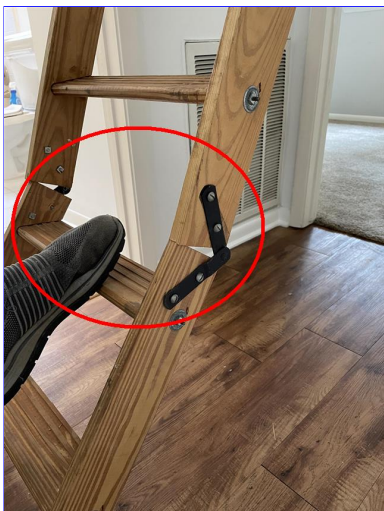
D. Item 4(Picture)

● (4) The attic ladder appears to be in poor condition and improvements or replacement is recommended.

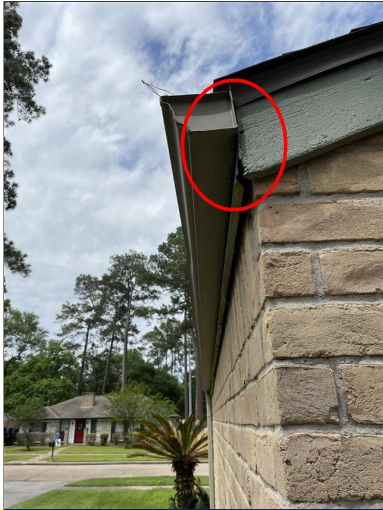
E. Item 1(Picture)

● (2) There are areas of the exterior wood siding, trim, Fascia, Drip edge, door jambs, etc. that have sustained varying levels of water (rot) damage and is in need of repair

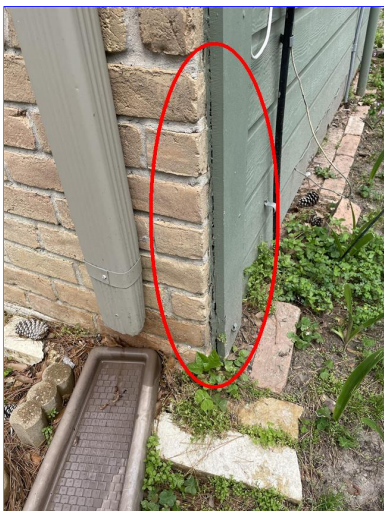
E. Item 7(Picture)

● (3) Caulking improvements are recommended for the area between the exterior brick veneer and the window frames, garage door trim boards, exterior doorframes, exterior water faucet(s), HVAC condenser/coils refrigerant lines needs to be properly sealed.

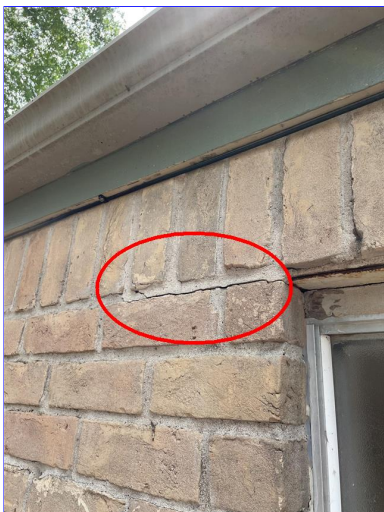
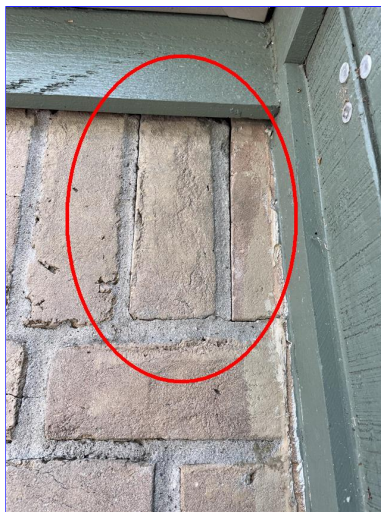
E. Item 8(Picture)

● (4) Set cracks in brick, stone and mortar observed in various locations. These cracks should be repaired to prevent moisture intrusion and further expansion.

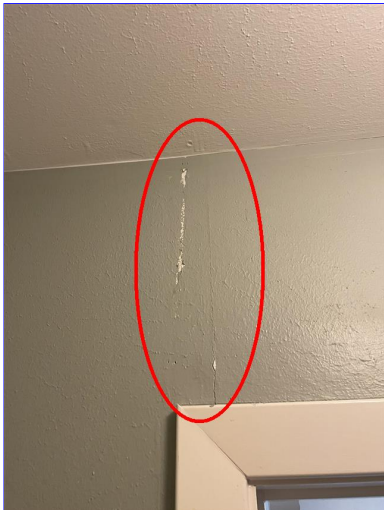
E. Item 10(Picture)

● (5) There are wall sheetrock cracks, seam bulges and tape wrinkles on the walls in various locations. These issues appear to be typical settlement/shifting joint cracks with no other visible displacement. Recommend sealing crack to prevent moisture incursion and correct any further settlement/separation

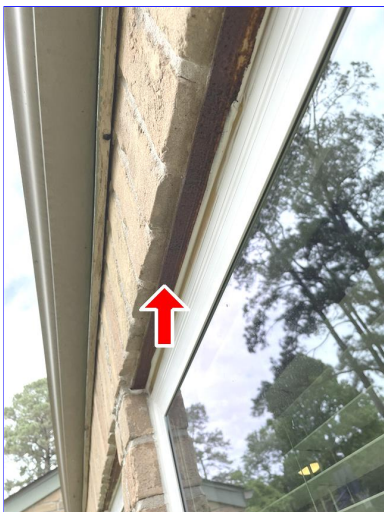
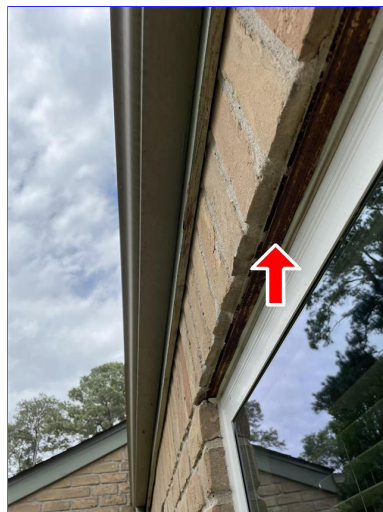
E. Item 17(Picture)

● (7) Lintels/headers above doorways, windows are rusting. Recommend remediation of rust, application of rust prohibitive paint.

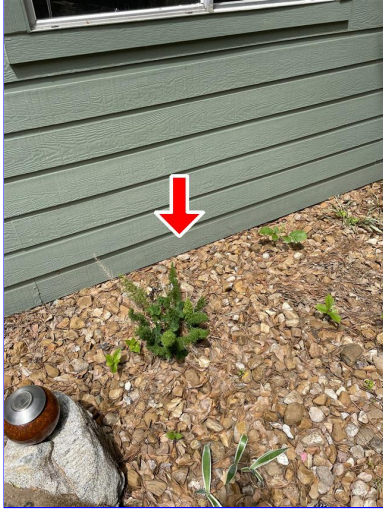
E. Item 19(Picture)

(8) Siding has been run all way down to grade covering foundation slab. This hidden area is a known conducive area for termite infestations. I recommend a pest control maintenance program that includes monitoring and treatments as needed.

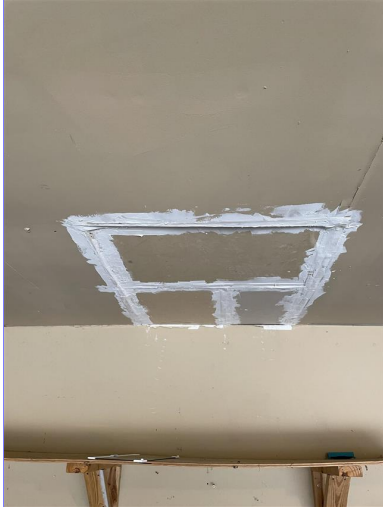
F. Item 1(Picture)

- (1) Observation of floors are related to structural performance and water penetration only. The inspection does not include obvious damage to carpets, tiles, wood, laminate or vinyl flooring
- (2) Evidence of painting and patching to the interior finish and prior sheetrock repairs were observed.

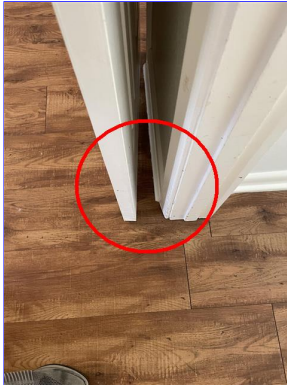
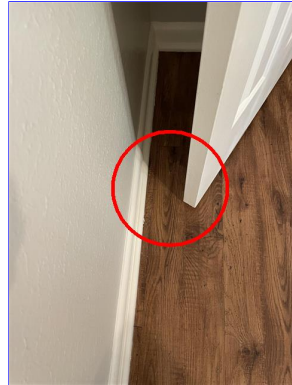
**●** (2) Doors and frames should be sealed, made weather tight. Seals at front and back entry doors are deficient and should be replaced.

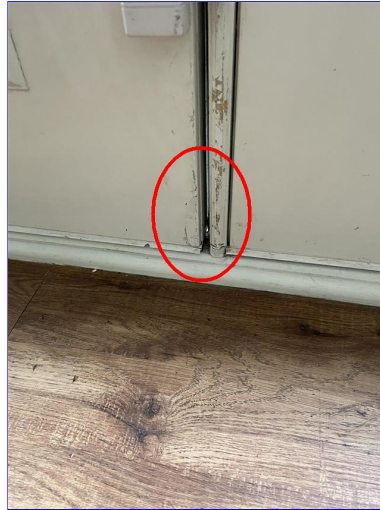
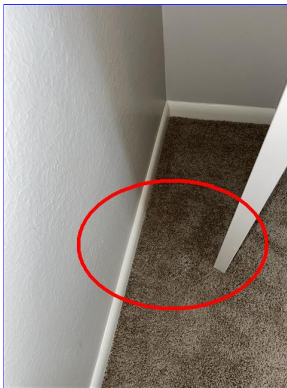
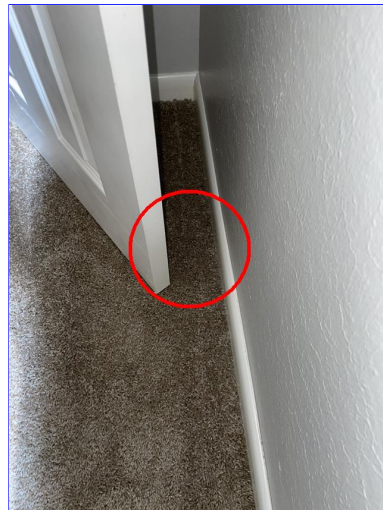
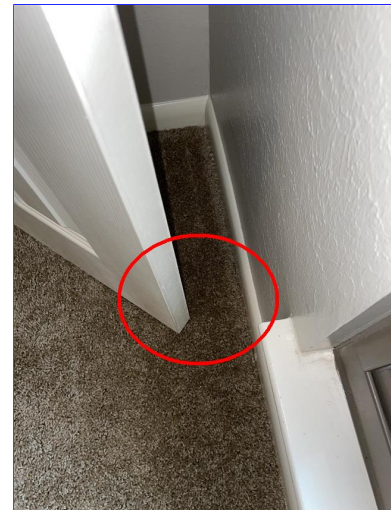
● (3) Doors in various areas are missing working door-stops. This is a maintenance issue and is for your information. A qualified person should repair or replace as needed.

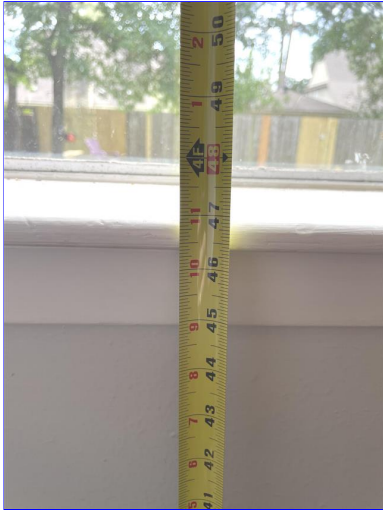
H. Item 1(Picture)

● (3) The windowsill height in one or more of the bedrooms measured more than 44" from the floor. Under current building standards, these windows are considered to high for a proper emergency egress (escape) exit. The occupants of these bedrooms should be aware of this hazard and be physically able to use this window as an emergency egress exit.

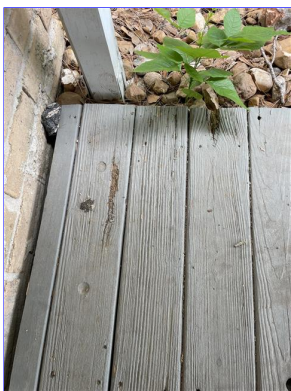
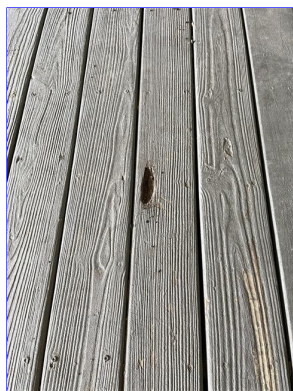
K. Item 1(Picture)

(2) Deck planks are weathered and deteriorated from water exposure. Consult with a deck contractor for repairing and a new sealant application may also be necessary.

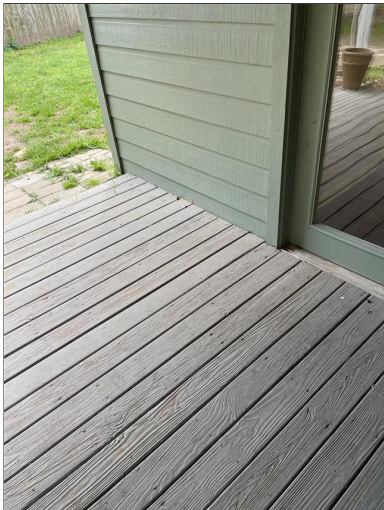
K. Item 3(Picture)

(3) Wood decks have areas in direct contact with soil. Condition is conducive to eventual wood rot and possible insect damage

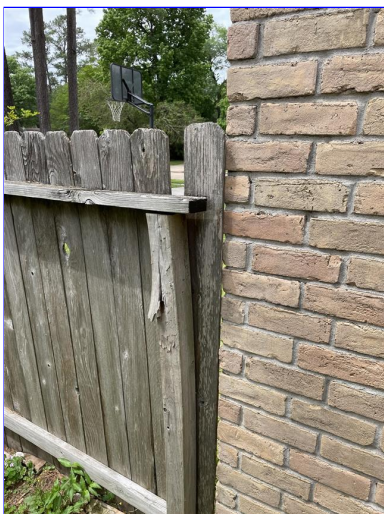
L. Item 1(Picture)

(2) Fence is in contact with structure, wall or wood siding. This is a conducive area for wood destroying insect entry. Fence boards should be kept 1.5-2 inches away from walls.

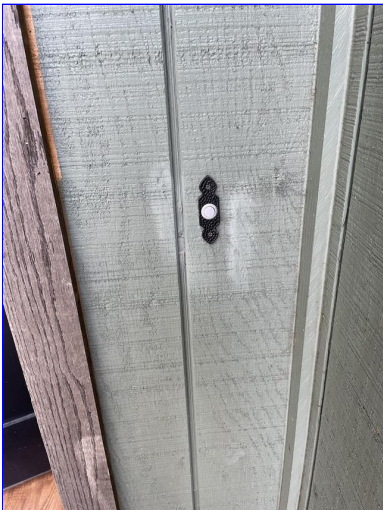
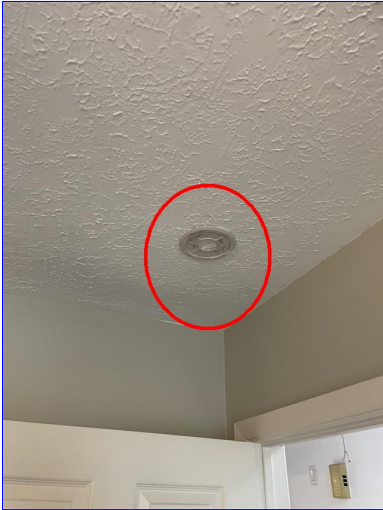
- (4) Smoke alarms not in all required locations (sleeping and adjoining common areas, interconnected, hard wired, battery back up). Recommend updating to current standards.
- (5) There are no bedroom smoke detectors installed. Today's standards now require smoke detectors

in and directly outside of (hallways) all sleeping areas and on each level for multiple story structures. Additionally today's modern detectors are interconnected, so if one sounds they all sound

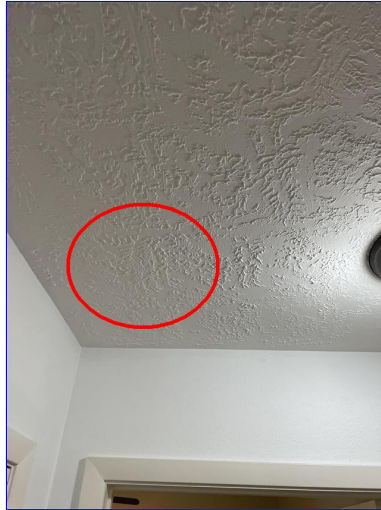
B. Item 3(Picture)

● (6) There are no GFCI (Ground Fault Circuit Interrupt) protected outlets in locations called for by today's standards (all kitchen, baths, non dedicated garage below 6', laundry, and exterior outlets)

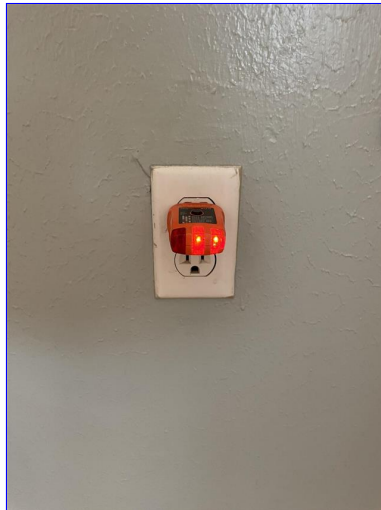
B. Item 5(Picture)

● (7) GFCI not functioning in Master Bath will need to be corrected.

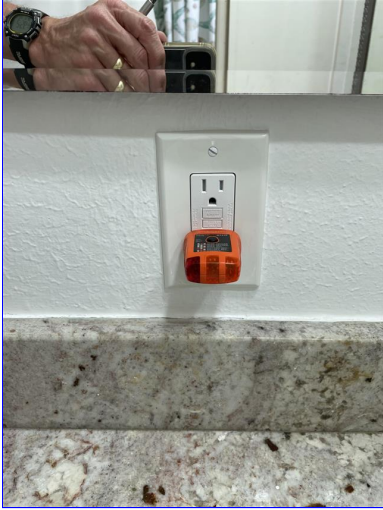
B. Item 6(Picture)

- (8) Ceiling fan on patio functions but sounds like bearing are going out. Recommend replacement.

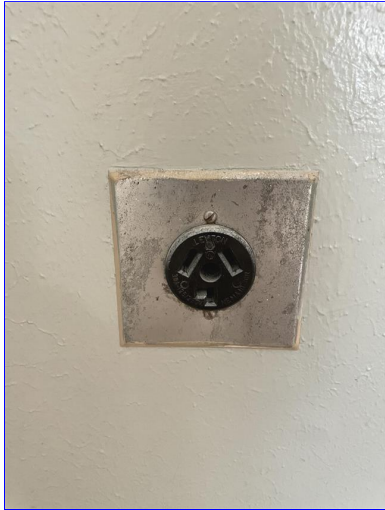
B. Item 8(Picture)

- (9) The utility 220 electric dryer outlet is a 3 prong type. Electric dryers today are now sold with a 4-prong plug. It may be necessary to swap out the 4-prong plug on newer units

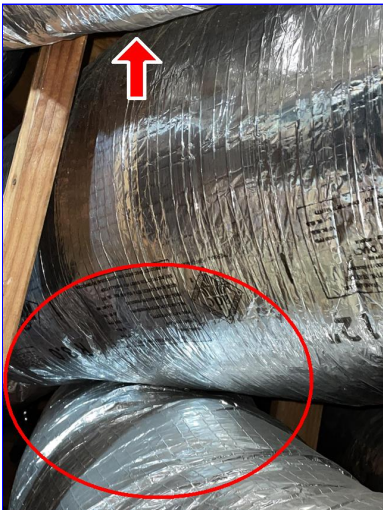
C. Item 1(Picture)

● (2) Some of the air ducts are in contact with each other, which can cause condensation to form on the outside of the ductwork. It is recommended that the ducts that are touching be separated. Typically, this is done by inserting a piece of fiberglass batt insulation or duct board between the ducts.

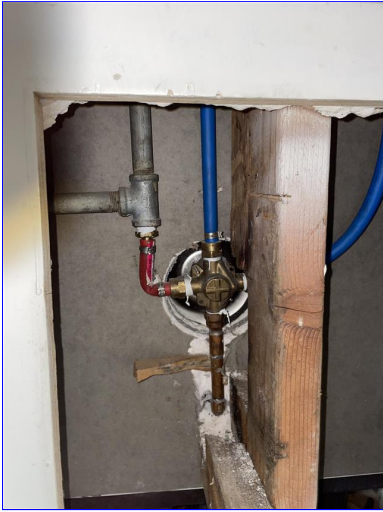
A. Item 1(Picture) PEX

(2) Plumbing and fixtures functioned normally.

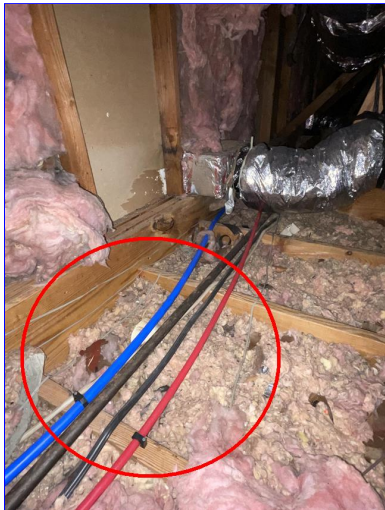
A. Item 4(Picture) PEX

(4) The plumbing supply and distribution piping is PEX. Some galvanized vertical piping may still be in use.

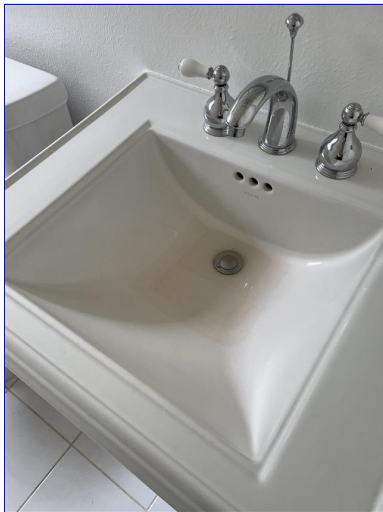
B. Item 1(Picture)

(2) Stopper(s) in tub(s), sink(s), or shower(s) where missing or not operating correctly, repair or replacement(s) is need.

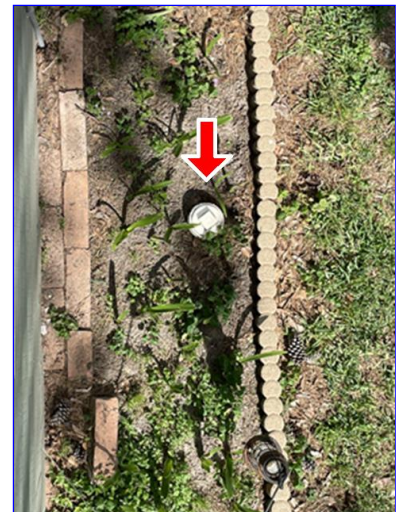
B. Item 4(Picture) PVC clean out

(3) The drains, wastes and vent piping are PVC.

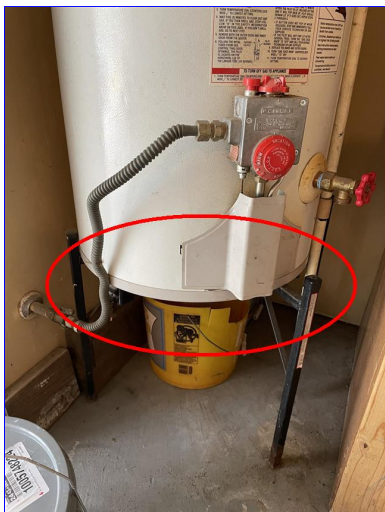
C. Item 2(Picture)

- (3) The water heater abuts an interior wall and there is no emergency leak catch pan installed. Today's standards now require a catch pan that is plumbed to the exterior in locations where tank leaks could cause interior water penetration

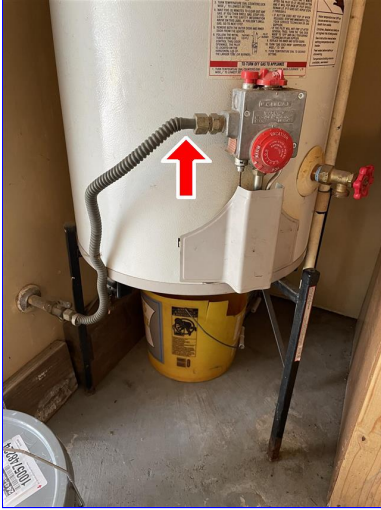
C. Item 3(Picture)

- (4) Gas supply line to unit missing settlement trap.

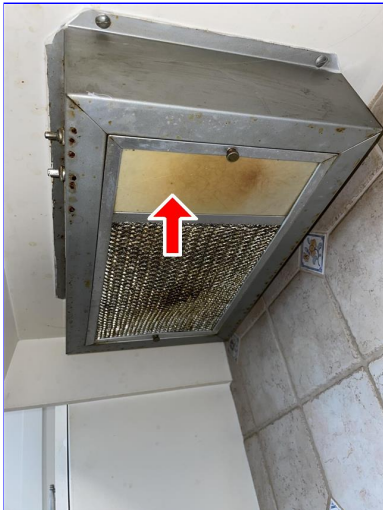
C. Item 1(Picture)

(2) Light(s) not working and or missing.

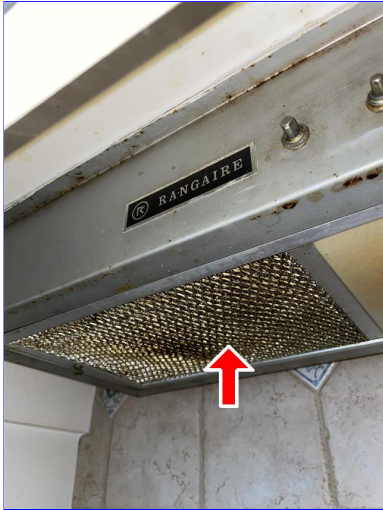
C. Item 2(Picture)

(3) Filter is very dirty and needs to be replaced.

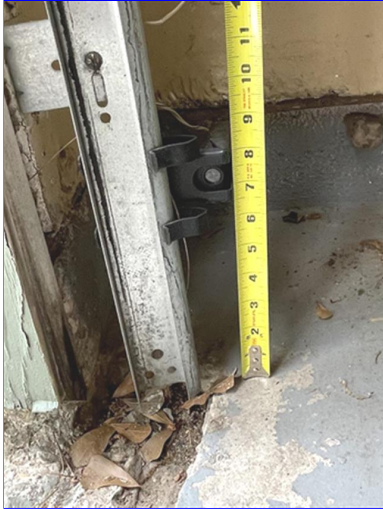
G. Item 1(Picture)

(1) Functional. Auto-reversed with moderate resistance.

(2) The garage door IR auto reversing sensors should be mounted no higher than 6" above the entry threshold

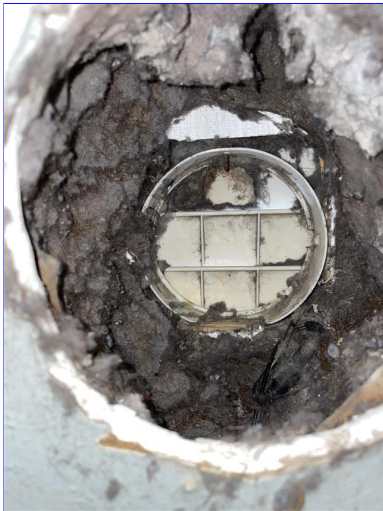
H. Item 1(Picture)

(2) Dryer vent has excessive lint build-up and should be cleaned prior to use
