Inspection Report

Property Address:
10102 Wiggins St
Houston TX 77029

HG Home Inspection

PROPERTY INSPECTION REPORT FORM

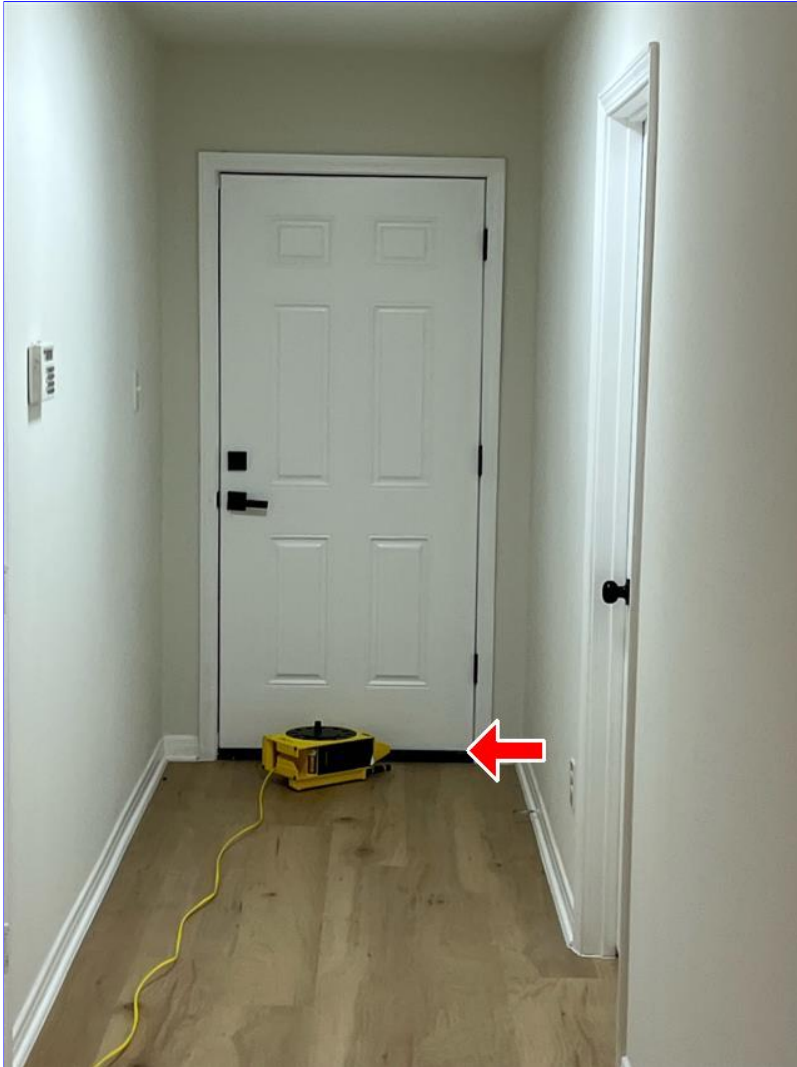
A. Item 1 (Picture) Starting point at front door hinge

(2) The foundation is showing signs of movement. I recommend consulting with a Structural Engineer or foundation professional.

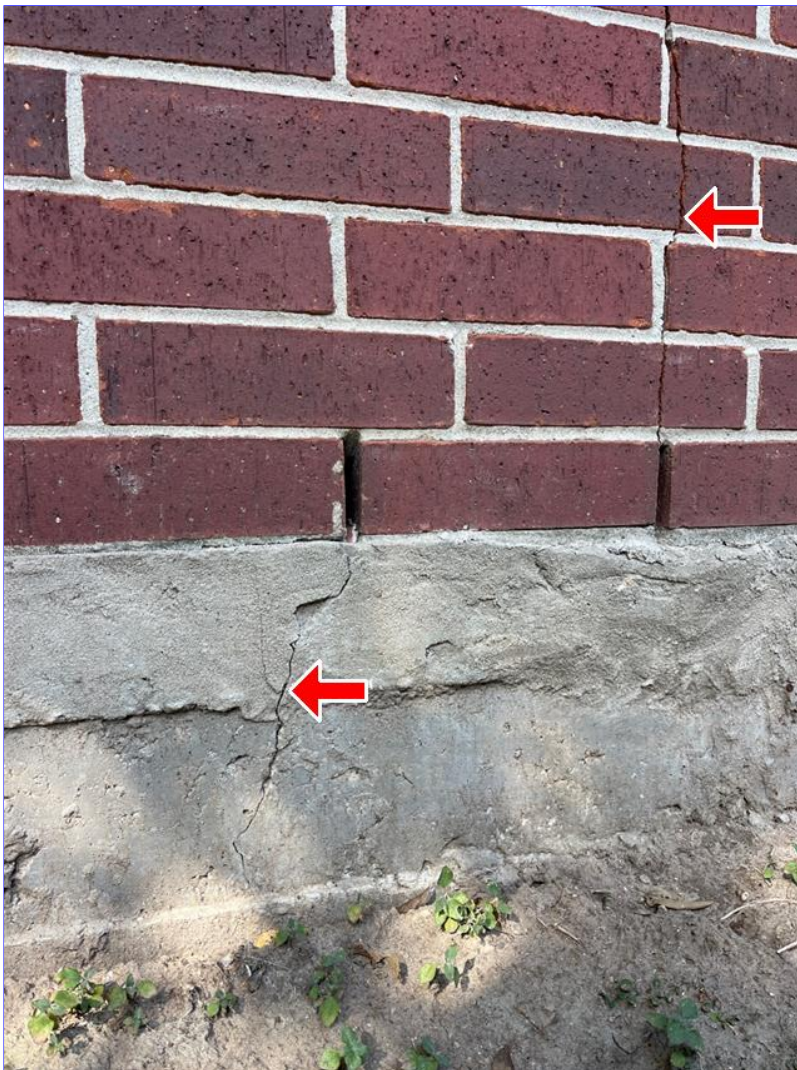
A. Item 4 (Picture)

(3) The foundation wall has visible cracking. I recommend having a foundation company or Structural Engineer further evaluate.

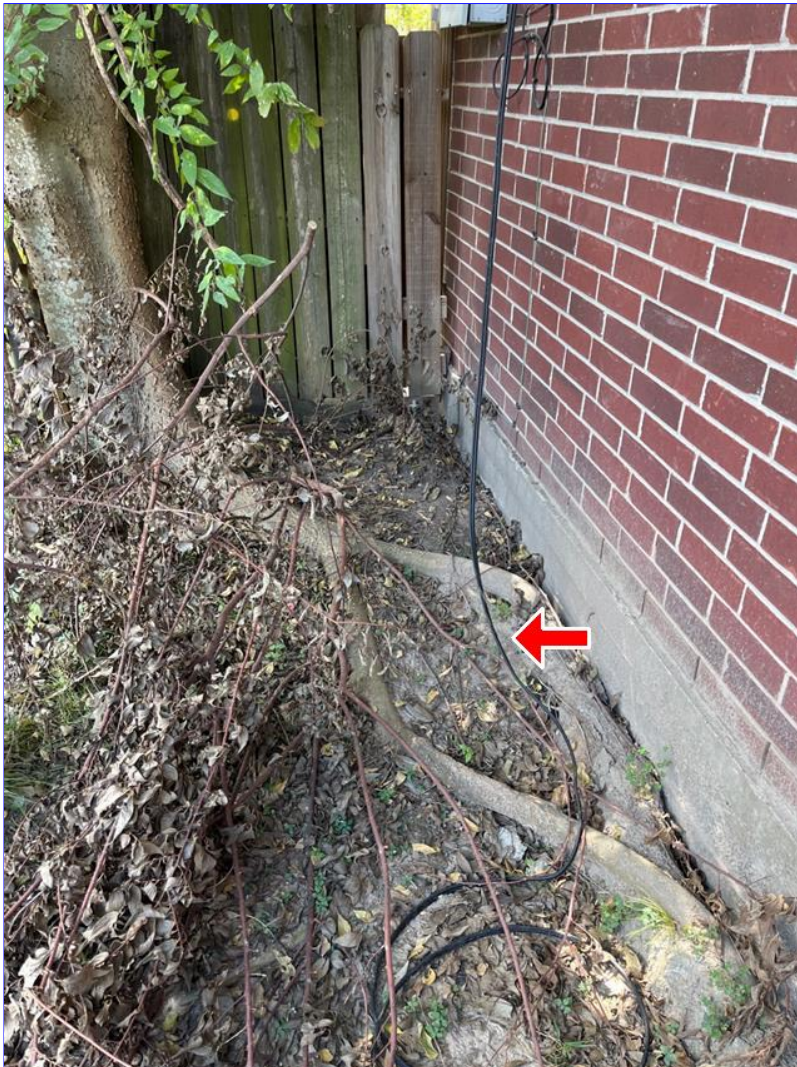
A. Item 5 (Picture)

(4) There are trees roots too close to the foundation. I recommend removal or the use of root diverters.

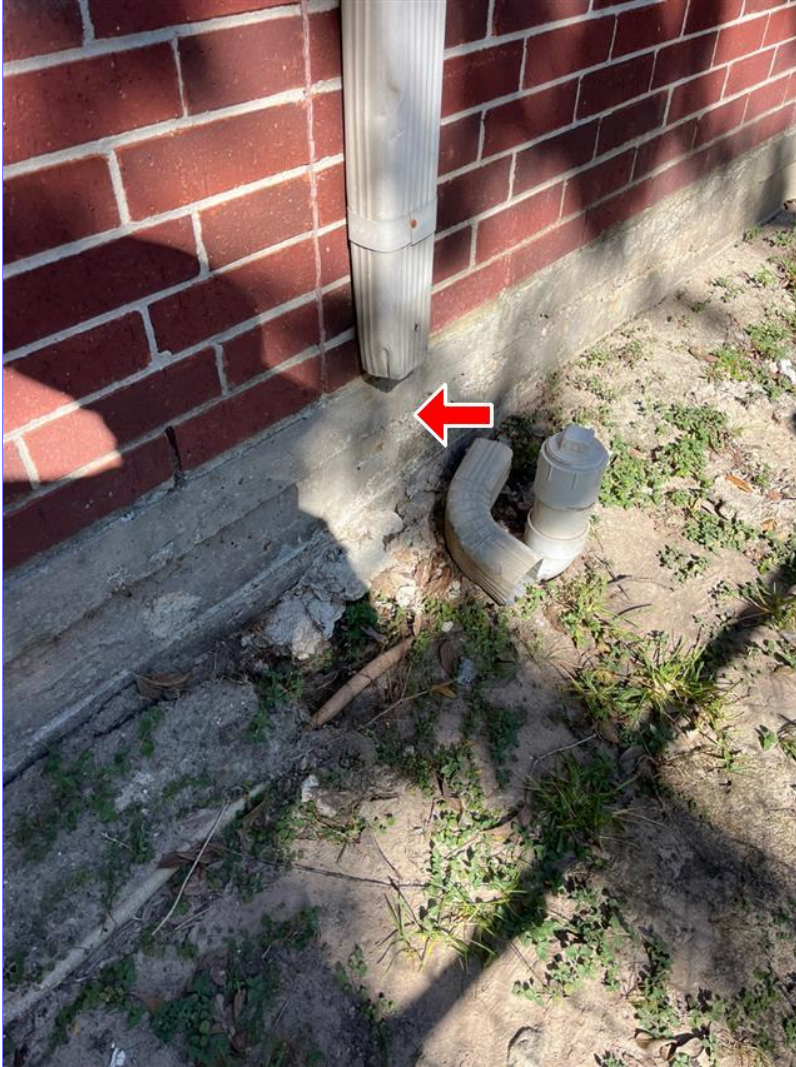
B. Item 1 (Picture)

(1) Gutters are not properly secured to the home. Further deterioration or erosion can occur if not corrected. I recommend having a qualified person make repairs as needed.

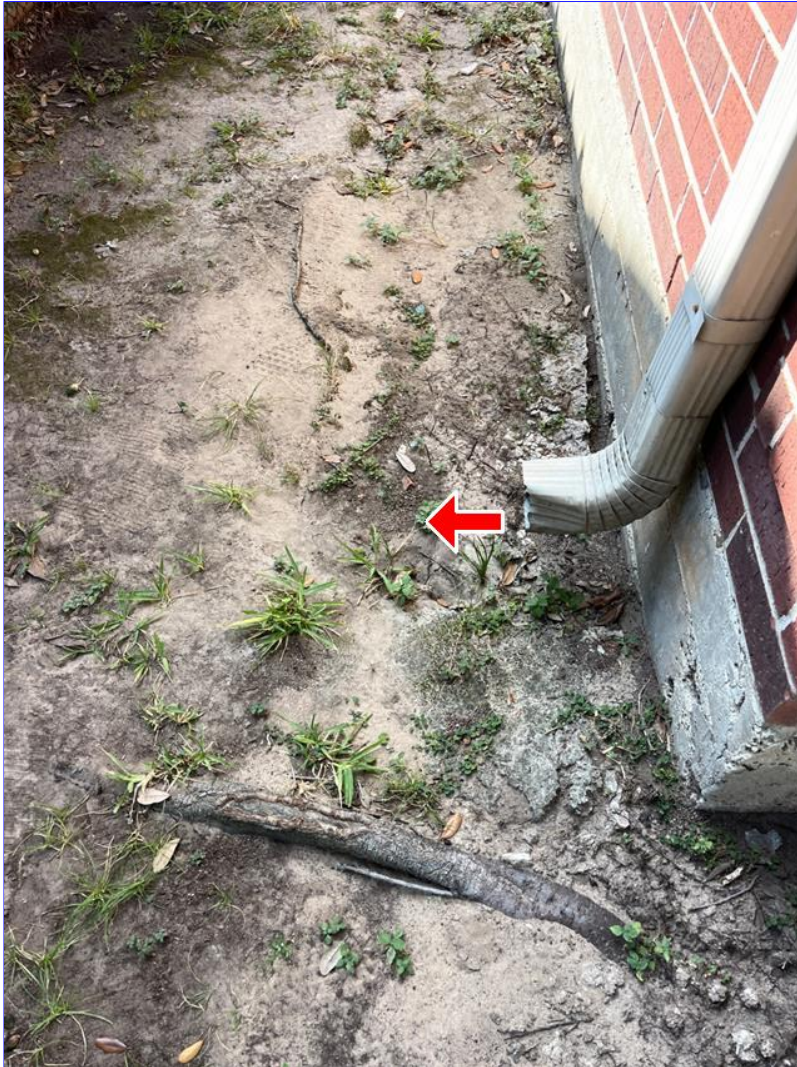
B. Item 2 (Picture)

(2) The gutter downspout(s) missing deflector(s) at the exterior. Erosion can continue or become worse if not corrected. A qualified contractor should inspect and replace as needed.

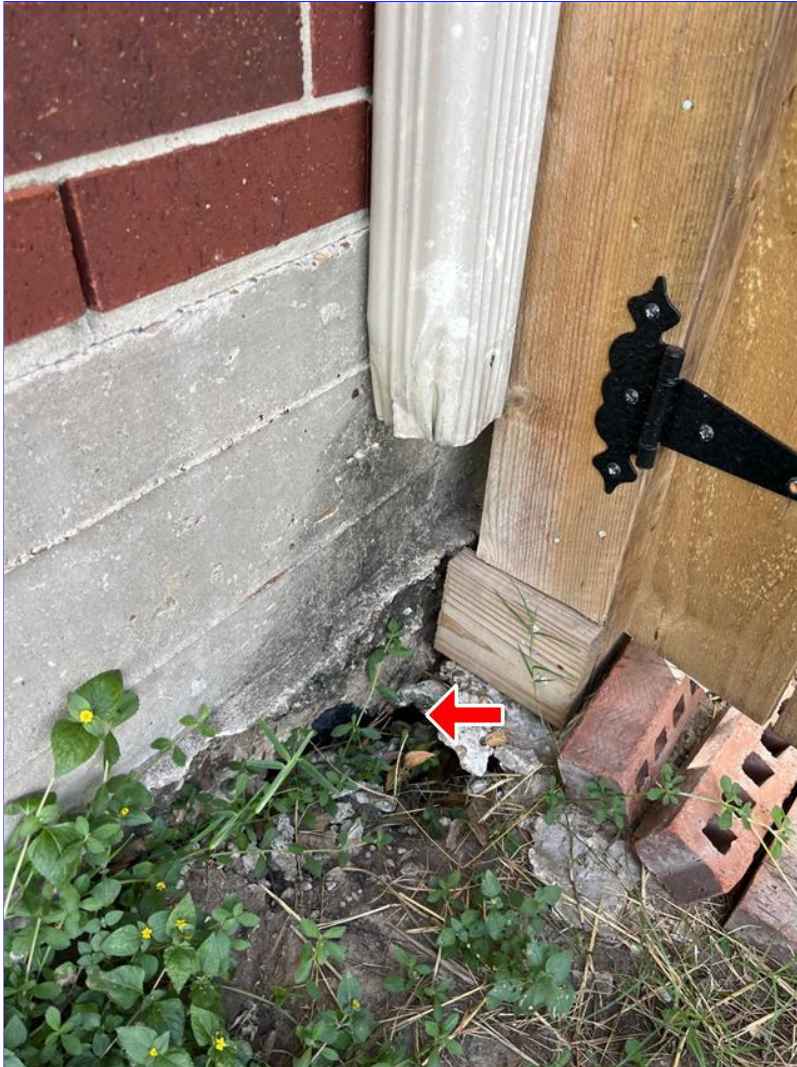
B. Item 3 (Picture)

(3) The gutter downspout(s) missing deflector(s) at the exterior. Erosion can continue or become worse if not corrected. A qualified contractor should inspect and replace as needed.

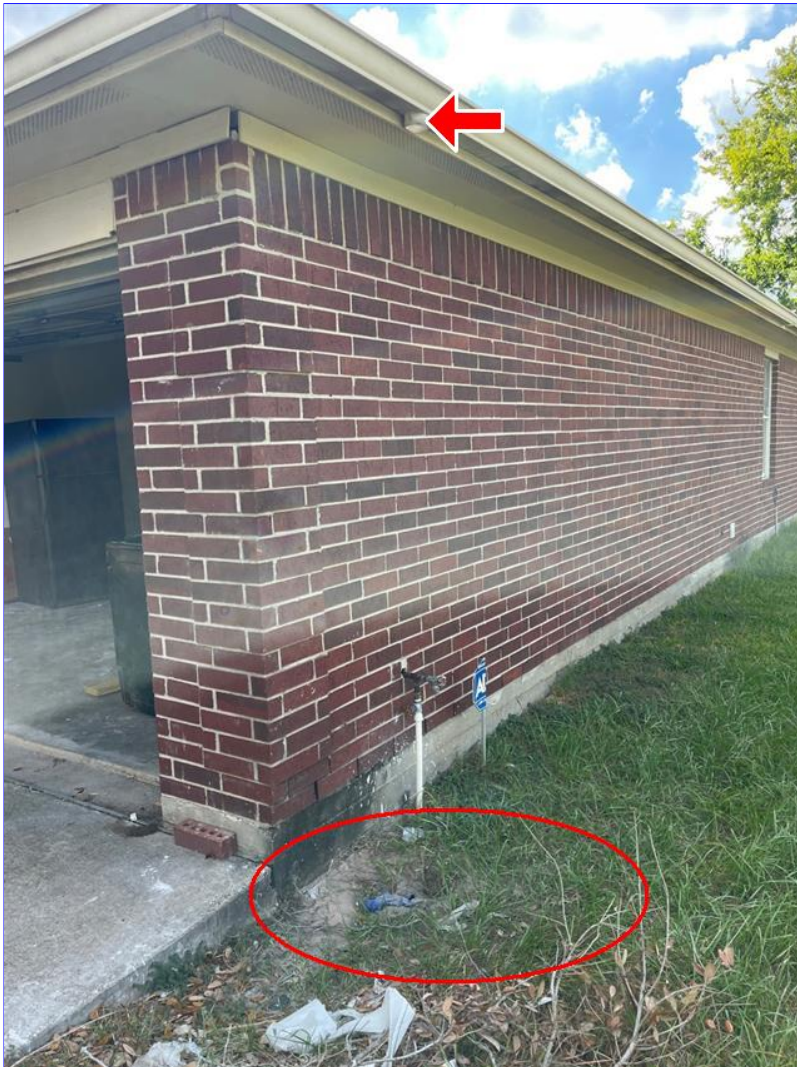
B. Item 4 (Picture) Right side

(4) Missing gutter downspouts, and areas of the Home. I would have a qualified professional to correct.

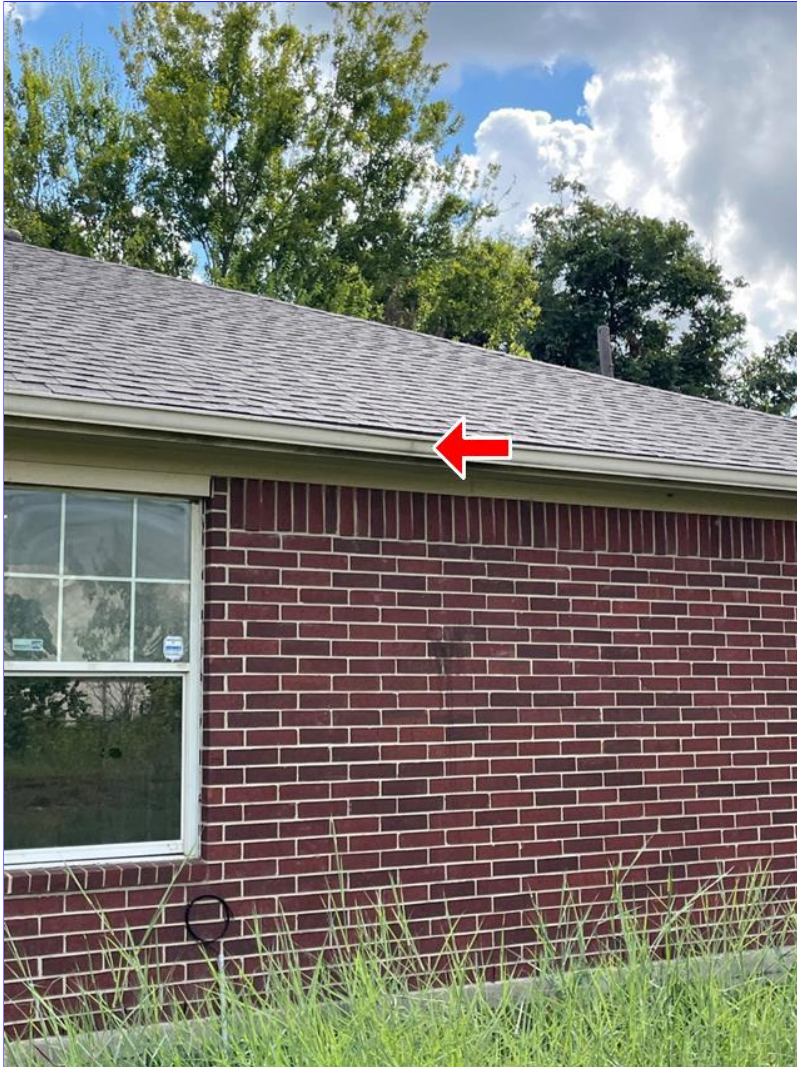
B. Item 6 (Picture) Right side

(5) Gutters are not properly secured to the home. Further deterioration or erosion can occur if not corrected. I recommend having a qualified person make repairs as needed.

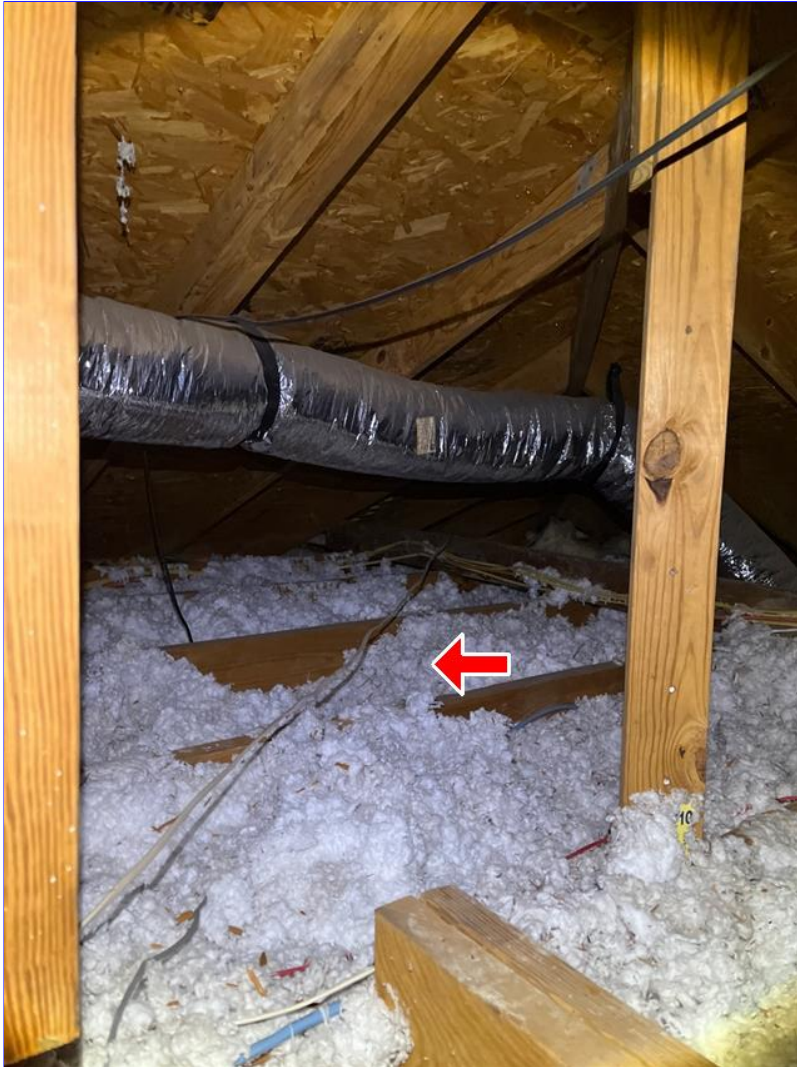
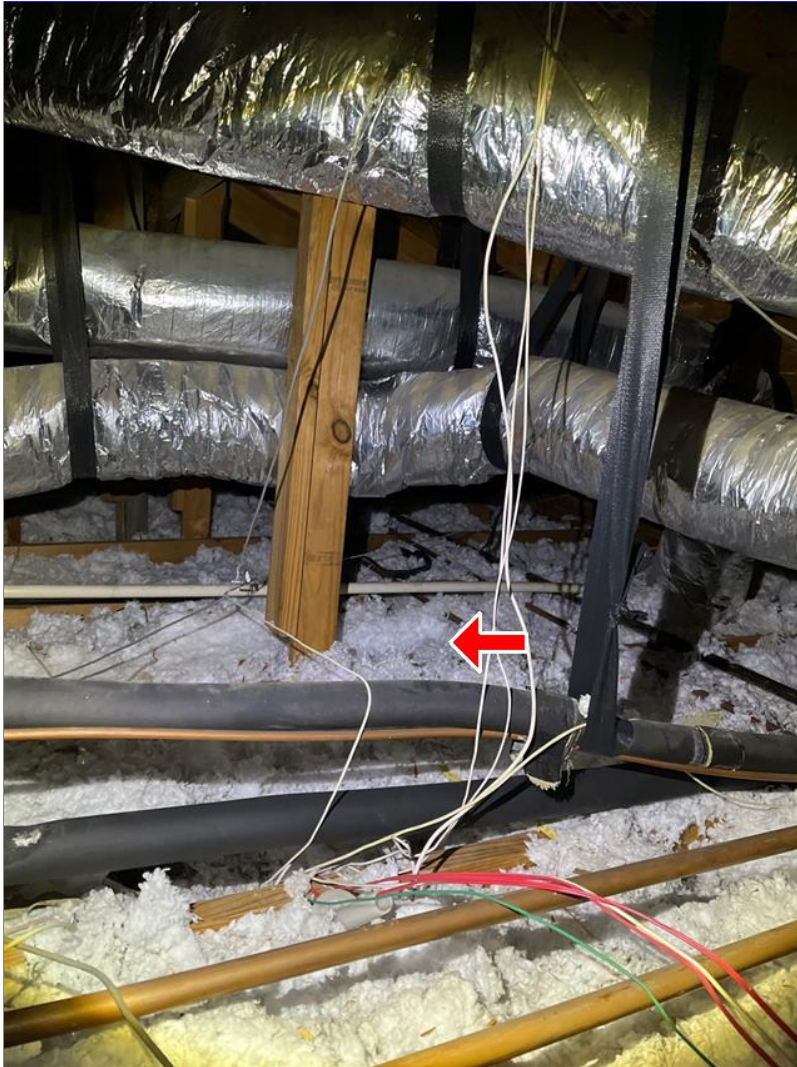
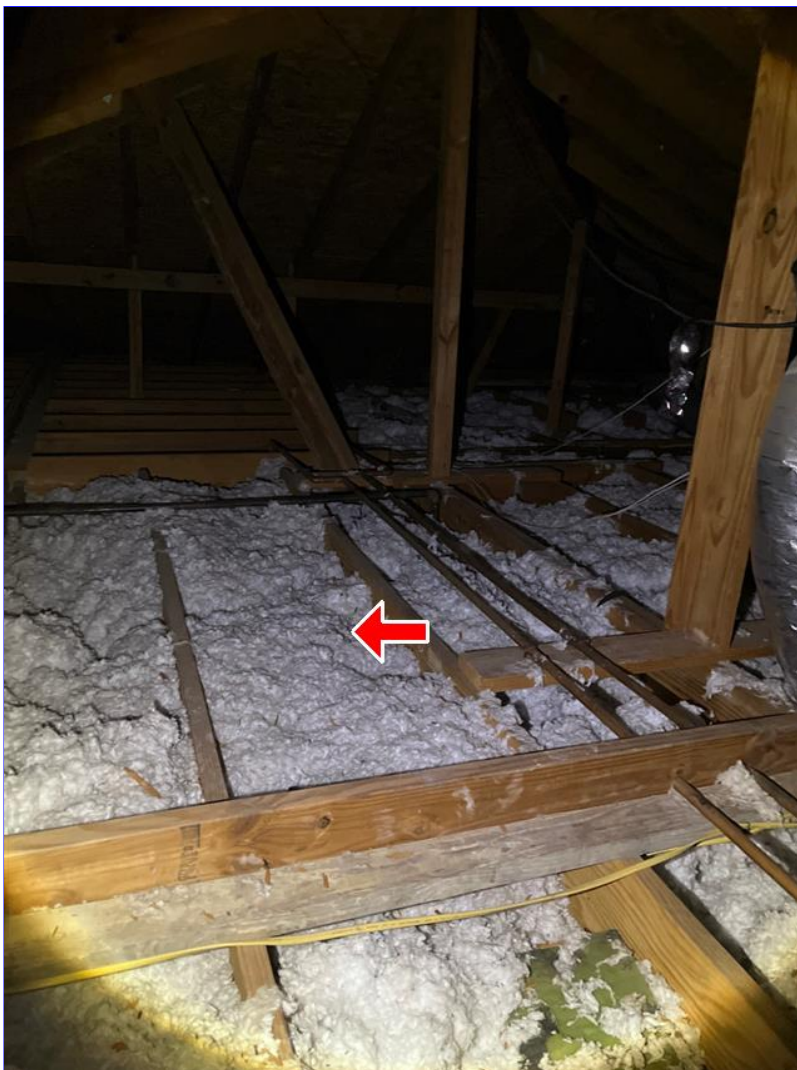
D. Item 1 (Picture)

(2) The attic space has areas of thin insulation. This is causing energy loss and is not today's standard. I recommend having a qualified person evaluate and add insulation as needed.

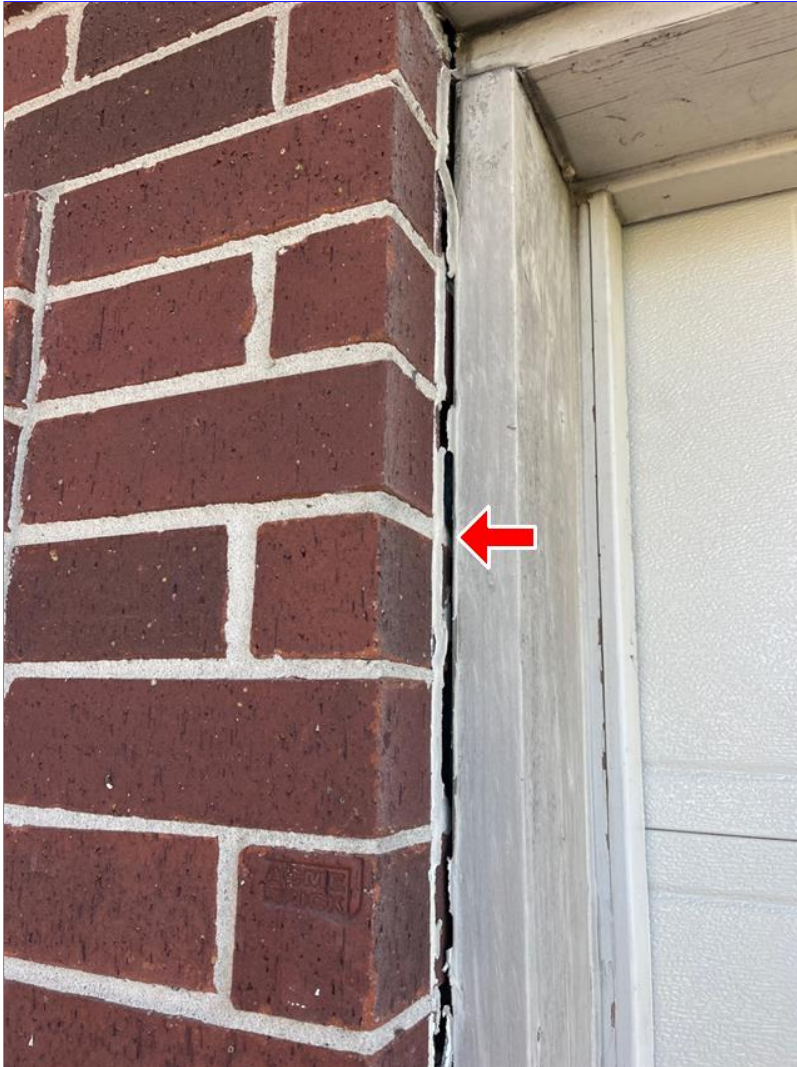
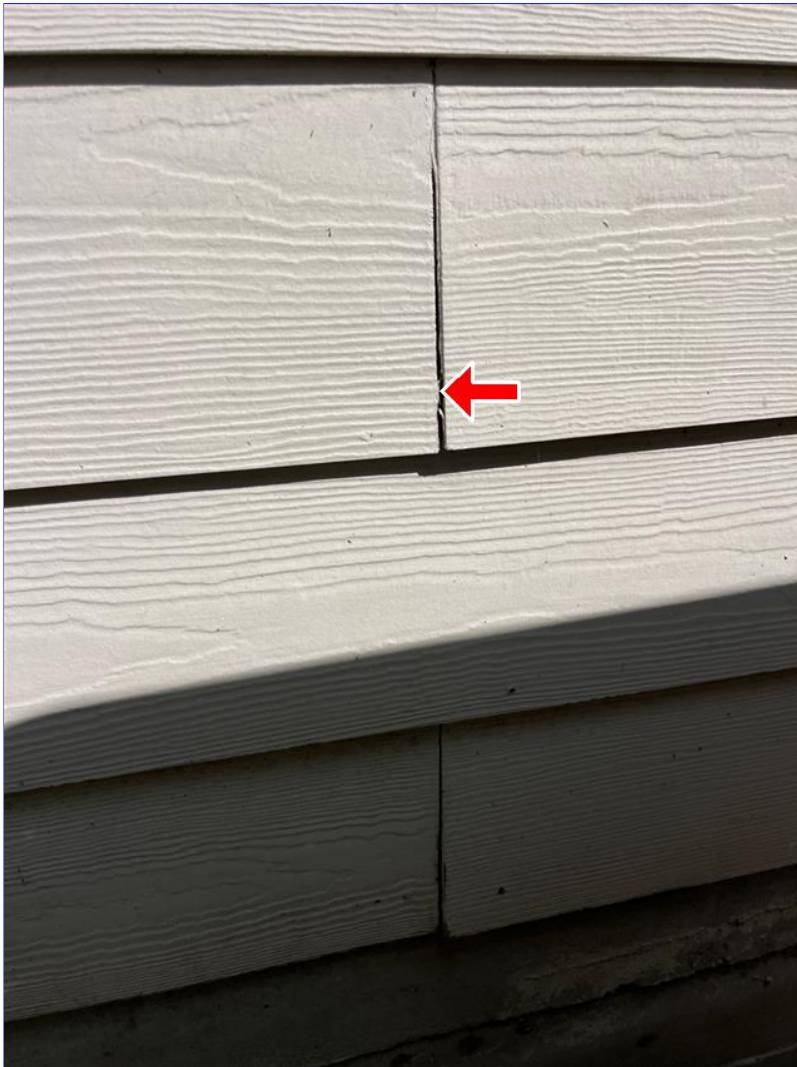
E. Item 1 (Picture) Garage

(1) Areas of the exterior have caulking or grout missing or damaged. Deterioration could occur if not corrected. I recommend having a qualified contractor inspect and make repairs as needed.

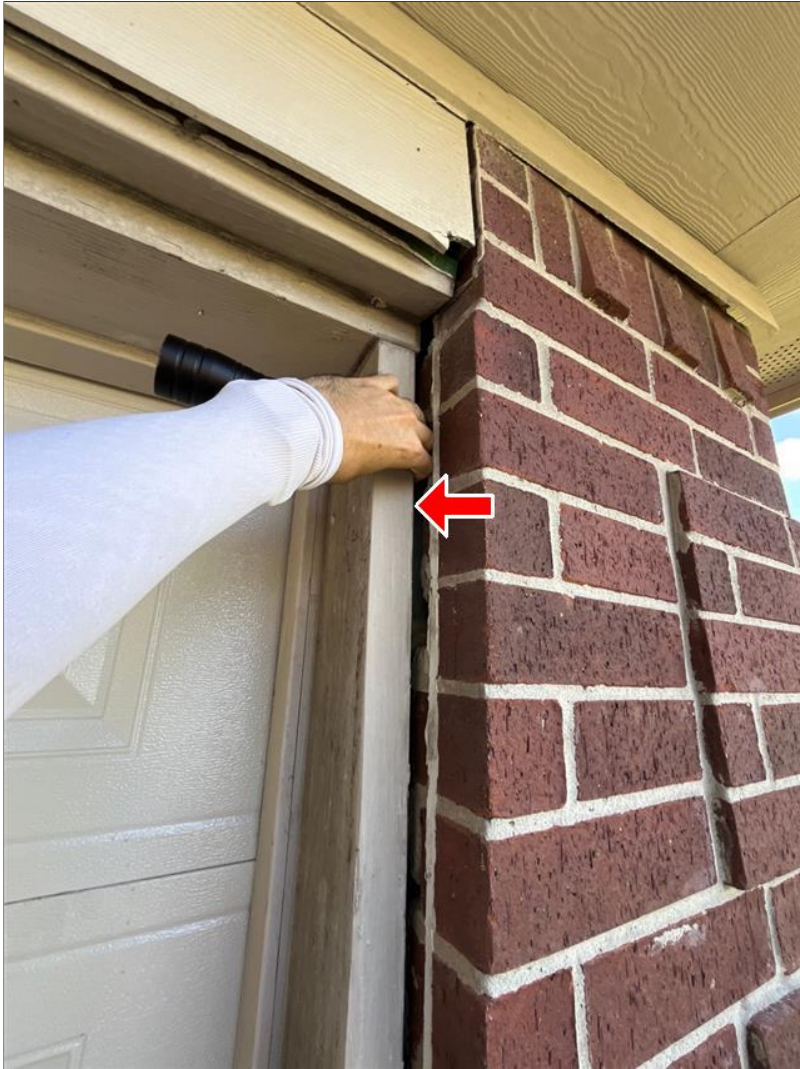
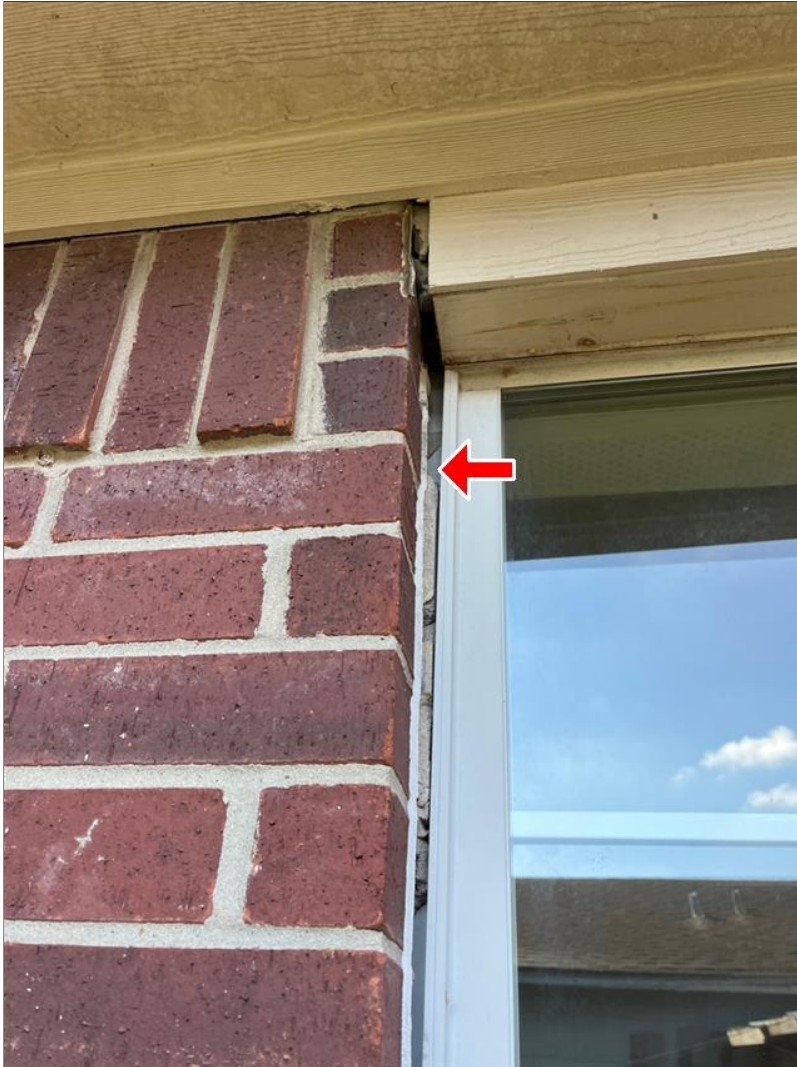
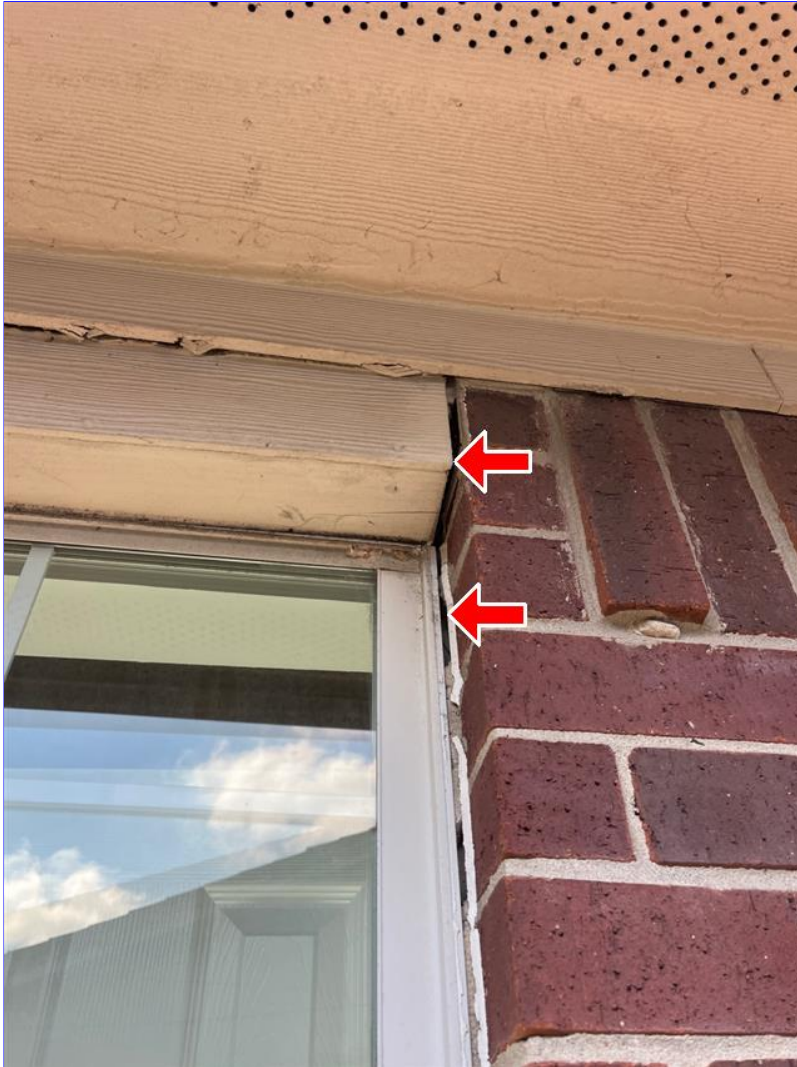
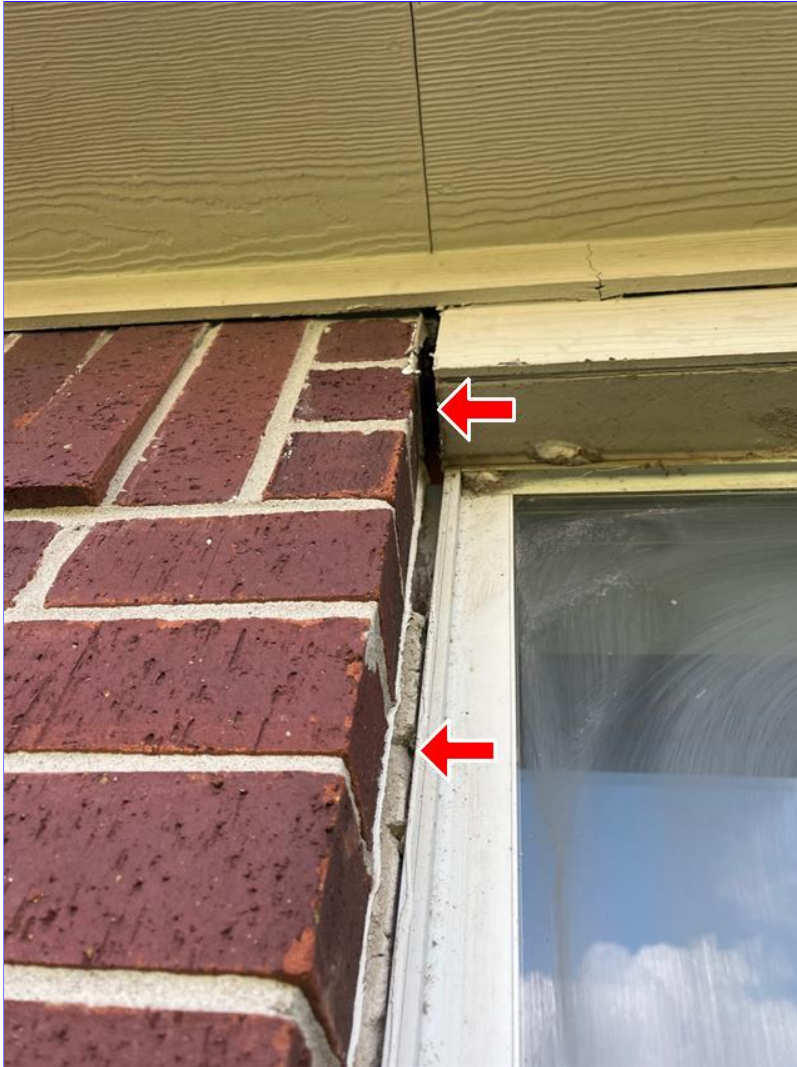
E. Item 3 (Picture) Garage

(2) Areas of the exterior wall have large openings leading to the interior. A lot of these areas are taper gaps, due to foundation settlement. I would have a qualified professional to correct.

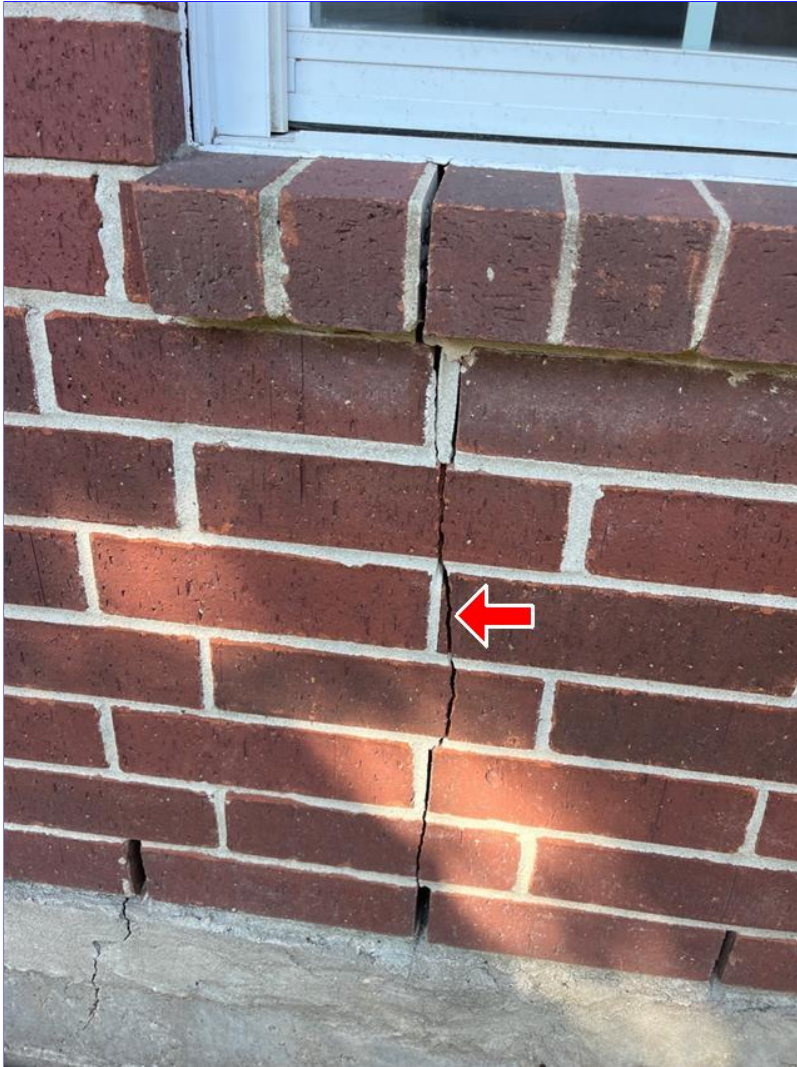
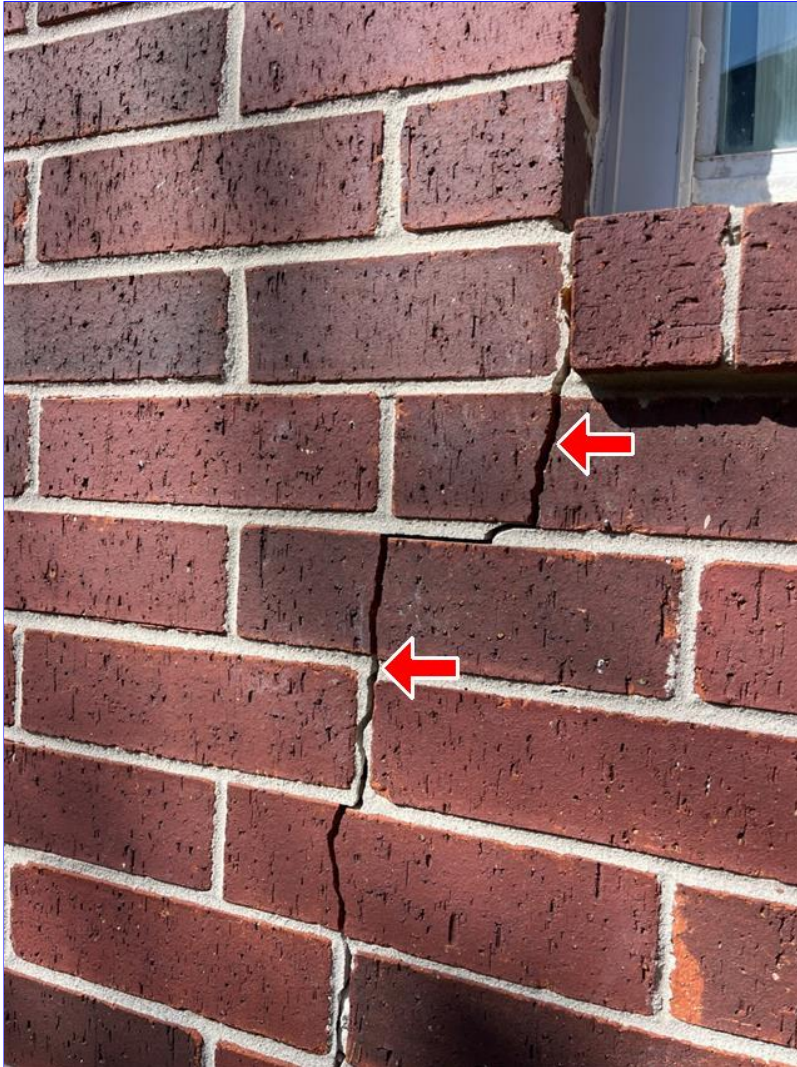
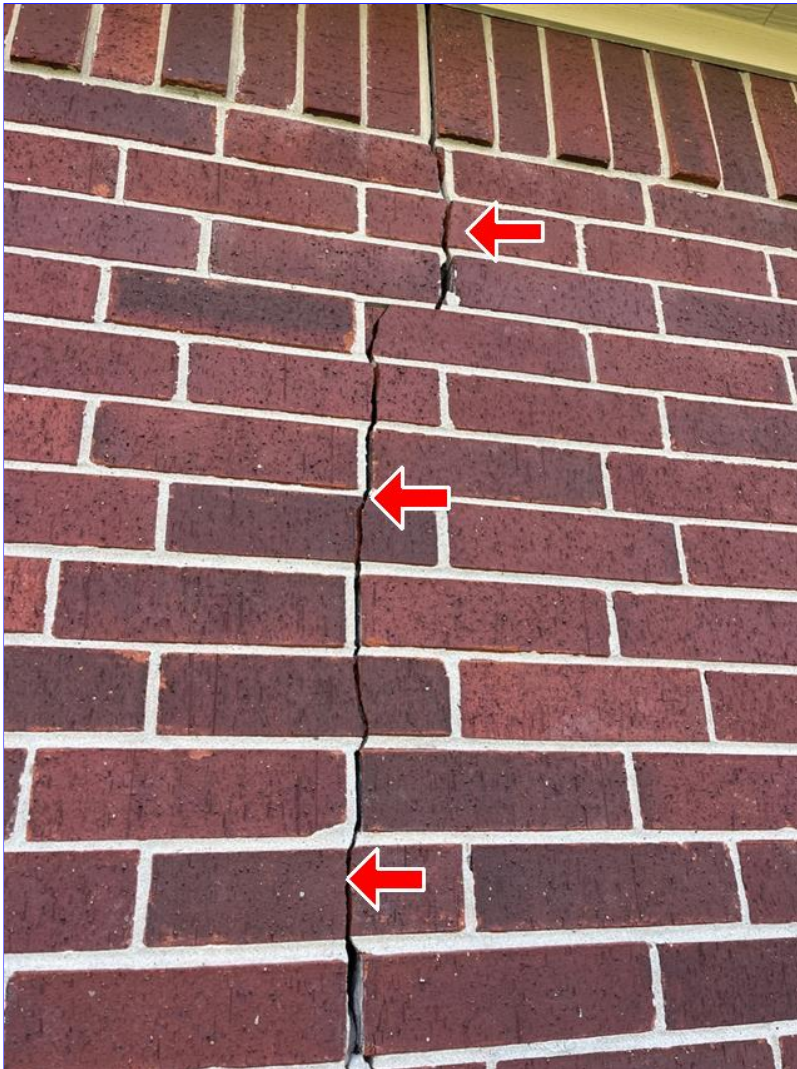
E. Item 7 (Picture) Left side

(3) The Brick siding at the exterior has step cracks caused from settlement. Deterioration can eventually occur if not corrected. A qualified contractor should inspect and repair as needed.

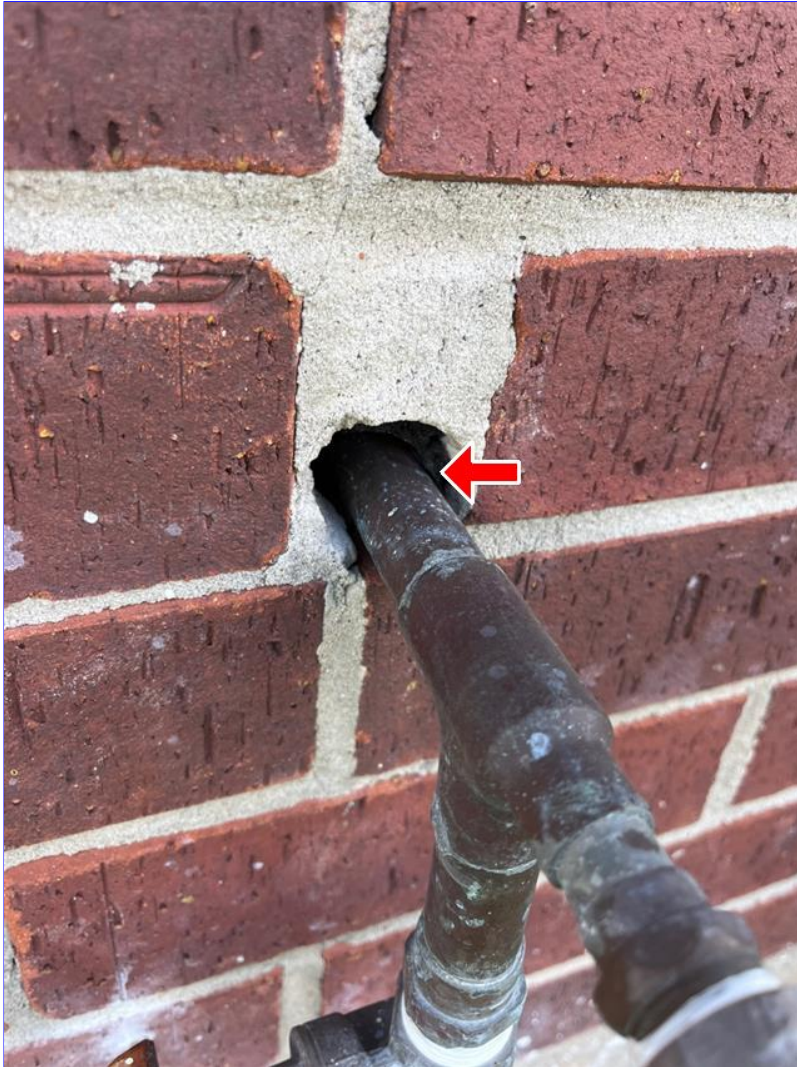
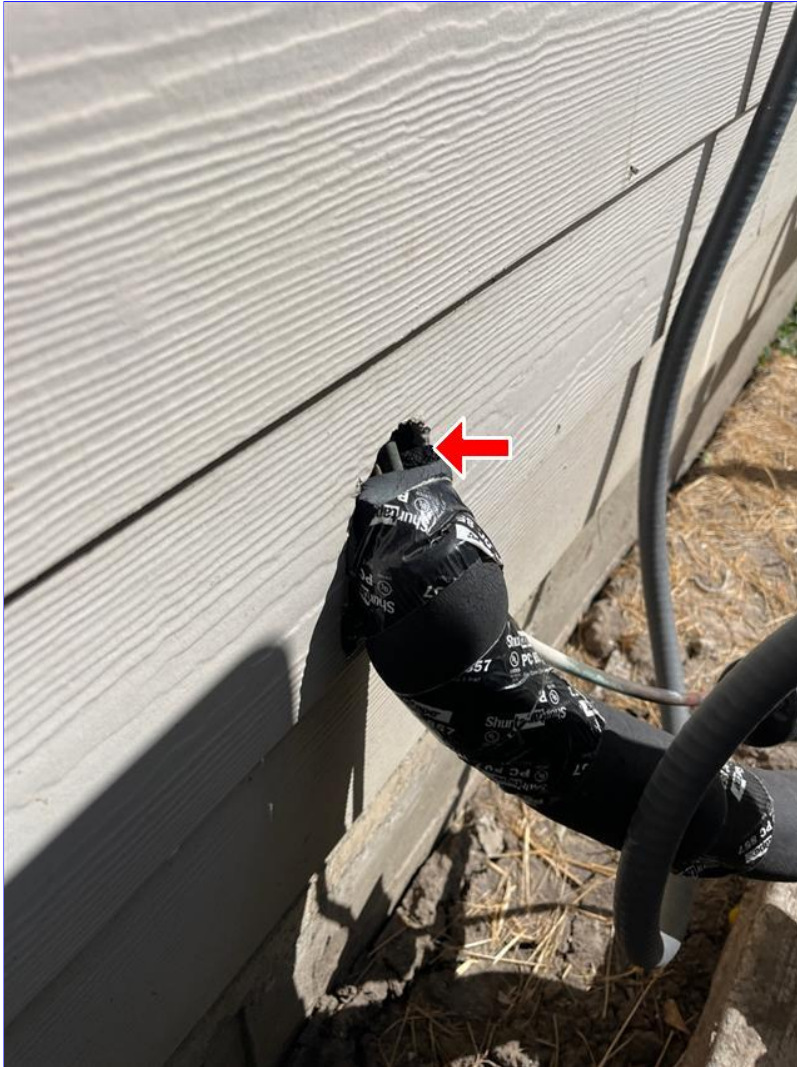
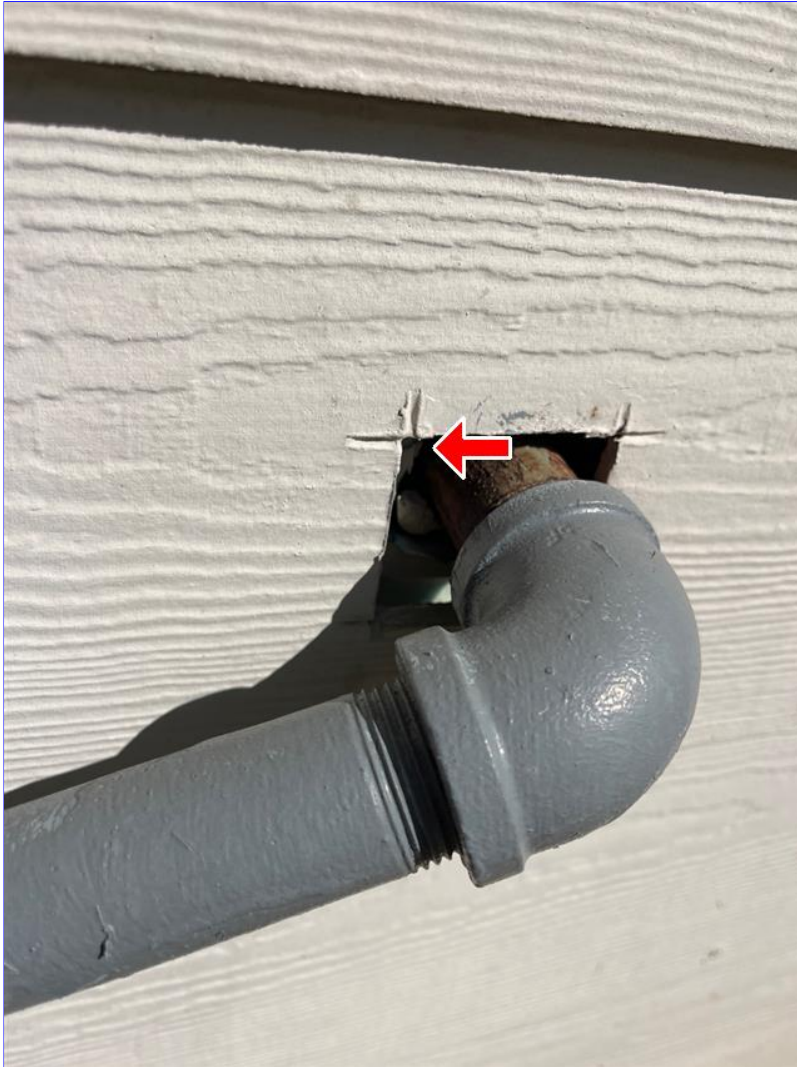
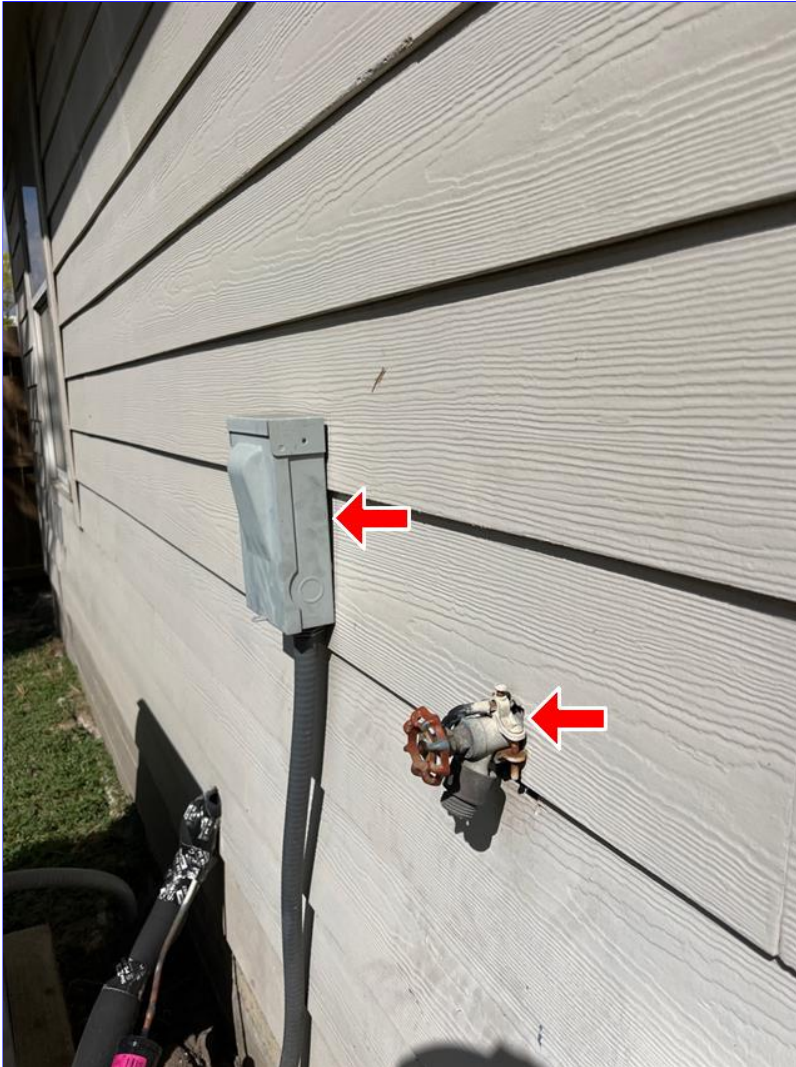
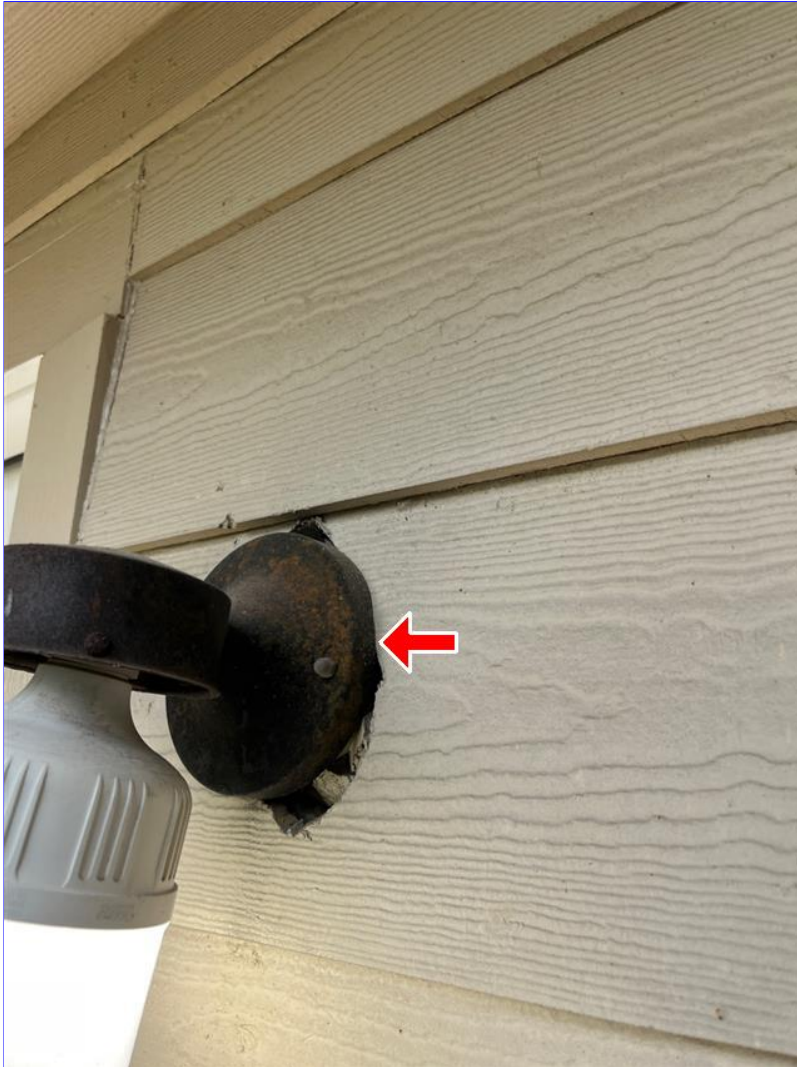
E. Item 10 (Picture) Left side

(4) Areas where wiring or piping passes through walls should be sealed. I recommend having a qualified person seal as needed.

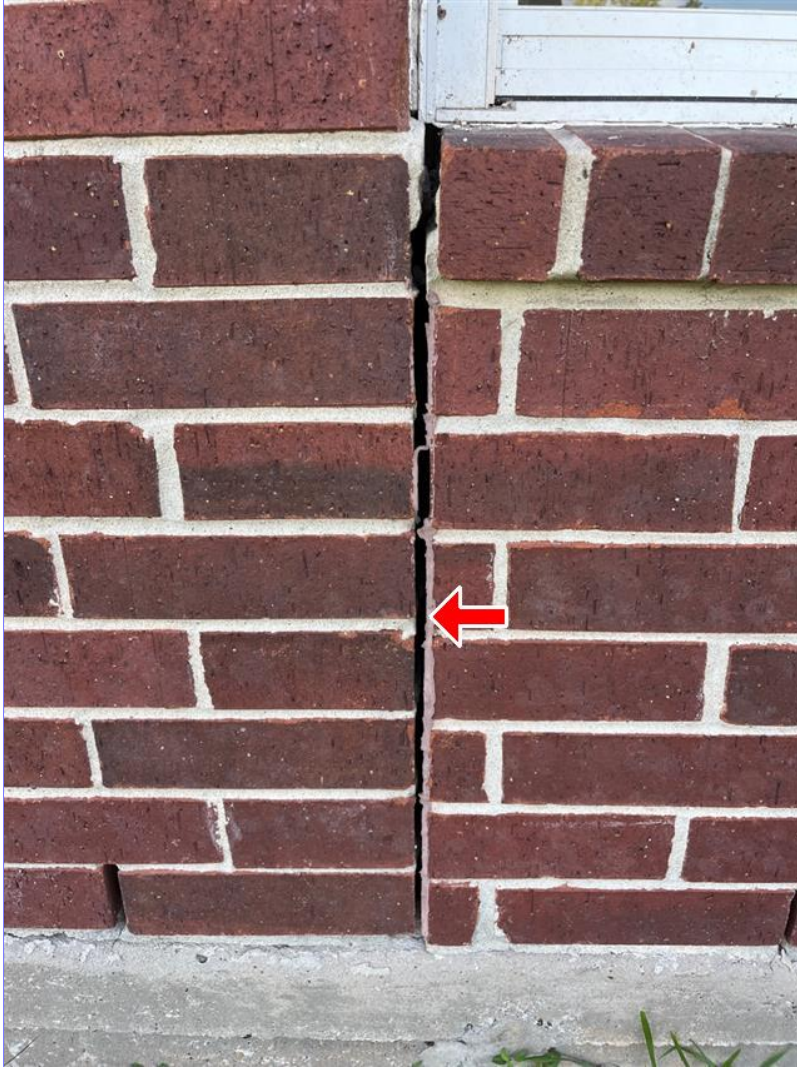
E. Item 15 (Picture)

(5) The brick siding at the exterior of the home has expansion joint sealant that is weathered or missing. Further deterioration can occur if not corrected. A qualified person should repair or replace as needed.
