Inspection Report

Property Address:
10102 Wiggins St
Houston TX 77029

HG Home Inspection

PROPERTY INSPECTION REPORT FORM

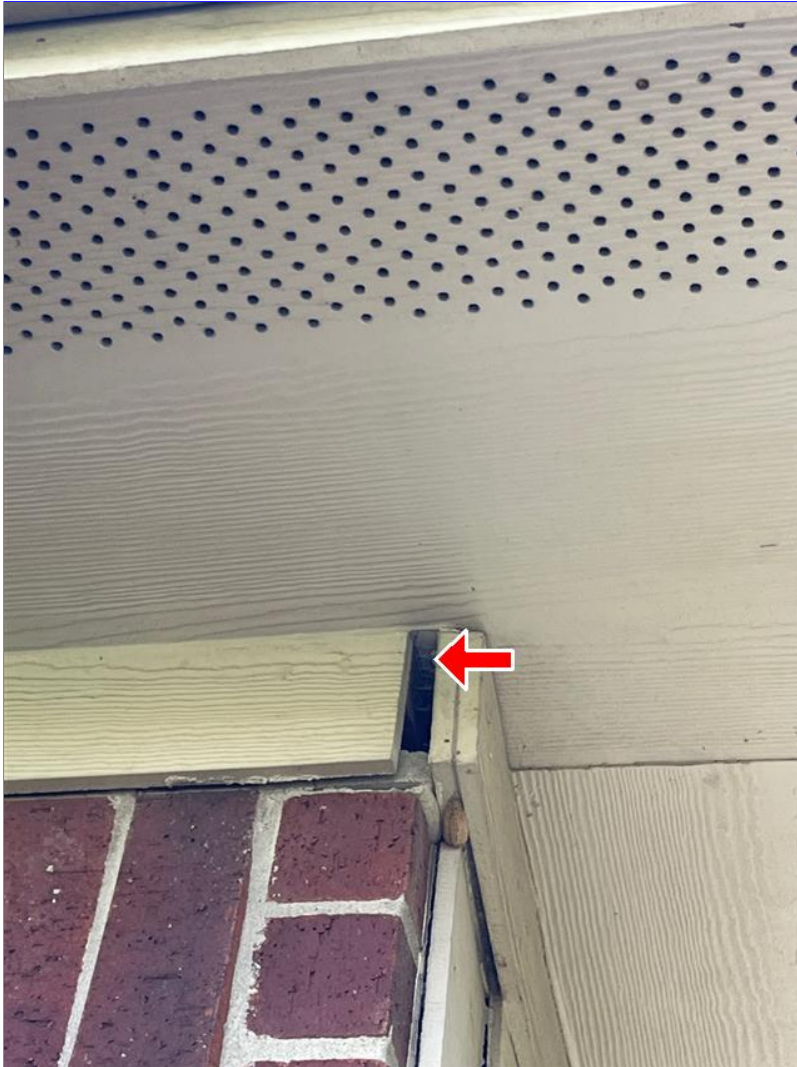
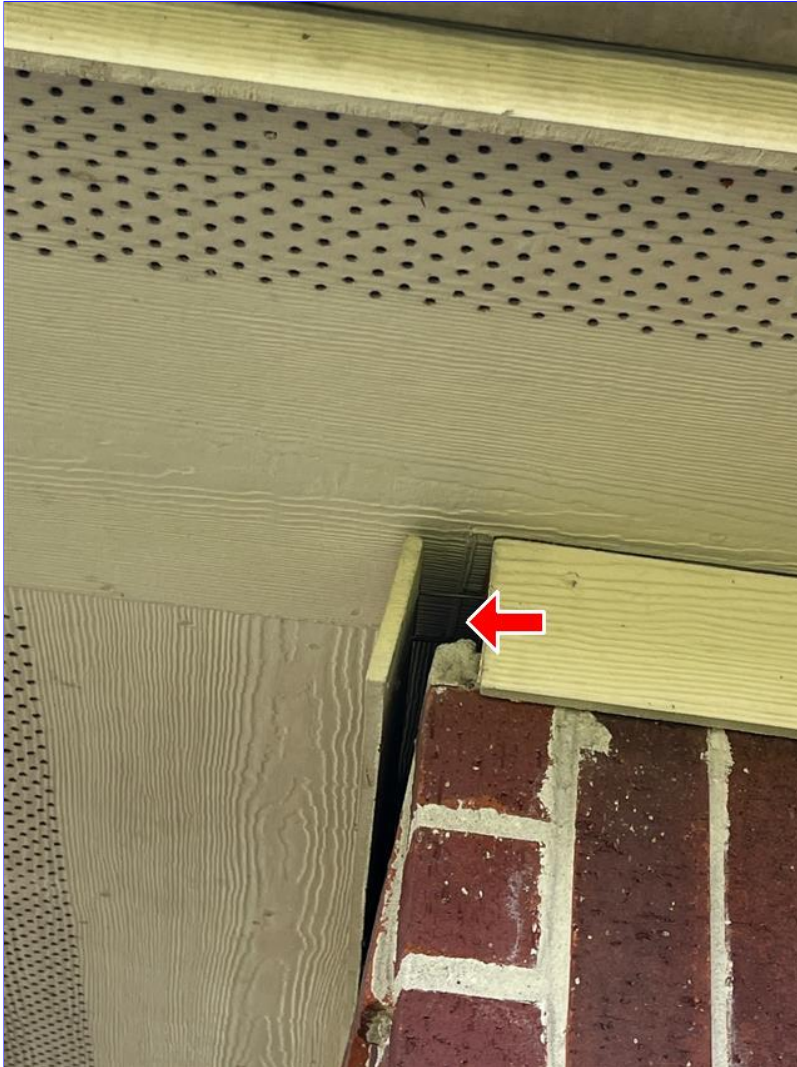
E. Item 16 (Picture)

(6) The exterior siding and trim is deteriorated in areas. Further deterioration will occur if not corrected. A qualified contractor should inspect and repair as needed.

The Siding exterior in areas loose. Further deterioration can occur if not corrected. A qualified person should repair or replace as needed.

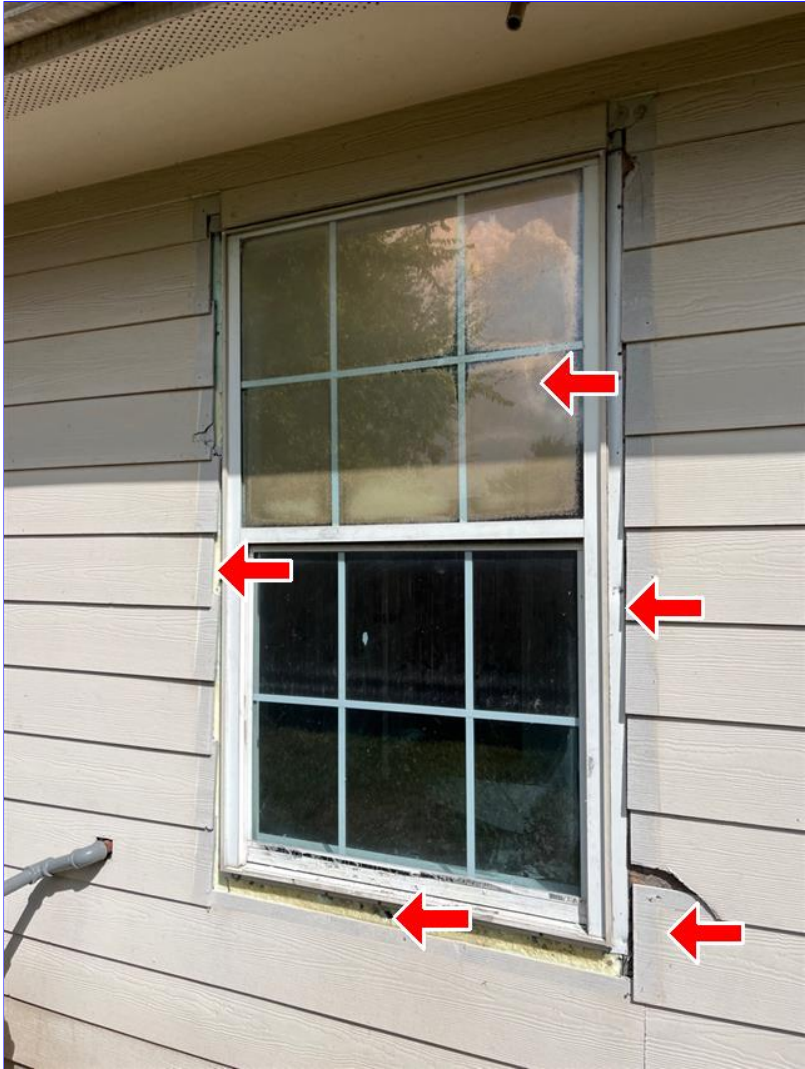
E. Item 18 (Picture) rear

(7) Missing areas of window trim at backyard. This is an entrance for water. I would have a qualified professional to correct

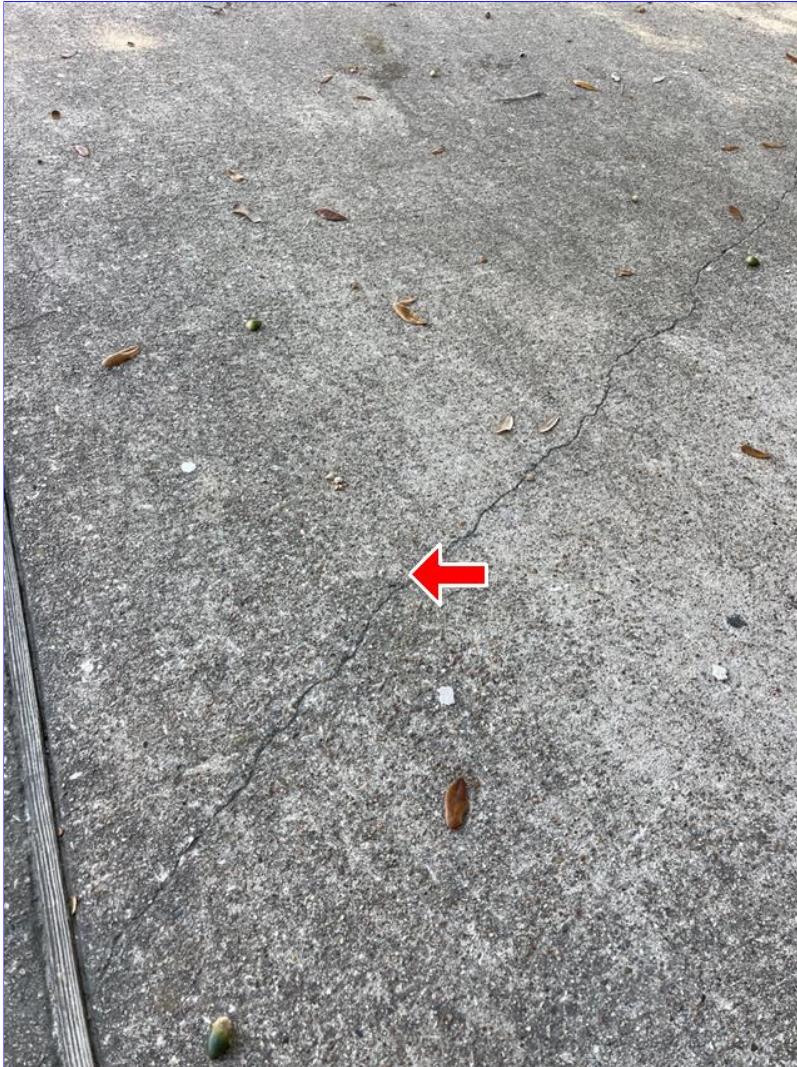
F. Item 1 (Picture)

Comments:
(1) Areas of the concrete have typical settlement/shrinkage cracks. I would recommend sealing larger cracks to avoid water intrusion.

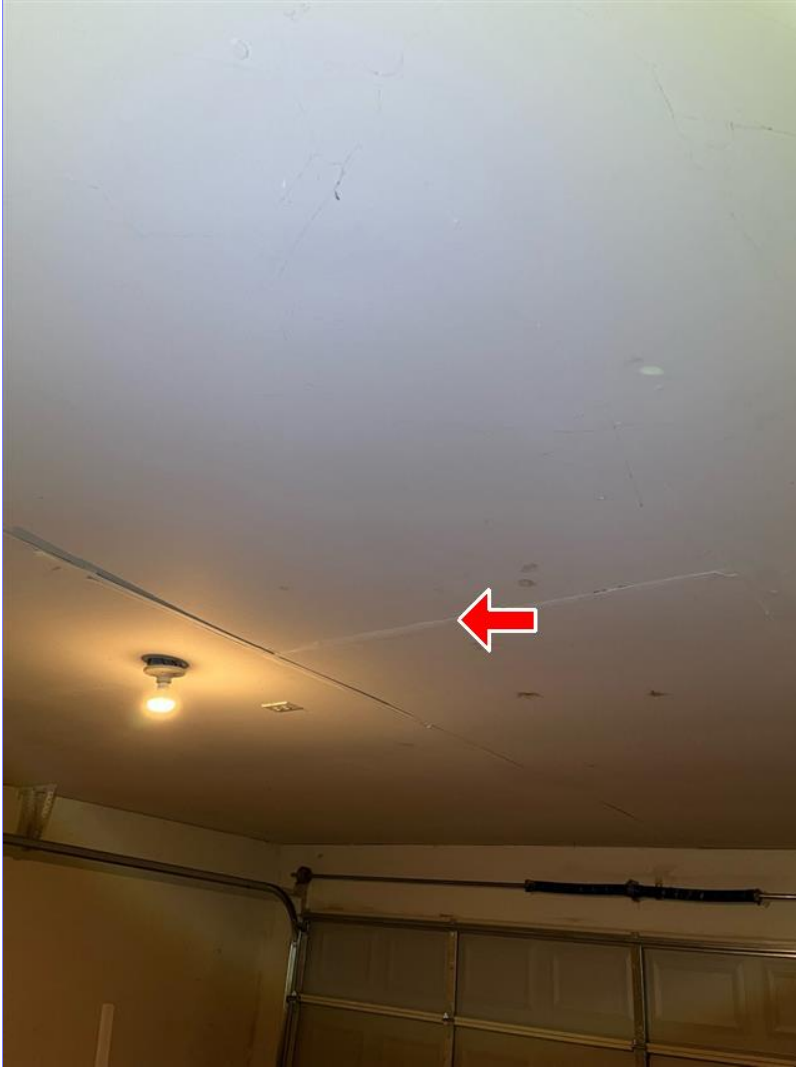
F. Item 5 (Picture)

(4) The Drywall on the ceiling reveals tape line cracks. This damage is considered cosmetic. A qualified contractor should inspect and repair as needed.

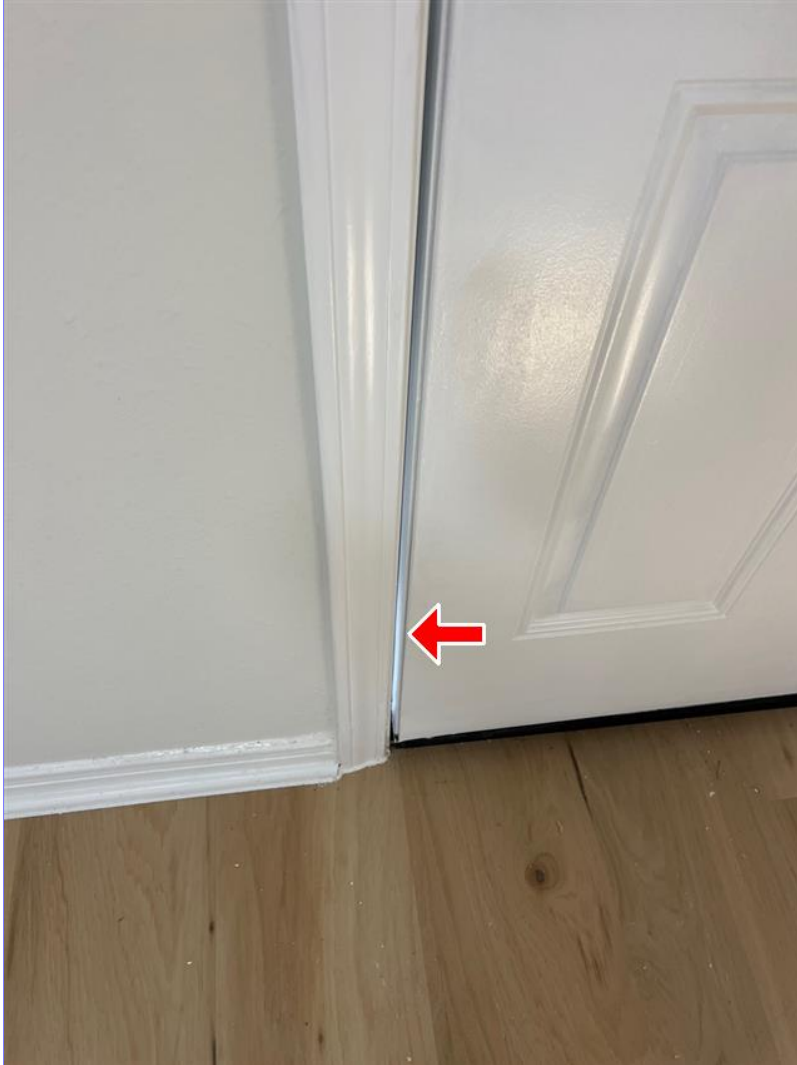
G. Item 1 (Picture)

(2) The Entry door rubs floor when opened. Door needs to be trimmed at bottom by a skilled craftsman in areas. This is a maintenance issue and is for your information. A qualified person should repair or replace as needed.

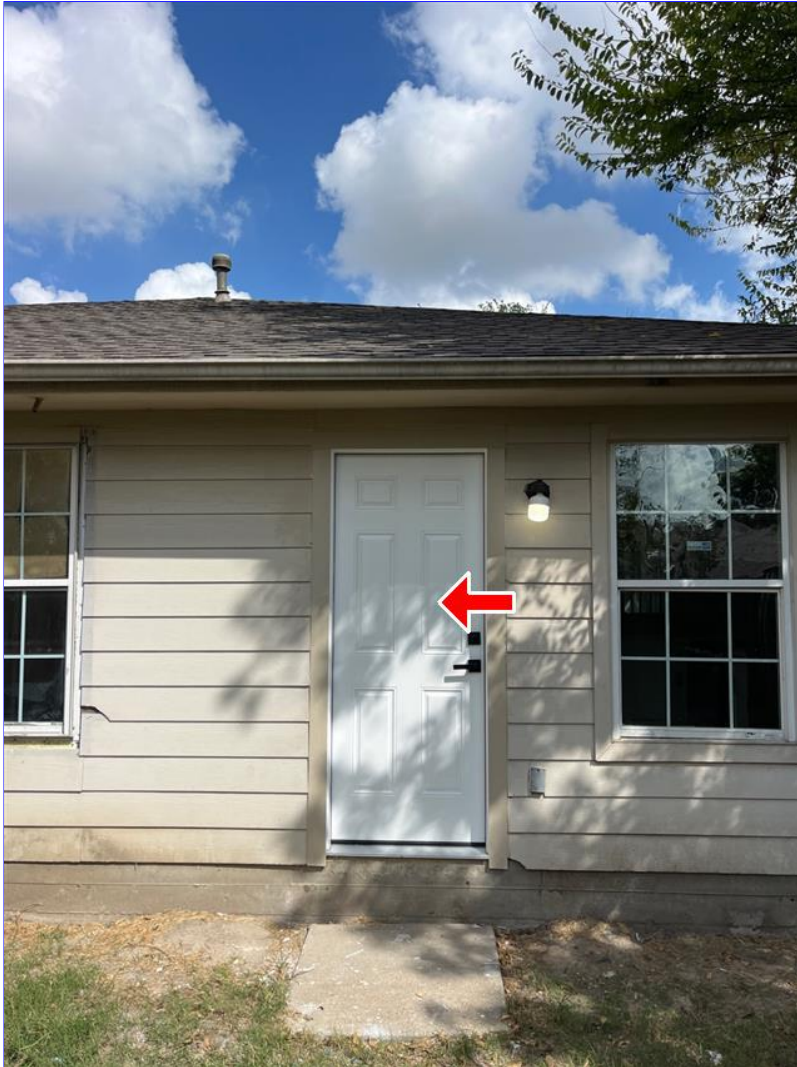
G. Item 3 (Picture)

(3) Door does not have sufficient roof covering and may be prone to water intrusion. This is for your information.

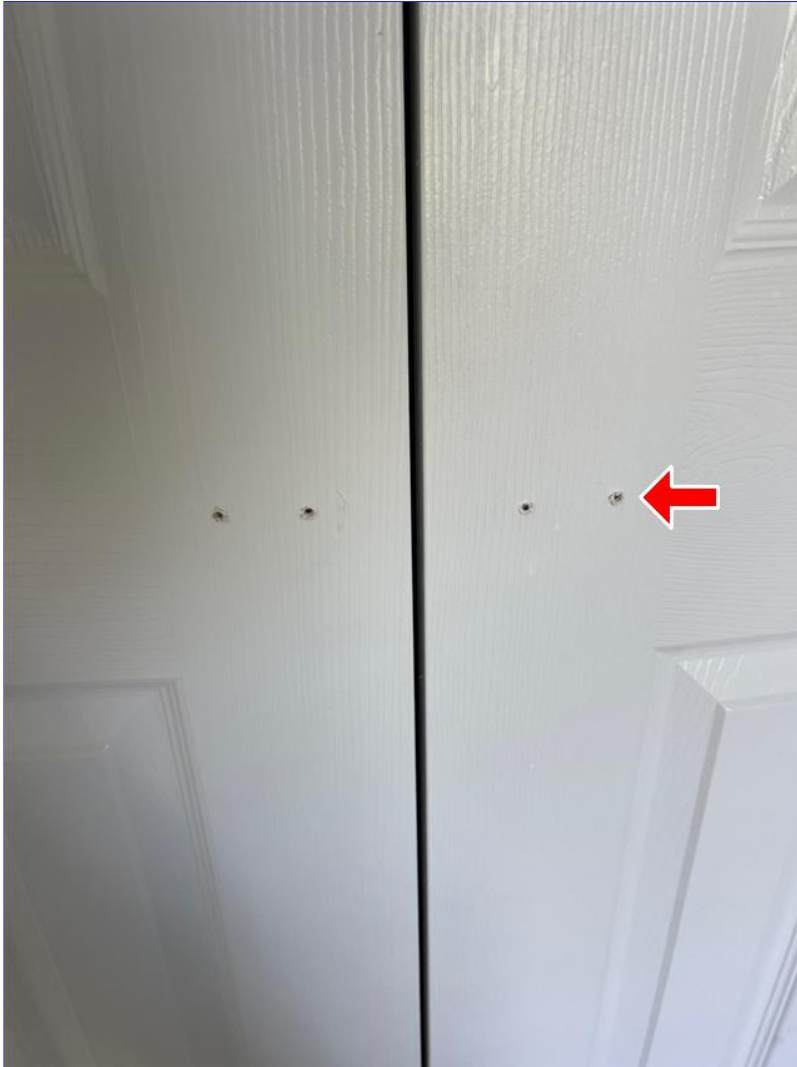
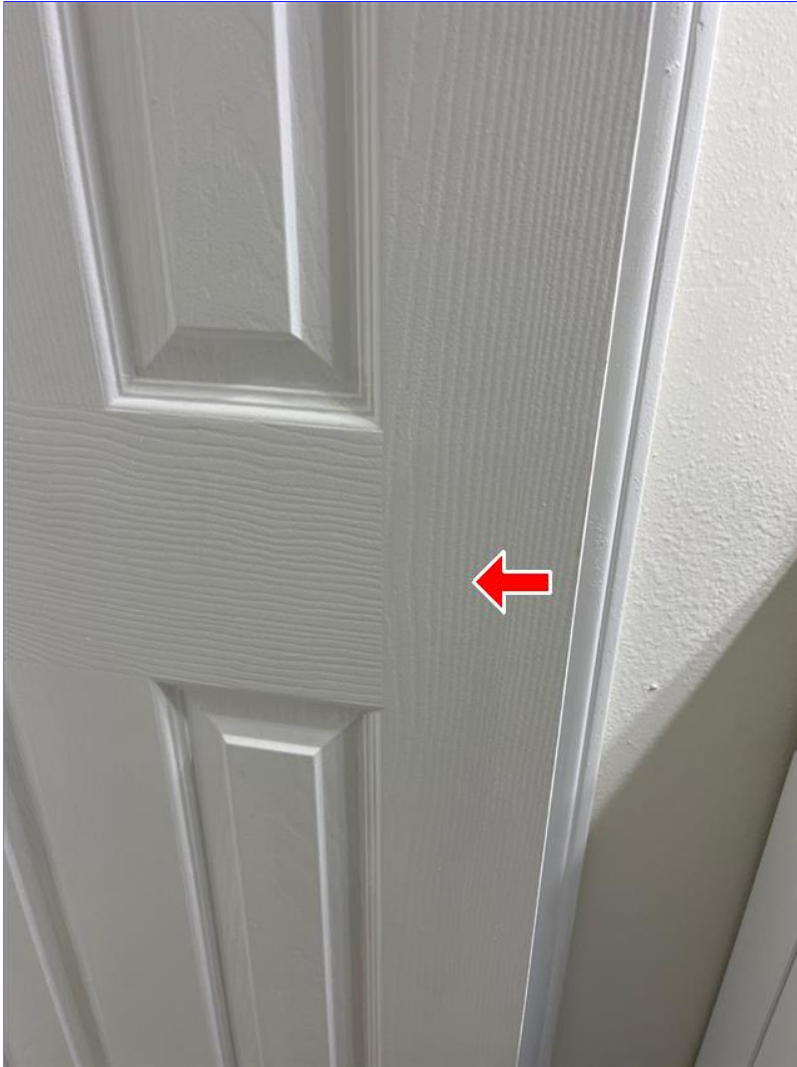
G. Item 4 (Picture) Guest br closet

(4) Missing door, knobs, guest bedroom closet

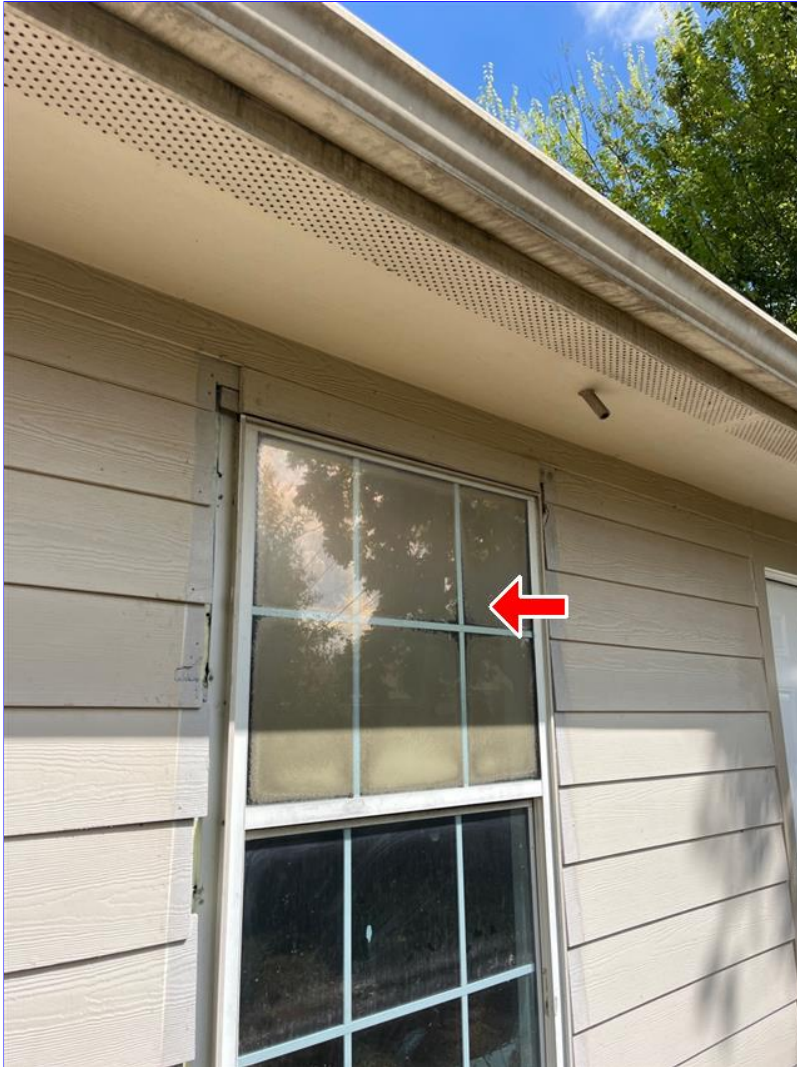
H. Item 1 (Picture)

(1) The glazing between glass panes appear to be failing at some windows causing cloudy glass (If there are multiple windows that are the same age and style it is safe to assume others will soon start to fail as well). I recommend having a qualified person make repairs as needed.

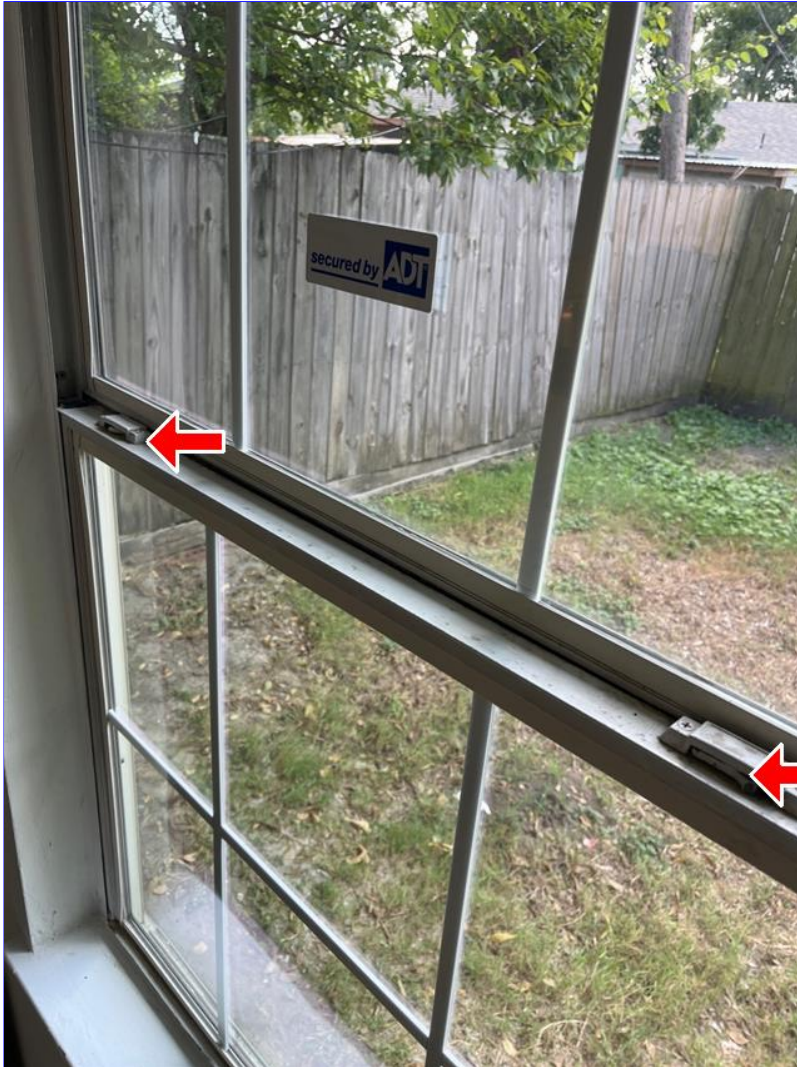
H. Item 2 (Picture)

(2) Missing window latches

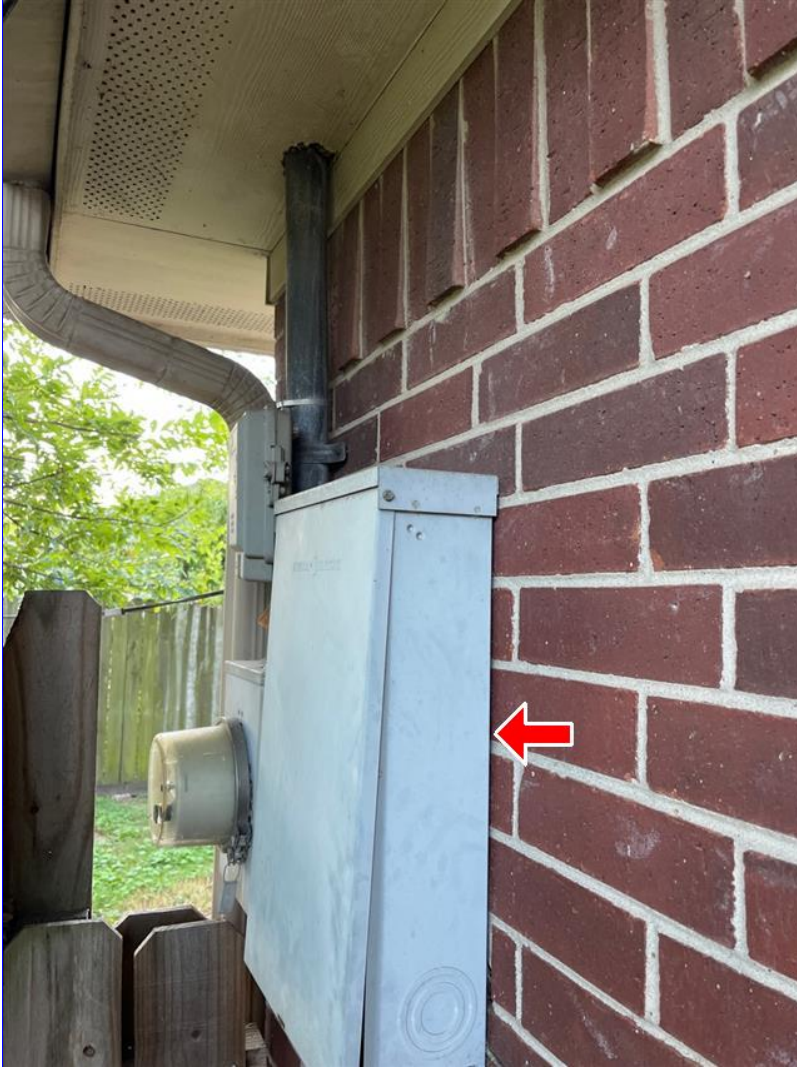
A. Item 1 (Picture)

(1) I recommend sealing breaker box and electric meter to wall to prevent water intrusion.

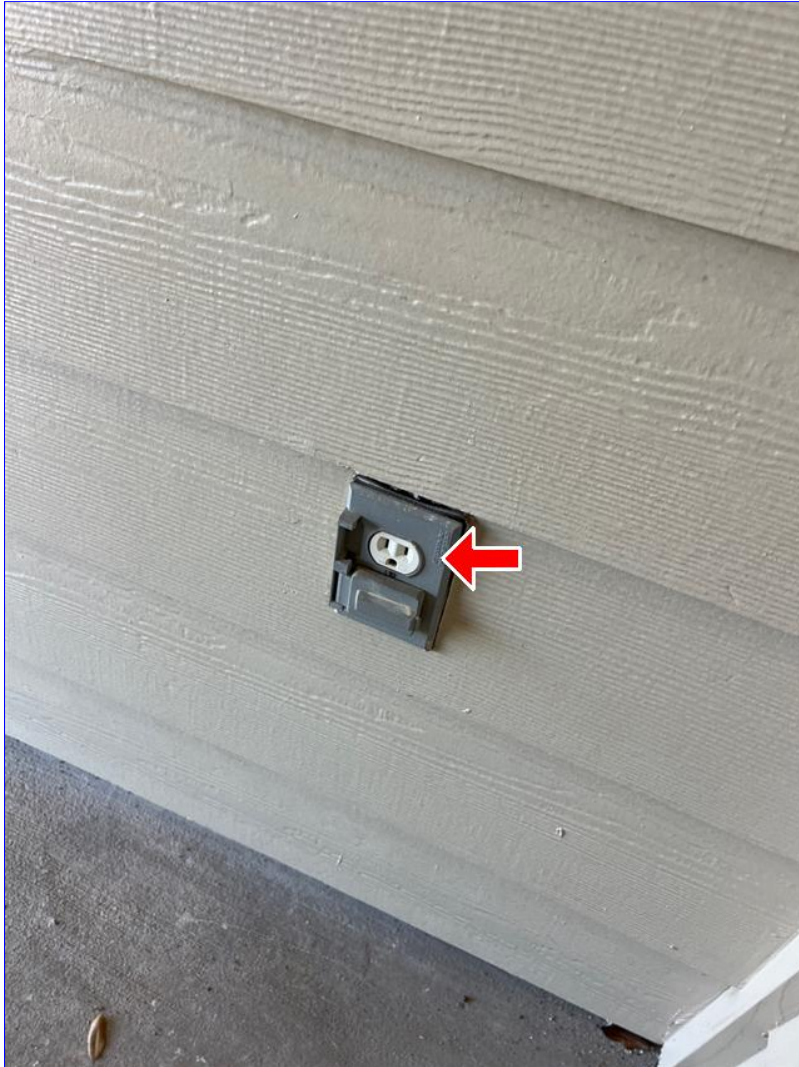
B. Item 1 (Picture)

- (1) I recommend checking all smoke detectors for functionality and putting fresh batteries in each unit upon move in. It is recommend to have smoke detection in each bedroom, hallways and living area. Carbon monoxide detection is recommended in all homes, especially if equipped with gas fired appliances. Some detectors may not be available for inspection due to limiting circumstances (ex. wired with alarm company).
- (2) The outlet cover is damaged and needs to be replaced. I recommend having a qualified person make repairs as needed.

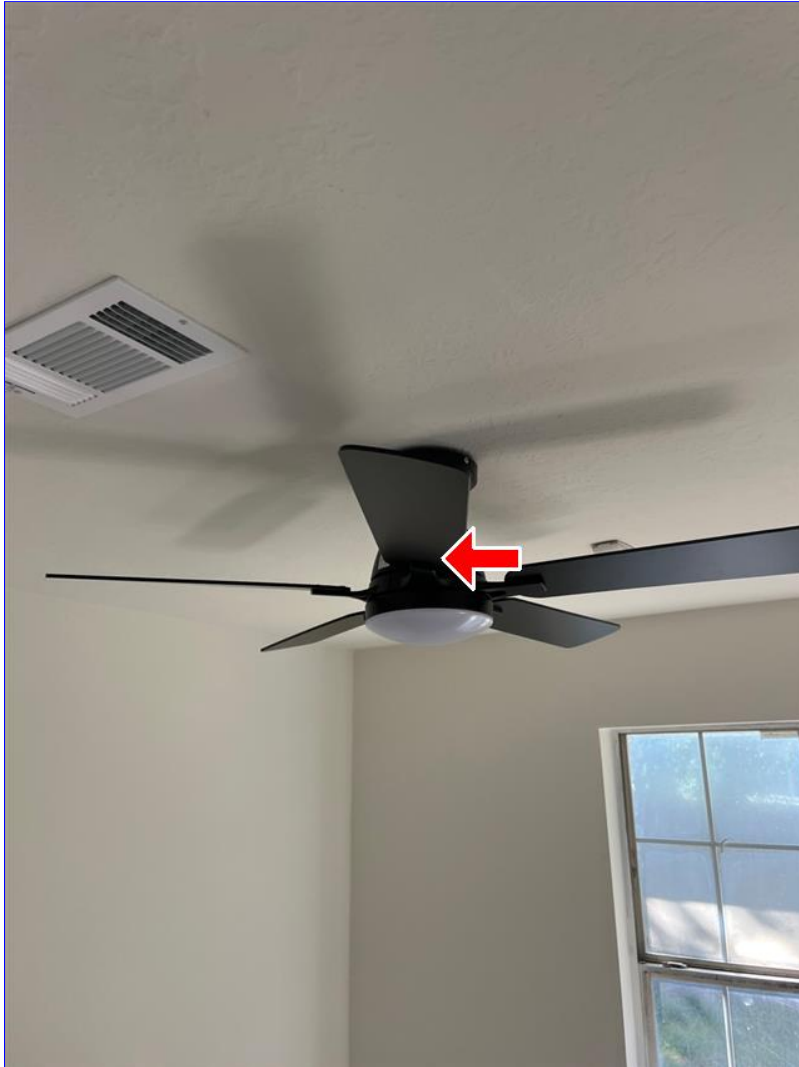
B. Item 2 (Picture)

(3) Ceiling fan did not work properly at time of inspection process. A qualified electrician should inspect and repair as needed.

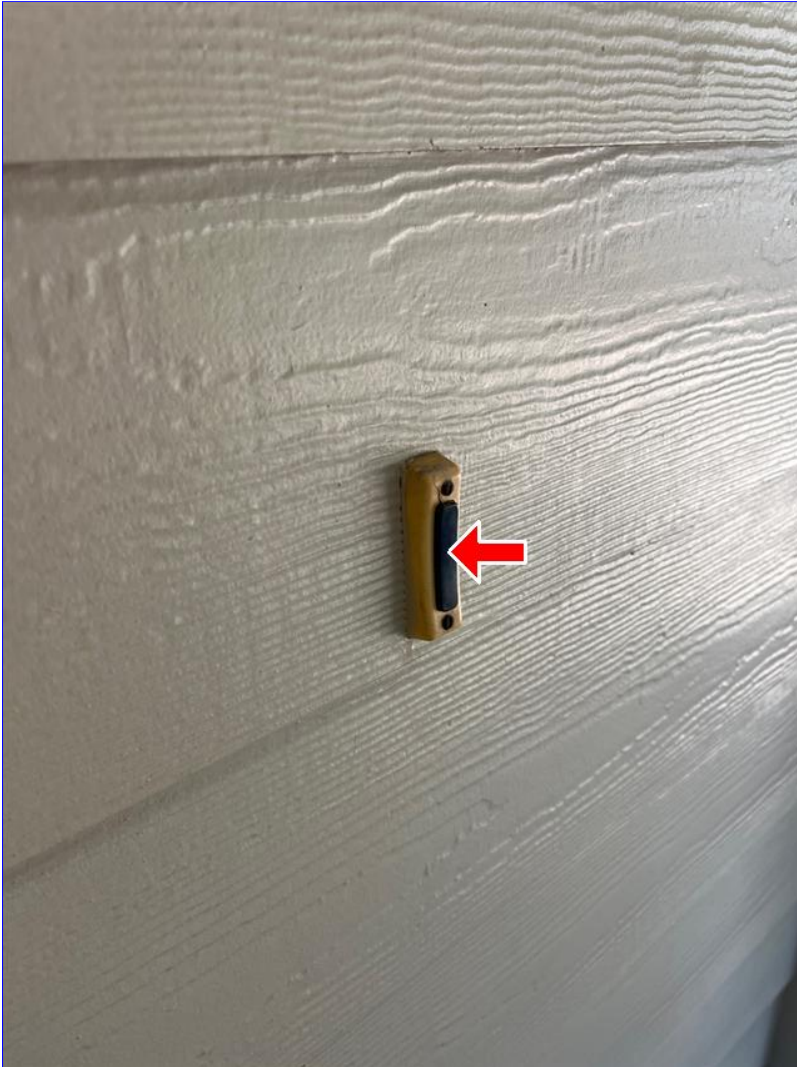
B. Item 3 (Picture)

(4) Doorbell did not work properly at the time of inspection. I recommend having a qualified person repair.

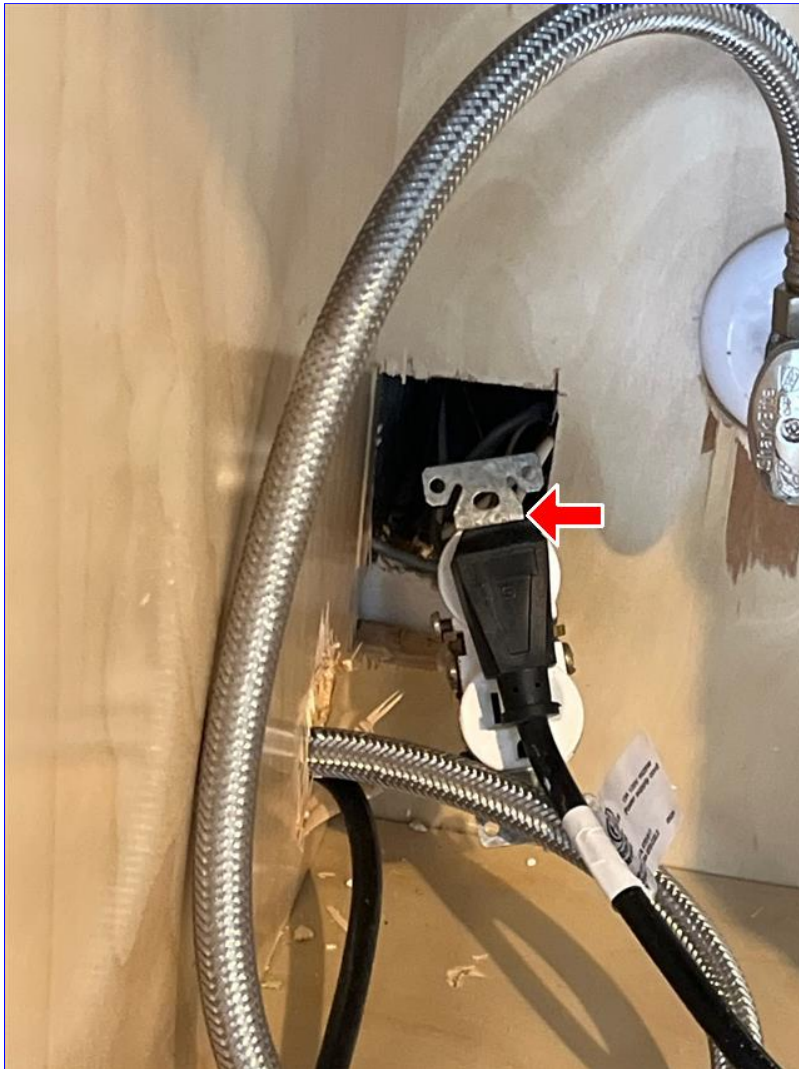
B. Item 4 (Picture) Back door

(5) Outlets are loose in wall in areas. Electrical issues are considered a hazard until repaired. I recommend repair as needed.

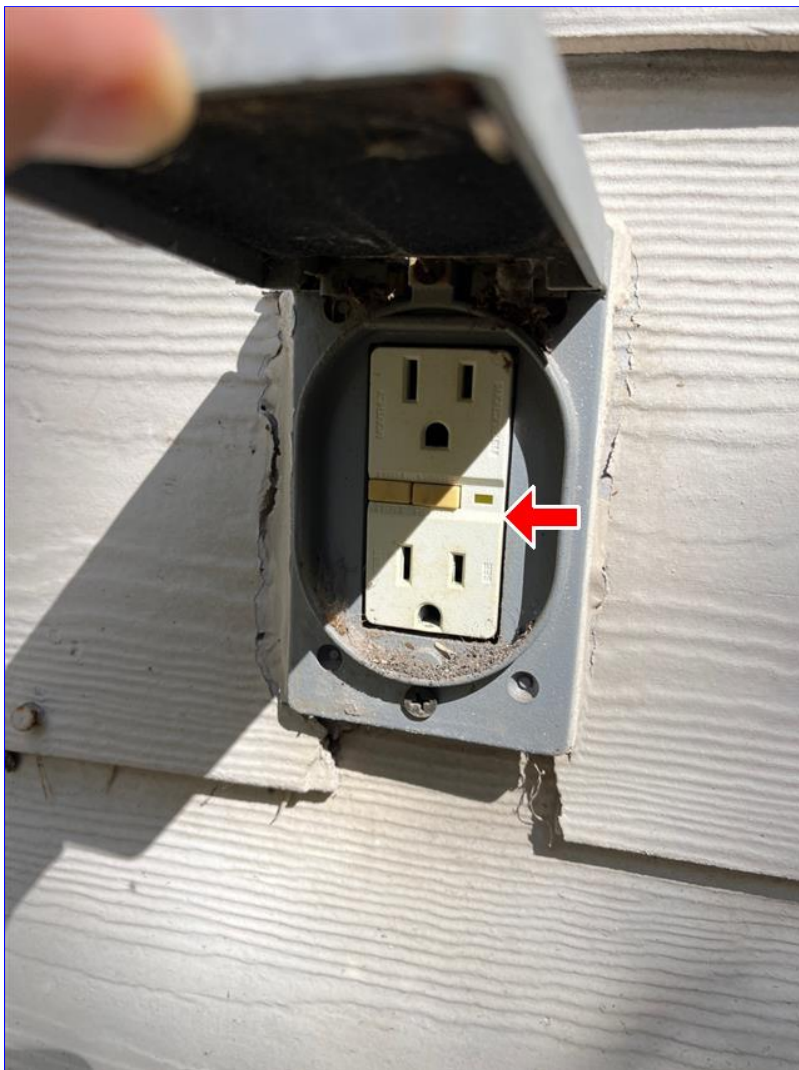
B. Item 6 (Picture)

(6) GFCI reset is stuck in the tripped position. Was unable to reset a time of inspection. I would have a qualified professional to correct.

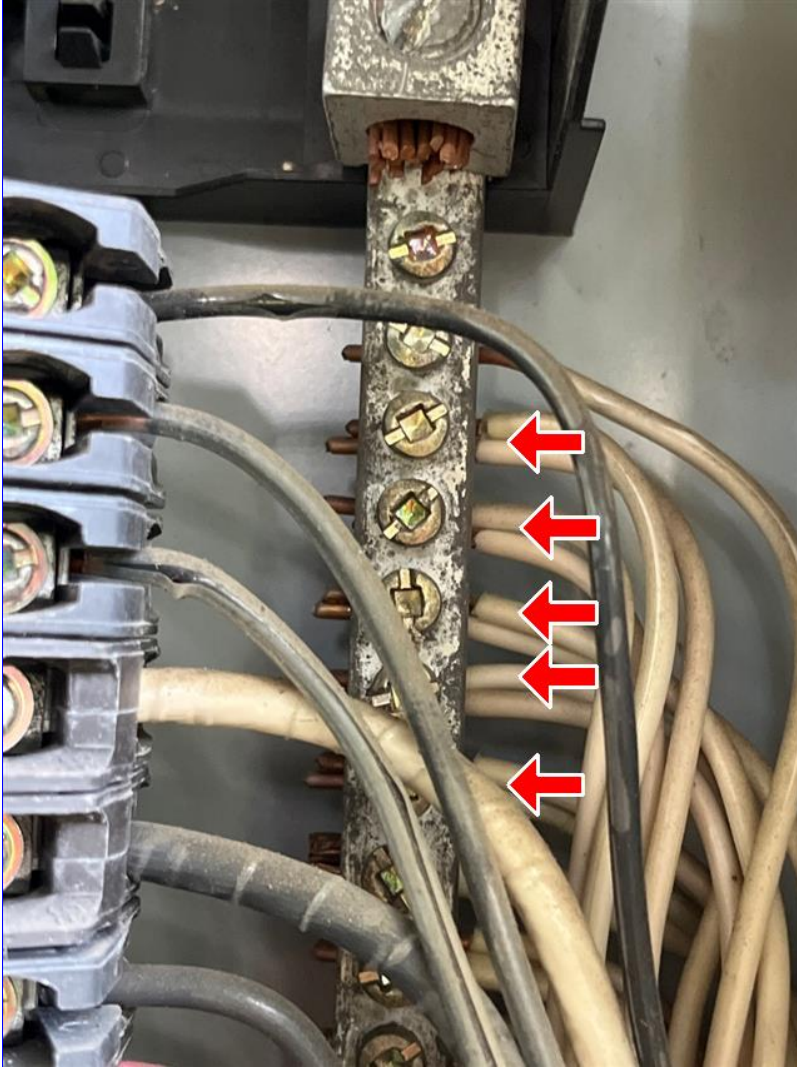
B. Item 7 (Picture)

(7) Arc fault breakers are not in required areas of home at electrical panel. This is not considered today's standard. I recommend having a qualified electrician inspect and make repairs as needed.

(8) Problem(s) discovered with Branch Circuits such as amateur wiring installation, doubled wiring at neutral/grounding bar, and any other problems that an electrical contractor may discover while performing repairs need correcting. I recommend a licensed electrical contractor inspect further and correct as needed.

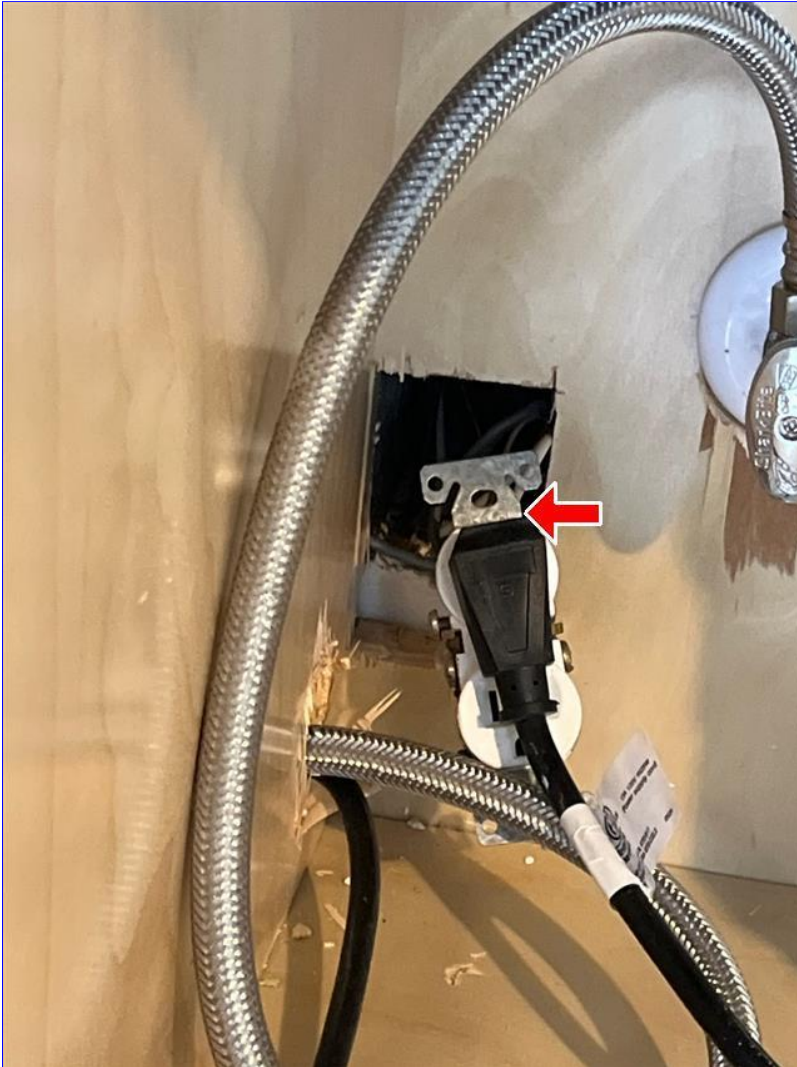
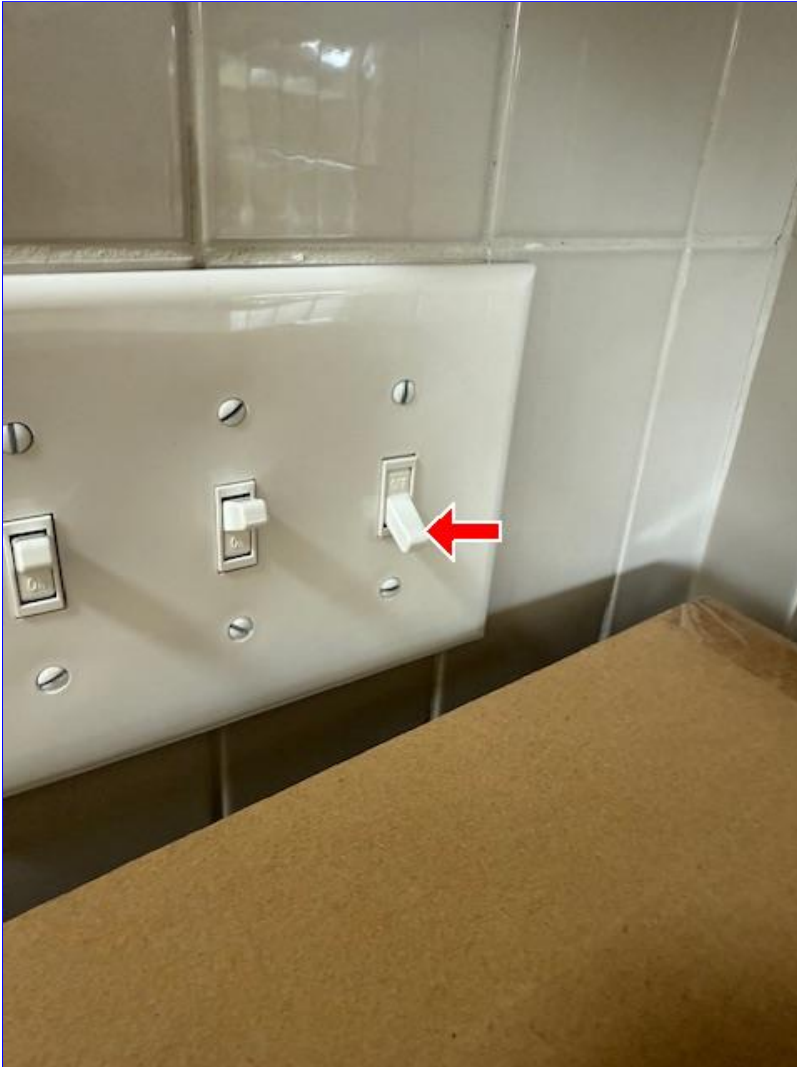
B. Item 8 (Picture)

(9) I recommend 2 outlets for disposer and dishwasher

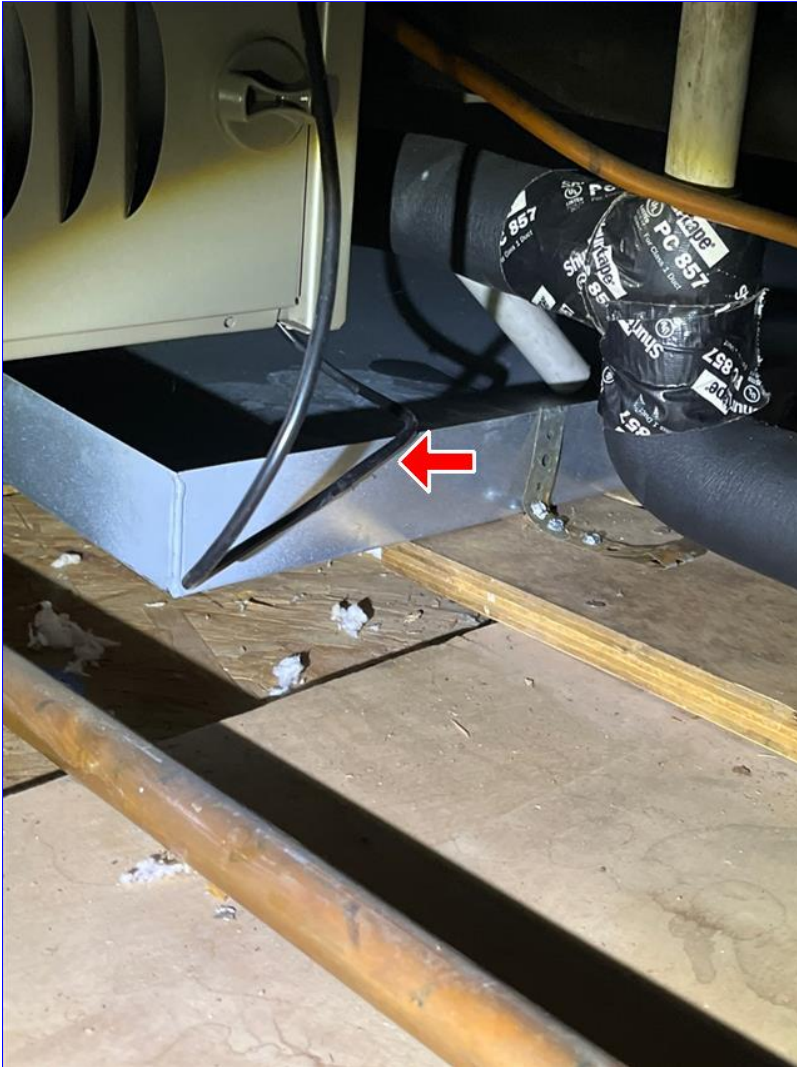
B. Item 3 (Picture)

(2) Unit is located in the attic space, however the secondary drain pan does not have a pan switch. I recommend having a qualified HVAC contractor make repairs as needed.

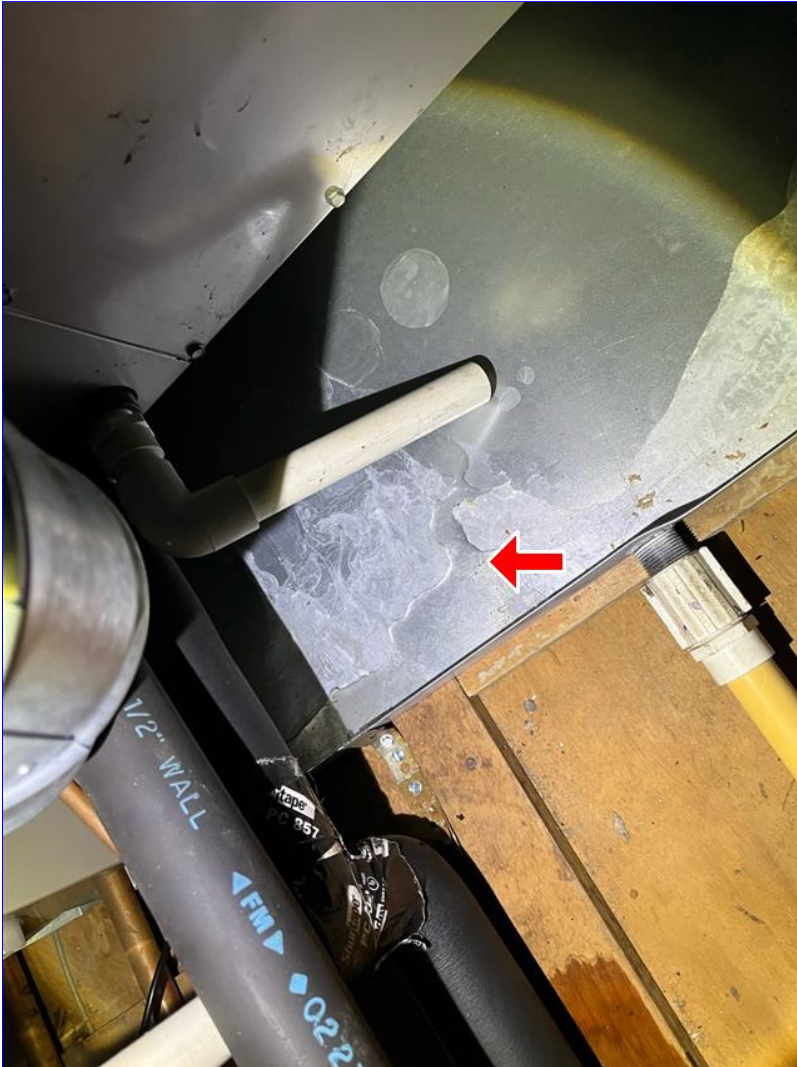
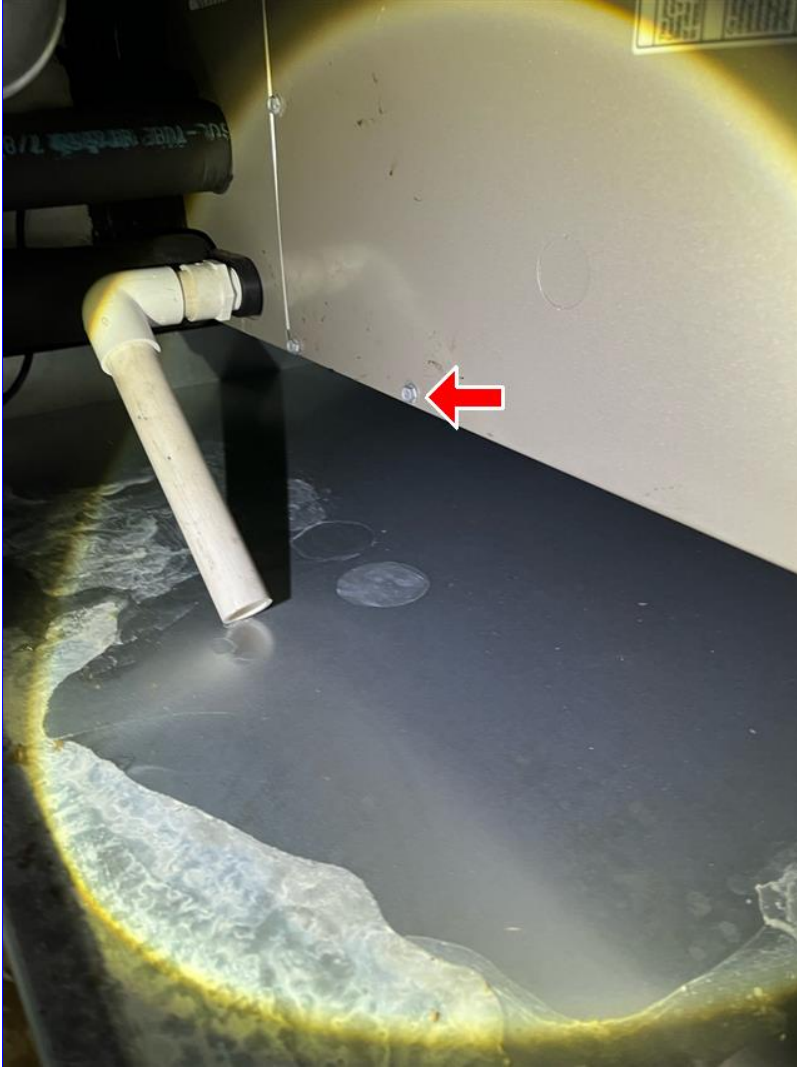
B. Item 4 (Picture)

(3) Drain pan has standing water. I would have a qualified professional to further evaluate.

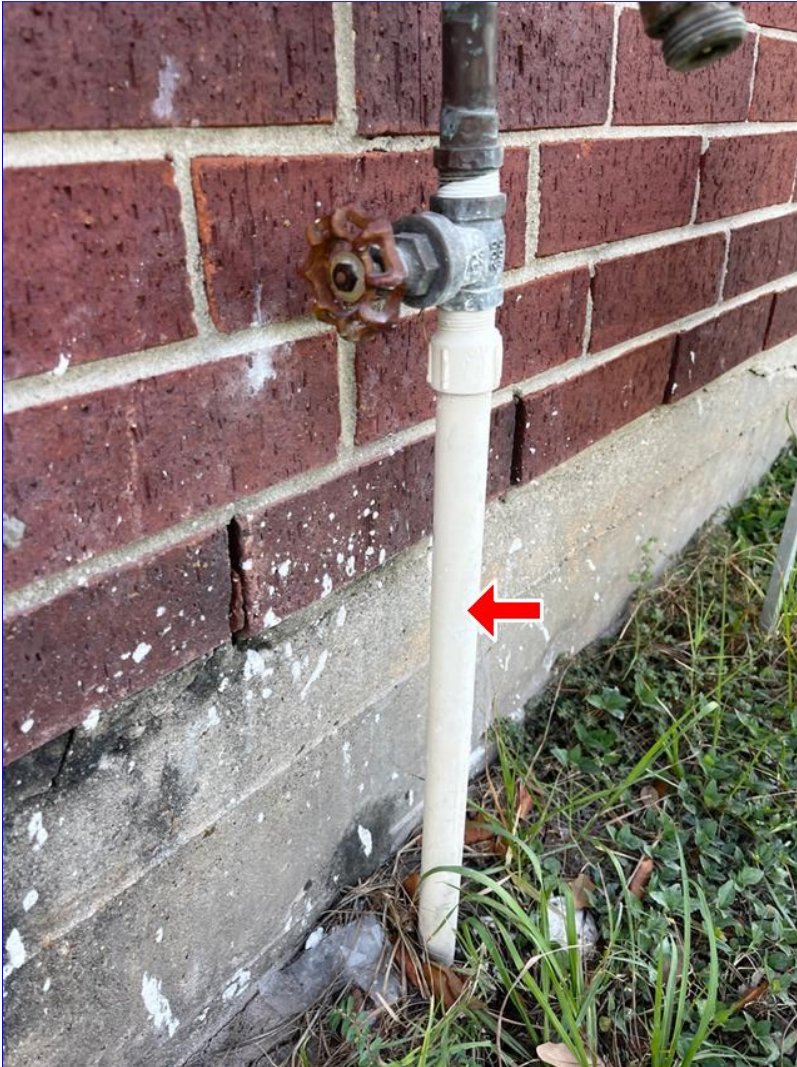
A. Item 1 (Picture)

(2) Supply line is not properly insulated in areas. I recommend having a qualified plumber inspect and repair as needed.

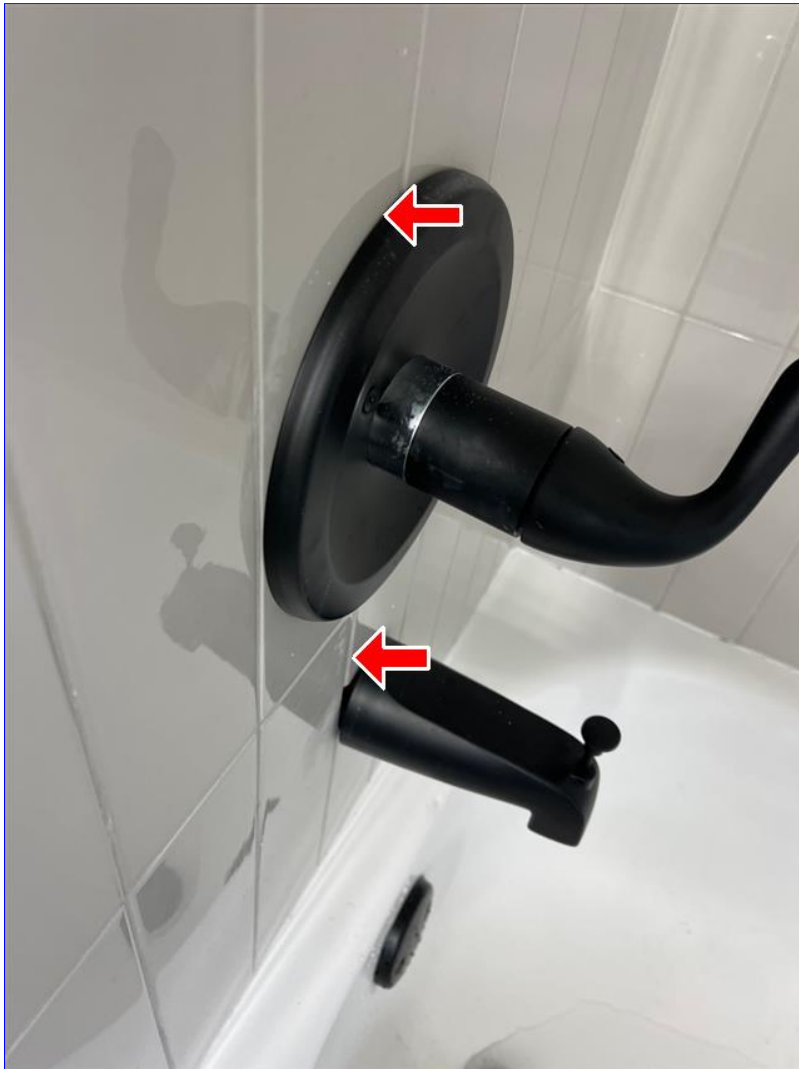
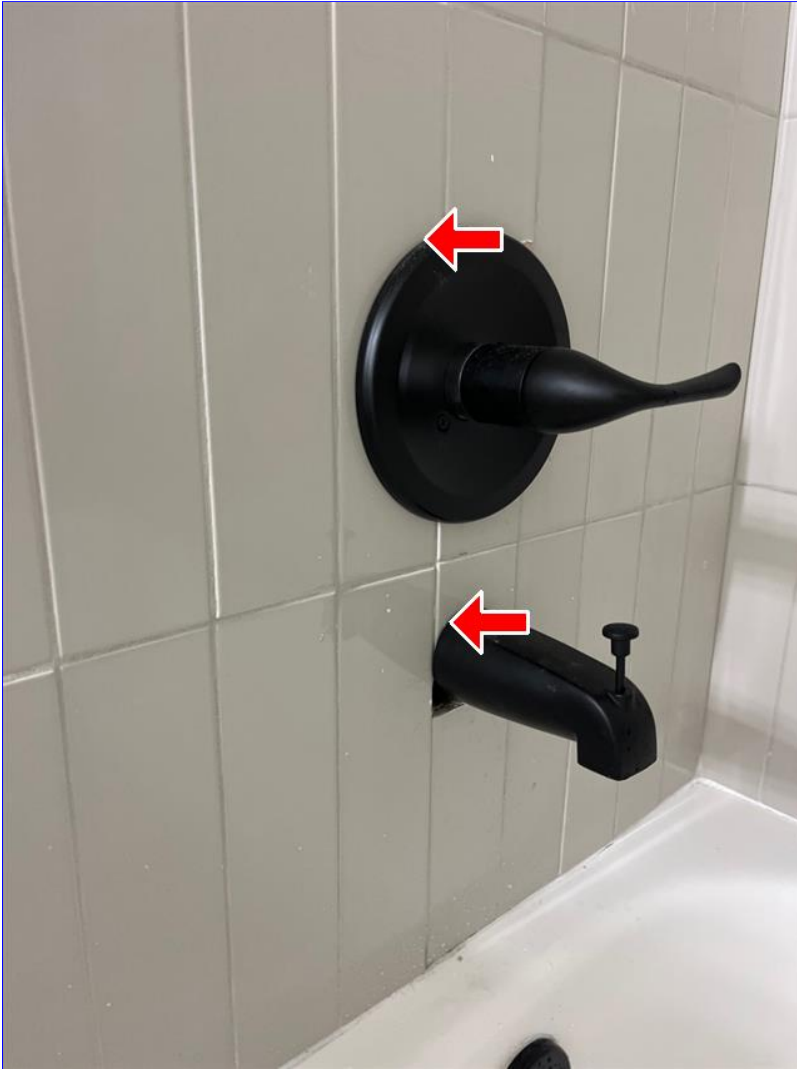
A. Item 2 (Picture)

(3) Wall fixtures should be sealed to wall to prevent water intrusion.
