Inspection Report

Property Address:
10102 Wiggins St
Houston TX 77029

HG Home Inspection

PROPERTY INSPECTION REPORT FORM

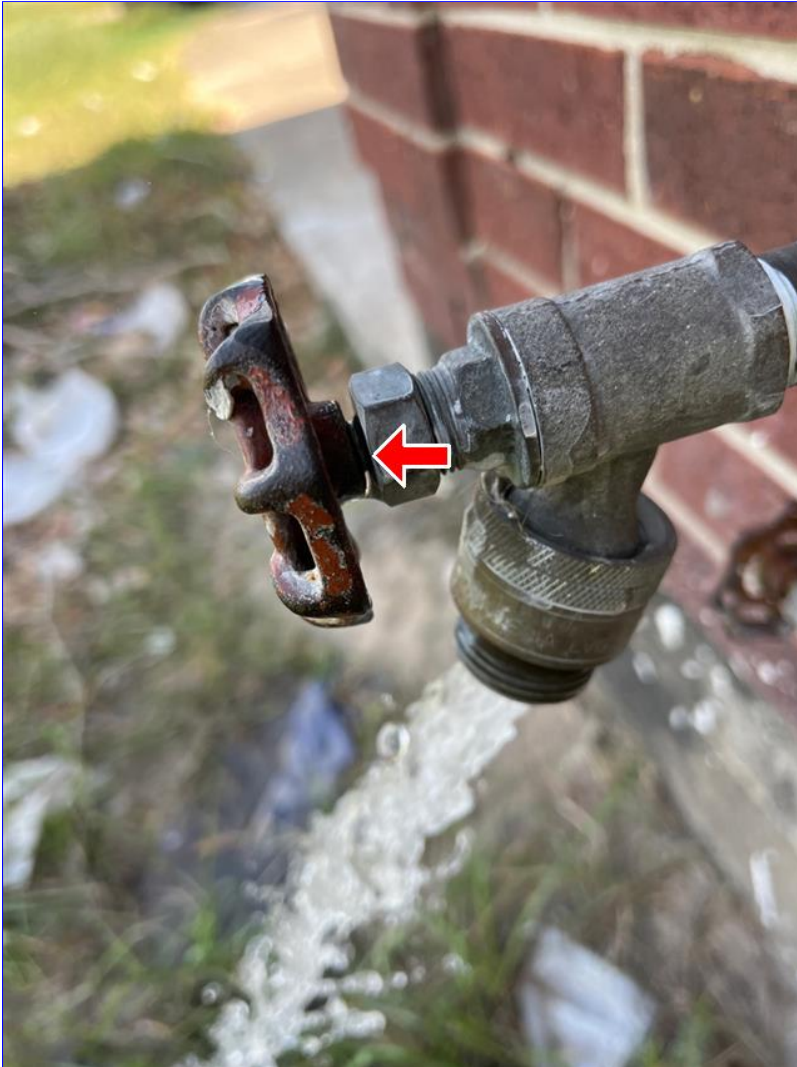
A. Item 4 (Picture)

(4) Active leak was discovered at the fixture. I would have a qualified professional to correct.

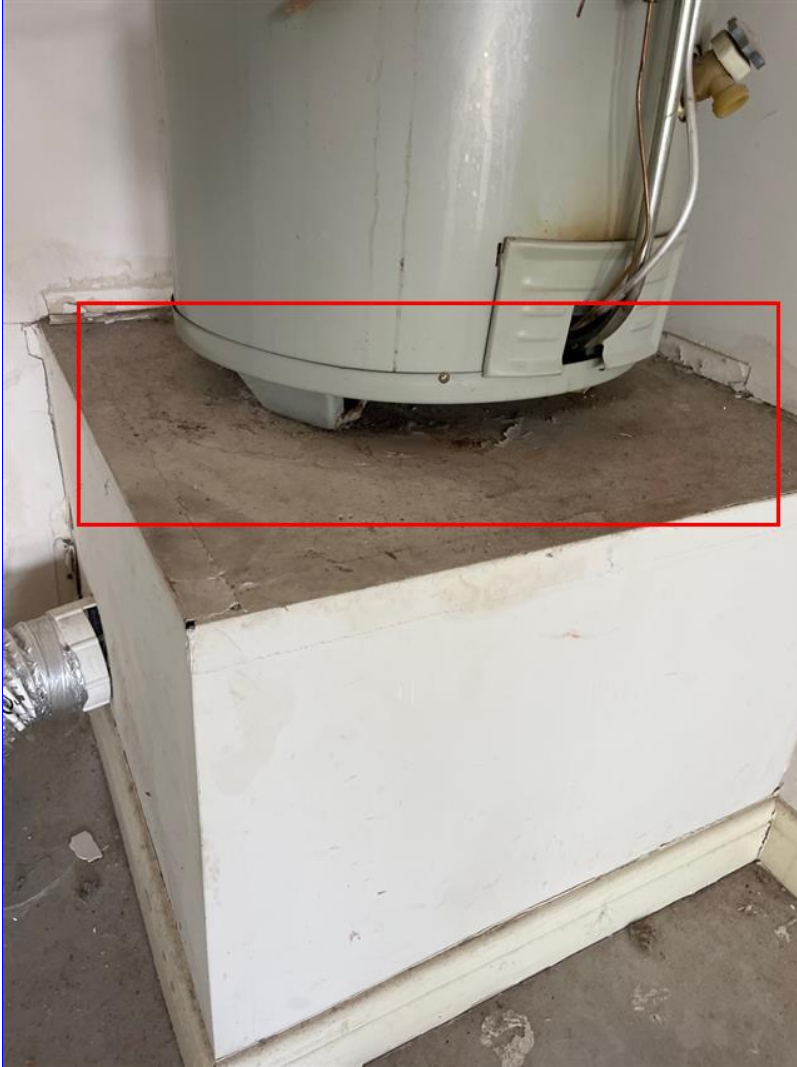
C. Item 1 (Picture)

(1) The water heater is installed without the recommended emergency overflow drain pan. This is not considered to be today's standard. I recommend having a drain pan installed by a qualified person.

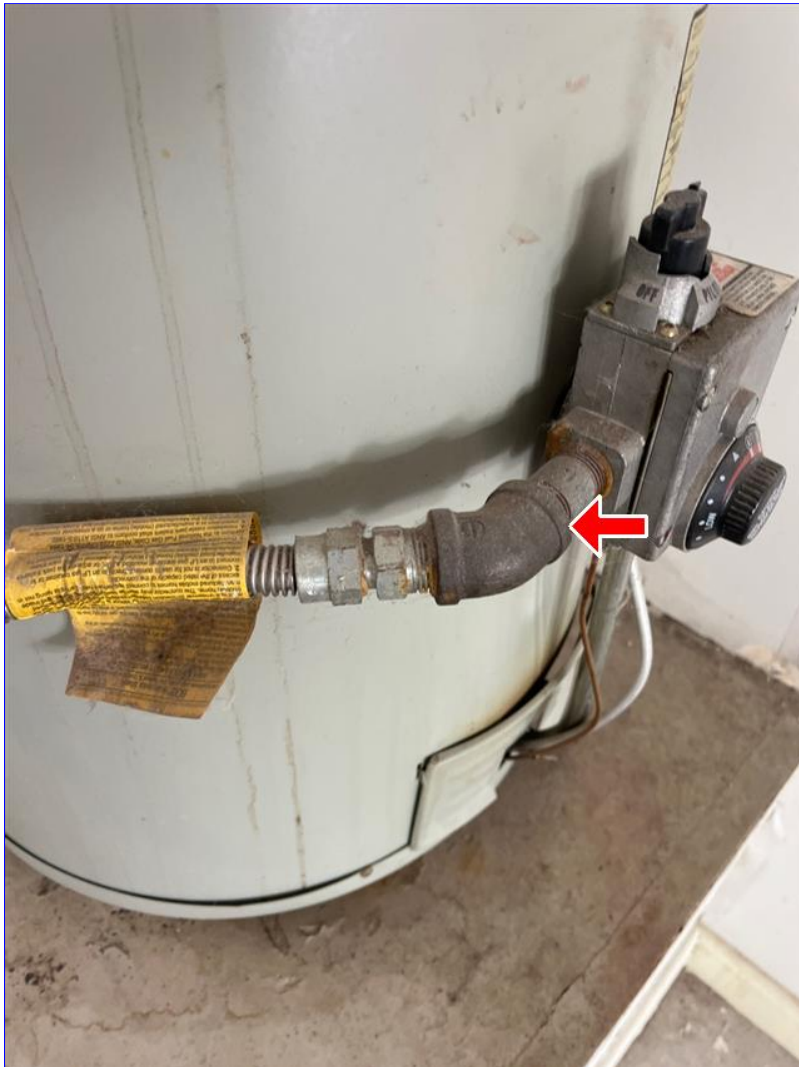
C. Item 3 (Picture)

(2) The water heater is installed without the recommended sediment trap or "drip leg" that is designed to extend the life of the unit. This is not considered to be today's standard. I recommend having a qualified plumber make repairs as needed.

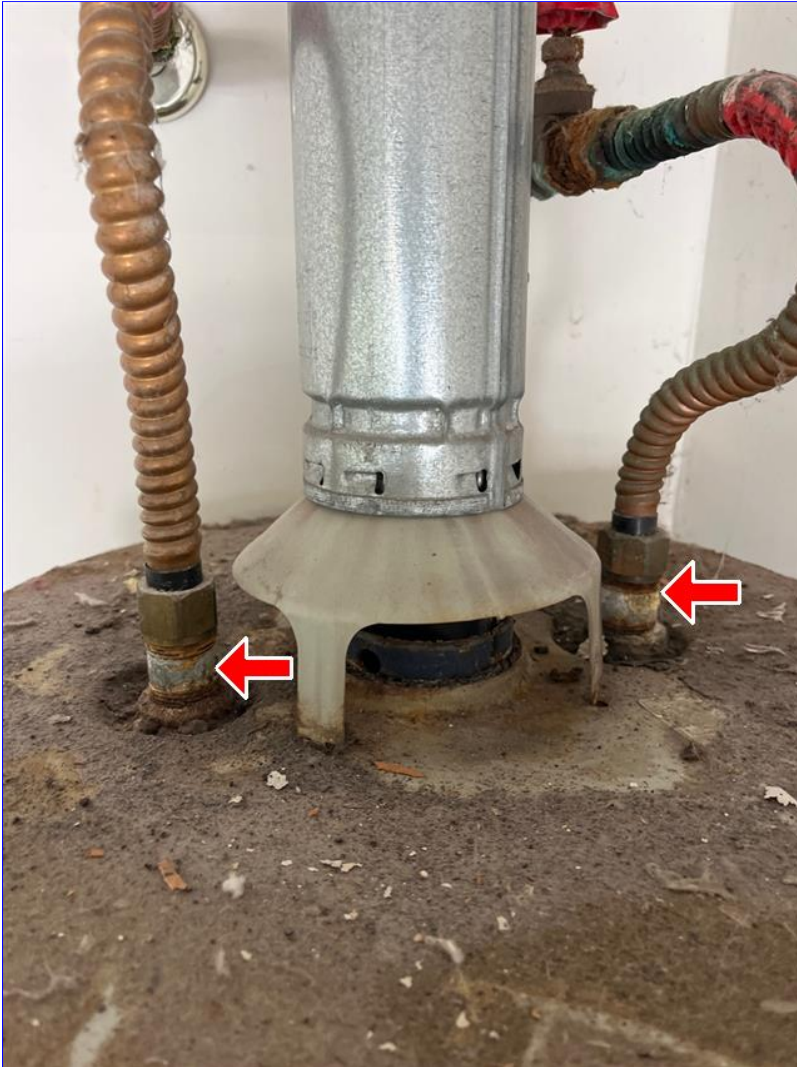
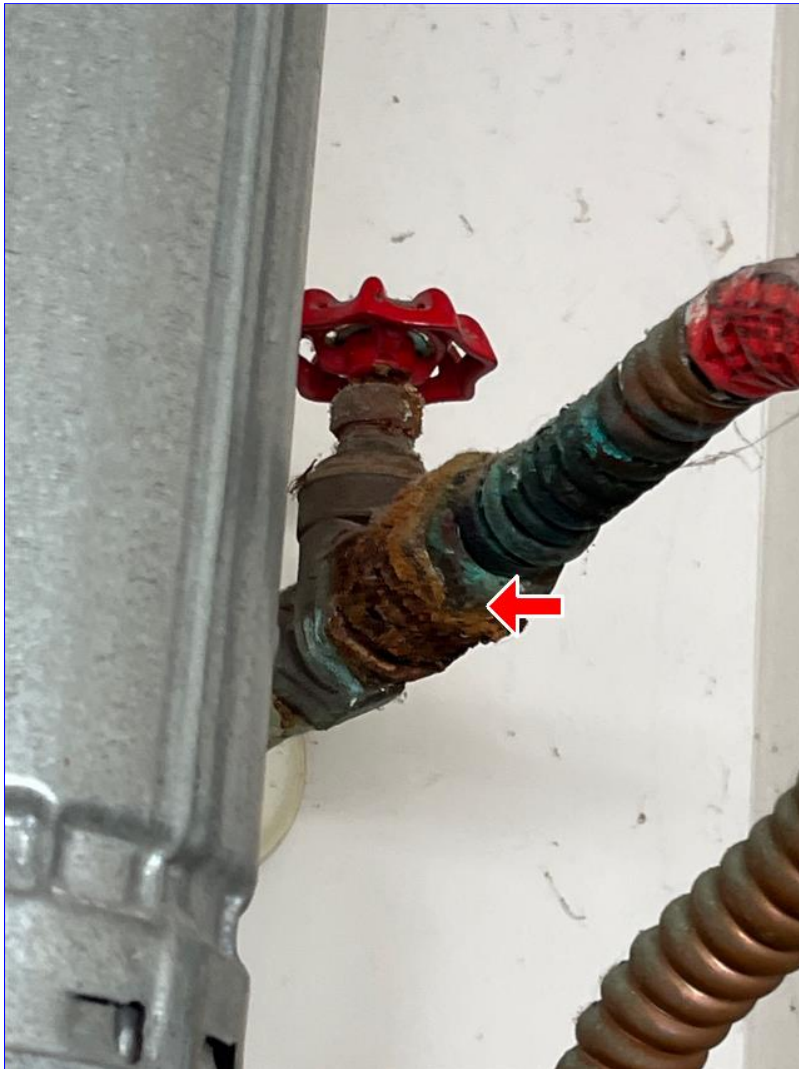
C. Item 4 (Picture)

(3) The water heater has corrosion at fittings. I recommend having a qualified person make repairs as needed.

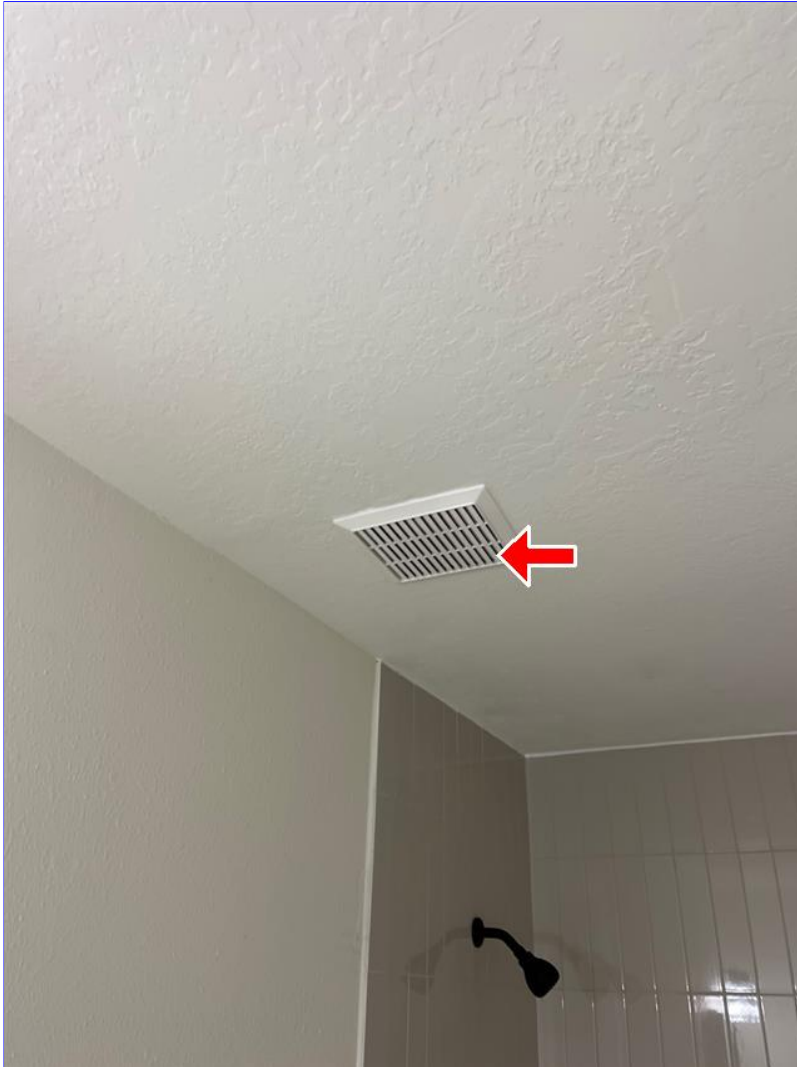
F. Item 1 (Picture) Guest bath

(2) The Exhaust fan does not vent to outside. This is not considered today,s standards. Vent pipes that terminate in attic space can sometimes cause moisture that can lead to mold or cause condensation. A qualified person should repair or replace as needed.
