125 E Park Dr
Montgomery, TX 77356

PROPERTY INSPECTION REPORT FORM

Howard Thomas <i>Name of Client</i>	01/30/2026 1:00 pm <i>Date of Inspection</i>
125 E Park Dr, Montgomery, TX 77356 <i>Address of Inspected Property</i>	
Keith Jeanes <i>Name of Inspector</i>	TREC# 22817-PI <i>TREC License #</i>
<i>Name of Sponsor (if applicable)</i>	<i>TREC License #</i>

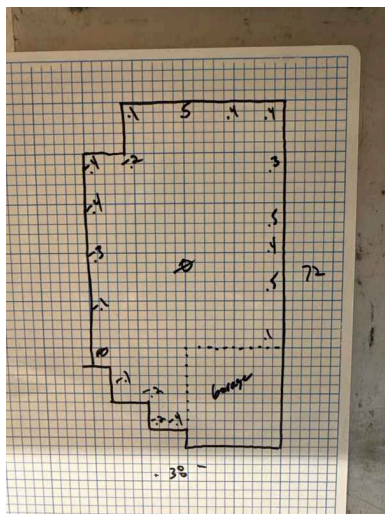
Approaching Limits:

Foundation is approaching limits (deflection from middle is > .8 and less than 1.5 inches and deflect is no more than 1 inch over 30 feet or 1 1/2 inches from side to side. Recommend to monitor

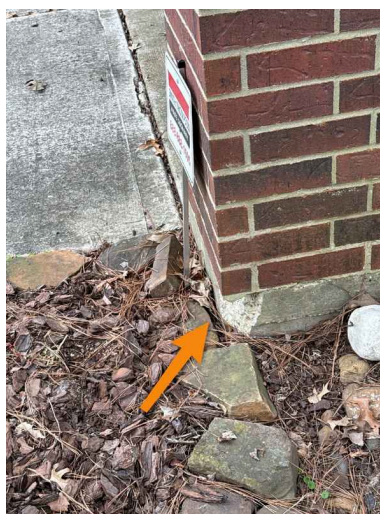
Example Front Exterior

1: Corner Pop(s) / Crack(s)

Corner pops/cracks were noted on one or more corners of the foundation. Corner pops/cracks are generally caused by the early removal of form boards and/or improper flashing installation between the slab and the brick veneer/stone veneer. This has or can lead to the foundation no longer providing the proper support for the brick cladding, and/or can be a conducive condition for wood destroying insects. We recommend having these areas patched/sealed/repared.

Recommendation: Contact a handyman or DIY project

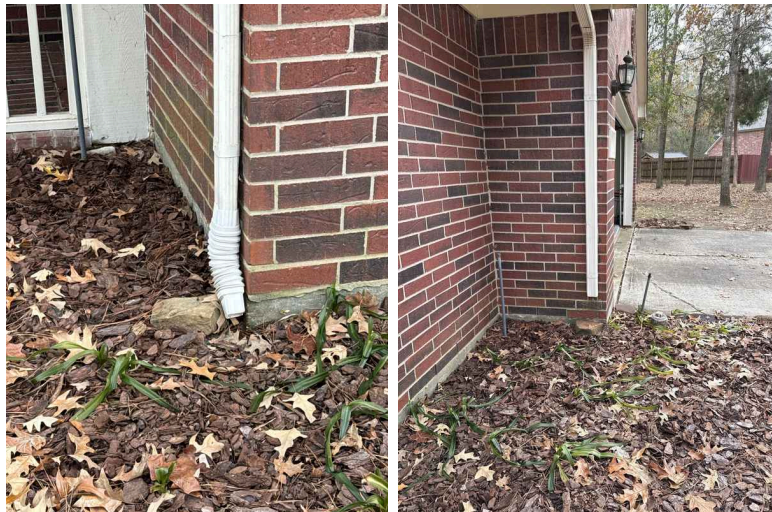
2: Gutter / Downspout Discharge Near Foundation

One or more downspouts were discharging too close to the foundation. We recommend having downspouts discharge water at least five (5) feet from the structure. Storm water should be encouraged to flow away from the building at the point of discharge.

Recommendation: Contact a handyman or DIY project

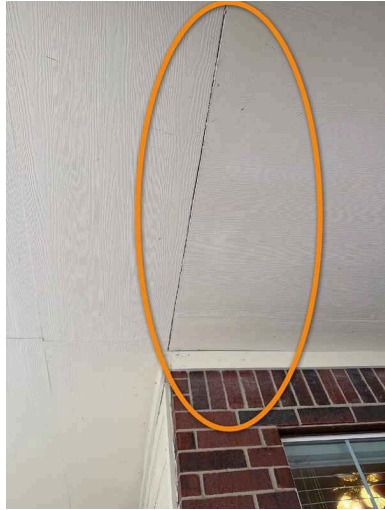
Example Front Exterior

A gap/penetration point was observed between the roof shingles and the soffit. We recommend having this patched/blocked to prevent intrusion into the attic space.

Recommendation: Contact a qualified professional.

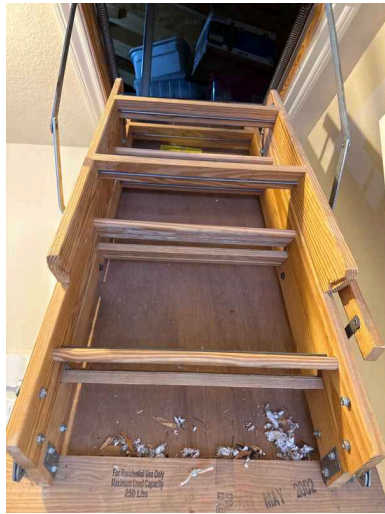
To improve air conditioning efficiency and to prevent loss of conditioned air to the attic, the attic hatches and doors should be insulated.

Today's standards typically require access doors from conditioned spaces to unconditioned spaces (e.g., attics and crawl spaces) to be weatherstripped and insulated to a level equivalent to the insulation on the surrounding surfaces. We recommend repair to improve the energy efficiency of the home.

Recommendation: Contact a handyman or DIY project

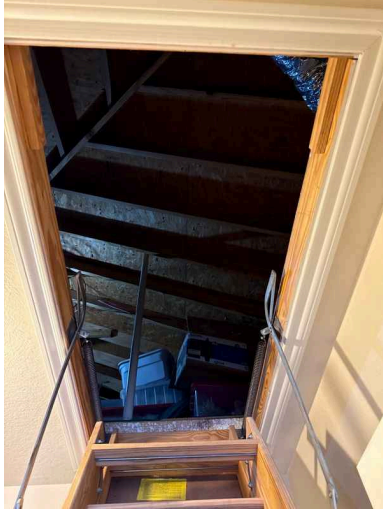
2: Attic Access / Hatch Weather Stripping Missing / Damaged

One or more attic accesses lacked weather stripping. We recommend having this detail added for improved energy efficiency.

Recommendation: Contact a handyman or DIY project

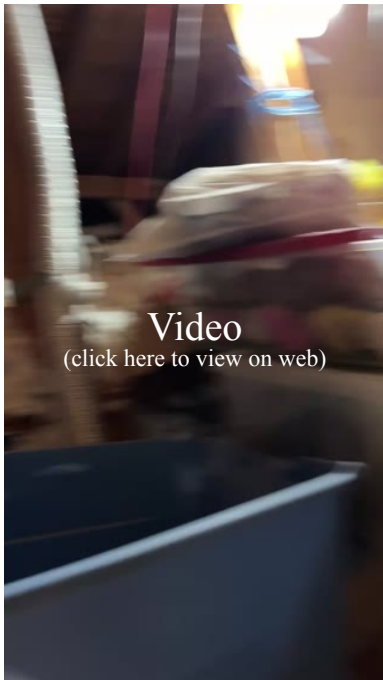
3: Storage Items in Attic - Safety Issue

Found items stored in an area not design to carry live loads. This is a safety issue due to items potentially falling through the ceiling into the living space. We recommend having storage and debris removed or relocated.

Recommendation: Contact a handyman or DIY project

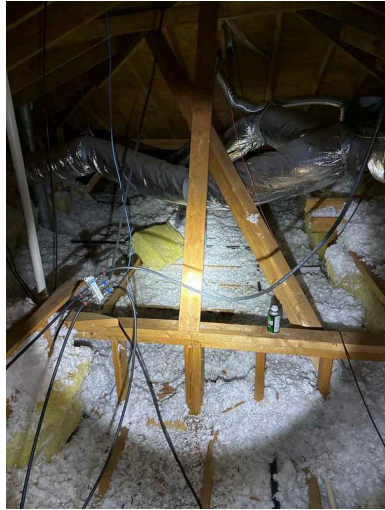
4: Compressed / Uneven Insulation

Recommendation: Contact a handyman or DIY project

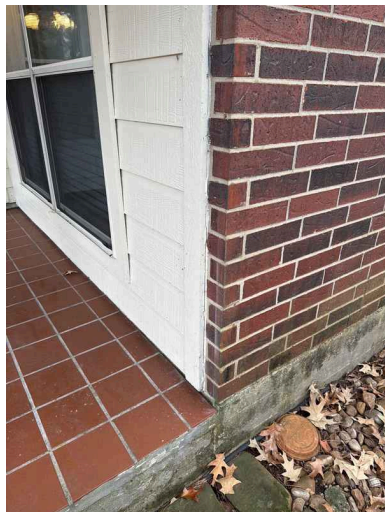
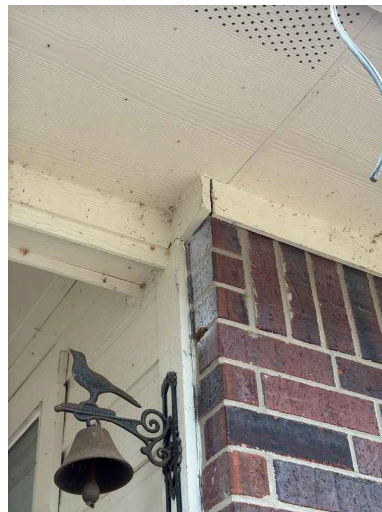
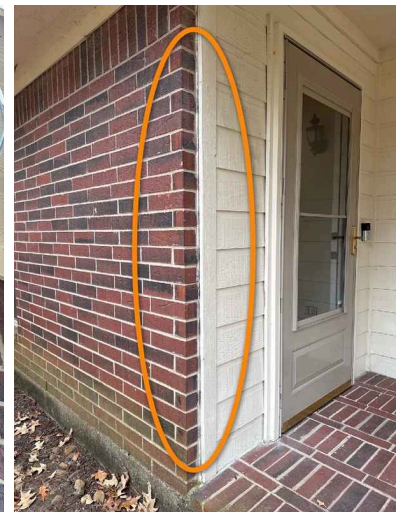
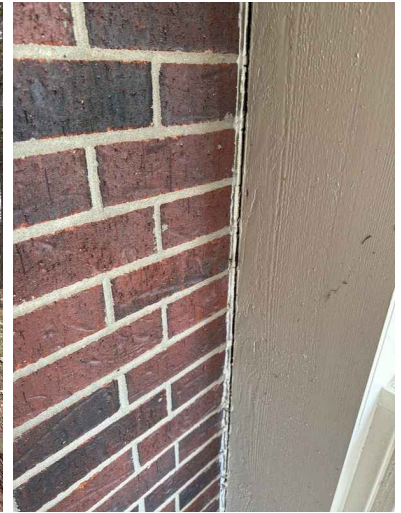
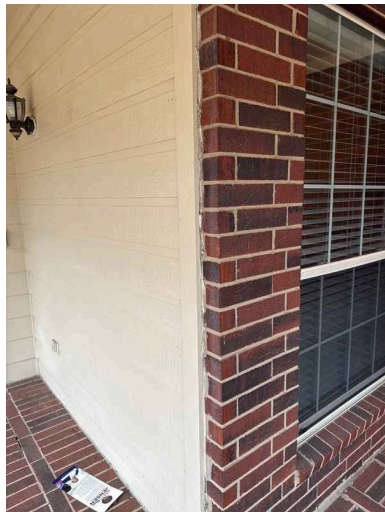
Example Front Exterior

1: Exterior Caulking Deteriorated / Insufficient

The exterior caulking in multiple areas around the house at various siding transitions, expansion joints, wall protrusions, doors, windows and other areas, was deteriorated or insufficient. Exterior caulking is the first energy efficient measure to install. This helps minimize air flow and moisture through cracks, seams, utility penetrations and openings. Controlling air infiltration is one of the most cost effective measure in modern construction practice. Good caulking and sealing will reduce dust, dirt, and prevent damage to structural elements. We recommend updating regularly.

Recommendation: Contact a qualified professional.

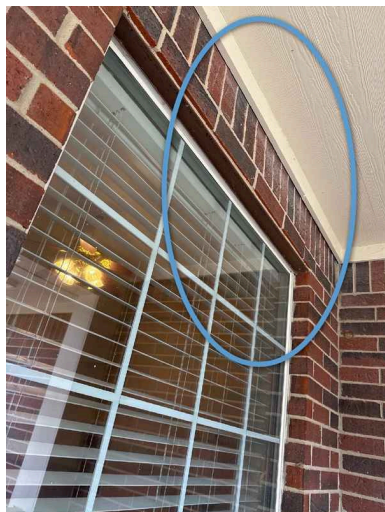
Example Front Exterior

2: Rusted Lintels

The lintels over the openings (windows/doors) were found to be rusted. These elements support the brick veneer above the openings. We recommend having them (re)ainted to prevent deterioration.

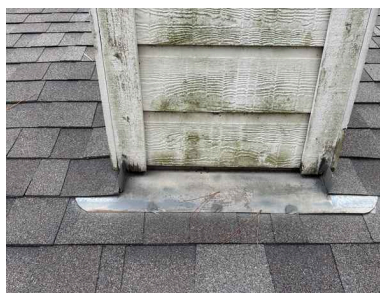
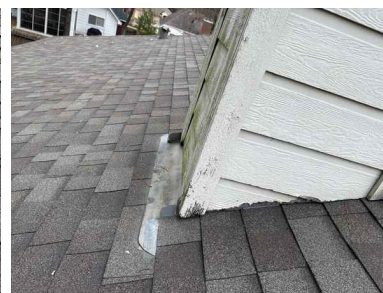
3: Siding / Trim General Damage

General damage was found to the exterior siding and/or trim. We recommend to repair as needed.

Recommendation: Contact a qualified handyman.

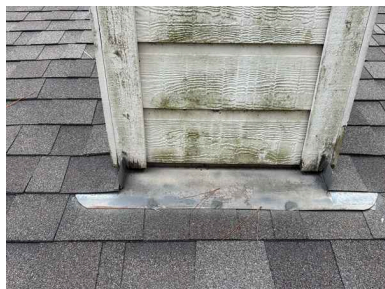
4: Organic Growth on Exterior

Organic growth was noted on the exterior of the home. This can be the result of multiple conditions such as roof run-off, insufficient grading, amount of sun exposure, and proximity to bodies of water or other structures, among others. While the presence of this growth is typically harmless, it can allow excess moisture into the wall cavity or other parts of the structure. We recommend regular cleaning to help keep the area dry.

Recommendation: Contact a handyman or DIY project

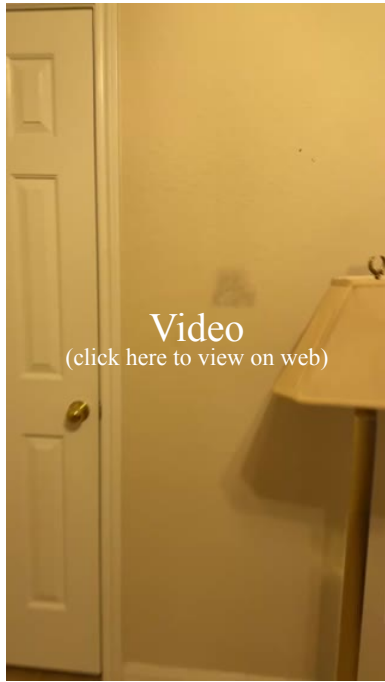
Moisture staining/damage was noted and the area was confirmed with a moisture meter and infrared thermal imager to be dry at the time of inspection. We recommend monitoring and having any active water sources identified and repaired.

Recommendation: Contact a qualified professional.

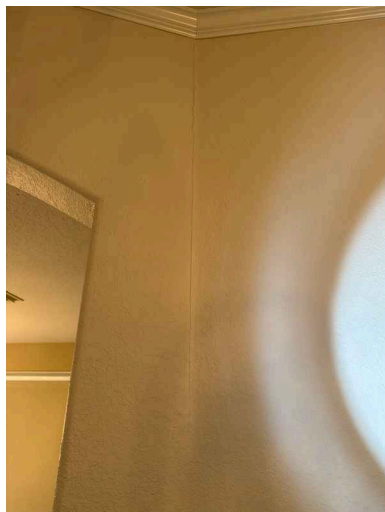
Example Living Room

6: Sheetrock General Damage

Recommendation: Contact a qualified professional.

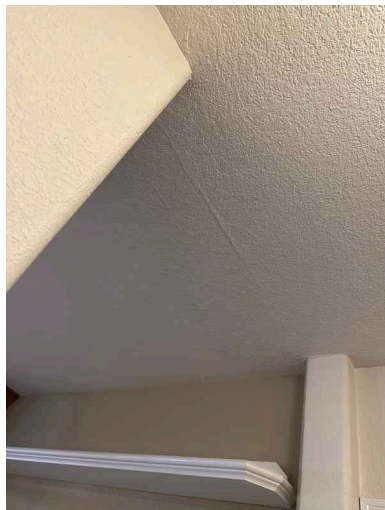
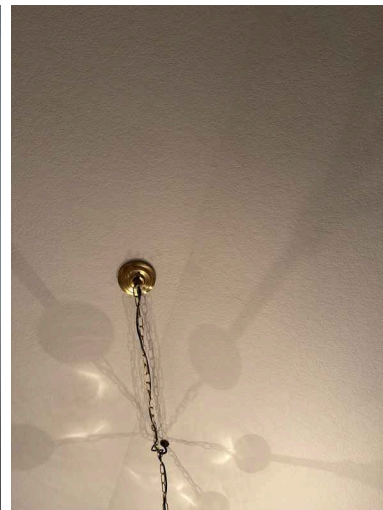
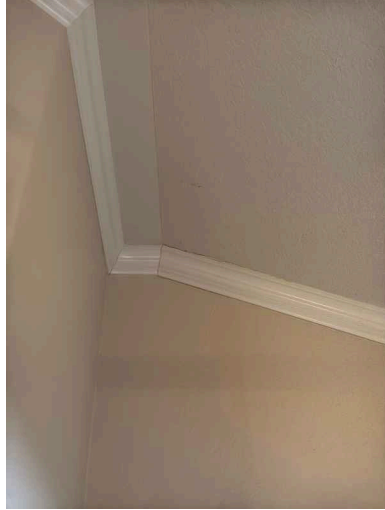
General damage or deterioration was visible at the ceiling finishes. The damage appeared to be cosmetic in nature. We recommend to repair as needed.

Recommendation: Contact a handyman or DIY project

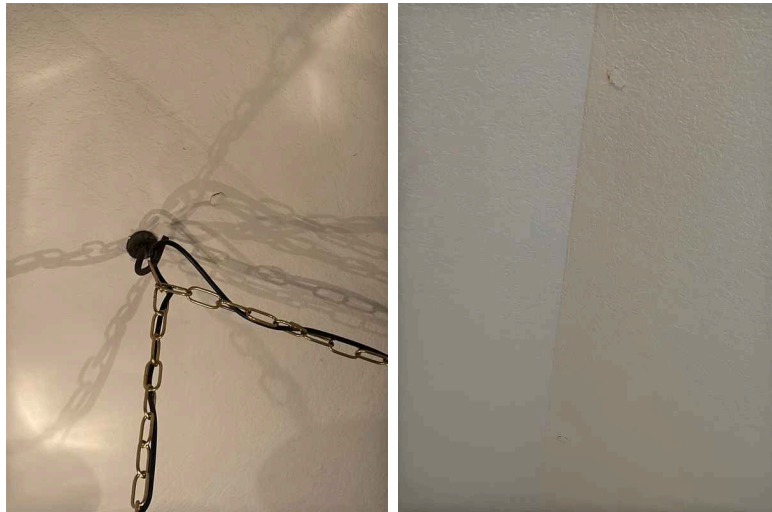
2: Nailpops

Nailpops, which are typically cosmetic in nature, were noted. We recommend these be re-secured, caulked and painted.

Recommendation: Contact a qualified drywall contractor.

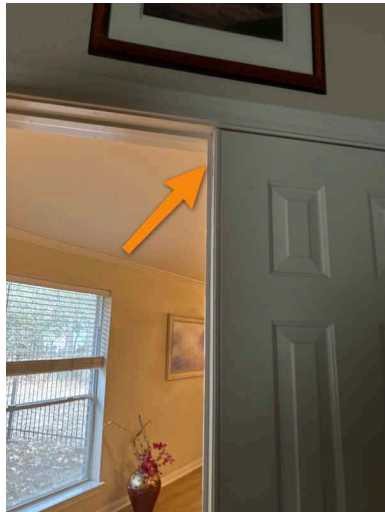
Example Office

A door would not latch when shut. We recommend having the door and/or hardware adjusted.

Recommendation: Contact a qualified professional.

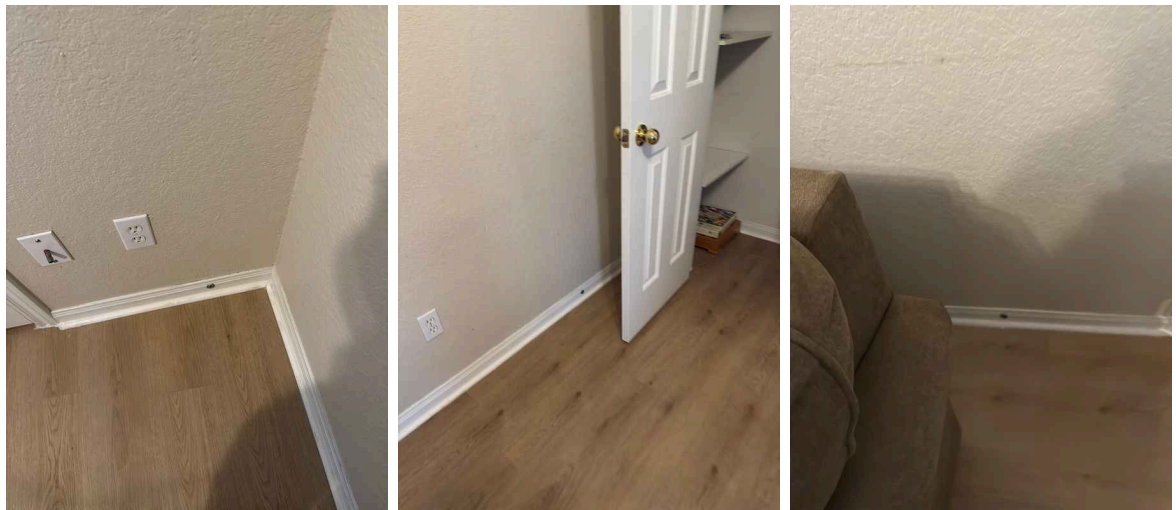
2: Damaged / Missing / Improperly Aligned Door Stop

Damaged/missing/improperly aligned door stops were noted. We recommend repair/replacement as needed to prevent cosmetic damage.

Recommendation: Recommended DIY Project

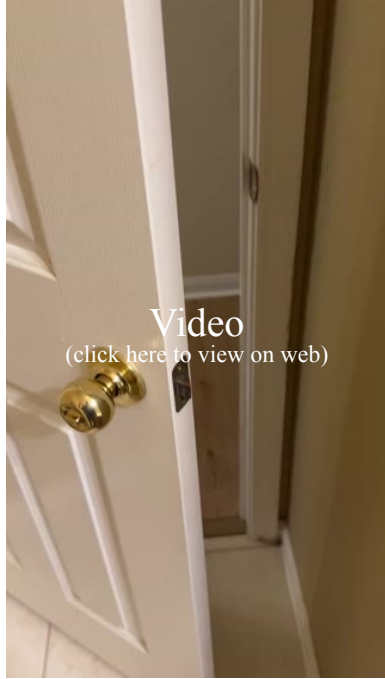
3: Damaged / Inoperative Hardware

Damaged/inoperative door hardware was noted. We recommend having this repaired or replaced.

Recommendation: Contact a handyman or DIY project

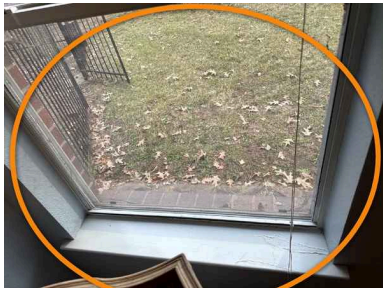
Example Primary Bedroom

The exterior and interior caulk around the windows was deteriorated and/or insufficient. We recommend repair. Exterior caulking is the first energy efficient measure to install. The purpose of exterior caulking is to minimize air flow and moisture through cracks, seams, utility penetrations and openings. Controlling air infiltration is one of the most cost effective measures in modern construction practices, a home that is not sealed will be uncomfortable due to drafts and will use about 30% more heating and cooling energy than a relatively air-tight home. In addition, good caulking and sealing will reduce dust and dirt in the home and prevent damage to structural elements.

Recommendation: Contact a handyman or DIY project

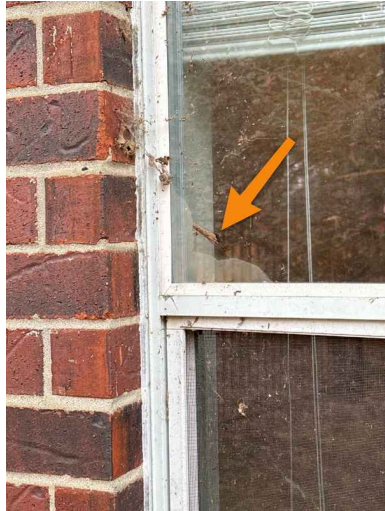
Example Left Exterior

One or more windows had lost its seal and/or experienced low-E failure. This had resulted in condensation/discoloration developing between the panes of glass. This is primarily a cosmetic deficiency, but can cause the window to lose some of its insulating properties. We recommend having the glass replaced as needed.

Recommendation: Contact a qualified window repair/installation contractor.

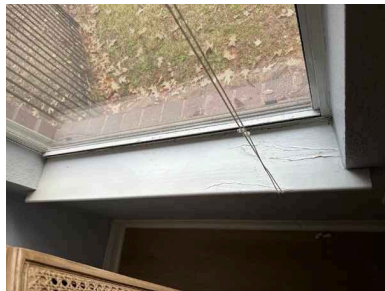
Example Primary Bedroom

Moisture staining/damage was noted near or at the sills however they were dry at the time of inspection. This appeared to be the result of build up condensation between the windows and closed blinds. We recommend opening/lifting the blinds on a daily basis to allow proper ventilation and drying.

Recommendation: Contact a qualified professional.

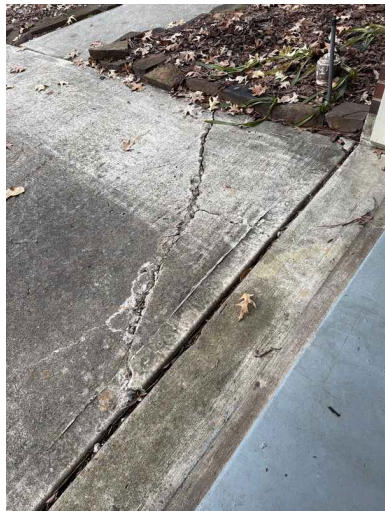
2: Driveway / Walkway Cracks With Displacement

The driveway and/or walkways had one or more cracks with displacement. These presented a trip hazard. We recommend having them repaired.

Recommendation: Contact a qualified concrete contractor.

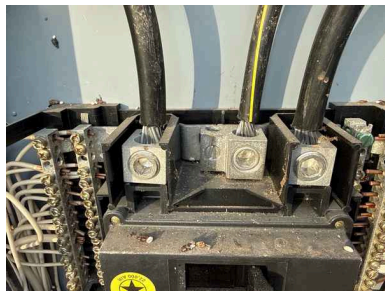
2: Missing Anti-oxidant Paste

Anti-oxidant was missing. Conductor termination compounds are for use on splice and termination connections of aluminum, copper-clad aluminum, and copper conductors and are intended to retard oxidation at the conductor/connector interface. These compounds do not have a deleterious effect on the conductor metal, insulation or equipment when used in accordance with the manufacturer’s installation instructions. Reference should be made to the product label located on the smallest unit container for specific instructions as to the proper use of the compound. We recommend having anti-oxidant paste added to prevent corrosion. Although neither the National Electrical Code nor the panel manufacturer may require this, our State Licensing Board obligates us to note this as a deficiency.

Recommendation: Contact a qualified professional.

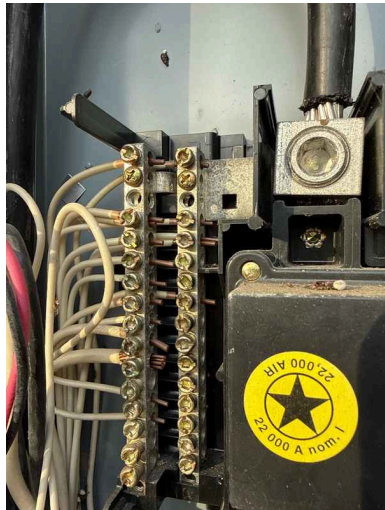
4: Double Tapping on Neutral Bus Bar

Double-tapping, a condition commonly used to describe multiple conductors being installed under the same terminal, was found at a neutral bus bar. In 2002, the National Electrical Code changed the standards to discontinue this practice. Houses built prior to 2002 were not required to change their panels; however, if any electrical work is done on the panel, it will typically be required for the electrician to bring this condition into compliance.

Recommendation: Contact a qualified professional.

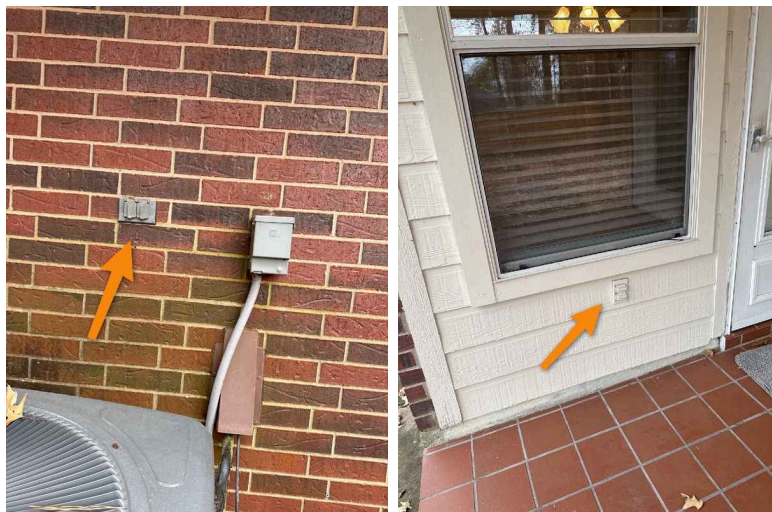
Example Rear Exterior

2: Exterior Outlet / Switch Needs Weatherproof Housing

Today's standards typically require exterior outlets/switches exposed to the elements to be housed in a bubble - style cover. We recommend to upgrade or repair covers as needed.

Recommendation: Contact a qualified electrical contractor.

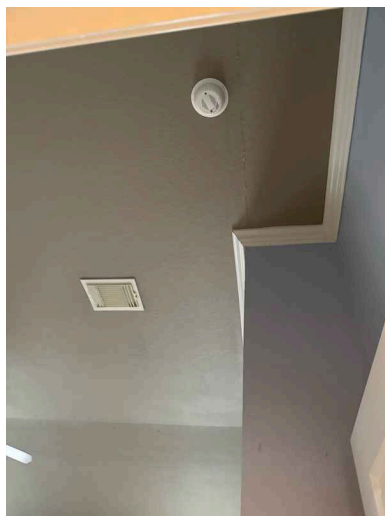
Example Primary Bedroom

Smoke detectors failed to sound when tested. Recommend to replace batteries and retest.. further repairs may be required.

Recommendation: Contact a qualified professional.

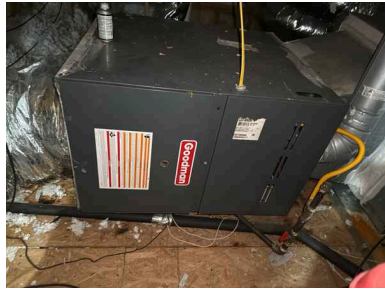
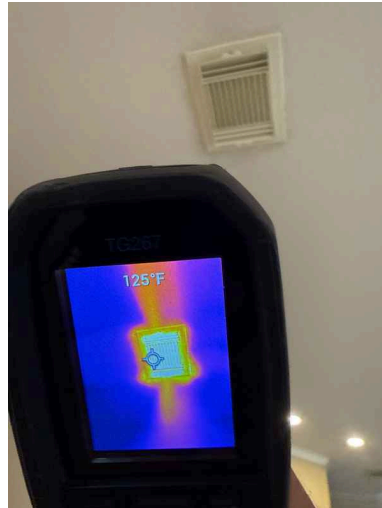
Unit 1: Photo of hot air temperature, Photo Manufactures Label

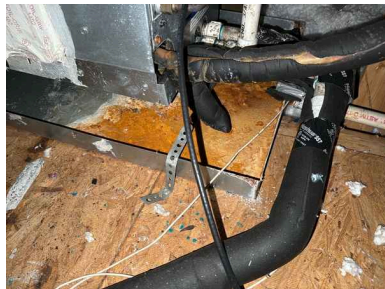
2: Rusted evaporative drain pan.

Rusted drain pans can be an indication of the primary line being clogged or a system not operating efficiently. Recommend to have evaluated and repaired by a licence HVAC technician. Replacement of the drain pan and flushing of the lines may be required.

Recommendation: Contact a qualified HVAC professional.

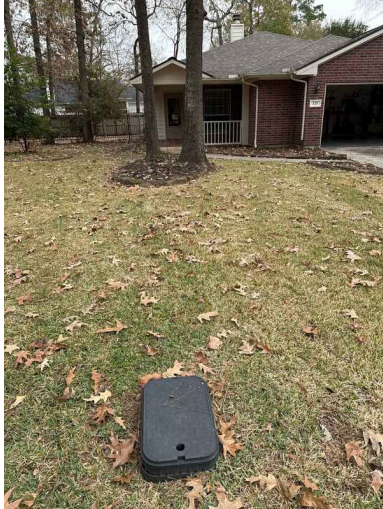
Photo of Location of Water Meter: Front Yard

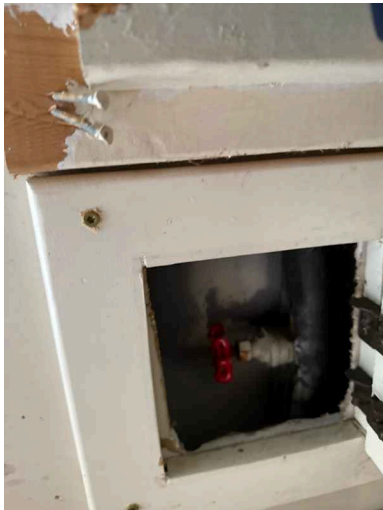
Photo of Location of Main Water Supply Valve : Garage interior wall

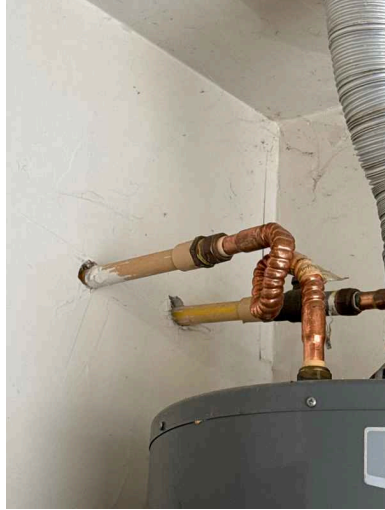
Photo of Type of Supply Piping Material: PVC, CPVC

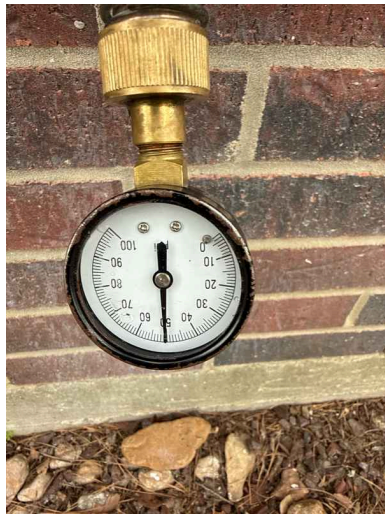
Photo of Static Water Pressure Reading: 50 PSI

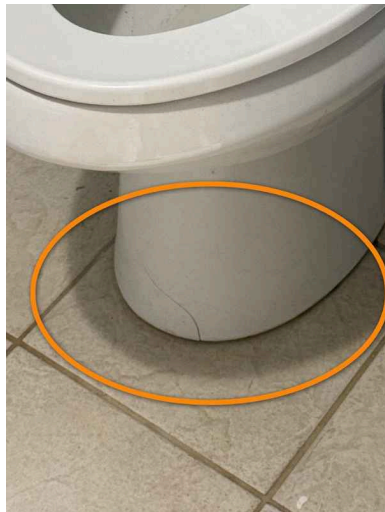
Example Guest Bathroom

1: Caulk around toilet

Recommend sealing toilet to the floor.

Recommendation: Contact a qualified professional.

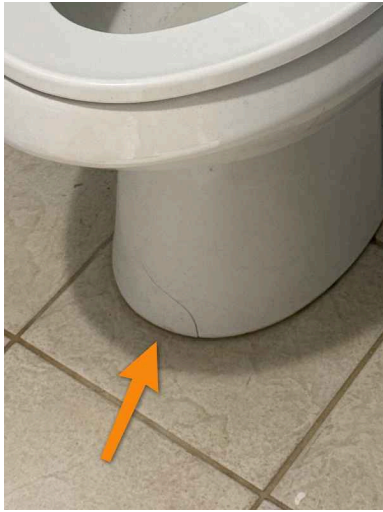
Example Primary Bathroom

2: Toilet Cracked

The toilet is cracked and should, ideally, be replaced.

Recommendation: Contact a handyman or DIY project

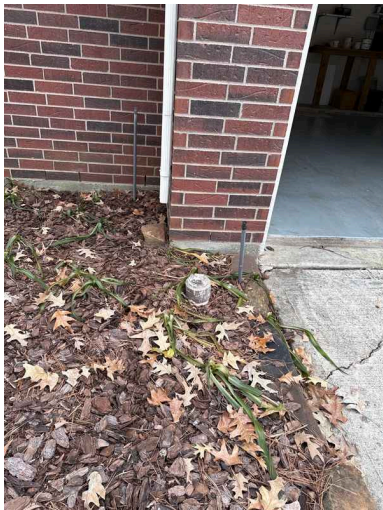
Photo of the Location of sewer drain cleanout: Front

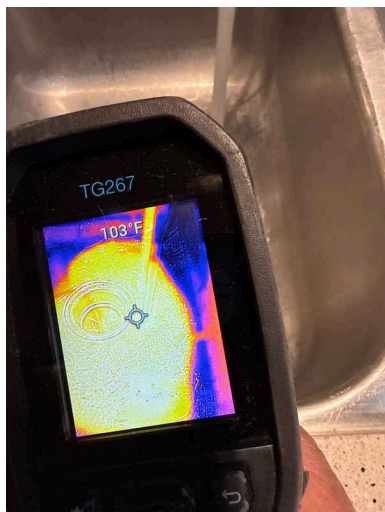
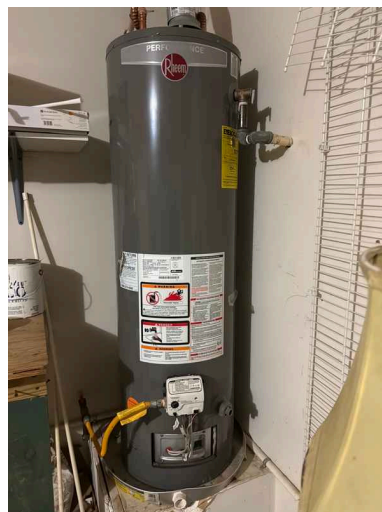
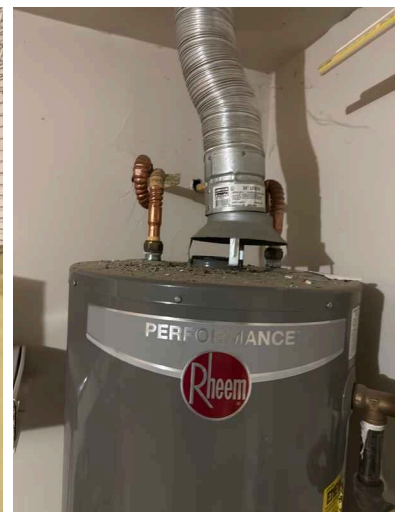
Photos Unit 1: Hot water temperature, Manufacture Label, Top of Unit Capacity

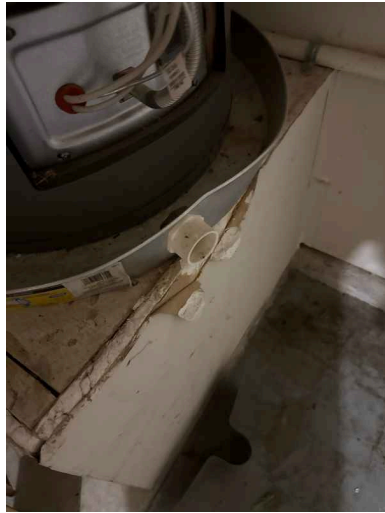
1: Drain Pan - Missing Drain Line

The water heater safety pan terminated in the room and did not have a drain line to the exterior. We recommend having a drain line installed to prevent damage to the structure in the event of a leak.

Recommendation: Contact a qualified professional.

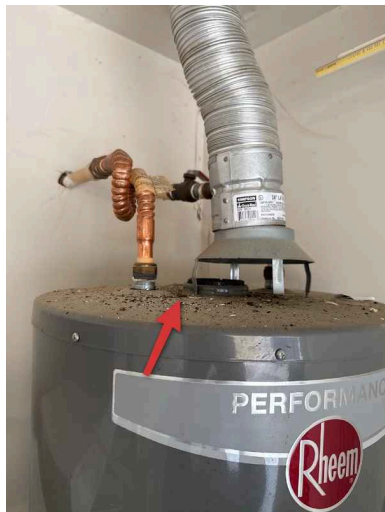
2: Exhaust Flue - Improper

Recommendation: Contact a qualified professional.

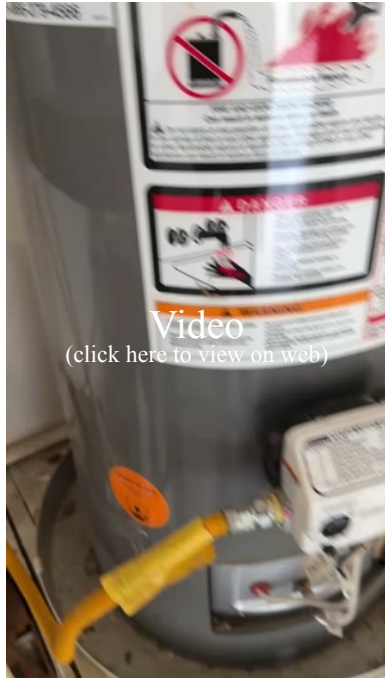
3: Rotten egg smell (water heater)

Recommendation: Contact a qualified professional.

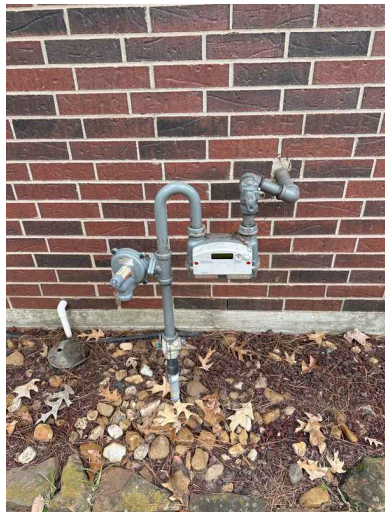
F. Gas Distribution Systems and Gas Appliances
Location of Gas Meter: Right Exterior Wall

Type of Gas Distribution Piping Material: Black Steel
Comments:

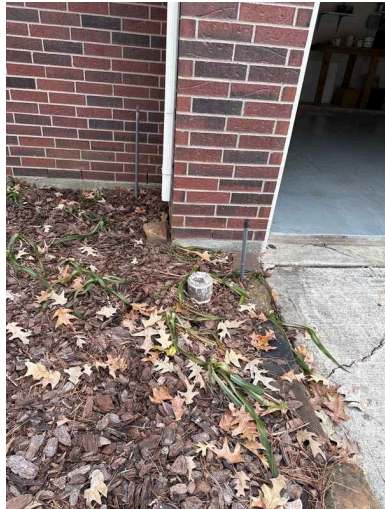
Photo of Sewer Scope Point of Entry: Main Cleanout

Client Approved Sewer Scope: The main sewer line from the point of entry toward the public connection was inspected. We recommend having regular maintenance/inspection performed every three to five years and cleaned as needed.

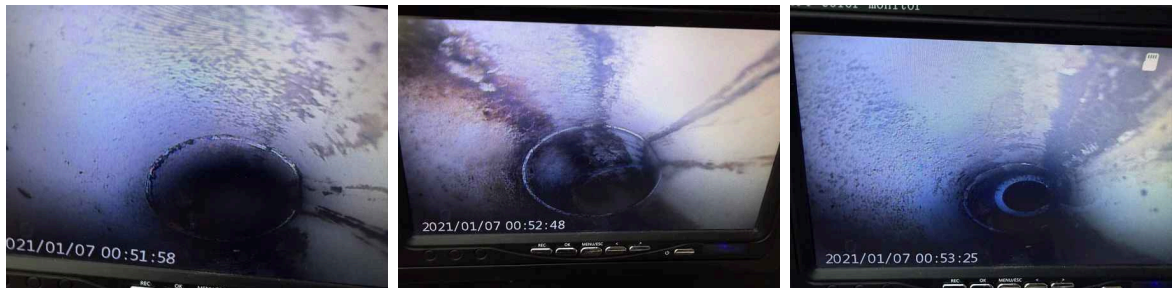
Photos of Sewer Scope: Photos of sewer scope

Material Type: PVC -

The main drain line appeared to be made of the following material(s).

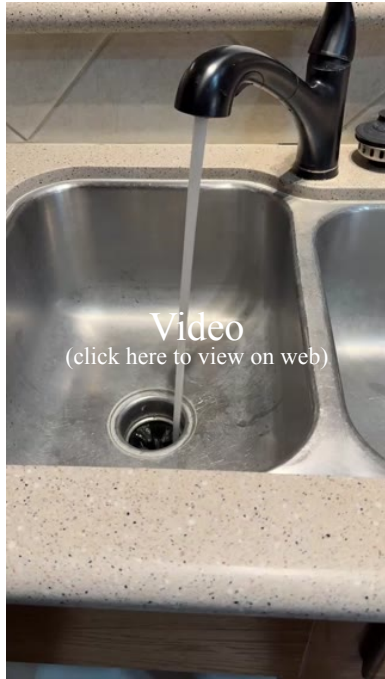
Videos of each unit being operated

The garbage disposal was excessively noisy, may have worn components and may need to be replaced soon.

Recommendation: Contact a qualified professional.

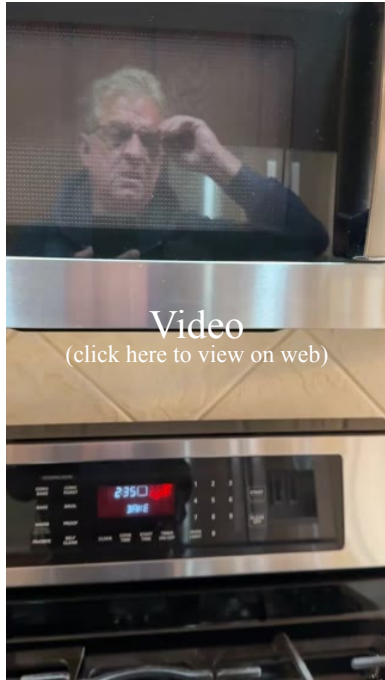
Installation of the range hood vent was incomplete at the time of the inspection. We recommend having this further evaluated for functionality once installation has been completed.

Recommendation: Contact a qualified professional.

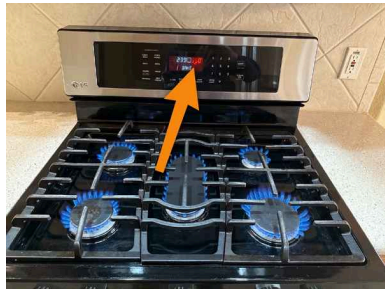
The digital display at the oven was not operating as designed and made it difficult to read. We recommend repair.

Recommendation: Contact a qualified professional.

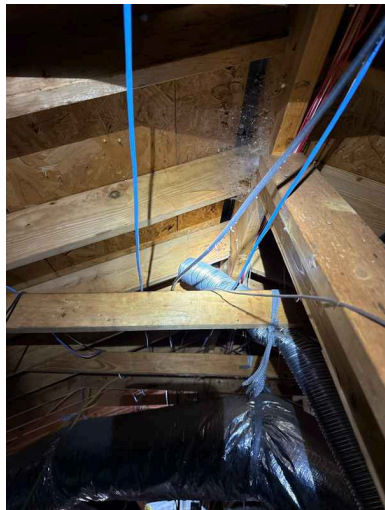
One or more bathroom exhaust vents terminated in the attic space. This condition is improper and will introduce excessive amounts of moisture to the attic space. Excessive moisture deposited into the attic may result in damage to home materials from decay or lead to organic growth. Exhaust vents should terminate at the home exterior. We recommend correction by a qualified contractor.

Recommendation: Contact a qualified professional.

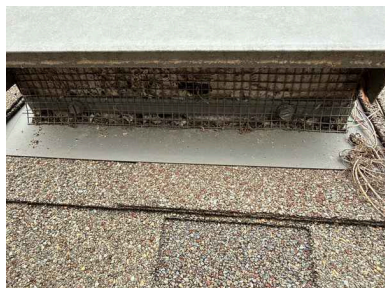
Photo of Dryer Vent:

Experts say dryer exhaust vents should be inspected and cleaned at least once a year. Depending on the size of the household and dryer usage more frequent cleaning may be required. We recommend to clean and remove any debris from vents before move in.

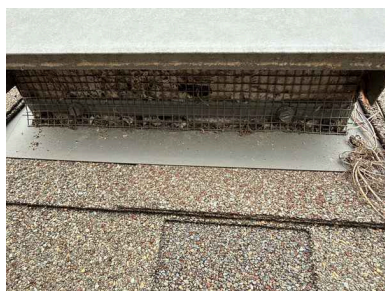
1: Dryer Vent Dirty

The dryer vent had lint build up on the interior of the exhaust duct. This in turn could lead to clogging of the dryer vent, preventing proper drying of the clothes and overheating of the dryer, which are potential fire hazards. We recommend having the dry vent cleaned.

Recommendation: Contact a qualified professional.

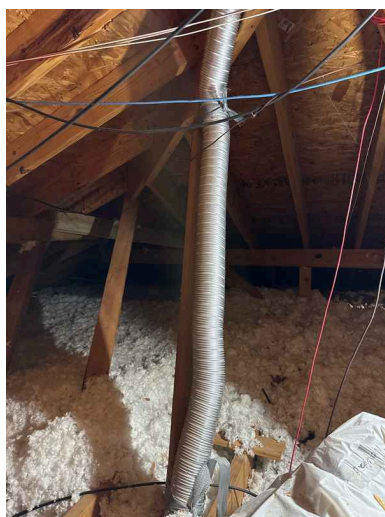
2: Improper Vent Connector Material

Dryer vent installed using improper vent connector material.

Recommendation: Contact a qualified professional.
