LAKESIDE HOME INSPECTIONS

LAKESIDE HOME INSPECTION REPORT

7983 Ethel St
Houston, TX 77028

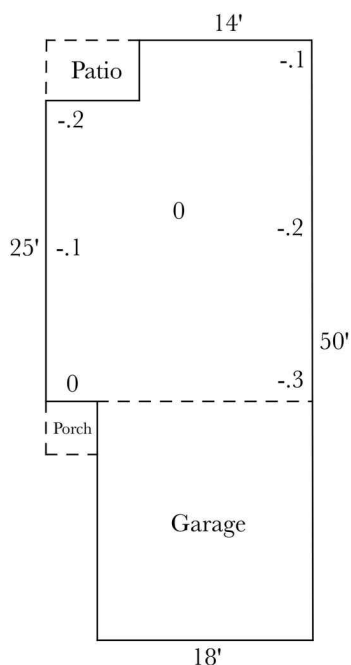
Foundation performance: Functioning as intended:

The foundation integrity appears to be performing the function intended. No visible differential movement was noted at the interior and exterior of the structure.

Note: Zip level readings were within normal ranges. View rendering for reference.

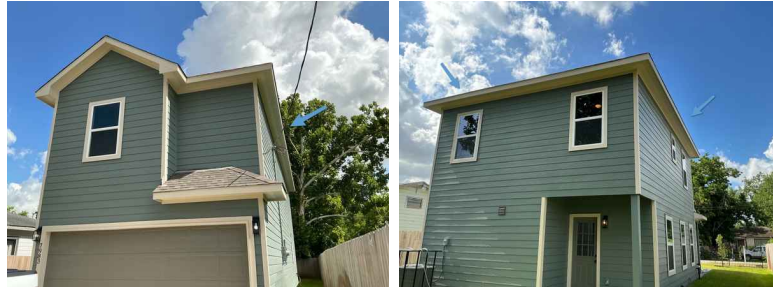
1: Grading and drainage: Gutters absent

All roof slopes

Missing gutters were observed during the home inspection. Gutters are an essential component of the home's drainage system, and their absence can cause water damage to the foundation and exterior walls. The lack of gutters can also result in soil erosion and damage to landscaping. It is recommended that the missing gutters be installed by a qualified professional to prevent water damage and maintain the integrity of the home's structure."

Recommendation: Contact a qualified professional.

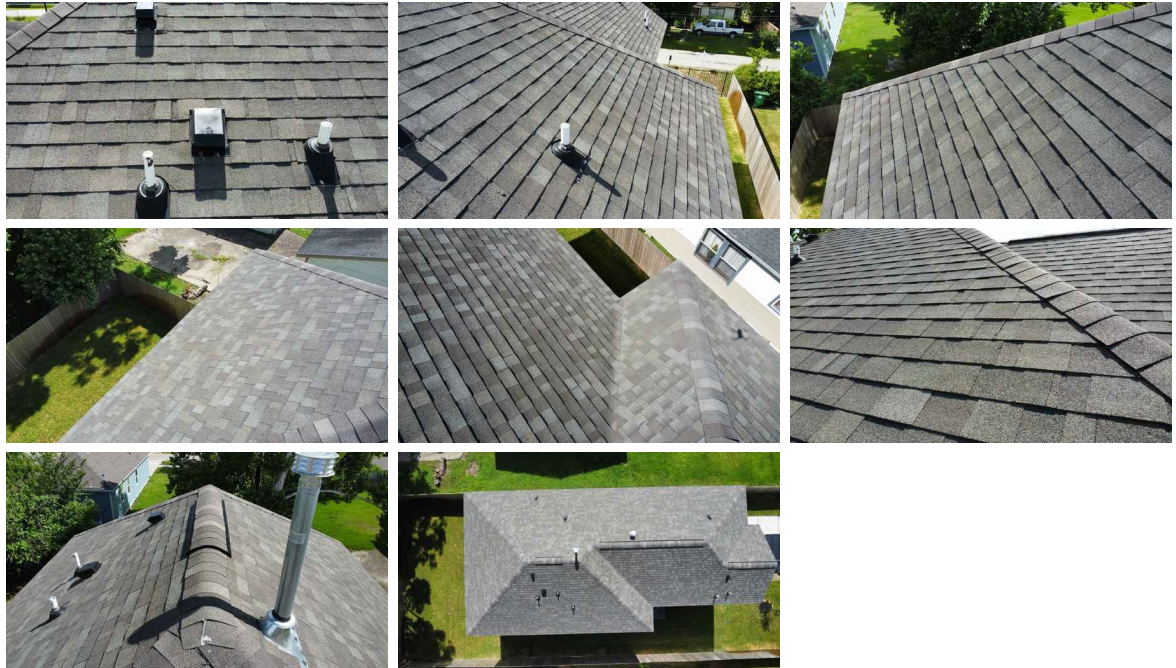
1: Shingles: Lifting/Loose

Multiple shingles were observed to not be properly secured. This could cause lifting of the shingle in the case of high winds or possible moisture intrusion. Recommend contacting a professional roofer to evaluate and determine the extent of repairs needed.

Recommendation: Contact a qualified professional.

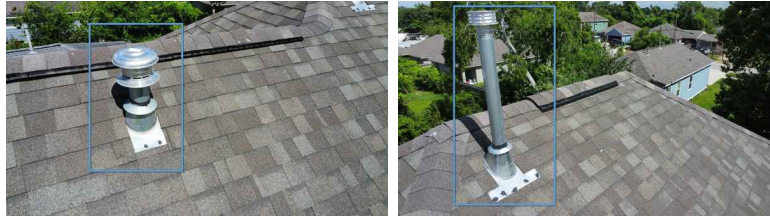
2: Roof covering: Unpainted materials

Several locations including exposed flashing, vents assemblies, and/or plumbing vents were observed to have not been painted. All areas exposed above the roofline are required to be properly painted to avoid premature deterioration. Recommend correction or remedy as needed.

Recommendation: Contact a qualified professional.

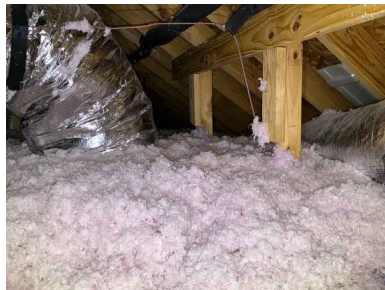
Approximate Average Depth of Insulation: 12 12 inches -

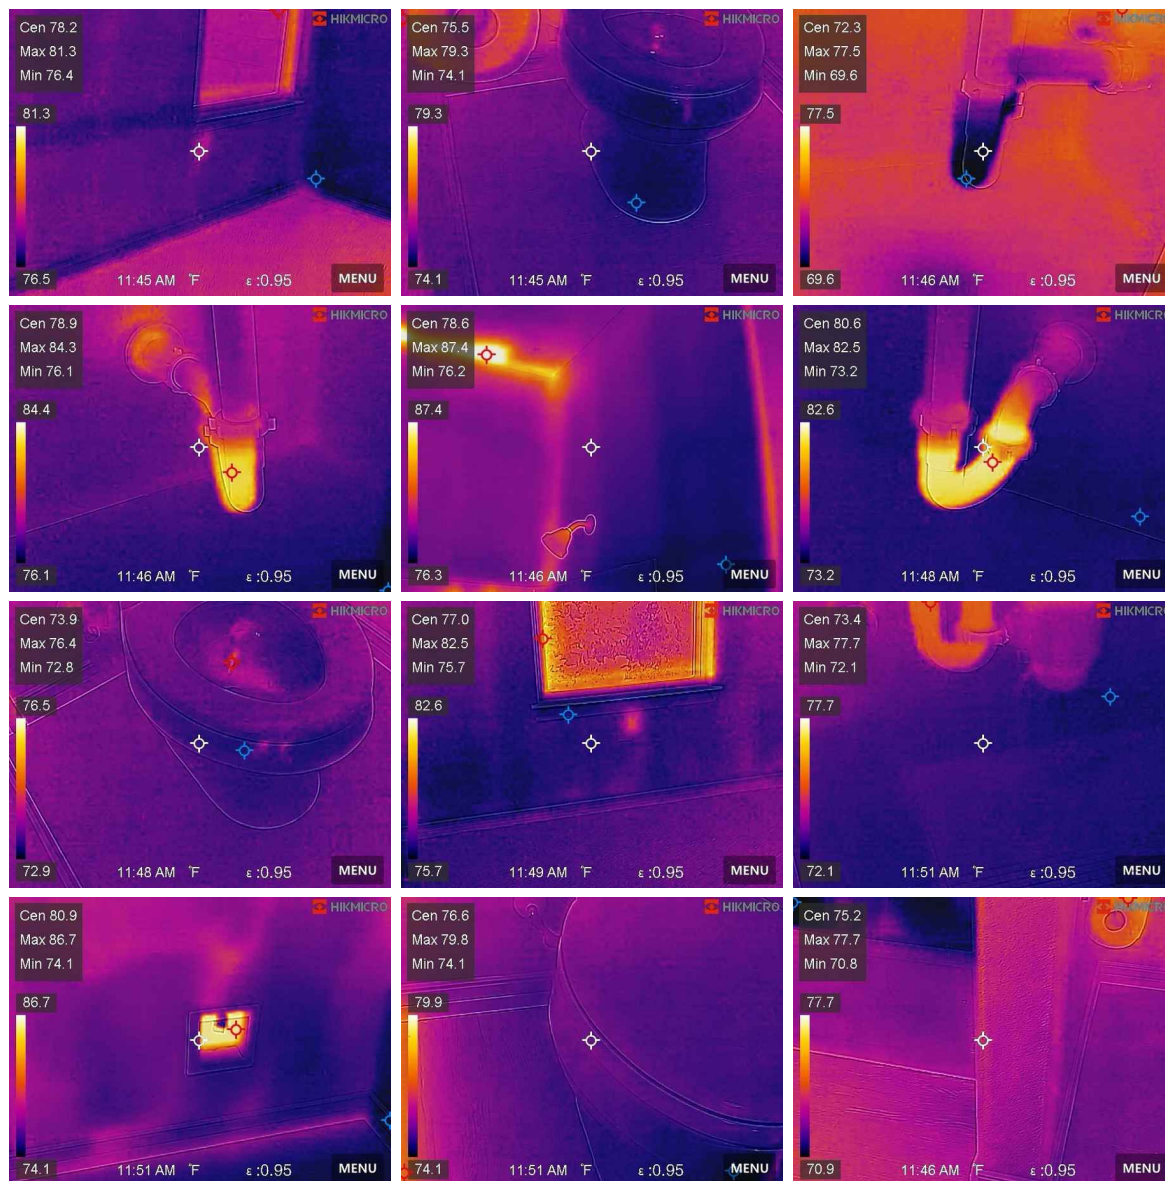
Thermal imaging scan:

A FLIR thermal imaging camera was used to scan the walls at the time of the inspection. Thermal imaging uses an infrared camera to detect temperature changes within a home by showing thermal differences along the color spectrum. With a thermal imaging camera, a scan of the home reveals pockets of energy or heat loss that need to be fixed. These pockets could be created by roof leaks, missing insulation, or airtightness issues.

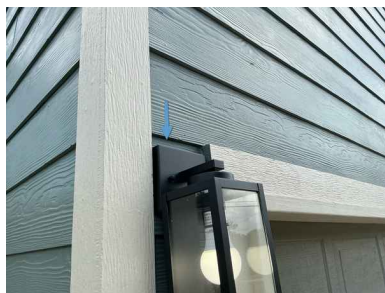
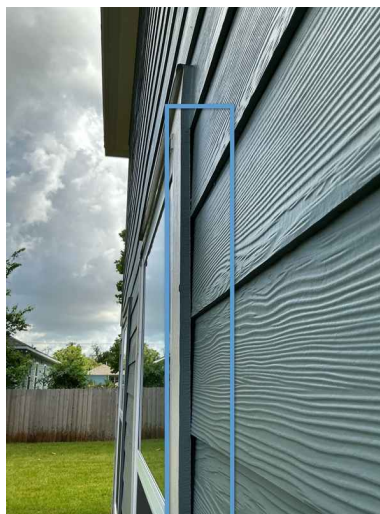
1: Walls: Caulking and sealing needed

The following locations were observed to be in need of sealing. Recommend these areas be properly sealed to avoid moisture intrusion.

- Light fixtures
- Around windows

Front

Left

Recommendation: Contact a qualified professional.

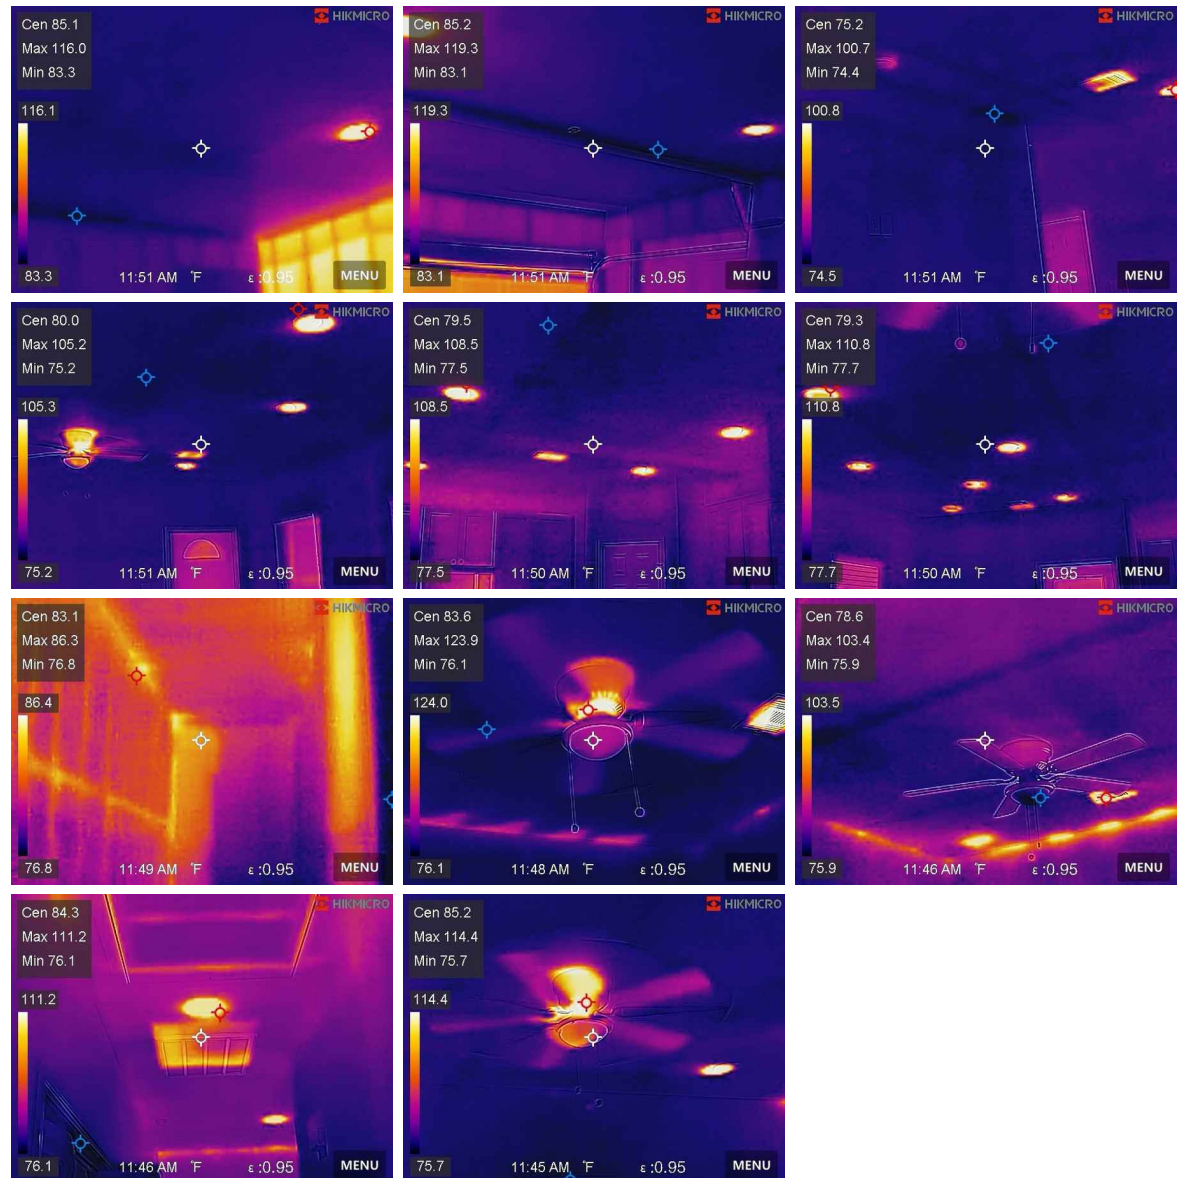
Thermal imaging scan:

A FLIR thermal imaging camera was used to scan the ceilings and floors at the time of the inspection. A FLIR thermal imaging camera was used to scan the ceiling at the time of the inspection. Thermal imaging uses an infrared camera to detect temperature changes within a home by showing thermal differences along the color spectrum. With a thermal imaging camera, a scan of the home reveals pockets of energy or heat loss that need to be fixed. These pockets could be created by roof leaks, missing insulation, or airtightness issues.

All portions of the ceiling and floors or performing as it intended at the time of the inspection. The thermal imaging camera shows no signs of any moisture intrusion at the time of inspection.

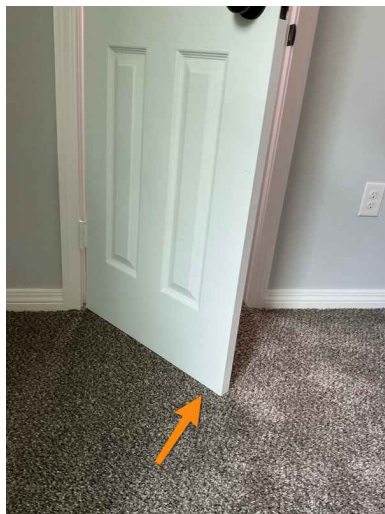
1: Interior door: Binding/Rubbing

A 2nd floor bedroom door was observed to bind/rub when attempting to close. Binding can be caused by several factors, such as hinges that are loose, worn, or improperly installed as well as door frames that are out of square or warped. Recommend contacting a qualified contractor to evaluate and determine the extent of repairs needed.

2nd Floor Bedroom

Recommendation: Contact a qualified professional.

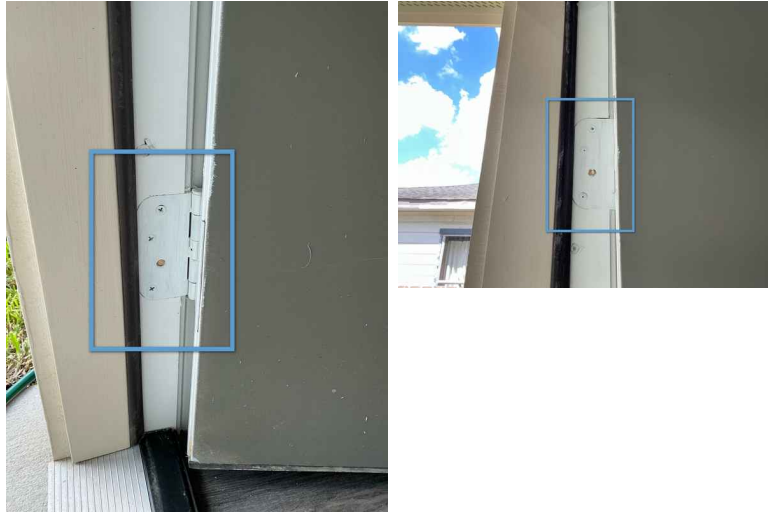
2: Doors: Missing hinge screws

The front and rear exterior doors were observed to be missing screws at the hinges. Recommend installation by the builder.

Recommendation: Contact a qualified professional.

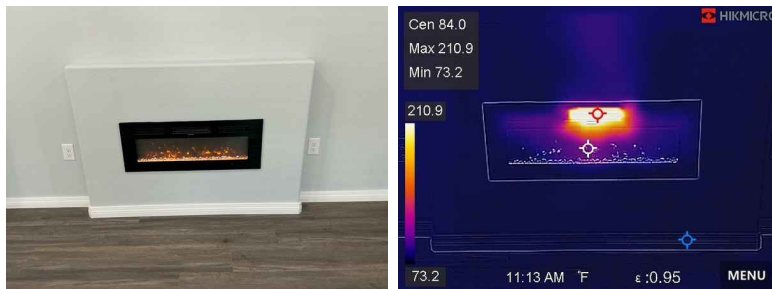
Fireplace: Performing as intended:

All portions of the fireplace/chimney or performing as intended at the time of the inspection.

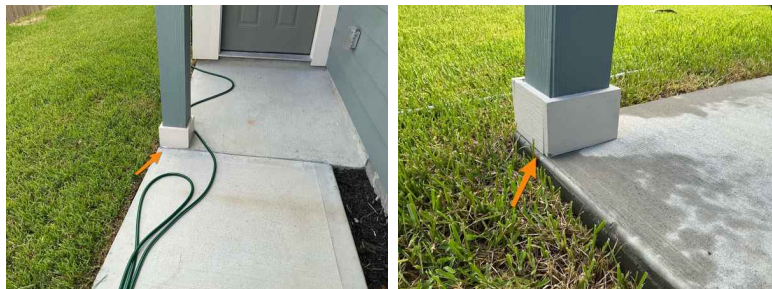
1: Patio: Wood/siding post in contact w grade/concrete

Wood/siding posts at the patio covering were in direct contact with the grade/concrete. This can lead to excessive moisture at the base and wood rot. Recommend correction to avoid possible moisture penetration.

Recommendation: Contact a qualified professional.

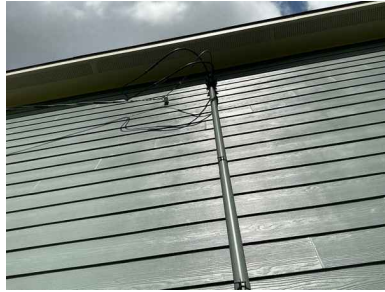
Service entrance method: Overhead

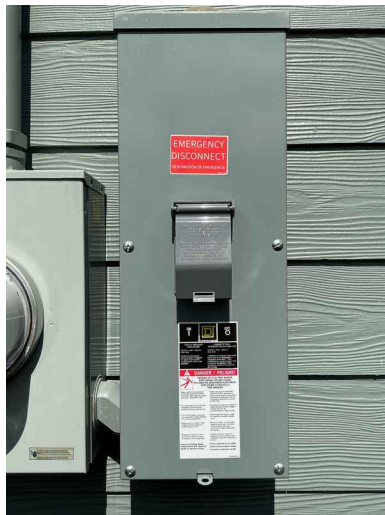
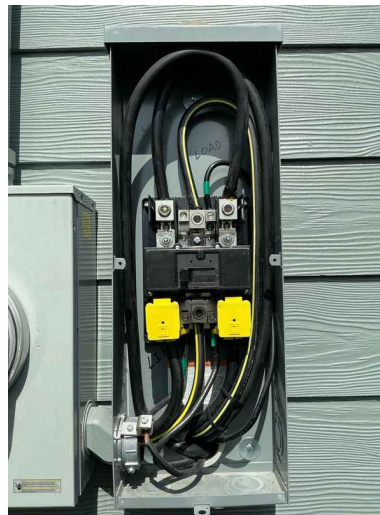
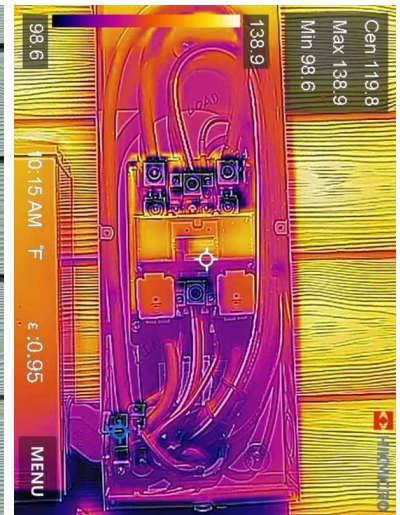
Service entrance method: Underground

Service size: 200 amps

Wire material: Aluminum

Right exterior

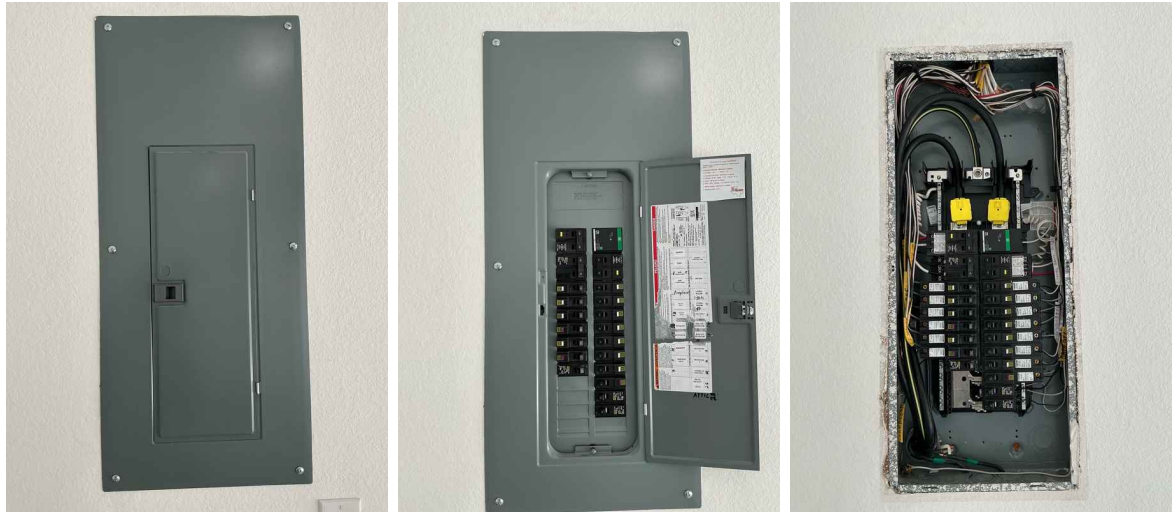
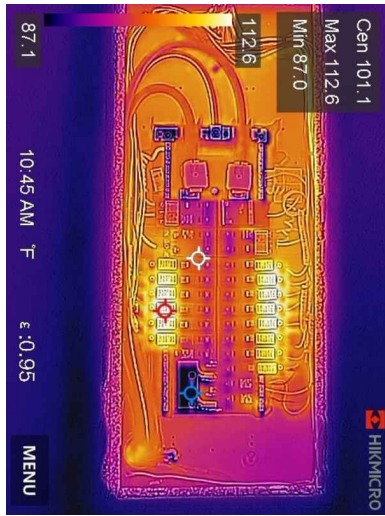
Photo of distribution panel:
Garage

Electrical Panel: Performing as intended:

All portions of the service entrance and panel was performing as intended at the time of inspection.

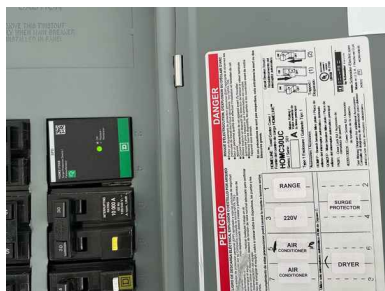
Additional information: Surge protection:

The home is equipped with whole home surge protection.

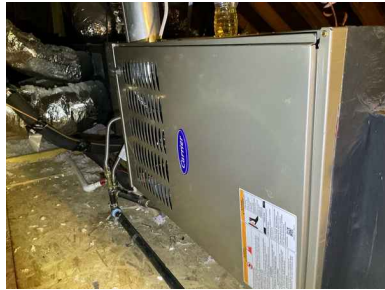
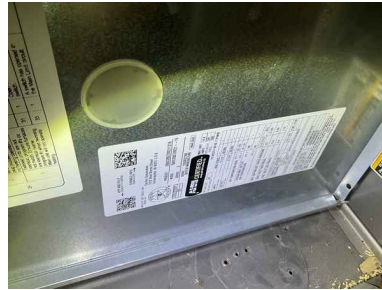
Source: Natural gas

Mfd. date: 2025

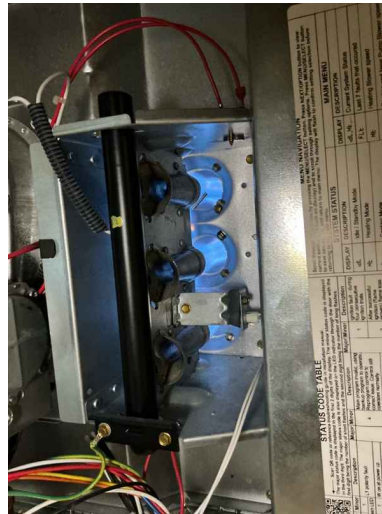
Heating equipment: Performing as intended:

All portions of the heating equipment appear to be performing as intended at the time of the inspection.

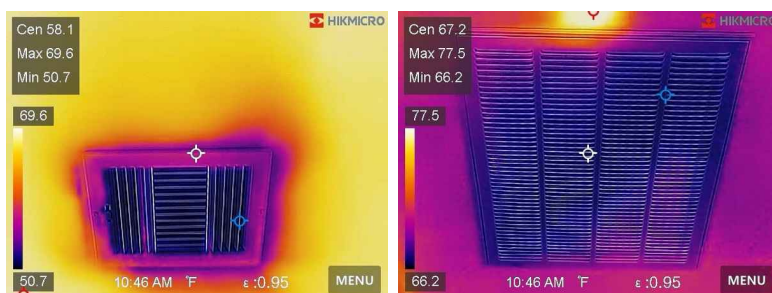
Ambient air test:

Ambient air test was performed by using thermometers on air handler of the systems to determine if the difference in temperatures of the supply and return air are between 15° and 25° which indicates unit is cooling as intended.

Supply temperature: 50 degrees F

Return temperature: 66 degrees F

Temperature differential: 16 degrees F

The system was cooling as intended at the time of the inspection.

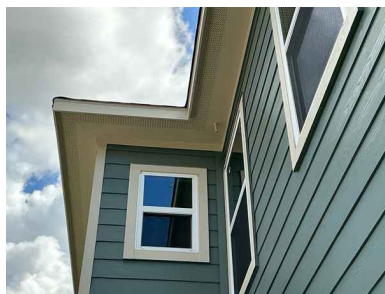
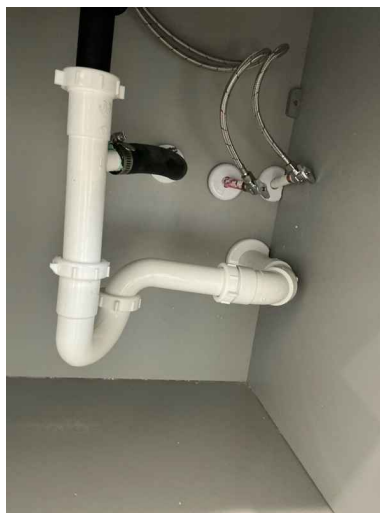
Primary condensate line is located in the primary bathroom

Secondary condensate drain line is located at the front exterior.

Front

'Primary bathroom

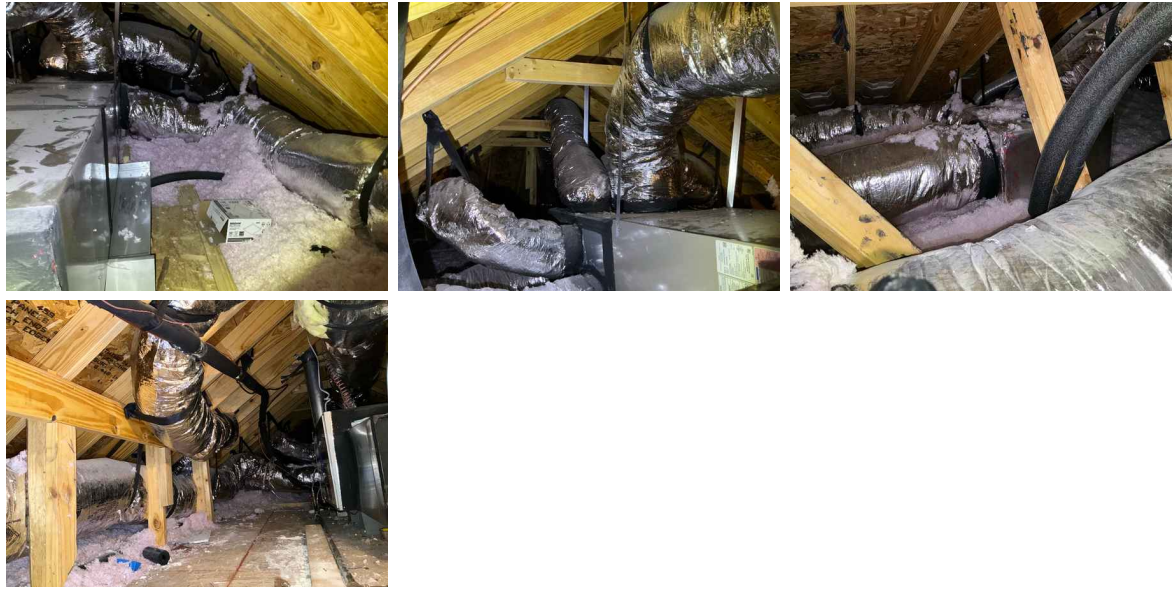
Ducts: Performing as intended:

All visible portions of the ducts were appeared to be in overall good condition and performing as intended at the time of the inspection.

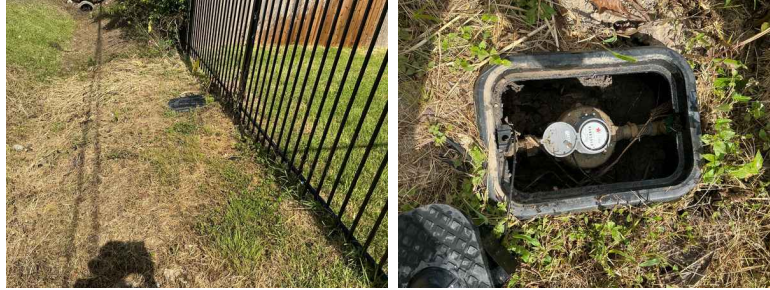
Location of Water Meter: Front yard near street

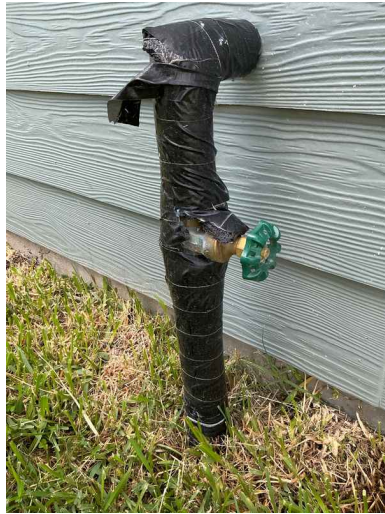
Location of Main Water Supply Valve : Left exterior

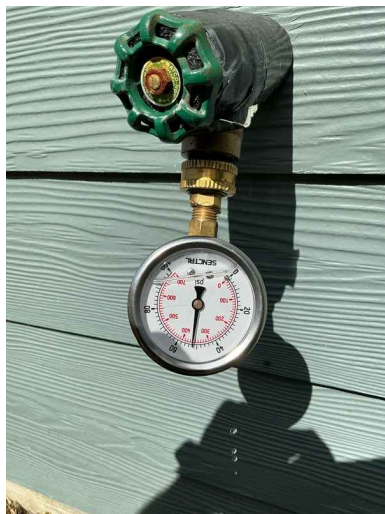
Static water pressure reading: 55 - 60 55-60 psi

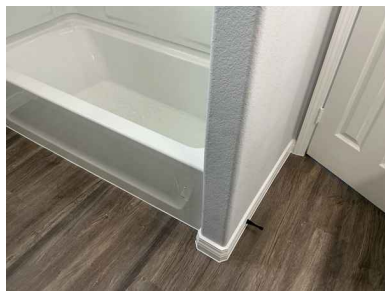
Inaccessible drains:

Multiple plumbing drains were inaccessible at the time of the inspection.

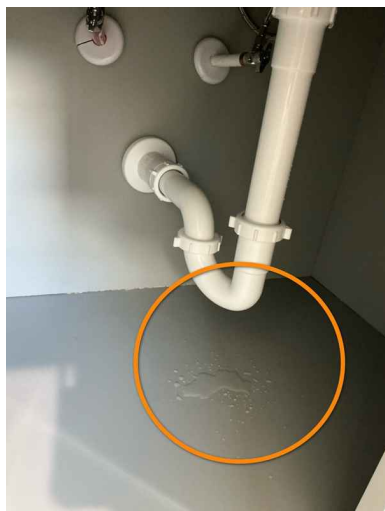
1: Drains: Active leak

The inspection revealed a leak in the plumbing drain system. Water was observed dripping from the drain pipe under 2nd floor hallway bathroom sink. If left unaddressed, this leak can lead to water damage and other related issues. Recommend contacting a licensed plumber to evaluate and determine the extent of repairs needed.

2nd Floor Bathroom

Recommendation: Contact a qualified professional.

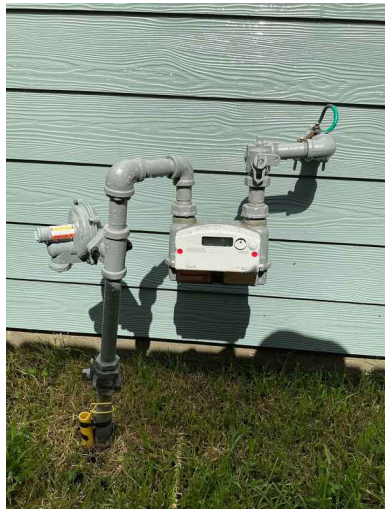
Gas distributions systems: Performing as intended:

All portions of the gas distribution system were performing as intended the time of the inspection.

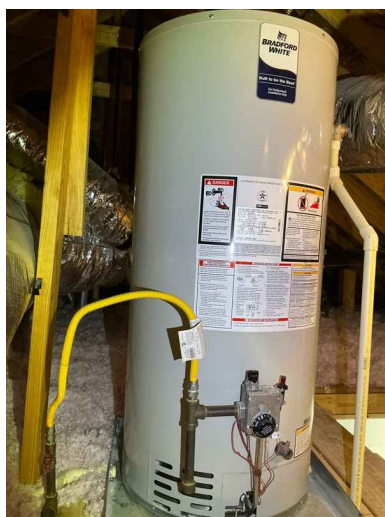
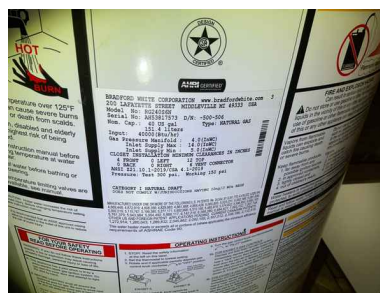
Water heater: Data labels:

Brand: Bradford White

Source: Natural gas

Size: 40 gallons

Mfd. date: 2024

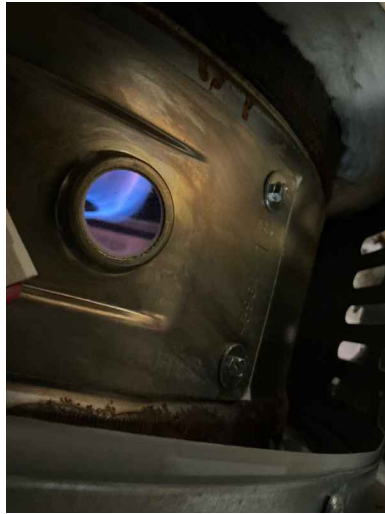
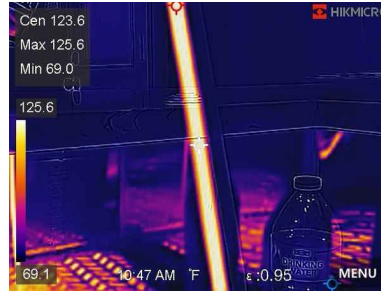
Water heater: Performing as intended:

All portions of the water heating equipment were observed to be performing as intended at the time of the inspection.

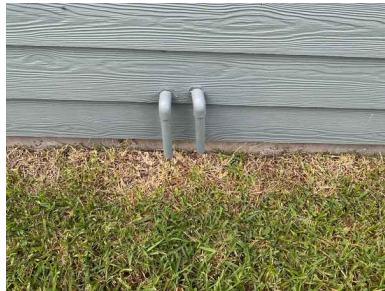
Left

Additional information:

Water heater drains are located at the left exterior.

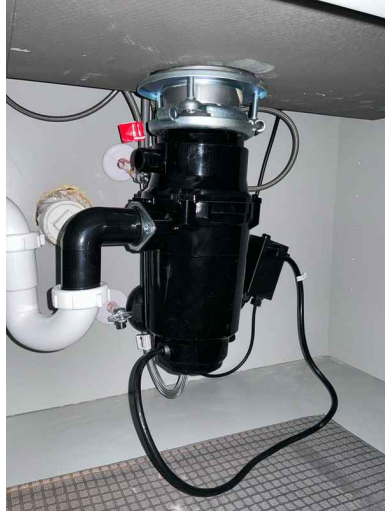
- B. Food Waste Disposers**
Food disposal: Performing as intended:
The food disposal was performing as intended at the time of the inspection.

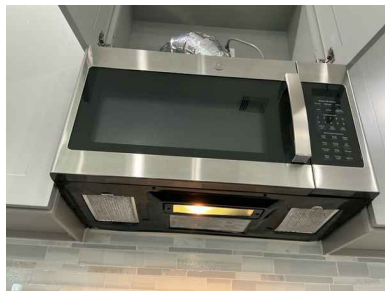
- C. Range Hood and Exhaust Systems**
Exhaust systems: Performing as intended:
All portions of the exhaust system or performing as intended at the time of the inspection.

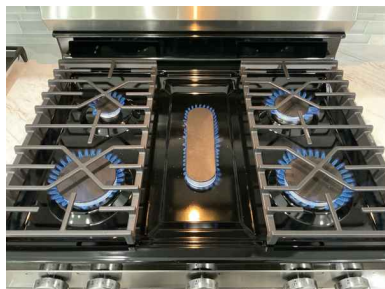
Range: Performing as intended:
All portions of the range were performing as intended.

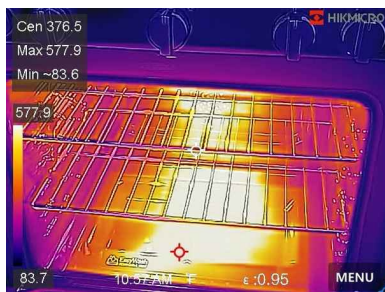
Oven: Performing as intended:
All portions of the oven was performing as intended at the time of the inspection.

Note: Testing of the oven was performed at 350 degrees.

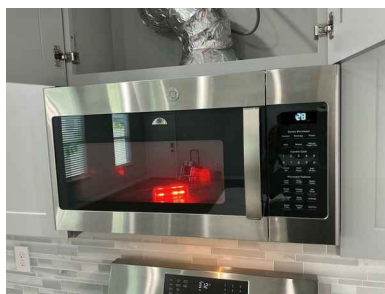
Note: Microwave magic light tool was used to test the unit. Red lights indicate the unit is heating properly.

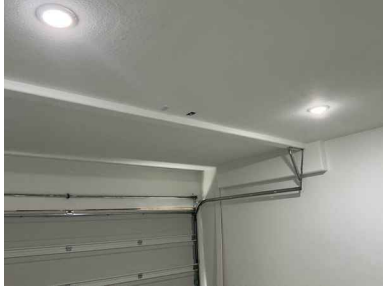
The garage door operator was not installed at the time of inspection.
