# PROPERTY INSPECTION REPORT FORM

02/24/2026 8:30 am

1814 Wagon Gap Trail, Houston, TX 77090

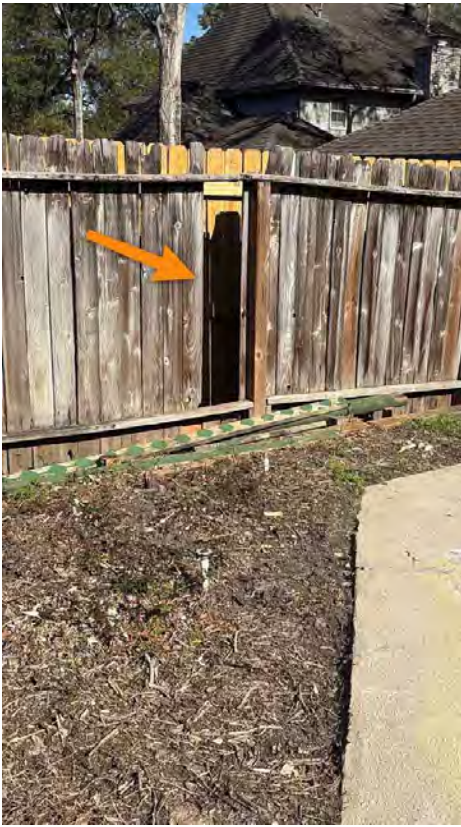
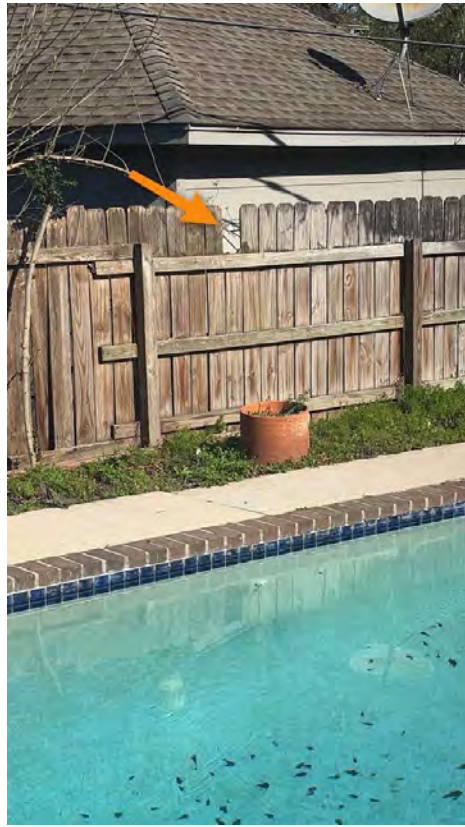
Exposed openings, damage and corrosion, leaning, gate openings or loosely fastened fence at time of inspection. The fence is not part of the home inspection. This is just a note to make you aware of the condition.

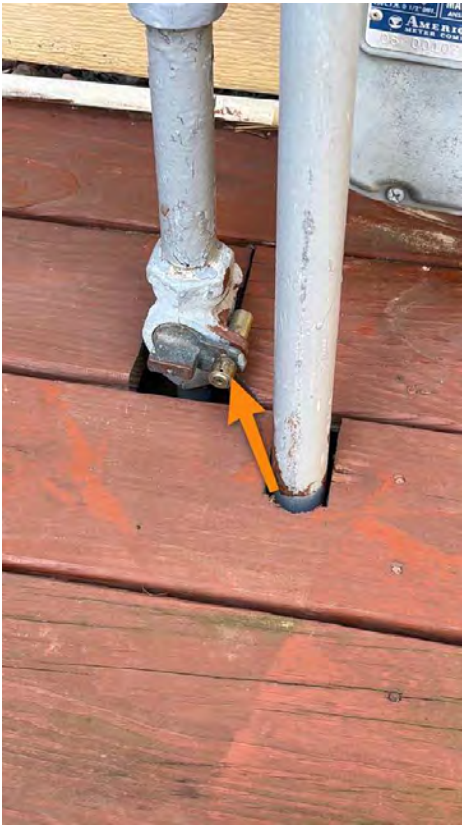
At time of inspection if all utilities are not provided certain equipment will not be tested for proper functionality due to lack of. Gas, electrical and water all need to be available to the home in order for the inspector to provide a full inspection of the property and the equipment that need those utilities. It is the responsibility of the seller, listing agent and buyers agent to ensure that the property has all utilities available prior to the actual inspection date. A return visit to check the items that were not fully inspected due to lack of certain utilities will incur a fee. The buyer will be responsible for all return fees.

Gas off and locked at meter

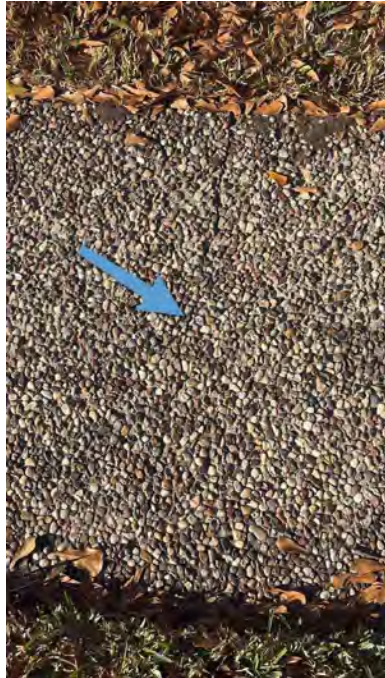
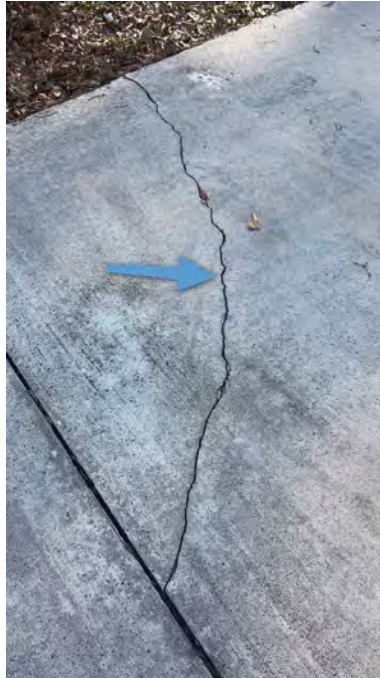
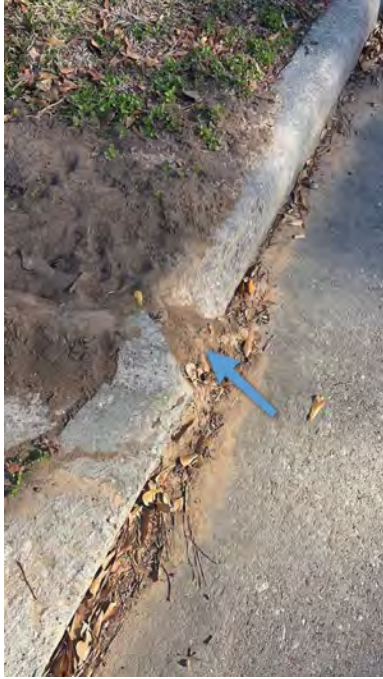
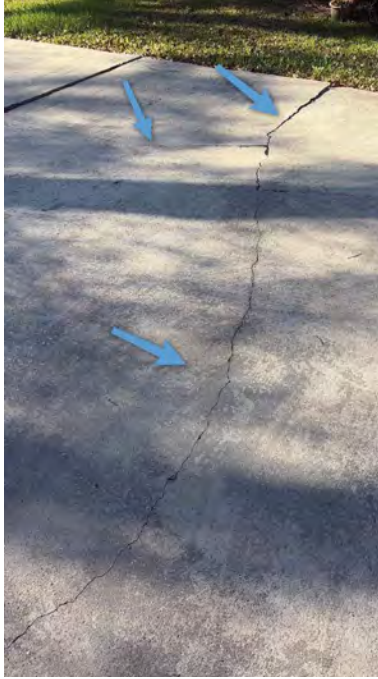
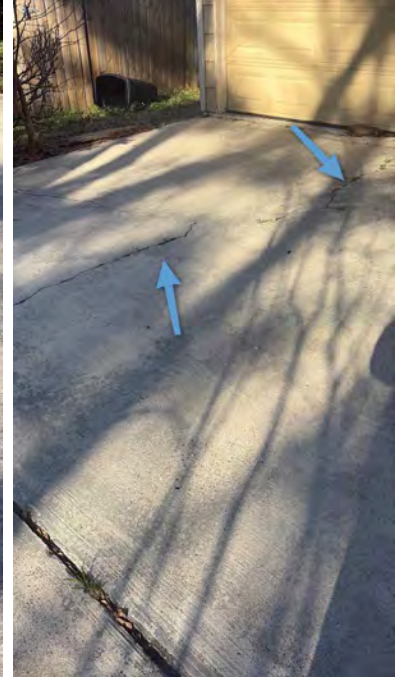
Observed damaged or cracked driveway, patio or other slab at time of inspection. Driveway and patio concrete slabs are not connected to homes foundation and is not as thick as the foundation slab. Cracks that are in close proximity to the foundation can allow moisture intrusion in impacted area and cause the soil to erode. Tree roots, heavy equipment, wear and tear, settlement and grading erosion all or individually contribute to causing concrete to crack.

Recommendation: Contact a qualified professional.

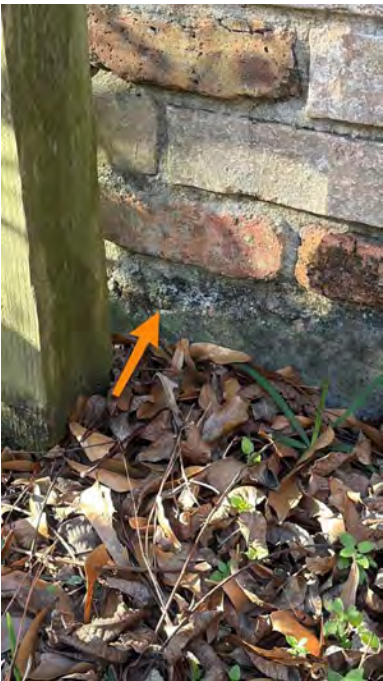
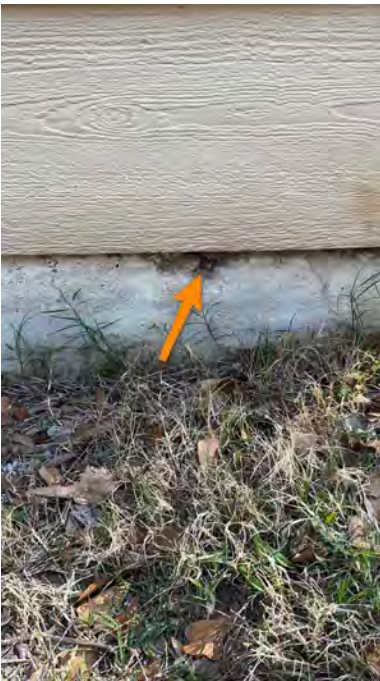
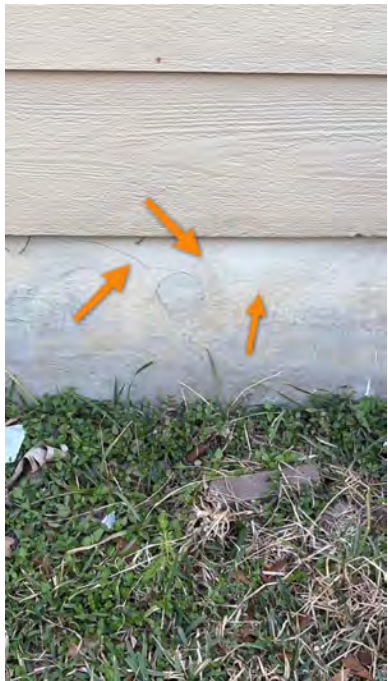
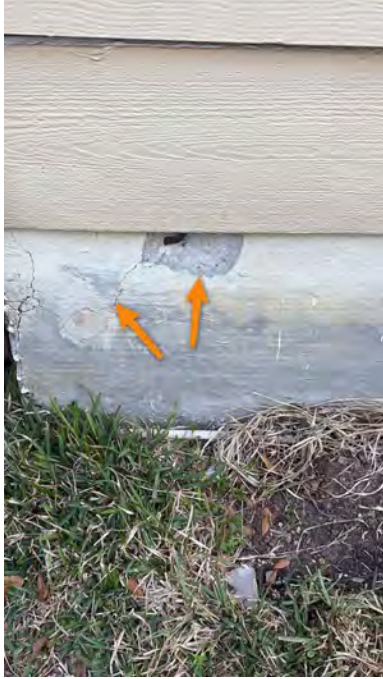
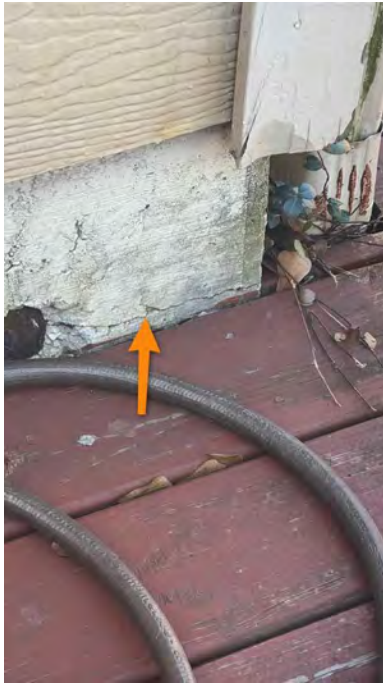
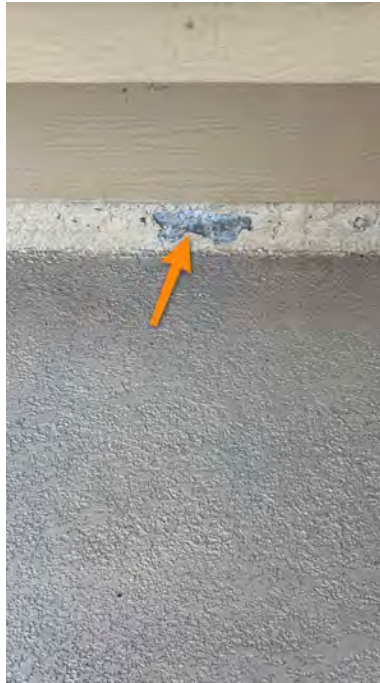
Right Side- chipped

Left Side- chipped

Recommendation: Contact a foundation contractor.

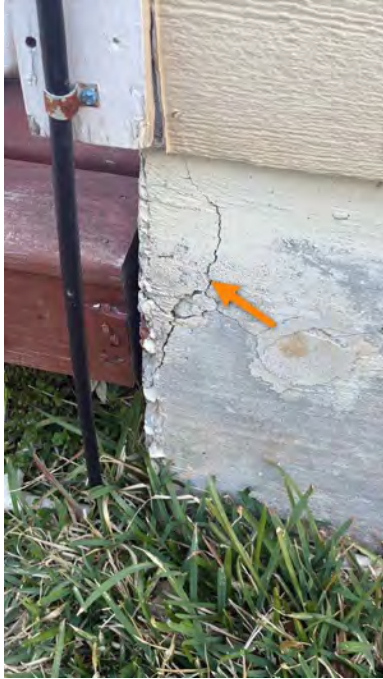
### 3: Foundation Cracks- Corner

Left Side/rear right corner

Recommendation: Recommend monitoring.

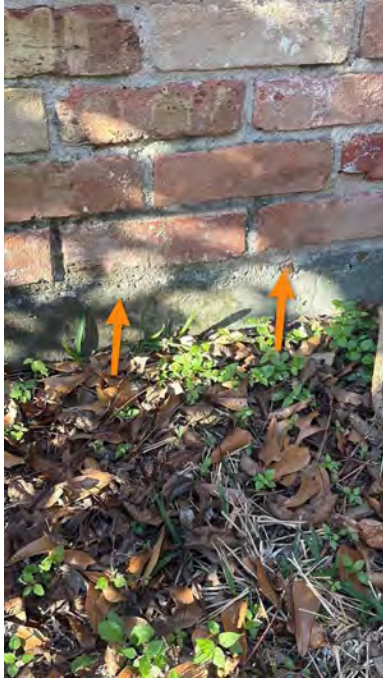
#### 4: Spalling

Recommendation: Contact a qualified professional.

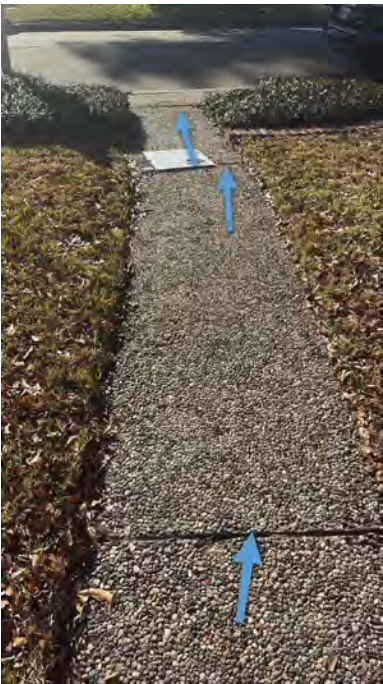
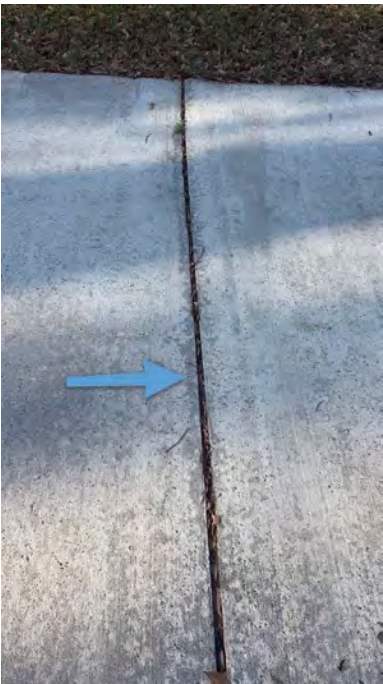
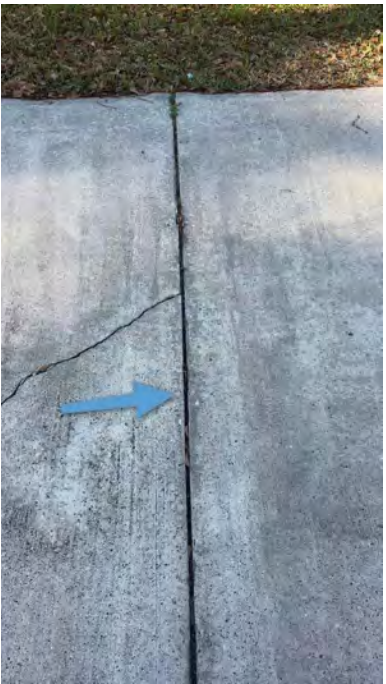
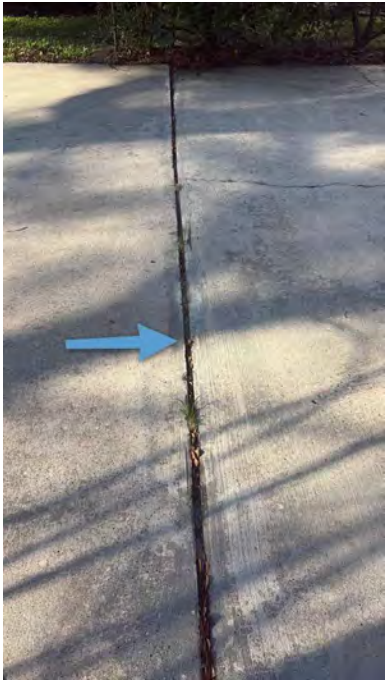
Observed missing, deteriorated, insufficient or lifted joint seal(s) at time of inspection. The key purpose of an expansion seal or joint is to provide a flexible connection point between two concrete, cement or similar structures and to help prevent moisture intrusion between two concrete slabs. Moisture intrusion between two slabs will cause the soil beneath the slabs to erode, which will increase the chance of excessive movement. Expansion seals and joints also allow two concrete slabs to expand during the drying period and help minimize moisture from entering under slab potentially undermining structure. Expansion joints that are not level with the walking surface become a trip hazard and will not function as they are intended.

Recommendation: Contact a qualified professional.

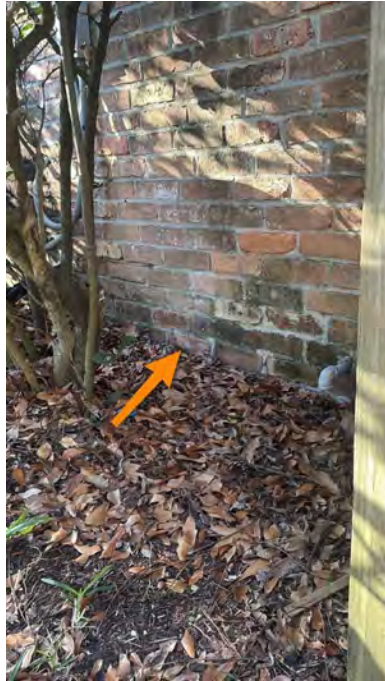
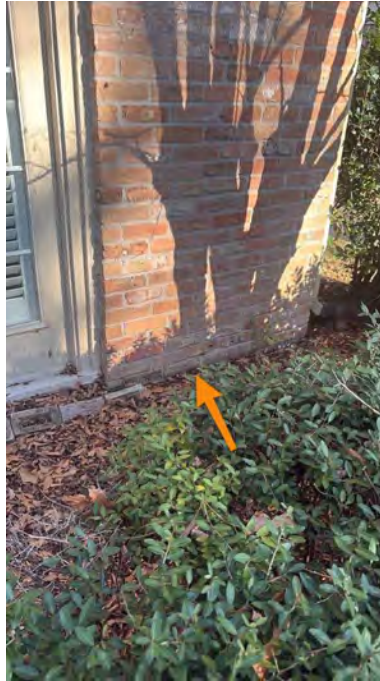
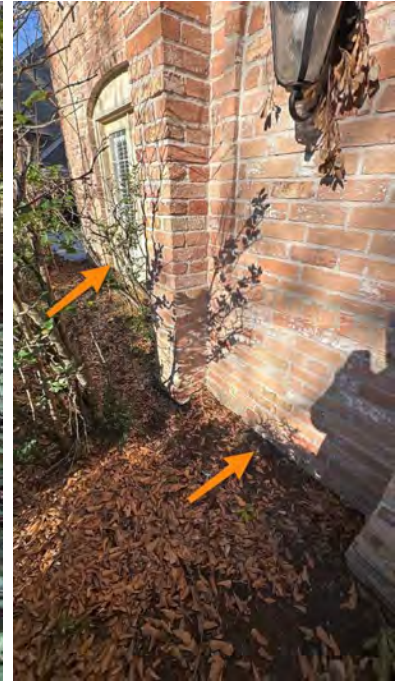
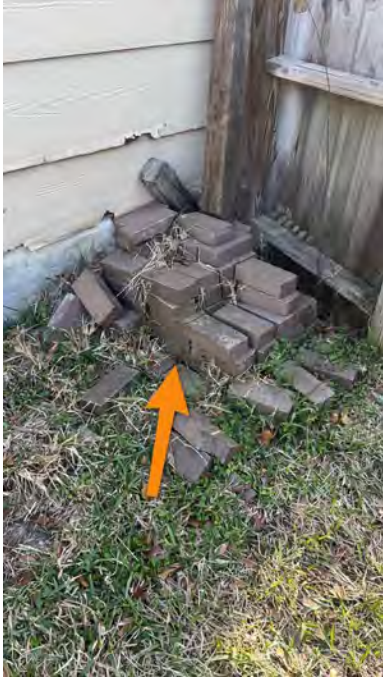
Foundation could not be completely inspected due to low siding, stored items, high soil or vegetation, inaccessibility, concrete patio, equipment, and/or a wrap around deck. With siding installed on exterior walls it is recommended that 3-4" of the foundation wall be visible; with brick at least 1-2". Foundation walls should be visible when inspecting for cracks and pest. Due to the inability to fully inspect the exterior foundation wall we recommend a foundation contractor if any concerns arise or if further information is needed.

Recommendation: Contact a qualified professional.

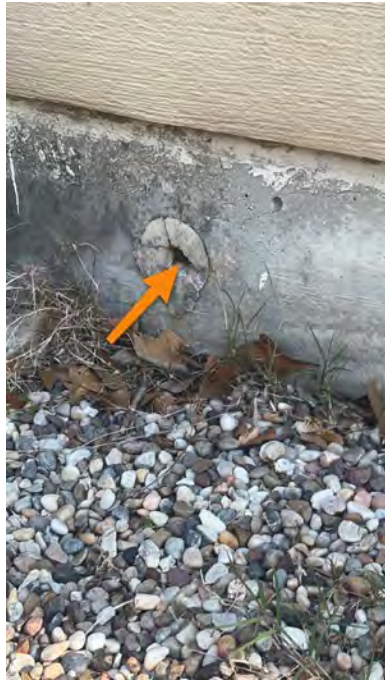
Left Side

Post-tensioned cable or cap exposed due to missing mortar. As cables are exposed to moisture they will rust which causes expansion and eventual corrosion to the cable or cracking in foundation. Recommend the cable ends be cleaned (clear any rust or dirt) and re-covered with a non-shrink grout.

Recommendation: Contact a qualified professional.

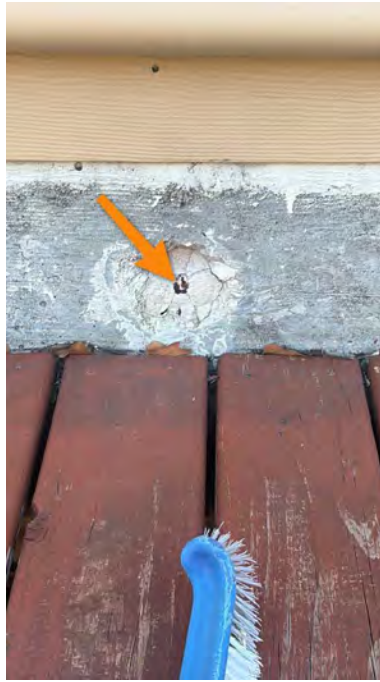
Rear Right

## 7: Post-Tension Cables/Caps- Exposed

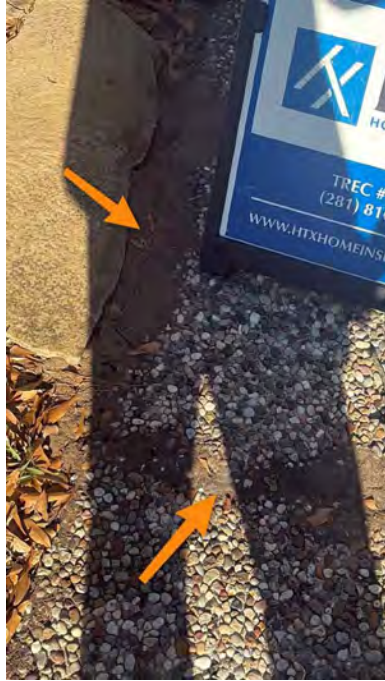
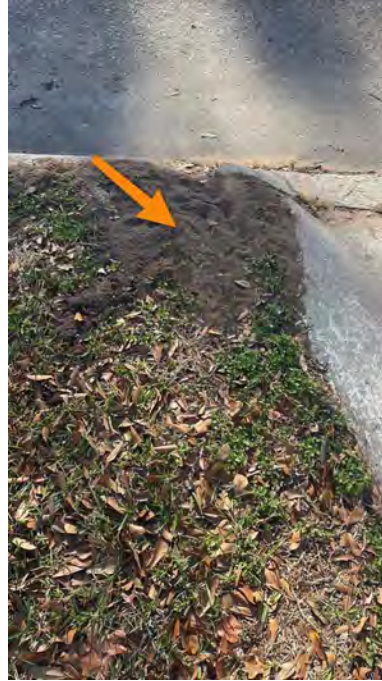
Observed signs of pest intrusion at time of inspection. Pest identifiers such as chewing/tearing on fiberglass insulation or foam pipe coverings, rodent droppings, rodent traps, drill holes in slabs, mud tubes on exterior foundation walls, actual sightings of pest during inspection and nest are an indication that there has been previous pest control attempts or current pest activity. Pest such as ants and wood destroying insects build nest utilizing the soil and can go undetected if soil level or grass is not kept at a proper height around foundation wall. Pest intrusion that has caused damage to structure could be an indication that wood destroying insects or termites have been present or are currently present.

Recommendation: Contact a qualified pest control specialist.

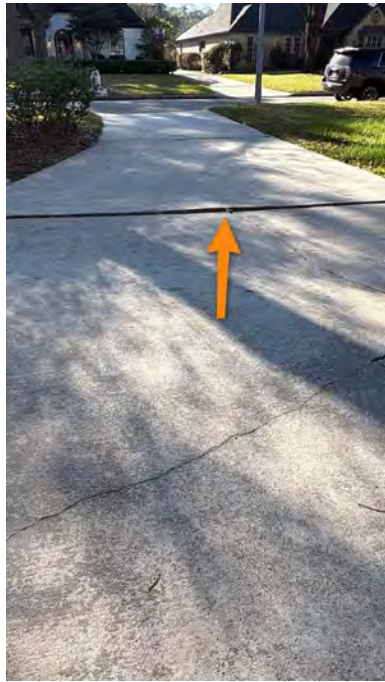
Driveway

The transition from the garage to the driveway, from the driveway to the street, or the driveway was observed to be uneven. This condition can occur due to soil settlement, erosion, tree root growth, or movement in the concrete or asphalt over time. An unlevel transition may create a tripping hazard, cause vehicle clearance issues, and allow water to pool or flow toward the structure, potentially leading to moisture intrusion or surface damage.

Recommendation: Contact a qualified professional.

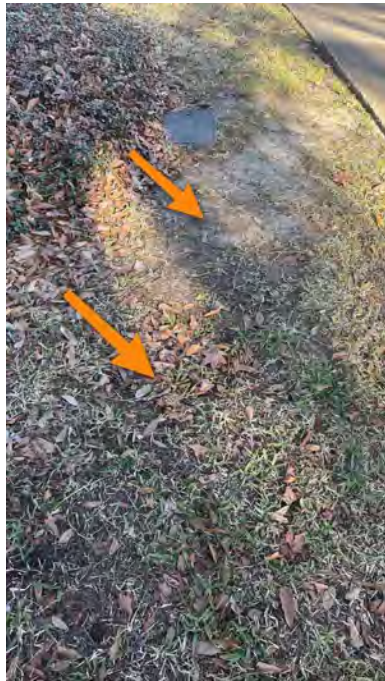
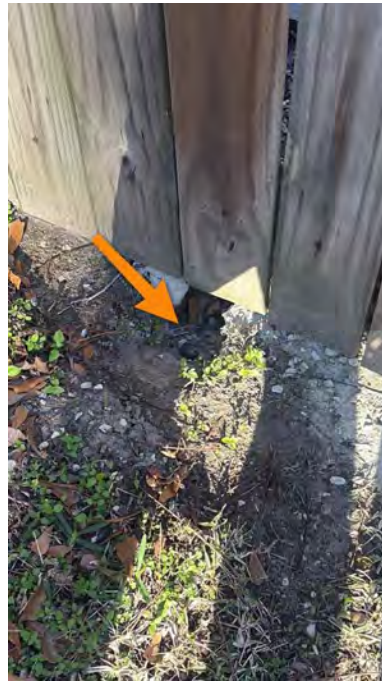
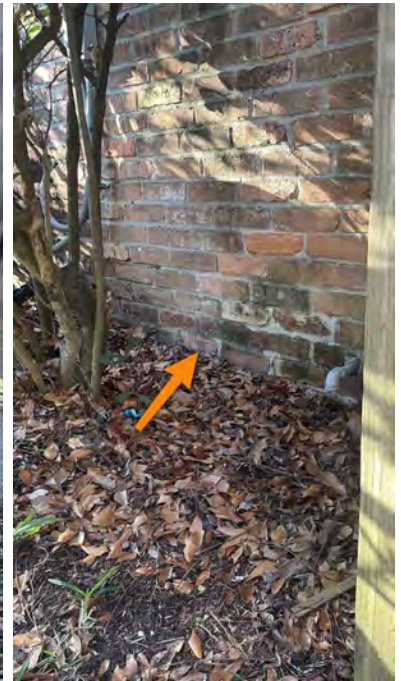
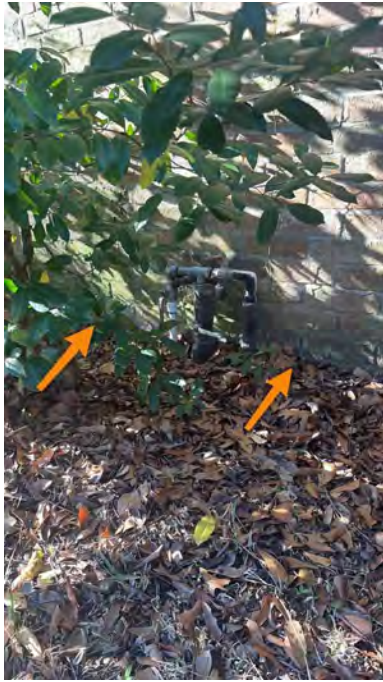
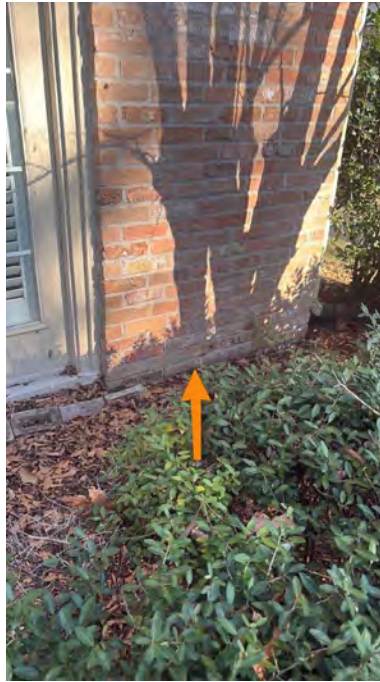
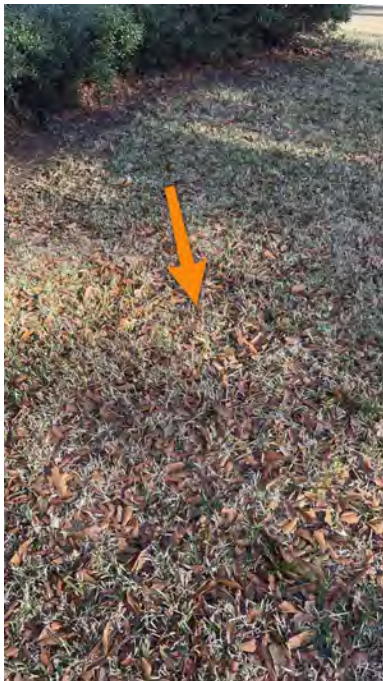
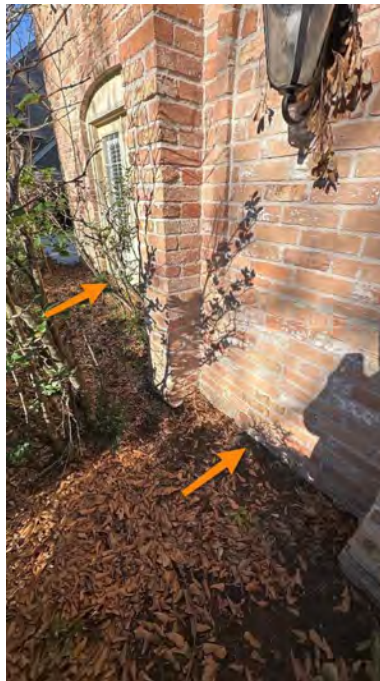
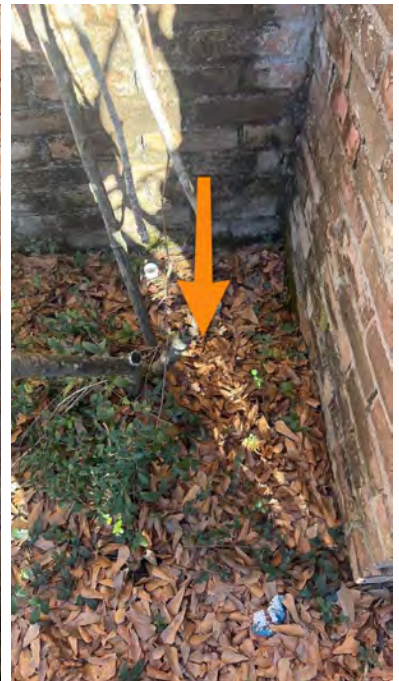
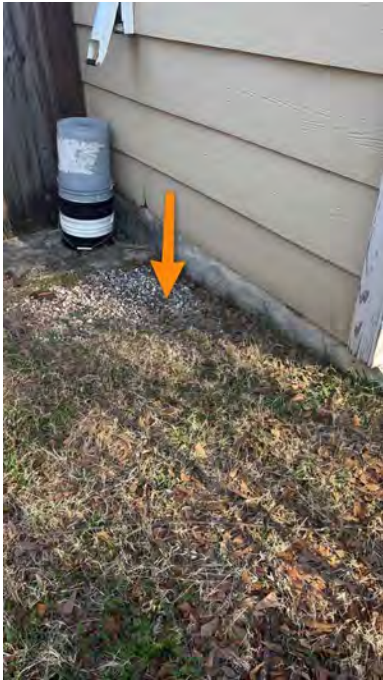
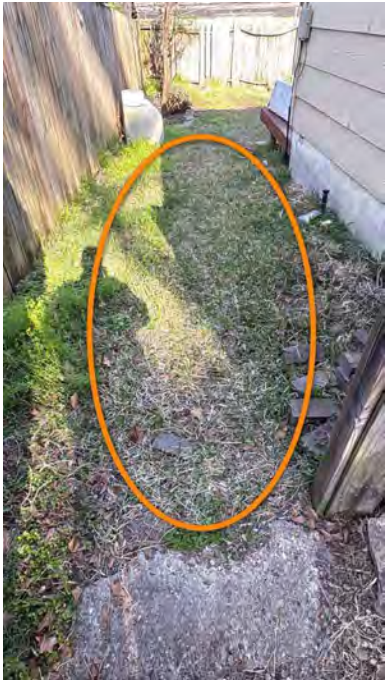
Grading around the home is not performing as intended, one or more of the following is present, but not limited to; negative slope, standing water, improper drainage slope, obstructions at grade, and/or insufficient soil-to-foundation clearance were observed. These conditions do not promote proper drainage away from the structure as required by TREC SOP, and may contribute to foundation movement, moisture intrusion, or conducive conditions for wood-destroying insects. It is recommended that grading around the home be improved to provide a positive slope away from the foundation, with at least 6" of fall in the first 10' where possible. Remove or relocate objects that obstruct drainage, and maintain proper soil-to-foundation clearance. If standing water persists after rainfall events, evaluation by a drainage contractor may be necessary to design and install corrective measures such as surface drains, swales, or extensions of downspouts.

Recommendation: Contact a qualified landscaping contractor

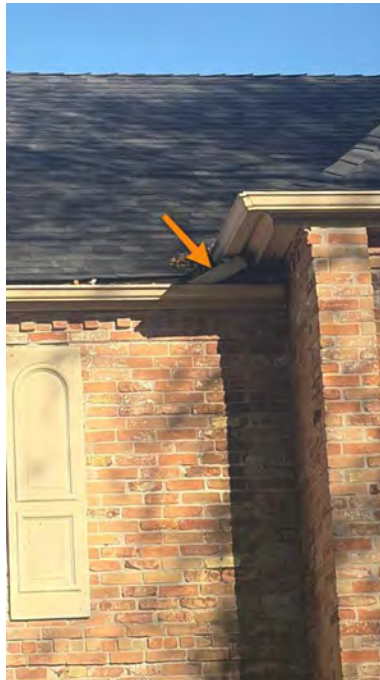
Front- upper to lower discharge

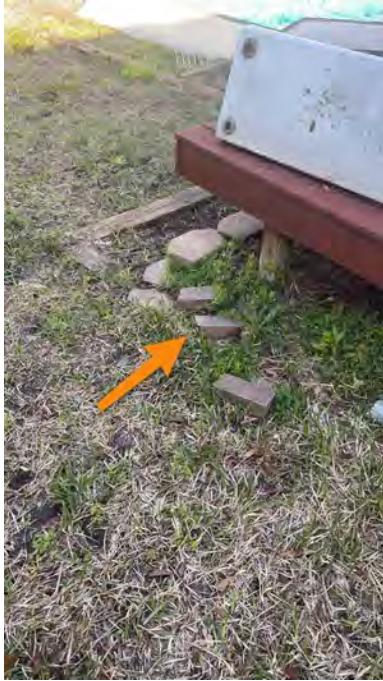
Observed unlevel walking surface or protruding object in walking surface that poses a trip hazard at time of inspection. Unlevel surfaces that are unknown to others can cause potential injury due to tripping.

Rear Right Corner

Recommendation: Contact a qualified professional.

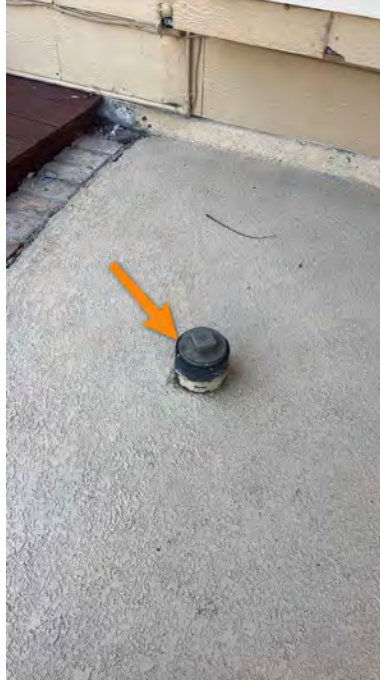
Rear

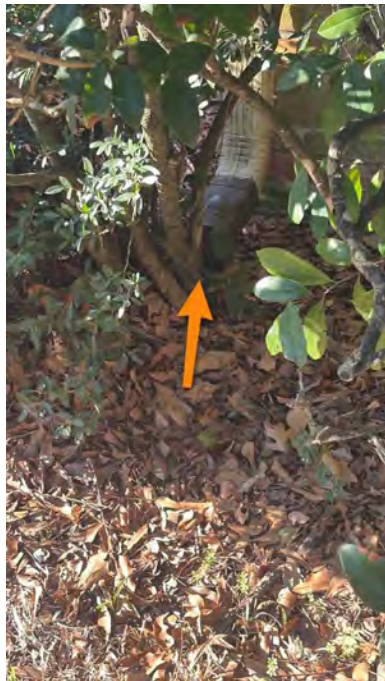
Gutter elbow was observed without a proper extension, or a downspout was not properly connected to its underground extension. This condition can allow roof runoff to discharge too close to the foundation, contributing to erosion, standing water, or negative drainage, which may impact foundation performance. The Texas Real Estate Commission (TREC) Standards of Practice require inspectors to report deficiencies in roof drainage systems that do not direct water away from the structure. It is recommended that the downspout be properly extended or securely connected to the underground drain line to ensure roof runoff is directed away from the foundation.

Right Side- extension does not not extend far enough

Recommendation: Contact a qualified landscaping contractor

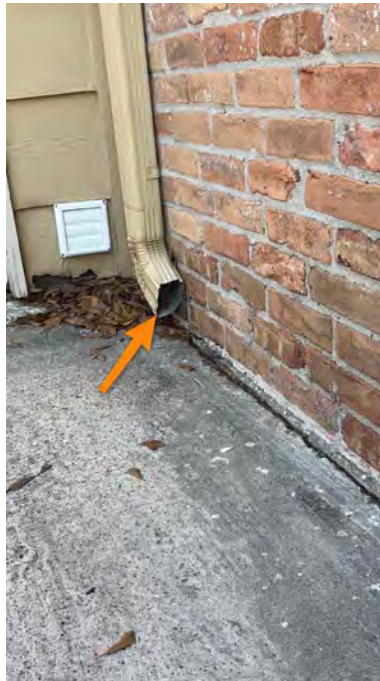
Left Side- elbow should not discharge along foundation

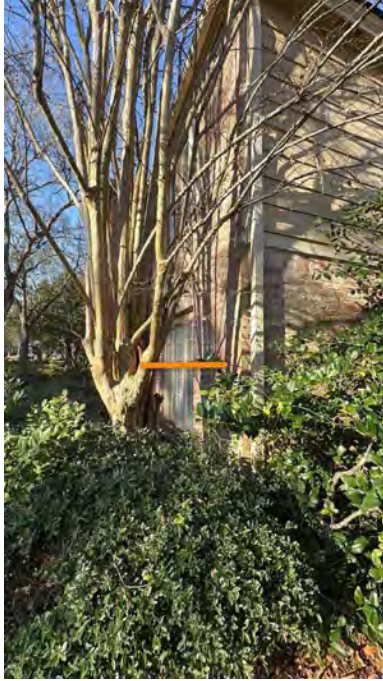
Observed a tree that appears to be too close to the home at time of inspection. Generally, a tree should be planted at least fifteen feet away from the foundation of a home. For larger, overstory species (taller than sixty feet), that distance should be increased to at least twenty feet from foundations and landscape features.

Front Right

Recommendation: Contact a qualified tree service company.

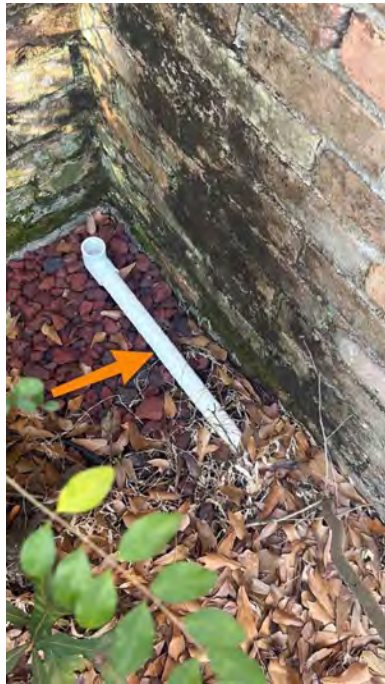
Front

Exposed pipe or wiring observed at surface of grading. Pipes or wiring at the surface of a yard's grading is often a sign of improper installation. It may not have been buried to the correct depth or secured properly, causing it to shift or become exposed over time. This can result from poor planning, failure to account for soil settling, landscaping changes, or skipping proper trenching during installation.

Recommendation: Contact a qualified professional.

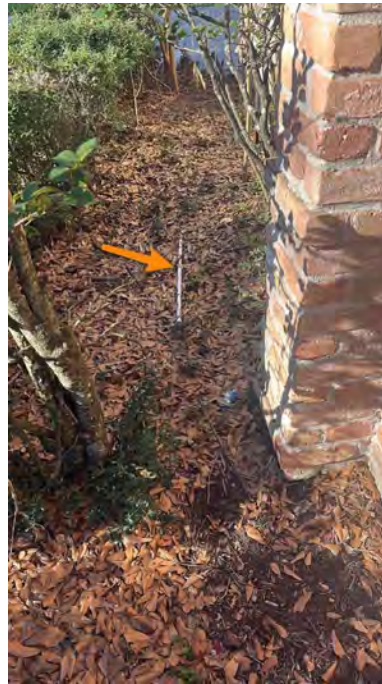
Front Left

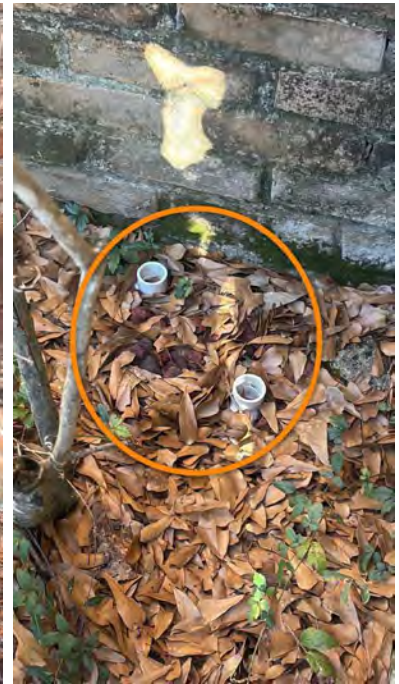
Front

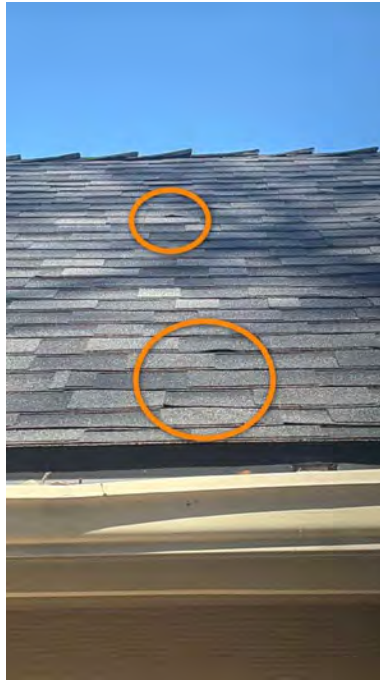
The roof covering was observed to have visible deficiencies and conditions that may affect its performance or service life. Possible issues include one or more of the following: missing, damaged, loose, lifted, debris, curled, or deteriorated materials; exposed fasteners; improper nailing or fastening; tree limb distance from surface, poor adhesion, patchwork repair, mechanical damage; or inadequate sealing at joints and transitions. Granule loss, surface wear, multiple layers, discoloration, or cracking may be present on composition shingles, while metal roof coverings may show rust, loose panels, missing fasteners, oil-canning, or inadequate sealant at seams and penetrations. Tile or slate roofs may have broken, cracked, or displaced tiles, improper underlayment, or loose ridge and hip caps. Flat or low-slope coverings such as modified bitumen, rolled roofing, or TPO may exhibit open seams, punctures, blistering, ponding water, or deteriorated coatings. These conditions can allow water intrusion, accelerate aging, or reduce the roof's intended service life. A qualified roofing contractor should further evaluate and repair or replace all deficient materials as needed to restore proper function and weather protection. Inspection limited to visible and accessible roof surfaces only.

Above garage- lifted

Recommendation: Contact a qualified roofing professional.

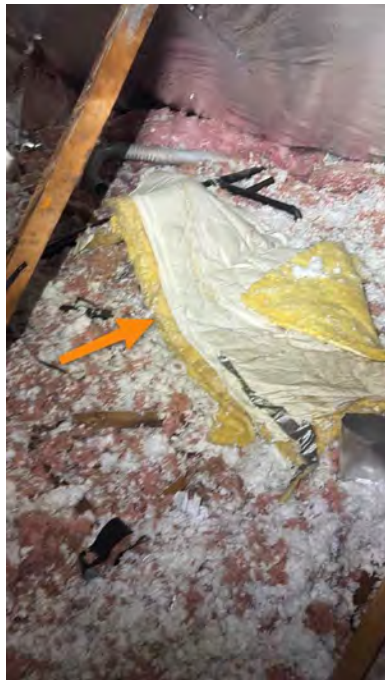
The attic insulation was observed to have one or more deficiencies including, but not limited to: areas of missing, displaced, or insufficient insulation coverage; insulation installed in the wrong location or improperly placed against framing members. Insulation installed along roof rafters instead of the attic floor, can suggest an attempt to create a conditioned attic space without proper air sealing, HVAC design, or vapor barrier installation. This configuration can trap moisture, reduce ventilation, and compromise overall energy efficiency.

Improper install

Recommendation: Contact a qualified insulation contractor.

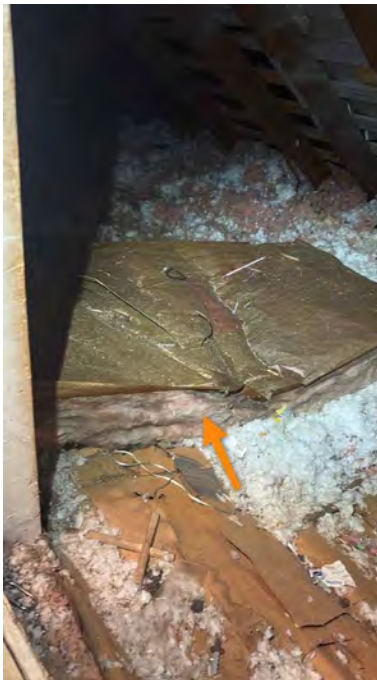
Bedroom 3 scuttle door- improper install

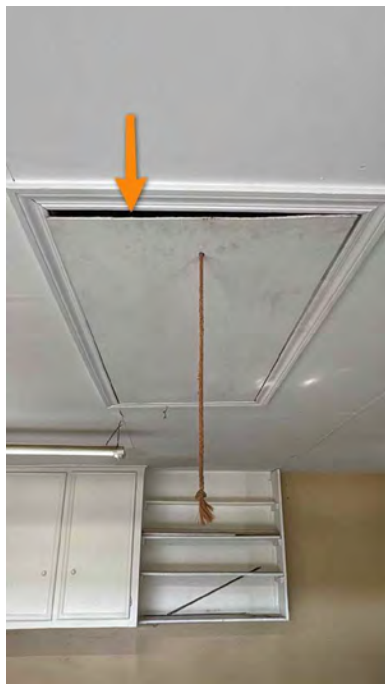
The attic stairway was observed to have one or more deficiencies including, but not limited to: missing or insufficient insulation at the stair cover, improper or incomplete installation, inadequate clearance, or failure to open and close properly. The stairway assembly may also be loosely fastened, utilize improper fasteners, be of insufficient length, or be non-fire-rated where a fire separation is required. Damage or deterioration may also be present. These conditions can reduce energy efficiency, present safety concerns, or compromise the integrity of the ceiling assembly. Recommend repair or replacement as needed by a qualified contractor.

Garage attic

Recommendation: Contact a qualified professional.

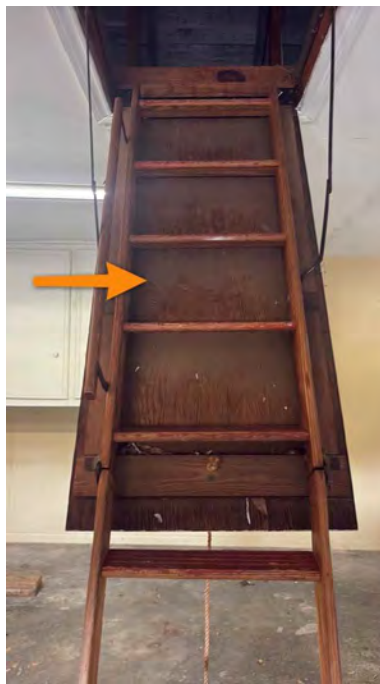
Garage attic-missing insulation

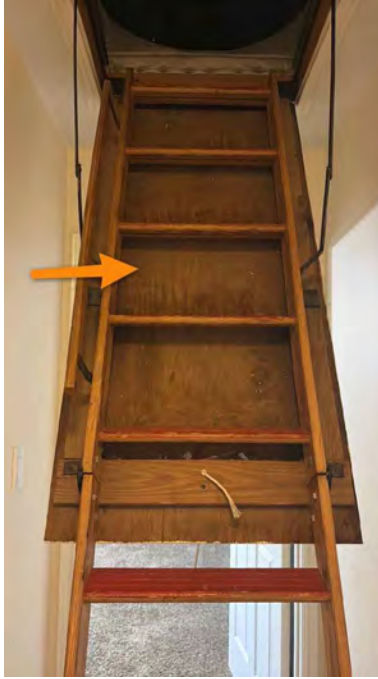
Main attic- missing insulation

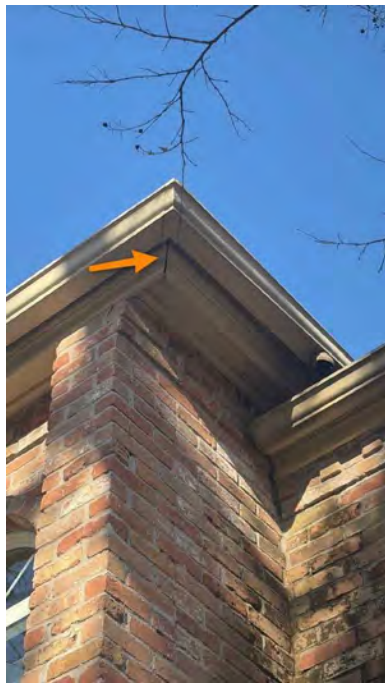
The fascia board was observed to be in adverse condition in one or more areas of the structure. Conditions show signs of one or more of the following, but not limited to; deterioration, damage, rot, warping, separation from adjoining trim or roof components, improper installation, or complete absence in some locations. In some cases, wide gaps were observed between the fascia and soffit or roof covering, which can allow moisture intrusion, pest entry, and deterioration of underlying roof or framing components. Missing or improperly fastened sections may result in insufficient support for gutters and compromised roof edge protection. These conditions typically develop from prolonged moisture exposure, inadequate flashing or drip-edge installation, improper fastening, or deferred maintenance.

Front- sealant

Recommendation: Contact a qualified professional.

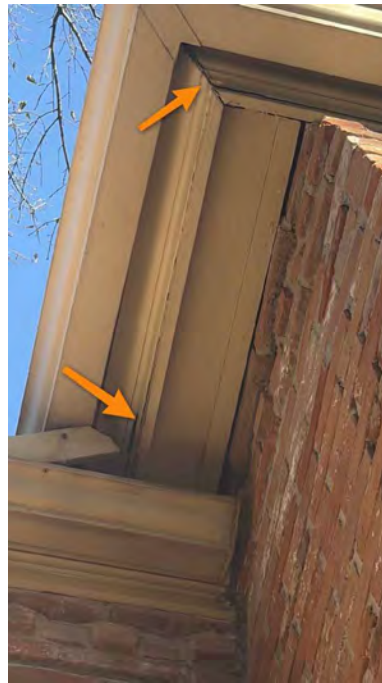
Front- sealant and damage

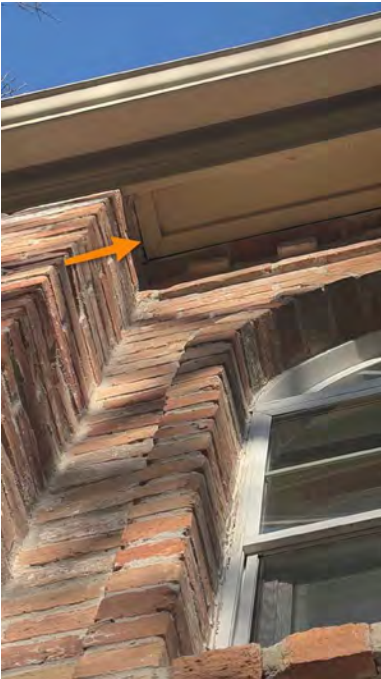
The soffit was observed to be in adverse condition in one or more areas of the structure. Conditions show one or more of the following, but not limited to; deterioration, sagging, physical damage, separation from adjoining materials, missing or improperly installed panels, unsealed penetrations, blocked venting or evidence of prior repairs. Open gaps or unsealed openings may allow moisture, rodents, or insects to enter the attic or eave cavities. Sagging or detached soffit panels can indicate improper fastening, inadequate framing support, or previous water intrusion. Deterioration and staining may result from roof leaks, poor ventilation, or prolonged exposure to moisture and humidity.

Front- sealant

Recommendation: Contact a qualified professional.

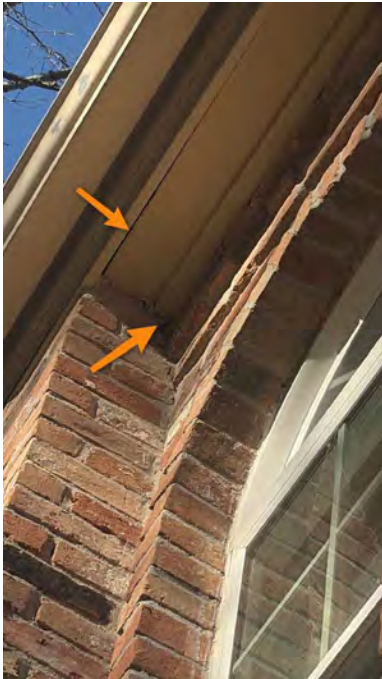
Front-opening and sealant

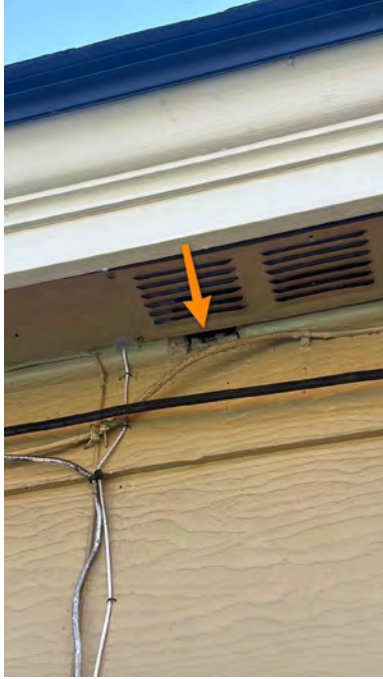
Rear- opening

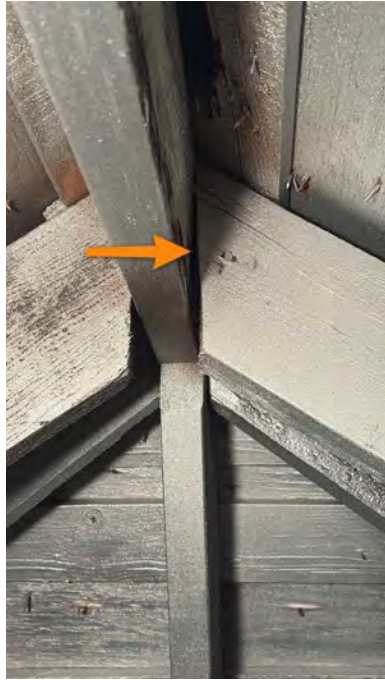
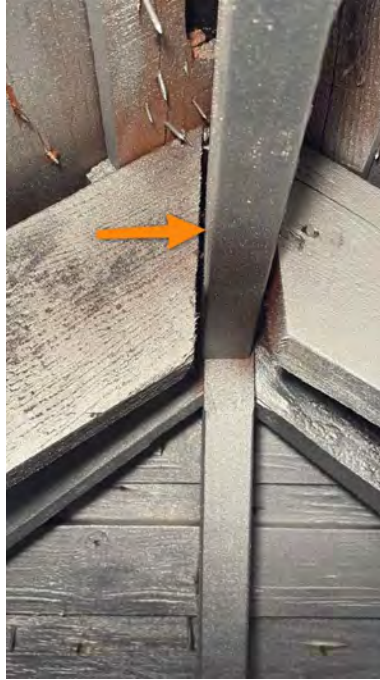
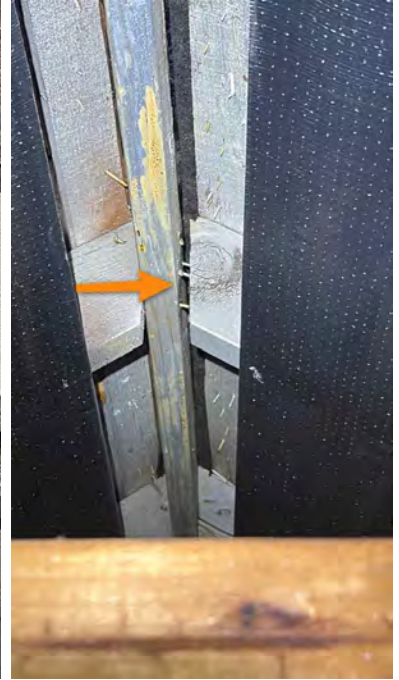
Observed what appears to insufficient/improper nailing or connecting of roof rafters at roof ridge board. Rafters should be long enough and cut at proper angles to butt flush against ridge board.

Recommendation: Contact a qualified professional.

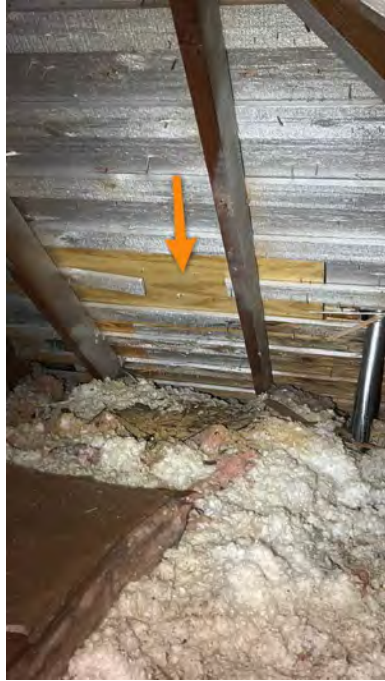
Observed area(s) where the roof decking appears to have one or more of the following, but not limited to; damage, moisture has penetrated, insufficient fastening, organic substance, heat damage, previous repairs done, or showing signs of deterioration during inspection. Damage can happen during the installation and walking on roof. Deterioration of roof decking occurs from continued moisture intrusion, moisture penetration or moisture that has occurred at the time or prior to installation of materials. In either event and depending on the severity of the deterioration we recommend verifying that this will not prevent the decking from performing as intended. It is unknown to the inspector the cause of any previous repairs performed.

Bedroom 3 scuttle door- damaged

Recommendation: Contact a qualified professional.

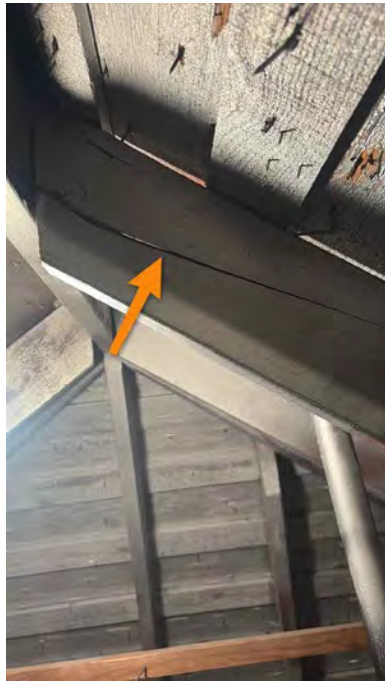
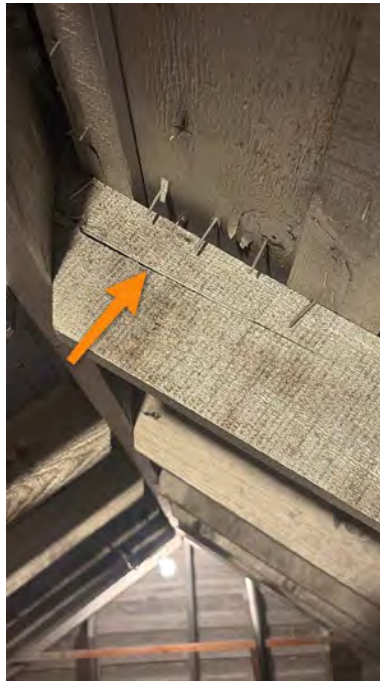
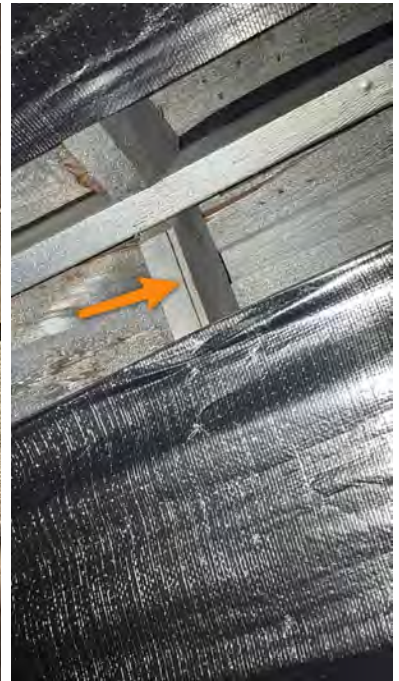
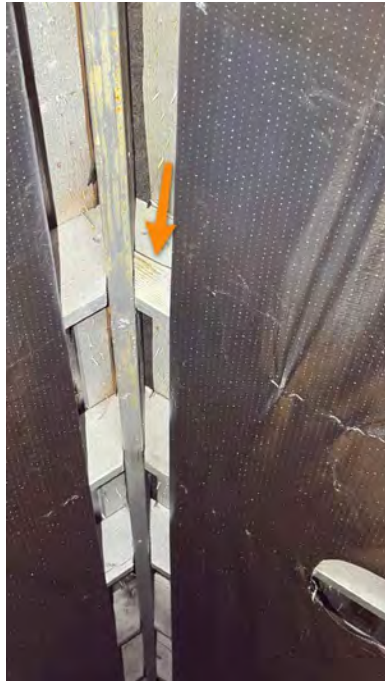
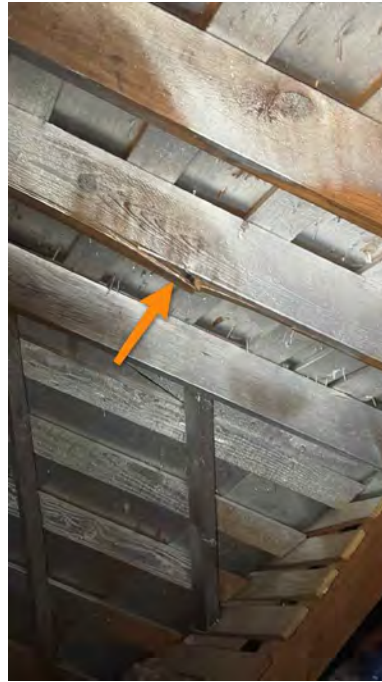
Observed damaged, cracked, notched, deteriorating, corrosion, inconsistent rafter size, or cut rafter(s) at time of inspection. This can be caused by settlement or repairs to the foundation, roof replacement, drying out of framing members, moisture contact, previous installation or defective framing member. Rafters are designed to support the roof deck, shingles, and everything else that goes with the roof.

Recommendation: Contact a qualified professional.

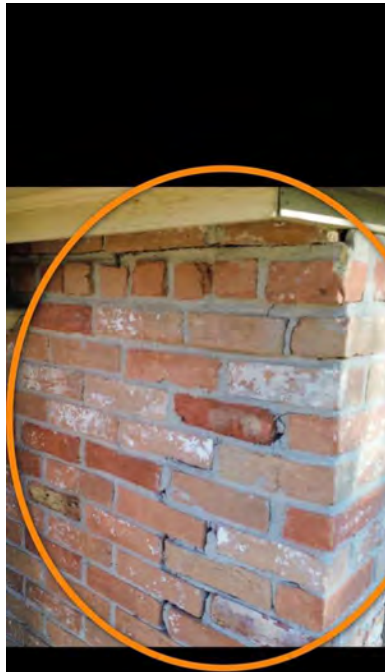
Observed one or more of the following conditions, but not limited to; cracks, underdriven fasteners, deterioration, rust stains, patchwork repair, loose exterior wall covering, bubbling/peeling paint, wavy siding, insufficient or missing mortar, improperly installed flashing, incomplete or improper installation, vegetation, unpainted siding or flashing, caulk shrinkage, missing caulk, exposed openings or damage. Cracks occur from expansion and contraction of building materials, brick ties that have come loose from rust, settlement of foundation, defects in brick veneer or foundation cracking. Hairline cracks or a common occurrence usually seen in mortar joints. Cracks that appear through brick veneer walls that are 1/8" in width could be a sign that the foundation movement is beyond normal settlement. There are several factors that can cause paint to peel or bubble such as moisture, poor surface preparation, low quality paint, wear and tear, excessive humidity, structural movement and poor ventilation. **The photos in this section are a representation of the type of deficiencies identified by the inspector and can be located in one or more locations throughout the home.**

Front- mortar cracks

Recommendation: Contact a qualified professional.
