# PROPERTY INSPECTION REPORT FORM

02/24/2026 8:30 am

1814 Wagon Gap Trail, Houston, TX 77090

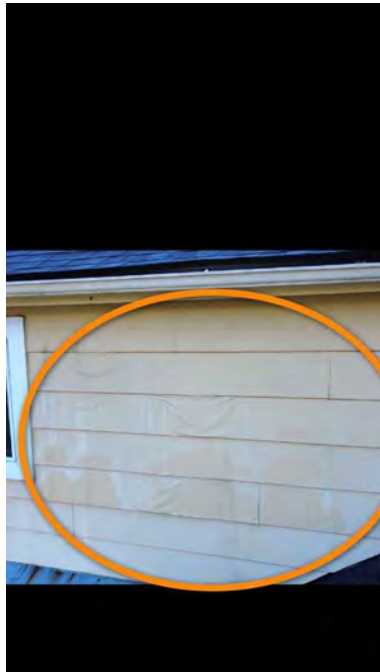
Observed one or more of the following conditions, but not limited to; cracks, underdriven fasteners, deterioration, rust stains, patchwork repair, loose exterior wall covering, bubbling/peeling paint, wavy siding, insufficient or missing mortar, improperly installed flashing, incomplete or improper installation, vegetation, unpainted siding or flashing, caulk shrinkage, missing caulk, exposed openings or damage. Cracks occur from expansion and contraction of building materials, brick ties that have come loose from rust, settlement of foundation, defects in brick veneer or foundation cracking. Hairline cracks or a common occurrence usually seen in mortar joints. Cracks that appear through brick veneer walls that are 1/8" in width could be a sign that the foundation movement is beyond normal settlement. There are several factors that can cause paint to peel or bubble such as moisture, poor surface preparation, low quality paint, wear and tear, excessive humidity, structural movement and poor ventilation. **The photos in this section are a representation of the type of deficiencies identified by the inspector and can be located in one or more locations throughout the home.**

Rear- bubbling paint and missing sealant at joints

Recommendation: Contact a qualified professional.

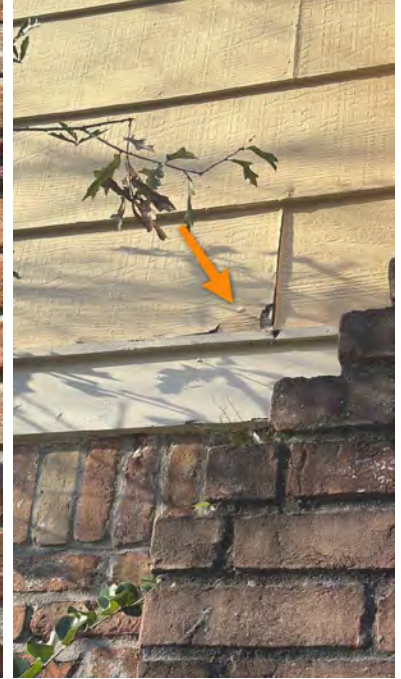
Right Side- damage

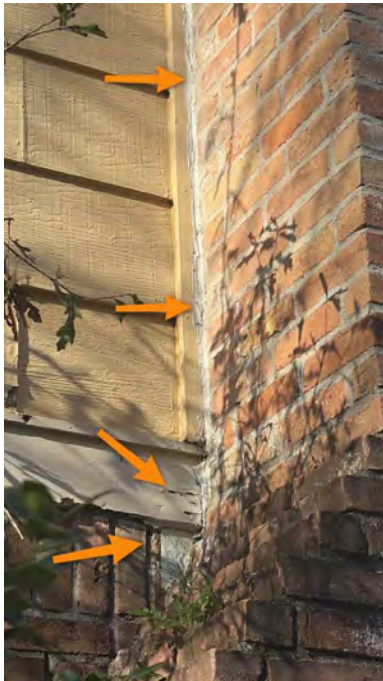
Right Side- mortar, damage, caulk

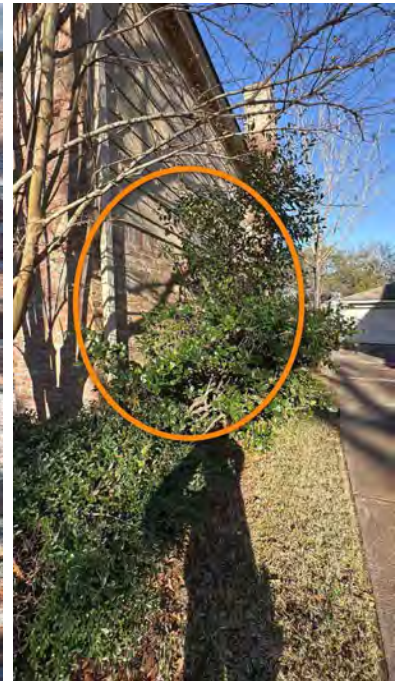
Right Side- vegetation

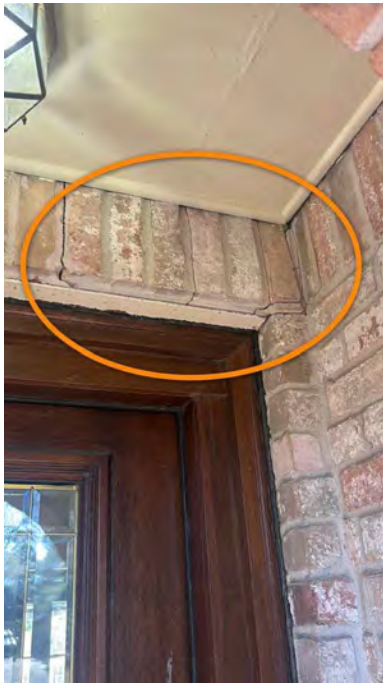
Above front door-mortar cracks

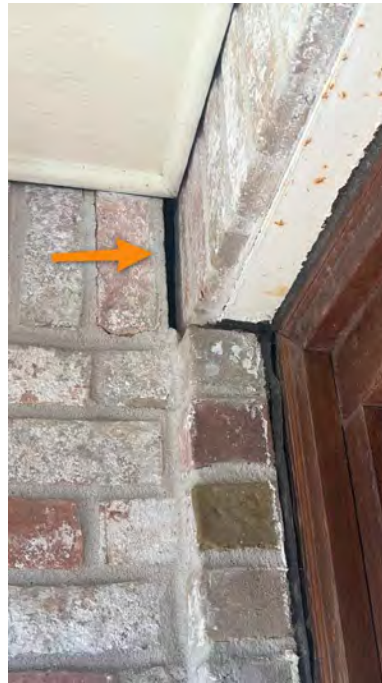
Above front door- missing mortar/opening

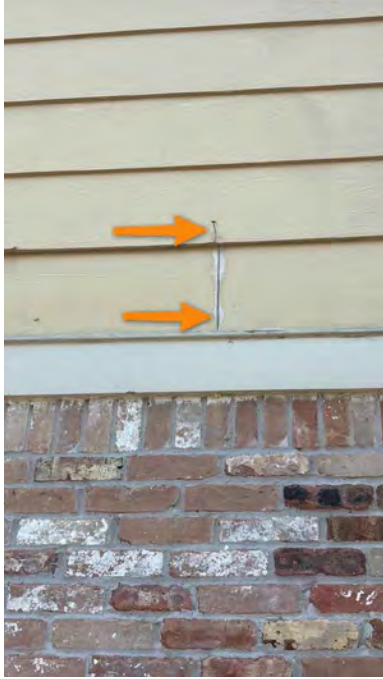
Left Side- damage and sealant

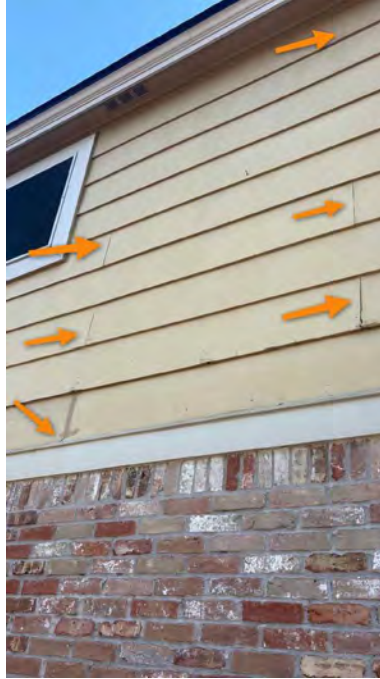
Left Side- sealant

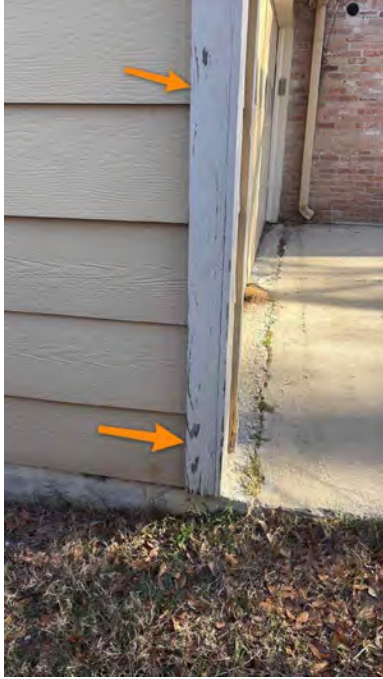
Left Side- damage

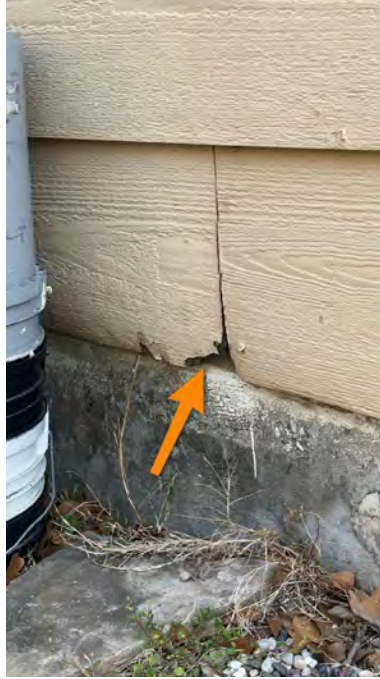
**1: Exterior Wall Condition****Recommendation**

Left Side- deterioration

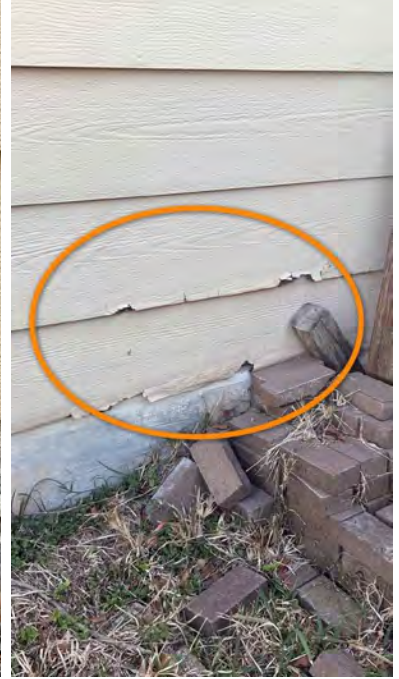
Left Side- deterioration

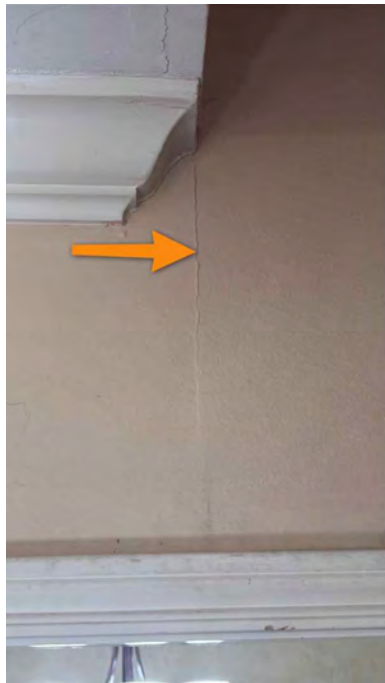
Stairwell

Observed one or more of the following conditions, but not limited to; cracks, damage, caulk shrinkage or deteriorated, deteriorated or rotted wood, moisture penetration, grout cracks, missing caulk, bubbling paint, opening around electrical outlet(s), exposed openings, warped, loose wall covering/trim, previous patchwork repair, or nail pops on interior wall(s) in one or more locations at time of inspection. Drywall cracks and nail pops form primarily due to foundation settlement, foundation heave, fluctuations in temperature, humidity, improper installation, or seismic activity; all of which add undue pressure and stress on the drywall organic materials. Damage to interior walls can happen from forceful contact, wear and tear and other reasons unknown to the inspector. Recurring cracks or drywall cracks larger than 1/8" wide are usually signs of significant structural concerns that should be addressed as soon as possible. Vertical cracks in walls are the most common and happen mostly in corners and where panels are butted together. Horizontal cracks are more of a concern due to the fact they tend to be an indicator of foundational failure. Deterioration can be a sign of previous or current moisture penetration. Grout cracks in wet locations will allow moisture penetration in the area that is impacted. There are several factors that can cause paint to peel or bubble such as moisture, poor surface preparation, low quality paint, wear and tear, excessive humidity, structural movement and poor ventilation. **The photos in this section are a representation of the type of deficiencies identified by the inspector and can be located in one or more locations throughout the home.**

Recommendation: Contact a qualified professional.

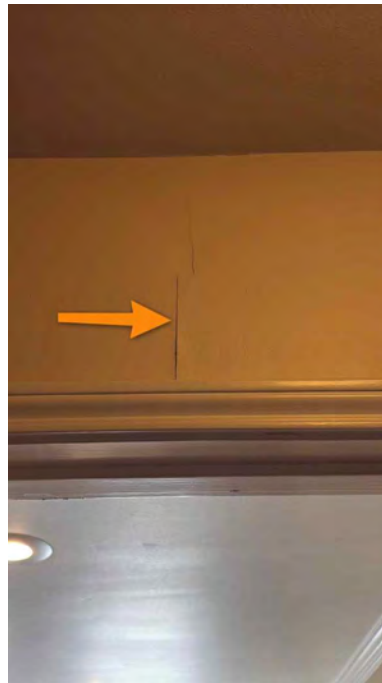
Above primary bedroom door

**2: Interior Wall Condition****Recommendation**

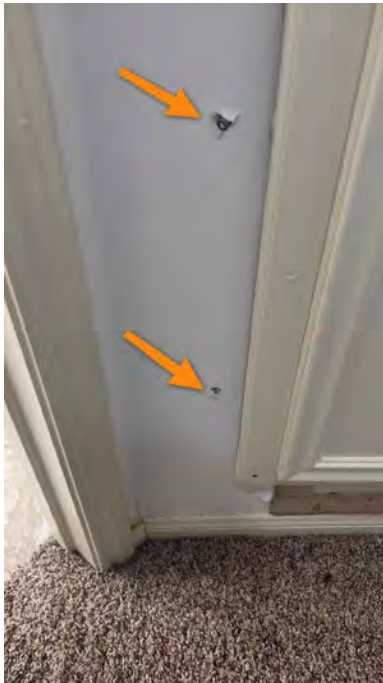
Priamry right closet- nail pop

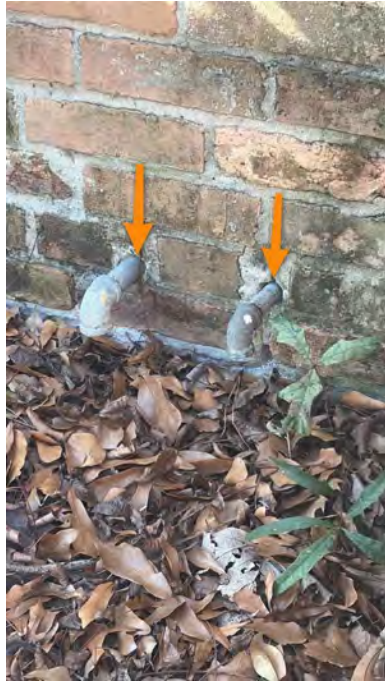
Right Side

### 3: Penetration Opening- Unsealed

Observed unsealed penetration opening in one or more locations on exterior wall. The opening should be sealed to help prevent moisture and/or pest intrusion in that area.

Recommendation: Contact a qualified professional.

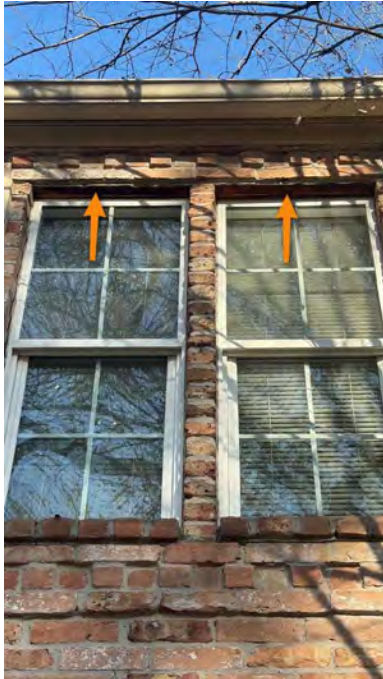
#### 4: Lintel Condition

Observed lintel(s) that were one or more of the following; rust, unpainted, exposed or missing mortar. Rusting of lintels cause expansion and weakening of the steel which may cause further damage to exterior wall structure. We recommend that the lintels be primed sanded, primed and painted to prevent rust and corrosion from forming.

Front- rusted

Recommendation: Contact a handyman or DIY project

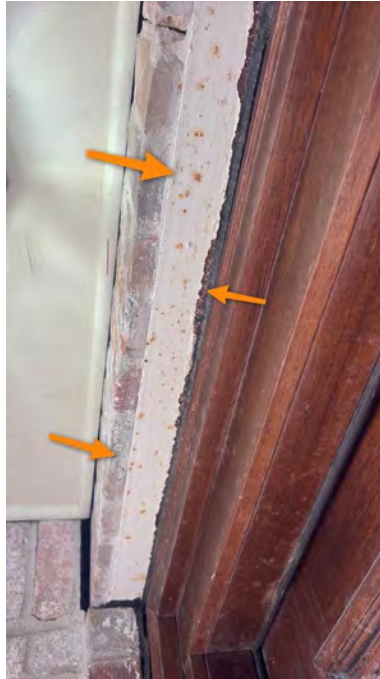
Above front door- rust

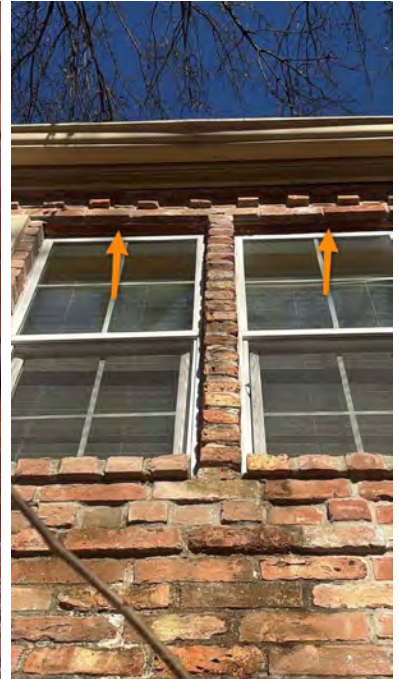
Front Left- rust

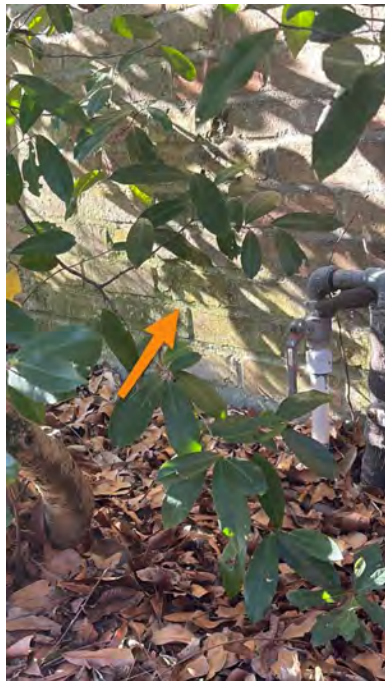
Right Side

Observed what appears to be an organic growth at time of inspection. Water on exterior walls happens all the time from precipitation like rain and snow. When gutters aren't installed and moving water away properly, the outside of the home can be exposed to water far more frequently and in far greater volume. Mold and mildew need water to grow, so exterior walls below a roof line without gutters see much more organic growth. This could also lead to moisture penetration on the interior wall of impacted areas. Mildew or mold formation on interior walls is primarily attributed to excess moisture and inadequate ventilation. When humidity levels rise, especially in enclosed spaces with poor air circulation, it creates an ideal environment for mold spores to thrive. Common contributors include water leaks, seepage, or condensation from activities like cooking or bathing and poor grading drainage. To identify if mold exist, testing of substance must be performed to verify "if" the substance is actually mold or mildew.

Recommendation: Contact a qualified professional.

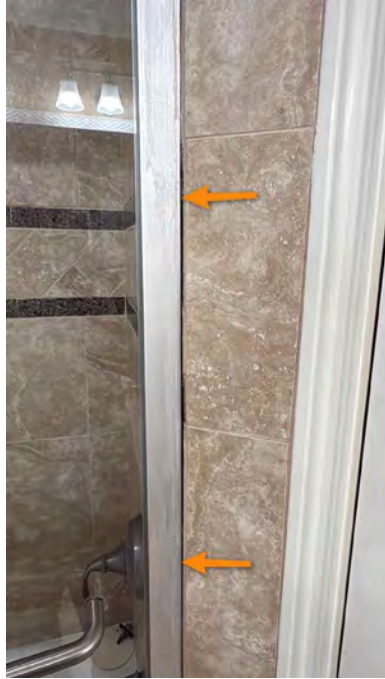
Primry Shower

Observed area with deteriorated, shrinking and/or missing grout at one or more wet locations (sinks, bathtub or shower). It is beyond the scope of this inspection to determine if moisture penetration has occurred and/or is present in non-visible areas, such as behind wall coverings. This should be sealed to help prevent moisture penetration in those areas.

Recommendation: Contact a qualified professional.

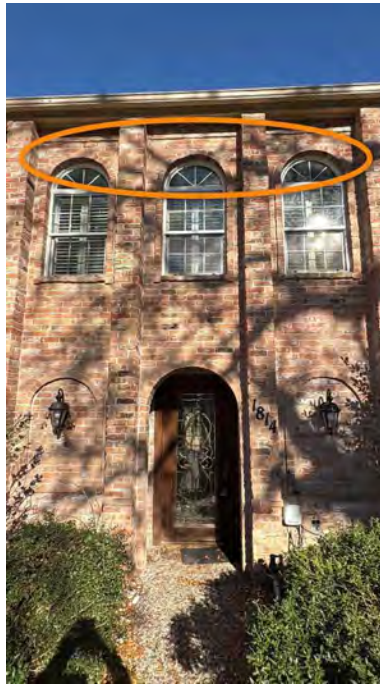
## 7: Weep Holes Condition

Observed one or more of the following: plugged, blocked, missing, wrong location, excessive or oversized weep holes at time of inspection. Weep holes are part of the wall drainage system and helps potential moisture that may enter wall cavity to drain. We recommend assessing the condition of the weep holes and make the necessary repairs to allow proper functionality of the whole wall drainage system.

Uninstalled

Recommendation: Contact a qualified professional.

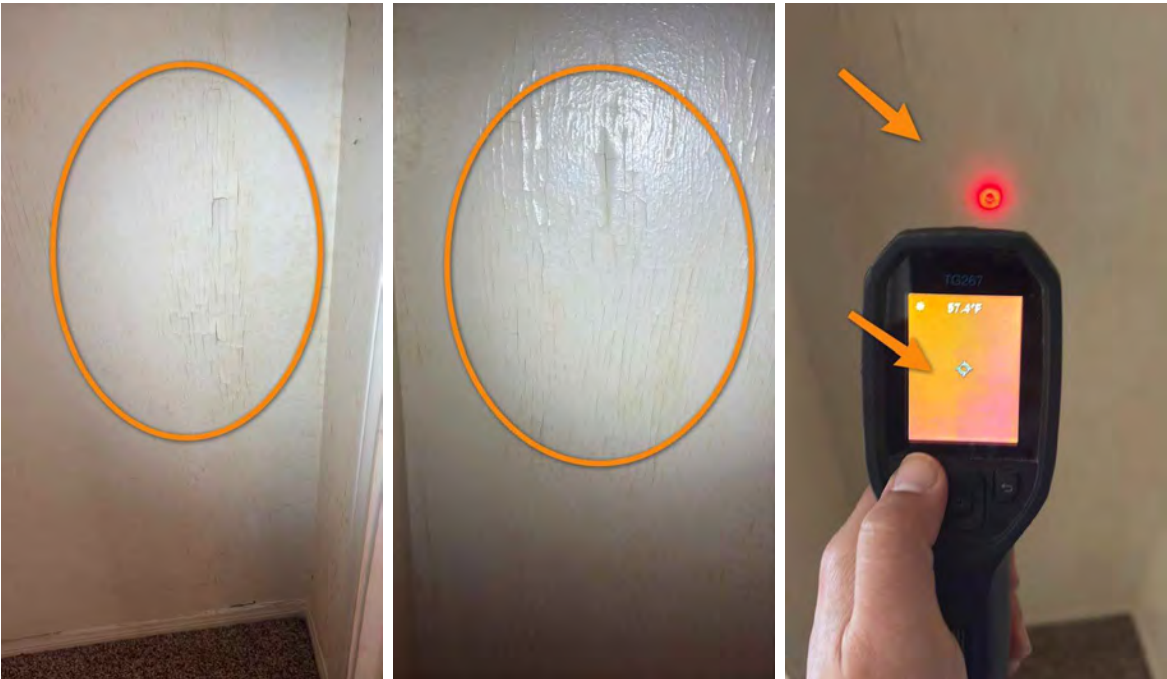
Moisture stains were observed on the wall surface, indicating previous or possible ongoing moisture intrusion. This condition may be associated with plumbing leaks, roof or exterior wall penetration, window or flashing deficiencies, or condensation-related issues. Staining suggests that water intrusion has occurred and may result in material deterioration or concealed damage if not corrected. Further evaluation is recommended to identify and address the moisture source, with repairs made by a qualified contractor as needed.

Coat closet 2- peeling paint indicates possible imposture penetration

Coat closet 2- bubbling paint indicates moisture penetration

Recommendation: Contact a qualified professional.

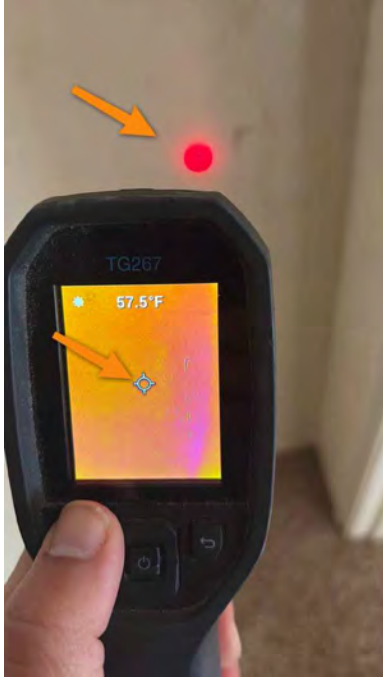
8: Moisture Penetration

Dry

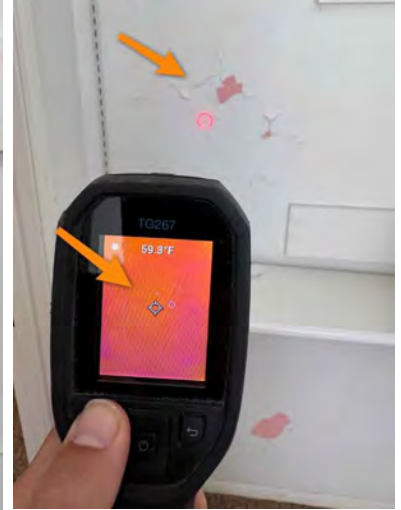
Bedroom 4 closet- Dry

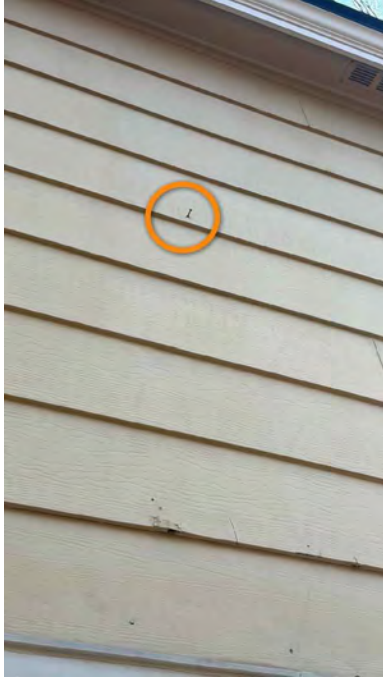
Left Side

Observed nails or screws that were not fully driven or should be removed at time of inspection. We recommend fully driving fastener to achieve what it's intended for or removing it to prevent possible injury depending on location.

Recommendation: Contact a handyman or DIY project

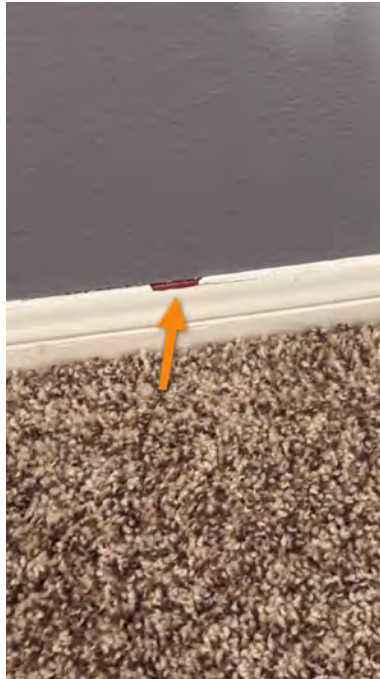
Bedroom 2

### 10: Baseboard/Moulding Condition

Observed separated, damaged, previous moisture penetration or missing baseboard/mouldings in one or more locations. This could occur from natural settlement of the foundation which would cause the caulk to crack, caulk shrinkage, wear and tear or previous moisture penetration.

Recommendation: Contact a qualified professional.

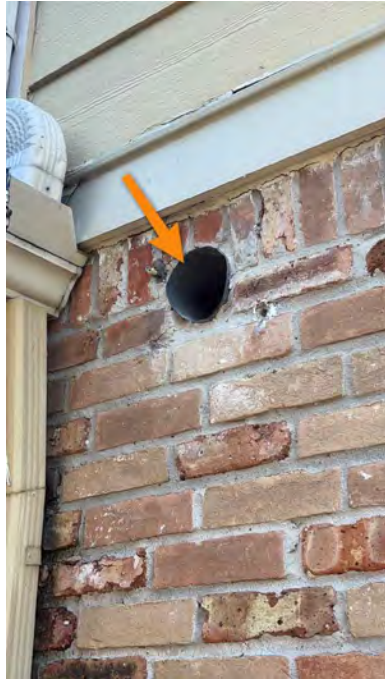
Left Side

Observed what appears to be a missing or damaged vent cover on exterior wall. Recommend replacing/installing cover to prevent pest and/or moisture intrusion in impacted area.

Recommendation: Contact a qualified professional.

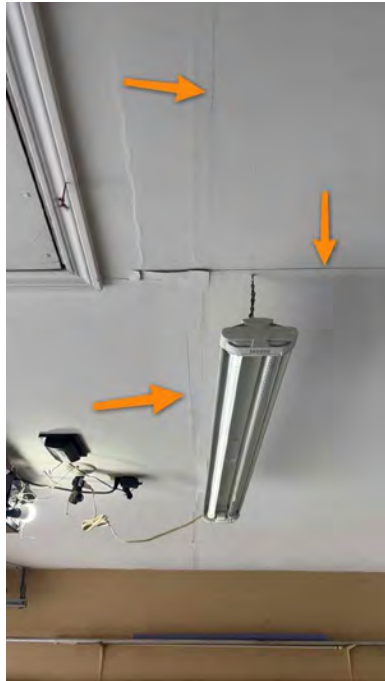
Garage

Observed one or more of the following conditions, but not limited to; drywall cracking, nail-pops, peeling paint or patchwork repair in ceiling at time of inspection. Drywall cracking and nail pops can be a result of foundation settlement, drying out of framing materials, recent foundation repairs and nails or screws that are not fully driven in drywall surface. Patchwork repair is a sign that previous repairs were made due to an event that may have caused damage. **The photos in this section are a representation of the type of deficiencies identified by the inspector and can be located in one or more locations throughout the home.**

Recommendation: Contact a qualified professional.

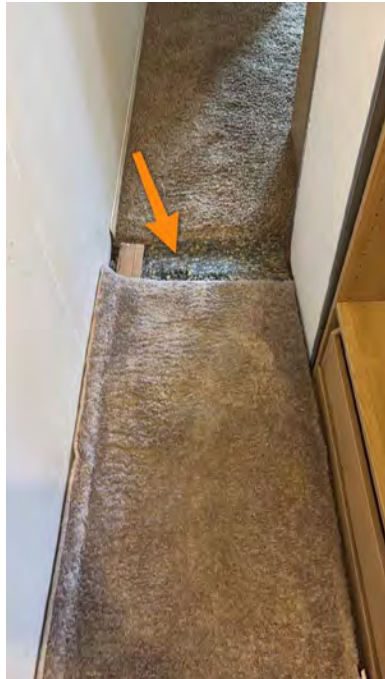
Primary / bedroom 2 closet

Observed flooring materials that are showing signs of one or more of the following conditions, but not limited to; wear, damage, previous repair, previous moisture penetration, or improperly/insufficiently installed. Flooring materials such as tile, wood, laminate and carpets are prone to normal wear and tear due to the amount of foot traffic throughout a home. Cracking in floor tiles could be due to natural settlement of the foundation, direct impact unbeknownst to the inspector or from original installation.

Recommendation: Contact a qualified professional.

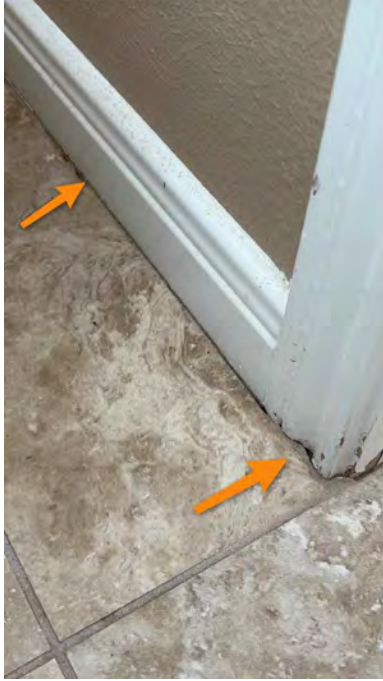
By Primary toilet

Observed caulk shrinkage, deterioration or missing at time of inspection in one or more areas. Caulking shrinks over time due to drying out of building materials or deterioration caused by normal wear and tear.

Recommendation: Contact a qualified professional.

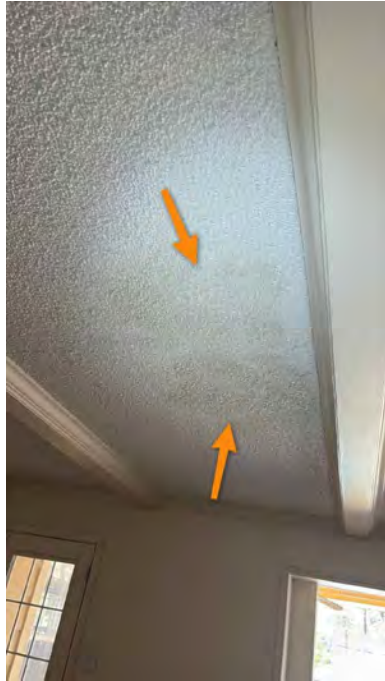
Living Room

Observed what appears to be moisture stains/penetration in ceiling at time of inspection. Moisture stains/penetration on the ceiling surface of the home can occur from previous or current water leakage from within the attic space. Although the leak may be in the attic space it may originate from a defect in the roofing system or a leak from a secondary drain pan, water heater or plumbing lines. If possible the inspector will attempt to locate the source of the moisture penetration in the event of an active leak. If the inspector is unable to identify the source, we recommend a qualified professional be acquired for further evaluation.

Recommendation: Contact a qualified professional.

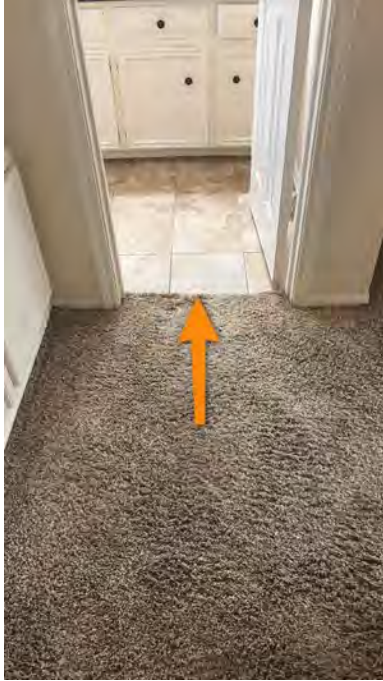
Floor appears to be sloping to one side at time of inspection. The most common causes of floors sloping is foundation issues, unlevel or inadequate block and beam, water damage or poor construction. When the foundation of the home has shifted or settled, it can cause the floors to slope. This can be caused by a variety of factors, such as soil movement or inadequate foundation support. Water damage can cause the floors to slope if the joists or subflooring become warped or rotted. This can be caused by leaks, flooding, or high humidity levels. Sloping floors can also be caused by poor construction practices, such as inadequate support or incorrect spacing of floor joists.

2md floor hallway- sloped into  
bathroom

Recommendation: Contact a qualified professional.

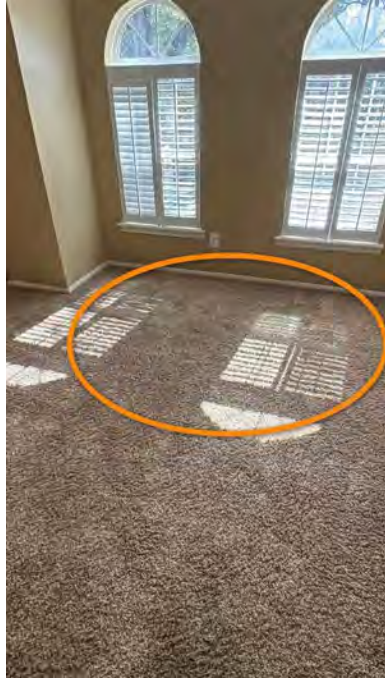
Primary bedroom

Observed unlevel floor at time of inspection. Subfloor fastening, foundation settlement, moisture penetration in wood floor covering, cracks or repair, high traffic walking areas, padding or transition between different types of floor covering could cause the floor to feel higher or spongy in some areas. Recommend a qualified professional for further evaluation.

Recommendation: Contact a qualified professional.

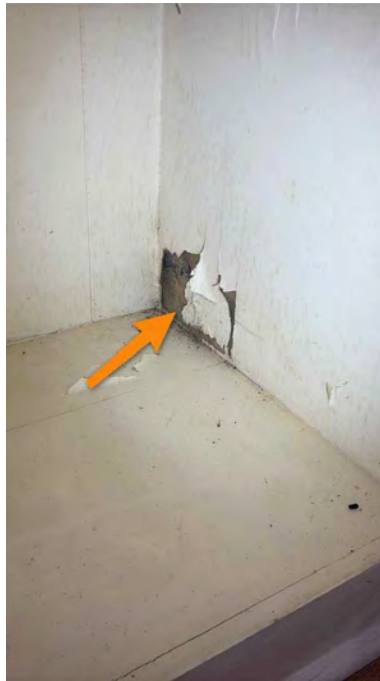
Left of fireplace

The cabinet base is showing signs of damage, moisture penetration, repairs, or organic substance. In the event of a repair, it is unknown to the inspector what the condition is beneath the replaced cabinet base. In the event that moisture intrusion occurred in the past or present, concealed conditions may exist below the cabinet, including but not limited to deteriorated sub-flooring, residual moisture, or conditions conducive to microbial growth. Further evaluation is recommended if concerns exist. This may include removal of the cabinet base or additional invasive evaluation by a qualified contractor to verify that all moisture-related damage has been properly addressed and that no concealed issues remain.

Recommendation: Contact a qualified professional.

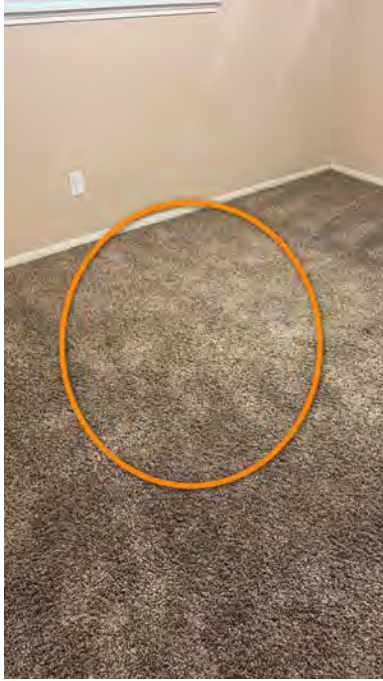
Bedroom 3

Sub-floor appears to be raised/deflecting at time of inspection. Subfloor deflection can be caused by one or more of the following: excessive load, inadequate structural support, moisture damage, improper installation, age and wear, material type and temperature changes.

Recommendation: Contact a qualified professional.

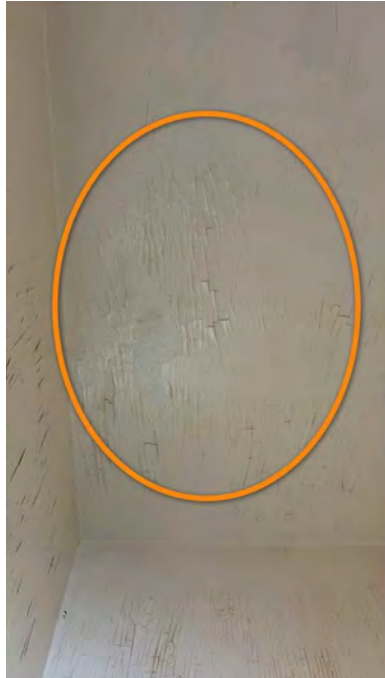
Observed signs of what appears to be moisture penetration/intrusion at time of inspection. Moisture penetration that has gone undetected for an extended amount of time will eventually cause building materials in the impacted area to break down, deteriorate and lose its structural integrity. Moisture penetration can also cause mold to form when in locations that have poor ventilation combined with a humid, moist environment. If possible the inspector will attempt to identify source of moisture intrusion. If the inspector is unable to identify the source we recommend a qualified professional for further evaluation.

Cost closet 2- bubbling paint indicates moisture penetration

Recommendation: Contact a qualified professional.

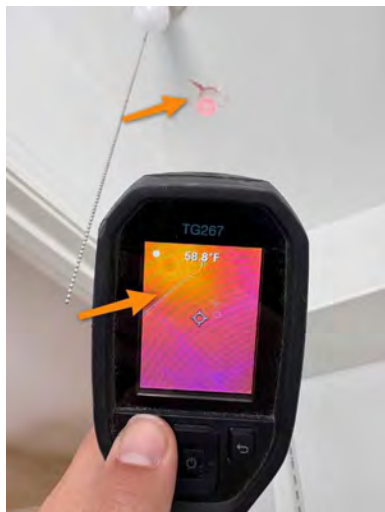
Bedroom 4 closet- dry

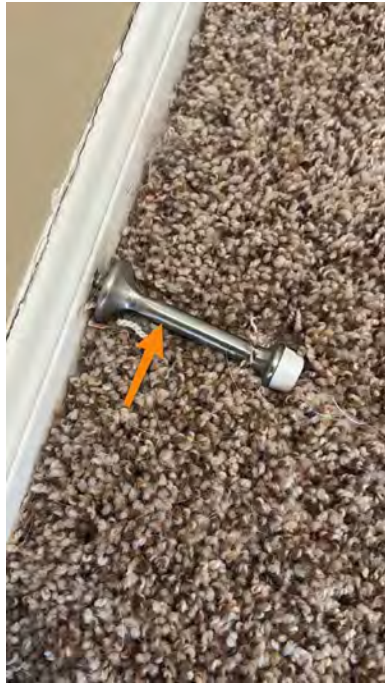
Observed missing or improperly functioning door stops in one or more locations at time of inspection. Door stops help prevent damage to walls, wood trimming or anything that may be in the way when the door has been fully opened.

Priamry bedroom- loose

Recommendation: Contact a handyman or DIY project

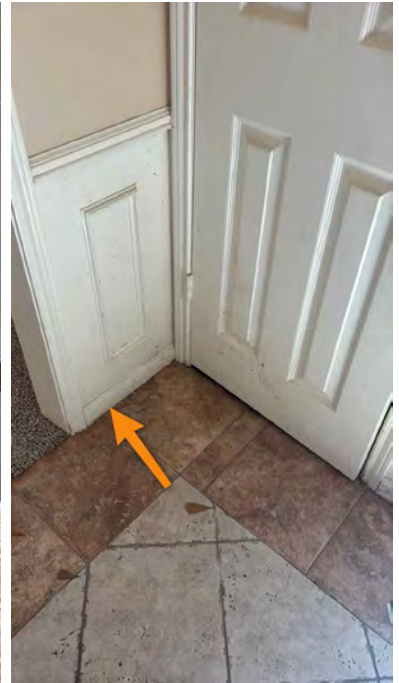
Front entry coat closet- uninstalled

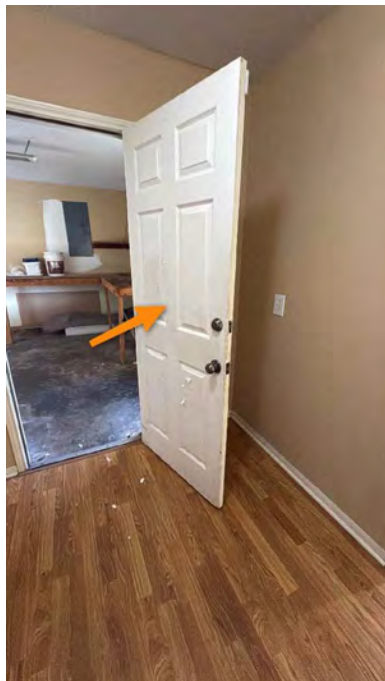
Garage door

Doors between home and garage, attics and spaces and that house carbon producing equipment may expose the interior living space to carbon monoxide gases. These spaces along with certain multifamily buildings, such as condominium's, should have self-closing capabilities and sufficient weatherstripping around perimeter of door that will create a seal. Achieving a seal from a self closing door will help prevent possible carbon monoxide from entering home from vehicles or mechanical equipment. It is recommended that the door to theses spaces utilize spring loaded hinges that will close the door without the use of force.

Recommendation: Contact a qualified professional.

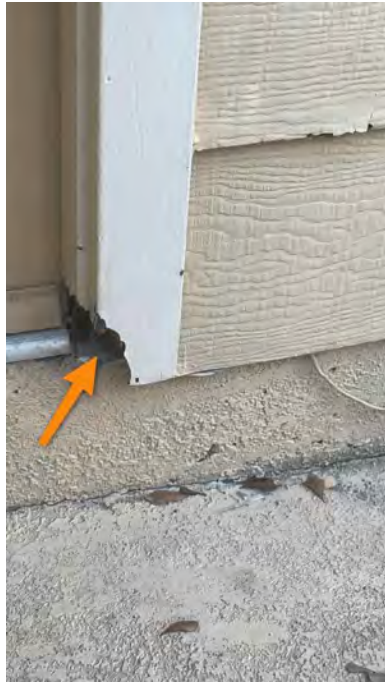
Garage door to back patio

Observed door frame that is showing signs of one or more of the following, but not limited to; damaged, deteriorating, over trimmed, or improperly fastened door trim/framing or shims in place at time of inspection. Damaged/deteriorating door frames may be caused from the wood drying out, moisture penetration, forced entry, wood destroying insects, being struck by, pawing from animal or improper installation. Depending on type of damage it is recommended that the door frame be repaired or replaced to prevent future penetration into wood members.

Recommendation: Contact a qualified professional.

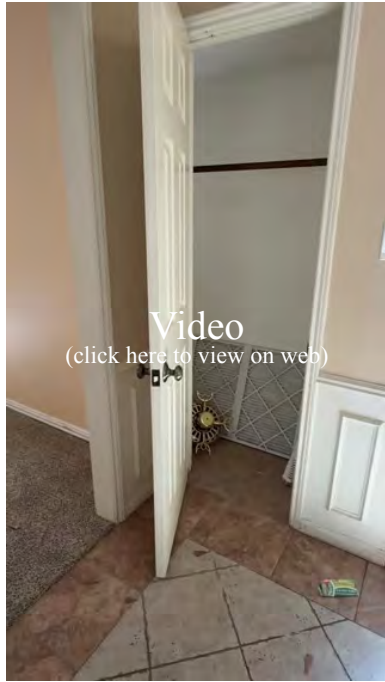
Front entry coat closet

Observed door that is moving on its own, opening or closing, when testing. This could be from the door being slightly out of level, the hinges have lost friction over time or the home has not settled properly.

Recommendation: Contact a qualified professional.

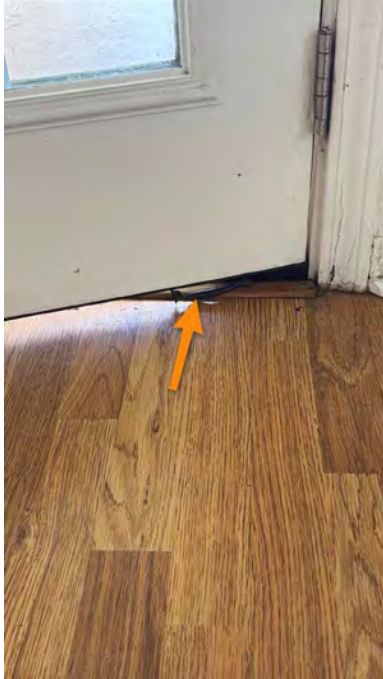
Backdoor

Observed insufficient, uninstalled or damaged door sweep at time of inspection. Recommend replacing or installing door sweep to prevent conditioned air loss, possible pest intrusion and moisture from entering home.

Recommendation: Contact a handyman or DIY project

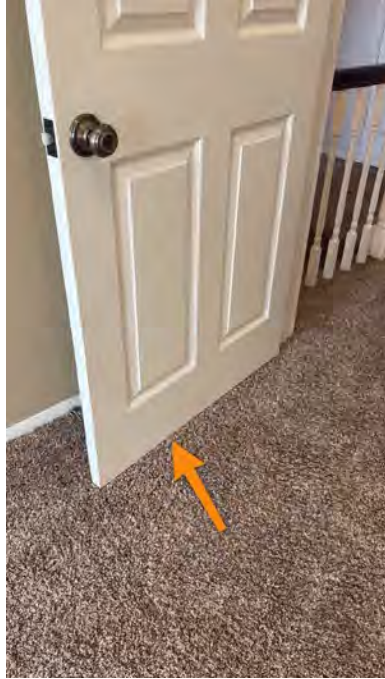
Primary bedroom

Observed area where door(s) didn't open smoothly due to bottom of door grazing carpet, tile or threshold.

Recommendation: Contact a qualified professional.

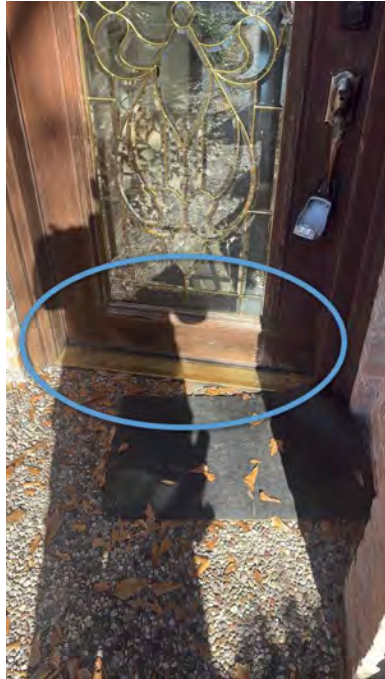
Front door

Door finish is worn. Recommend refinish and/or paint to maximize service life.

Recommendation: Recommended DIY Project

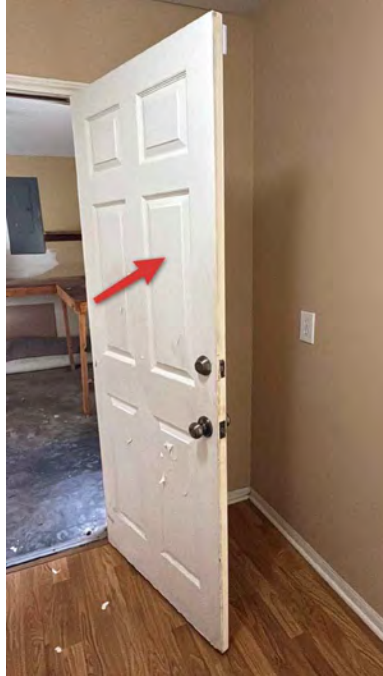
Garage door

Door between home and garage doesn't appear to be fire rated. A fire-rated door acts as a barrier, slowing down the progression of flames and smoke, providing occupants with valuable time to evacuate in the event of a fire. This crucial safety feature helps contain the fire within the garage, preventing it from quickly reaching the interior of the home and allowing emergency responders more time to intervene. Doors between the home and garage should be solid core or steel, have a minimum 20-minute fire rating and be at least 1-3/8" in thickness.

Recommendation: Contact a qualified professional.

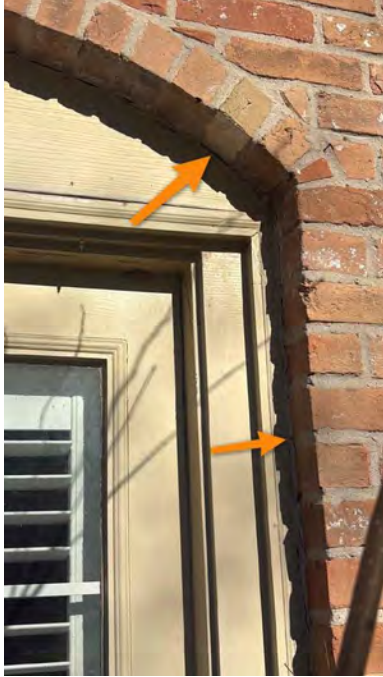
Front Left

Observed missing/deteriorating caulk around door(s) at time of inspection.

Recommendation: Contact a qualified professional.

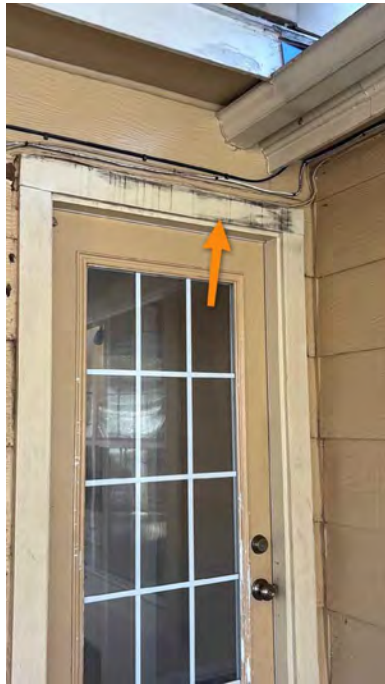
Backdoor

Observed what appears to be an organic dark substance, algae or mildew at time of inspection. This type of growth occurs in damp areas around the home that receive minimal sunlight or that are in constant contact with wet humid environments over a period of time. The inspector does not take a sample of the substance to confirm if this is actually mold or mildew. This is a visual observance and depending on location of substance and its proximity to moisture penetration, there is a possibility that it could be mold. We recommend contacting a qualified professional that will take the proper steps to verify the origin and status of the substance.

Recommendation: Contact a qualified professional.

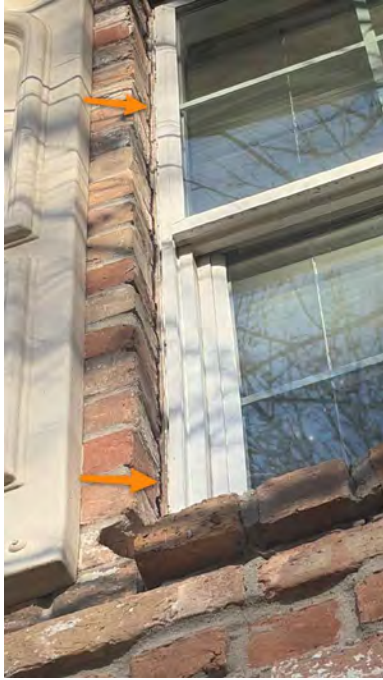
Front

Observed missing or shrinkage of caulk around window(s) at time of inspection. Missing or caulk shrinkage on the exterior of a home will allow moisture penetration into wall cavity. Interior caulk shrinkage may allow for conditioned air to escape from inside the home to the exterior.

Recommendation: Contact a qualified professional.

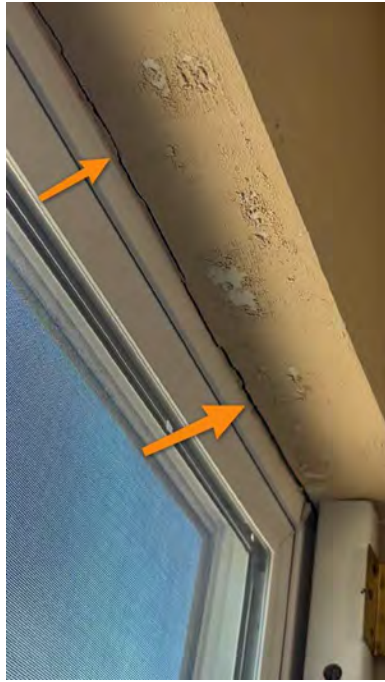
Bedroom 3

Observed one or more windows with damaged, missing or not properly fitted window screens at time of inspection. The primary advantage is that a window screen keep your home protected. Window screens are mandatory if you like to let fresh air into the home without the risk of pest entering the space. Screens serves as the primary barrier between the exterior and interior of your home and provide an added layer of security.

Recommendation: Contact a qualified window repair/installation contractor.

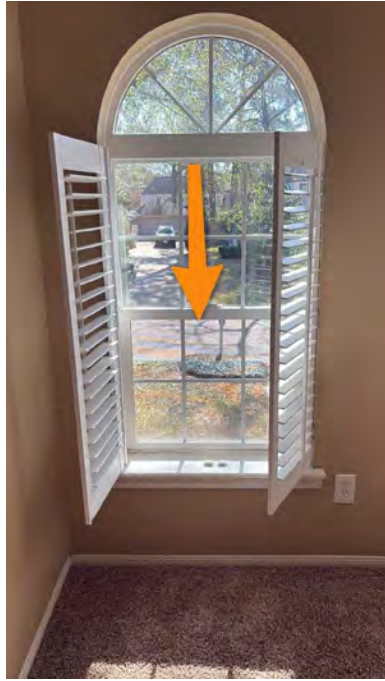
Observed one or more windows not opening or closing properly. Window(s) appear to be one or more of the following: painted shut, screw in track, spring balance not functioning as intended, needs adjustment, hits top sash, requires a crank shaft, double window or is improperly installed. Recommend a qualified professional to further evaluate.

Primary left window- does not stay in up position

Recommendation: Contact a qualified window repair/installation contractor.

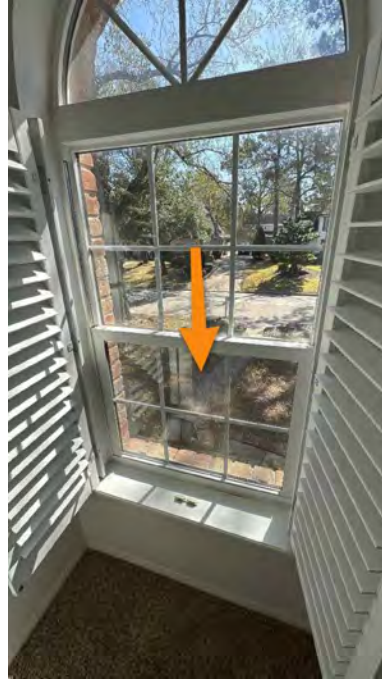
Bedroom 4 closet- does not stay up

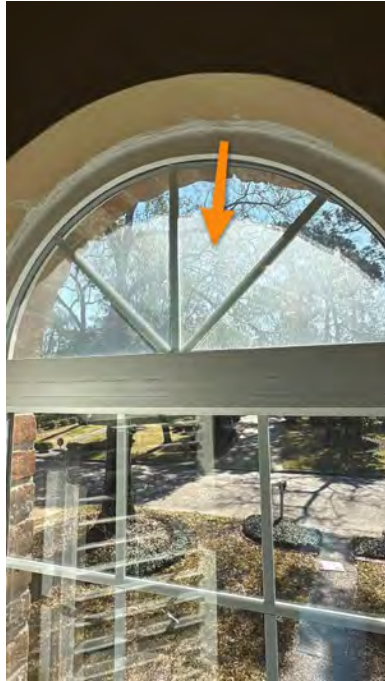
Primary right window

Windows in need of cleaning and therefore fogging (evidence of lost thermal seals) cannot be observed. Please clean windows and observe for the presence of moisture between panes and/or "halo effect" around dividers/frames. If evidence is found, please consult a window professional for remedies.

Recommendation: Contact a qualified professional.

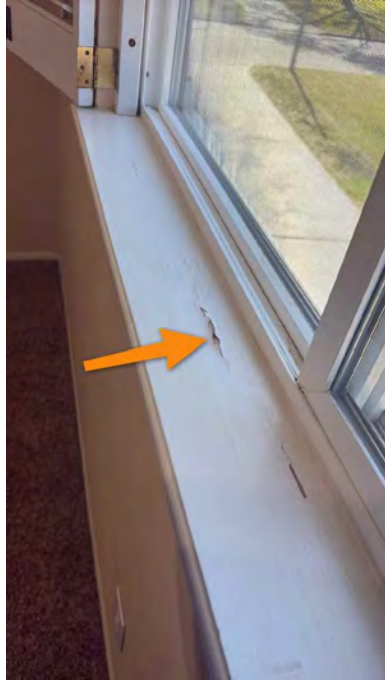
Bedroom 3

The window sill shows signs of previous moisture penetration, deterioration, or damage. This condition indicates that water has likely intruded at the window assembly at some point, which can lead to further deterioration of materials and potential concealed damage within the wall system if not addressed. Active moisture was not necessarily present at the time of inspection; however, the visible condition suggests the window sill may no longer be adequately protected. Further evaluation and repair or replacement of the affected materials by a qualified contractor is recommended to help prevent continued moisture intrusion and related damage.

Recommendation: Contact a qualified professional.

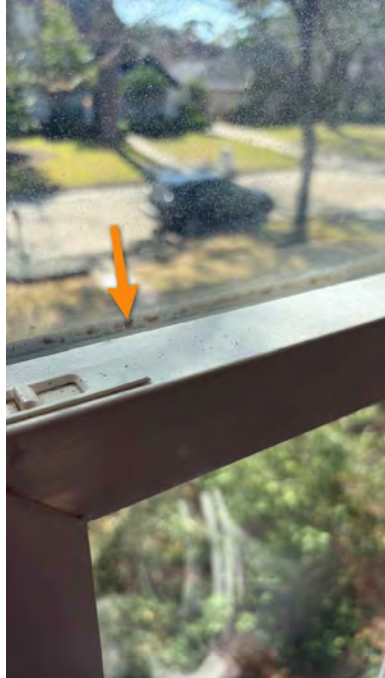
Primary bathroom by toilet

Observed what appears to be an organic dark substance or algae at time of inspection. This type of growth occurs in damp areas around the home that receive minimal sunlight or that are in constant contact with wet humid environments over a period of time. The inspector does not take a sample of the substance to confirm if this is actually mold or mildew. This is a visual observance and depending on location of substance and its proximity to moisture penetration, there is a possibility that it could be mold. We recommend contacting a qualified professional that will take the proper steps to verify the origin and status of the substance.

Recommendation: Contact a qualified professional.

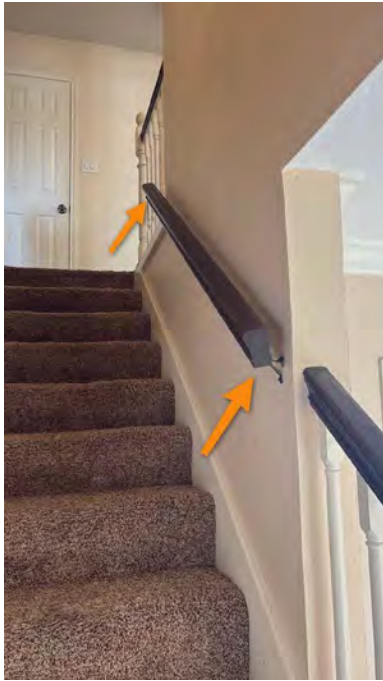
Observed handrail not making a smooth return to wall or newel post. Handrail termination is important so clothes or equipment doesn't get stuck on the end of the handrail, especially in emergency situations.

Recommendation: Contact a qualified professional.

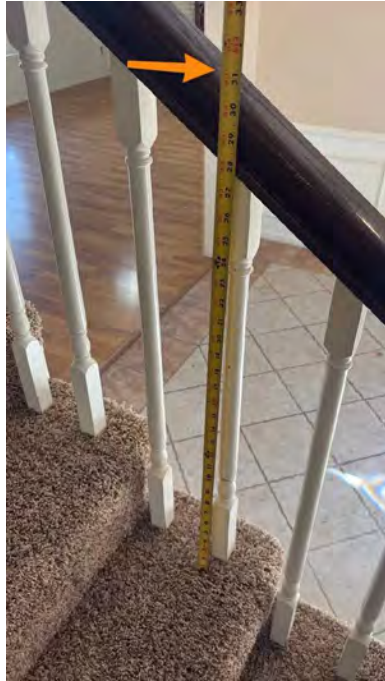
Observed handrail(s) that does not meet current building standards. Top of gripping surfaces of handrails shall be 34 inches minimum and 38 inches maximum vertically above walking surfaces, stair nosings, and ramp surfaces. The minimum clearance between handrails and other objects (e.g. walls) is 2.25 inches. Handrails should allow for the strongest and most comfortable grip to maximize safety. To achieve this, a circular cross section of 1¼" to 2 ⅝", is required. Other shapes are permitted but only if they provide an equivalent grasping surface.

Recommendation: Contact a qualified professional.

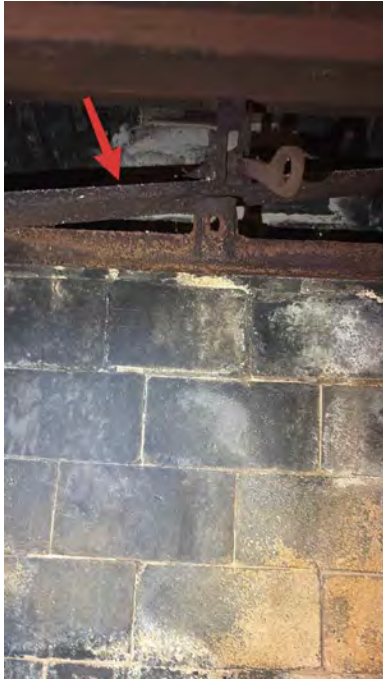
Damper clamp not installed at time of inspection. When artificial gas logs are present it is recommended that a damper clamp/block be installed to prevent carbon monoxide from accidentally entering the house. It is recommended that a damper block be installed for safety.

Recommendation: Contact a qualified professional.

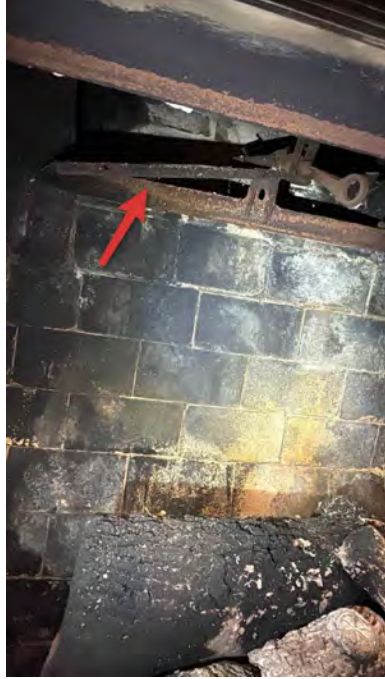
Damper was inoperable, not functioning properly or corrosion has been observed at time of inspection. The damper in a fireplace, when functioning properly, is used to allow carbon monoxide gases to exit the home. Dampers that have damaged or missing control handles, deteriorating or that doesn't open when in use will allow toxic fumes into the home. Corrosion occurs in dampers once water or corrosion finds its way inside the chimney. Corrosion overtime can prevent the damper from operating as intended. Recommend a qualified fireplace contractor evaluate and repair.

Rusted and not fastened to control mechanism

Recommendation: Contact a qualified fireplace contractor.

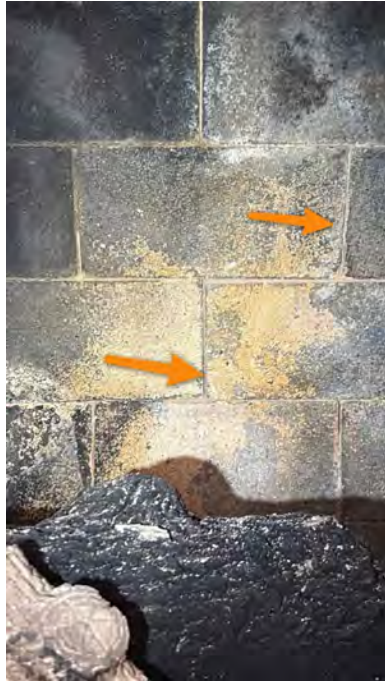
Observed areas in firebox that is showing signs of mortar failure. The mortar between the bricks have started to deteriorating due to expansion and contraction of the materials as they go from room temp to higher heating temperatures.

Recommendation: Contact a qualified fireplace contractor.
