# PROPERTY INSPECTION REPORT FORM

02/24/2026 8:30 am

1814 Wagon Gap Trail, Houston, TX 77090

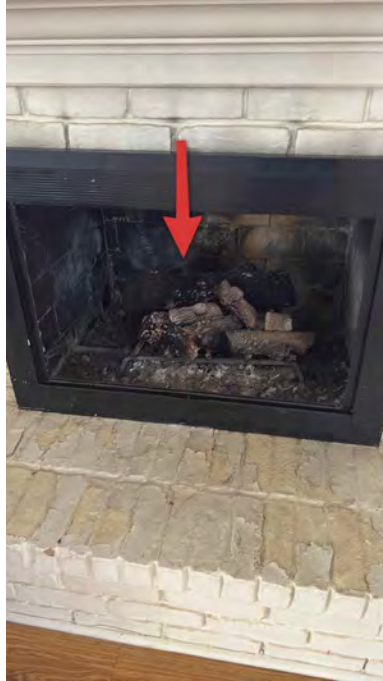
Observed missing spark arrestor on fireplace opening. Spark arrestors prevent embers from leaping out of a fireplace opening and potentially igniting flammable materials, they can also pose as a safety device for pets and small children.

Recommendation: Contact a qualified fireplace contractor.

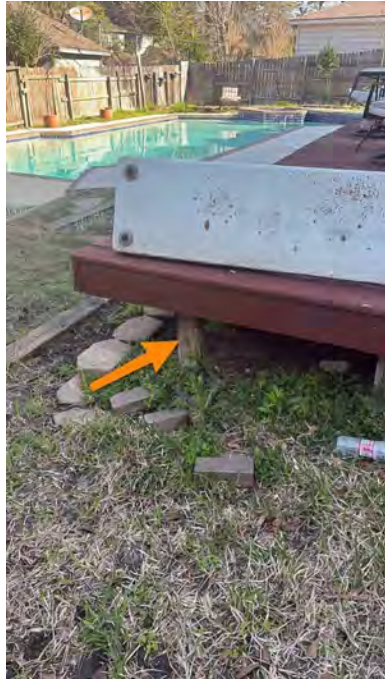
Rear

Observed deck that appears to be constructed of materials that are not rated for ground contact. This may invite wood destroying insects into materials and eventually into home.

Recommendation: Contact a qualified professional.

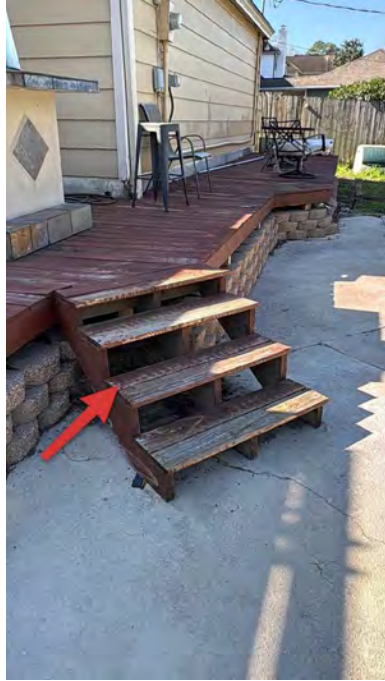
Observed elevated location that did not have a sufficient railing system in place at time of inspection. Stairways having 4 or more steps (risers) must have a well-secured handrail system on at least one side of the stairwell. Decks or porches that are 30" or more above the ground require a guardrail on all open sides. Guardrails must be a minimum of 36" high from the surface. If there is adjacent, fixed seating against the edge the guardrails must be at least 36".

Recommendation: Contact a qualified professional.

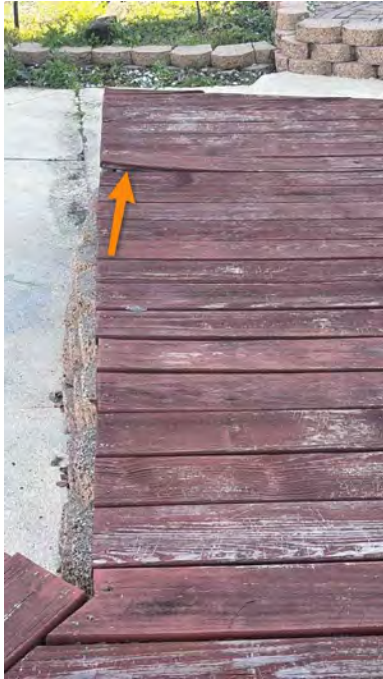
Deck boards appear to be in one or more of the following conditions: damaged, deteriorating, weathered, spacing too wide (typical gap is 1/8" to 1/4"), loosely fastened, warped, cracked or missing. Prolonged exposure to moisture and poor drainage can lead to rot, mold, and mildew, particularly in wood decks. UV rays from the sun can cause fading, drying, and cracking over time. Improper installation, such as insufficient spacing between boards, can lead to warping and buckling as the boards expand and contract with temperature changes. Heavy foot traffic, impacts, or excessive weight can also cause surface damage and stress fractures. For composite decks, poor manufacturing quality or exposure to extreme temperatures may lead to surface cracking or delamination. Regular maintenance and proper installation is important to prevent these issues.

Recommendation: Contact a qualified deck contractor.

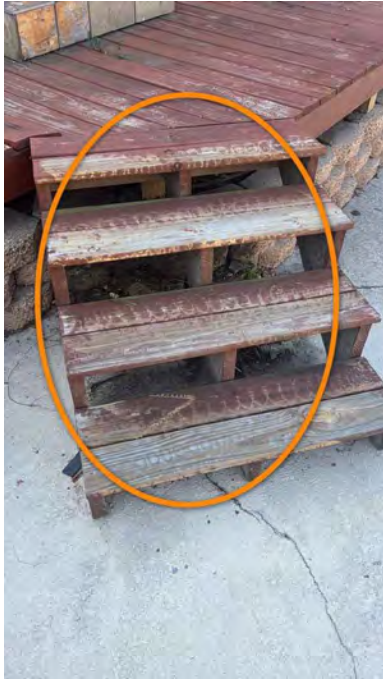
Observed what appears to be a damaged, missing, mismatched or loosely fastened tread on stairway at time of inspection.

Boards loose

Recommendation: Contact a qualified professional.

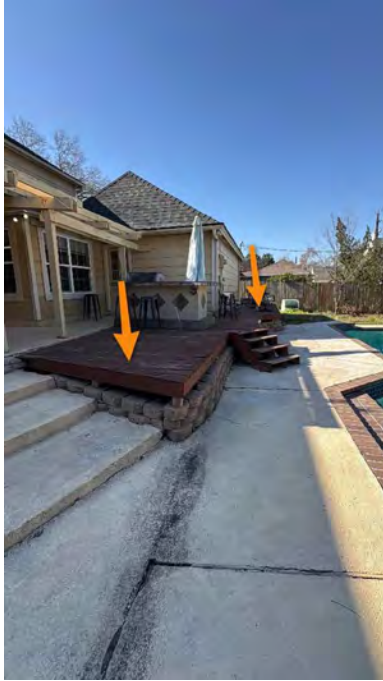
Observed location around an elevated deck that would be better suited with guard railing. The purpose of guard railing on an elevated deck is to provide safety and security by preventing accidental falls from the elevated surface. Guard railings act as a protective barrier, especially for children, pets, and individuals with mobility challenges, ensuring the deck is a safe space for use.

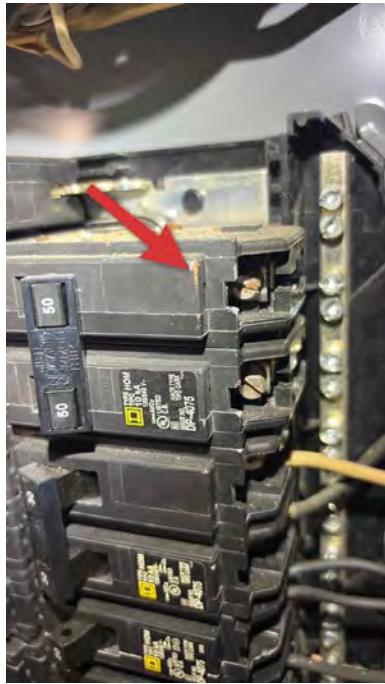
One or more circuit breakers in the electrical panel were observed to show signs of damage, looseness, corrosion/rust, moisture intrusion or improper operation. Circuit breakers are designed to provide overcurrent protection by safely shutting off power when a circuit becomes overloaded or shorted. If a breaker is damaged, deteriorated, or not functioning as intended, it may fail to trip properly, creating a risk of overheating, arcing, electrical shock, or fire. Conditions such as loose or corroded connections can also contribute to poor electrical contact, increased resistance, and excessive heat buildup. Rust or visible deterioration may indicate moisture intrusion, which can further compromise the safety and reliability of the electrical system. Due to these potential hazards, evaluation and correction by a licensed electrician is recommended to ensure the panel and its components remain in safe working condition.

Recommendation: Contact a qualified electrical contractor.

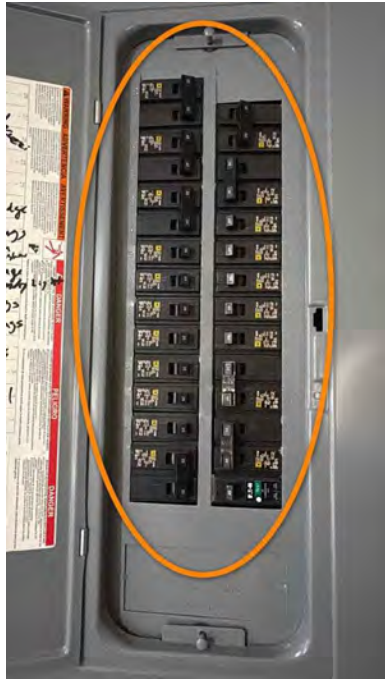
AFCI circuit breakers were not observed or missing during inspection of breaker panel. Depending on age of home AFCI protection may not have been required at the original time of build. New construction homes are required to have AFCI circuit breaker protection. AFCI protection is currently required for all 15 and 20 amp branch circuits providing power to outlets in residential family rooms, dining rooms, living rooms, parlors, libraries, dens, bedrooms, sunrooms, recreation rooms, closets, hallways, and similar rooms or areas.

Recommendation: Contact a qualified electrical contractor.

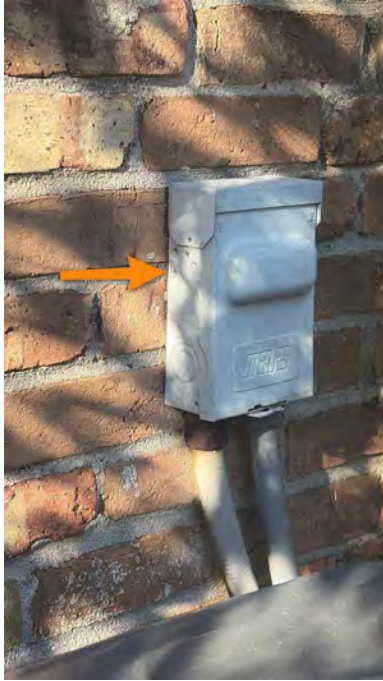
Right Side

Observed main emergency disconnect, electric meter or breaker panel that doesn't have sealant or the sealant is deteriorating between wall and cabinet enclosure.

Recommendation: Contact a qualified professional.

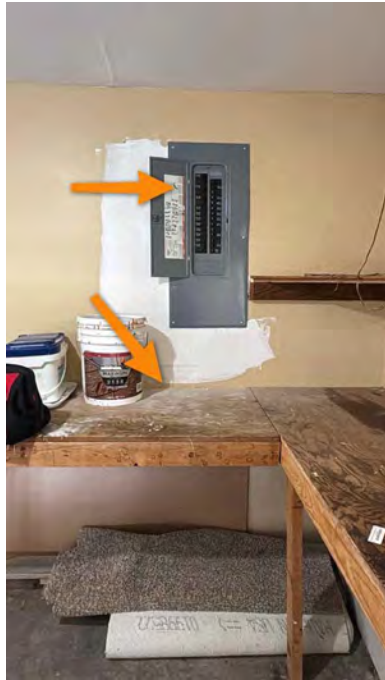
Observed breaker panel that does not meet the proper clearance for maintenance, repair or inspection. Breaker panels must have clearance of 36 inches in front, 30 inches to the sides, and a working area with a clearance of 6 foot 5 inches. Stored items in front of breaker panel(s) will prevent inspector from removing front cover. TREC, the governing body of home inspectors, states that the home inspector will not move furnishing or stored items in order to perform the home inspection.

Recommendation: Contact a qualified professional.

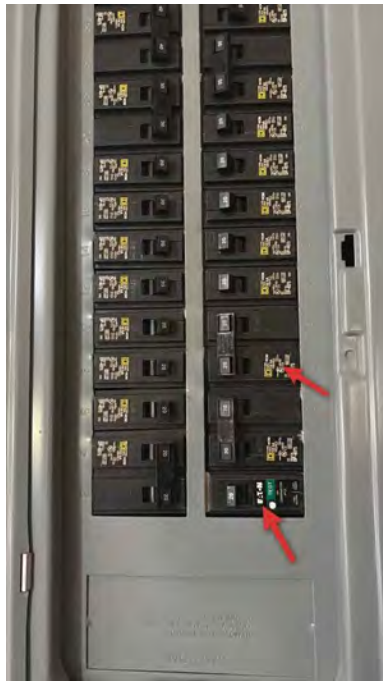
Observed what appears to be incompatible or different brand circuit breakers during inspection. Using mixed breakers in a breaker panel, especially those not listed or approved for that specific panel, can lead to serious safety hazards. Incompatible breakers may not fit securely, causing loose connections that lead to arcing, overheating, and potential electrical fires. Additionally, breakers designed for different panels may not trip correctly in overload or short-circuit situations, increasing the risk of equipment damage and electrical shock. To ensure proper function and compliance with electrical codes, always use manufacturer-approved breakers listed for the panel.

Square D and Eaton

Recommendation: Contact a qualified electrical contractor.

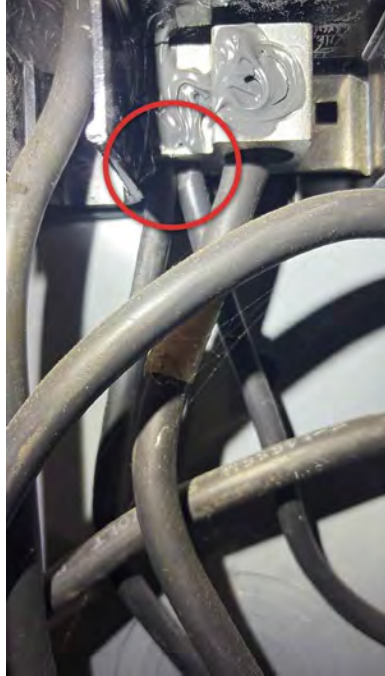
Observed a double tapped circuit breaker in breaker panel at time of inspection. A double-tapped circuit breaker occurs when two wires are connected to the same terminal of a circuit breaker in an electrical panel. A double tapped circuit breaker can have several potential consequences such as overheating/fire hazard, tripping issues, electrical malfunctions and it is a violation of electrical codes. We recommend contacting a licensed electrical contractor to verify and rectify issue.

Recommendation: Contact a qualified electrical contractor.

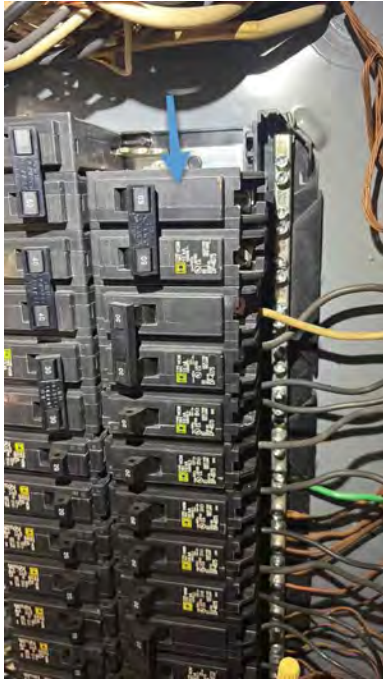
Observed what appears to be a unused/spare breaker in breaker panel at time of inspection. Breaker doesn't have any conductors connected to it and could be serving as a temporary knockout.

Recommendation: Contact a qualified electrical contractor.

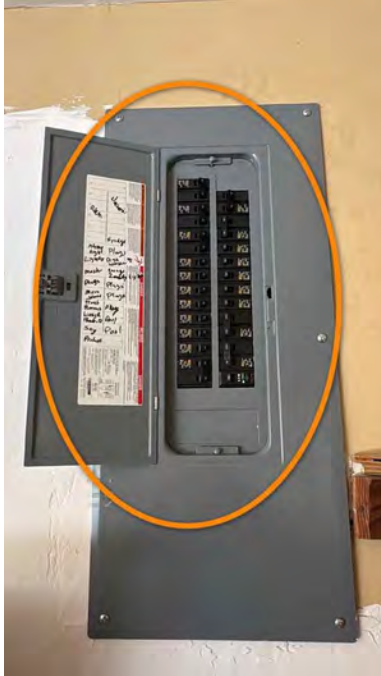
Electrical panel to home does not have a emergency service disconnect switch. An emergency disconnect is a switch that will shut off the power coming from the utility power service to the entire house in case of an emergency. The National Electrical Code 230.71 permits up to six disconnects in a single enclosure that does not have a "single" primary means of disconnecting electrical current to dwelling. Homes built prior to this 2020 code are not required, although it is recommended, to have a single primary service disconnect as long as it has a max of 6 disconnect switches to shut off power throughout dwelling.

No disconnect installed or observed

Recommendation: Contact a qualified electrical contractor.

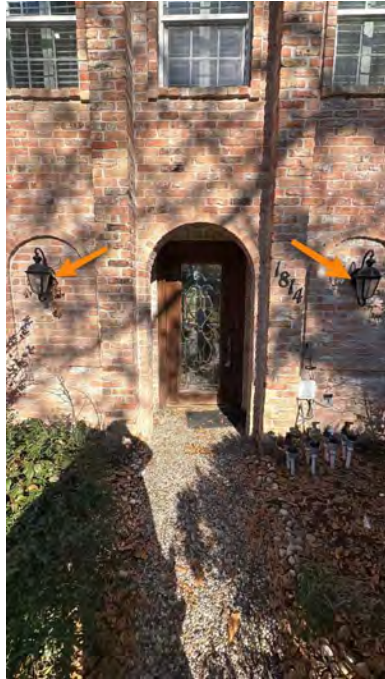
Front

Observed one or more lights are not operating properly at time of inspection. New light bulb possibly needed or a potential wiring problem exists.

Recommendation: Contact a qualified professional.

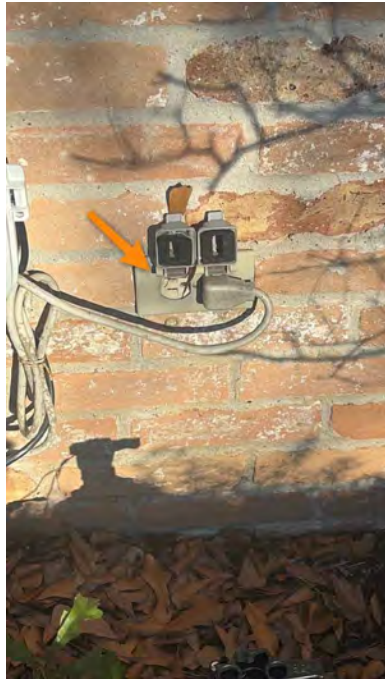
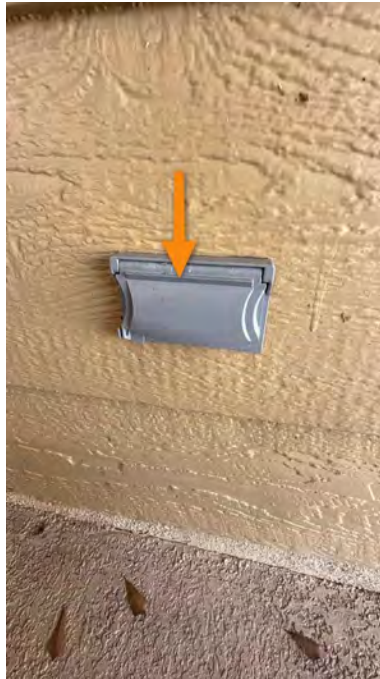
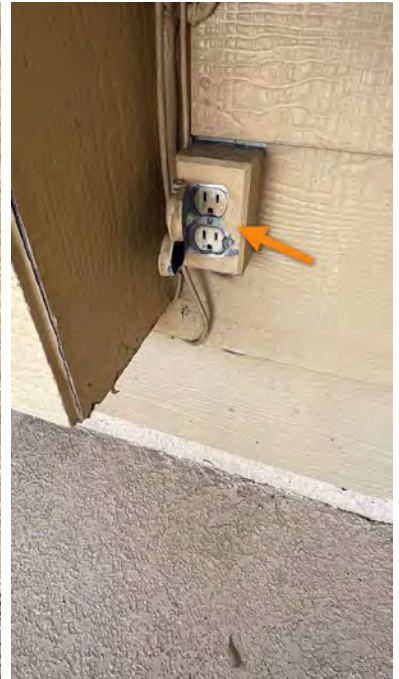
Observed missing or damaged bubble cover at one or more exterior outlets. Bubble covers protect outlets from moisture more effectively when they are in use than flip cover protectors. Bubble covers are required on all new construction and therefore this recommendation may not apply to the current structure.

Recommendation: Contact a qualified electrical contractor.

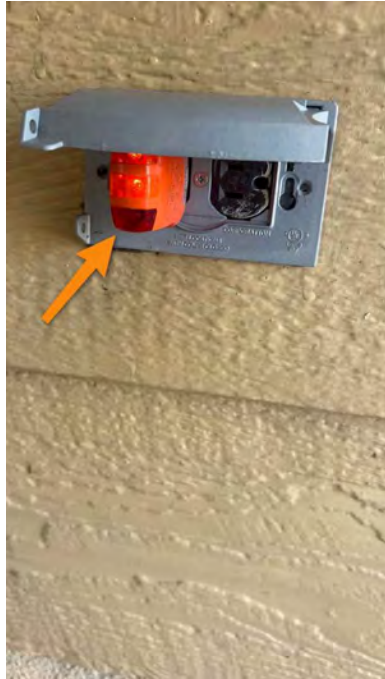
Observed locations where GFCI protection is required, but either not present or functioning properly at time of inspection. Any area within six feet of a sink, water source, kitchen countertop or exterior of home is required to have GFCI protected outlets. Outlets in unfinished attic spaces that have an HVAC unit or water heater have the potential to be exposed to water. In this instance a GFCI outlet will be required.

All exterior outlets

Recommendation: Contact a qualified electrical contractor.

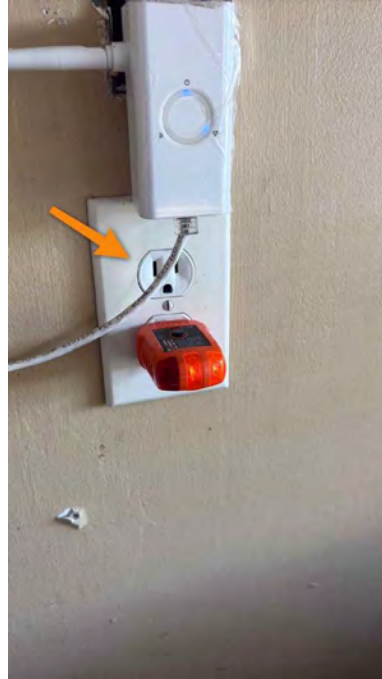
Garage x3

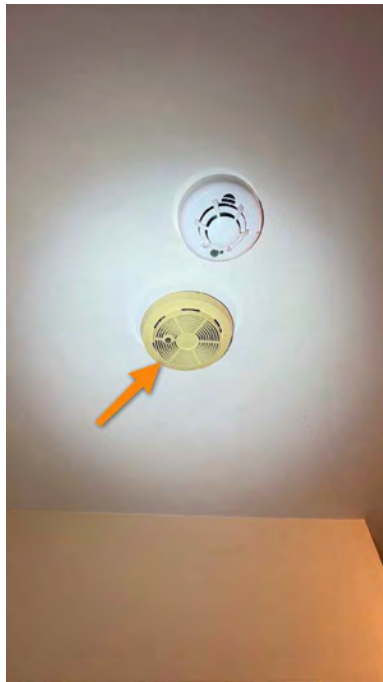
Observed smoke detector with one or more of the following conditions: constant chirping, inoperable, wrong location, uninstalled or outdated. The lifespan of a smoke detector can vary depending on the type of detector. There are two main types of smoke detectors: ionization and photoelectric.

2nd floor hallway- old

Recommendation: Contact a qualified professional.

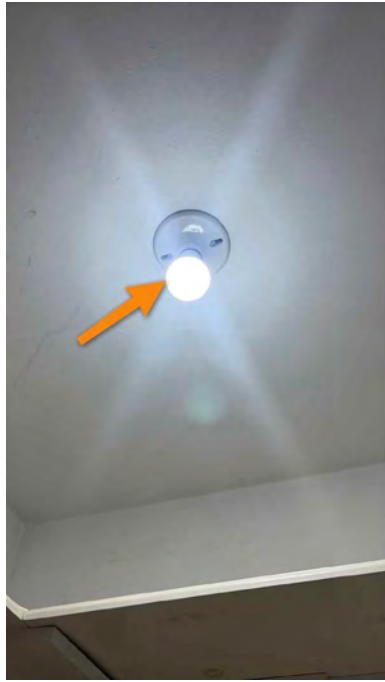
Observed one or more light fixtures with missing light cover. All light fixtures should be protected from potential damage/breakage. Bulbs in attic space that are not shatter resistant should have a protective cover over it.

Primary right closet

Recommendation: Contact a handyman or DIY project

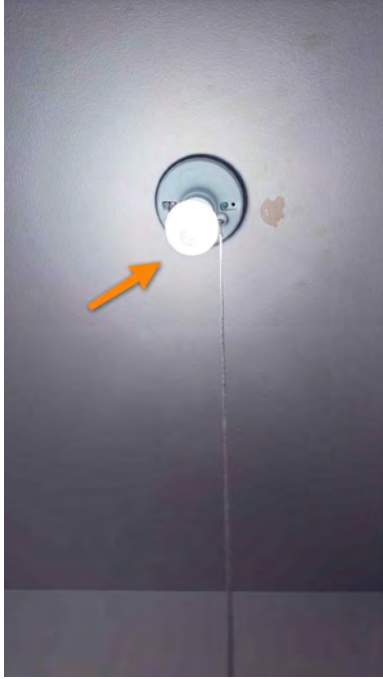
Bedroom 3 closet

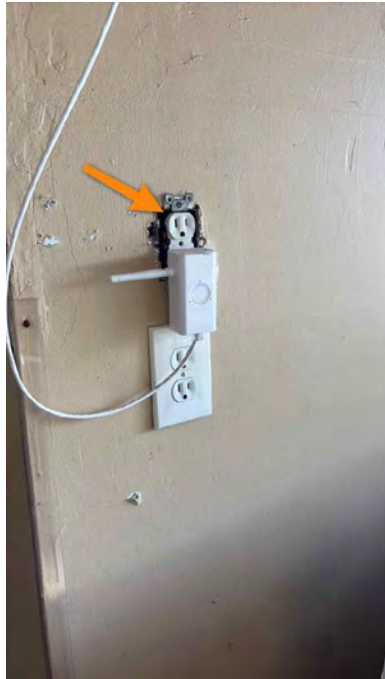
Garage

Observed damaged, loose, missing cover plate for outlet, data box, doorbell chimes, ceiling fan, or light switch at time of inspection. Cracked or damaged outlet cover plates can expose the outlets terminals and invite a small child to poke a metal object into the open space.

Recommendation: Contact a qualified professional.

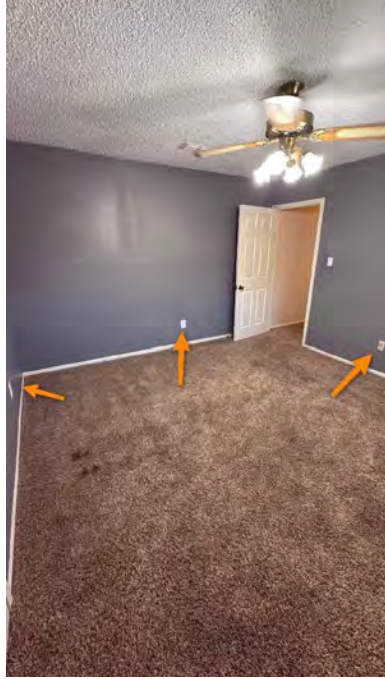
Bedroom 2- loose

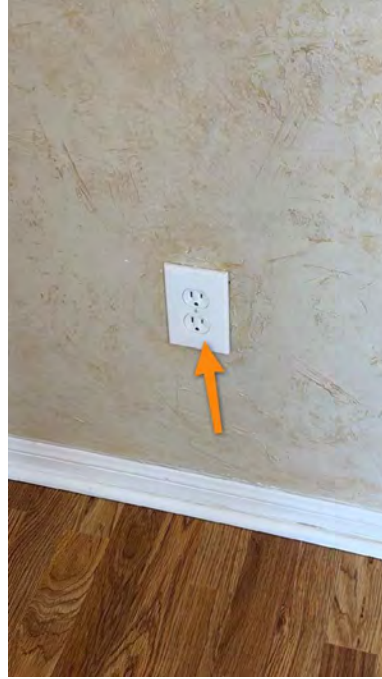
Dining room- loose

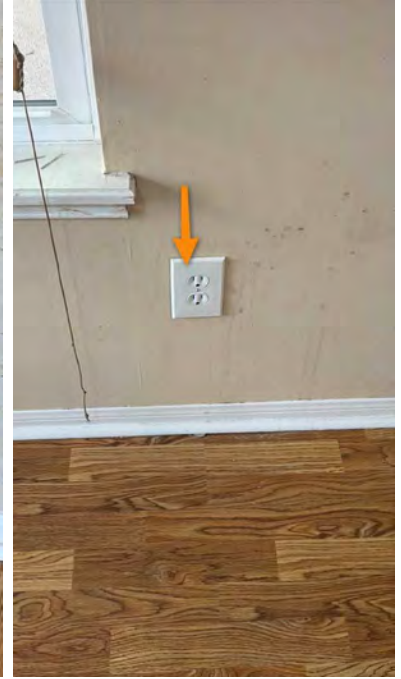
Kitchen Dining Room- loose

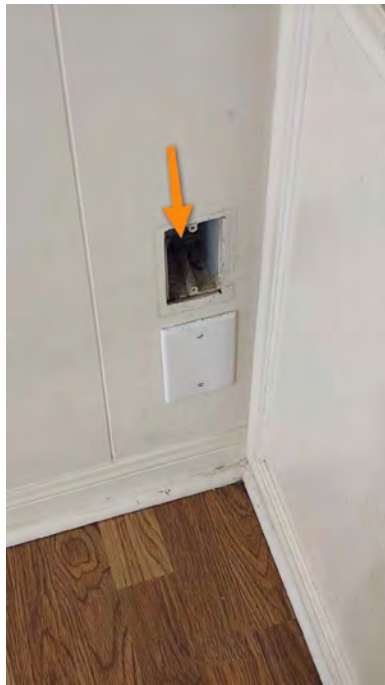
Living Room- missing

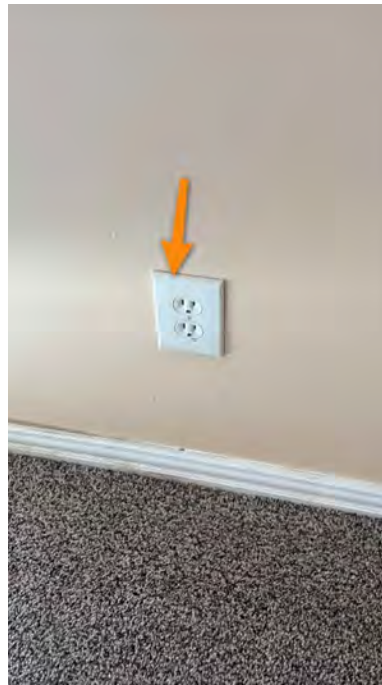
Office- loose

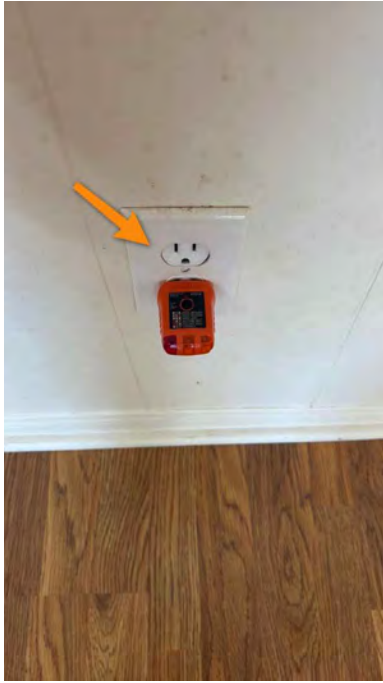
Living Room

Observed an inoperable outlet when testing at time of inspection. Receptacle didn't produce any signs of power when tested. Outlets in bathroom and kitchen areas that are within 6' of a water supply should be GFCI protected. It is unknown to the inspector if an inoperable outlet in aforementioned locations meet this requirement.

Recommendation: Contact a qualified electrical contractor.

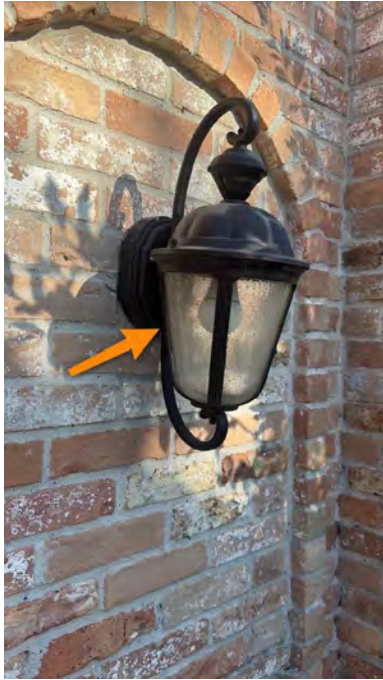
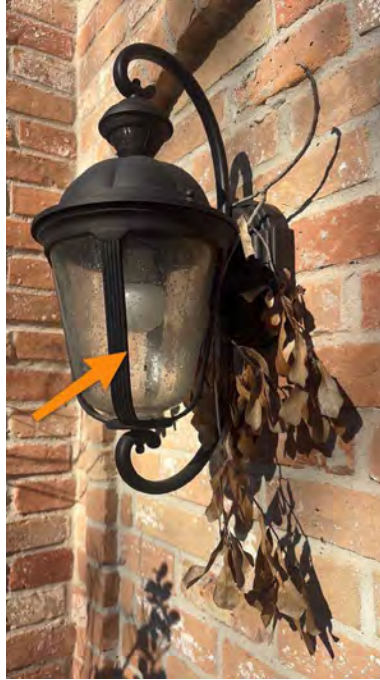
Front

Observed what appears to be a light fixture that isn't flush or improperly fastened at time of inspection. This could be due to fastening or clips not fully expanding at installation site.

Recommendation: Contact a qualified professional.

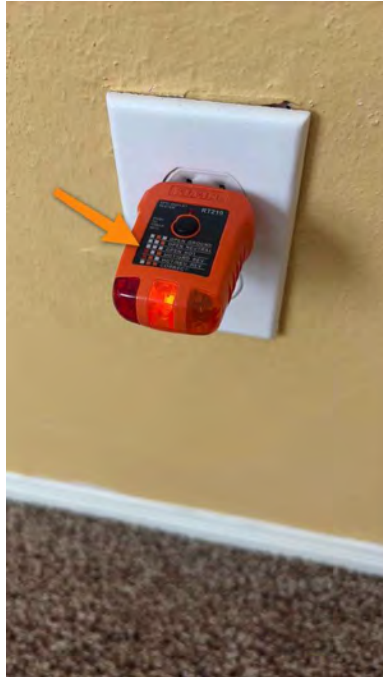
Bedroom 2

Observed open ground on one or more outlets. An open ground refers to a situation in an electrical system where the ground wire, which is crucial for providing a safe pathway for electrical currents to dissipate in case of a fault, is interrupted or not properly connected. This can occur due to factors such as a broken wire, a loose connection, or a faulty grounding component. Outlets installed in homes built in the early 60's - 70's were wired with two wires and didn't require a grounding wire. Recommend consulting an electrical contractor for further evaluation.

Recommendation: Contact a qualified electrical contractor.

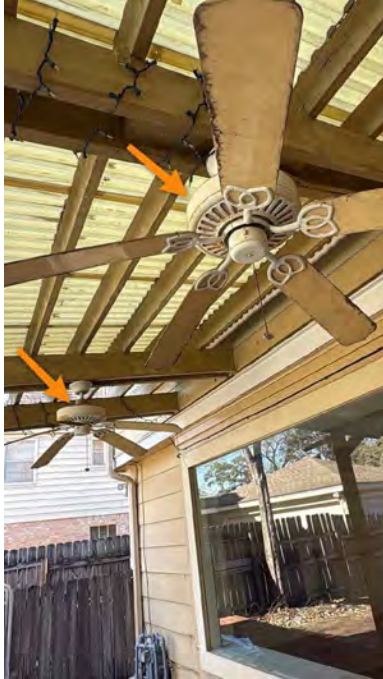
Observed a ceiling fan that has one or more of the following conditions: missing parts, loosely fastened, unbalanced, inoperable or making a louder than normal sound. We recommend repairing or replacing a fan that is not performing as intended.

Back pario- rusted and blades warped

Recommendation: Contact a handyman or DIY project

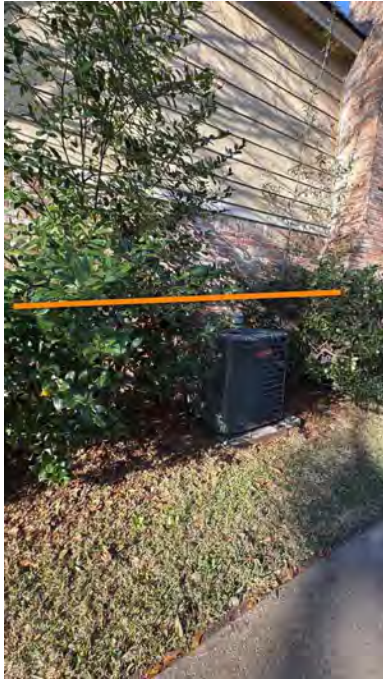
Right Side

Observed missing outlet in location that requires a service outlet. Because a receptacle is often necessary for servicing HVAC equipment, the National Electrical Code (NEC 210.63) specifies that a 125-volt, single-phase, 15- or 20-amp receptacle outlet must be installed in an accessible location within 25 feet of the equipment and on the same level.

Recommendation: Contact a qualified professional.

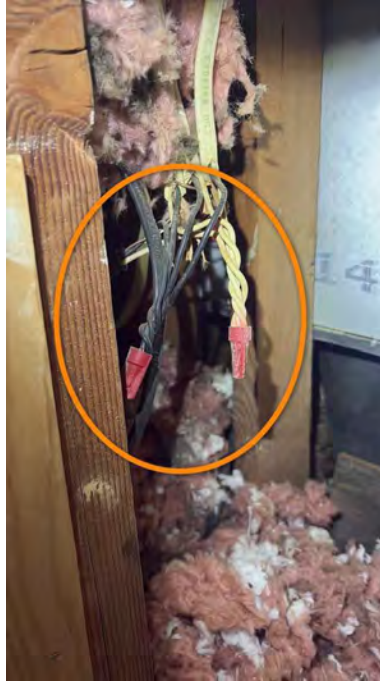
Live electrical conductors were observed that are not enclosed within a proper junction box. Exposed connections outside of an approved enclosure create a potential shock and fire hazard, as they are not adequately protected from physical damage or accidental contact. Junction boxes are required to contain and secure wire splices, provide strain relief, and allow for safe inspection and servicing.

2nd floor plumbing access panel

Recommendation: Contact a qualified electrical contractor.

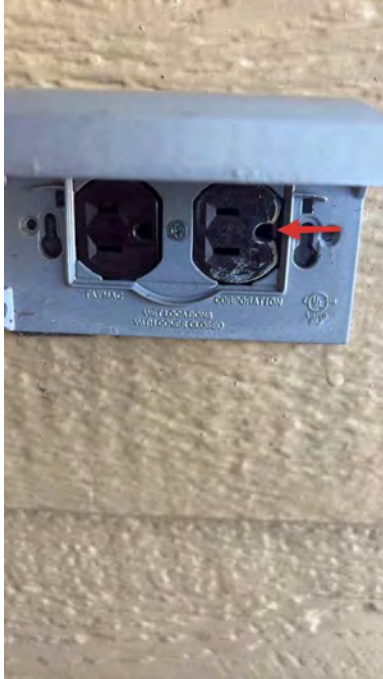
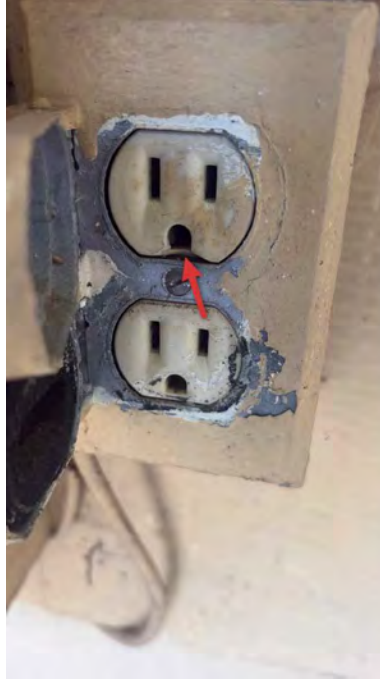
Rear by backdoor

Observed damaged electrical outlet(s) at time of inspection. Damaged or cracked electrical outlet loses the ability to hold hanging plugs and expose someone to a potential shock or fire hazard; this is mainly because plug prongs are exposed while they are energized.

Recommendation: Contact a qualified electrical contractor.

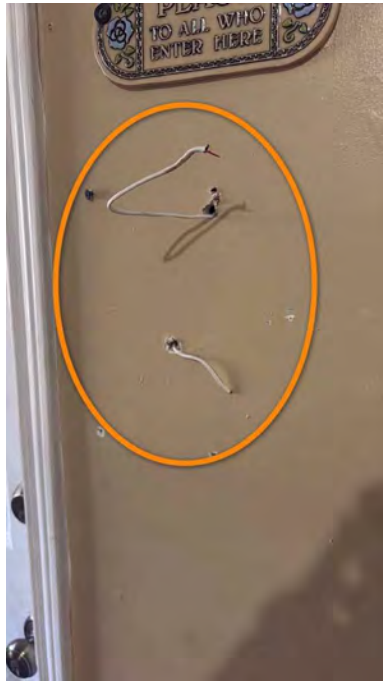
Garage

Observed low voltage, low hanging wire, unprotected or loosely connected wire at time of inspection. Although low voltage wire doesn't have the same impact on the electrical system it can be needed for cable, phone, home security system, etc. We recommend increasing height of line, properly fastening or protecting to prevent potential damage by impact.

Recommendation: Contact a qualified electrical contractor.

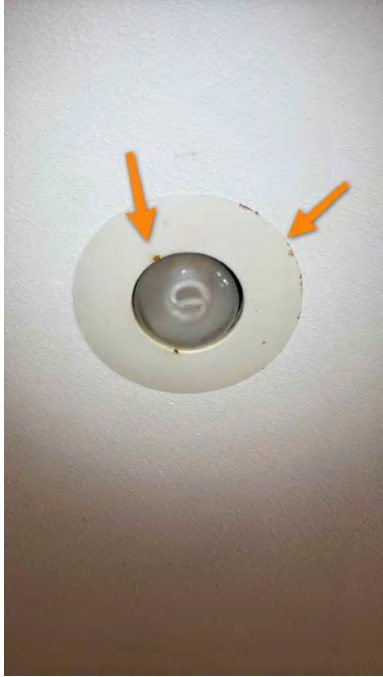
Observed damaged/rusted light fixture cover at time of inspection.

Primary bedroom- rusted

Recommendation: Contact a handyman or DIY project

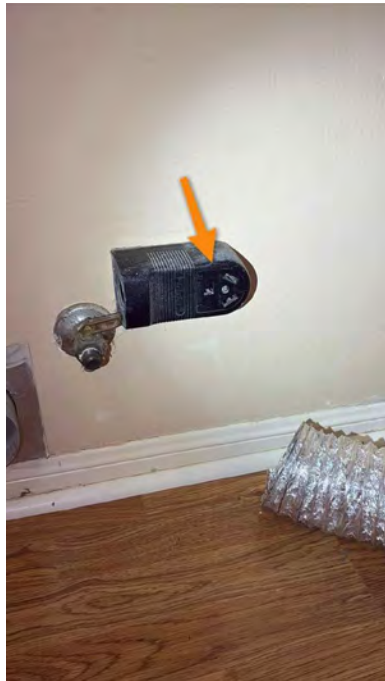
Three prong 220V outlet installed for dryer is outdated by current standards. Three-prong 220V outlets, commonly used for older dryers and ranges, are considered acceptable if they were installed before electrical code updates in 1996. However, current code requires four-prong outlets for all new 220V installations to provide a dedicated ground wire for improved safety. While existing three-prong outlets are typically grandfathered and not required to be replaced unless the circuit is modified, upgrading to a four-prong outlet is recommended when replacing appliances or performing electrical work to ensure compliance with modern safety standards.

Recommendation: Contact a qualified electrical contractor.

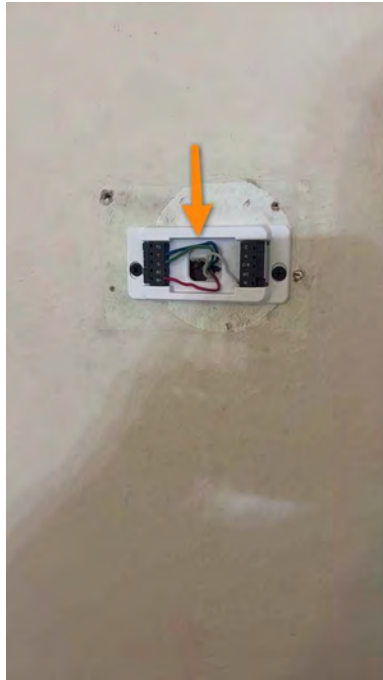
Observed furnace not operating or properly heating when testing at time of inspection. When testing furnace for proper functionality unit did not perform as intended. If gas supply to home or unit is disconnected/off the inspector will be unable to test furnace for proper functioning. If temperature in home exceeds setting for thermostat this will prevent testing as well. Recommend a qualified HVAC professional for further evaluation if cause for lack of operation is due to something beyond the gas being off to unit or home.

Thermostat uninstalled- unable to operate system

Recommendation: Contact a qualified HVAC professional.

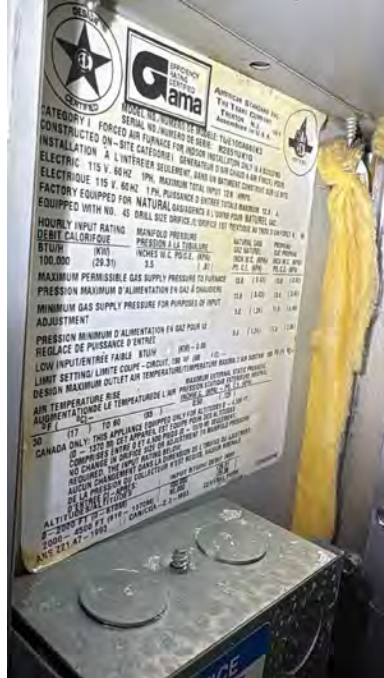
It is also unknown to the inspector how frequently preventative maintenance has occurred. Depending on how the unit has been maintained the life expectancy could be less or more than the average 15-30 years. Furnace annual maintenance allows technicians to check, clean, adjust, lubricate, and test all the system's essential components.

Manufactured in 2000

Recommendation: Contact a qualified HVAC professional.

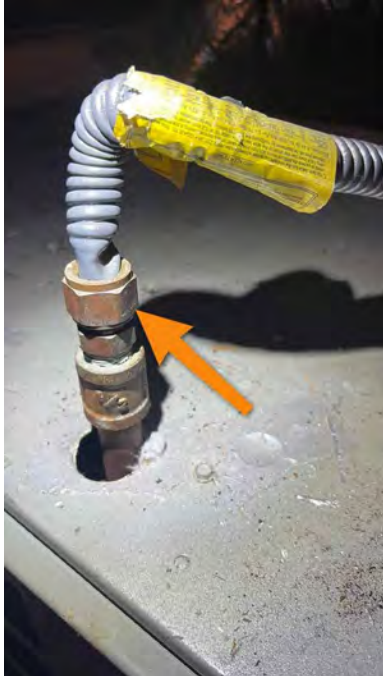
Missing, improperly installed or insufficient length sediment trap on gas connection for furnace at time of inspection. A sediment trap, also known as a drip leg, is designed to catch debris, moisture, and sediment in gas lines before they enter appliances like water heaters or furnaces. It works by forcing gas to make a 90-degree turn, allowing heavier particles to drop into a capped vertical section of pipe below the gas flow.

Recommendation: Contact a qualified professional.

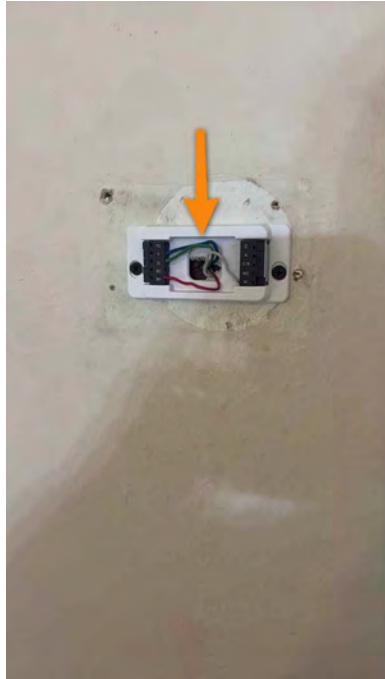
Observed inoperable, improperly functioning, inaccessible, uninstalled or locked thermostat at time of inspection. Without control from thermostat inspector will not be able to test unit for proper functionality and performance.

Uninstalled

Recommendation: Contact a qualified HVAC professional.

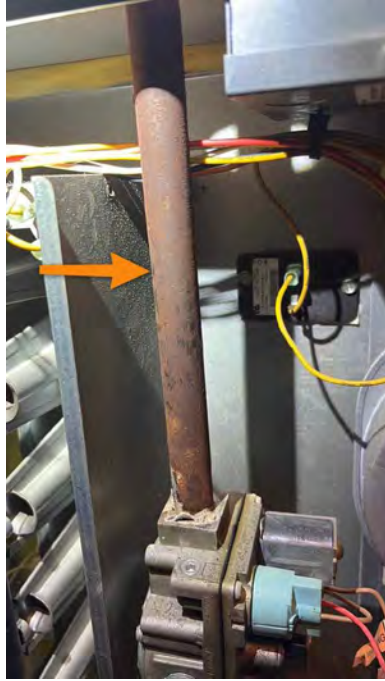
Rust was noted on the gas line connected to the furnace. This type of surface corrosion can occur over time due to moisture exposure, condensation, or environmental conditions within the mechanical area. While the pipe may still be functional, continued rusting can gradually affect the condition of the material and its long-term reliability. It is recommended to have a licensed professional evaluate the extent of the corrosion and determine if any maintenance, cleaning, or protective measures are needed to help preserve the gas line and ensure the system continues to operate safely and efficiently.

Recommendation: Contact a qualified professional.

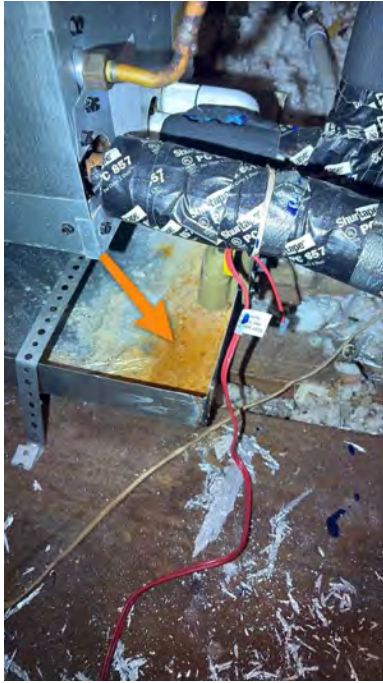
Secondary drain pan has signs of rust/corrosion. Rust in the secondary drain pan is typically caused by water accumulation due to poor drainage or excessive condensation from the HVAC system. When the primary drain pan overflows or there is a blockage in the drain lines, water can collect in the secondary pan. If this water sits for extended periods, it leads to corrosion, especially if the pan is made from a metal prone to rust.

Recommendation: Contact a qualified HVAC professional.

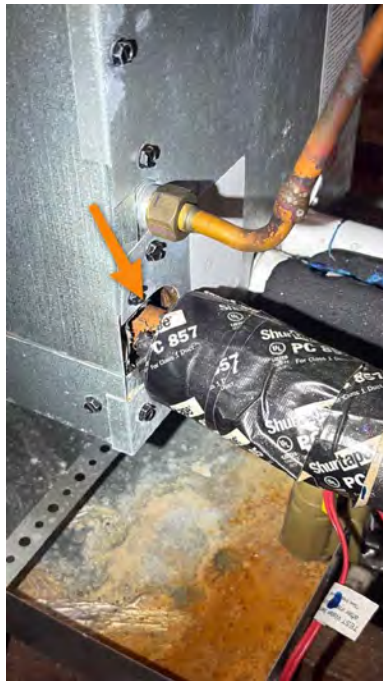
Observed sealant used to seal furnace/evaporator cabinet at seams or penetrations appear to be insufficient or not functioning as intended. All unused conduit knockouts should be sealed with UL-listed tape or mastic. Fixed seams in the cabinets, and all seams between the cabinet and the supply or return plenums should be sealed with mastic or mastic and fiberglass mesh fabric. It is recommended that UL-approved gaskets, mastic, mastic plus embedded fiberglass mesh fabric, or UL 181 A or B tape should be used to seal all cabinet seams and junctures between the air handler or furnace cabinet and the evaporator coil cabinet, the supply plenum, and the return plenum. Leaky ducts or cabinets can dump conditioned air into attics and crawlspaces, or pull in air from these same types of spaces. Both outcomes waste energy and reduce the amount of heated or cooled air that reaches its destination, and can cause the HVAC system not to function as intended.

Recommendation: Contact a qualified HVAC professional.

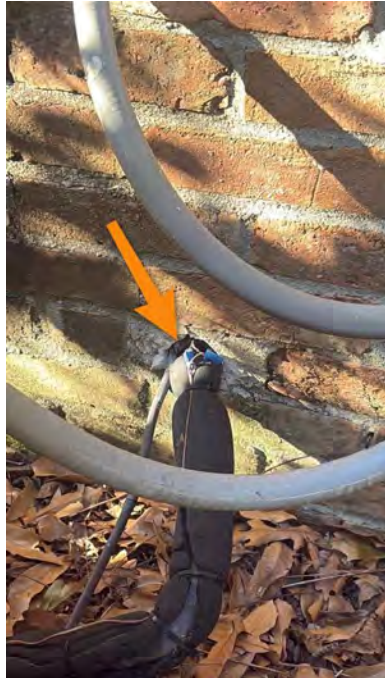
Right Side

Condenser lineset flashing was showing signs of damage, insufficient for application, uninstalled or loosely fastened at time of inspection. Lineset flashing that is not suitable or properly installed can allow water intrusion into the wall assembly (which can cause organic growth and deterioration of adjacent framing members) and potential pest intrusion into to wall or attic space. Exterior wall penetrations should be properly sealed and flashed to maintain the integrity of the building envelope.

Recommendation: Contact a qualified professional.

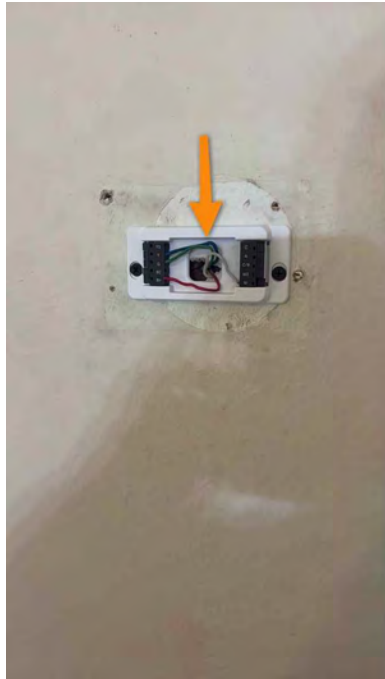
HVAC system, when testing for proper cooling, unit did not operate or function properly at time of inspection. When testing AC for proper functioning unit didn't achieve proper temperature variances between the supply and return registers or didn't meet sufficient cooling when set in low temperatures. Low refrigerant levels, broken condenser fan(s), inoperable compressor, dirty filters, damaged or poorly connected supply ducts or improperly functioning thermostat are all causes of an AC unit not functioning as intended.

No thermostat, unable to operate system

Recommendation: Contact a qualified HVAC professional.

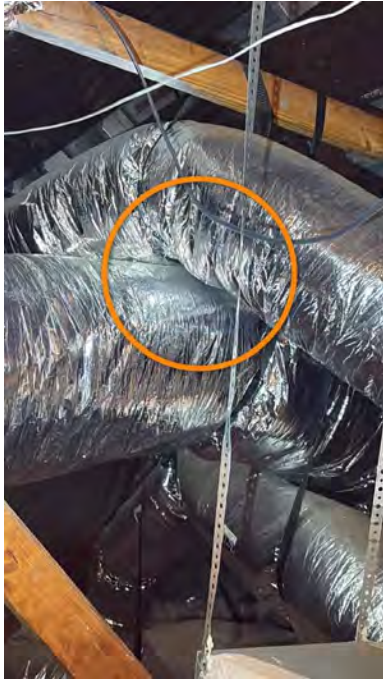
Observed ductwork that is touching or in contact with other ducts at time of inspection. Where ductwork is touching it forms a cold spot and could potentially cause condensation to form.

Recommendation: Contact a qualified HVAC professional.

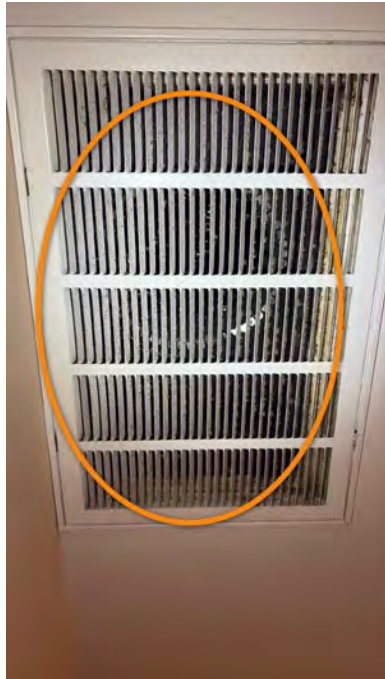
2nd floor return

Observed dirty supply/return vents in one or more locations at time of inspection. Dirty vents can be caused by one or more of the following: dust and debris over time, lack of maintenance, pet dander, mildew (which will cause an odor), inadequate filtration, previous construction/renovation and dirty return vent filters. It is recommended that a licensed HVAC technician be contacted to verify exact cause of buildup and a course of action.

Recommendation: Contact a qualified HVAC professional.

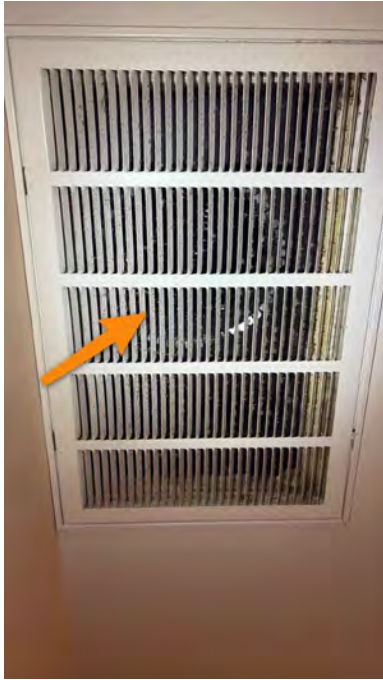
2nd floor

Observed debris in supply vent at time of inspection. Debris in supply registers can partially block the flow of air and possibly cause the HVAC system to run longer than normal to cool or heat the living space. In doing so, more electricity will be consumed causing an increase in utility bills.

Recommendation: Contact a qualified professional.

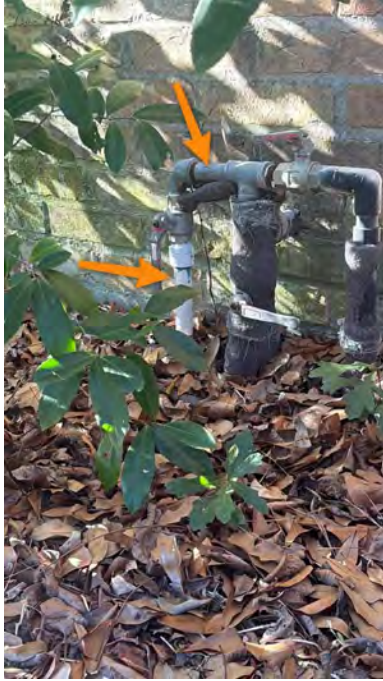
Right Side

Observed damaged or missing water pipe or hose bibb insulation at time of inspection. We recommend wrapping pipes that supply water to home that are located in uninsulated areas, within attic space or exterior of home.

Recommendation: Contact a handyman or DIY project

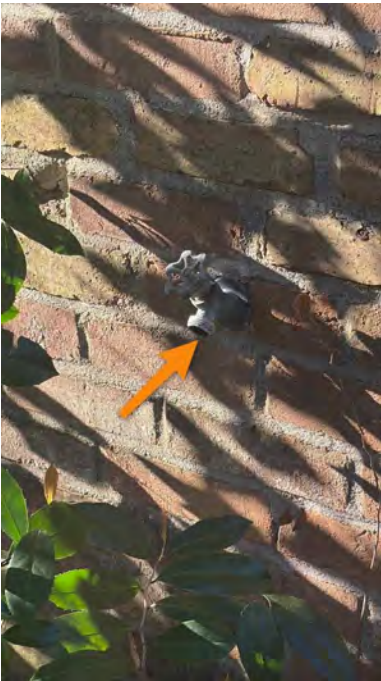
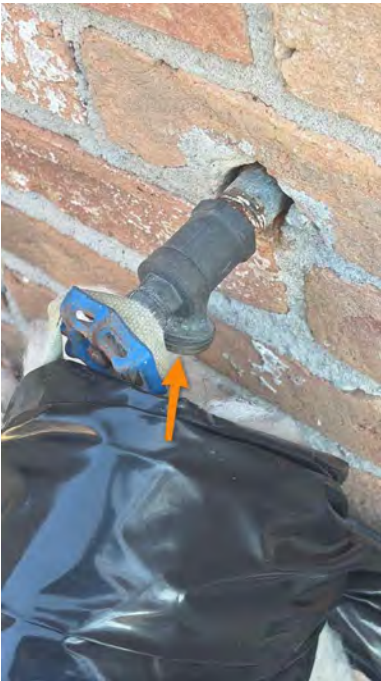
Hose bibb is missing or has a defective backflow preventer. This device helps to stop and prevent contaminated water, contaminants and chemicals from entering into the water supply. A hose bibb backflow preventer can become defective due to several factors, including wear and tear, mineral buildup, or debris clogging the internal components. Over time, the seals or valves inside the preventer can degrade, leading to leaks or reduced functionality.

Recommendation: Contact a handyman or DIY project

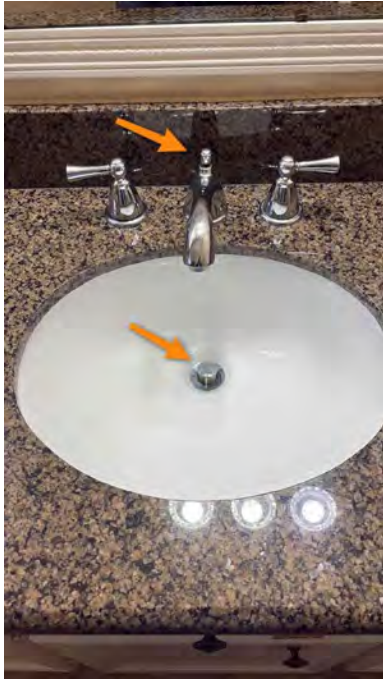
2nd floor bathroom right sink

Sink stopper not adequately seating, installed or functioning properly in drain orifice. Sink stopper(s), when functioning properly, should have the capability to allow the sink to be filled with water and not drain.

Recommendation: Contact a qualified professional.

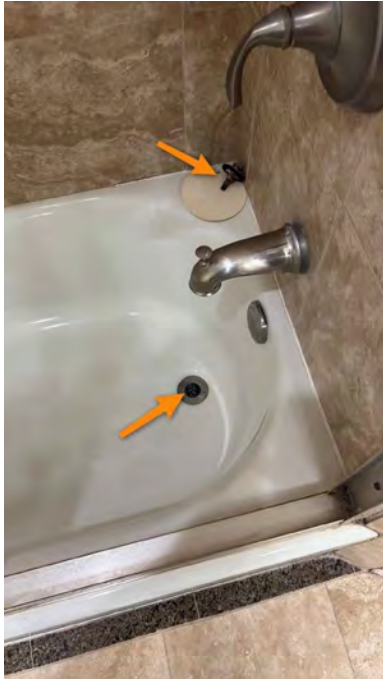
Primary shower

Tub stopper missing, not seating or functioning properly at time of inspection. Tub stopper helps prevent water from draining when filling.

Recommendation: Contact a handyman or DIY project

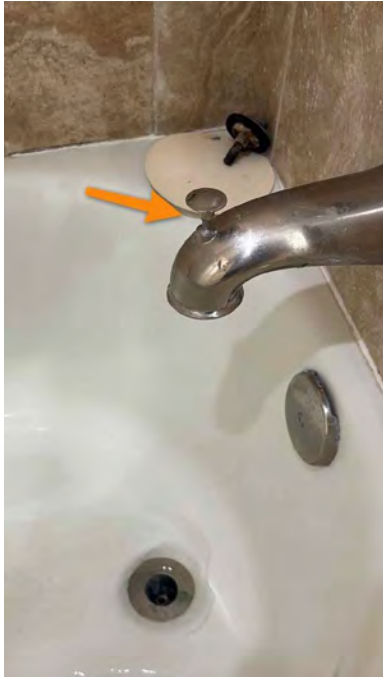
Shower/Tub diverter didn't function properly or not installed at time of inspection. Diverter didn't operate or when pulled/turned didn't completely divert water from faucet to shower head/sprayer or vice versa.

Primary tub- diverter stuck in shower mode

Recommendation: Contact a qualified professional.

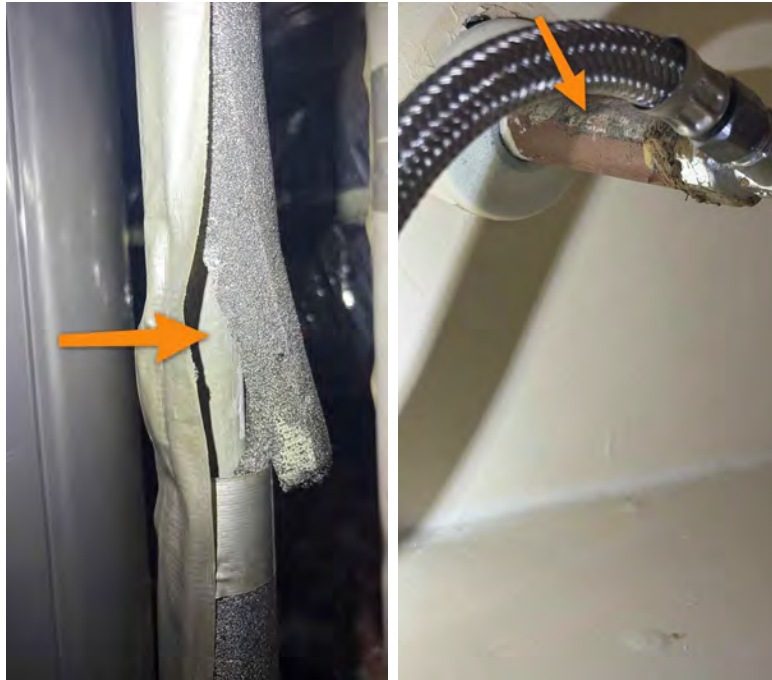
Observed galvanized plumbing on the interior or exterior of the home at time of inspection. Galvanized plumbing pipes are known to allow sediment buildup within the lines and overtime corrosion will begin to form. As this corrosion builds up rust will weaken the lines, slow the flow of water to home, show signs of rust in sinks and tubs, and eventually leak or burst due to freezing temperatures. Galvanized pipes have a life expectancy of 40-50yrs.

Recommendation: Contact a qualified plumbing contractor.

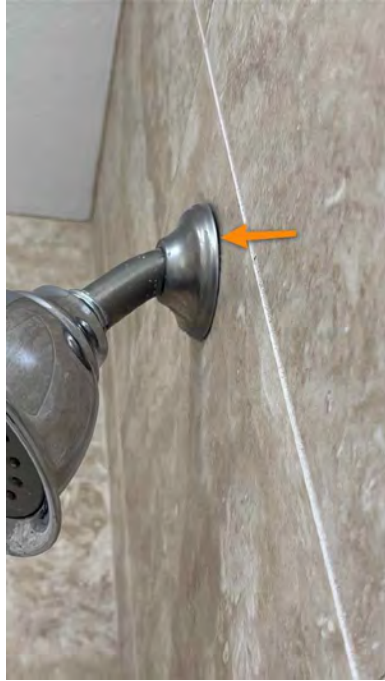
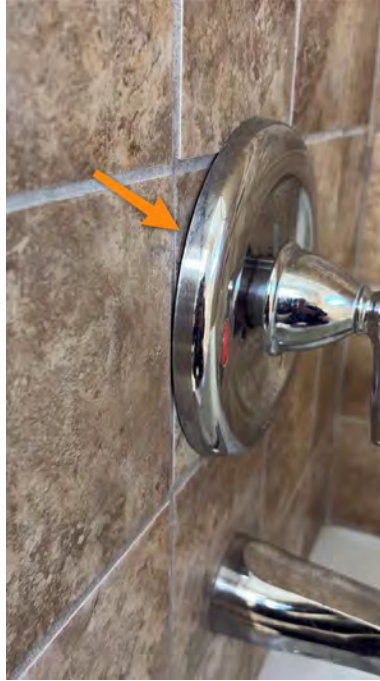
Observed missing caulk around sink bowl or tub at time of inspection. Recommend sealing around sinks and tubs to prevent moisture intrusion into or around wall cavity.

Recommendation: Contact a qualified professional.
