# PROPERTY INSPECTION REPORT FORM

02/24/2026 8:30 am

1814 Wagon Gap Trail, Houston, TX 77090

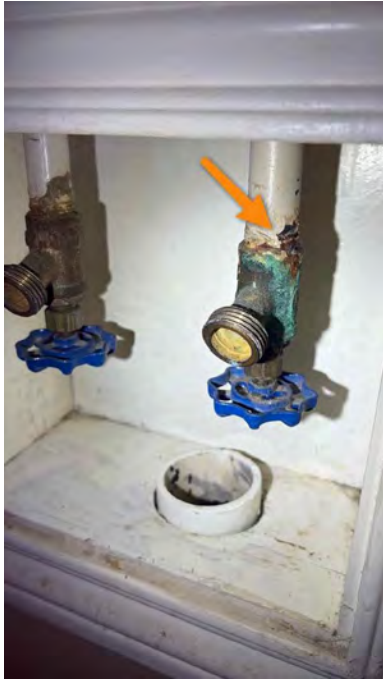
Washing machine supply lines

Galvanized steel supply piping is exhibiting visible rust and corrosion. Galvanized pipes are prone to internal deterioration over time, which can lead to restricted water flow, leaks, and eventual pipe failure. The rust observed may also indicate scaling or mineral buildup inside the piping, which is not fully visible during a visual inspection.

Recommendation: Contact a qualified professional.

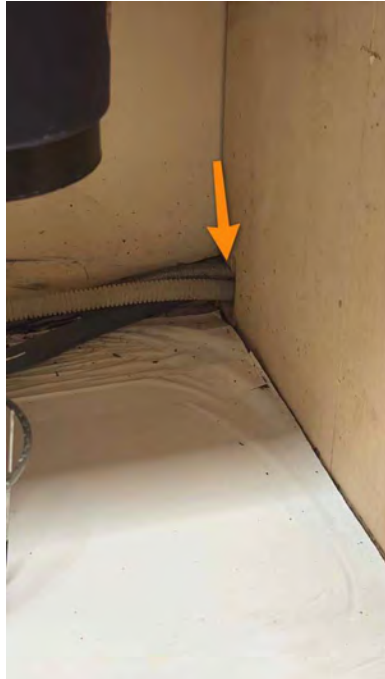
Kitchen

A flexible braided stainless steel or pex water supply line was observed passing through the cabinet wall without protection at the penetration. Although on braided steel lines provide some resistance to abrasion, repeated movement or vibration may cause the line to rub against the raw or sharp cabinet edge over time. This can lead to wear on the line's outer sheath, increasing the risk of leaks or damage.

Recommendation: Contact a qualified professional.

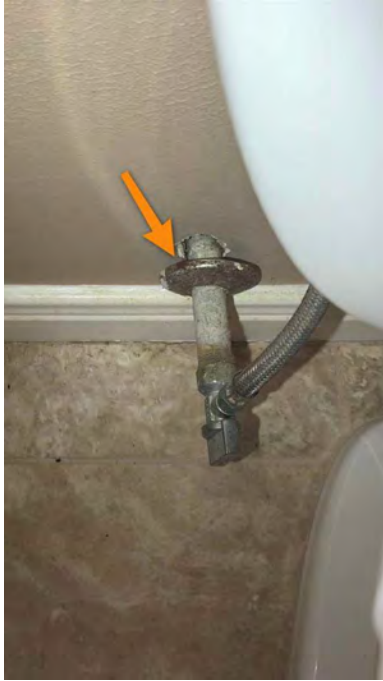
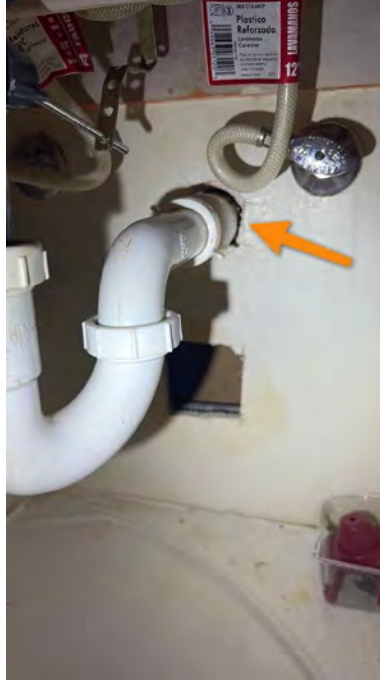
Observed exposed around drain/supply/gas arm penetrations through rear cabinet bulkheads and/or walls. Openings should be sealed or a collar be placed around penetrations to help prevent possible pest intrusion.

Recommendation: Contact a qualified professional.

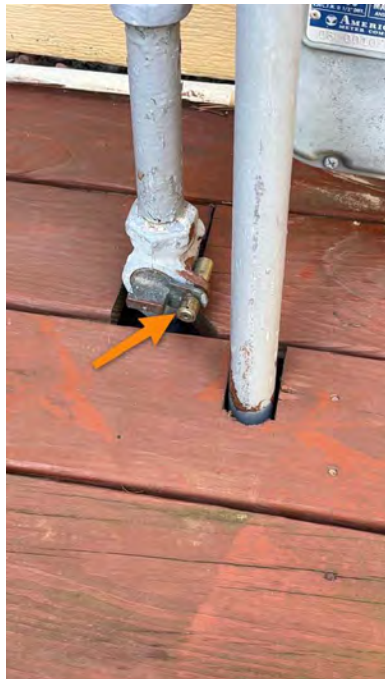
At time of inspection observed gas or electric water heater(s) not performing as intended or uninstalled. Inadequate water temperature, lack of gas supply, unlit pilots, electrical power, or old age are common factors that render the unit inoperable or not functioning properly. If it was verified at the time of inspection that the gas supply to home or the unit is in the off position air can build up in gas plumbing lines. Air build-up in gas lines will need to be bled off in order for unit to receive gas to function.

Gas off and locked at meter

Recommendation: Contact a qualified plumbing contractor.

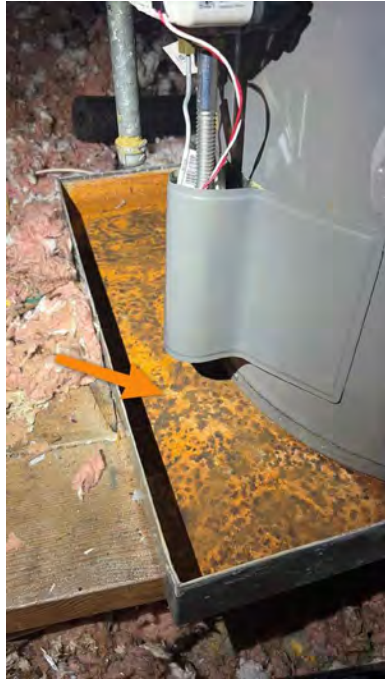
Observed rust in water heater pan at time of inspection. Rust in water heater pan can be from a previous water leak with the current water heater or the pan can be from an old water heater that has been replaced prior to the inspection. Depending on severity of rust, future water leaks can drain outside of the pan due to corrosion and the pans inability to hold water.

Recommendation: Contact a qualified professional.

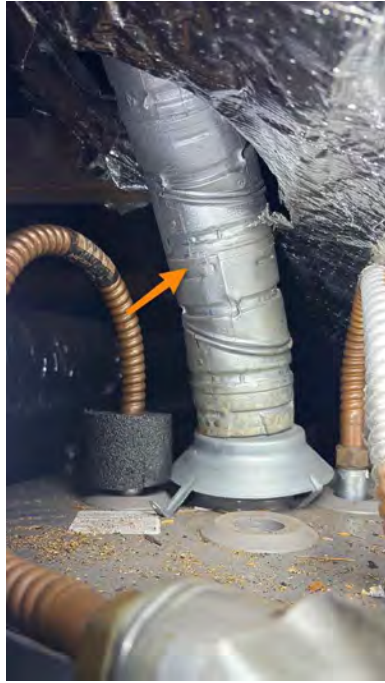
Draft hood connection to flue vent connector should provide at least 12" vertical inches of flue vent between the draft hood outlet and the first elbow or sloping flue vent connector. This is a manufacturer-recommended detail to improve the flow of exhaust gases. It is unknown to the inspector what the manufacturer recommendation is for this application.

Recommendation: Contact a qualified professional.

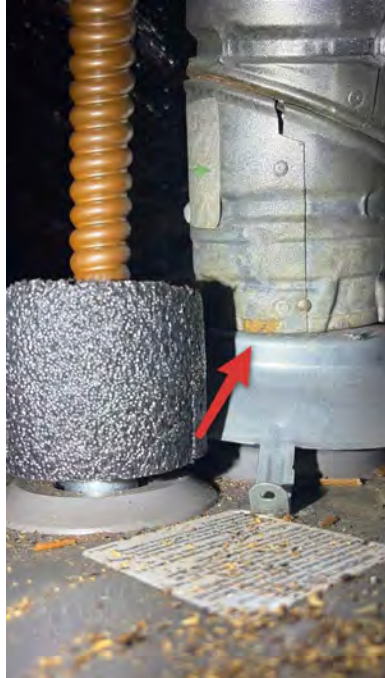
The exhaust vent is showing signs of rust and appears to have been extended or modified in an unprofessional manner. It is not properly secured and does not appear to have been installed to industry standards. In some areas, the vent has been extended above the draft hood using non-standard materials or connections, which may compromise proper draft and safe exhaust flow. Rust can indicate ongoing moisture exposure and may lead to deterioration or vent leakage. This condition may affect the performance and safety of the combustion appliance.

Recommendation: Contact a qualified professional.

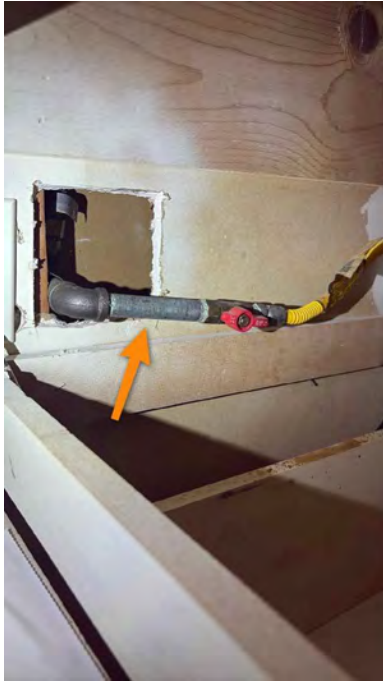
Observed galvanized steel used for gas supply in parts of the home at time of inspection. Galvanized pipe is not recommended for gas because of the galvanized coating. Over time pieces of the galvanized steel will flake off and clog gas regulators and burner units. Mixing galvanized and black iron, where they touch, corrosion will be accelerated.

Recommendation: Contact a qualified plumbing contractor.

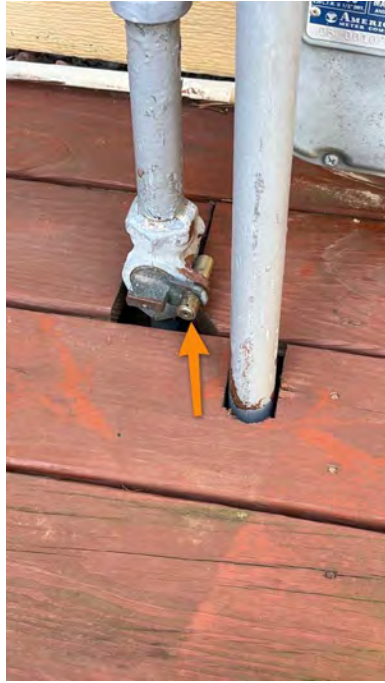
The gas meter was observed to be either not properly connected or locked in the off position by the utility company at the time of inspection. As a result, gas could not be supplied to the home, and the following appliances were not tested for operation (if applicable): the furnace, water heater, gas range, and any other gas-powered equipment.

Gas off and locked

Recommendation: Contact a qualified plumbing contractor.

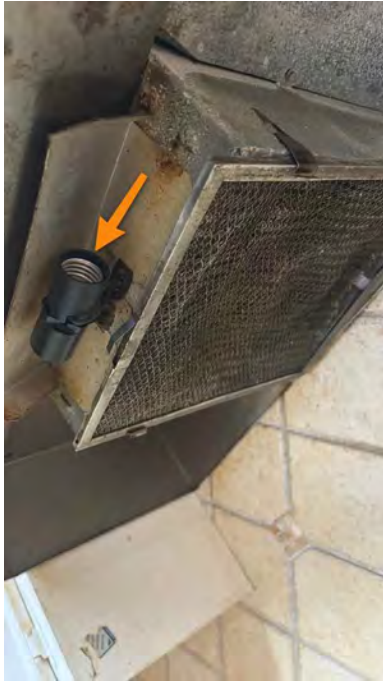
Observed inoperable light or missing cover on exhaust hood at time of inspection, this may indicate the bulb needs replacing.

Recommendation: Recommended DIY Project

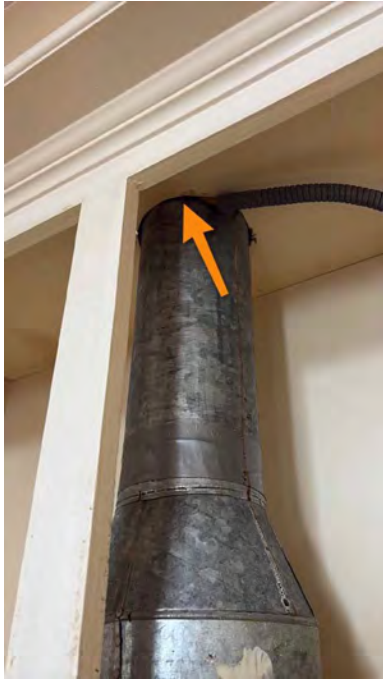
Observed missing or insufficiently sealed collar on kitchen exhaust vent at time of inspection. Placing a collar or proper joint tape will prevent pest or conditioned air from entering/exiting the home.

Recommendation: Contact a qualified professional.

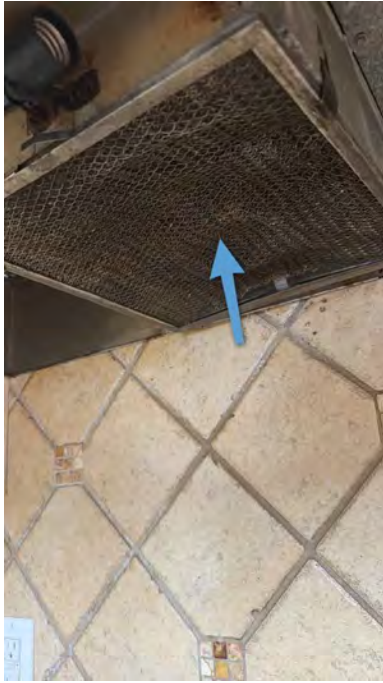
A dirty exhaust filter on a kitchen exhaust fan is a common issue that can lead to various problems if not addressed. The exhaust filter in a kitchen hood is designed to trap grease, smoke, and other airborne particles generated during cooking. Over time, these particles accumulate on the filter, causing it to become dirty and less effective in filtering the air. Recommend replacing filters.

Recommendation: Contact a qualified professional.

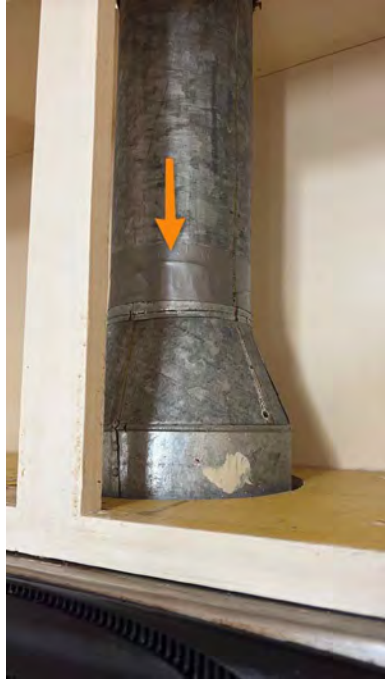
Observed improper joint tape on range hood exhaust vent. The appropriate joint tape shall be UL 181 rated and certified.

Recommendation: Contact a handyman or DIY project

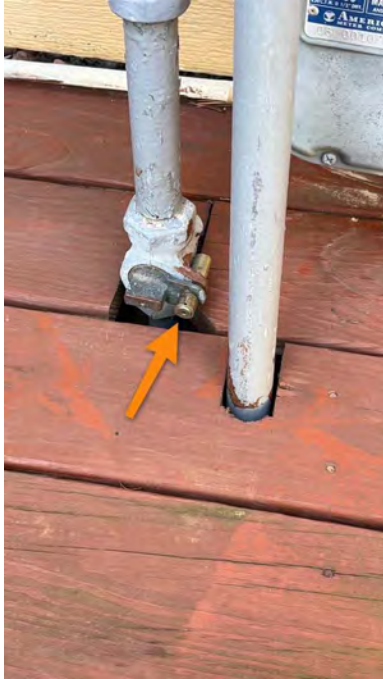
Observed what appears to be an inoperable or improperly functioning cooktop and/or oven at time of inspection. Burners and/or oven did not heat up, unable to open oven door or didn't function accordingly when testing. If gas to home or unit is not on or disconnected it will impede inspection of appliance.

Gas off and locked at meter

Recommendation: Contact a qualified appliance repair professional.

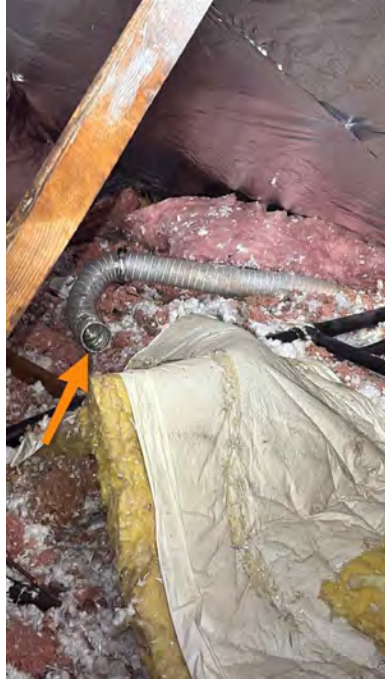
Exhaust fan is not properly vented to the exterior of the home; instead, it terminates within the attic space (or soffit vents). This condition does not meet best practices for moisture control and can contribute to excessive humidity accumulation within the attic. Over time, this trapped moisture can promote mold or mildew growth, cause deterioration of attic insulation and structural components, and reduce overall indoor air quality. Industry standards and building codes generally require bathroom exhaust fans to discharge directly to the exterior of the home through a properly sealed, insulated duct.

Venting into attic

Recommendation: Contact a qualified professional.

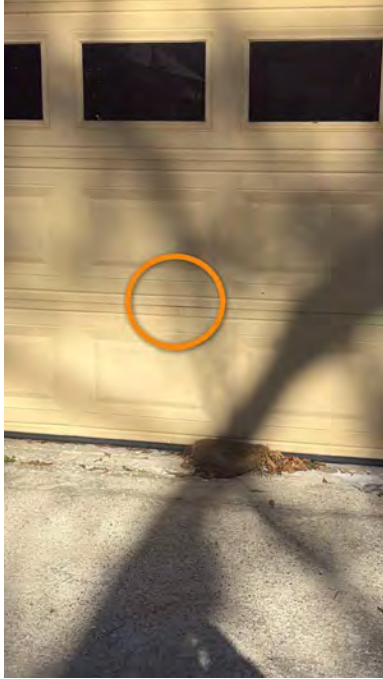
Observed damage to garage door at time of inspection. Damage to garage door will impact proper operation and functionality.

Dented

Recommendation: Contact a qualified professional.

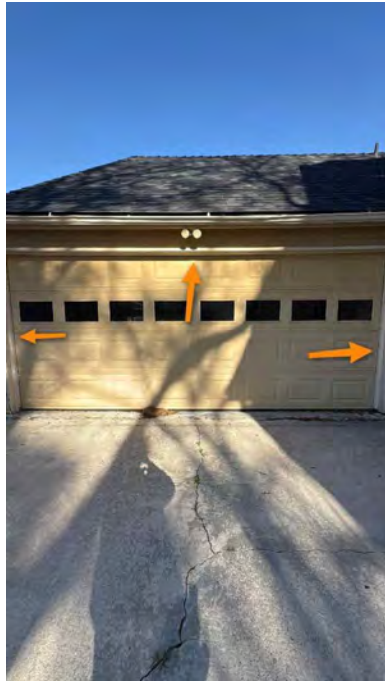
Garage

Observed areas around garage door missing, damaged insufficient or poorly fastened weatherstripping at time of inspection. Weatherstripping help to prevent moisture from entering into garage space.

Recommendation: Contact a qualified professional.

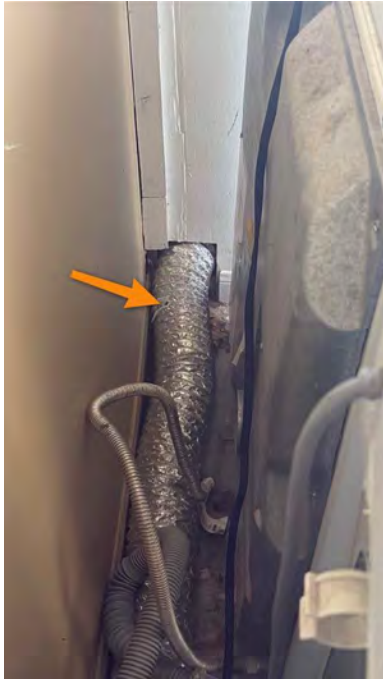
Observed dryer transition duct concealed in wall or used in attic space at time of inspection. Flexible transition duct can only be used from the back of the dryer to the wall exhaust pipe. Transition ducts used to connect the dryer to the exhaust duct system shall be a single length that is listed and labeled in accordance with UL 2158A. Transition ducts shall be not greater than 8 feet (2438 mm) in length. Transition ducts shall not be concealed within construction.

Recommendation: Contact a qualified professional.

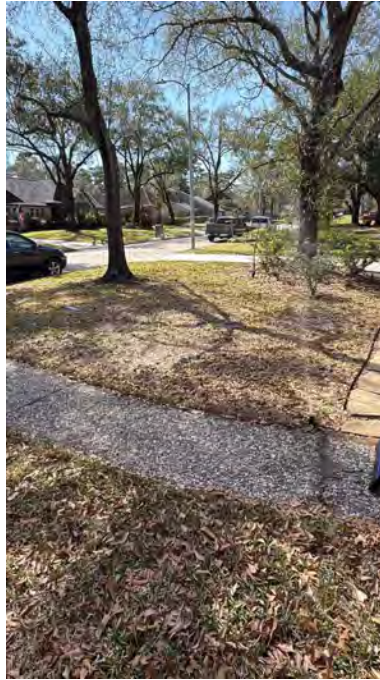
Zone 2

Observed one or more zones not functioning properly at time of inspection. Sprinkler zones that are not functioning properly could be caused by one or more of the following: low water supply, programming at control panel, a partially open or closed water cutoff valve, a bad solenoid valve, disconnected wiring, pressure regulator issues, disconnected due to changes in landscaping or blocked /damaged sprinkler heads.

Recommendation: Contact a qualified landscaping contractor

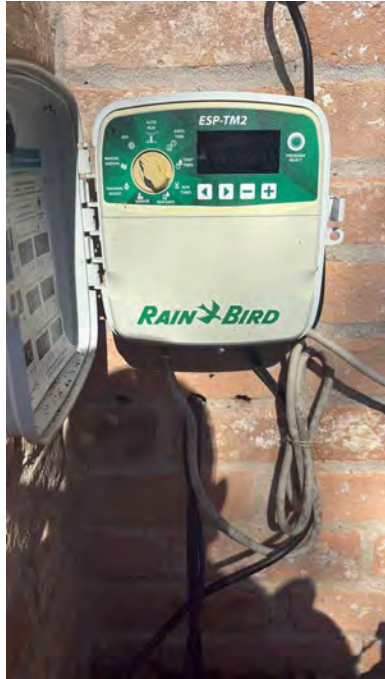
Control panel

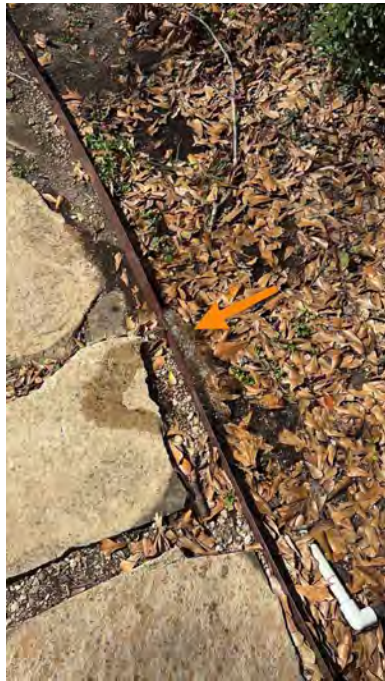
Zone 1

Broken sprinkler heads observed at time of inspection. Damaged lawn sprinkler head(s) can have an impact on the coverage and effectiveness of the irrigation system. The extent of the impact depends on the nature and severity of the damage. Here are some ways in which a damaged sprinkler head can affect coverage: uneven water distribution, reduced reach, water waste and soil erosion.

Recommendation: Contact a qualified landscaping contractor

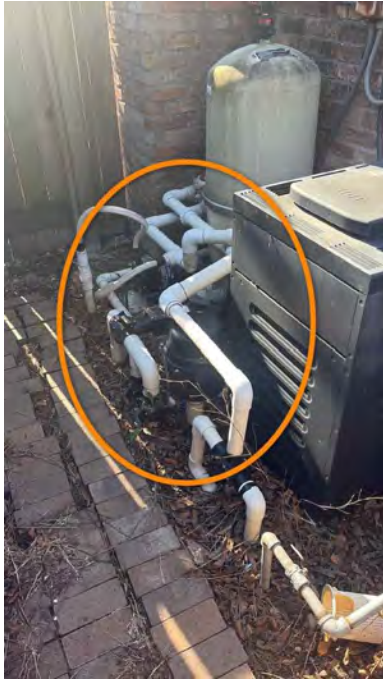
Observed unpainted PVC pipes on pool equipment. Painted PVC protects pipes from the sun's UV rays which will cause degradation to the plumbing that will negatively impact the strength of the piping.

Recommendation: Contact a handyman or DIY project

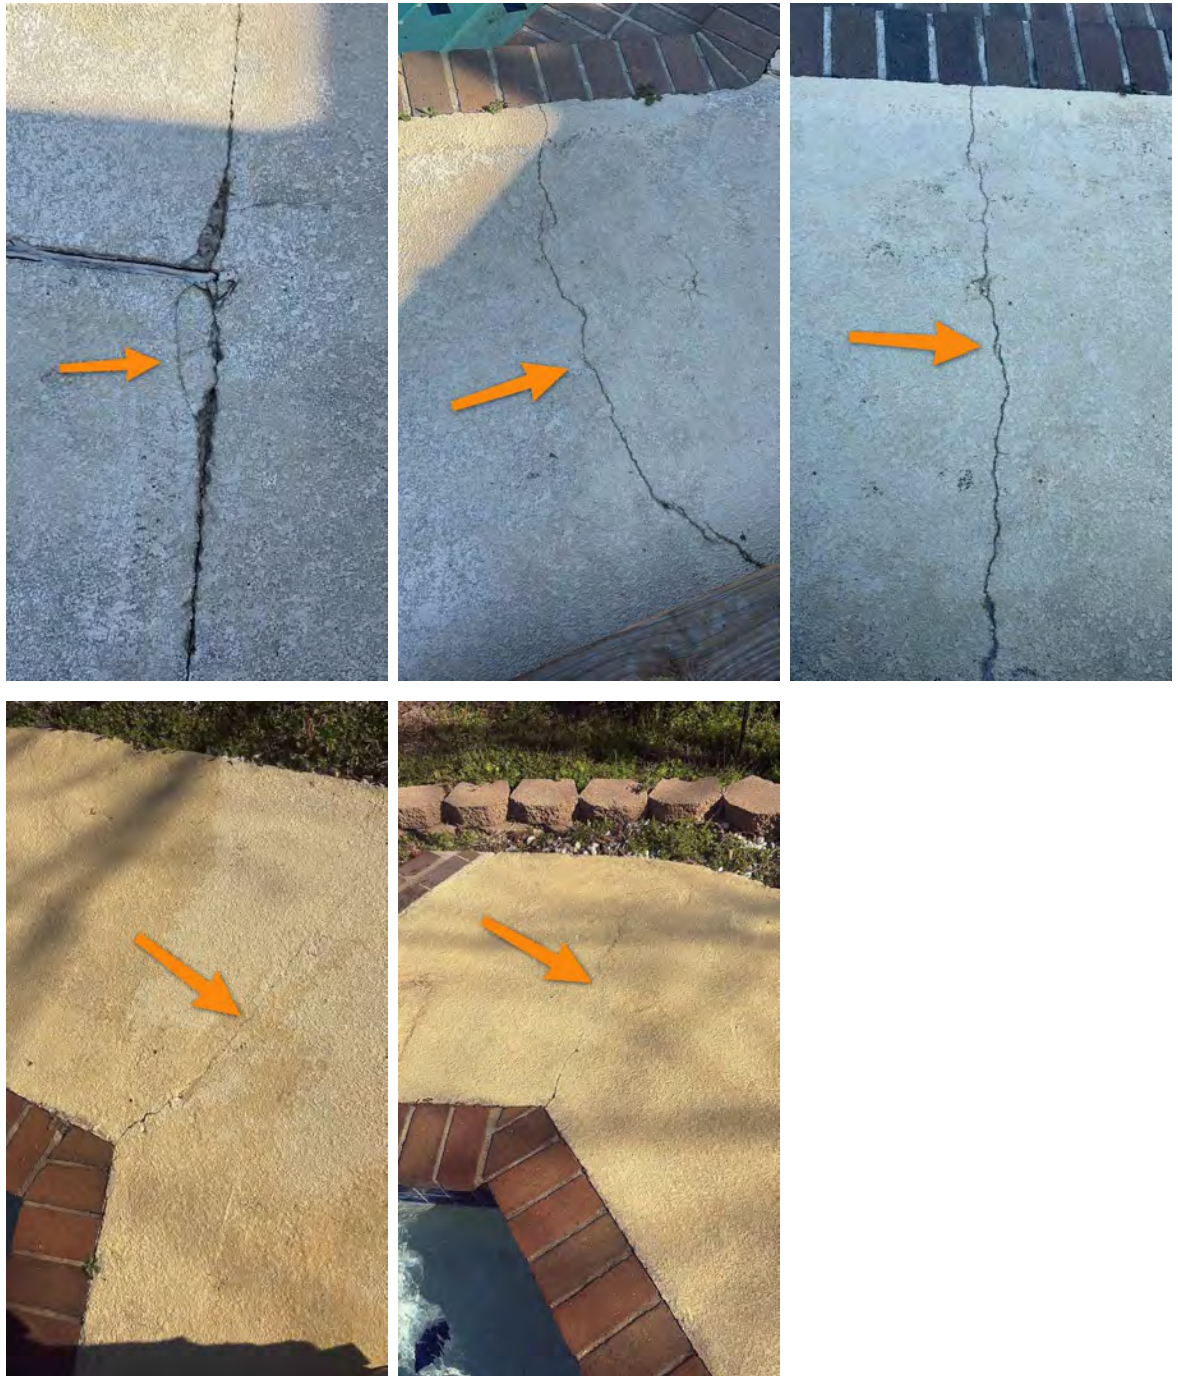
Observed cracks in pool decking. Cracks allow moisture penetration which can erode soil underneath and possible cause movement of the pool structure if left unattended. Cracks in pool decks are a common concern that requires prompt attention to maintain the structural integrity and safety of the entire pool area. These cracks often result from a variety of factors, including ground settling, temperature fluctuations, or underlying structural issues.

Recommendation: Contact a qualified swimming pool contractor

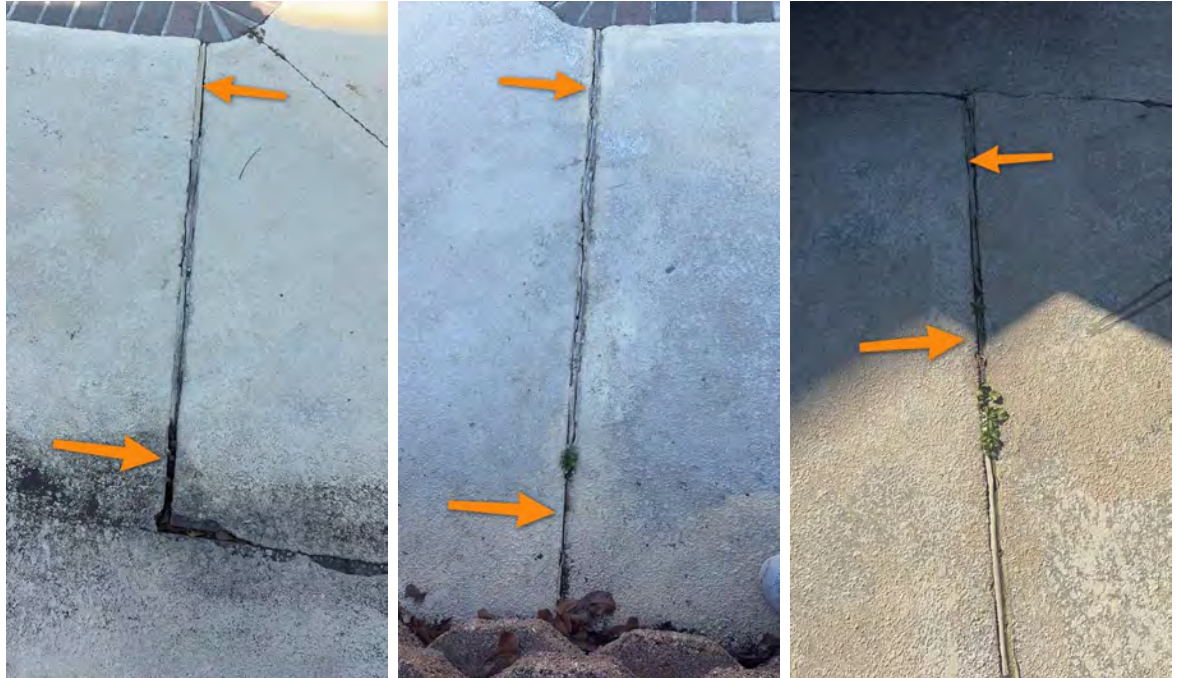
Observed deterioration/shrinkage of deck joint seals around pool or spa. Deterioration of joint seals around a pool or spa is a common issue that can lead to water leakage and damage if not addressed promptly. Joint seals are typically used to seal gaps and joints between different pool elements, such as the pool shell, coping stones, tiles, and expansion joints. Over time, exposure to sunlight, water chemicals, and general wear and tear can cause these seals to degrade.

Recommendation: Contact a qualified swimming pool contractor

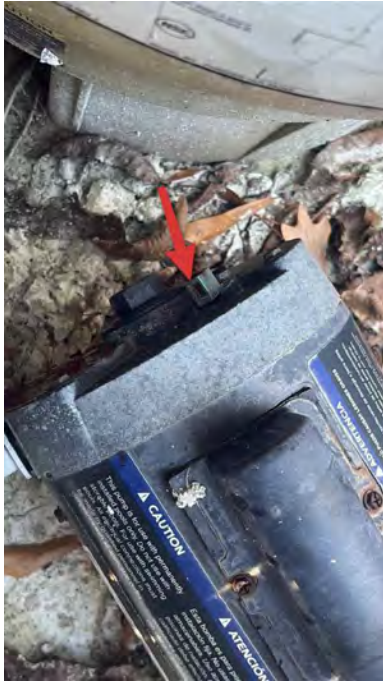
Metal parts of electrical equipment associated with the pool water circulating system, including pump motors and metal parts of equipment associated with pool covers, including electric motors, shall be bonded. Pool pump bonding wire should be a solid #8 awg copper conductor.

Recommendation: Contact a qualified professional.

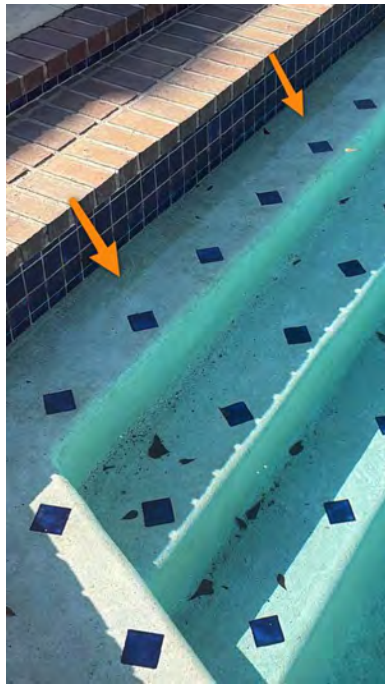
Observed stains on the pool/spa walls or surface at time of inspection. Pool surface stains can result from various factors, and identifying the cause is essential for effective treatment. Some common reasons for surface stains on a pool include: metals such as iron, copper, or manganese, organic debris, algae growth, mineral deposits or chemical imbalance.

Recommendation: Contact a qualified swimming pool contractor

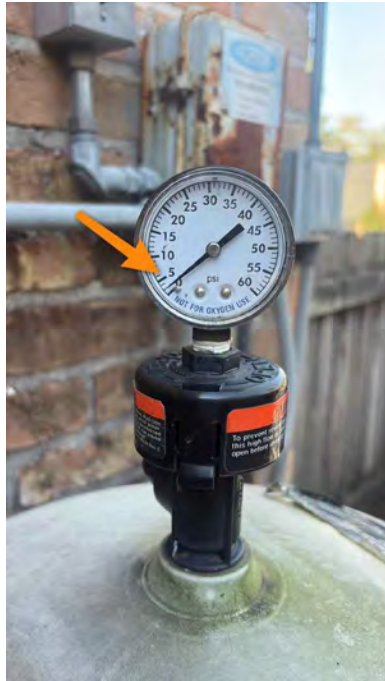
Observed pool filter pressure below or above 10-25 psi at time of inspection. This is an indication that the filter needs servicing. Pressure gauges can fail or not function for several reasons. If the gauge remains at zero when the pump is on, the problem could be that the filter needs servicing or the air bleeder assembly under the gauge, which measures the pressure, could simply be clogged.

Recommendation: Contact a qualified swimming pool contractor

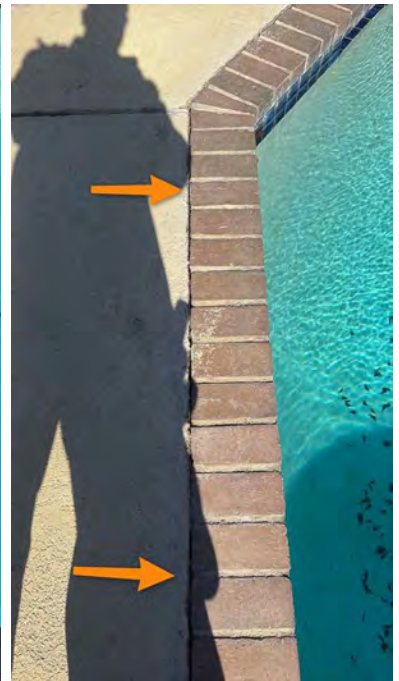
Observed cracks in one or more locations between coping or tile surfaces. Grout cracks around a pool are a common issue and can lead to water leakage, damage to the pool's structure, and an unsightly appearance. Grout is often used to fill the gaps between tiles or stones around the pool, and it can crack due to various factors, including temperature changes, ground movement, or improper installation.

Missing around coping

Recommendation: Contact a qualified swimming pool contractor

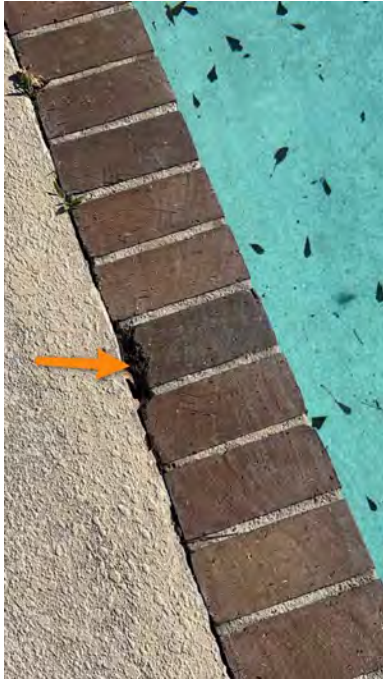
Observed cracked coping around pool in one or more locations at time of inspection. Cracked coping can be caused by settling of the pool, improper drainage or expansive soil.

Damaged

Recommendation: Contact a qualified swimming pool contractor

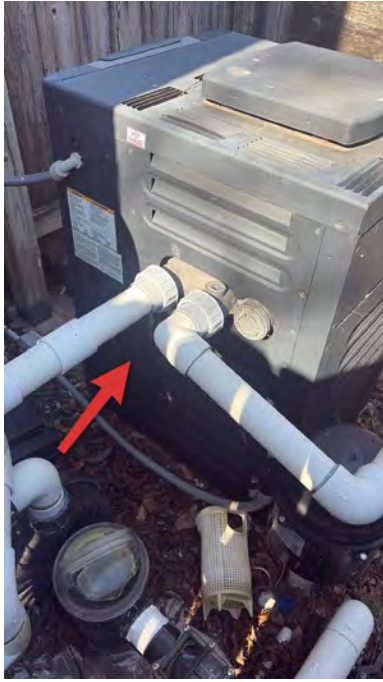
Metal parts of electrical equipment associated with the pool water circulating system, including pump motors and pool heaters shall be bonded.

Recommendation: Contact a qualified professional.

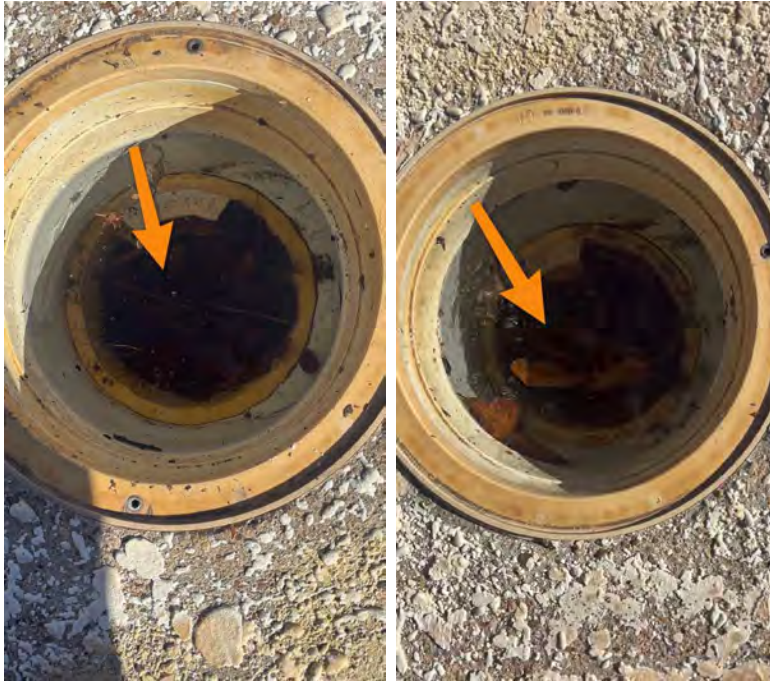
Pool skimmer basket/strainer has debris in strainer or crack in side wall at time of inspection. Recommend cleaning/checking skimmer frequently to prevent debris build up and allow skimmer to function as intended. Recommend repairing any cracks in skimmer wall to prevent water from escaping and getting behind pool surface

Recommendation: Contact a qualified swimming pool contractor

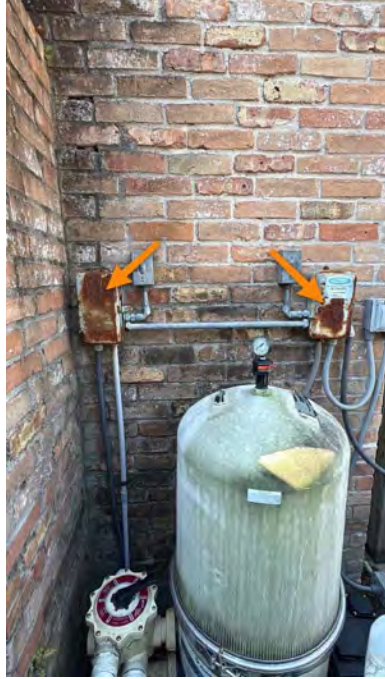
Control panel for pool/spa equipment was loosely fastened, damaged or showing signs of rust and corrosion at time of inspection. A pool control panel can become loose due to several factors, including improper installation, vibration, and environmental wear. If the panel was not securely fastened during installation, it might not be able to withstand regular use and vibrations from pool equipment, causing it to loosen over time. Damaged and rust can occur from normal exposure to environmental elements or contact by an unknown source.

Rusted

Recommendation: Contact a qualified swimming pool contractor

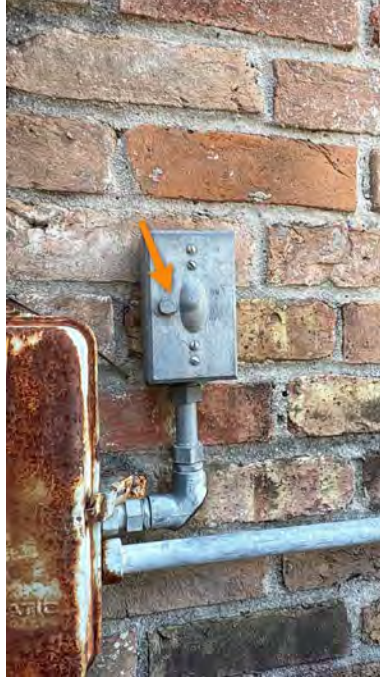
Broken switch

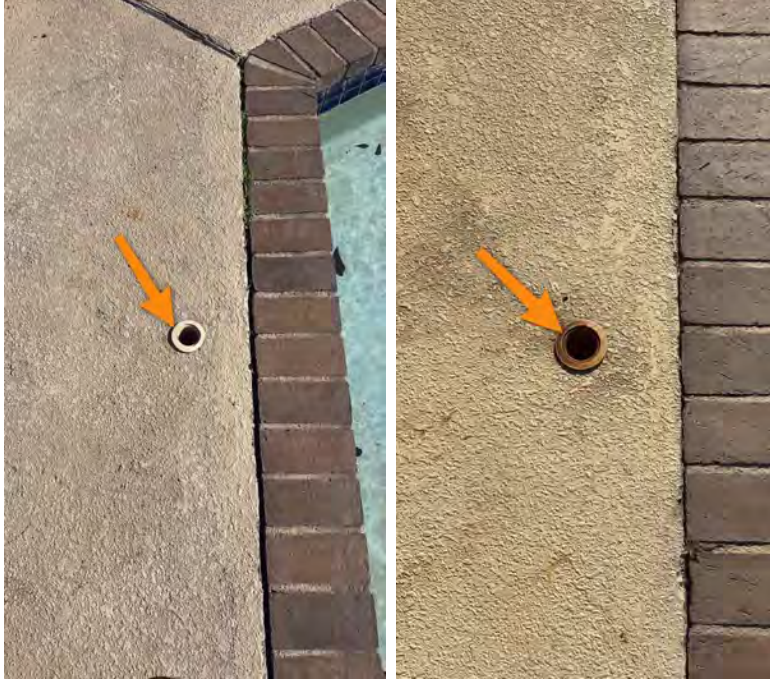
Observed missing/damaged caps or plug at Multiple locations in and outside the swimming pool. The missing caps can cause debris to enter the pool plumbing or drains. Recommend further evaluation and repairs as needed.

Recommendation: Contact a qualified swimming pool contractor
