Inspection Report

Property Address:
4042 Glen Cove Dr.
Houston Texas 77021

Inspectall LLC

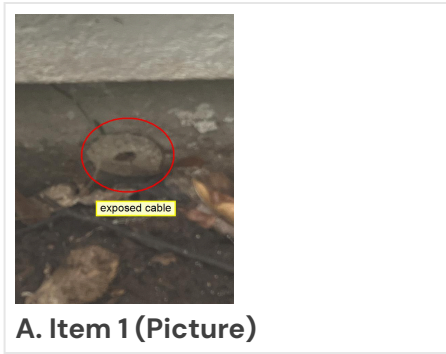
(1) **Deficiencies:** Observed exposed cable on the foundation exterior left side wall. It is recommended to check, clean and seal exposed rebar. A qualified contractor is needed to make the correction.

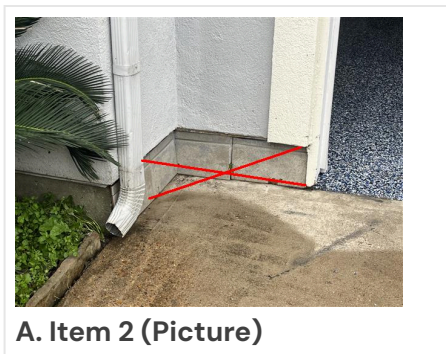
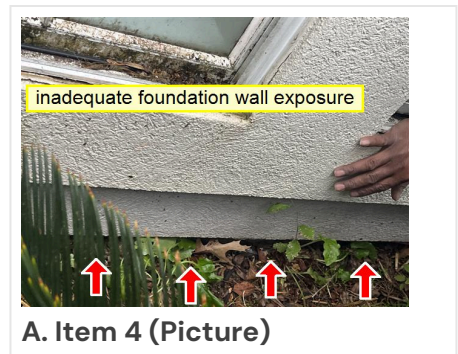
(2) **Comments:** Foundation wall was not fully accessible along the front and rear flower beds. Section of the foundation was not readily accessible on right side of garage due to installed tile. *"Inaccessible areas are not inspected"*

It is recommended to have 4-6 inches of foundation wall exposure around the entire house.

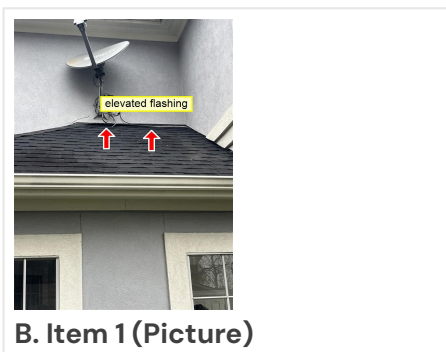
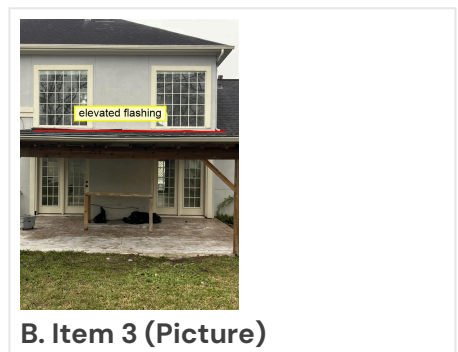
Deficiencies: Shingles are discolored and worn. Fiberglass appears on the rear roof line. Shingles are missing on rear second level of the roof. Shingles are broken along the left and front outer edges of roof. Roof depression noted on front left side. Vent boots are damaged. Flashing is elevated over patio and rear night side of roof (under Direct TV disk).

It appears that this roof is the original roof. In my opinion, the roof has neared its life expectancy. A qualified roofer is needed to further evaluate the roof and make the replacement accordingly.

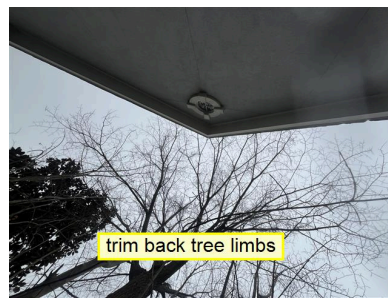
C. Item 1 (Picture)

(1) **Deficiencies:** The tree limbs on left side of house are in contact with roof or hanging near roof. Trim back tree limbs to eliminate further roof damage. A qualified tree trimmer is needed to make the correction. There are shallow roots on left side of property that could be potential trip hazard, if not corrected.

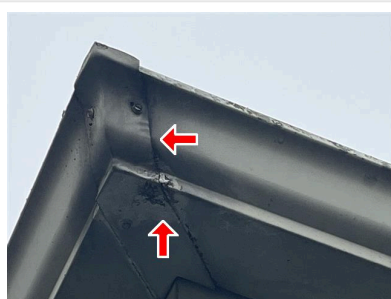
C. Item 2 (Picture)

(2) **Deficiencies:** Downspout on right side of house is insecure and gutters along rear side of house need sealing at seams in some areas to prevent premature deterioration to fascia boards as already seen in some areas. Correction is needed.

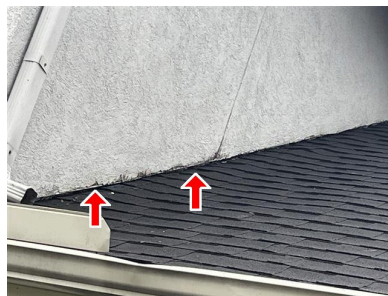
E. Item 1 (Picture)

(1) **Deficiencies:** Stucco siding is damaged in several areas [rear right, left, front left and at window ledges], There are seams that need caulking. A qualified contractor is needed to evaluate and make corrections.

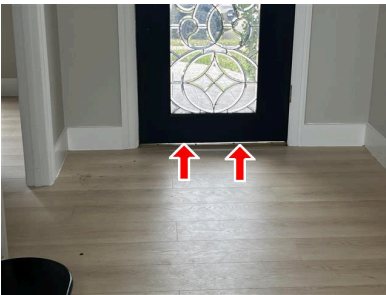
F. Item 1 (Picture)

(1) **Deficiencies:** Door sweep and weather strip is missing at front door and garage man door. This can cause some heat loss in winter and loss of cool air in summer if not corrected. A qualified contractor should inspect and repair as needed.

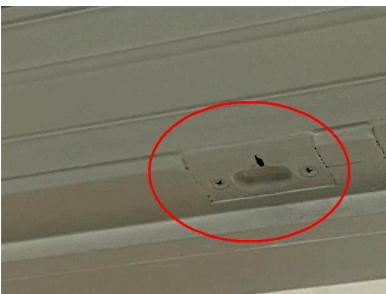
F. Item 4 (Picture)

(2) **Deficiencies:** Ball latch is missing &/or need adjusting at the following doors: formal dining room and 2 upstairs bedroom closet doors. A qualified contractor is needed to make the correction.

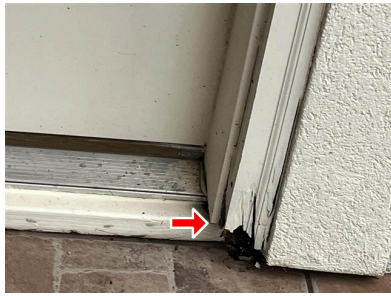
F. Item 6 (Picture)

(3) **Deficiencies:** Damaged door jambs at rear French doors and garage exterior man door. Garage near exterior man door is damaged at footing. A qualified contractor is needed to make the correction.

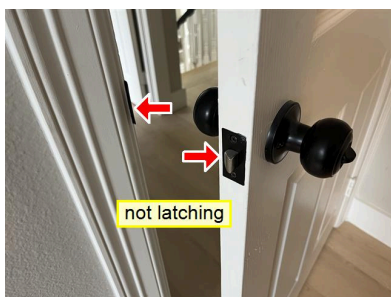
F. Item 11 (Picture)

(4) **Deficiencies:** Entry door to upstairs right side bedroom do not latch at strike plate. A qualified contractor is needed to make the correction.

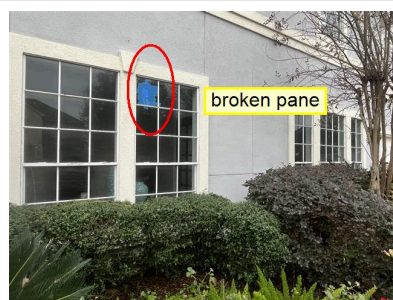
H. Item 1 (Picture)

Deficiencies: Missing window screens throughout. Observed paint peeling and some damaged to weather strip at several windows. Observed damaged / insecure weather strip at round stationary window located on left side of house. Windowpane located in front of house is broken. Window pane at top of the return staircase is not sealed. Exterior caulking is worn around some window frames. Window in the utility room is not closing properly as intended. Balance rod is bad at formal dining room middle window and game room window. A qualified contractor is needed to make the correction.

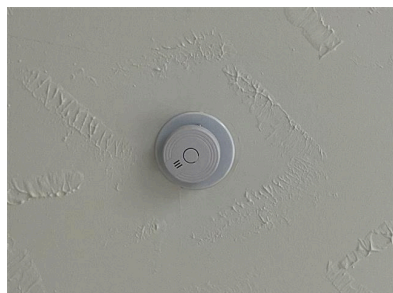
A. Item 1 (Picture)

Deficiencies: Smoke detectors are not in series. A licensed electrician is needed to make the correction. It is also recommended to install carbon monoxide detectors when there is gas supply in home.

NOTE: The smoke detector should be tested at common hallway to bedrooms upon moving in to home.

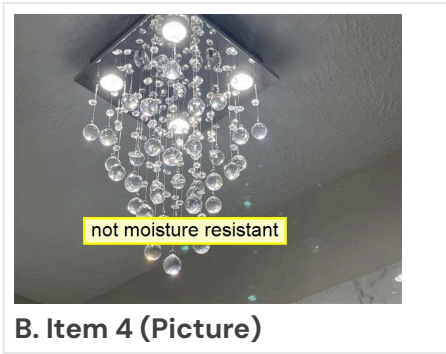
(3) **Deficiencies:** Light fixture over master shower stall is not moisture resistant. A licensed electrician is needed to make the correction.

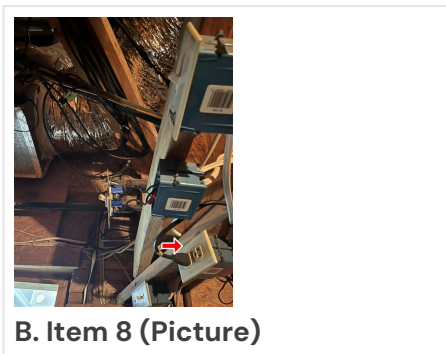
(4) **Deficiencies:** No GFCI receptacles located in bathrooms. The [2] rear exterior GFCI receptacles are bad. The receptacles inside attics are not GFCI. A licensed electrician is needed to make the correction.

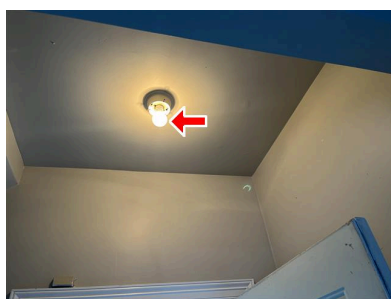
B. Item 13 (Picture)

(7) **Deficiencies:** Shield / globe is missing at closet ceiling light fixture. A qualified contractor is needed to make the correction.

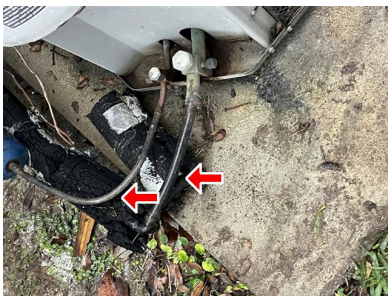
B. Item 1 (Picture)

(1) **Deficiencies:** Insulation is needed at the Ruud condenser's supply lines. The platform is damaged that the Ducane condenser is on. A qualified contractor is needed to make the correction.

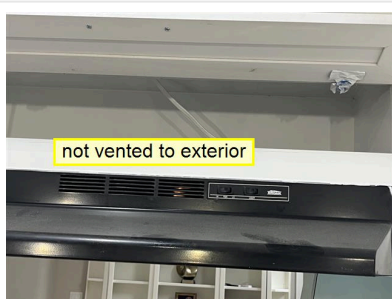
D. Item 1 (Picture)

Deficiencies: Vent hood does not exhaust to the exterior; correction is needed. A qualified contractor is needed to make the correction.

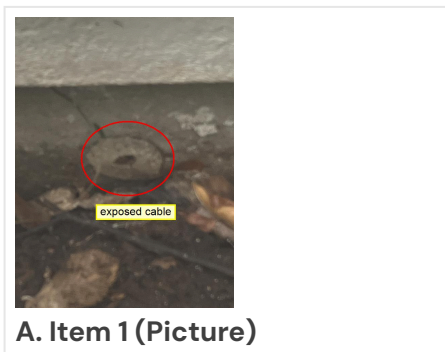
(1) **Deficiencies:** Observed exposed cable on the foundation exterior left side wall. It is recommended to check, clean and seal exposed rebar. A qualified contractor is needed to make the correction.

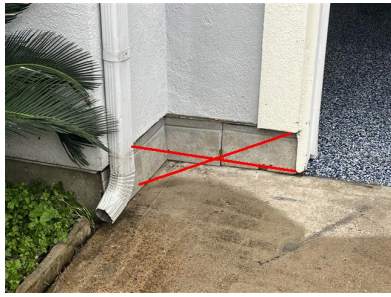
A. Item 2 (Picture)

(2) **Comments:** Foundation wall was not fully accessible along the front and rear flower beds. Section of the foundation was not readily accessible on right side of garage due to installed tile. *"Inaccessible areas are not inspected"*

It is recommended to have 4-6 inches of foundation wall exposure around the entire house.

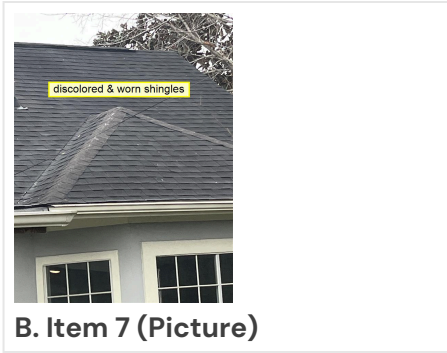
Deficiencies: Shingles are discolored and worn. Fiberglass appears on the rear roof line. Shingles are missing on rear second level of the roof. Shingles are broken along the left and front outer edges of roof. Roof depression noted on front left side. Vent boots are damaged. Flashing is elevated over patio and rear night side of roof (under Direct TV disk).

It appears that this roof is the original roof. In my opinion, the roof has neared its life expectancy. A qualified roofer is needed to further evaluate the roof and make the replacement accordingly.

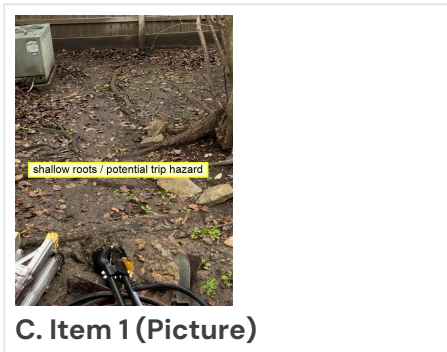
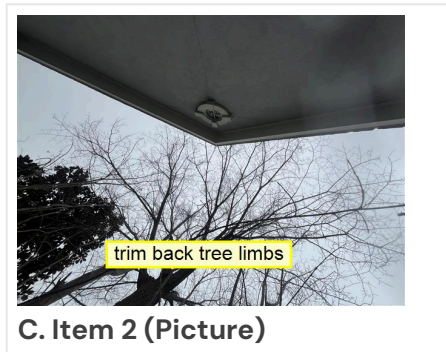
(1) **Deficiencies:** The tree limbs on left side of house are in contact with roof or hanging near roof. Trim back tree limbs to eliminate further roof damage. A qualified tree trimmer is needed to make the correction. There are shallow roots on left side of property that could be potential trip hazard, if not corrected.

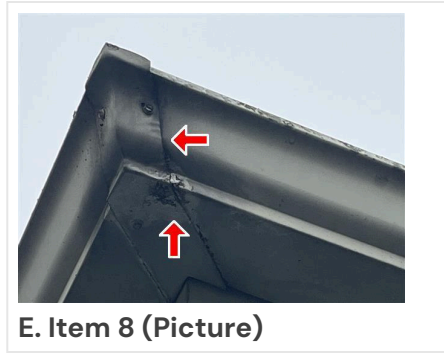
(2) **Deficiencies:** Observed damaged &/ or missing fascia boards in some areas on rear side of house. A qualified contractor is needed to make the correction.

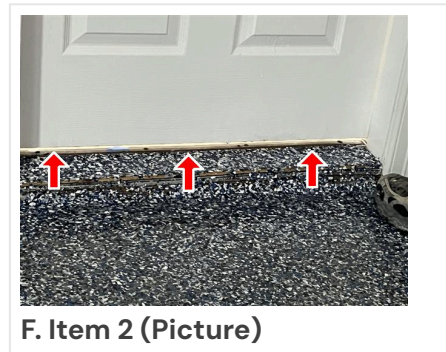
(1) **Deficiencies:** Door sweep and weather strip is missing at front door and garage man door. This can cause some heat loss in winter and loss of cool air in summer if not corrected. A qualified contractor should inspect and repair as needed.

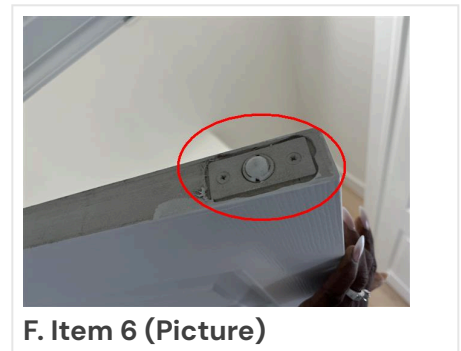
(2) **Deficiencies:** Ball latch is missing &/or need adjusting at the following doors: formal dining room and 2 upstairs bedroom closet doors. A qualified contractor is needed to make the correction.

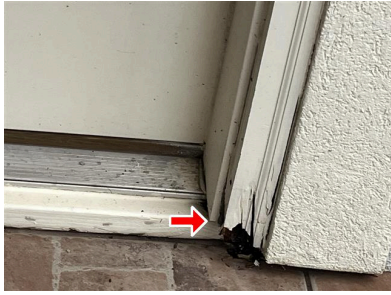
(3) **Deficiencies:** Damaged door jambs at rear French doors and garage exterior man door. Garage near exterior man door is damaged at footing. A qualified contractor is needed to make the correction.

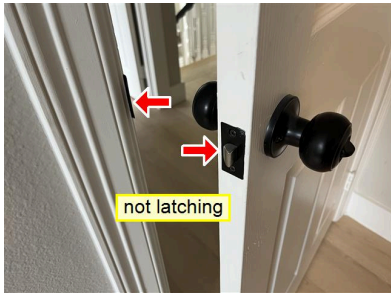
(4) **Deficiencies:** Entry door to upstairs right side bedroom do not latch at strike plate. A qualified contractor is needed to make the correction.

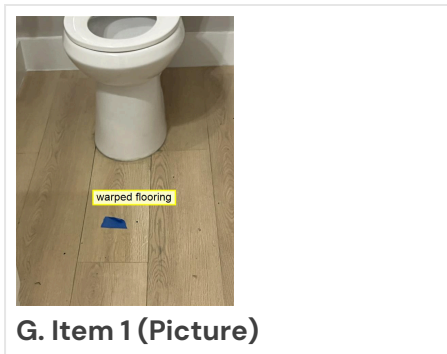
G. Item 1 (Picture)

Deficiencies: Powder room floor covering is warped, damaged due to water damage. A qualified contractor is

needed to make the correction.

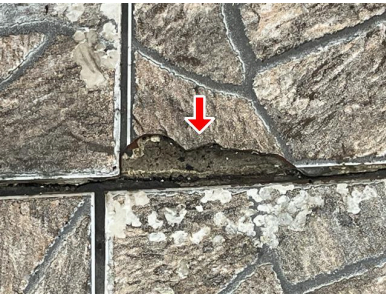
L. Item 1 (Picture)

Deficiencies: Observed damaged tile on front porch / sidewalk. Correction is needed to prevent potential trip hazard. A qualified contractor is needed to make the correction.

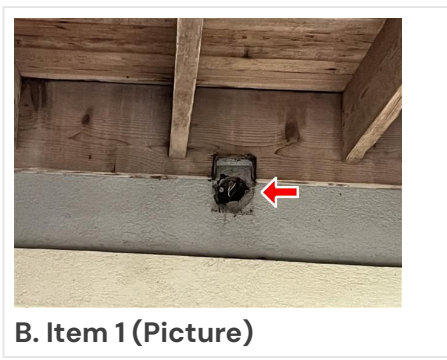
(1) **Deficiencies:** Exterior light fixtures / lanterns are missing in several areas. A licensed electrician is needed to make the correction.

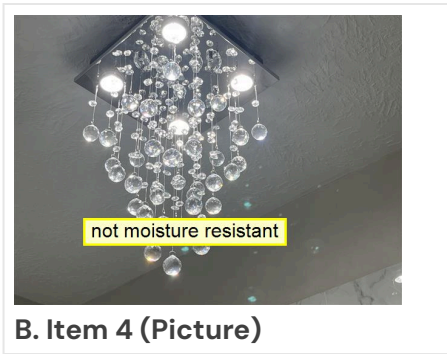
(3) **Deficiencies:** Light fixture over master shower stall is not moisture resistant. A licensed electrician is needed to make the correction.

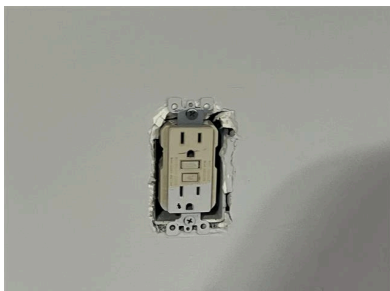
B. Item 10 (Picture)

(6) **Deficiencies:** Missing cover plates in several areas throughout the house. A qualified contractor is needed to make the correction.

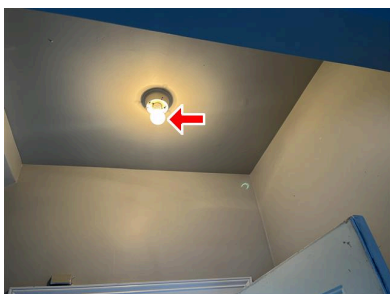
B. Item 13 (Picture)

(7) **Deficiencies:** Shield / globe is missing at closet ceiling light fixture. A qualified contractor is needed to make the correction.

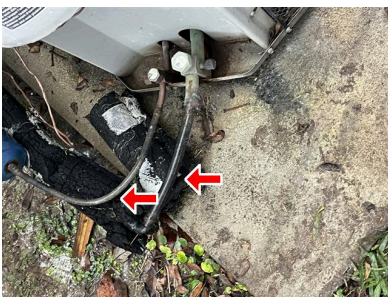
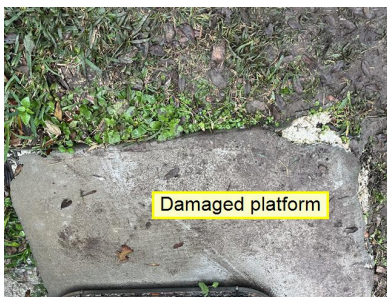
B. Item 1 (Picture)

(1) **Deficiencies:** Insulation is needed at the Ruud condenser's supply lines. The platform is damaged that the Ducane condenser is on. A qualified contractor is needed to make the correction.

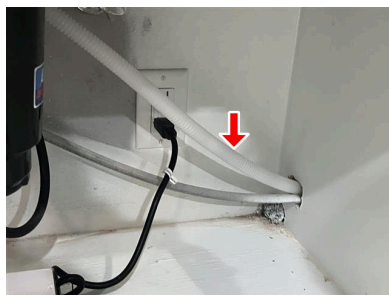
B. Item 2 (Picture)

Deficiencies: Dishwasher is malfunctioning. Dishwasher is not installed level. Dishwasher's drain hose need to be looped. A qualified contractor or appliance technician is needed to evaluate and make the correction.
